## PRE CONSTRUCTION CONDITION SURVEY

Fort Street Public School, Millers Point NSW

Upper Fort Street Public School  
MILLERS POINT NSW 2000

19 January 2021

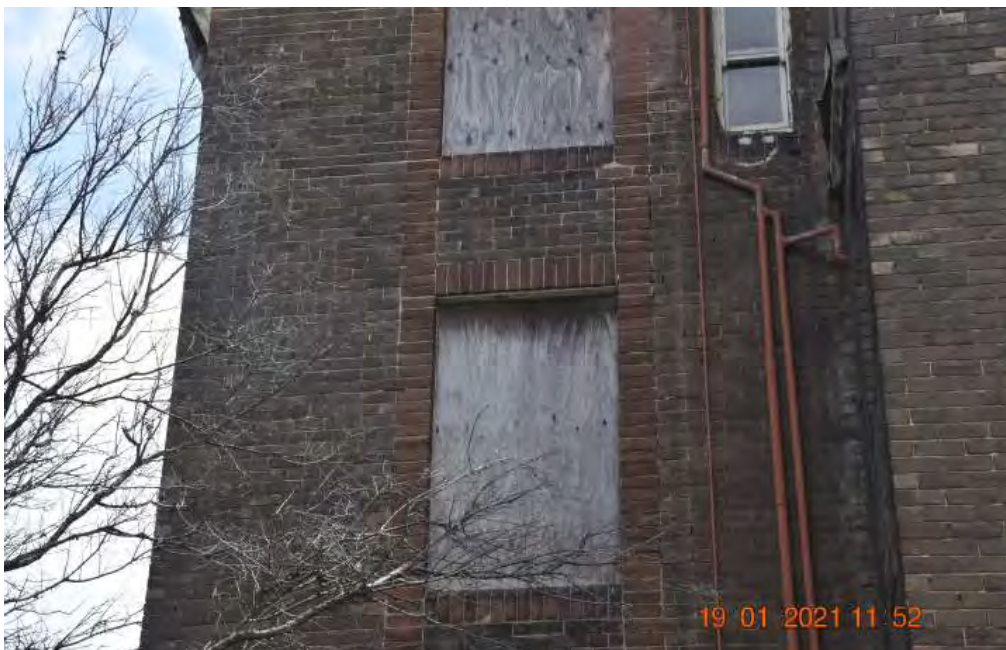
Figure: 1407

South wall of building  
B, west side.

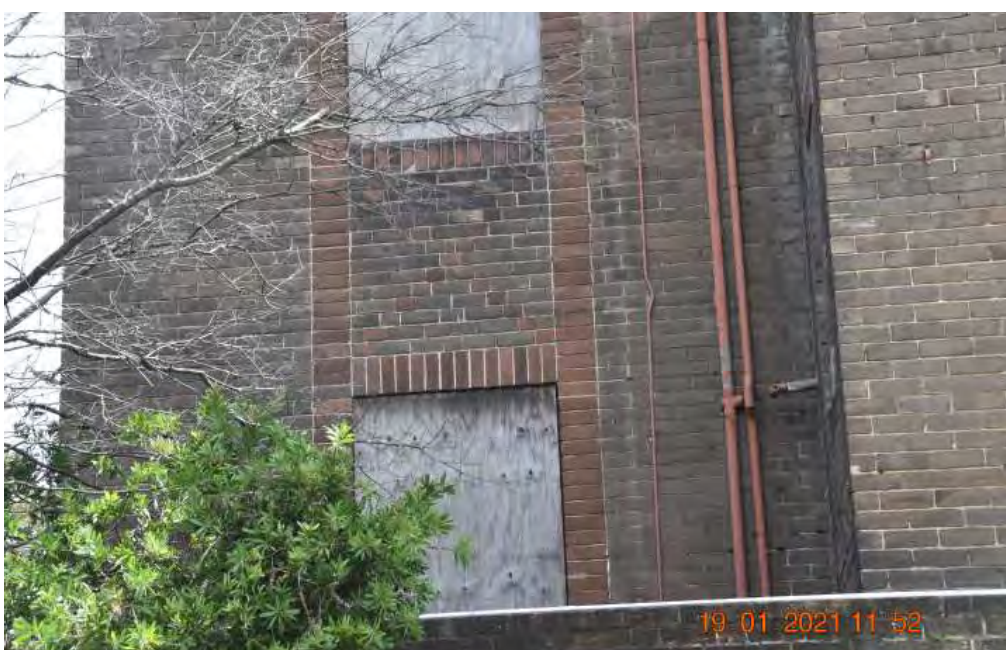
Figure: 1408

South wall of building  
B, west side.

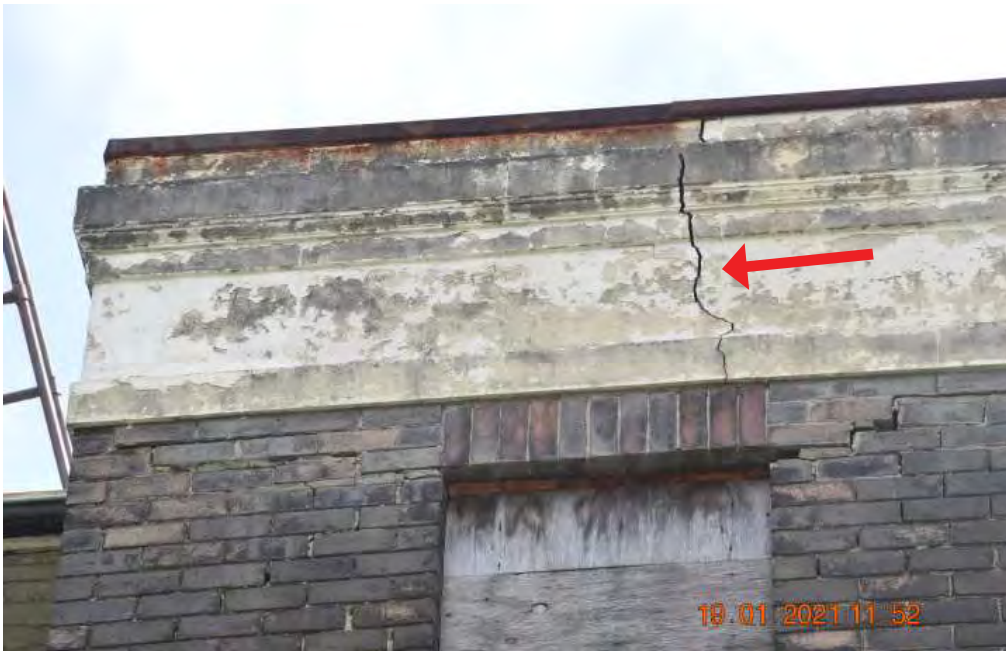
Figure: 1410

Wide cracking above the window in the south wall of building B.

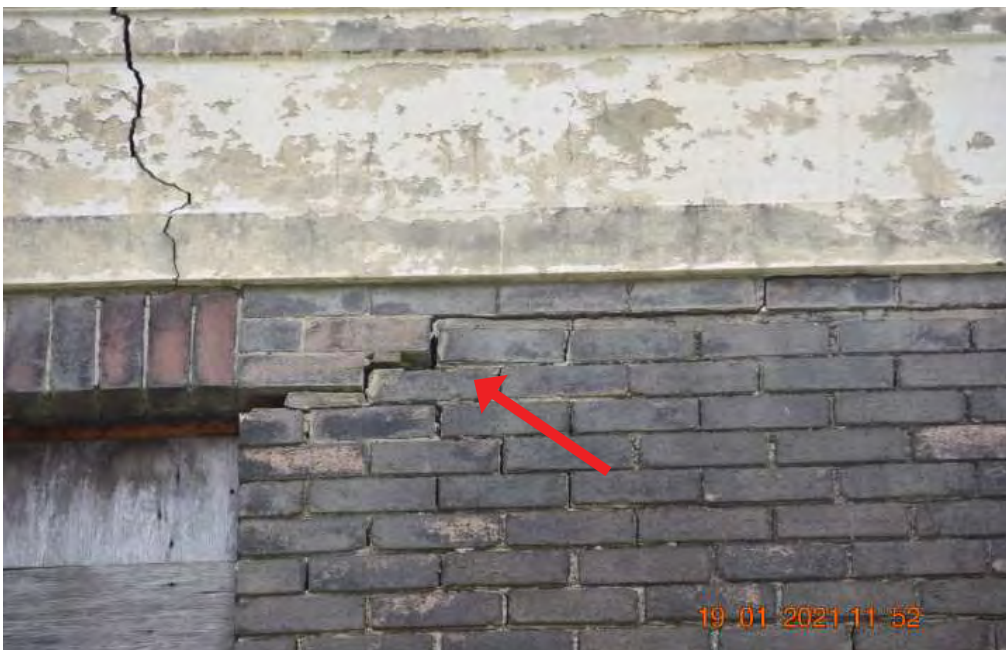
Figure: 1411

Cracking and movement in the south wall of building B.

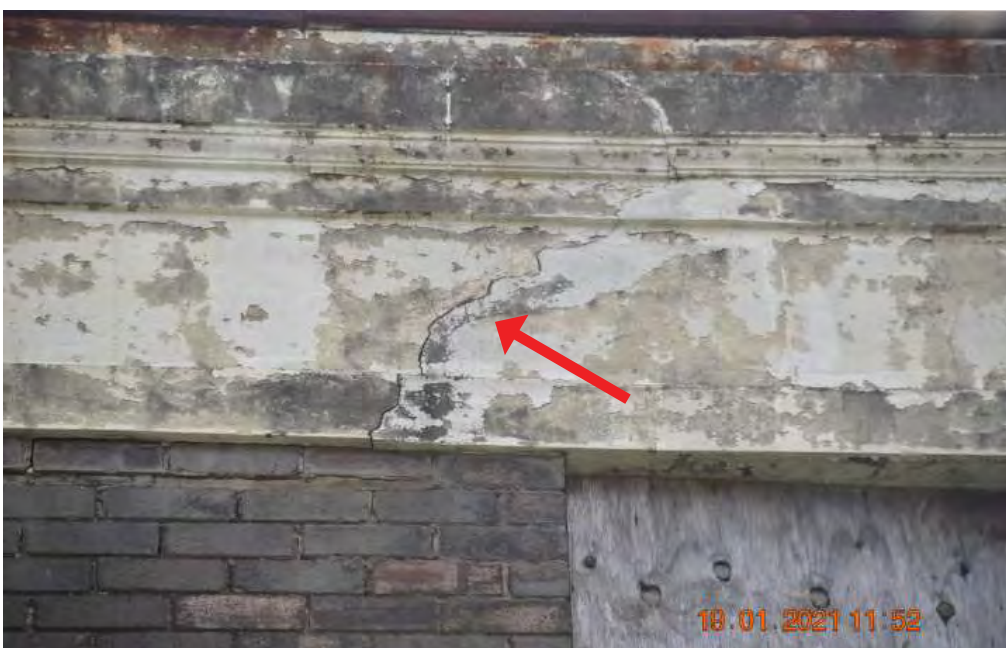
Figure: 1412

Cracking in the south wall of building B.

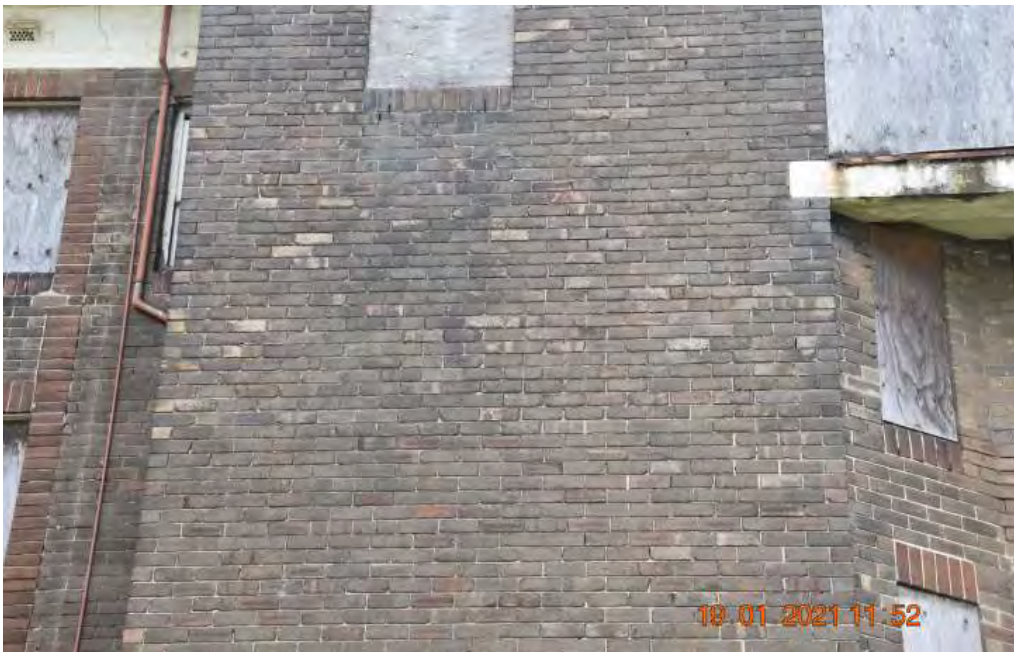
Figure: 1413

South wall of building B.

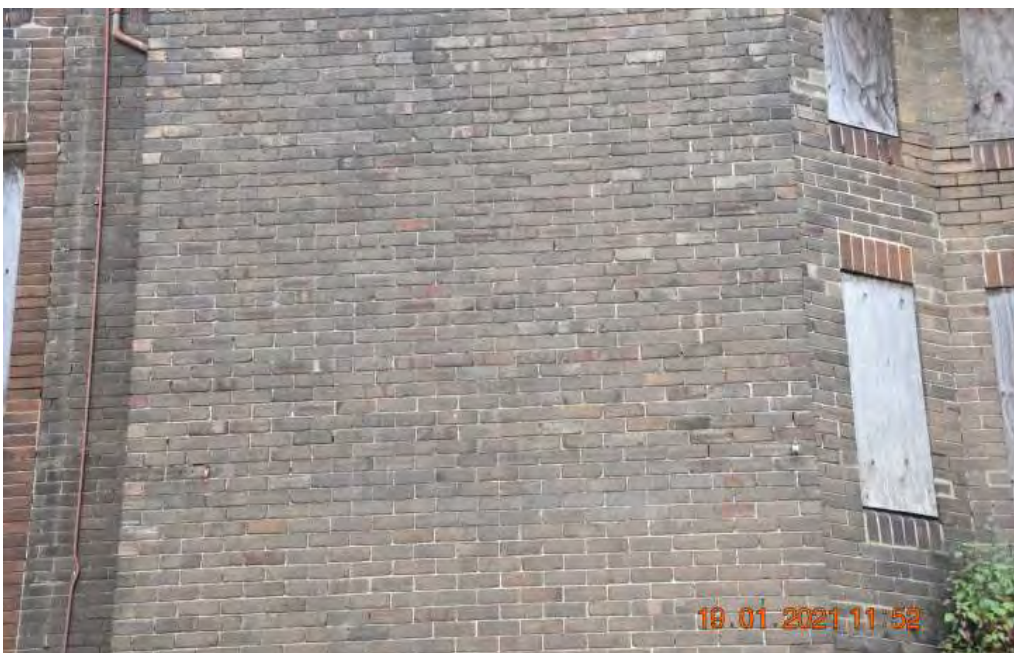
Figure: 1414

South wall of building B.

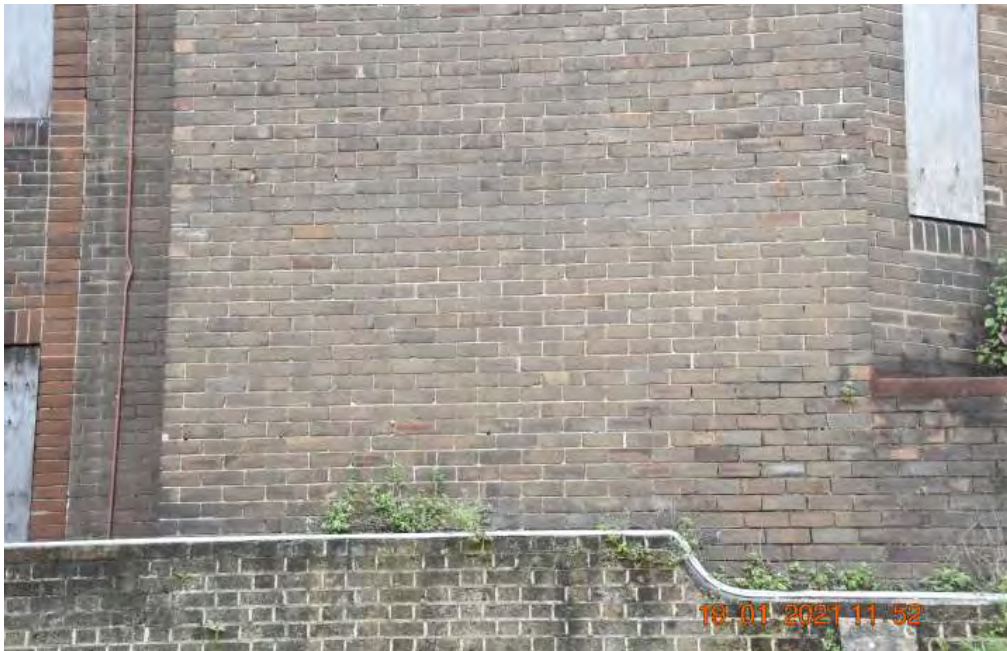
Figure: 1415

South wall of building B.

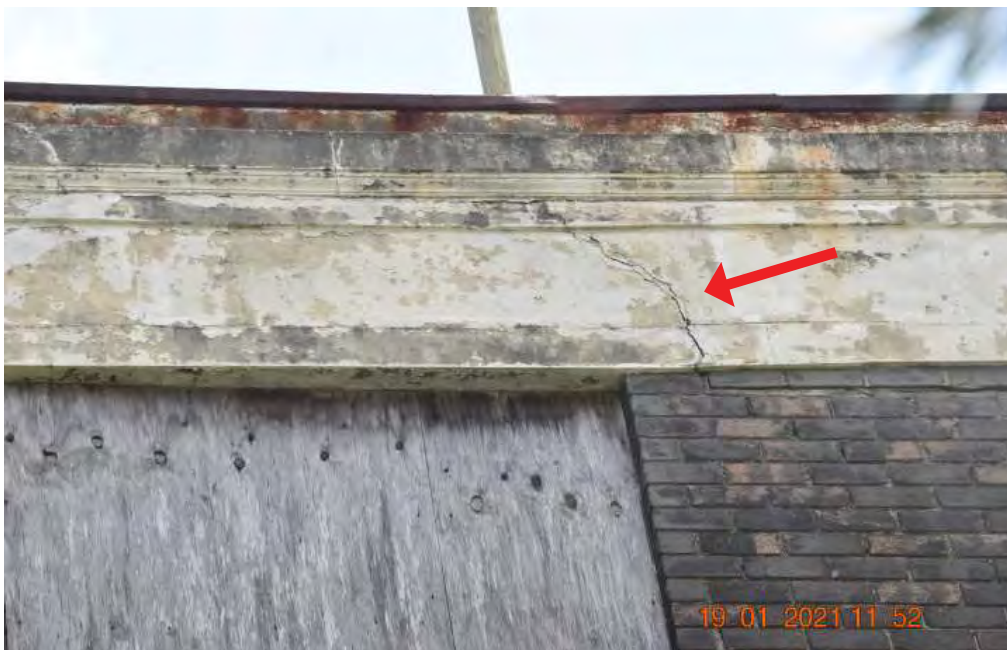
Figure: 1416

South wall of building B.

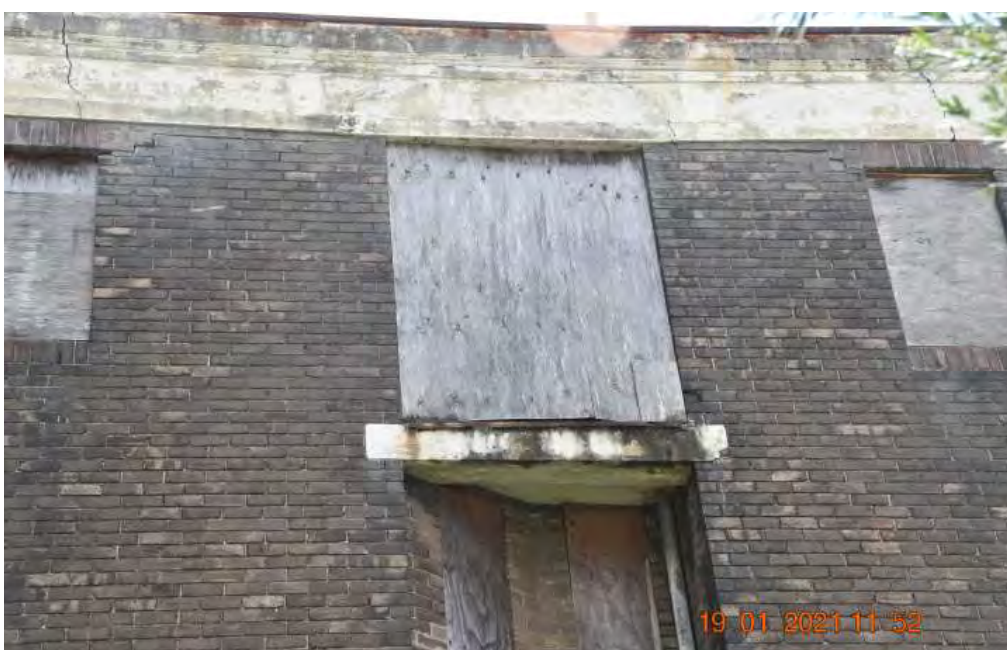
Figure: 1417

Cracking in the south wall of building B.

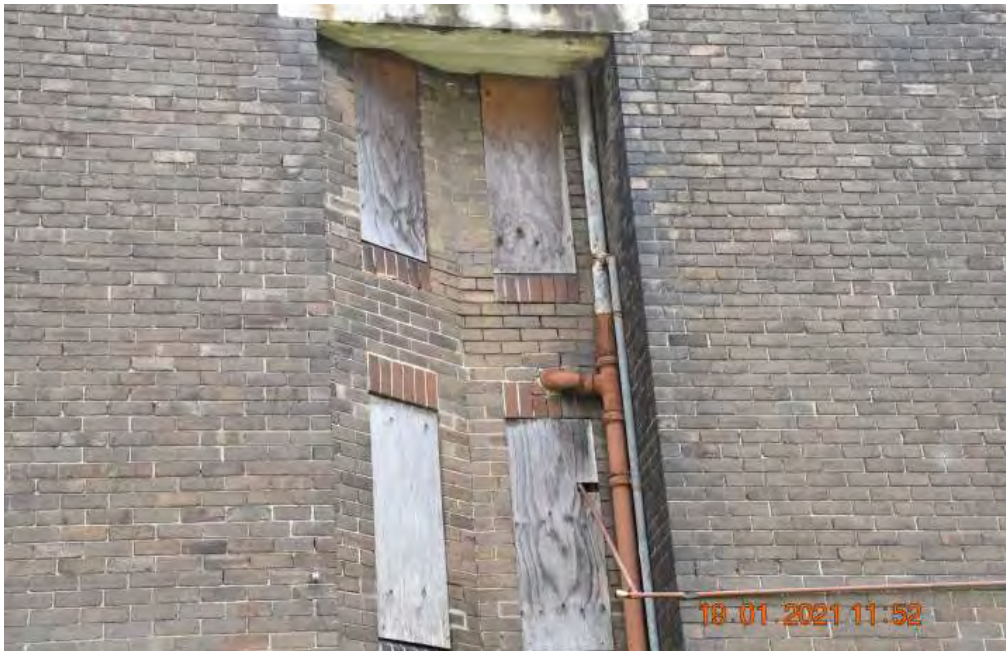
Figure: 1418

South wall of building B.

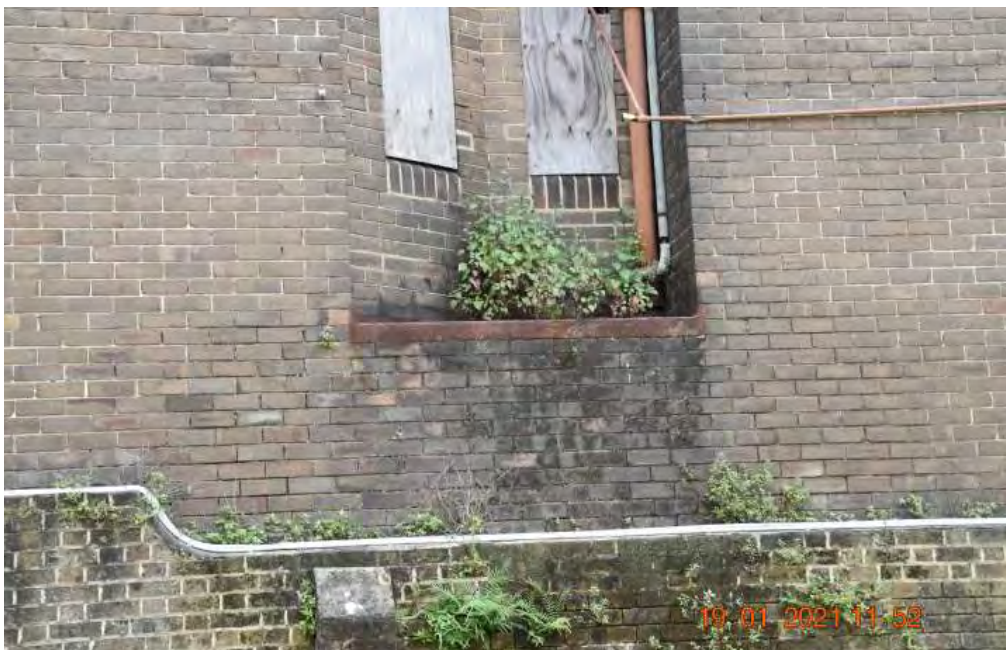
Figure: 1419

South wall of building B.

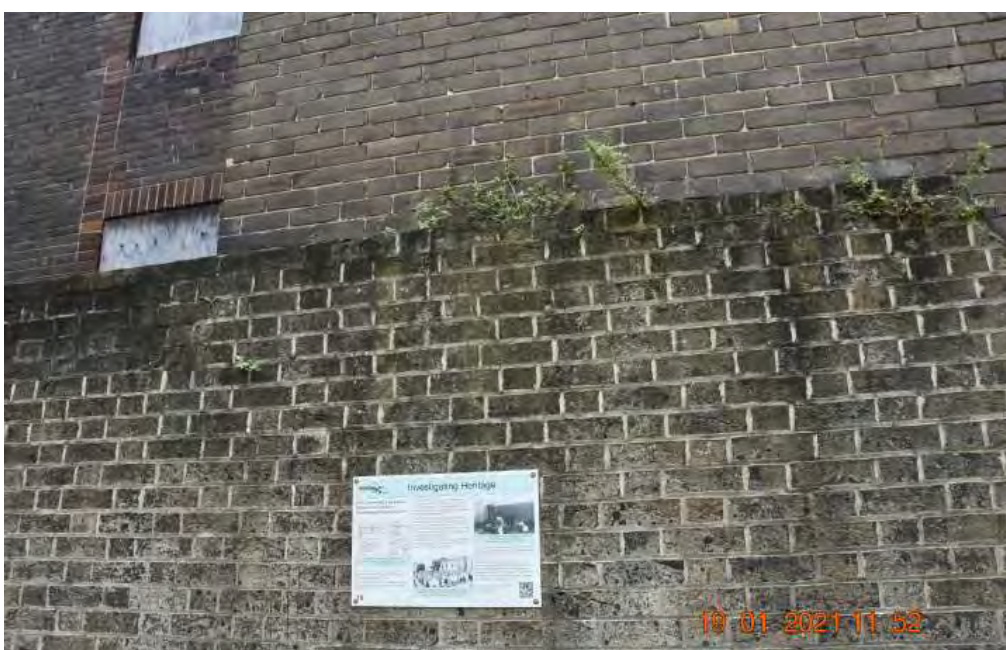
Figure: 1420

South wall of building B.

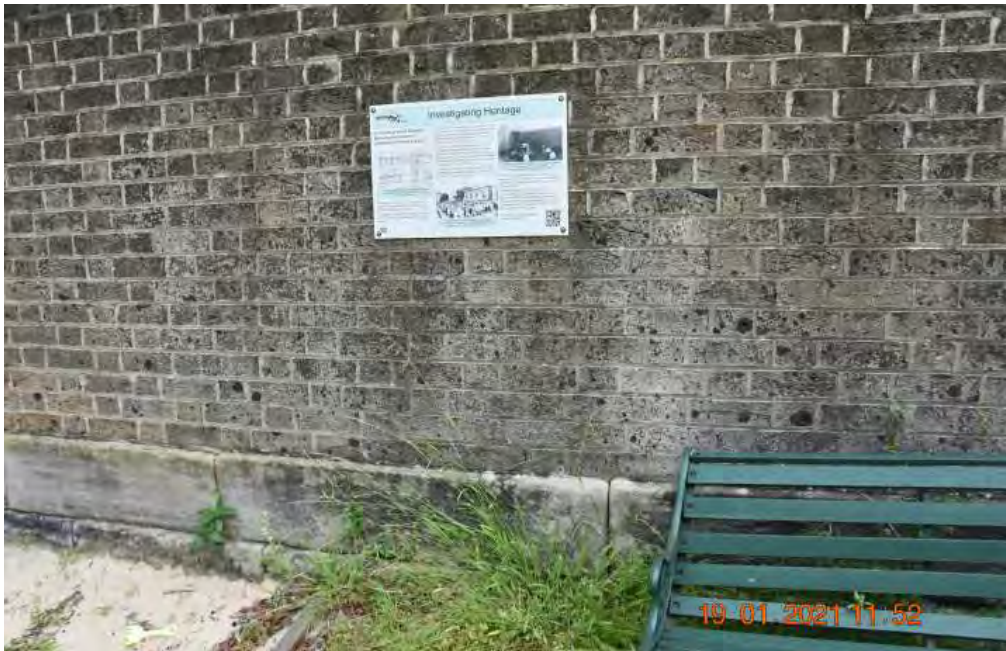
Figure: 1421

General view of the heritage wall on the south side of building B.

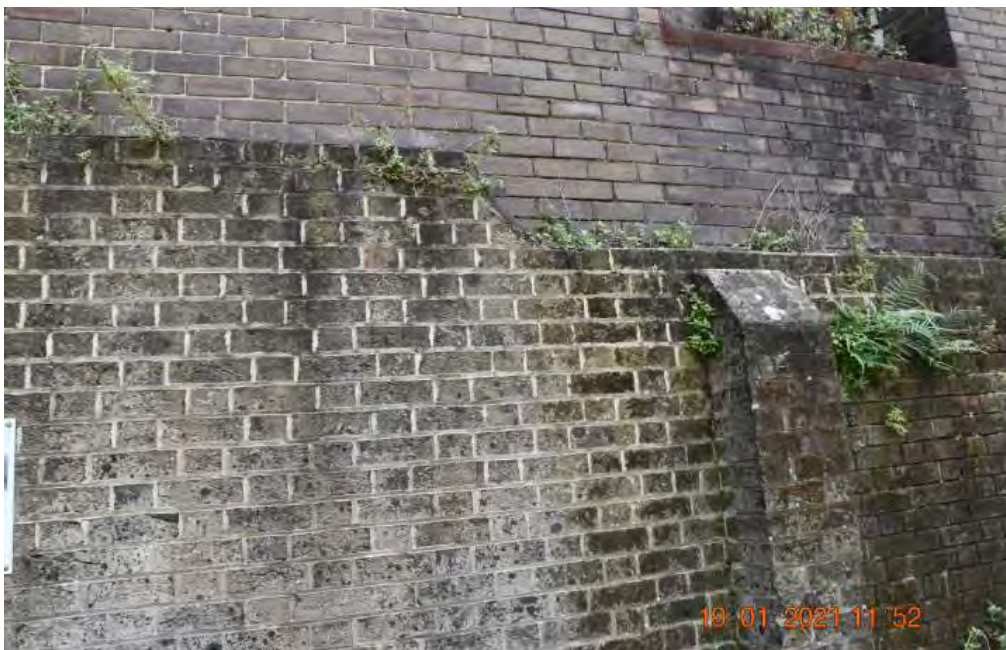
Figure: 1422

General view of the heritage wall on the south side of building B.

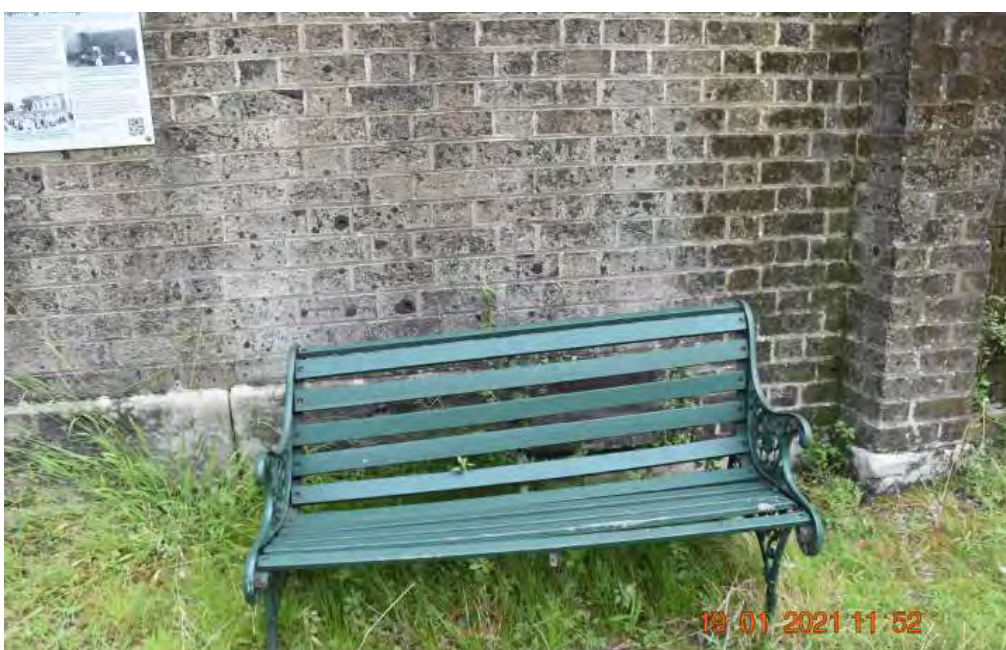
Figure: 1423

General view of the heritage wall on the south side of building B.

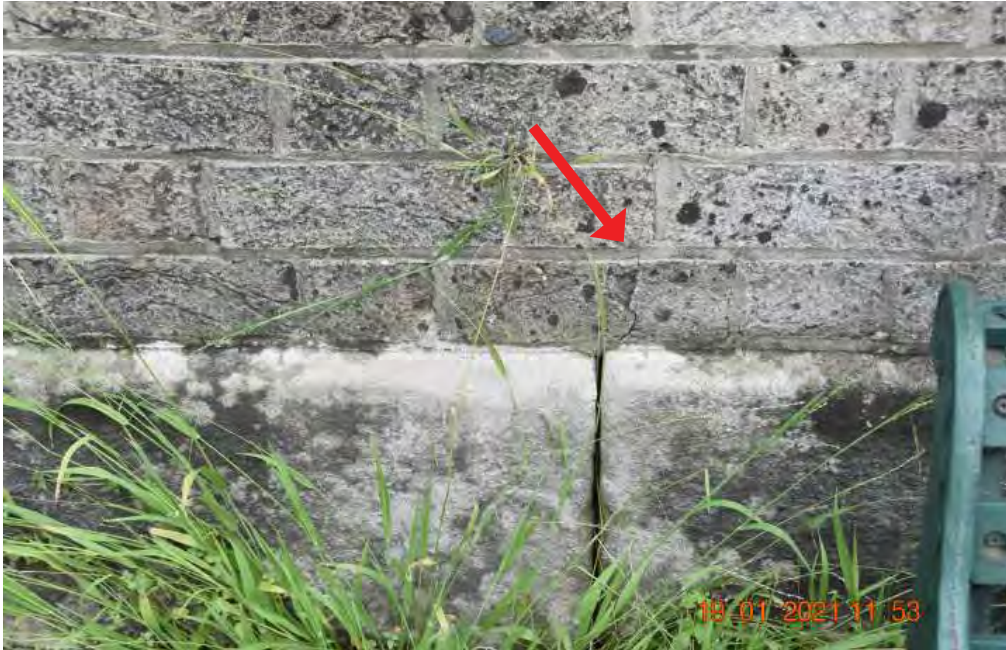
Figure: 1424

General view of the heritage wall on the south side of building B.

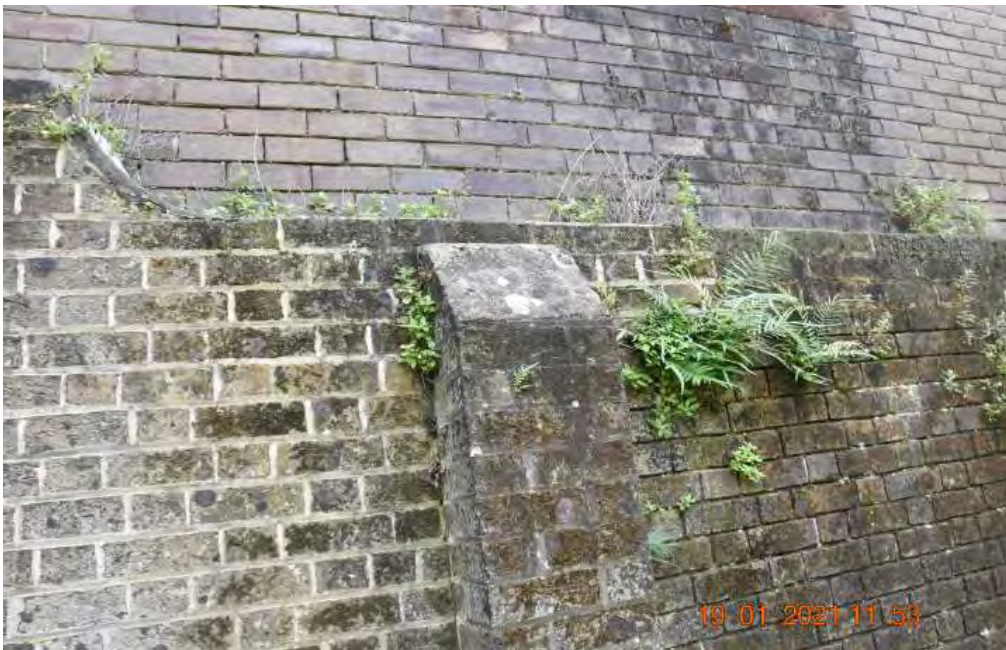
Figure: 1425

Cracking in the heritage wall on the south side of building B.

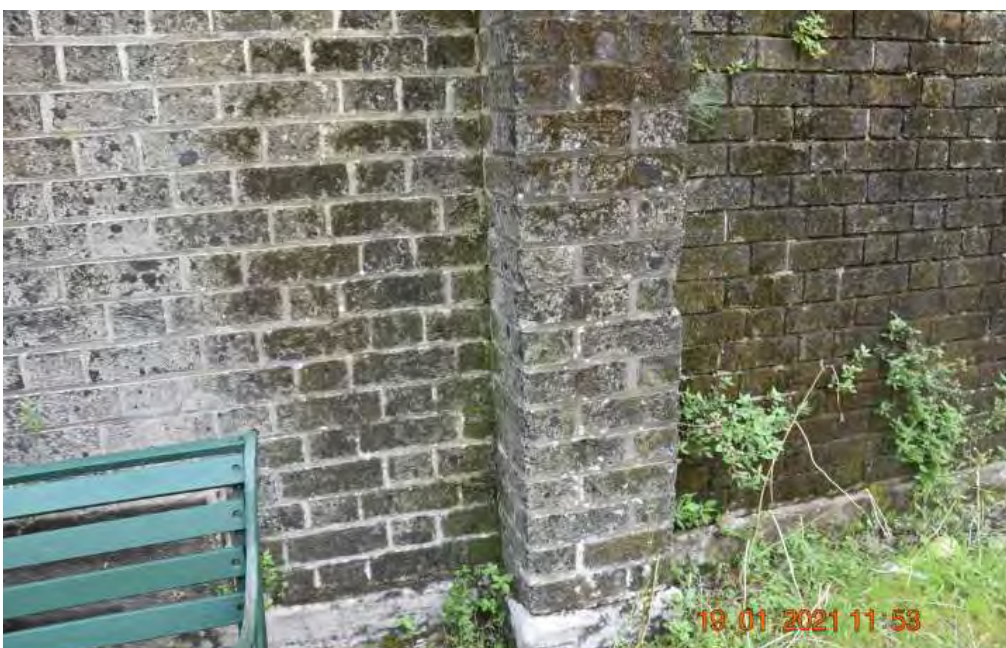
Figure: 1426

General view of the heritage wall on the south side of building B.

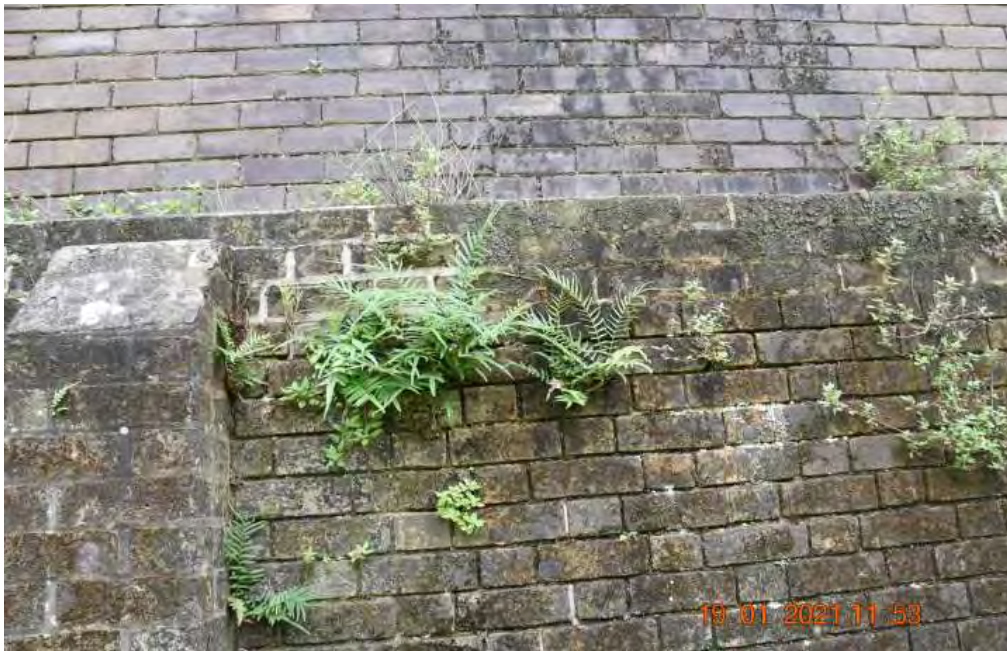
Figure: 1427

General view of the heritage wall on the south side of building B.

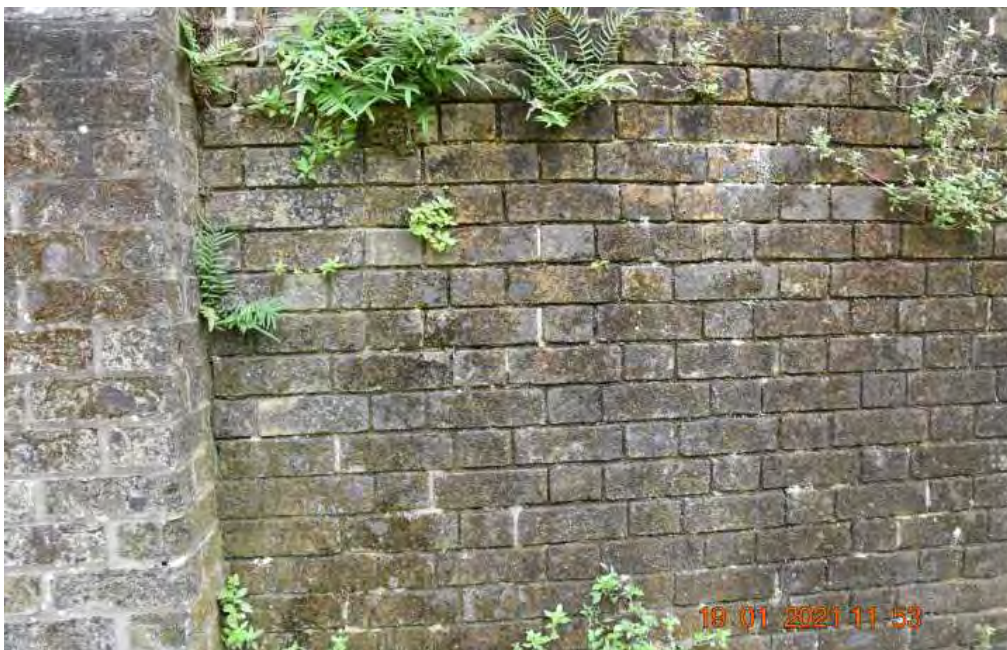
Figure: 1428

General view of the heritage wall on the south side of building B.

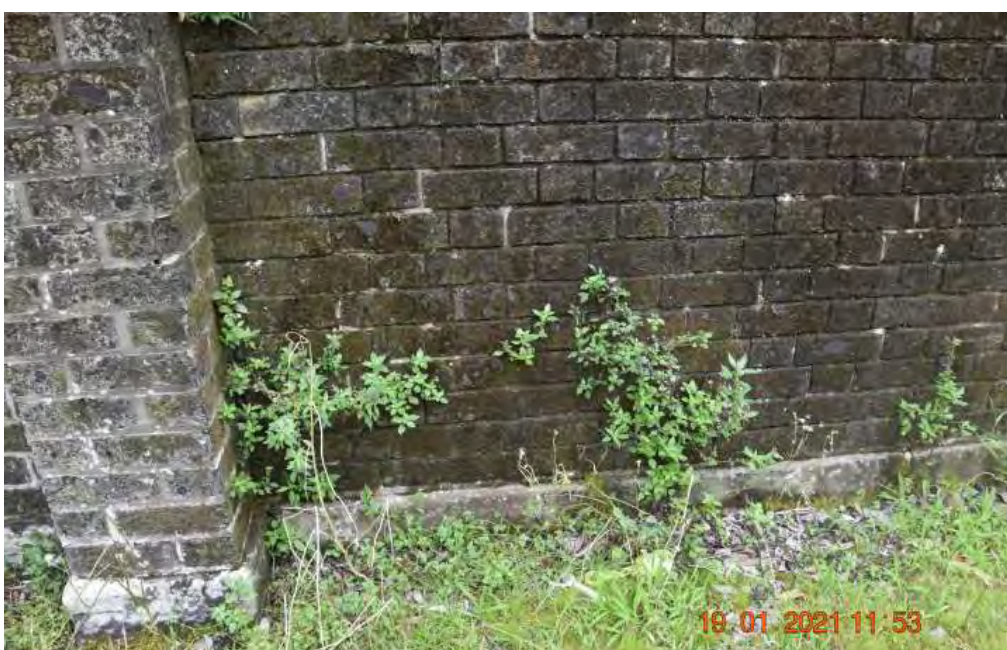
Figure: 1429

General view of the heritage wall on the south side of building B.

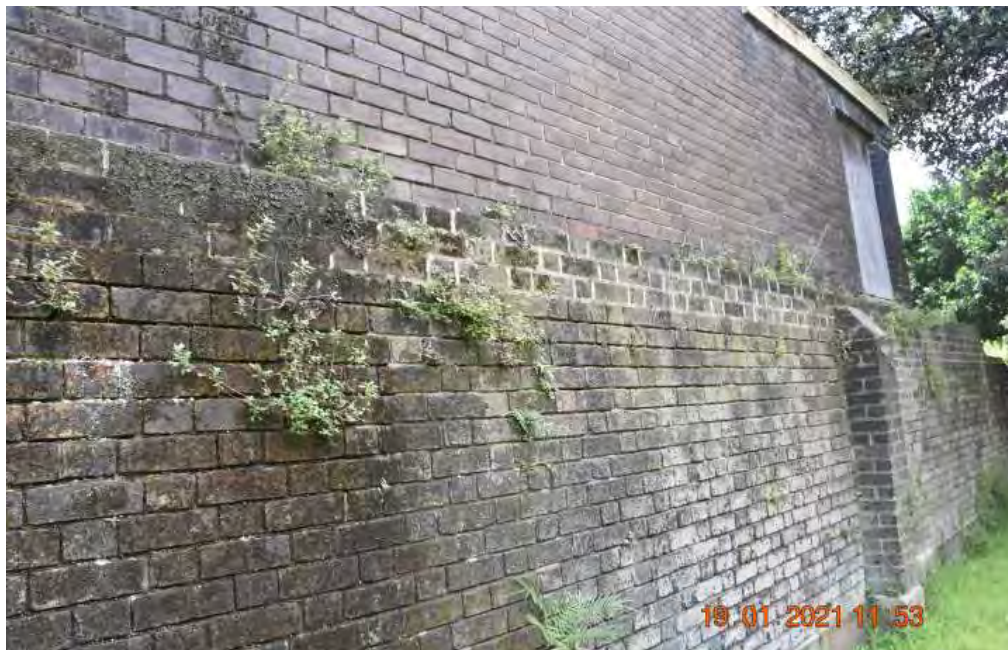
Figure: 1430

General view of the heritage wall on the south side of building B.

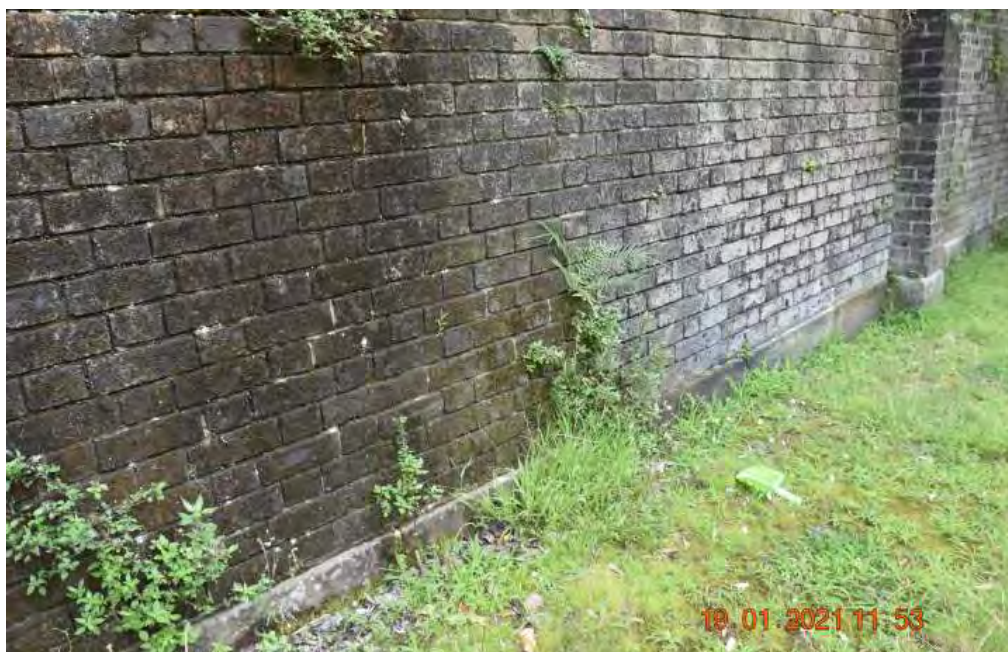
Figure: 1431

General view of the heritage wall on the south side of building B.

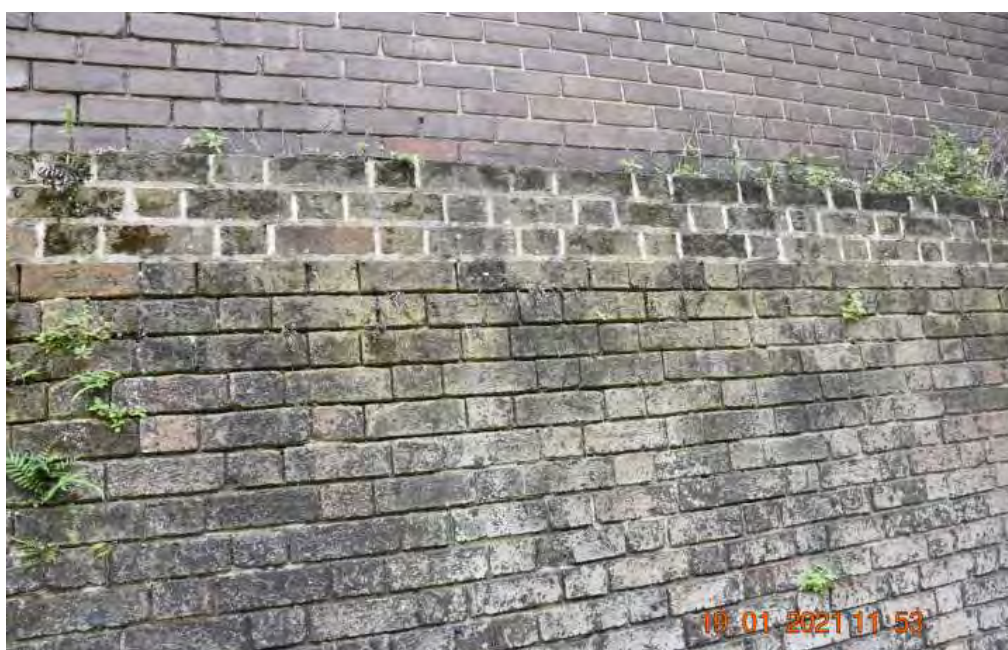
Figure: 1432

General view of the heritage wall on the south side of building B.

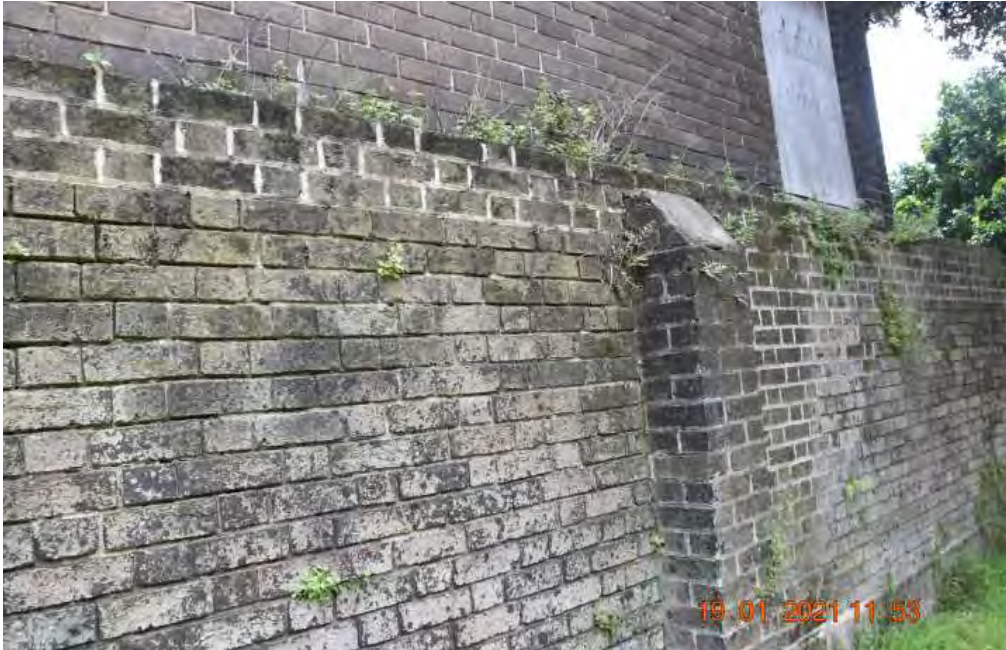
Figure: 1434

General view of the heritage wall on the south side of building B.

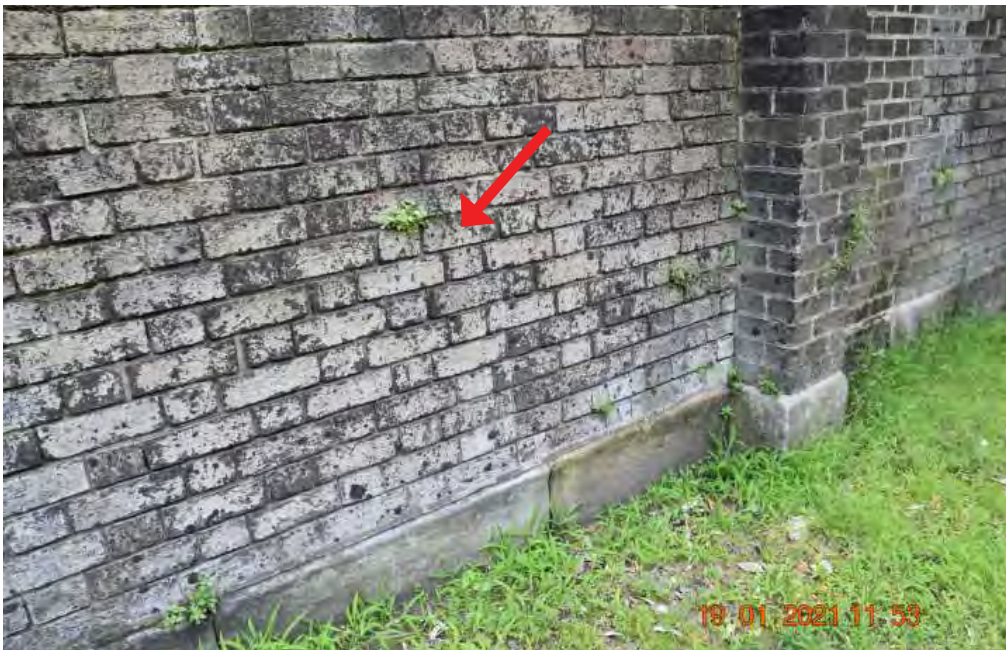
Figure: 1435

General view of the heritage wall on the south side of building B. Showing erosion in the mortar joints.

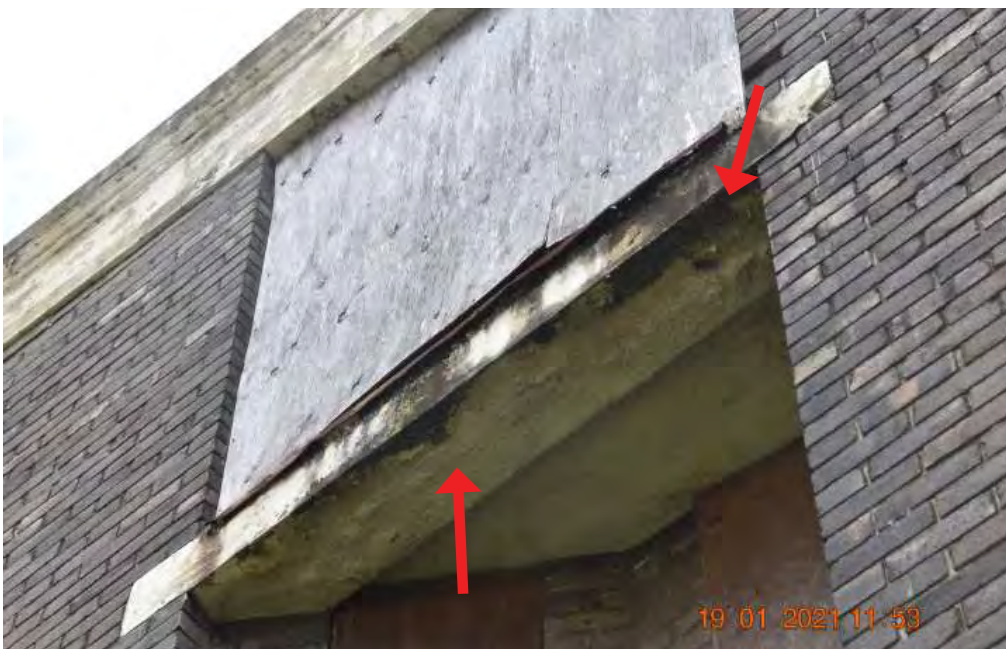
Figure: 1436

Mold and signs of water in the soffit on the south side of building B.

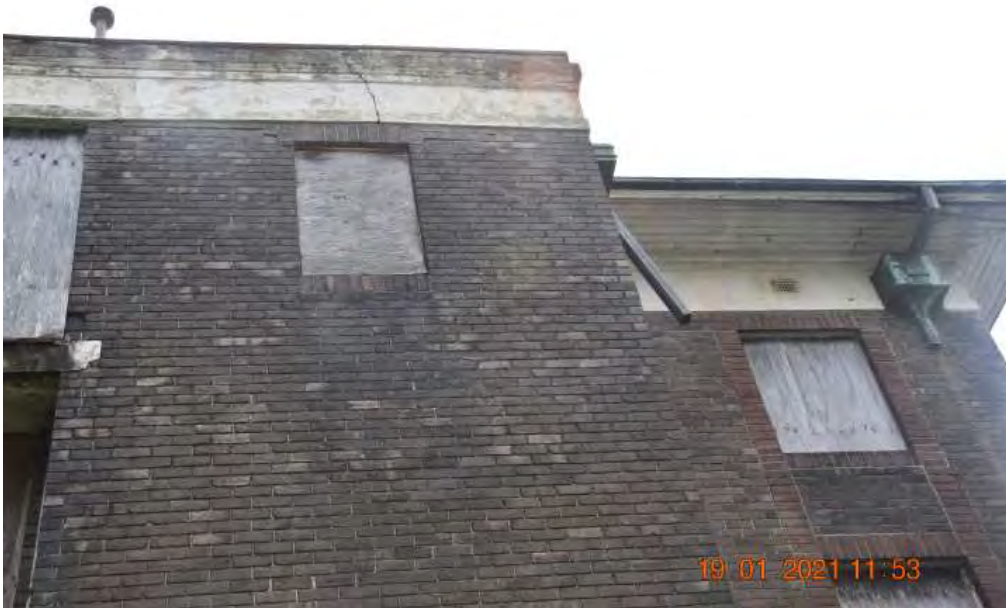
Figure: 1437

South wall of building  
B.

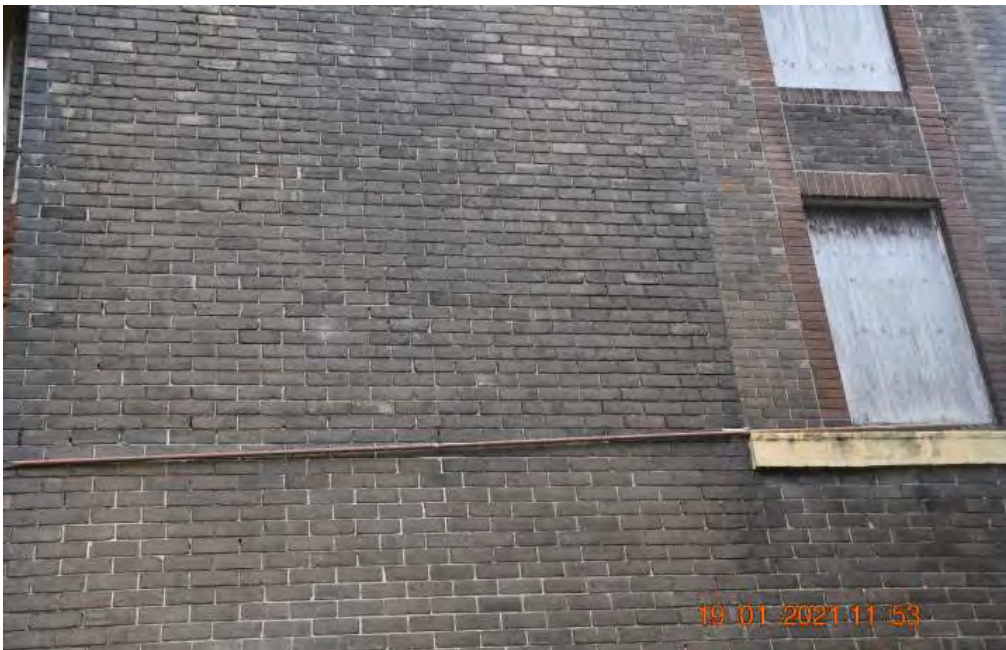
Figure: 1438

South wall of building  
B.

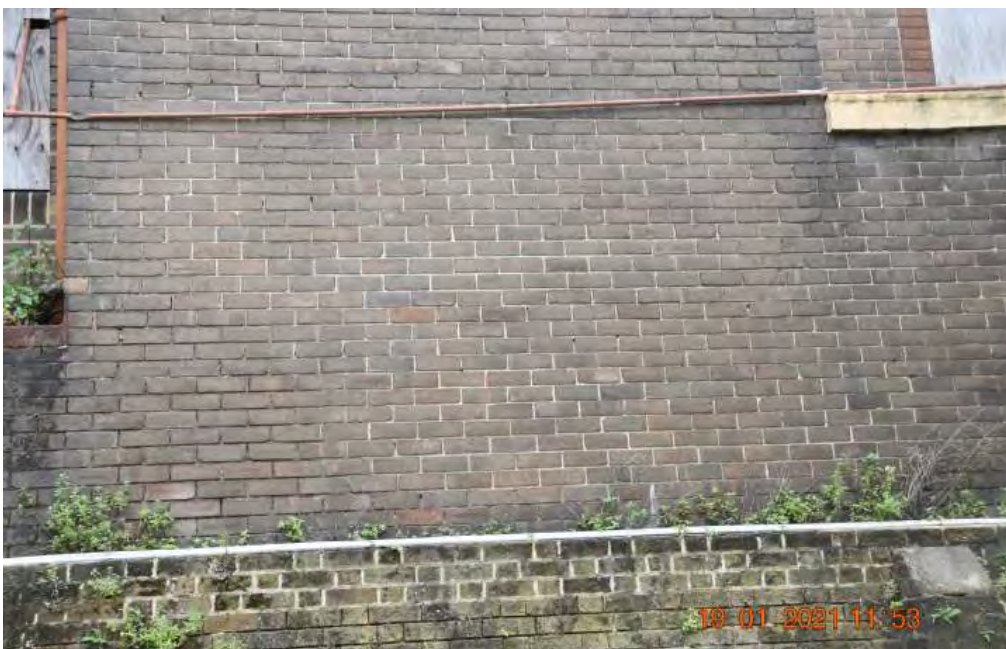
Figure: 1439

South wall of building  
B.

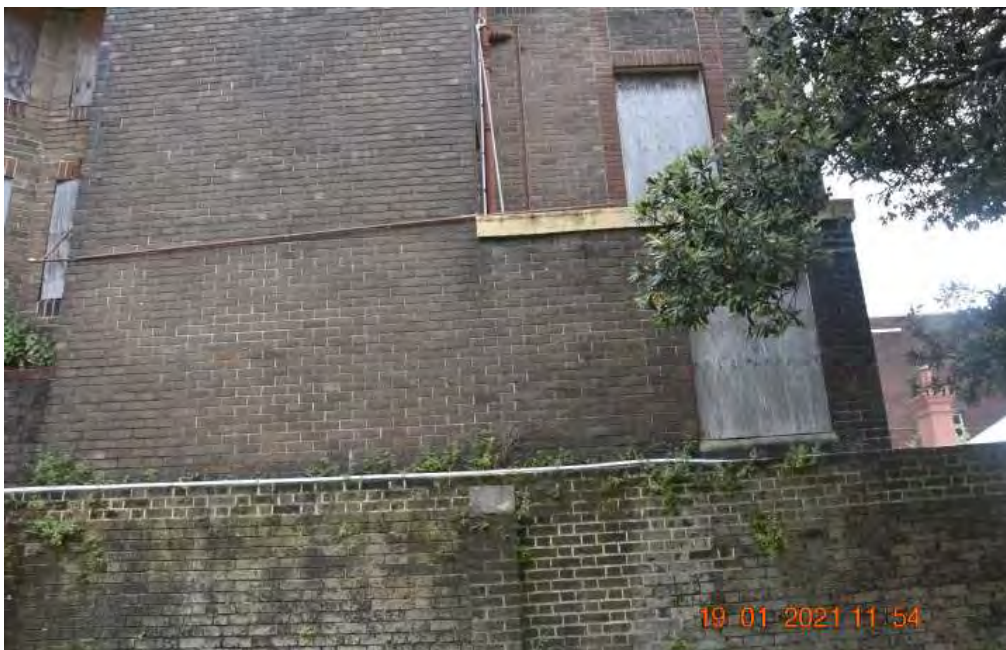
Figure: 1440

South wall of building B.

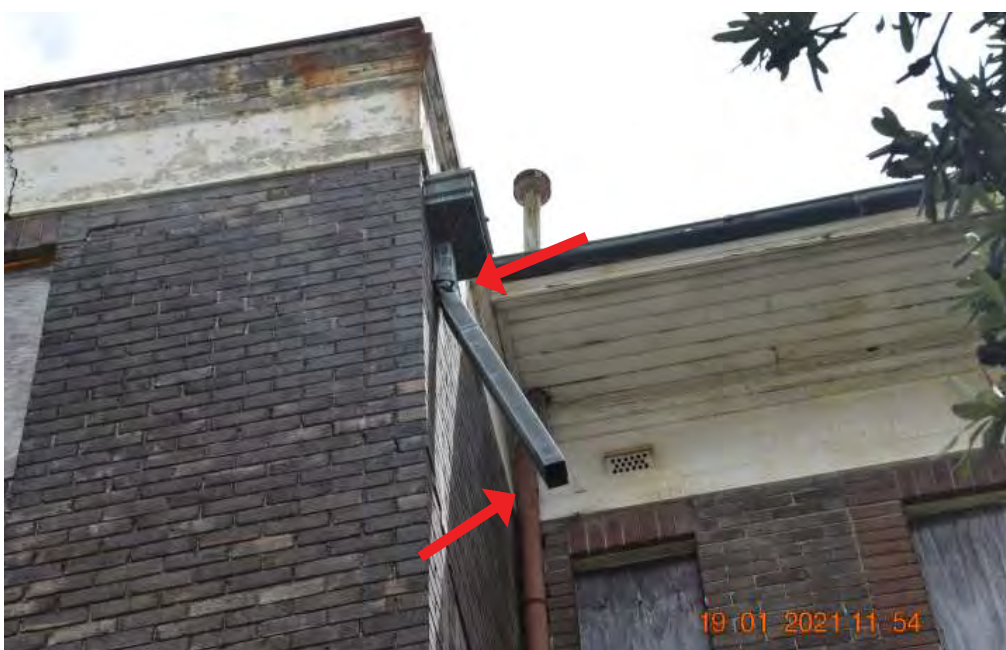
Figure: 1441

South wall of building B.

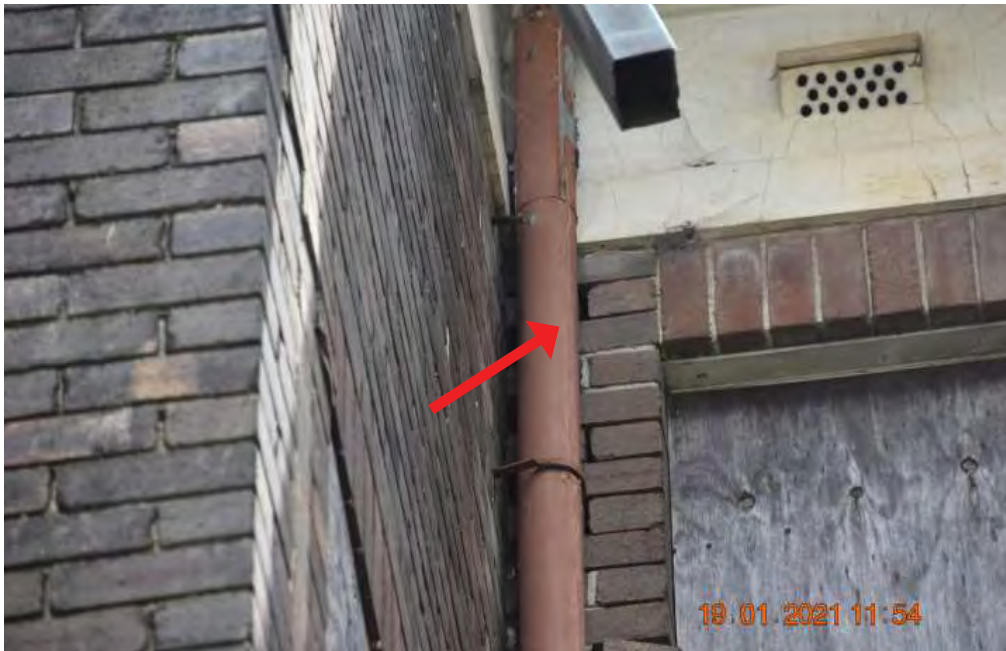
Figure: 1442

Detached down pipe in the south wall of building B.
