## PRE CONSTRUCTION CONDITION SURVEY

Fort Street Public School, Millers Point NSW

Upper Fort Street Public School  
MILLERS POINT NSW 2000

19 January 2021

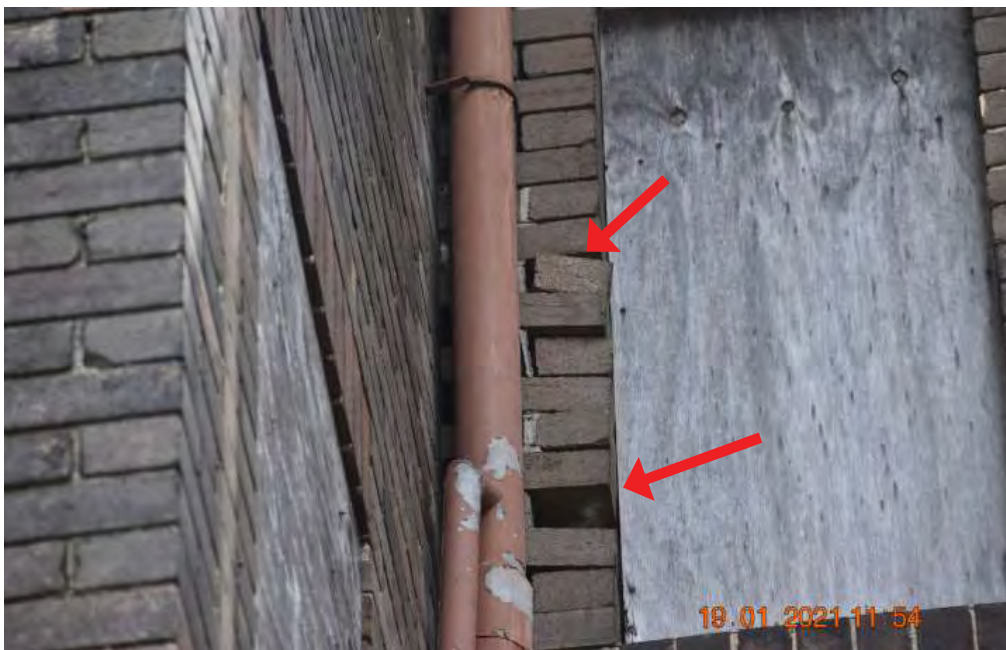
Figure: 1443

Movement in the bricks in the south wall of building B.

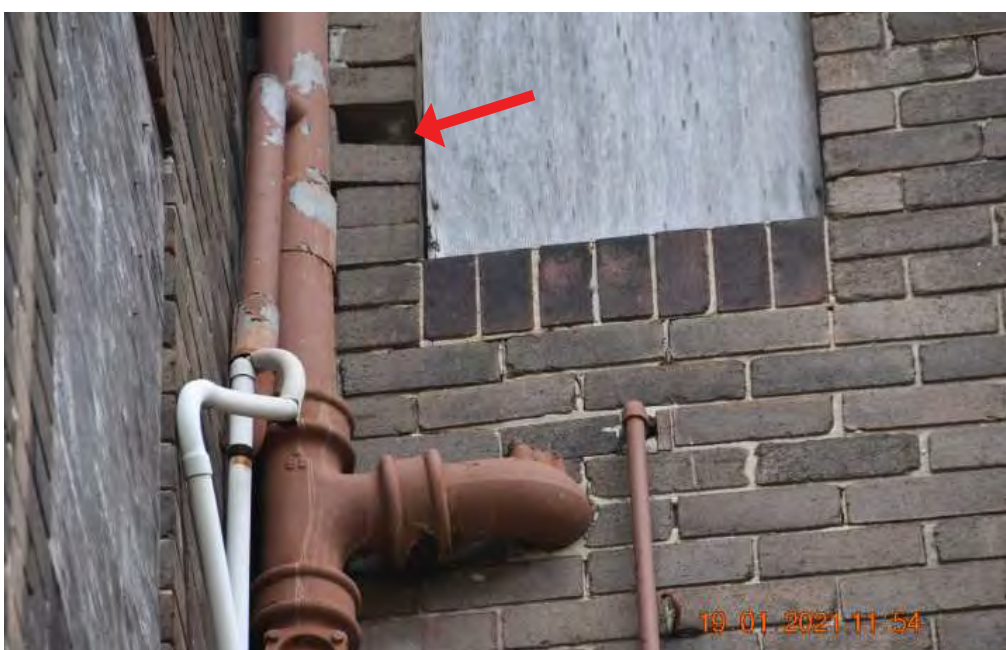
Figure: 1444

Movement in the bricks in the south wall of building B.

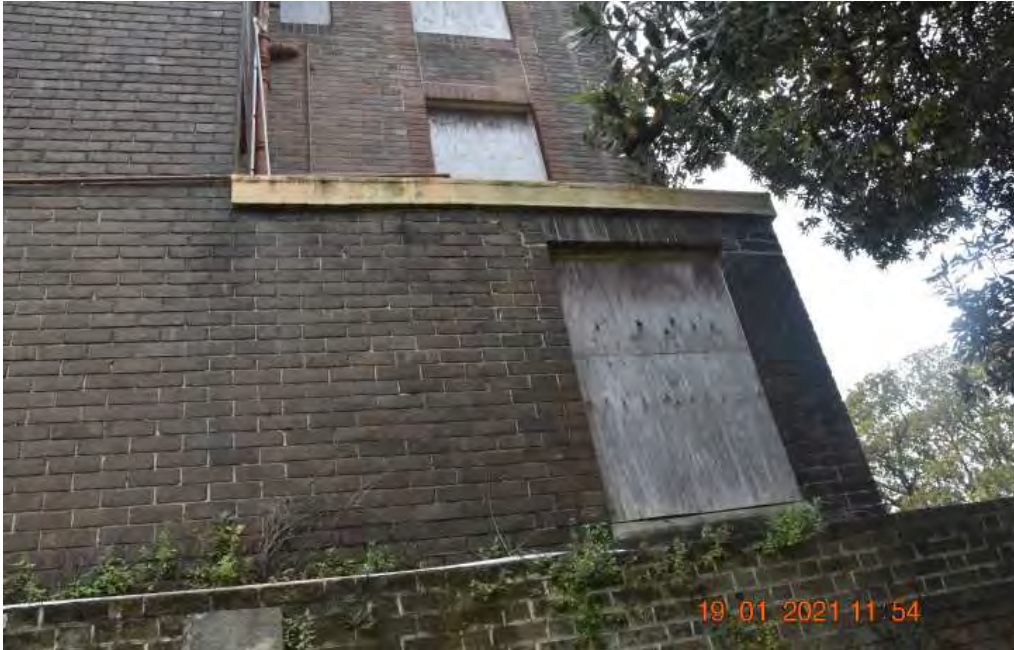
Figure: 1445

Movement in the bricks in the south wall of building B.

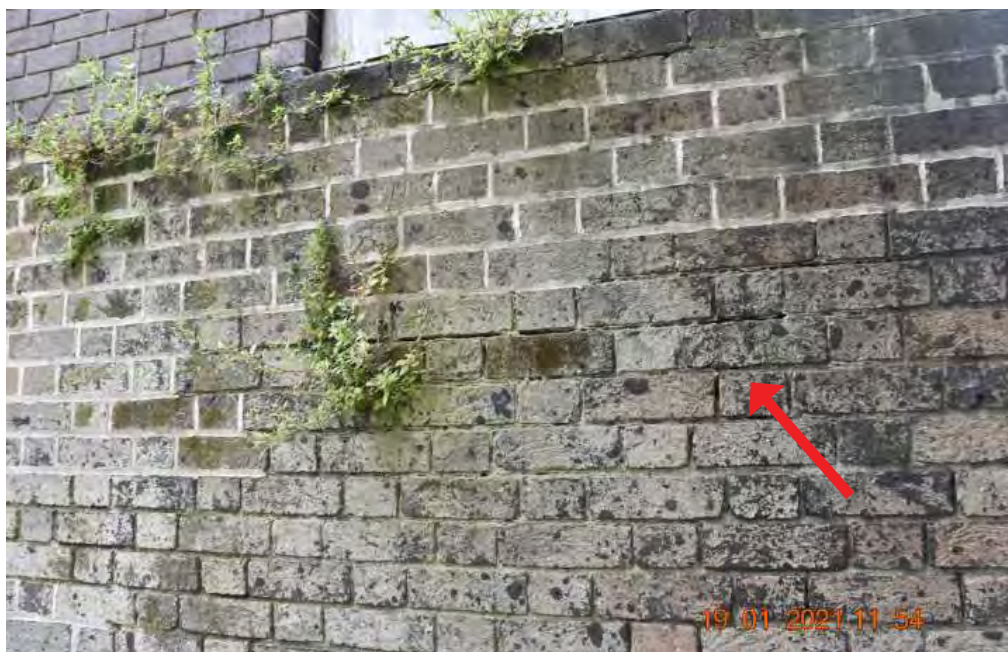
Figure: 1455

General view of the heritage wall on the south side of building B. Showing erosion in the mortar joints.

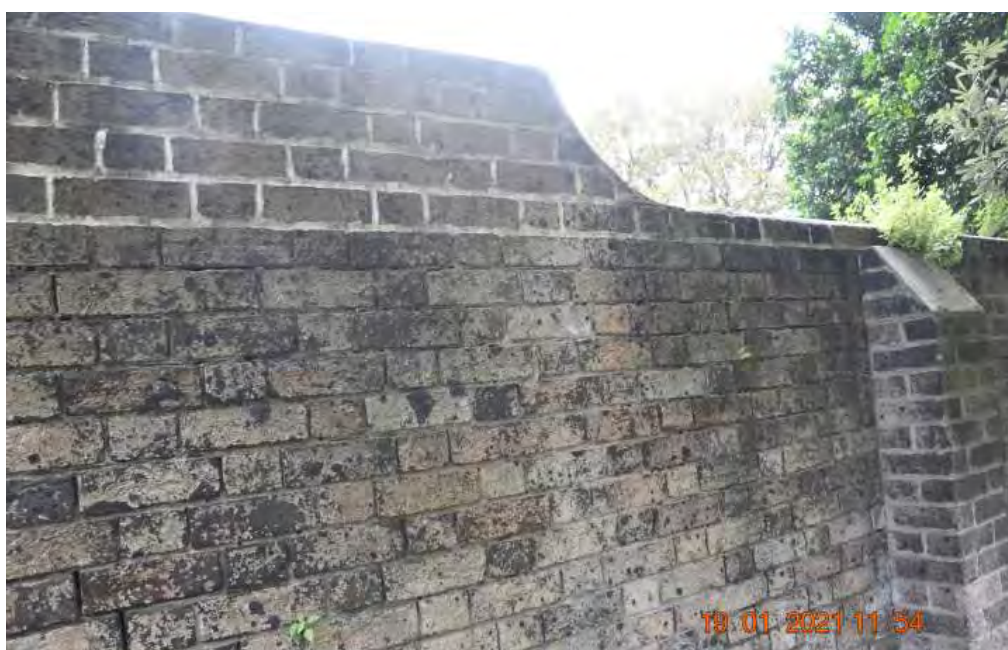
Figure: 1456

General view of the heritage wall on the south side of building B. Showing erosion in the mortar joints.

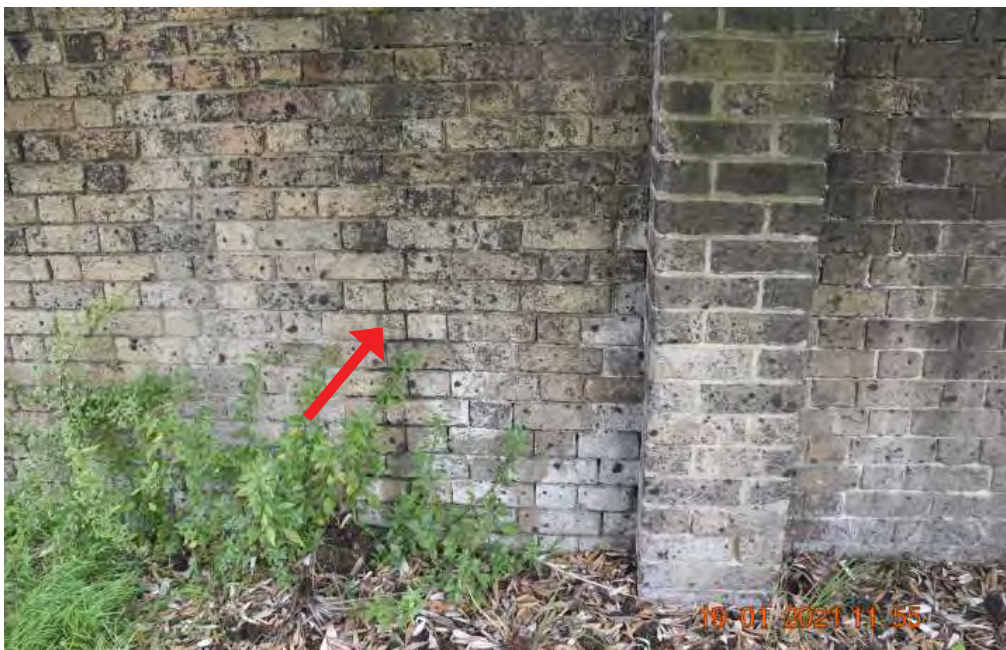
Figure: 1467

General view of the heritage wall on the south side of building B. Showing erosion in the mortar joints.

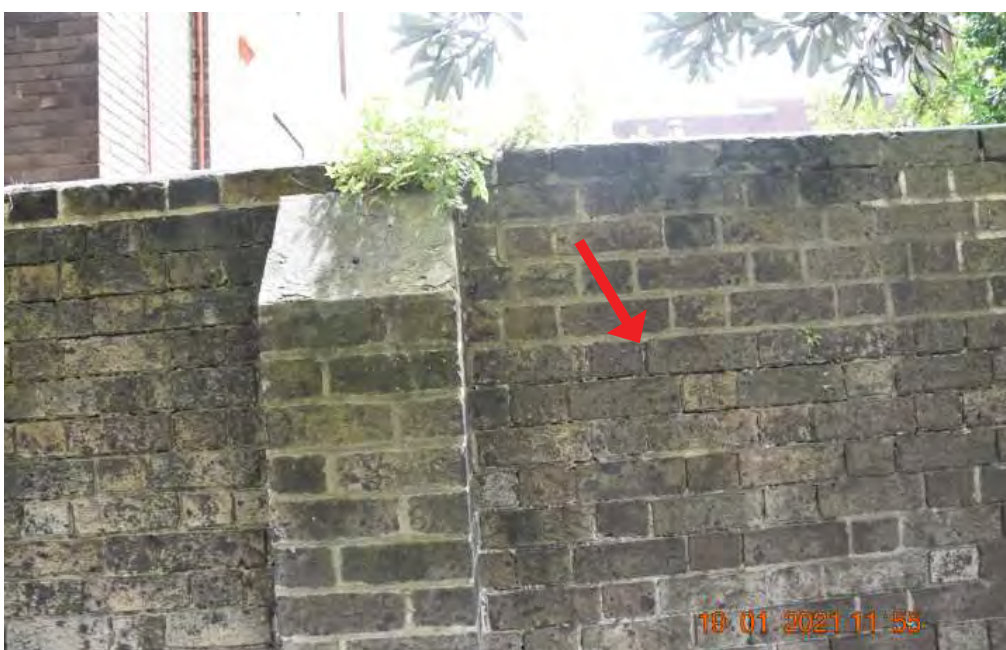
Figure: 1468

General view of the heritage wall on the south side of building B. Showing erosion in the mortar joints.

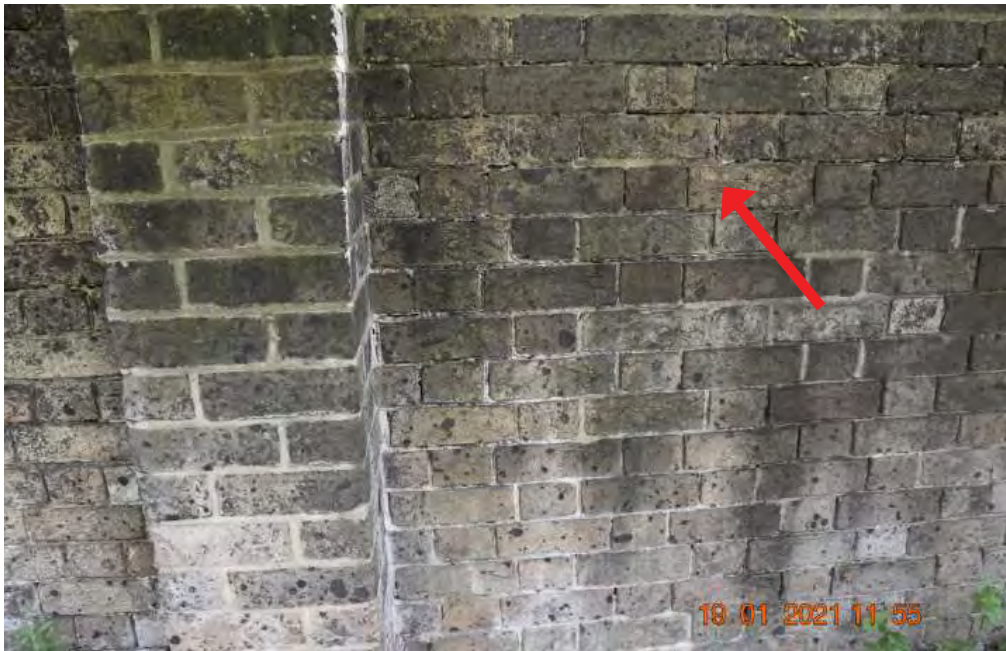
Figure: 1469

General view of the heritage wall on the south side of building B. Showing erosion in the mortar joints.

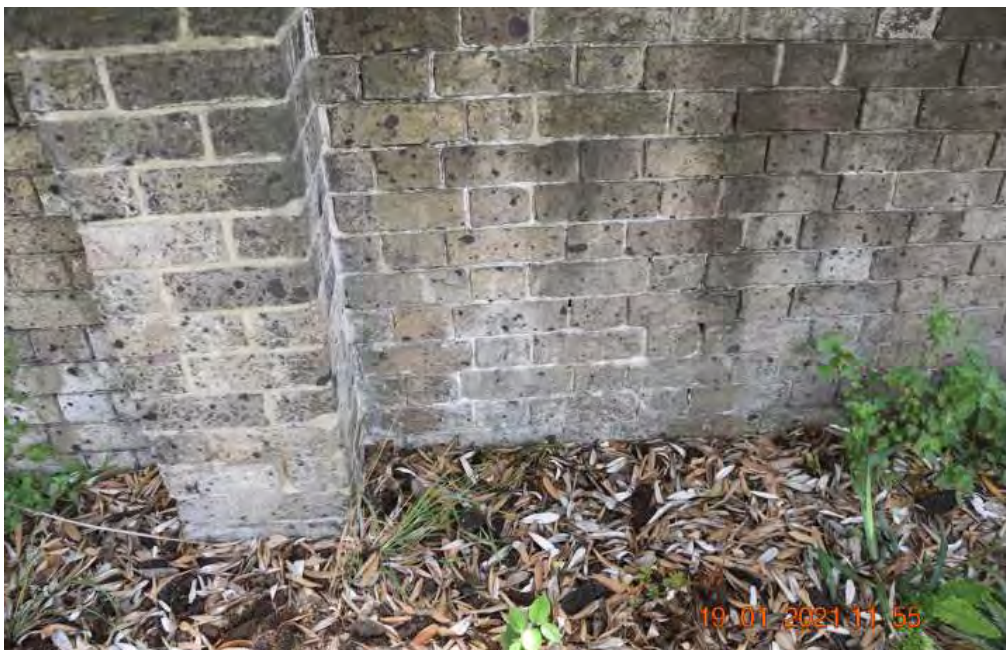
Figure: 1470

General view of the heritage wall on the south side of building B. Showing erosion in the mortar joints.

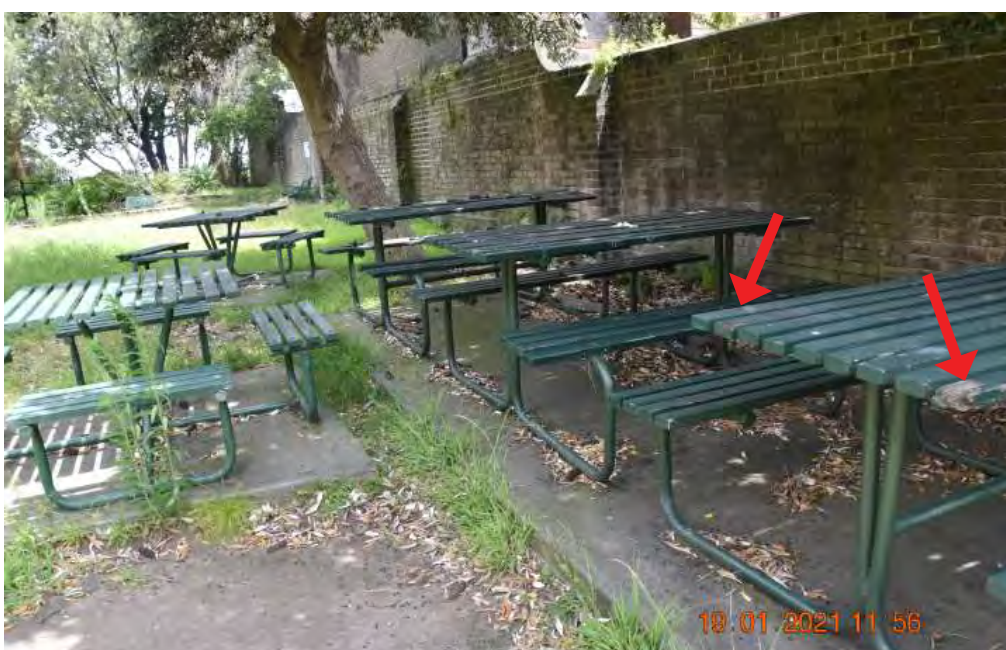
Figure: 1477

Damage in the seats on the south side of building C.

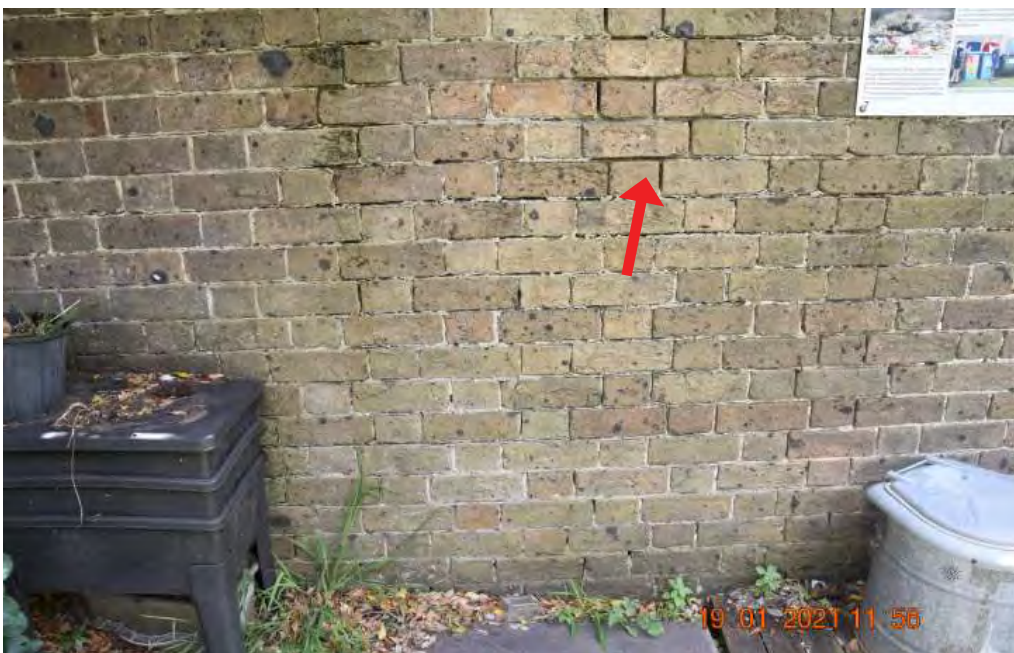
Figure: 1480

General view of the heritage wall on the south side of building C. Showing erosion in the mortar joints.

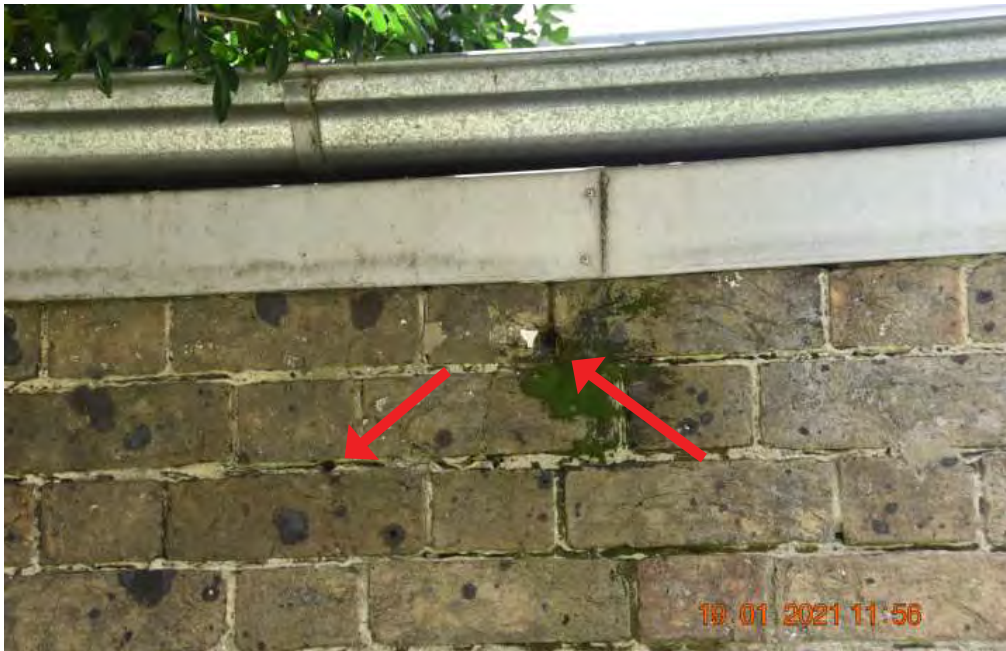
Figure: 1481

General view of the heritage wall on the south side of building C. Showing erosion in the mortar joints.

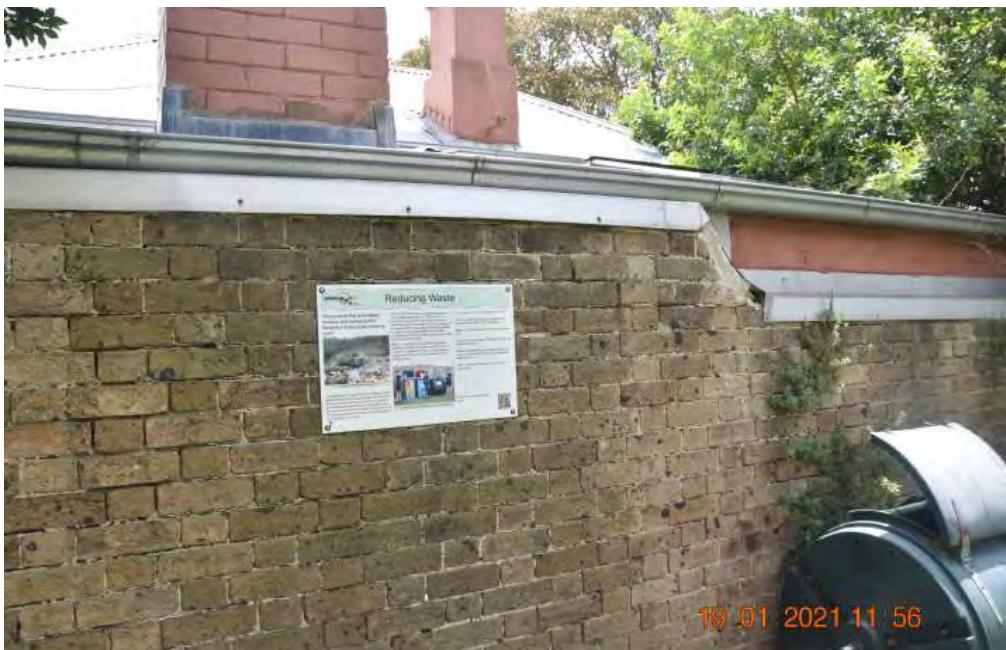
Figure: 1482

Nail holes the heritage wall on the south side of building C.

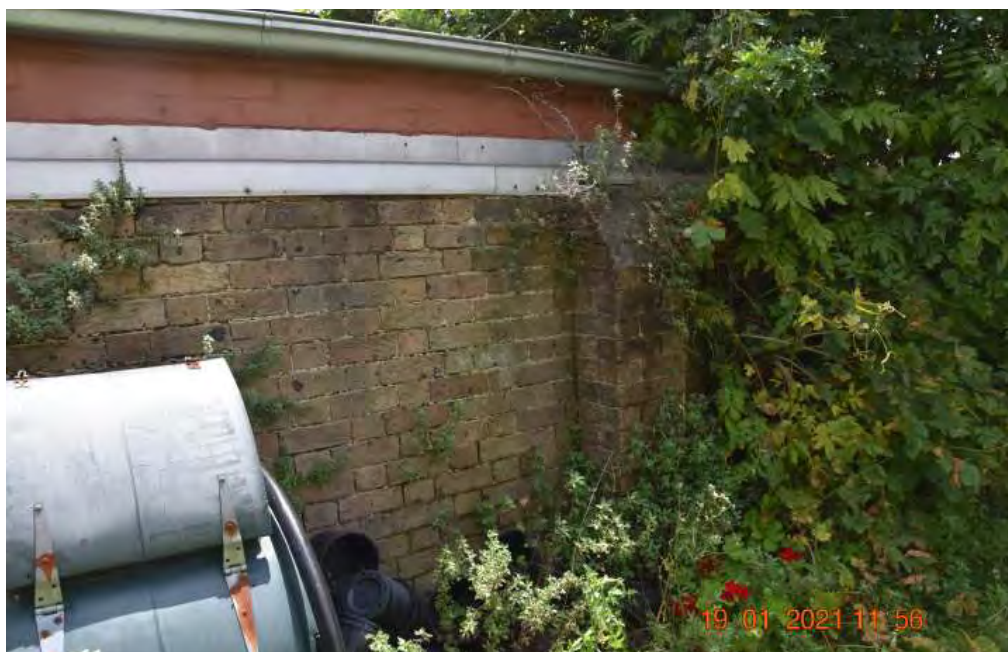
Figure: 1485

Damage in the heritage wall on the south side of building C.

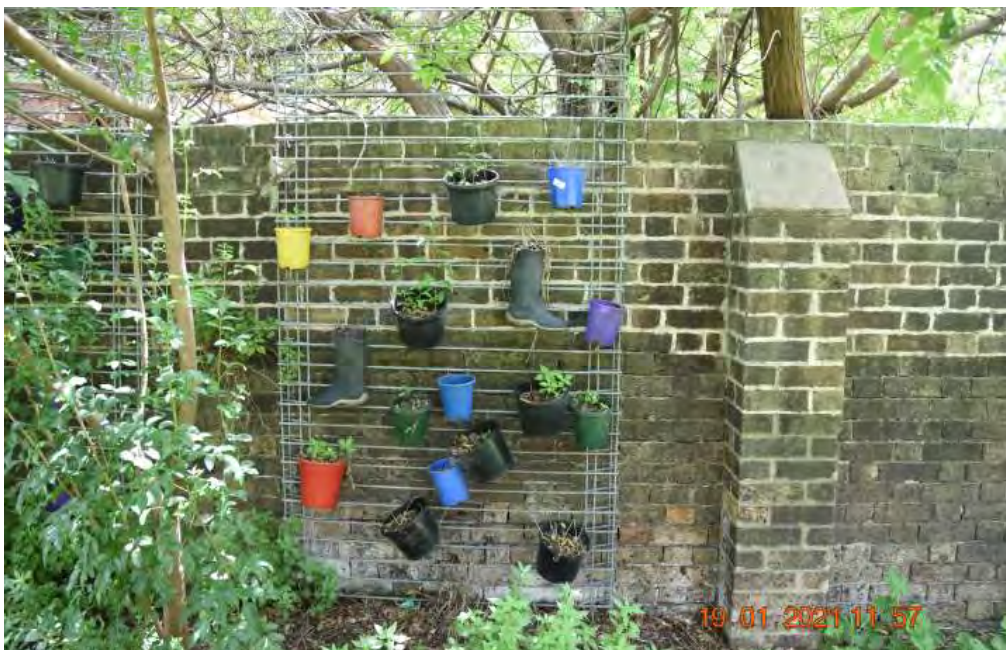
Figure: 1488

General view of the heritage wall on the south side of building C. Showing obstructed view.

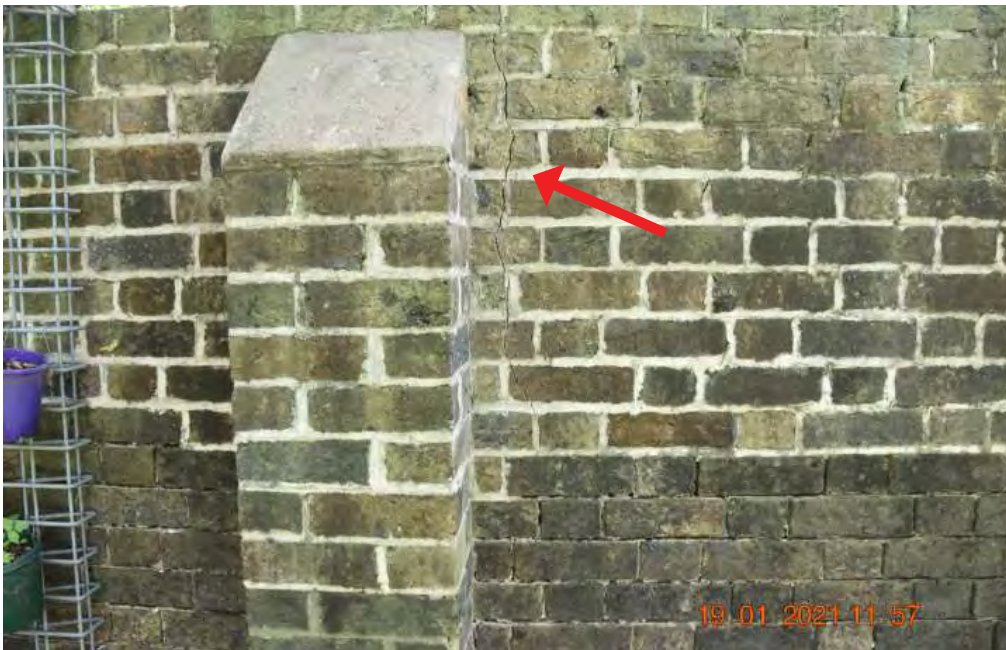
Figure: 1491

Slight cracking in the heritage wall on the south side of building C.

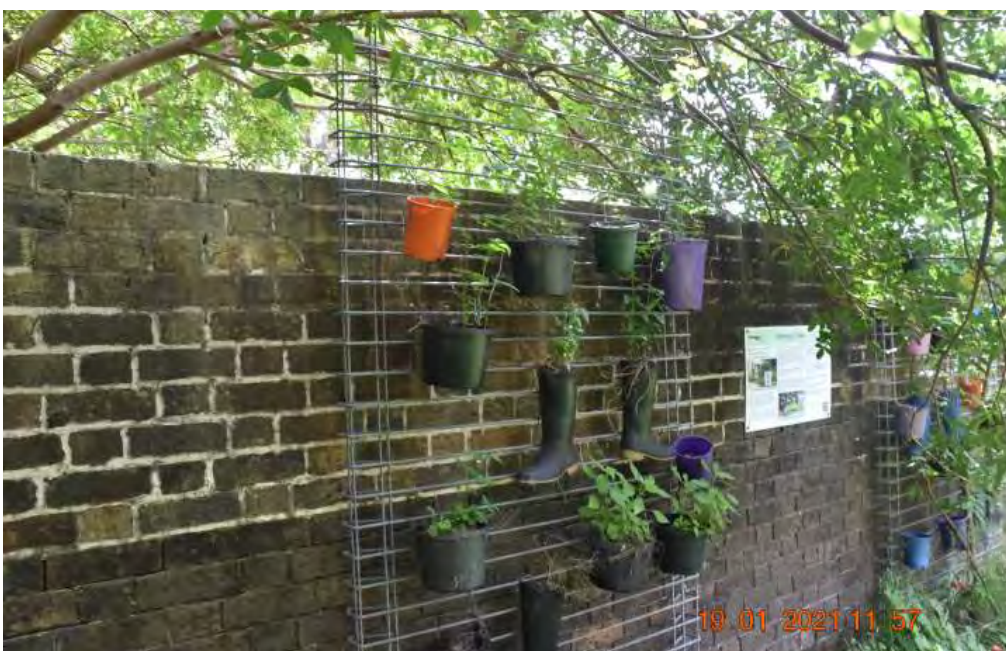
Figure: 1492

Slight cracking in the heritage wall on the south side of building C.

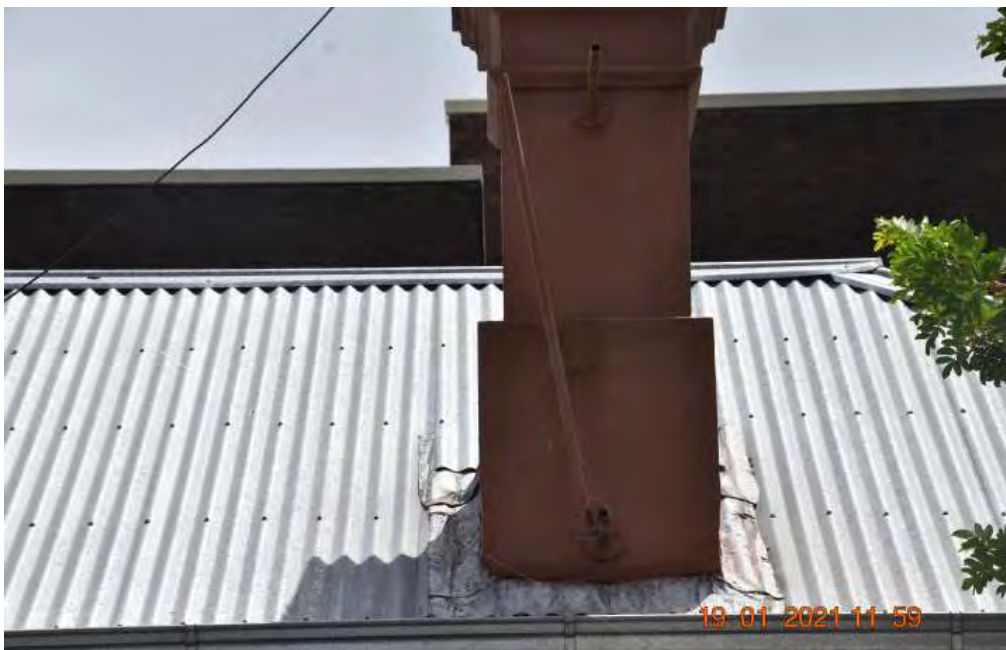
Figure: 1512

General view of the chimney on the south side of building C. Showing chipping.

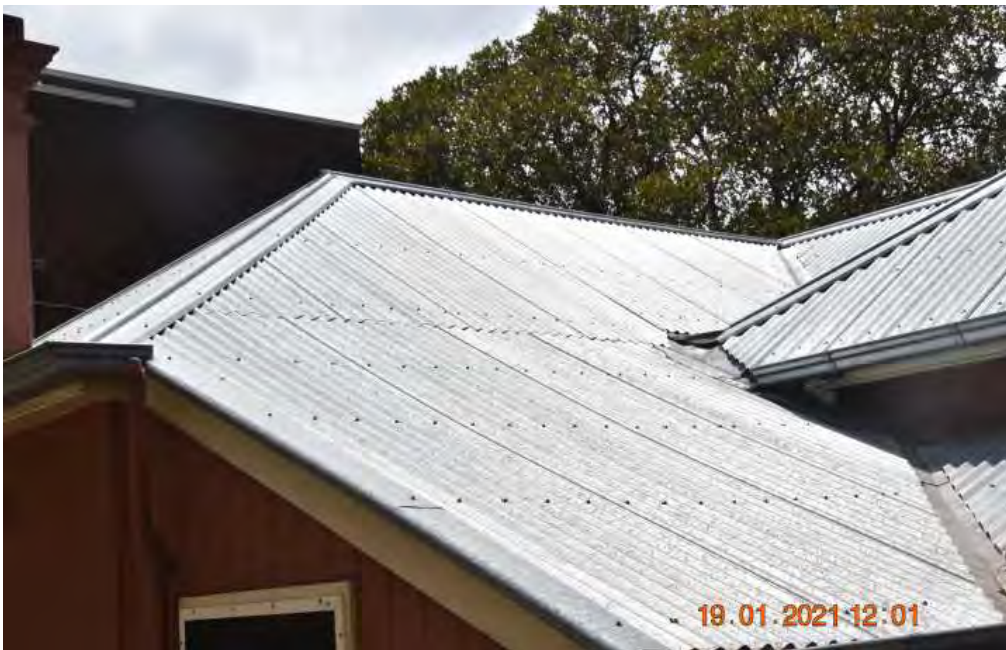
Figure: 1524

General view of the roof on the west side of building C.

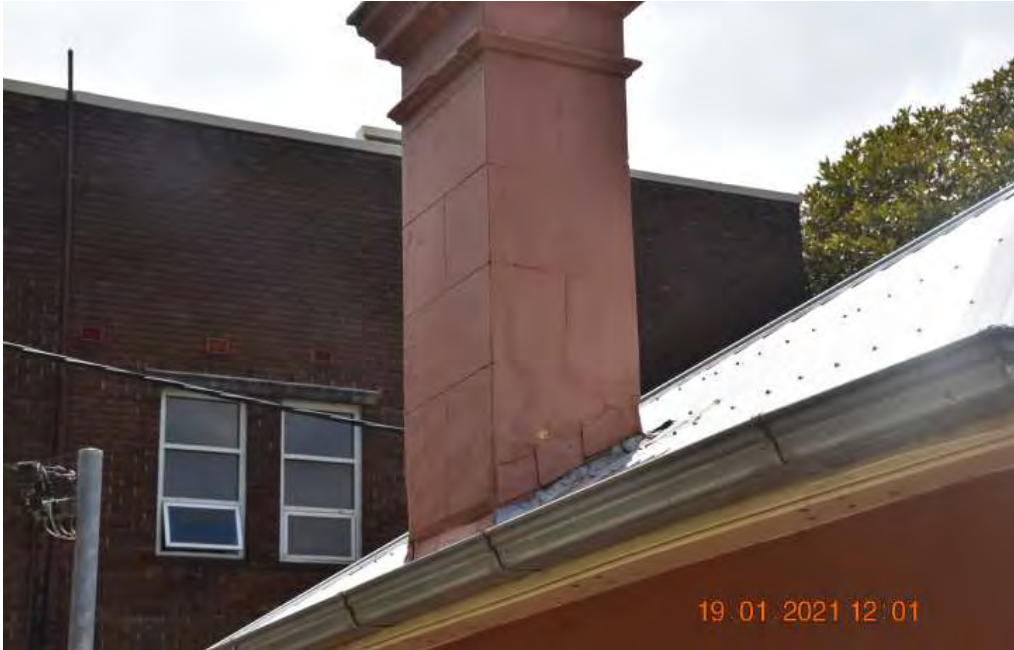
Figure: 1526

General view of the chimney on the west side of building C.

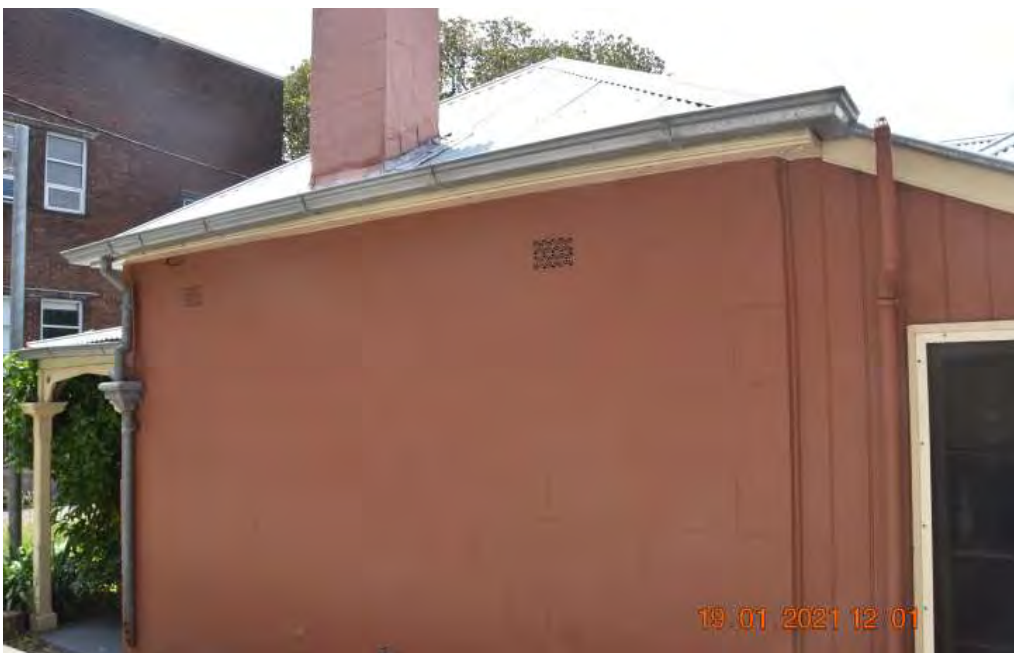
Figure: 1528

West wall of building C.

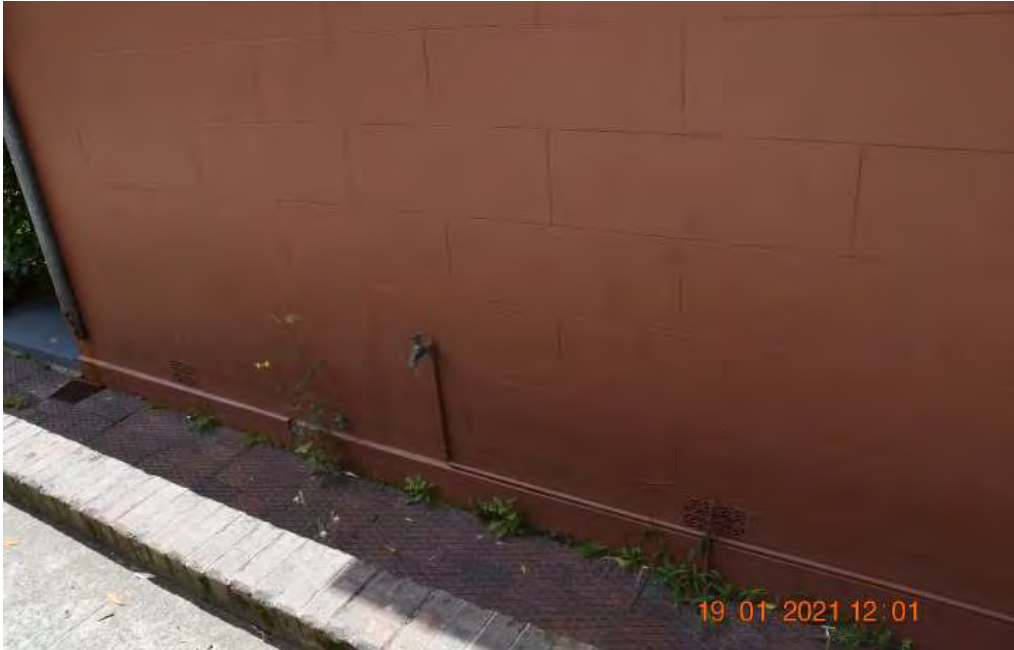
Figure: 1529

West wall of building C.

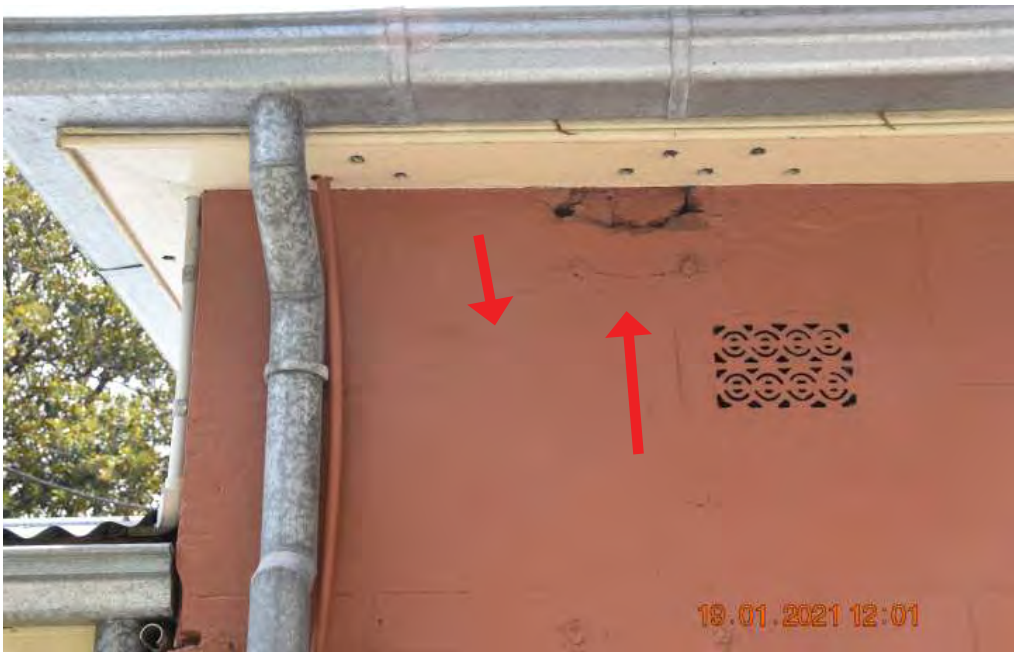
Figure: 1530

West wall of building C.

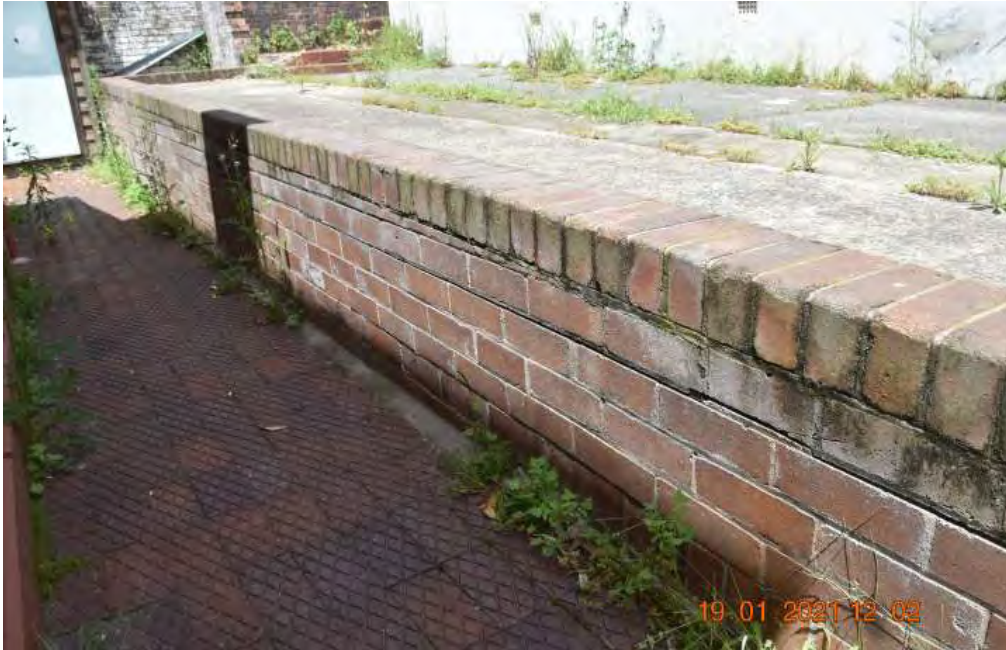
Figure: 1535

Movement in the retaining wall on the west side of building C. Also showing slight cracking in the mortar joints.

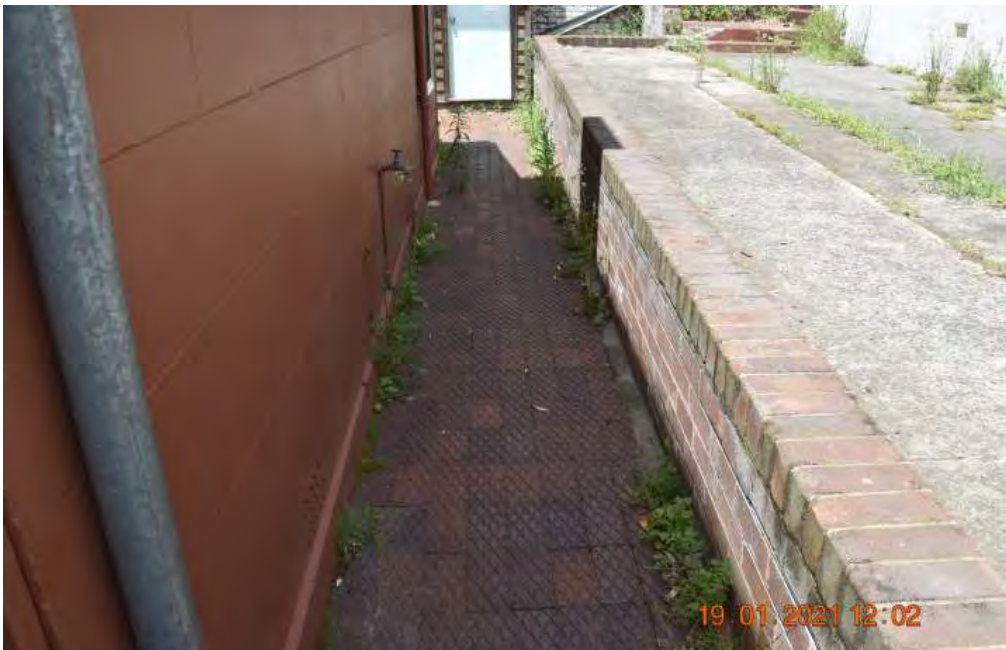
Figure: 1536

General view of the retaining wall on the west side of building C.

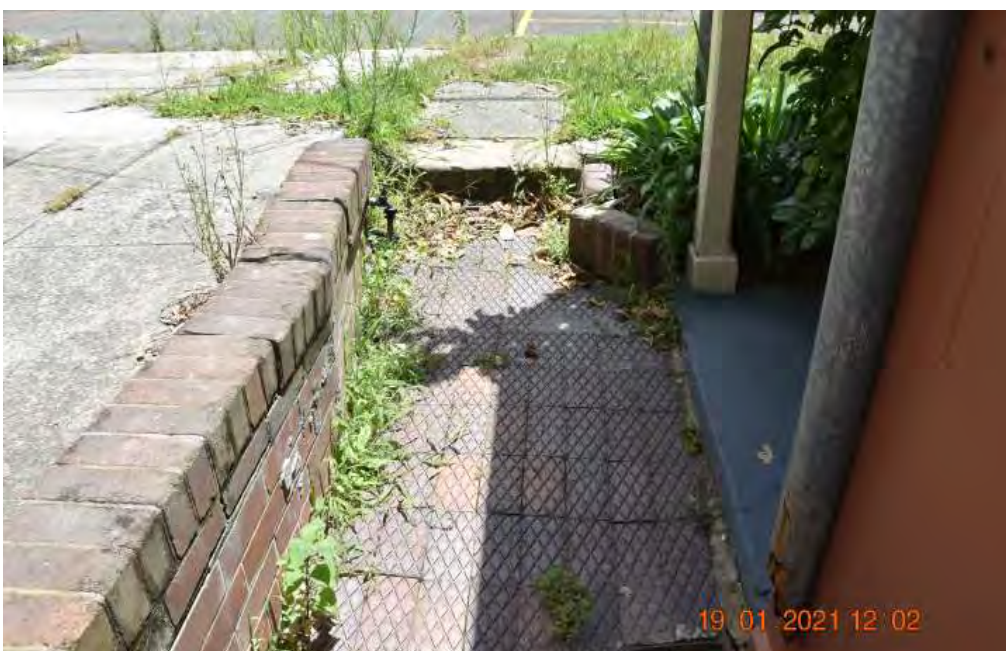
Figure: 1537

General view of the pathway on the west side of building C.

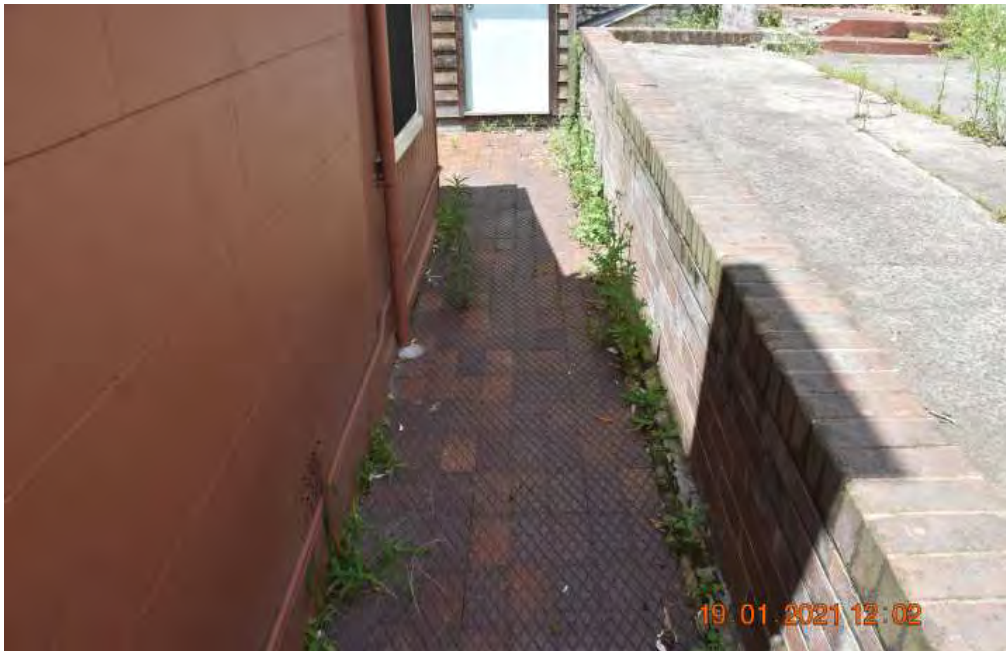
Figure: 1538

General view of the pathway on the west side of building C.

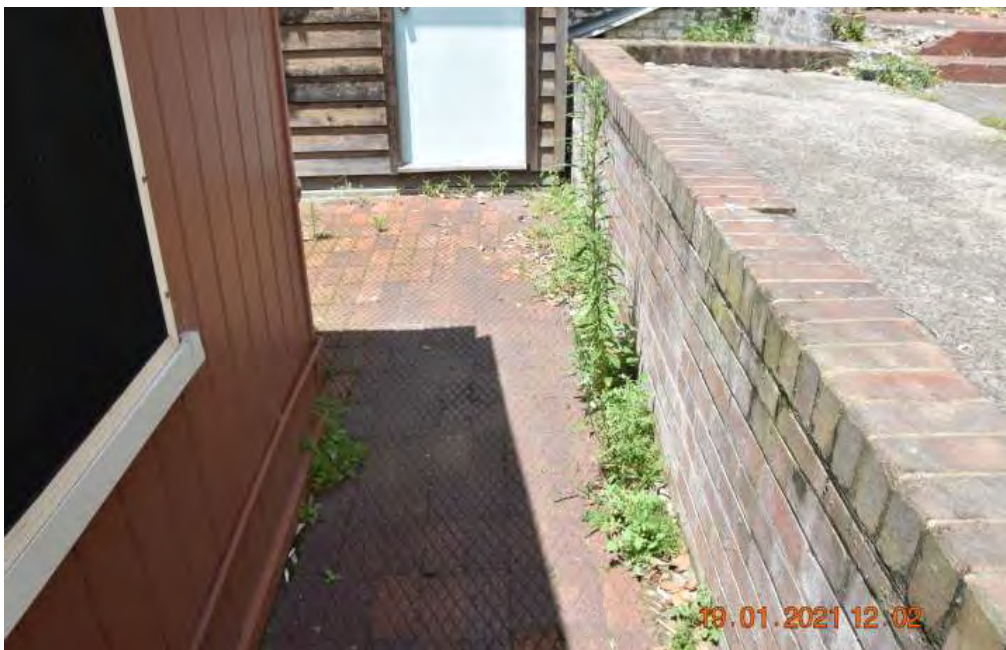
Figure: 1539

General view of the pathway on the west side of building C.

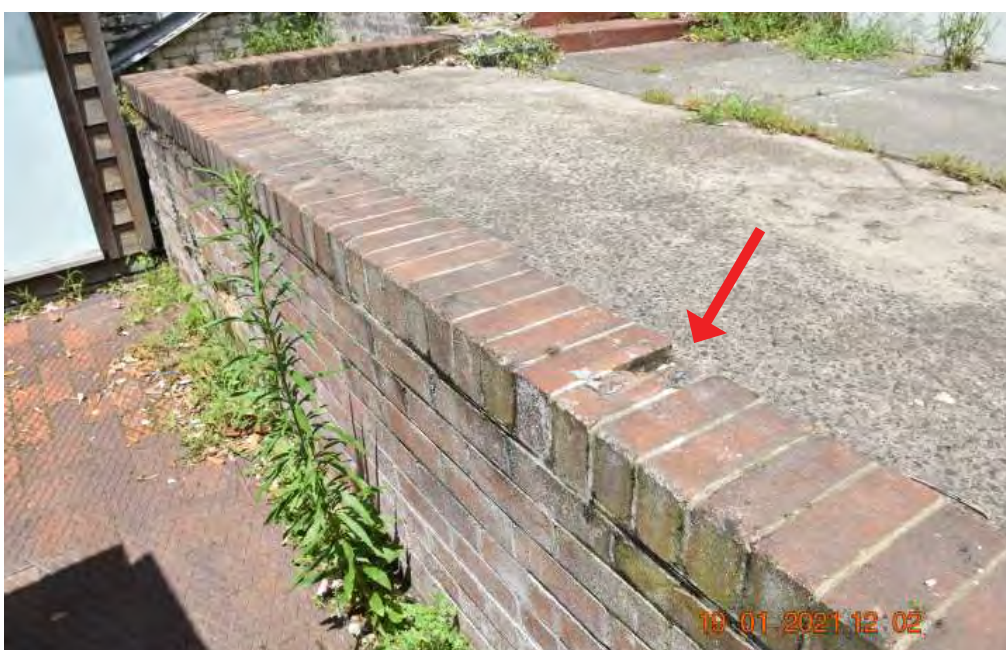
Figure: 1540

General view of the pathway on the west side of building C.

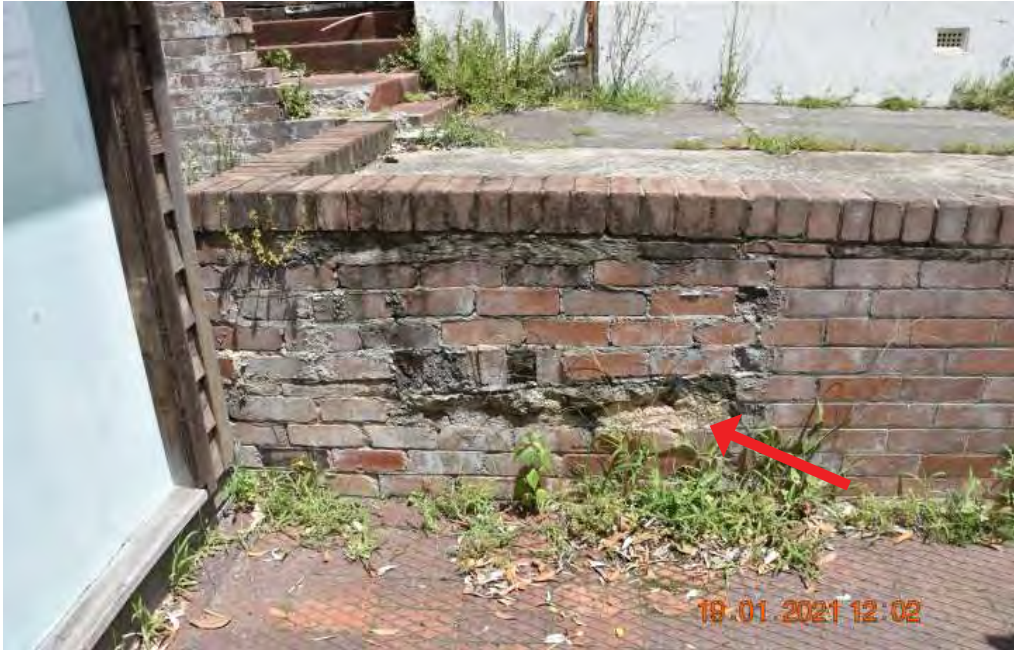
Figure: 1541

Chipping in the retaining wall on the west side of building C.

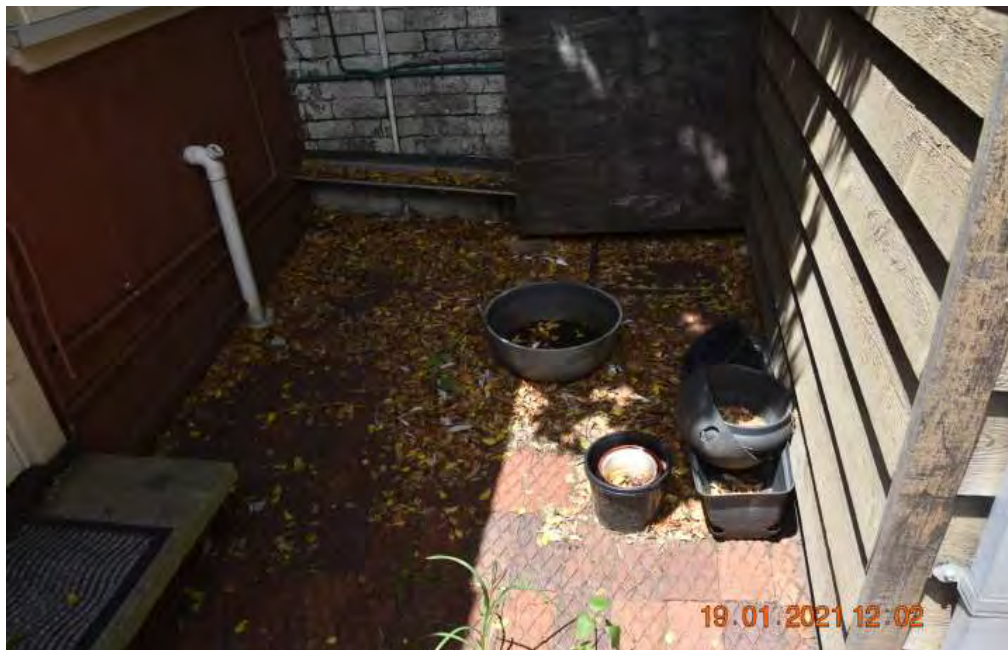
Figure: 1544

Paving at the southwest corner of building C.

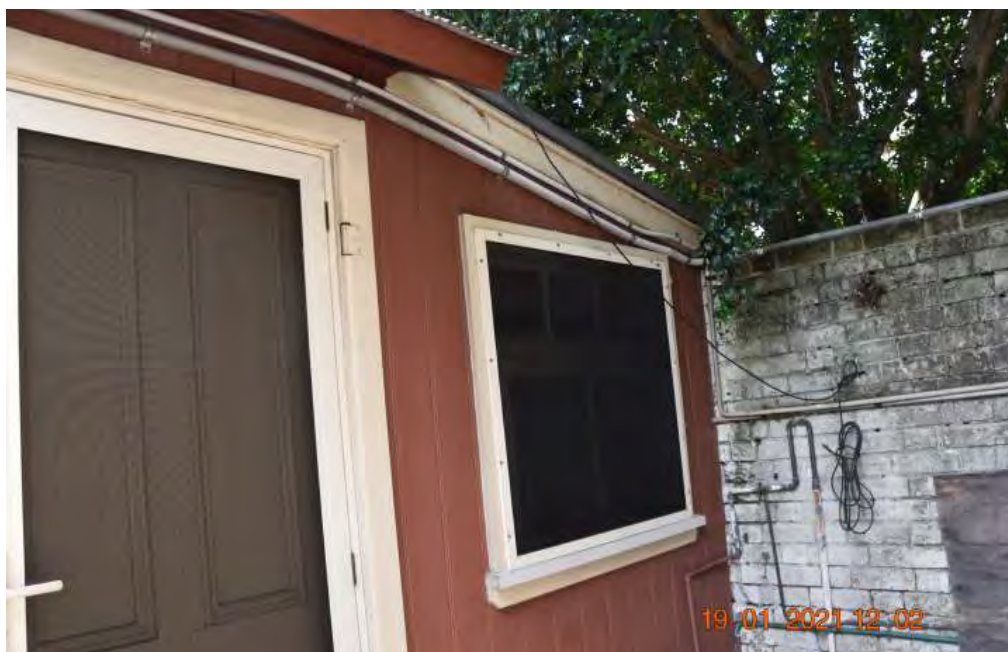
Figure: 1545

Paving at the southwest corner of building C.

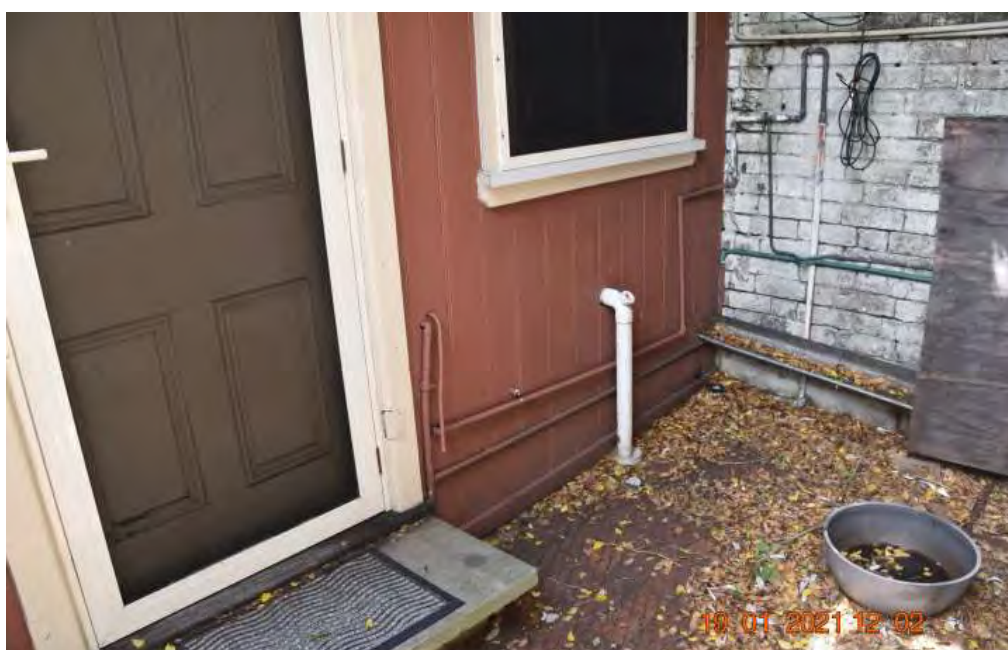
Figure: 1546

West wall of building C.

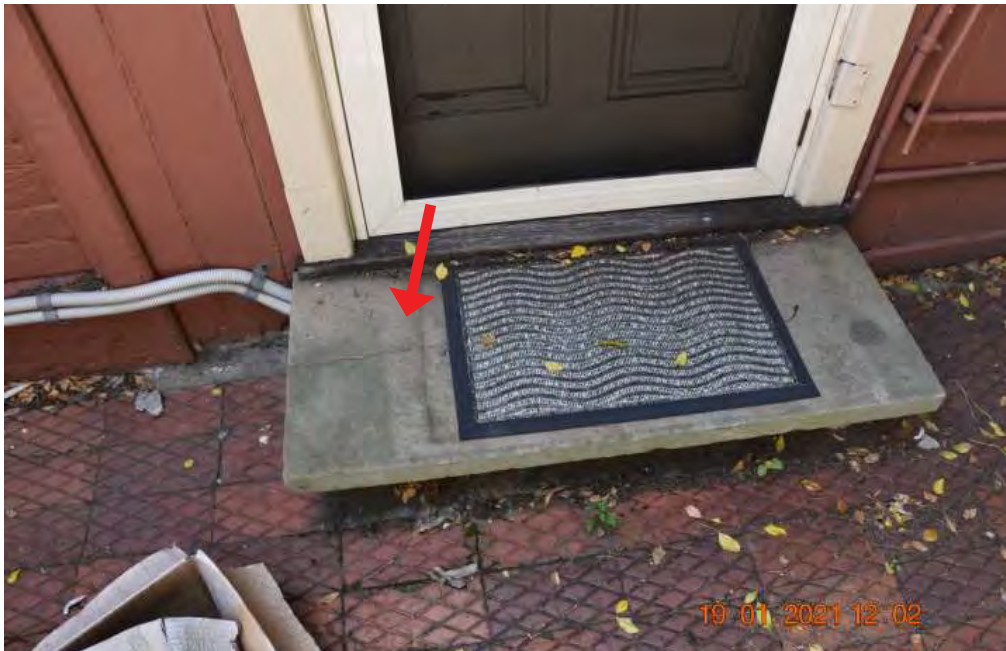
Figure: 1547

West wall of building C.
