## PRE CONSTRUCTION CONDITION SURVEY

Fort Street Public School, Millers Point NSW

Upper Fort Street Public School  
MILLERS POINT NSW 2000

19 January 2021

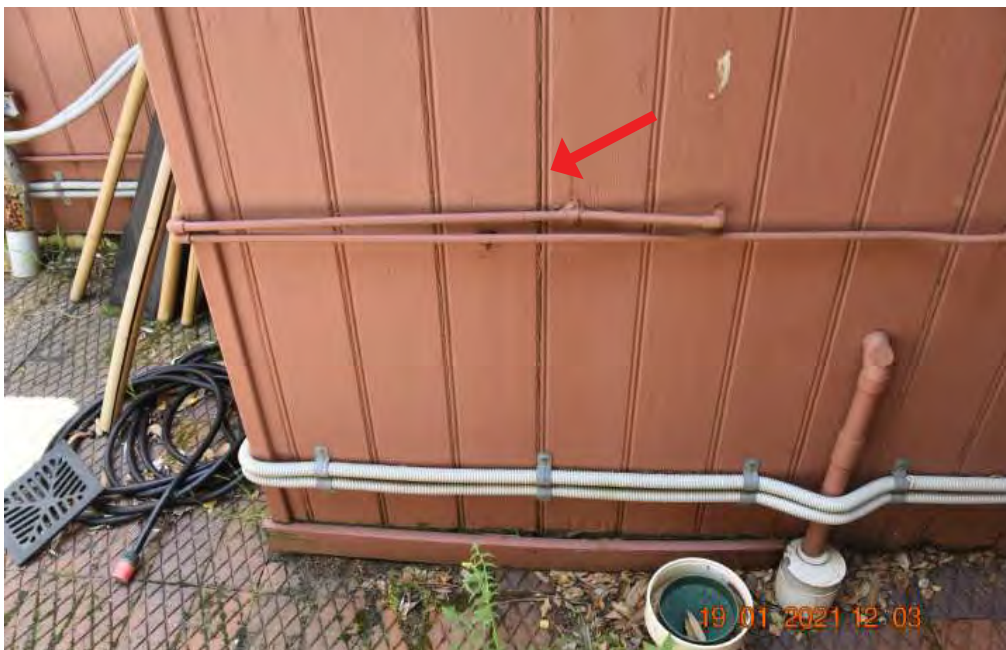
Figure: 1551

South wall of building C.

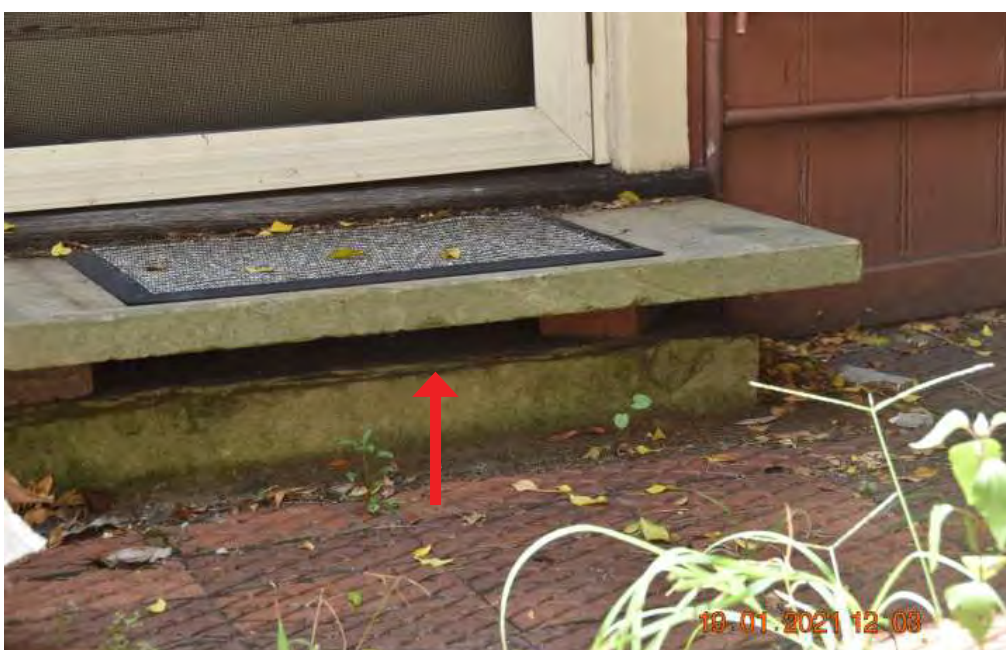
Figure: 1552

South wall of building C. Showing separation in the cladding.

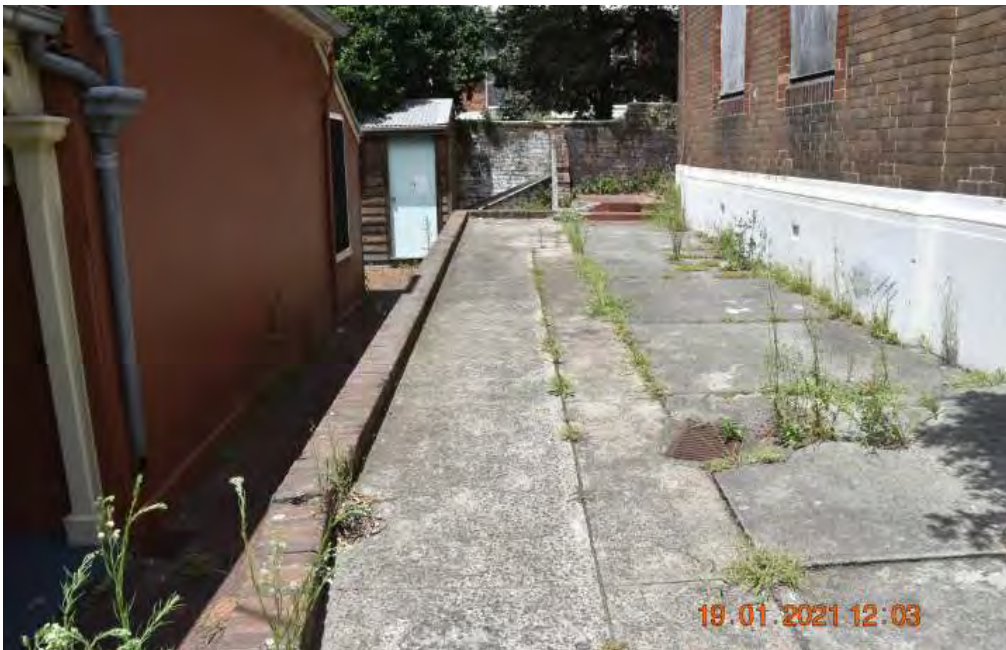
Figure: 1554

General view of the paving at the northwest corner of building C.

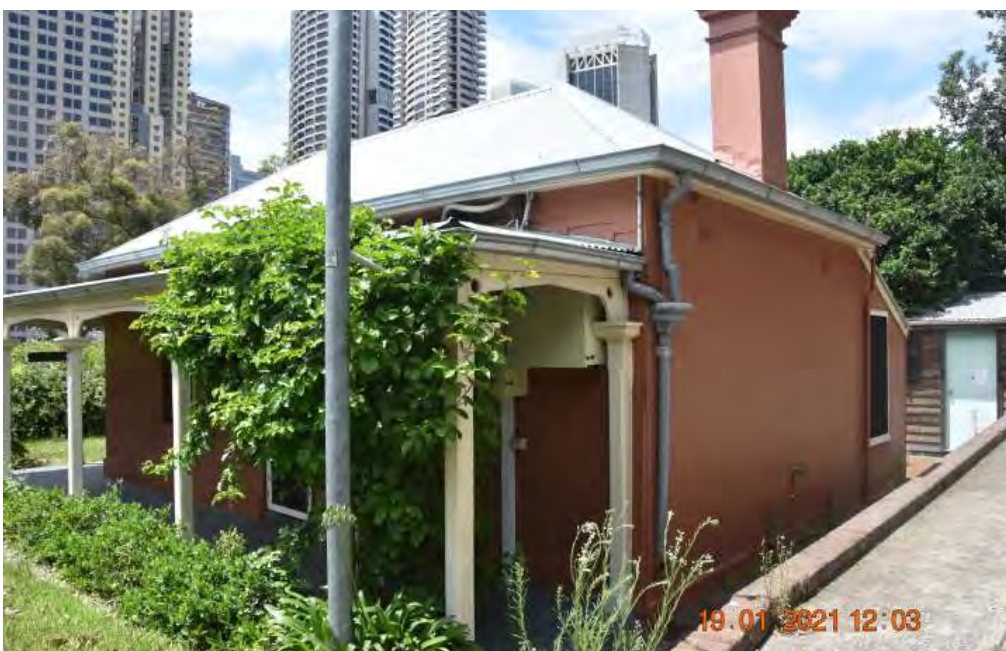
Figure: 1555

General view of the paving on the west side of building B.

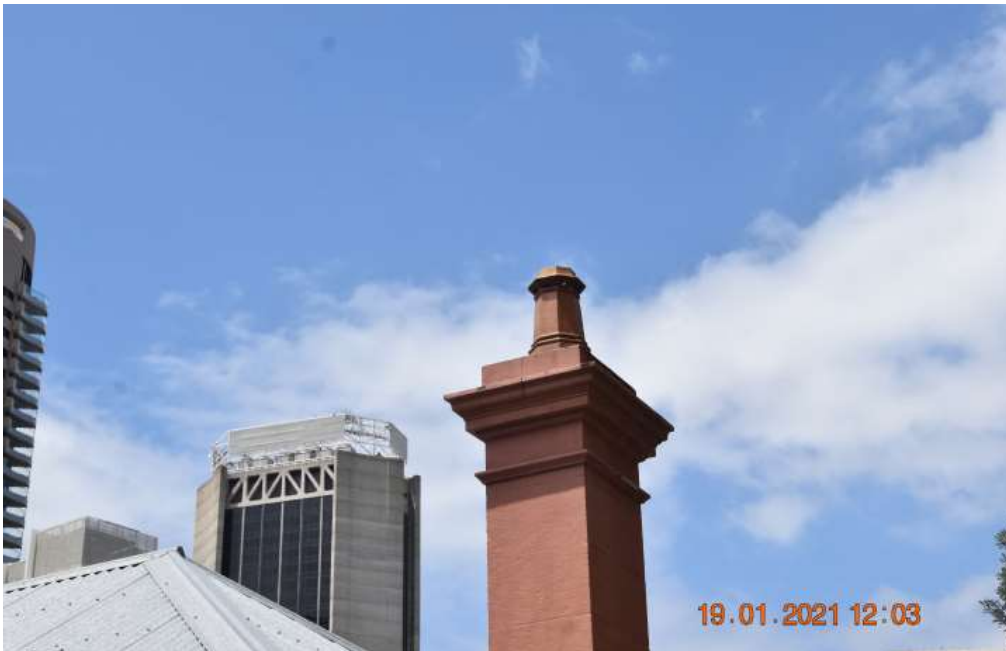
Figure: 1557

Northwest corner  
of the chimney on  
building C.

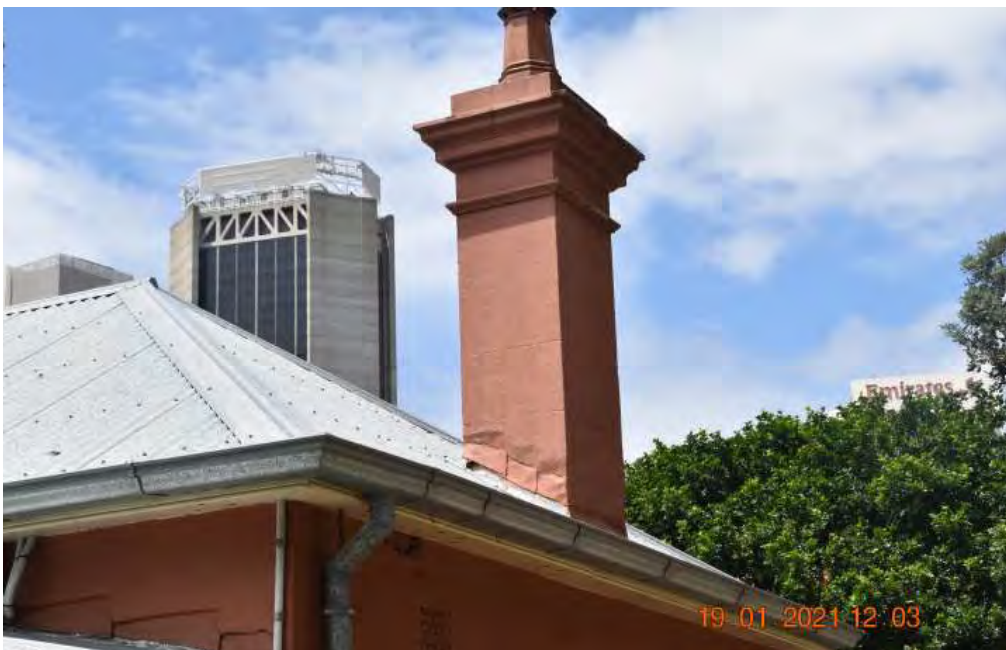
Figure: 1558

Northwest corner  
of the chimney on  
building C.

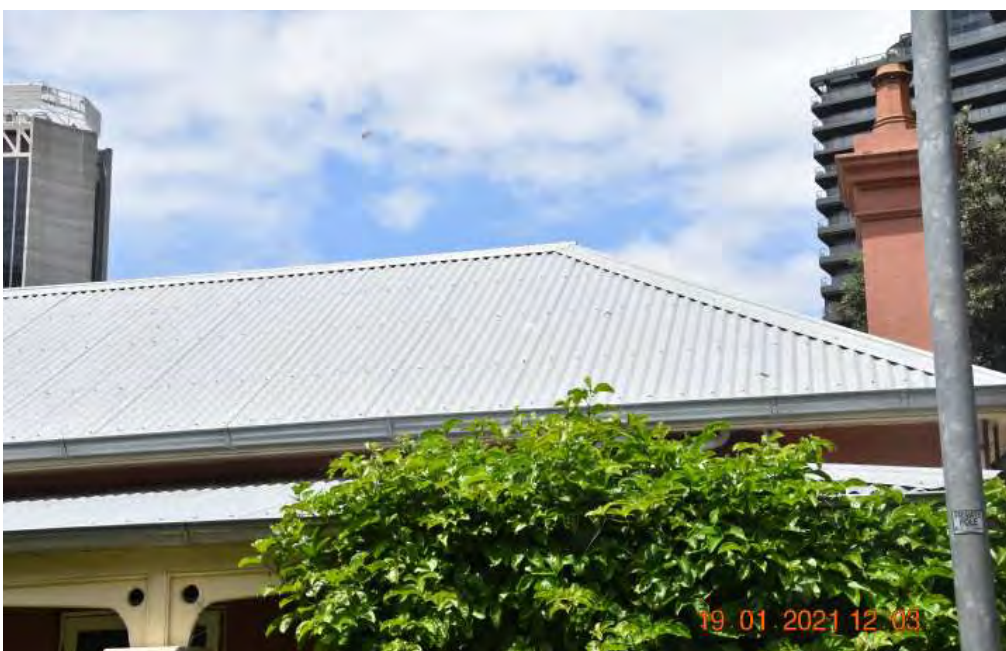
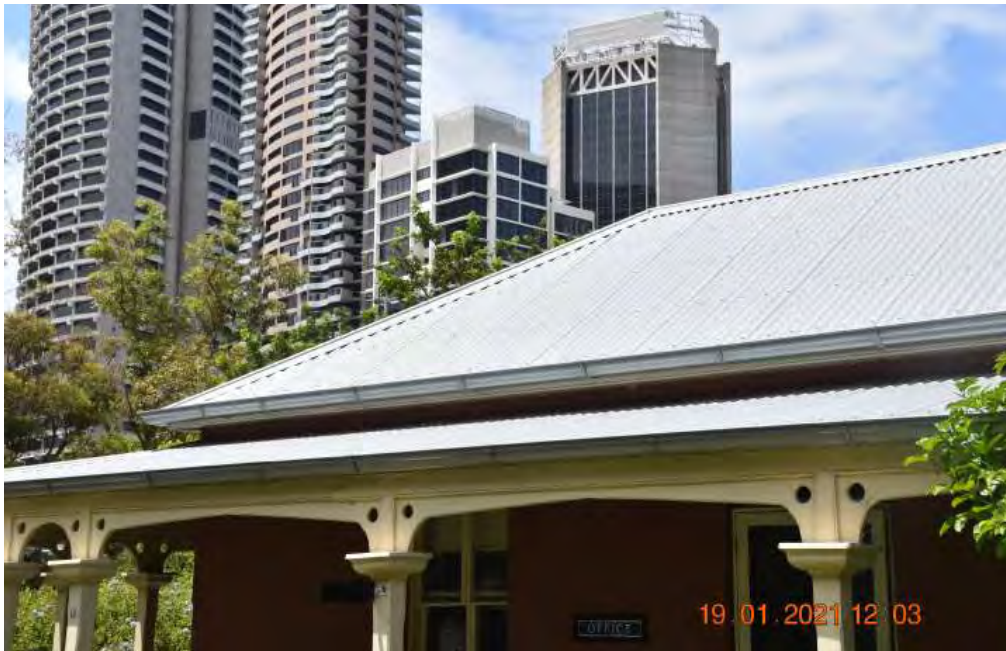
Figure: 1559

General view of the  
roof on the north side  
of building C.

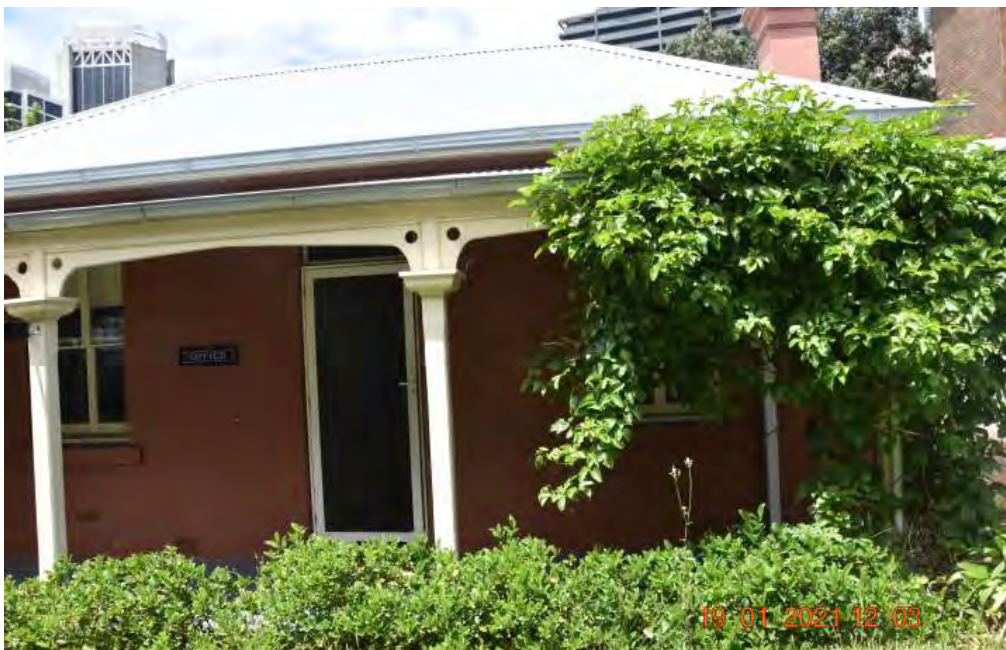
Figure: 1560

General view of the roof on the north side of building C.

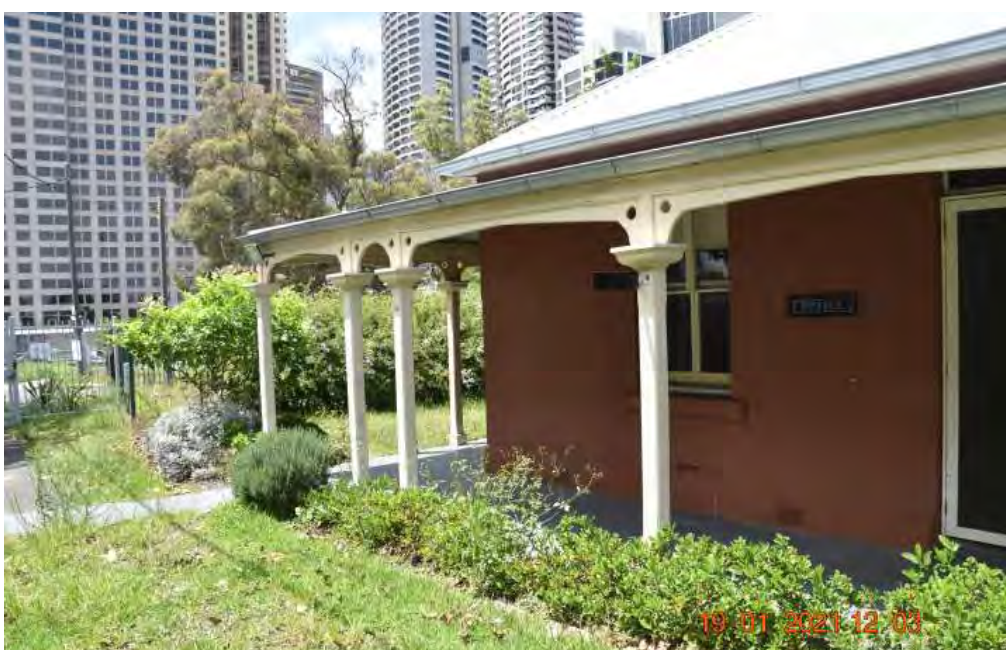
Figure: 1561

General view of the columns on the north side of building C.

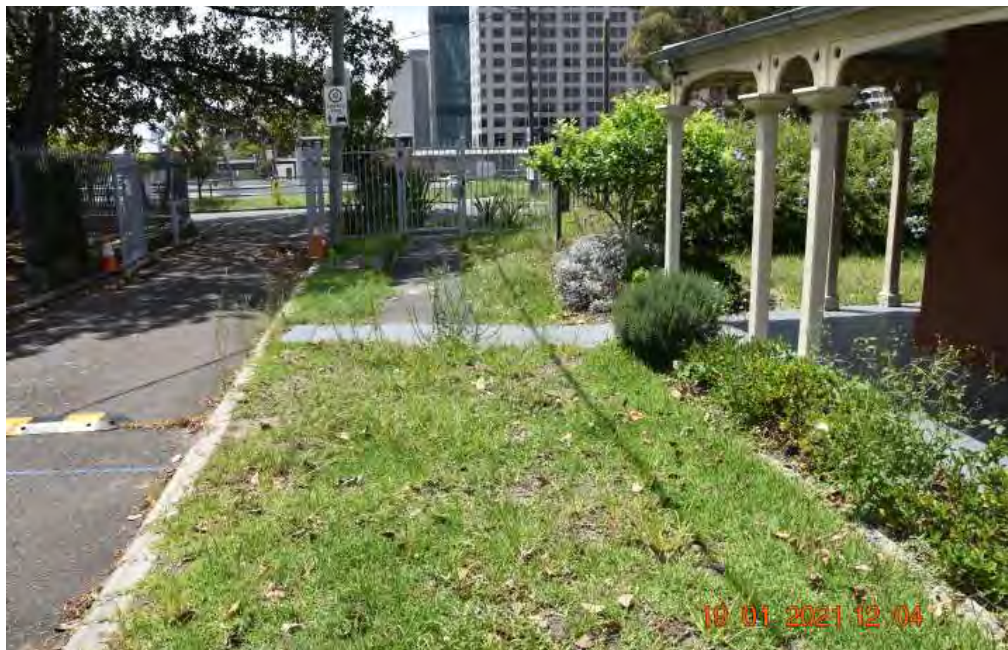
Figure: 1562

General view of the columns on the north side of building C.

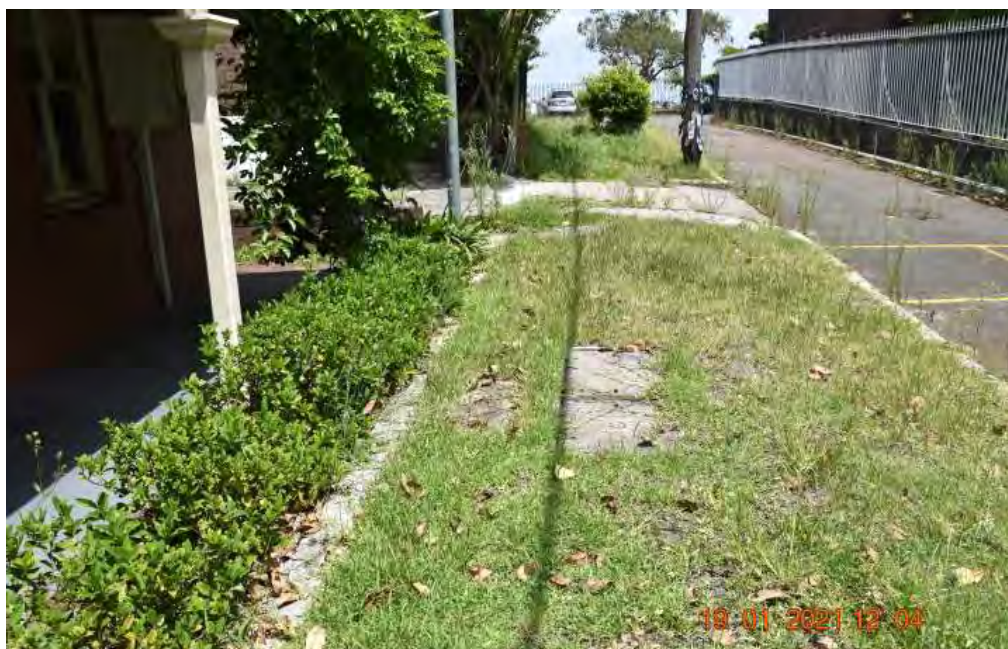
Figure: 1563

General view of the grass area on the north side of building C.

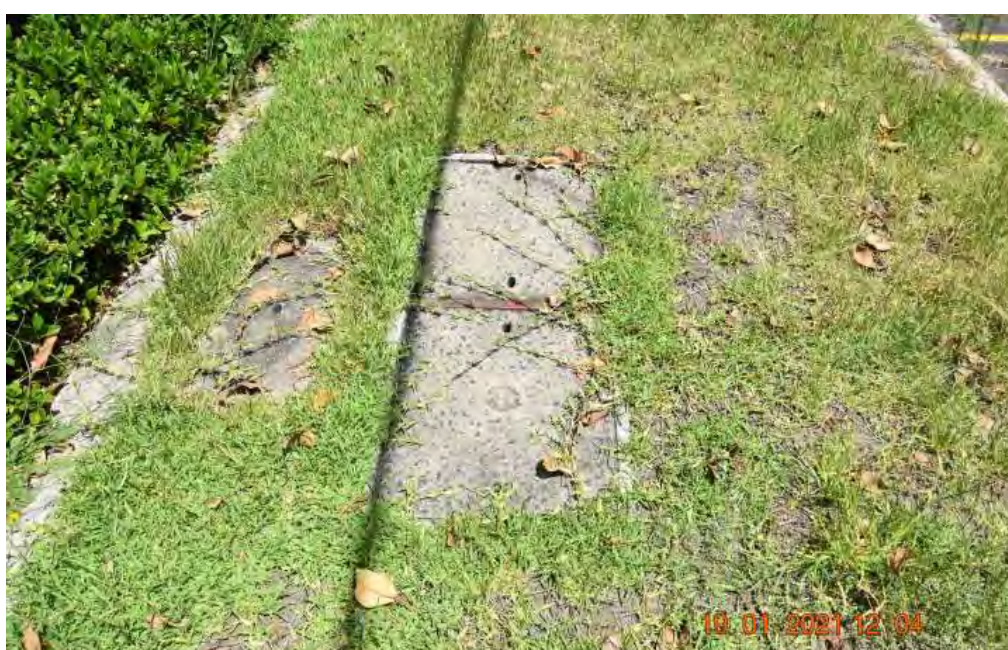
Figure: 1564

General view of the grass area on the north side of building C.

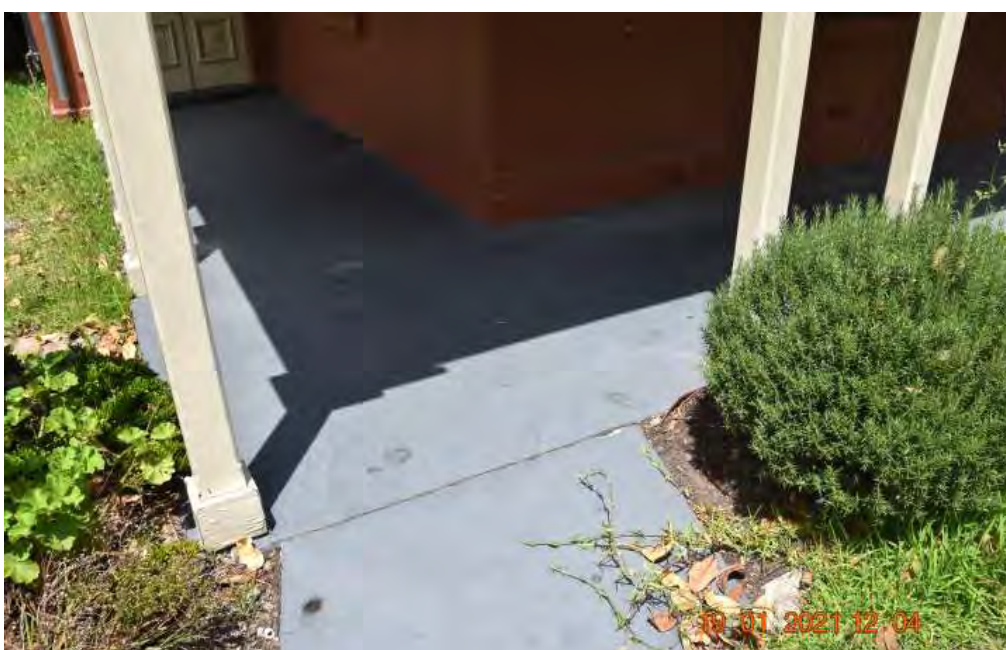
Figure: 1567

General view of the paving at the northeast corner of building C.

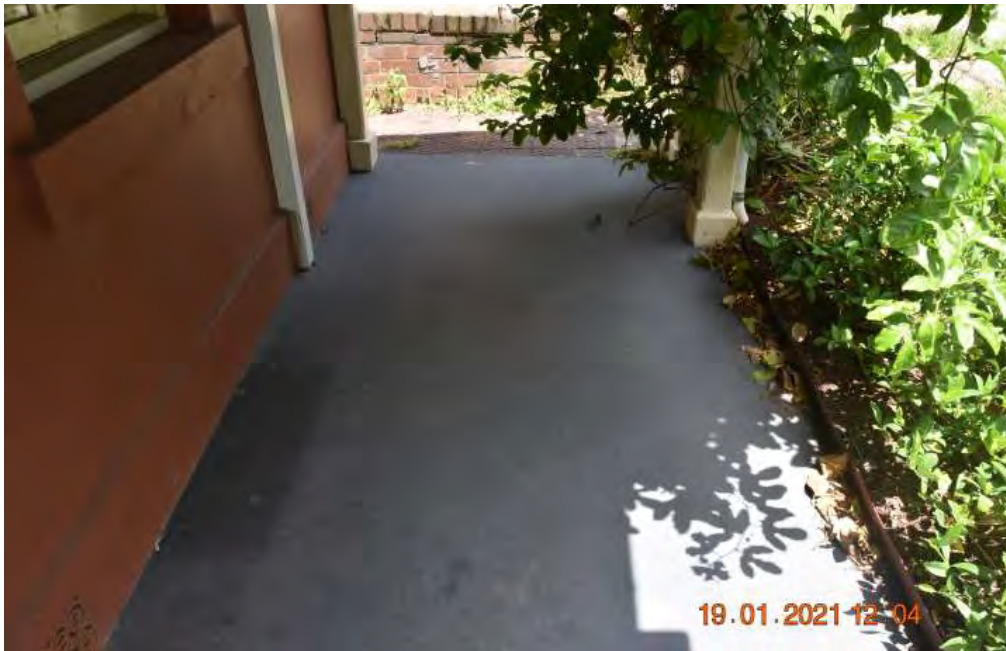
Figure: 1568

General view of the paving at the northeast corner of building C.

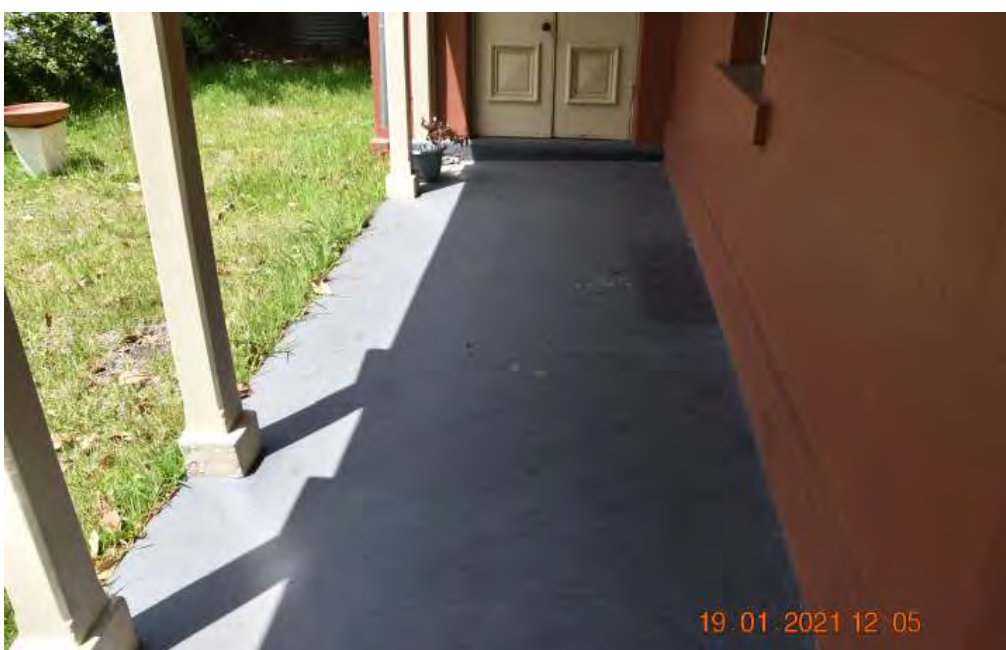
Figure: 1582

Cracking in the paving at the northeast corner of building C.

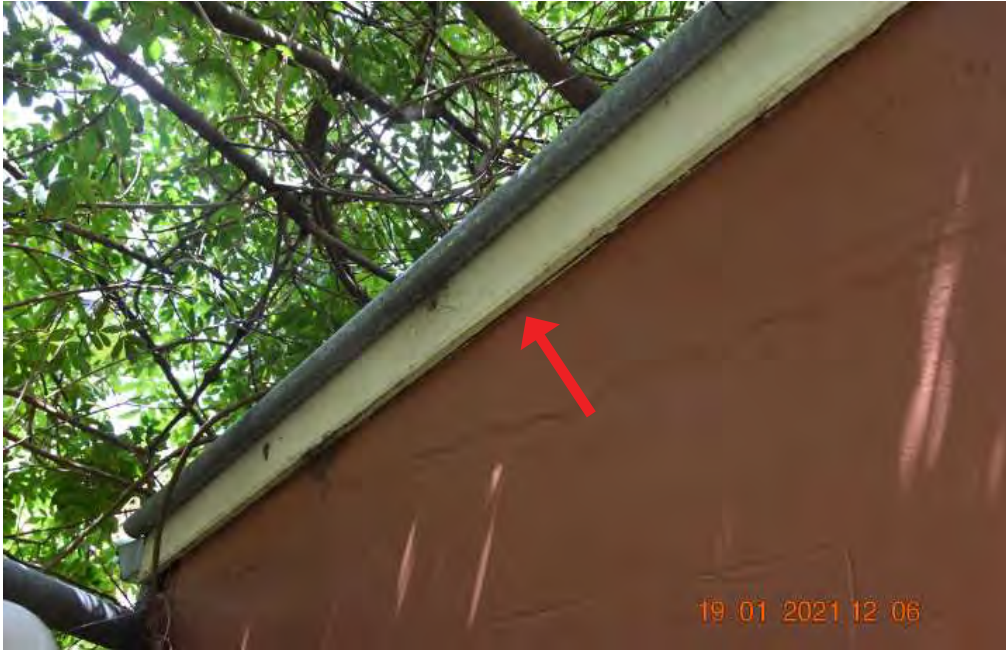
Figure: 1604

Fine cracking in the east wall of building C.

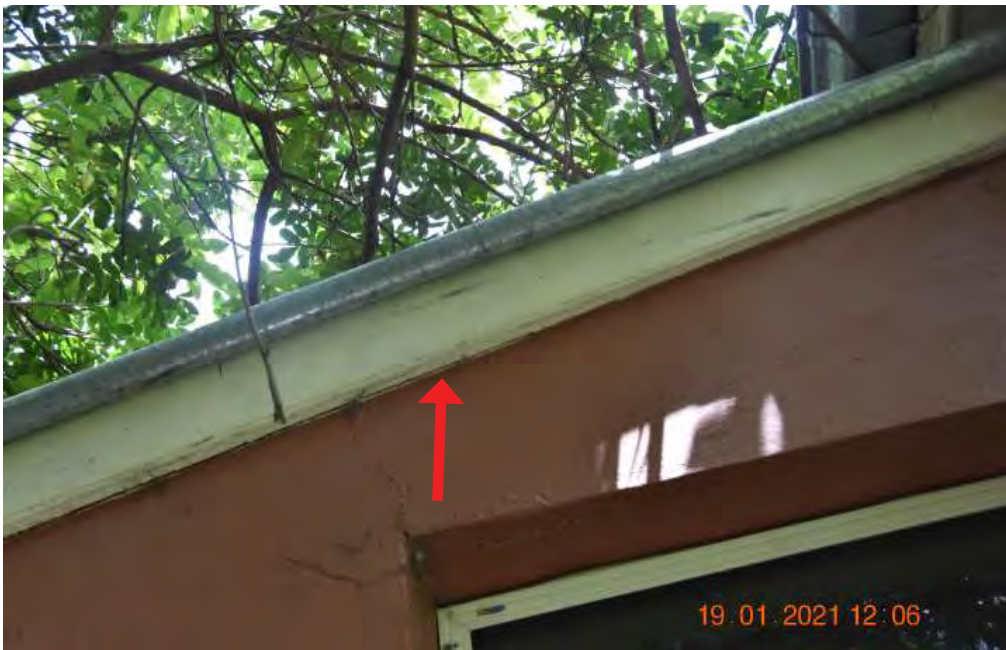
Figure: 1605

Separation between the fascia and east wall of building C.

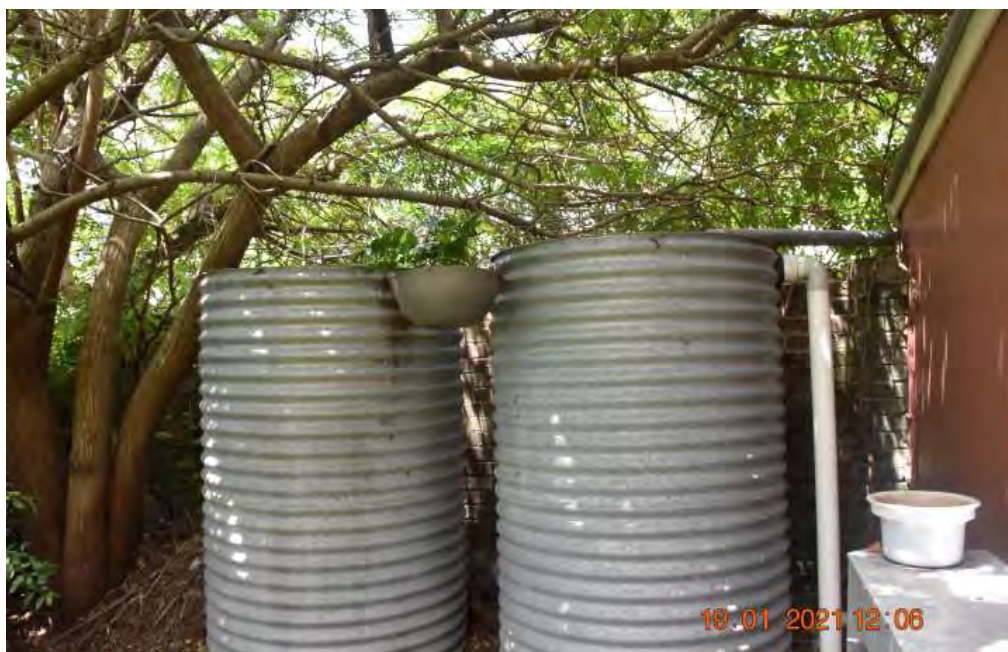
Figure: 1608

General view of the heritage wall on the south side of building C.

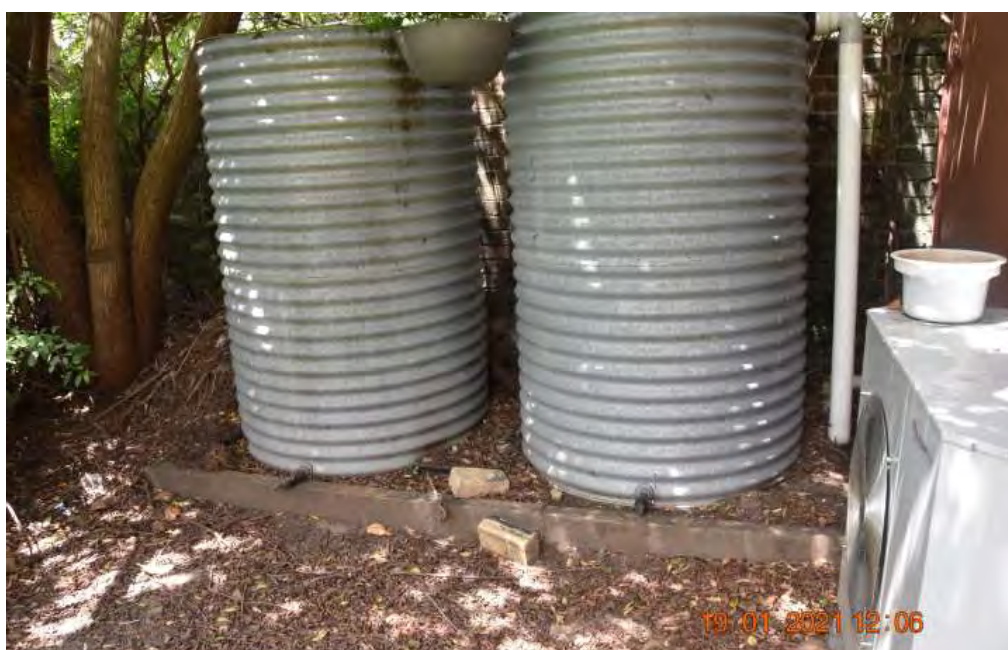
Figure: 1609

General view of the water tanks at the southeast corner of building C.

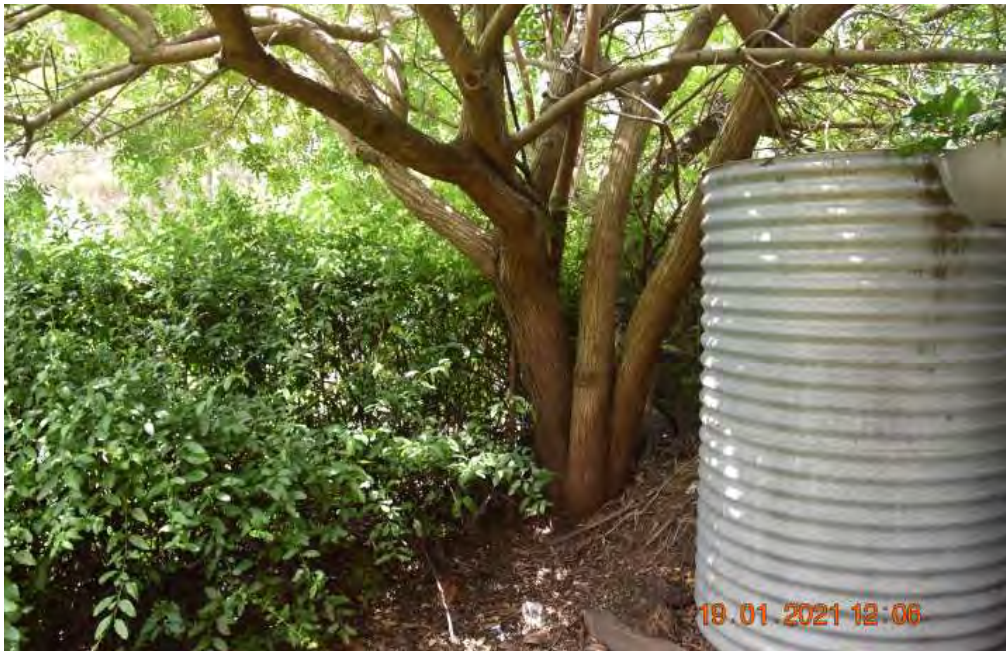
Figure: 1610

General view of the water tanks at the southeast corner of building C.

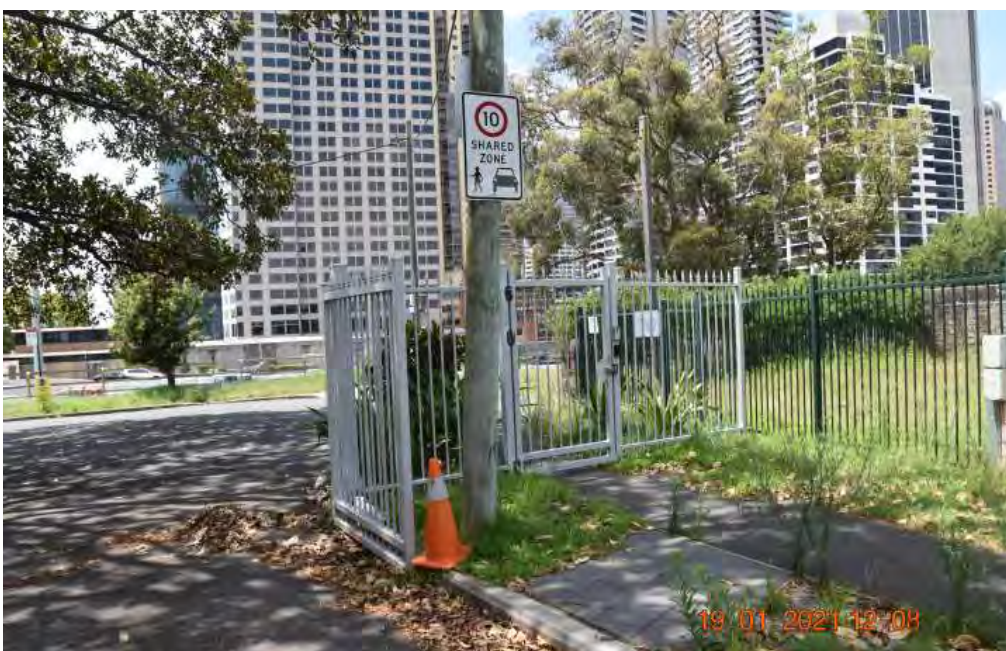
Figure: 1615

General view of the power pole at the northeast corner of building C.

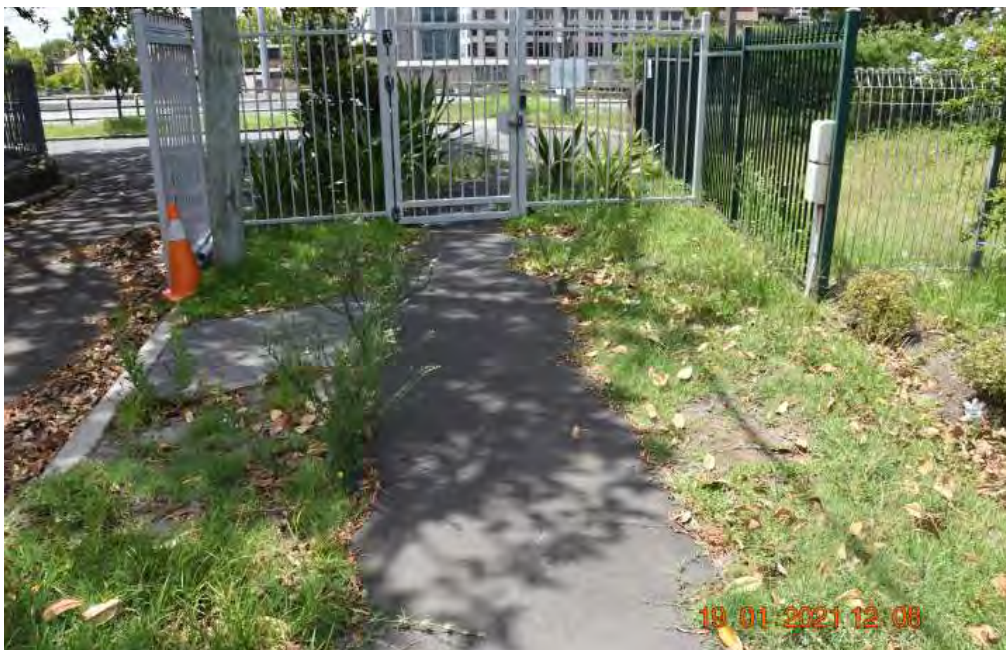
Figure: 1617

General view of the paving at the northeast corner of building C.

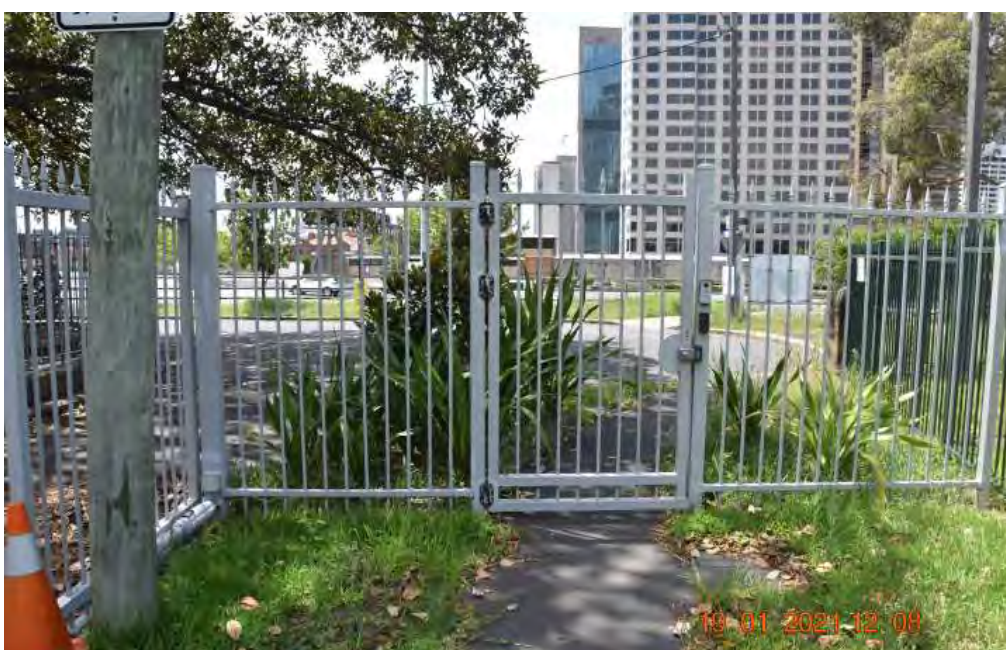
Figure: 1618

General view of the paving at the northeast corner of building C.

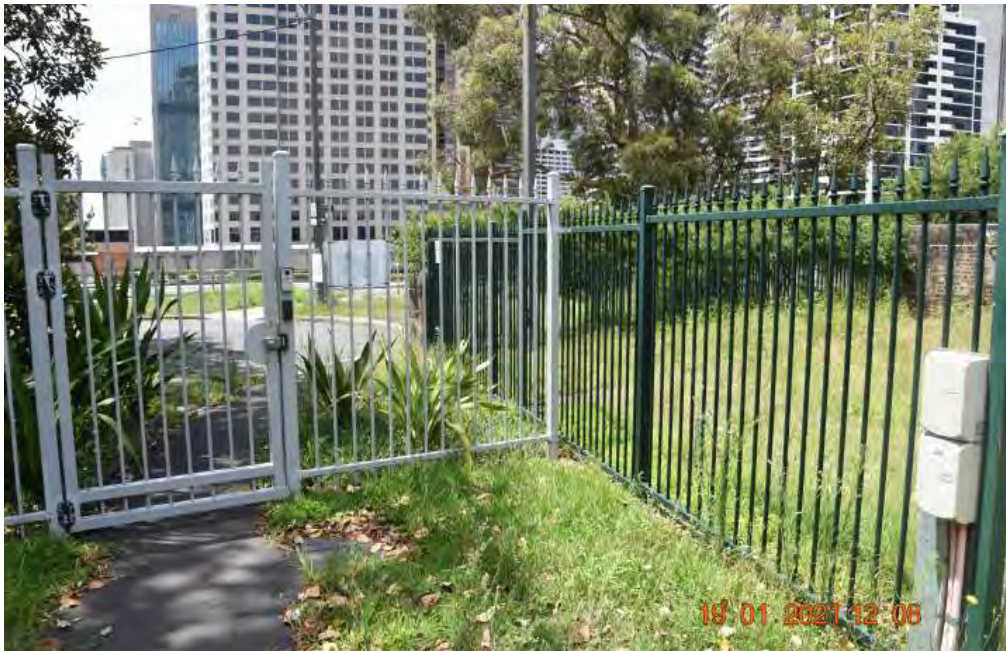
Figure: 1619

General view of the fence on the east side of building C.

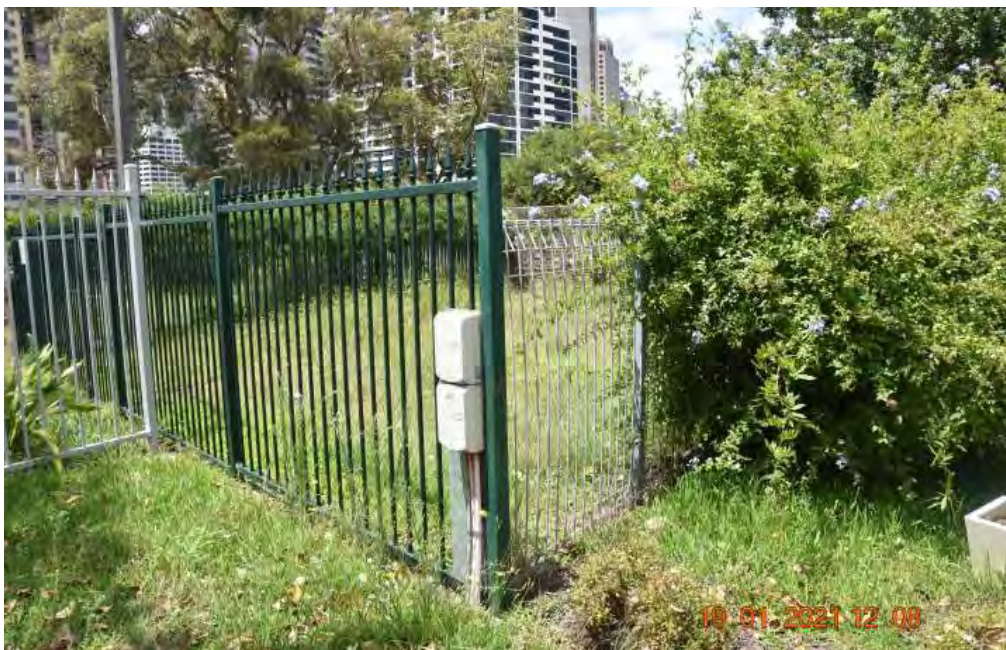
Figure: 1620

General view of the fence on the east side of building C.

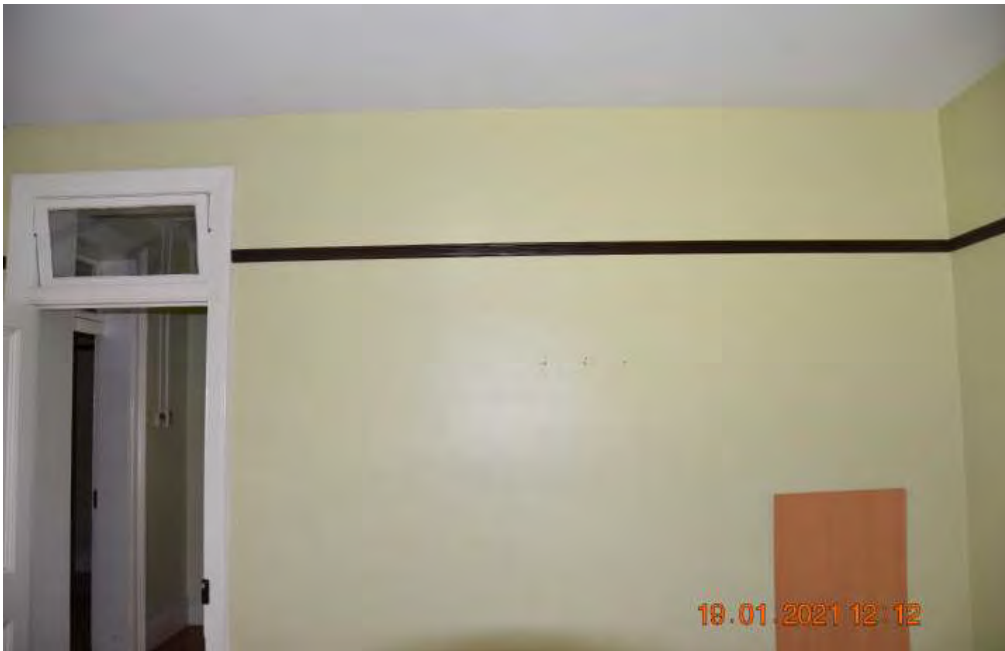
Figure: 1623

South wall in reception.

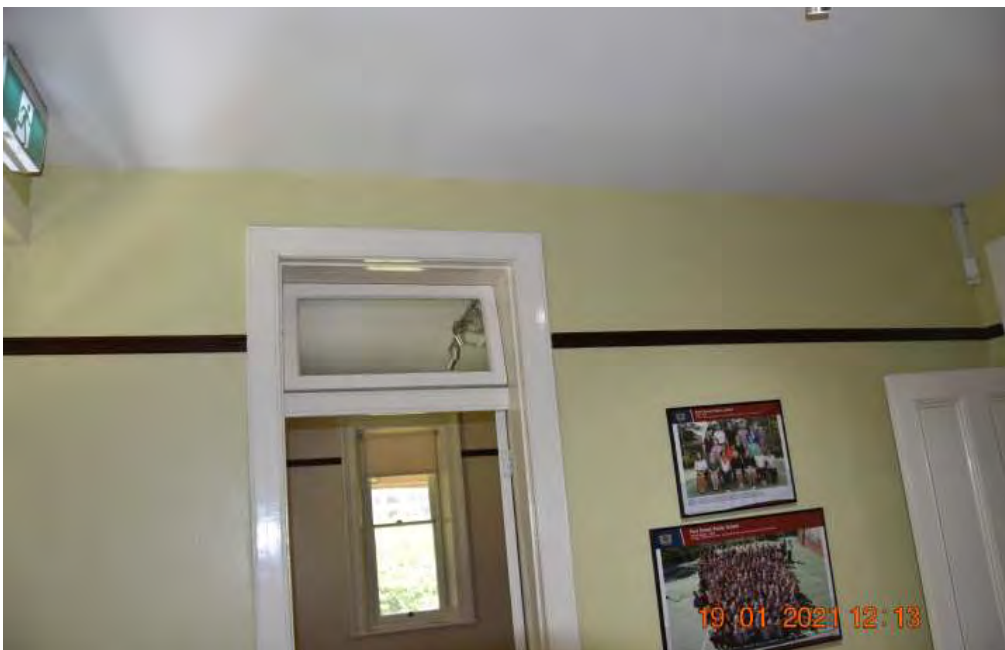
Figure: 1624

East wall in reception.

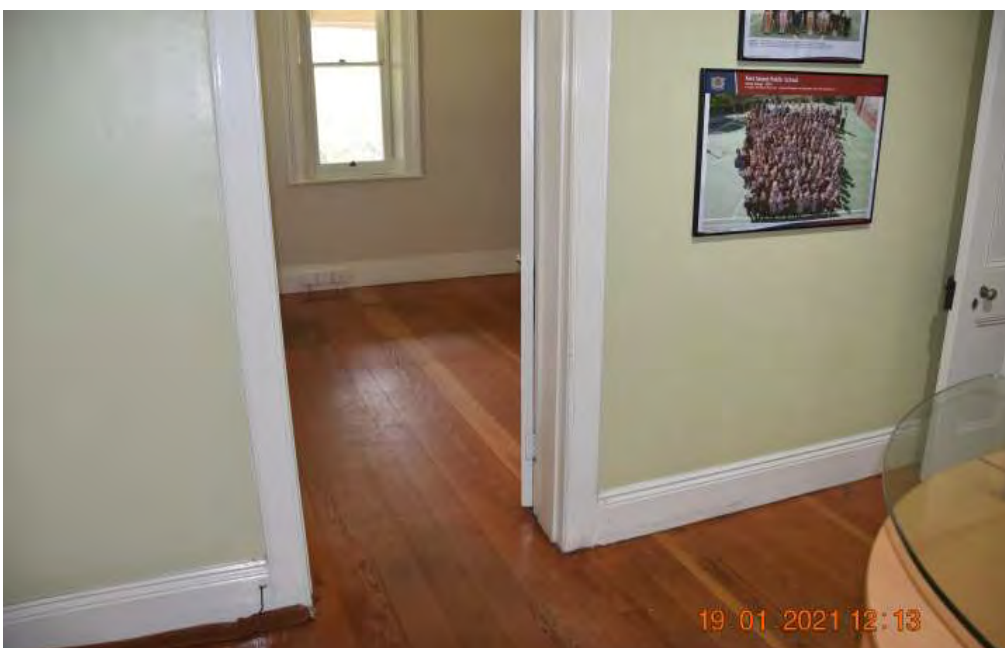
Figure: 1625

East wall in reception.

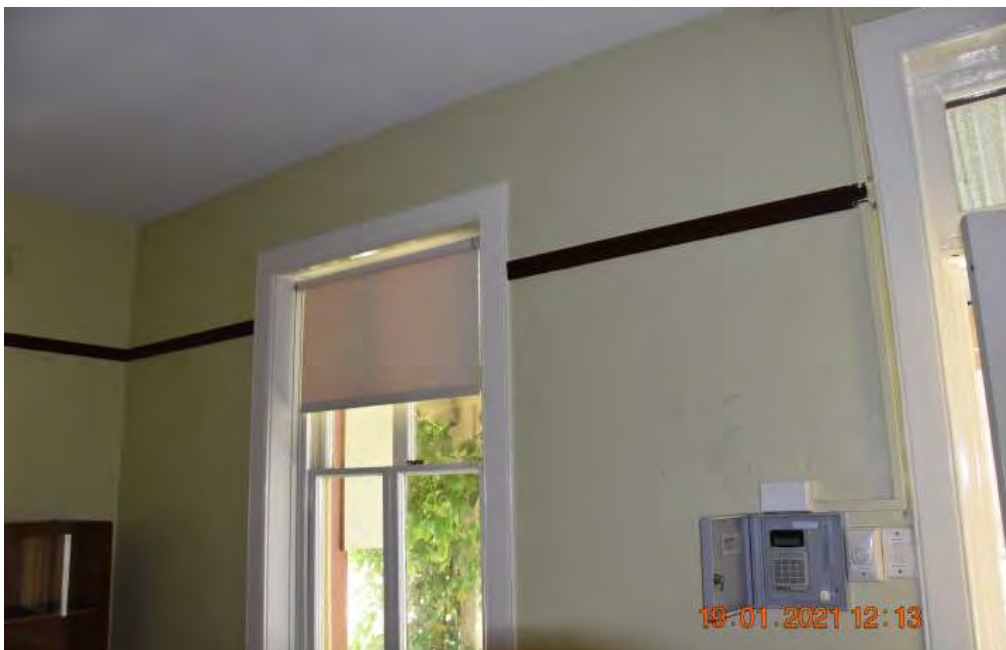
Figure: 1626

North wall in reception.

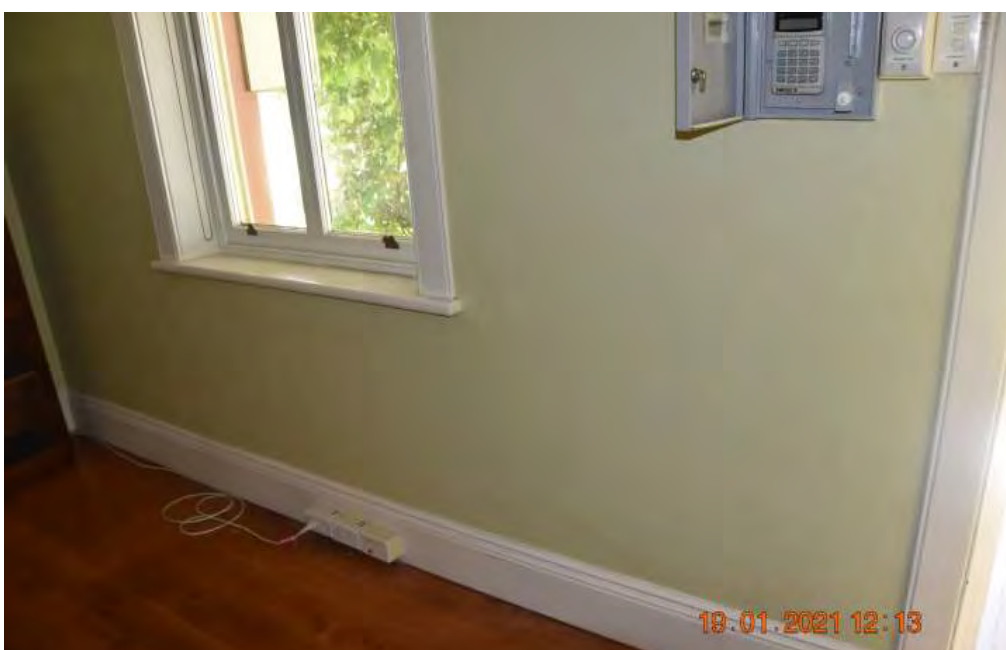
Figure: 1627

North wall in reception.

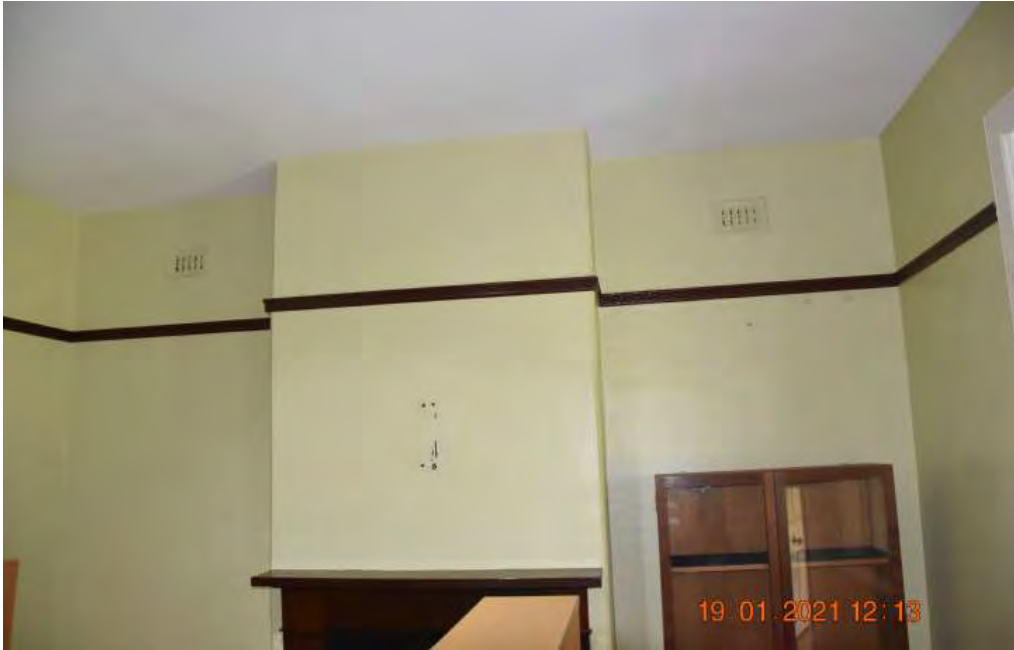
Figure: 1628

North wall in reception.

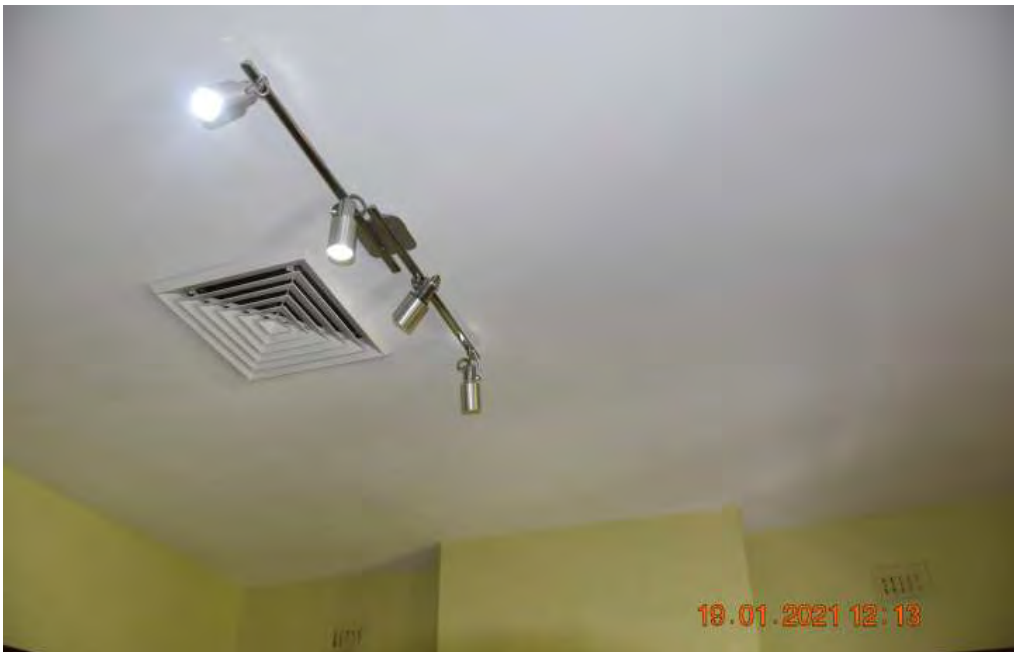
Figure: 1629

West wall in reception.

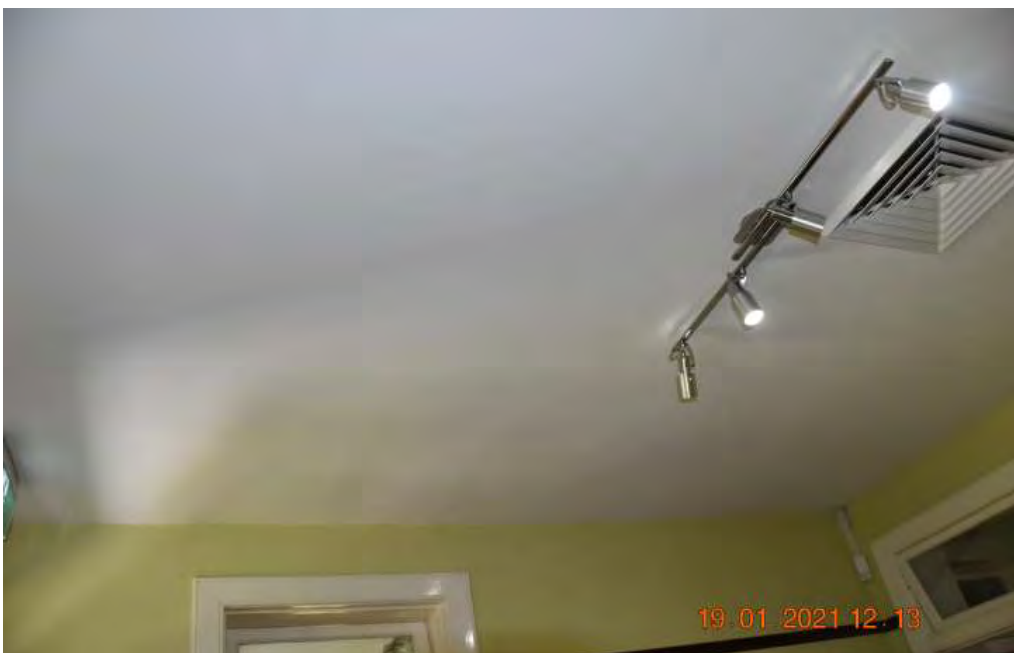
Figure: 1630

Ceiling in reception.
