## PRE CONSTRUCTION CONDITION SURVEY

Fort Street Public School, Millers Point NSW

Upper Fort Street Public School  
MILLERS POINT NSW 2000

19 January 2021

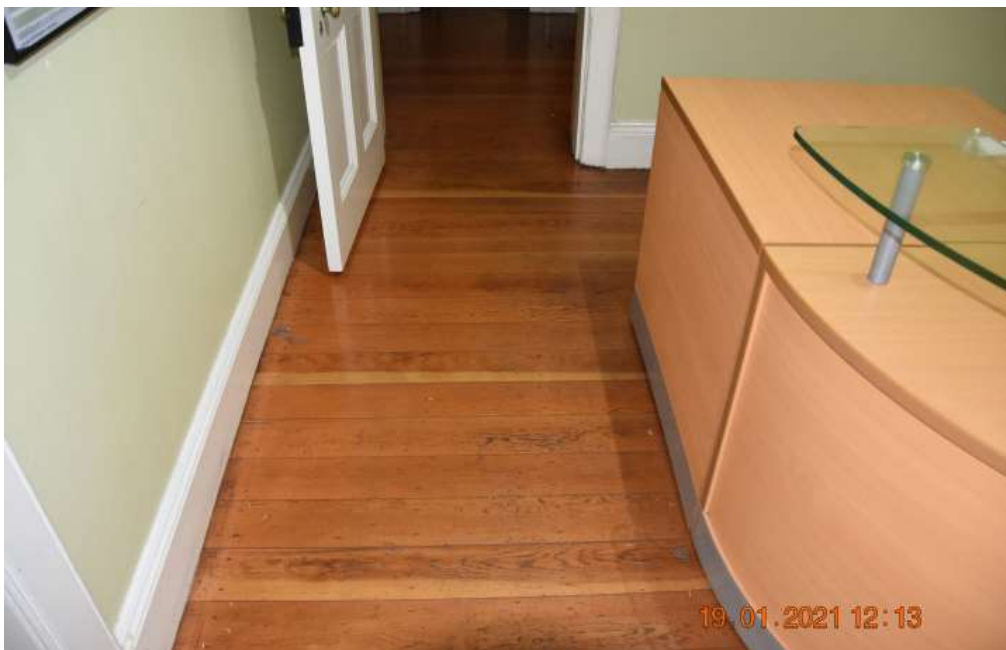
Figure: 1632

Timber floor in reception.

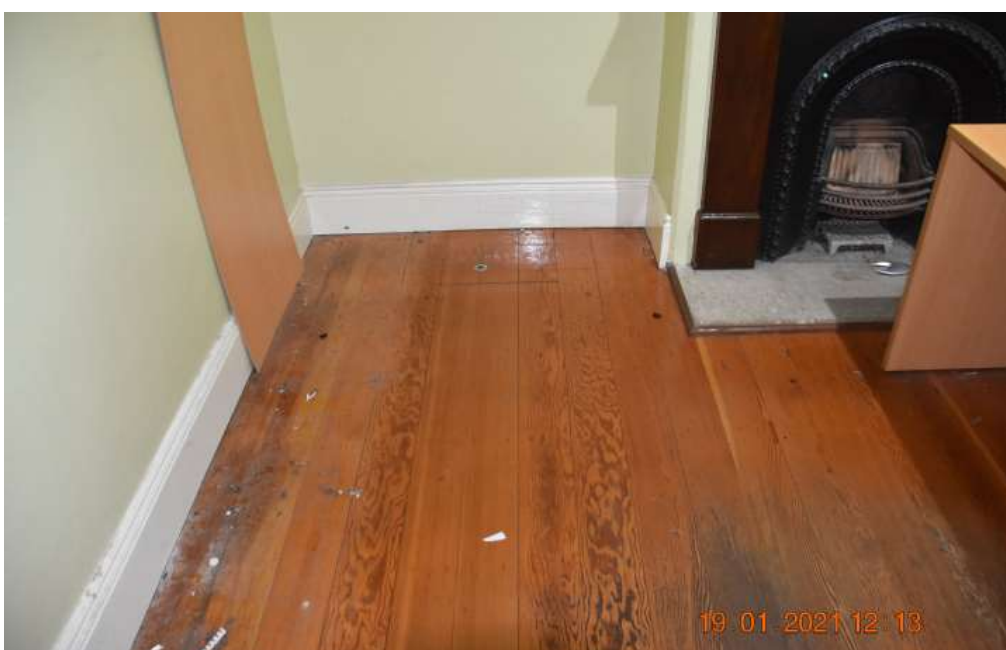
Figure: 1633

Timber floor in reception.

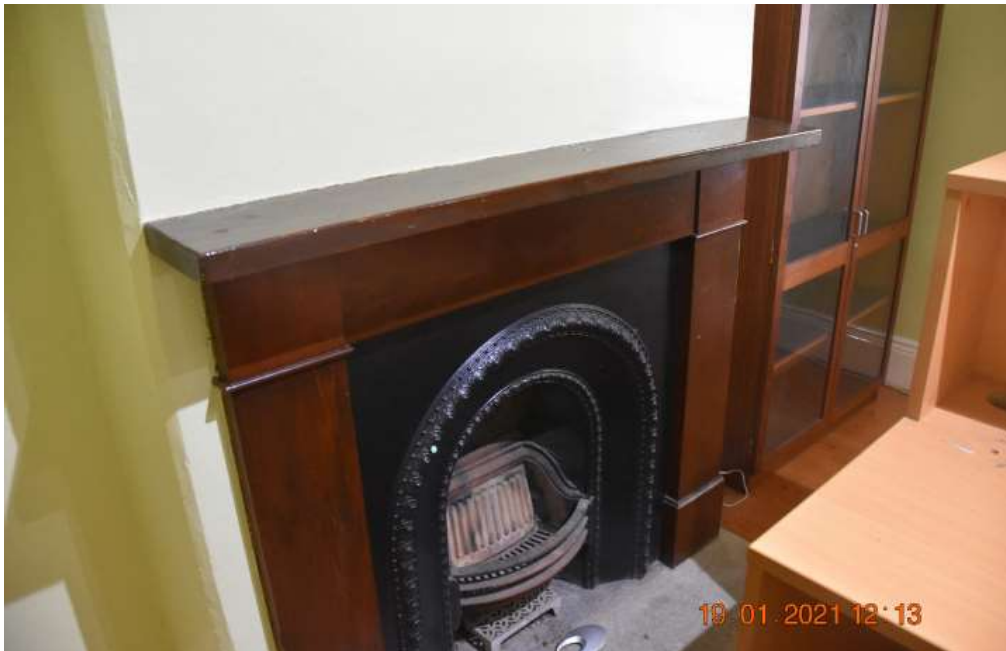
Figure: 1634

Timber floor in reception.

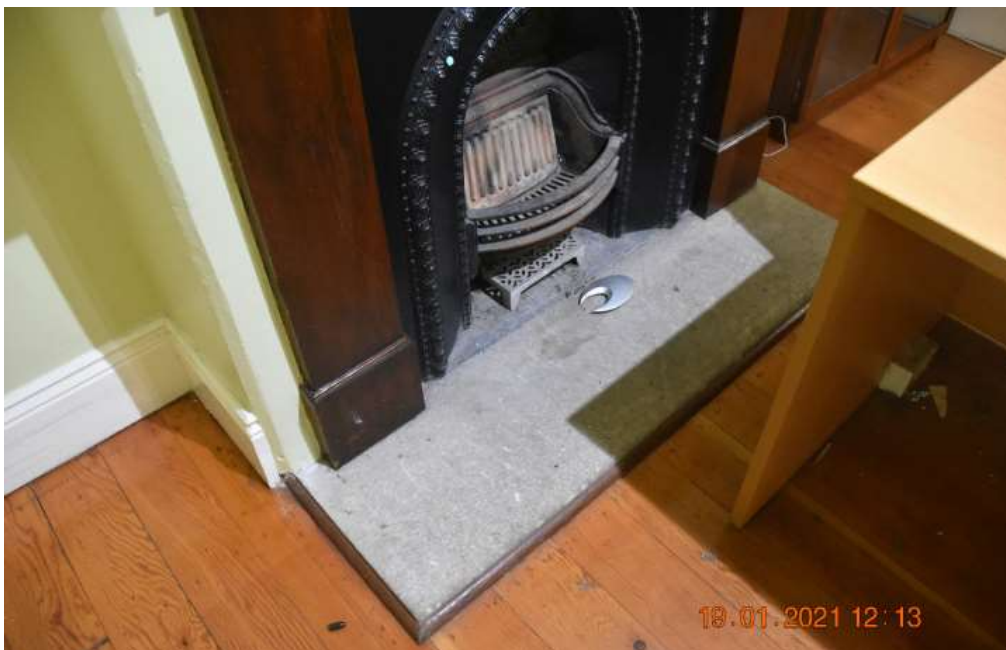
Figure: 1635

General view of the fireplace in the west wall in reception.

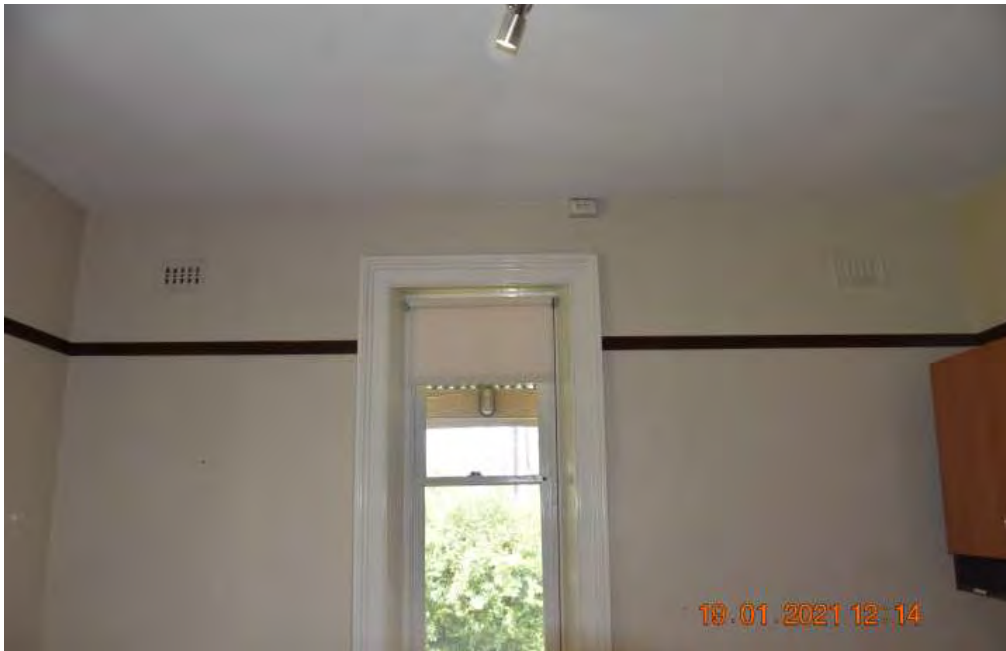
Figure: 1637

South wall in office 1.

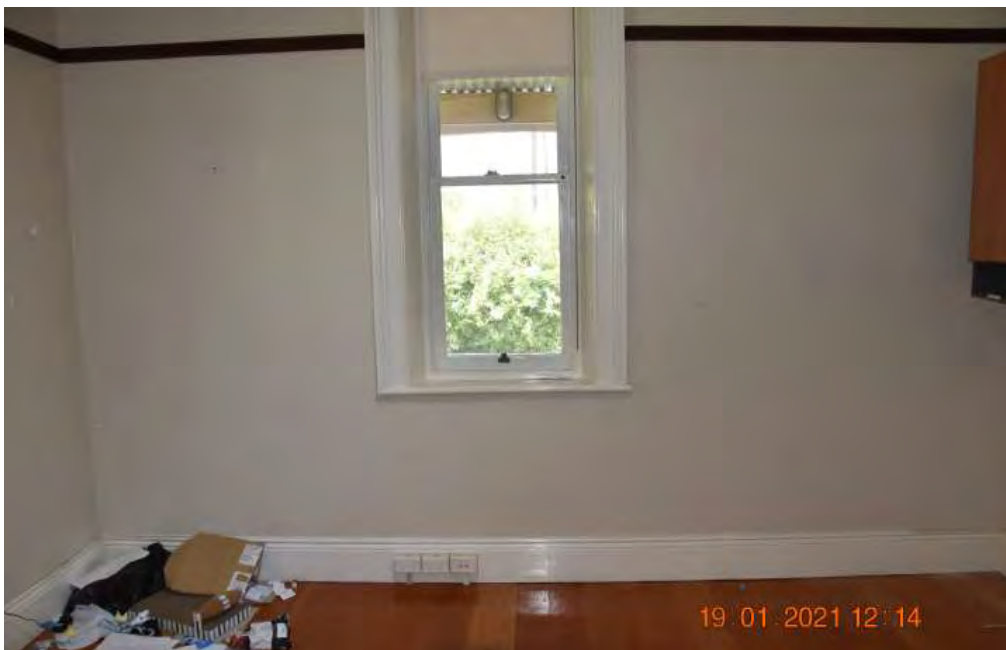
Figure: 1638

East wall in office 1.

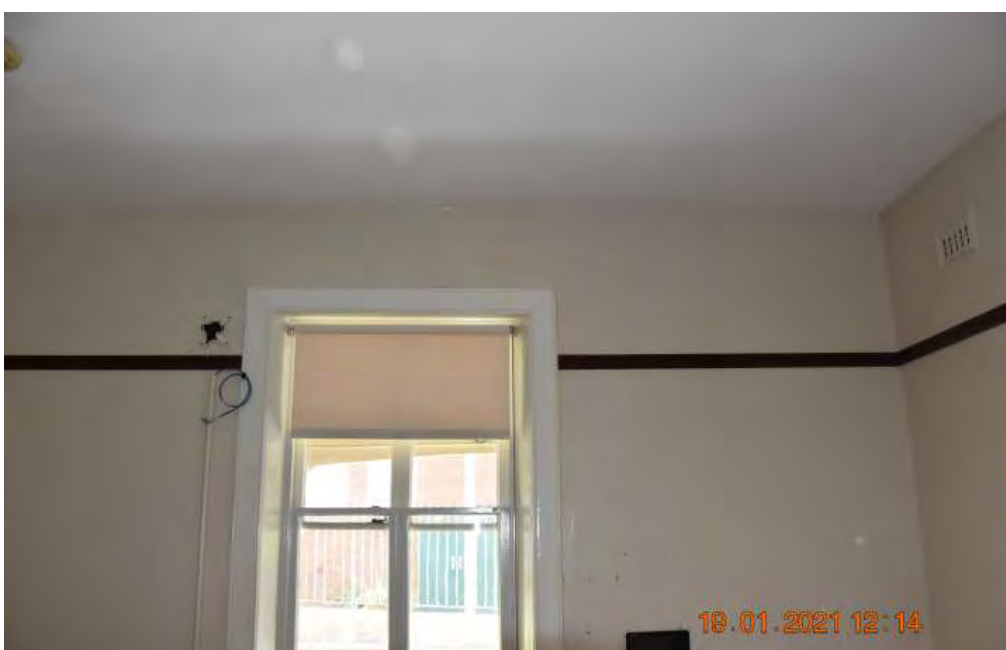
Figure: 1639

East wall in office 1.

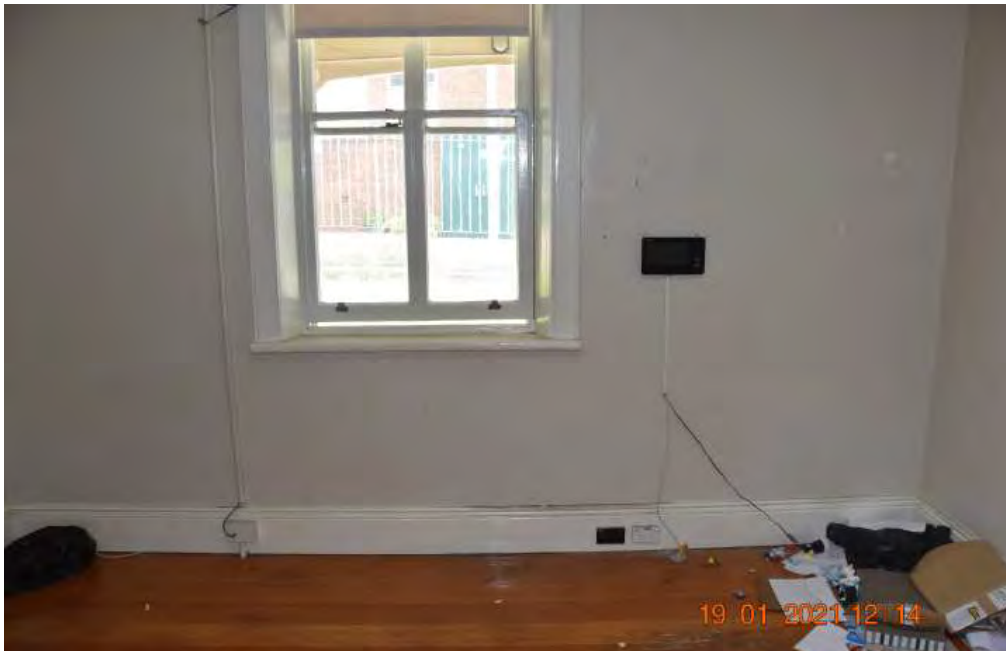
Figure: 1640

North wall in office 1.

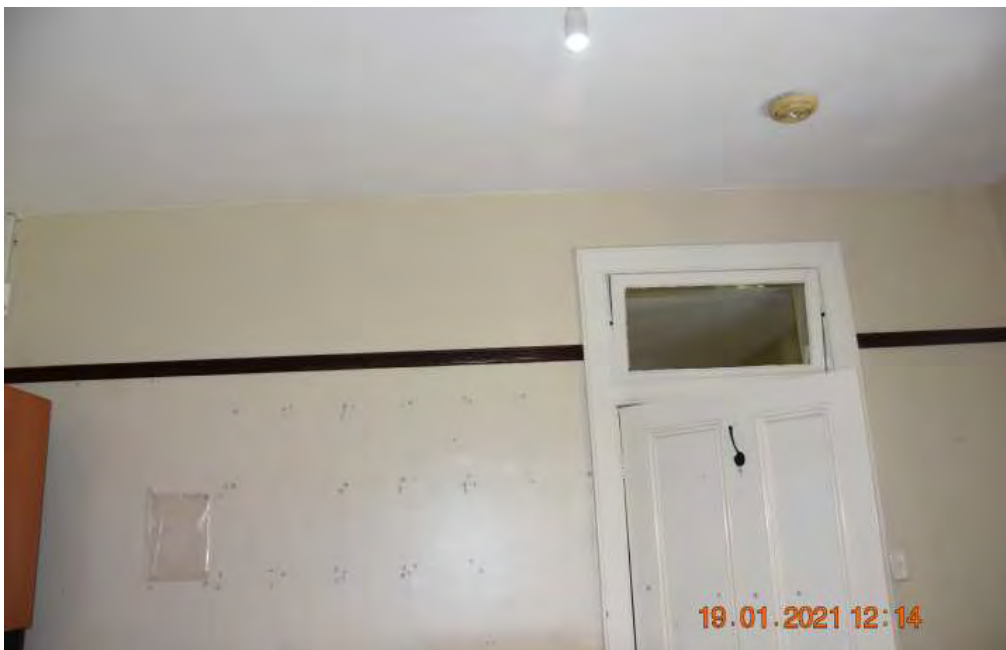
Figure: 1641

North wall in office 1.

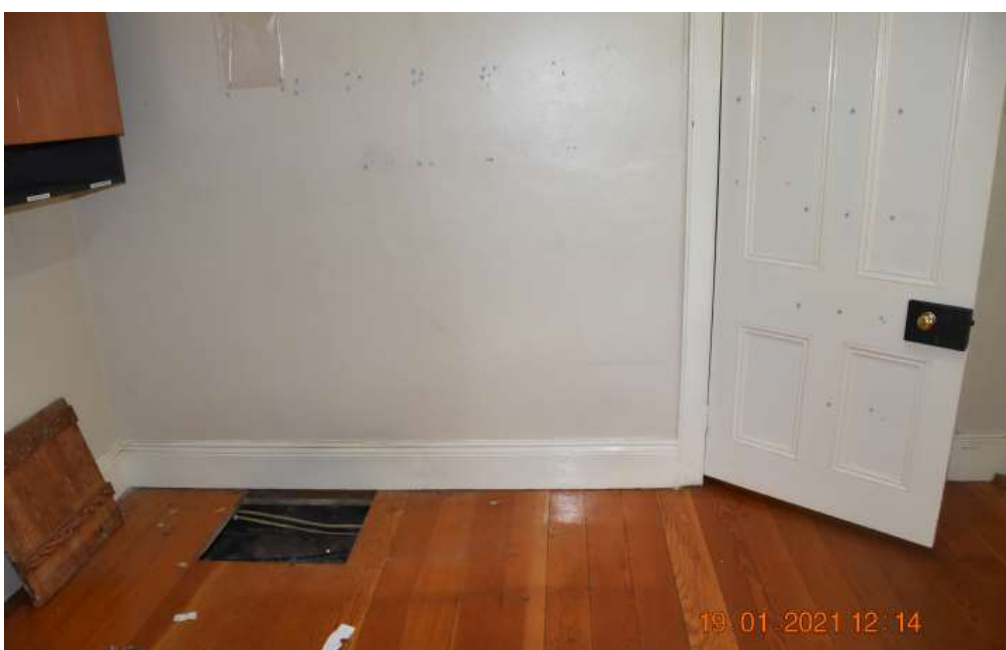
Figure: 1642

West wall in office 1.

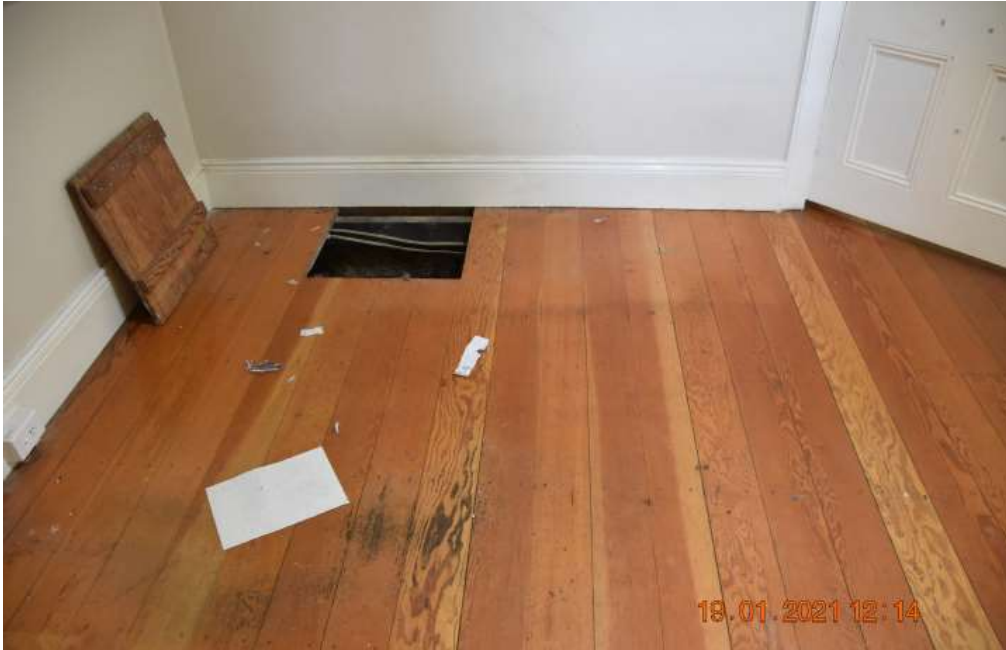
Figure: 1644

Timber floor in office  
1.

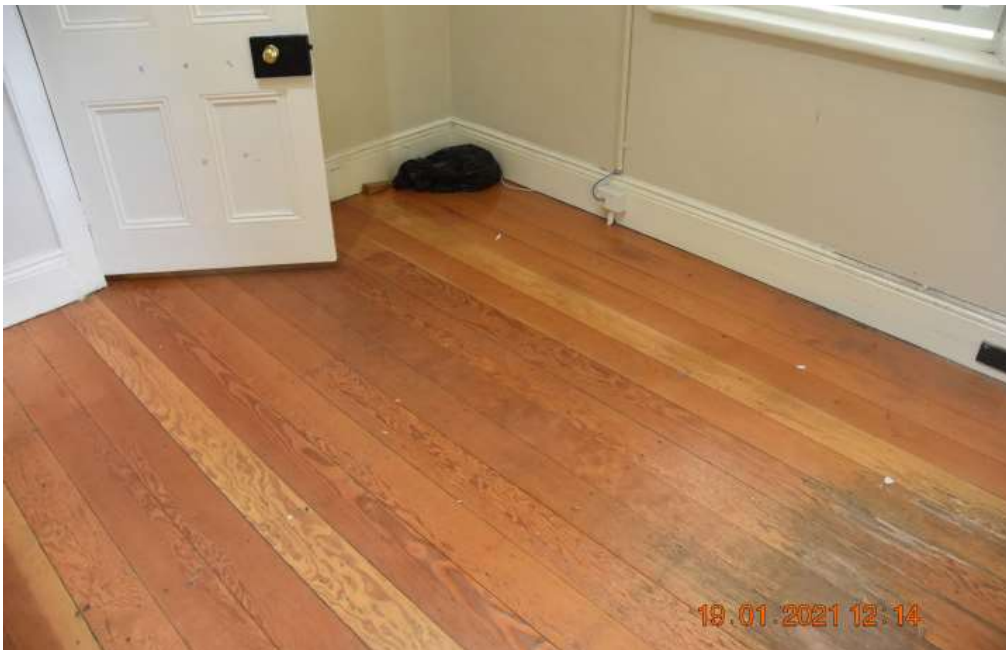
Figure: 1645

Timber floor in office  
1.

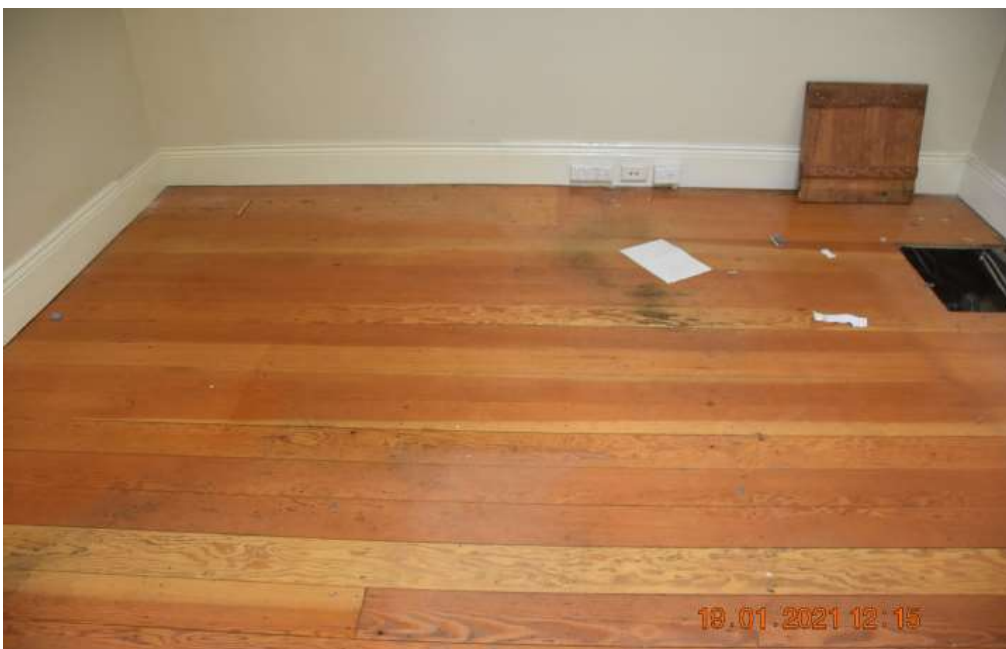
Figure: 1646

Timber floor in office  
1.

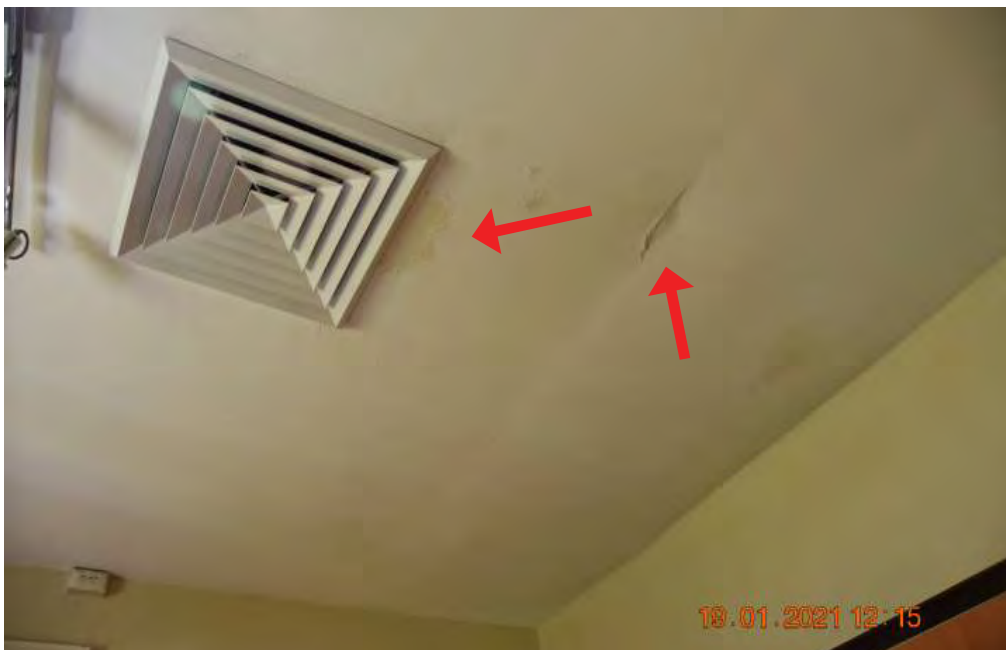
Figure: 1648

Peeling paint and staining in the ceiling in office 1.

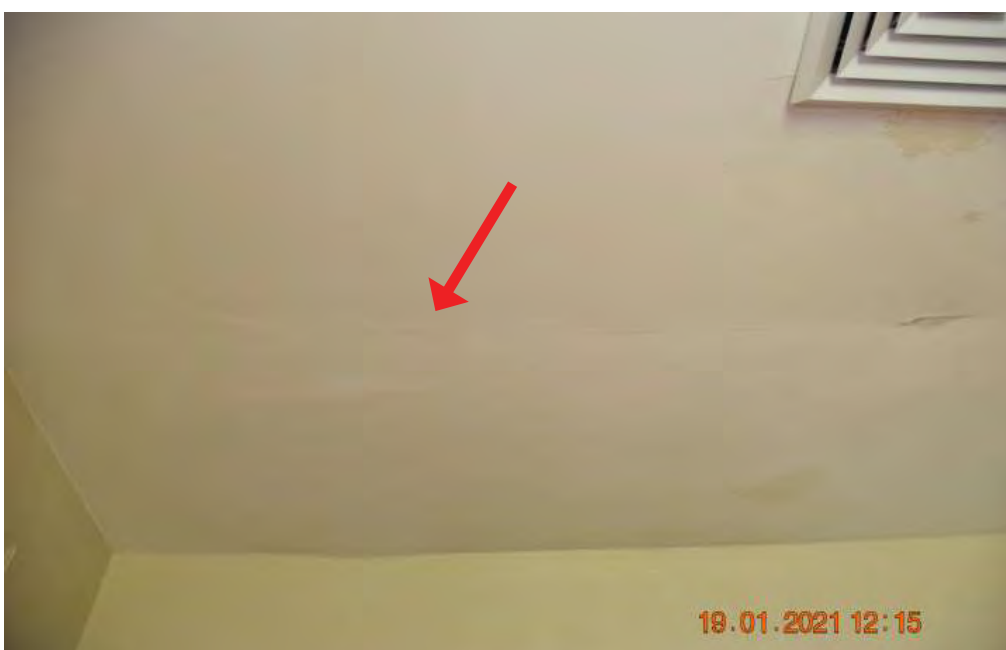
Figure: 1649

Patching in the ceiling in office 1.

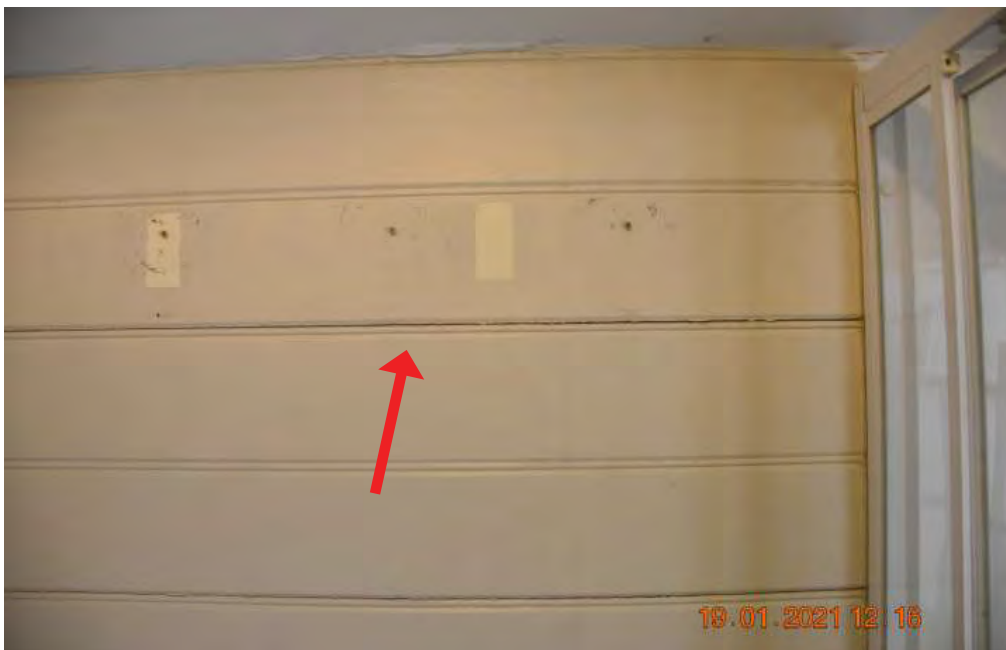
Figure: 1660

Separation in the cladding in the south wall in the bathroom.

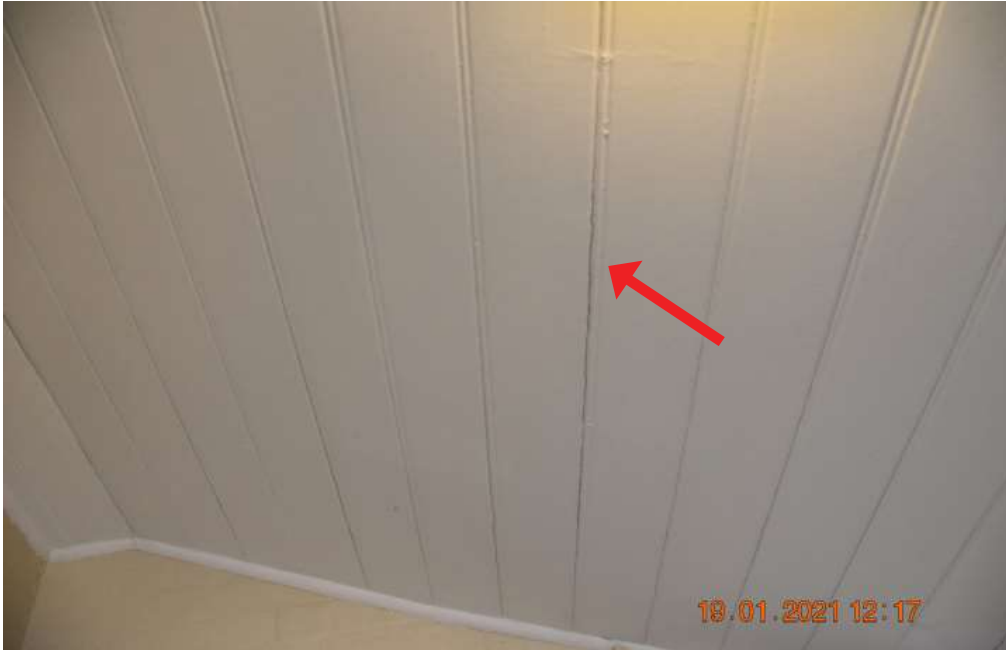
Figure: 1669

Ceiling in the bathroom. Showing separation between cladding.

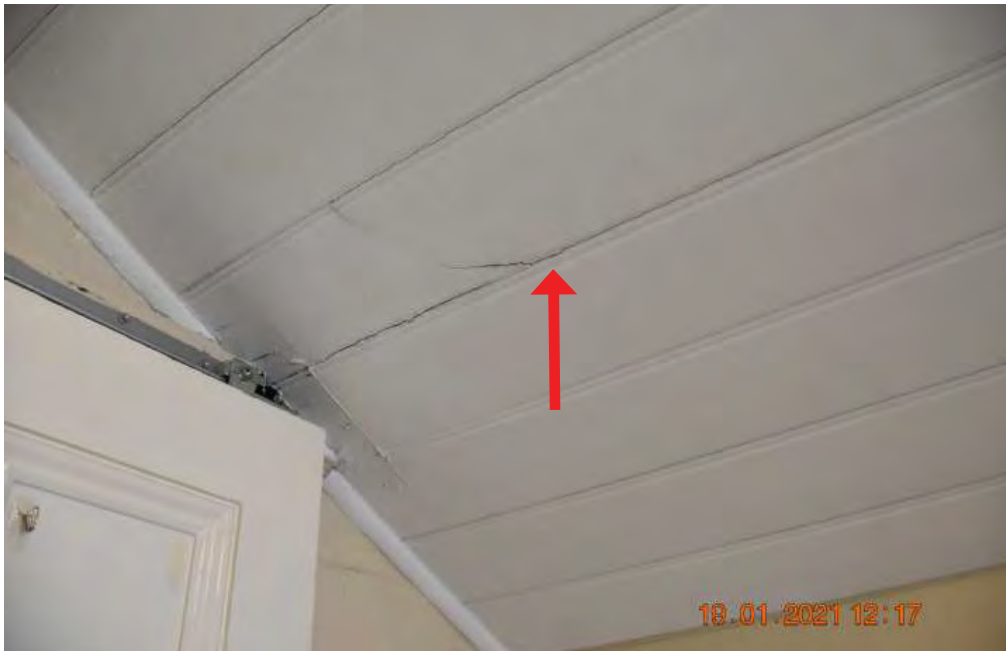
Figure: 1672

Ceiling in the bathroom. Showing separation between cladding.

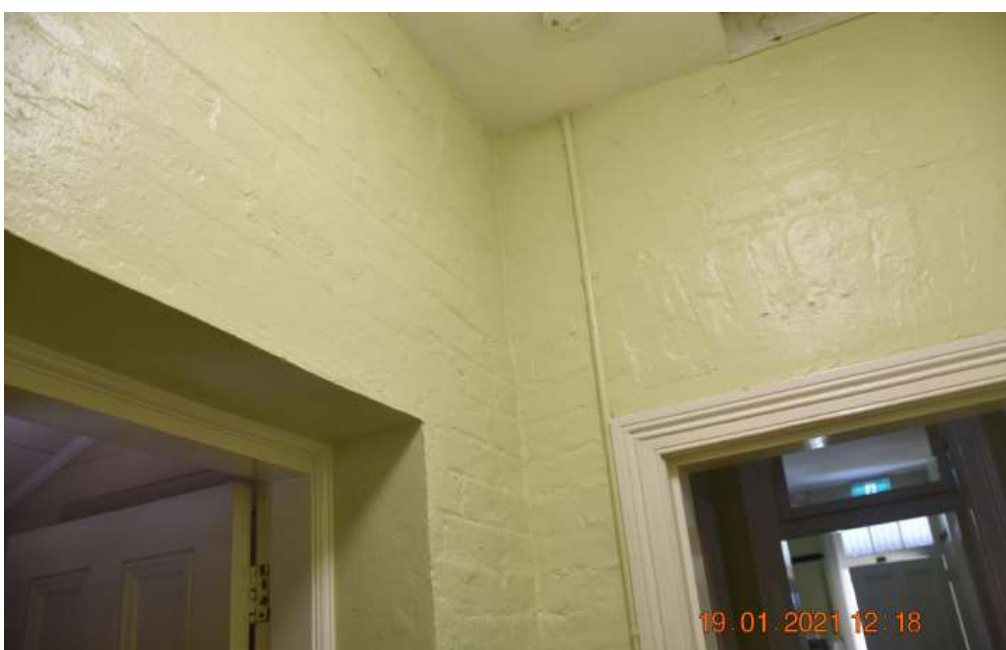
Figure: 1687

General view in the hallway, outside the kitchen.

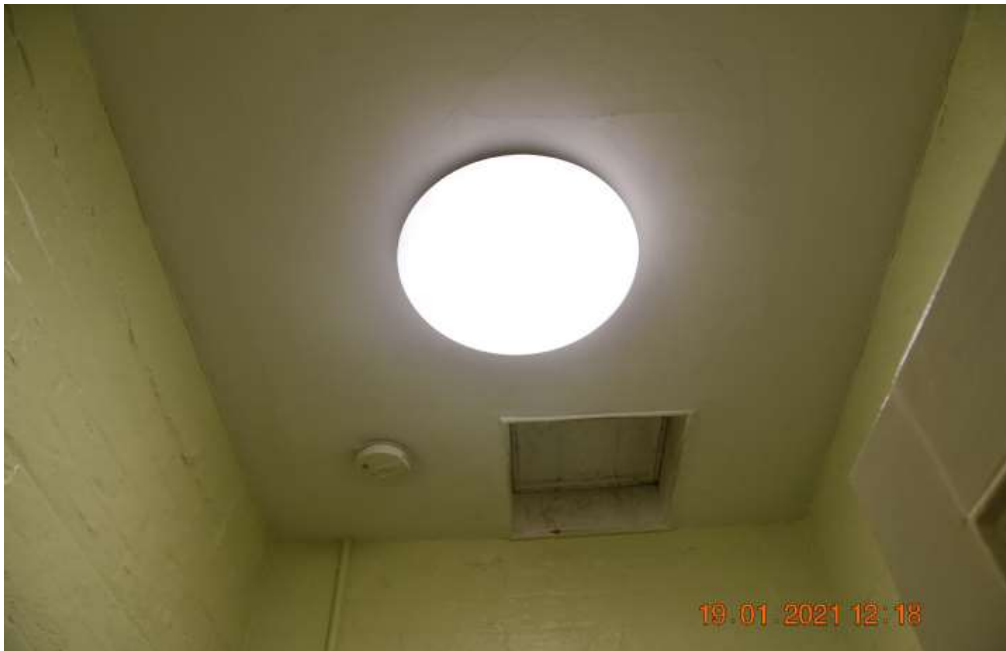
Figure: 1688

General view in the hallway, outside the kitchen.

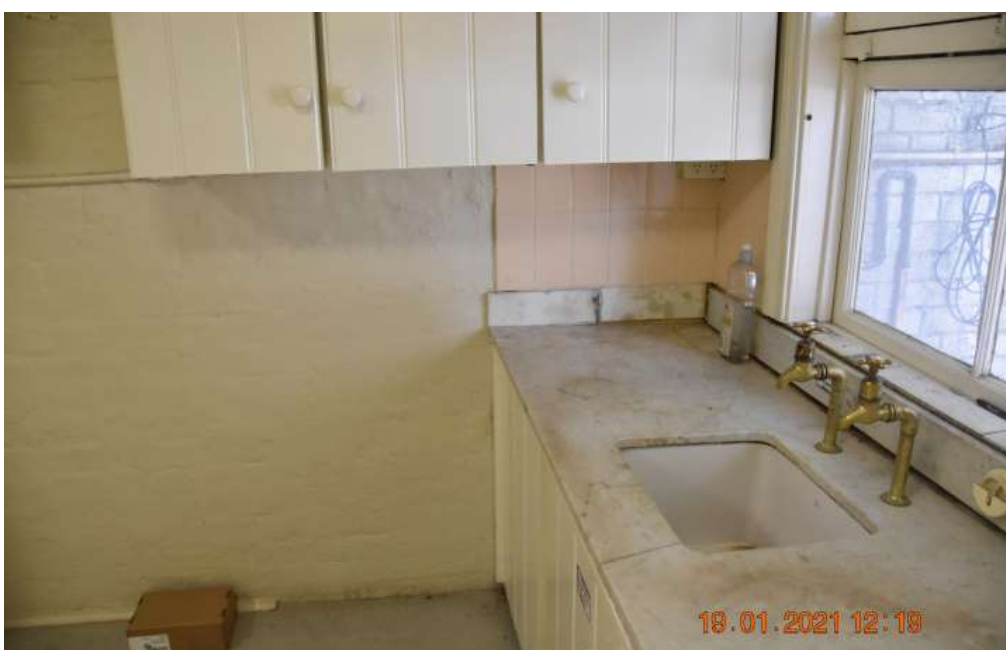
Figure: 1690

South wall in the kitchen.

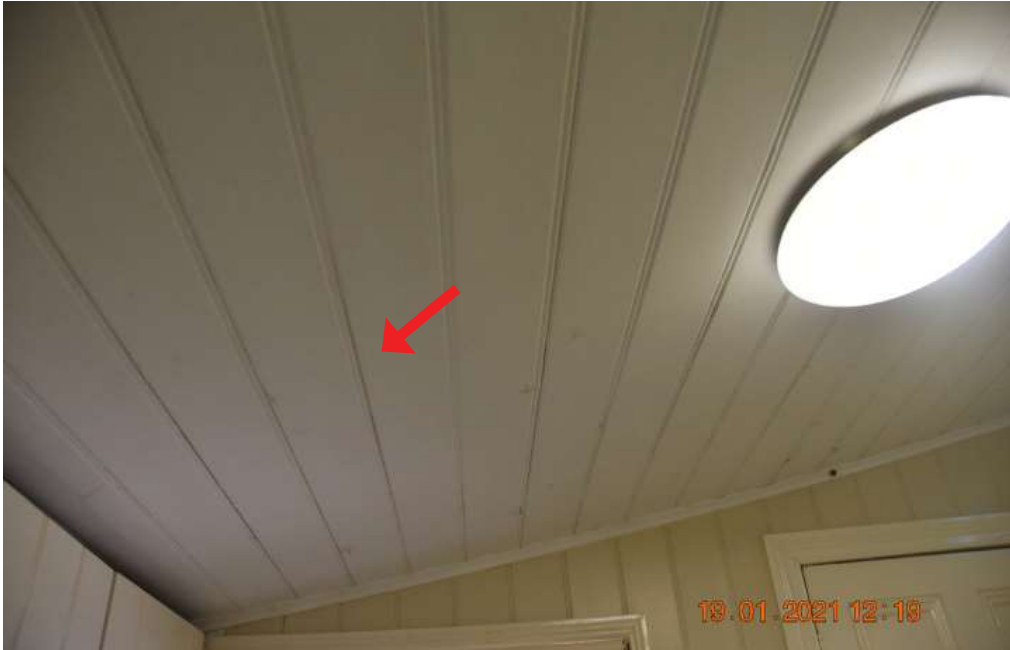
Figure: 1698

Ceiling in the kitchen.  
Showing separation  
between cladding.

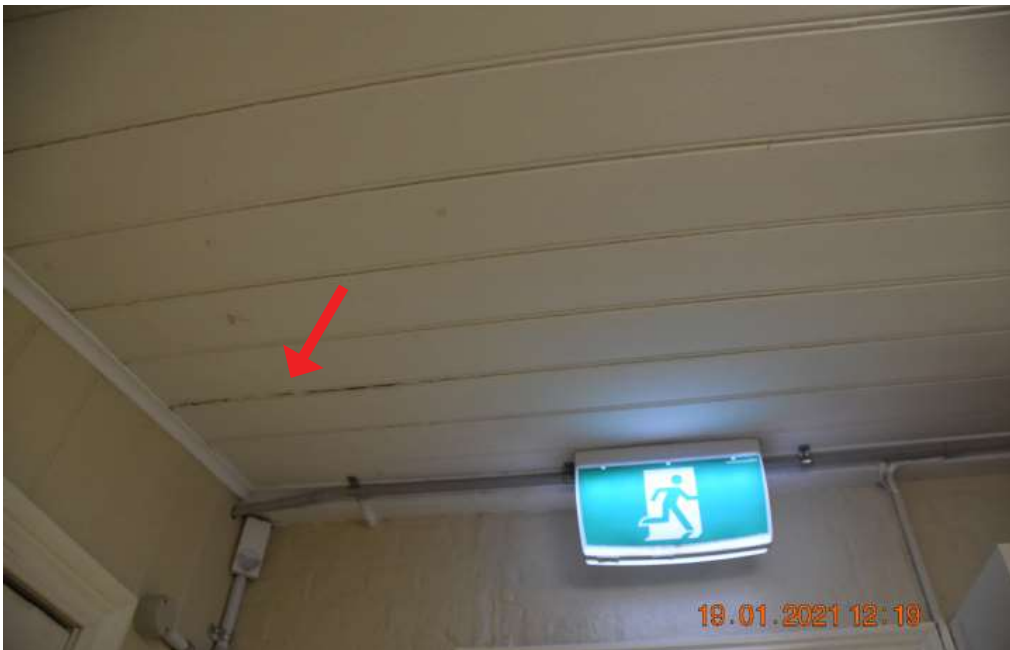
Figure: 1699

Ceiling in the kitchen.  
Showing separation  
between cladding.

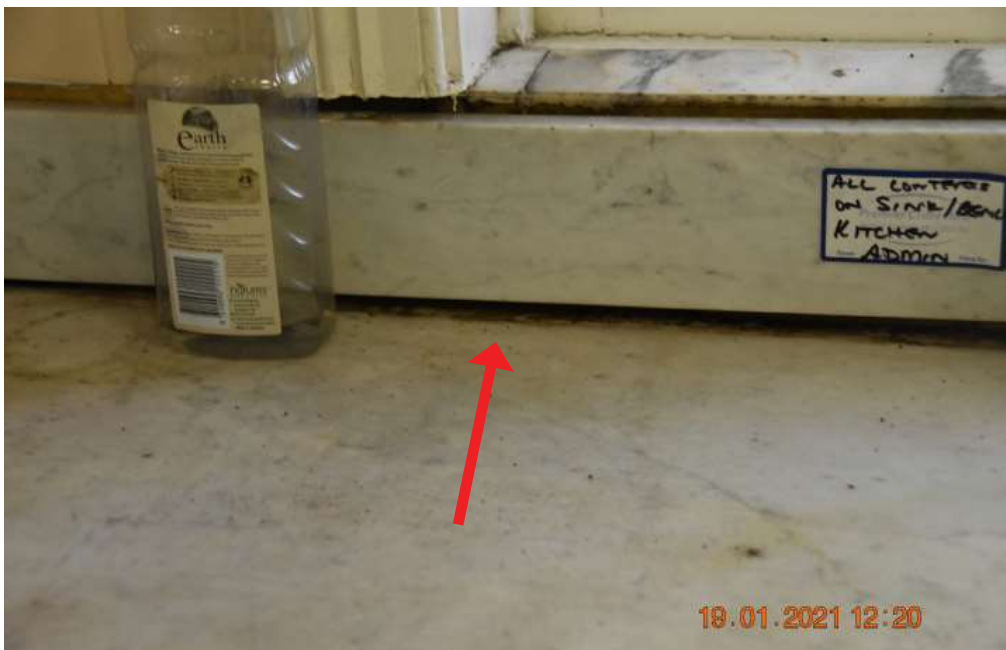
Figure: 1710

Separation between the counter and the west wall in the kitchen.

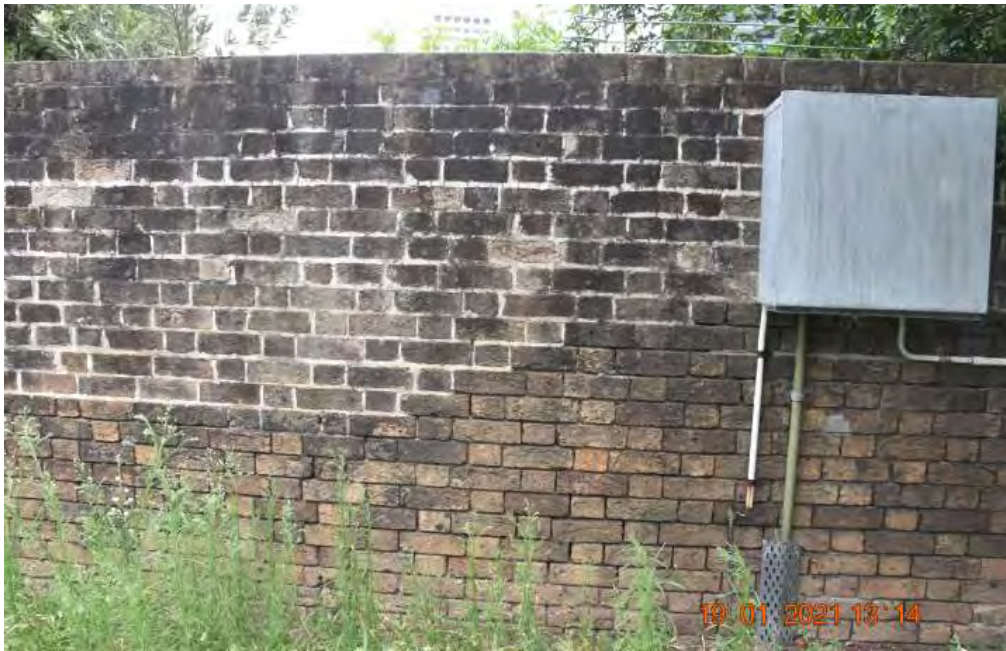
Figure: 1721

General view of the heritage wall on the south side of building C. Showing erosion in the mortar joints.

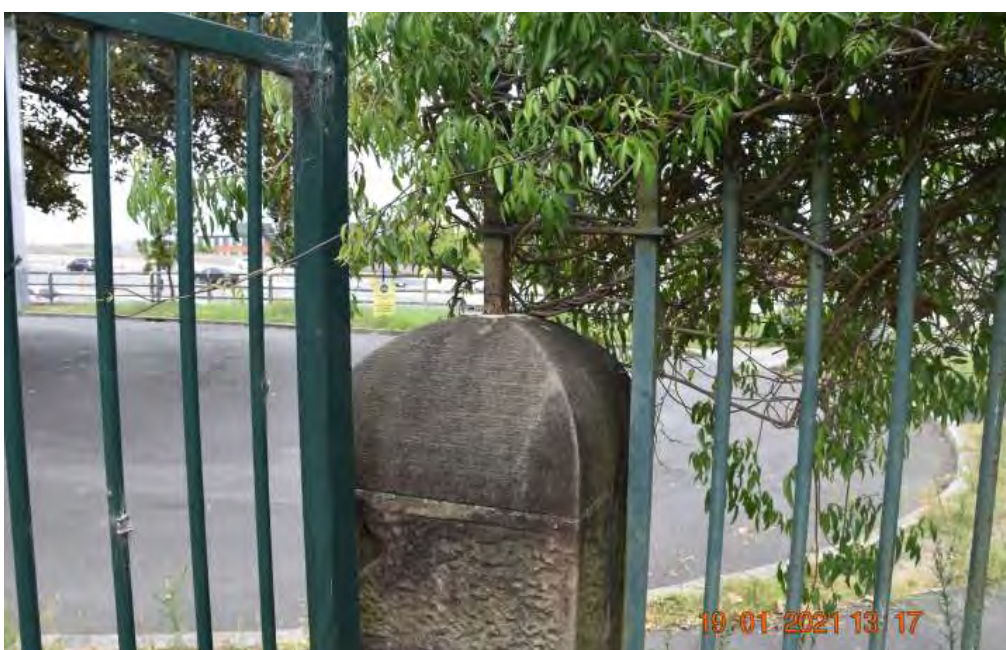
Figure: 1741

Damage in the base of the fence on the south side of the driveway.

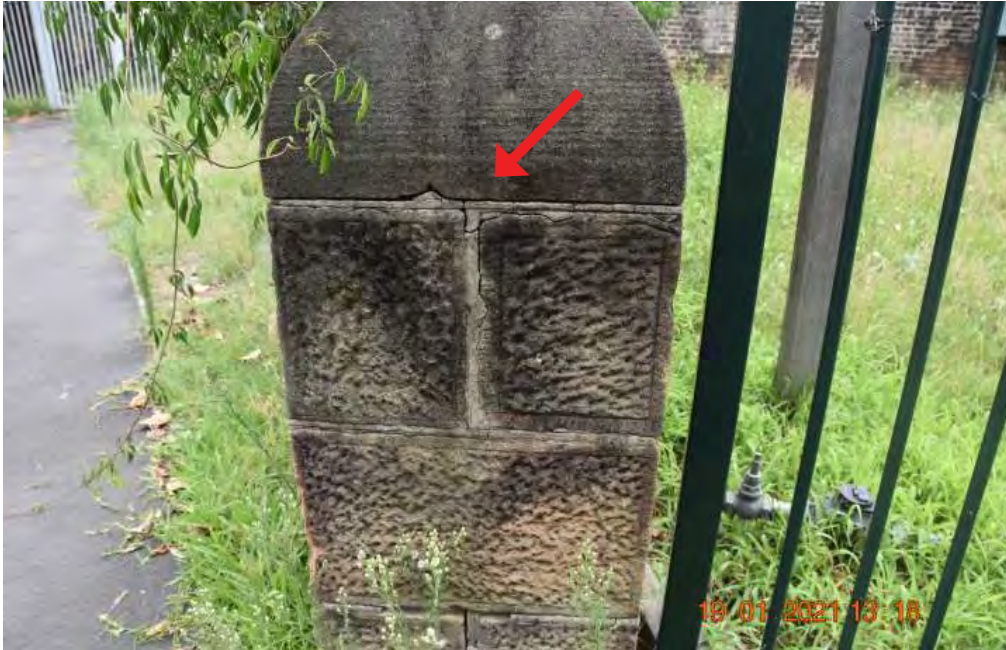
Figure: 1748

General view of the heritage post on the south side of the driveway. Showing cracking in the mortar joints.

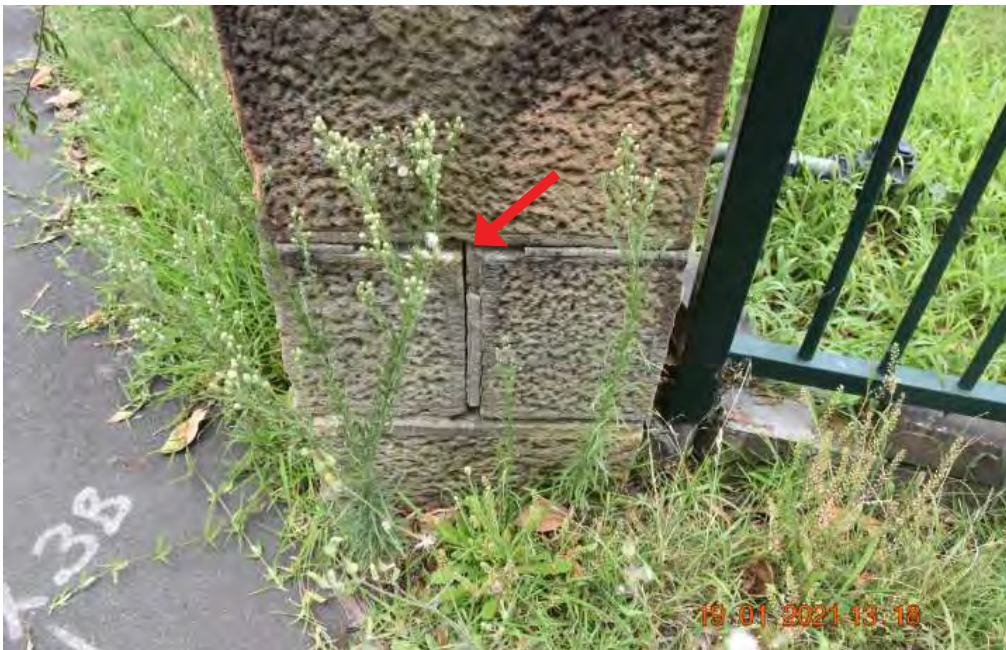
Figure: 1749

General view of the heritage post on the south side of the driveway. Showing cracking in the mortar joints.

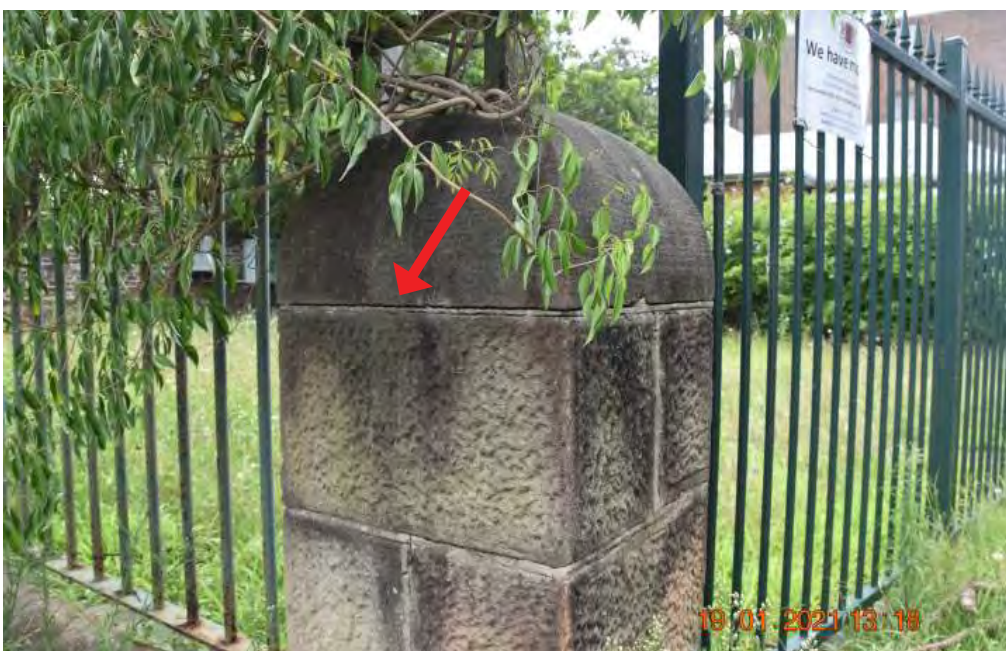
Figure: 1750

General view of the heritage post on the south side of the driveway. Showing cracking in the mortar joints.

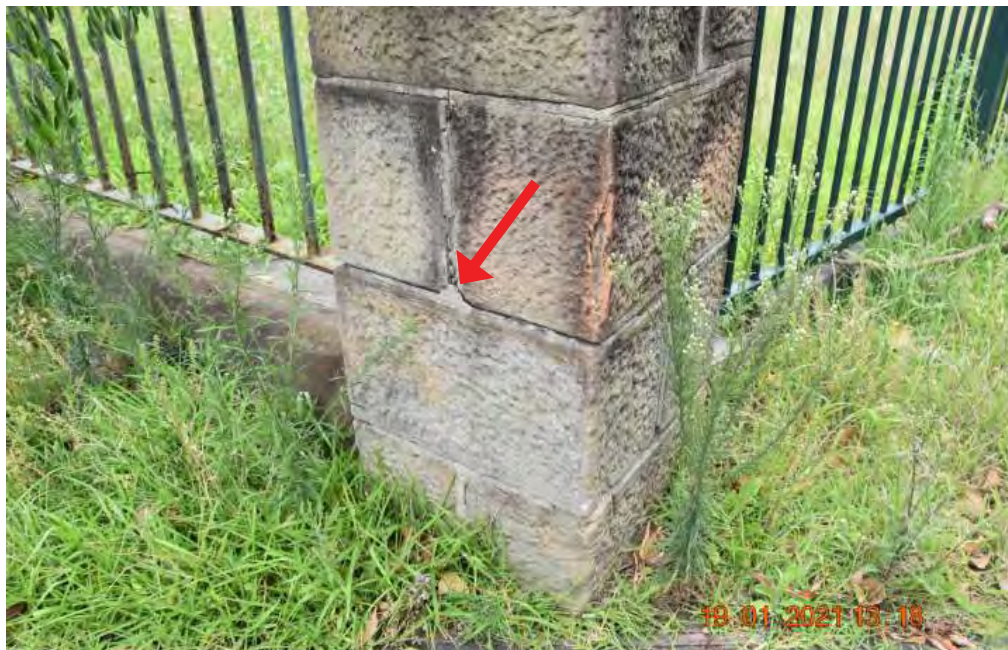
Figure: 1751

General view of the heritage post on the south side of the driveway. Showing erosion in the mortar joints.

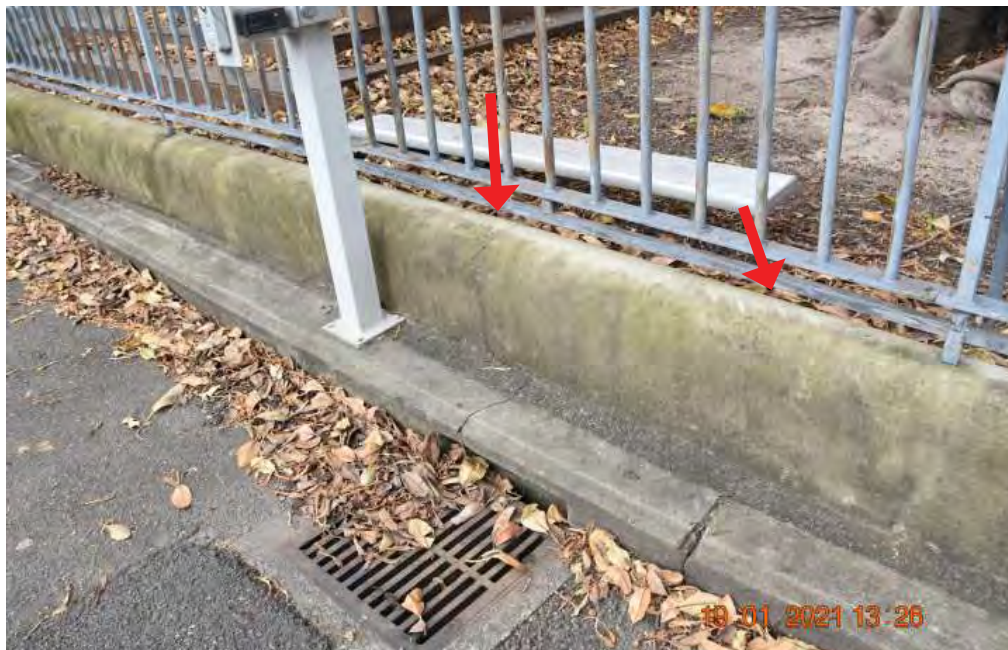
Figure: 1763

Chipping in the base of the fence on the north side of the driveway.

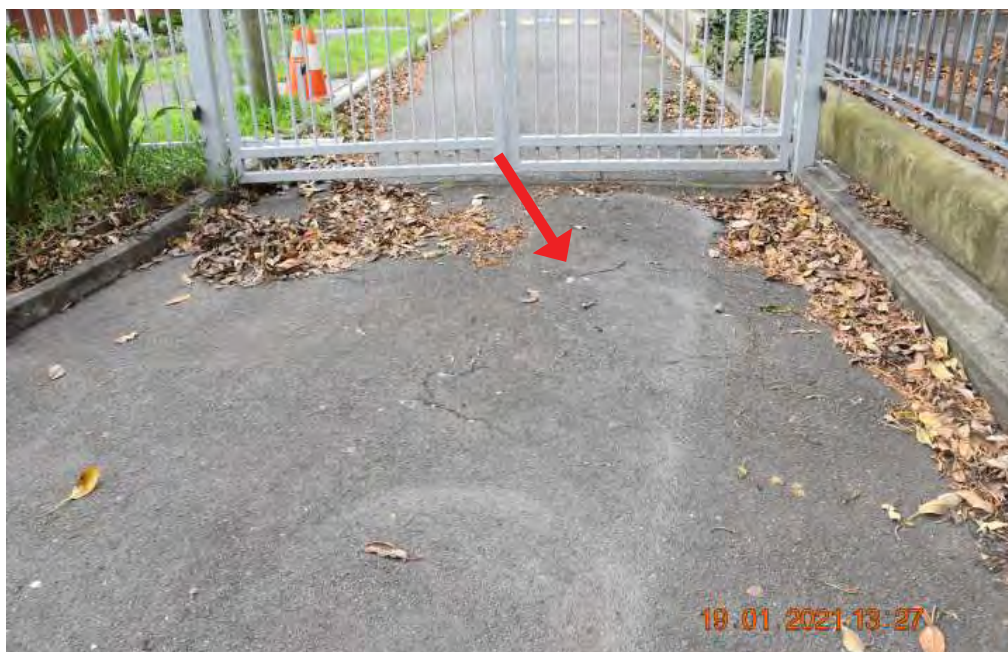
Figure: 1764

Cracking in the base of the fence on the north side of the driveway.

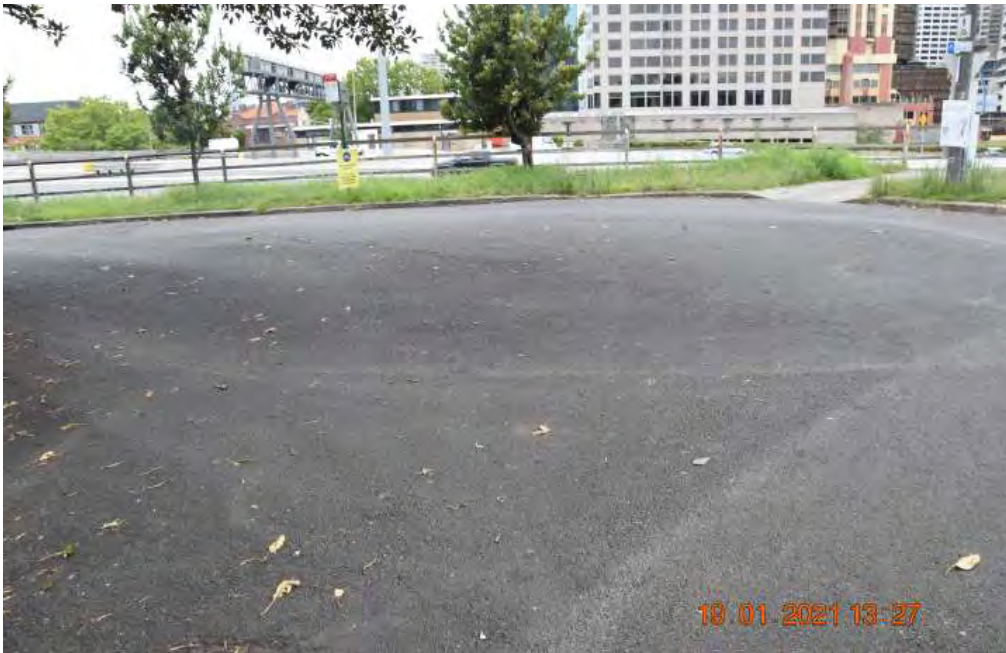
Figure: 1769

General view of the roadway, looking from the driveway.

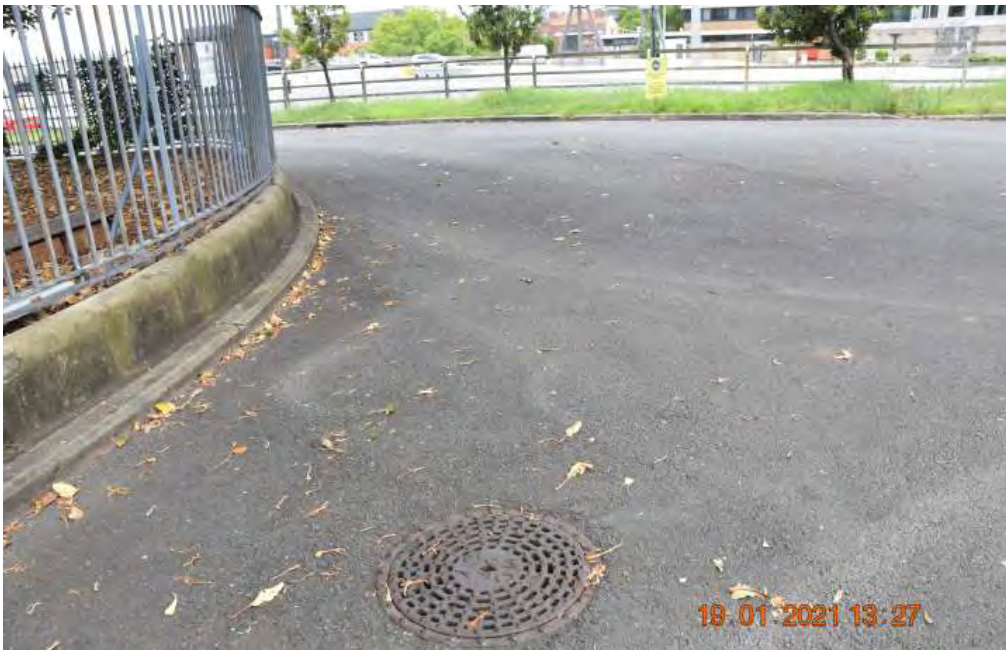
Figure: 1770

General view of the roadway, looking from the driveway.
