## PRE CONSTRUCTION CONDITION SURVEY

Fort Street Public School, Millers Point NSW

Upper Fort Street Public School  
MILLERS POINT NSW 2000

19 January 2021

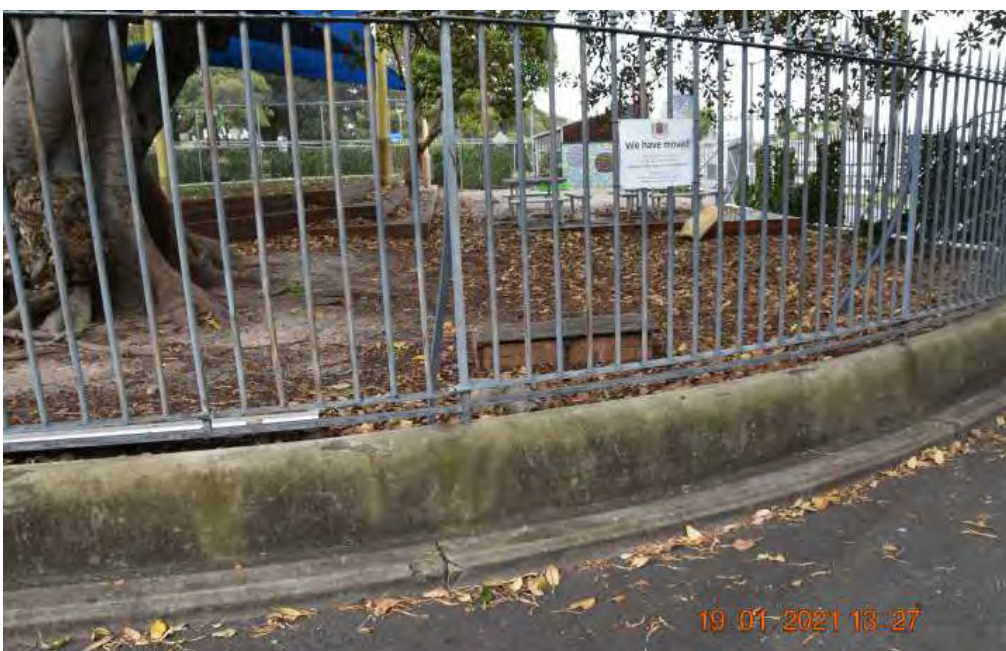
Figure: 1771

General view of the roadway, looking from the driveway.

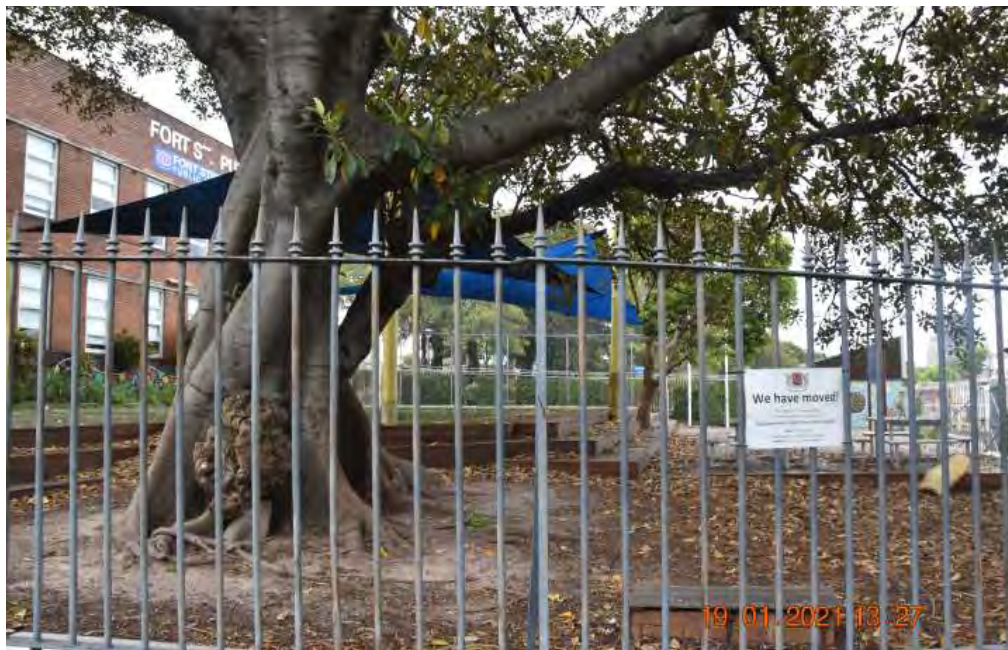
Figure: 1772

General view of the fence on the north side of the driveway.

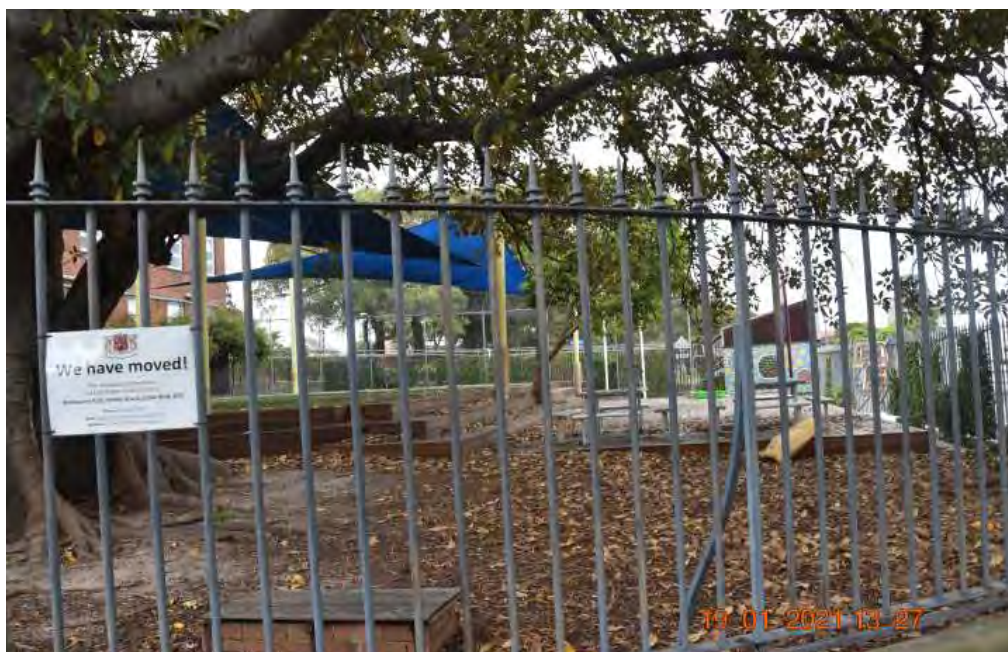
Figure: 1773

General view of the fence on the north side of the driveway.

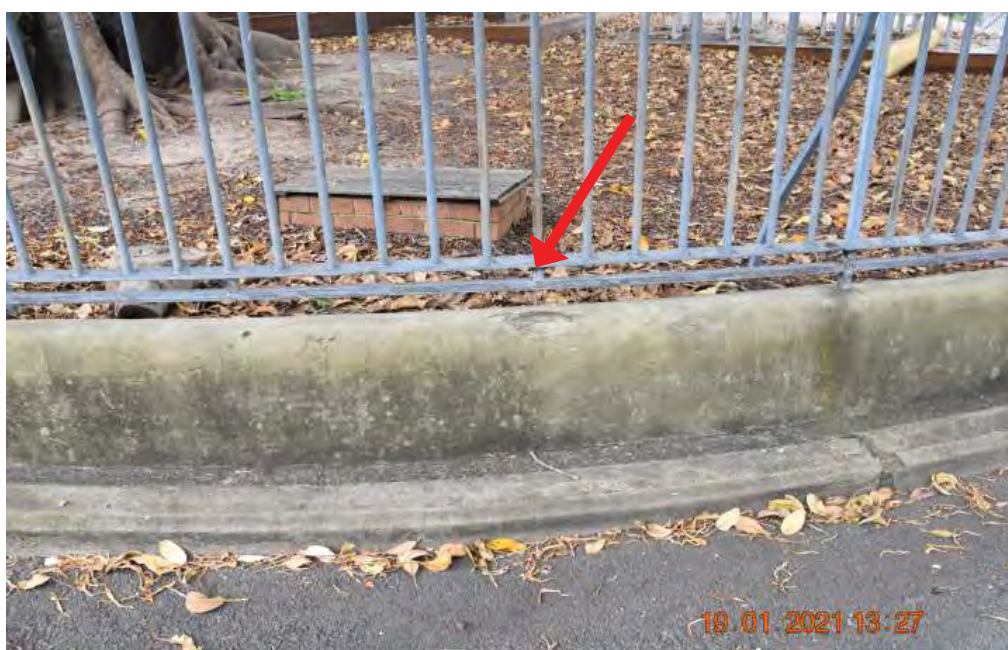
Figure: 1774

General view of the fence on the north side of the driveway.

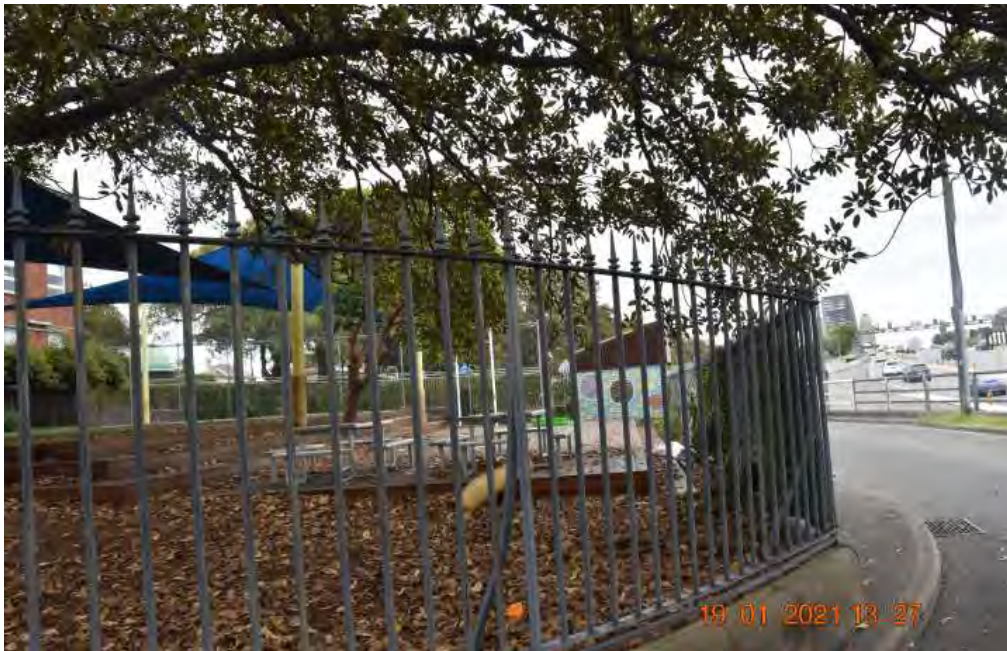
Figure: 1775

General view of the fence on the north side of the driveway. Showing chipping in the base.

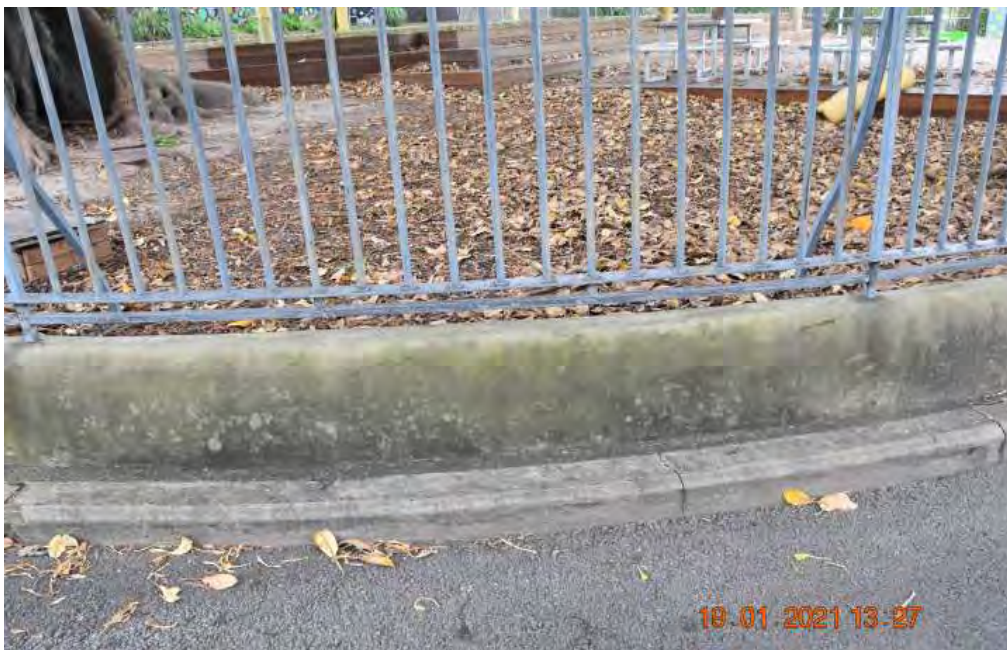
Figure: 1776

General view of the fence on the north side of the driveway.

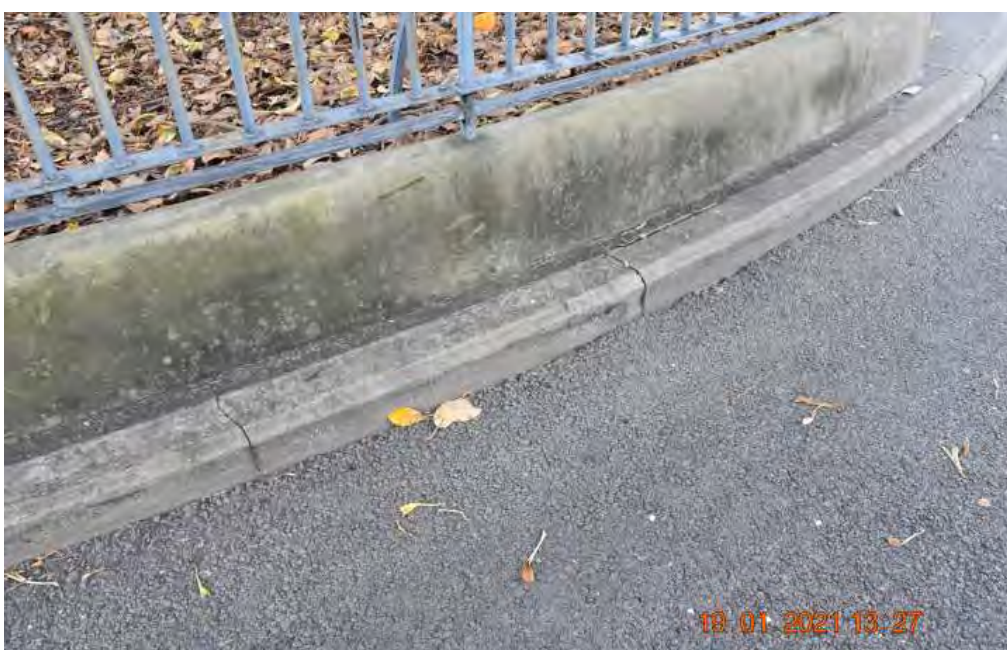
Figure: 1777

General view of the fence on the north side of the driveway.

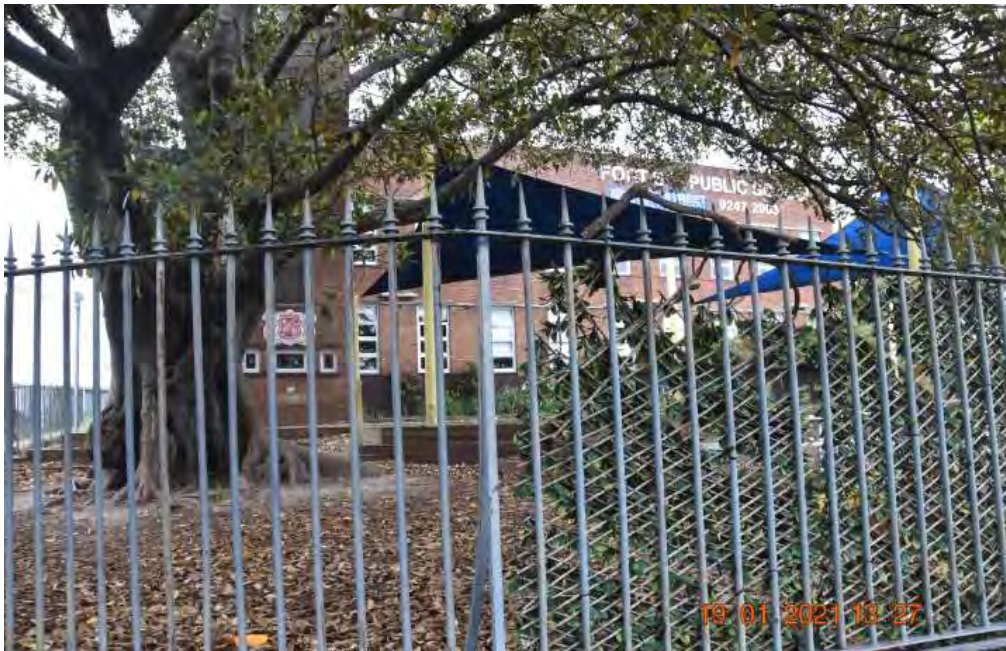
Figure: 1778

General view of the fence on the north side of the driveway.

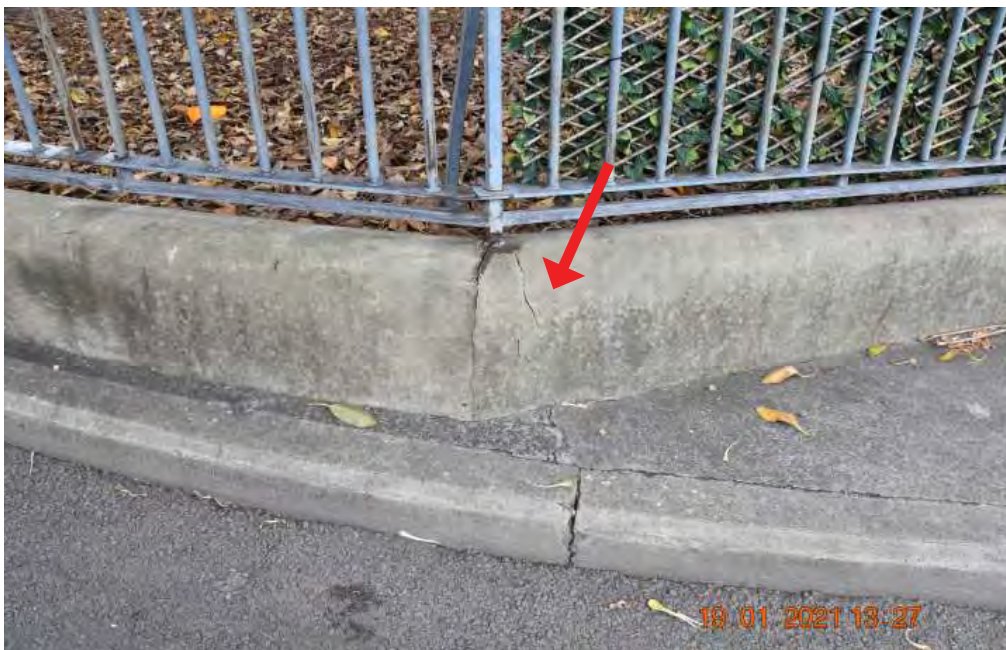
Figure: 1779

General view of the fence on the north side of the driveway.

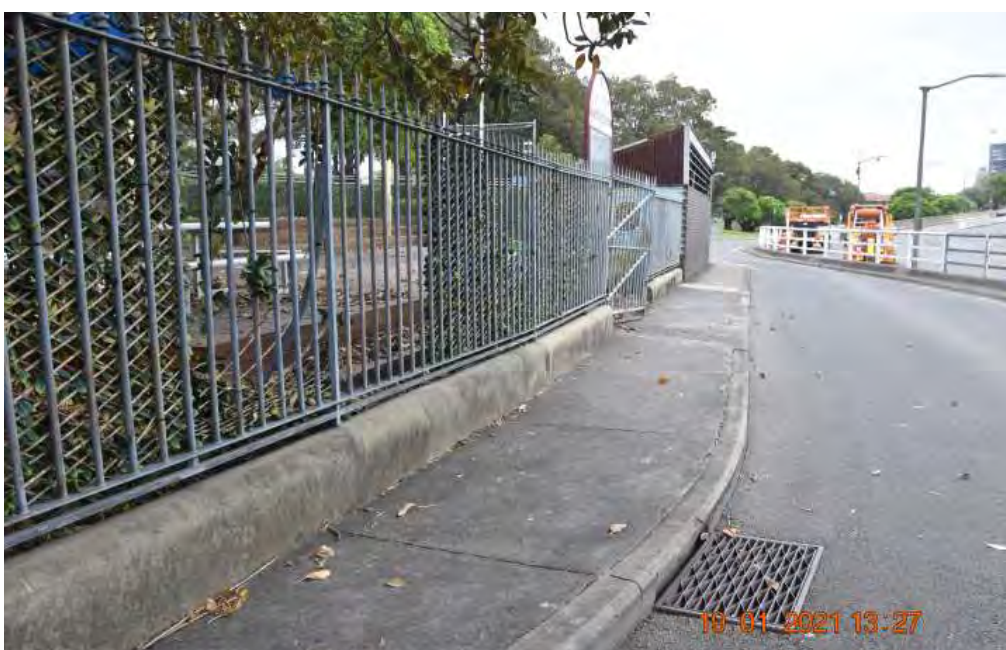
Figure: 1780

General view of the fence on the north side of the driveway. Showing cracking in the base.

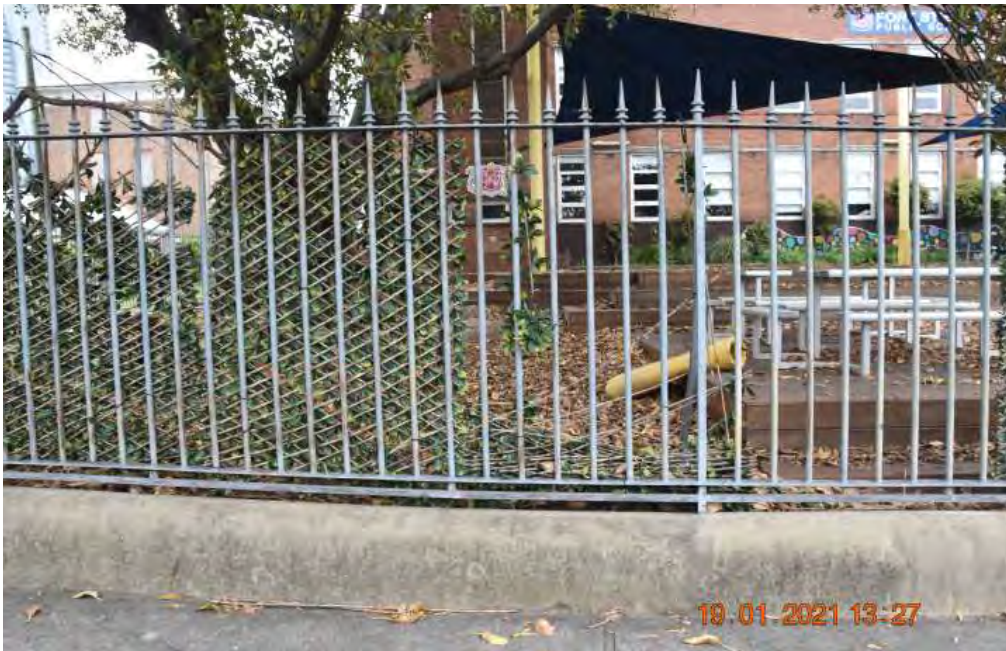
Figure: 1781

General view of the fence on the east side of the property.

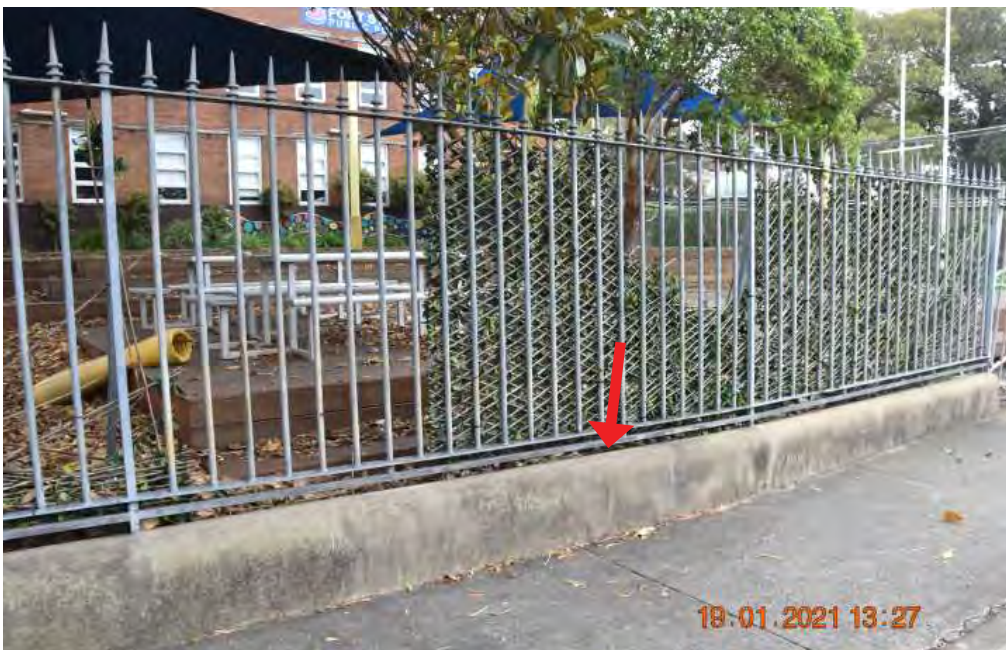
Figure: 1782

General view of the fence on the east side of the property.

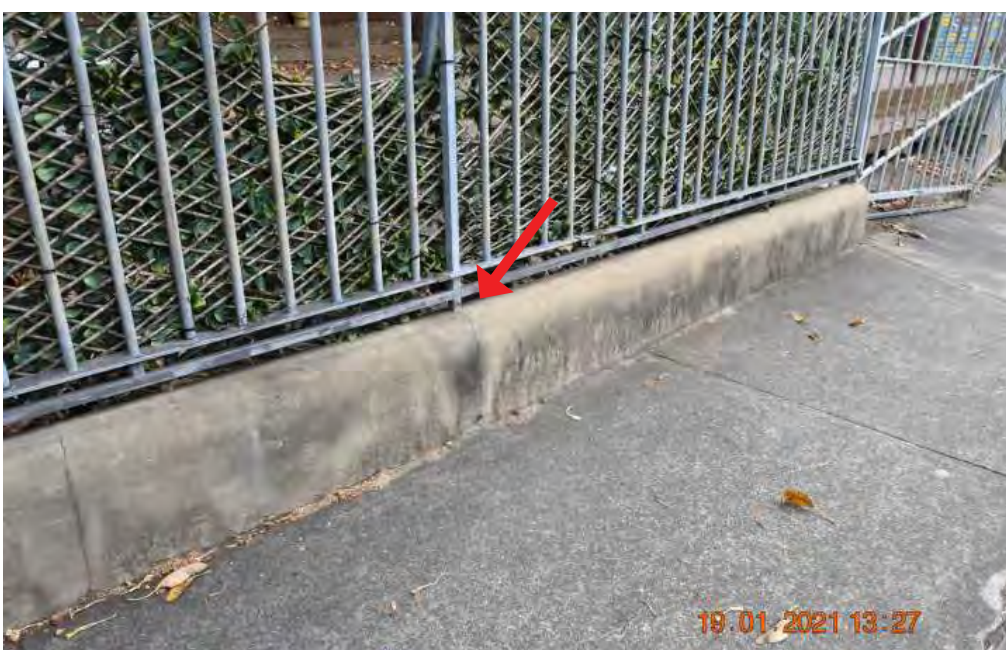
Figure: 1783

Cracking in the base of the fence on the east side of the property.

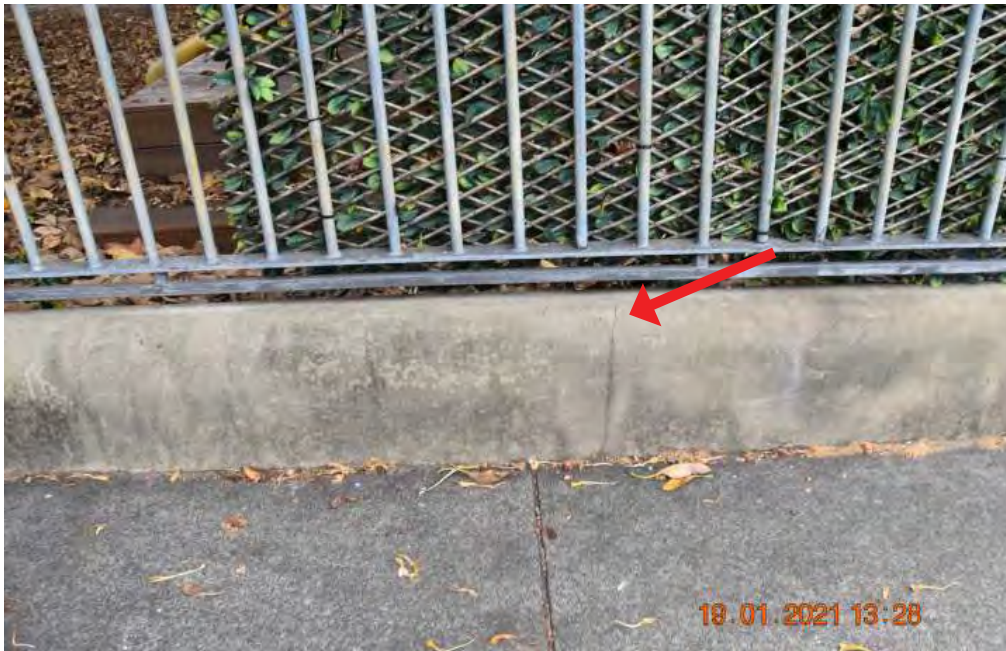
Figure: 1784

Cracking in the base of the fence on the east side of the property.

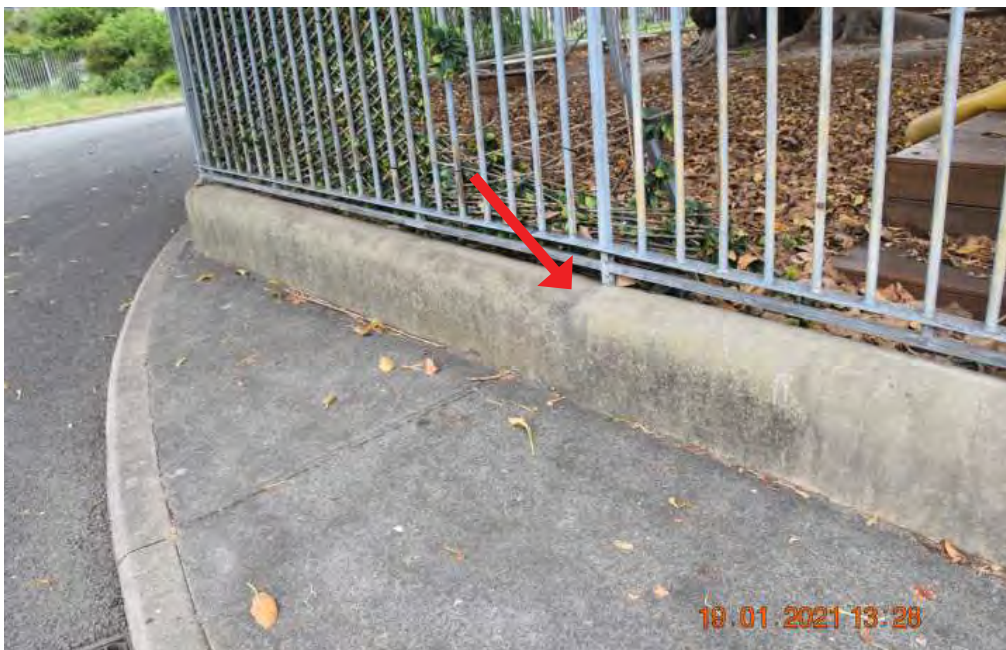
Figure: 1785

Cracking in the base of the fence on the east side of the property.

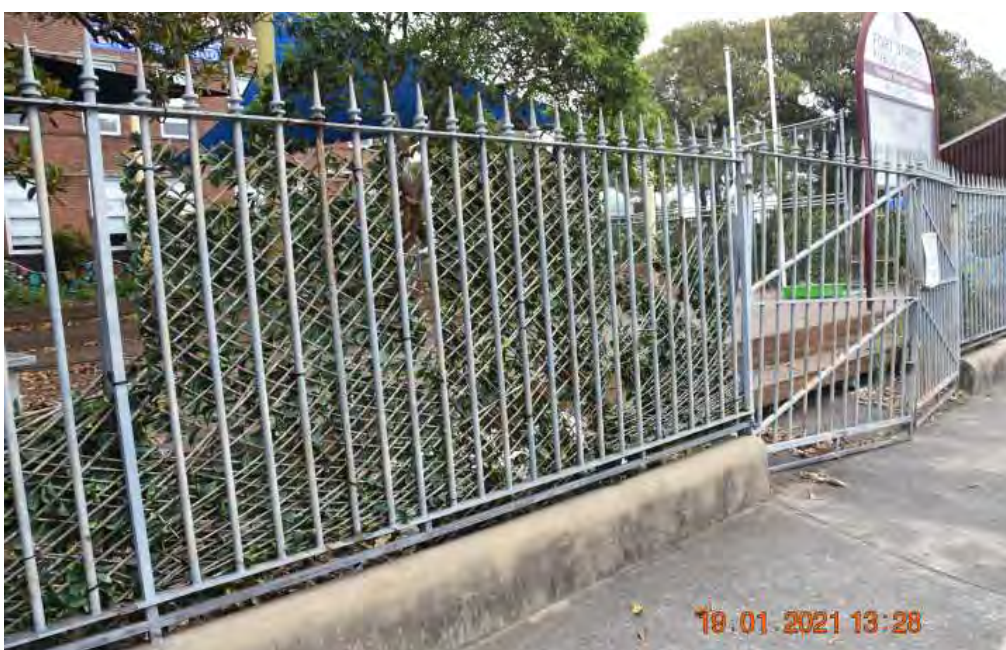
Figure: 1786

Cracking in the base of the fence on the east side of the property.

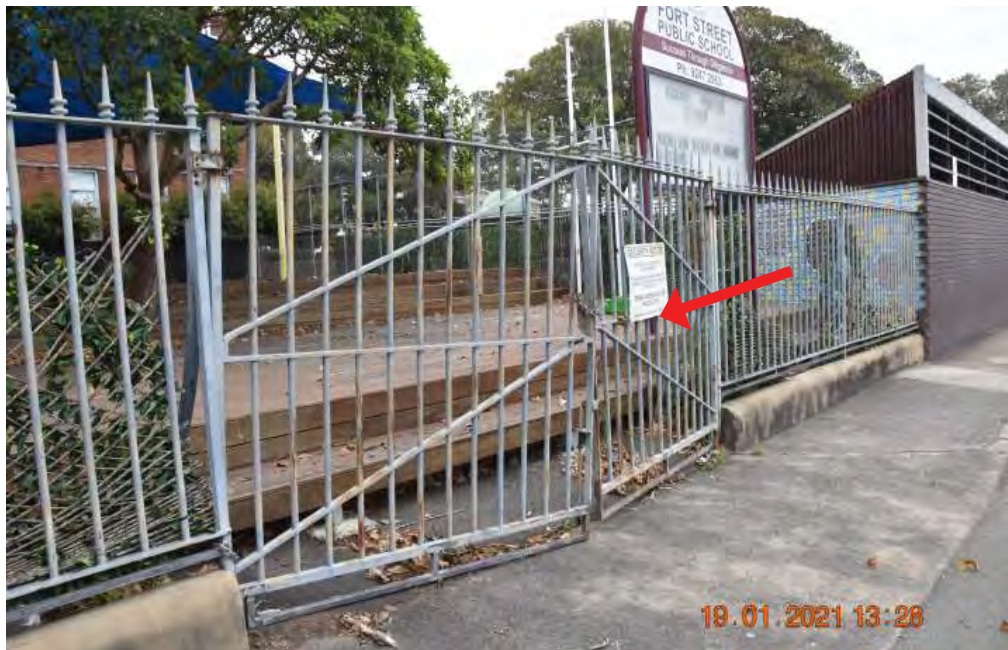
Figure: 1787

General view of the fence on the east side of the property.

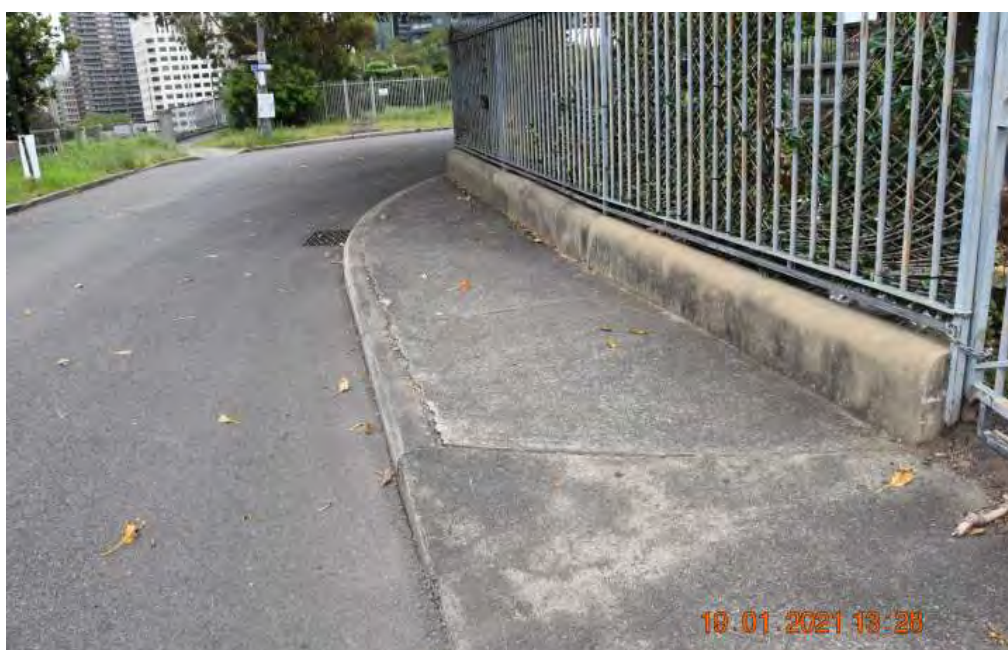
Figure: 1789

General view of the footpath on the east side of the property. Showing chipping.

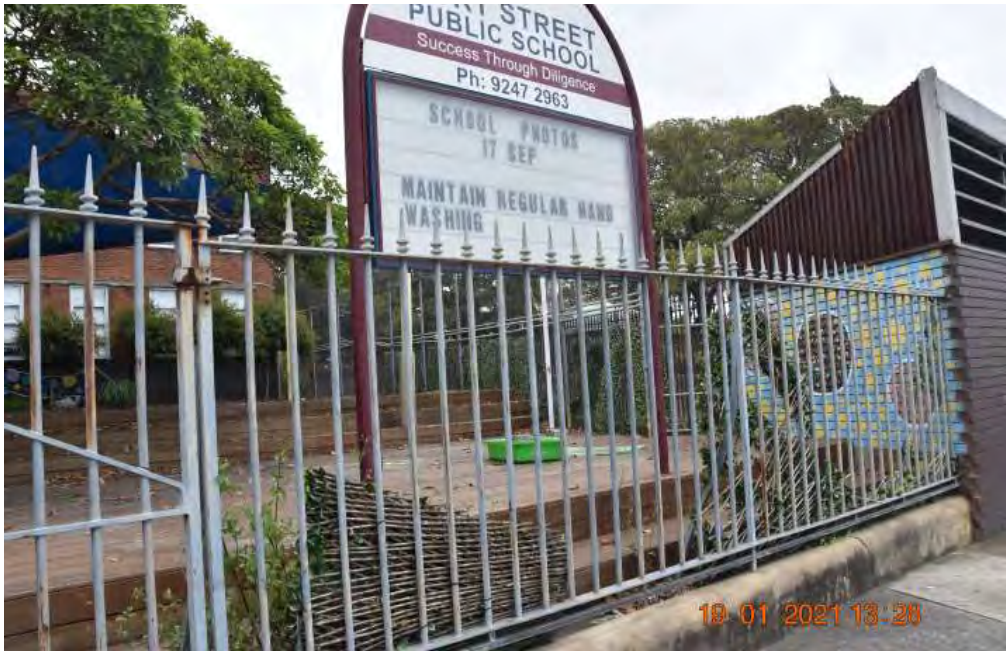
Figure: 1790

General view of the footpath on the east side of the property.

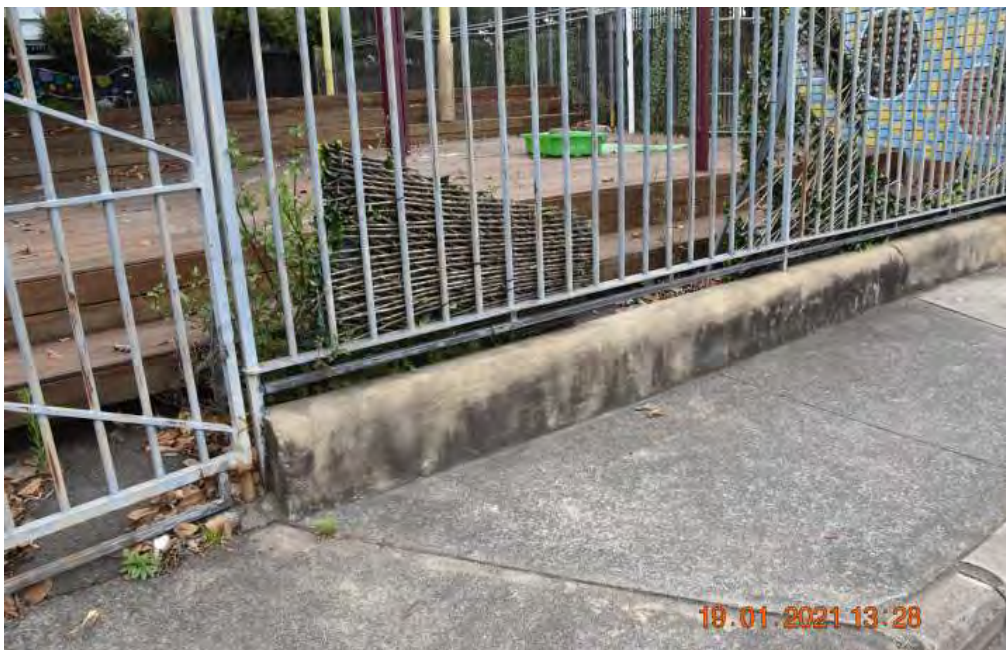
Figure: 1791

General view of the fence on the east side of the property.

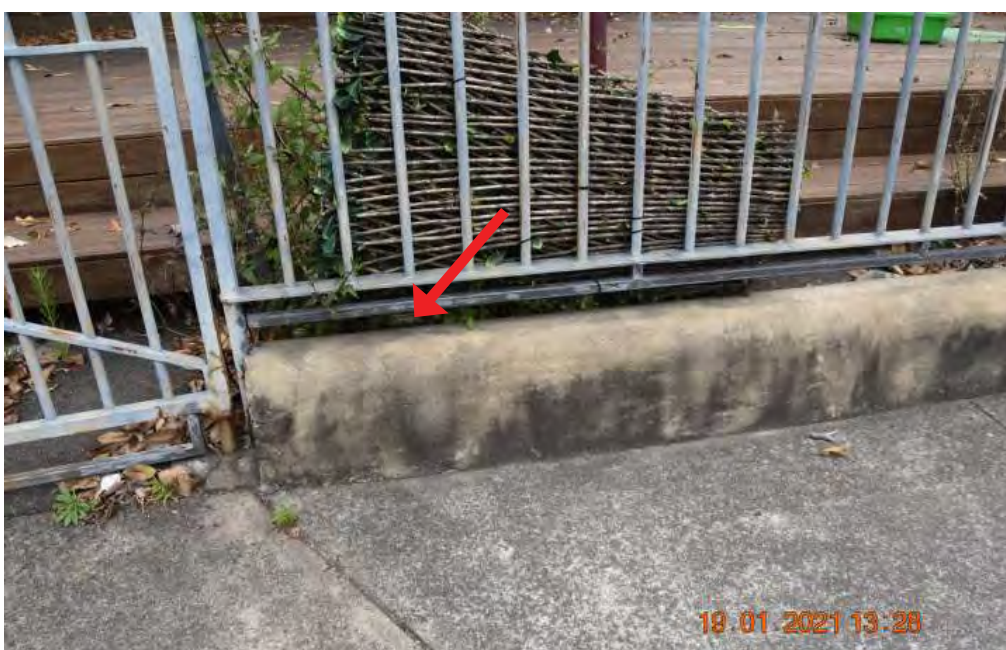
Figure: 1792

General view of the fence on the east side of the property.

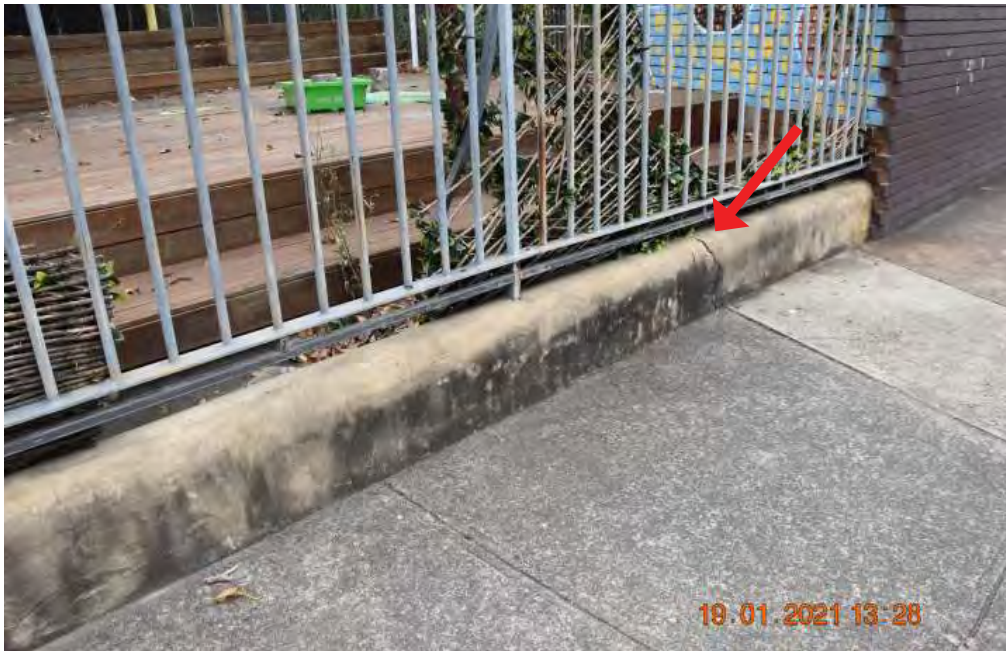
Figure: 1793

Cracking in the base of the fence on the east side of the property.

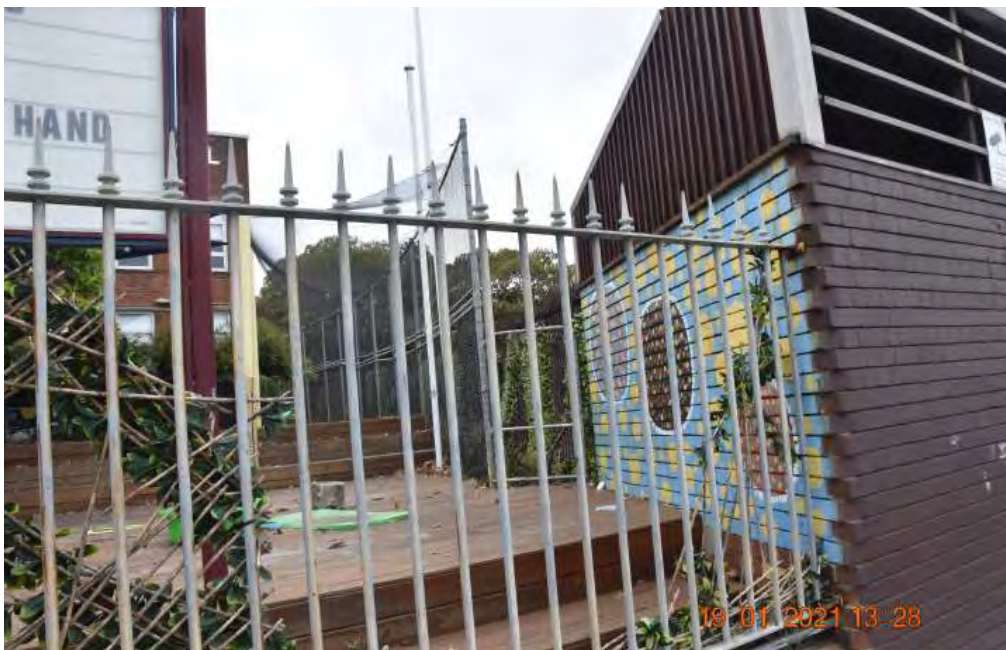
Figure: 1794

Cracking in the base of the fence on the east side of the property.

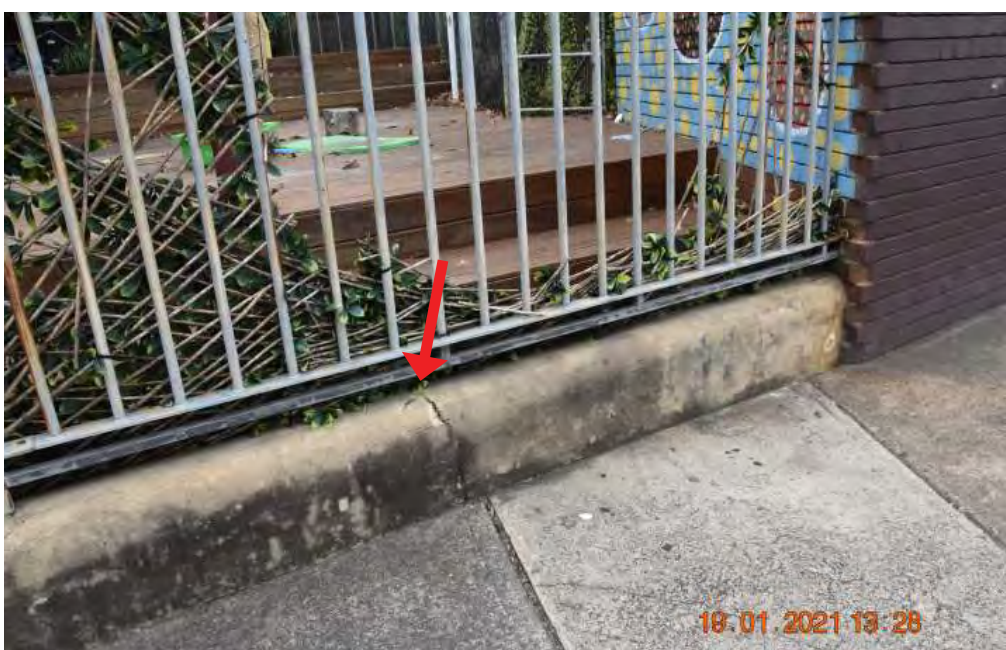
Figure: 1795

General view of the fence on the east side of the property.

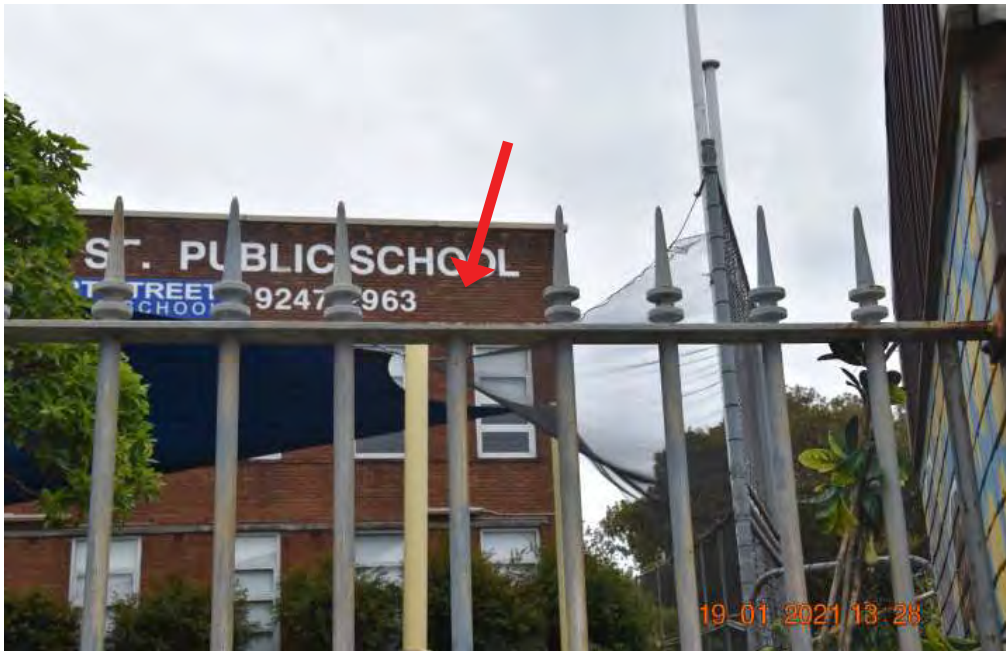
Figure: 1796

Cracking in the base of the fence on the east side of the property.

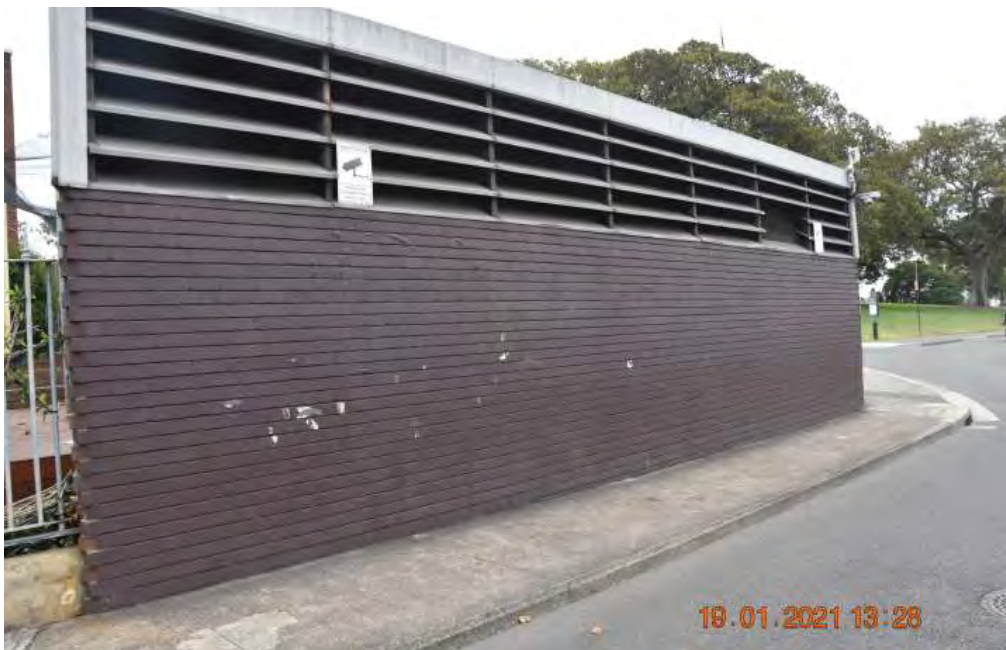
Figure: 1797

General view of the fence on the east side of the property. Showing missing top.

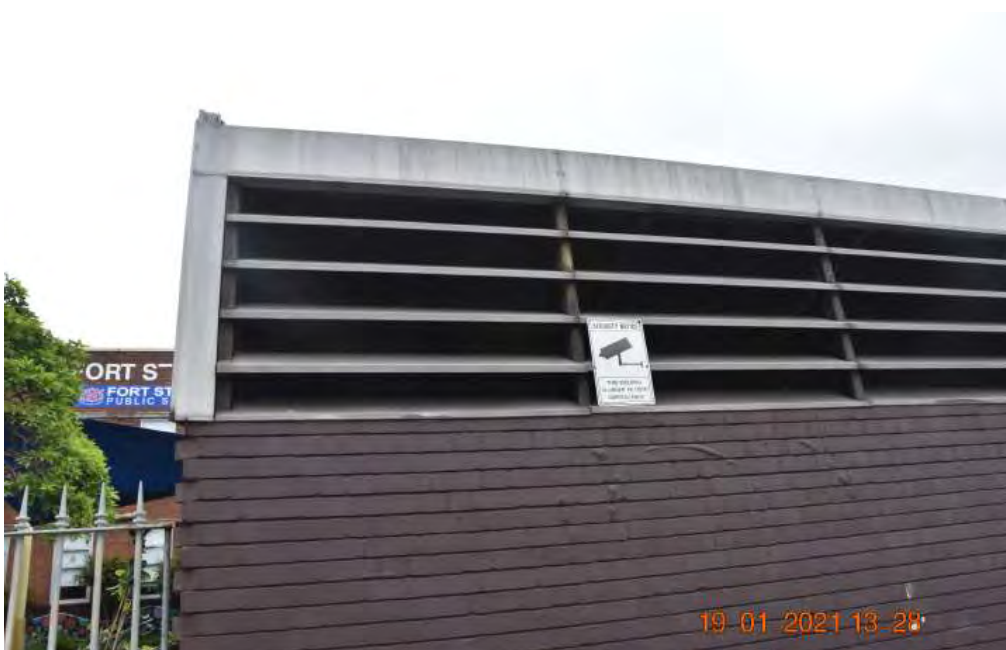
Figure: 1798

East wall of the ventilation shed.

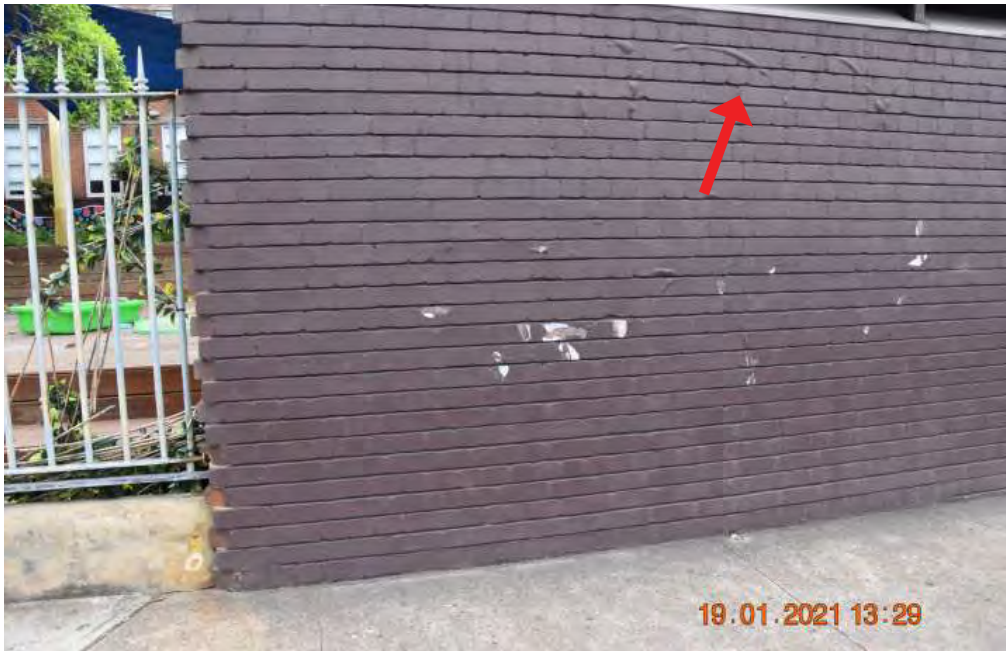
Figure: 1799

East wall of the ventilation shed.

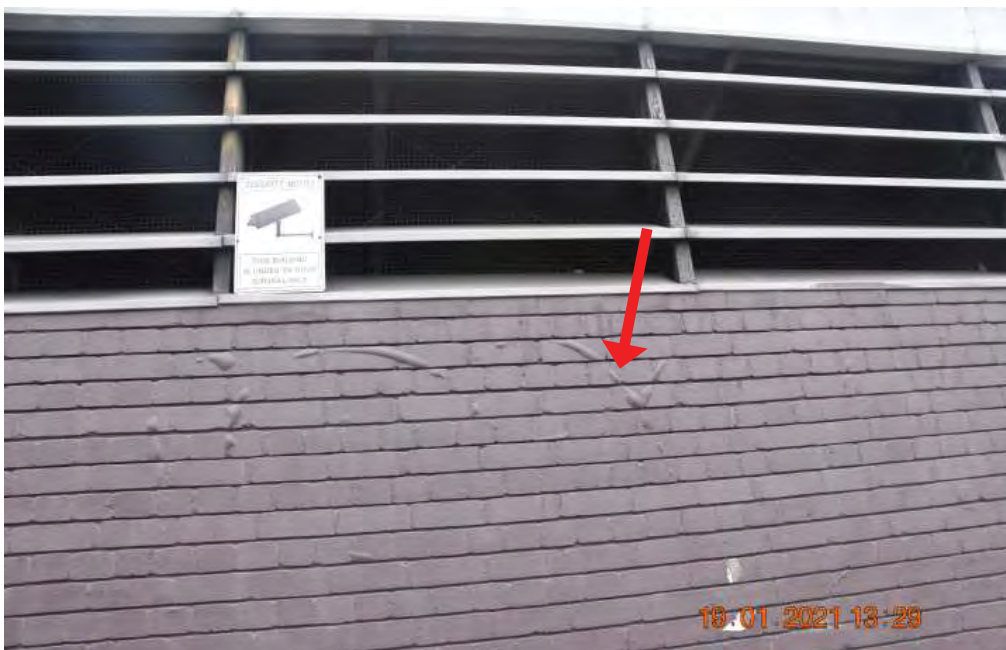
Figure: 1800

East wall of the ventilation shed. Showing bubbling paint.

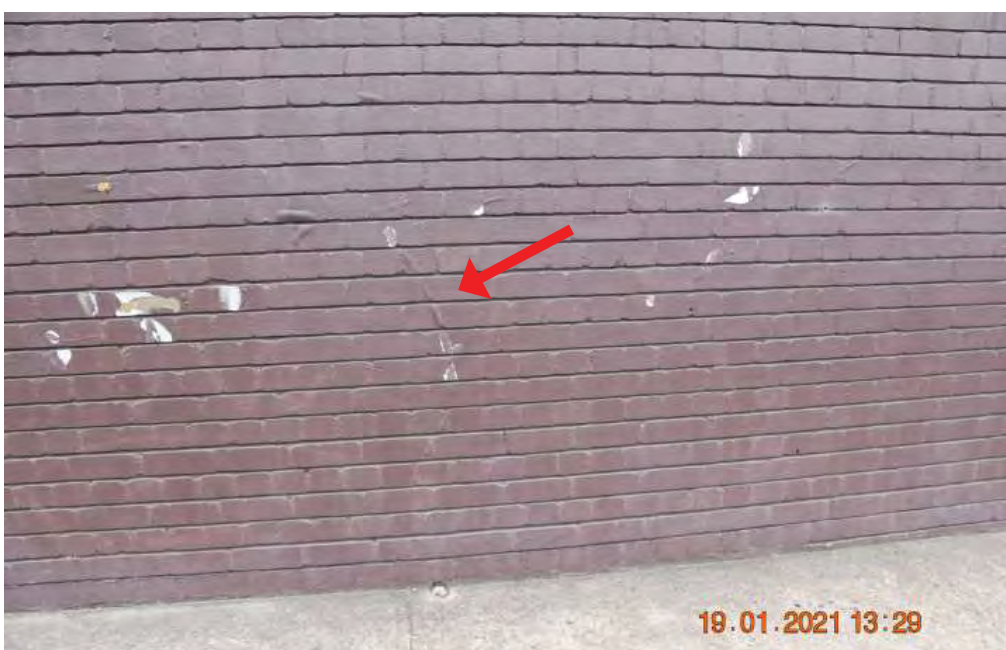
Figure: 1801

East wall of the ventilation shed. Showing bubbling paint.

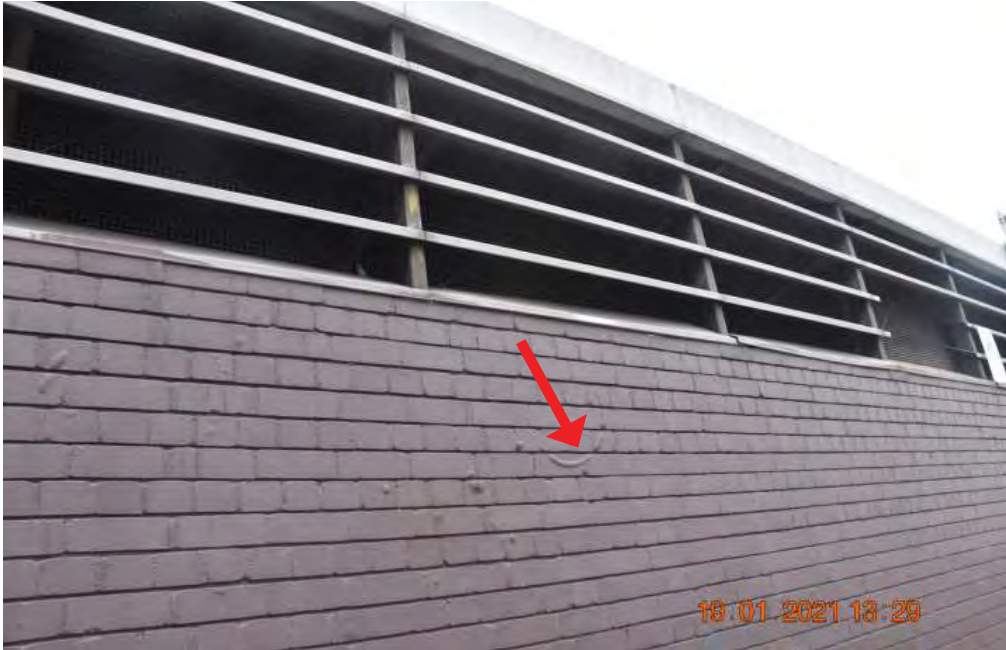
Figure: 1803

East wall of the ventilation shed. Showing bubbling paint.

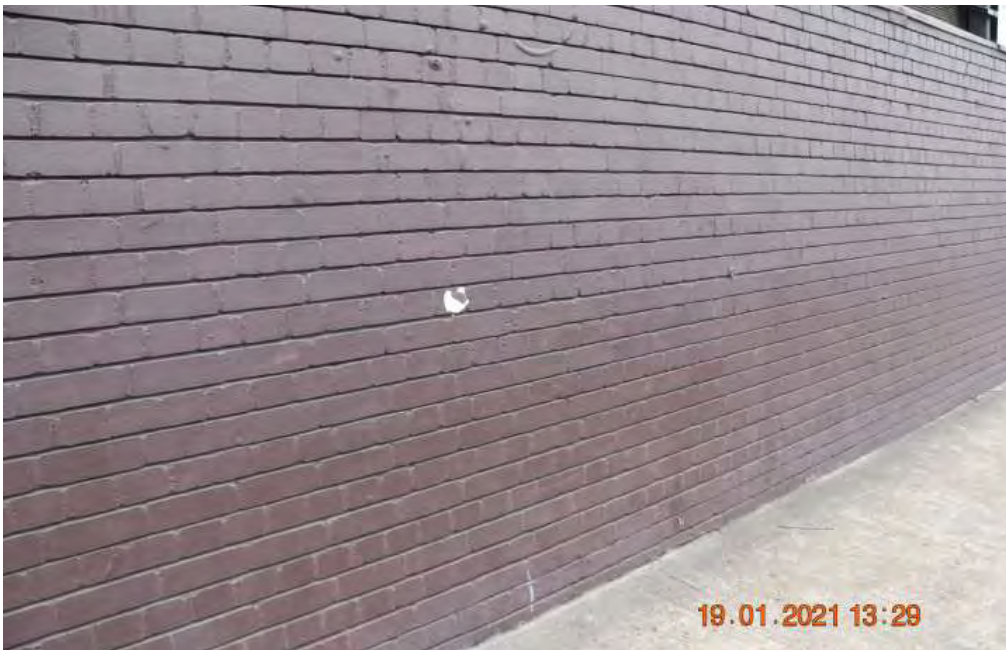
Figure: 1804

East wall of the ventilation shed.

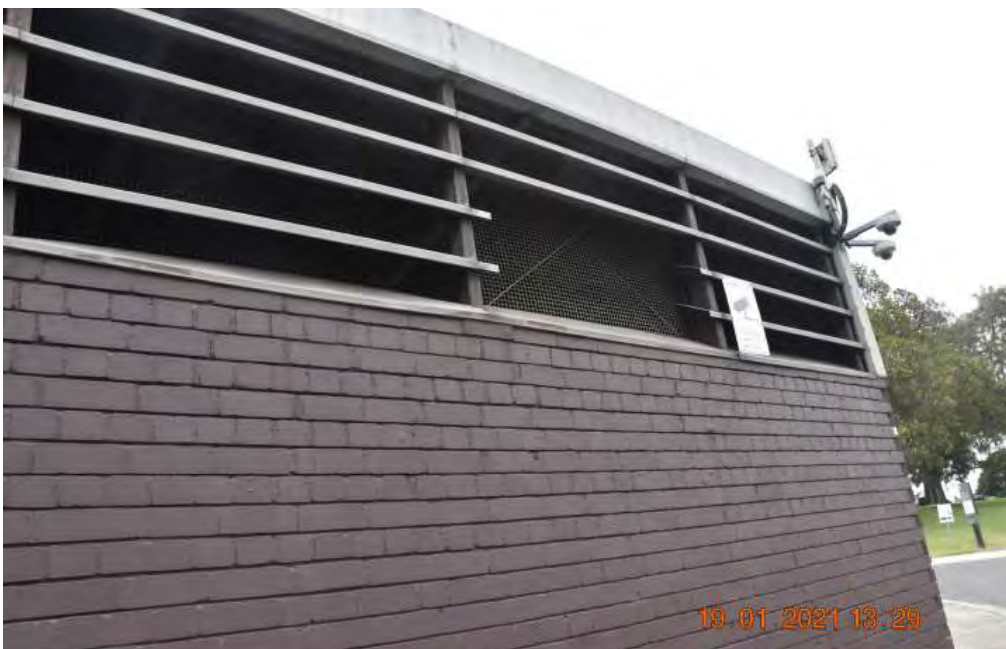
Figure: 1805

East wall of the ventilation shed.

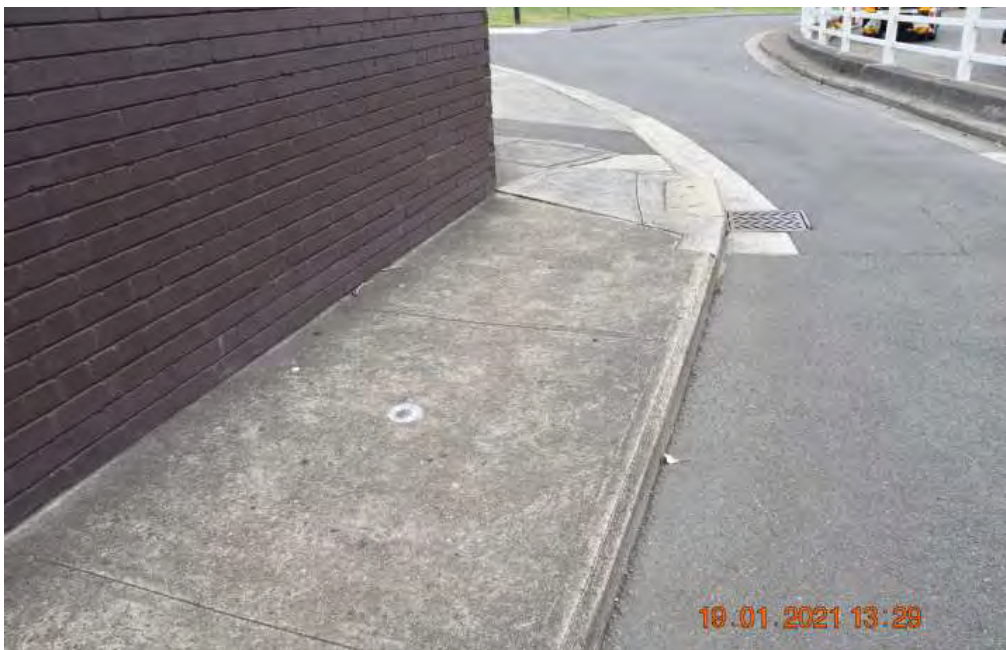
Figure: 1806

East wall of the ventilation shed.
