## PRE CONSTRUCTION CONDITION SURVEY

Fort Street Public School, Millers Point NSW

Upper Fort Street Public School  
MILLERS POINT NSW 2000

19 January 2021

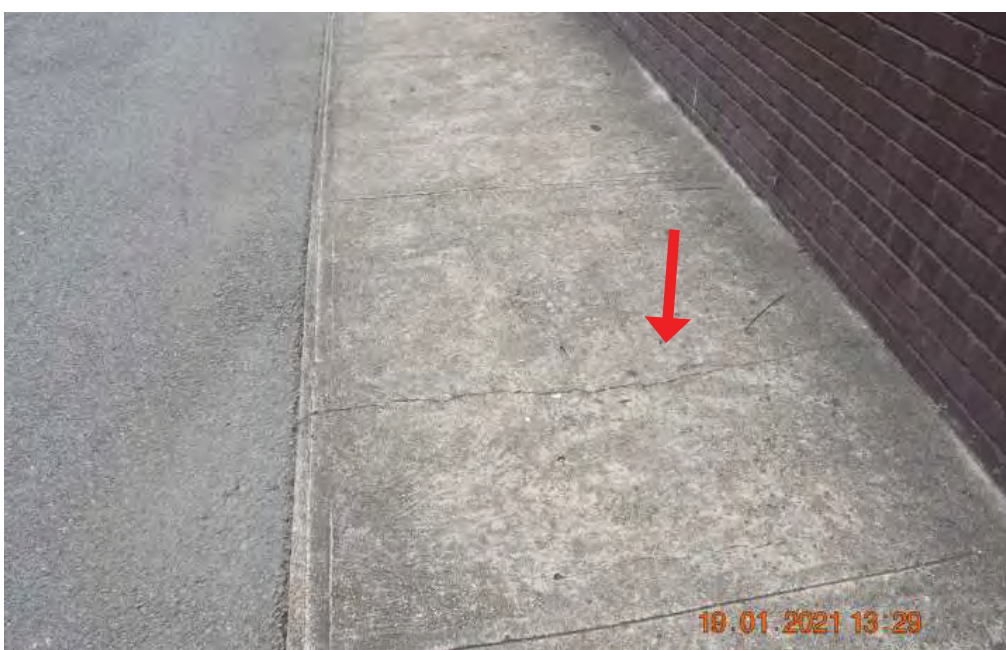
Figure: 1807

General view of the footpath on the east side of the ventilation shed.

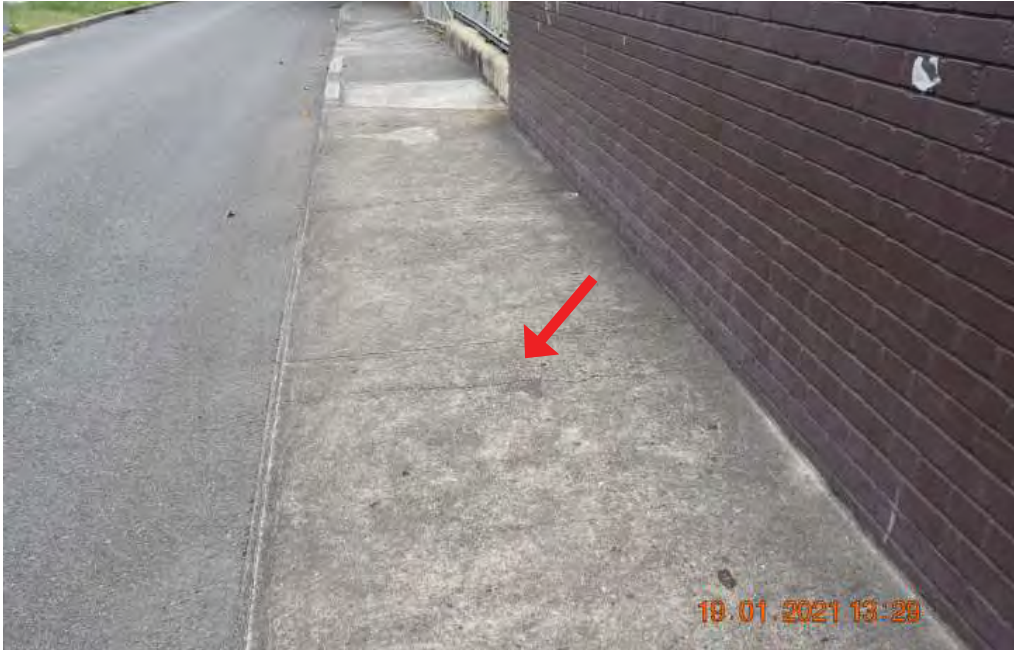
Figure: 1809

Cracking in the footpath on the east side of the ventilation shed.

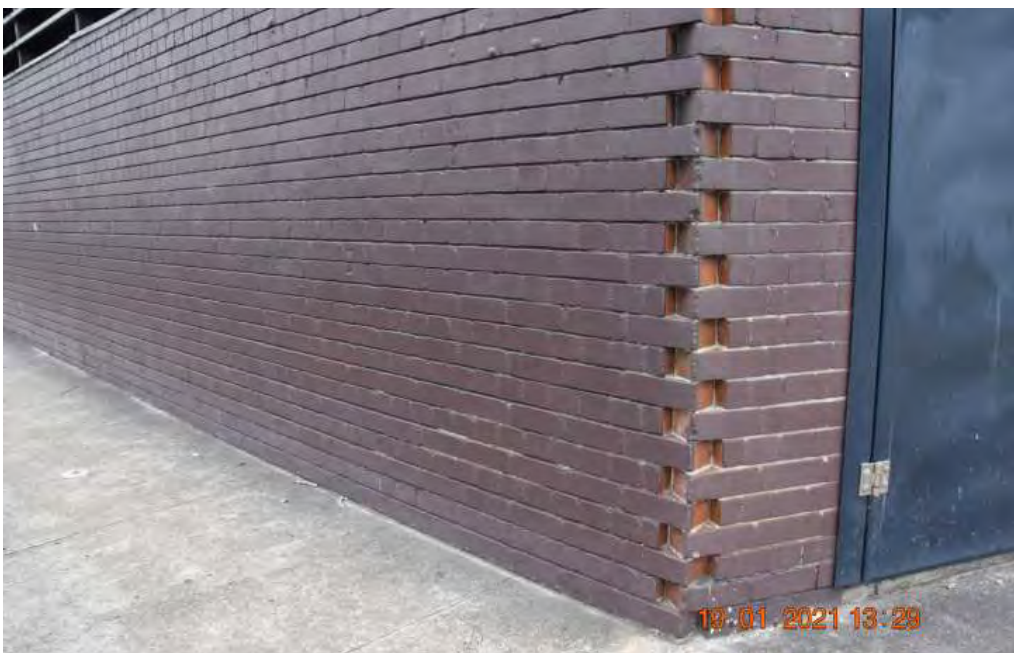
Figure: 1810

East wall of the ventilation shed.

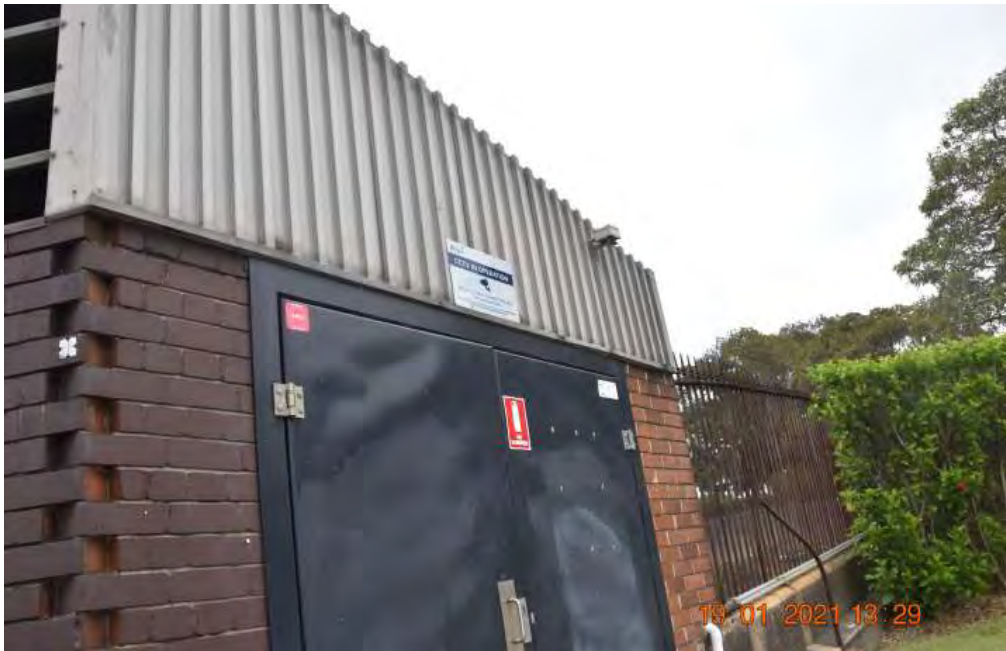
Figure: 1811

East wall of the ventilation shed.

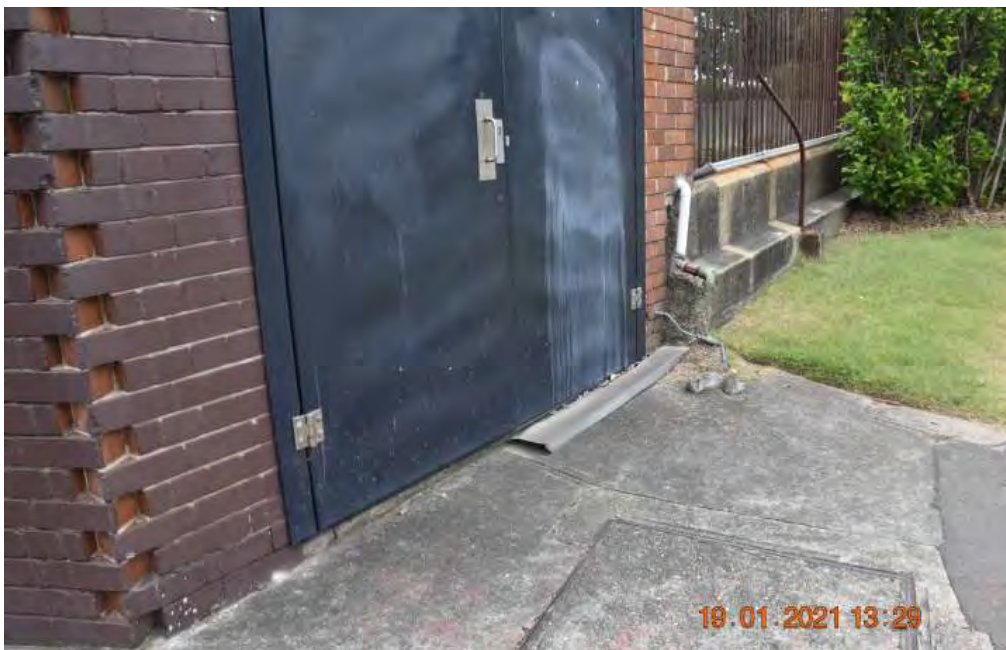
Figure: 1812

North wall of the ventilation shed.

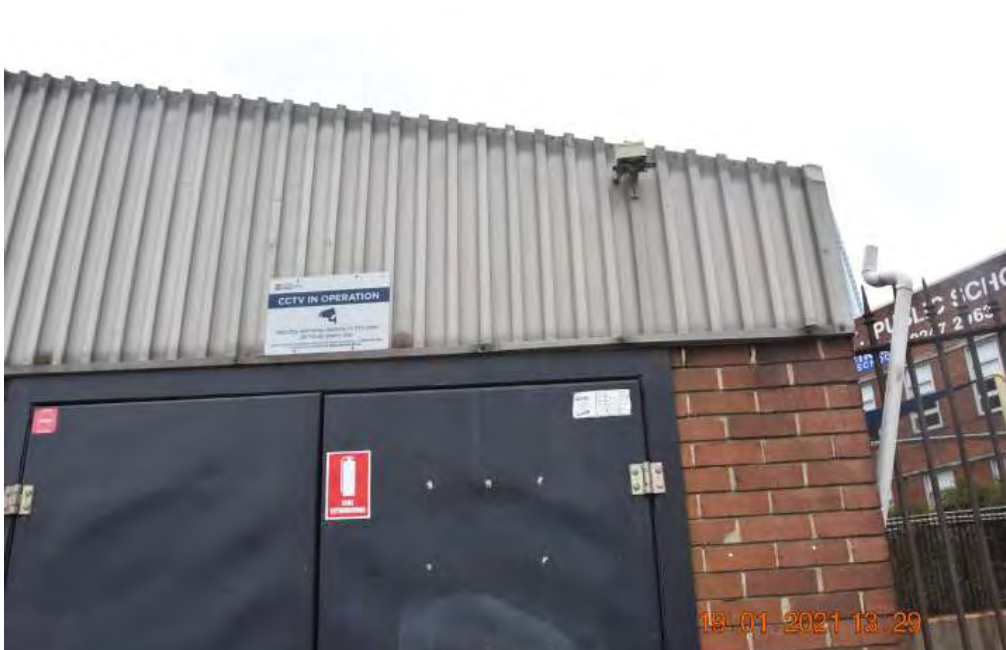
Figure: 1813

North wall of the ventilation shed.

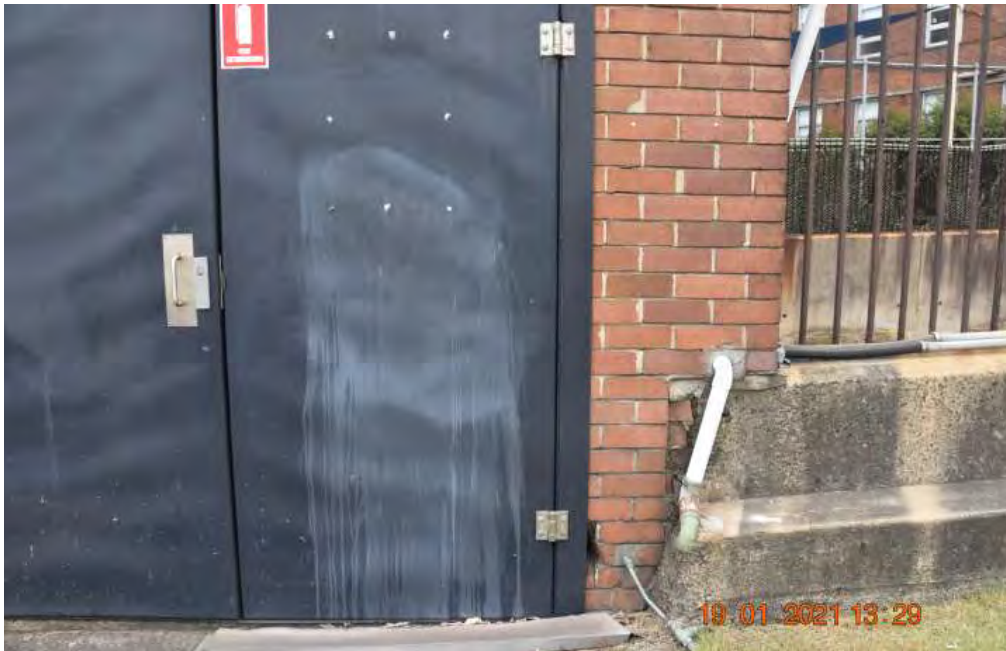
Figure: 1814

North wall of the ventilation shed.

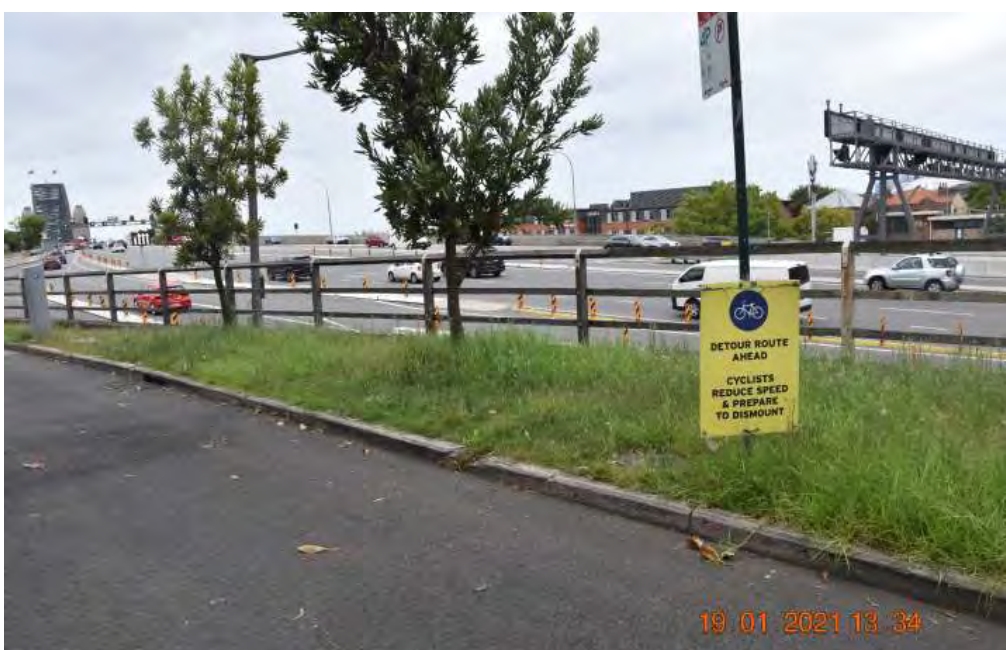
Figure: 1816

General view of the paving on the north side of the ventilation shed. Showing patching.

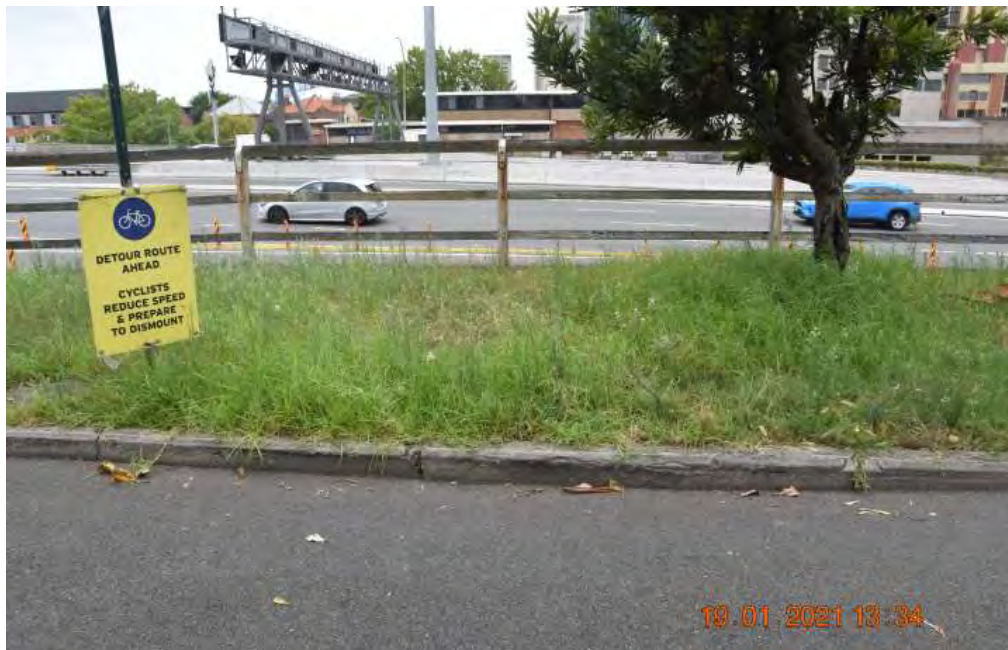
Figure: 1817

General view of the grass area on the east side of Upper Fort Street.

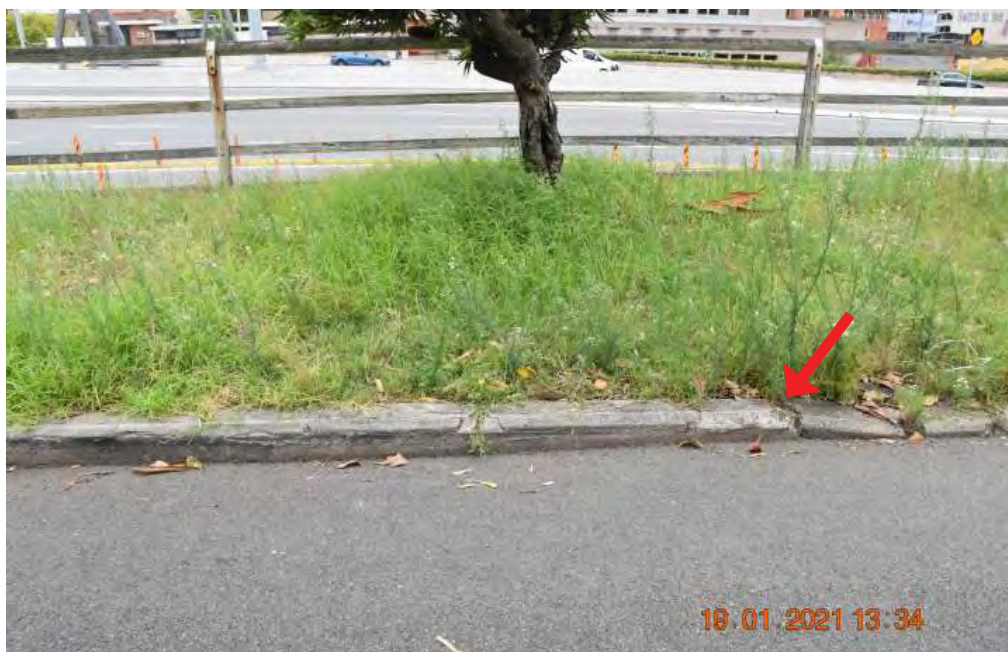
Figure: 1818

General view of the grass area on the east side of Upper Fort Street.

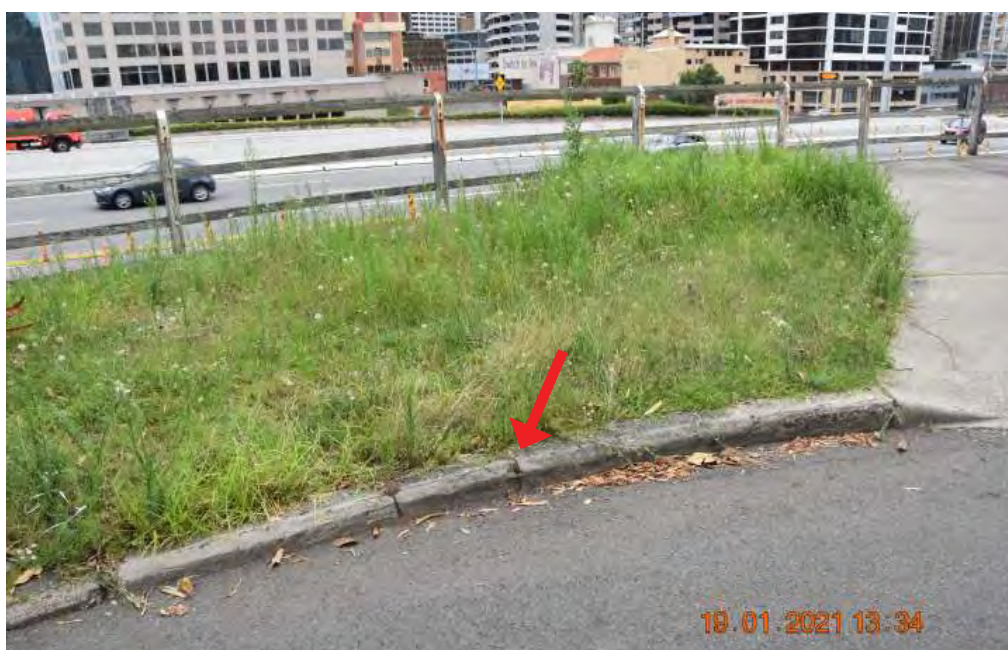
Figure: 1819

General view of the grass area on the east side of Upper Fort Street. Showing chipping in the kerb.

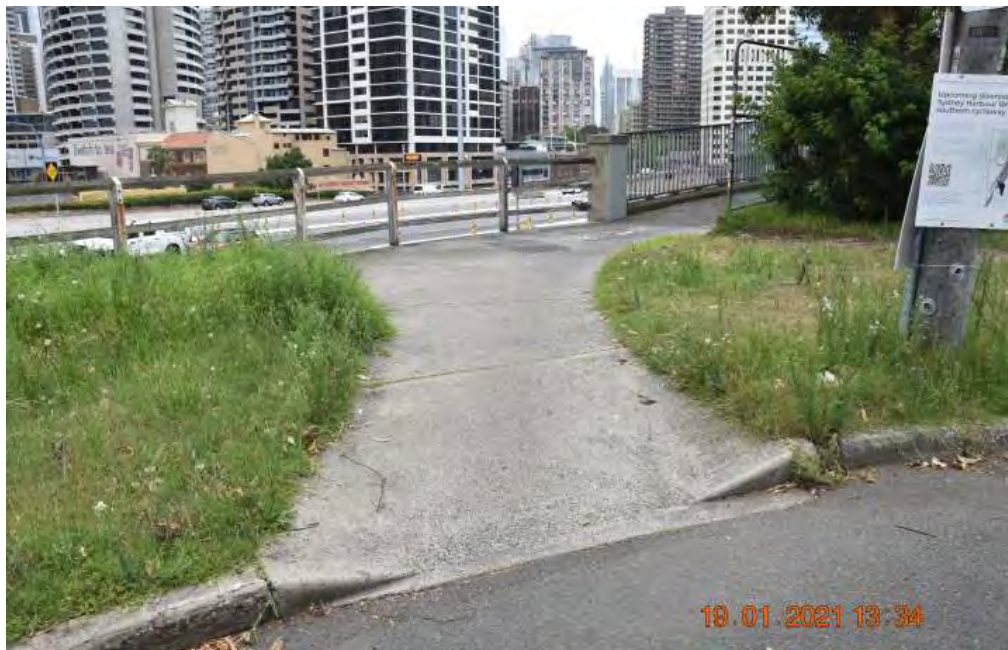
Figure: 1820

General view of the grass area on the east side of Upper Fort Street. Showing chipping in the kerb.

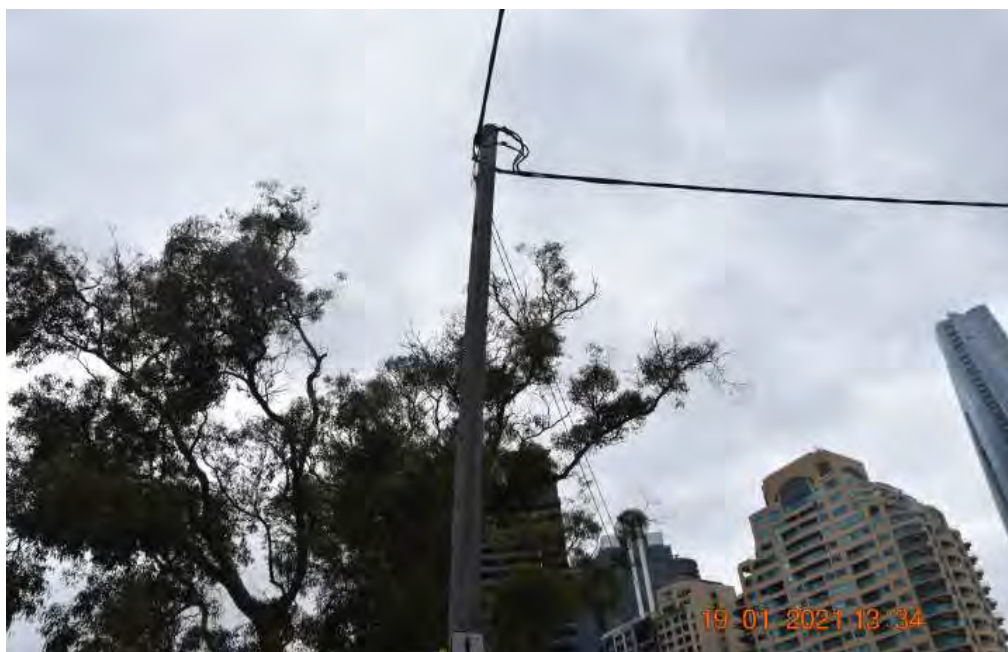
Figure: 1821

General view of the cycle way on the east side of Upper Fort Street.

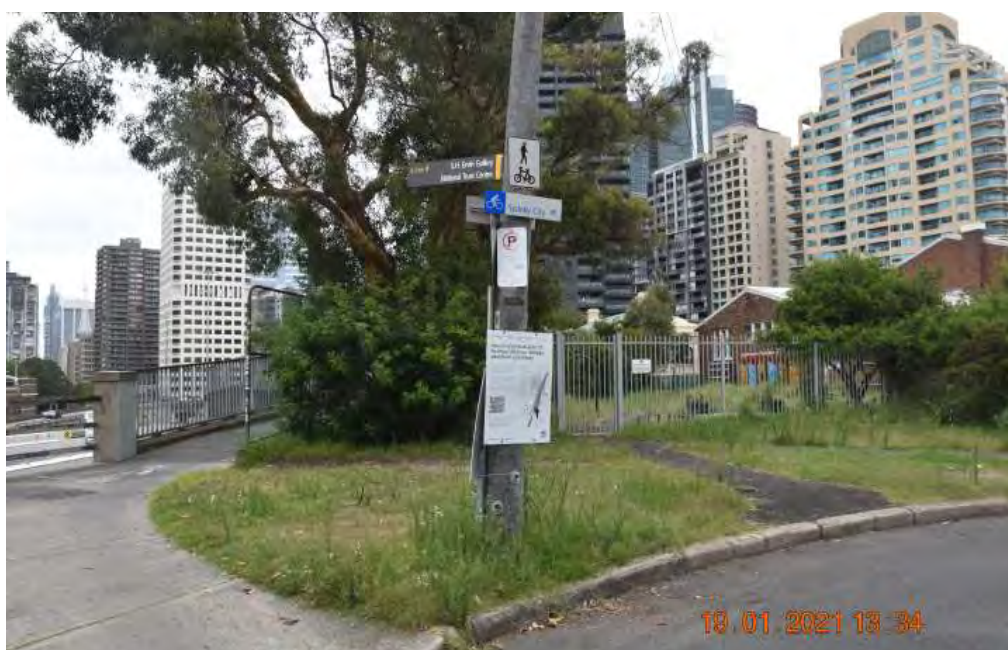
Figure: 1822

General view of the power pole on the east side of Upper Fort Street, adjacent to the cycle way.

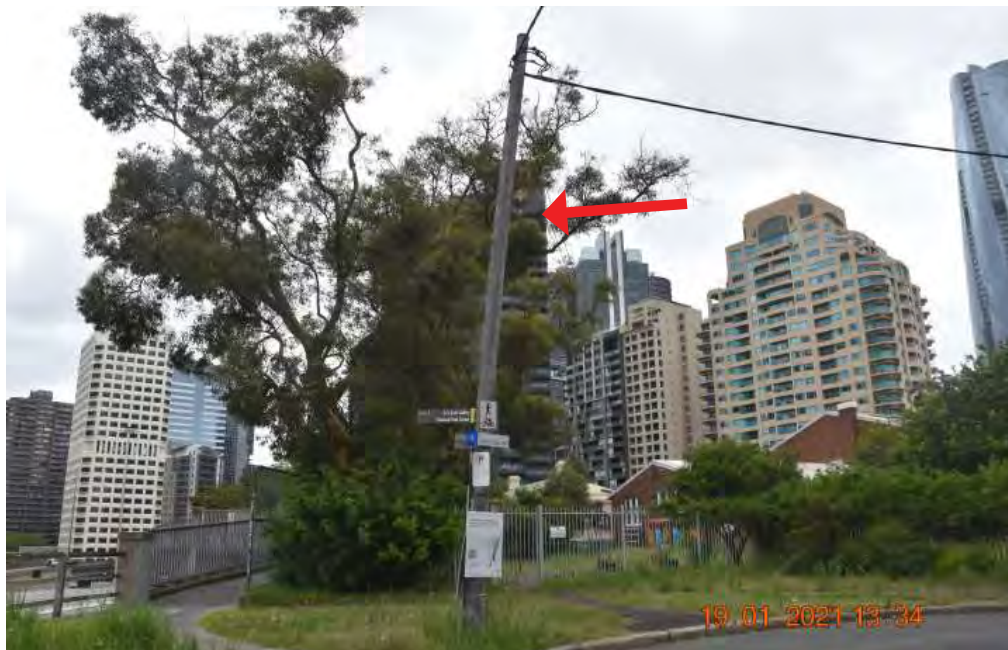
Figure: 1823

General view of the power pole on the east side of Upper Fort Street, adjacent to the cycle way.

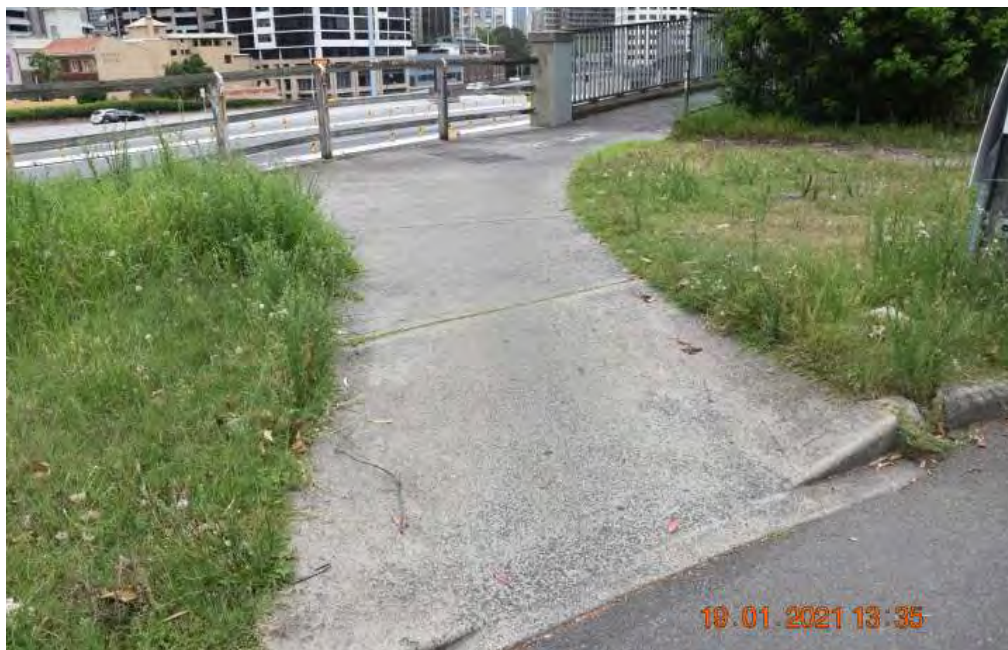
Figure: 1824

General view of the power pole on the east side of Upper Fort Street, adjacent to the cycle way. Showing leaning.

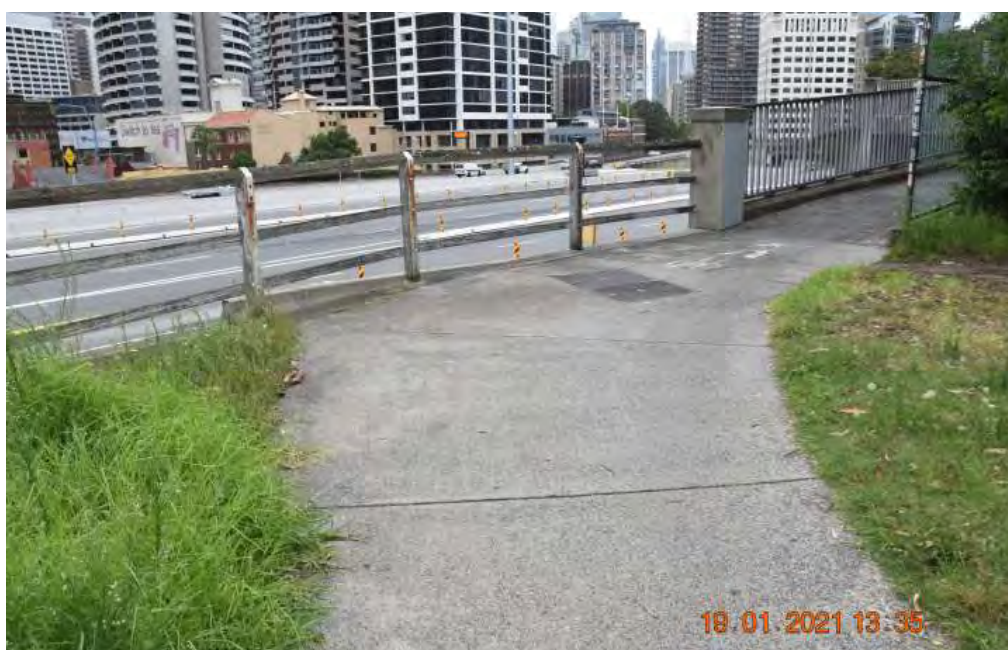
Figure: 1825

General view of the cycle way on the east side of Upper Fort Street.

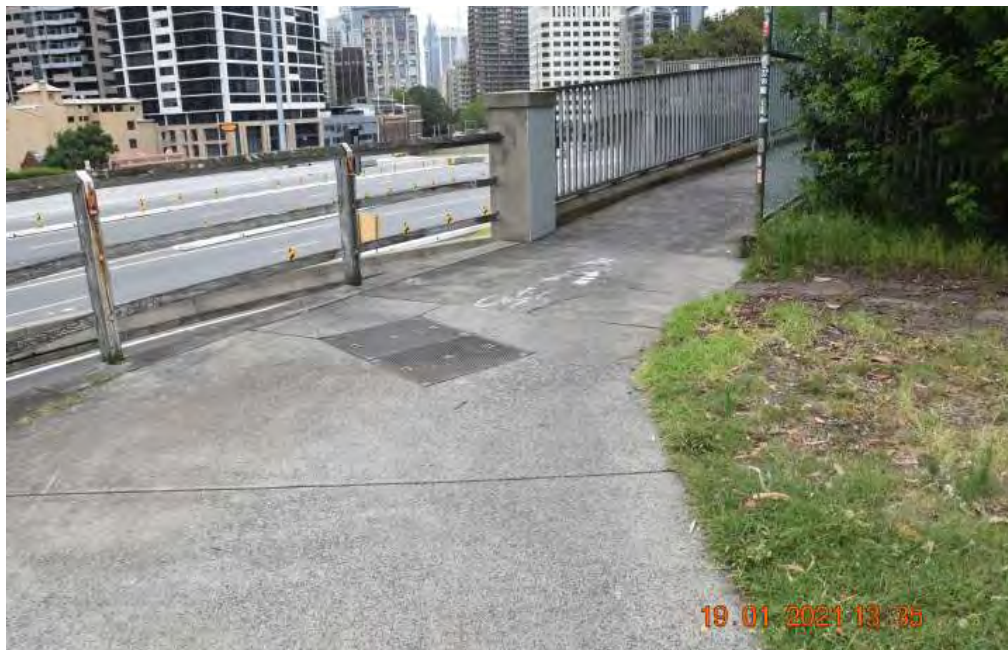
Figure: 1826

General view of the cycle way on the east side of Upper Fort Street.

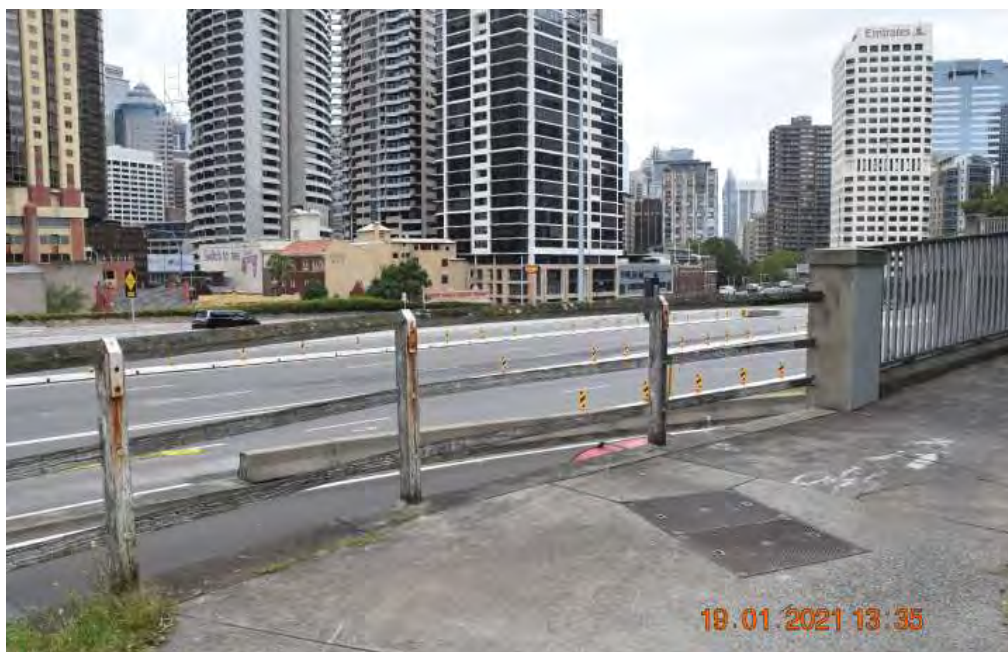
Figure: 1827

General view of the cycle way on the east side of Upper Fort Street.

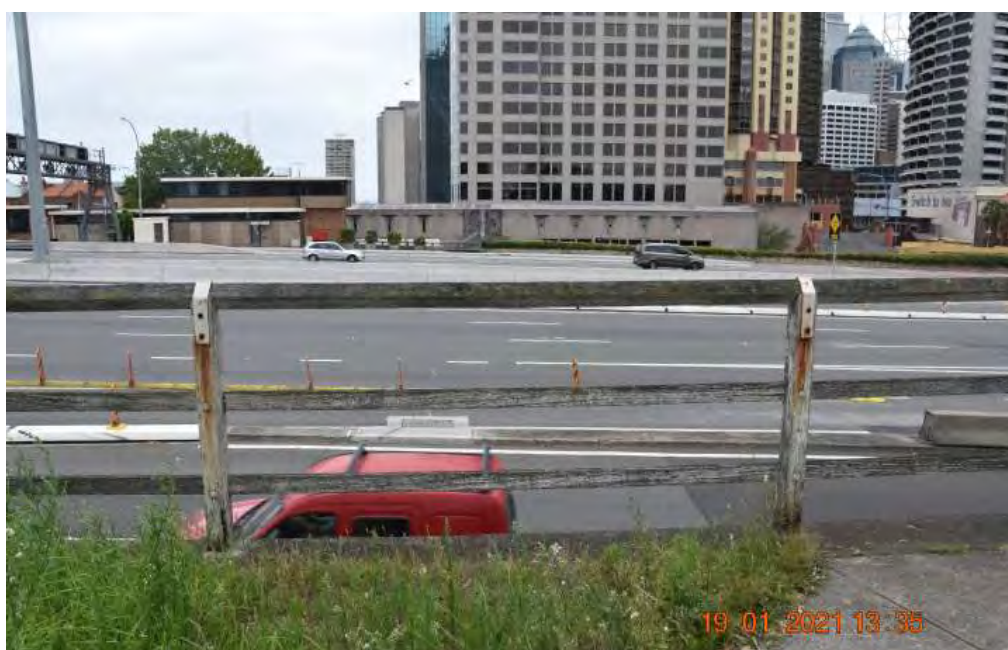
Figure: 1828

General view of the fence on the east side of Upper Fort Street.

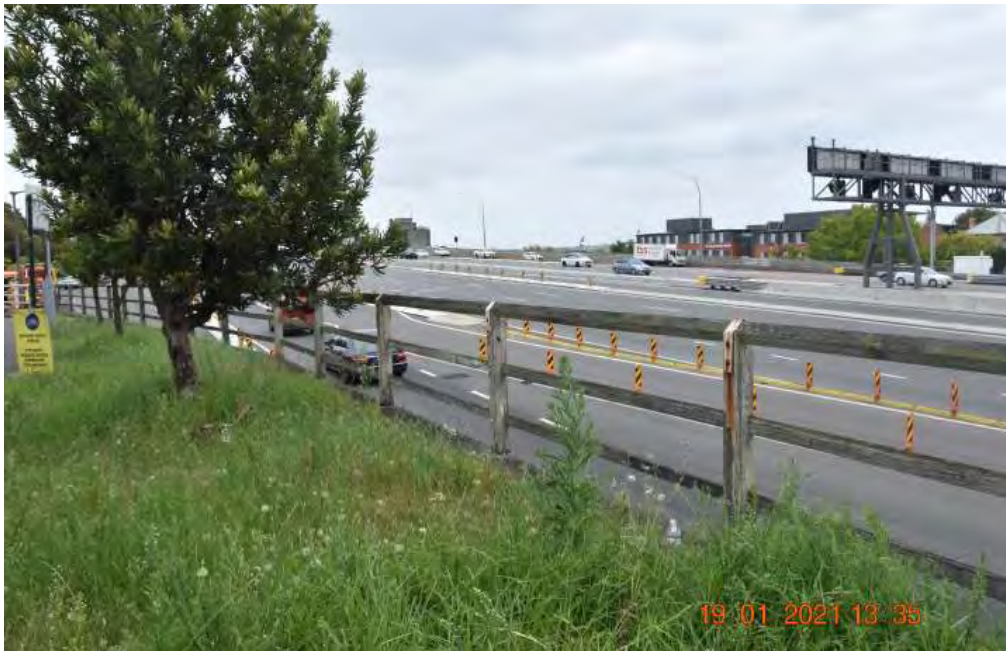
Figure: 1829

General view of the fence on the east side of Upper Fort Street.

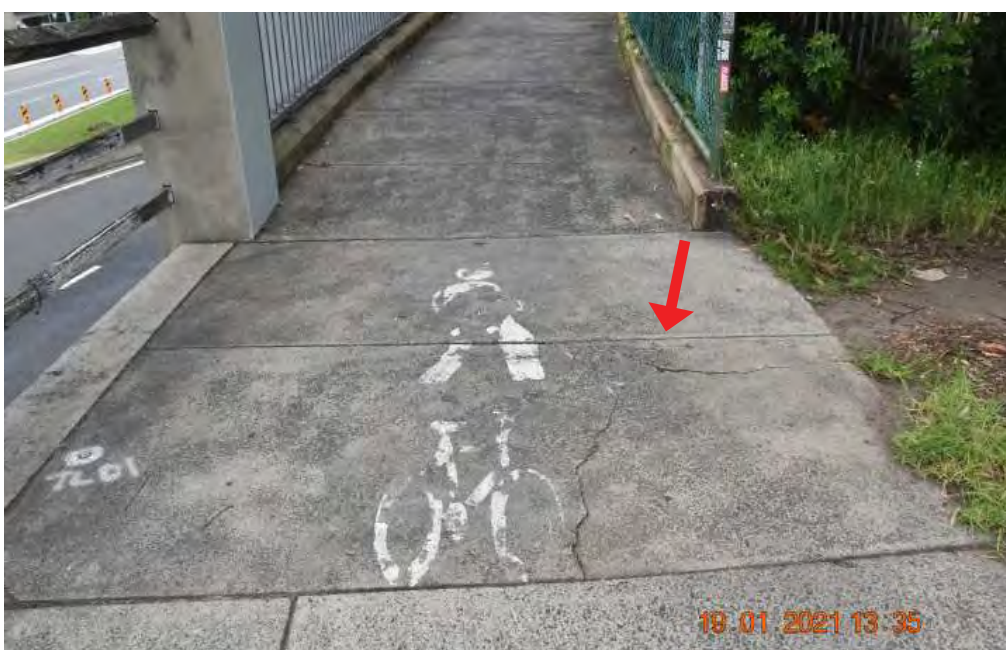
Figure: 1831

General view of the cycle way. Showing cracking.

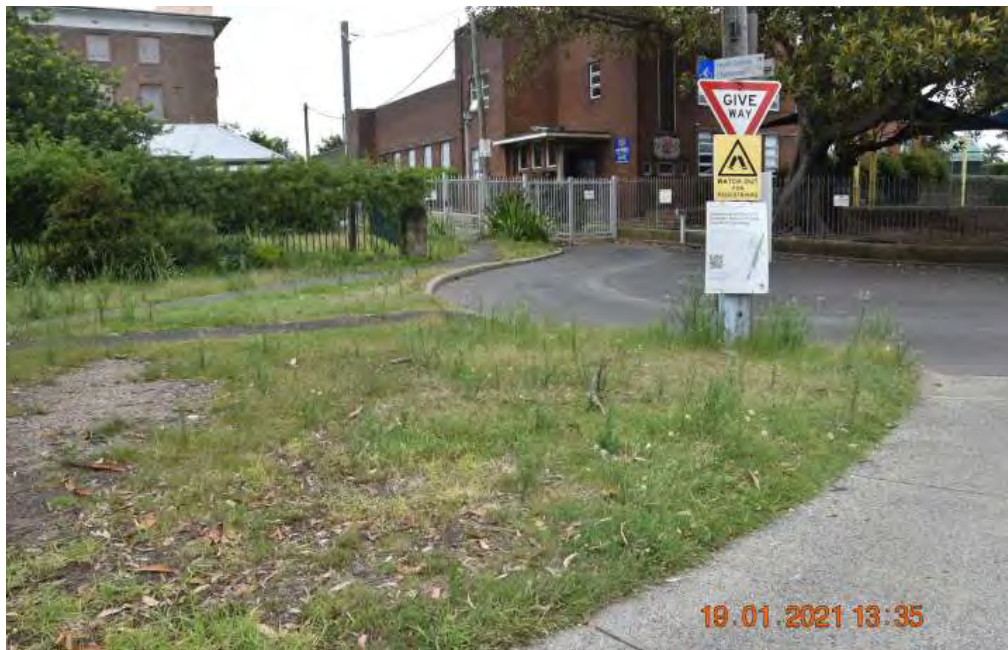
Figure: 1832

General view of the cycle way. Showing cracking.

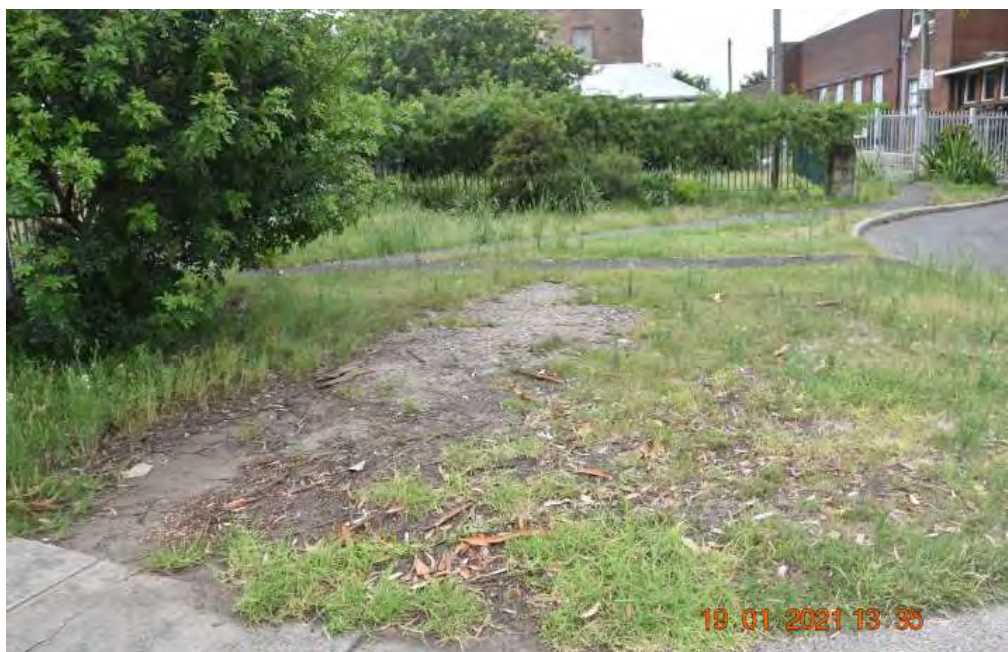
Figure: 1833

General view of the grass area on the west side of the cycle way.

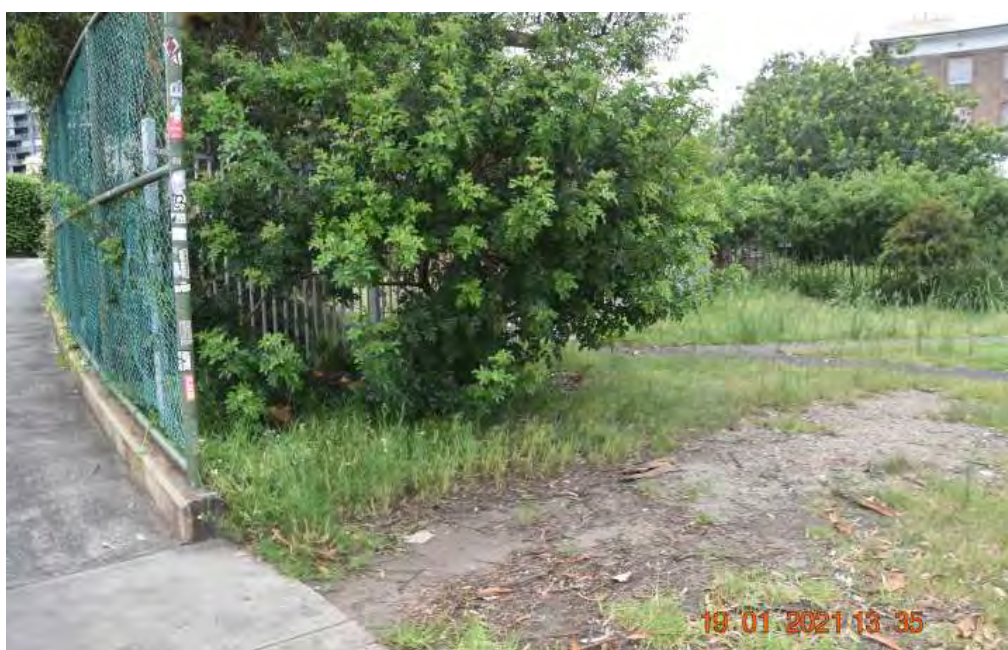
Figure: 1834

General view of the grass area on the west side of the cycle way.

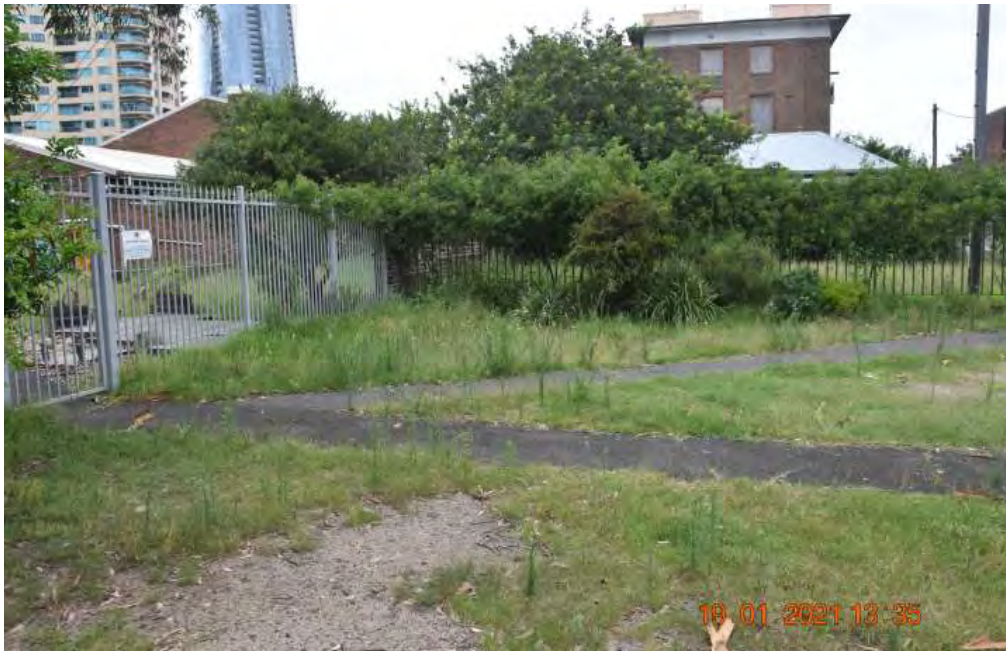
Figure: 1835

General view of the grass area on the west side of the cycle way.

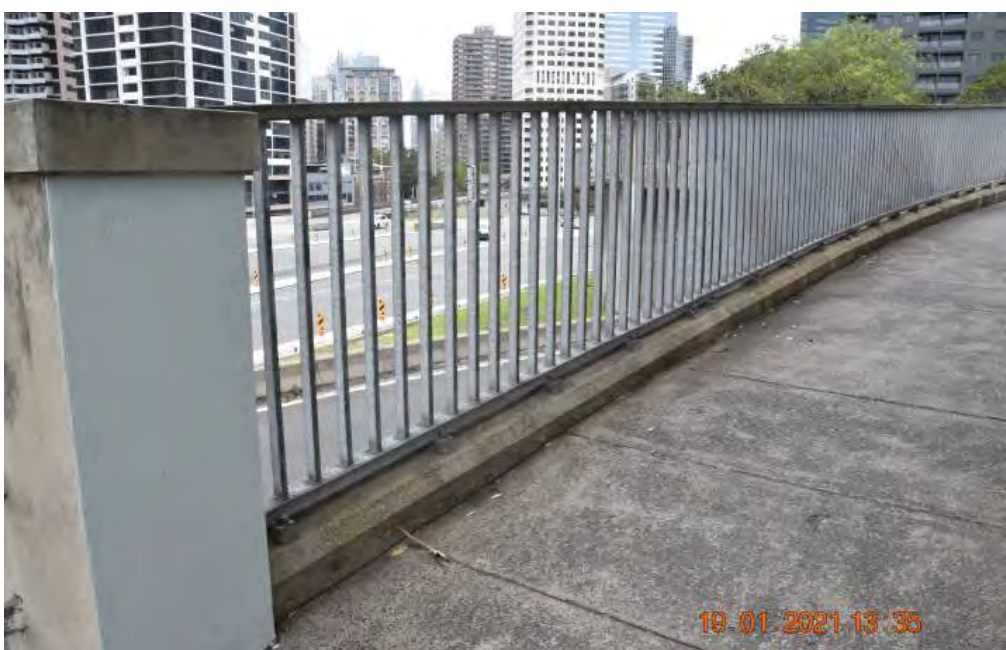
Figure: 1837

General view of the cycle way.

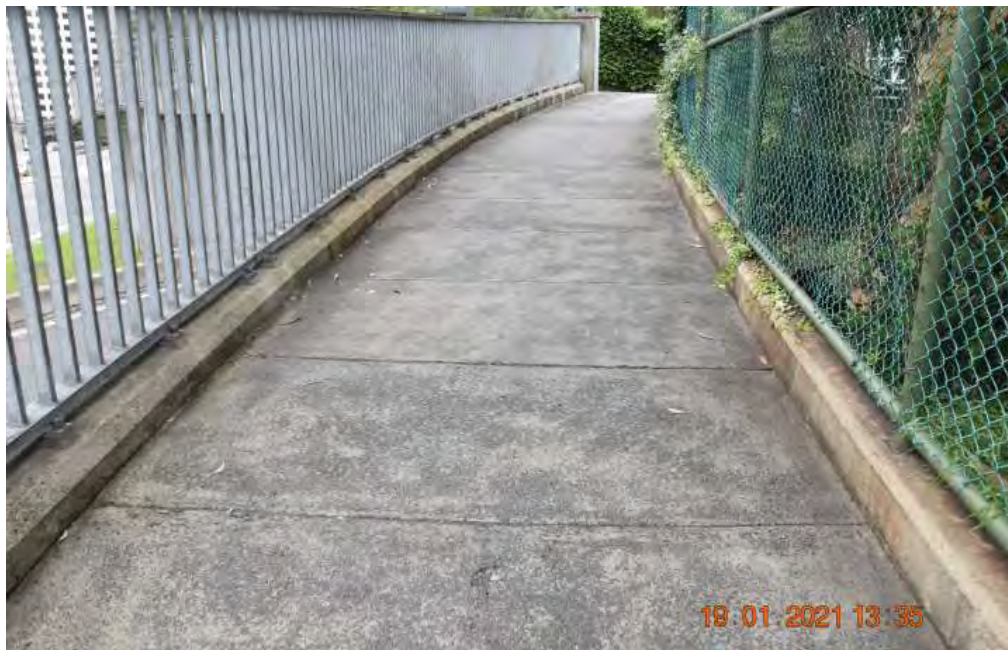
Figure: 1838

General view of the cycle way.

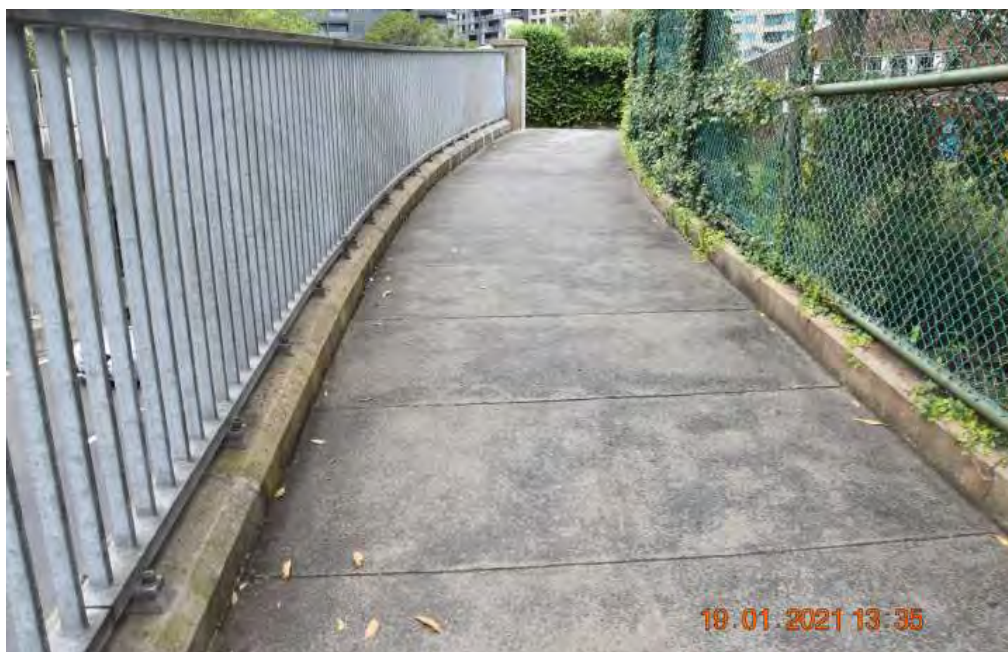
Figure: 1839

General view of the cycle way.

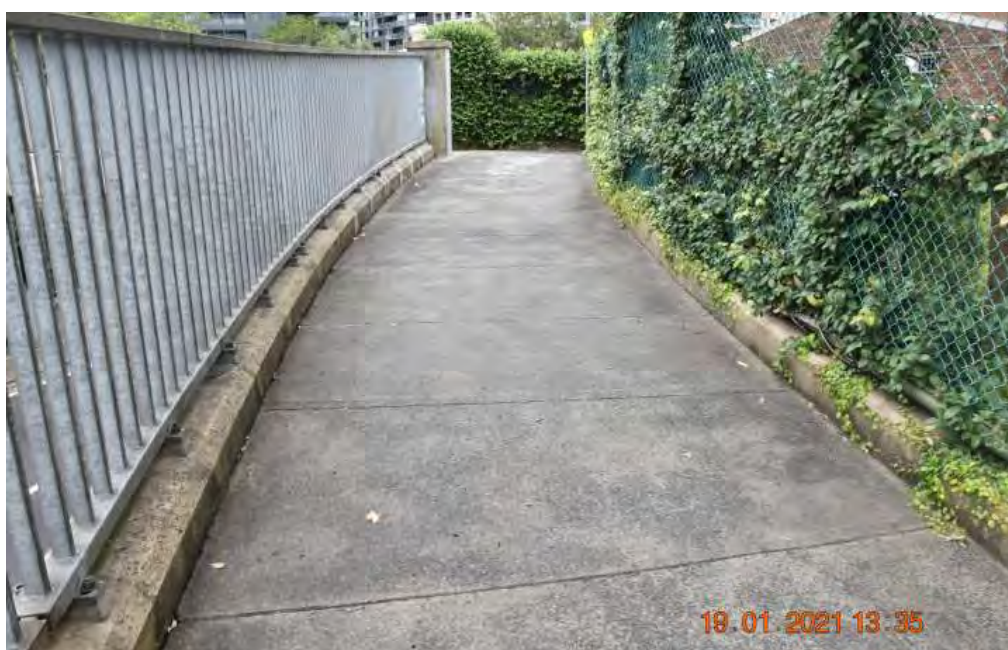
Figure: 1840

General view of the cycle way.

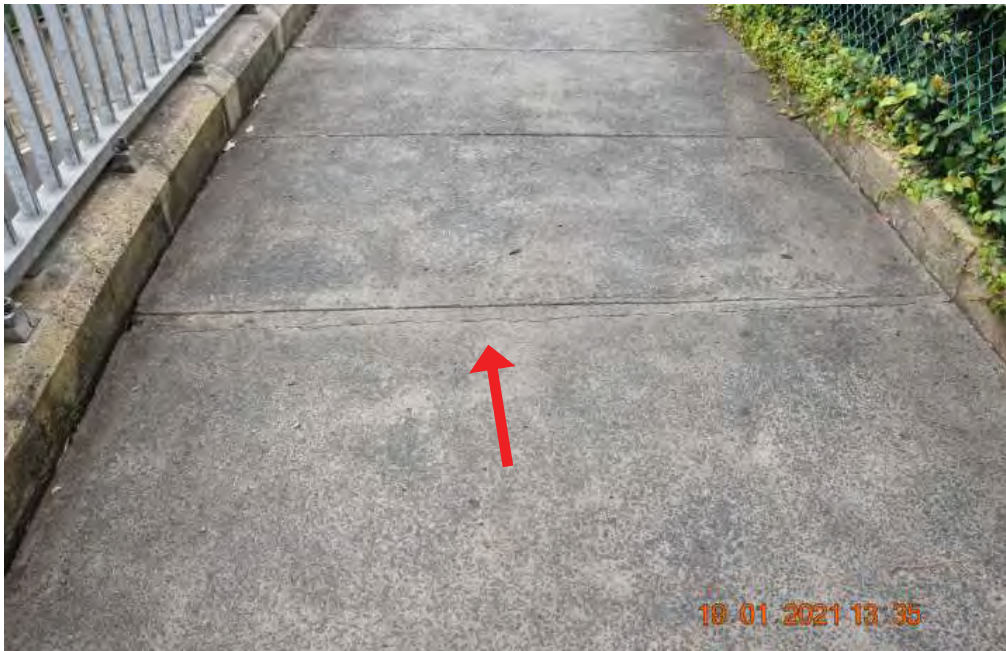
Figure: 1841

General view of the cycle way.

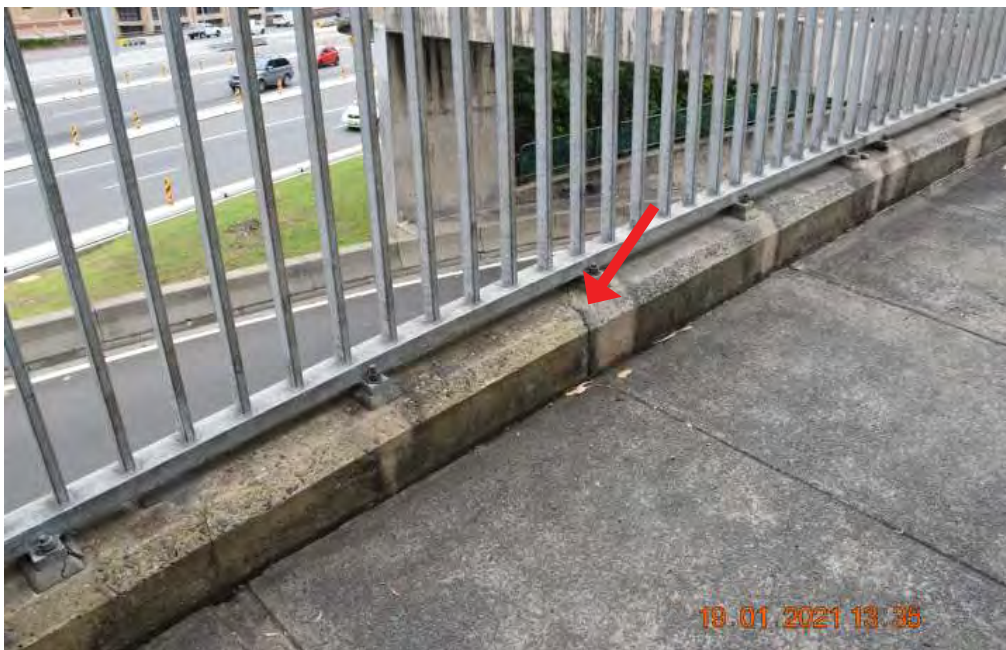
Figure: 1842

Cracking in the cycle way.

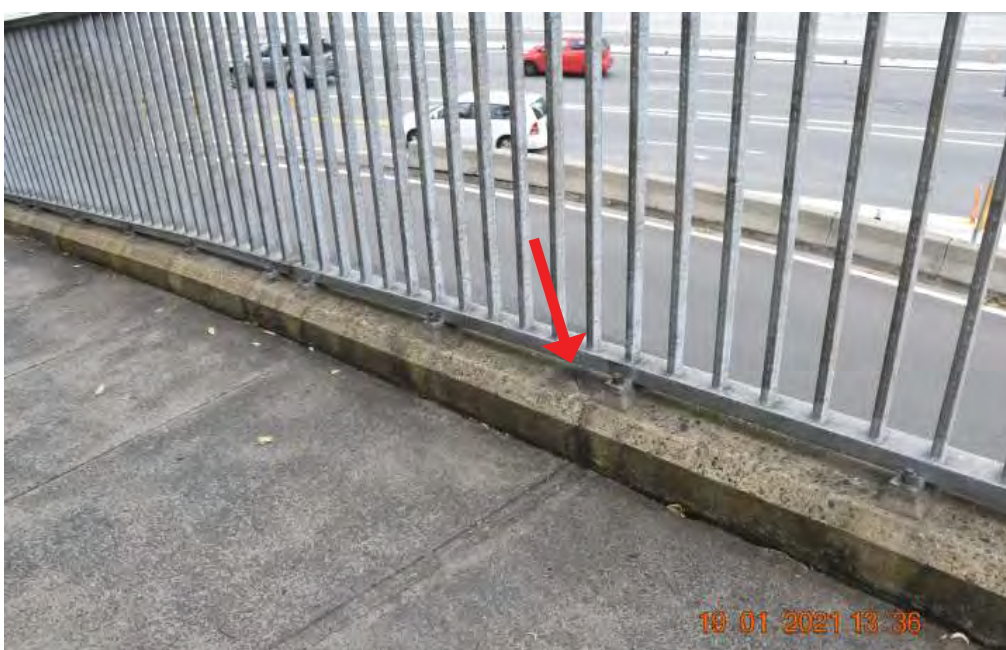
Figure: 1843

Cracking in the kerb on the east side of the cycle way.

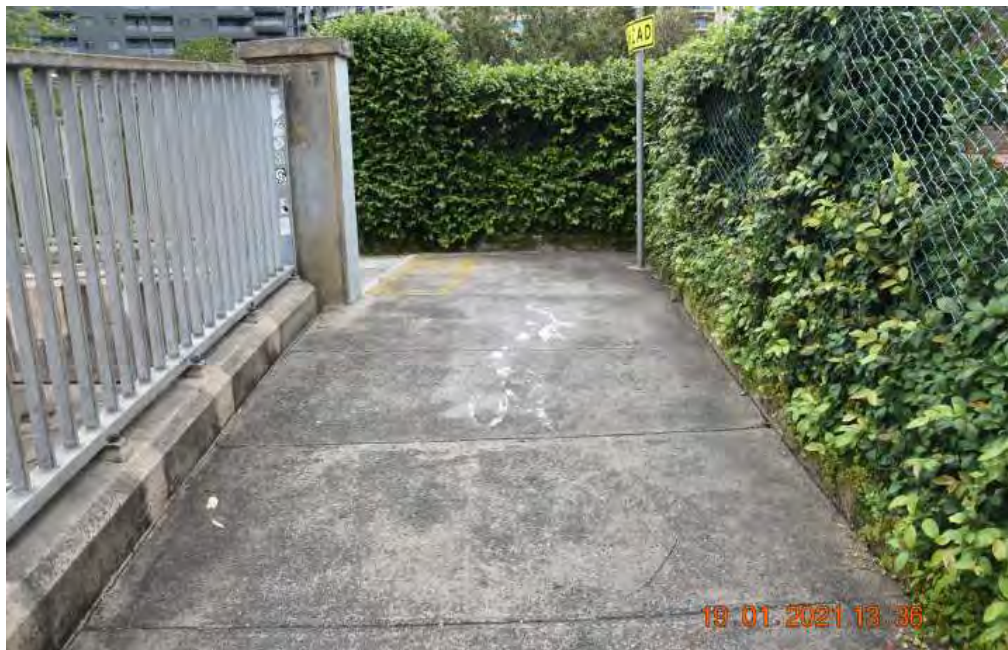
Figure: 1844

Cracking in the kerb on the east side of the cycle way.
