## PRE CONSTRUCTION CONDITION SURVEY

Fort Street Public School, Millers Point NSW

Upper Fort Street Public School  
MILLERS POINT NSW 2000

19 January 2021

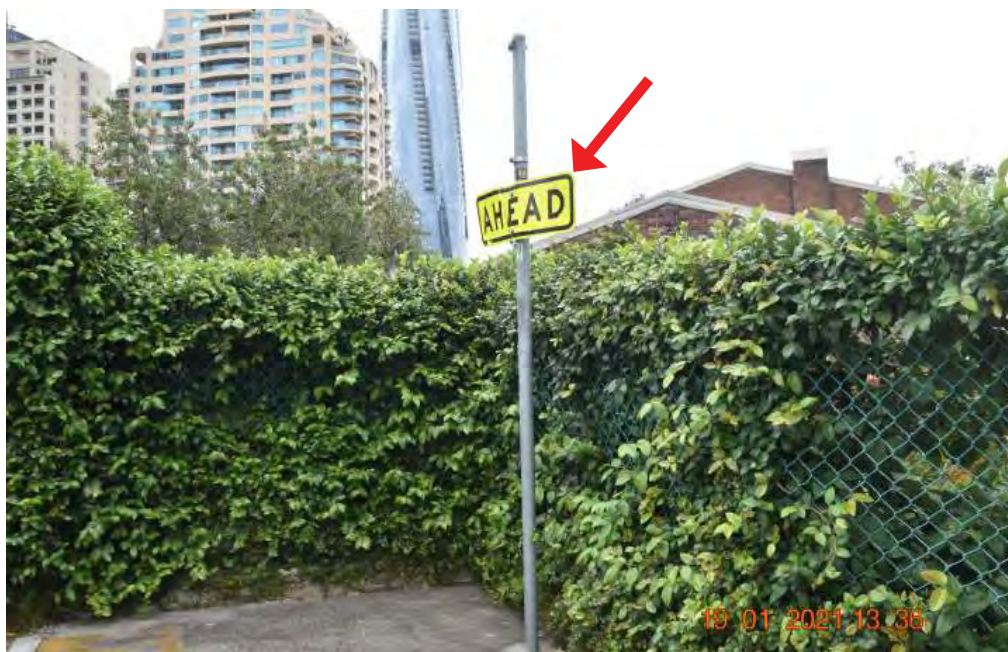
Figure: 1845

General view of the cycle way.

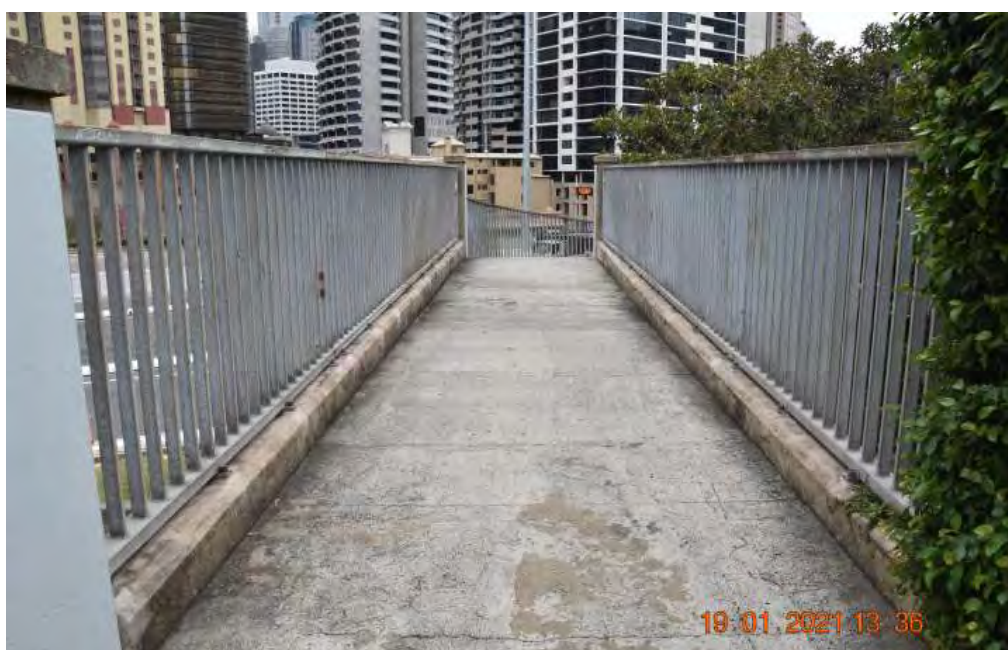
Figure: 1846

Damage in the street sign in the cycle way.

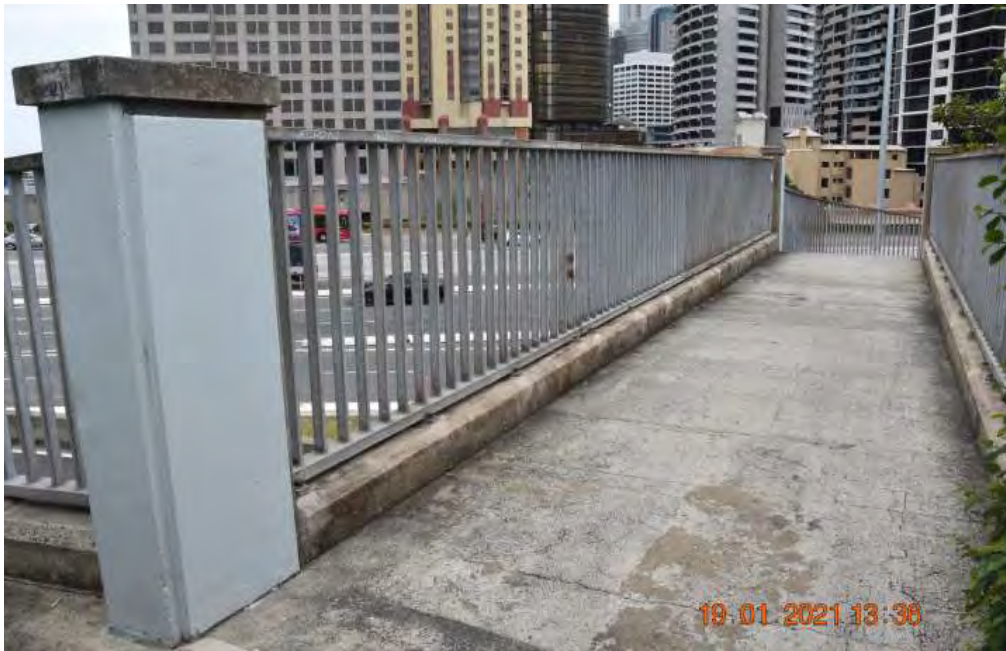
Figure: 1847

General view of the cycle way.

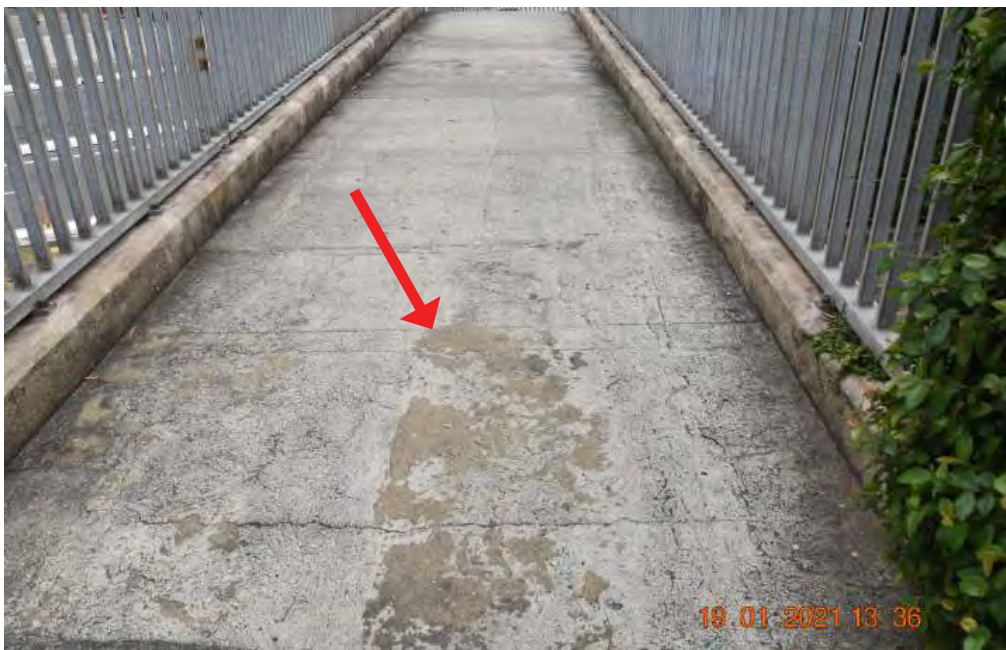
Figure: 1848

General view of the cycle way.

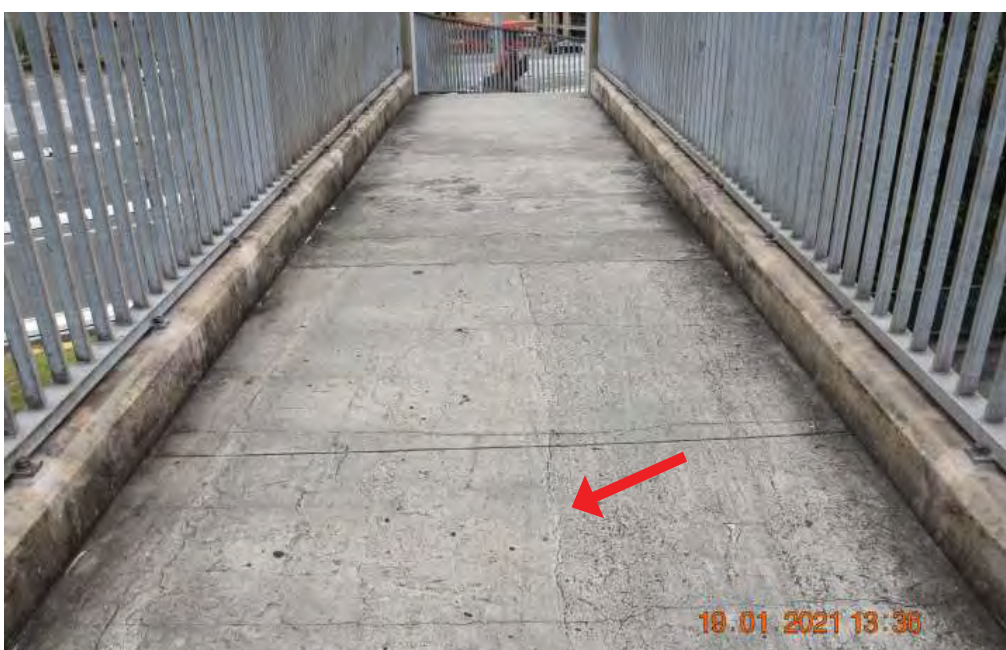
Figure: 1849

Cracking in the cycle way.

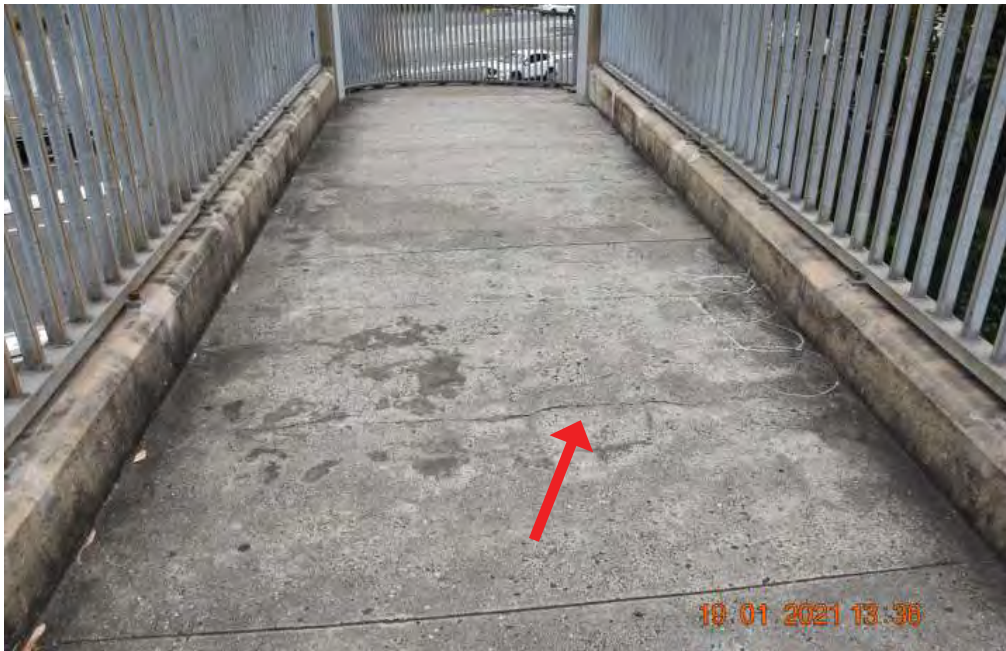
Figure: 1850

Cracking in the cycle way.

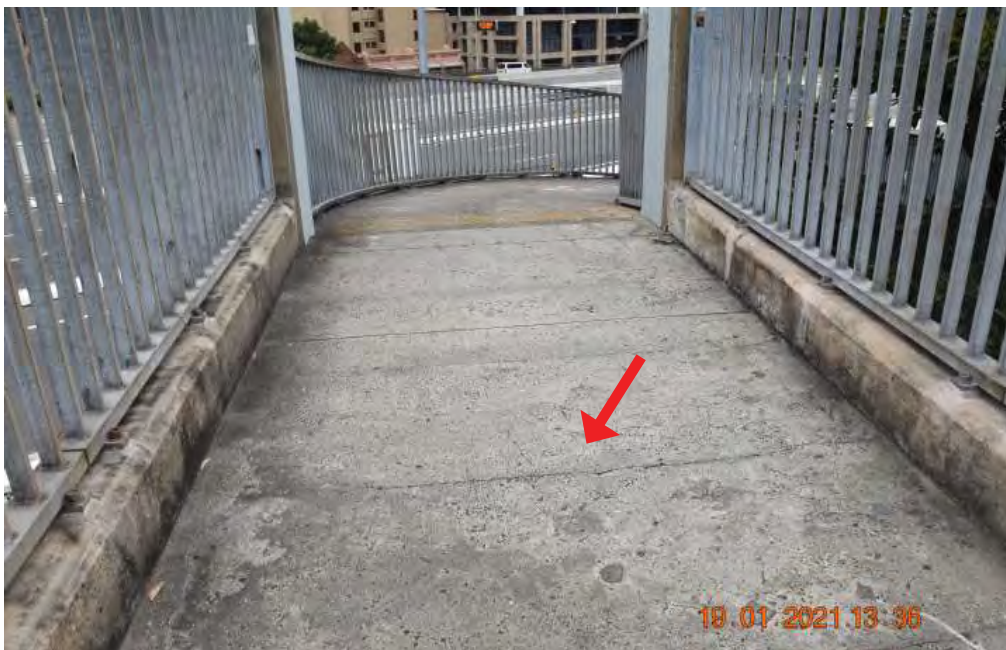
Figure: 1851

Cracking in the cycle way.

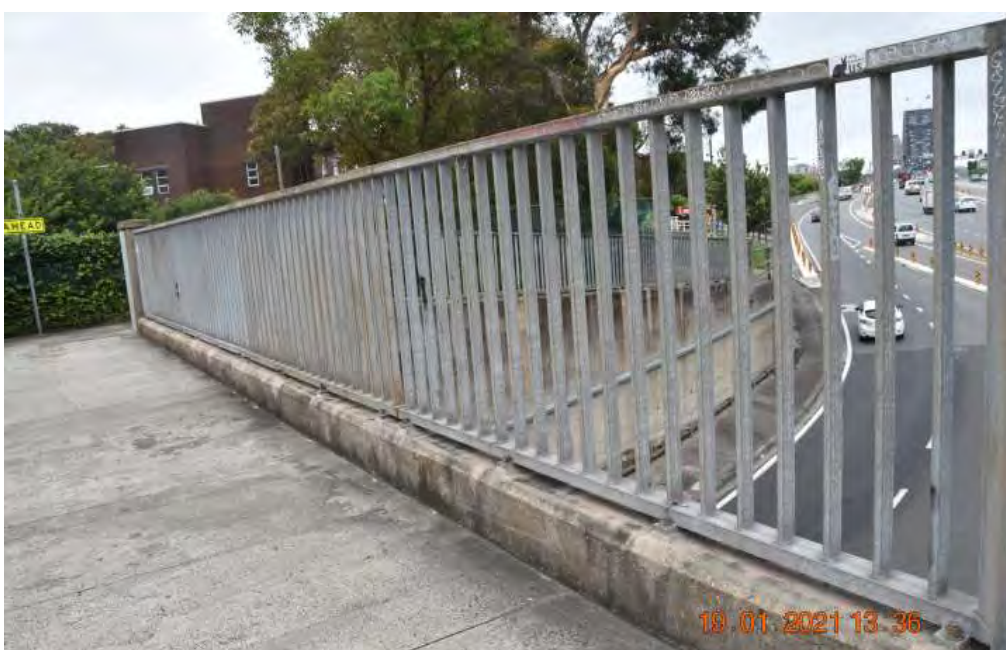
Figure: 1852

Cracking in the cycle way.

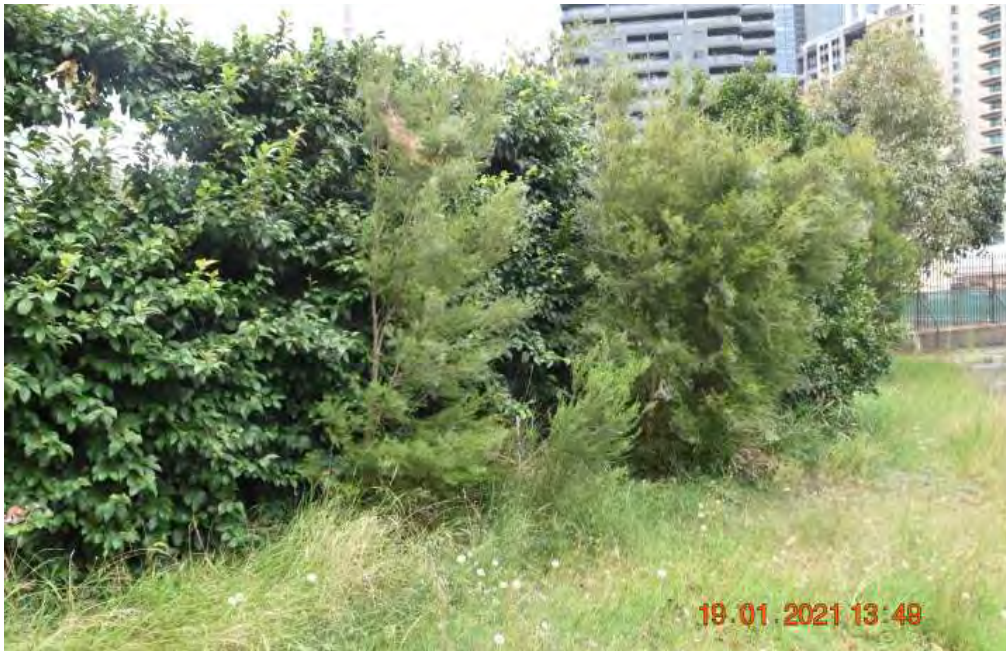
Figure: 1862

General view of the fence on the east side of the property. Showing obstructed view.

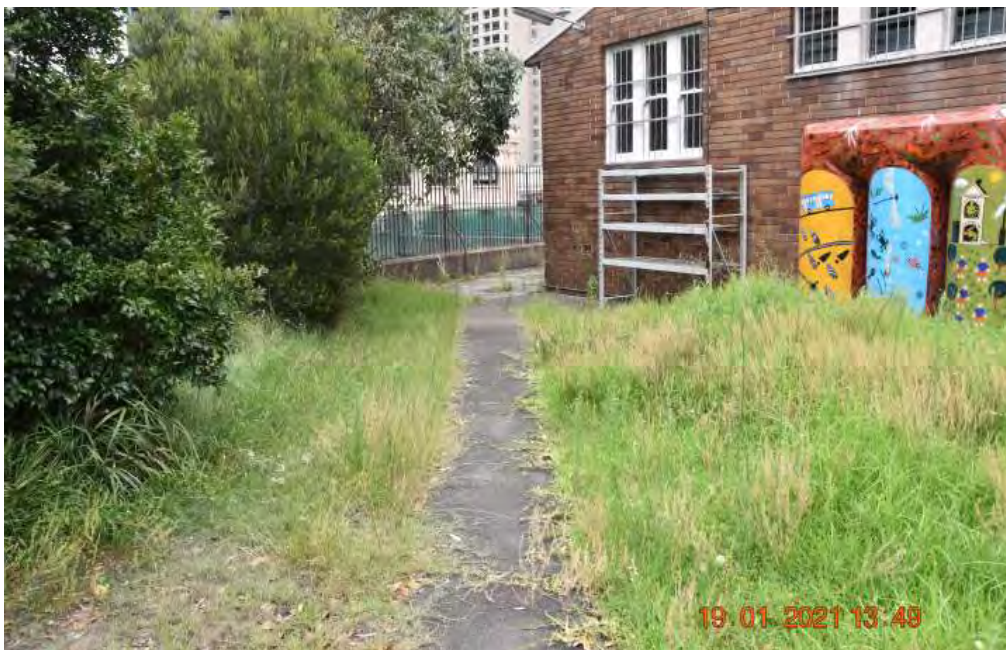
Figure: 1863

General view of the fence on the east side of the property. Showing obstructed view.

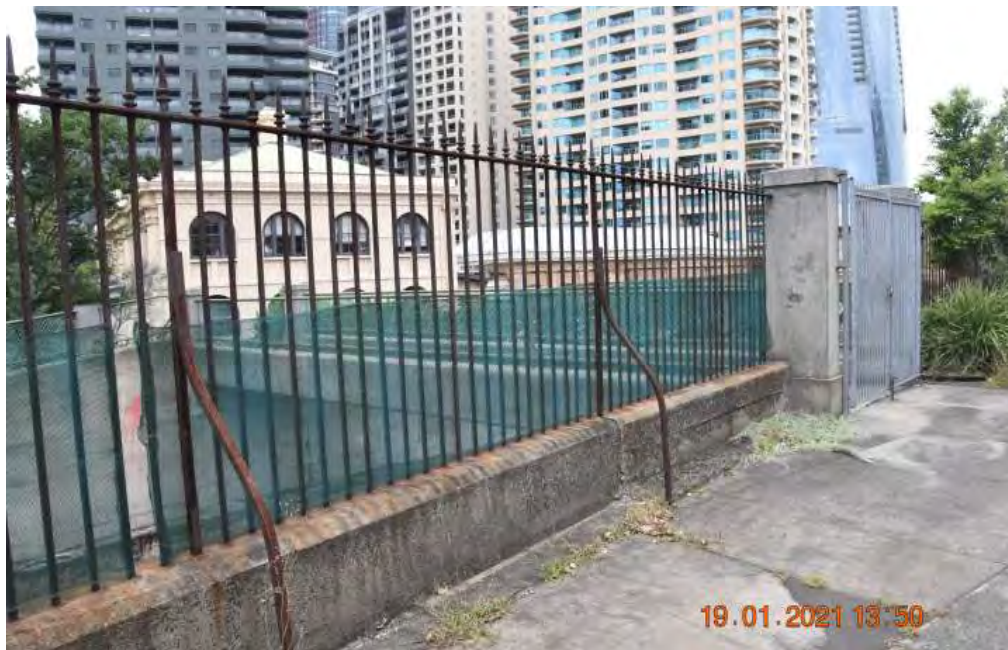
Figure: 1868

Separation in the base of the fence on the south side of building G.

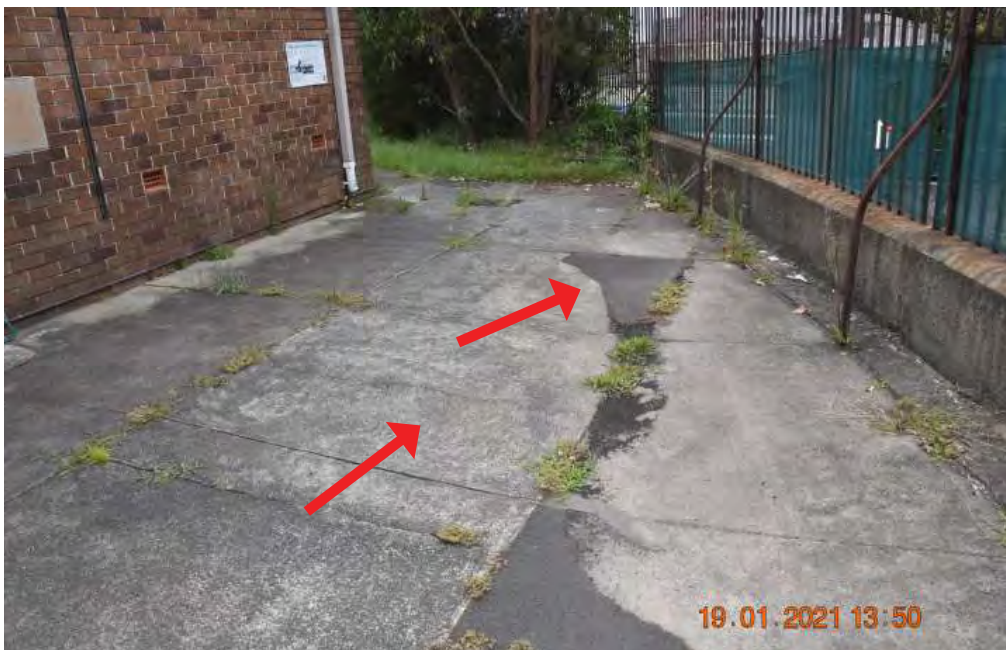
Figure: 1875

General view of the fence on the south side of building G. Showing cracking in the base.

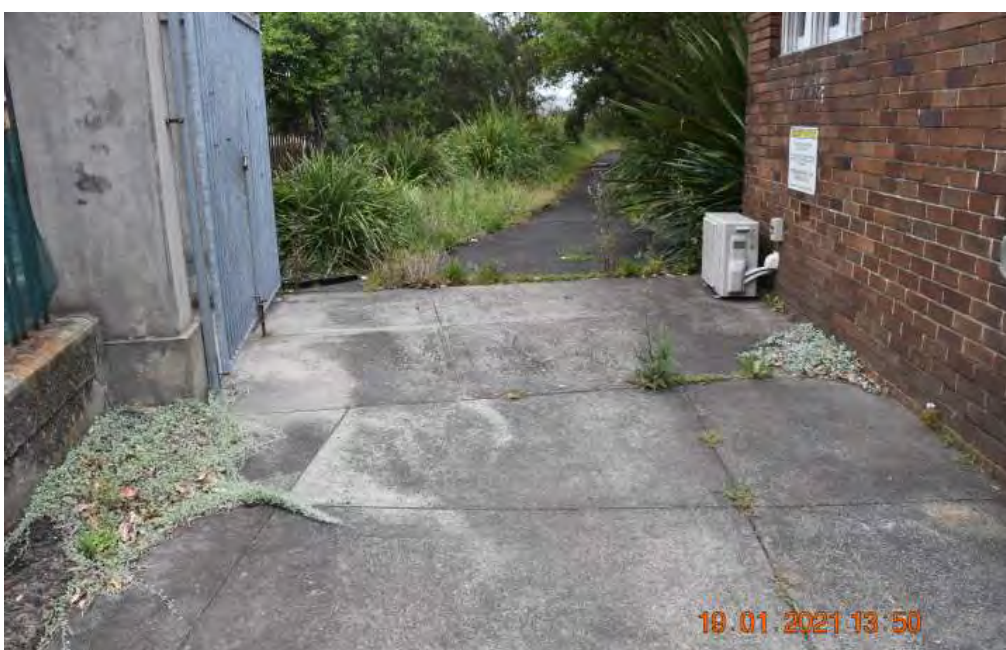
Figure: 1876

General view of the paving on the south side of building G. Showing cracking and patching.

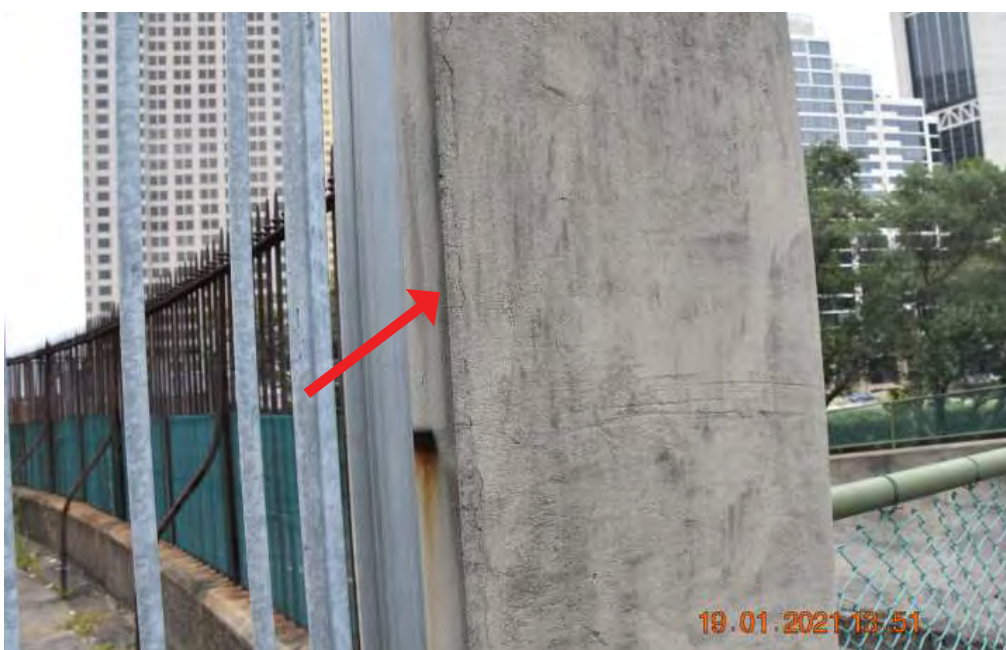
Figure: 1879

Cracking in the post on the east side of the pedestrian bridge on the south side of building G.

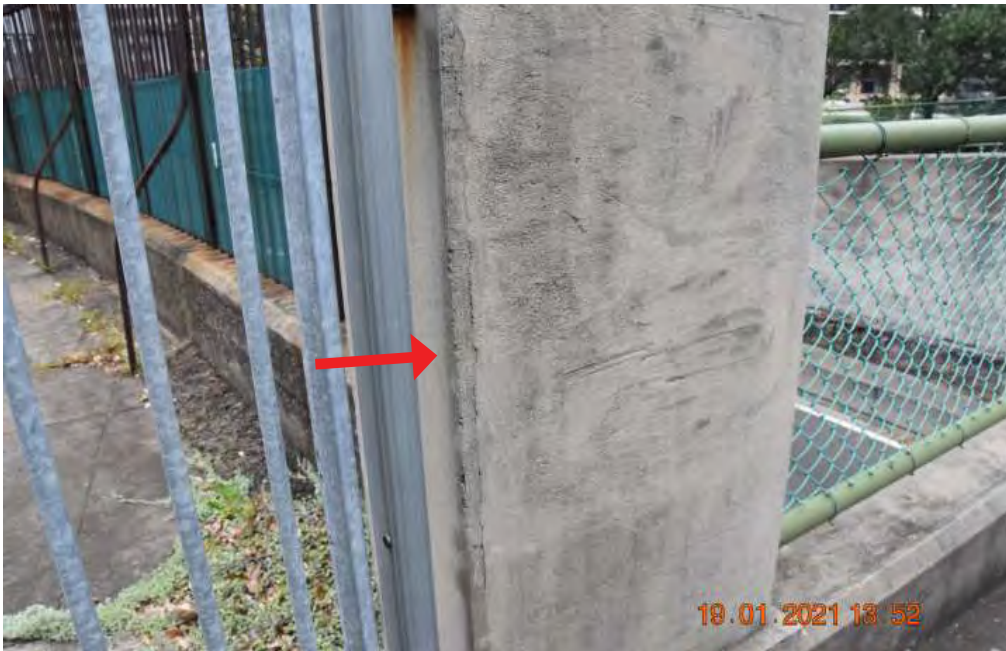
Figure: 1881

Cracking in the post on the east side of the pedestrian bridge on the south side of building G.

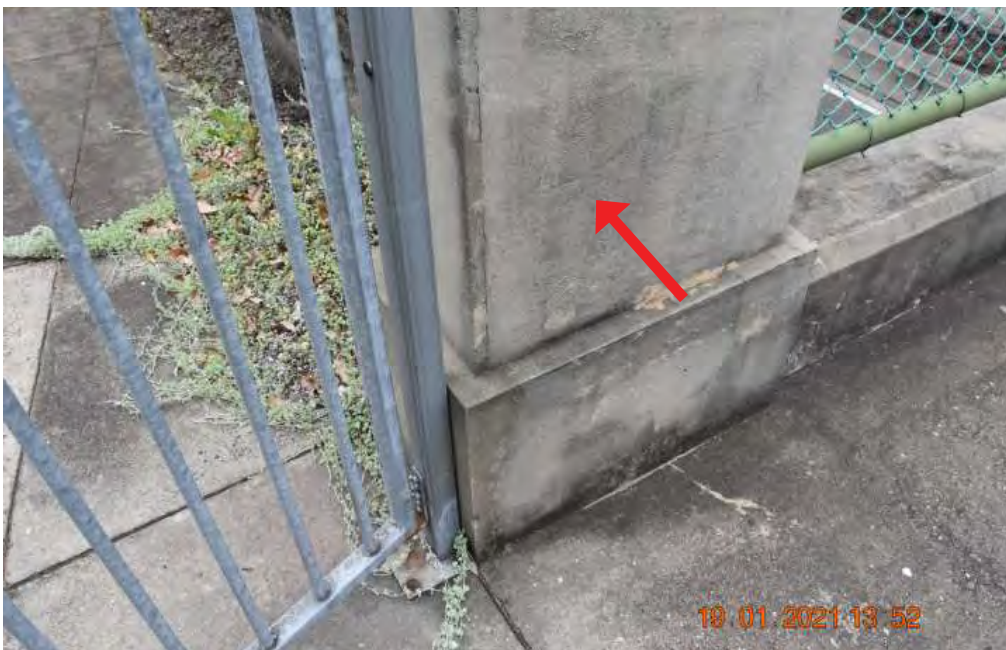
Figure: 1882

Cracking in the post on the east side of the pedestrian bridge on the south side of building G.

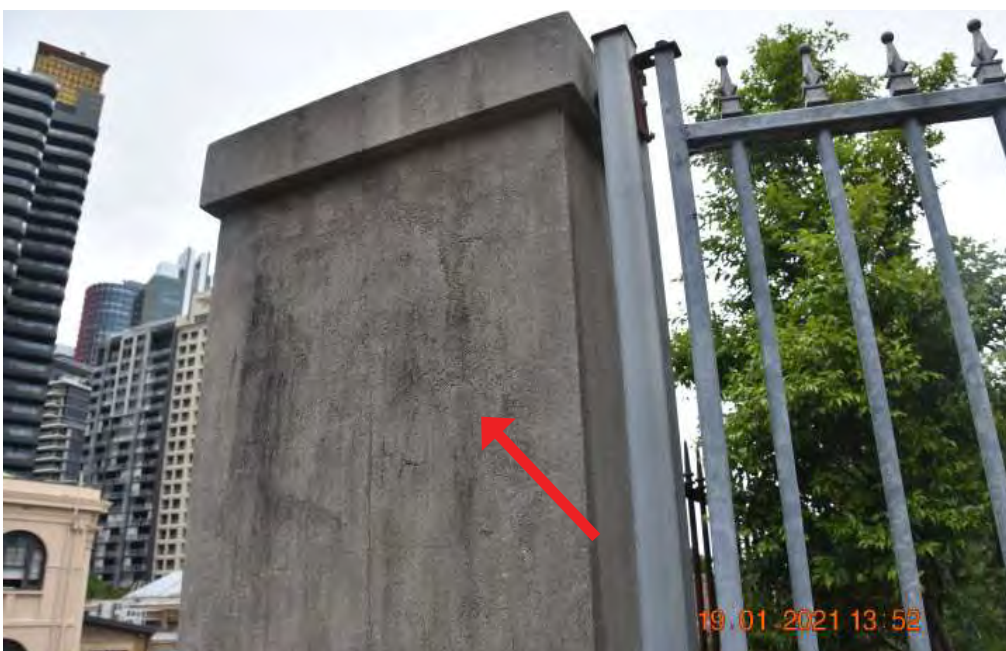
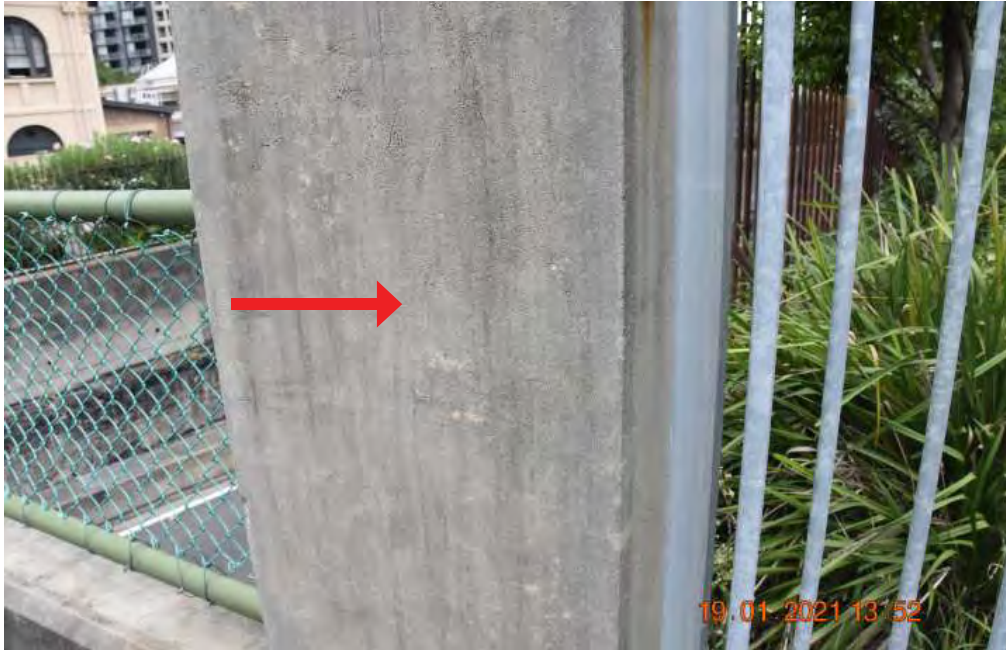
Figure: 1883

Crazing in the post on the west side of the pedestrian bridge on the south side of building G.

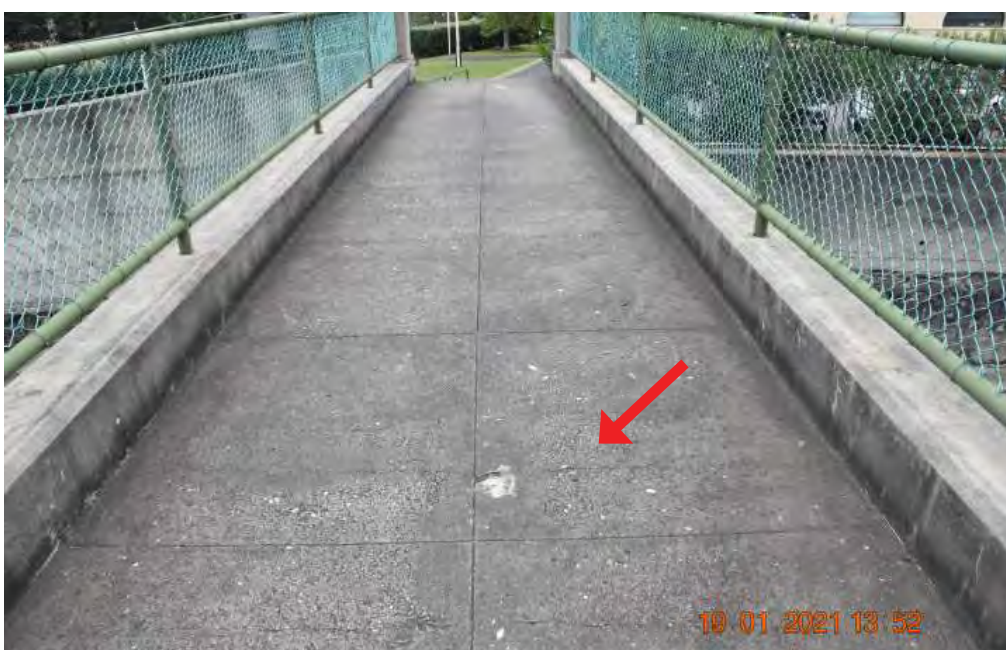
Figure: 1885

Cracking in the pedestrian bridge on the south side of building G.

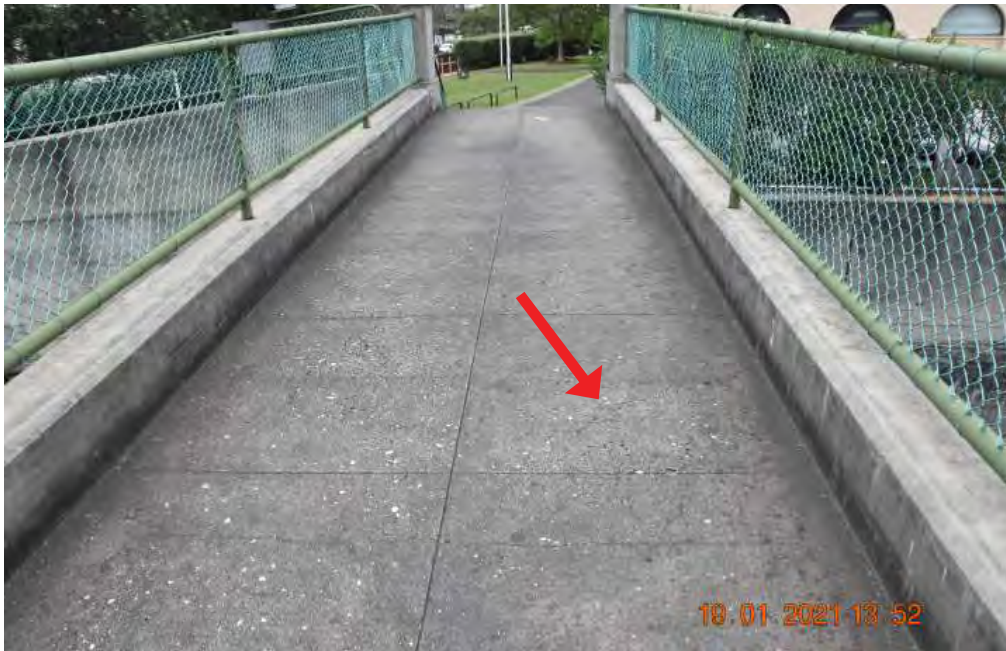
Figure: 1886

Cracking in the pedestrian bridge on the south side of building G.

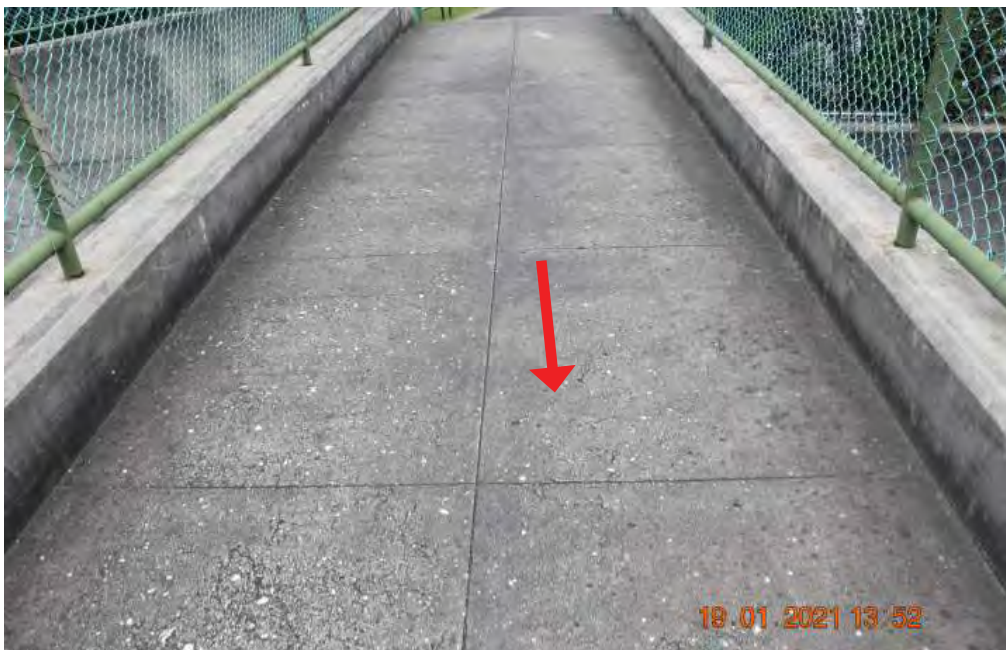
Figure: 1887

Cracking in the pedestrian bridge on the south side of building G.

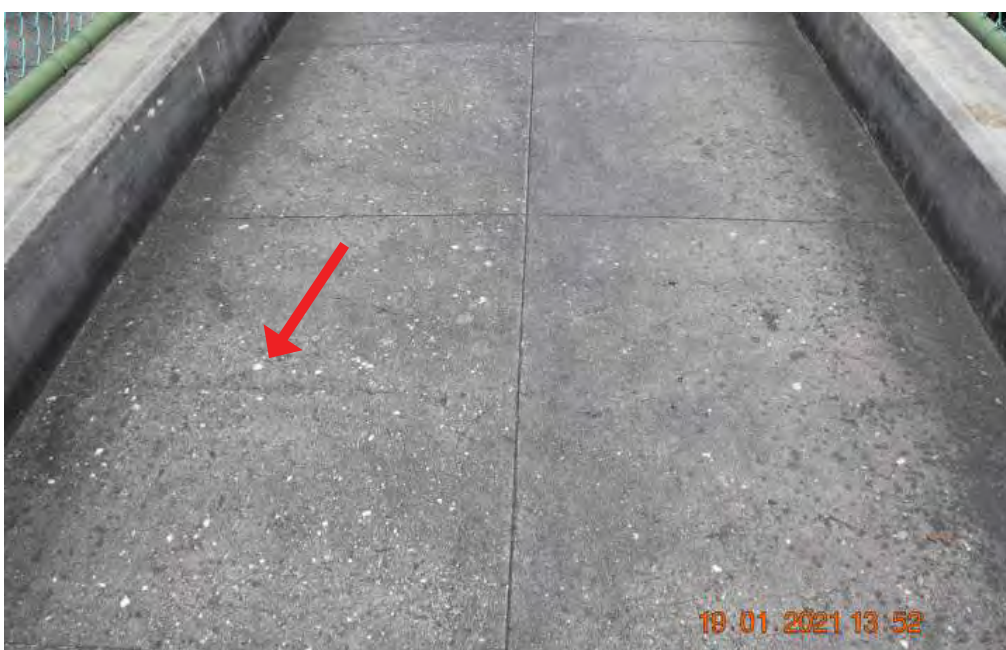
Figure: 1888

Cracking in the pedestrian bridge on the south side of building G.

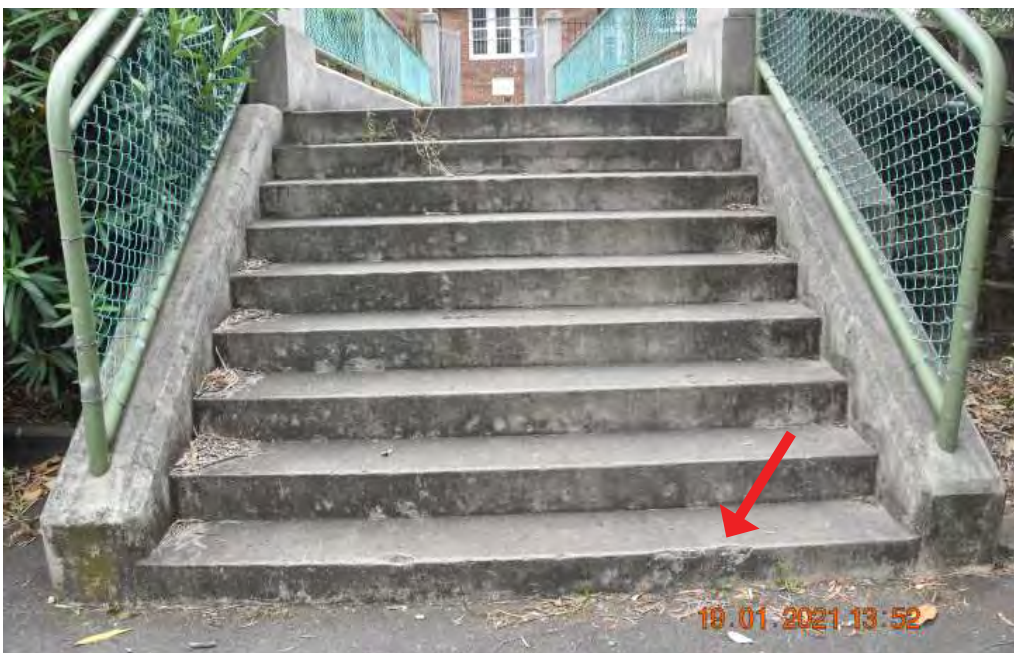
Figure: 1892

General view of the steps on the south side of the pedestrian bridge on the south side of building G. Showing chipping.

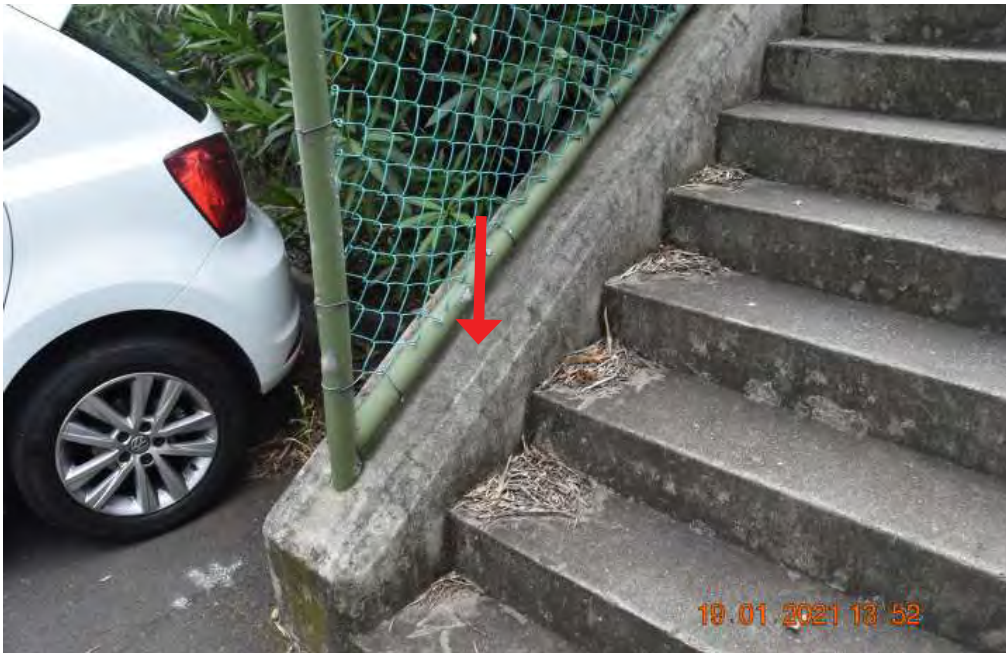
Figure: 1894

Crazing in the wing wall of the steps on the south side of the pedestrian bridge on the south side of building G.

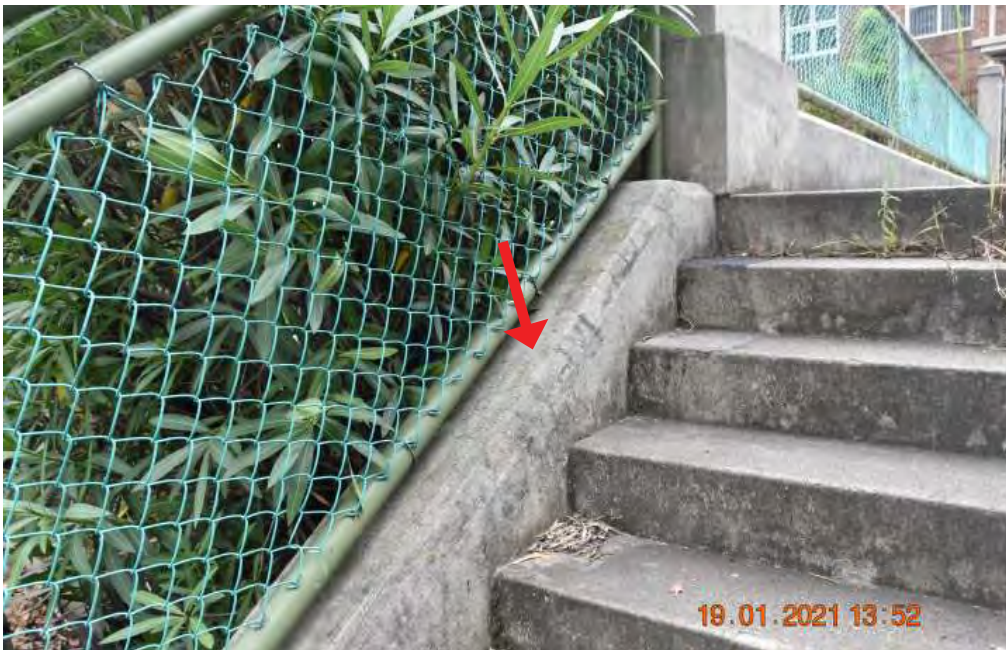
Figure: 1895

Crazing in the wing wall of the steps on the south side of the pedestrian bridge on the south side of building G.

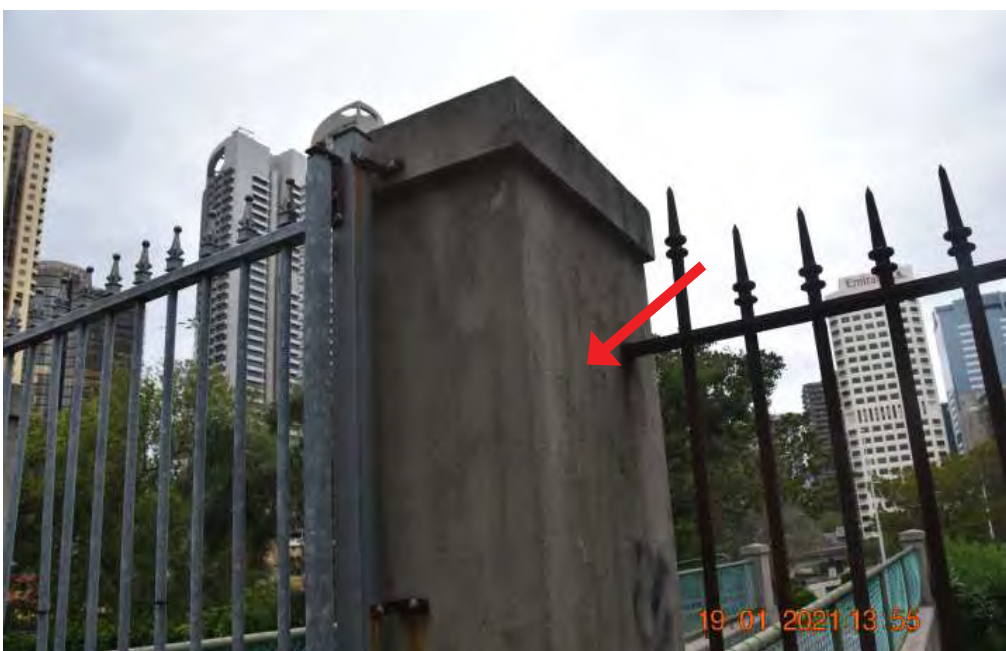
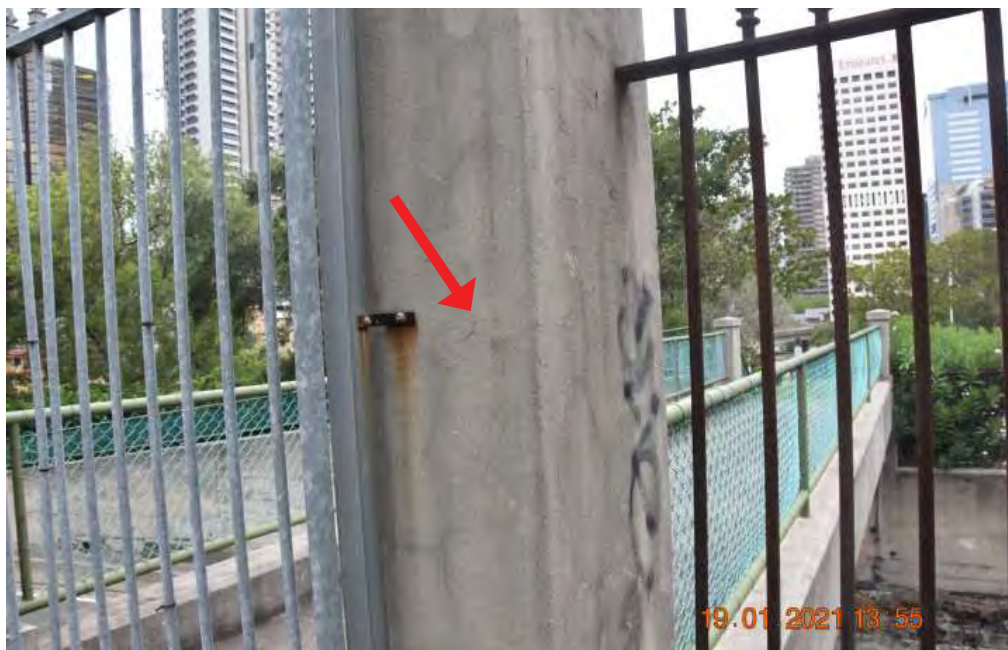
Figure: 1911

Cracking in the post on the west side of the pedestrian bridge.

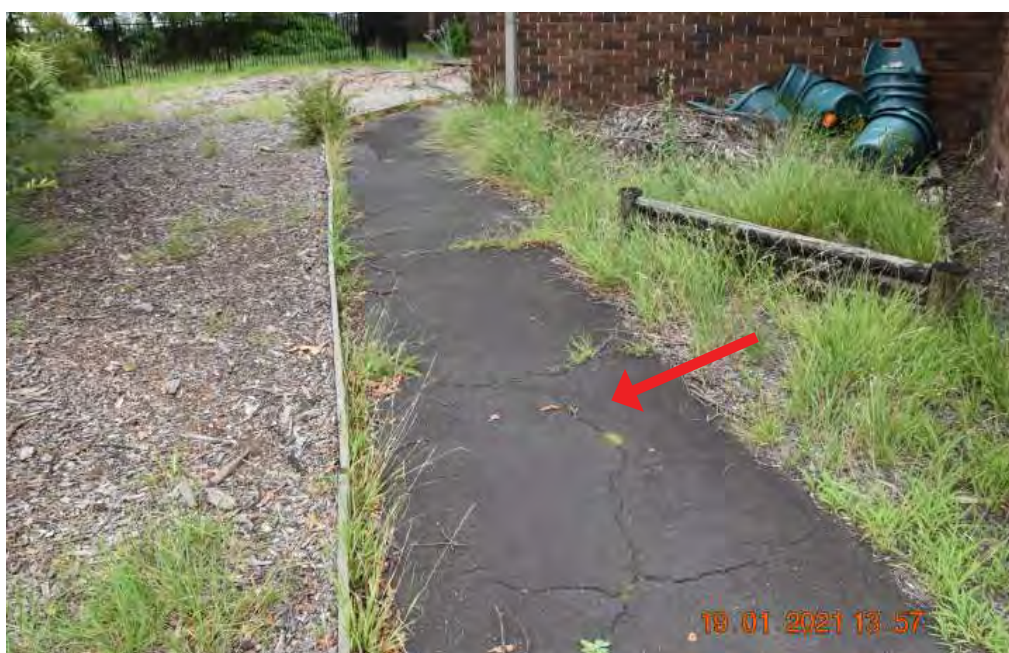
Figure: 1925

Cracking in the paving on the west side of building J.

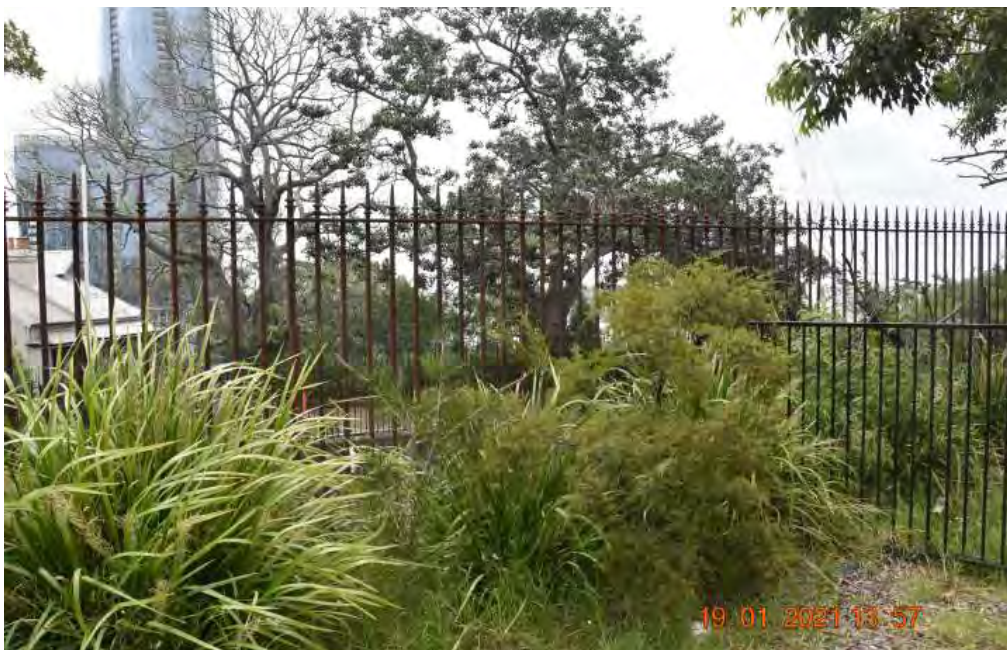
Figure: 1929

General view of the fence on the south side of building J.

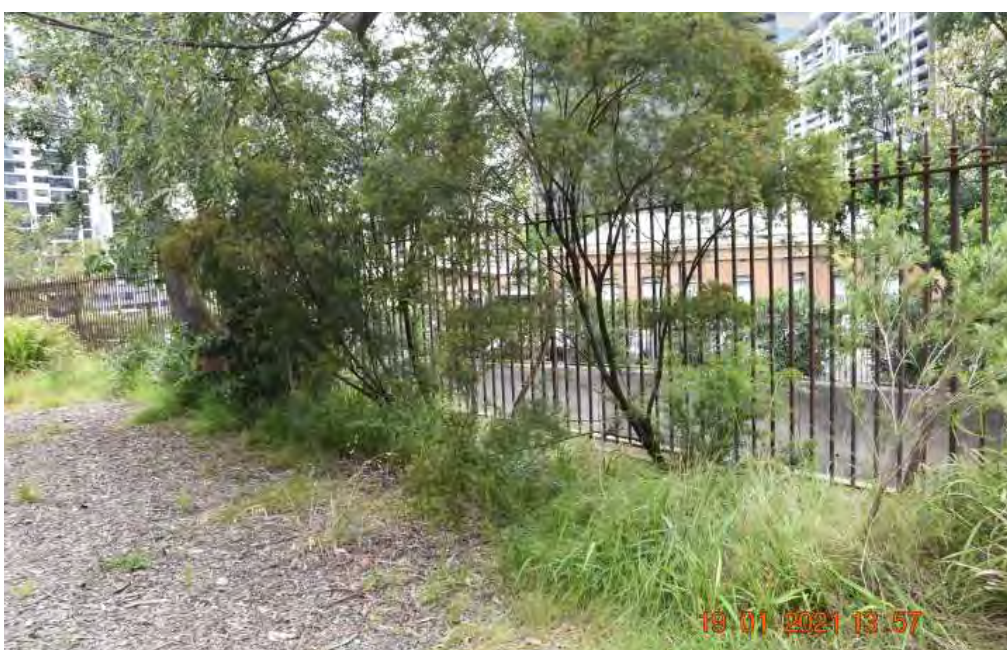
Figure: 1930

General view of the fence on the south side of building J.

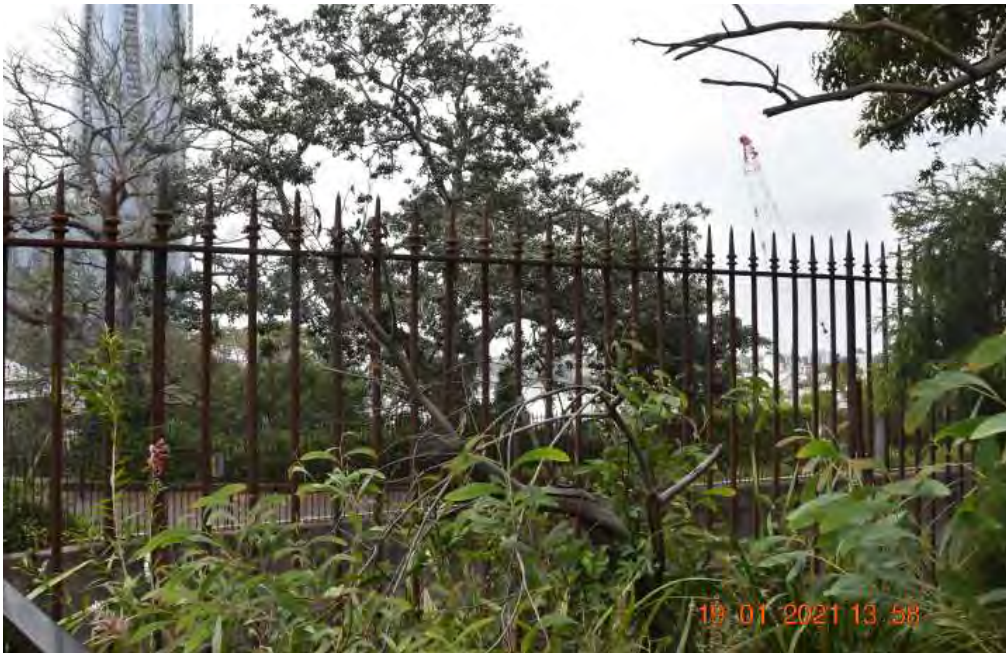
Figure: 1931

General view of the fence on the south side of building J.

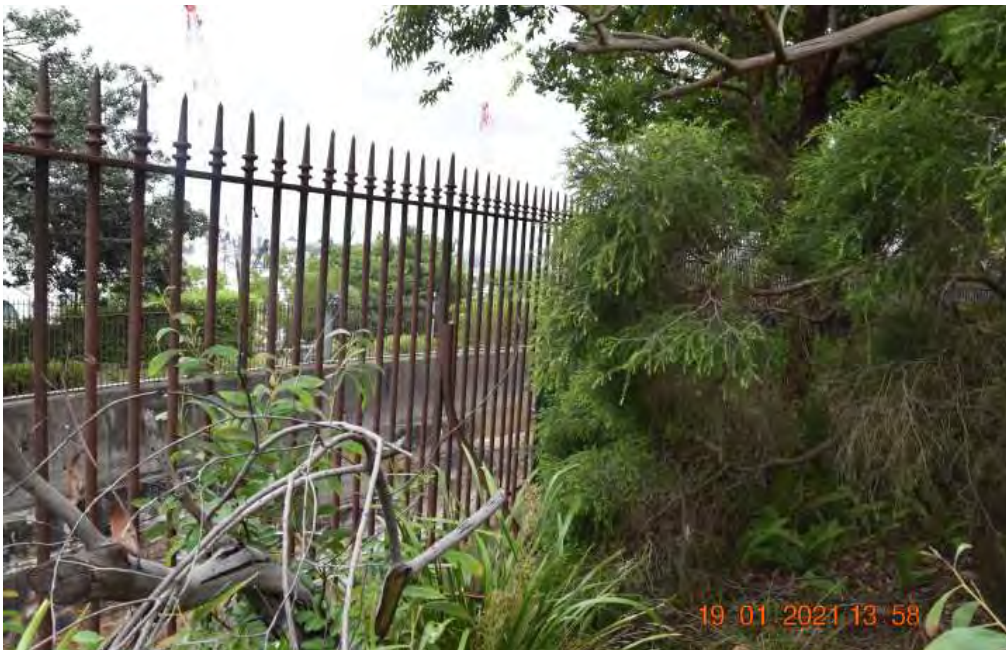
Figure: 1932

General view of the fence on the south side of building J.

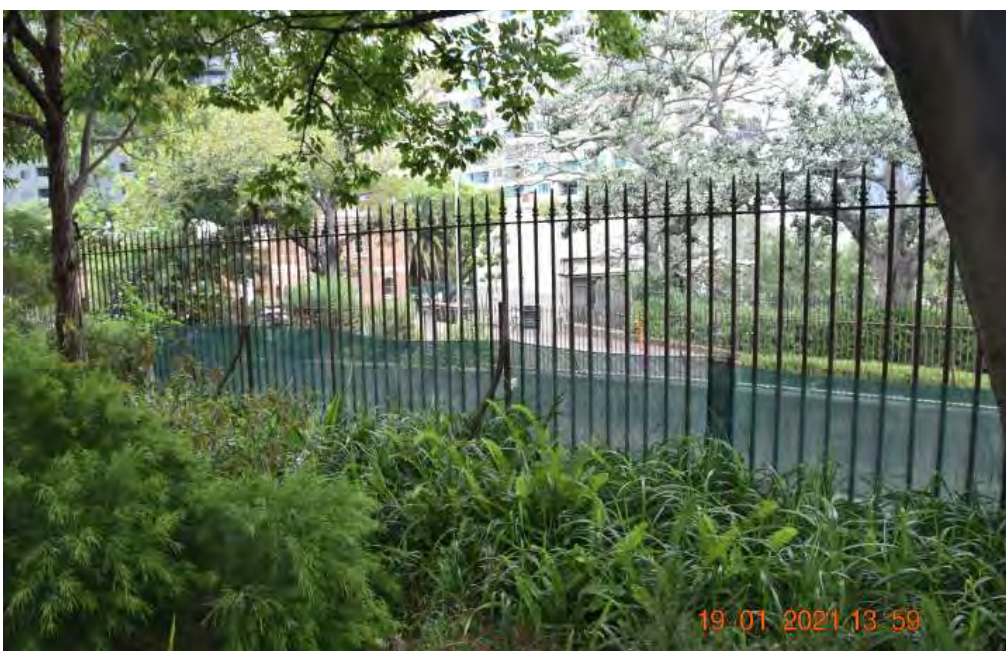
Figure: 1933

General view of the fence on the south side of building J. Showing obstructed view.

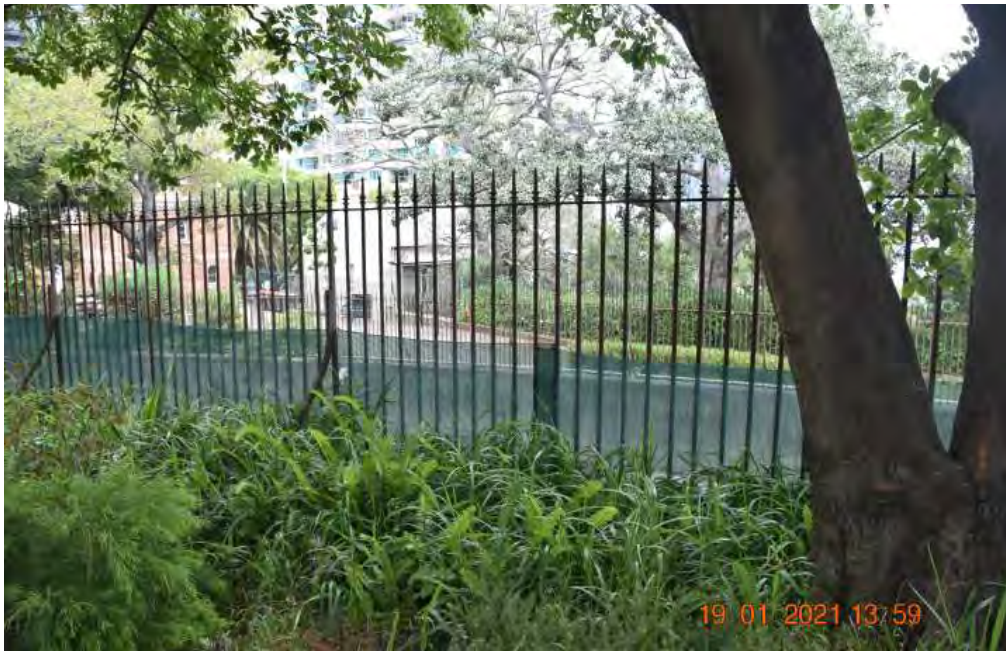
Figure: 1934

General view of the fence on the west side of the property, looking from building F.
