## PRE CONSTRUCTION CONDITION SURVEY

Fort Street Public School, Millers Point NSW

Upper Fort Street Public School  
MILLERS POINT NSW 2000

19 January 2021

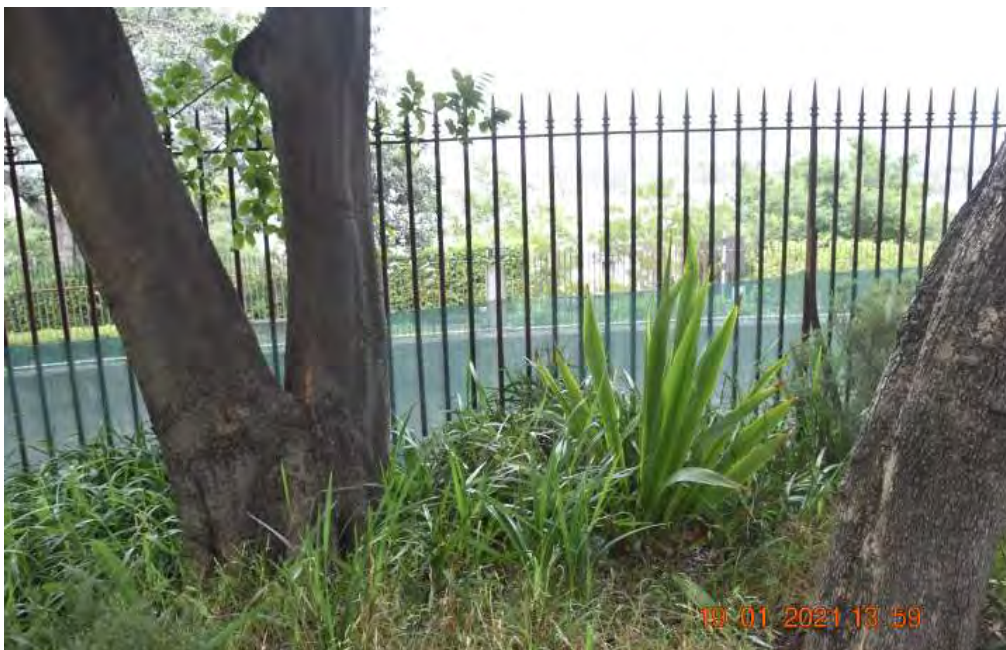
Figure: 1935

General view of the fence on the west side of the property, looking from building F.

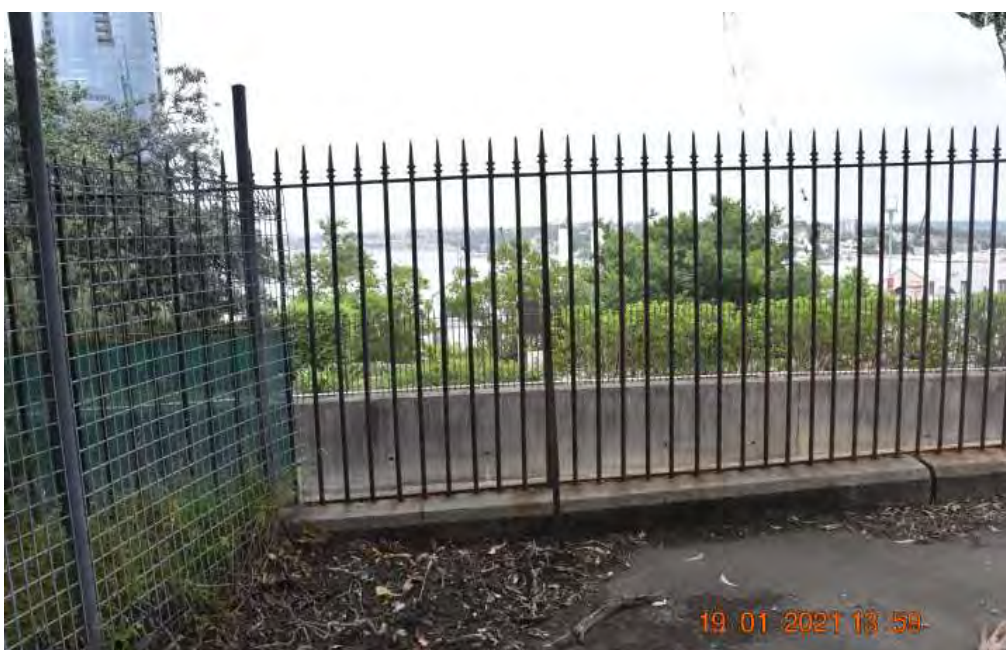
Figure: 1936

General view of the fence on the west side of the property, looking from building F.

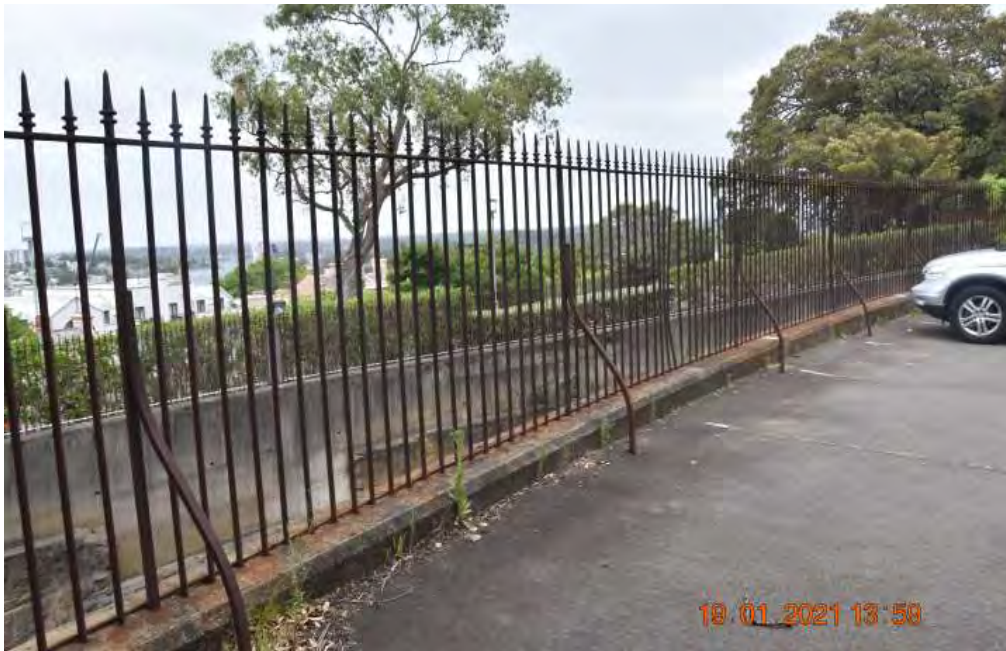
Figure: 1937

General view of the fence on the west side of the property, looking from building F.

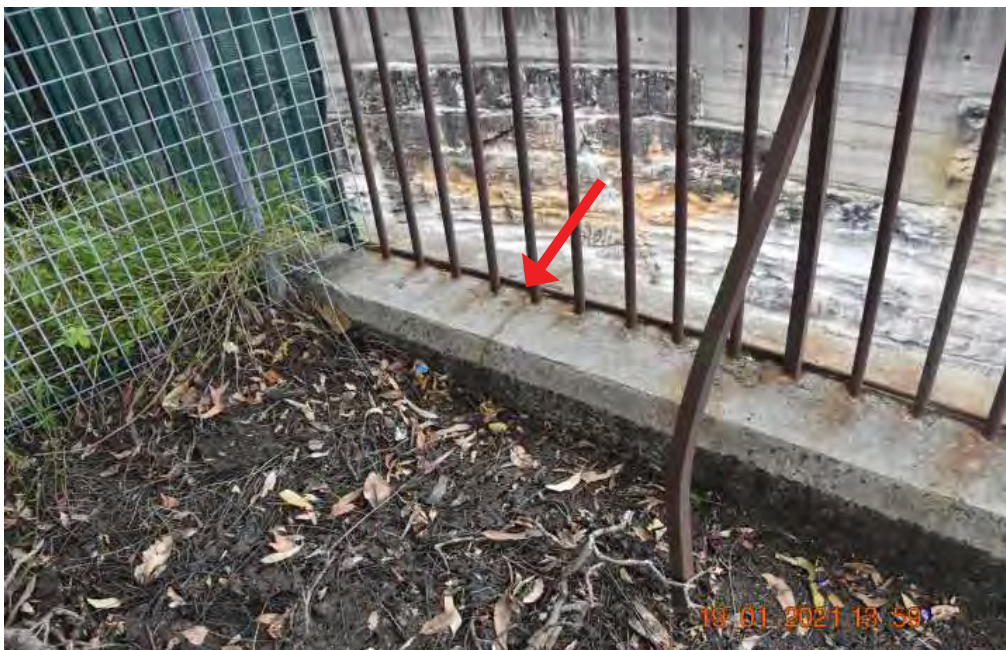
Figure: 1938

General view of the fence on the west side of the property, looking from building F.

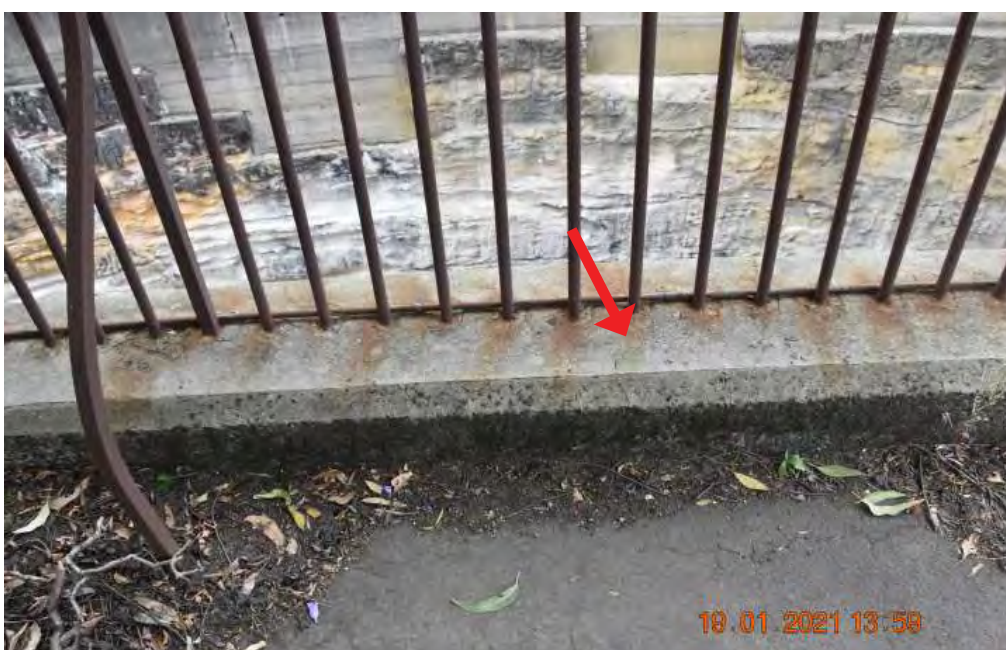
Figure: 1939

Cracking in the base of the fence on the west side of the property, looking from building F.

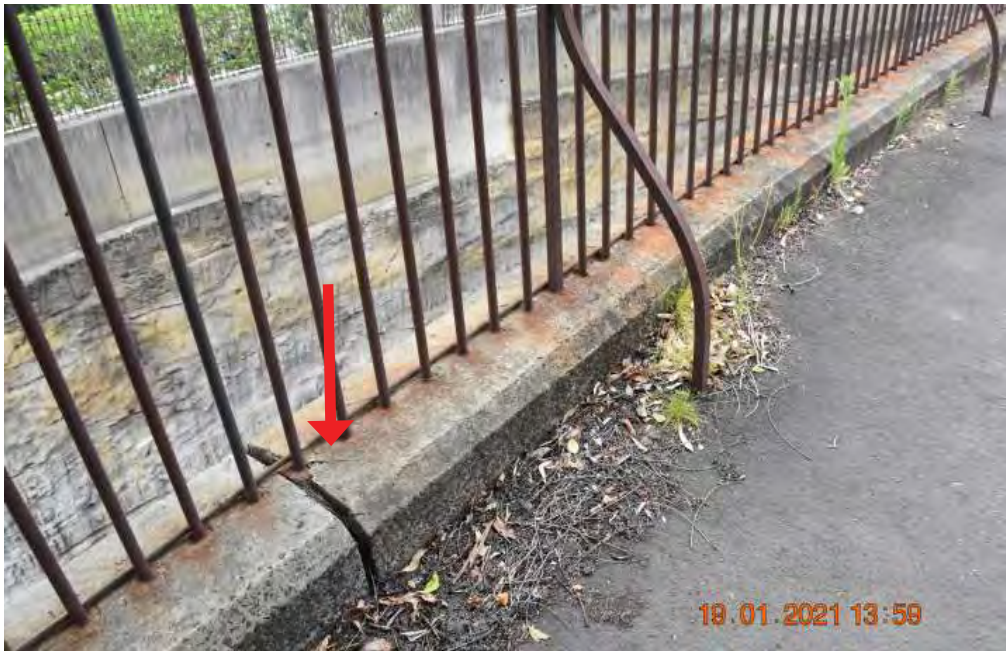
Figure: 1940

Cracking in the base of the fence on the west side of the property, looking from building F.

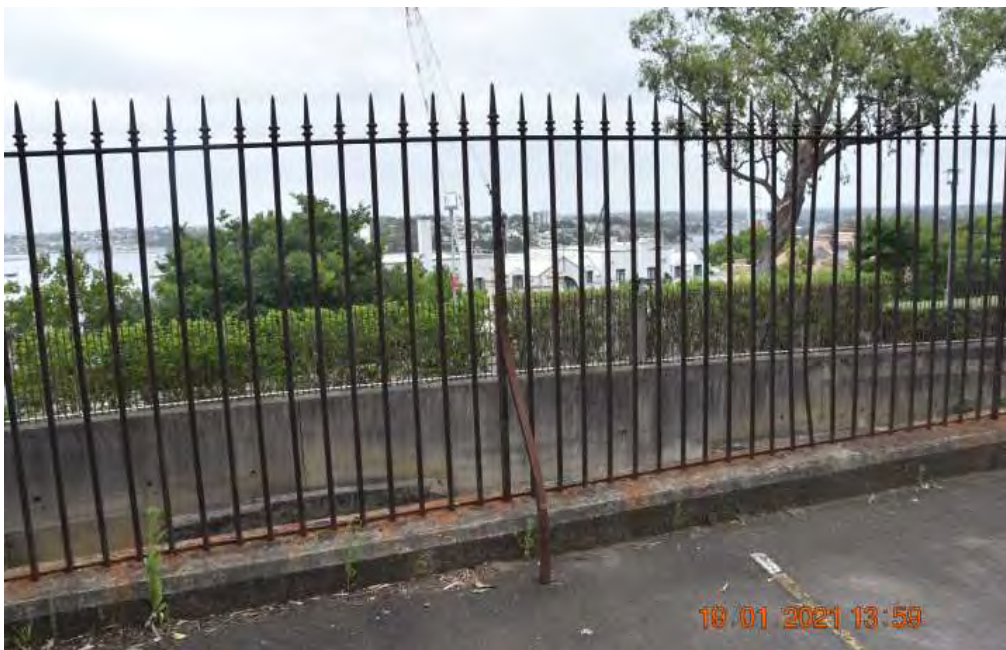
Figure: 1941

Cracking in the base of the fence on the west side of the property, looking from building F.

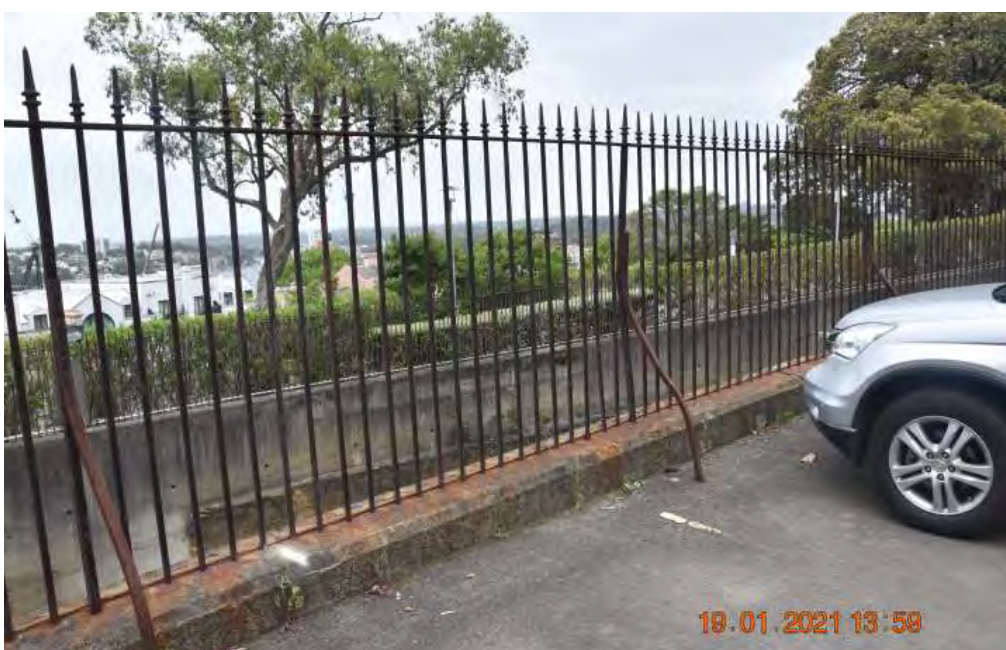
Figure: 1942

General view of the fence in the carpark on the west side of the property.

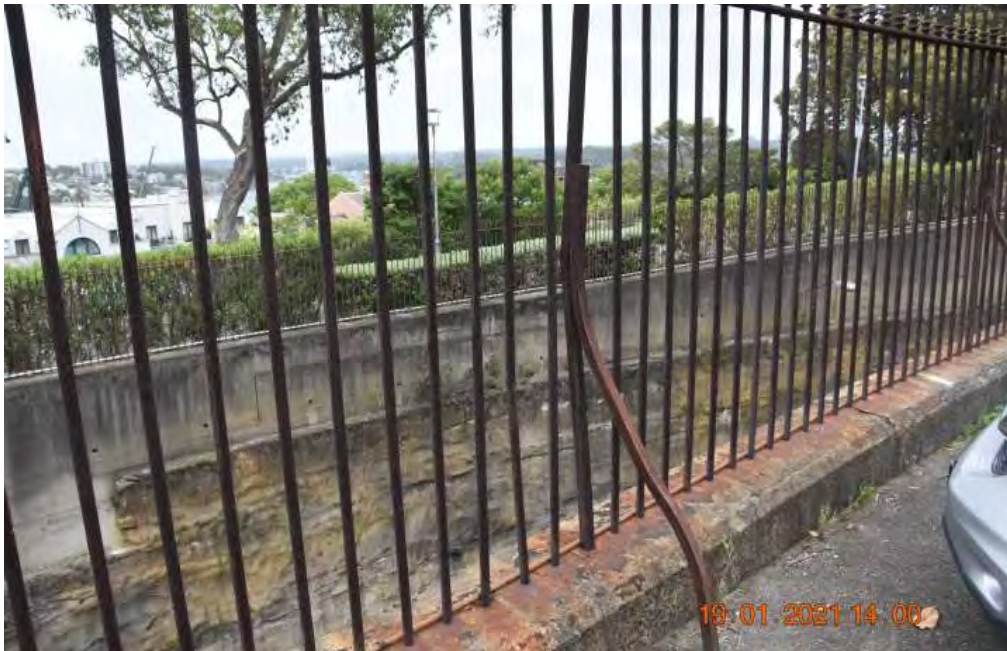
Figure: 1943

General view of the fence in the carpark on the west side of the property.

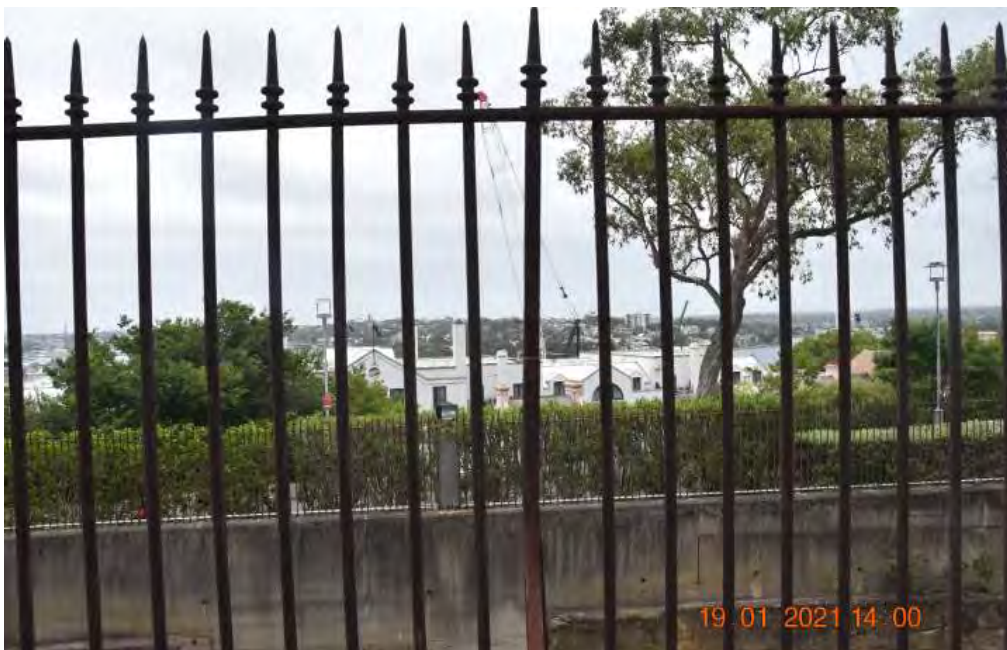
Figure: 1944

General view of the fence in the carpark on the west side of the property.

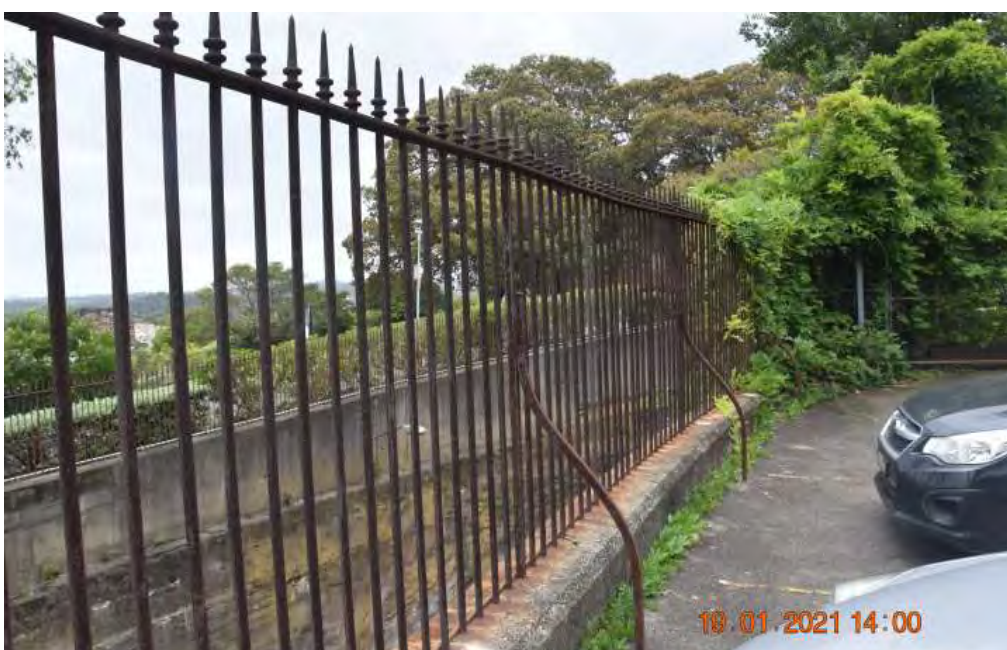
Figure: 1945

General view of the fence in the carpark on the west side of the property.

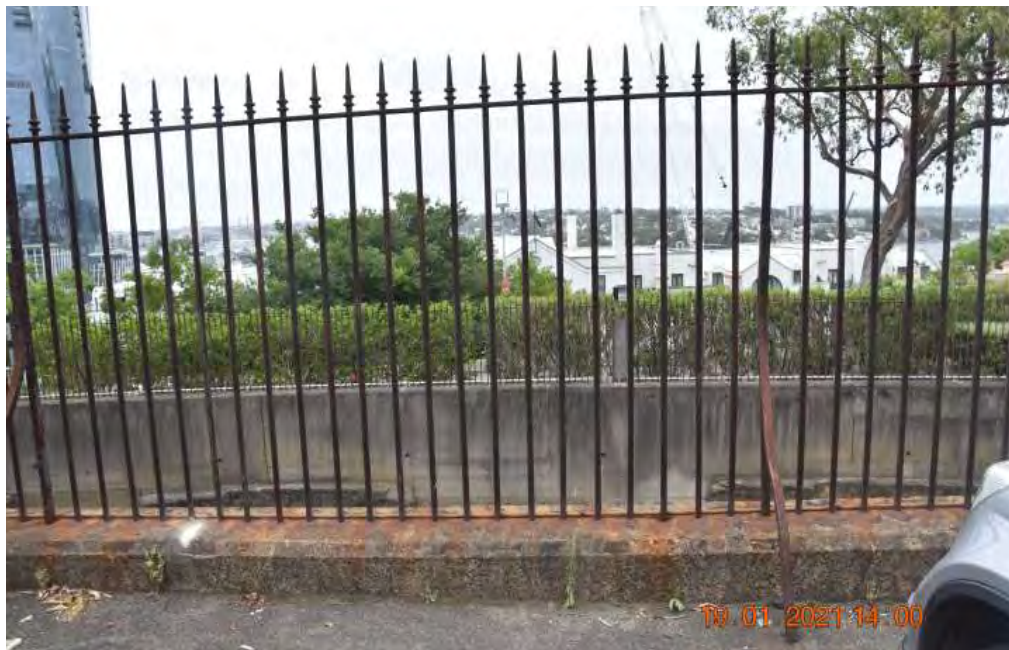
Figure: 1946

General view of the fence in the carpark on the west side of the property.

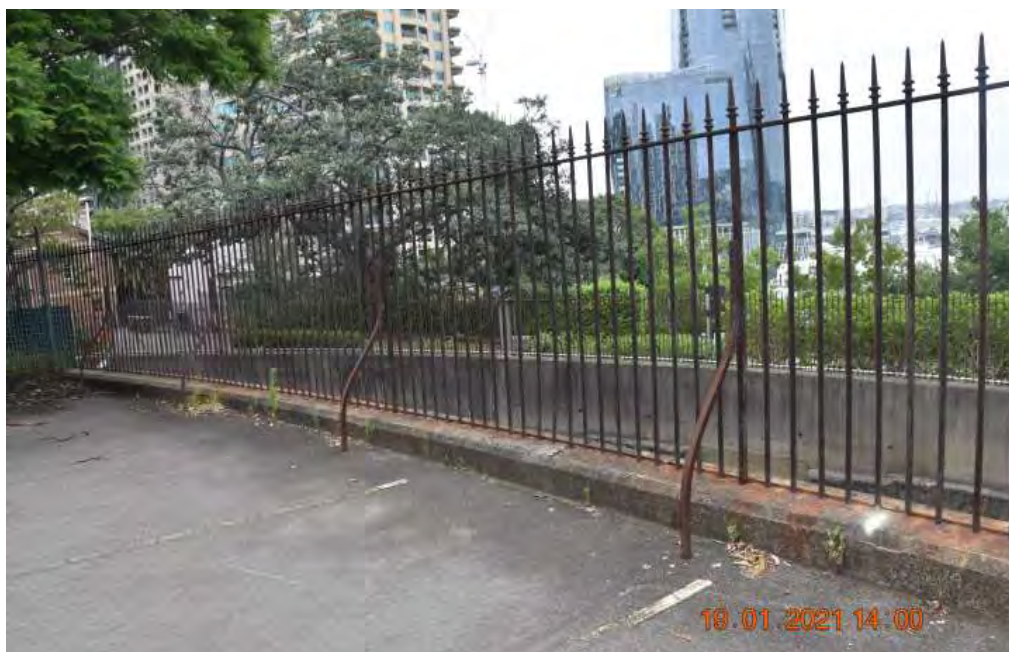
Figure: 1947

General view of the fence in the carpark on the west side of the property.

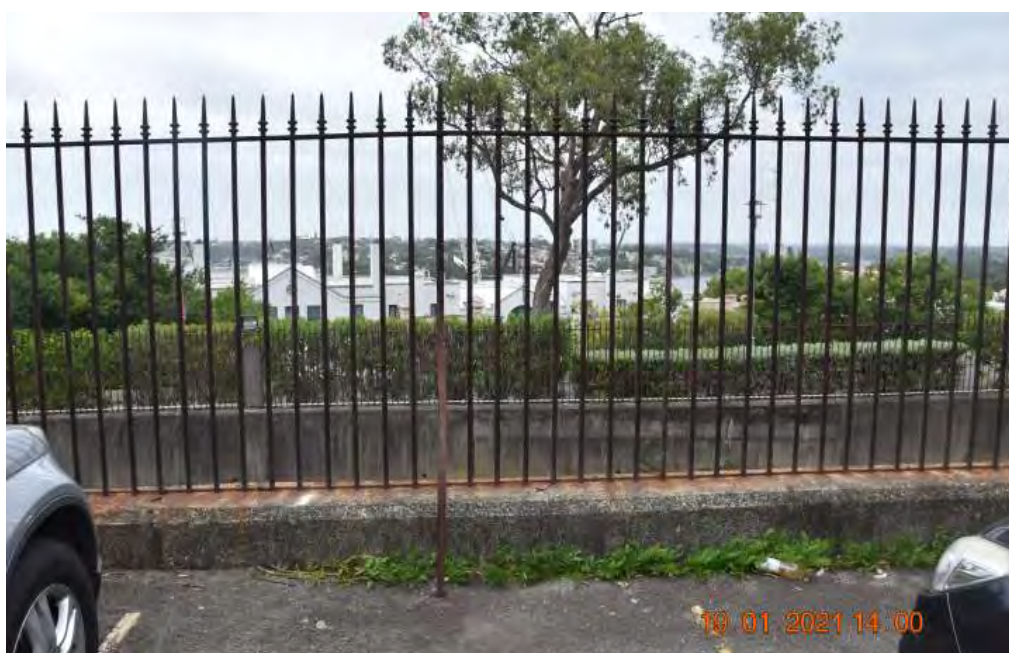
Figure: 1948

General view of the fence in the carpark on the west side of the property.

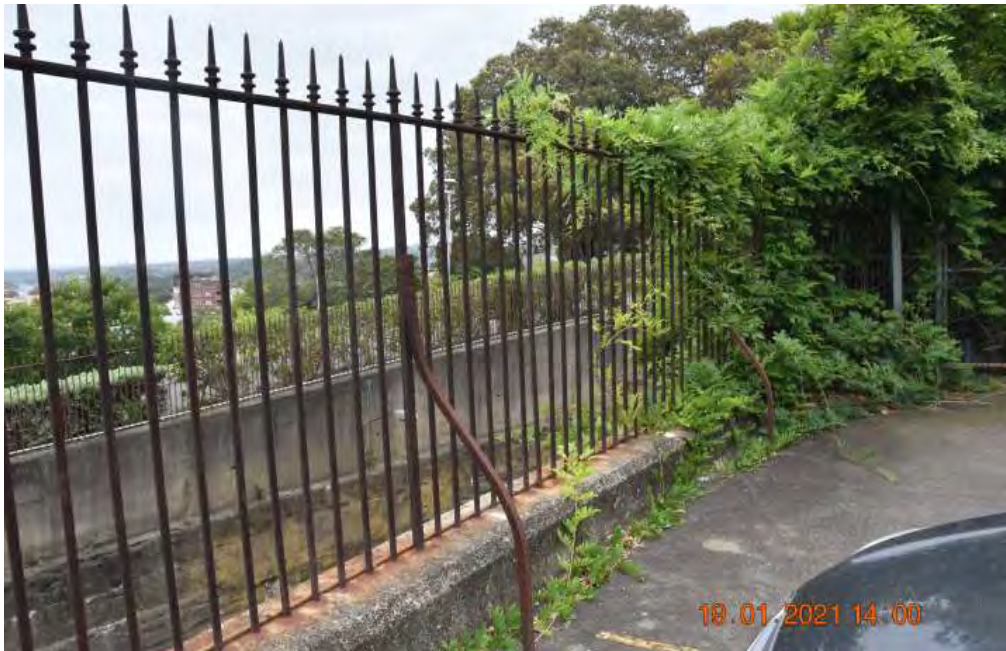
Figure: 1949

General view of the fence in the carpark on the west side of the property.

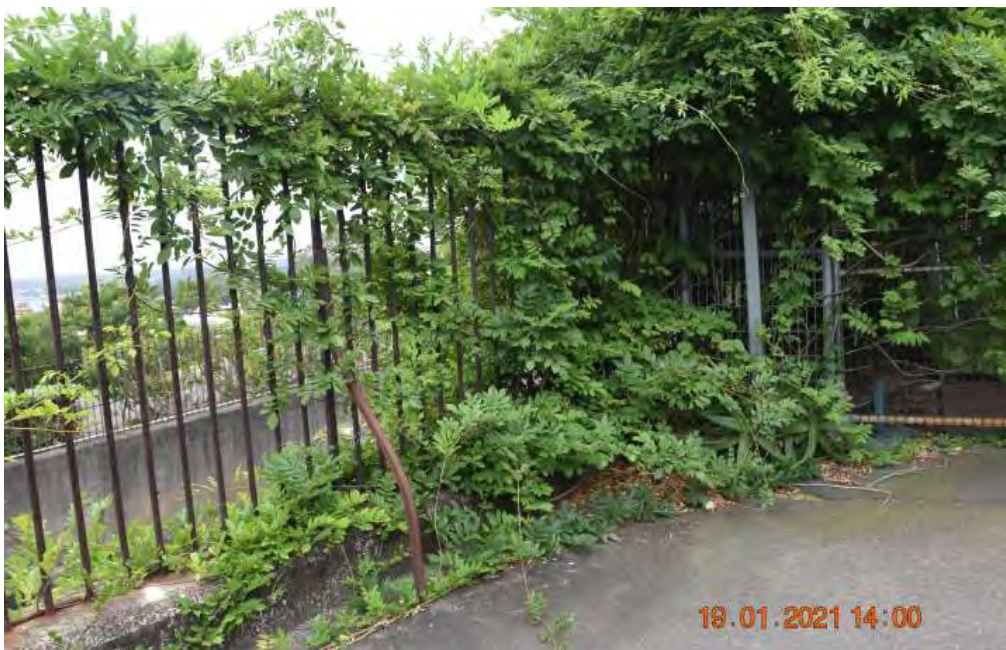
Figure: 1950

General view of the fence in the carpark on the west side of the property.

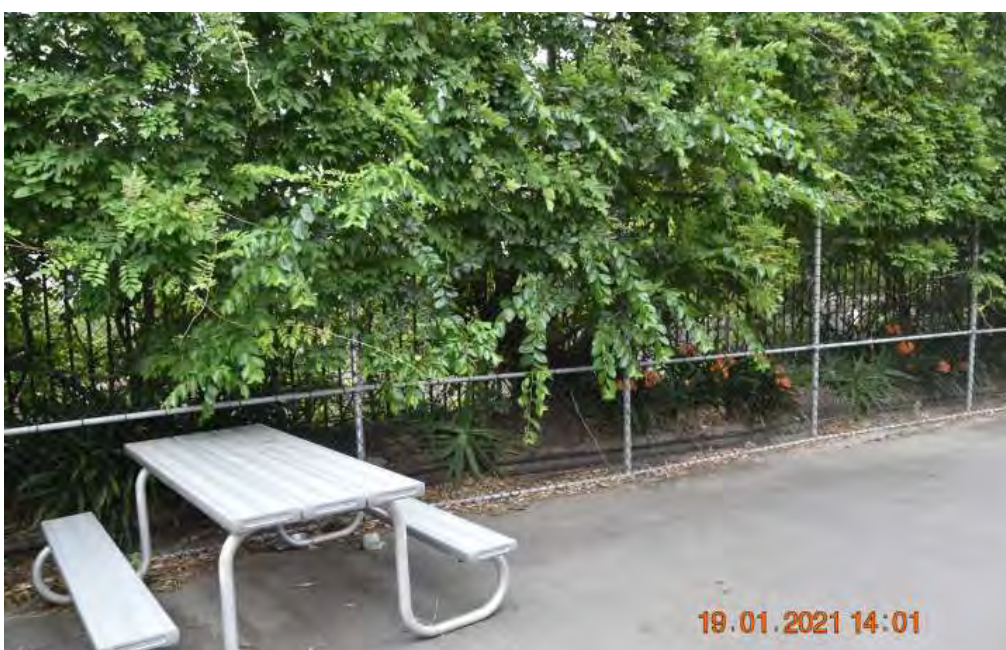
Figure: 1951

General view of the fence in the carpark on the west side of the property.

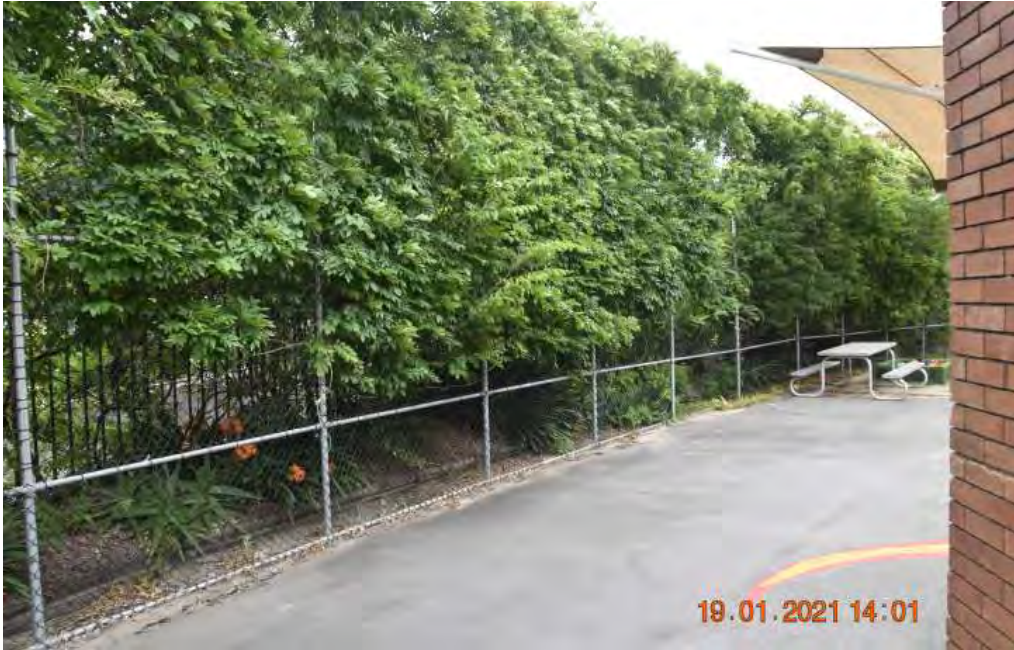
Figure: 1952

General view of the fence in the carpark on the west side of building A.

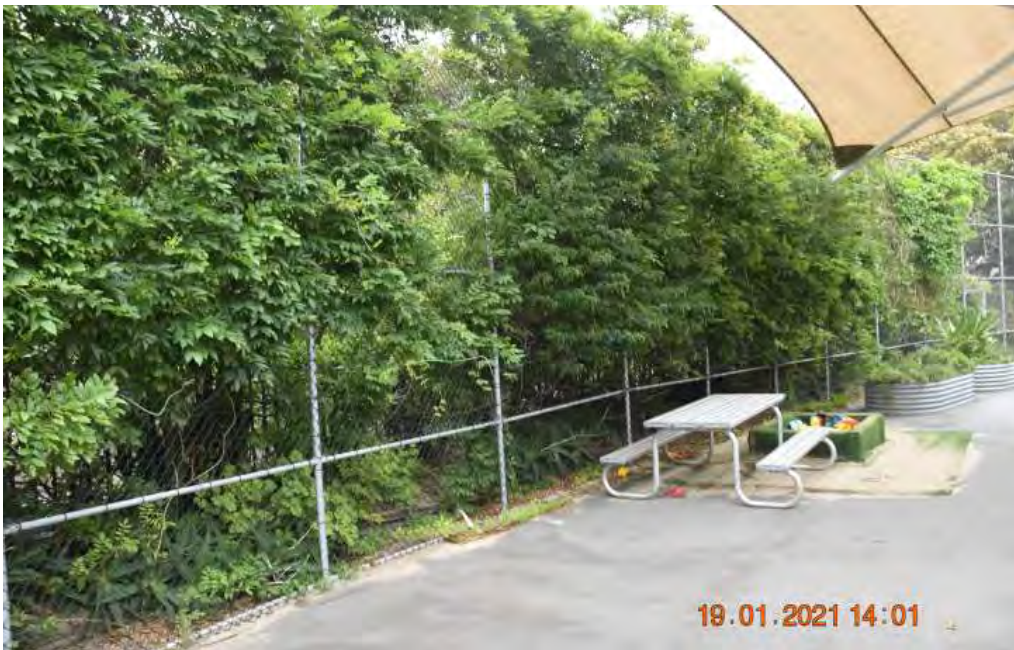
Figure: 1953

General view of the fence in the carpark on the west side of building A.

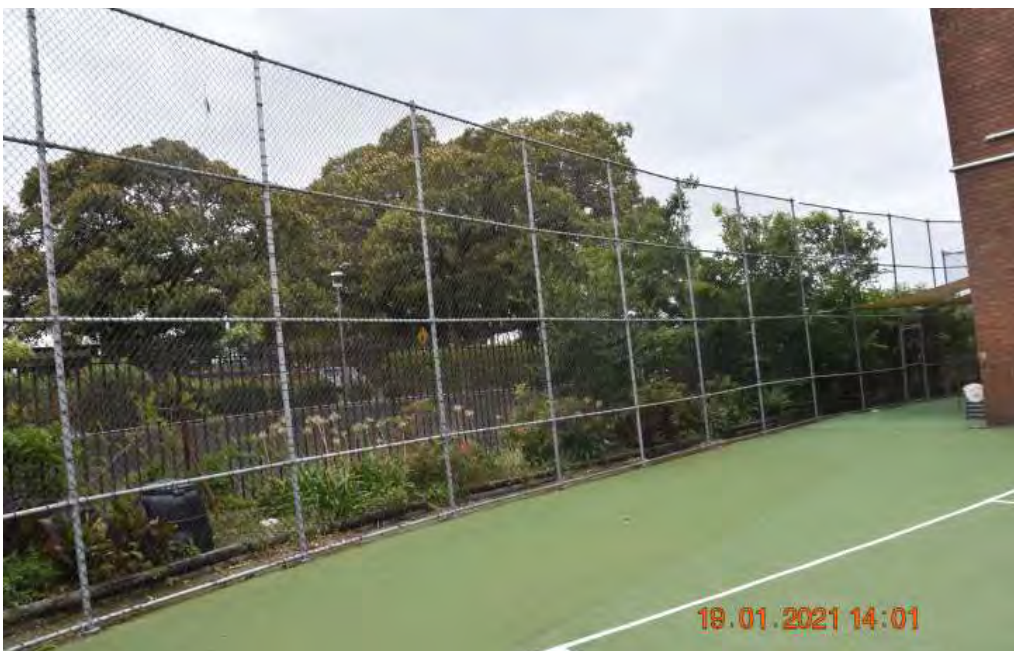
Figure: 1954

General view of the fence in the carpark on the north side of building A.

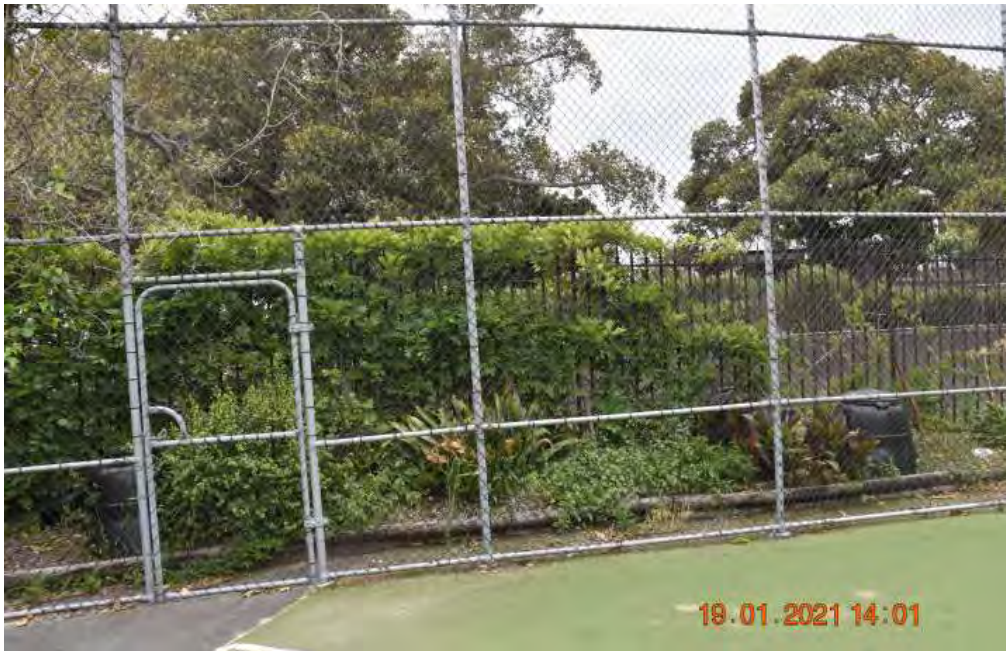
Figure: 1955

General view of the fence in the carpark on the north side of building A.

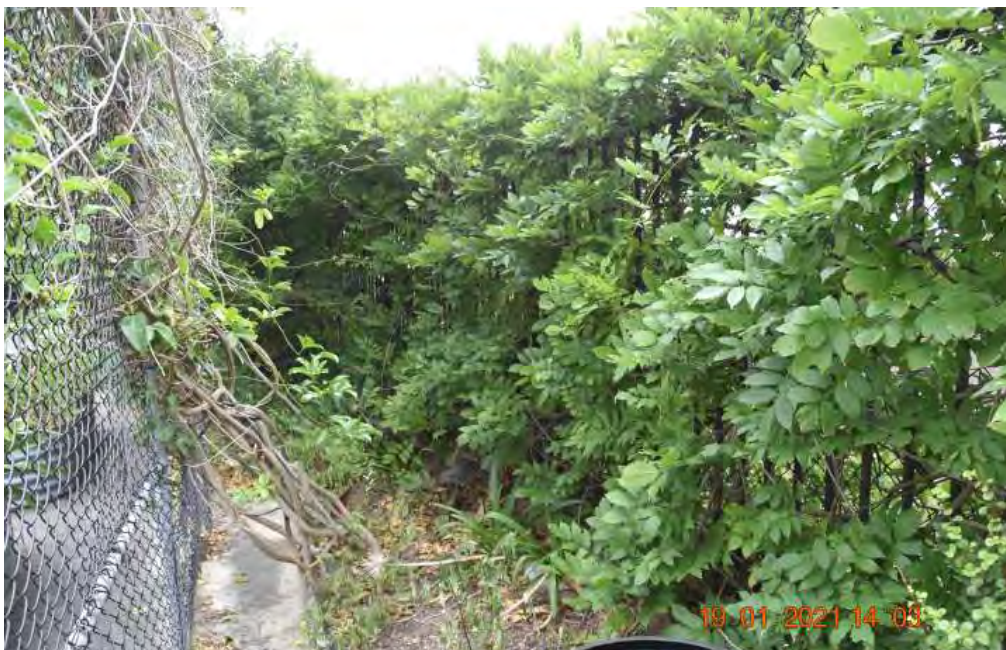
Figure: 1956

General view of the fence in the carpark on the north side of building A.

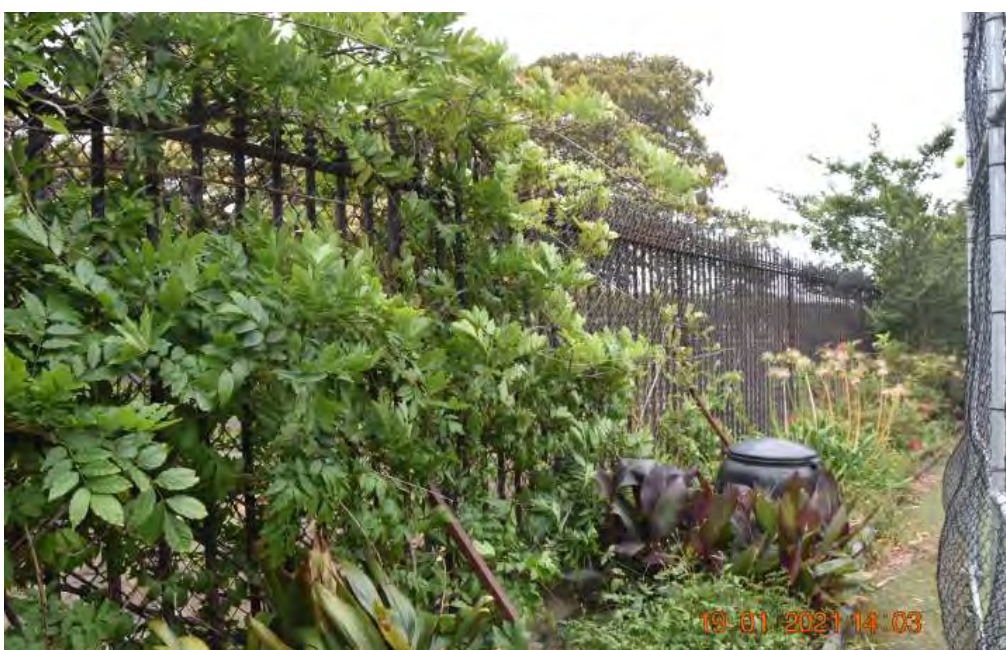
Figure: 1957

General view of the fence in the carpark on the north side of building A.

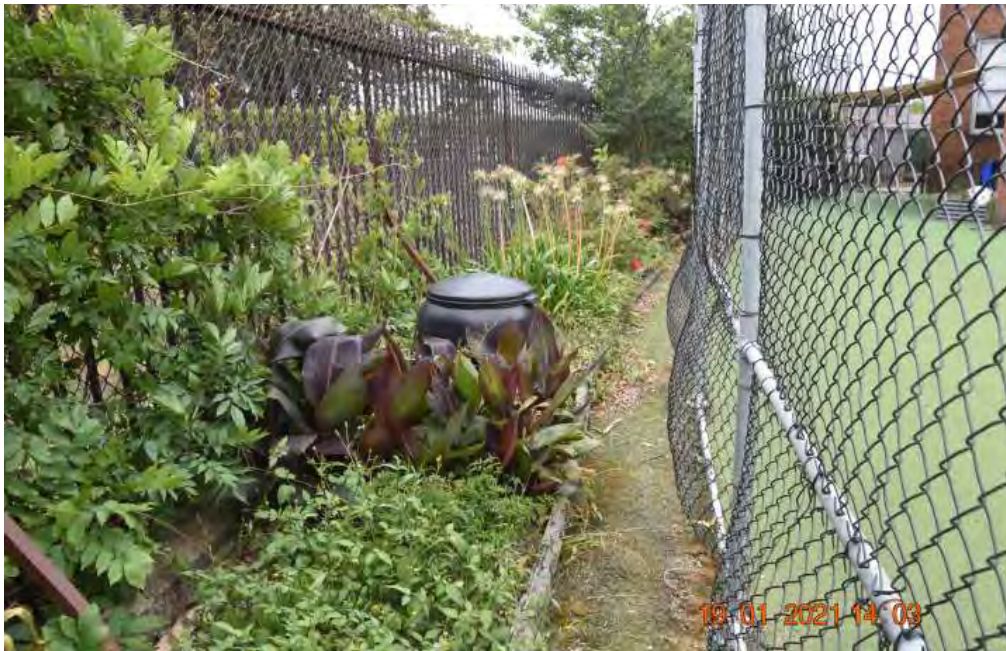
Figure: 1958

General view of the fence in the carpark on the north side of building A.

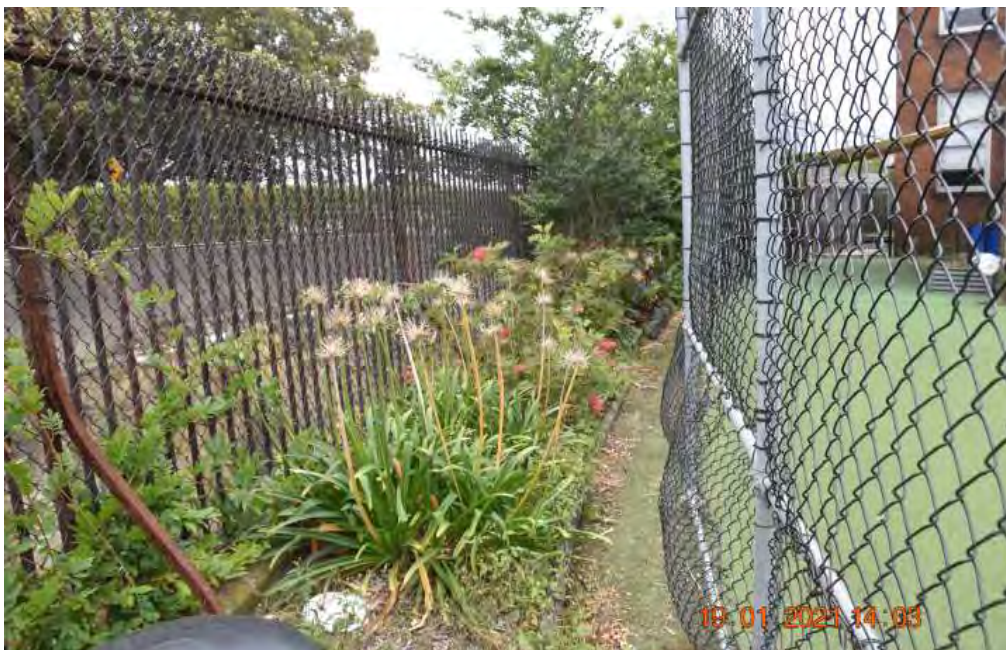
Figure: 1959

General view of the garden bed in the carpark on the north side of building A.

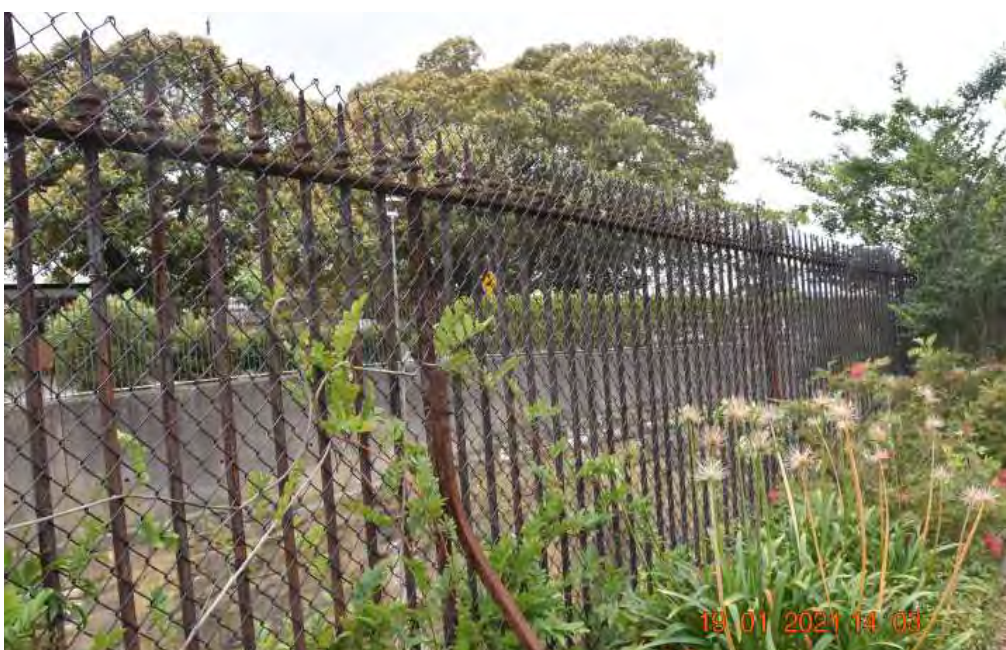
Figure: 1960

General view of the garden bed in the carpark on the north side of building A.

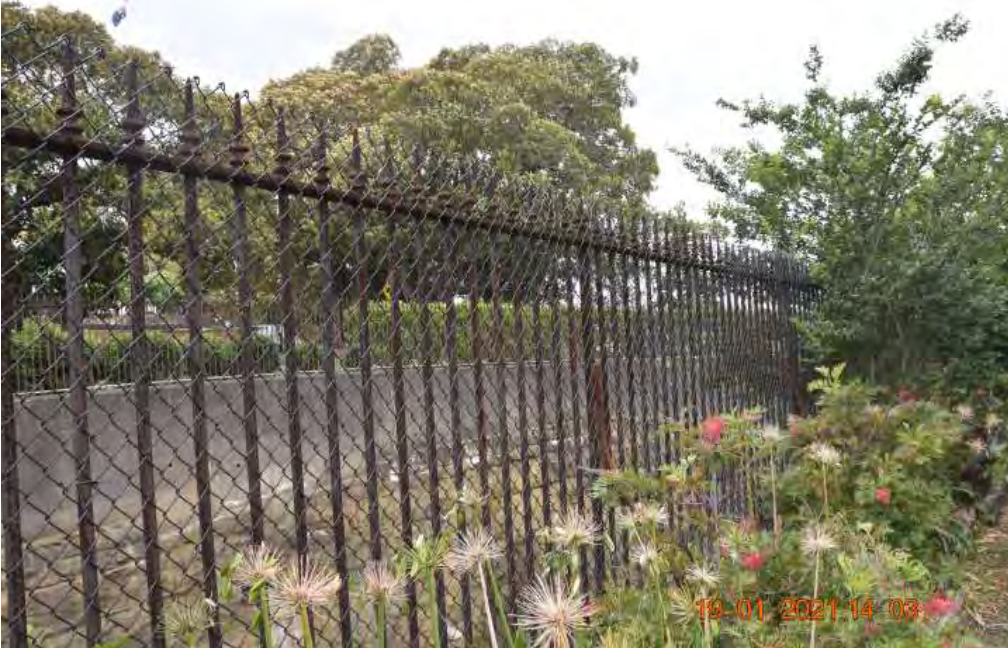
Figure: 1962

General view of the fence in the carpark on the north side of building A.

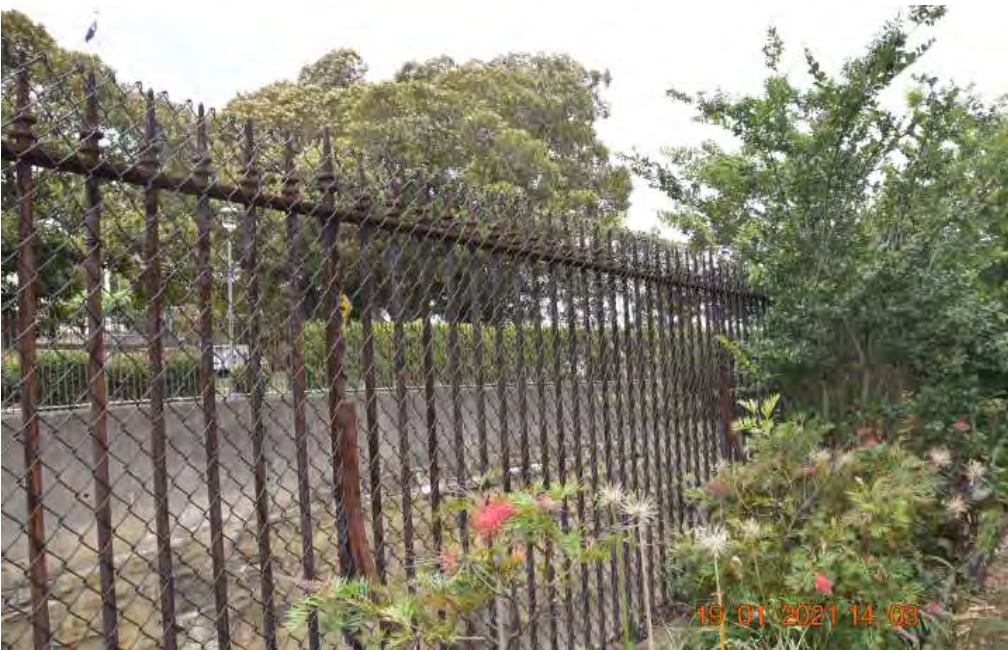
Figure: 1963

General view of the fence in the carpark on the north side of building A.

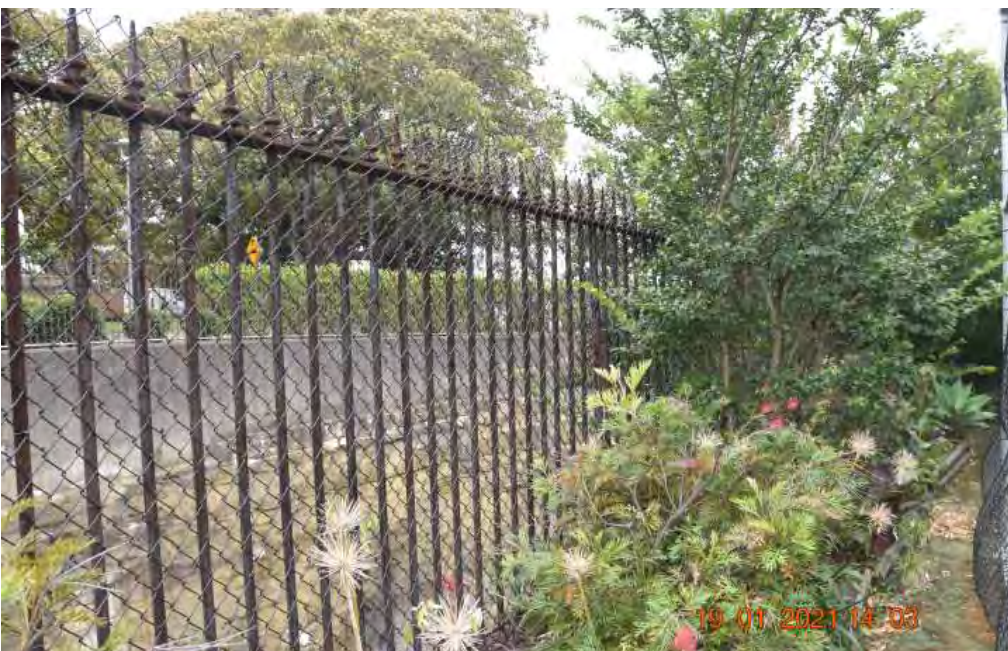
Figure: 1964

General view of the fence in the carpark on the north side of building A.

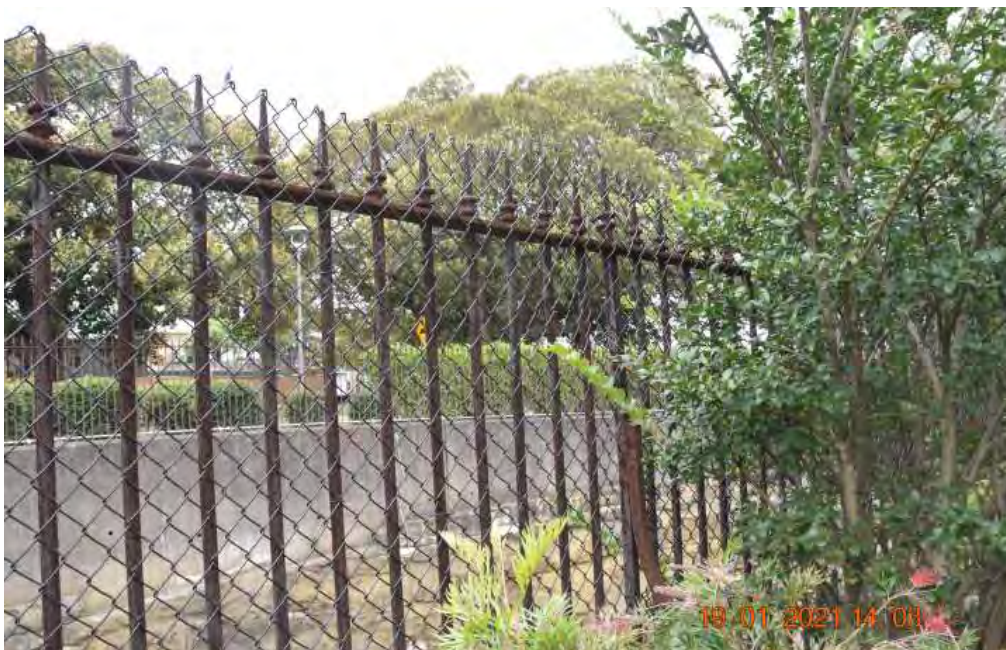
Figure: 1965

General view of the garden bed in the carpark on the north side of building A.

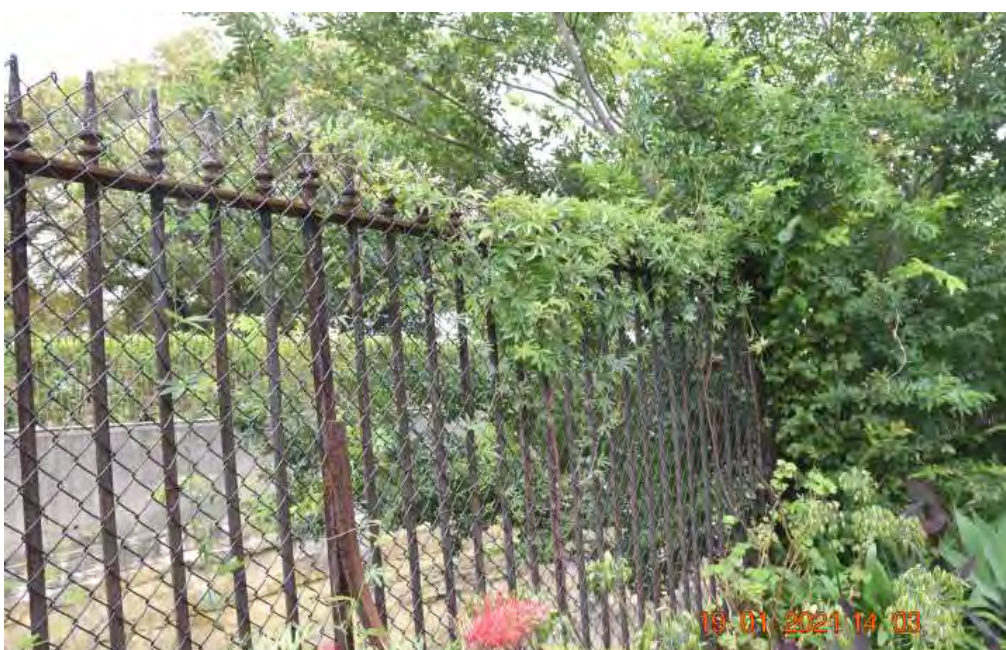
Figure: 1966

General view of the fence in the carpark on the north side of building A.

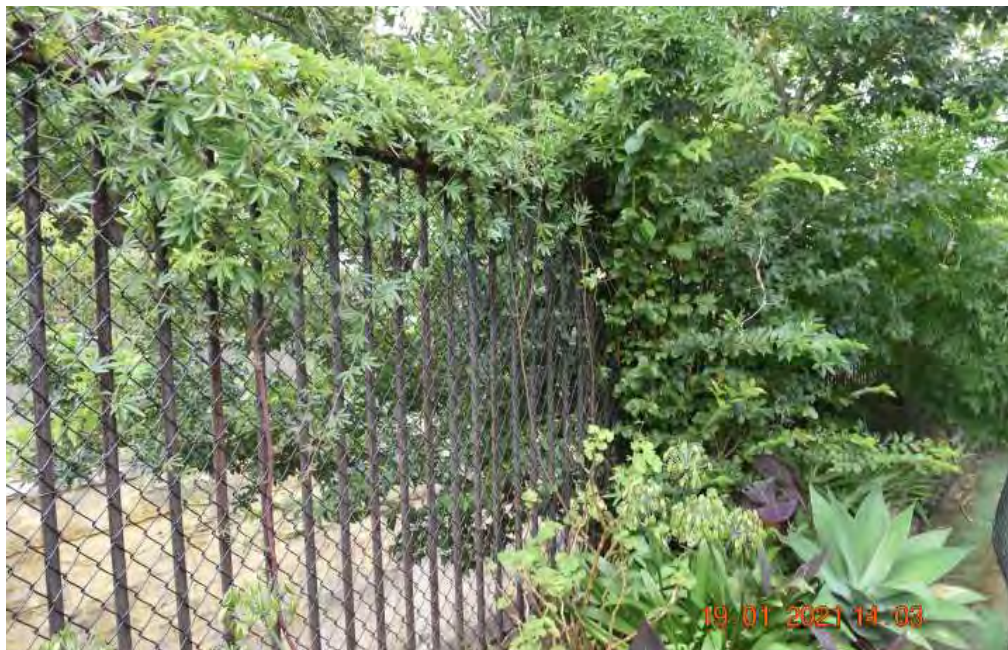
Figure: 1967

General view of the fence in the carpark on the north side of building A.

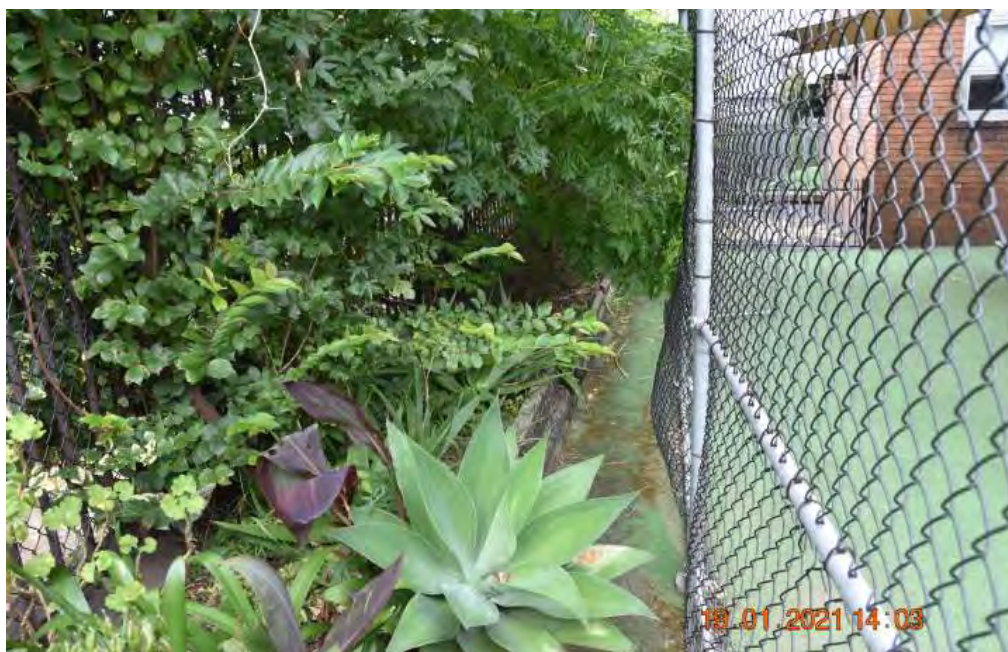
Figure: 1968

General view of the fence in the carpark on the north side of building A.

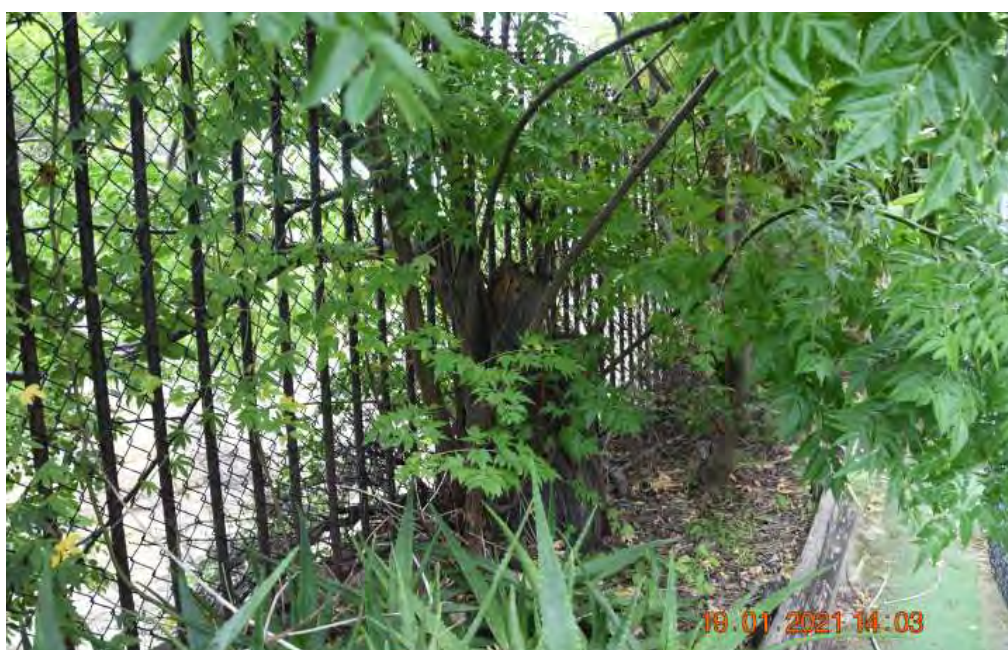
Figure: 1969

General view of the garden bed in the carpark on the north side of building A.
