## PRE CONSTRUCTION CONDITION SURVEY

Fort Street Public School, Millers Point NSW

Upper Fort Street Public School  
MILLERS POINT NSW 2000

19 January 2021

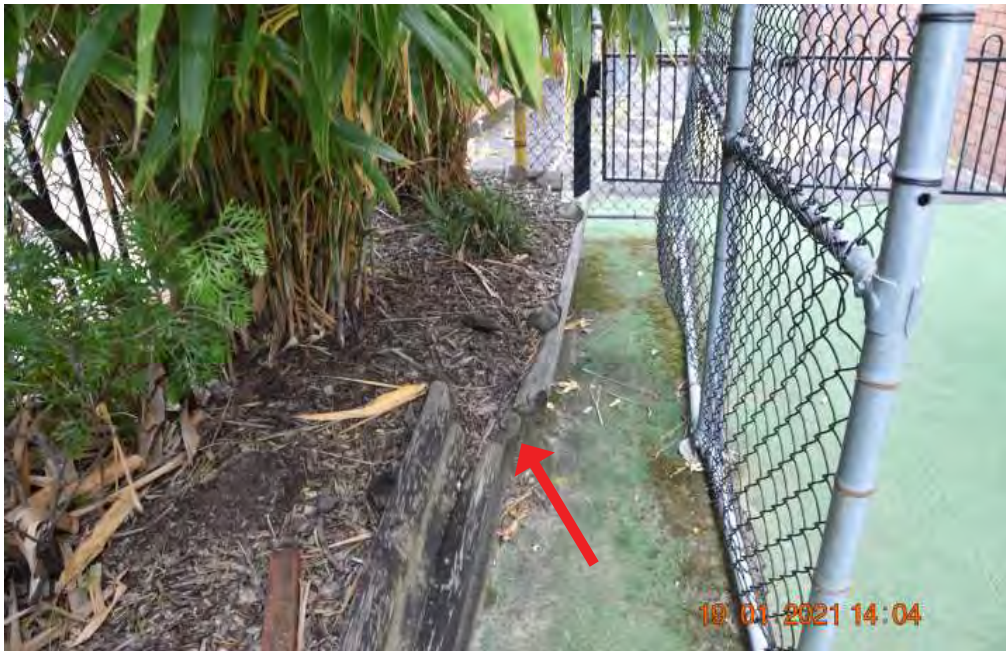
Figure: 1970

General view of the fence in the carpark on the north side of building A. Showing obstructed view.

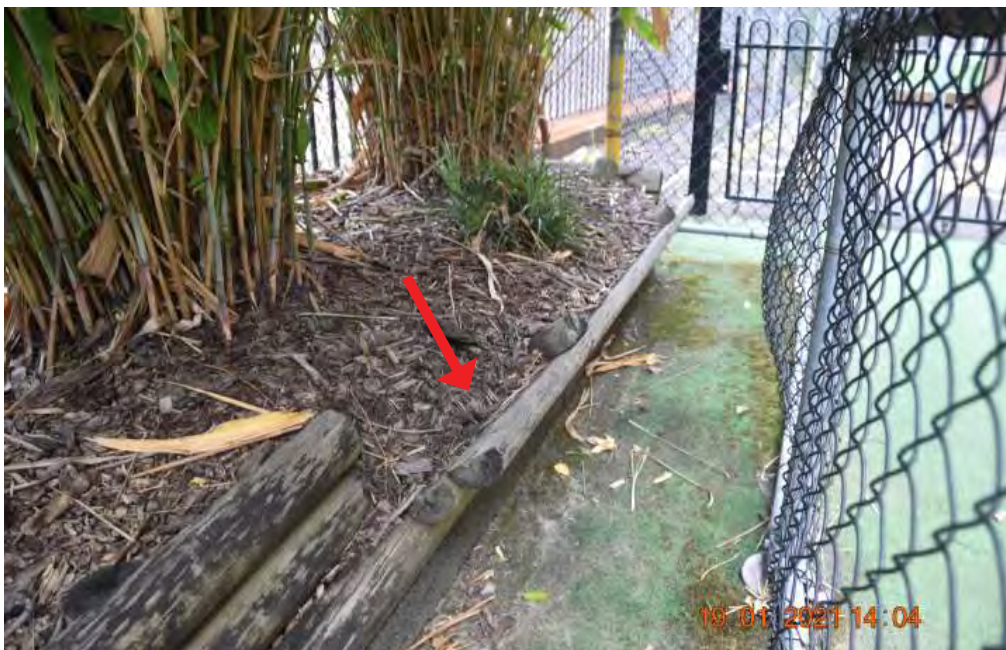
Figure: 1971

General view of the garden bed in the carpark on the north side of building A. Showing movement.

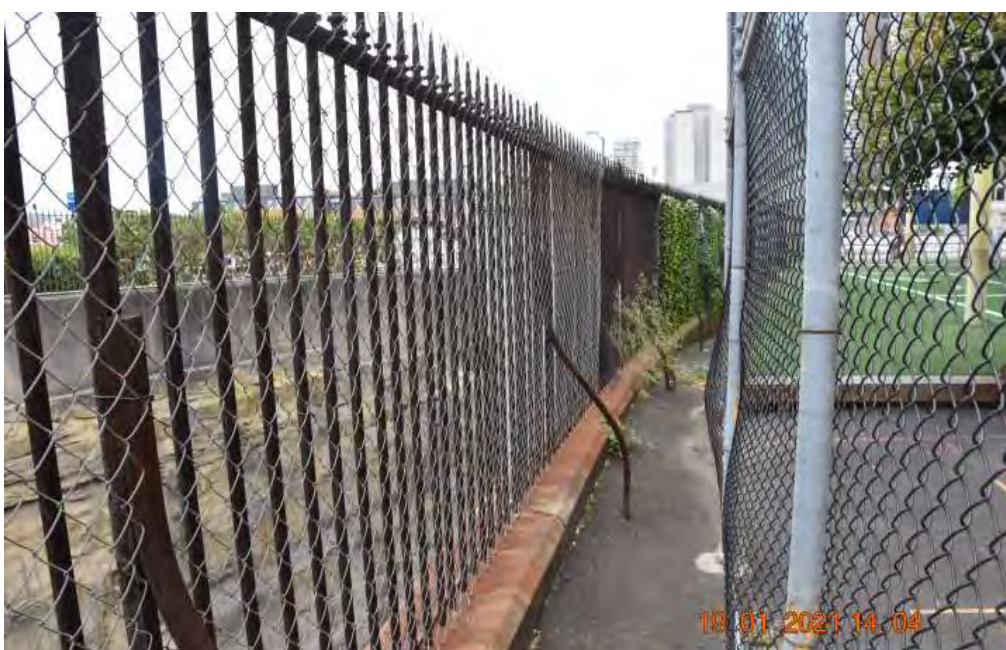
Figure: 1972

General view of the garden bed in the carpark on the north side of building A. Showing movement.

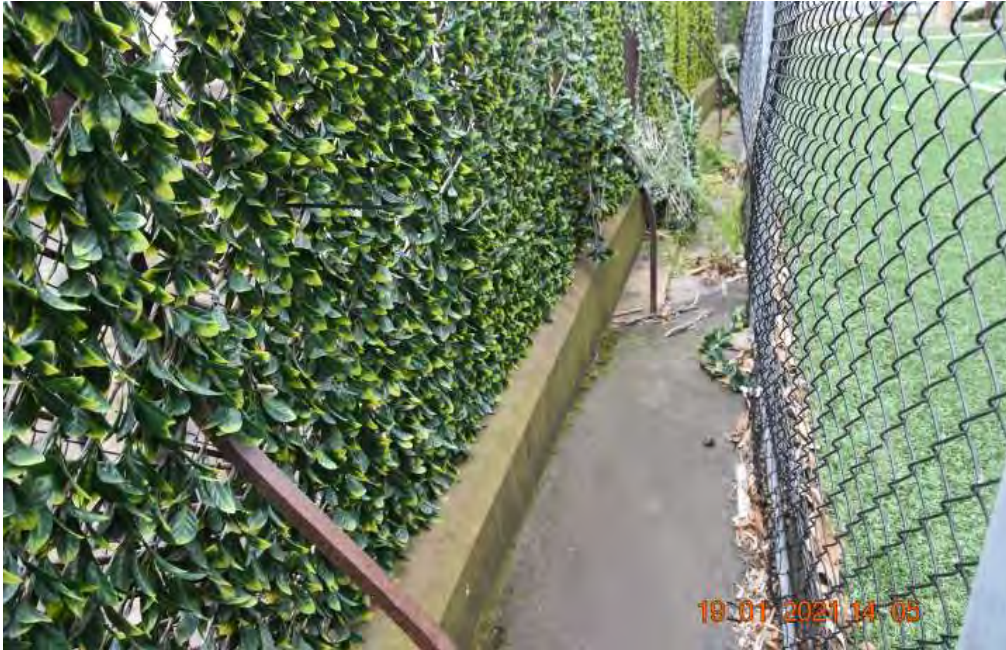
Figure: 1982

General view of the fence in the carpark on the north side of the playground. Showing obstructed view.

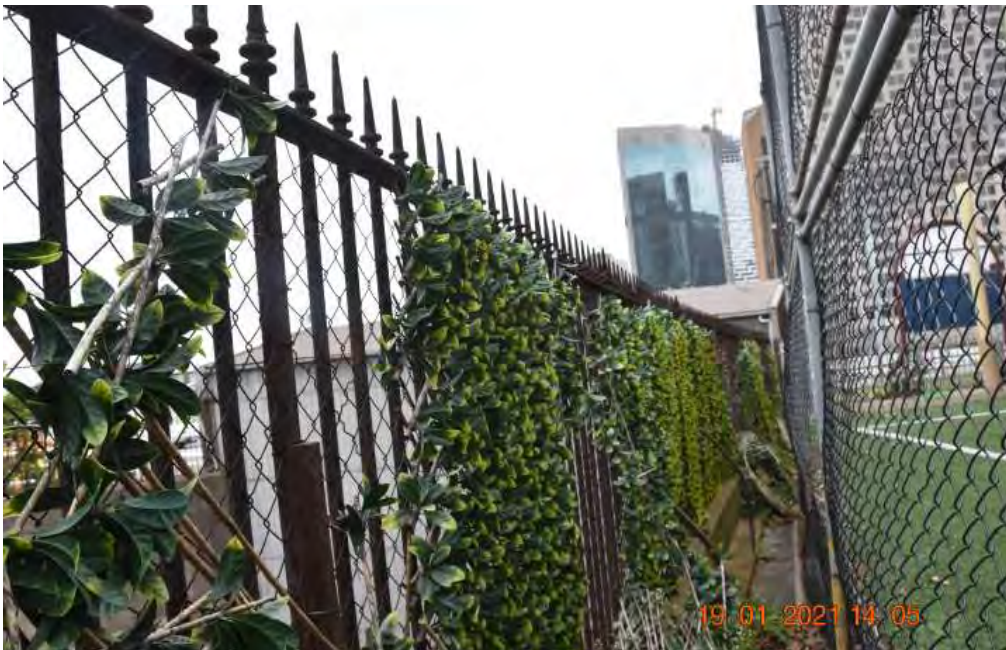
Figure: 1983

General view of the fence in the carpark on the north side of the playground. Showing obstructed view.

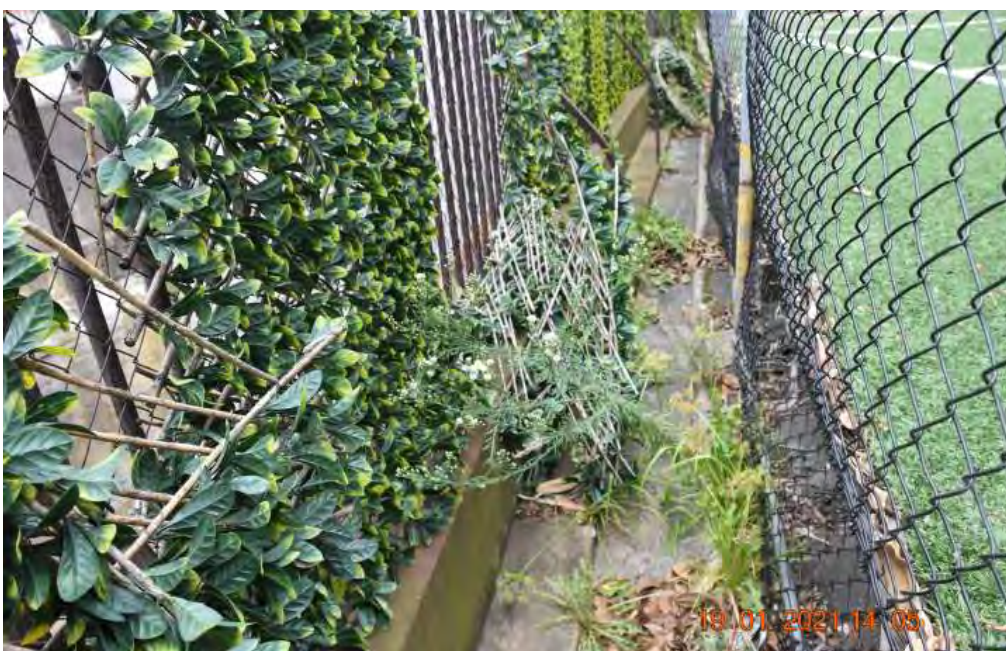
Figure: 1984

General view of the fence in the carpark on the north side of the playground. Showing obstructed view.

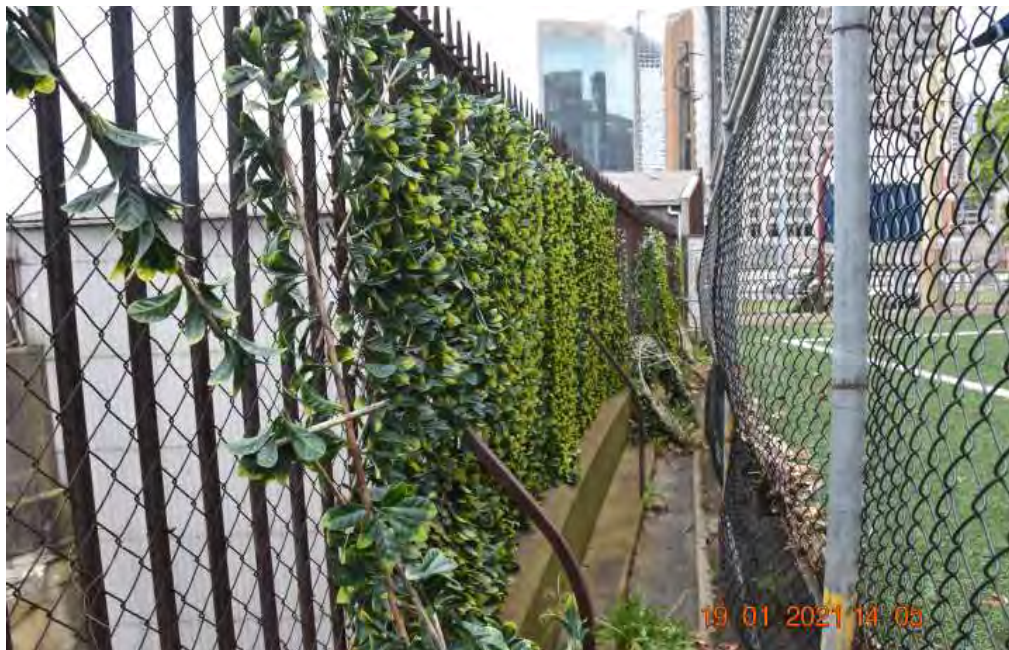
Figure: 1985

General view of the fence in the carpark on the north side of the playground. Showing obstructed view.

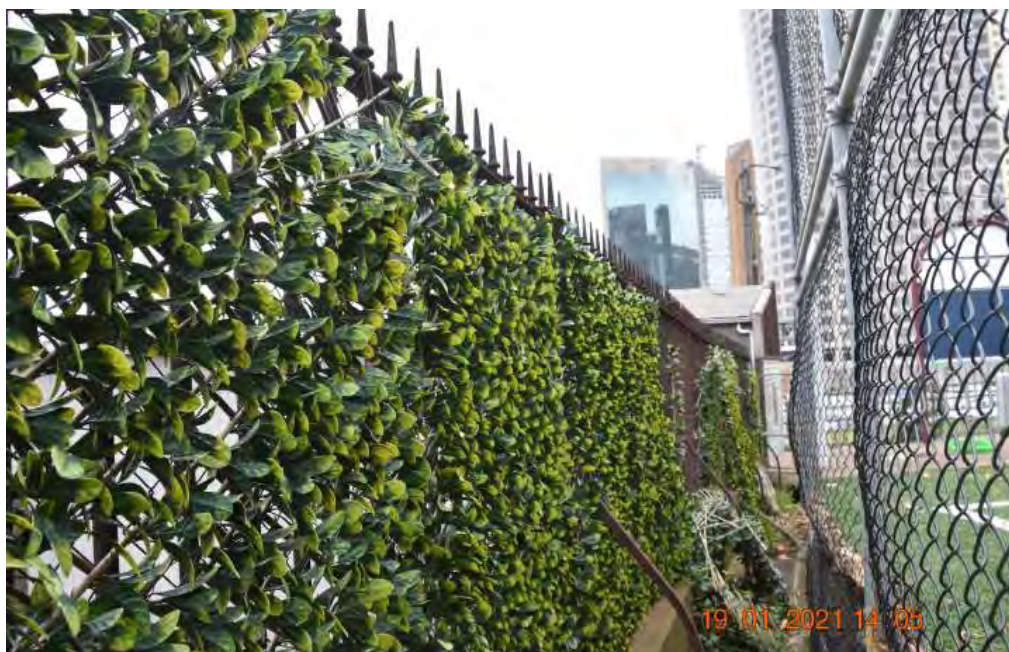
Figure: 1986

General view of the fence in the carpark on the north side of the playground. Showing obstructed view.

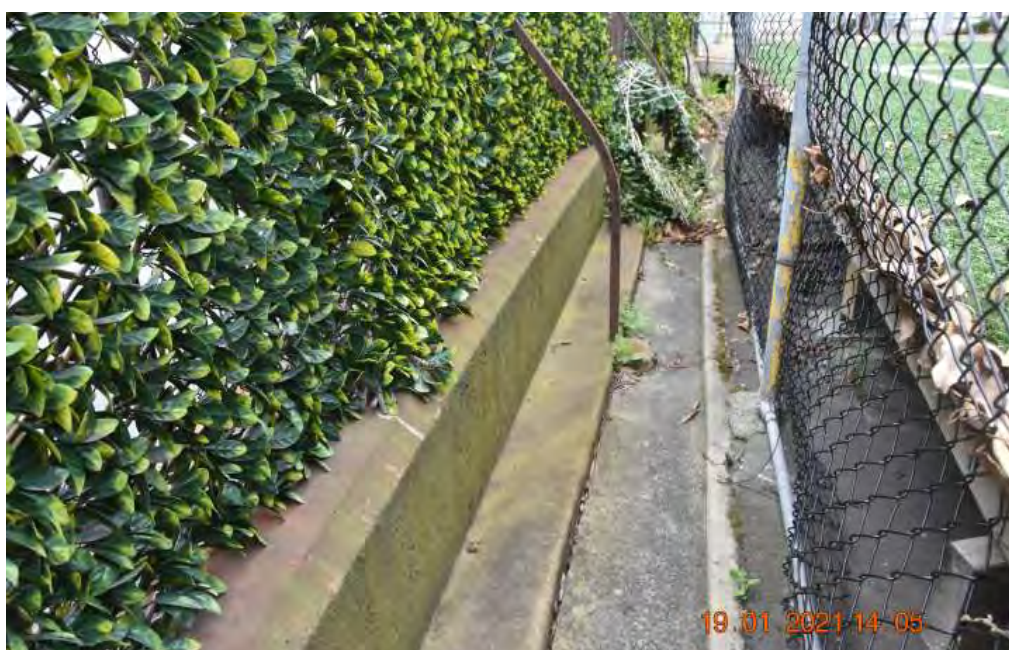
Figure: 1987

General view of the fence in the carpark on the north side of the playground. Showing obstructed view.

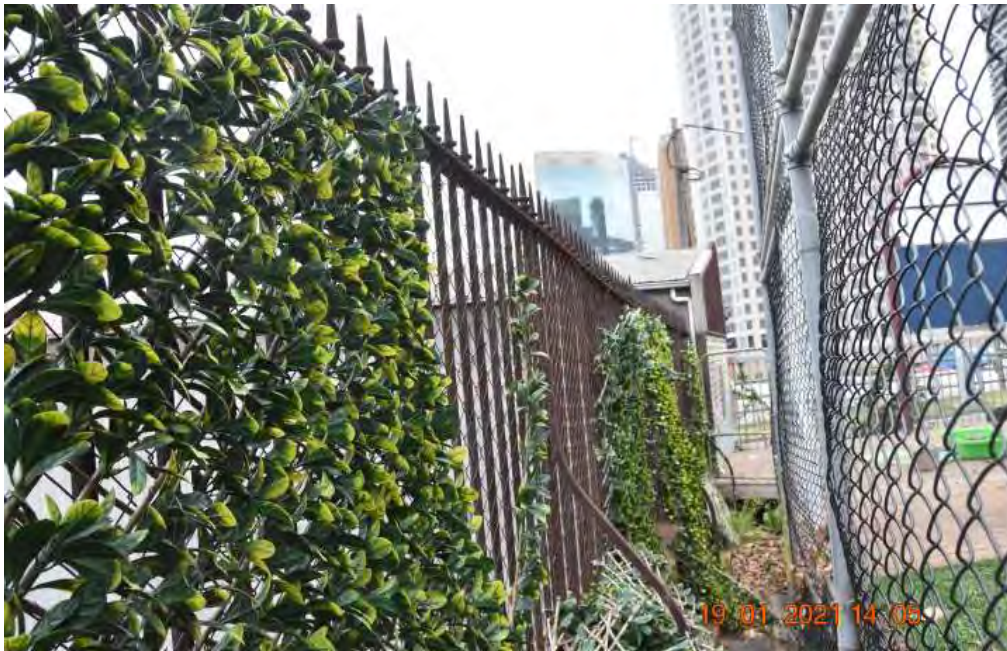
Figure: 1988

General view of the fence in the carpark on the north side of the playground. Showing obstructed view.

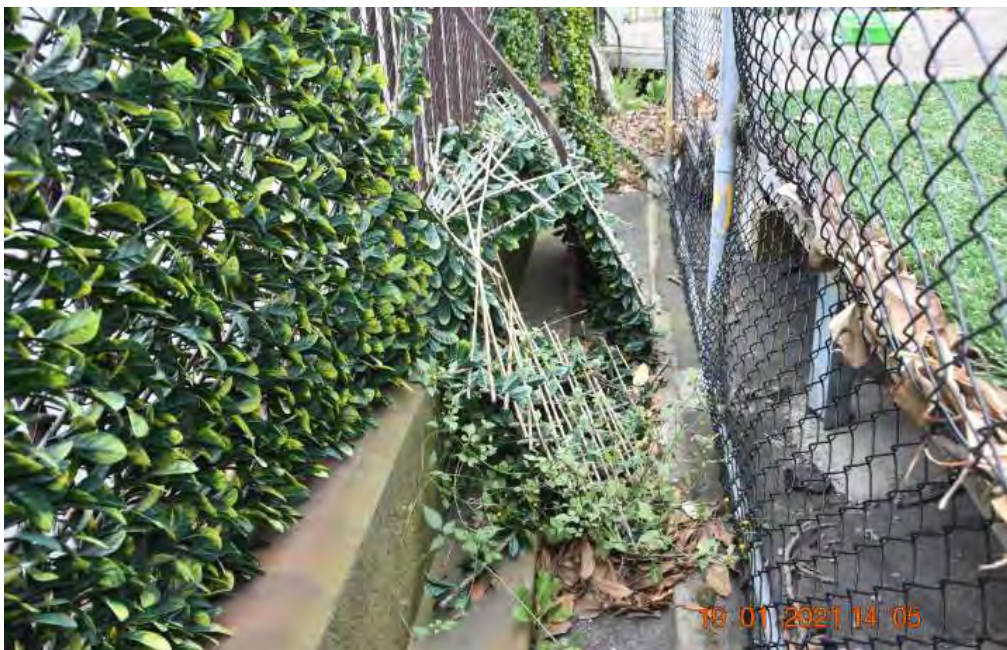
Figure: 1989

General view of the fence in the carpark on the north side of the playground. Showing obstructed view.

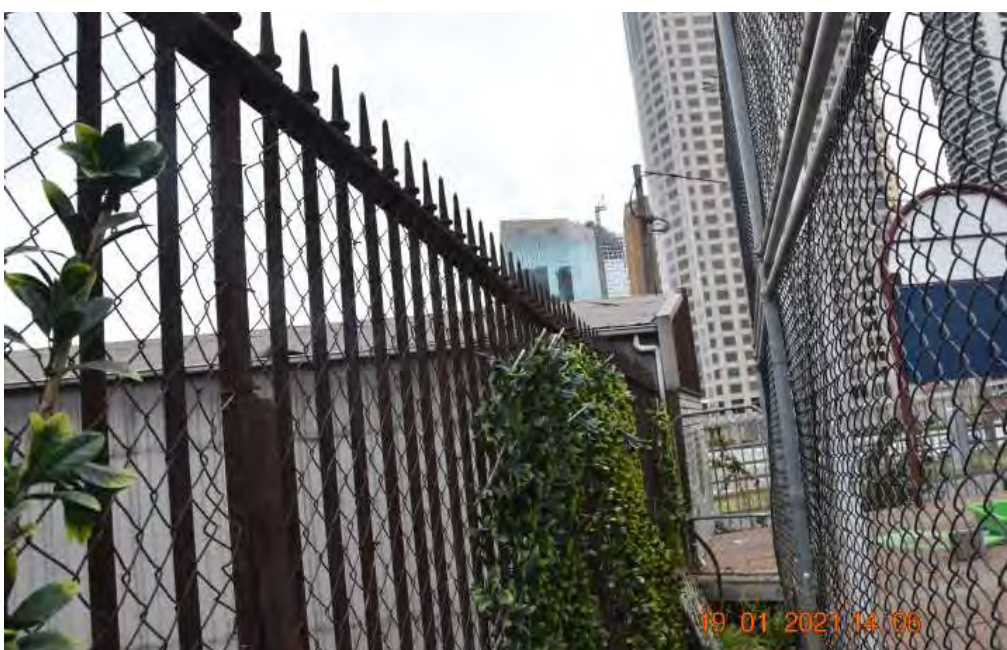
Figure: 1990

General view of the fence in the carpark on the north side of the playground. Showing obstructed view.

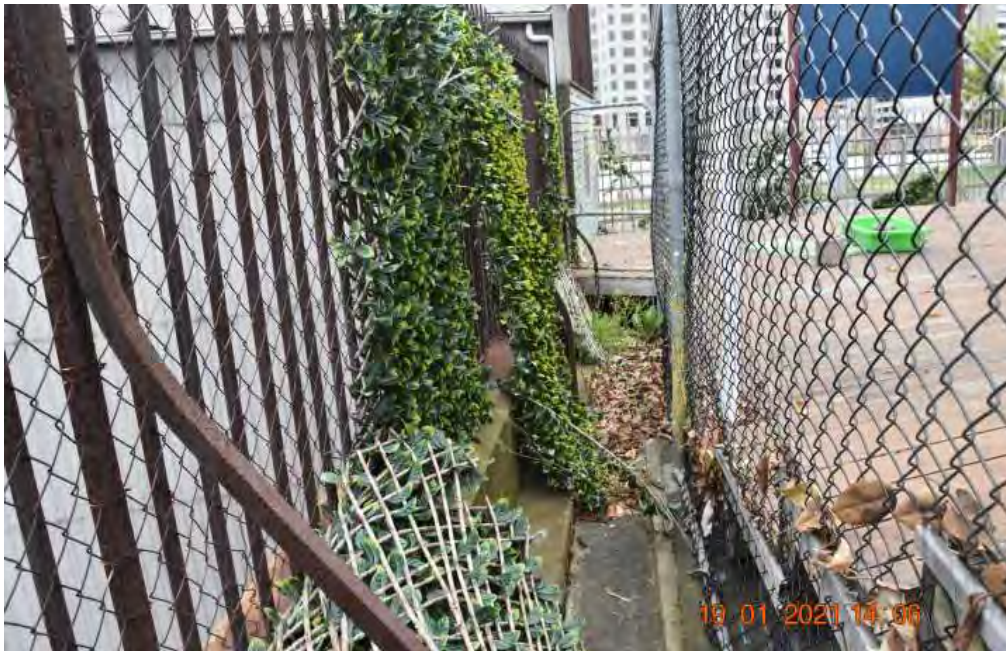
Figure: 1991

General view of the fence in the carpark on the north side of the playground. Showing obstructed view.

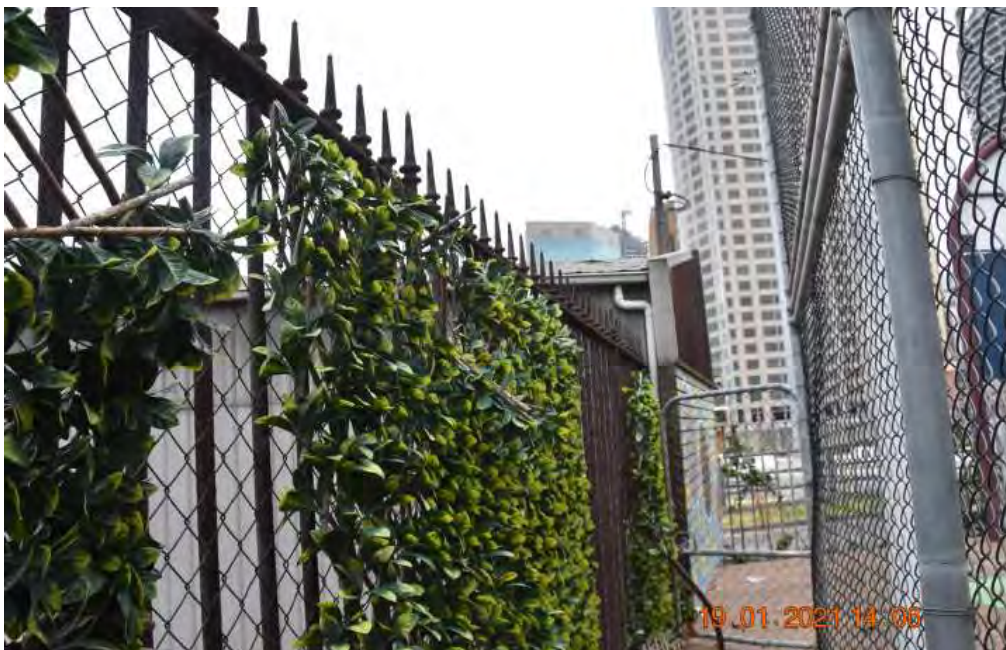
Figure: 1992

General view of the fence in the carpark on the north side of the playground. Showing obstructed view.

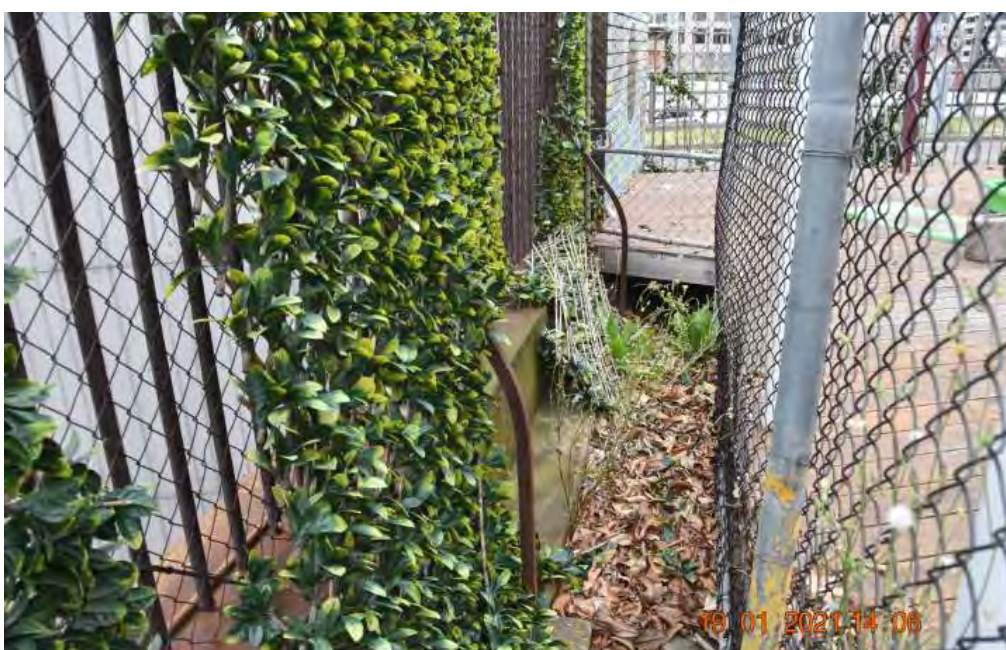
Figure: 1993

General view of the fence in the carpark on the north side of the playground. Showing obstructed view.

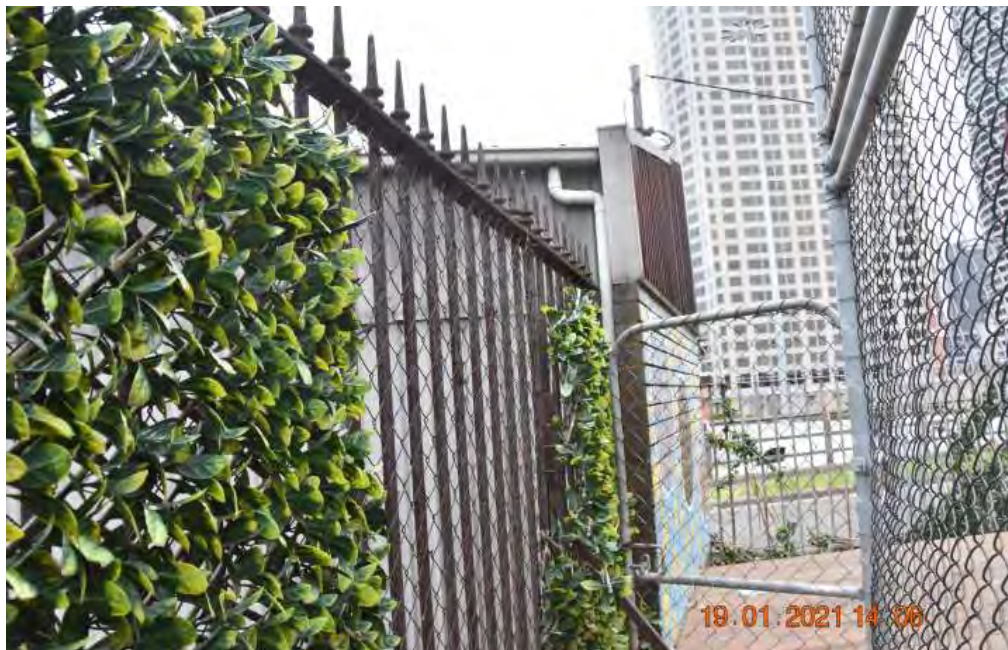
Figure: 1994

General view of the fence in the carpark on the north side of the playground. Showing obstructed view.

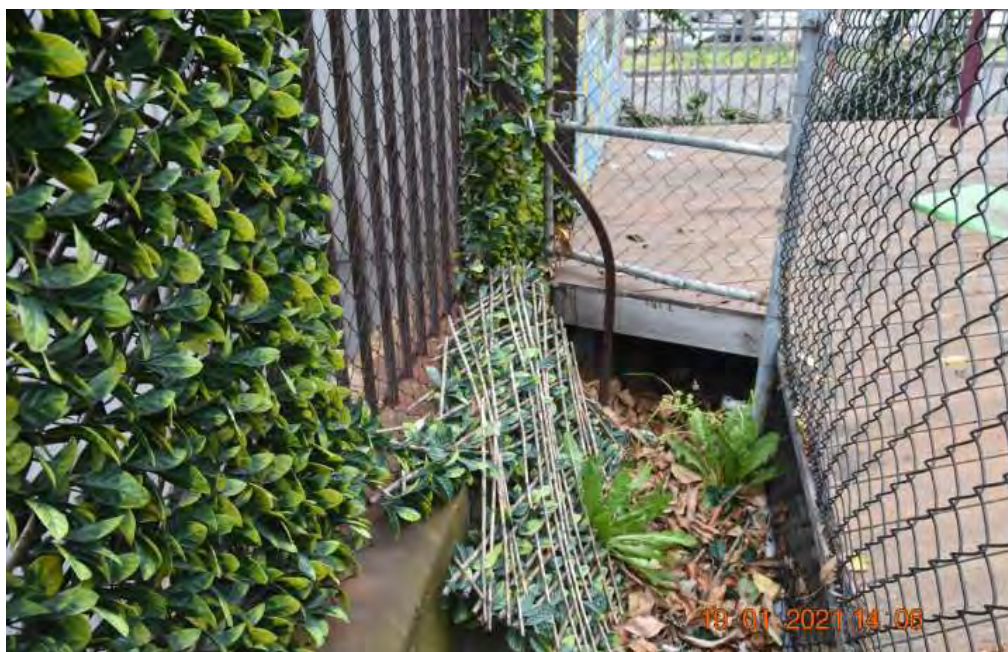
Figure: 1995

General view of the fence in the carpark on the north side of the playground. Showing obstructed view.

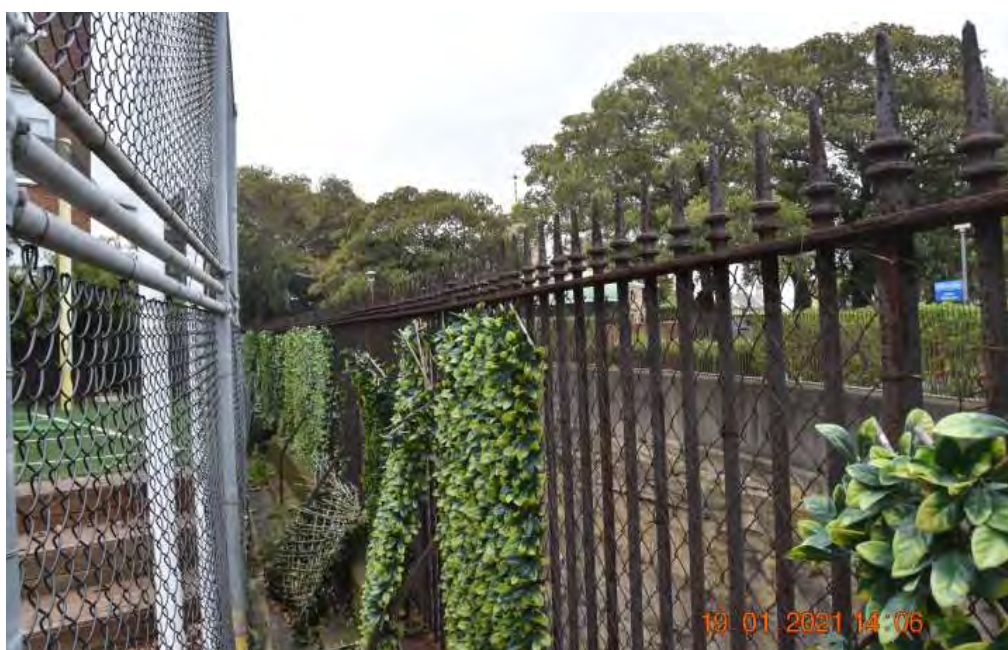
Figure: 1996

General view of the fence in the carpark on the north side of the playground. Showing obstructed view.

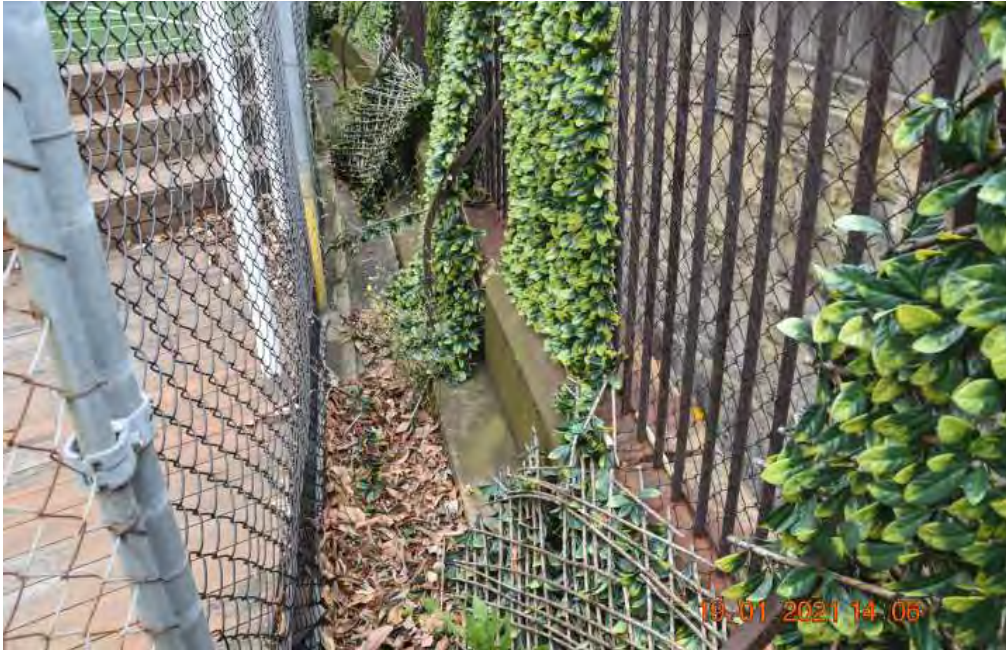
Figure: 1997

General view of the fence in the carpark on the north side of the playground. Showing obstructed view.

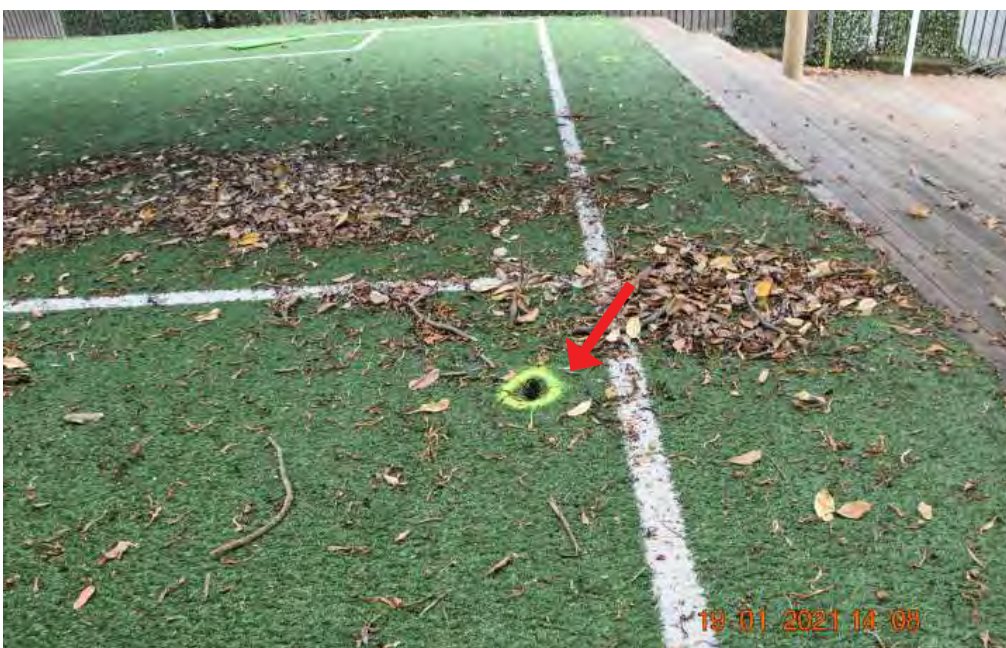
Figure: 1999

Hole in the artificial grass in the playground, east side.

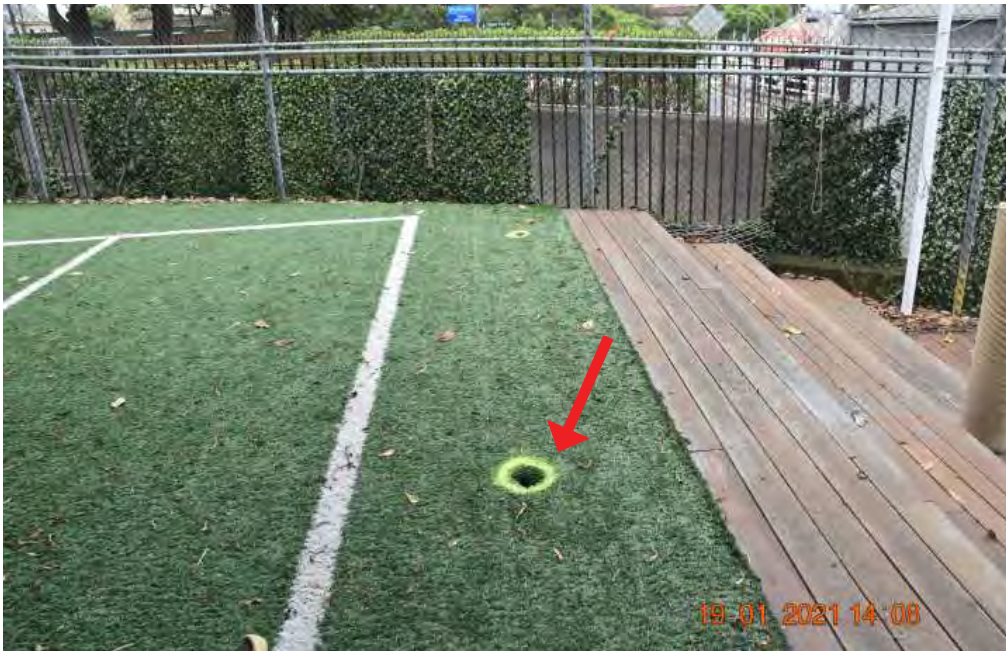
Figure: 2000

Hole in the artificial grass in the playground, east side.

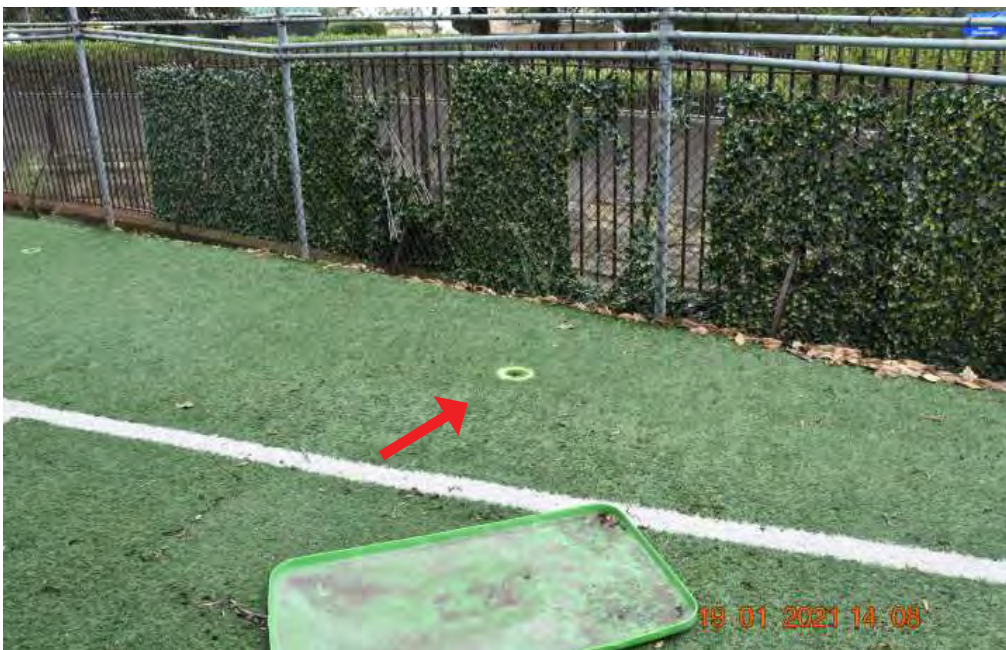
Figure: 2001

Hole in the artificial grass in the playground, east side.

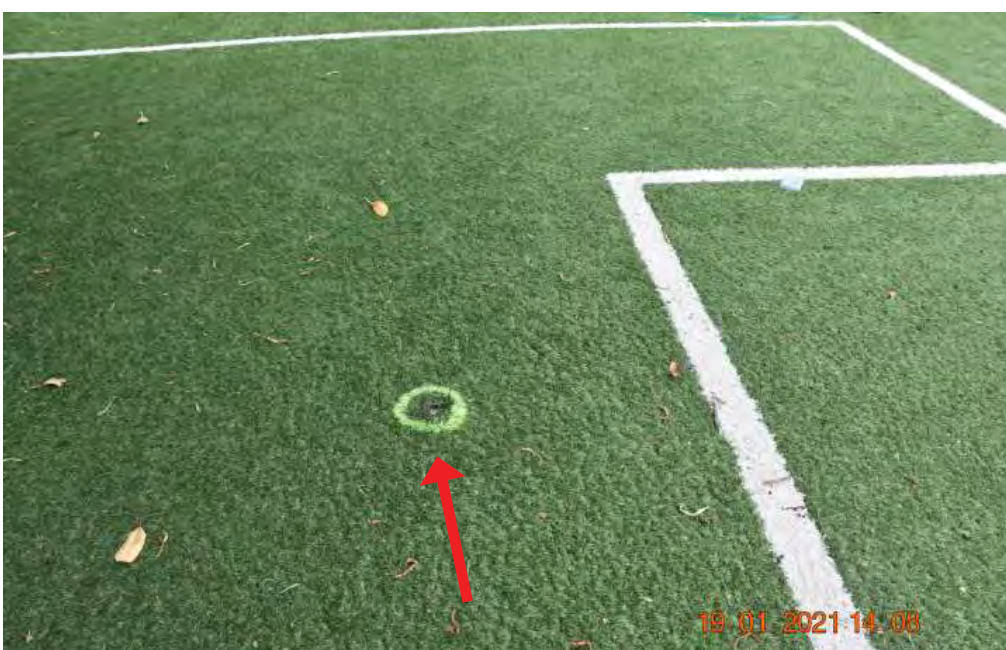
Figure: 2002

Hole in the artificial grass in the playground, north side.

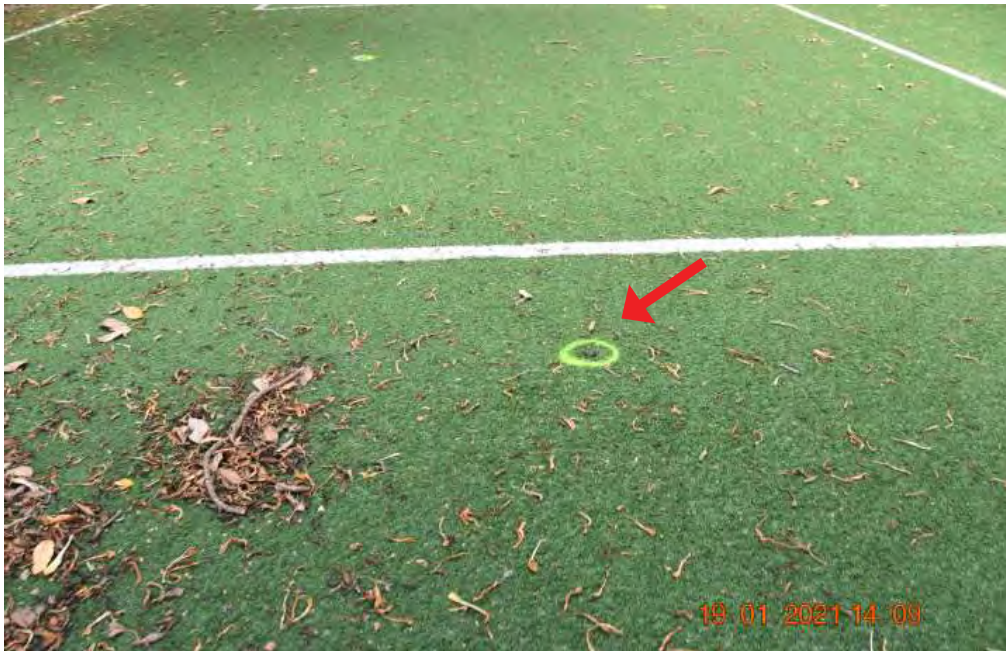
Figure: 2003

Hole in the artificial grass in the playground, north side.

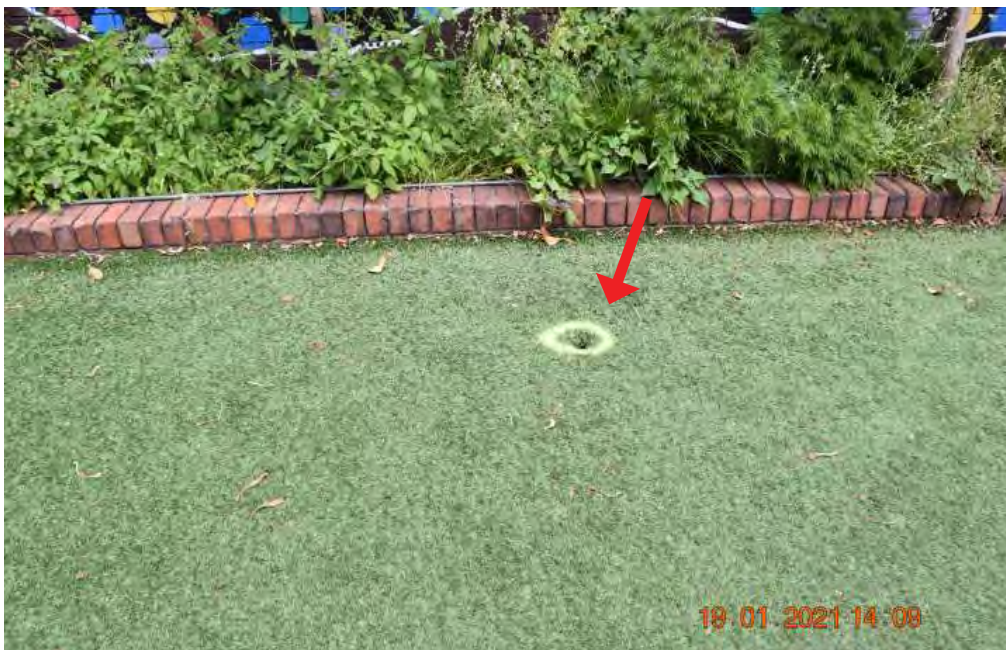
Figure: 2004

Hole in the artificial grass in the playground.

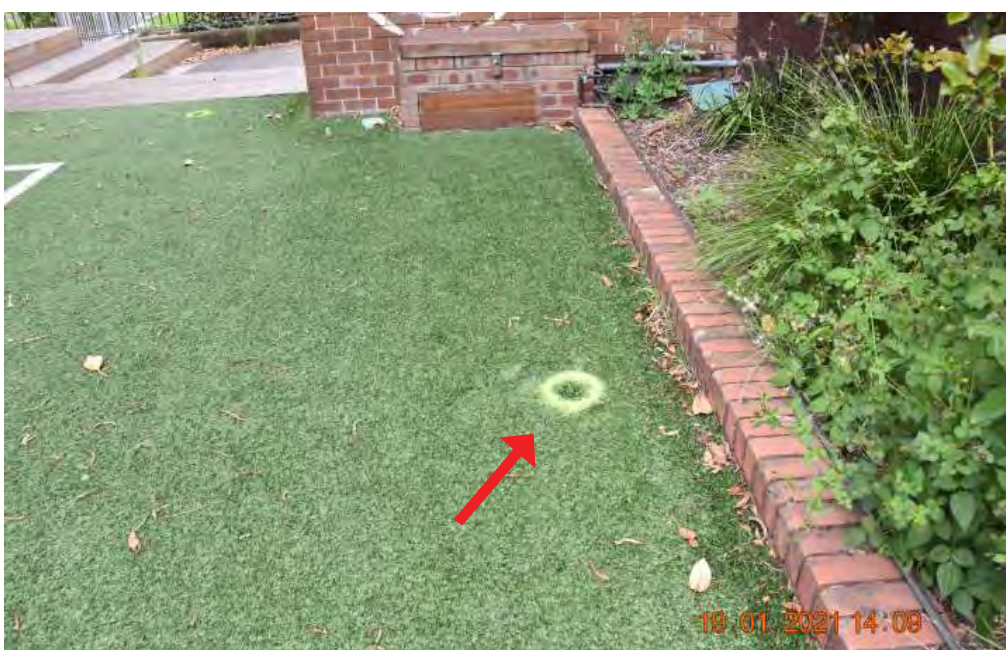
Figure: 2005

Hole in the artificial grass in the playground, west side.

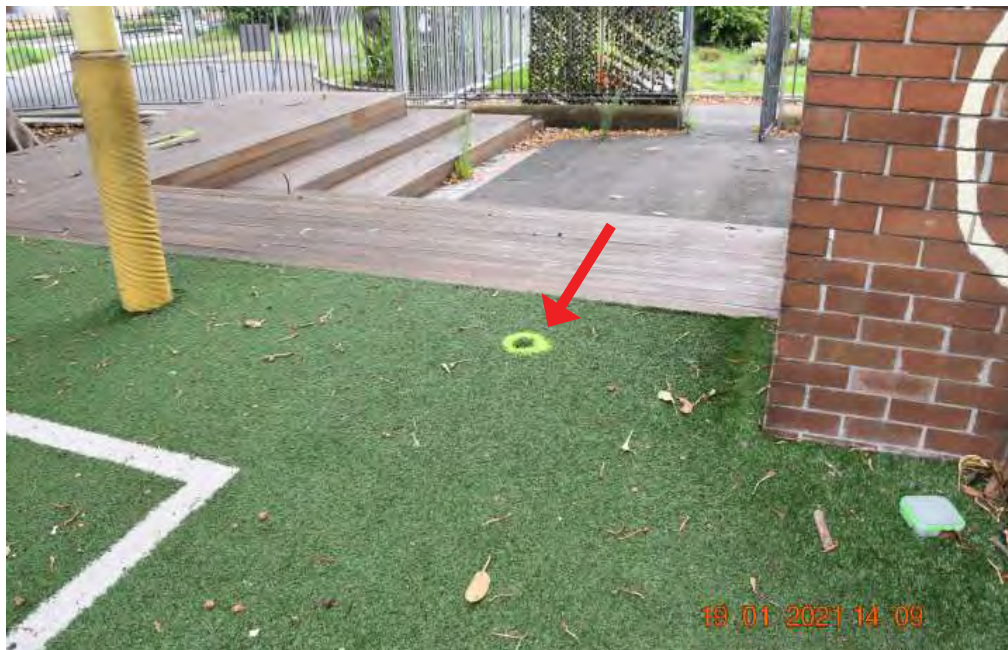
Figure: 2006

Hole in the artificial grass in the playground, west side.

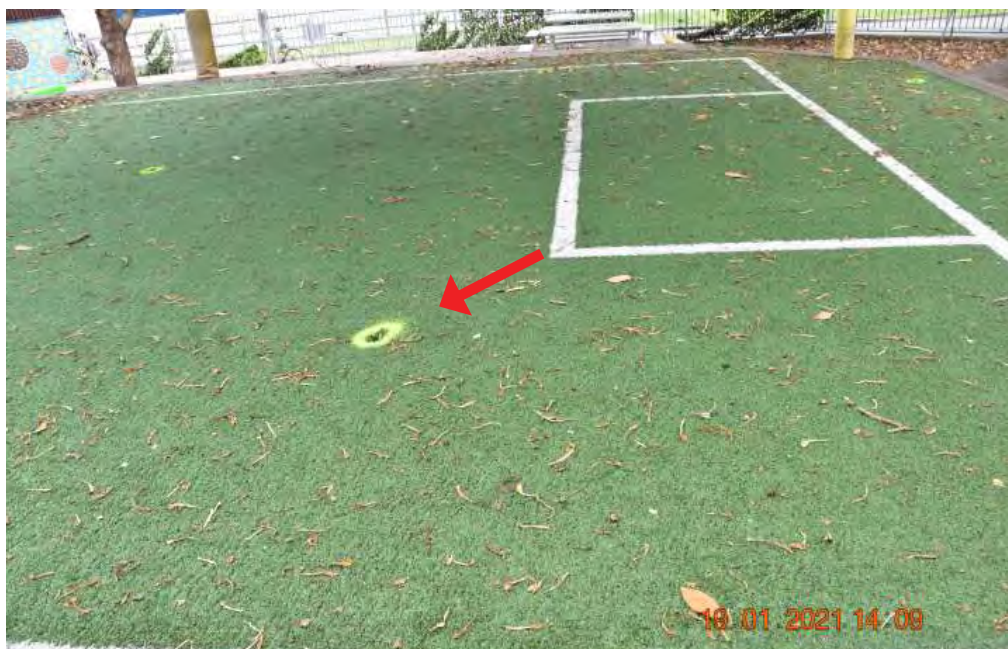
Figure: 2007

Hole in the artificial grass in the playground, south side.

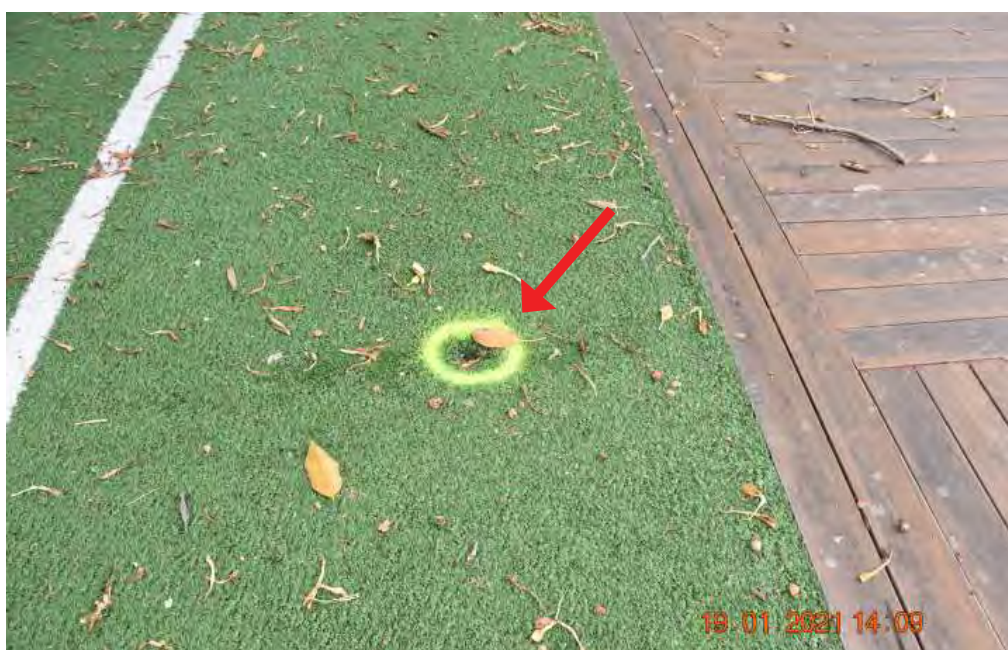
Figure: 2008

Hole in the artificial grass in the playground, south side.
