HAZARDOUS MATERIALS SURVEY

**Sutherland
Entertainment Centre –
30 Eton Street,
Sutherland NSW 2232**

**Prepared for:
Sutherland Shire
Council**

**Project No.
46702**

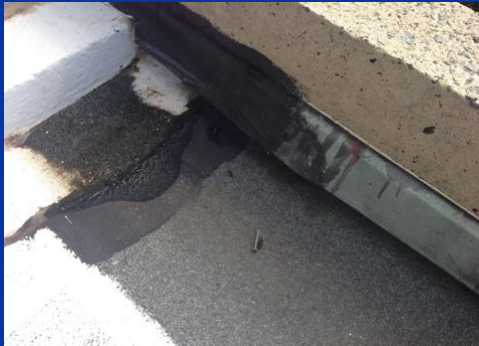
Photo No.
1

Roof

Bituminous Waterproofing – Positive for asbestos

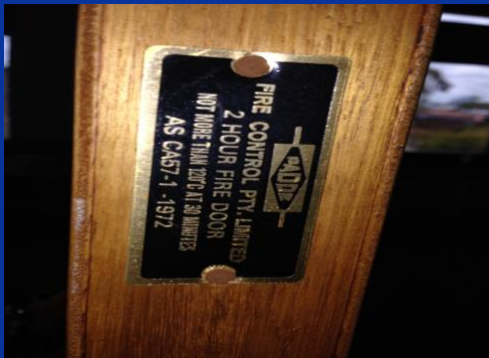
Photo No.
2

Throughout Building

“Black Padde - 1972” Fire Door core – Positive for asbestos

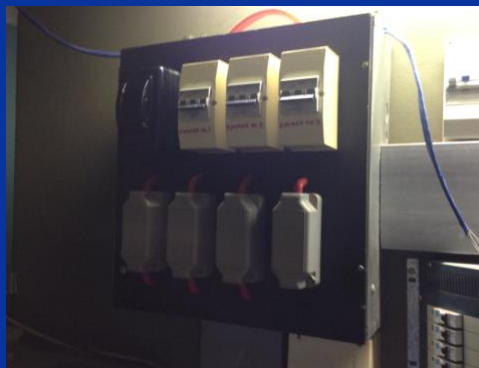
Photo No.
3

Audio Lighting Booth

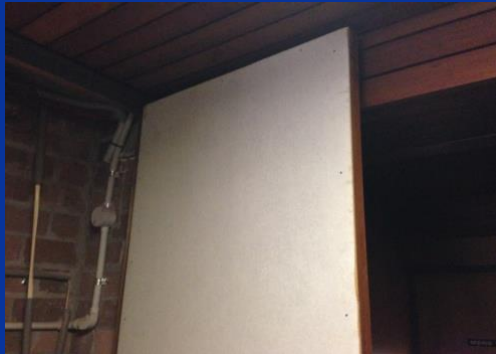
**Photo No.
5**

First Level

Northern Electrical room internal lining –
Positive for asbestos

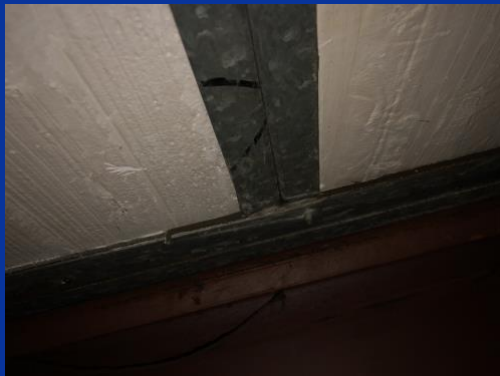
**Photo No.
7**

Theatre Room
