# Preliminary Site Investigation Richard Gill Music Academy, Muswellbrook

Prepared for  
Richard Gill National Music Academy Ltd

7 May 2020

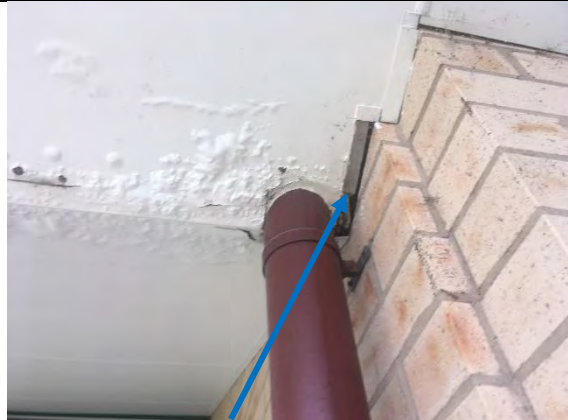
**Photo 4**  
Eave linings - Villaboard  
No asbestos detected  
Sample No: E73071

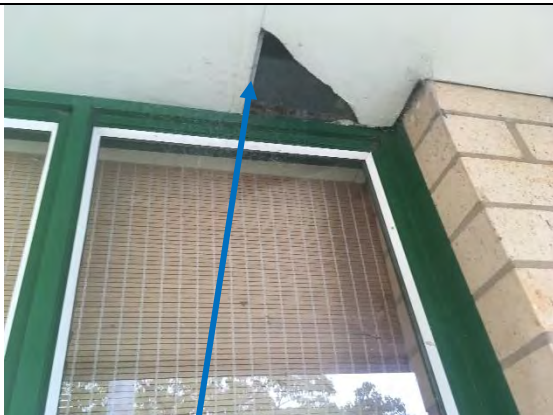
**Photo 5**  
Eave linings - Villaboard  
No asbestos detected  
Sample No: E73071

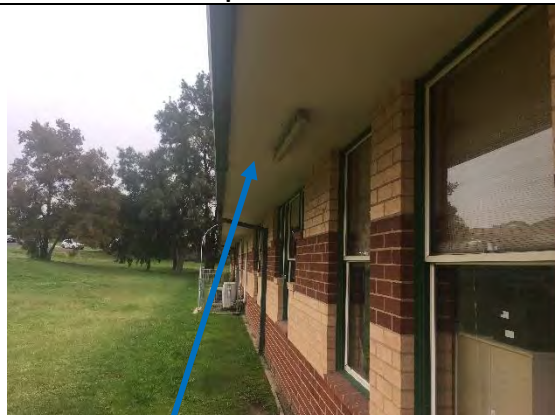
**Photo 6**  
Eave linings - Villaboard  
No asbestos detected  
Sample No: E73071
