# Dilapidation Report

## LHAP - Multistorey Carpark

**ADCO** / 10 December 2020

LHAP-ST-TTW-RPT-CP-120001

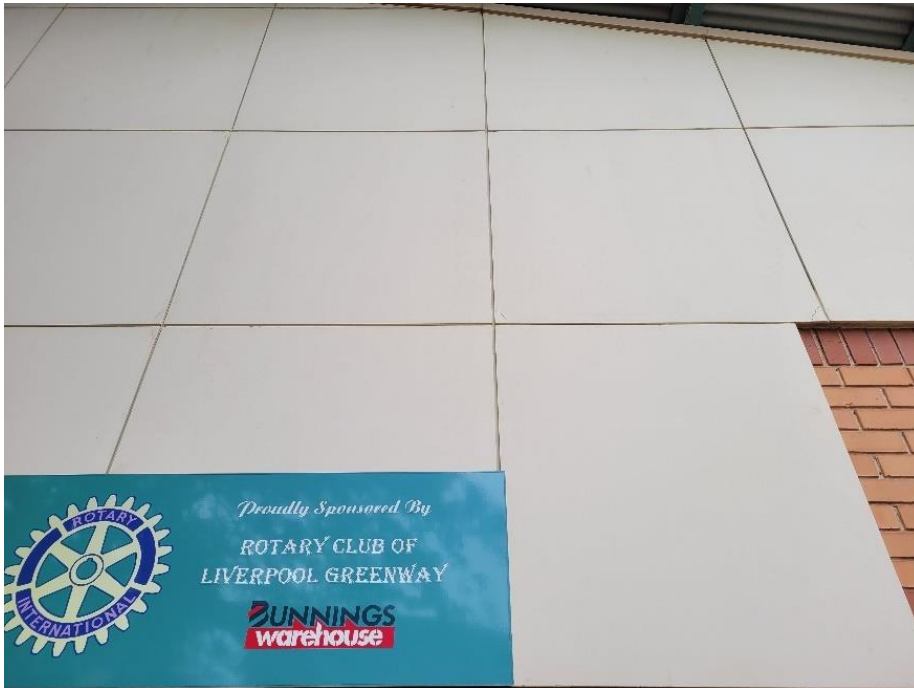
1. Cracked panel

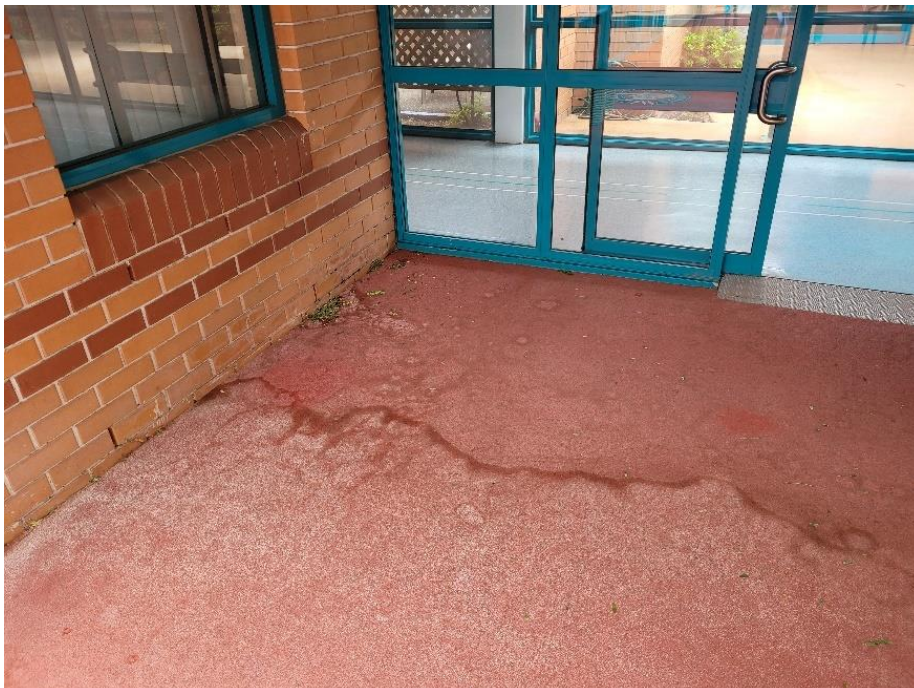
2. Water stains

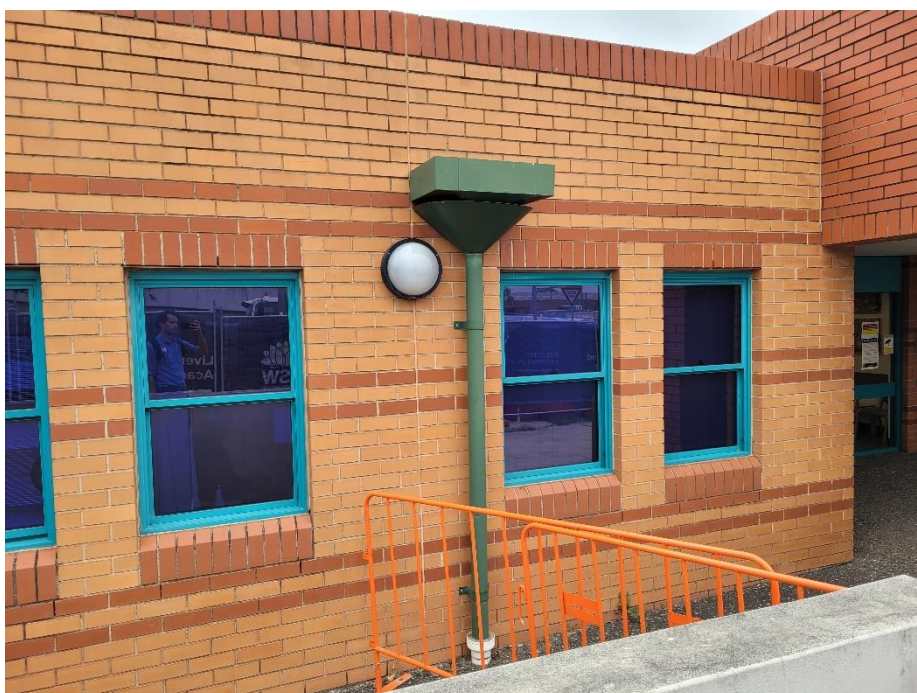
External 3. Typical  
external wall for western  
elevation

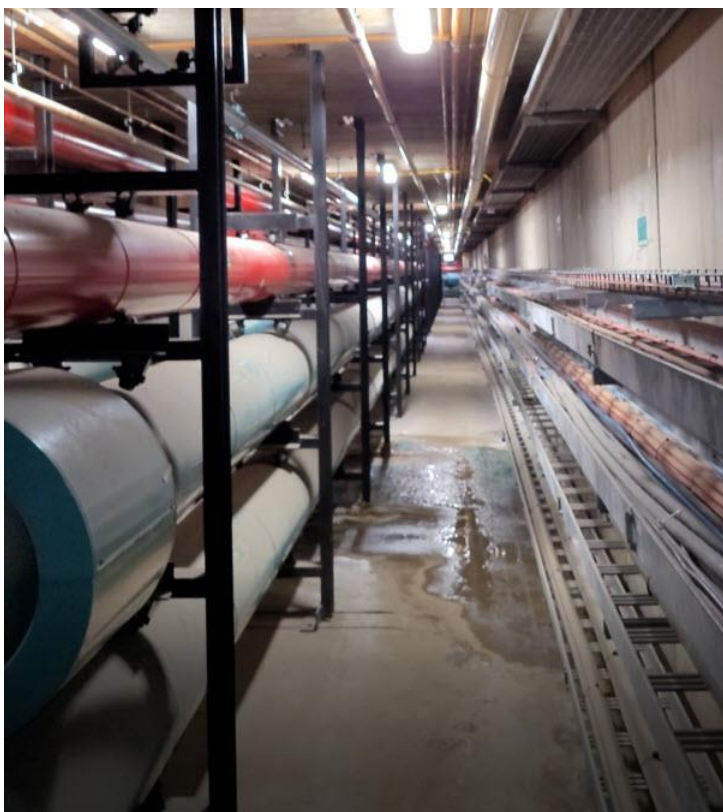
Service Tunnel 4. Leak noted in tunnel to East of BIU access point on southern side of central pipework, unknown origin

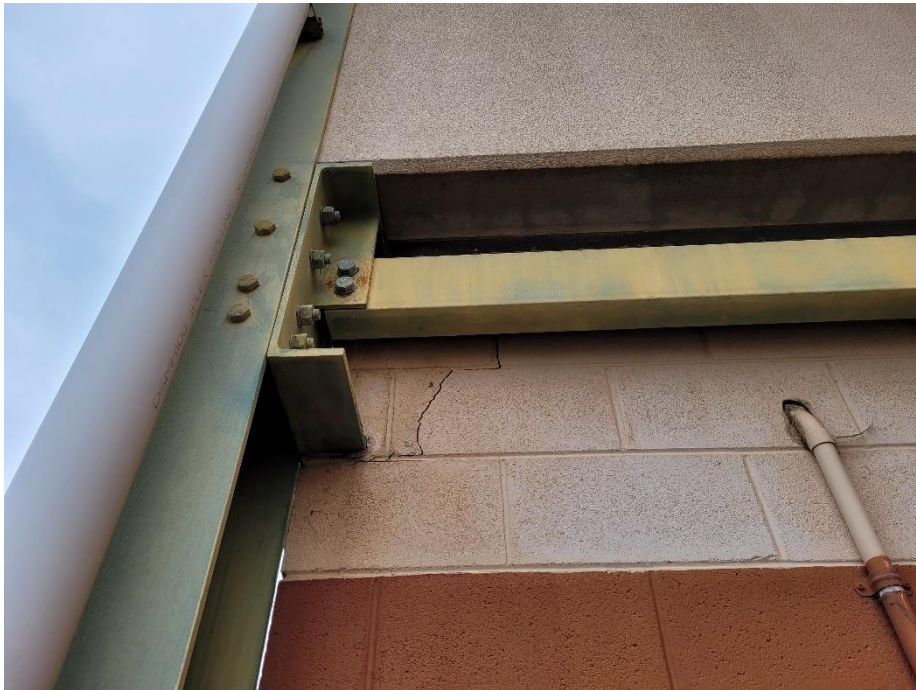
Existing Carpark 5.

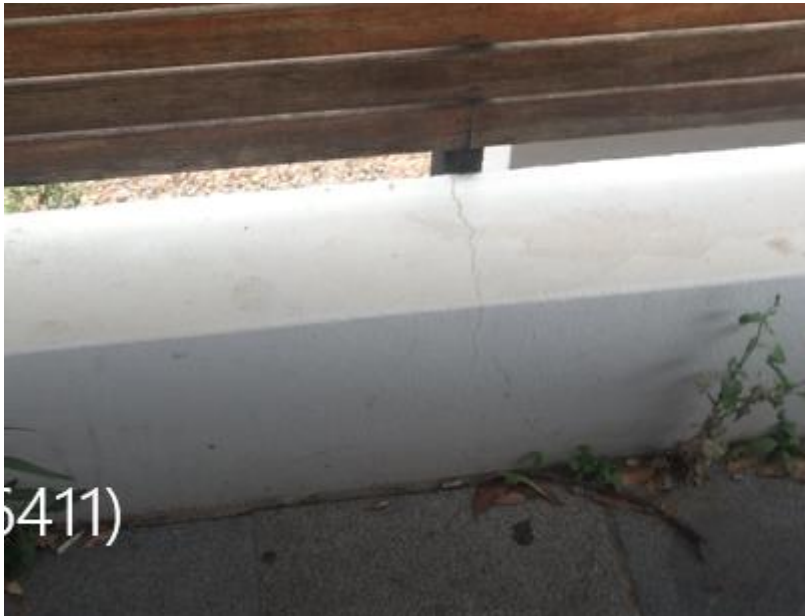
BIU perimeter 1. Cracks  
to existing wall

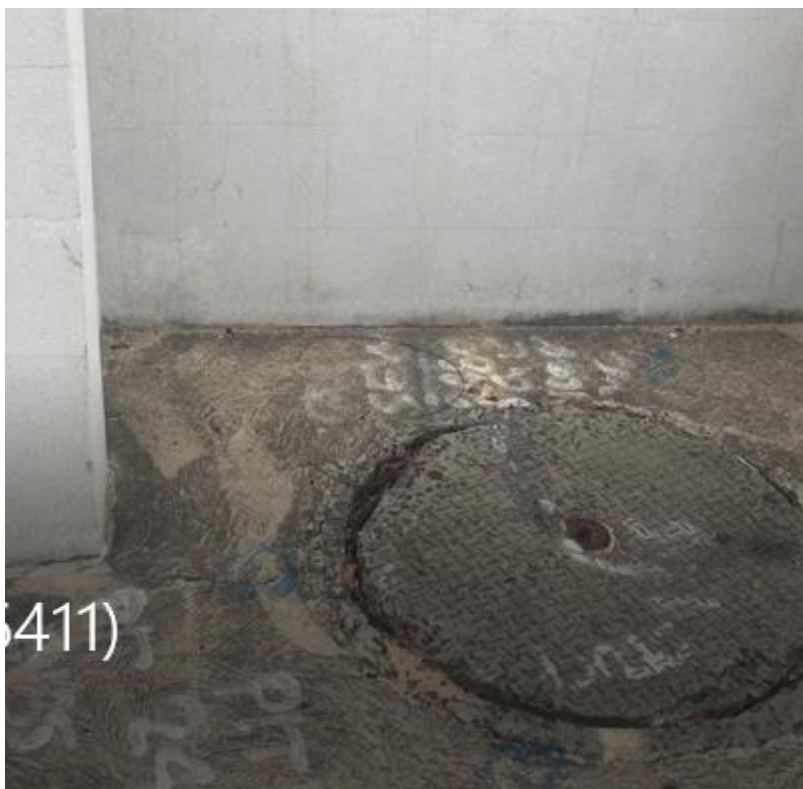
BIU perimeter 3. Sewer cover

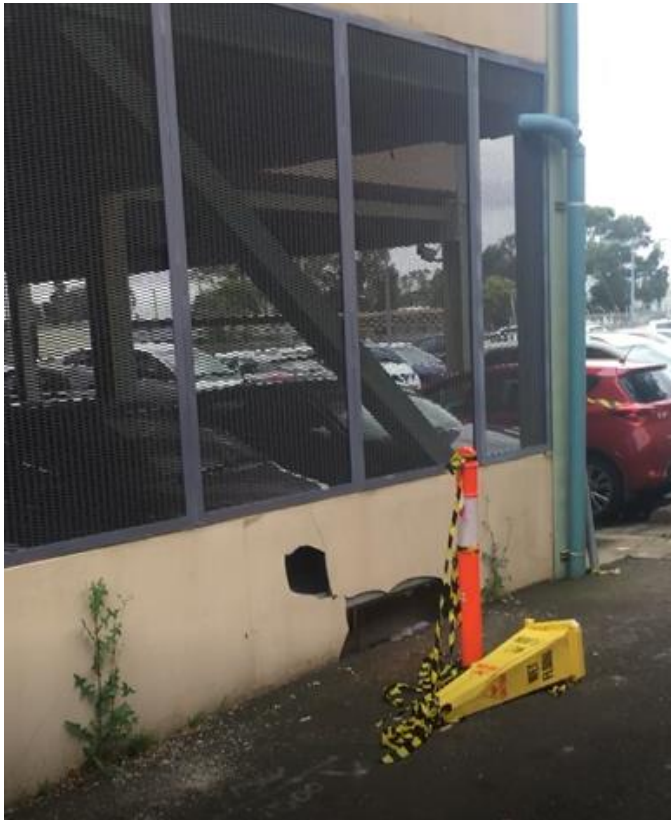
MSCP tie-in 2. Façade and downpipe connection.

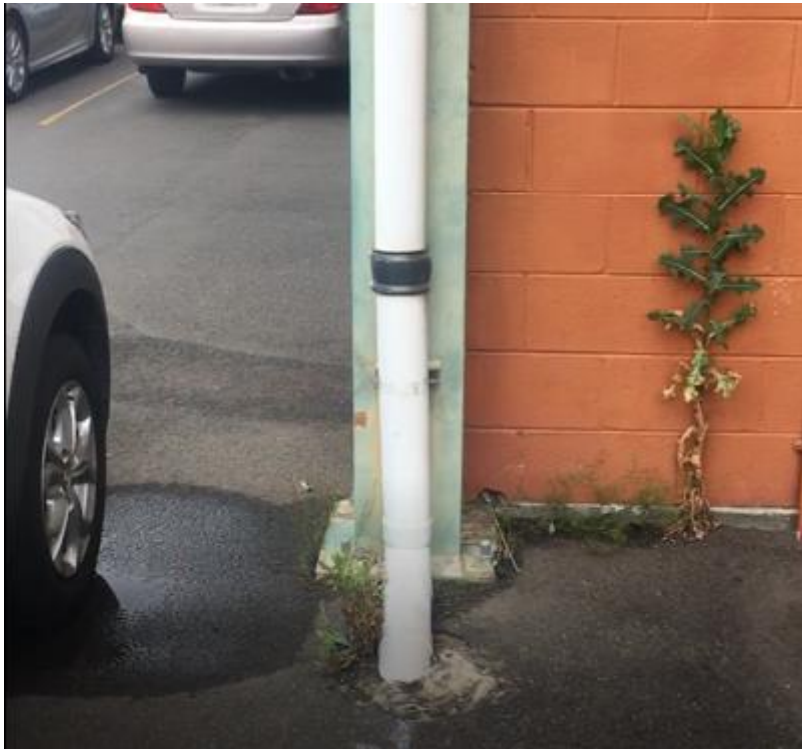
MSCP tie-in 4. Downpipe connection.

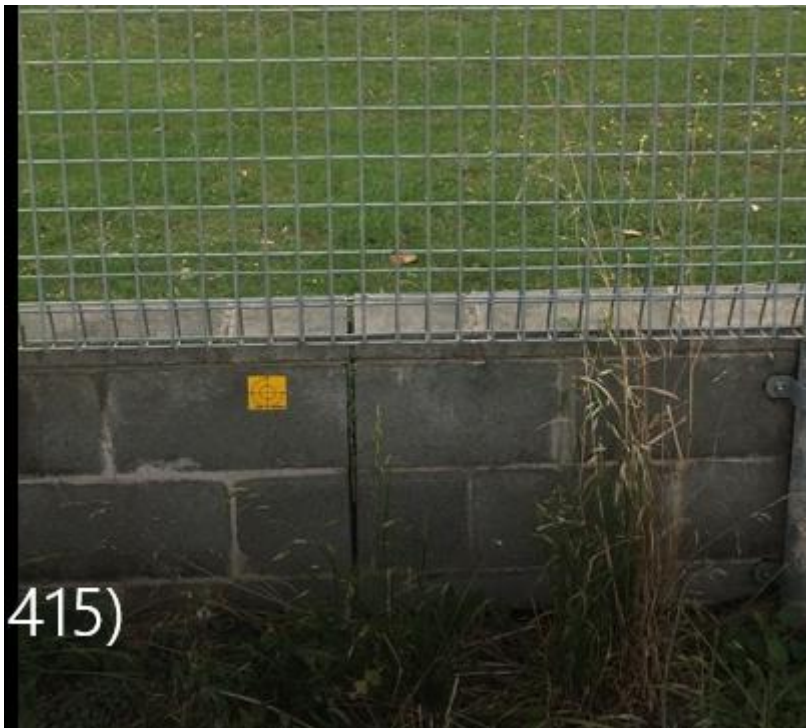
School fence 1. Retaining wall open joints

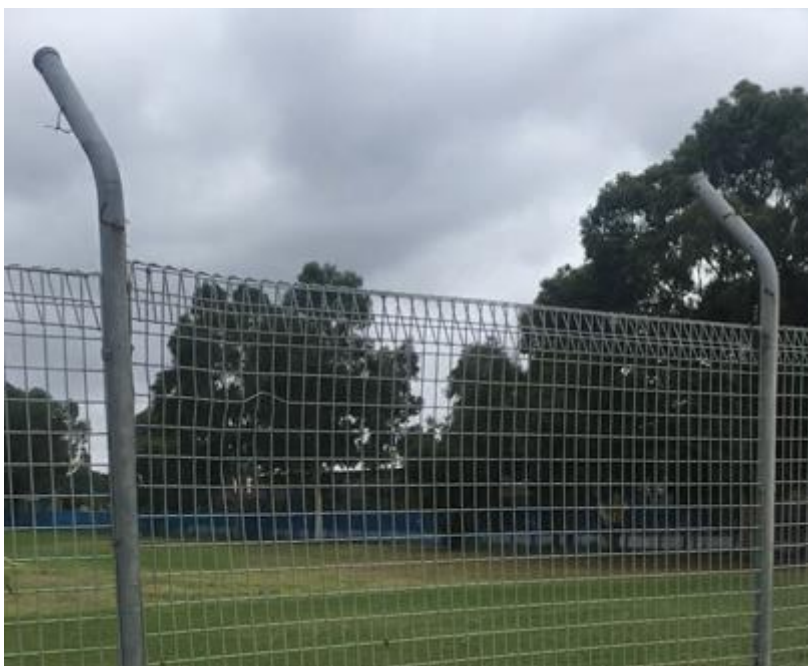
School fence 2. Barbed wire missing from top

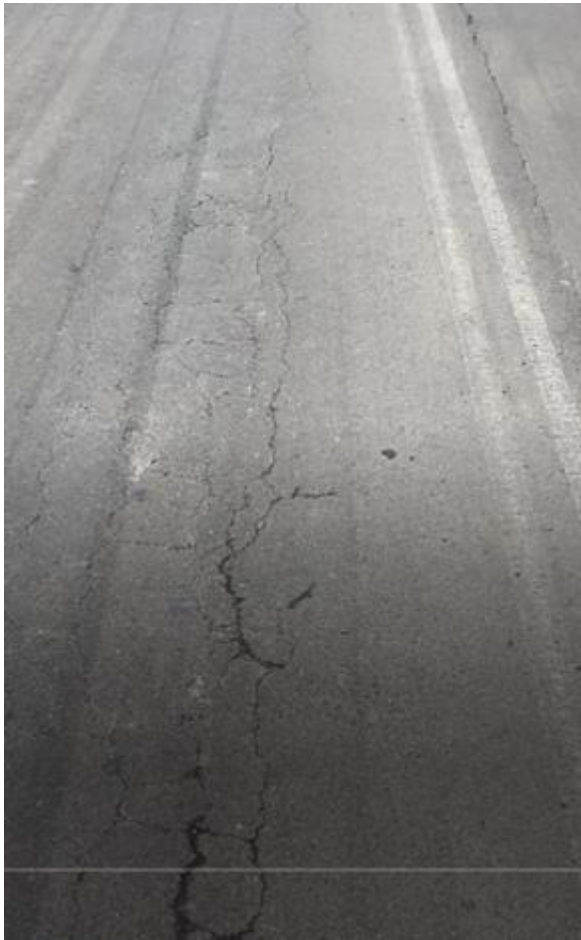
Burnside Drive 1.  
Longitudinal cracking at  
various locations

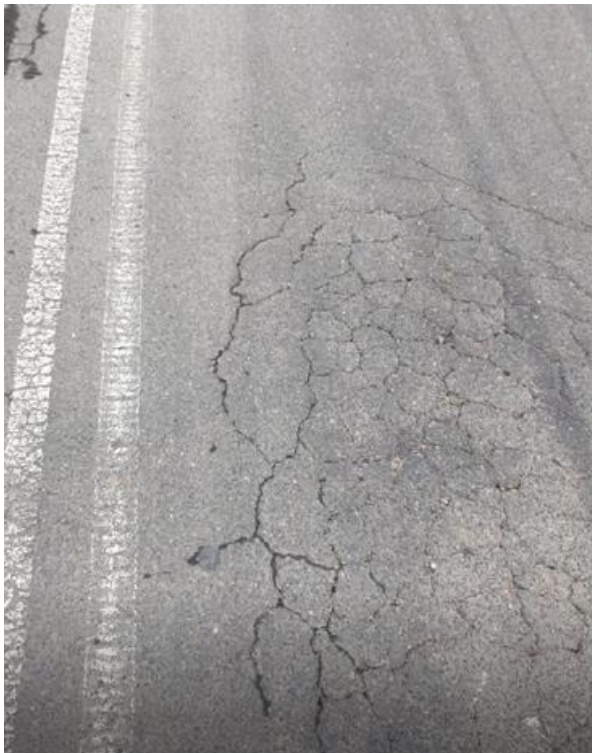
Burnside Drive 2.  
Pavement cracking

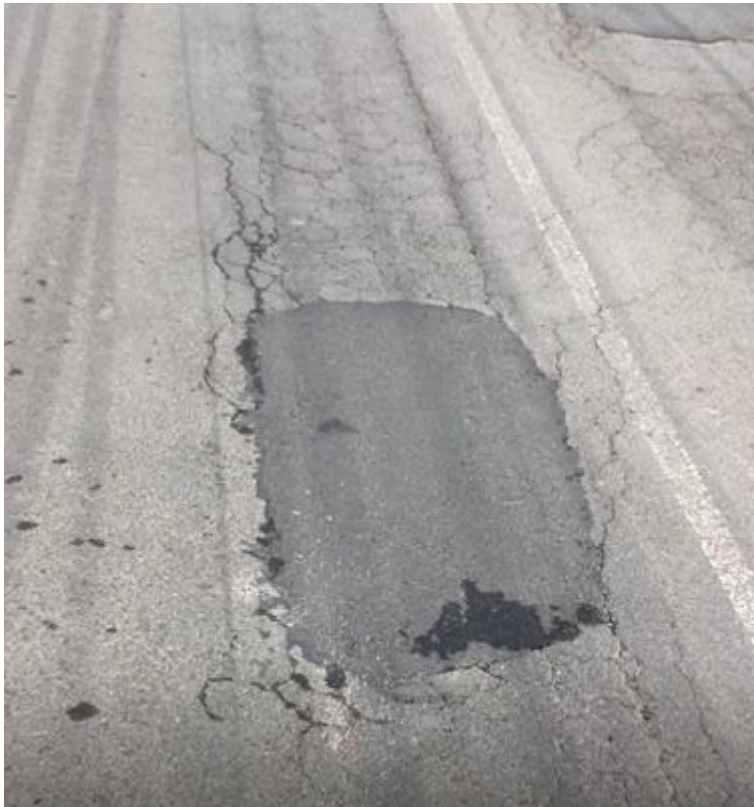
Burnside Drive 3. Patch repair

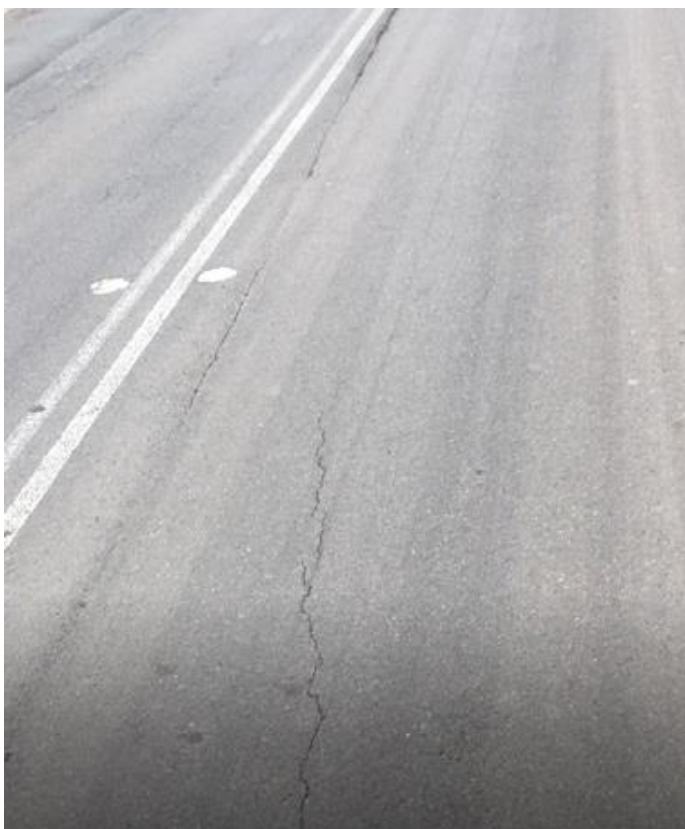
Burnside Drive 4.  
Longitudinal cracking at various locations

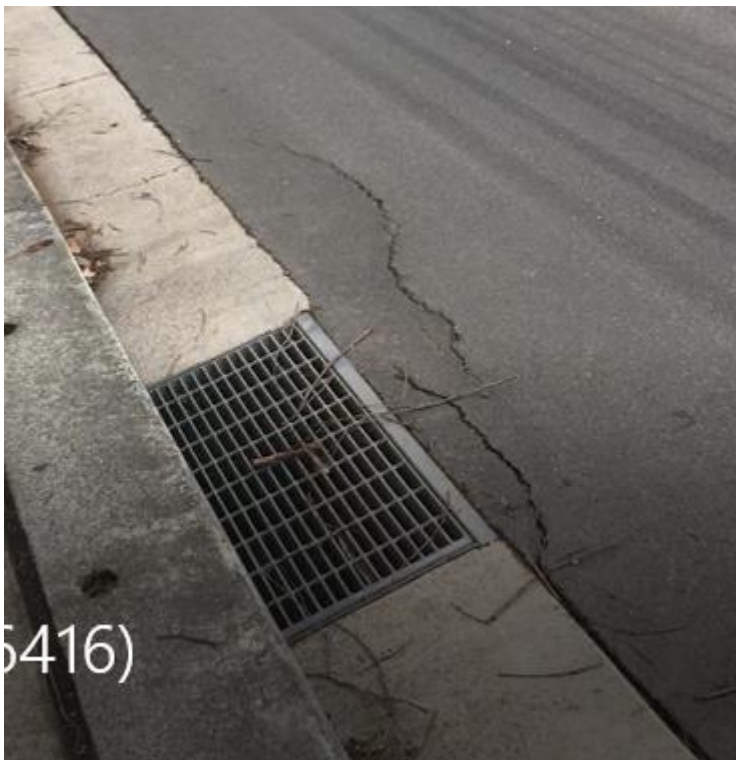
Burnside Drive 6.  
Pavement cracking at pit

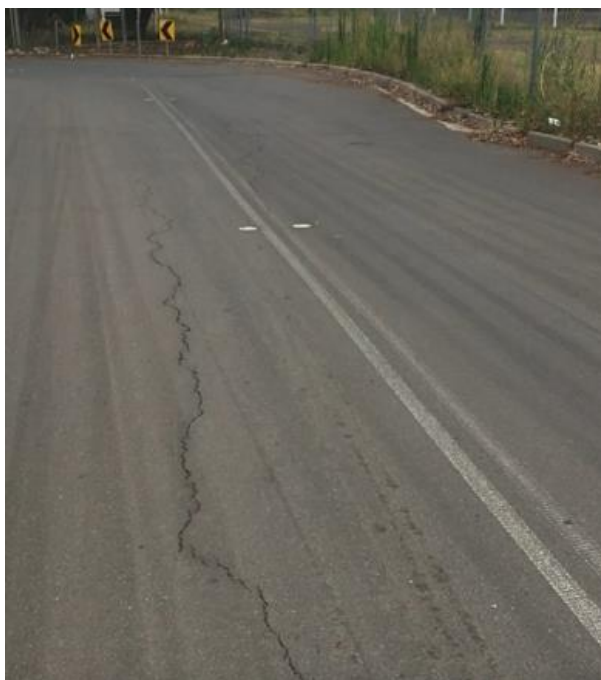
Burnside Drive 7.  
Longitudinal  
cracking at  
various locations

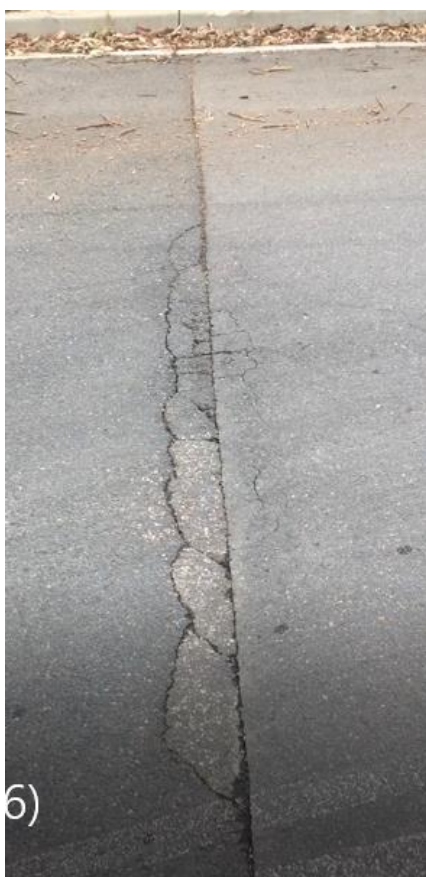
Burnside Drive 8.  
Cracking at tie-in
