**HAZARDOUS
MATERIALS SURVEY**

**St John of God
Richmond Hospital**

**Project No.
47543**

**Date:
18/10/19**

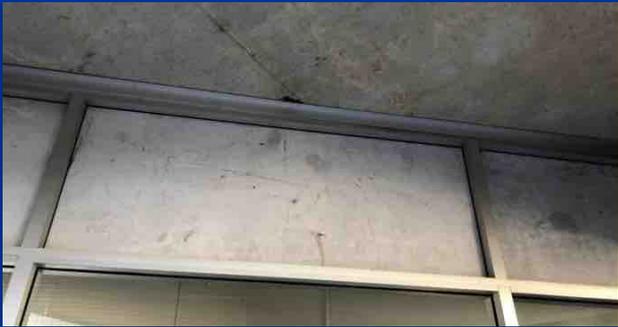
Photo 1

External – Lower floor – Gym – Infill panels above windows

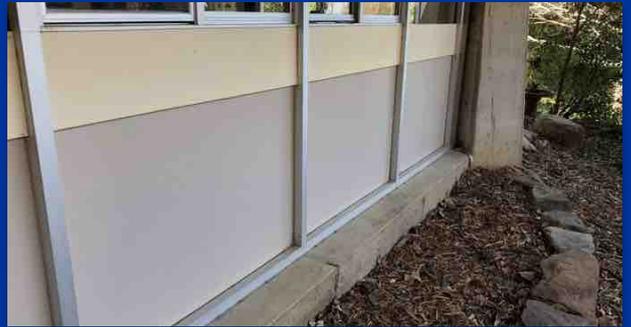
Photo 2

External – Lower floor – Gym – Infill panels below windows.

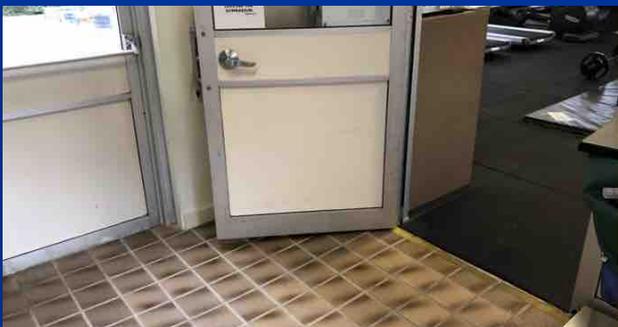
Photo 3

External – Lower floor – Doors either side of corridor south of gym and southern entrance to gym – Bottom of door panels.

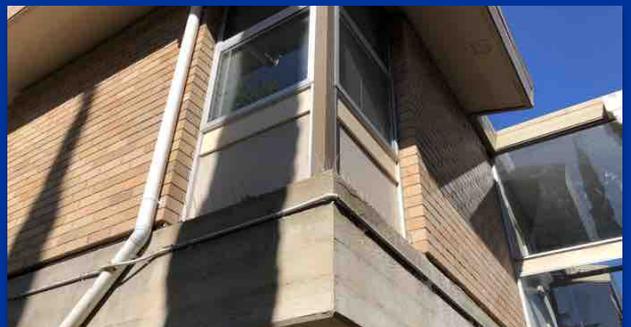
Photo 4

External –Upper floor– Infill panels underneath windows .

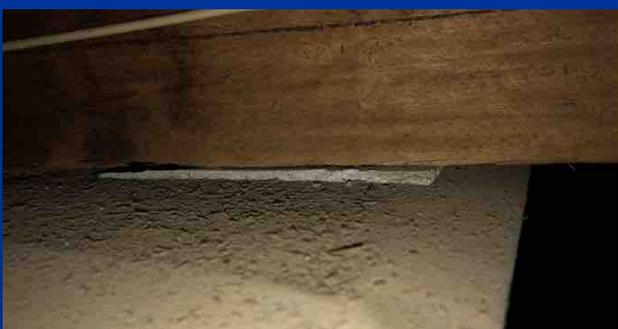
Photo 5

External – Sub-floor – Fibreboard fragments used as packing on support stumps

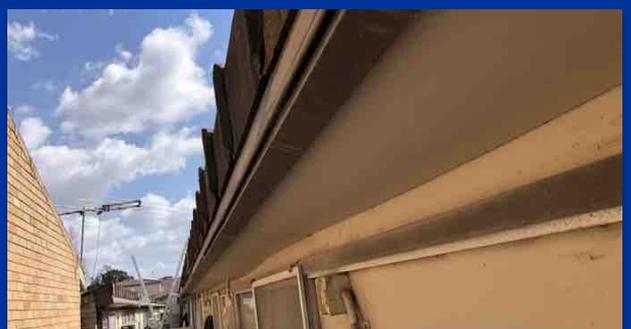
Photo 6

External – Rooftop – Thin eave in alcove roof section.

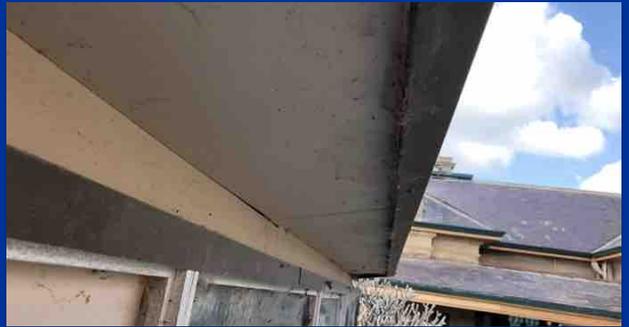
Photo 8

External - Rooftop - Thin eave in alcove roof area.

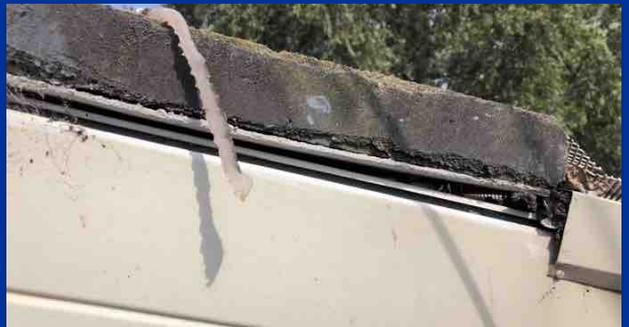
Photo 10

External - Cement sheet on edges of roof, underneath roof tiles.

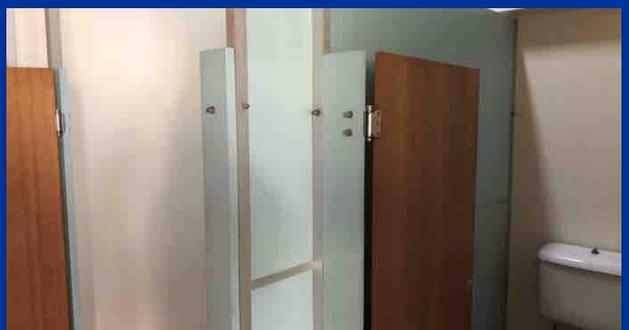
Photo 12

Internal - Lower floor - Existing female toilet (Southeast corner of building) - Cubicle partition and doors

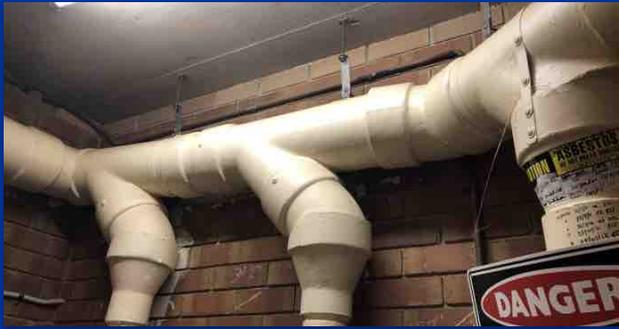
Photo 13

Internal – Lower floor – Hot water service cupboard – Flu pipe

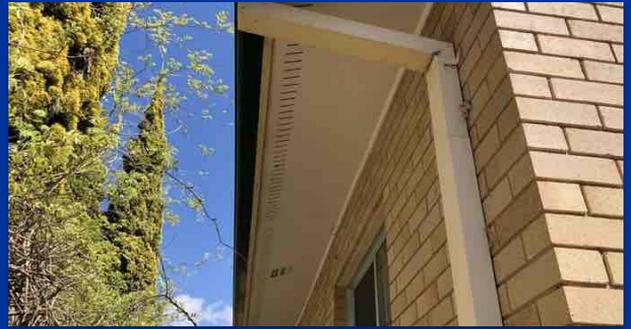
Photo 14

External – Eave sheeting (Bottom layer).

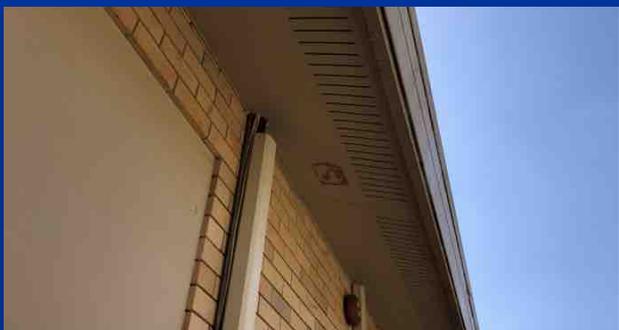
Photo 15

External – Infill panel on southeastern wall

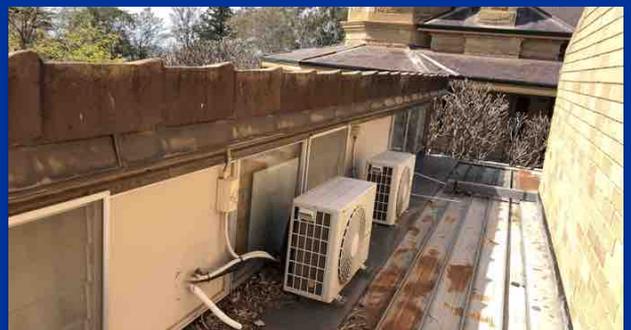
Photo 16

External – Rooftop – Infill panels beside windows

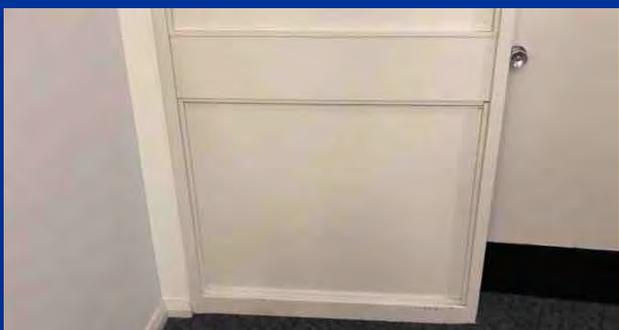
Photo 17

Internal – Lower floor – Lower infill panel on Northeastern corner office.

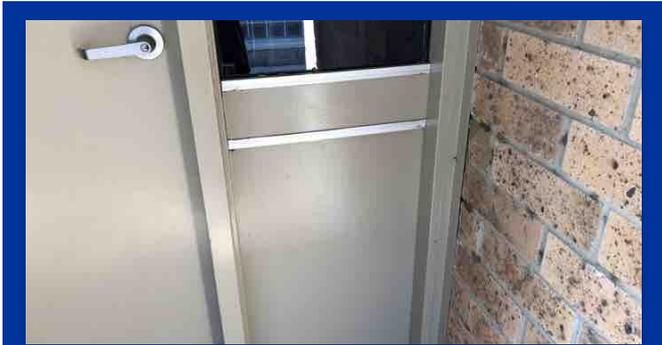
Photo 25

External – Northern building – Southeastern porch – Infill panel below window

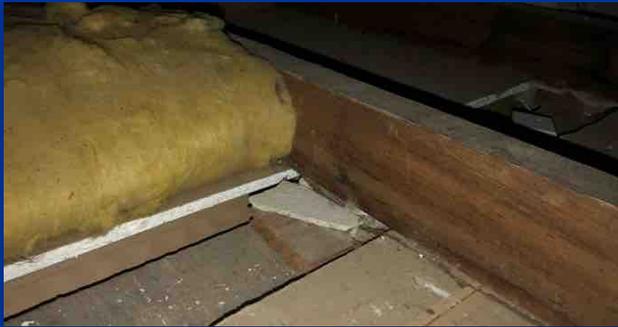
Photo 31

Internal – Northern building – Ceiling space – Fibreboard fragments used as packing material in framework

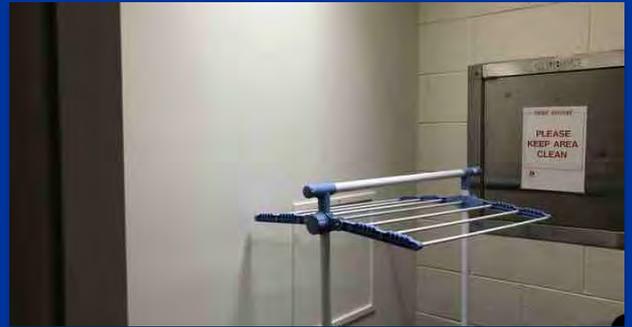
Photo 32

Internal – Northern building – Storeroom with garbage slot – Eastern wall .

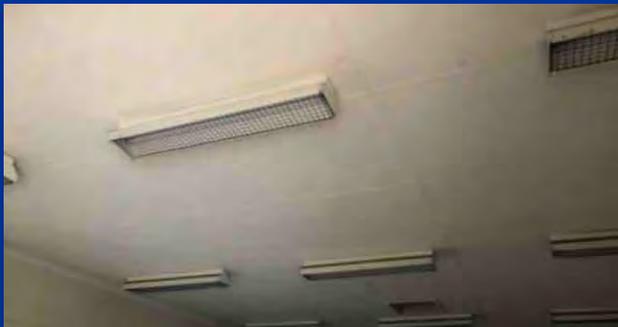
Photo 33

Internal – Squash court – Ceiling sheeting over play area and viewing deck.

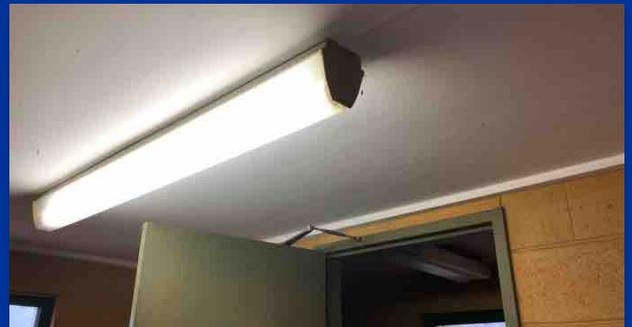
Photo 34

Internal – Squash court – Change rooms – Ceiling sheeting

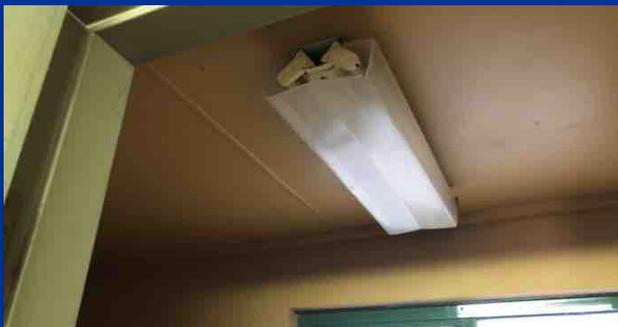
Photo 35

Internal – Squash court – Toilet and showers – Ceiling sheeting.

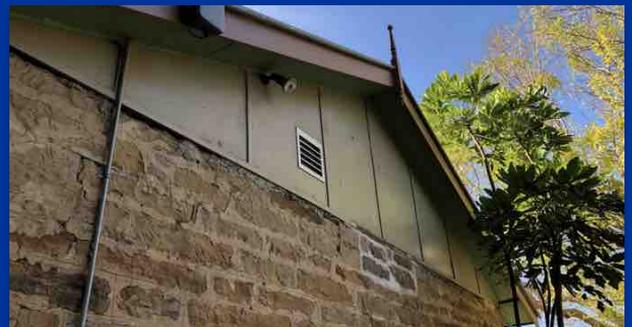
Photo 36

External – Group Therapy Building – Gable ends on western and eastern sides of building .

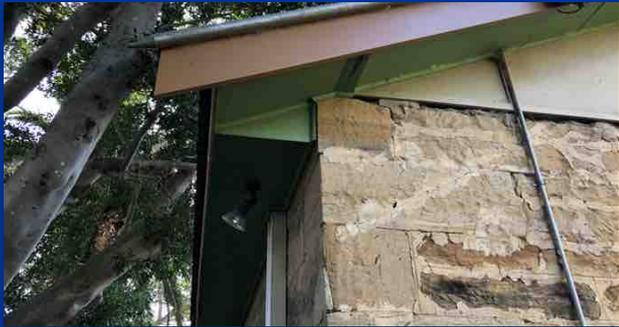
Photo 37

External – Group Therapy Building – Eave sheeting

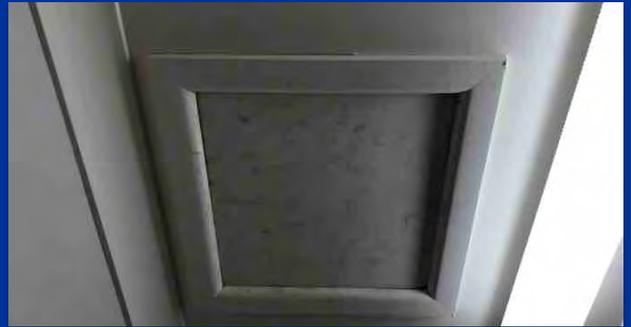
Photo 38

Internal – Group Therapy Building – Southwestern office – Manhole cover.

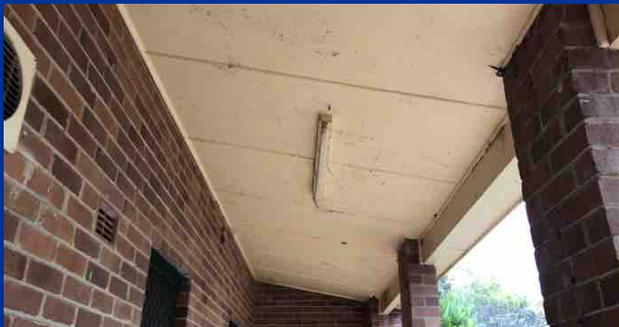
Photo 39

External – Northern verandah – Ceiling sheeting.

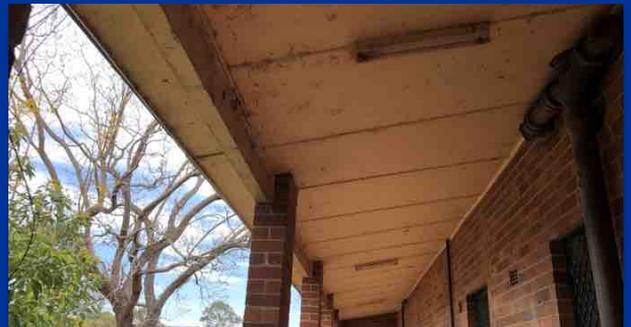
Photo 40

External – Southern verandah – Ceiling sheeting.

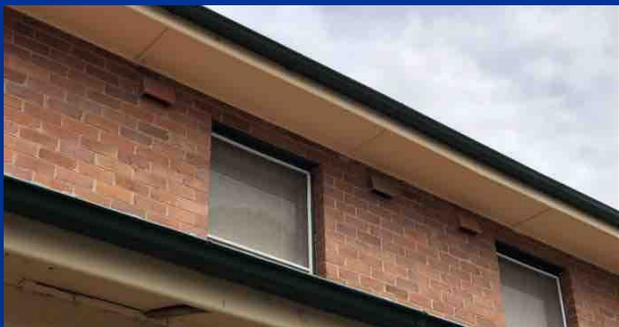
Photo 41

External – Eave sheeting [*Entire building*].

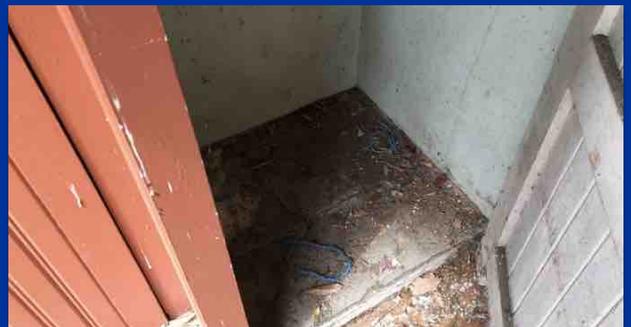
Photo 42

External – Northern verandah – Telephone box/storage cupboard – Material on floor surface.

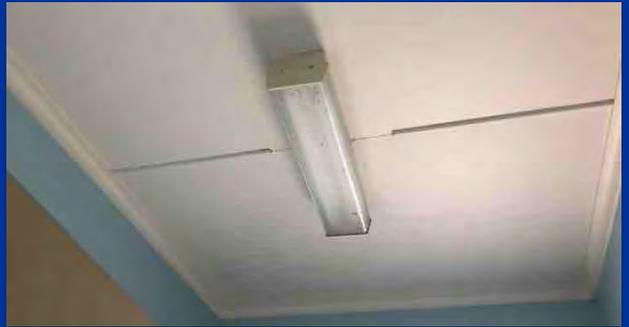
Photo 44

Internal – First floor – Eastern bathroom – Ceiling sheeting.

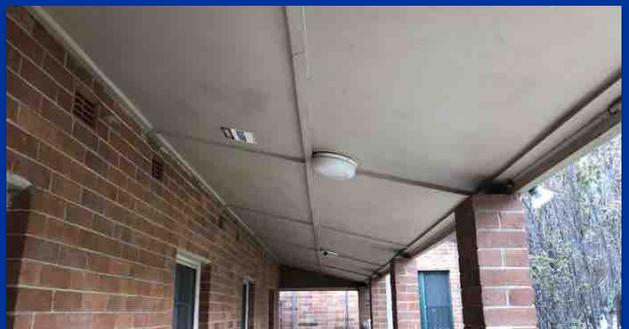
Photo 46

External – Northern verandah – Ceiling sheeting.

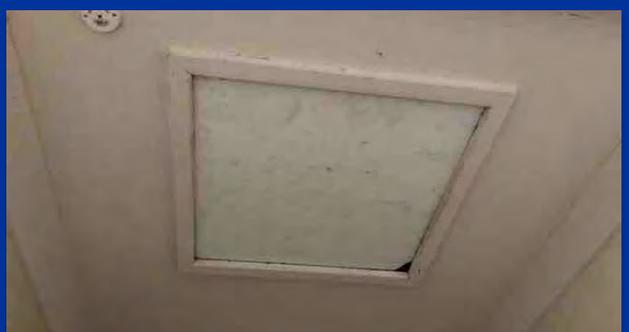
Photo 48

Internal – Eastern and western manhole covers

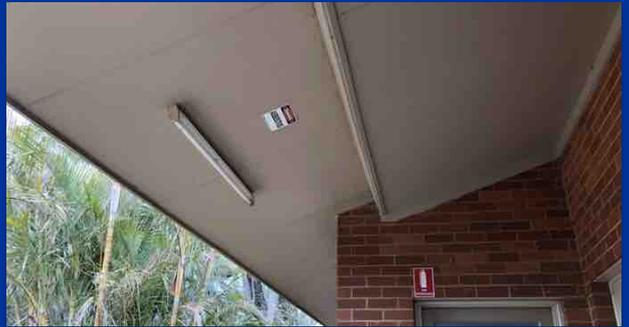
Photo 50

External – Northern porch sheeting.

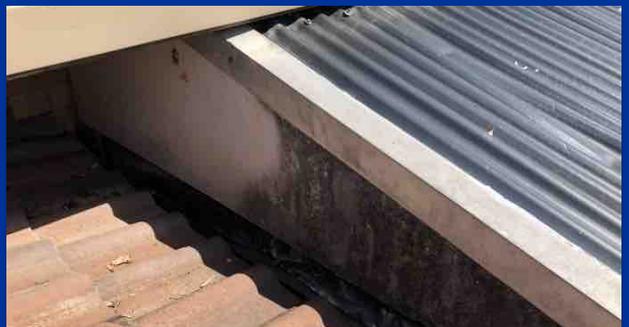
Photo 52

External – Rooftop – Small gable end section on rooftop above courtyard area.

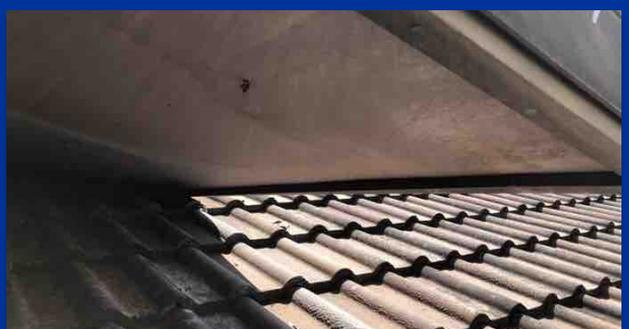
Photo 54

External – Rooftop – Small eave and gable section between roof sections

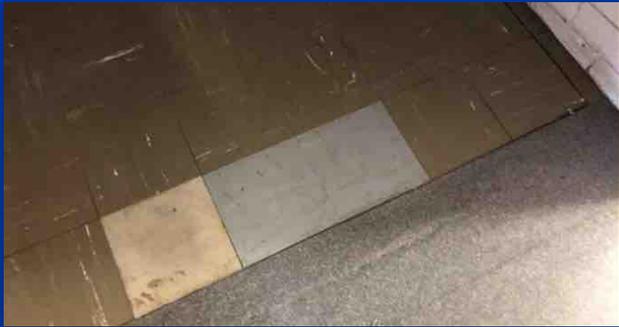
Photo 55

Internal – Food service unit – Southern corridor – Vinyl floor tiles (Gray)

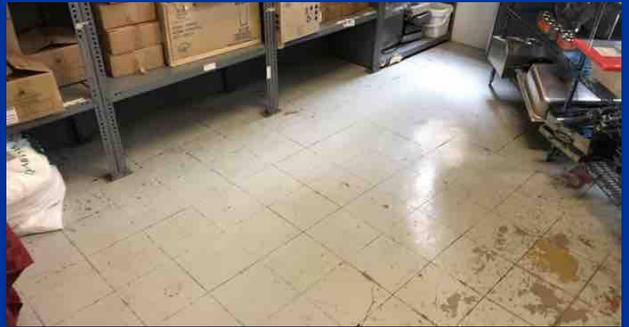
Photo 56

Internal – Food service unit – Western storeroom – Vinyl floor tiles & black adhesive.

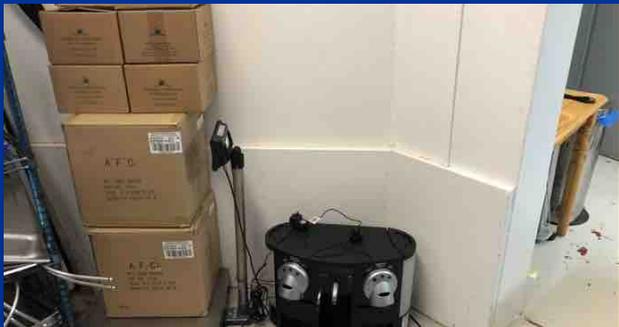
Photo 57

Internal – Food services unit – Western storeroom – Sheeting around bottom of walls .

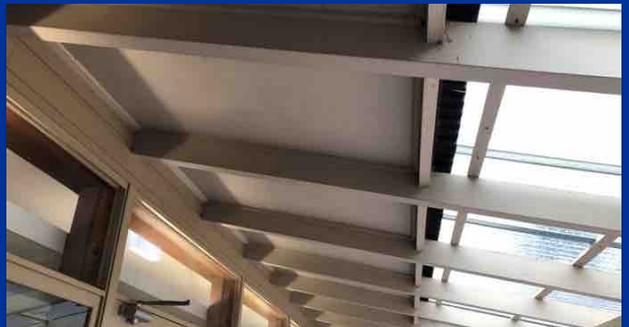
Photo 58

External – Courtyard – Verandah – Ceiling sheeting

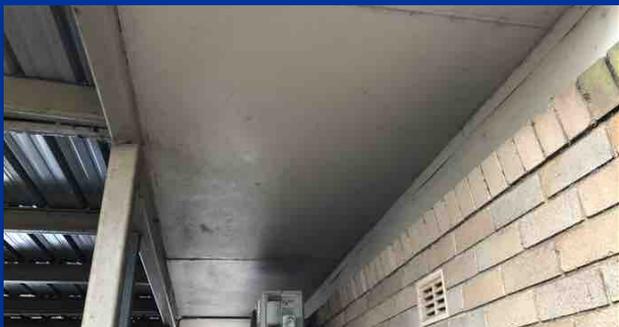
Photo 59

External – Eave sheeting [*Entire Building*] .

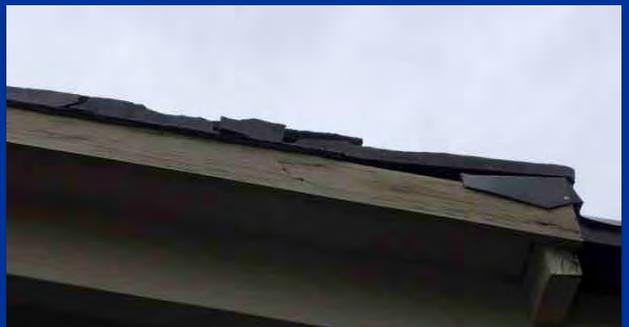
Photo 60

External – Cement sheet on edge of roof underneath roof tiles

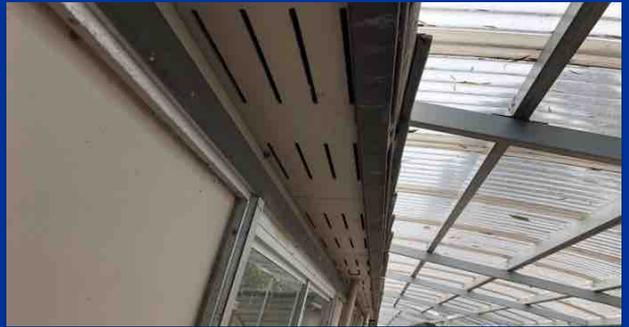
Photo 62

External – Rooftop – Alcove eave sheeting

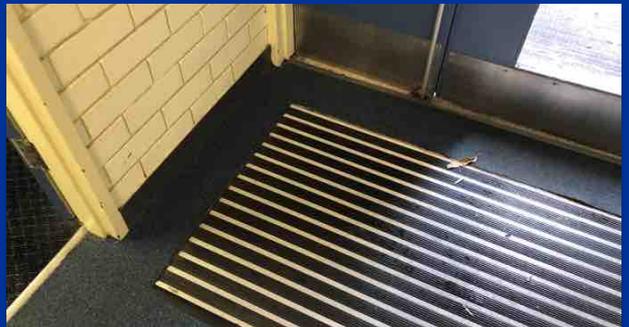
Photo 64

Internal – Corridor – Linoleum flooring underneath carpet .

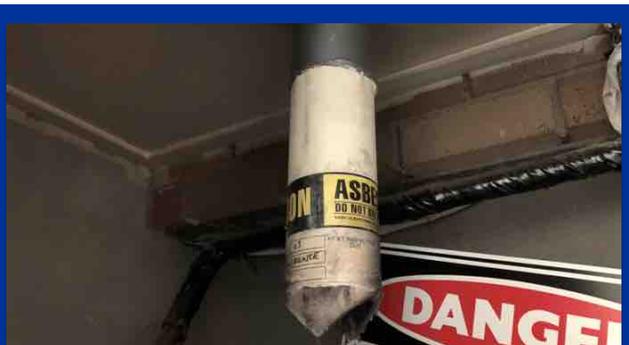
Photo 66

Internal – Hot water heater cupboard – Molded fibrous cement flue pipe.

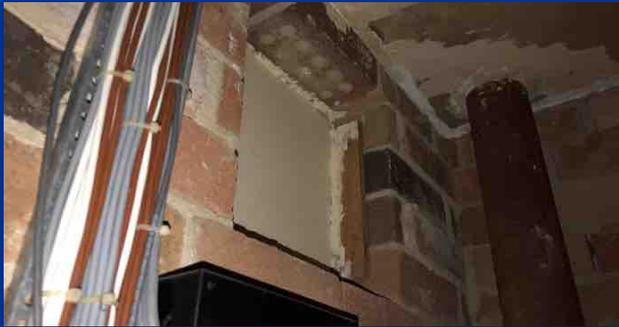
Photo 73

Internal – Duct Cupboards – Small fibrous cement sheet panels on penetrations into toilets

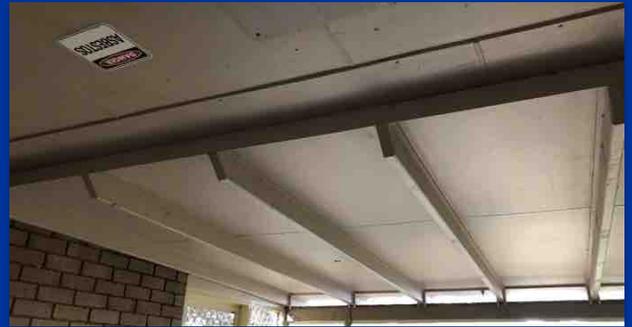
Photo 74

External – Northeastern balcony/verandah area – Ceiling sheeting .

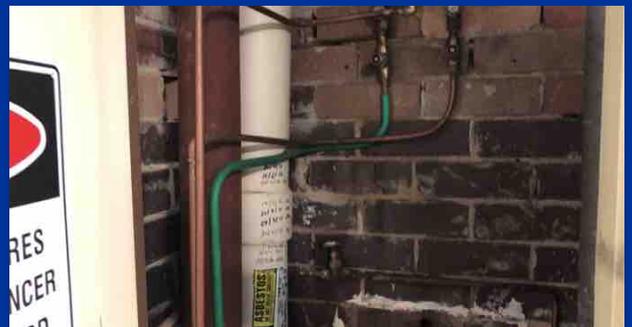
Photo 76

Internal – Duct 5 cupboard – Molded fibrous cement pipe.

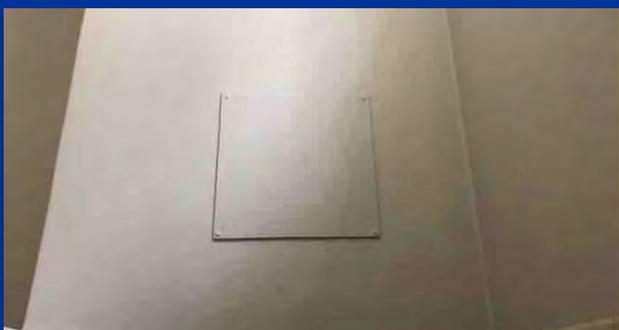
Photo 77

Internal – Staff toilets – Fibrous cement sheet panel above toilets which backs onto duct cupboards

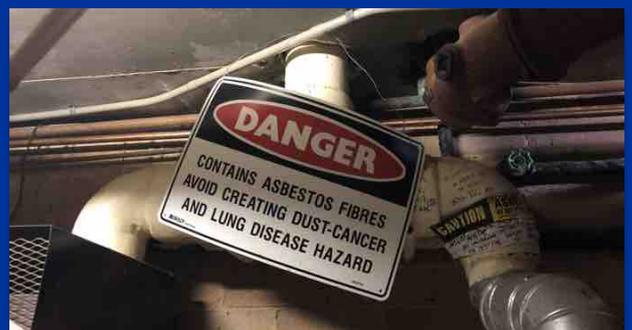
Photo 78

Sub-floor – Molded fibrous cement flu pipes off hot water heaters

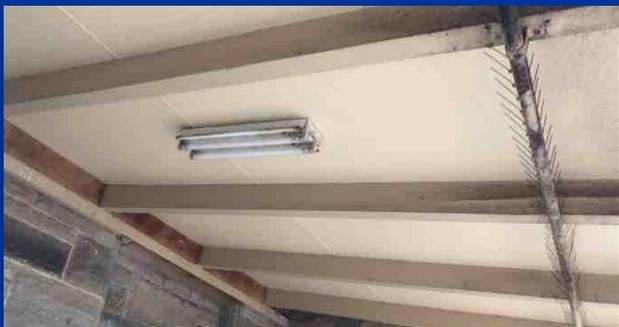
Photo 81

External – Courtyard – Verandah sheeting.

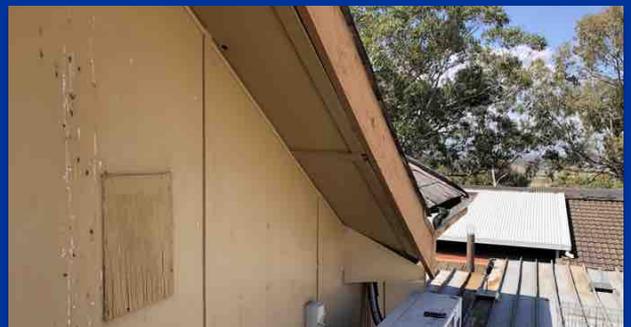
Photo 82

External – Rooftop – Upper wall and eave sheeting on southern side.

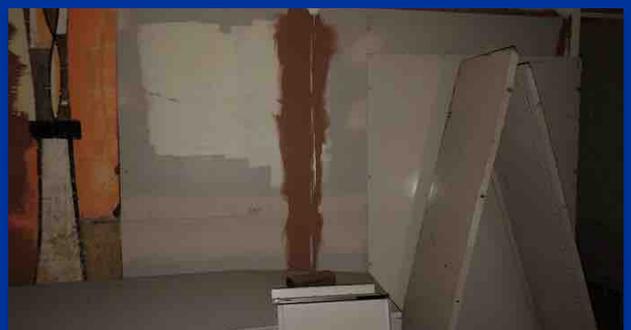
Photo 84

Internal – Basement – Medical records room – Southern wall sheeting (Partition wall of small room attached).

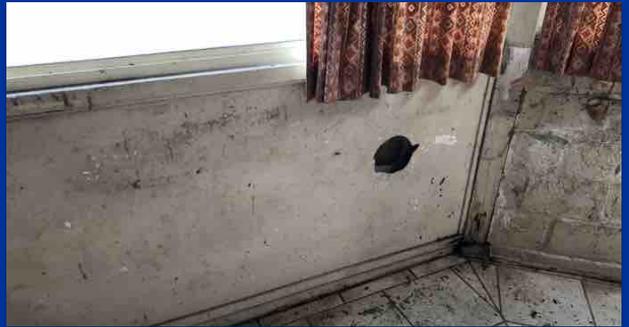
Photo 92

Internal – Rear sunroom area – Wall sheeting

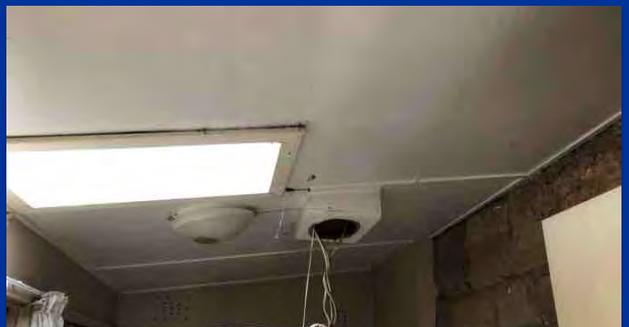
Photo 94

Internal – Bathroom – Ceiling and wall sheeting.

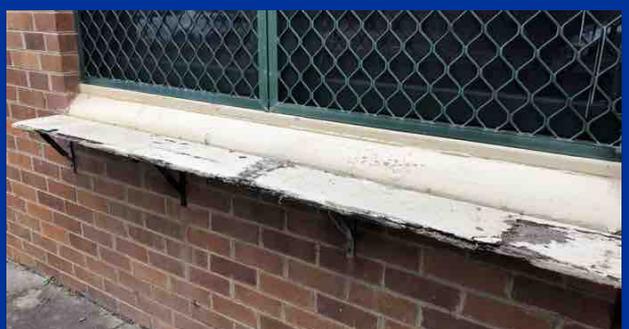
Photo 96

Monastery – External – Cream paint.

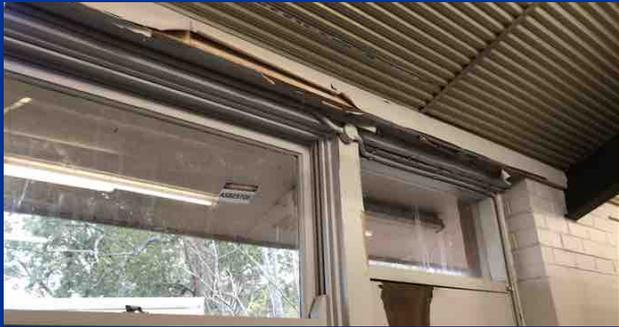
Photo 103

Archives – Internal – General archiving area –
Light gray wall paint

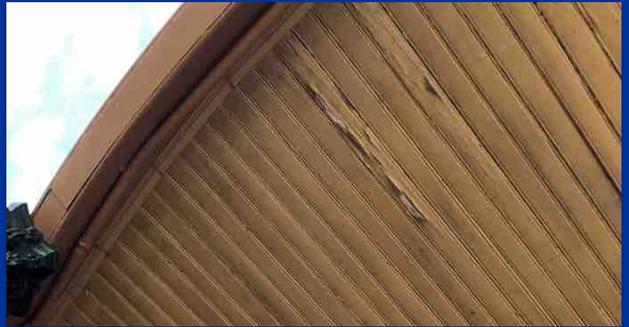
Photo 104

Belmont house – External – Yellow/brown
paint

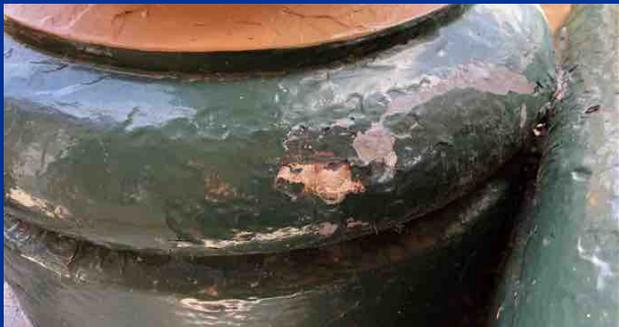
Photo 105

Belmont house – External – Dark green paint.

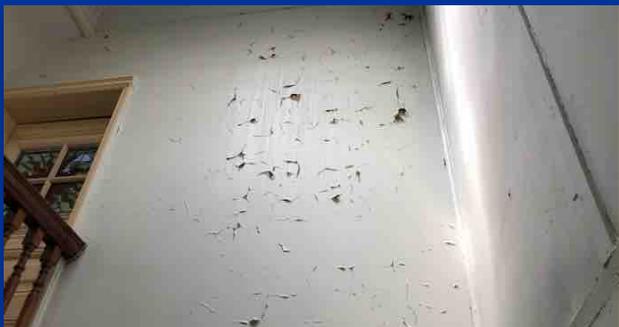
Photo 107

Belmont house – Northern staircase – Top of
staircase – White/blue wall paint

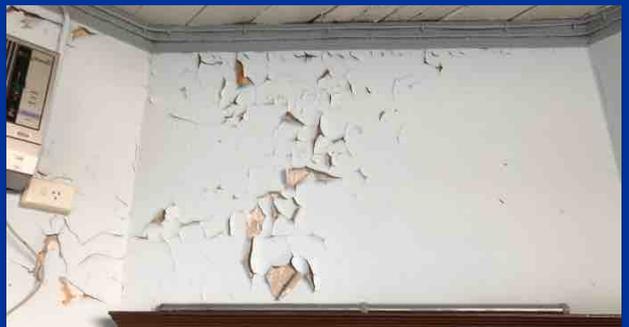
Photo 108

Belmont house – Tower room – Light blue
paint.

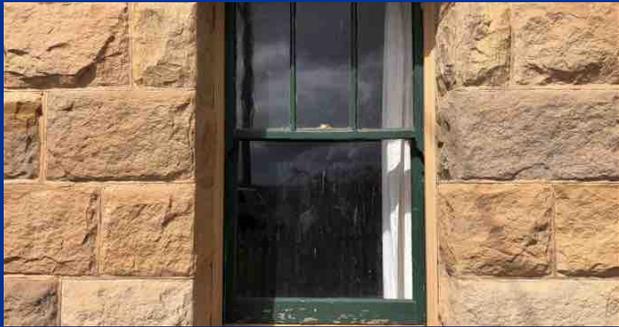
Photo 109

Gate house – External – External window frame - Dark green paint

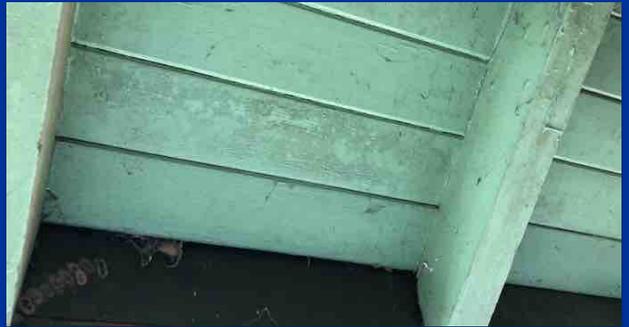
Photo 110

Gate house – External – Light green paint on eaves

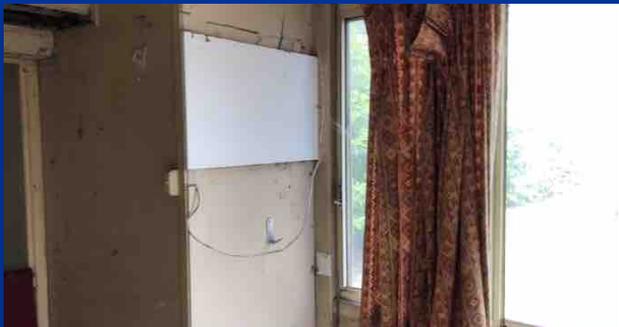
Photo 111

Gate house – Internal - Pink/orange paint in kitchen

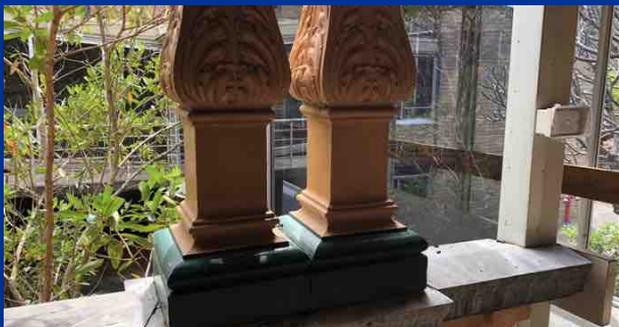
Photo 112

Belmont house – External – Dark green and mustard paint on external surfaces.
