**1-15 AND 2-12 CONFERTA AVENUE,  
ROUSE HILL NSW 2155  
TALLAWONG STATION PRECINCT SOUTH  
PRE-DILAPIDATION REPORT**

**DEICORP PROJECTS  
(TALLAWONG STATION) PTY LTD**

Job No. 191294.0  
05/07/2021

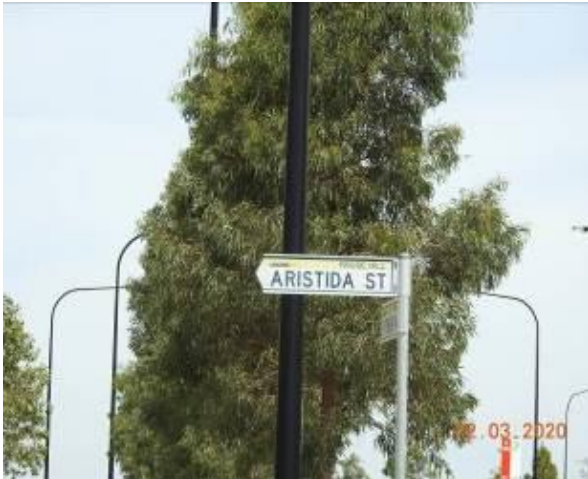
Figure 1 – The following images display condition of Aristida Street Council Assets

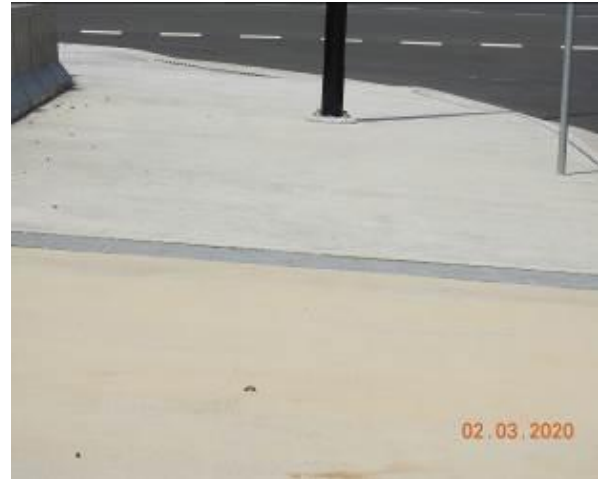
Figure 2 – General Condition of footpath pavement

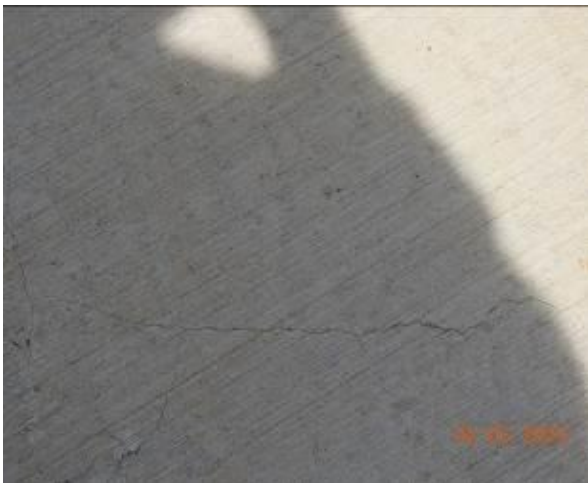
Figure 3 – Crack propagation through footpath pavement

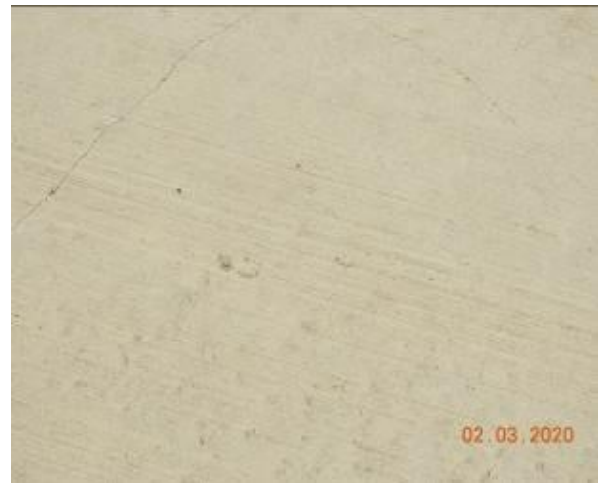
Figure 4 – Crack propagation through footpath pavement

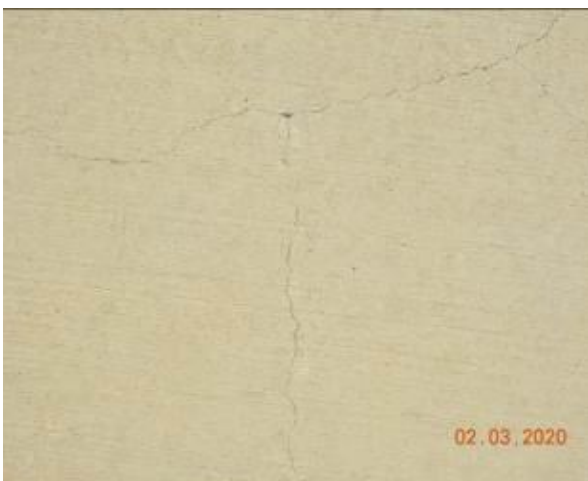
Figure 5 – Crack propagation through footpath pavement

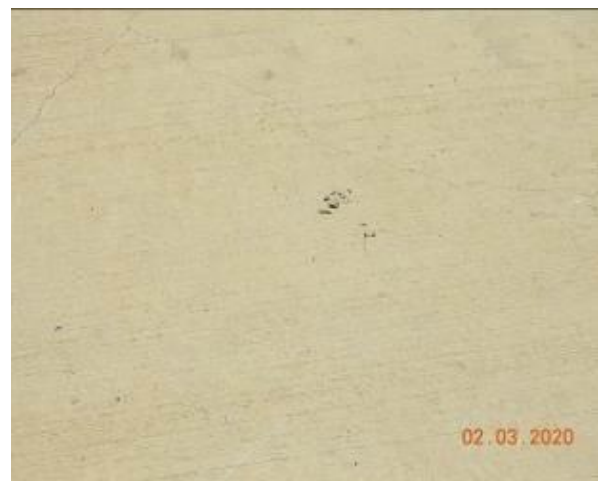
Figure 6 – Crack propagation through footpath pavement

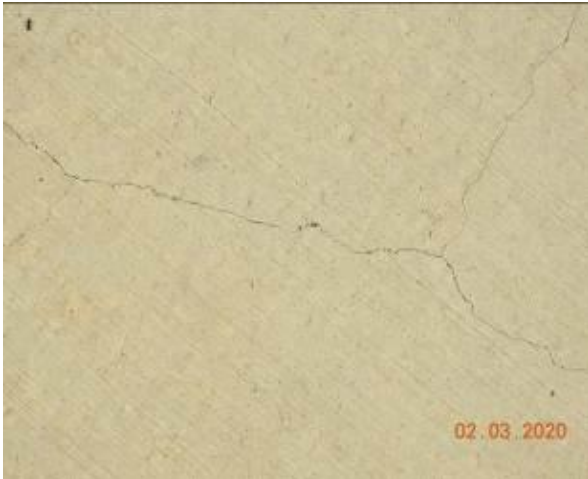
Figure 7 – Crack propagation through footpath pavement

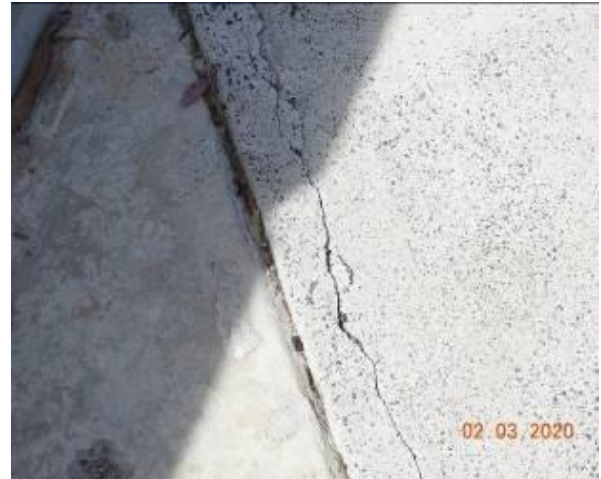
Figure 8 – Crack propagation and loss of material through footpath pavement

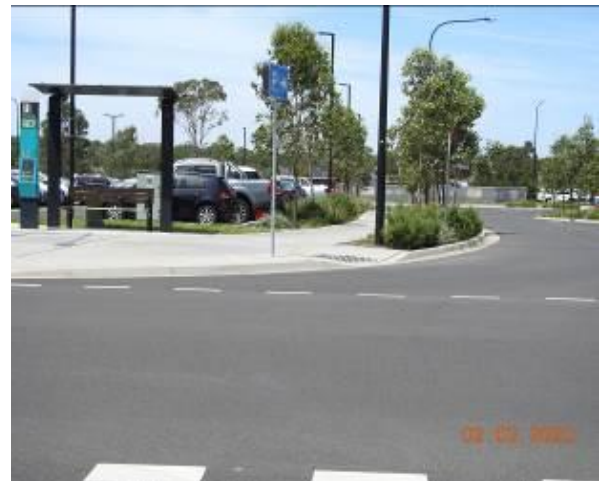
Figure 10 – General Condition of footpath pavement

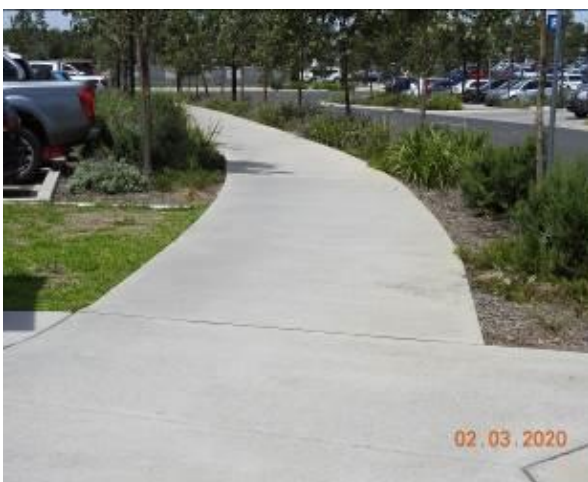
Figure 11 – General Condition of footpath pavement

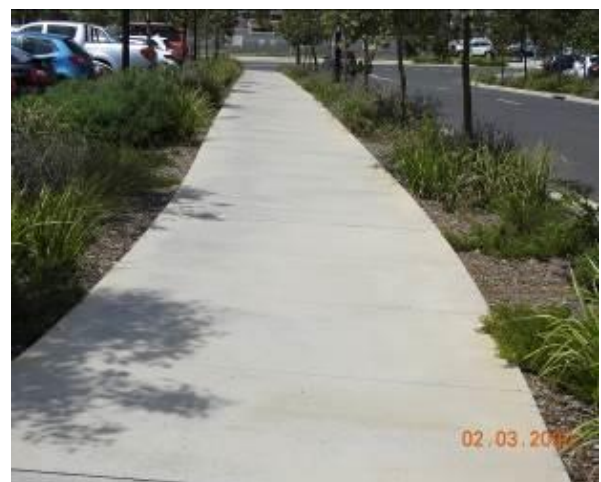
Figure 12 – General Condition of footpath pavement

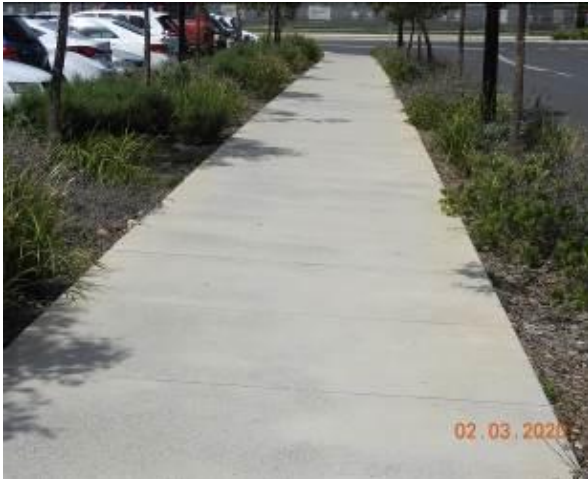
Figure 13 – General Condition of footpath pavement

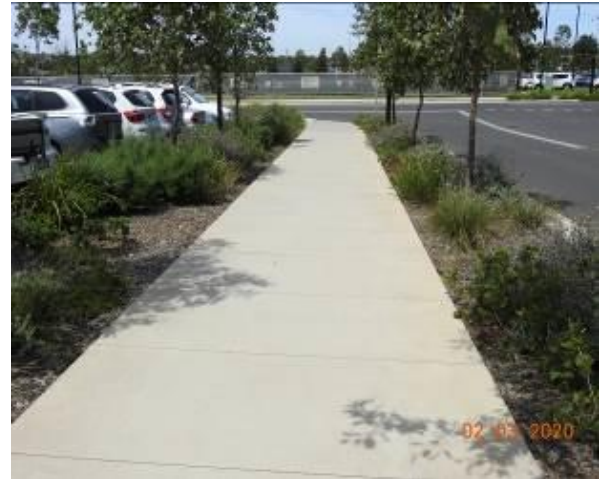
Figure 14 – General Condition of footpath pavement

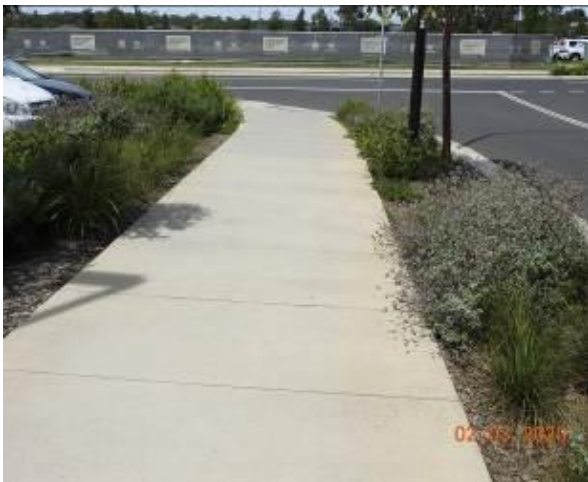
Figure 15 – General Condition of footpath pavement

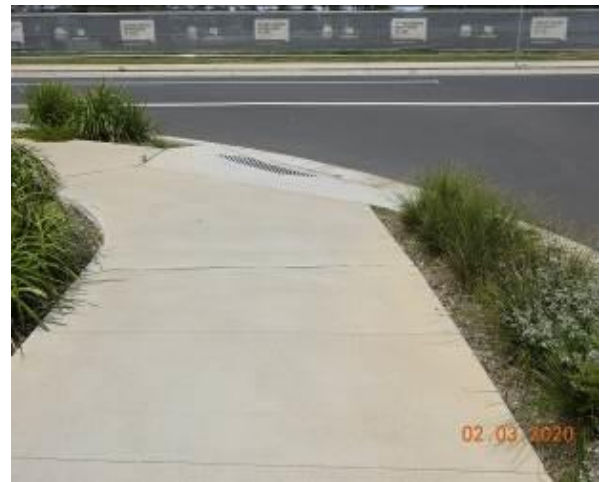
Figure 16 – General Condition of footpath pavement

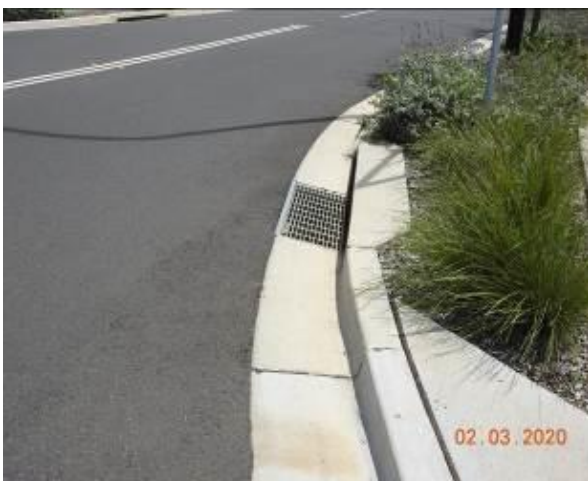
Figure 17 – General Condition of kerb and gutter

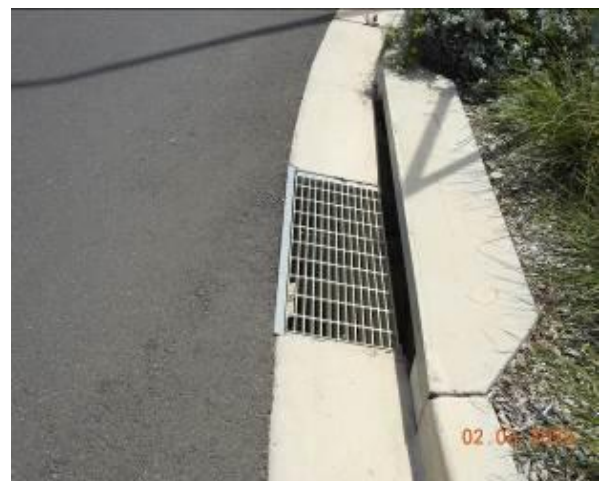
Figure 18 – General Condition of stormwater inlet pit

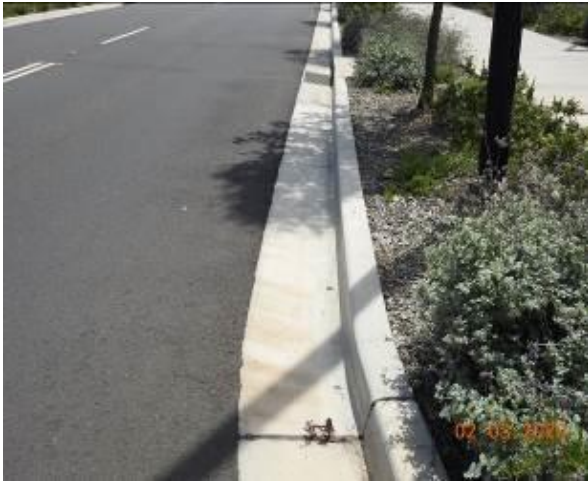
Figure 19 – General Condition of kerb and gutter

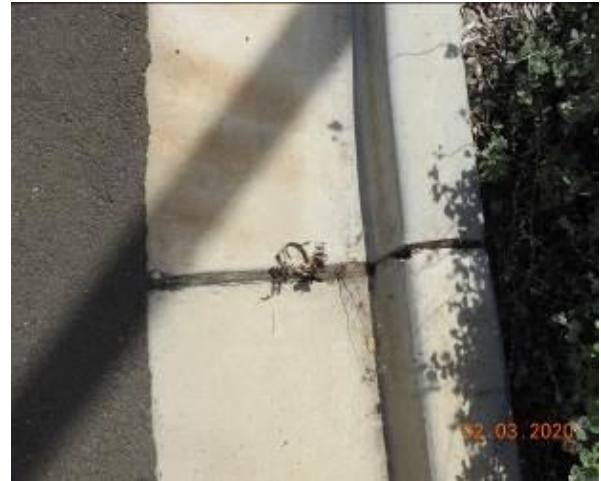
Figure 20 – Loss of material through kerb and gutter

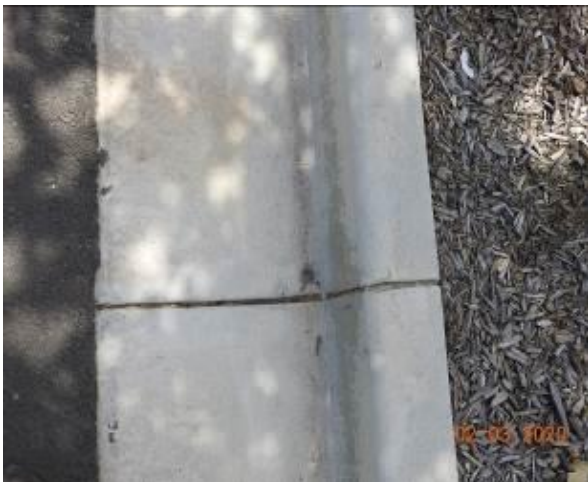
Figure 21 – Crack propagation through kerb and gutter

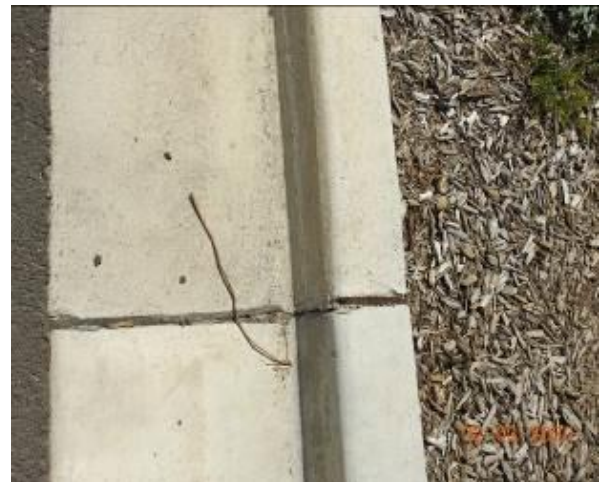
Figure 22 – Crack propagation through kerb and gutter

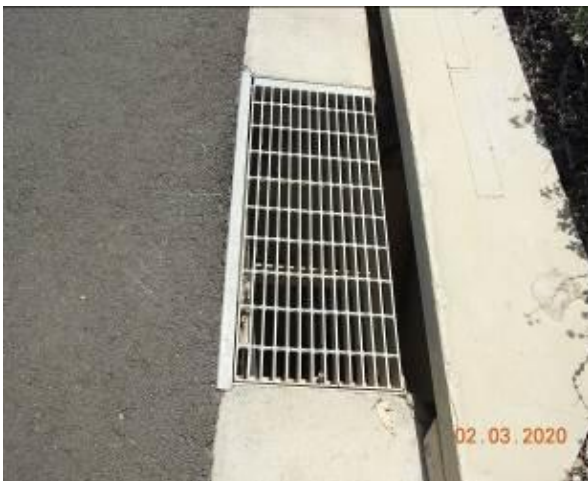
Figure 23 – General Condition of stormwater inlet pit

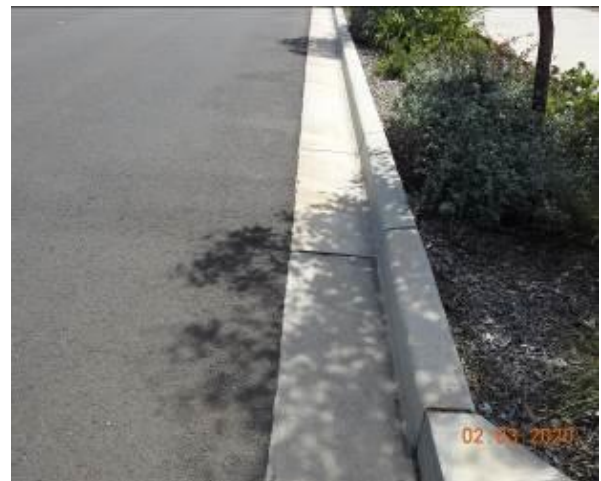
Figure 24 – General Condition of kerb and gutter

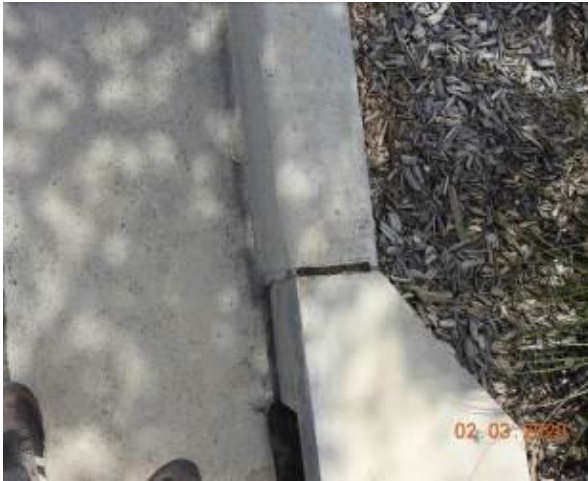
Figure 25 – Crack propagation through kerb and gutter

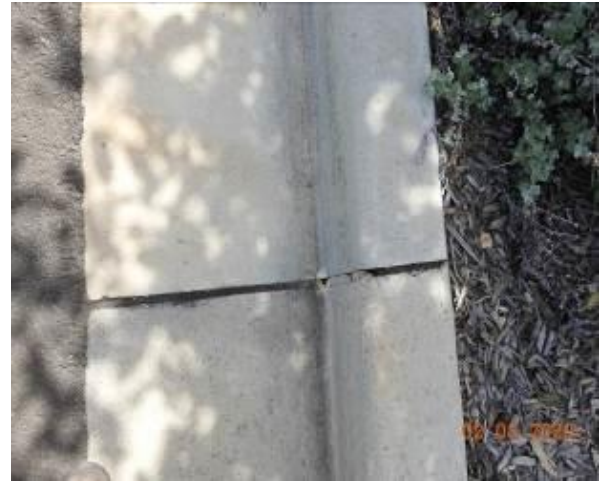
Figure 26 – Crack propagation through kerb and gutter

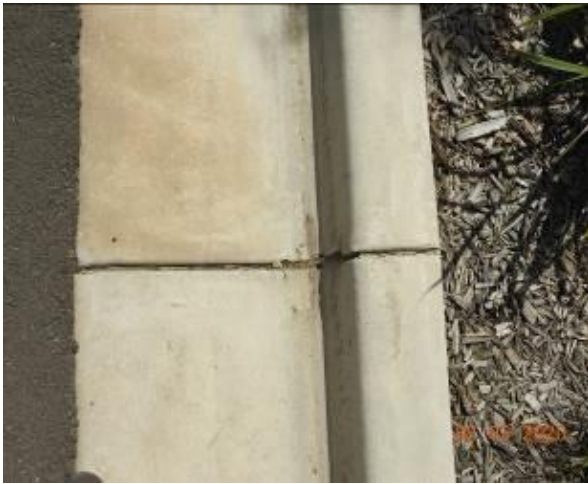
Figure 27 – Crack propagation through kerb and gutter

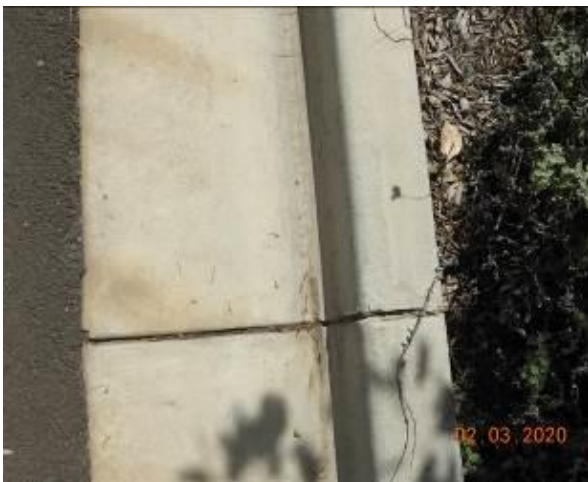
Figure 29 – Crack propagation through kerb and gutter

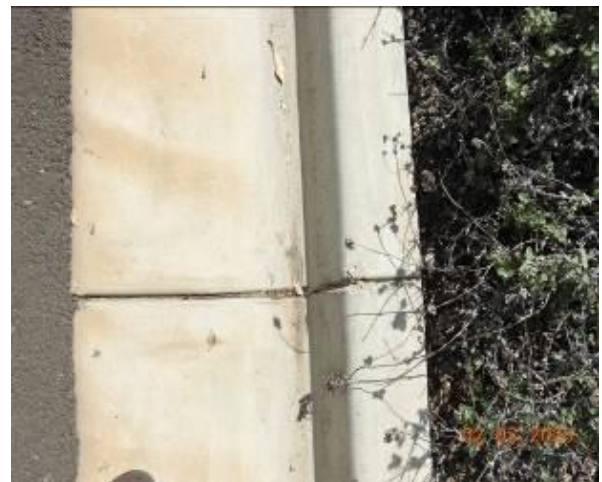
Figure 30 – Crack propagation through kerb and gutter

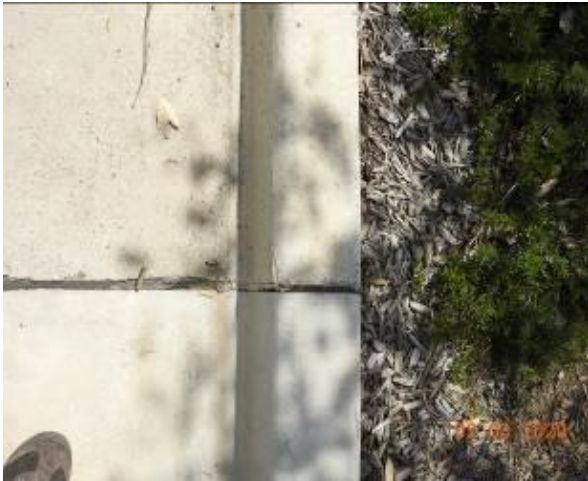
Figure 31 – Crack propagation through kerb and gutter

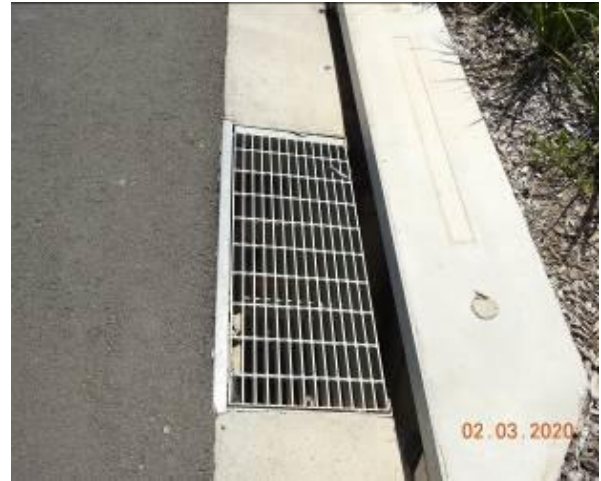
Figure 32 – General Condition of stormwater inlet pit

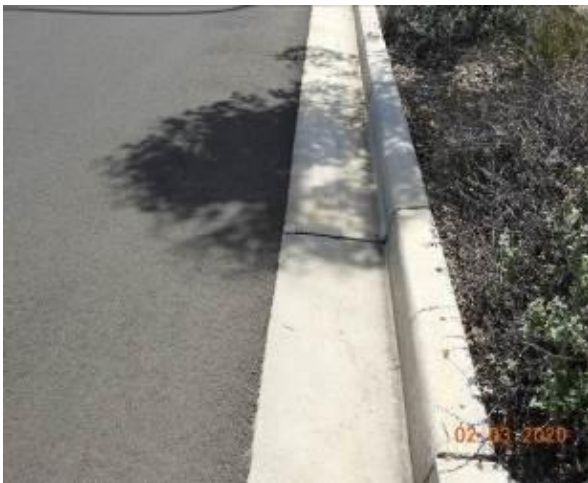
Figure 33 – General Condition of kerb and gutter

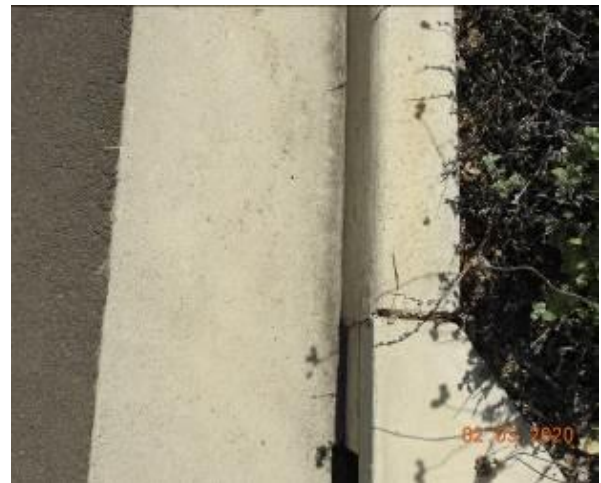
Figure 34 – Crack propagation through kerb and gutter

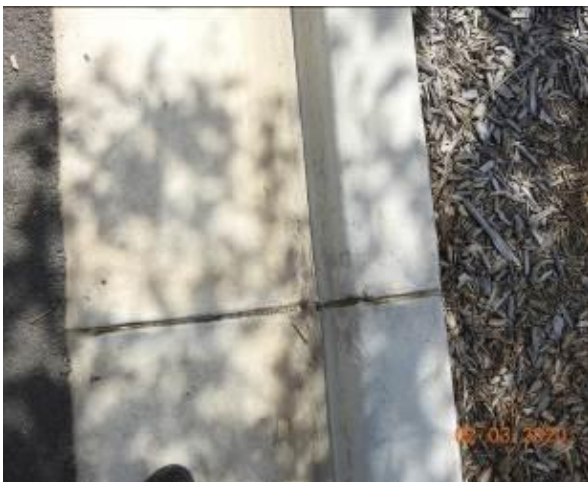
Figure 35 – Crack propagation through kerb and gutter

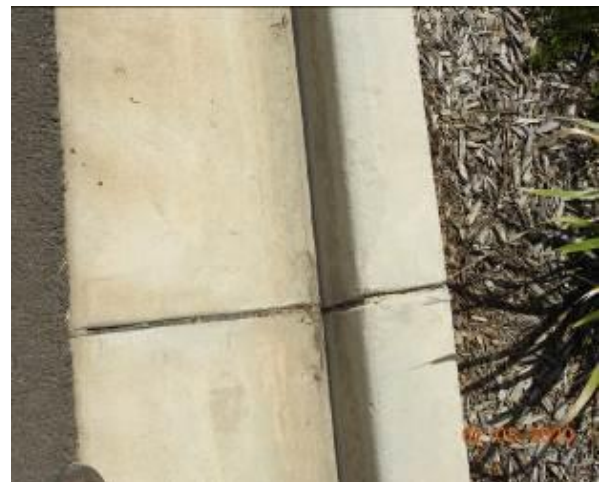
Figure 36 – Crack propagation through kerb and gutter

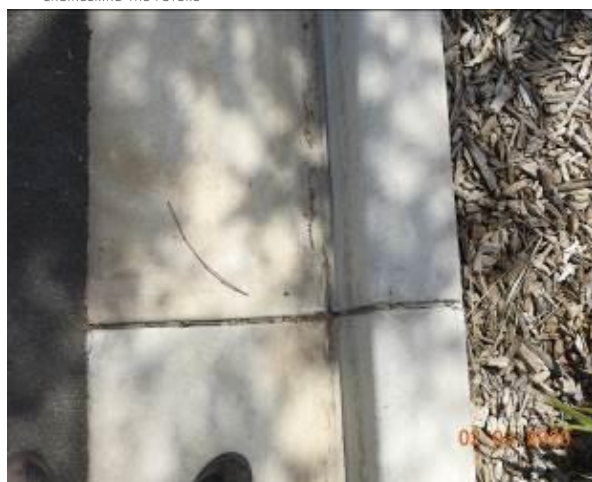
Figure 37 – Crack propagation through kerb and gutter

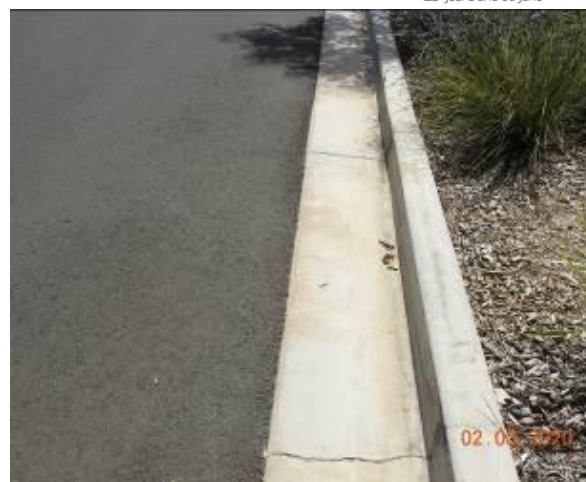
Figure 38 – General Condition of kerb and gutter

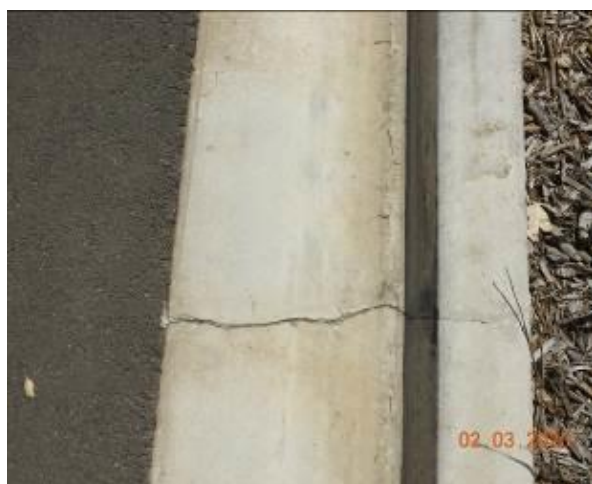
Figure 39 – Crack propagation through kerb and gutter

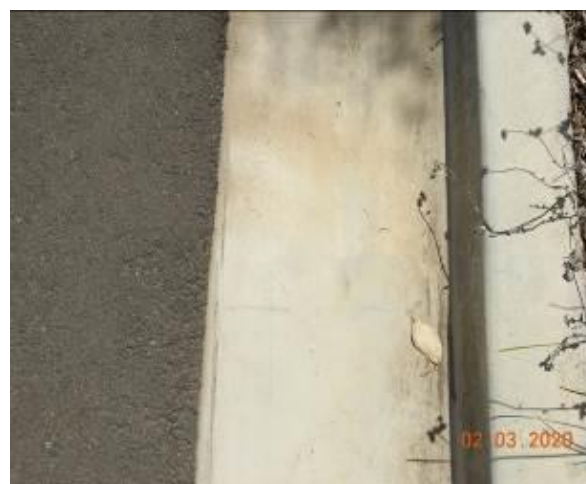
Figure 40 – Crack propagation through kerb and gutter

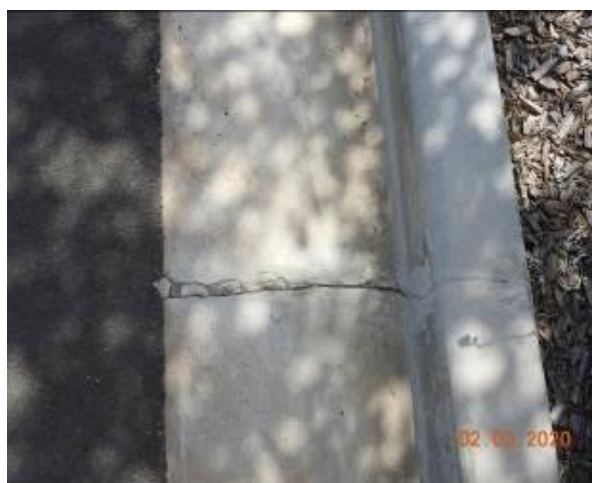
Figure 41 – Crack propagation and loss of material through kerb and gutter

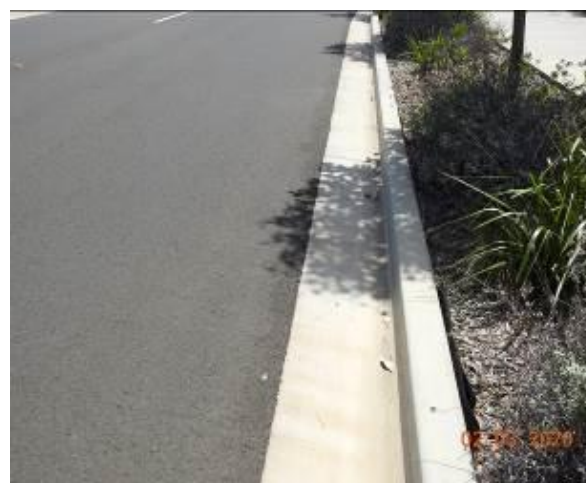
Figure 42 – General Condition of kerb and gutter

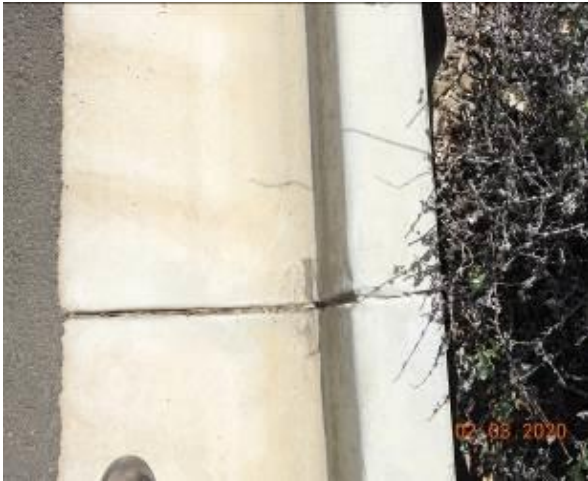
Figure 43 – Crack propagation through kerb

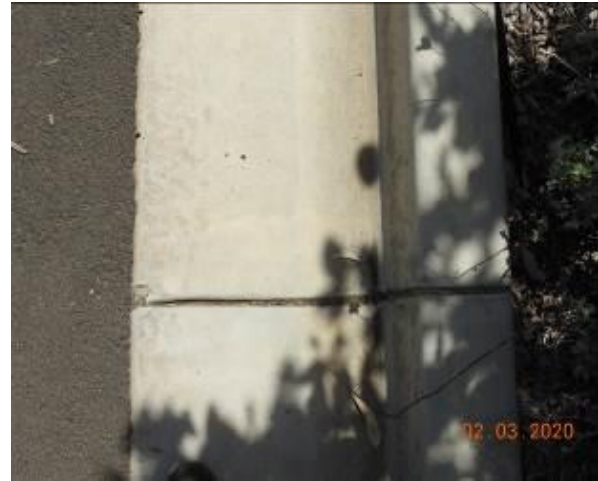
Figure 44 – Crack propagation and loss of material through kerb and gutter

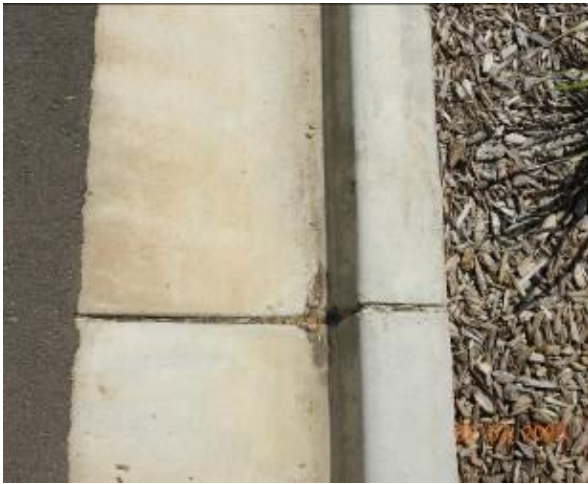
Figure 45 – Crack propagation through kerb

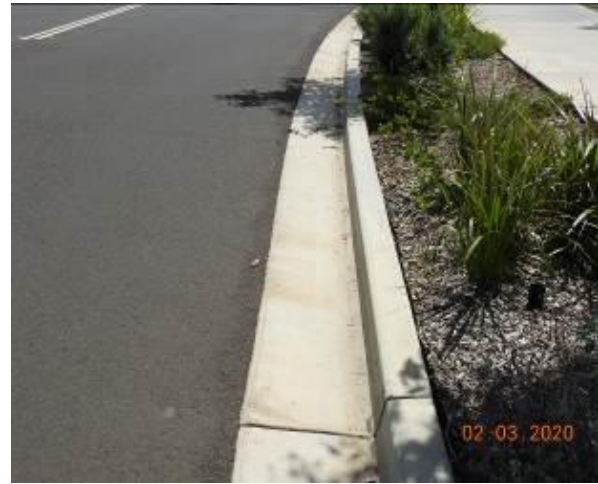
Figure 46 – General Condition of kerb and gutter

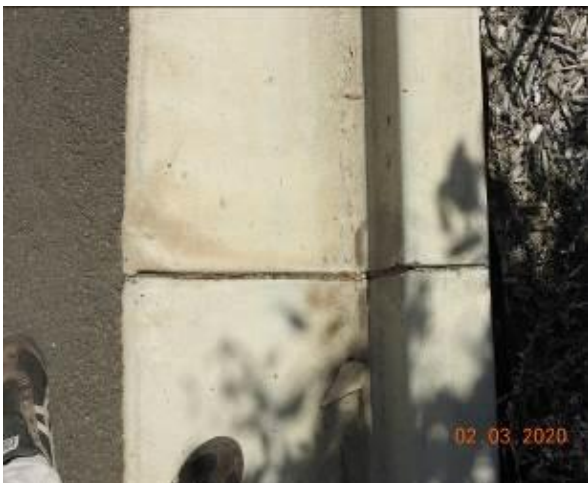
Figure 47 – Crack propagation through kerb

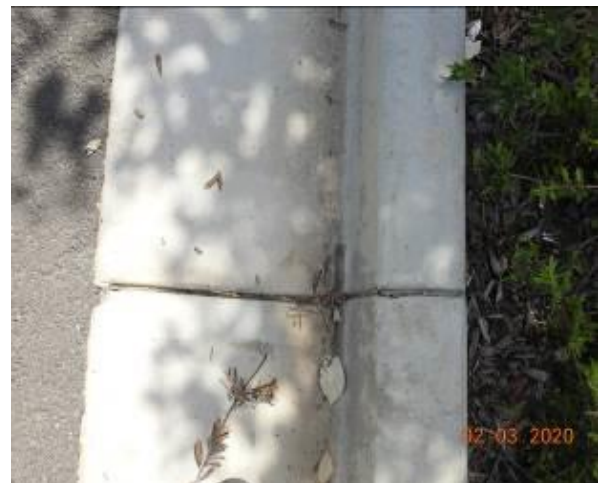
Figure 48 – Crack propagation through kerb and gutter

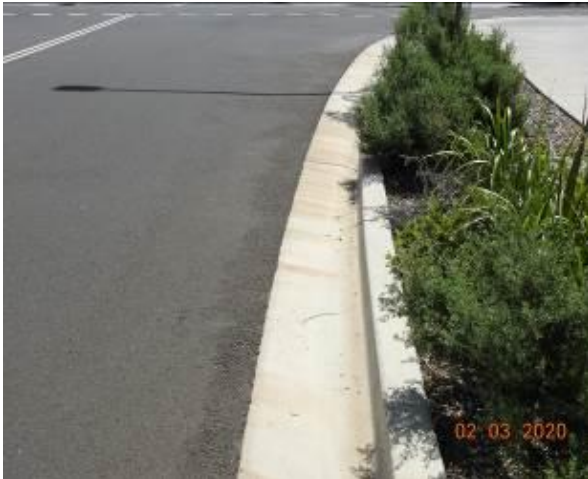
Figure 49 – General Condition of kerb and gutter

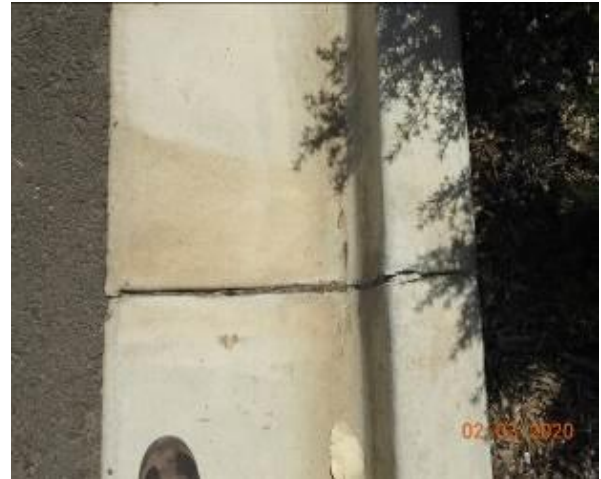
Figure 50 – Crack propagation through kerb and gutter

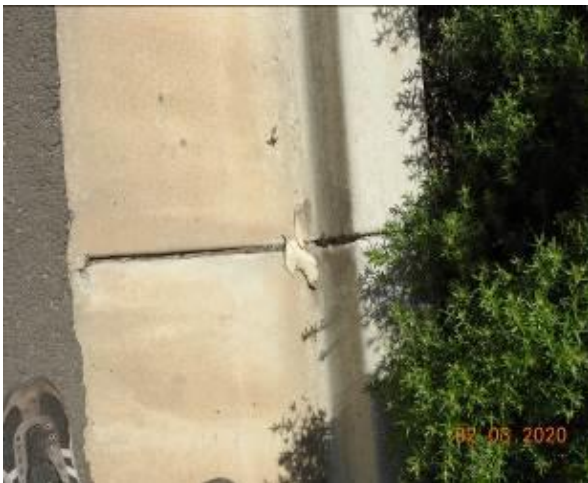
Figure 51 – Crack propagation through kerb and gutter

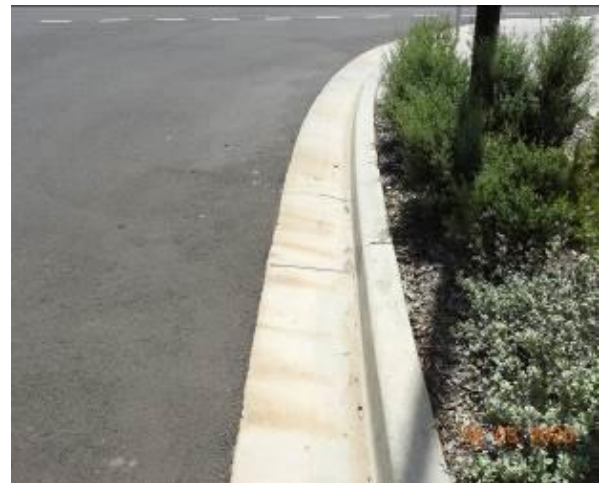
Figure 52 – General Condition of kerb and gutter

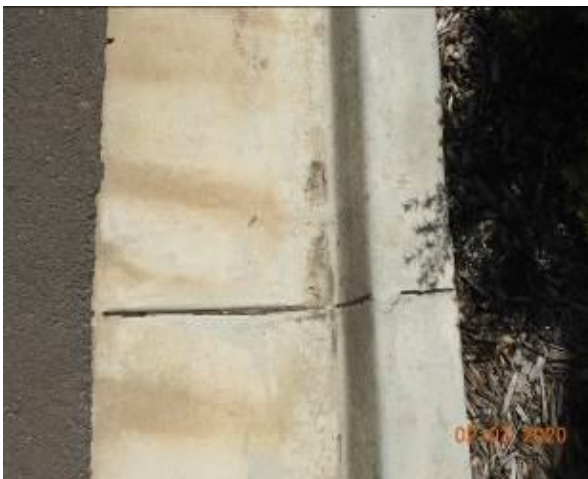
Figure 53 – Crack propagation through kerb and gutter

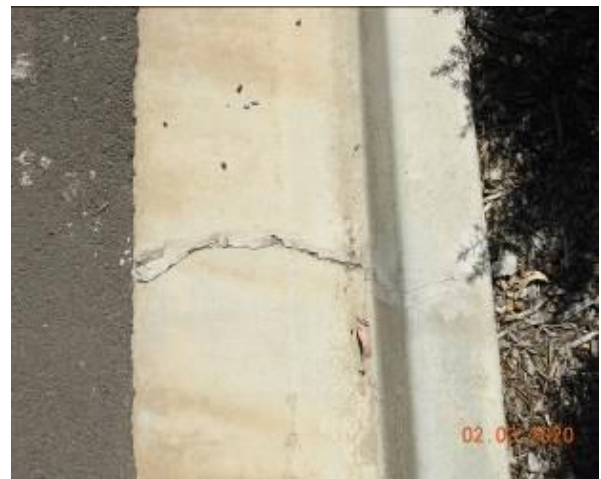
Figure 54 – Crack propagation and evidence of patchwork through kerb and gutter

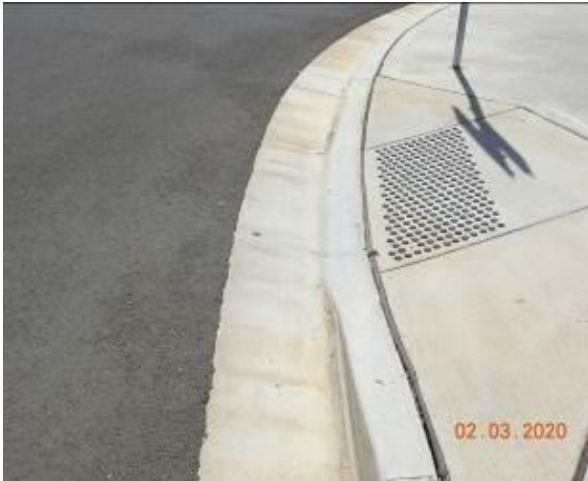
Figure 55 – Crack propagation through kerb and gutter

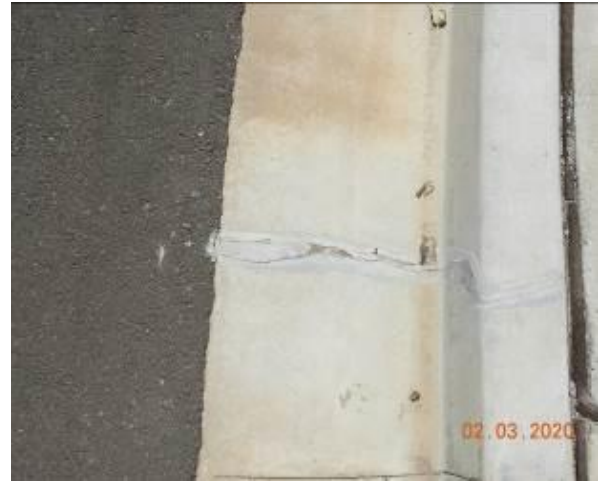
Figure 56 – Crack propagation and evidence of patchwork through kerb and gutter

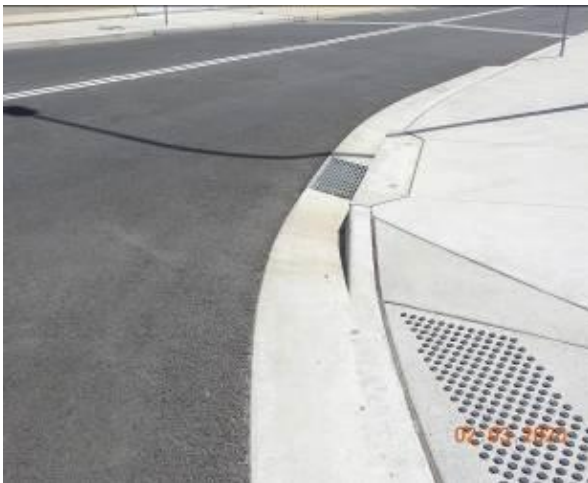
Figure 57 – General Condition of layback and gutter

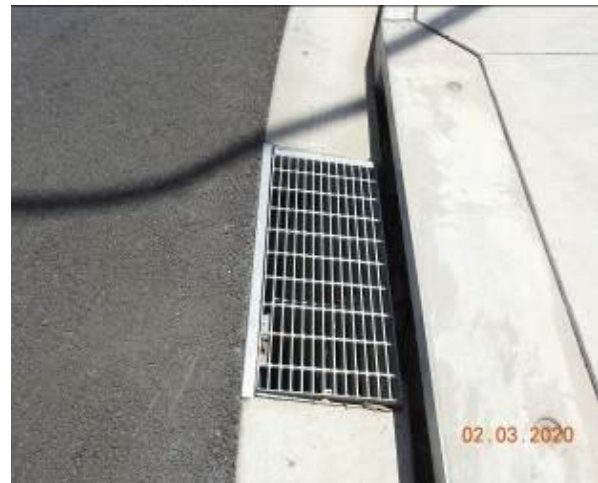
Figure 58 – General Condition of stormwater inlet pit

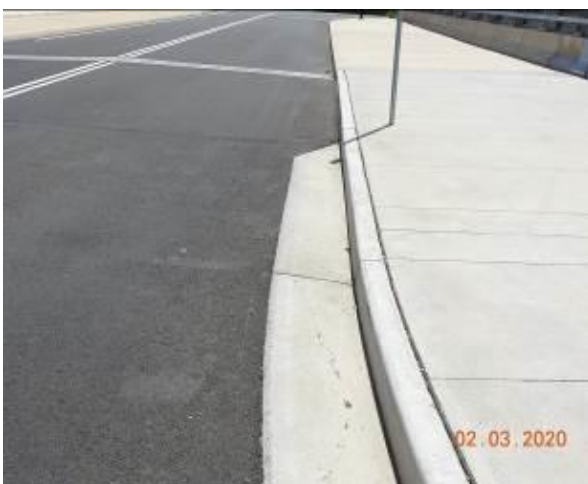
Figure 59 – General Condition of kerb and gutter

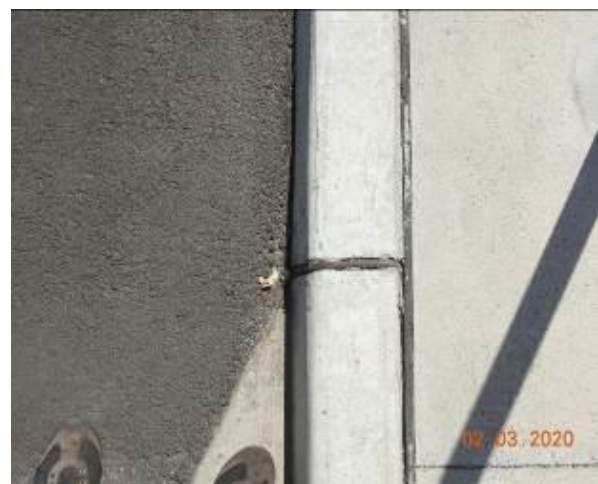
Figure 60 – Crack propagation through kerb

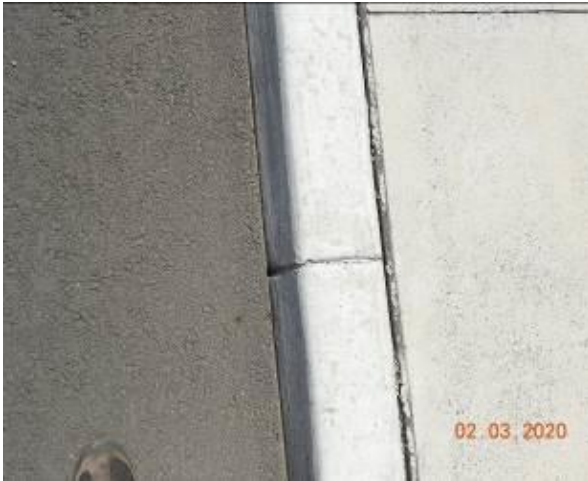
Figure 61 – Crack propagation through kerb

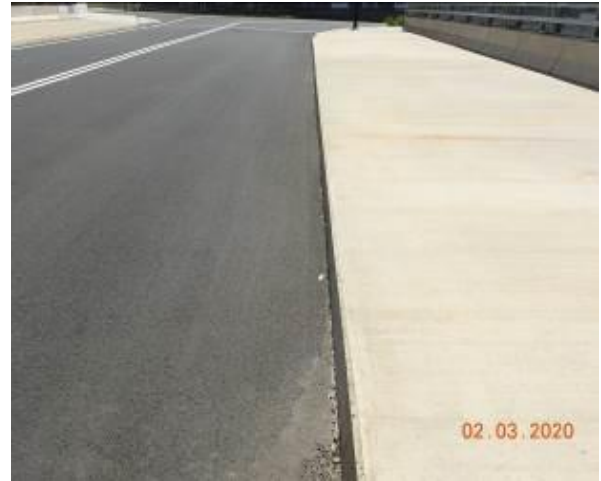
Figure 62 – General Condition of kerb

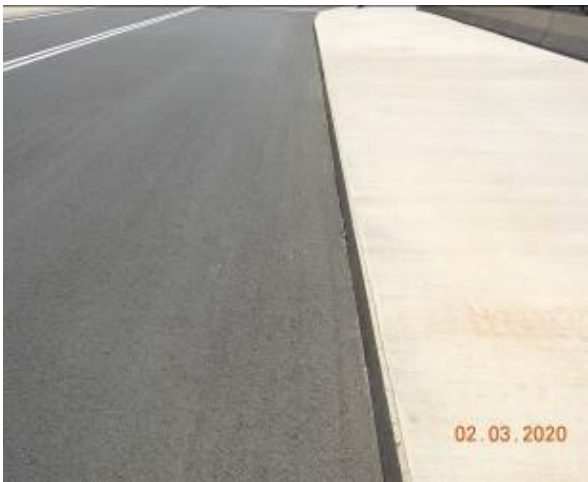
Figure 63 – General Condition of kerb

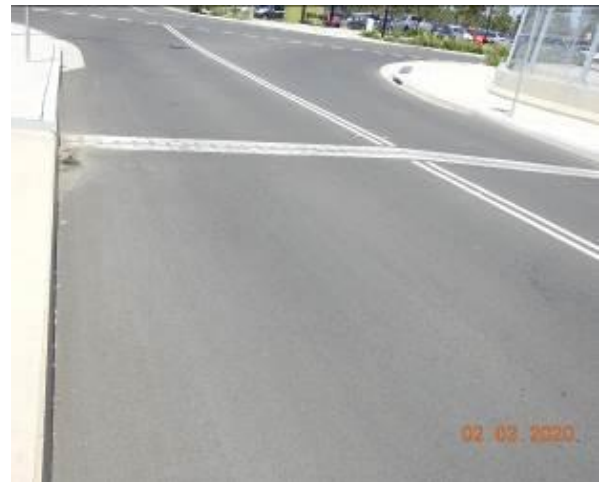
Figure 64 – General Condition of road surface

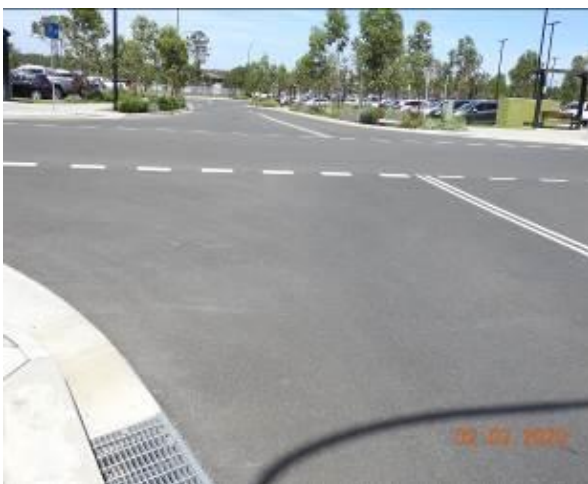
Figure 65 – General Condition of road surface

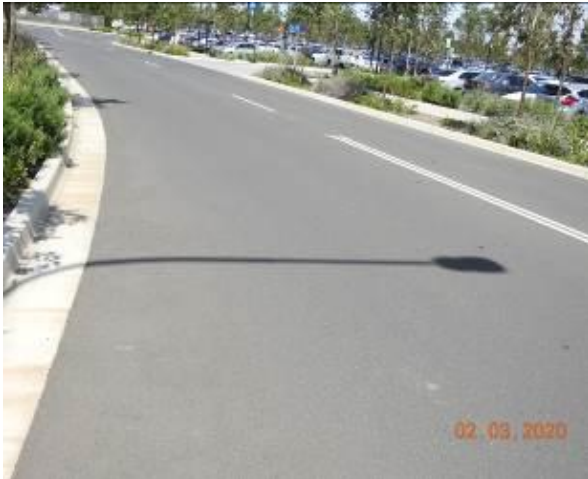
Figure 67 – General Condition of road surface

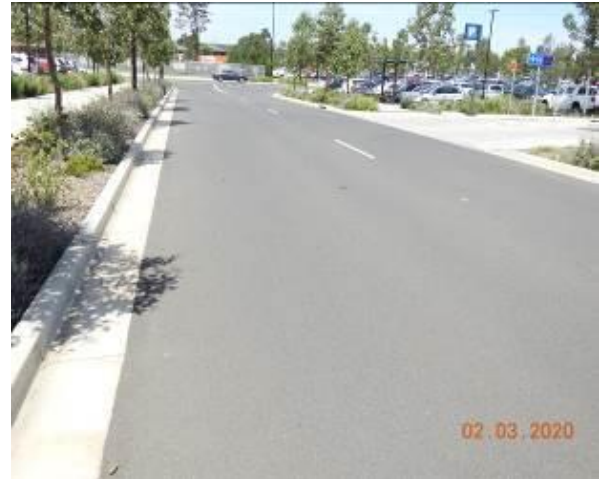
Figure 68 – General Condition of road surface

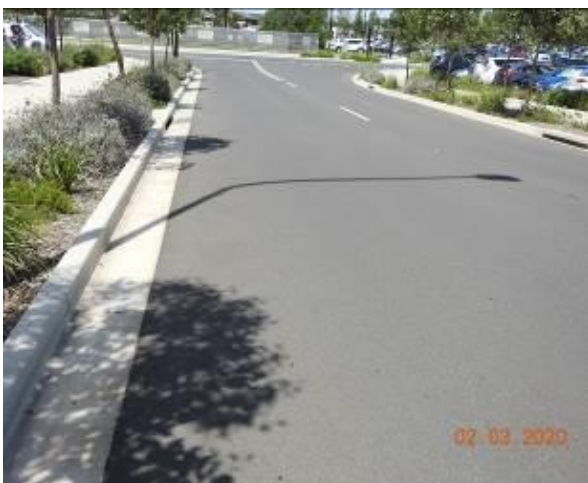
Figure 69 – General Condition of road surface

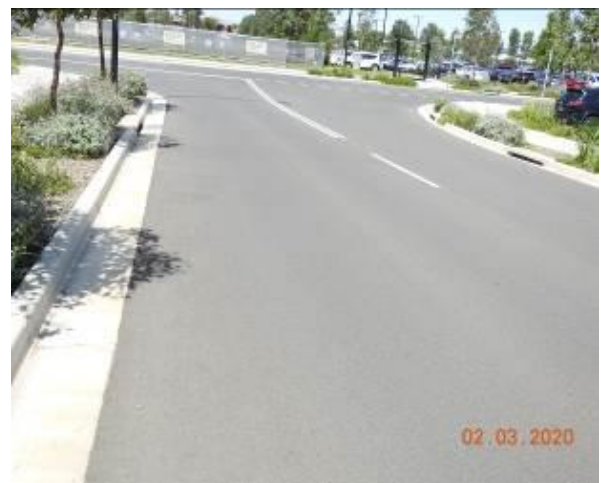
Figure 70 – General Condition of road surface

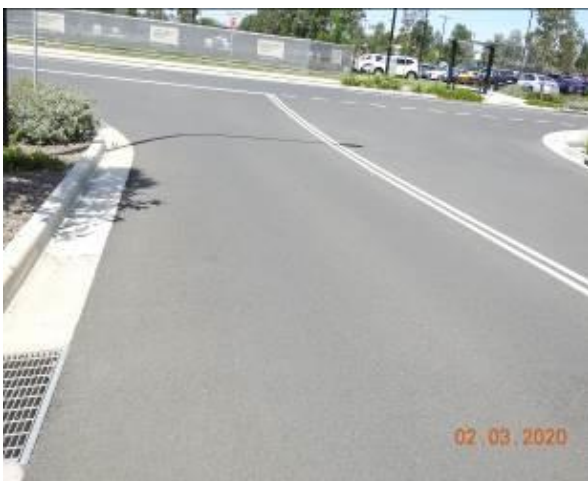
Figure 71 – General Condition of road surface

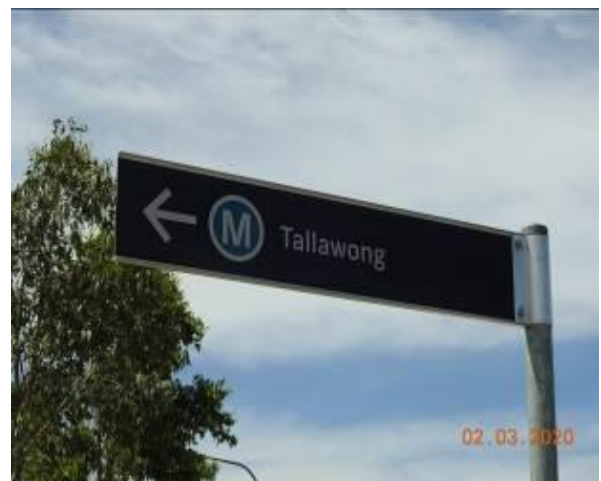
Figure 72 – General Condition of street sign

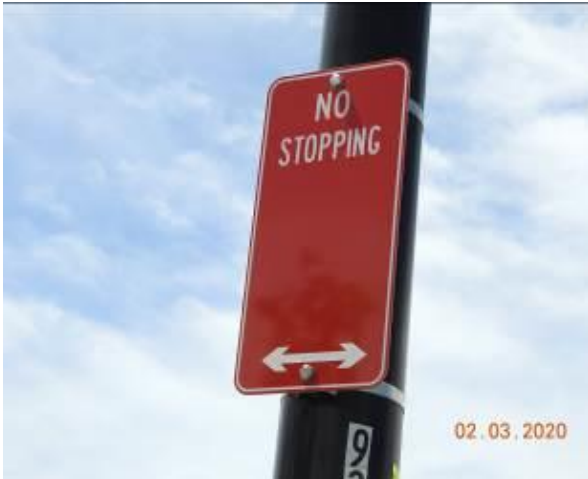
Figure 73 – General Condition of street sign

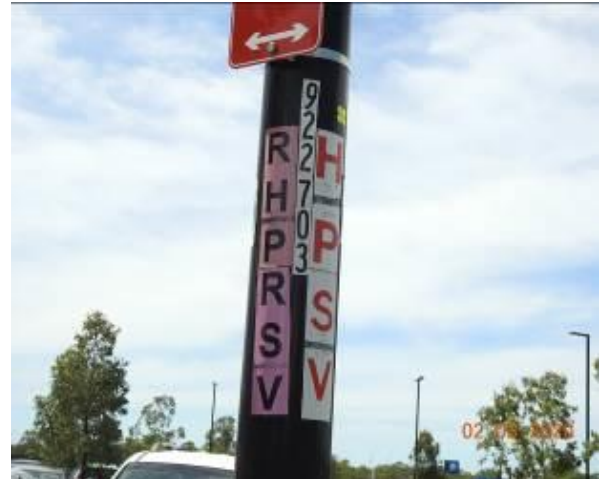
Figure 74 – General Condition of lamp post  
Identification No.922703

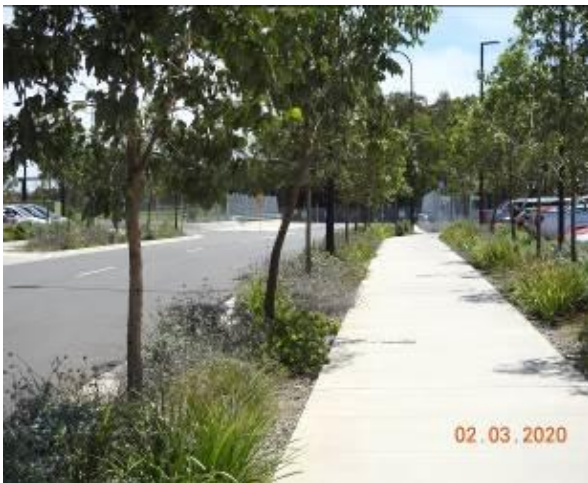
Figure 75 – General Condition of plantation

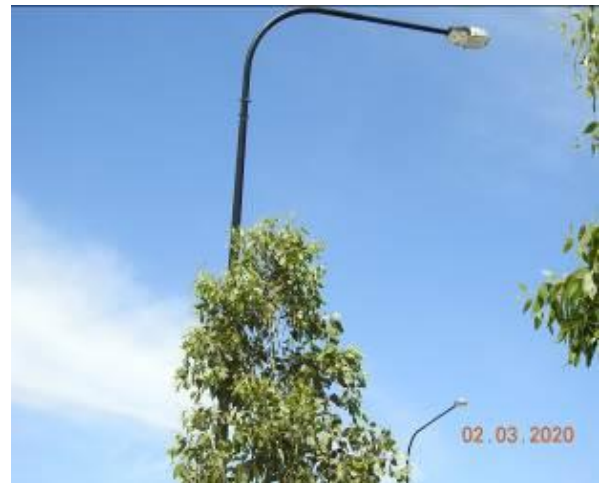
Figure 76 – General Condition of lamp post

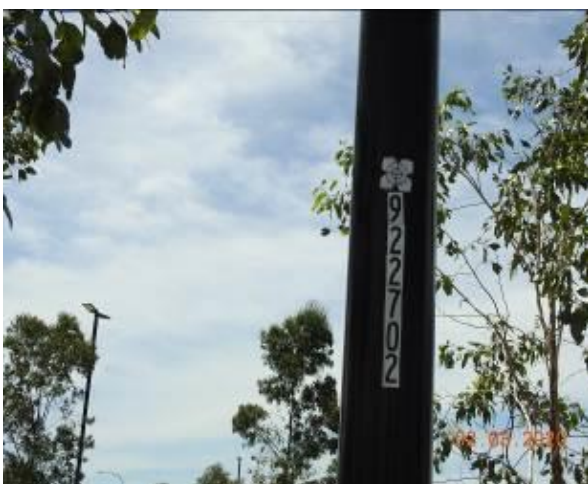
Figure 77 – General Condition of lamp post  
Identification No.922702

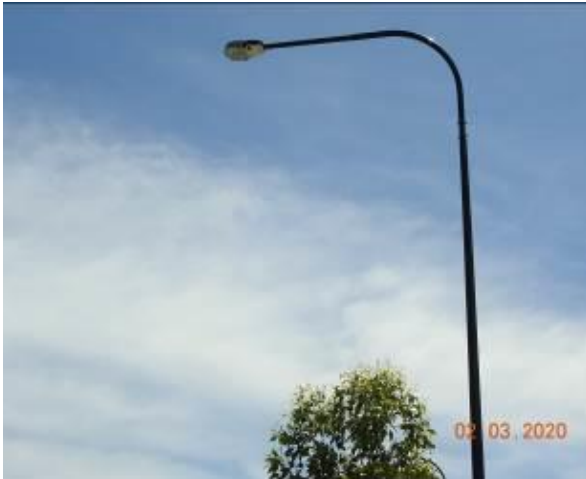
Figure 79 – General Condition of lamp post

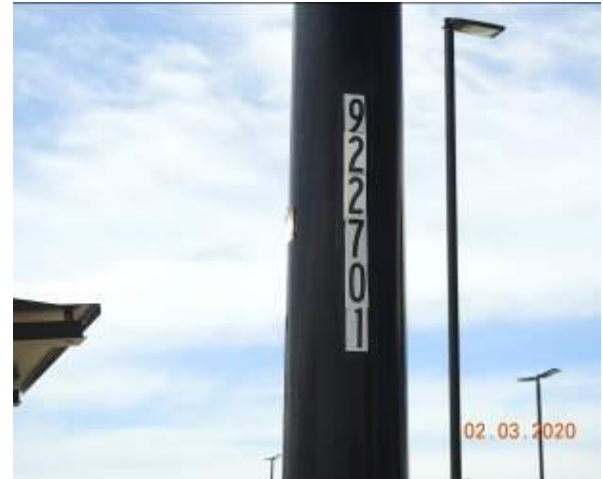
Figure 80 – General Condition of lamp post  
Identification No.922701

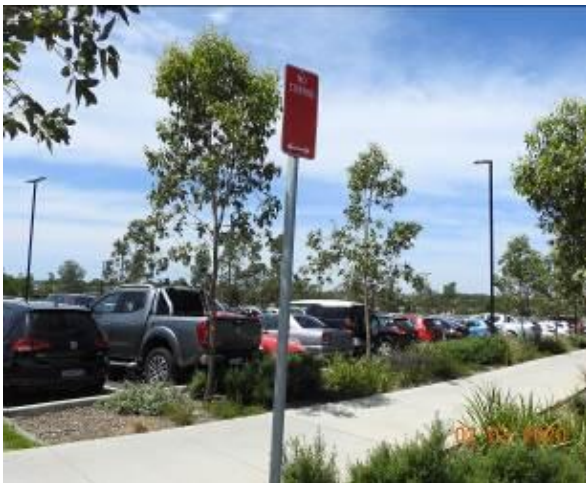
Figure 81 – General Condition of street sign
