**1-15 AND 2-12 CONFERTA AVENUE,  
ROUSE HILL NSW 2155  
TALLAWONG STATION PRECINCT SOUTH  
PRE-DILAPIDATION REPORT**

**DEICORP PROJECTS  
(TALLAWONG STATION) PTY LTD**

Job No. 191294.0  
05/07/2021

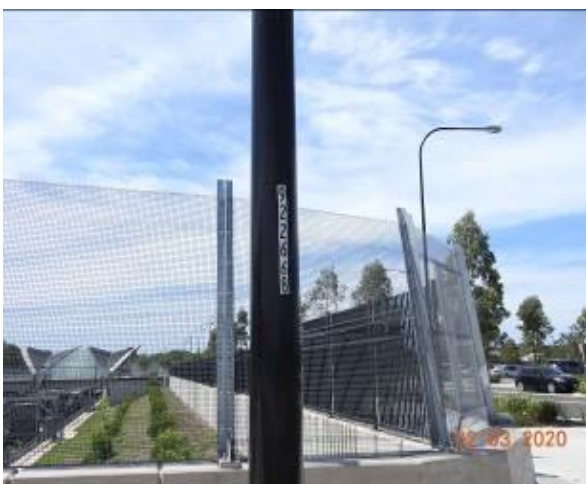
Figure 83 – General Condition of lamp post  
Identification No.922668

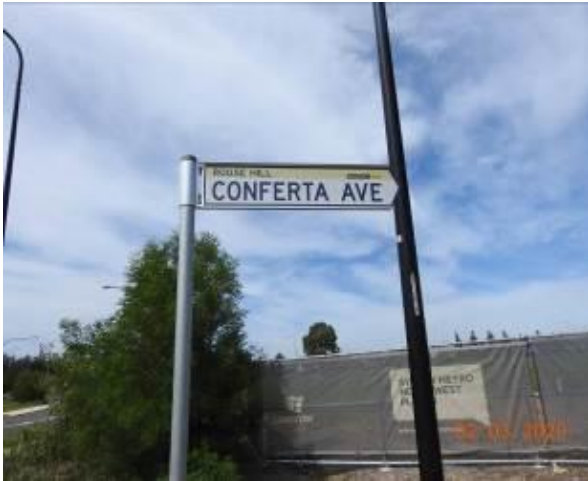
Figure 85 – The following images display condition of Conferta Avenue Council Assets

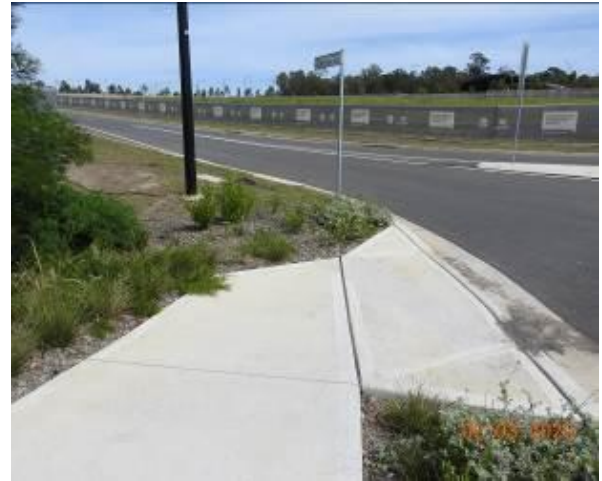
Figure 86 – General Condition of footpath pavement

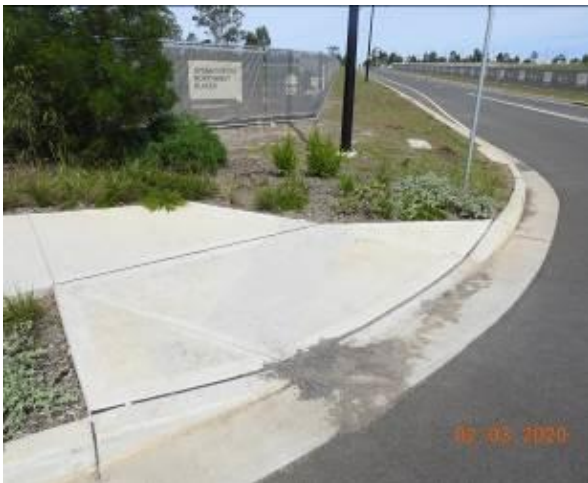
Figure 87 – General Condition of footpath pavement

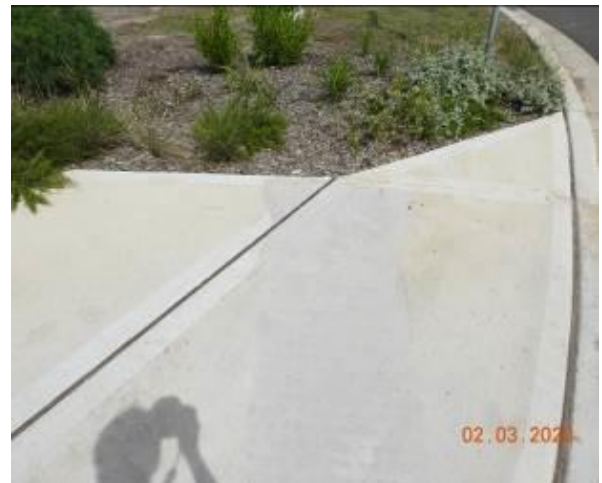
Figure 88 – General Condition of footpath pavement

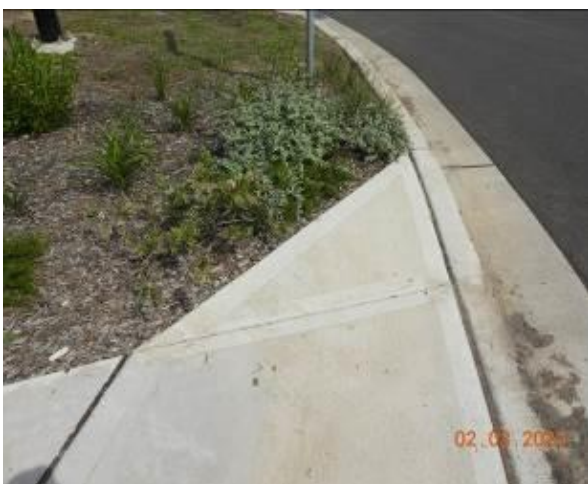
Figure 89 – General Condition of footpath pavement

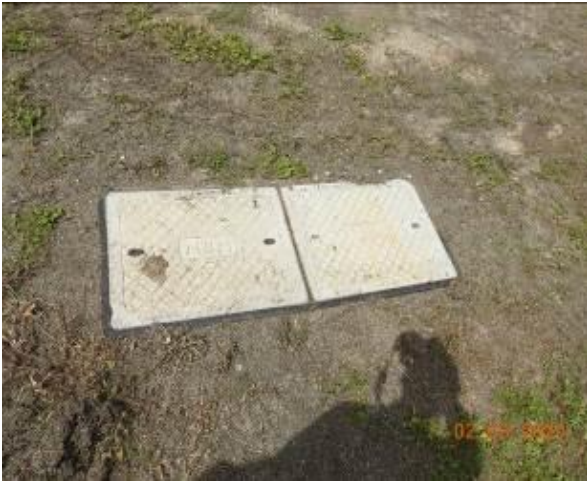
Figure 91 – General Condition of service pit

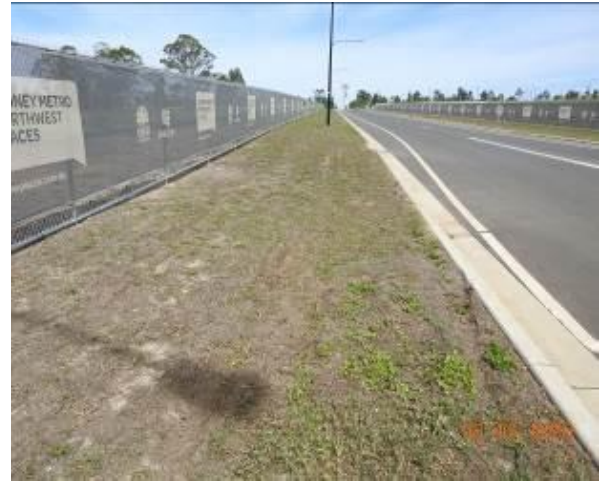
Figure 92 – General Condition of grass area

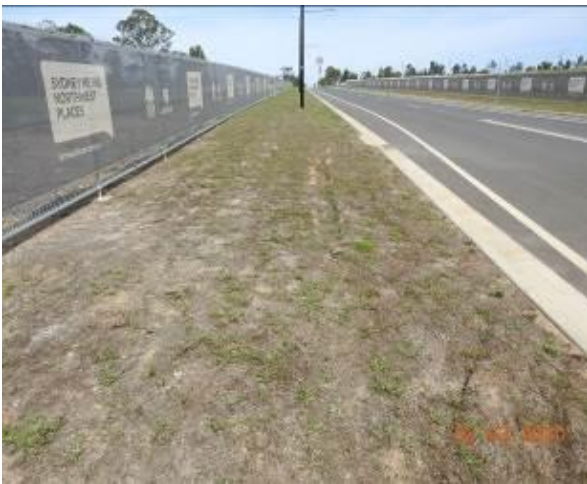
Figure 93 – General Condition of grass area

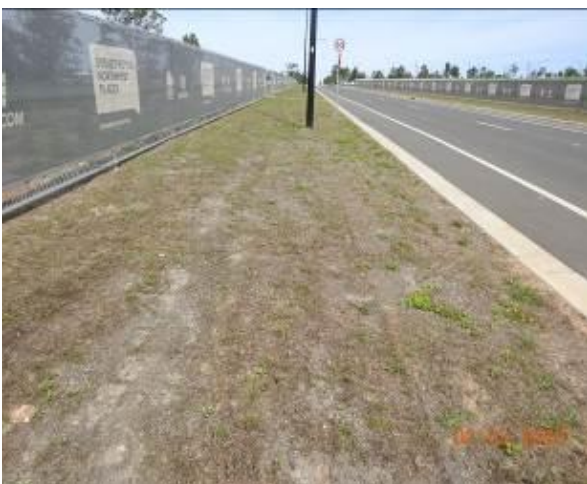
Figure 95 – General Condition of grass area

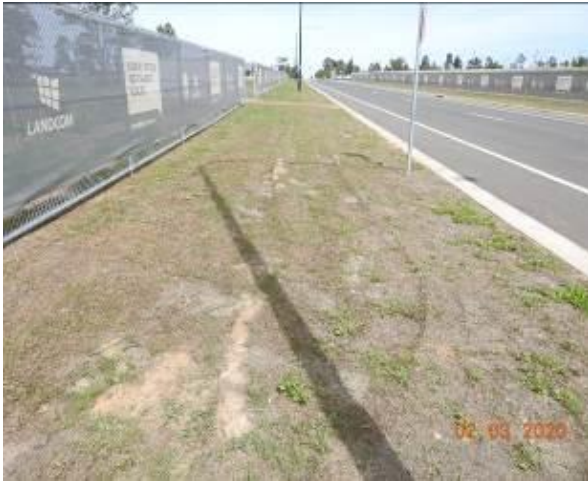
Figure 97 – General Condition of grass area

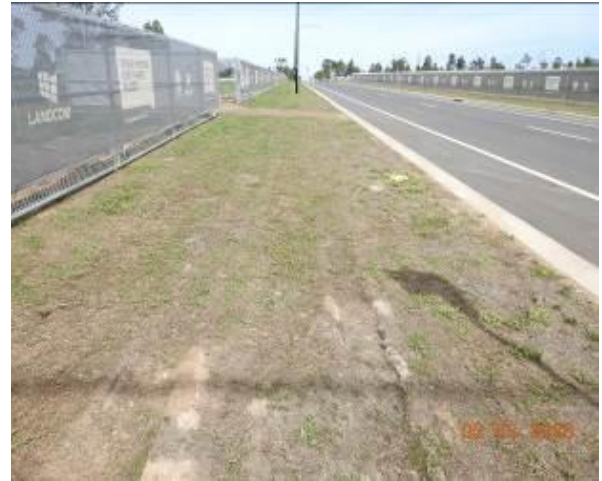
Figure 98 – General Condition of grass area

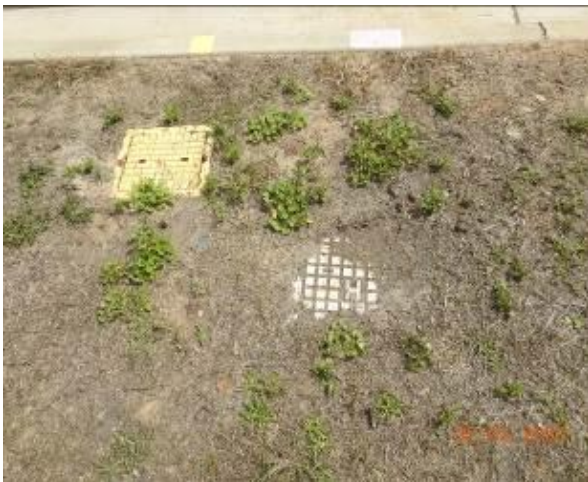
Figure 99 – General Condition of service pit

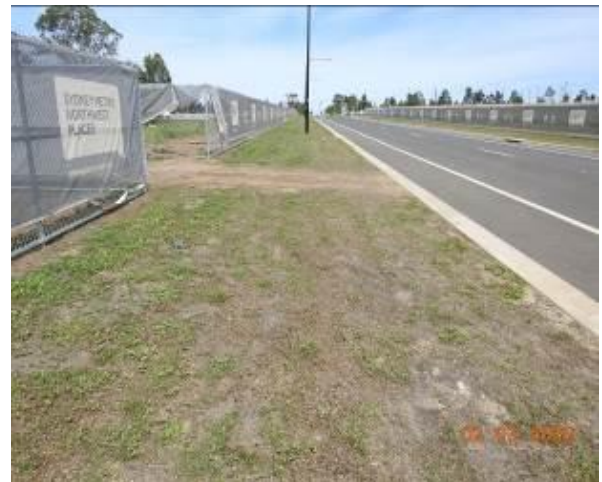
Figure 100 – General Condition of grass area

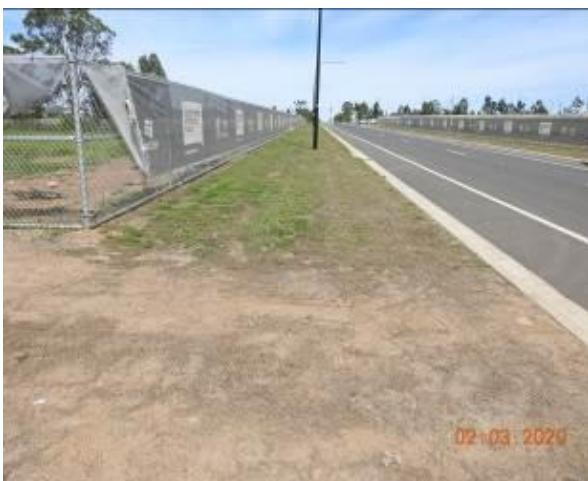
Figure 101 – General Condition of grass area

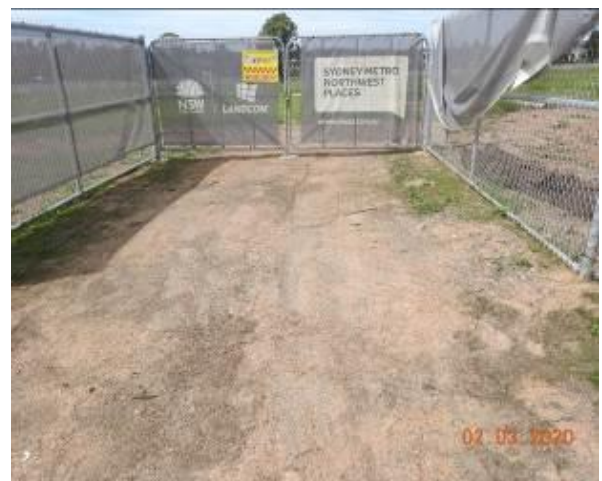
Figure 102 – General Condition of grass area

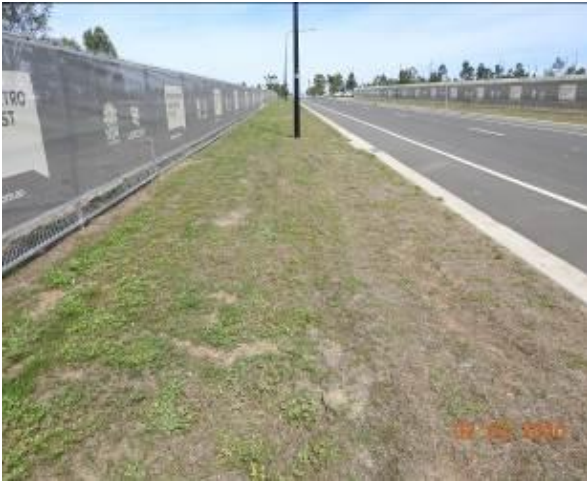
Figure 103 – General Condition of grass area

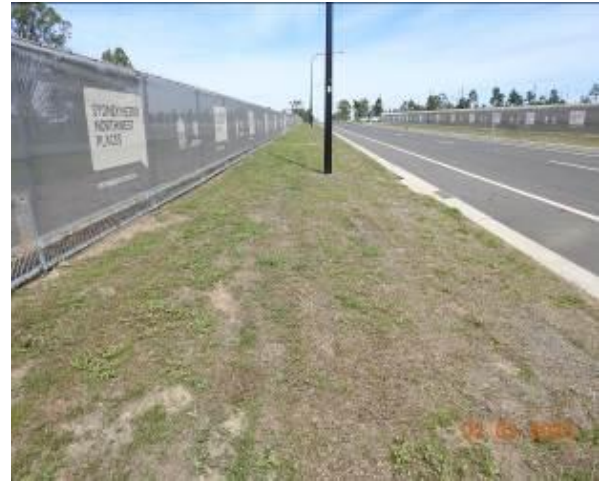
Figure 104 – General Condition of grass area

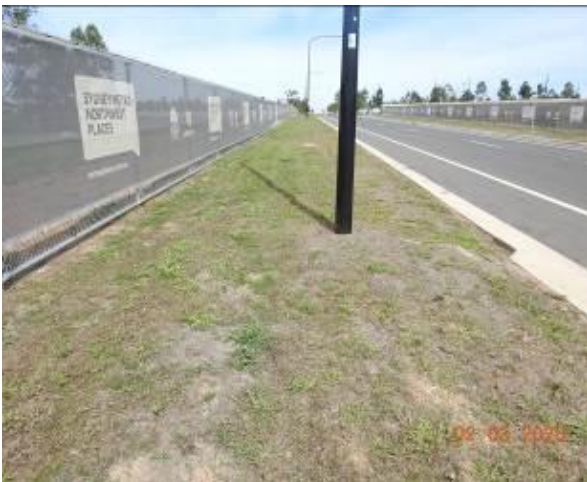
Figure 105 – General Condition of grass area

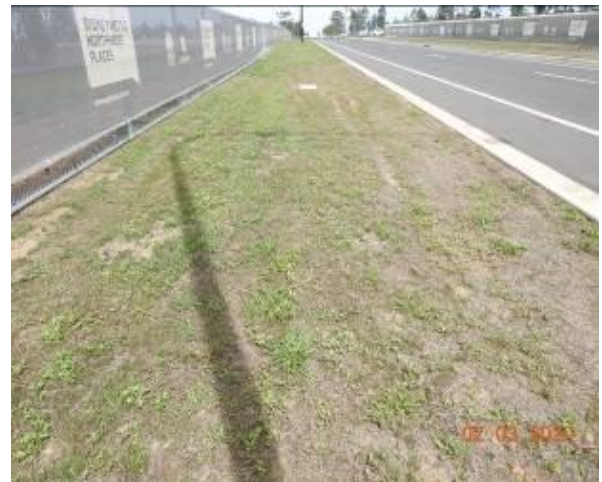
Figure 106 – General Condition of grass area

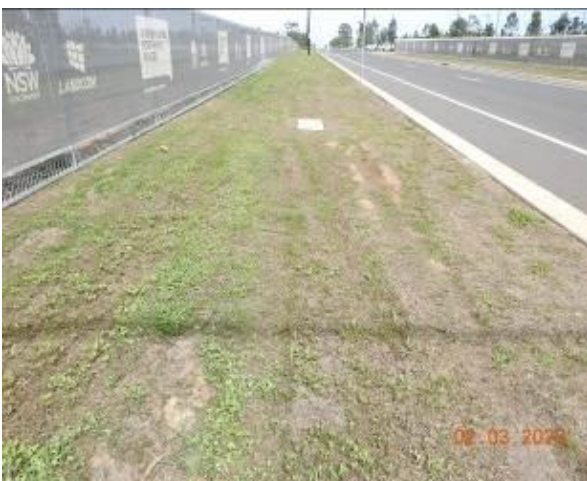
Figure 107 – General Condition of grass area

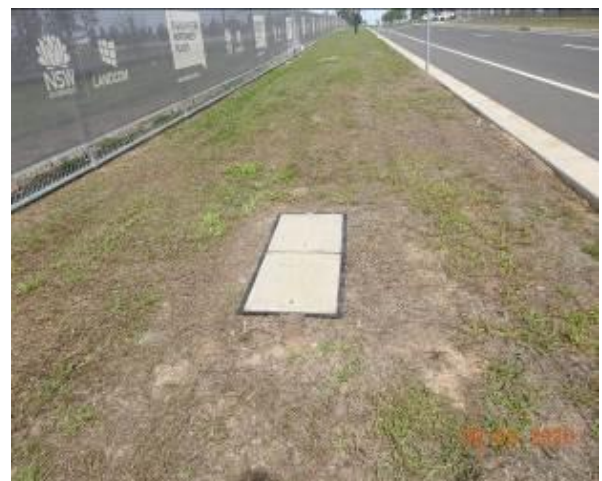
Figure 108 – General Condition of grass area

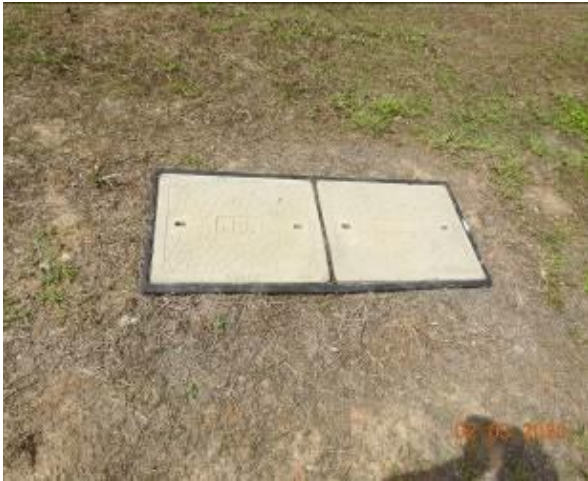
Figure 109 – General Condition of service pit

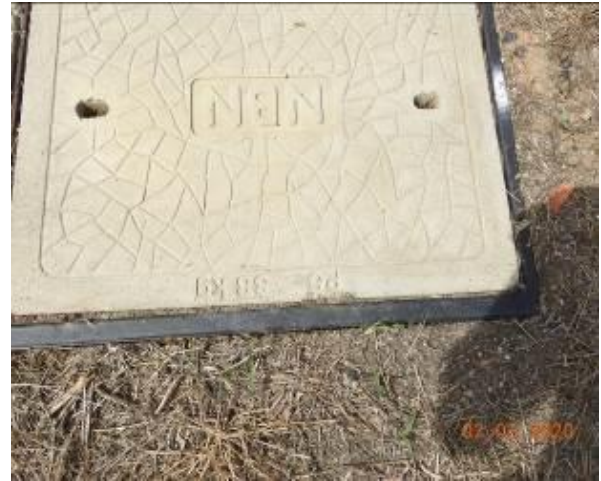
Figure 110 – Loss of material through service pit

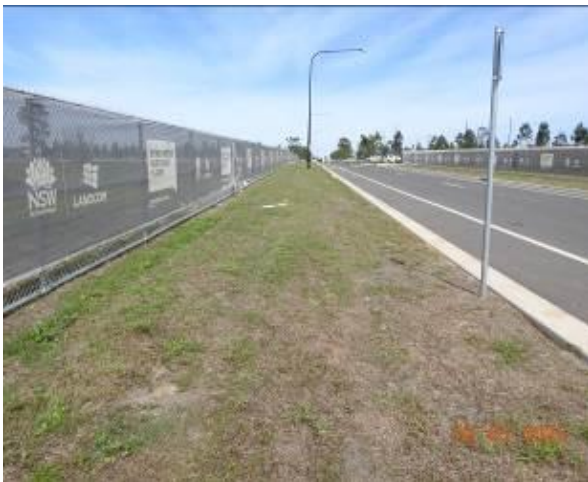
Figure 111 – General Condition of grass area

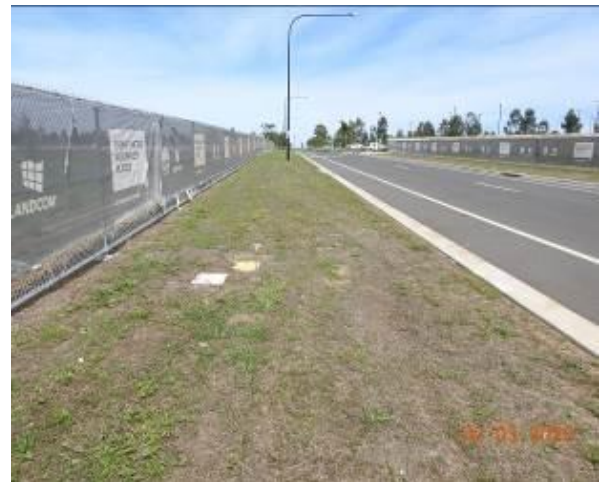
Figure 112 – General Condition of grass area

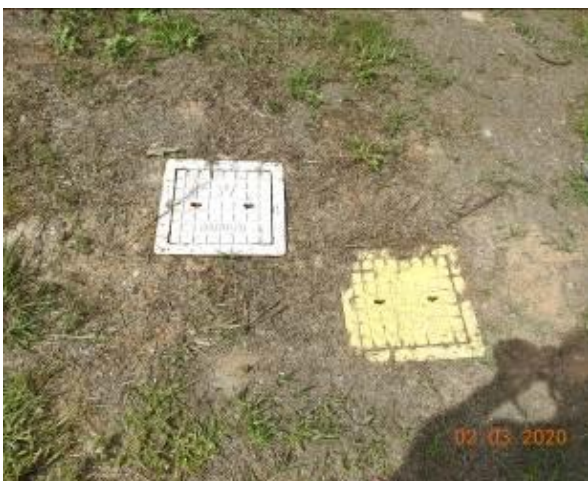
Figure 113 – General Condition of service pit

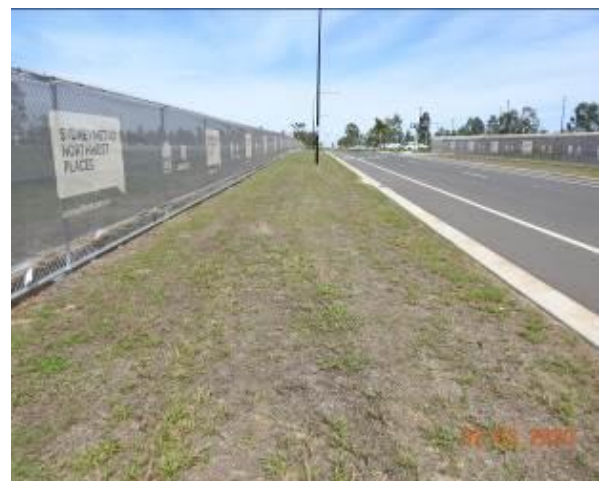
Figure 114 – General Condition of grass area

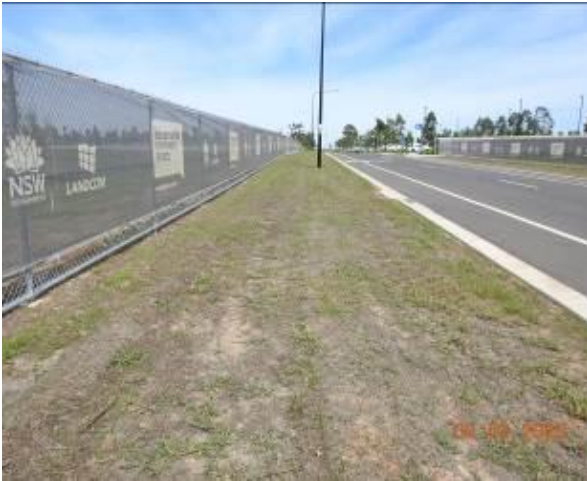
Figure 115 – General Condition of grass area

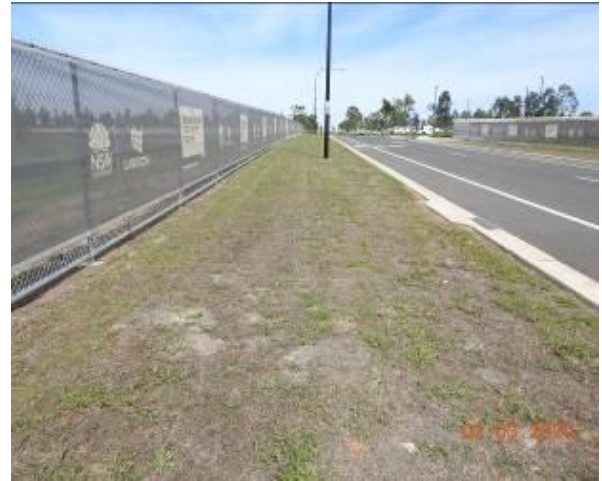
Figure 116 – General Condition of grass area

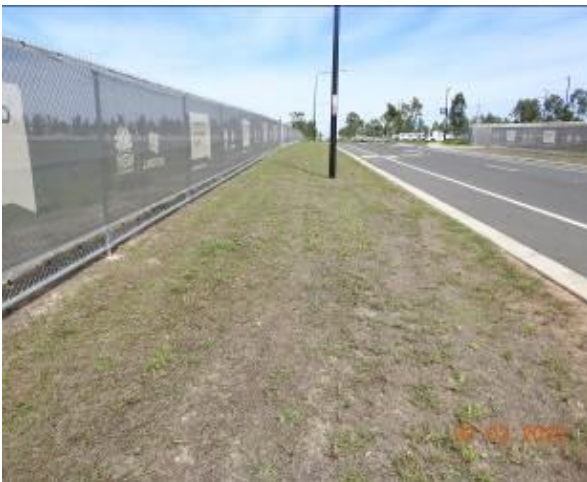
Figure 117 – General Condition of grass area

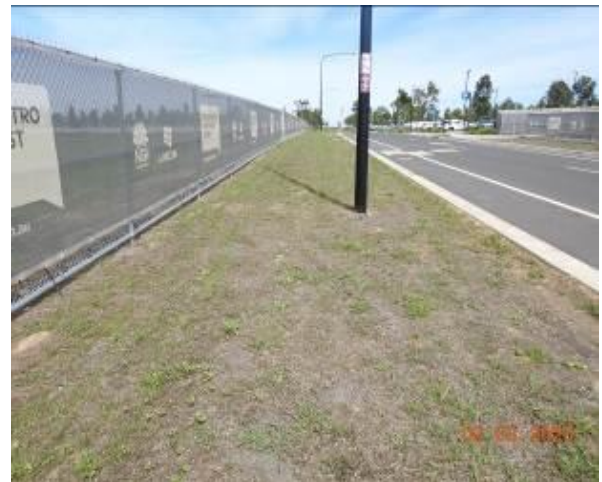
Figure 118 – General Condition of grass area

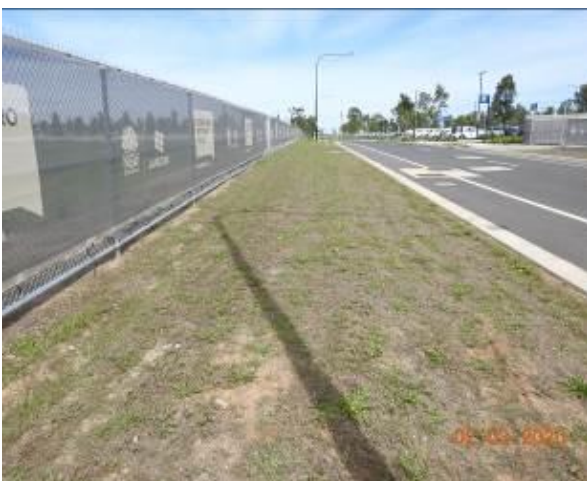
Figure 119 – General Condition of grass area

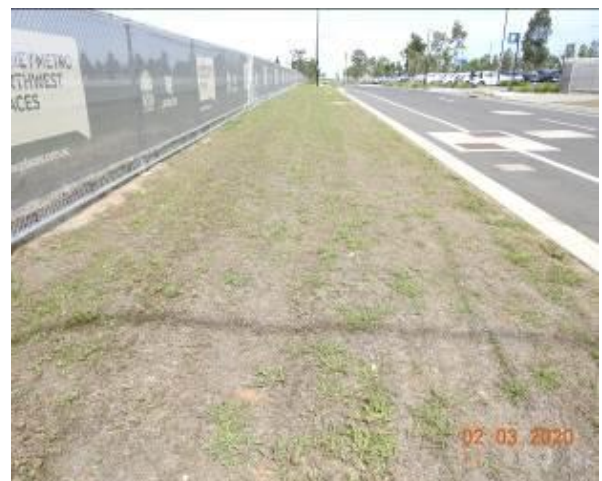
Figure 120 – General Condition of grass area

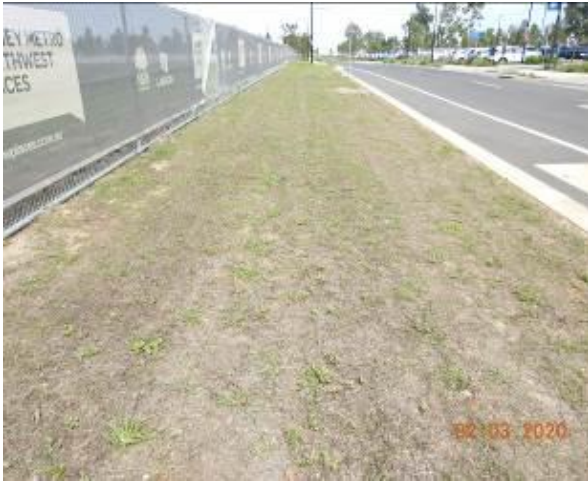
Figure 121 – General Condition of grass area

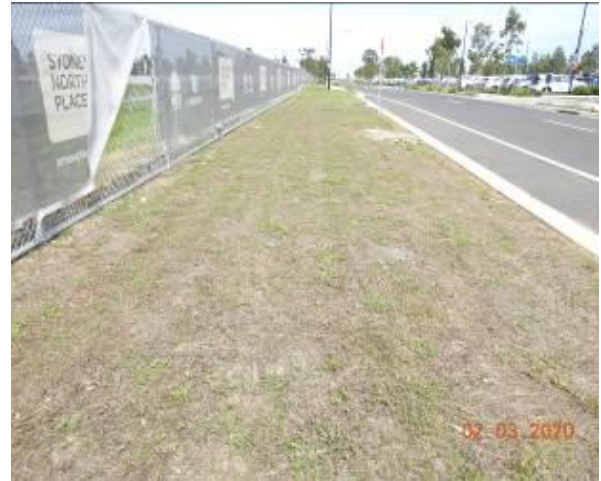
Figure 122 – General Condition of grass area

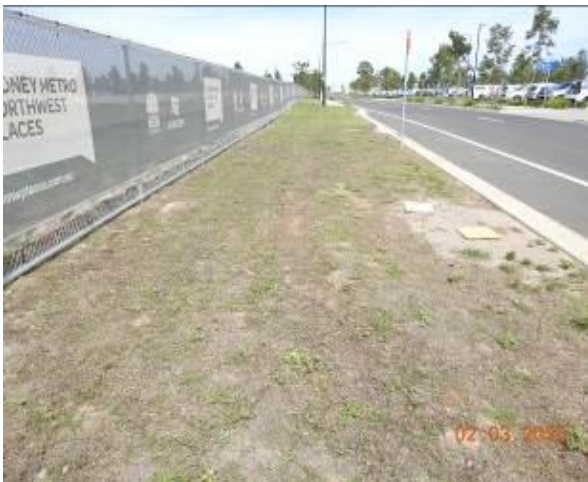
Figure 123 – General Condition of grass area

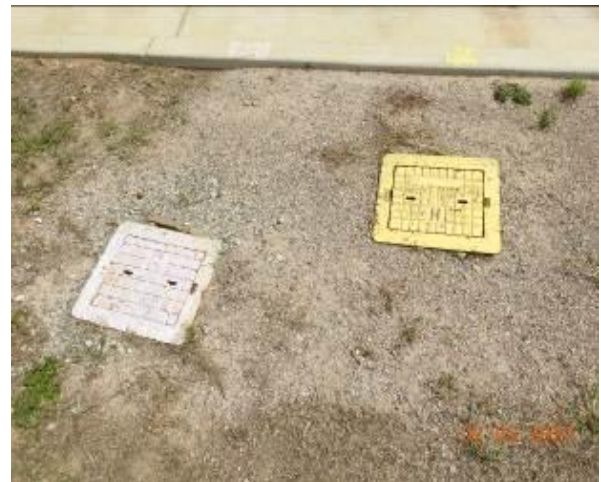
Figure 124 – General Condition of service pit

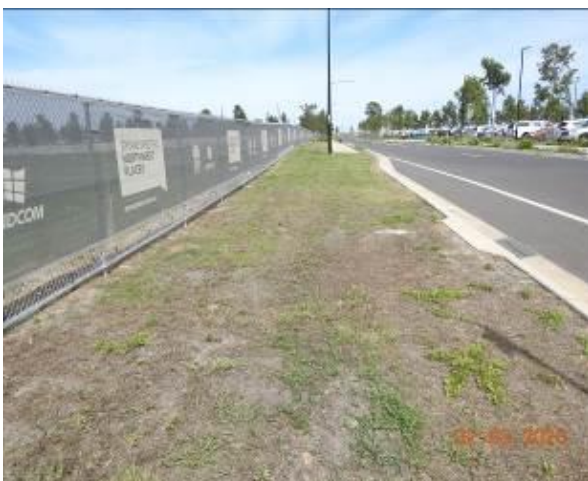
Figure 125 – General Condition of grass area

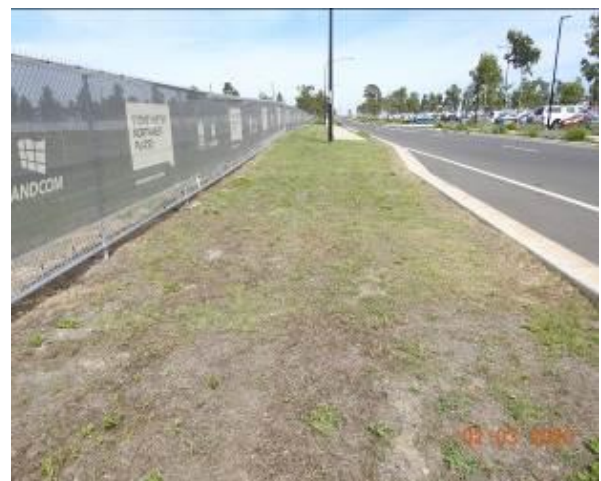
Figure 126 – General Condition of grass area

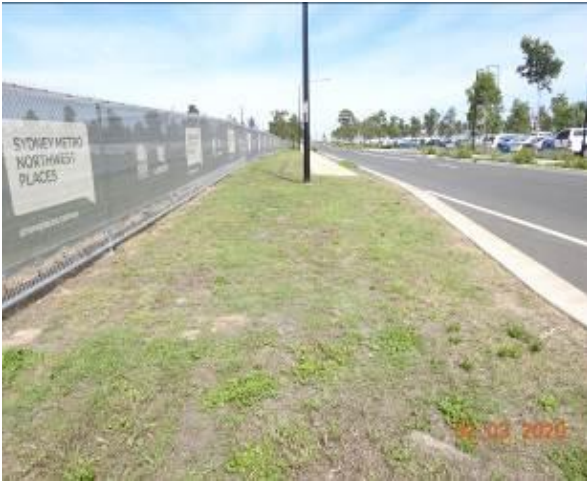
Figure 127 – General Condition of grass area

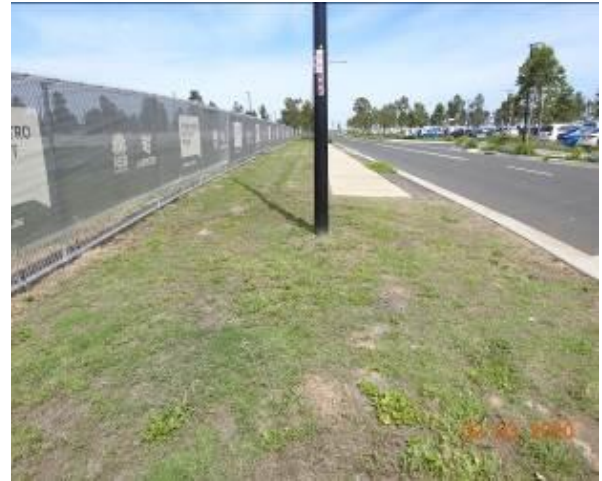
Figure 128 – General Condition of grass area

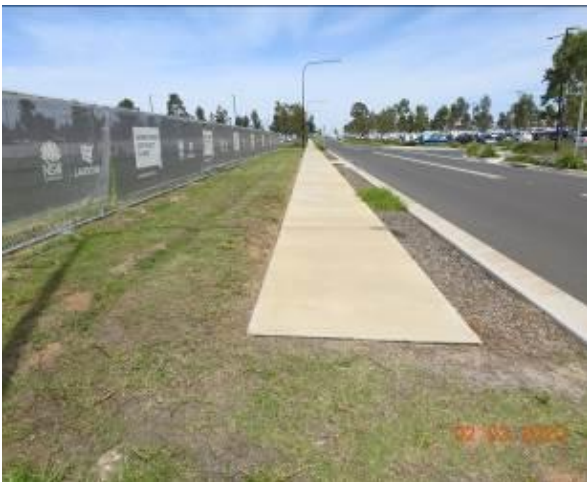
Figure 129 – General Condition of grass area

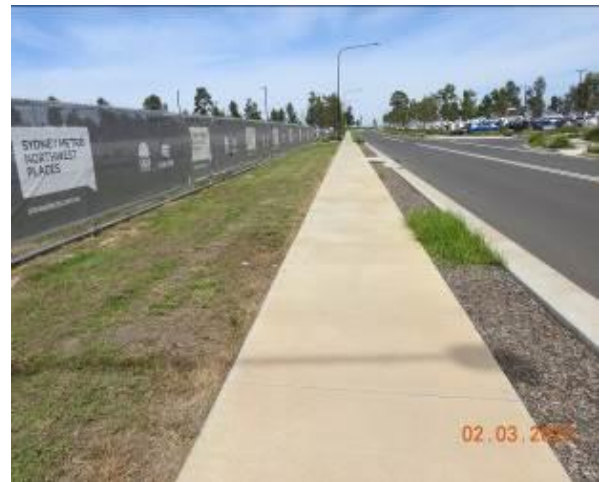
Figure 130 – General Condition of footpath pavement

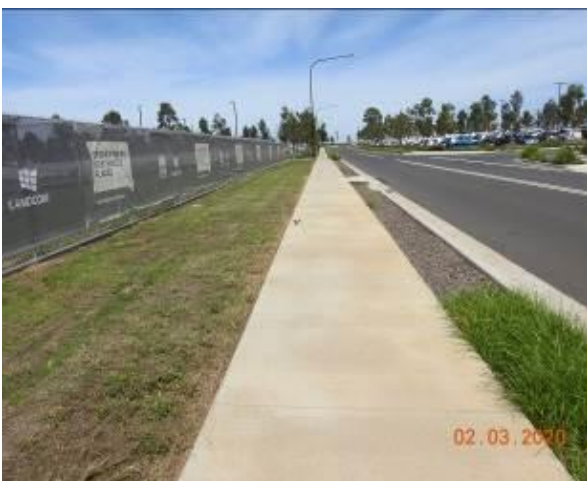
Figure 131 – General Condition of footpath pavement

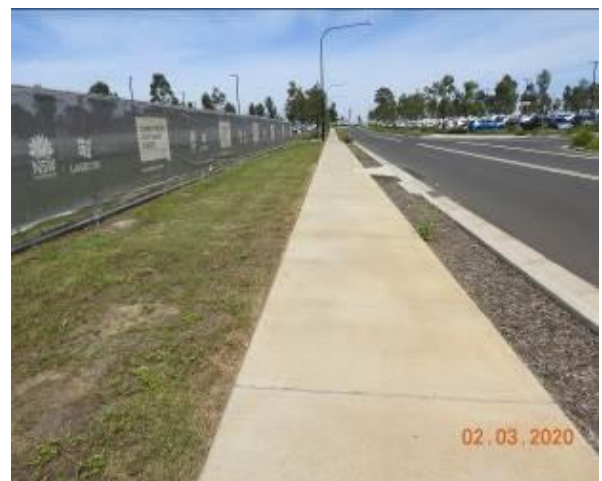
Figure 132 – General Condition of footpath pavement

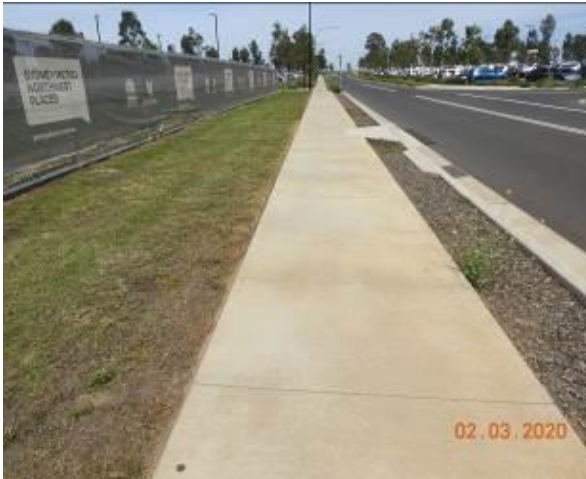
Figure 133 – General Condition of footpath pavement

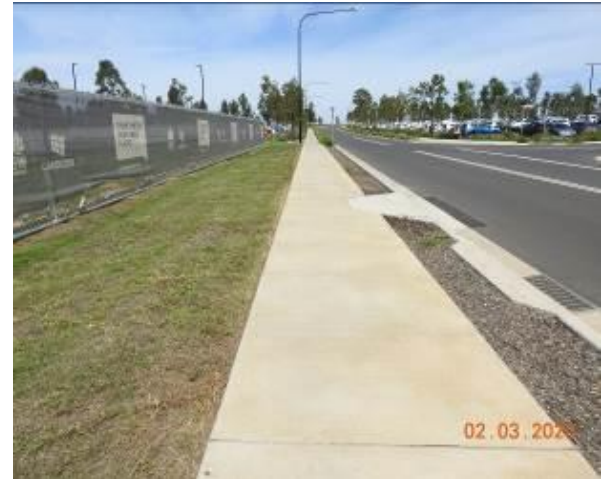
Figure 134 – General Condition of footpath pavement

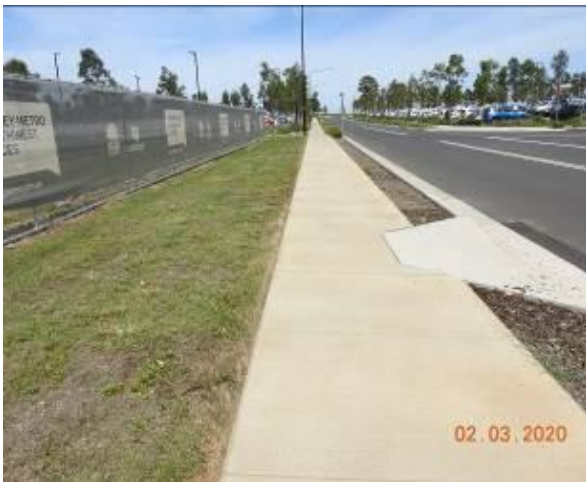
Figure 135 – General Condition of footpath pavement

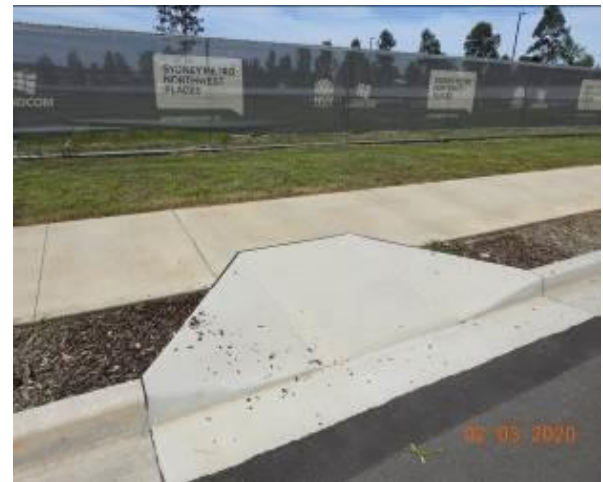
Figure 136 – General Condition of footpath pavement ramp

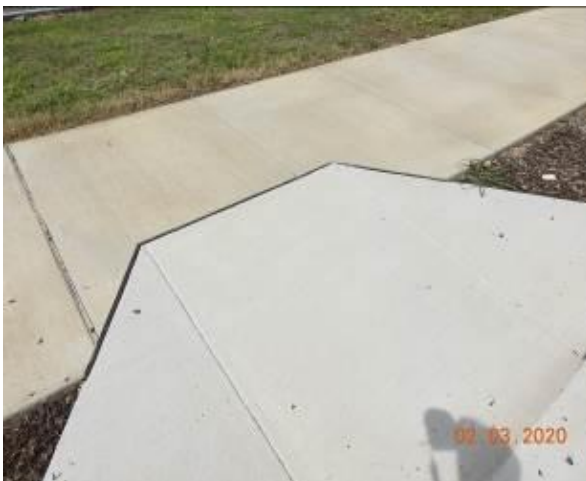
Figure 137 – General Condition of footpath pavement ramp

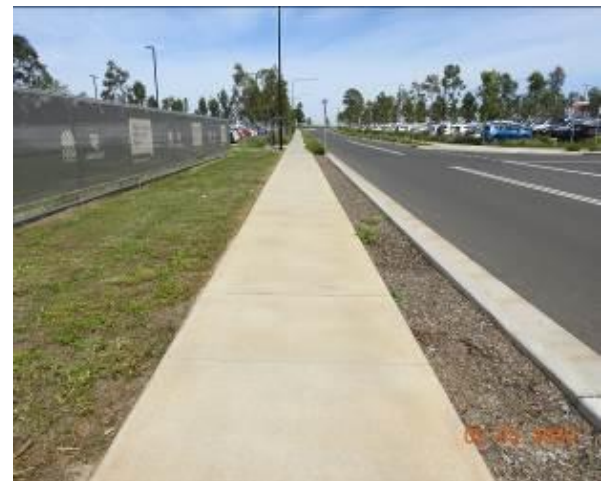
Figure 138 – General Condition of footpath pavement

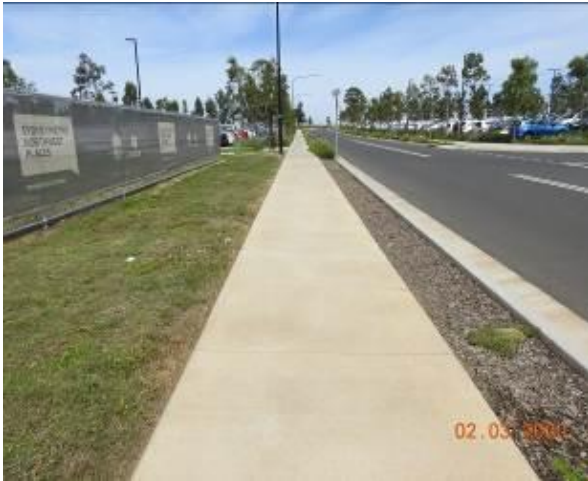
Figure 139 – General Condition of footpath pavement

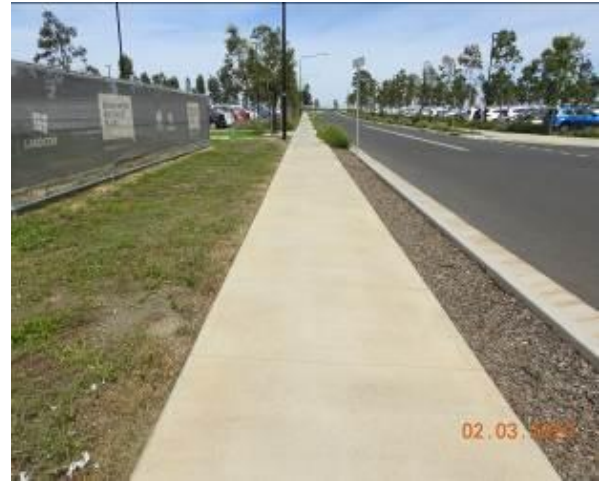
Figure 140 – General Condition of footpath pavement

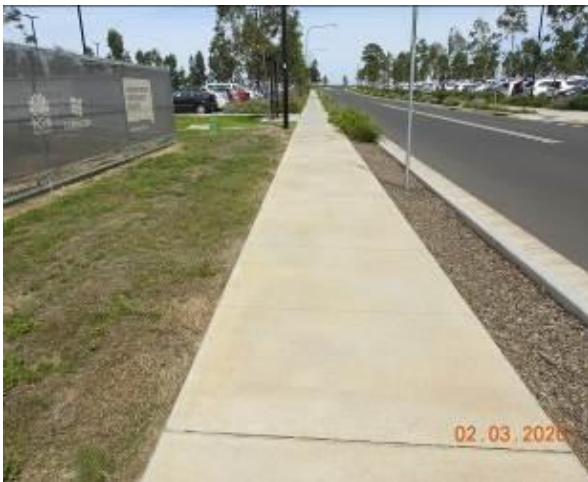
Figure 141 – General Condition of footpath pavement

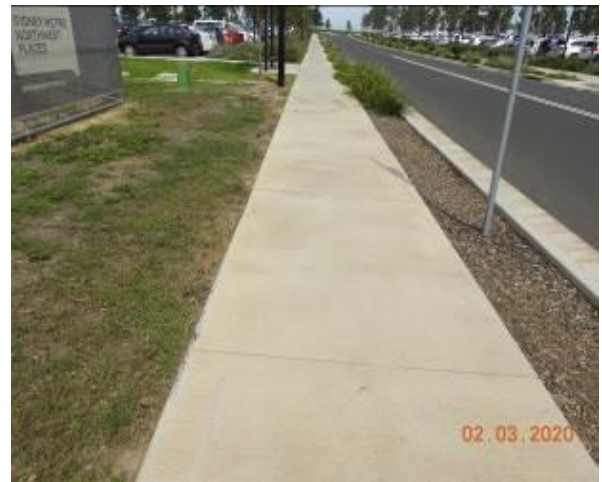
Figure 142 – General Condition of footpath pavement

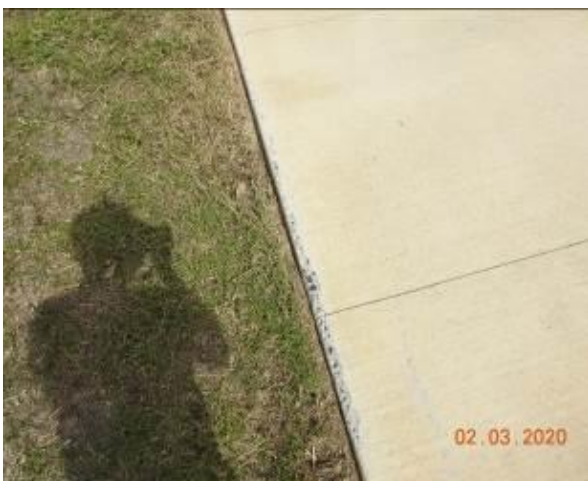
Figure 143 – Loss of material through footpath pavement

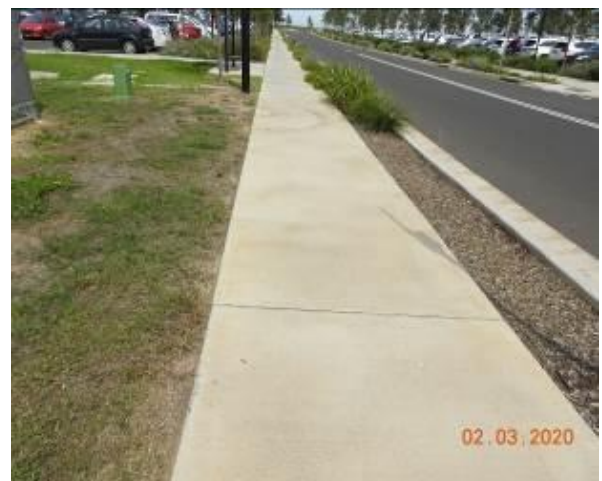
Figure 144 – General Condition of footpath pavement

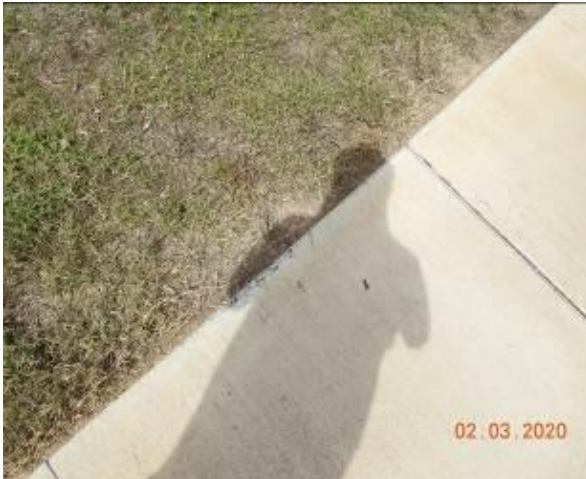
Figure 145 – Loss of material through footpath pavement

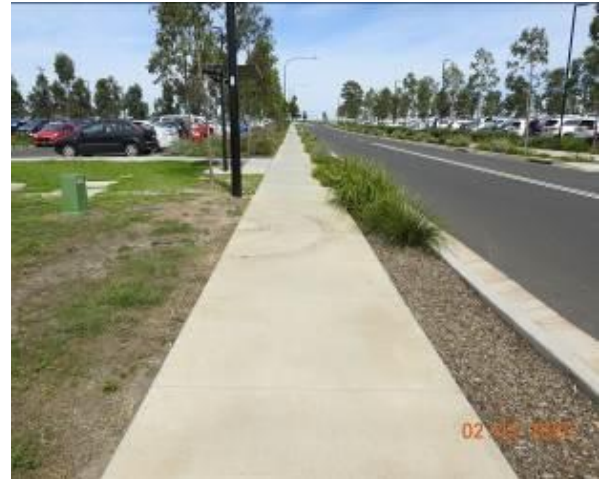
Figure 146 – General Condition of footpath pavement

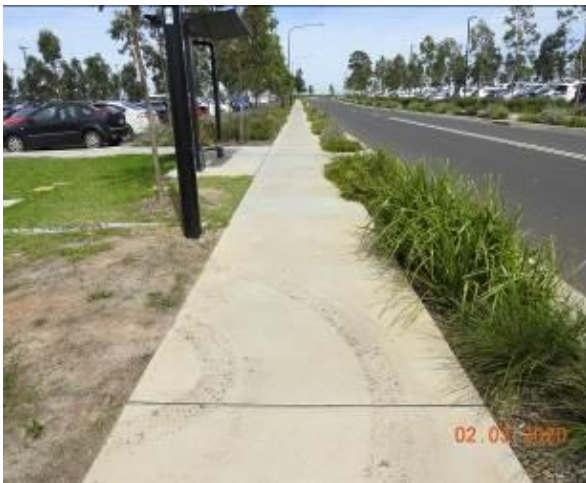
Figure 147 – General Condition of footpath pavement

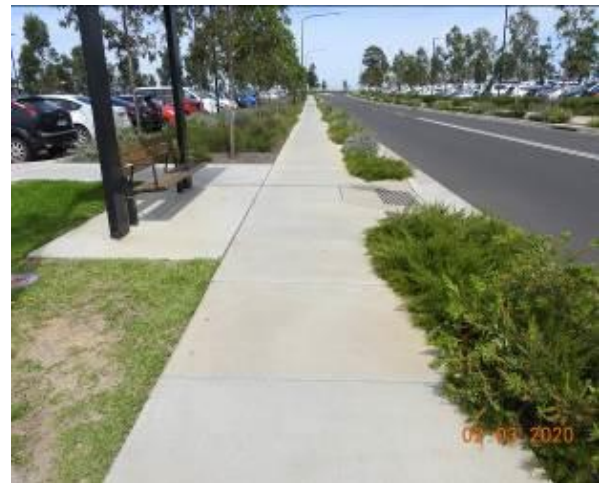
Figure 148 – General Condition of footpath pavement

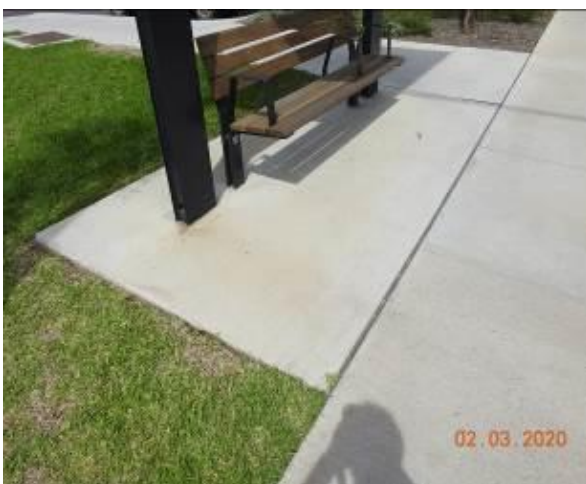
Figure 149 – General Condition of footpath pavement

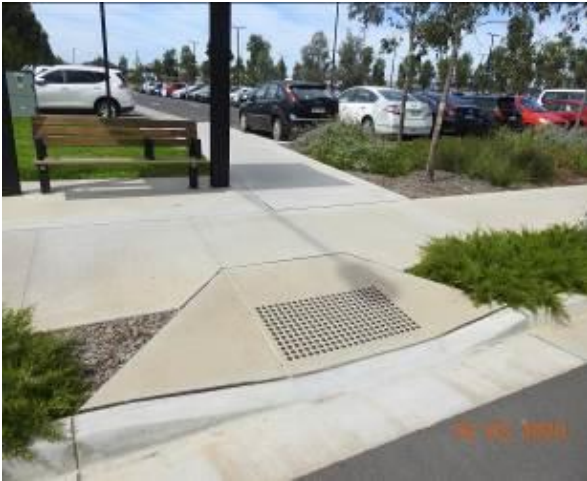
Figure 151 – General Condition of footpath pavement

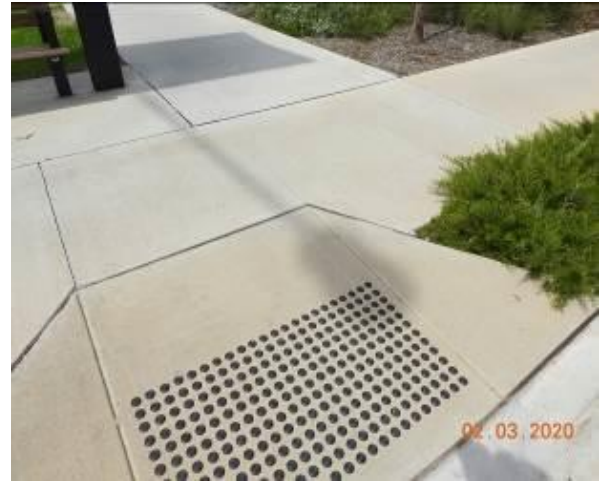
Figure 152 – General Condition of footpath pavement ramp

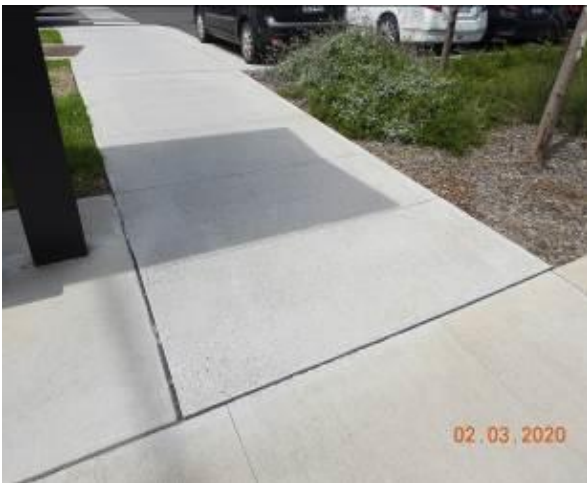
Figure 153 – General Condition of footpath pavement

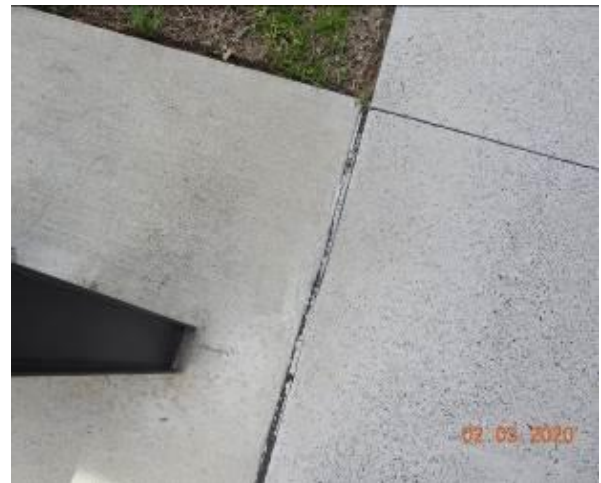
Figure 154 – Crack propagation through footpath pavement

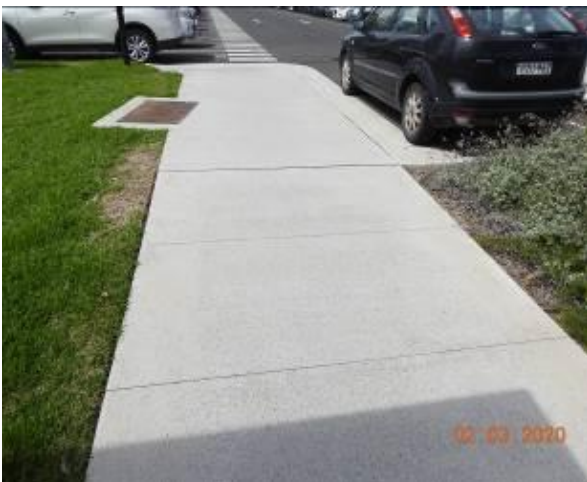
Figure 155 – General Condition of footpath pavement

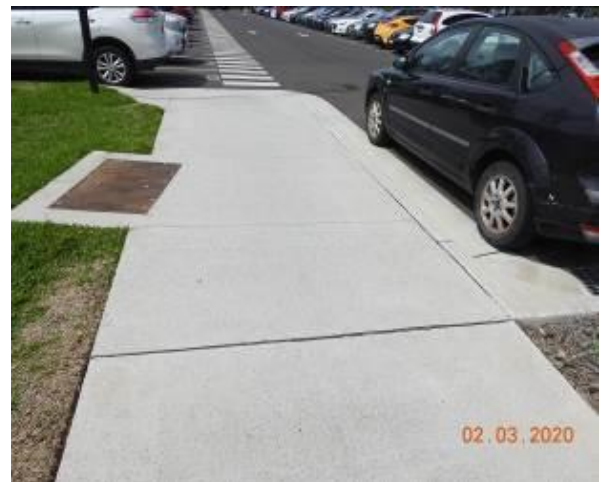
Figure 156 – General Condition of footpath pavement

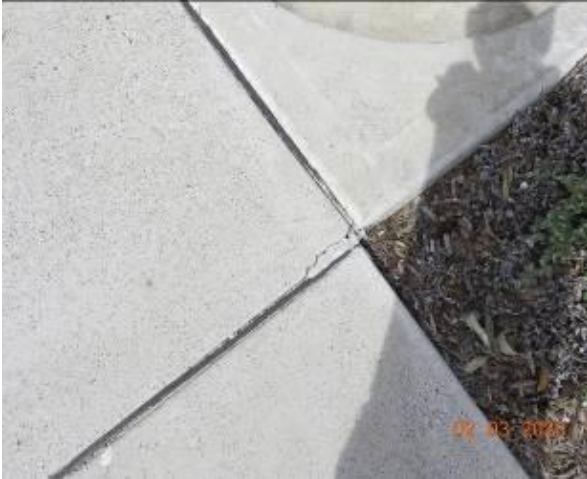
Figure 157 – Crack propagation through footpath pavement

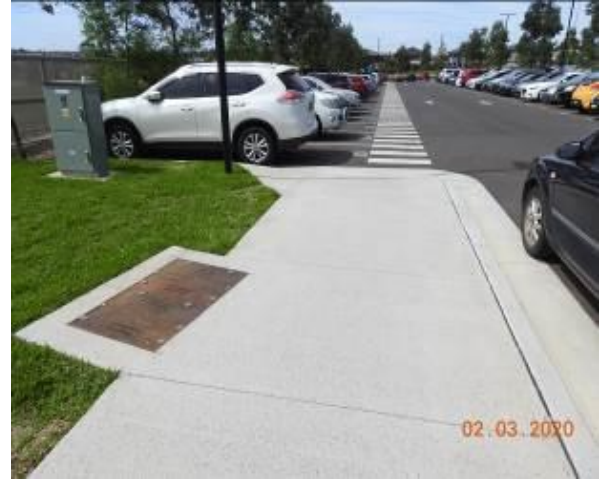
Figure 158 – General Condition of footpath pavement

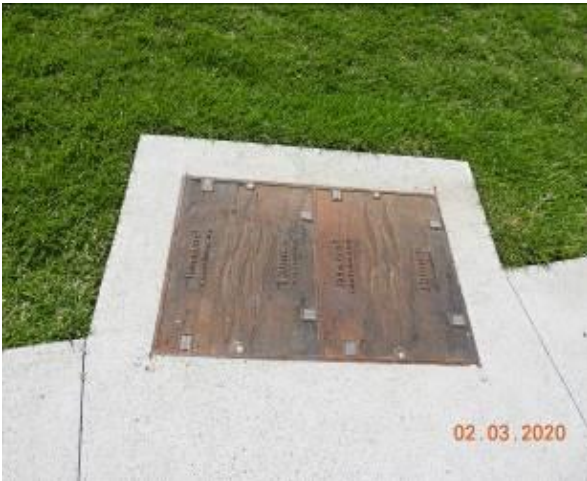
Figure 159 – General Condition of service pit

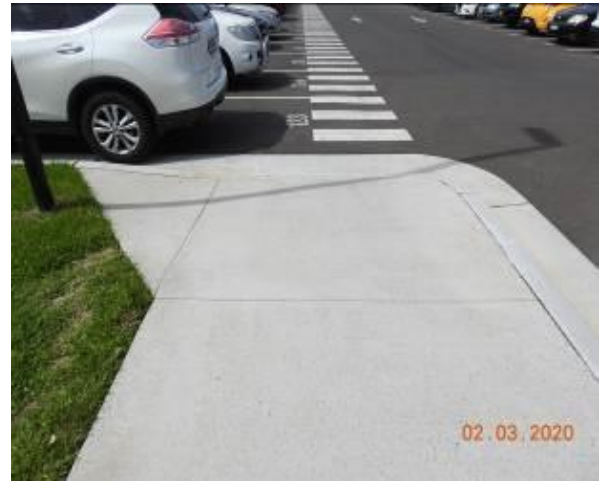
Figure 160 – General Condition of footpath pavement

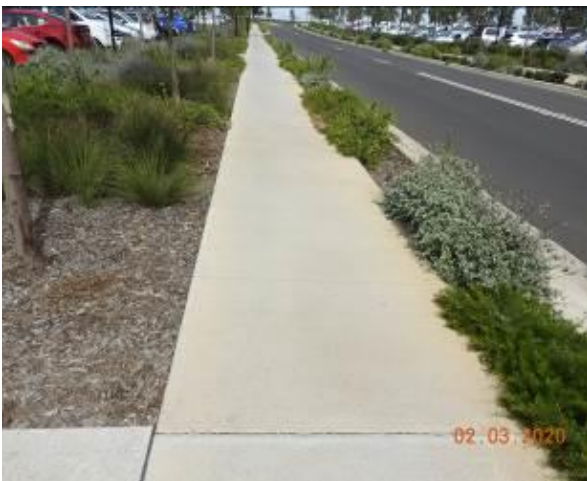
Figure 161 – General Condition of footpath pavement

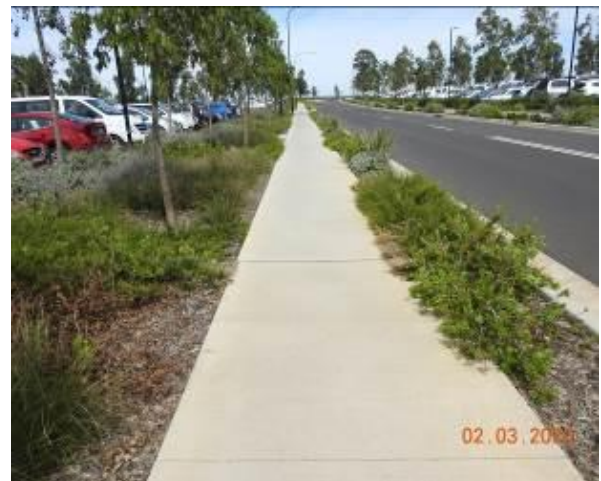
Figure 162 – General Condition of footpath pavement

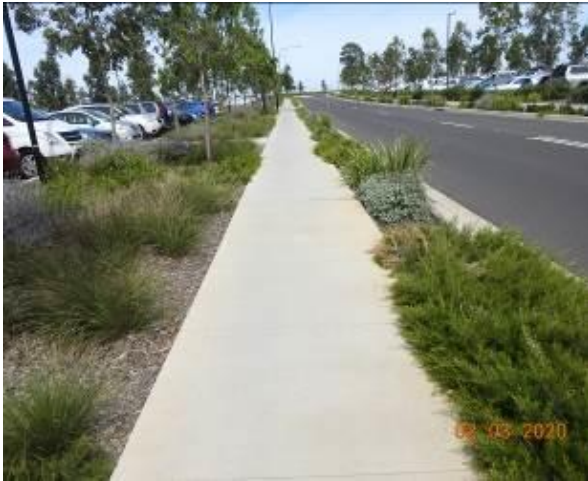
Figure 163 – General Condition of footpath pavement

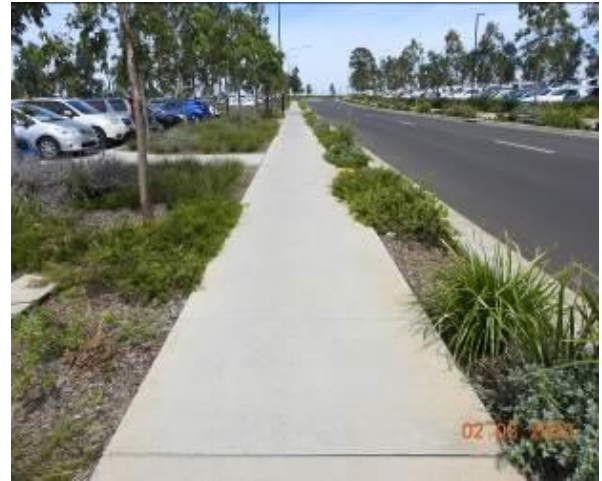
Figure 164 – General Condition of footpath pavement
