**1-15 AND 2-12 CONFERTA AVENUE,  
ROUSE HILL NSW 2155  
TALLAWONG STATION PRECINCT SOUTH  
PRE-DILAPIDATION REPORT**

**DEICORP PROJECTS  
(TALLAWONG STATION) PTY LTD**

Job No. 191294.0  
05/07/2021

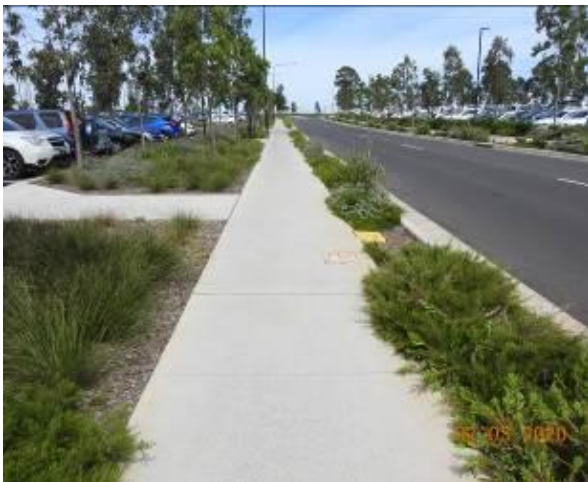
Figure 165 – General Condition of footpath pavement

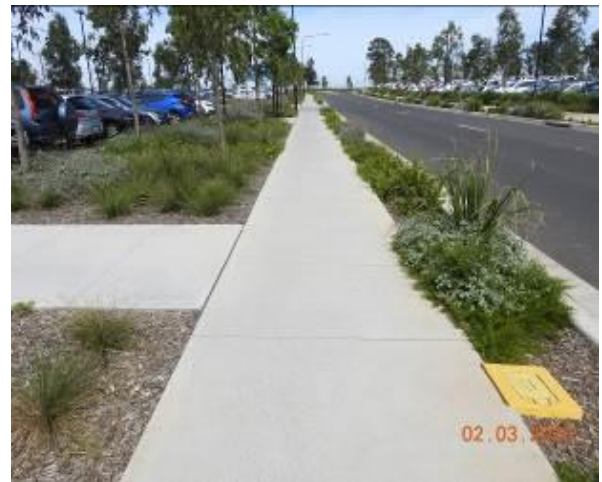
Figure 166 – General Condition of footpath pavement

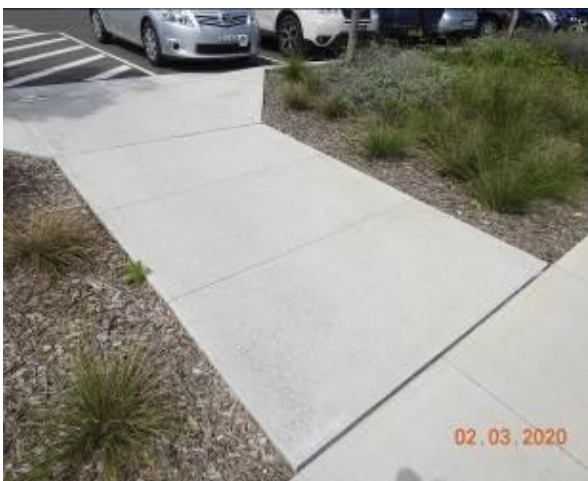
Figure 167 – General Condition of footpath pavement

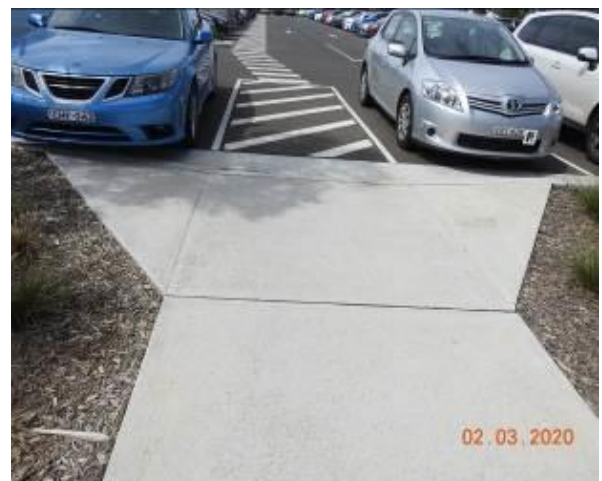
Figure 168 – General Condition of footpath pavement

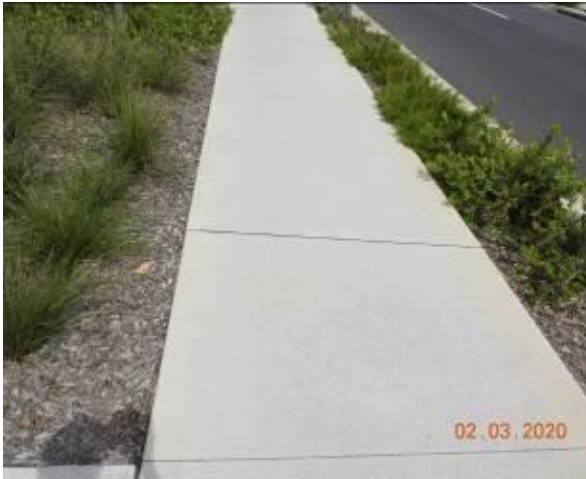
Figure 169 – General Condition of footpath pavement

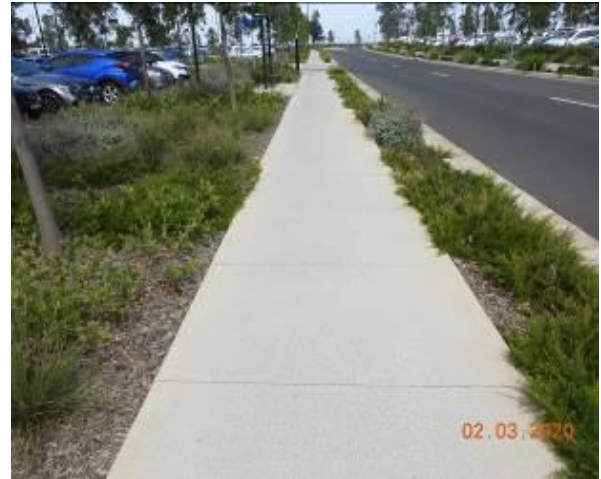
Figure 170 – General Condition of footpath pavement

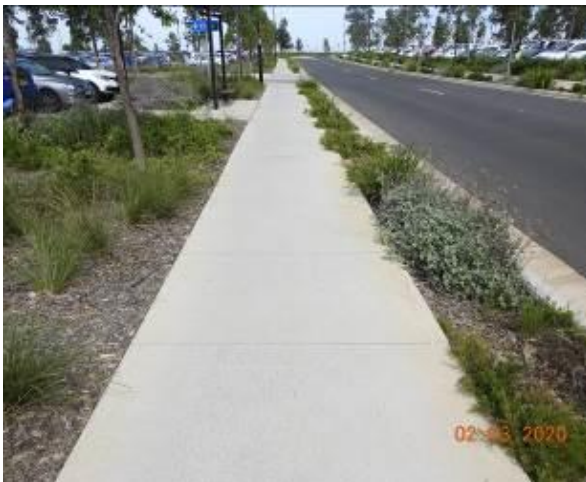
Figure 171 – General Condition of footpath pavement

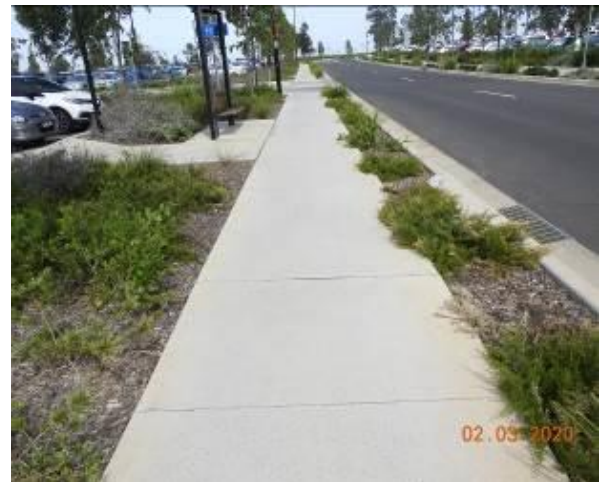
Figure 172 – General Condition of footpath pavement

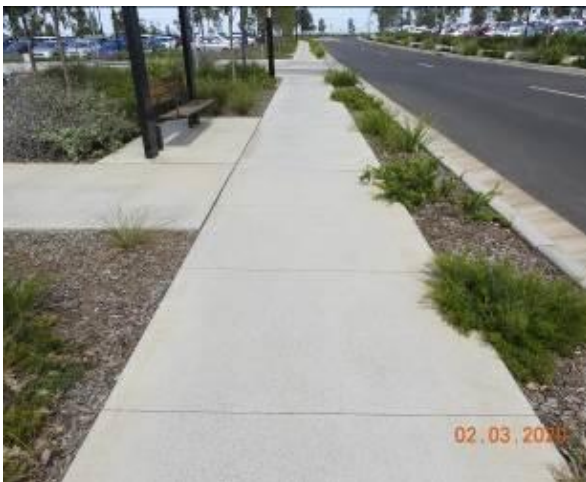
Figure 173 – General Condition of footpath pavement

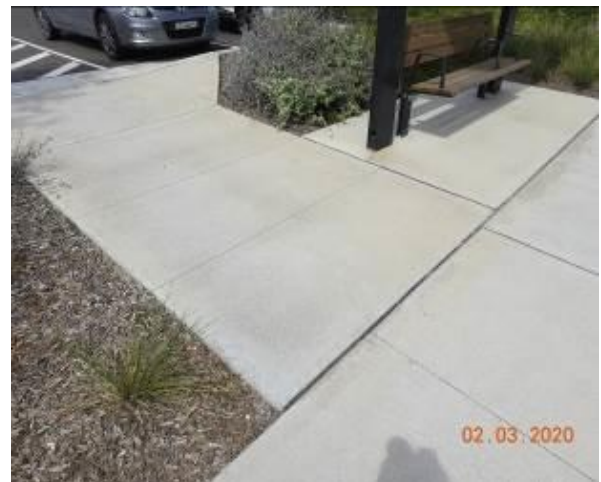
Figure 174 – General Condition of footpath pavement

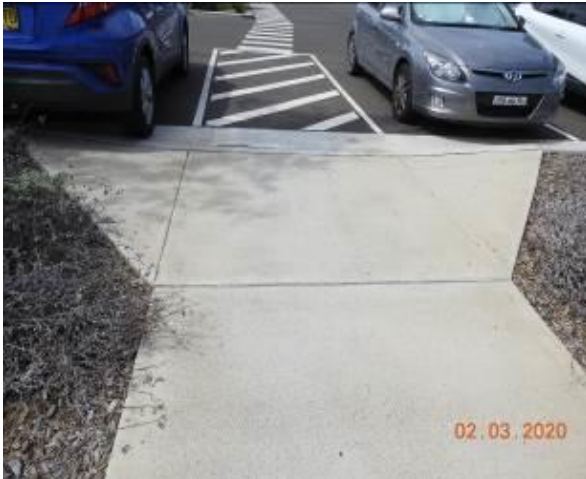
Figure 175 – General Condition of footpath pavement

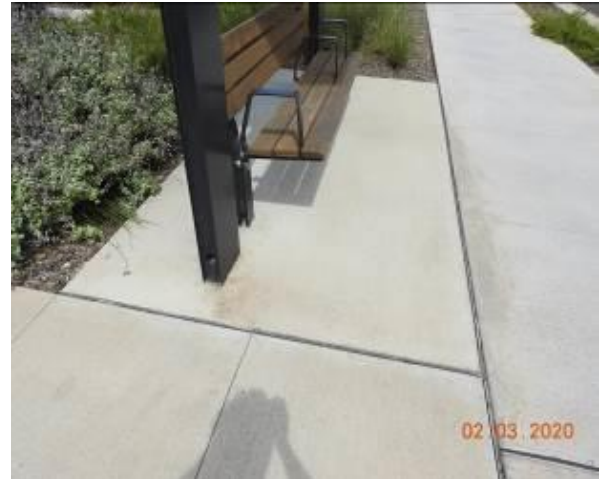
Figure 176 – General Condition of public bench

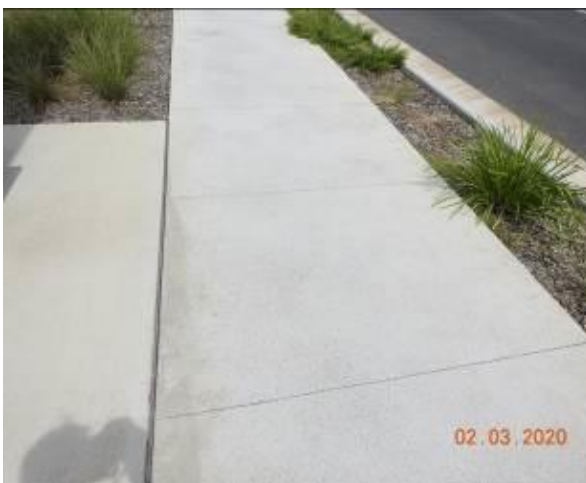
Figure 177 – General Condition of footpath pavement

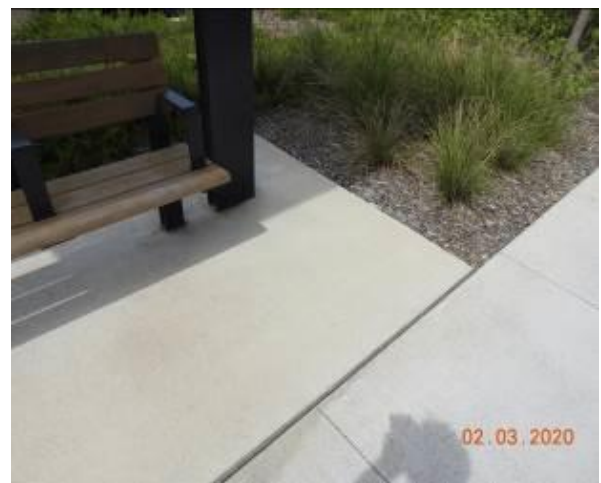
Figure 178 – General Condition of public bench

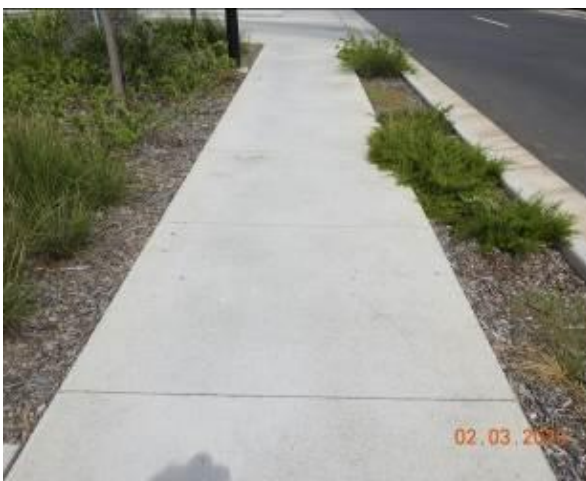
Figure 179 – General Condition of footpath pavement

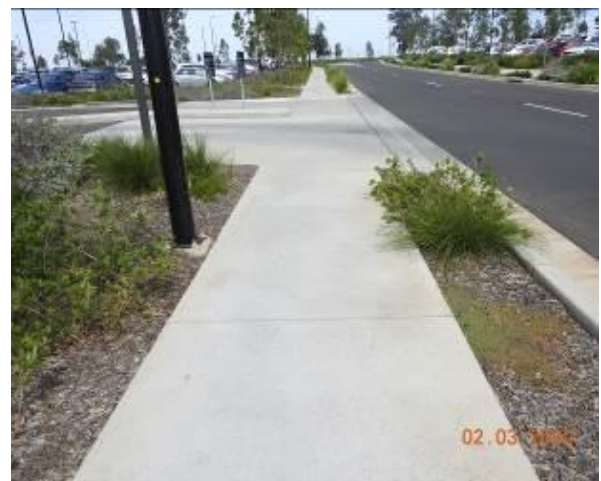
Figure 180 – General Condition of footpath pavement

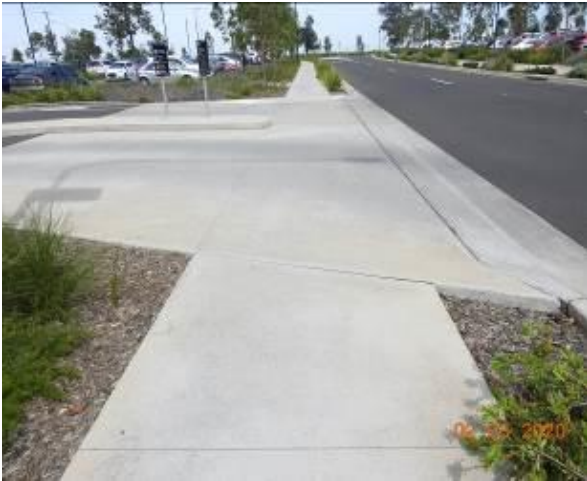
Figure 181 – General Condition of footpath pavement

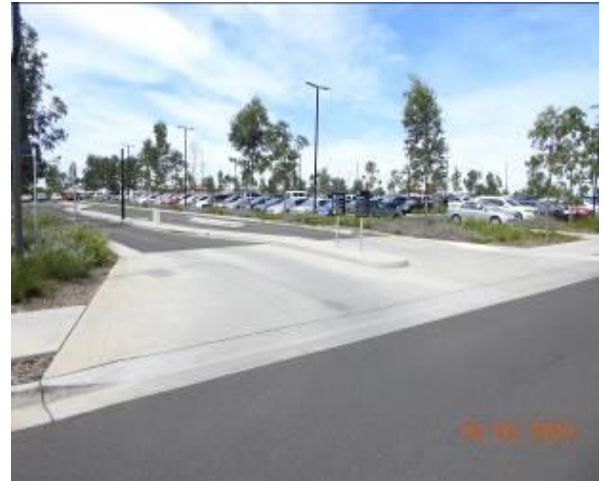
Figure 182 – General Condition of driveway pavement

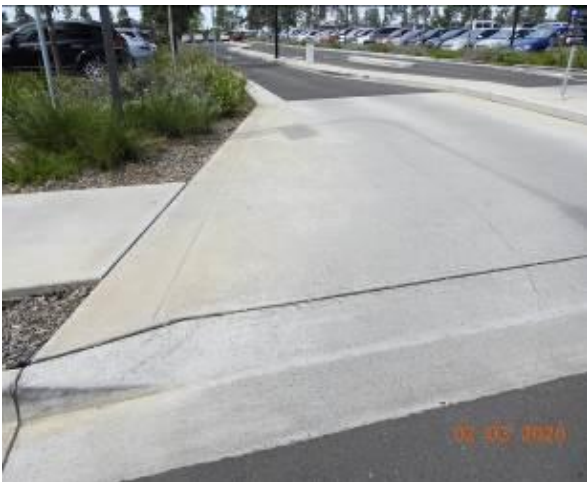
Figure 183 – General Condition of driveway pavement

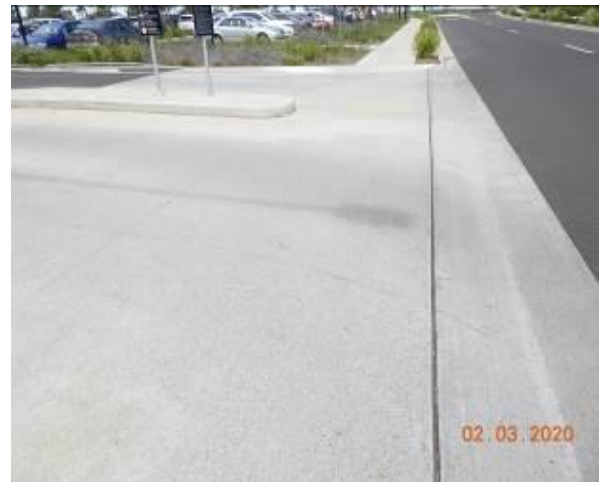
Figure 184 – General Condition of driveway pavement

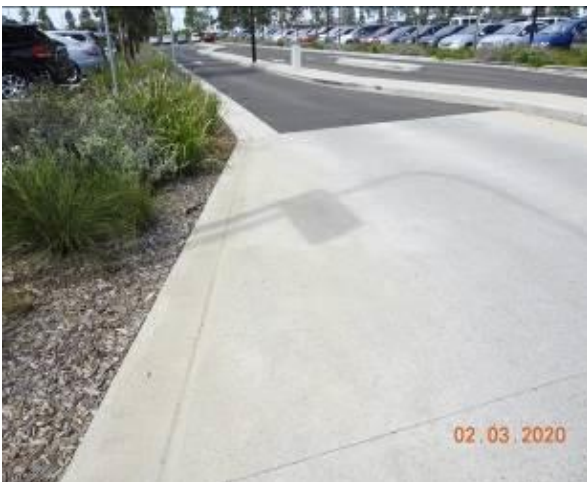
Figure 185 – General Condition of driveway pavement

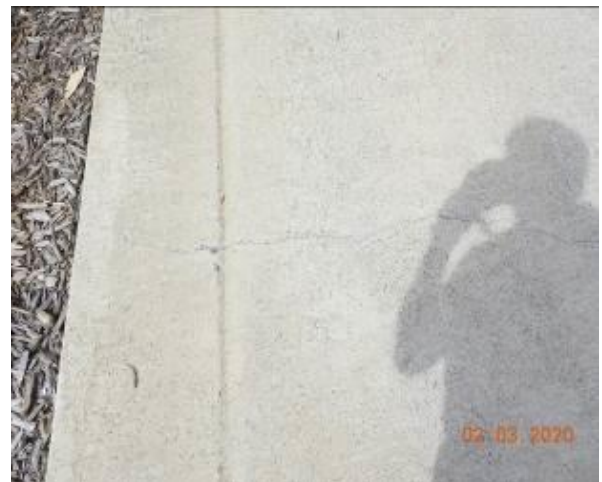
Figure 186 – Crack propagation through driveway pavement

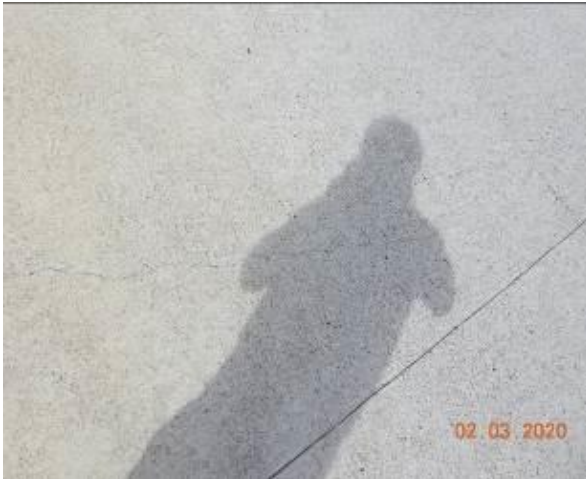
Figure 187 – Crack propagation through driveway pavement

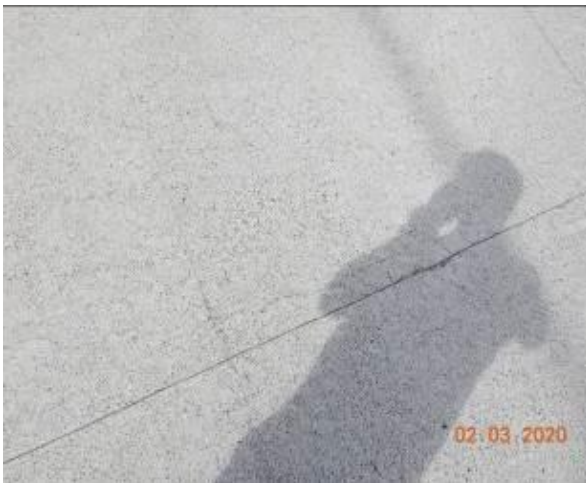
Figure 189 – Crack propagation through driveway pavement

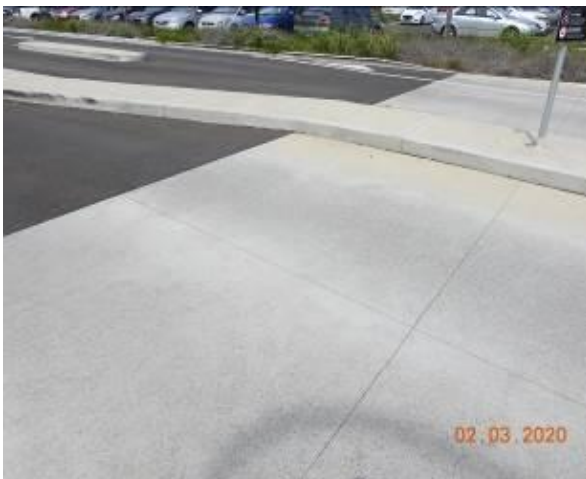
Figure 191 – General Condition of driveway pavement

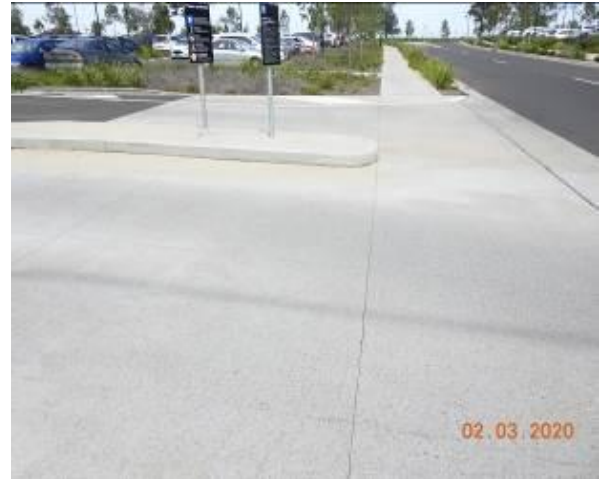
Figure 188 – General Condition of driveway pavement

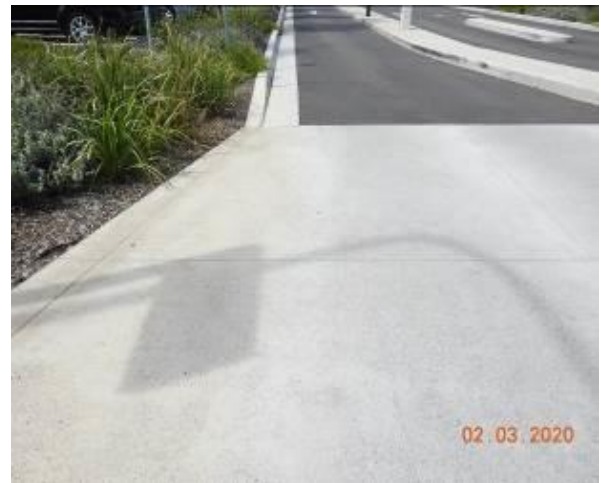
Figure 190 – General Condition of driveway pavement

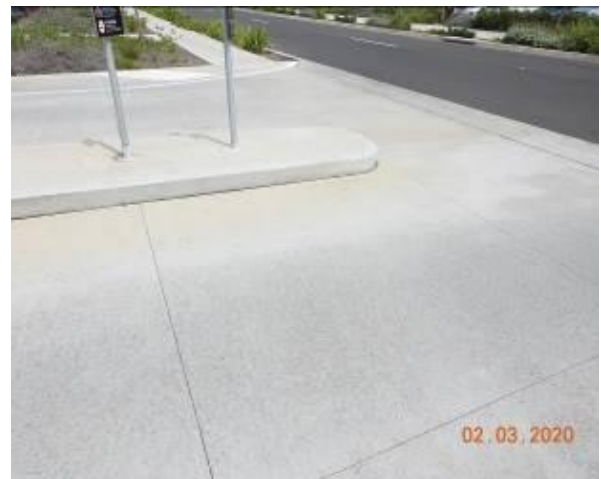
Figure 192 – General Condition of driveway pavement

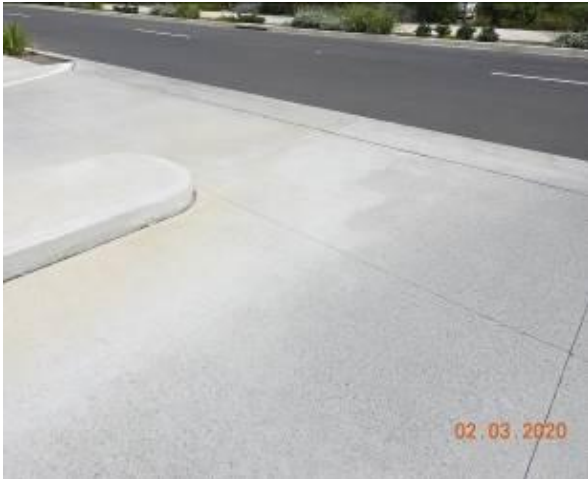
Figure 193 – General Condition of driveway pavement

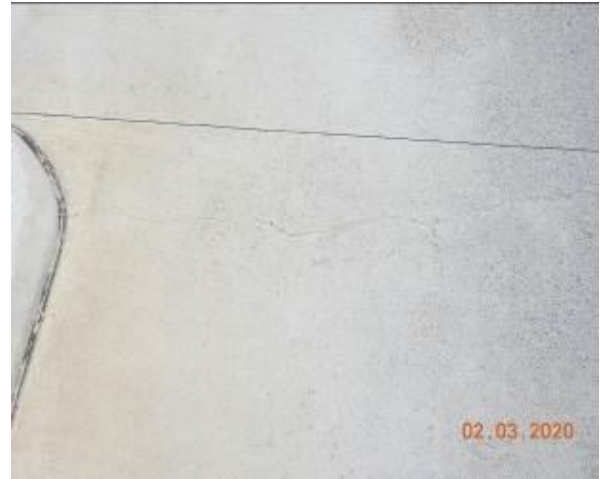
Figure 194 – Crack propagation through driveway pavement

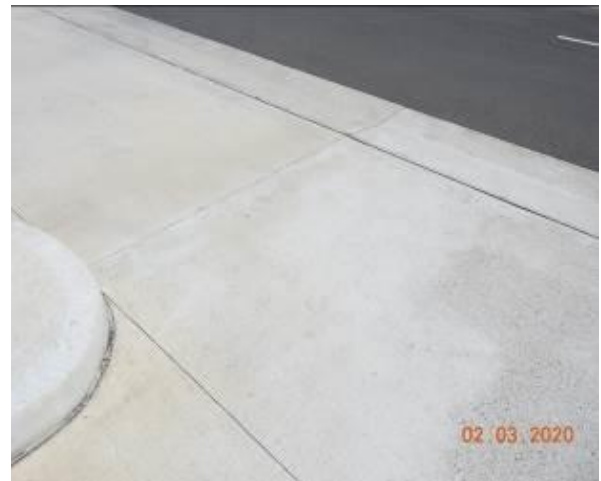
Figure 196 – General Condition of driveway pavement

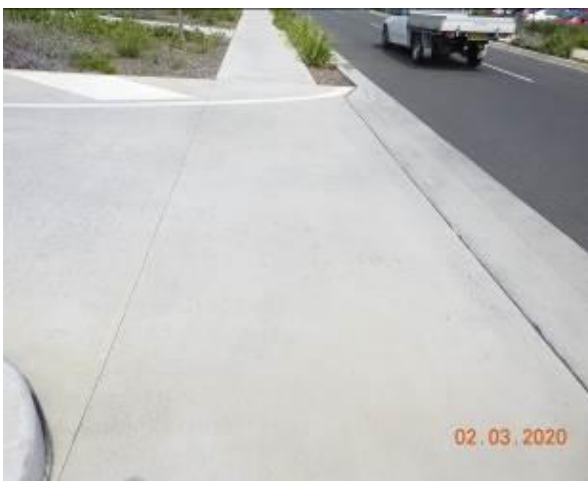
Figure 197 – General Condition of driveway pavement

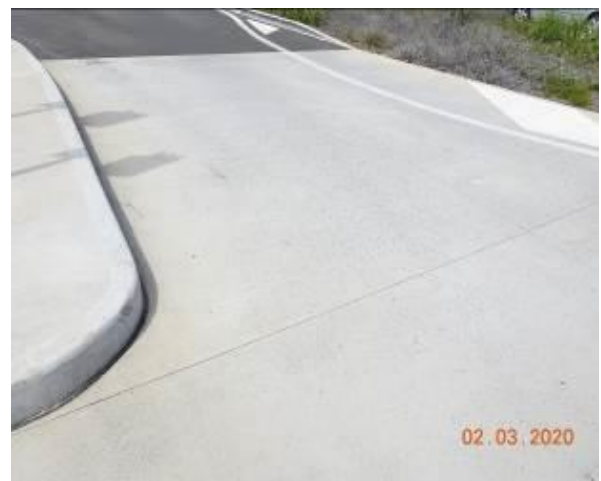
Figure 198 – General Condition of driveway pavement

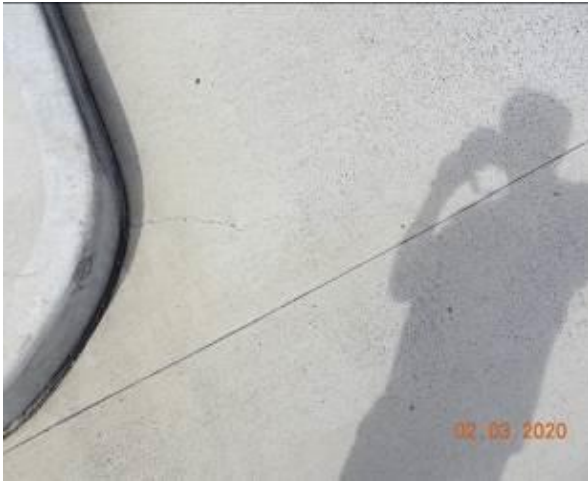
Figure 199 – Crack propagation through driveway pavement

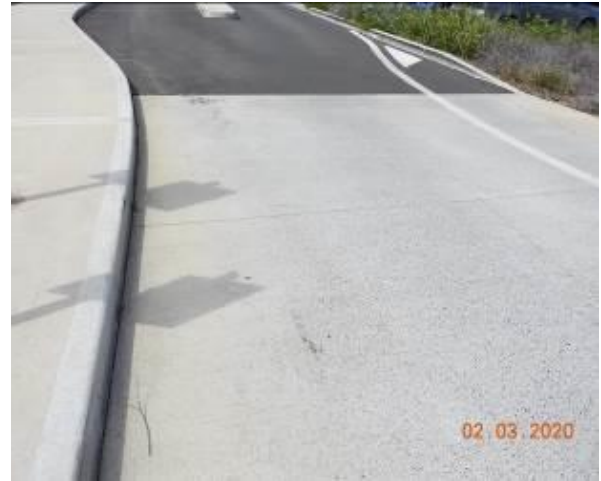
Figure 200 – General Condition of driveway pavement

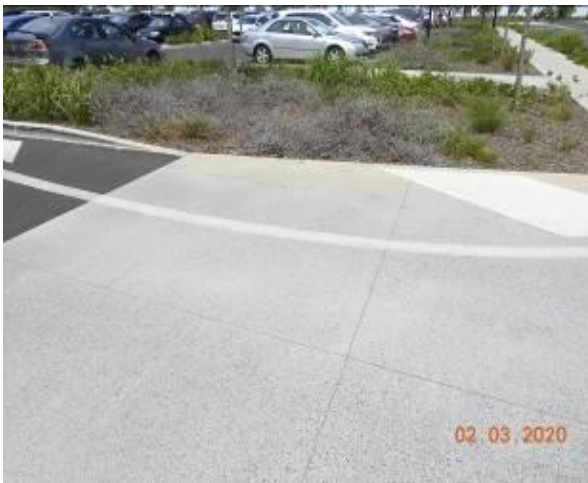
Figure 201 – General Condition of driveway pavement

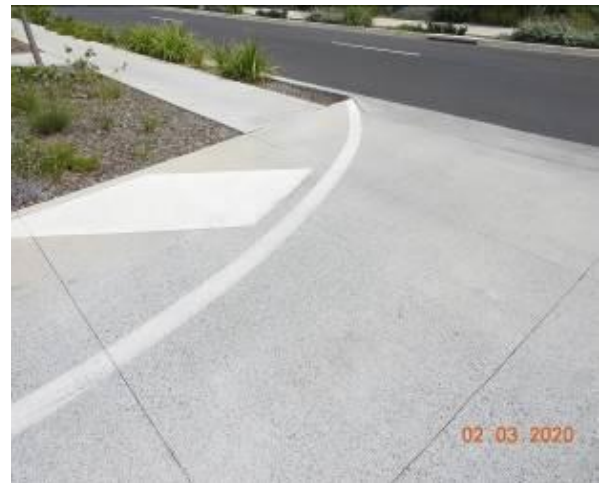
Figure 202 – General Condition of driveway pavement

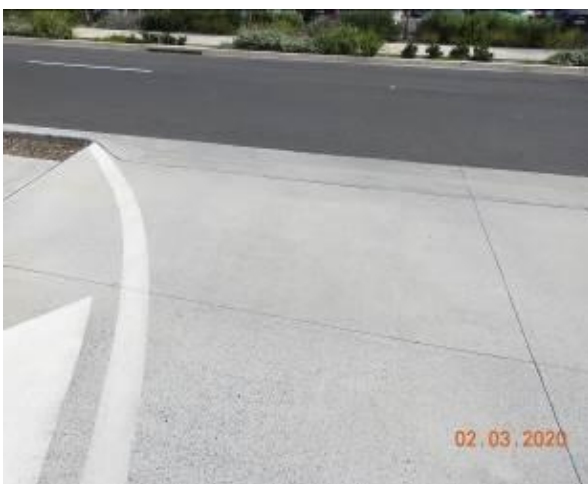
Figure 203 – General Condition of driveway pavement

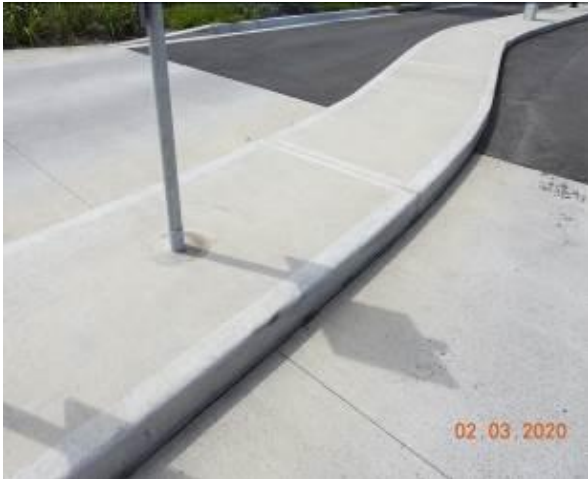
Figure 205 – General Condition of traffic island

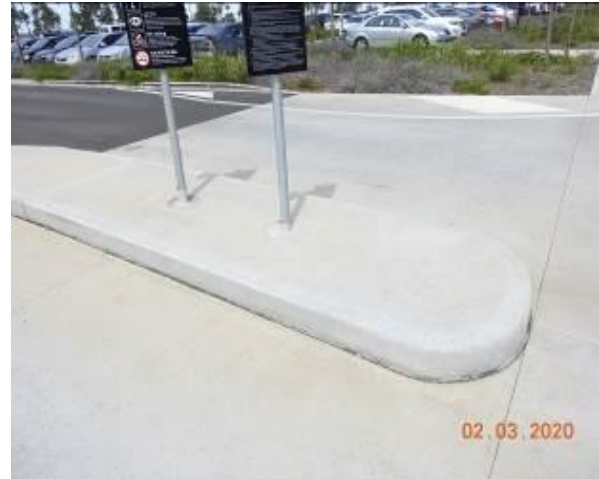
Figure 206 – General Condition of traffic island

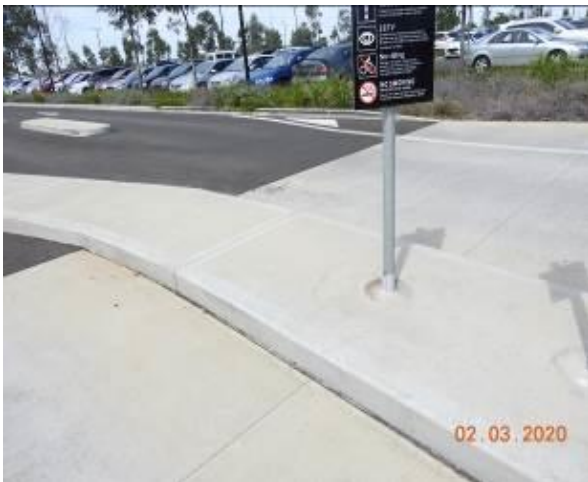
Figure 207 – General Condition of traffic island

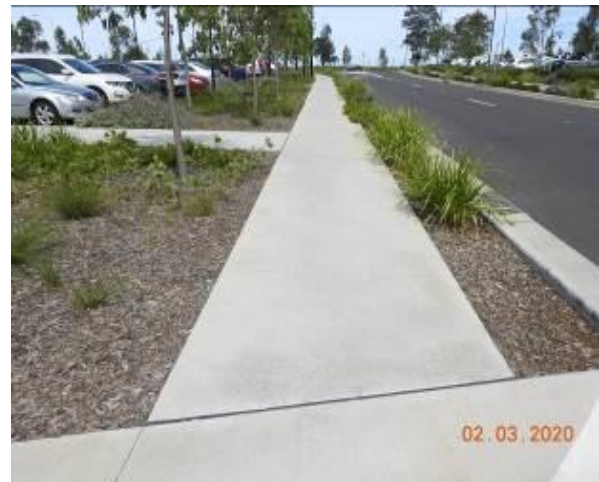
Figure 208 – General Condition of footpath pavement

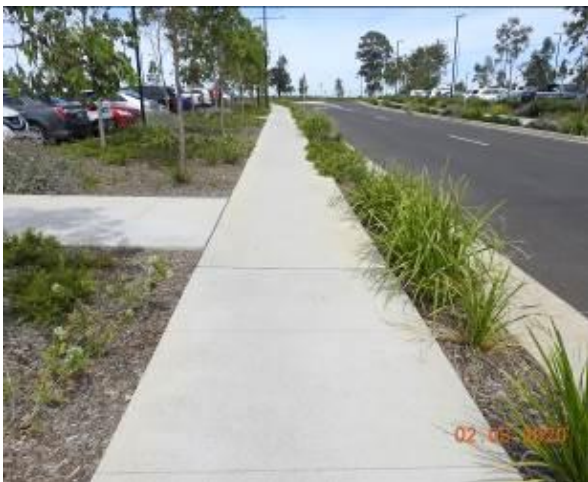
Figure 209 – General Condition of footpath pavement

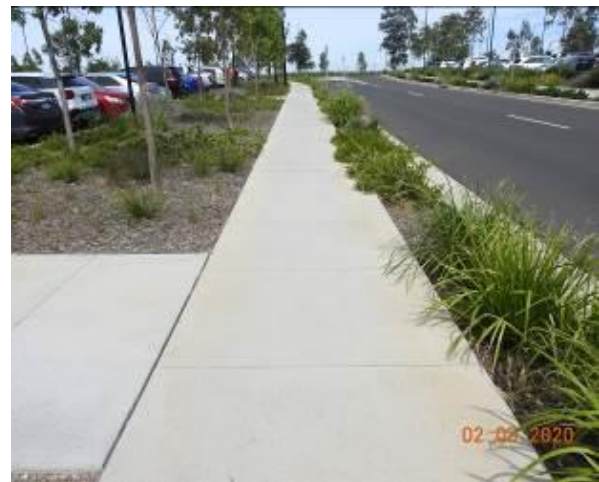
Figure 210 – General Condition of footpath pavement

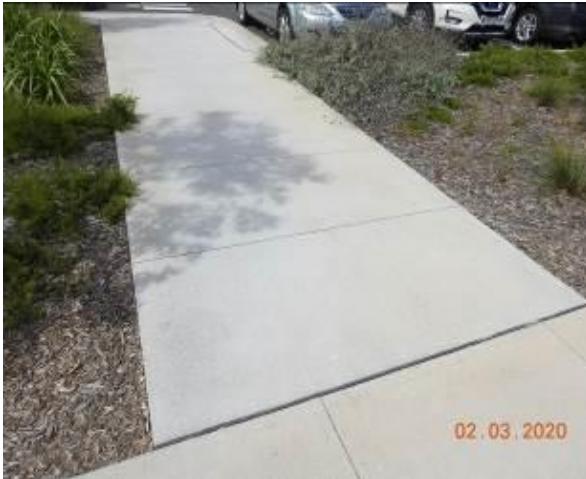
Figure 211 – General Condition of footpath pavement

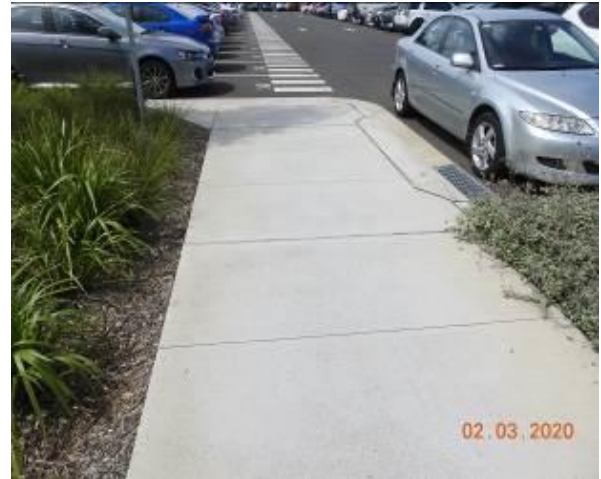
Figure 212 – General Condition of footpath pavement

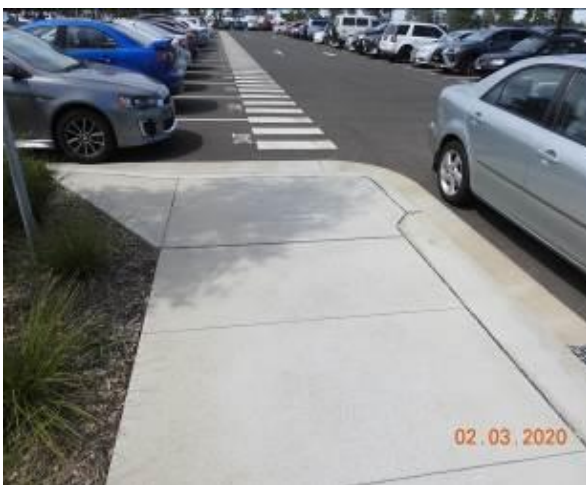
Figure 213 – General Condition of footpath pavement

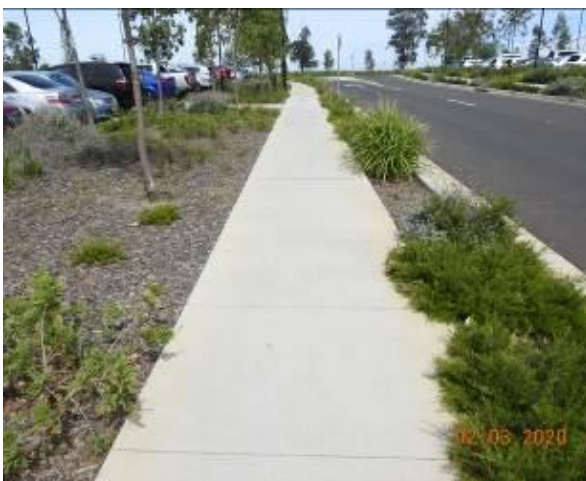
Figure 215 – General Condition of footpath pavement

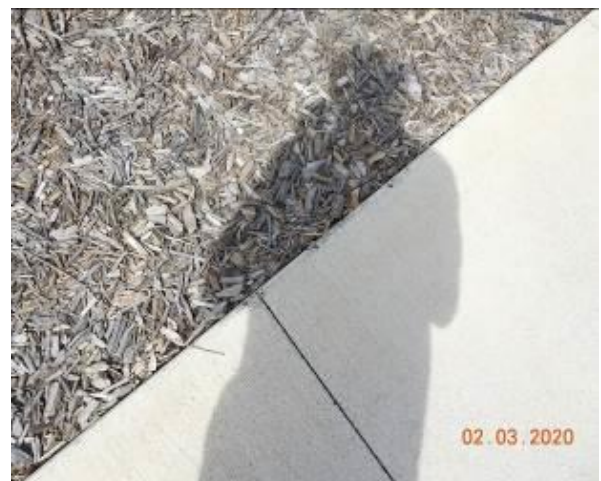
Figure 216 – Loss of material through footpath pavement

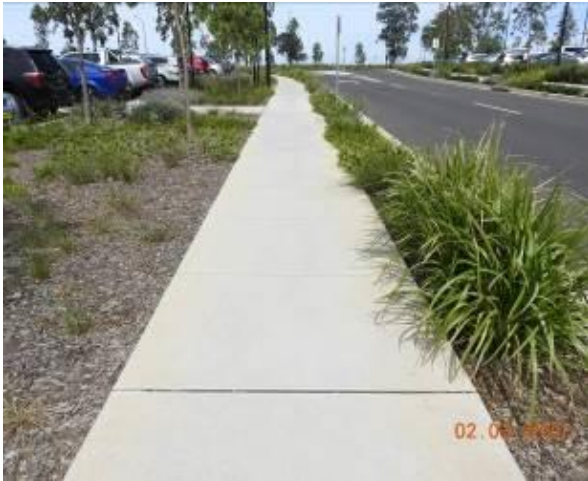
Figure 217 – General Condition of footpath pavement

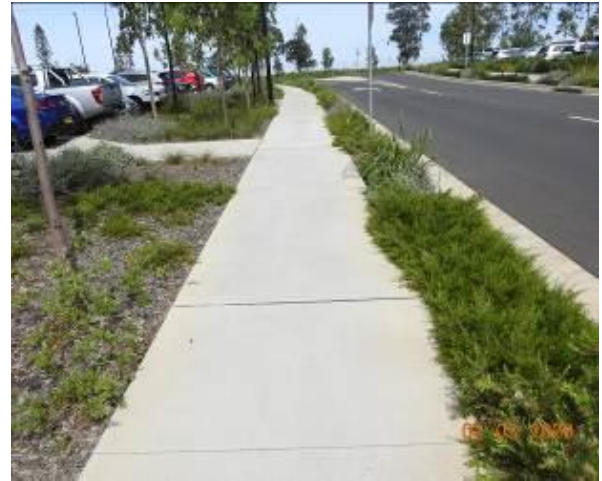
Figure 218 – General Condition of footpath pavement

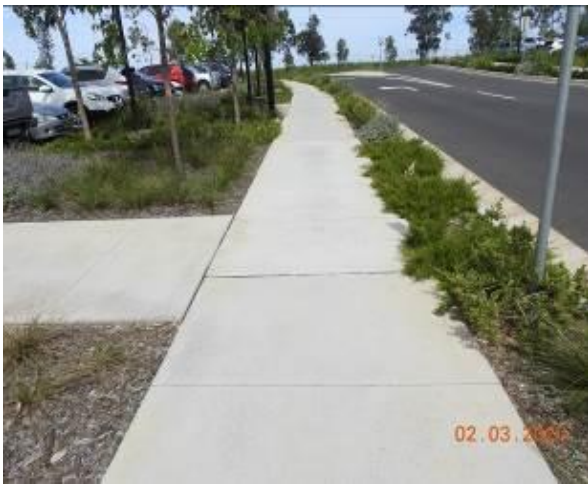
Figure 219 – General Condition of footpath pavement

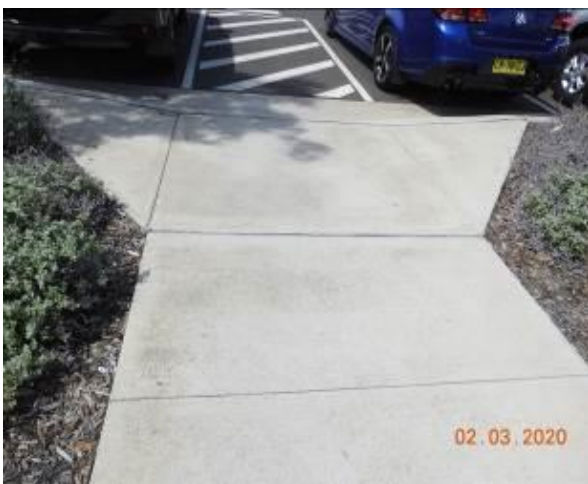
Figure 221 – General Condition of footpath pavement

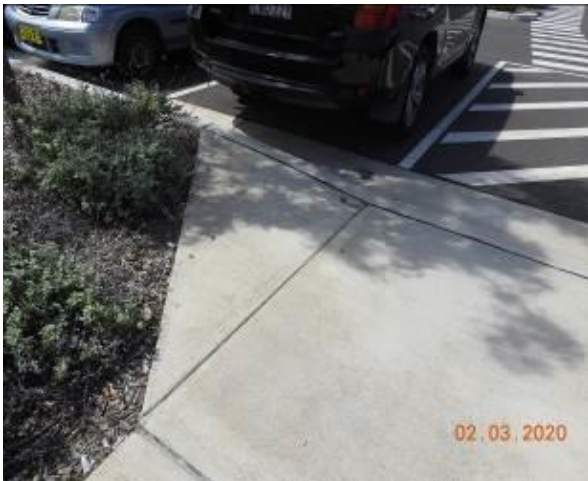
Figure 223 – General Condition of footpath pavement

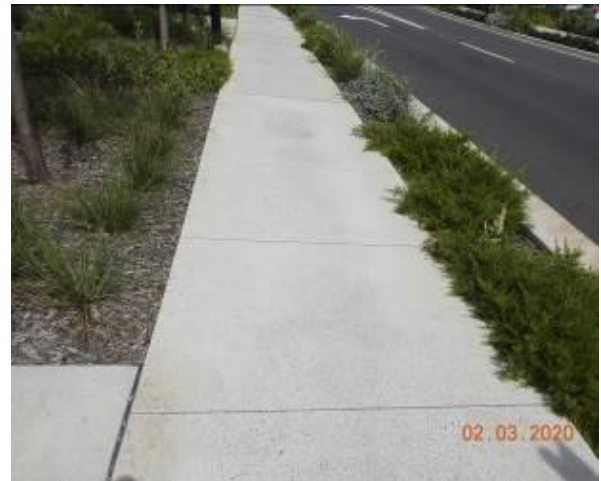
Figure 224 – General Condition of footpath pavement

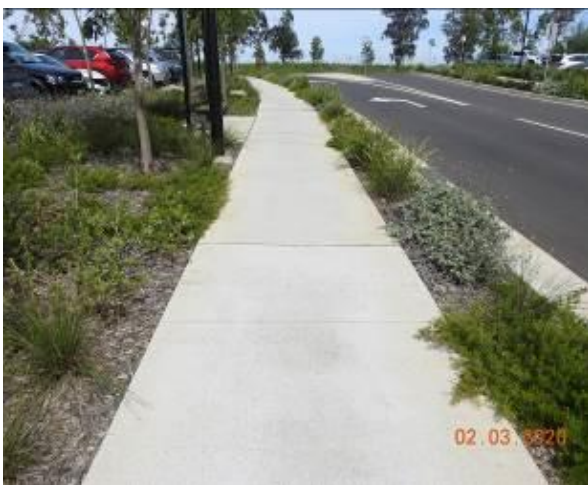
Figure 225 – General Condition of footpath pavement

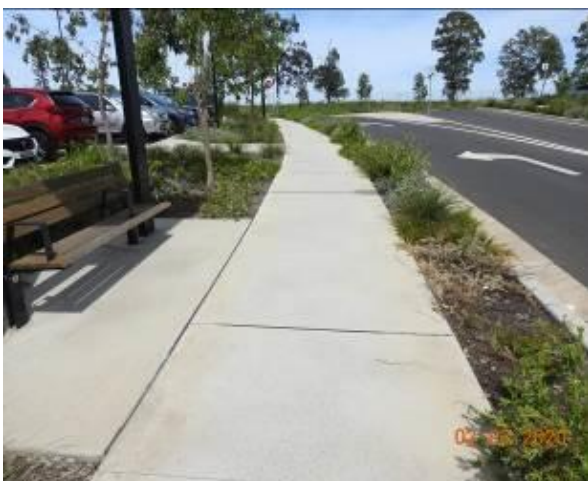
Figure 227 – General Condition of footpath pavement

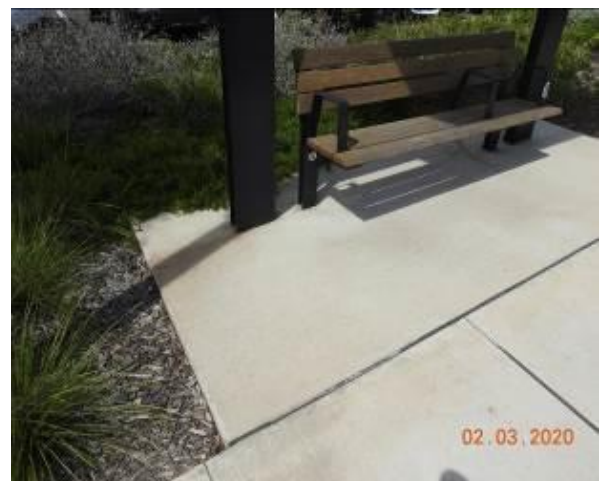
Figure 228 – General Condition of public bench

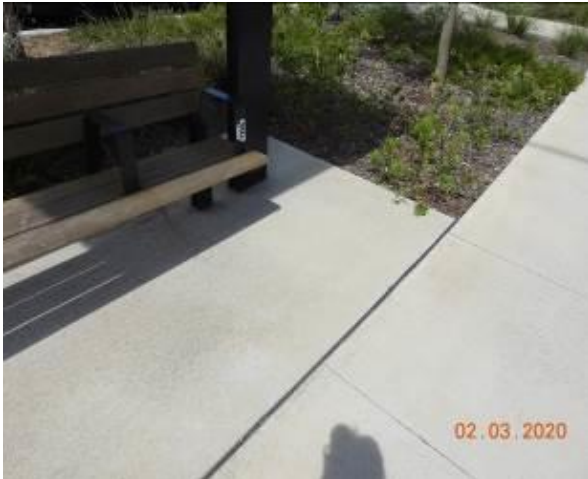
Figure 229 – General Condition of public bench

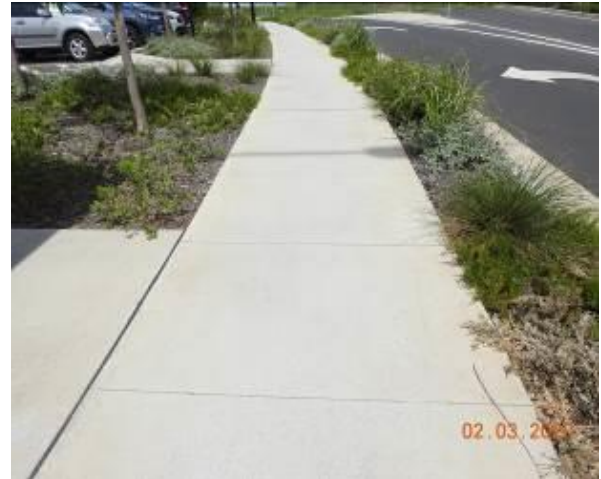
Figure 230 – General Condition of footpath pavement

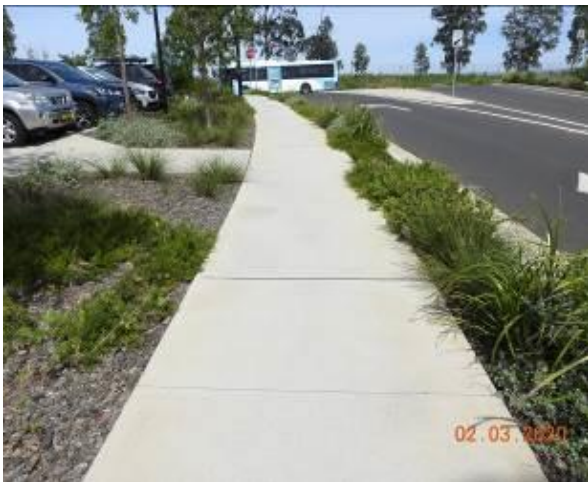
Figure 231 – General Condition of footpath pavement

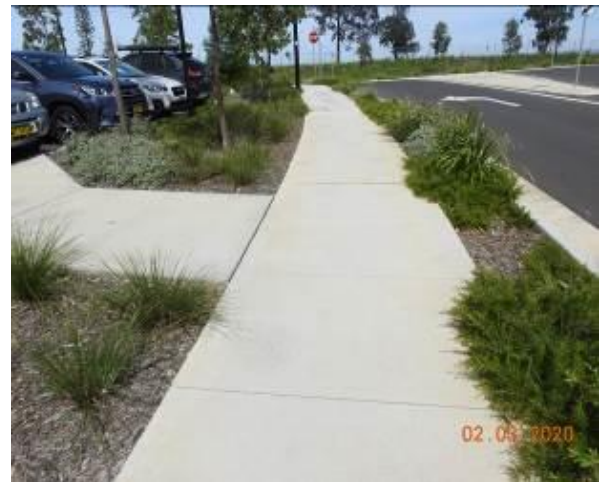
Figure 232 – General Condition of footpath pavement

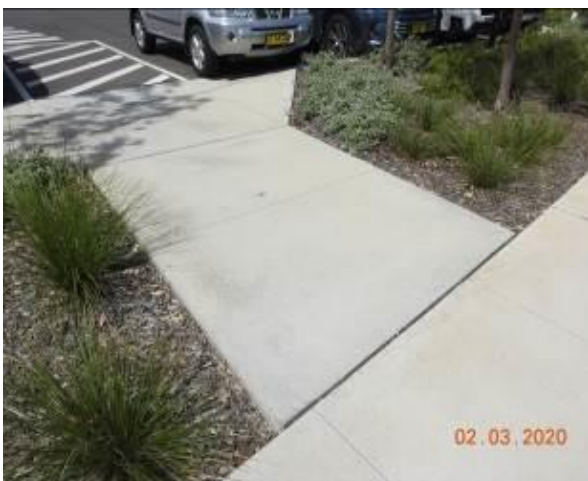
Figure 233 – General Condition of footpath pavement

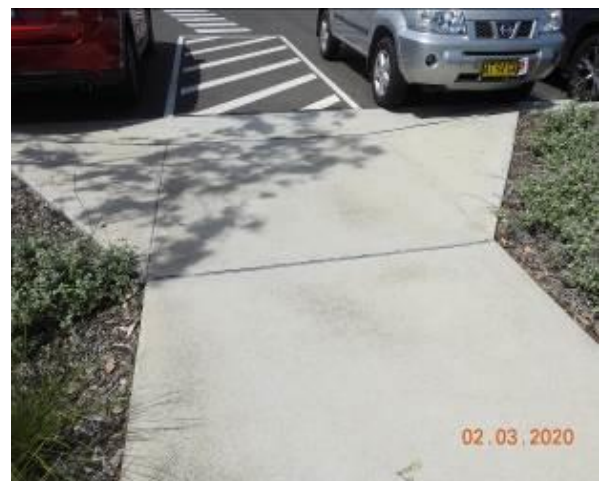
Figure 234 – General Condition of footpath pavement

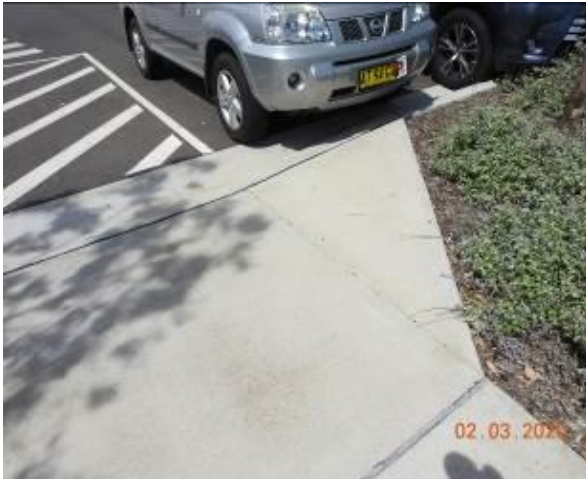
Figure 235 – General Condition of footpath pavement

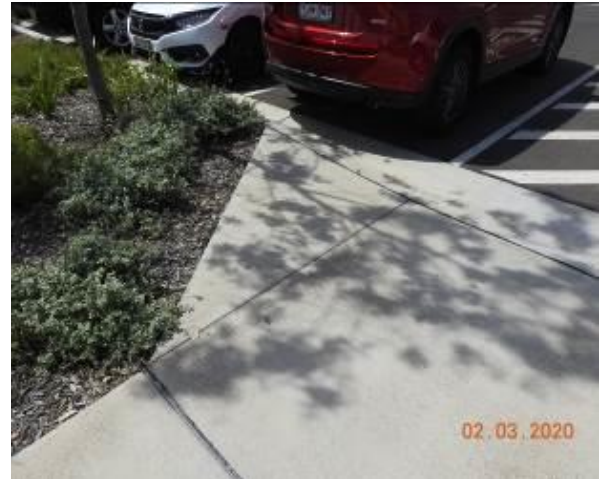
Figure 236 – General Condition of footpath pavement

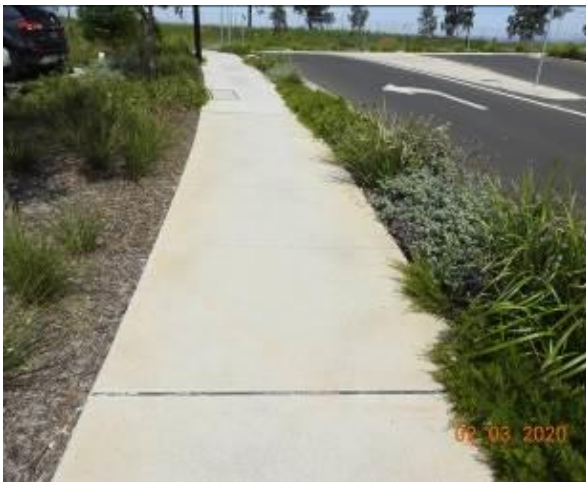
Figure 237 – General Condition of footpath pavement

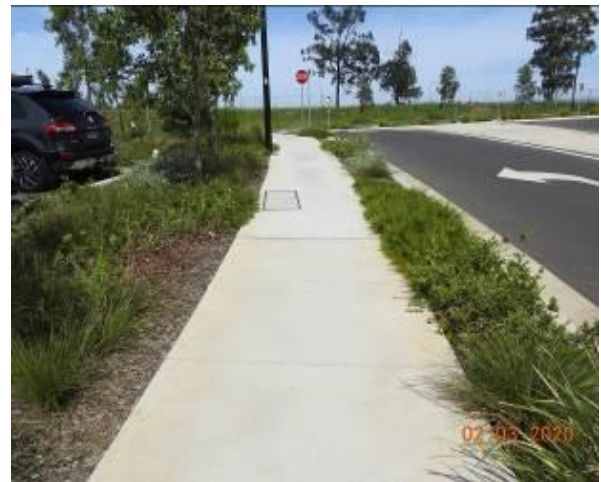
Figure 238 – General Condition of footpath pavement

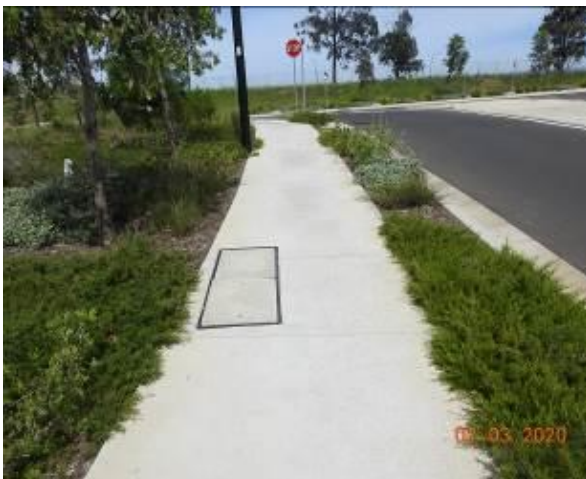
Figure 239 – General Condition of footpath pavement

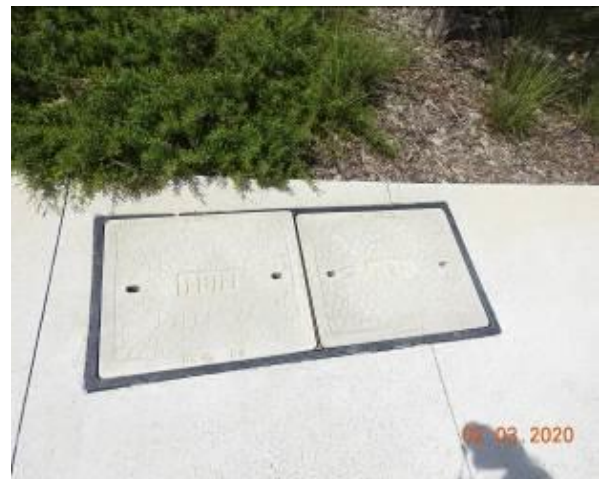
Figure 240 – General Condition of service pit

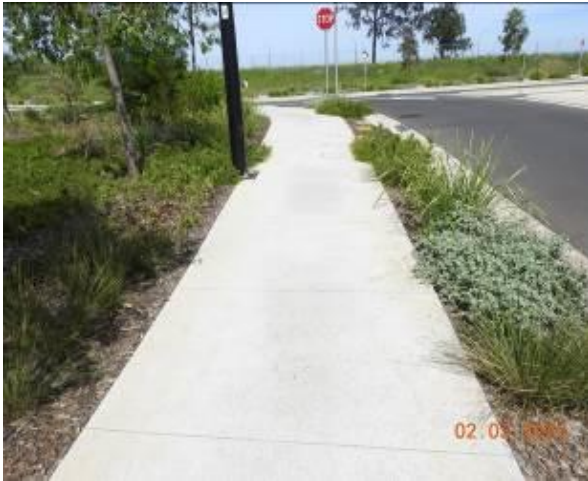
Figure 241 – General Condition of footpath pavement

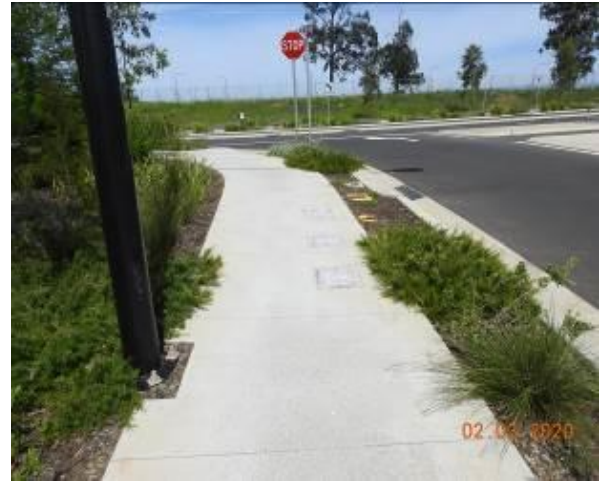
Figure 242 – General Condition of footpath pavement

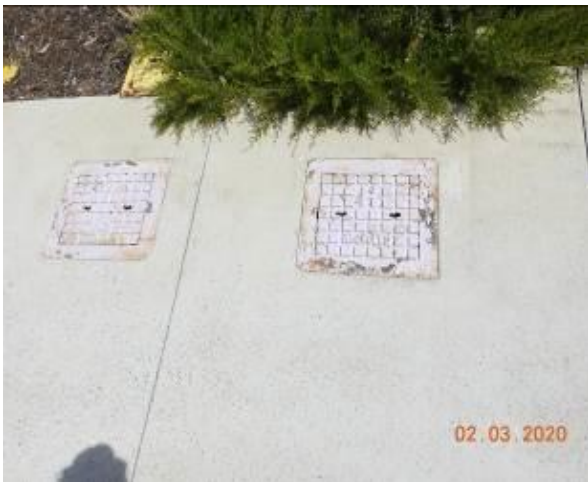
Figure 243 – General Condition of service pit

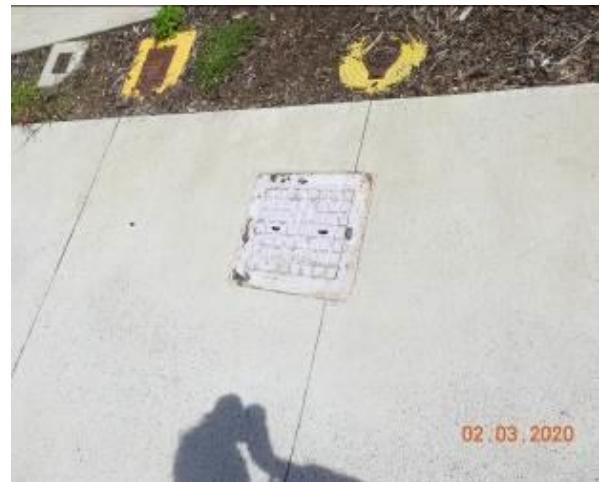
Figure 244 – General Condition of service pit

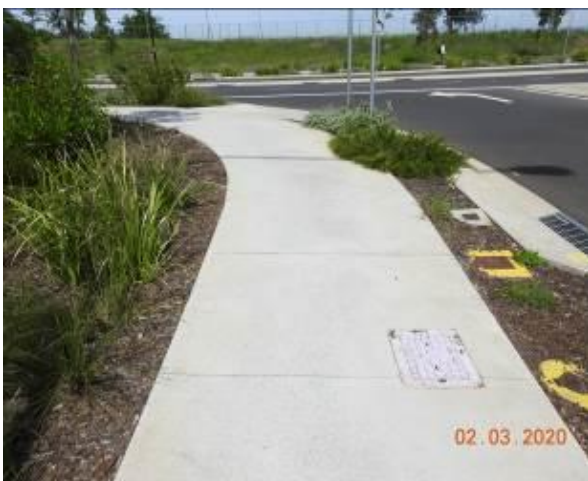
Figure 245 – General Condition of footpath pavement

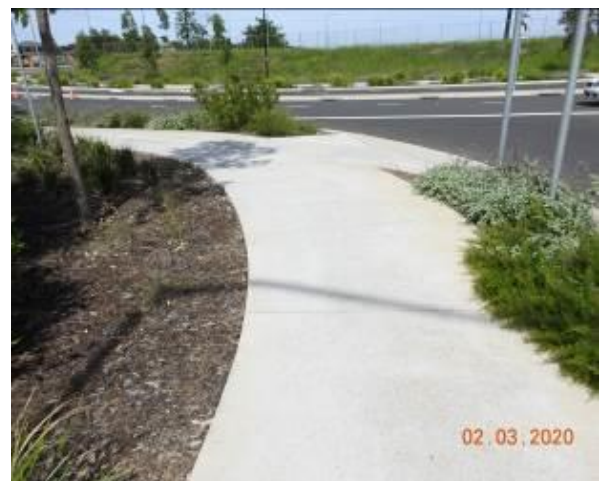
Figure 246 – General Condition of footpath pavement

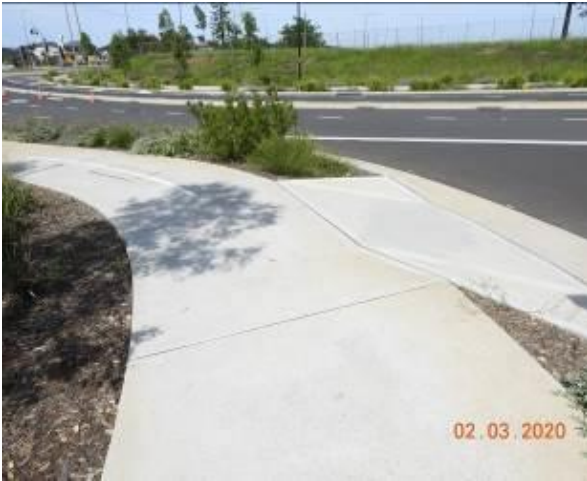
Figure 247 – General Condition of footpath pavement
