**1-15 AND 2-12 CONFERTA AVENUE,  
ROUSE HILL NSW 2155  
TALLAWONG STATION PRECINCT SOUTH  
PRE-DILAPIDATION REPORT**

**DEICORP PROJECTS  
(TALLAWONG STATION) PTY LTD**

Job No. 191294.0  
05/07/2021

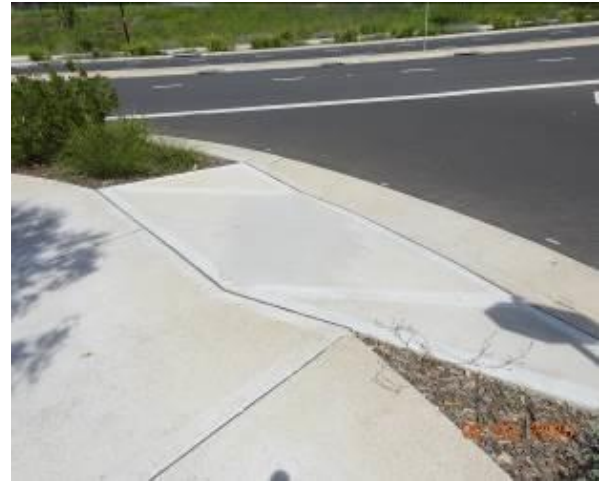
Figure 248 – General Condition of footpath pavement

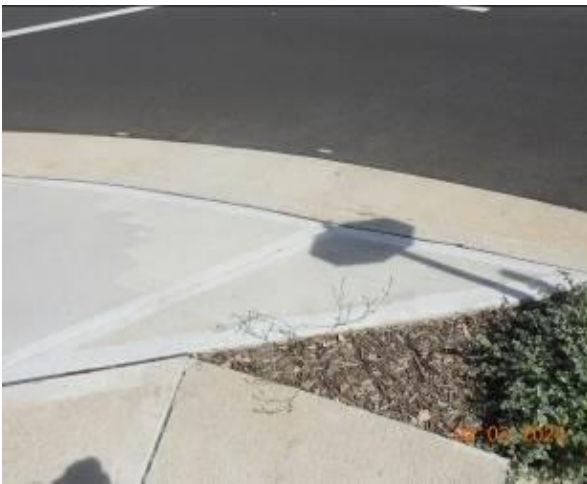
Figure 249 – General Condition of footpath pavement

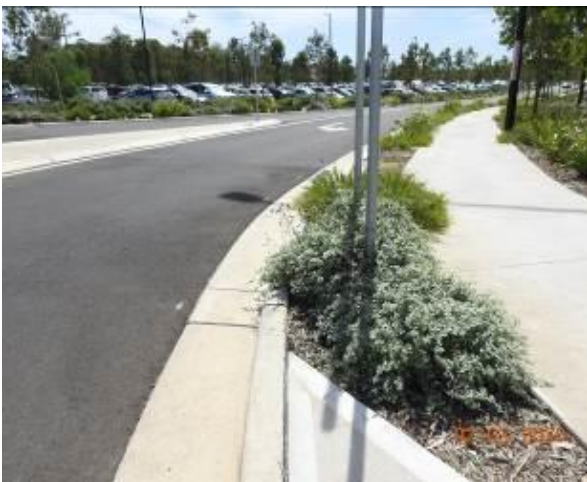
Figure 251 – General Condition of kerb and gutter

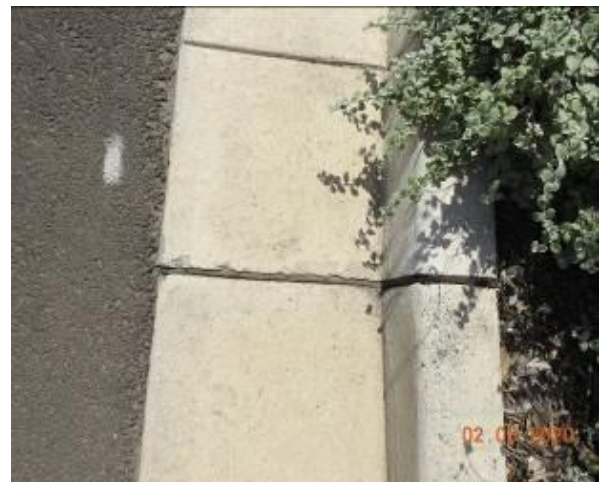
Figure 252 – Crack propagation through kerb and gutter

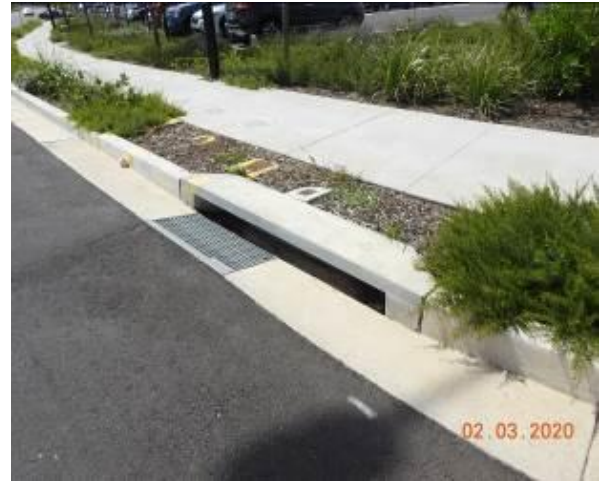
Figure 253 – General Condition of kerb and gutter

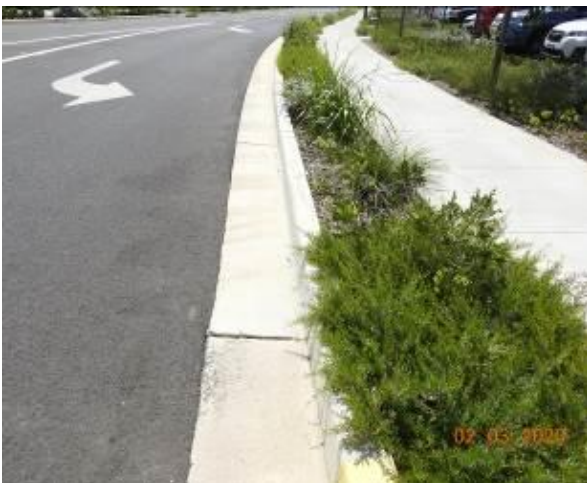
Figure 256 – General Condition of kerb and gutter

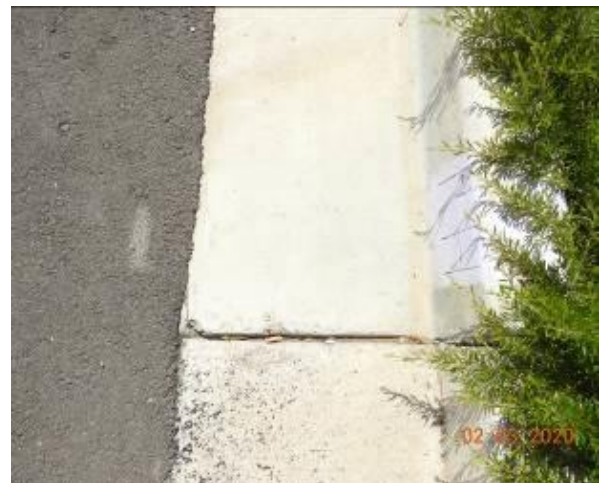
Figure 257 – General Condition of kerb and gutter

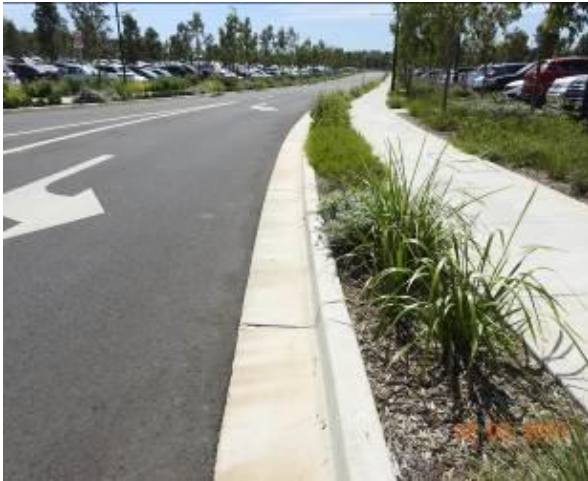
Figure 258 – Crack propagation through kerb and gutter

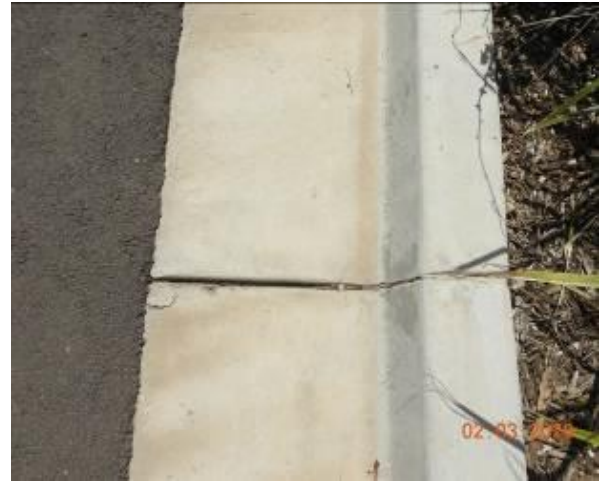
Figure 259 – General Condition of kerb and gutter

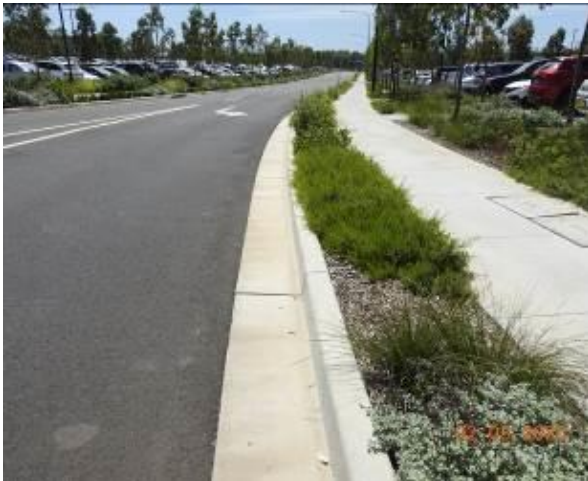
Figure 260 – Crack propagation through kerb and gutter

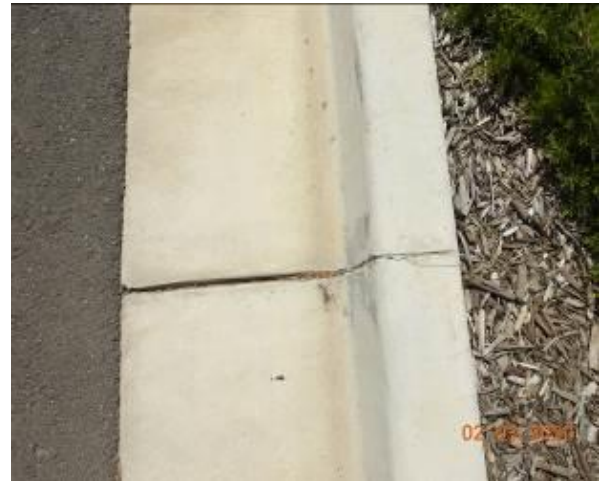
Figure 261 – General Condition of kerb and gutter

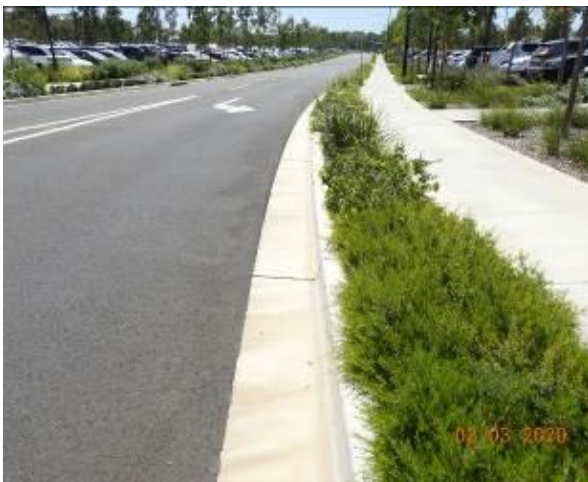
Figure 262 – Crack propagation through kerb and gutter

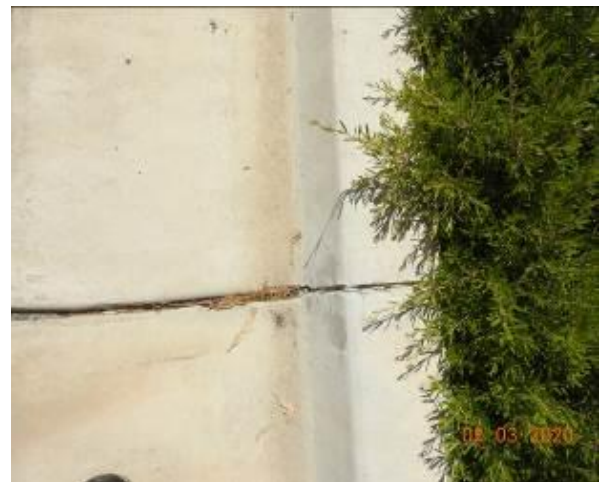
Figure 263 – General Condition of kerb and gutter

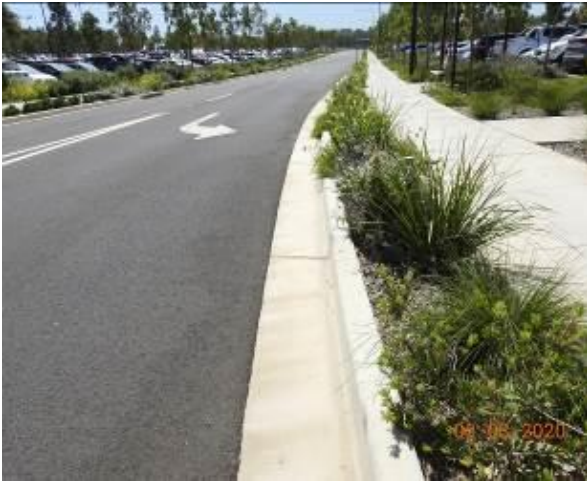
Figure 264 – Crack propagation through kerb and gutter

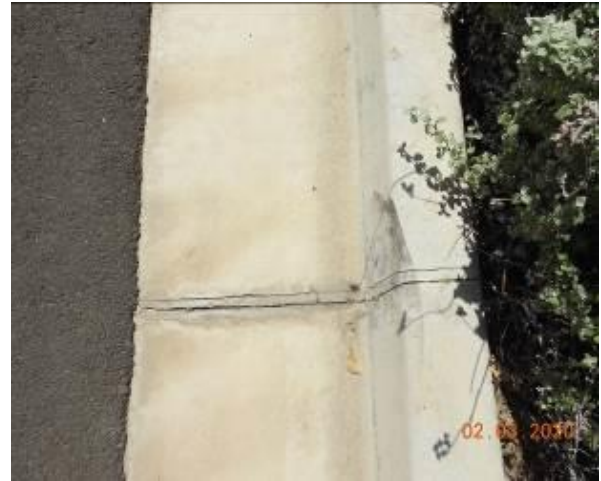
Figure 265 – General Condition of kerb and gutter

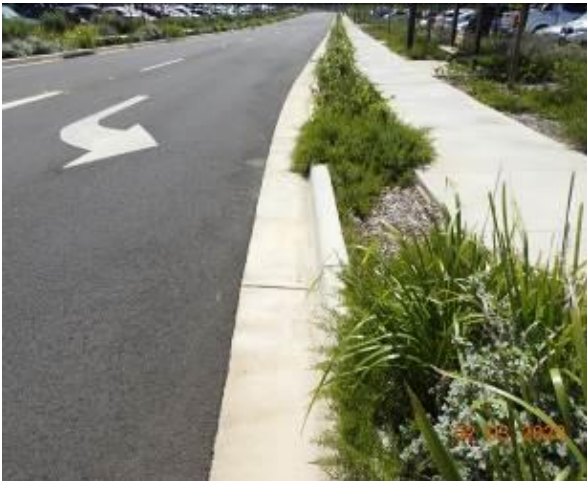
Figure 266 – Crack propagation through kerb and gutter

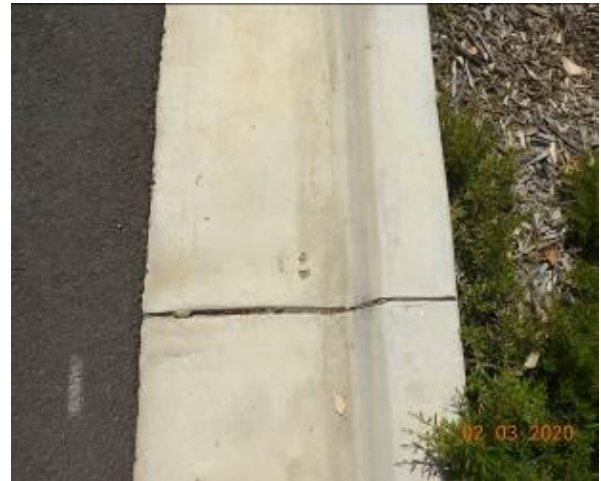
Figure 267 – General Condition of kerb and gutter

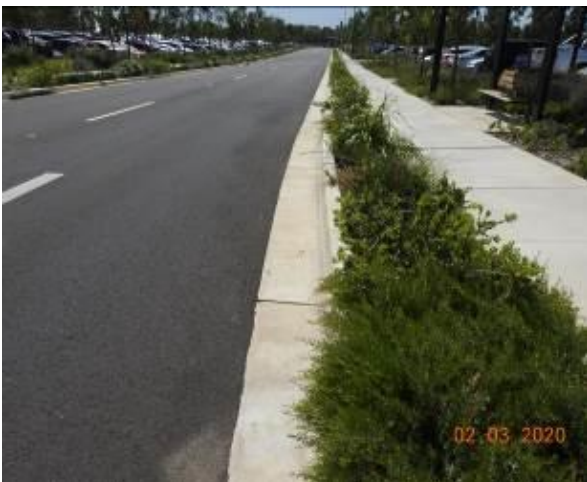
Figure 268 – Crack propagation through kerb and gutter

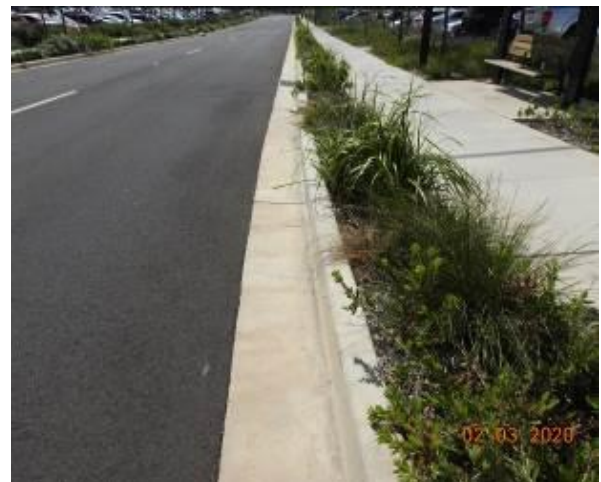
Figure 269 – General Condition of kerb and gutter

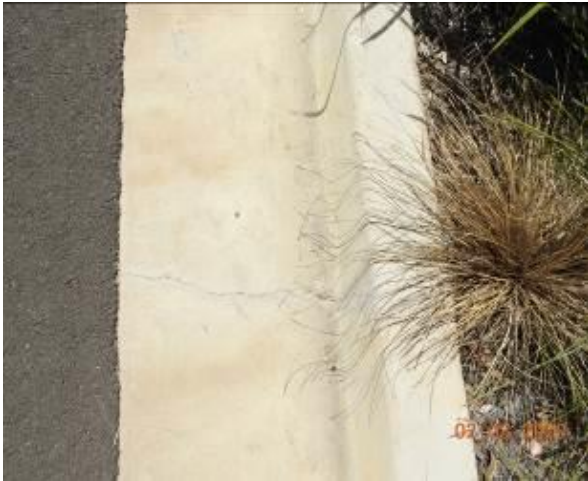
Figure 270 – General Condition of kerb and gutter

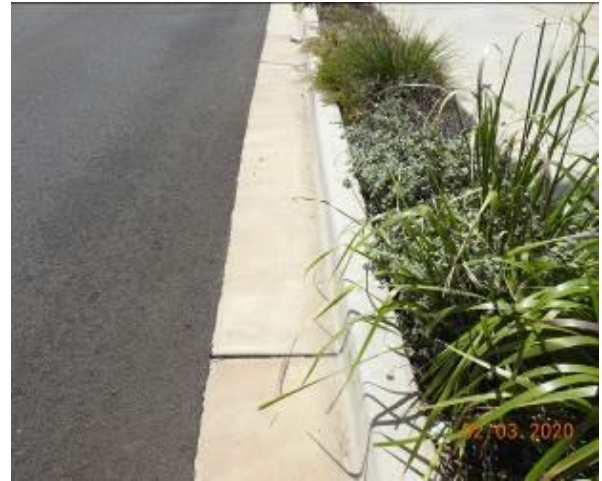
Figure 271 – Crack propagation through kerb and gutter

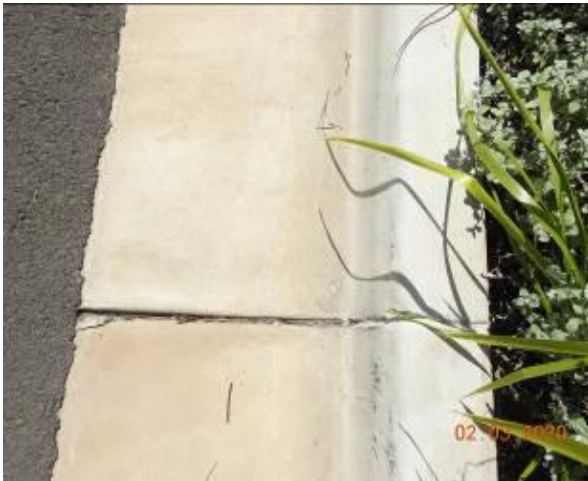
Figure 272 – General Condition of kerb and gutter

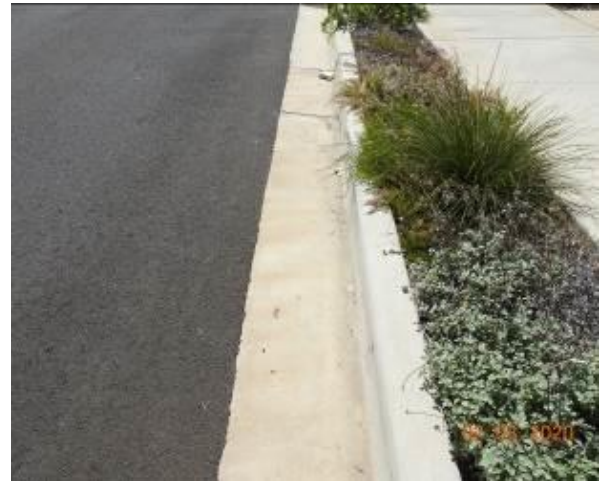
Figure 273 – Crack propagation through kerb and gutter

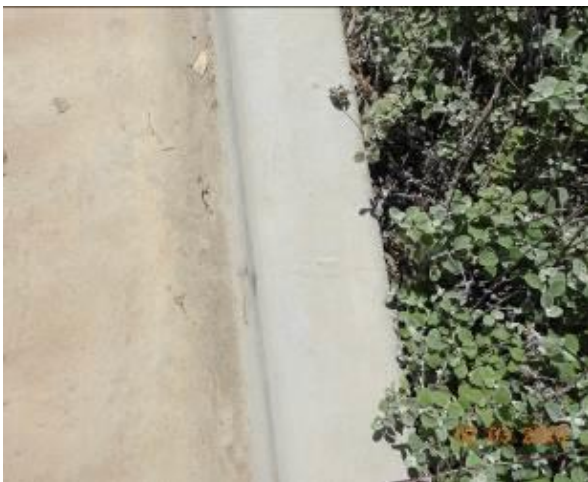
Figure 274 – General Condition of kerb and gutter

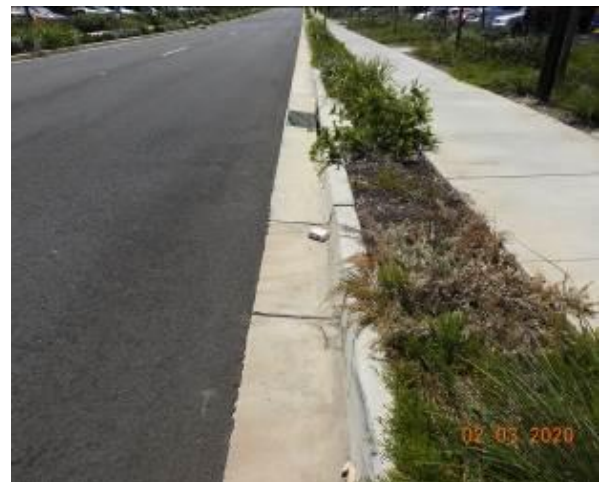
Figure 275 – General Condition of kerb

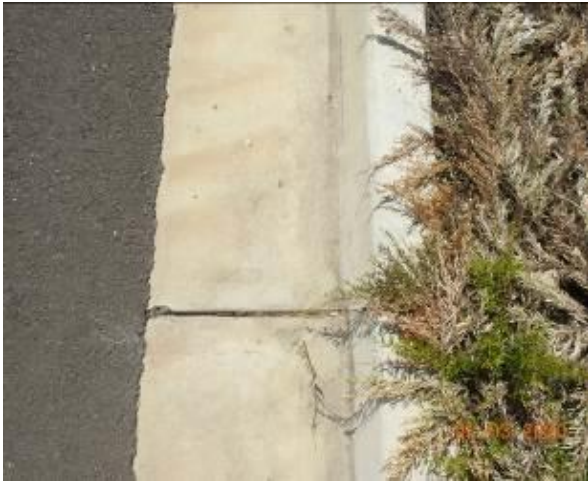
Figure 276 – General Condition of kerb and gutter

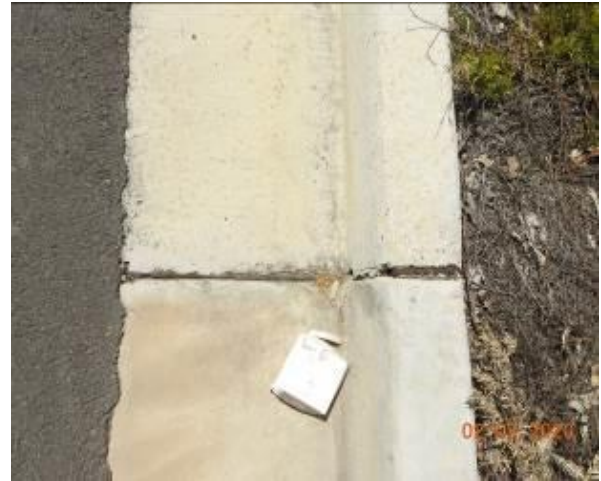
Figure 277 – Crack propagation through kerb and gutter

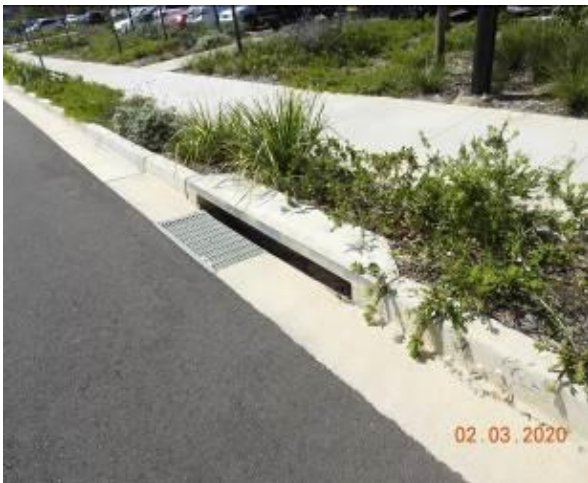
Figure 278 – Crack propagation through kerb and gutter

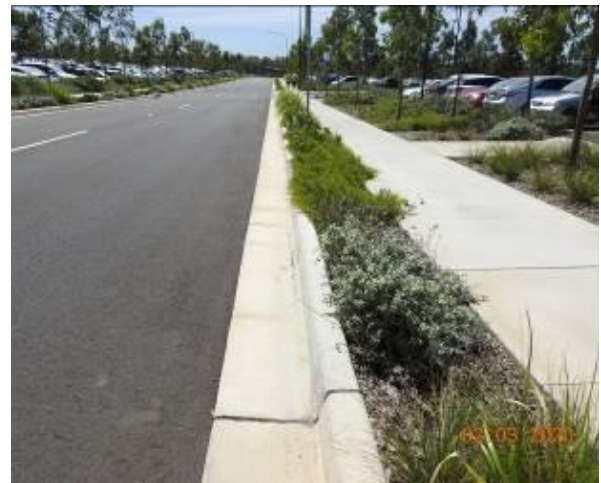
Figure 279 – General Condition of stormwater inlet pit

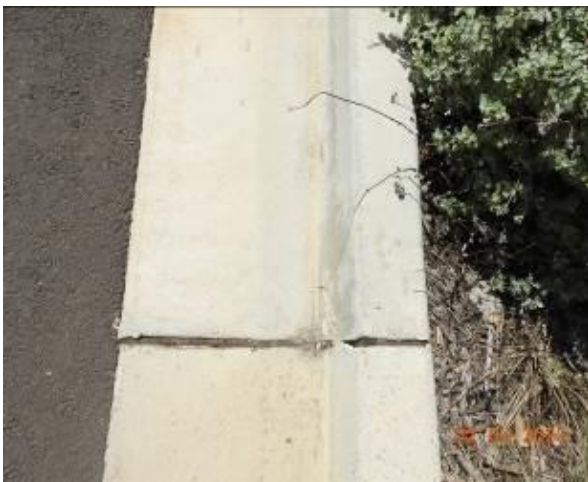
Figure 280 – General Condition of kerb and gutter

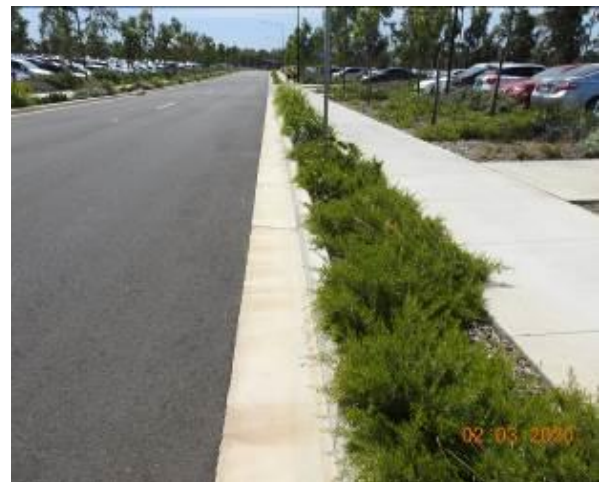
Figure 281 – Crack propagation through kerb and gutter

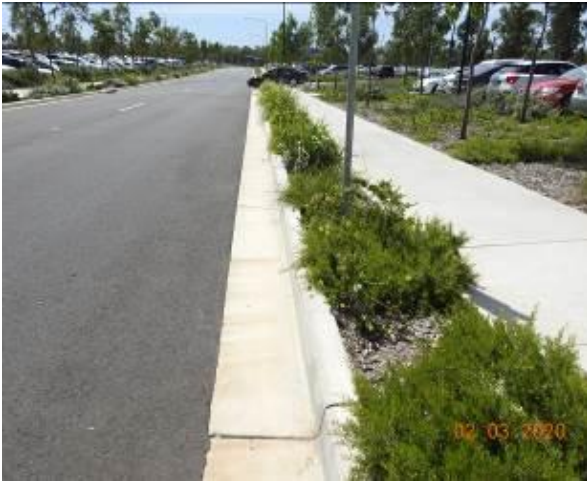
Figure 282 – General Condition of kerb and gutter

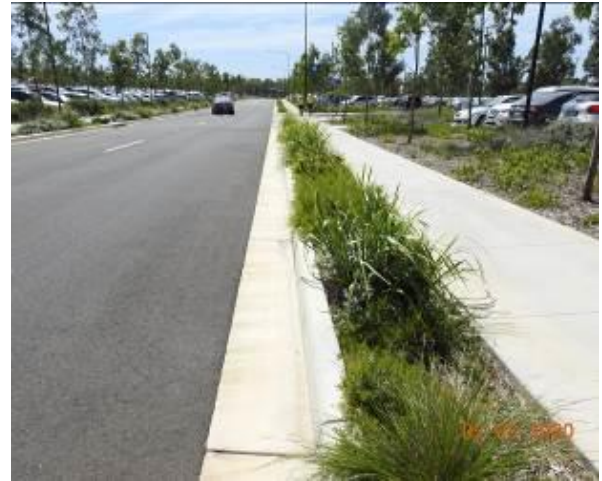
Figure 283 – General Condition of kerb and gutter

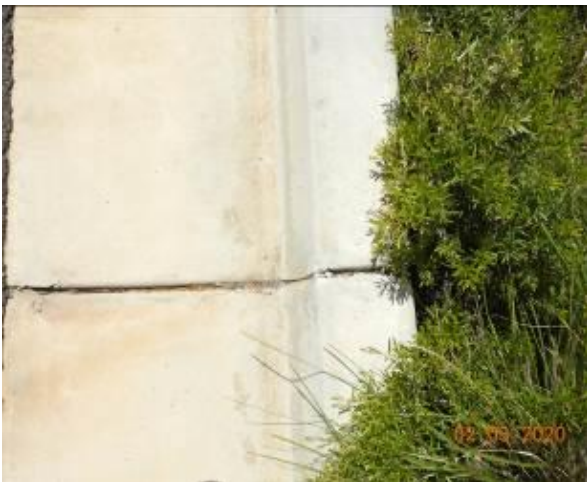
Figure 284 – General Condition of kerb and gutter

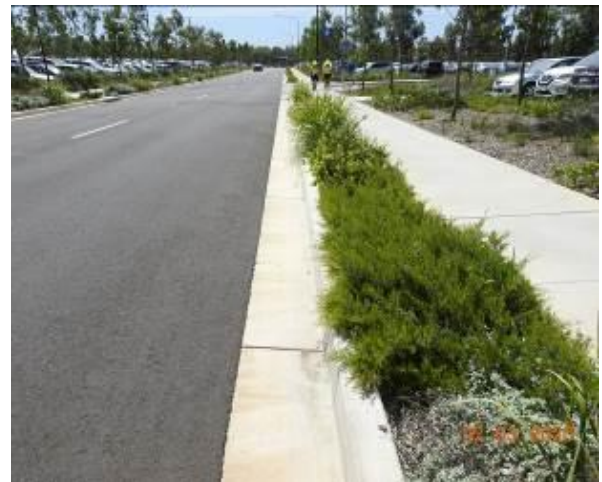
Figure 285 – Crack propagation through kerb and gutter

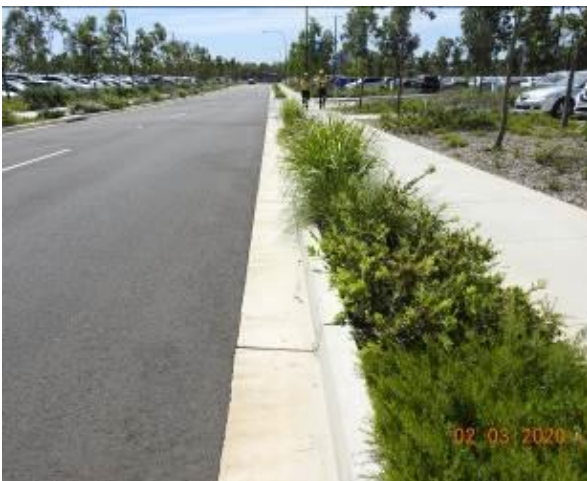
Figure 286 – General Condition of kerb and gutter

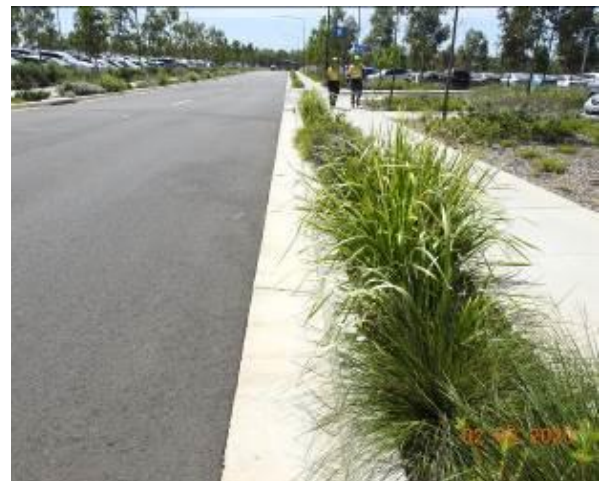
Figure 287 – General Condition of kerb and gutter

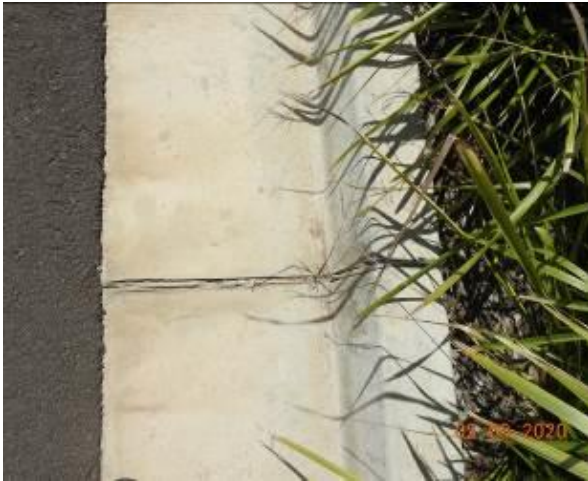
Figure 288 – General Condition of kerb and gutter

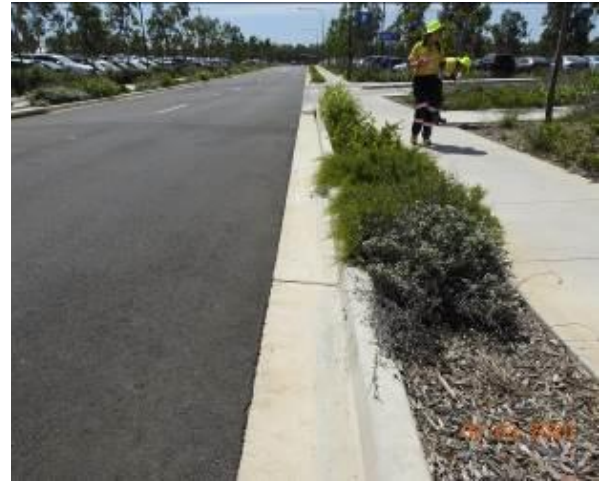
Figure 289 – Crack propagation through kerb and gutter

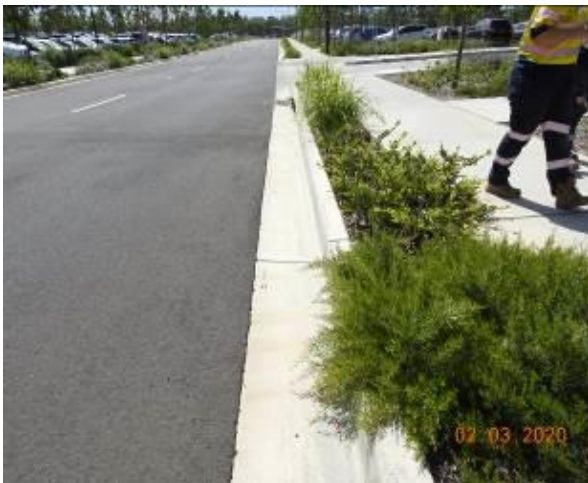
Figure 290 – General Condition of kerb and gutter

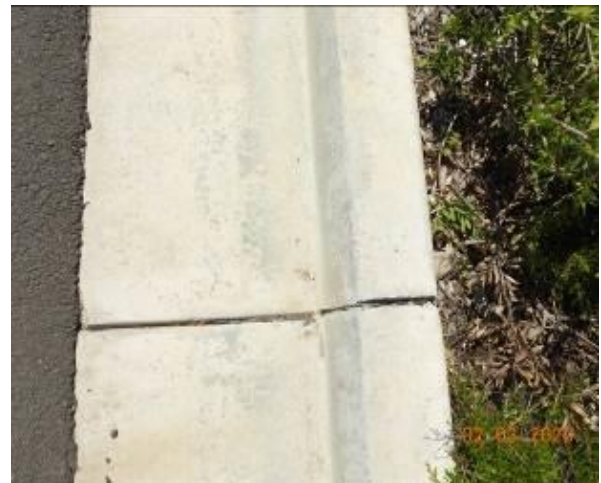
Figure 291 – General Condition of kerb and gutter

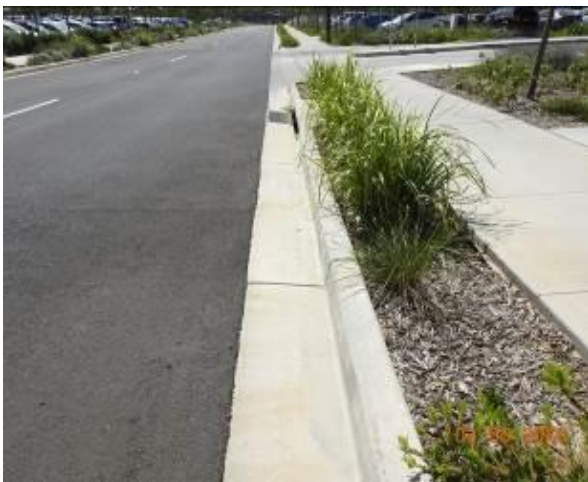
Figure 292 – Crack propagation through kerb and gutter

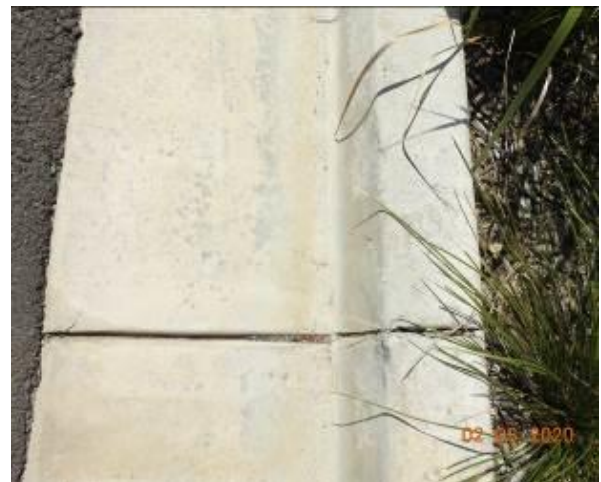
Figure 294 – Crack propagation through kerb and gutter

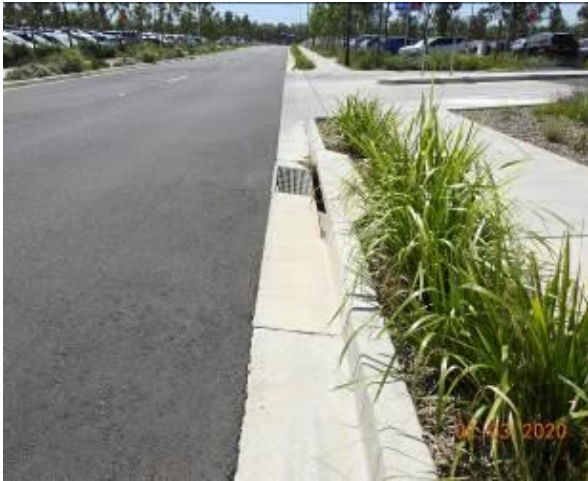
Figure 295 – General Condition of kerb and gutter

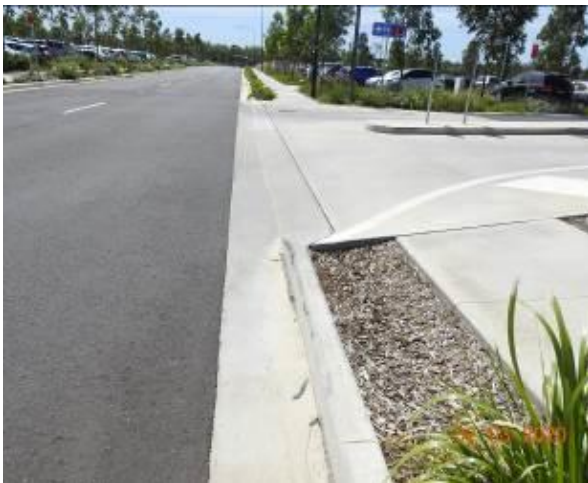
Figure 297 – General Condition of kerb and gutter

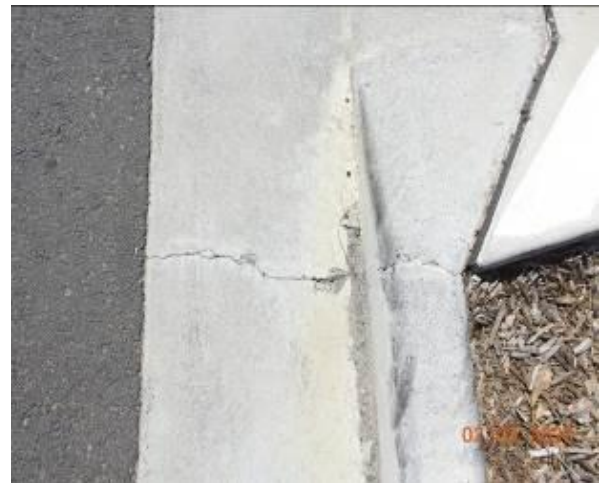
Figure 298 – Crack propagation through kerb and gutter

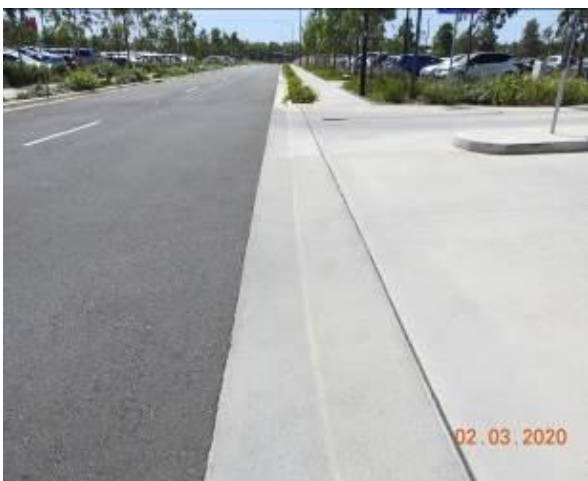
Figure 299 – General Condition of gutter

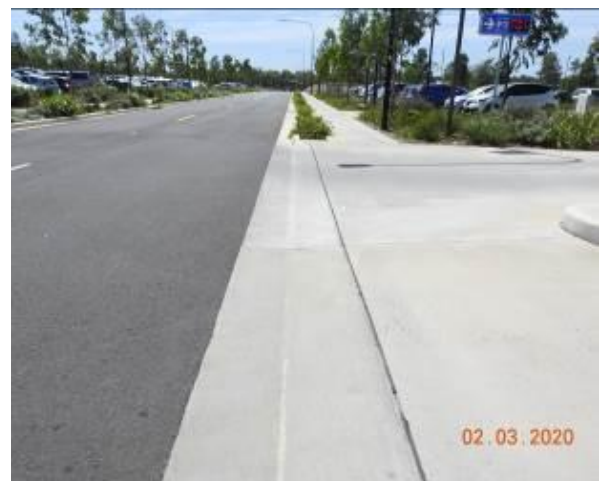
Figure 300 – General Condition of gutter

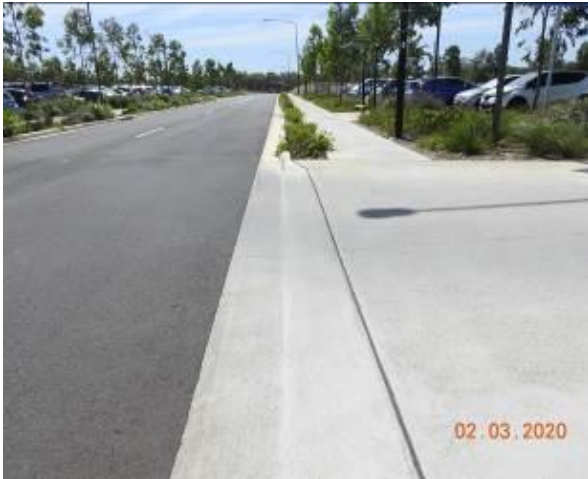
Figure 301 – General Condition of gutter

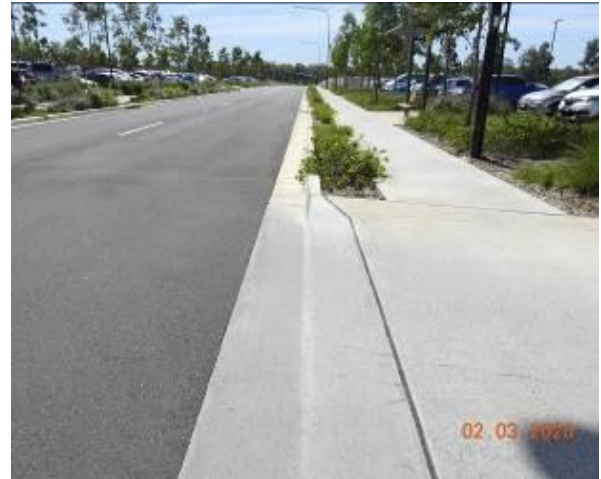
Figure 302 – General Condition of gutter

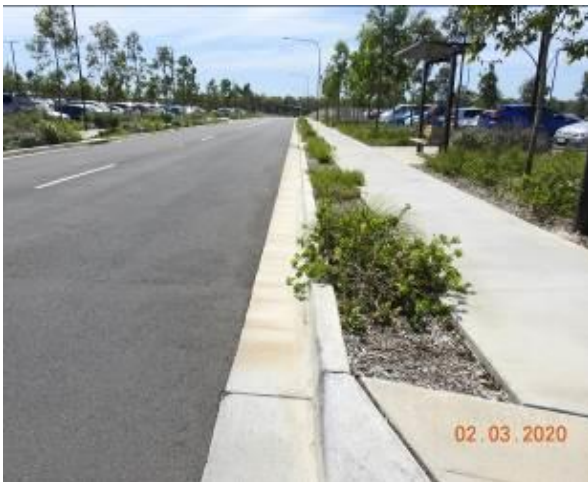
Figure 303 – General Condition of kerb and gutter

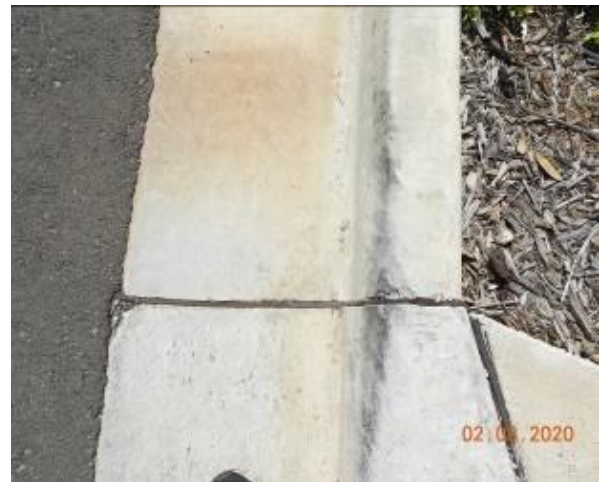
Figure 304 – Crack propagation through kerb and gutter

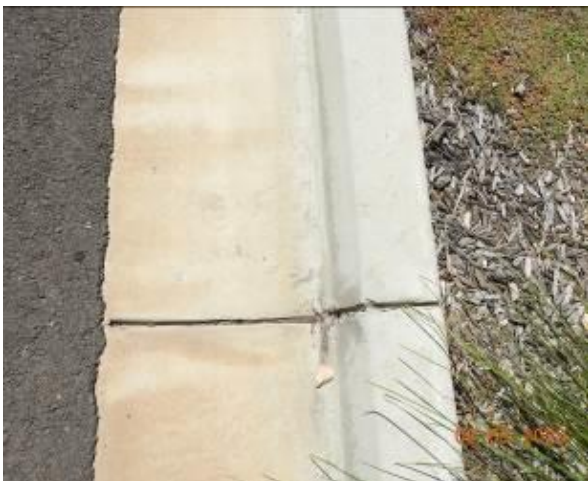
Figure 305 – Crack propagation through kerb and gutter

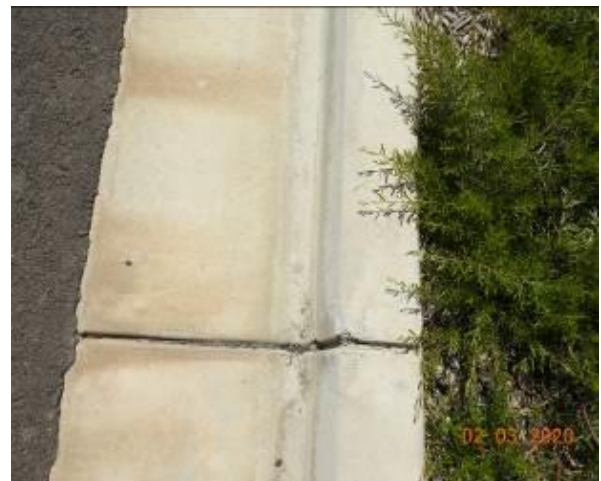
Figure 306 – Crack propagation through kerb and gutter

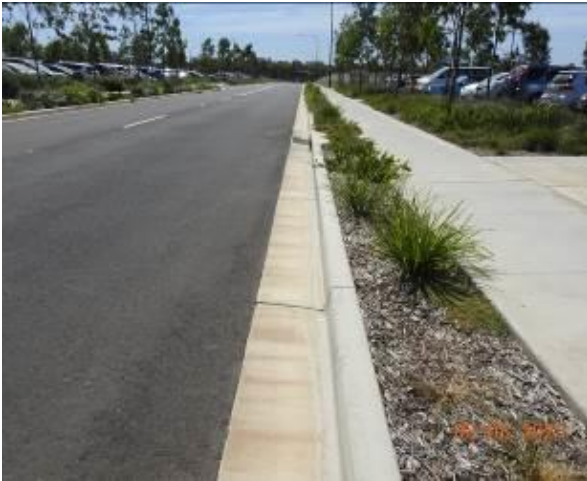
Figure 307 – General Condition of kerb and gutter

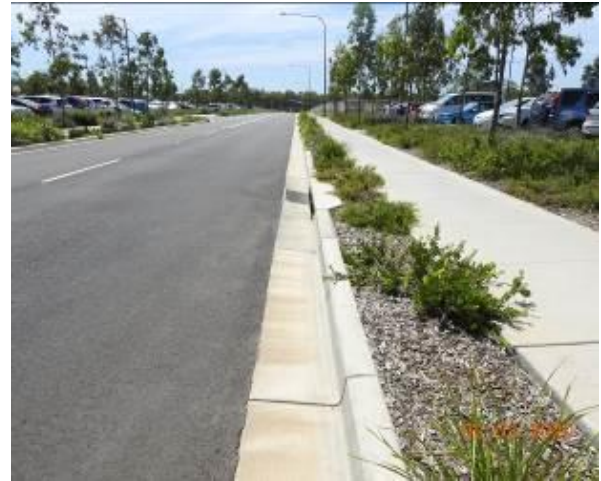
Figure 308 – General Condition of kerb and gutter

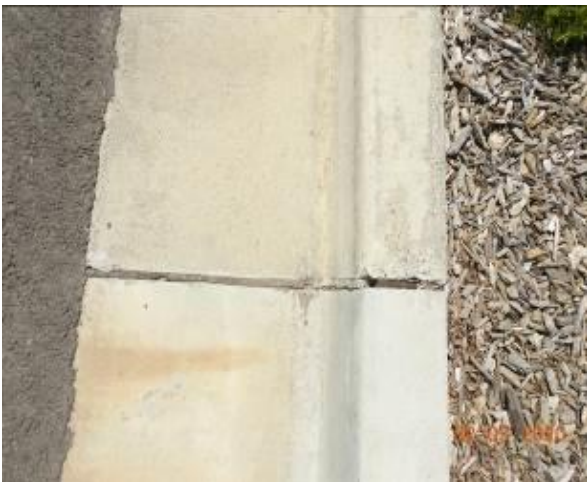
Figure 309 – Crack propagation through kerb and gutter

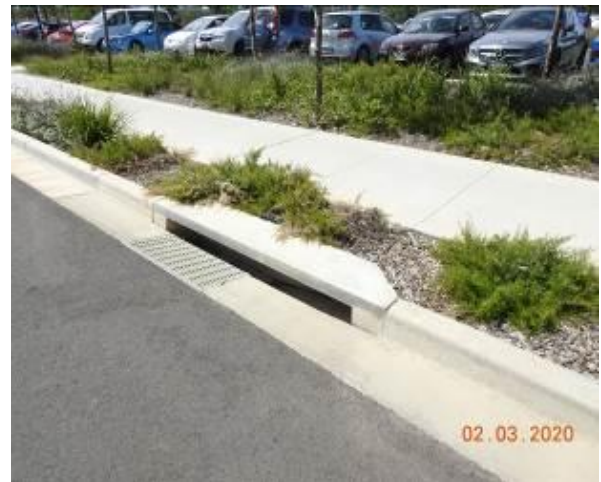
Figure 310 – General Condition of stormwater inlet pit

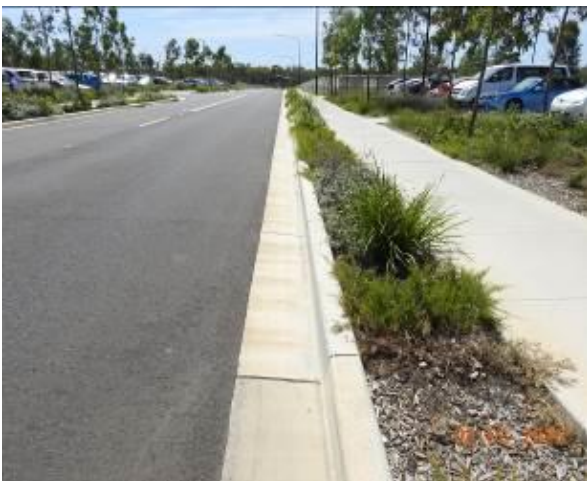
Figure 311 – General Condition of kerb and gutter

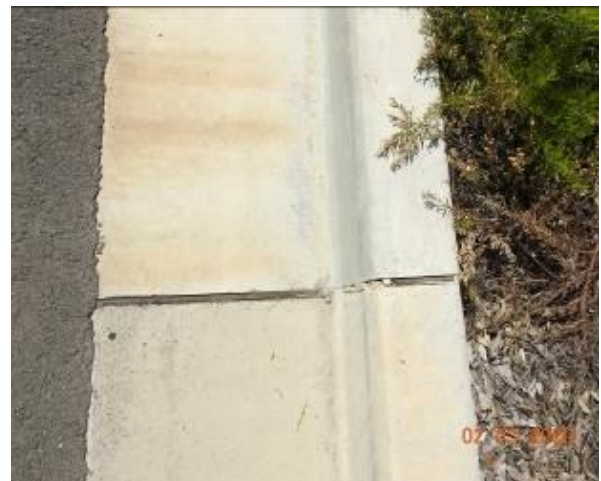
Figure 312 – Crack propagation through kerb and gutter

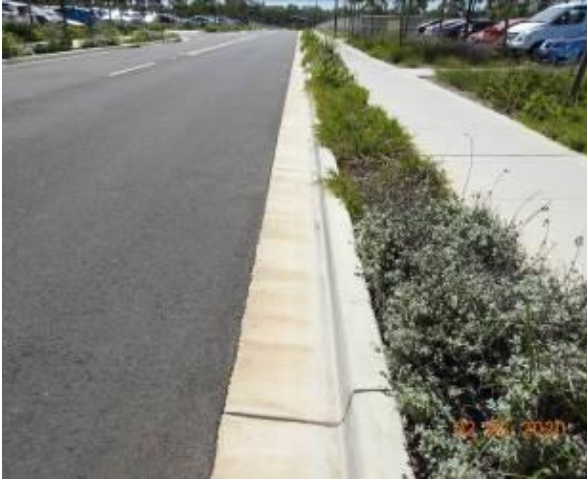
Figure 313 – General Condition of kerb and gutter

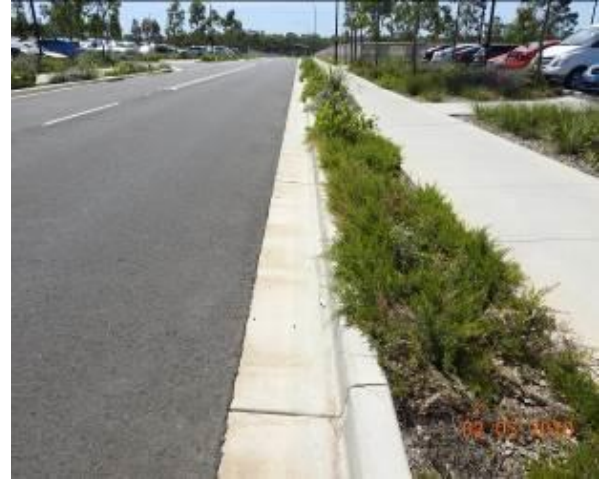
Figure 314 – General Condition of kerb and gutter

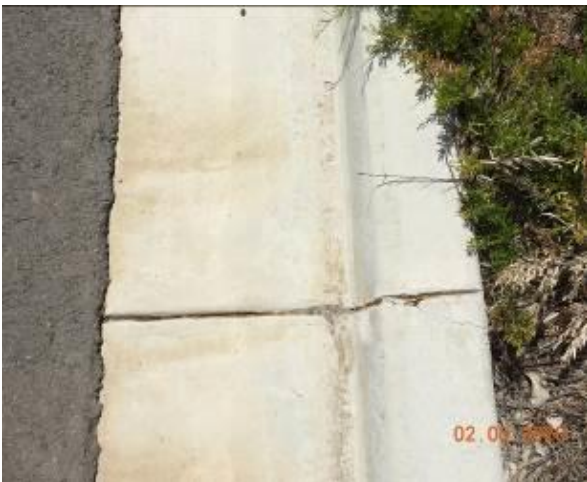
Figure 315 – Crack propagation through kerb and gutter

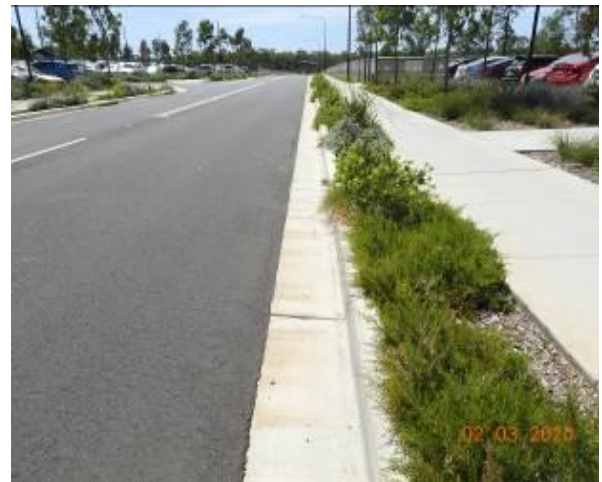
Figure 316 – General Condition of kerb and gutter

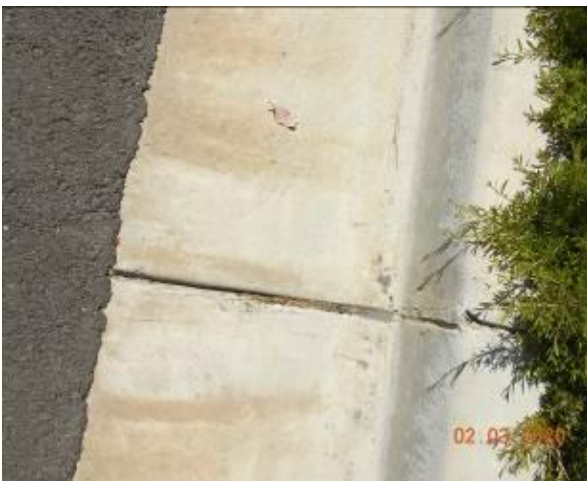
Figure 317 – Crack propagation through kerb and gutter

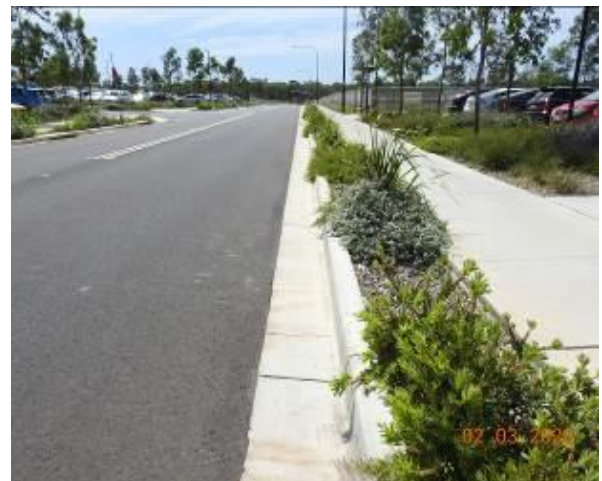
Figure 318 – General Condition of kerb and gutter

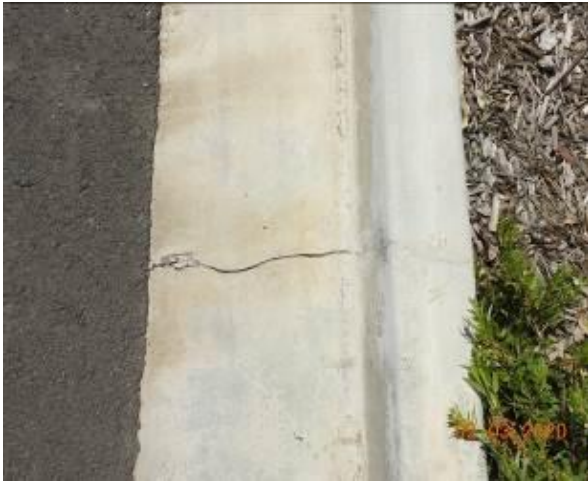
Figure 319 – Crack propagation and loss of material through kerb and gutter

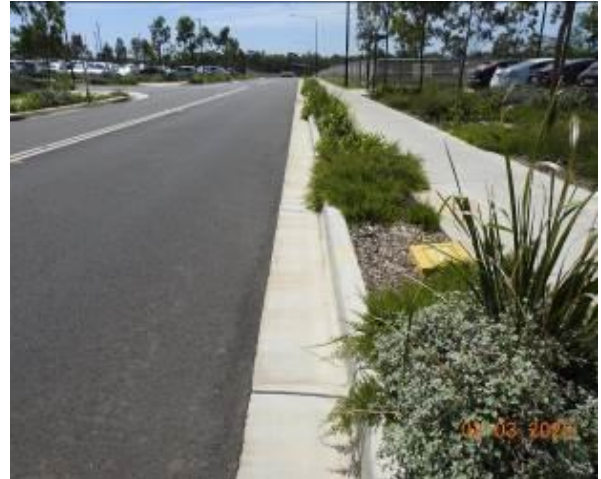
Figure 320 – General Condition of kerb and gutter

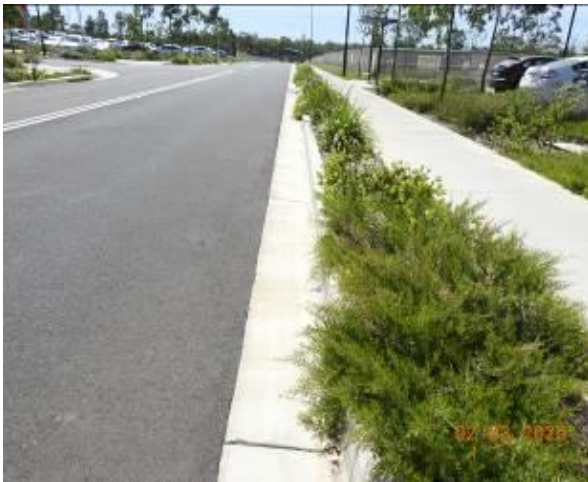
Figure 321 – General Condition of kerb and gutter

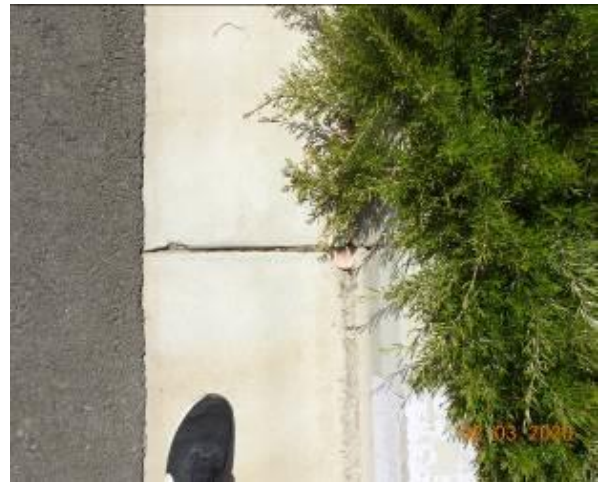
Figure 322 – Loss of material through kerb and gutter

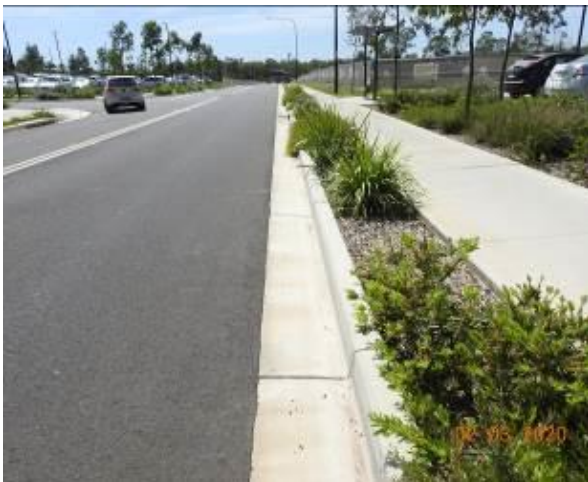
Figure 323 – General Condition of kerb and gutter

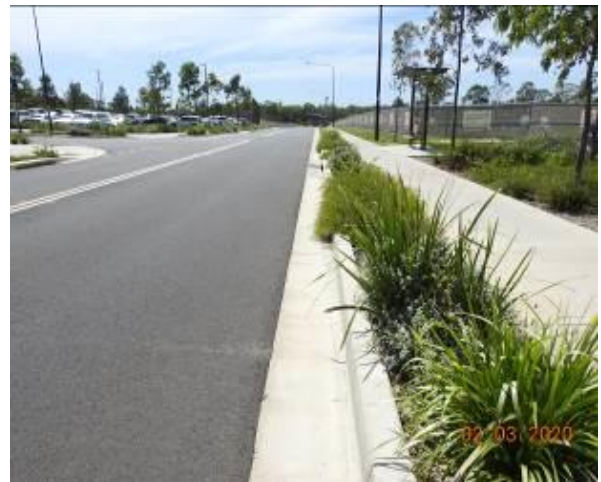
Figure 324 – General Condition of kerb and gutter

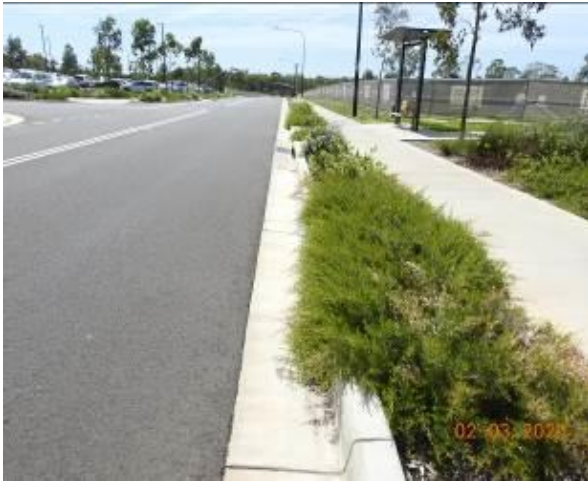
Figure 325 – General Condition of kerb and gutter

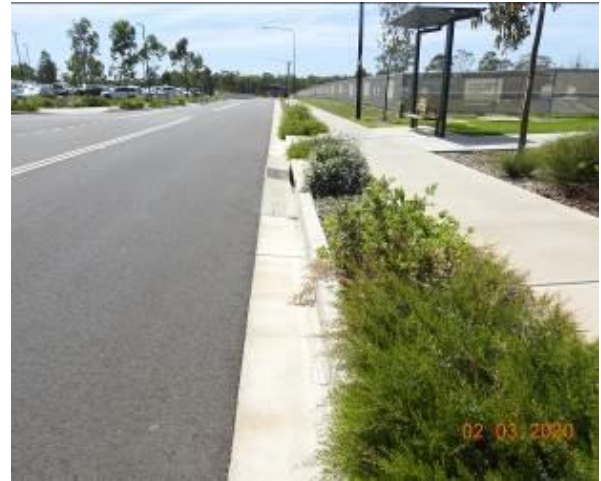
Figure 326 – General Condition of kerb and gutter

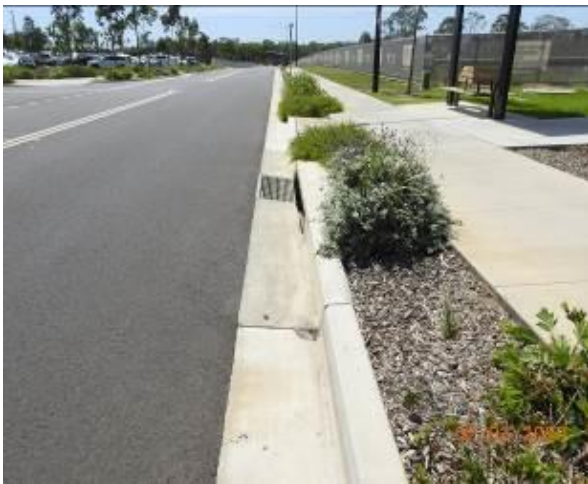
Figure 327 – General Condition of kerb and gutter

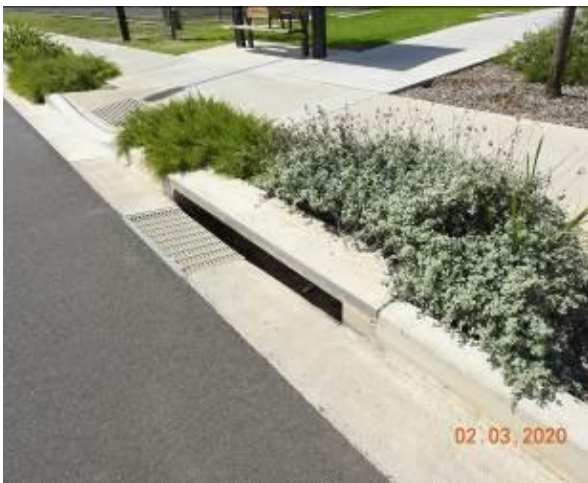
Figure 329 – General Condition of stormwater inlet pit

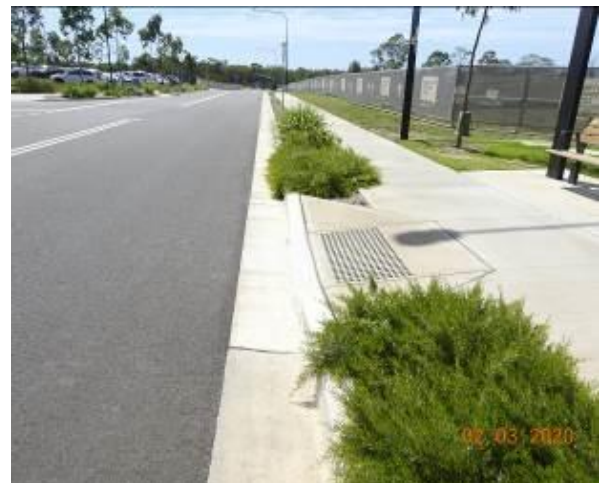
Figure 330 – General Condition of kerb and gutter
