**1-15 AND 2-12 CONFERTA AVENUE,  
ROUSE HILL NSW 2155  
TALLAWONG STATION PRECINCT SOUTH  
PRE-DILAPIDATION REPORT**

**DEICORP PROJECTS  
(TALLAWONG STATION) PTY LTD**

Job No. 191294.0  
05/07/2021

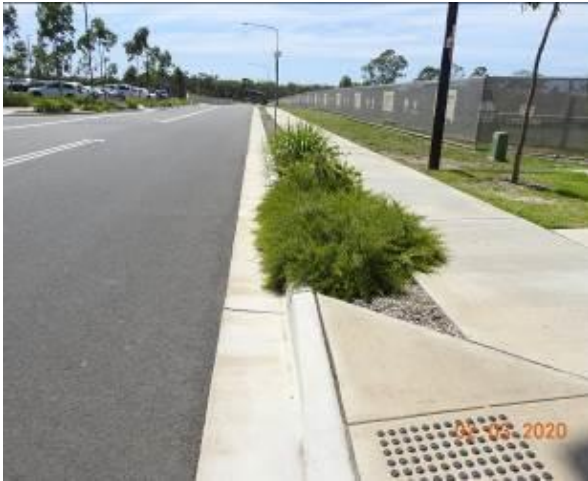
Figure 331 – General Condition of kerb and gutter

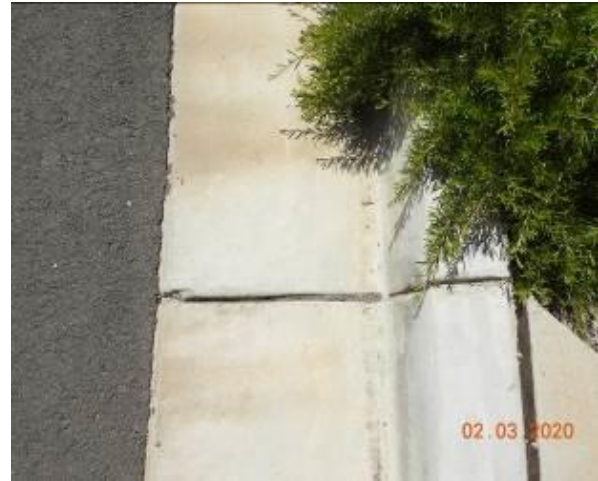
Figure 332 – Loss of material through kerb and gutter

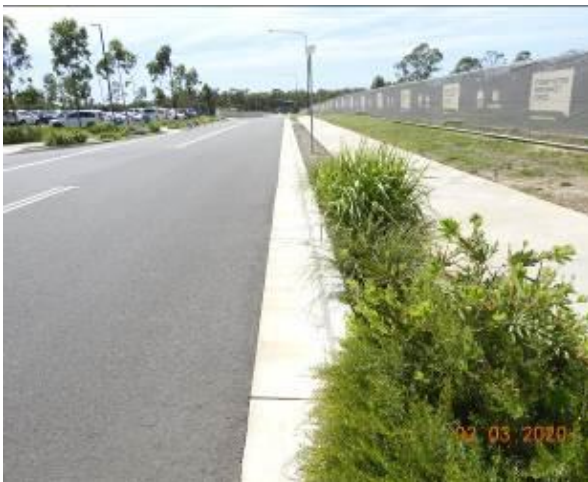
Figure 333 – General Condition of kerb and gutter

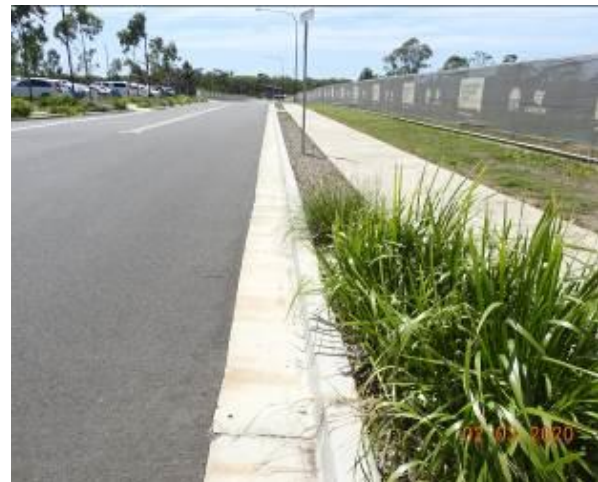
Figure 334 – General Condition of kerb and gutter

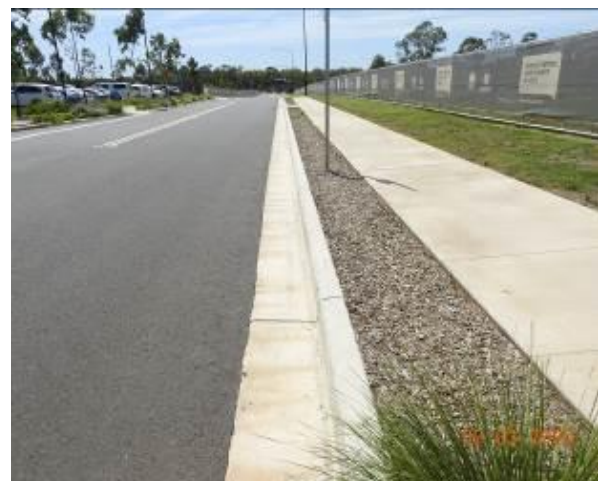
Figure 335 – Crack propagation and loss of material through kerb and gutter

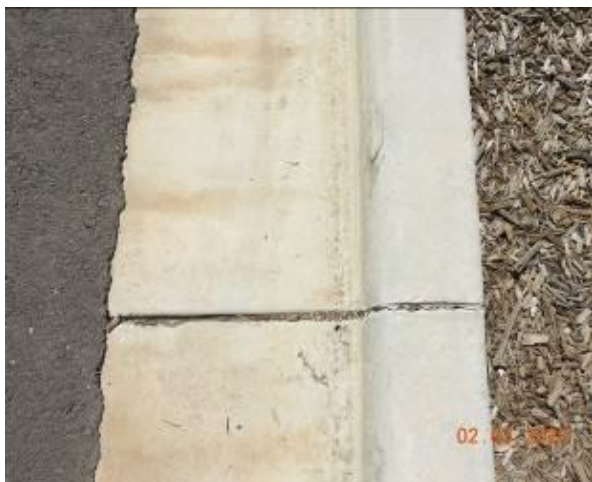
Figure 336 – General Condition of kerb and gutter

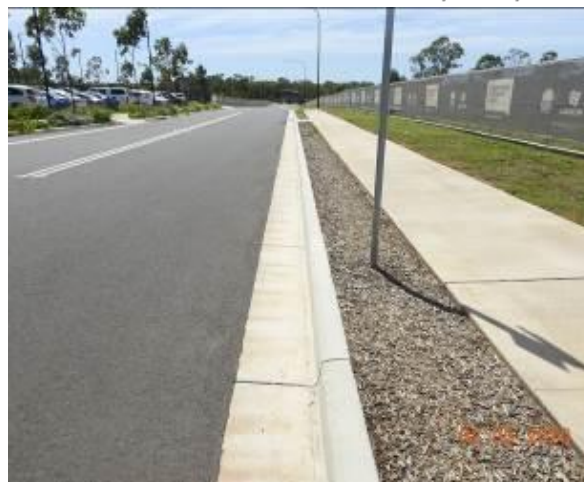
Figure 337 – Crack propagation through kerb and gutter

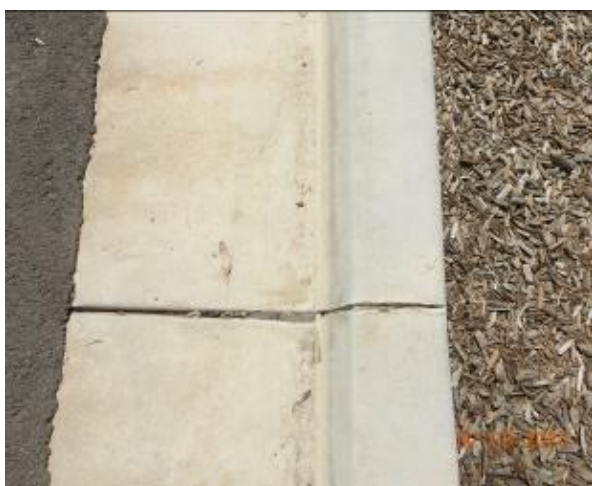
Figure 338 – General Condition of kerb and gutter

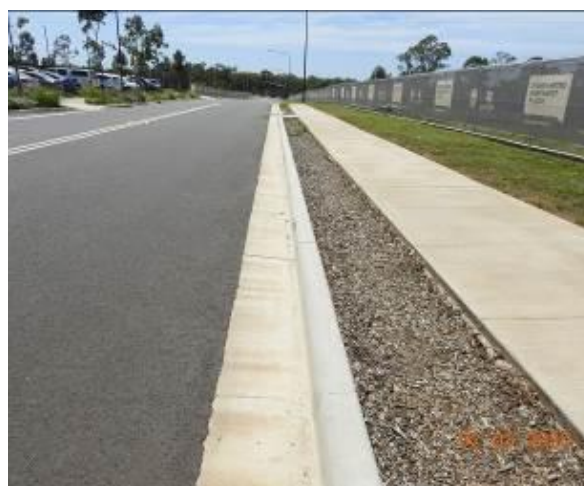
Figure 339 – Crack propagation through kerb and gutter

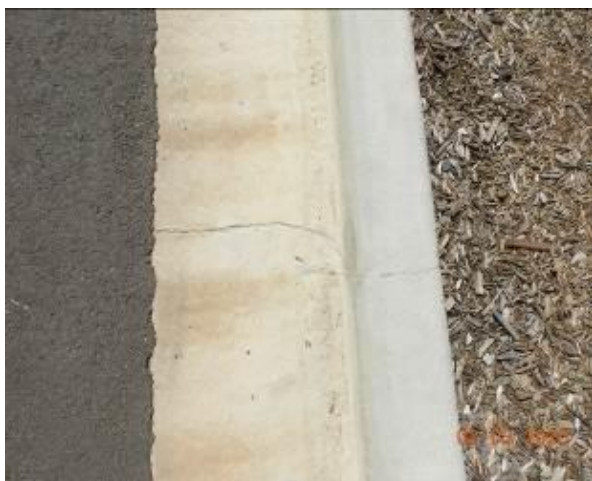
Figure 340 – General Condition of kerb and gutter

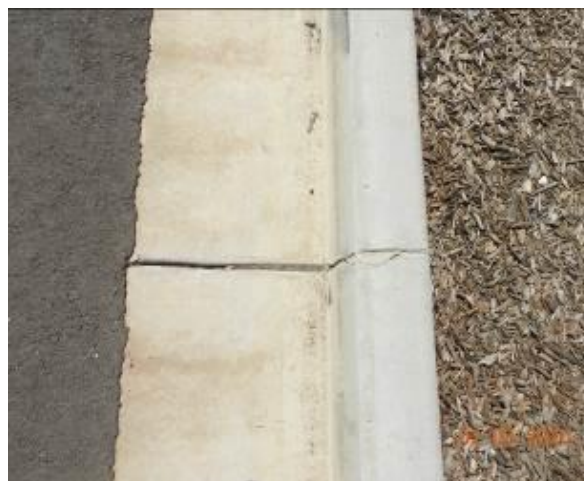
Figure 341 – Crack propagation through kerb and gutter

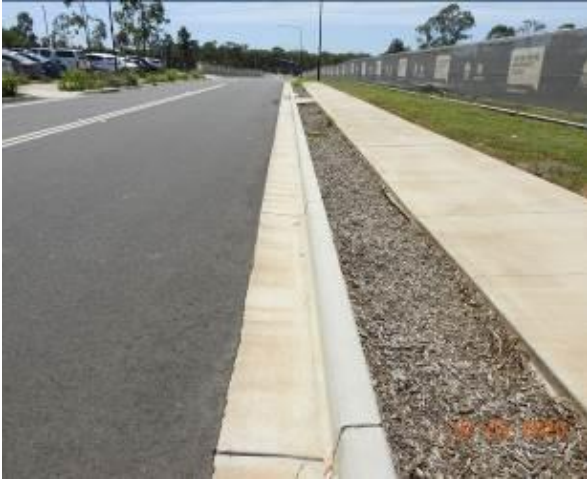
Figure 342 – Crack propagation through kerb and gutter

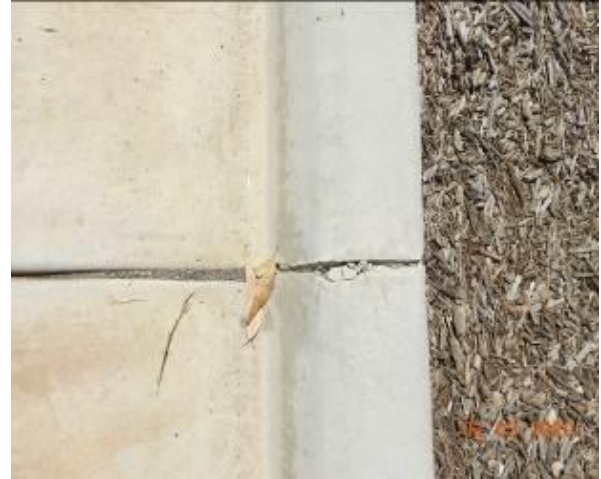
Figure 343 – General Condition of kerb and gutter

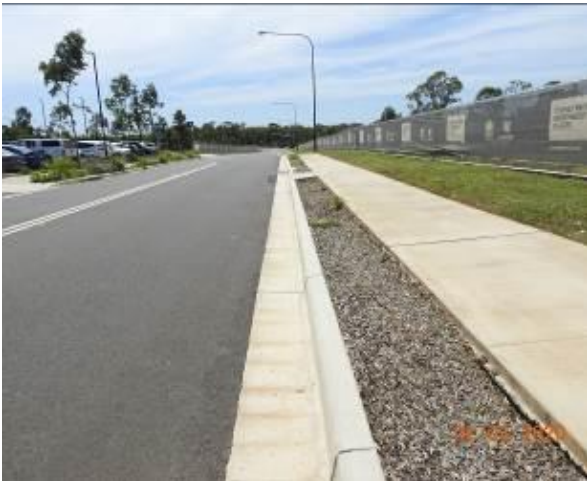
Figure 344 – Crack propagation through kerb and gutter

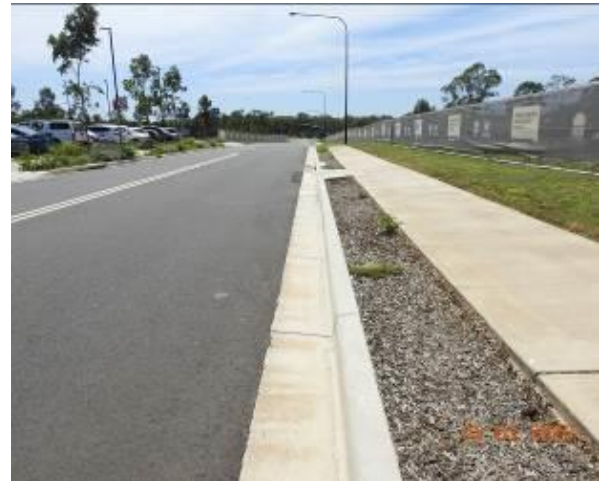
Figure 345 – General Condition of kerb and gutter

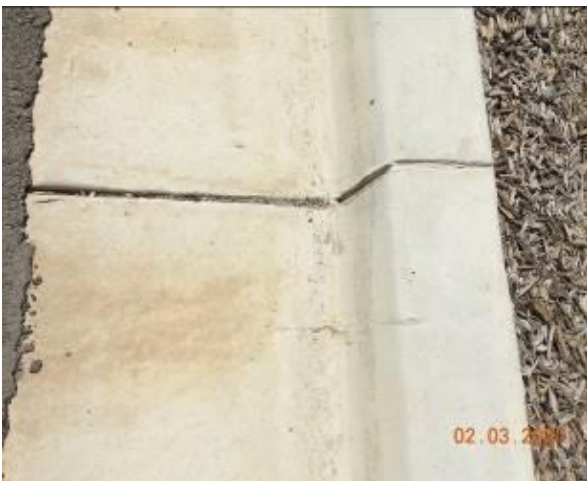
Figure 346 – General Condition of kerb and gutter

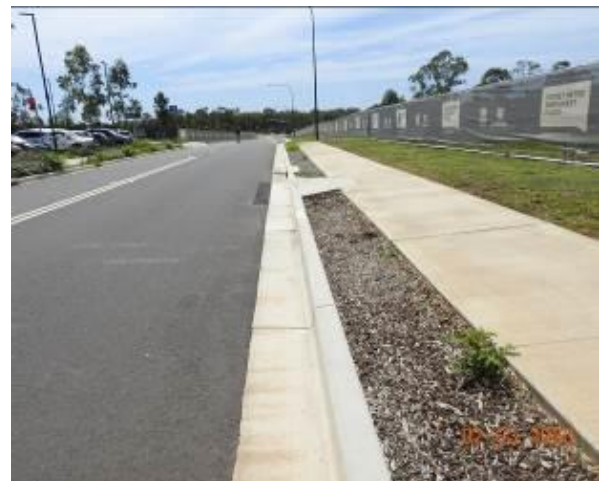
Figure 347 – Crack propagation through kerb and gutter

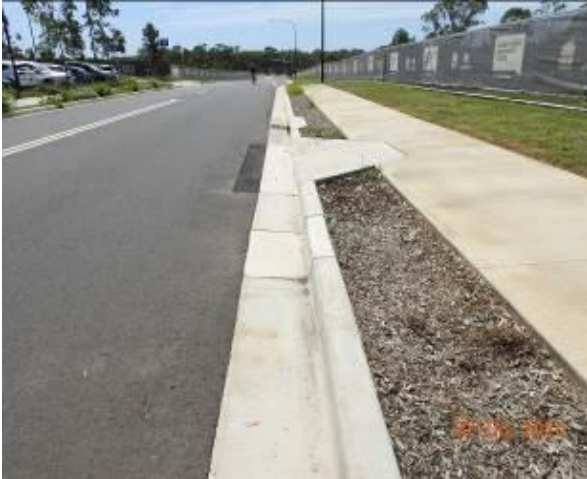
Figure 348 – General Condition of kerb and gutter

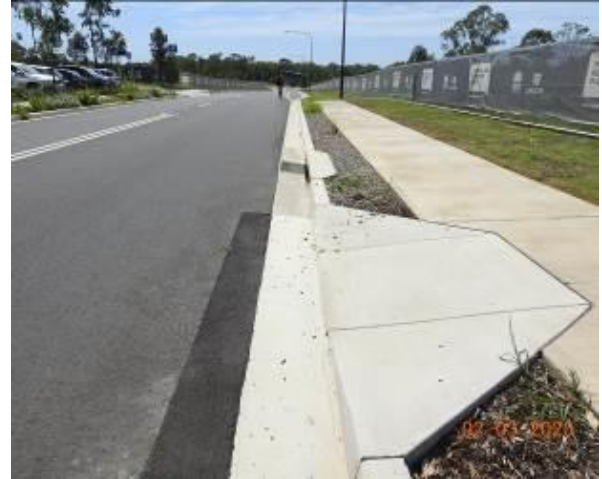
Figure 349 – General Condition of kerb and gutter

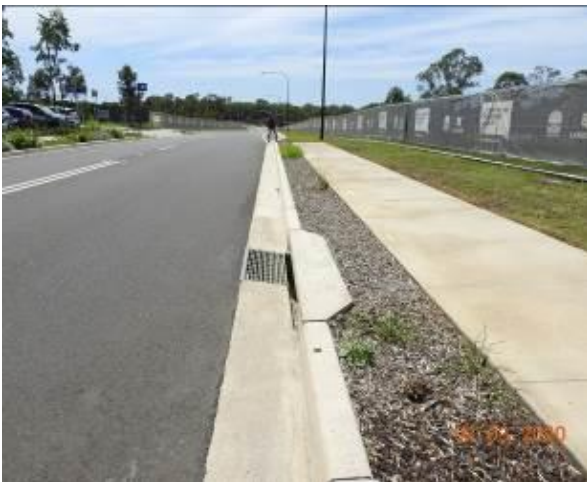
Figure 350 – General Condition of layback and gutter

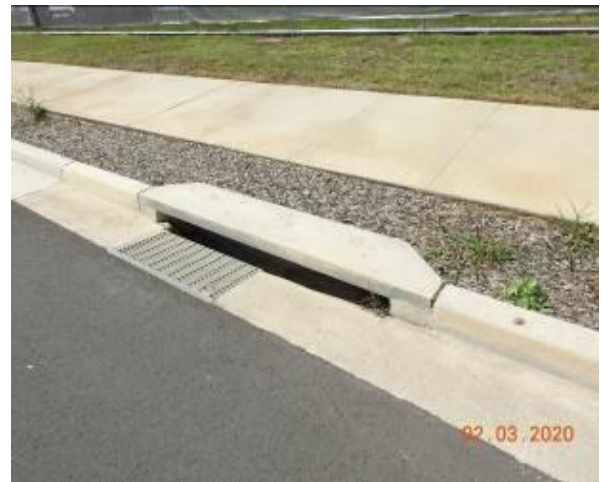
Figure 351 – General Condition of kerb and gutter

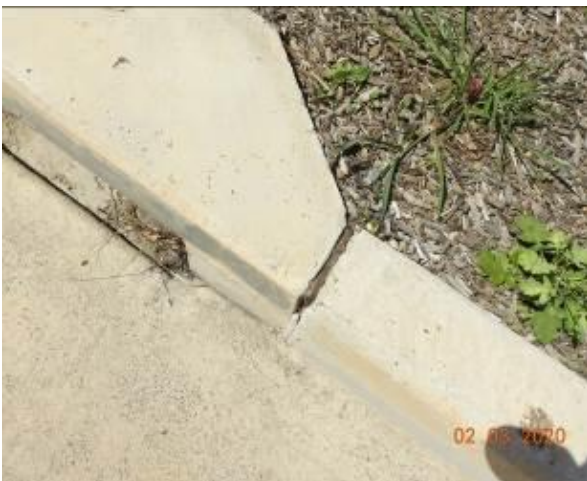
Figure 352 – General Condition of stormwater inlet pit

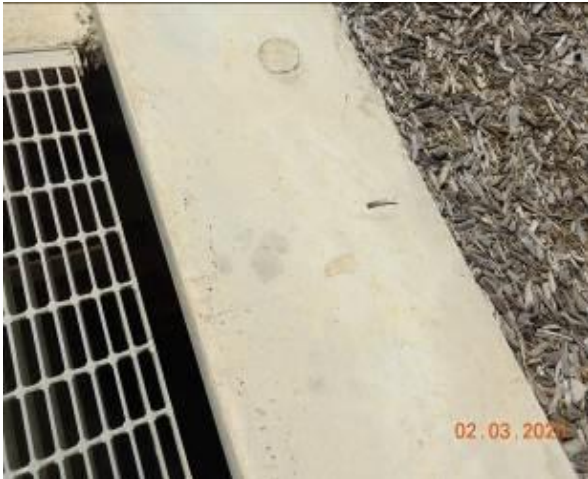
Figure 354 – Crack propagation through stormwater inlet pit

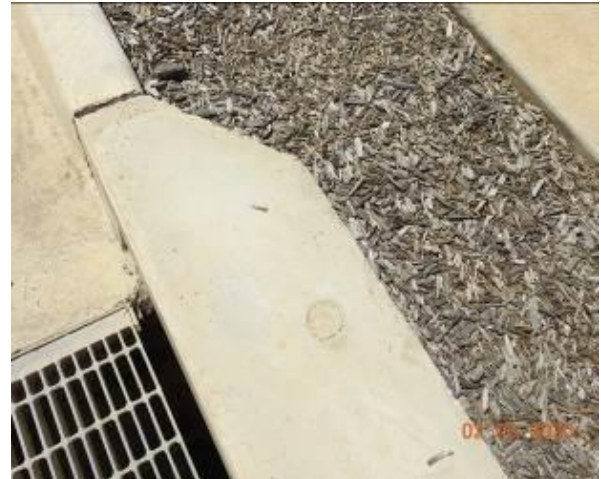
Figure 355 – Crack propagation through stormwater inlet pit

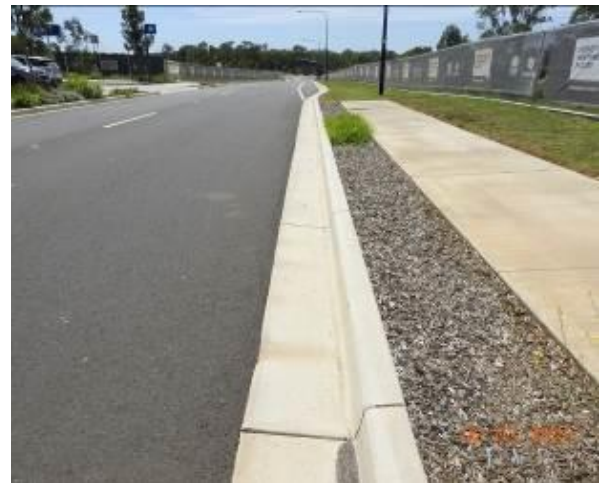
Figure 357 – General Condition of kerb and gutter

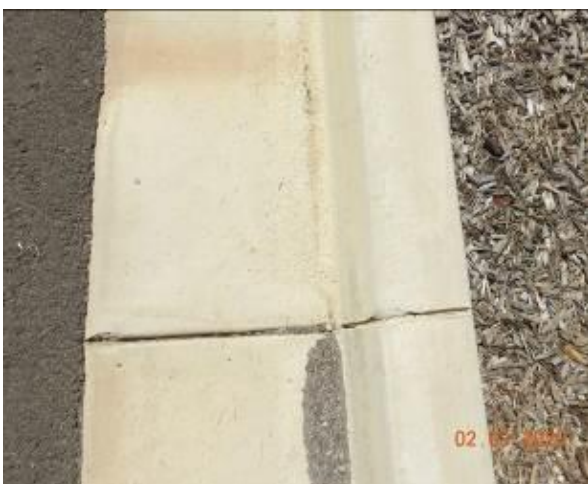
Figure 358 – General Condition of kerb and gutter

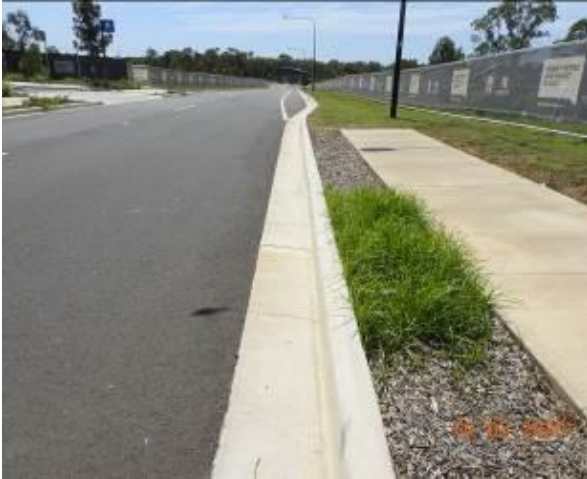
Figure 360 – General Condition of kerb and gutter

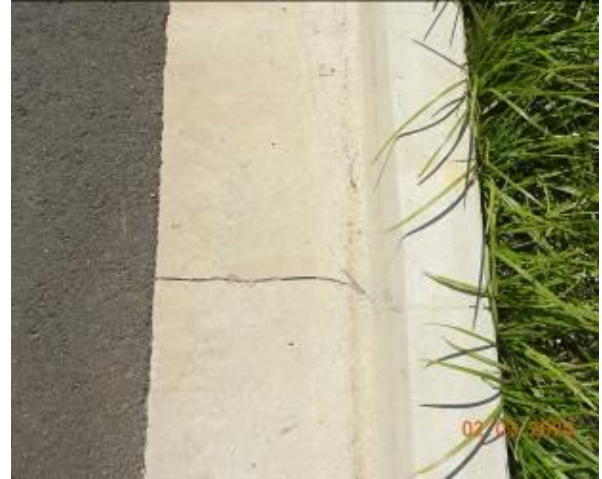
Figure 361 – General Condition of kerb and gutter

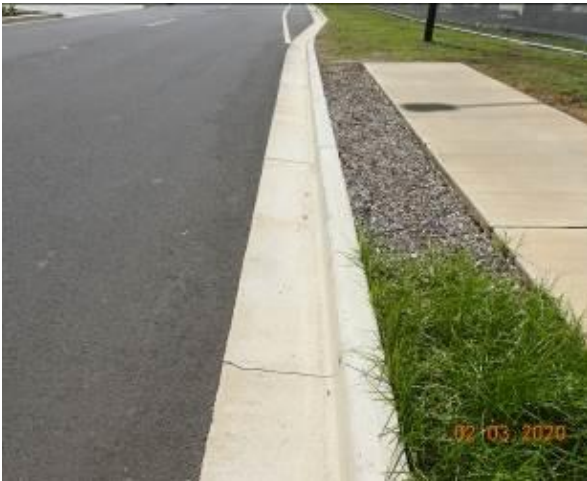
Figure 362 – Crack propagation through kerb and gutter

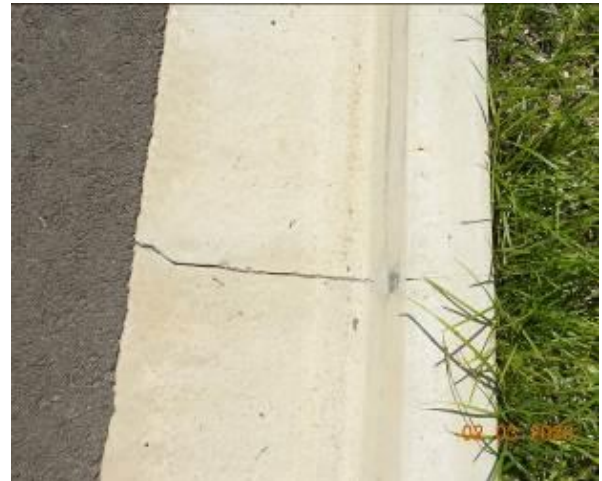
Figure 363 – General Condition of kerb and gutter

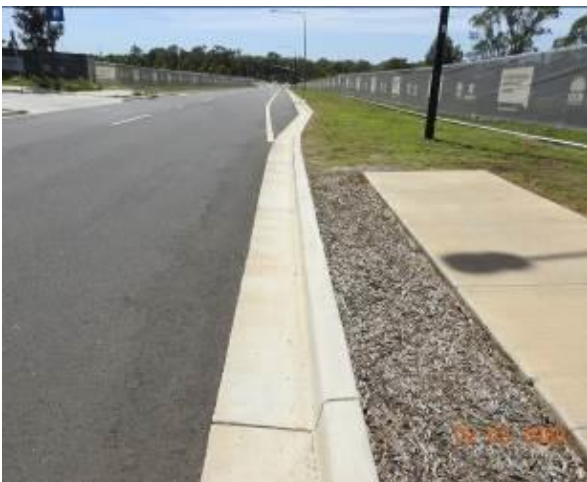
Figure 364 – Crack propagation through kerb and gutter

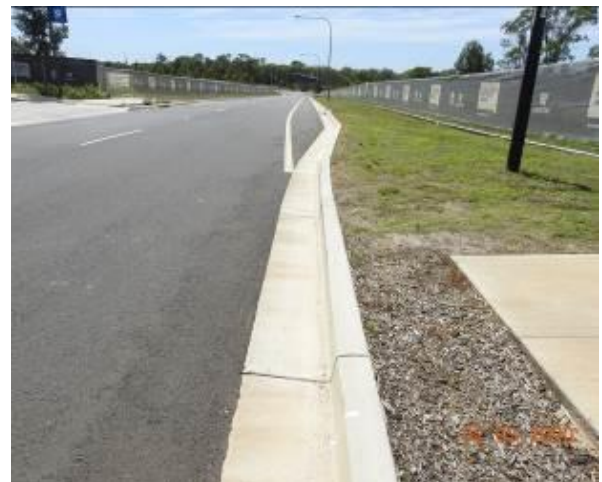
Figure 365 – General Condition of kerb and gutter

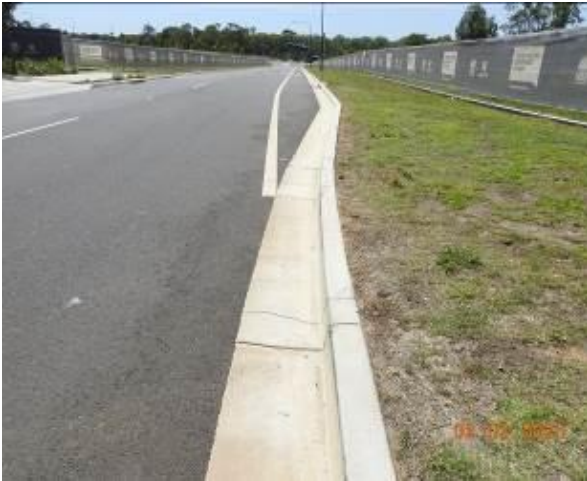
Figure 366 – General Condition of kerb and gutter

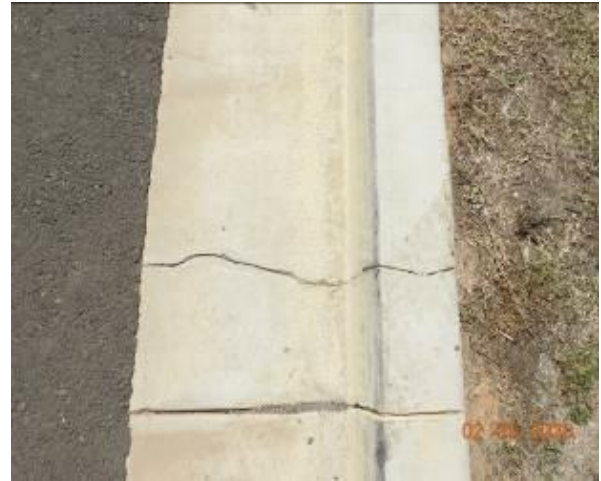
Figure 367 – General condition of kerb and gutter

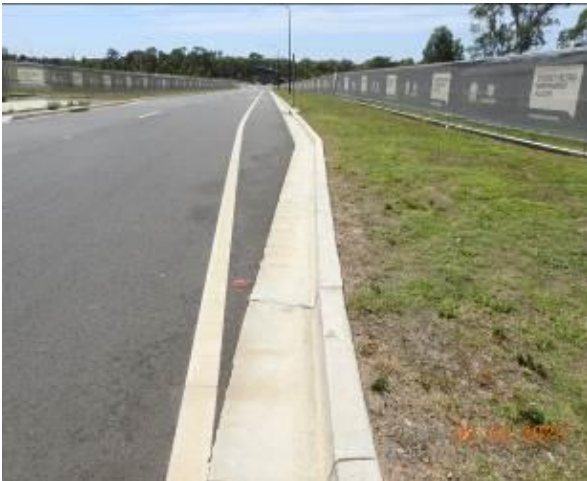
Figure 368 – Crack propagation through kerb and gutter

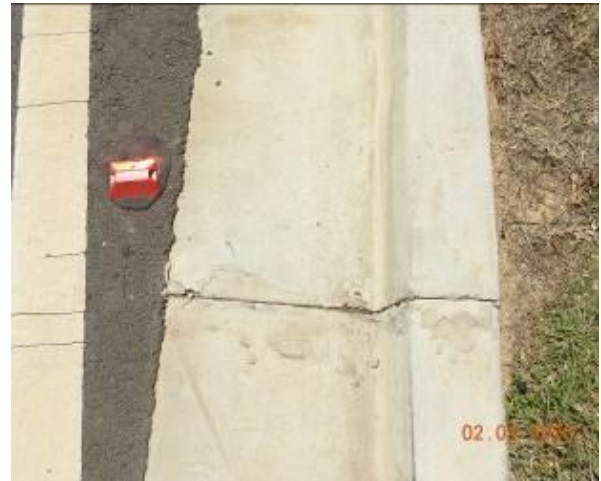
Figure 369 – General Condition of kerb and gutter

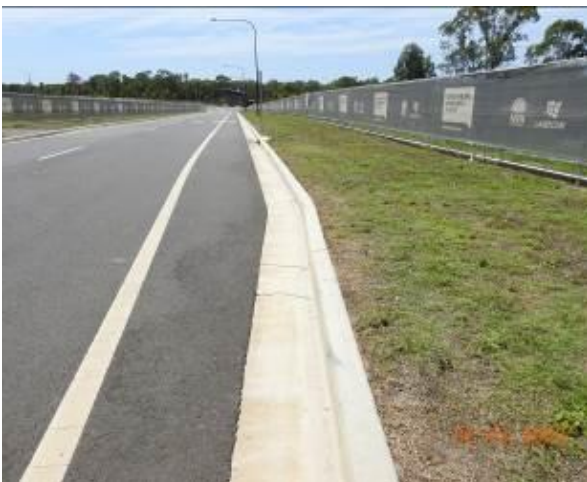
Figure 370 – Loss of material and Evidence of patchwork through kerb and gutter

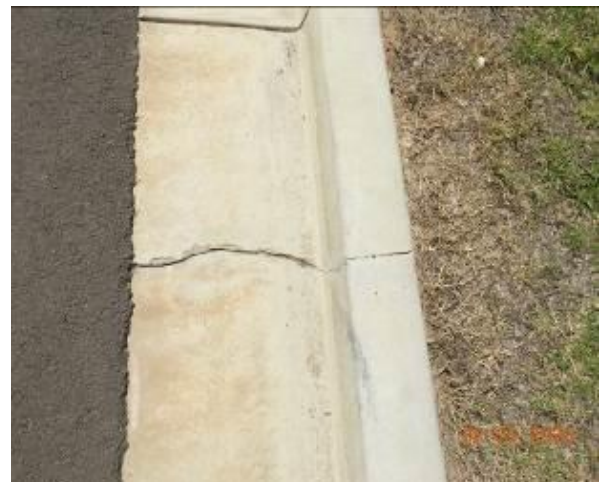
Figure 371 – General Condition of kerb and gutter

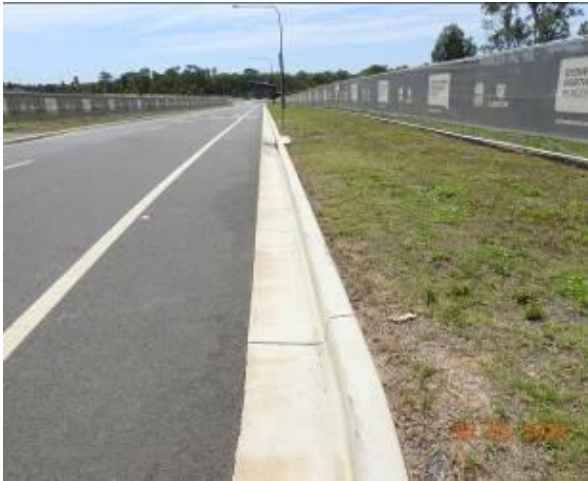
Figure 372 – Crack propagation through kerb and gutter

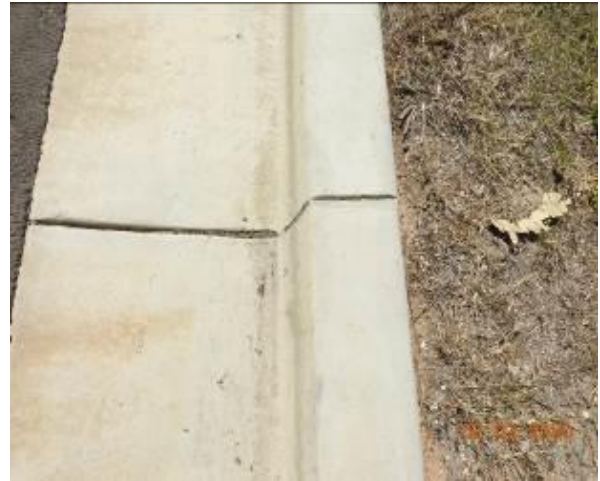
Figure 373 – General Condition of kerb and gutter

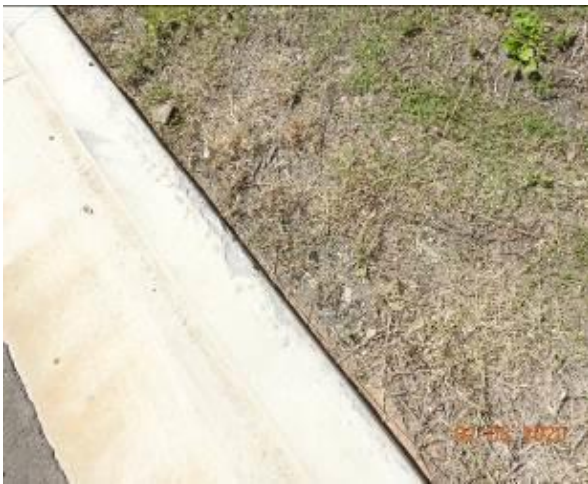
Figure 374 – Crack propagation through kerb

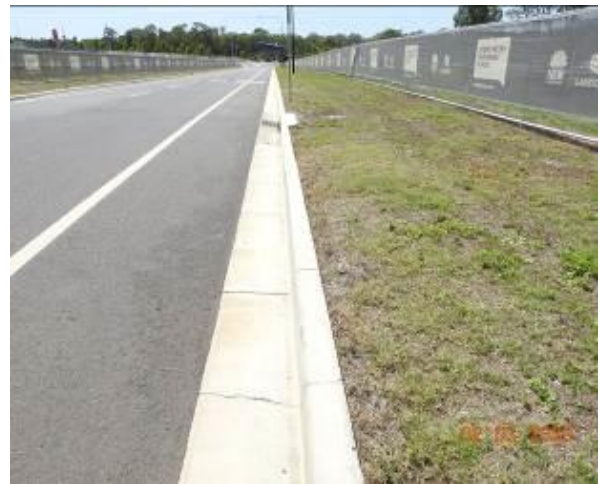
Figure 375 – Loss of material through kerb

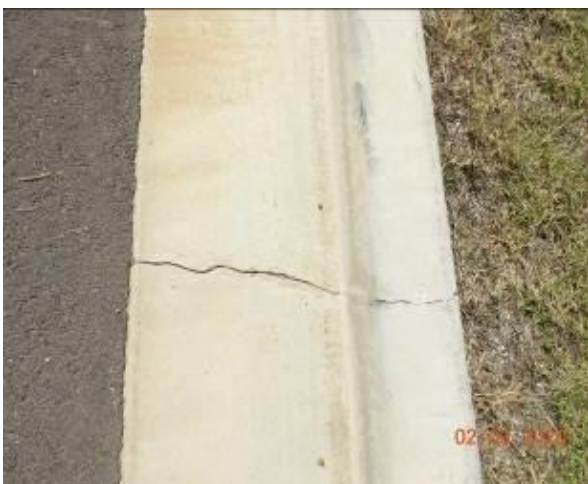
Figure 376 – General Condition of kerb and gutter

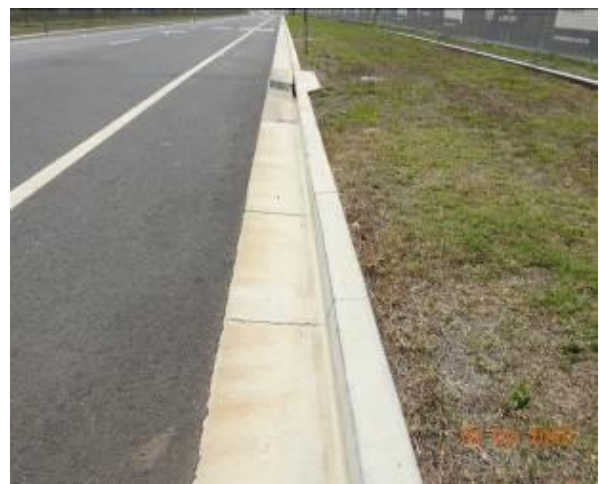
Figure 377 – Crack propagation through kerb and gutter

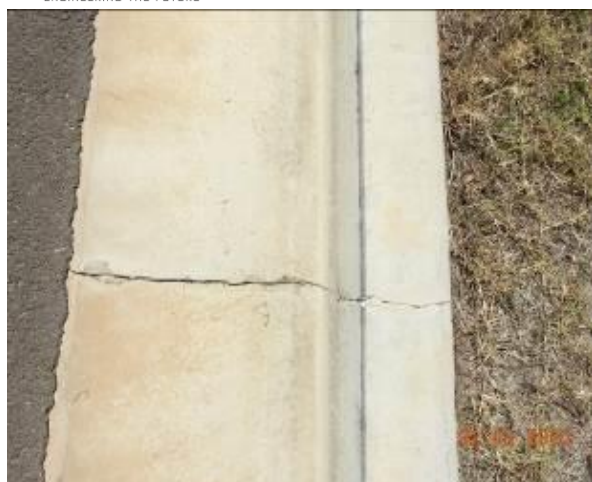
Figure 378 – General Condition of kerb and gutter

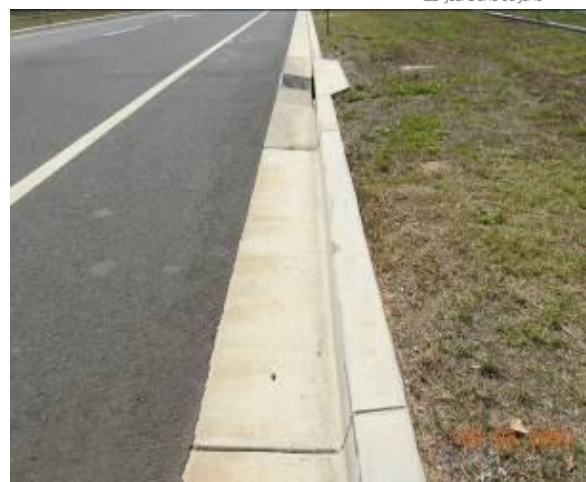
Figure 379 – Crack propagation through kerb and gutter

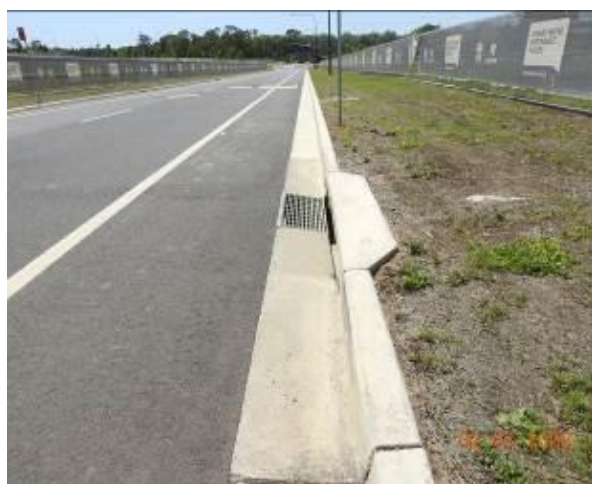
Figure 380 – General Condition of kerb and gutter

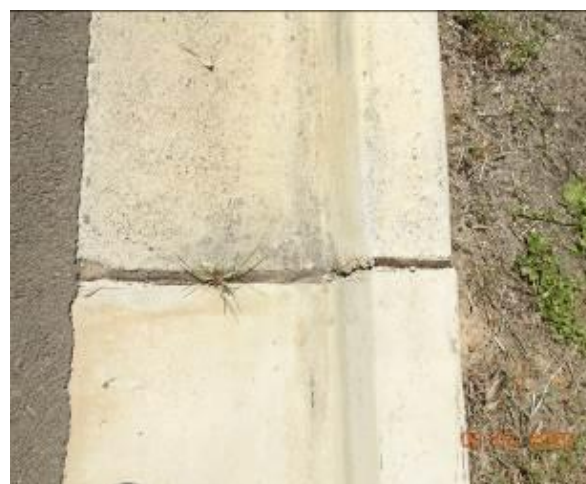
Figure 381 – General Condition of kerb and gutter

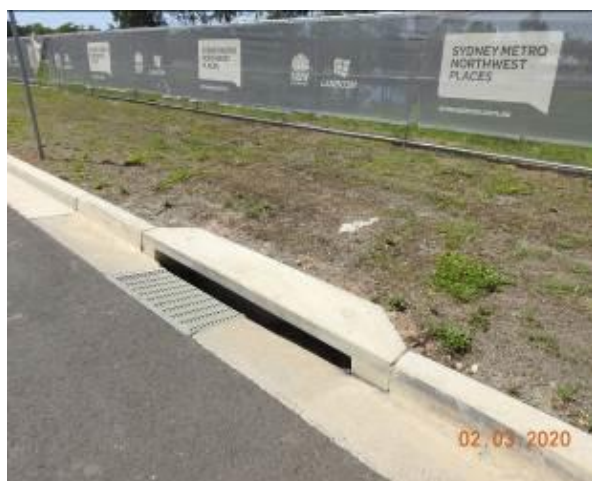
Figure 382 – Crack propagation through kerb and gutter

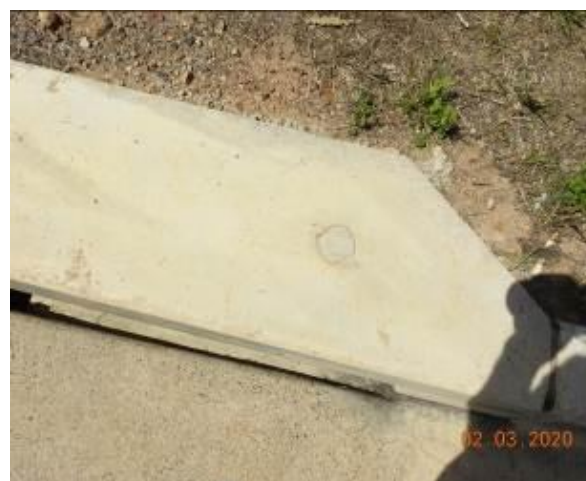
Figure 383 – General Condition of stormwater inlet pit

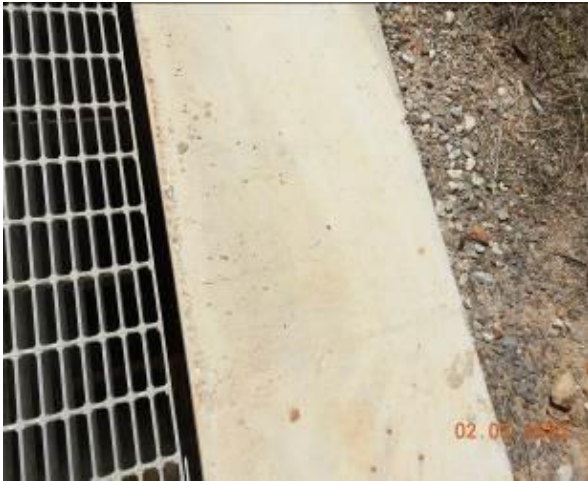
Figure 384 – Crack propagation through stormwater inlet pit

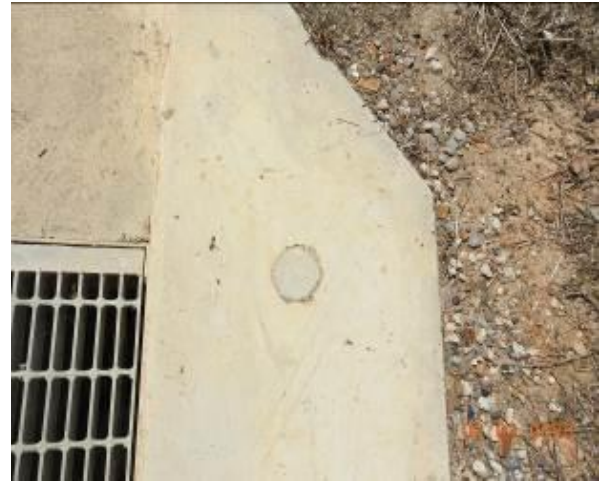
Figure 385 – Crack propagation through stormwater inlet pit

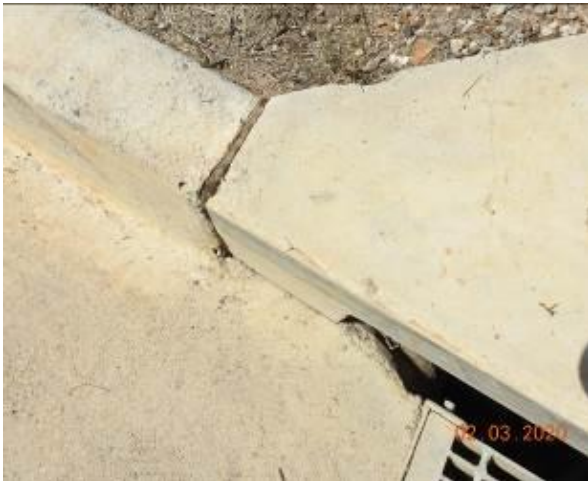
Figure 386 – Crack propagation through stormwater inlet pit

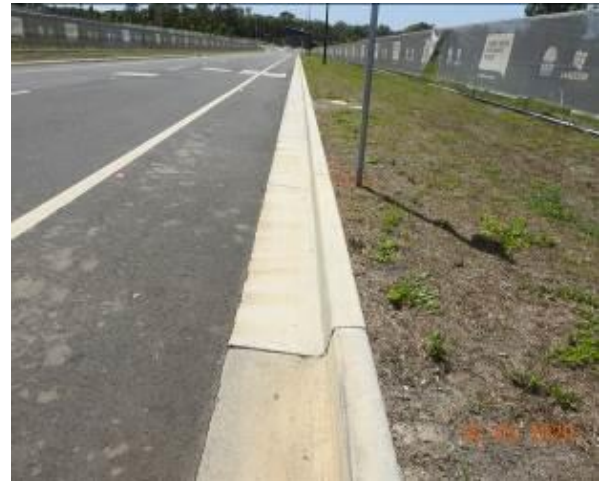
Figure 387 – Crack propagation through stormwater inlet pit

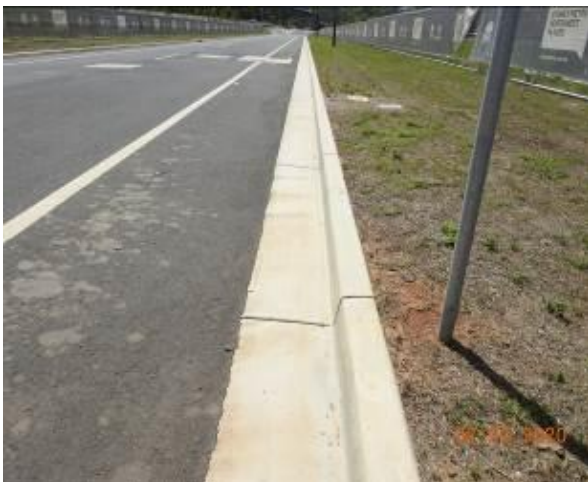
Figure 388 – General Condition of kerb and gutter

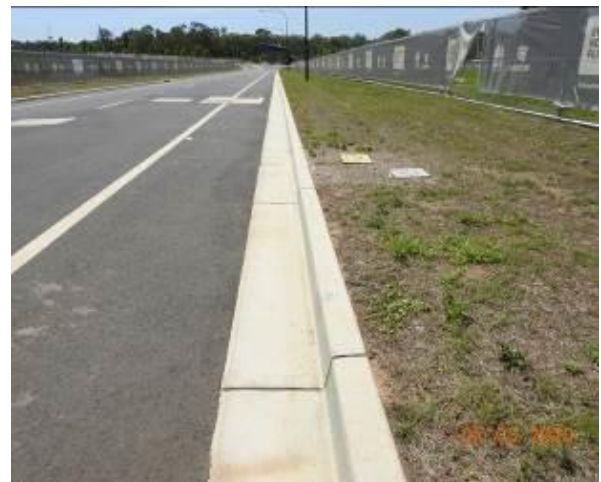
Figure 389 – General Condition of kerb and gutter

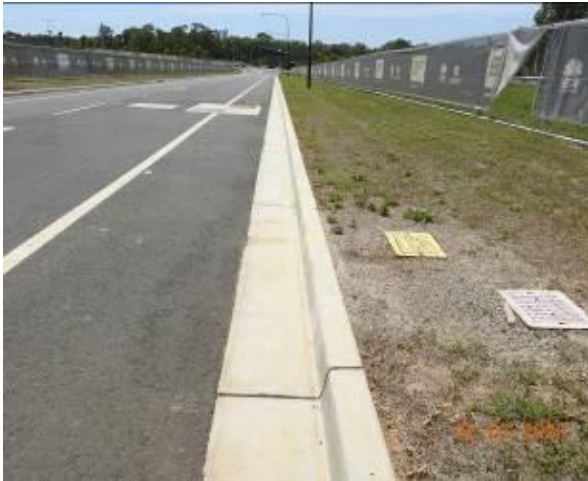
Figure 390 – General Condition of kerb and gutter

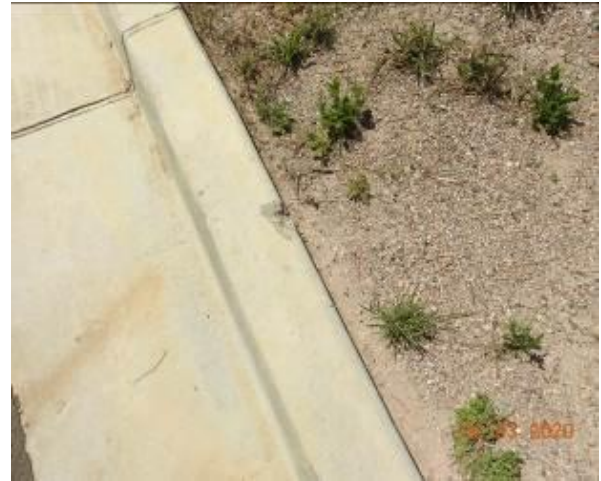
Figure 391 – General Condition of kerb and gutter

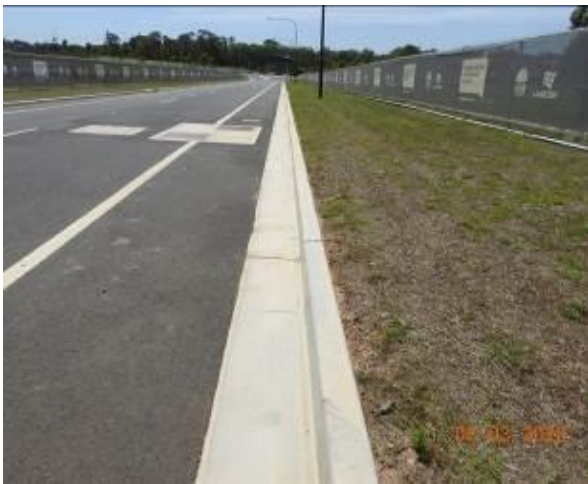
Figure 392 – Loss of material through kerb

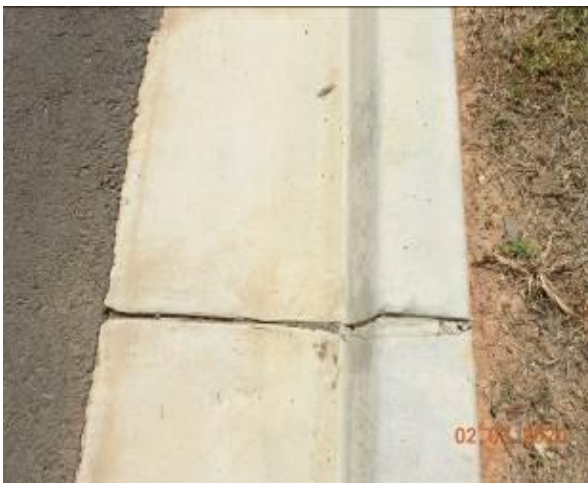
Figure 394 – Crack propagation through kerb and gutter

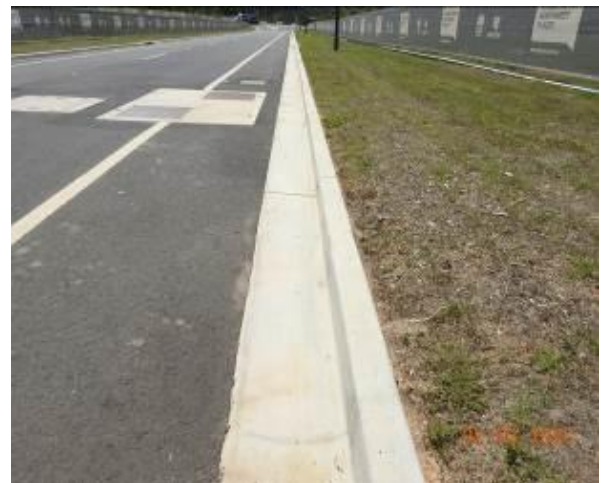
Figure 395 – Crack propagation through kerb and gutter

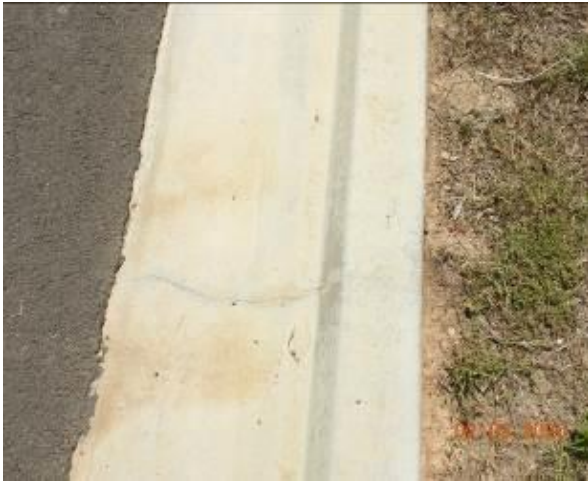
Figure 396 – General Condition of kerb and gutter

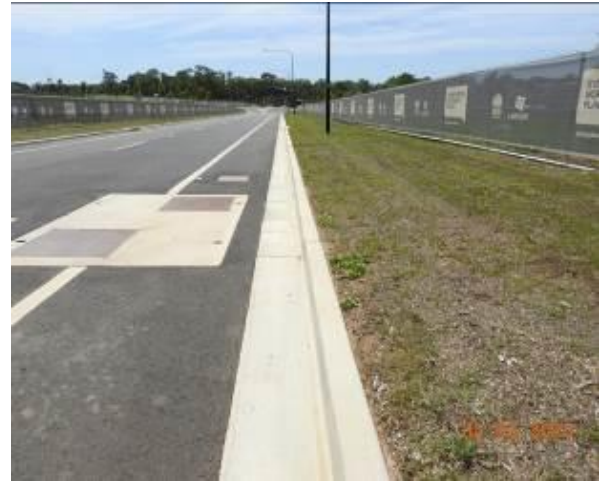
Figure 397 – Crack propagation through kerb and gutter

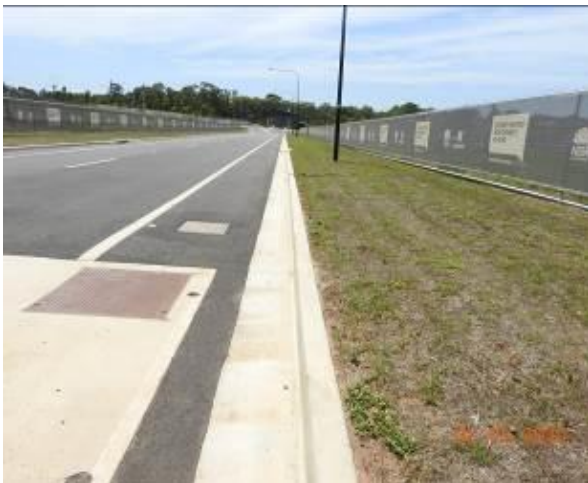
Figure 398 – General Condition of kerb and gutter

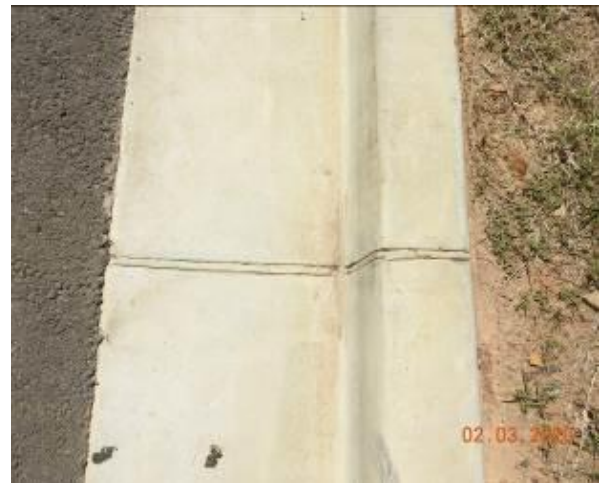
Figure 399 – General Condition of kerb and gutter

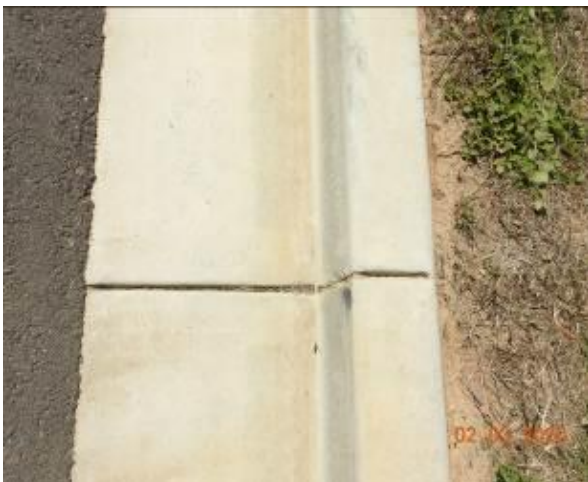
Figure 400 – Crack propagation through kerb and gutter

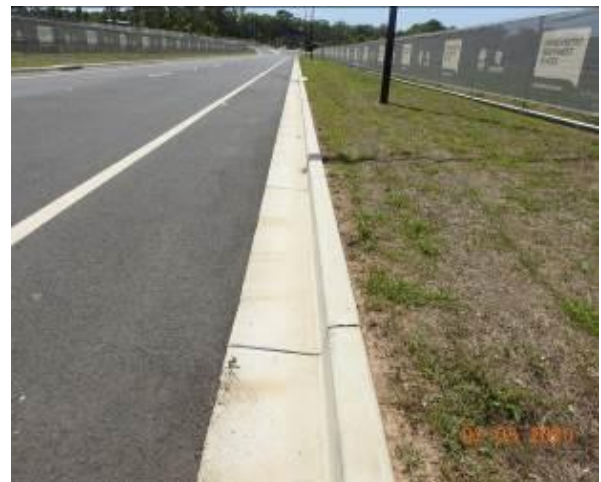
Figure 401 – Crack propagation through kerb and gutter

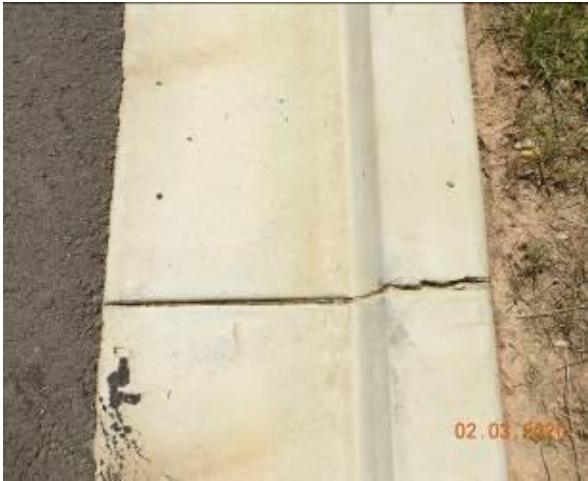
Figure 402 – General Condition of kerb and gutter

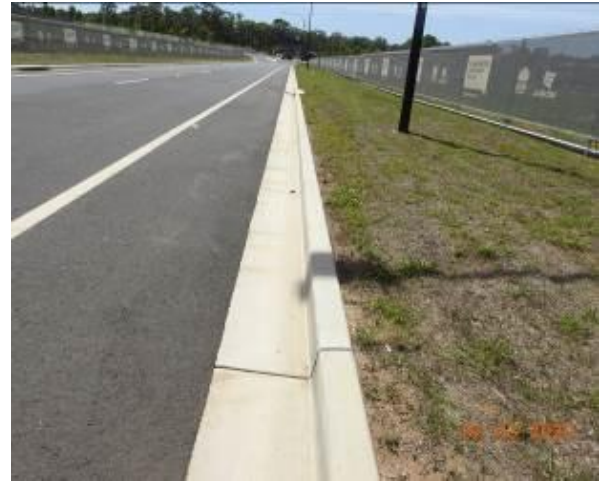
Figure 403 – Crack propagation through kerb and gutter

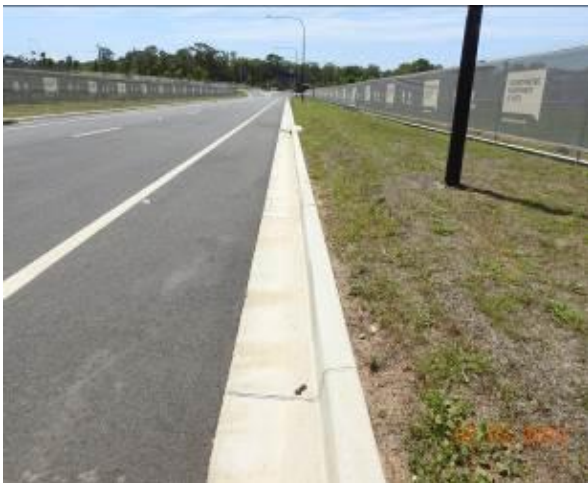
Figure 404 – General Condition of kerb and gutter

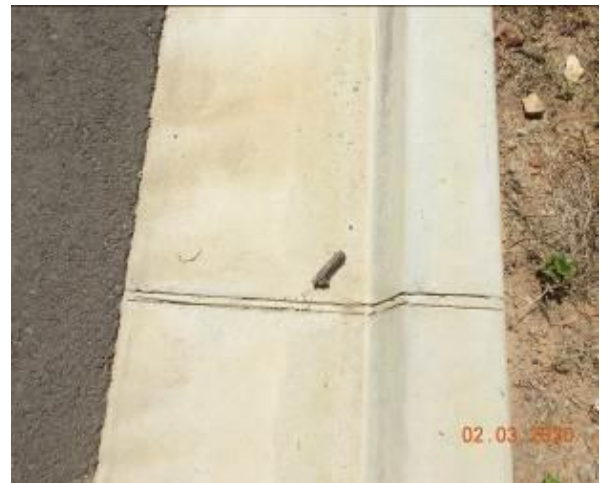
Figure 405 – General Condition of kerb and gutter

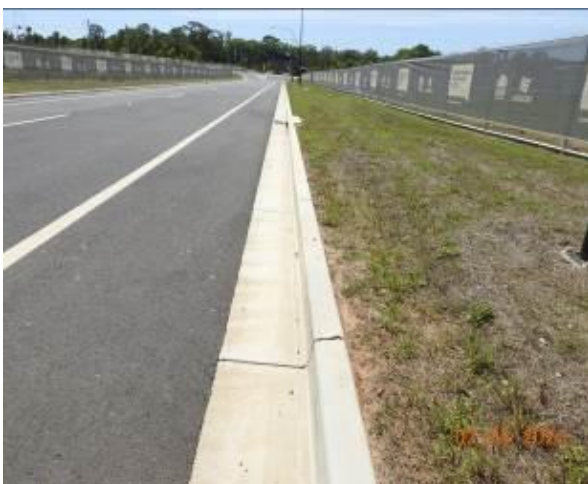
Figure 406 – Crack propagation through kerb and gutter

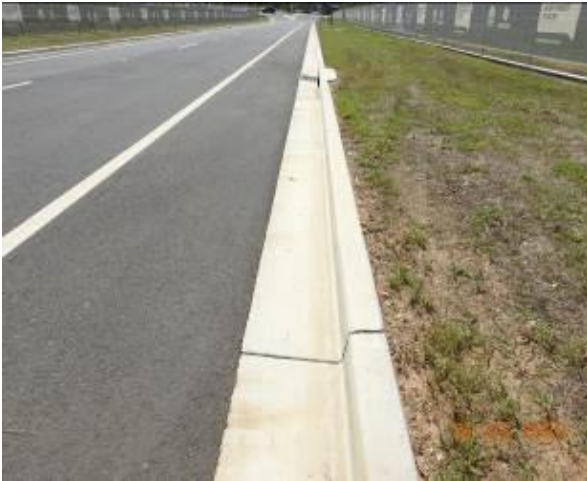
Figure 408 – Crack propagation through kerb and gutter

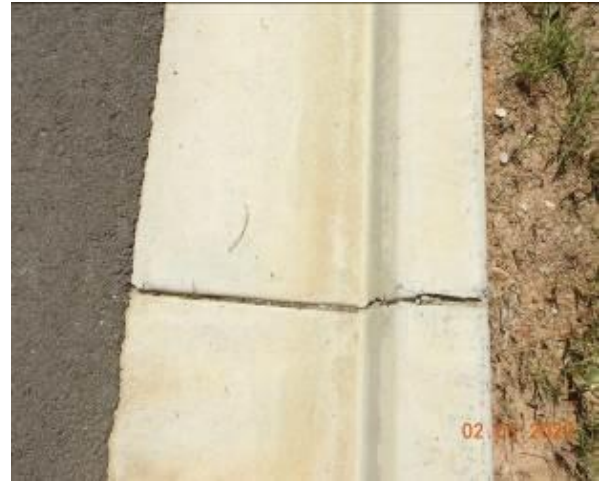
Figure 409 – General Condition of kerb and gutter

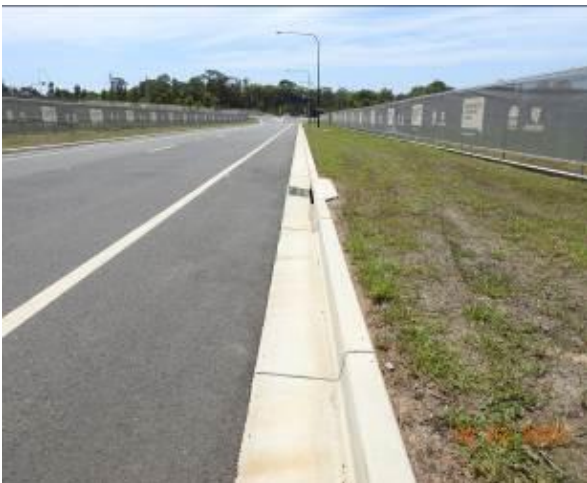
Figure 410 – Crack propagation through kerb and gutter

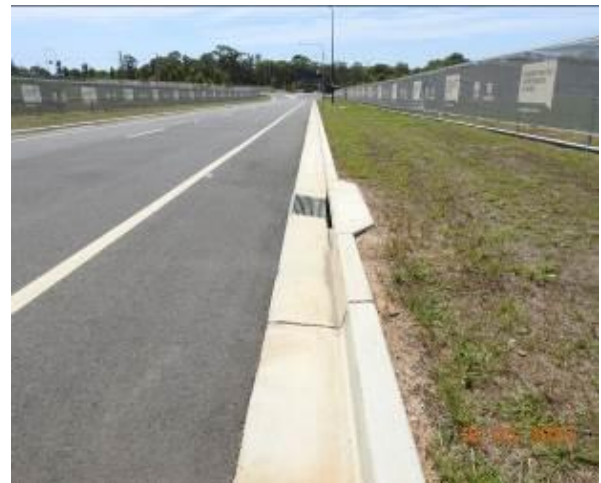
Figure 411 – General Condition of kerb and gutter

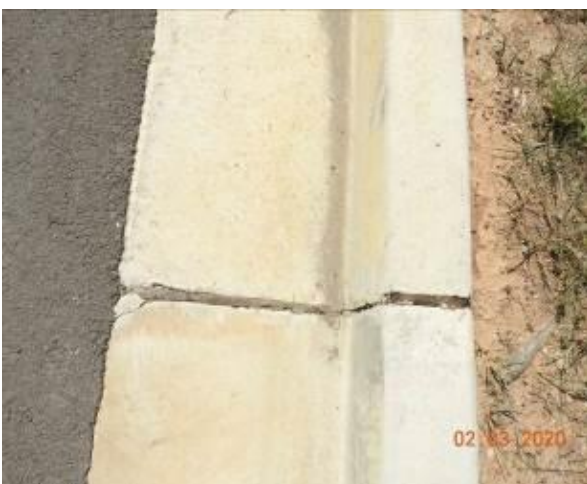
Figure 412 – General Condition of kerb and gutter
