**1-15 AND 2-12 CONFERTA AVENUE,  
ROUSE HILL NSW 2155  
TALLAWONG STATION PRECINCT SOUTH  
PRE-DILAPIDATION REPORT**

**DEICORP PROJECTS  
(TALLAWONG STATION) PTY LTD**

Job No. 191294.0  
05/07/2021

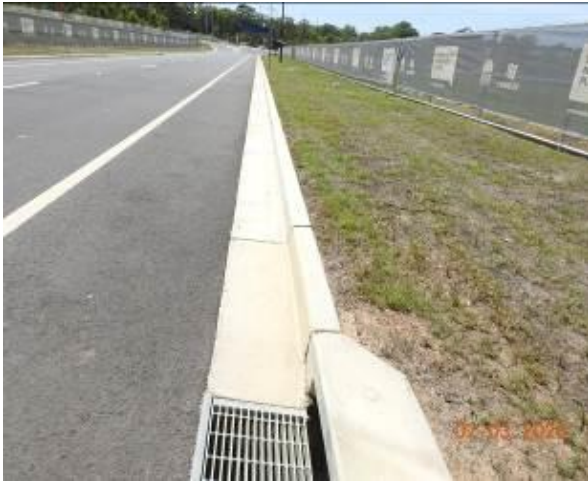
Figure 414 – General Condition of stormwater inlet pit

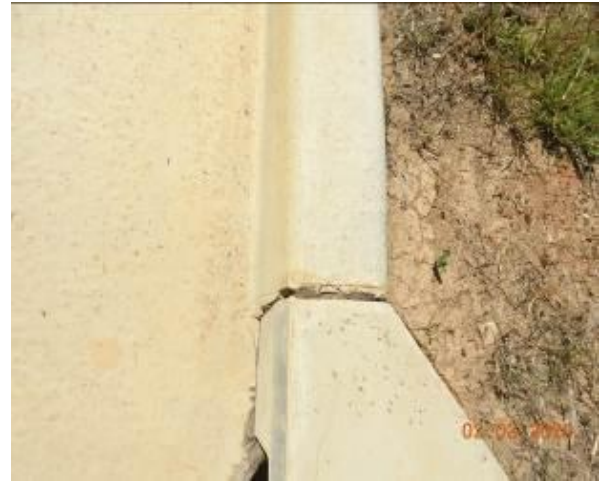
Figure 415 – General Condition of kerb and gutter

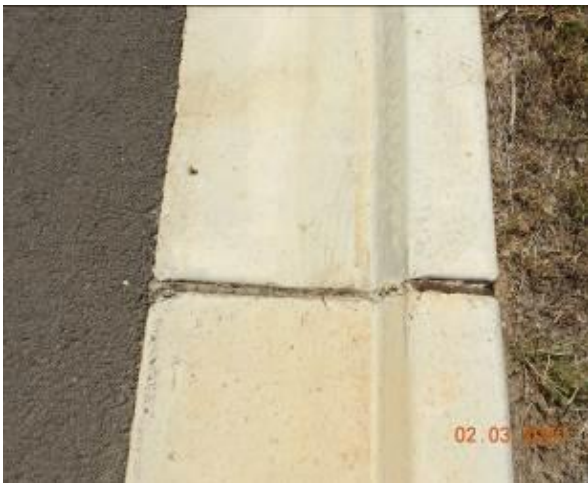
Figure 416 – Crack propagation through kerb and gutter

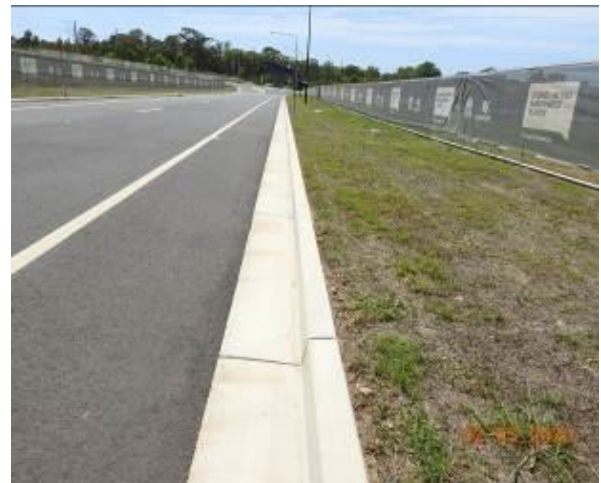
Figure 417 – Crack propagation through kerb and gutter

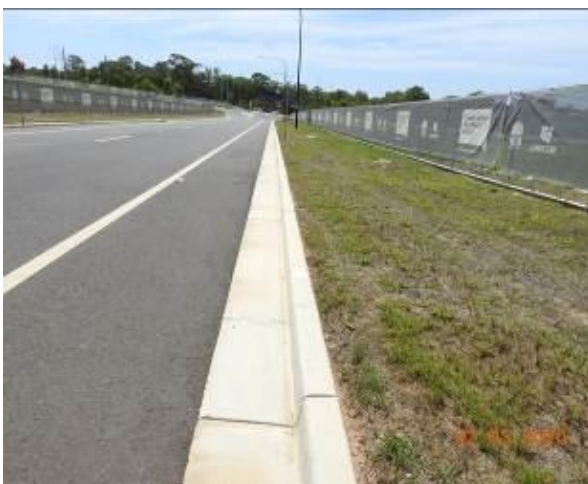
Figure 418 – General Condition of kerb and gutter

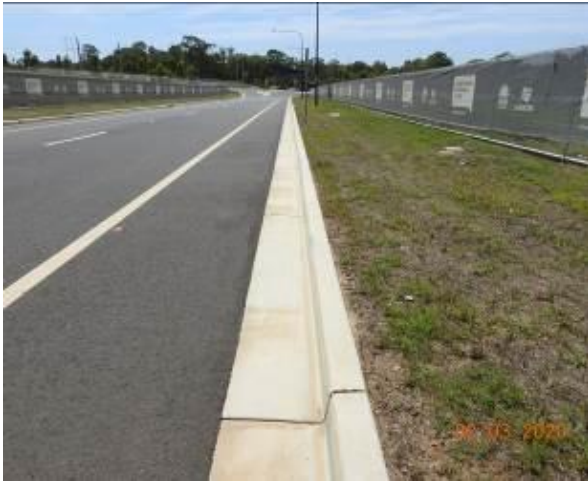
Figure 420 – Crack propagation through kerb and gutter

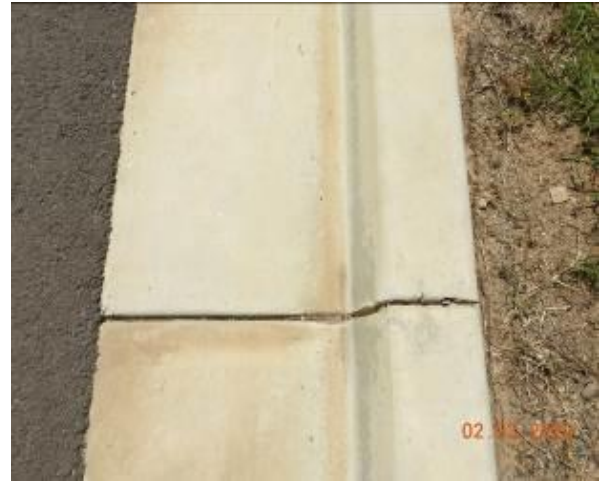
Figure 421 – General Condition of kerb and gutter

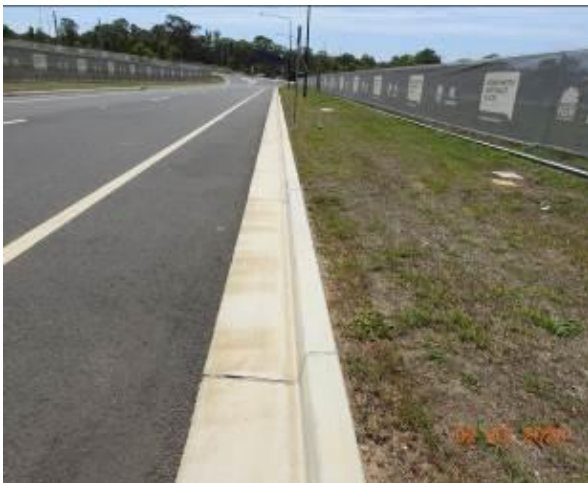
Figure 422 – Crack propagation through kerb and gutter

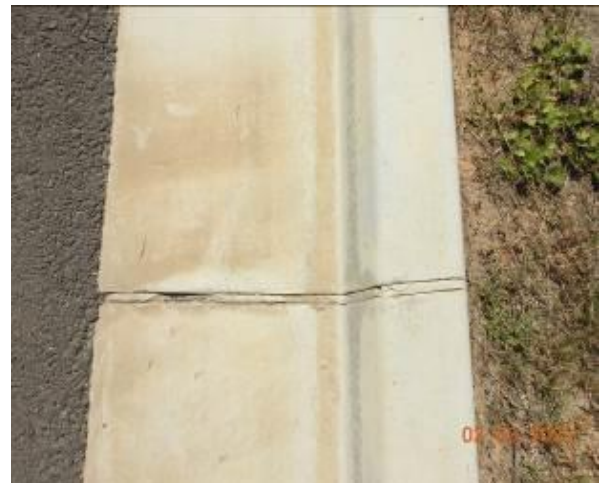
Figure 423 – General Condition of kerb and gutter

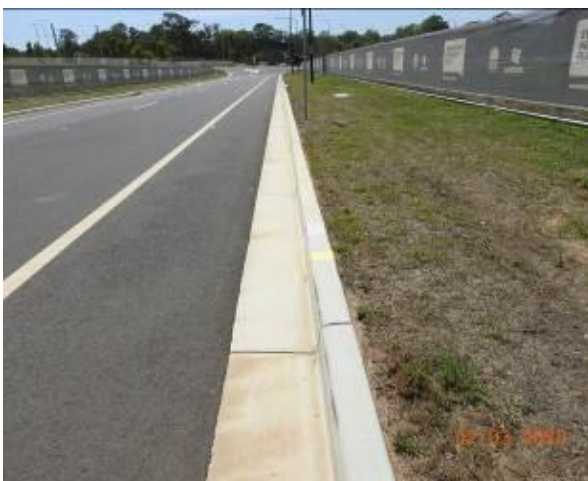
Figure 424 – Crack propagation through kerb and gutter

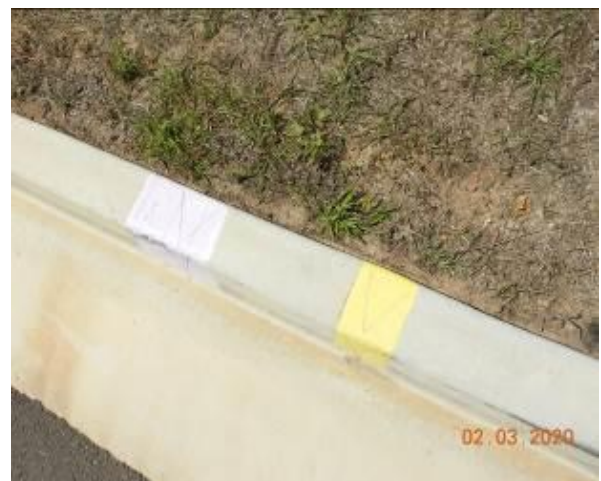
Figure 425 – General Condition of kerb and gutter

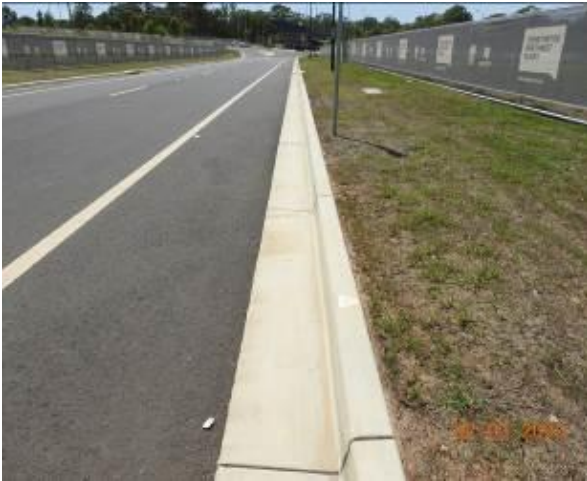
Figure 426 – General Condition of kerb and gutter

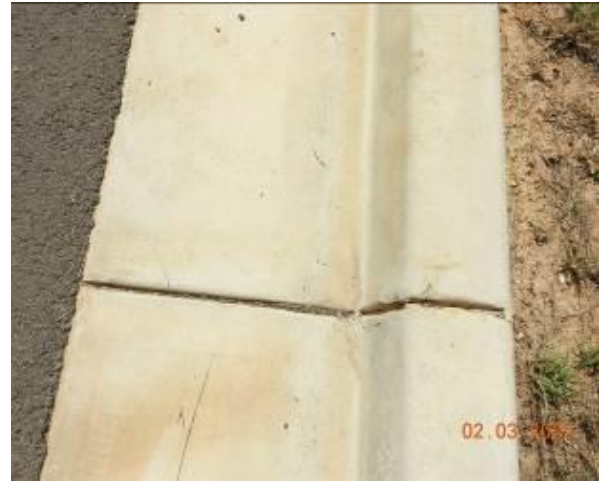
Figure 427 – General Condition of kerb and gutter

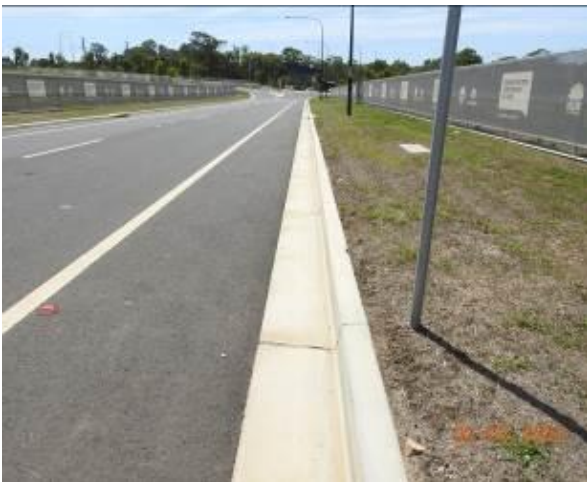
Figure 428 – Loss of material through kerb and gutter

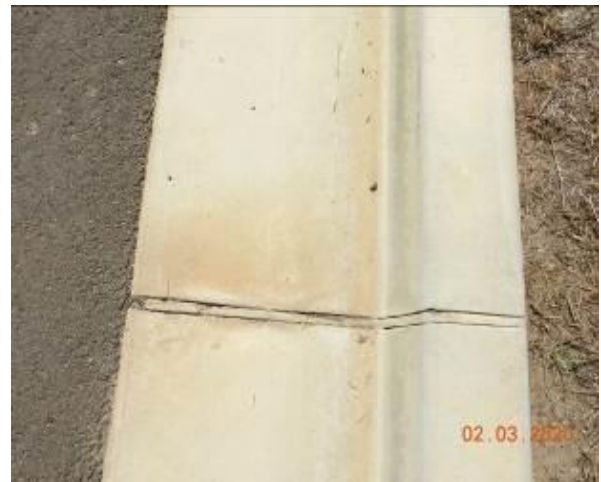
Figure 429 – General Condition of kerb and gutter

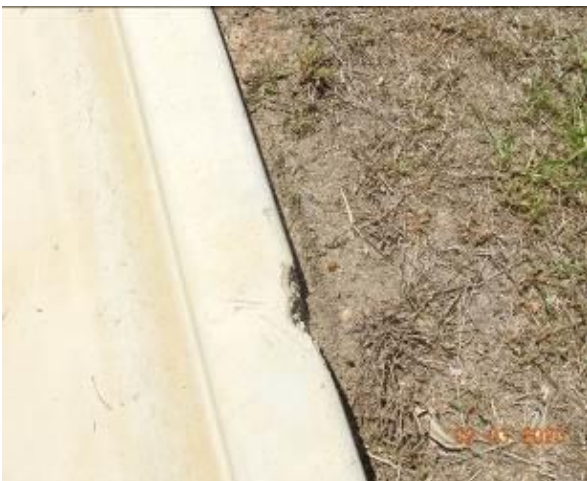
Figure 430 – Crack propagation through kerb and gutter

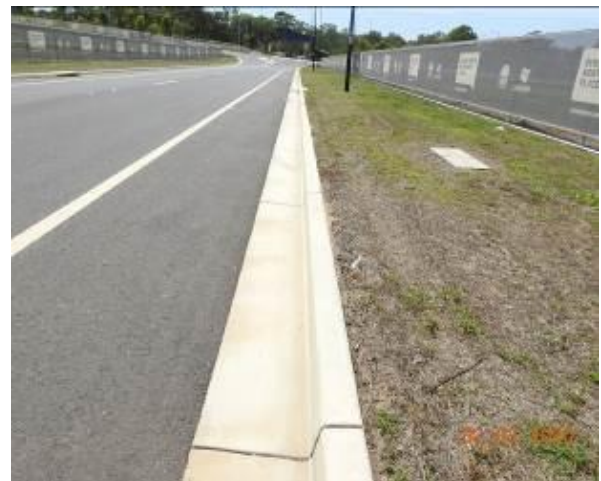
Figure 431 – Loss of material through kerb

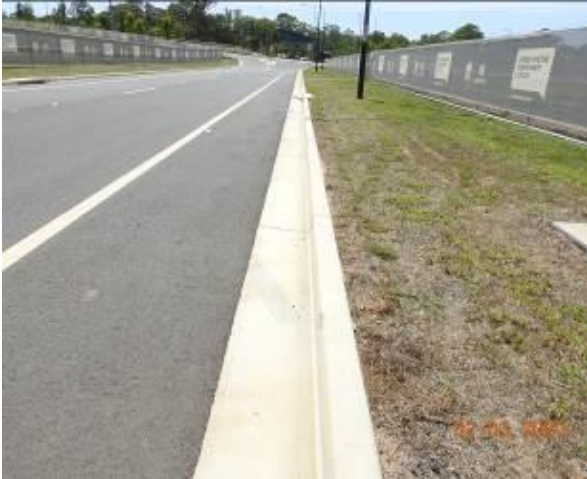
Figure 432 – General Condition of kerb and gutter

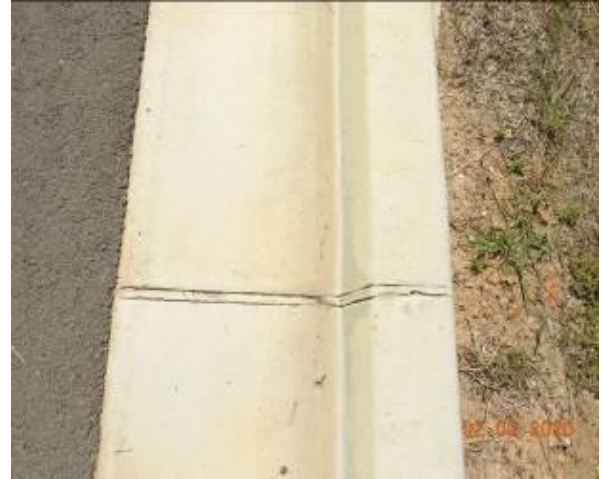
Figure 433 – General Condition of kerb and gutter

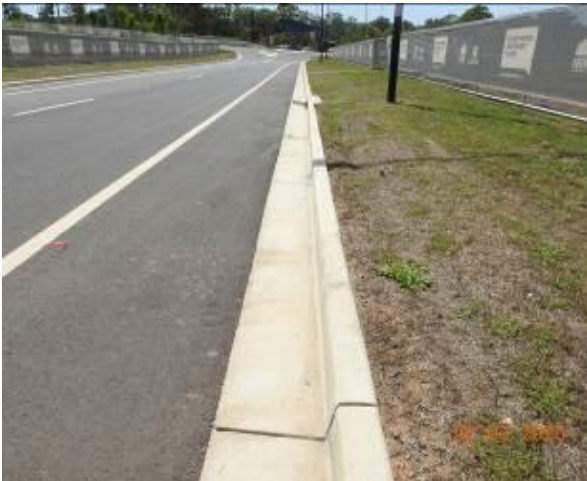
Figure 434 – Crack propagation through kerb and gutter

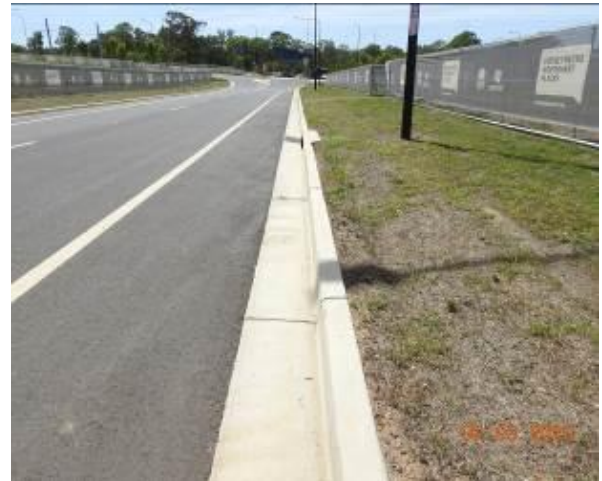
Figure 435 – General Condition of kerb and gutter

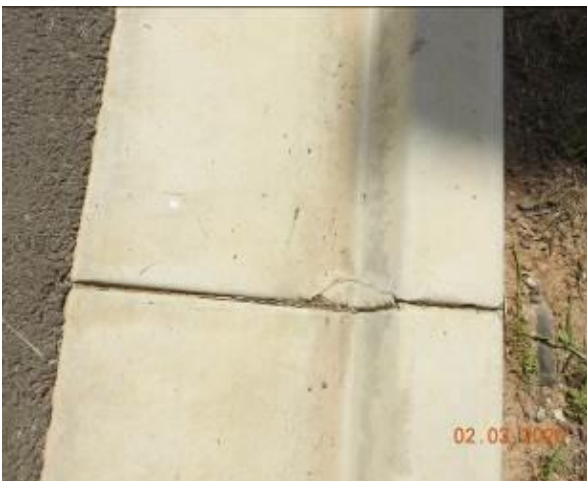
Figure 436 – General Condition of kerb and gutter

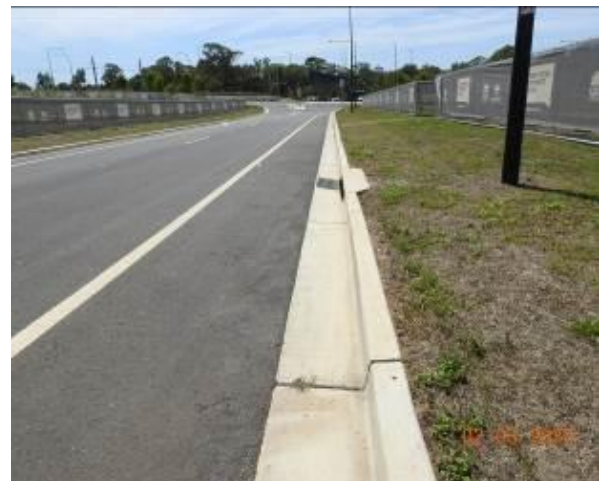
Figure 437 – Crack propagation through kerb and gutter

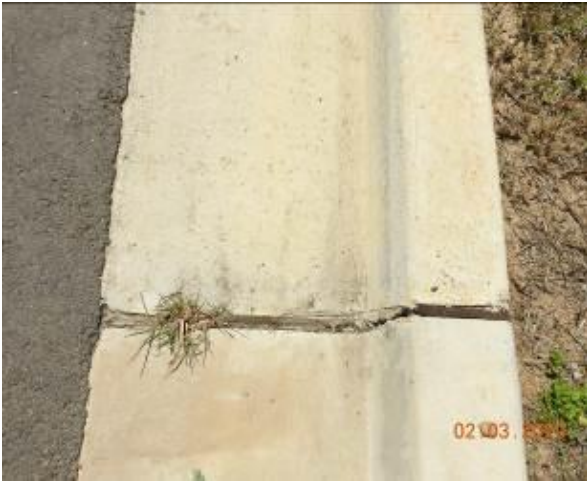
Figure 438 – General Condition of kerb and gutter

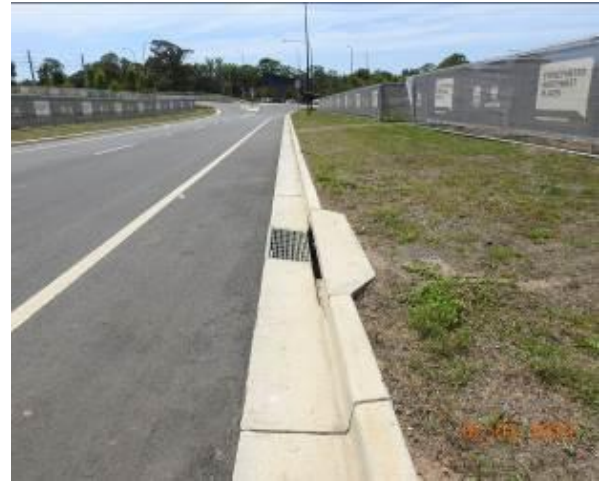
Figure 439 – Crack propagation through kerb and gutter

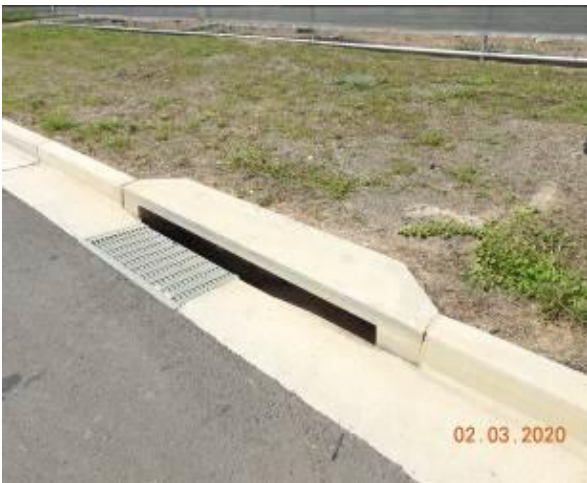
Figure 440 – General Condition of kerb and gutter

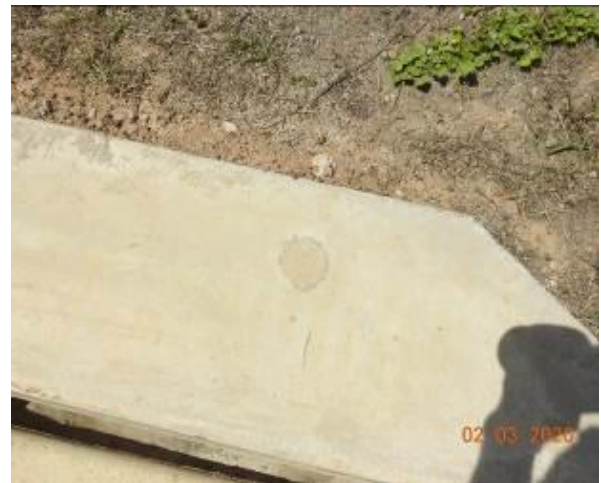
Figure 441 – General Condition of stormwater inlet pit

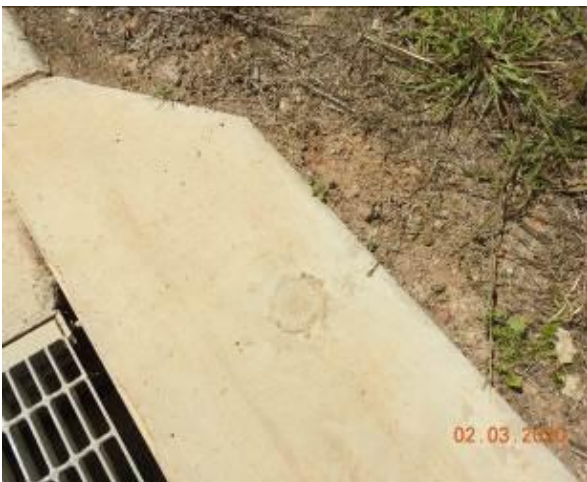
Figure 442 – Crack propagation through stormwater inlet pit

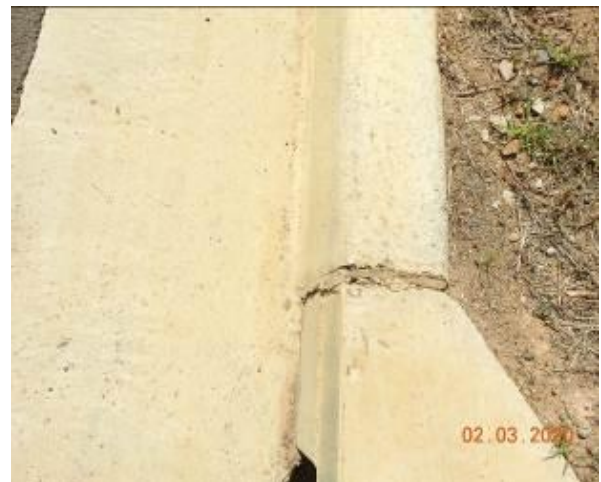
Figure 443 – Crack propagation through stormwater inlet pit

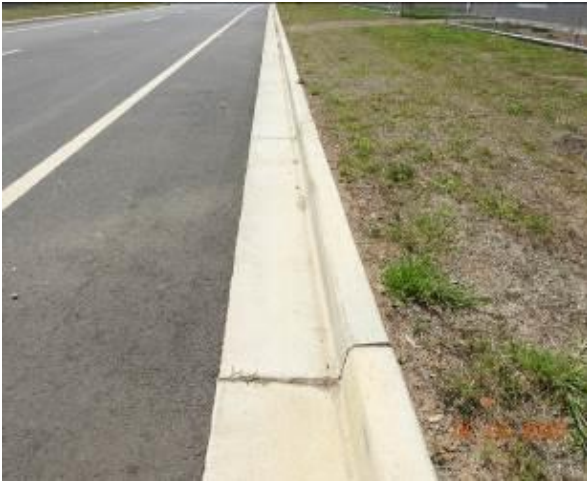
Figure 444 – Crack propagation through stormwater inlet pit

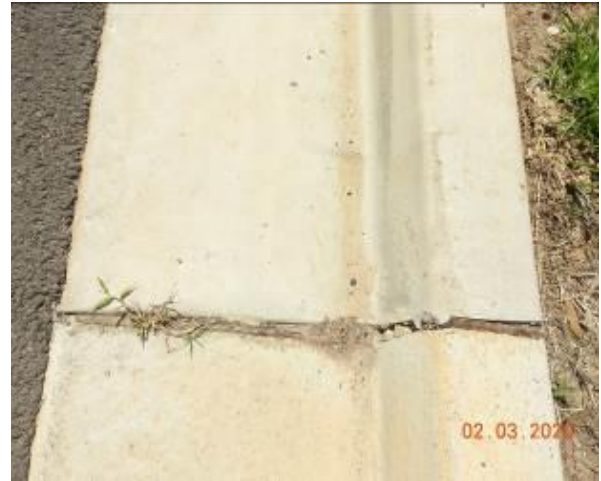
Figure 445 – General Condition of kerb and gutter

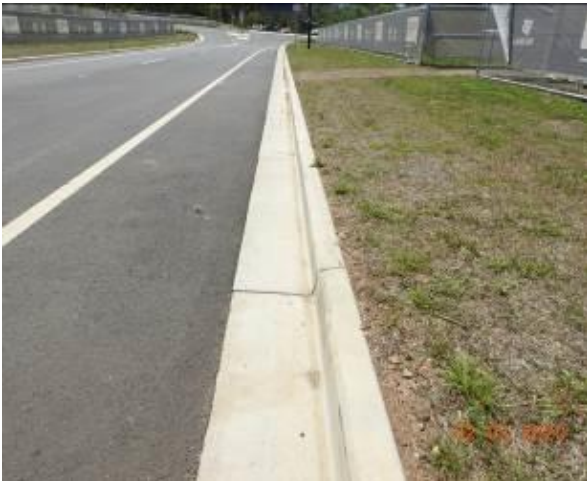
Figure 446 – Crack propagation through kerb and gutter

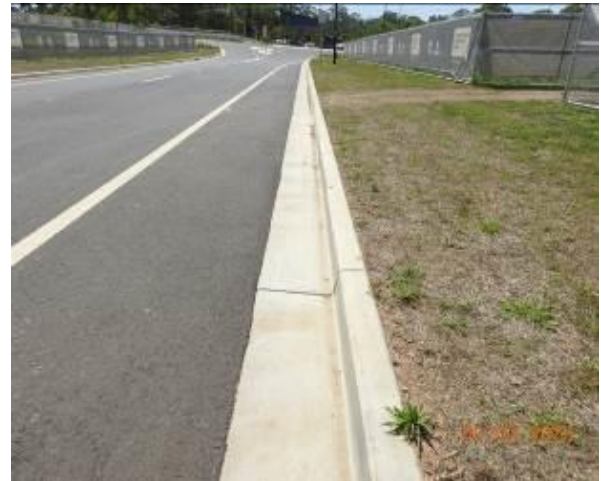
Figure 447 – General Condition of kerb and gutter

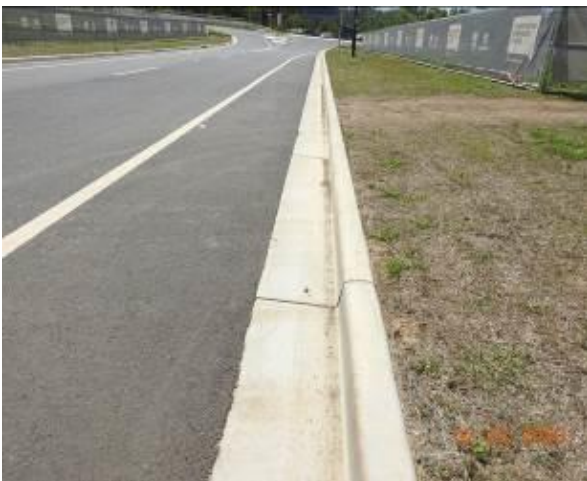
Figure 448 – General Condition of kerb and gutter

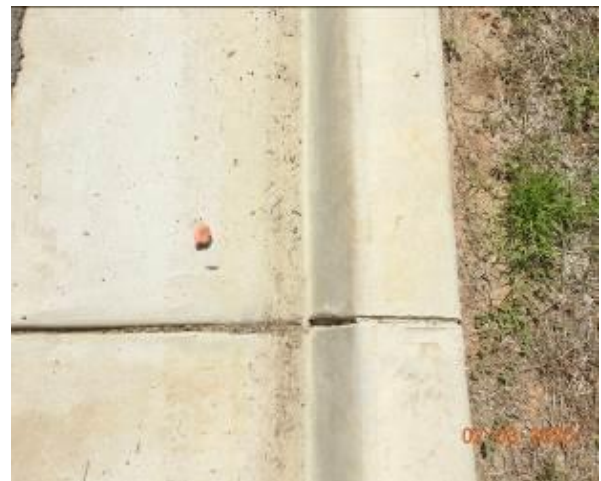
Figure 449 – General Condition of kerb and gutter

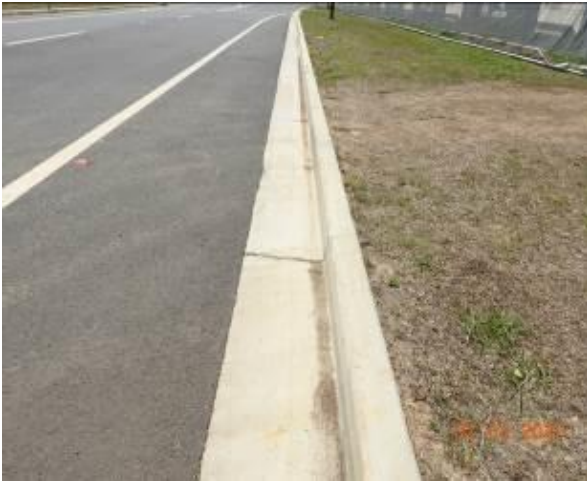
Figure 450 – Crack propagation through kerb and gutter

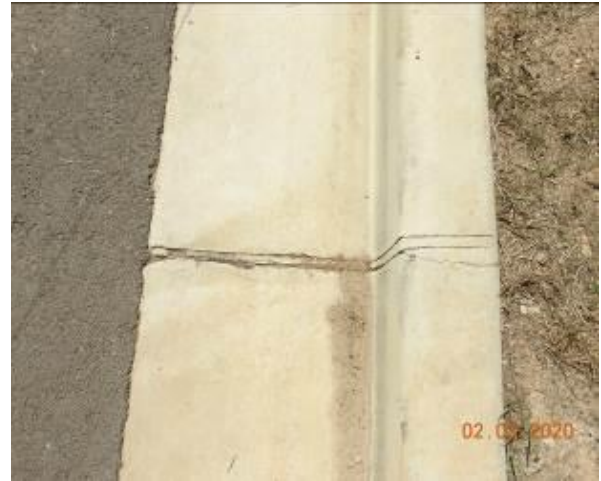
Figure 451 – General Condition of kerb and gutter

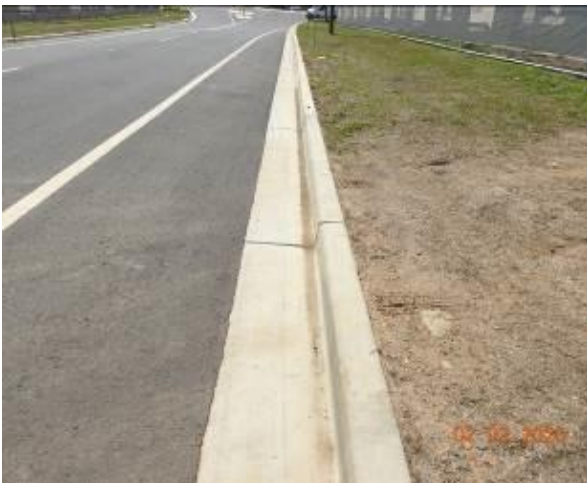
Figure 452 – Crack propagation through kerb and gutter

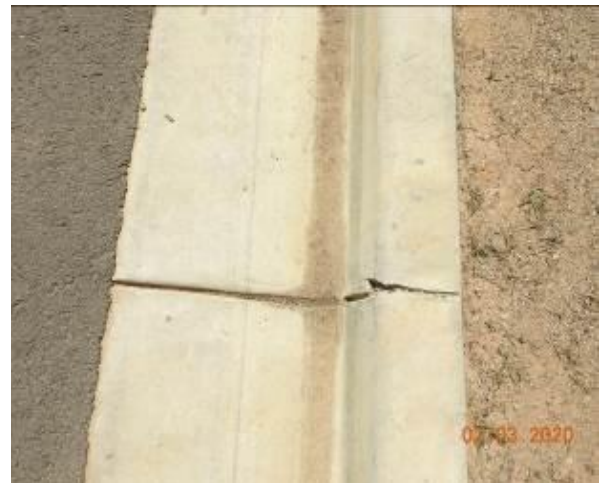
Figure 453 – General Condition of kerb and gutter

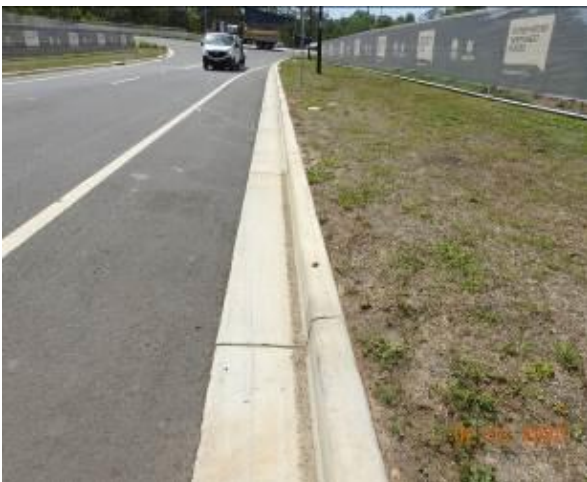
Figure 454 – Crack propagation through kerb and gutter

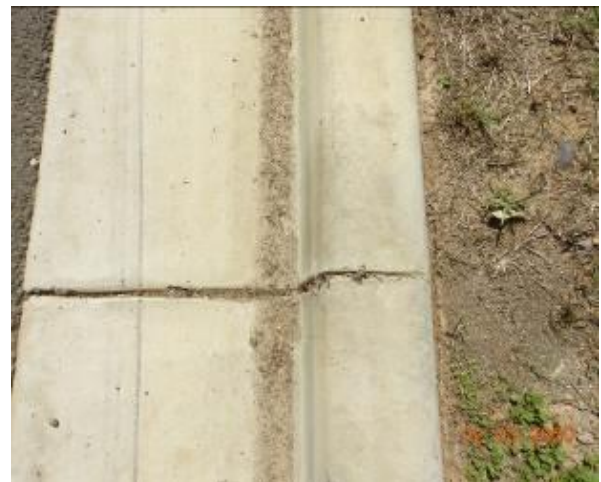
Figure 455 – General Condition of kerb and gutter

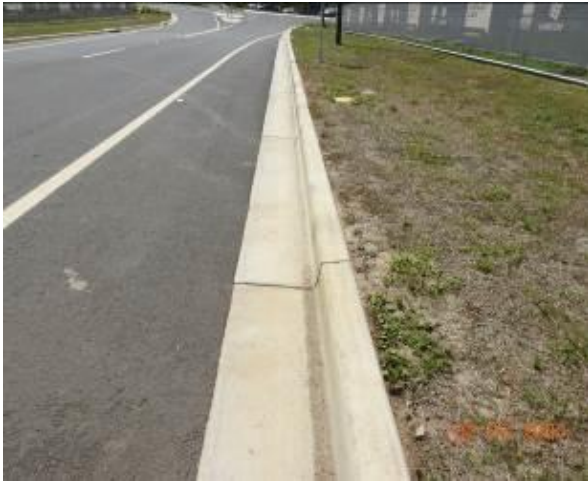
Figure 456 – Crack propagation through kerb and gutter

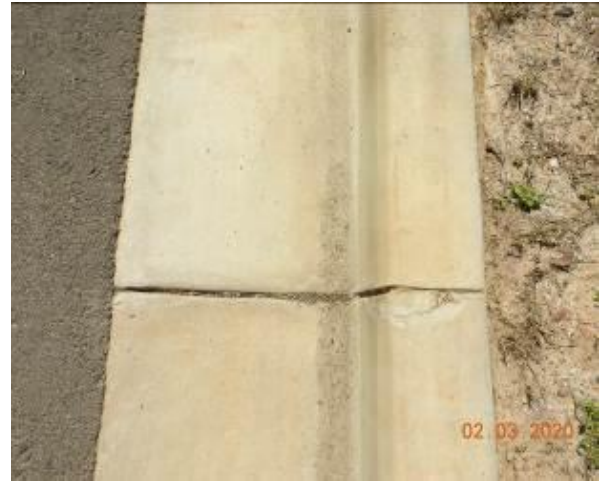
Figure 457 – General Condition of kerb and gutter

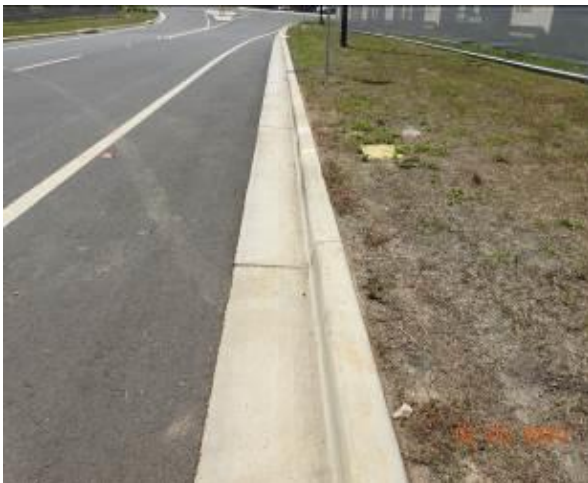
Figure 458 – Crack propagation through kerb and gutter

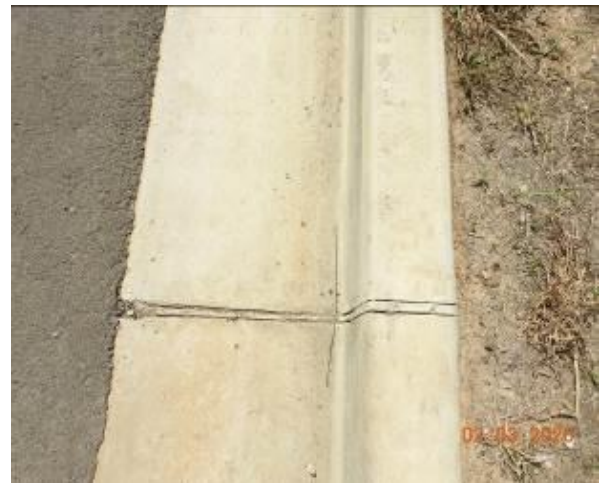
Figure 460 – Crack propagation through kerb and gutter

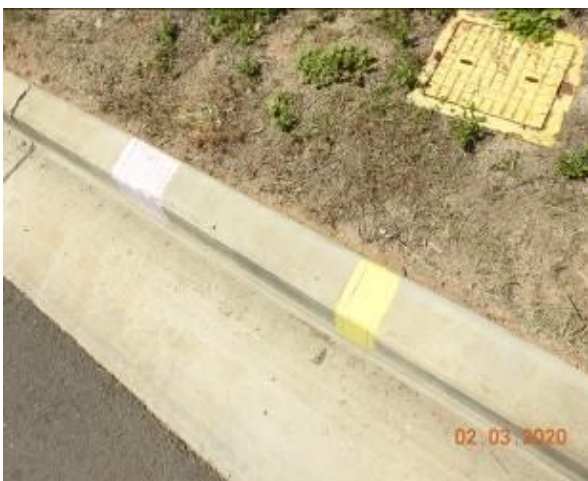
Figure 461 – General Condition of kerb and gutter

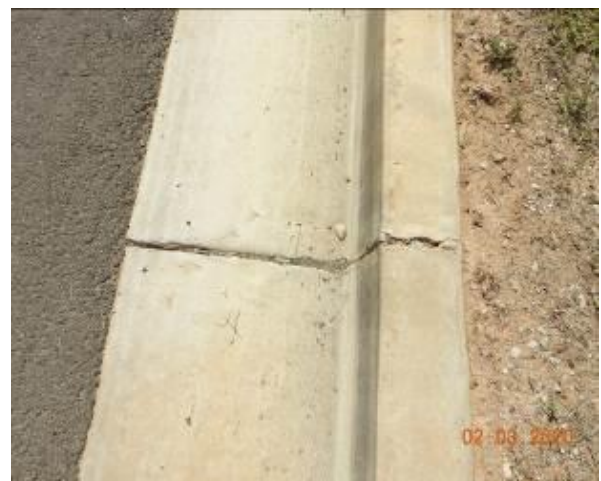
Figure 462 – Crack propagation through kerb and gutter

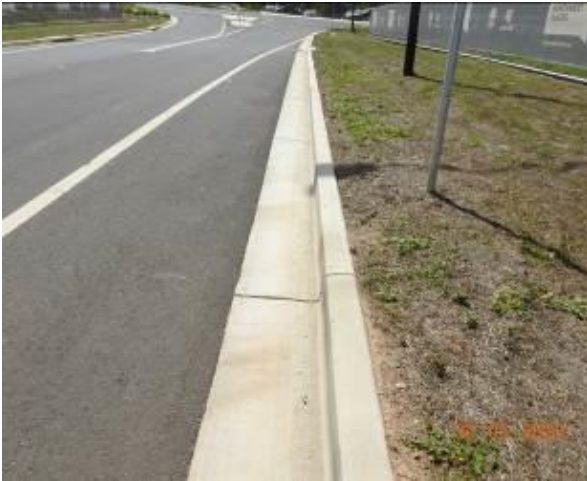
Figure 463 – General Condition of kerb and gutter

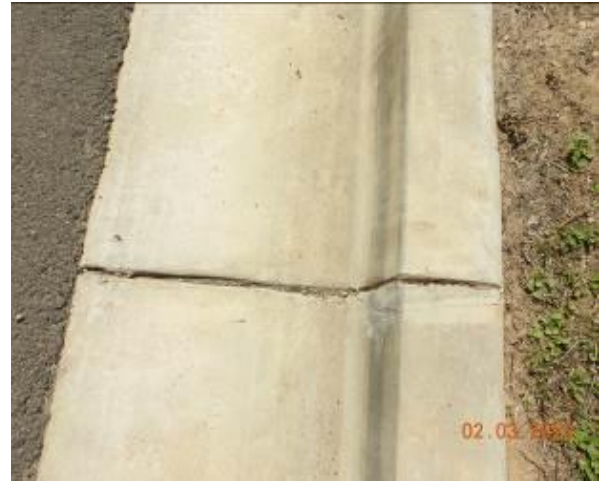
Figure 464 – Crack propagation through kerb and gutter

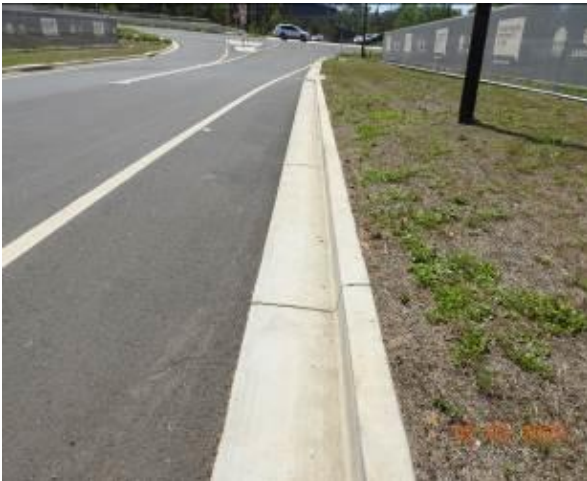
Figure 465 – General Condition of kerb and gutter

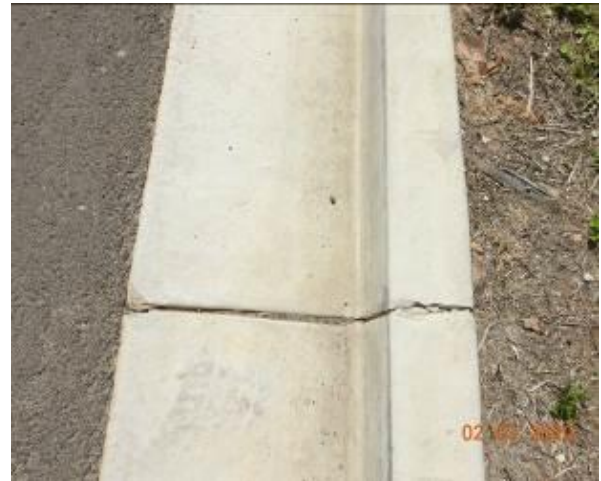
Figure 466 – Crack propagation through kerb and gutter

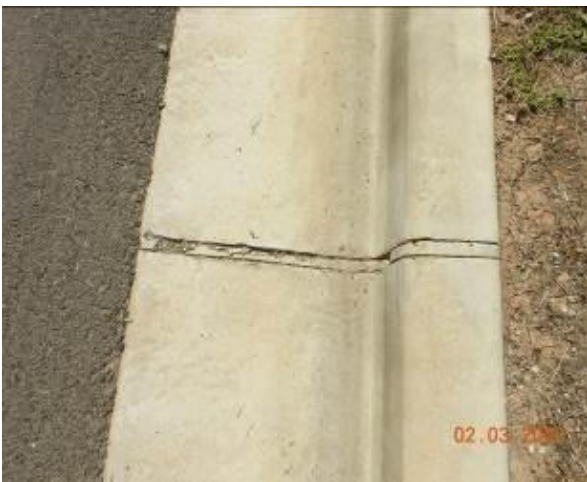
Figure 467 – Crack propagation through kerb and gutter

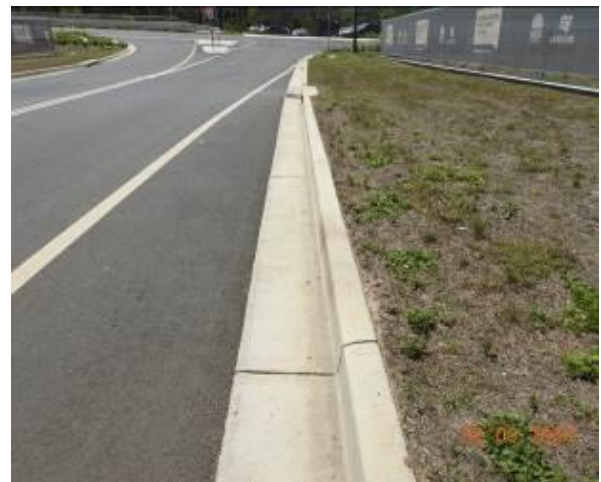
Figure 468 – General Condition of kerb and gutter

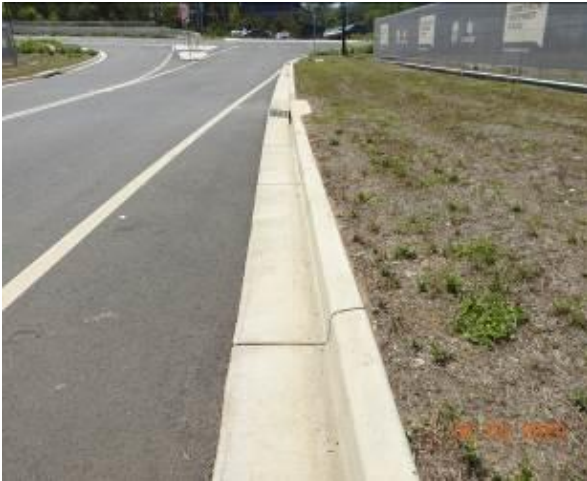
Figure 469 – General Condition of kerb and gutter

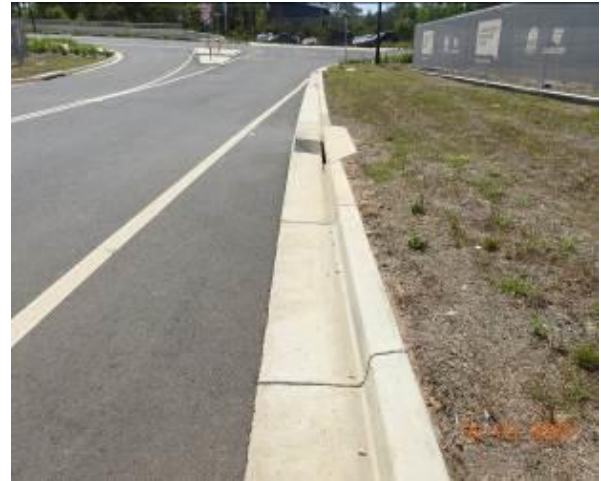
Figure 470 – General Condition of kerb and gutter

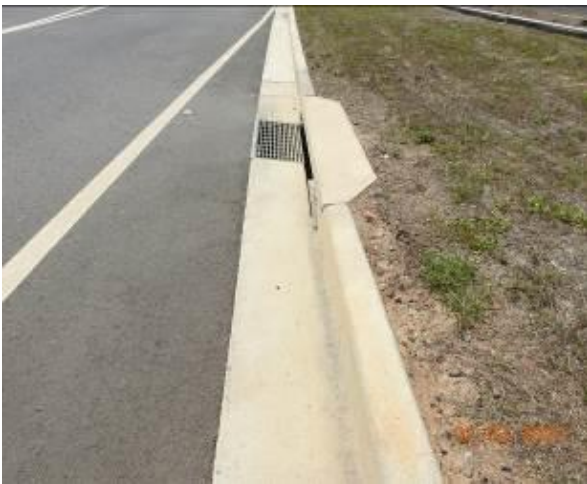
Figure 471 – General Condition of kerb and gutter

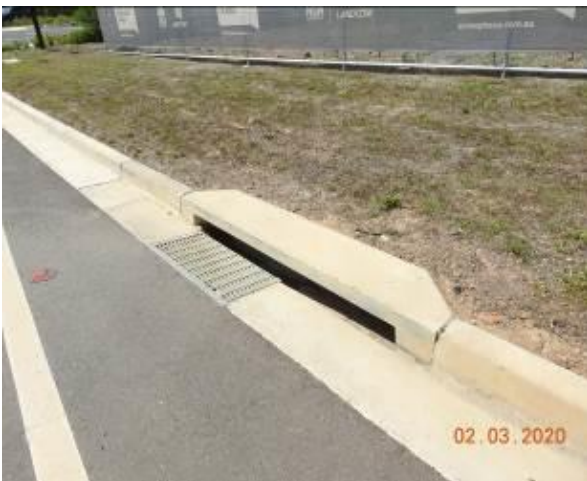
Figure 473 – General Condition of stormwater inlet pit

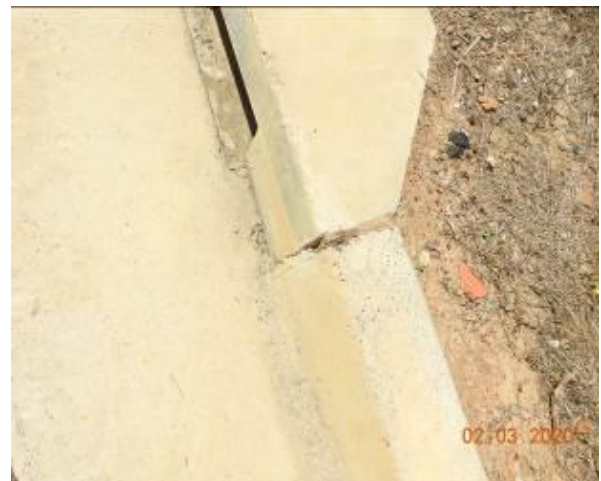
Figure 474 – Crack propagation through stormwater inlet pit

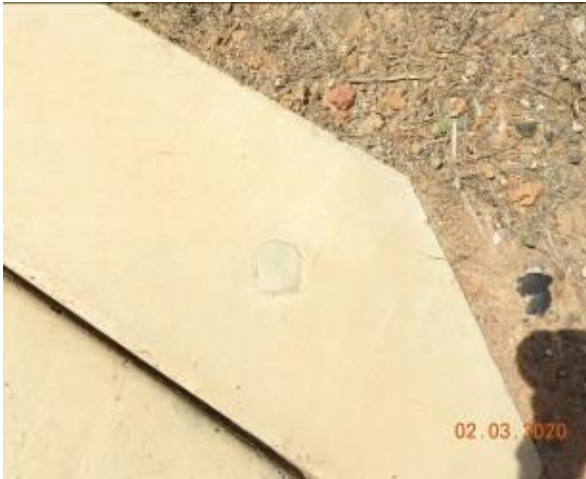
Figure 475 – Crack propagation through stormwater inlet pit

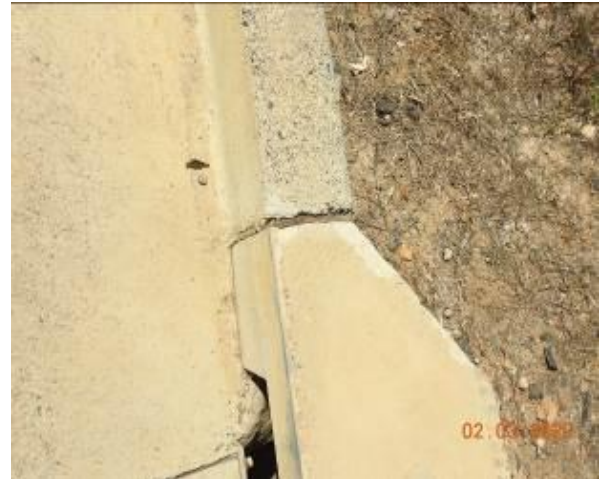
Figure 476 – Crack propagation through stormwater inlet pit

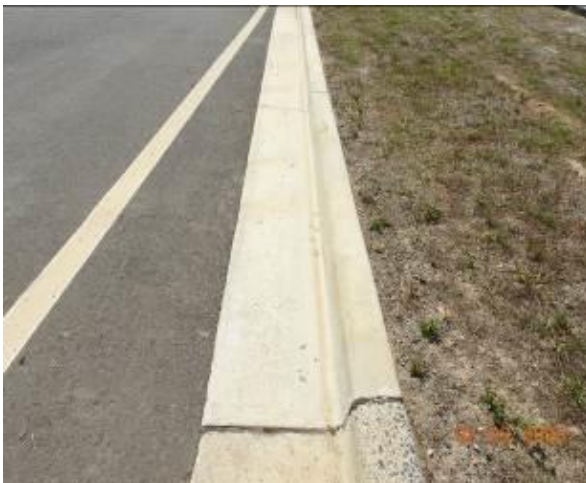
Figure 477 – General Condition of kerb and gutter

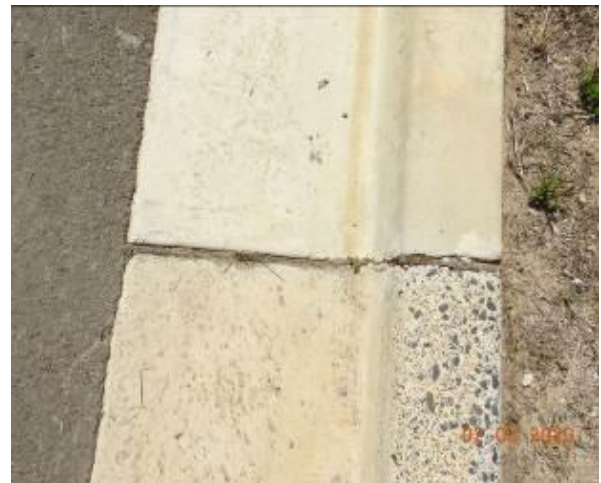
Figure 478 – Crack propagation through kerb and gutter

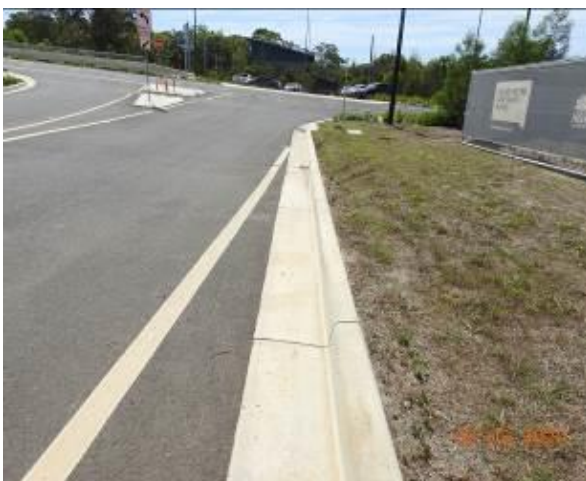
Figure 479 – General Condition of kerb and gutter

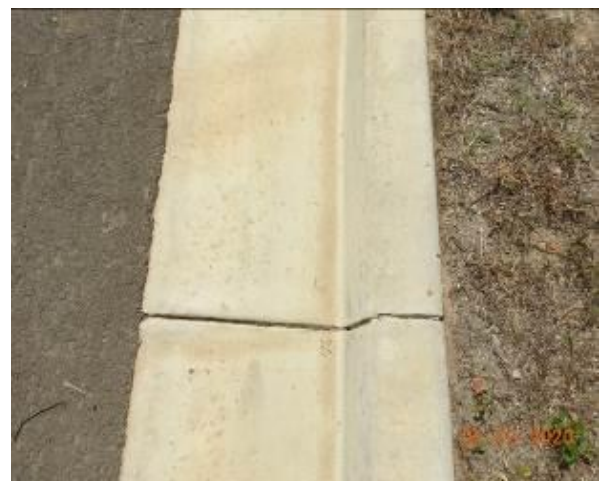
Figure 480 – Crack propagation through kerb and gutter

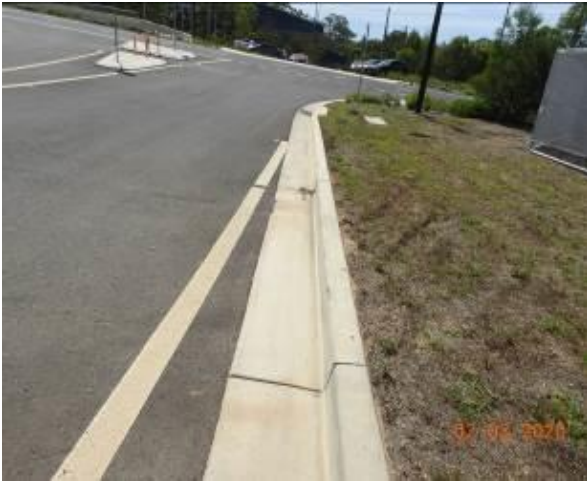
Figure 481 – General Condition of kerb and gutter

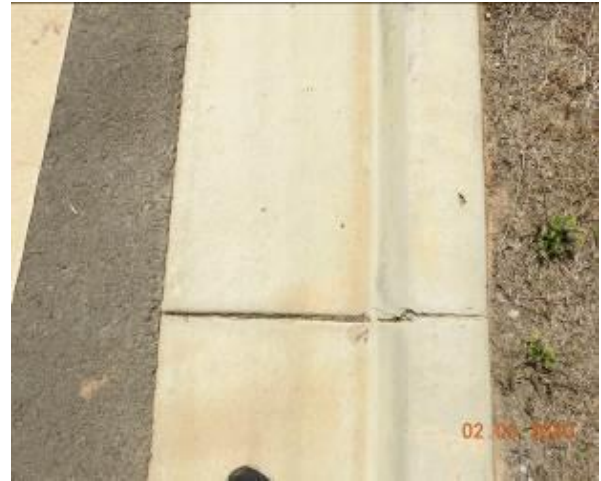
Figure 482 – General Condition of kerb and gutter

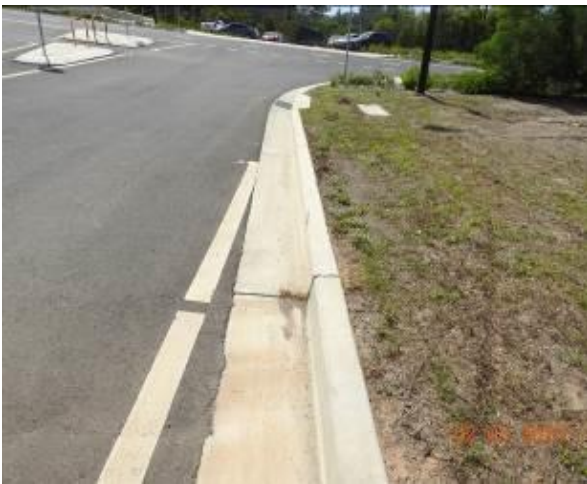
Figure 483 – General Condition of kerb and gutter

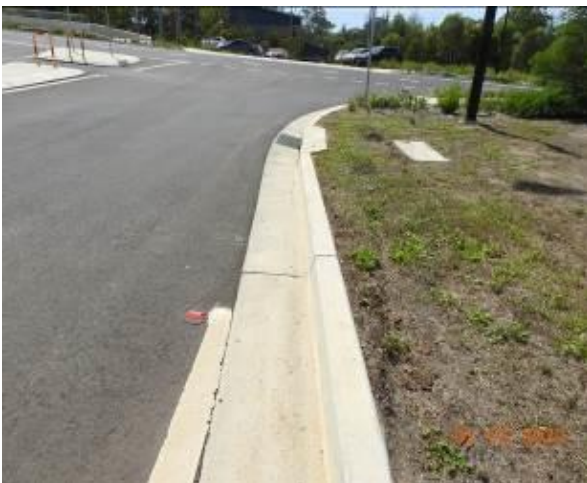
Figure 485 – General Condition of kerb and gutter

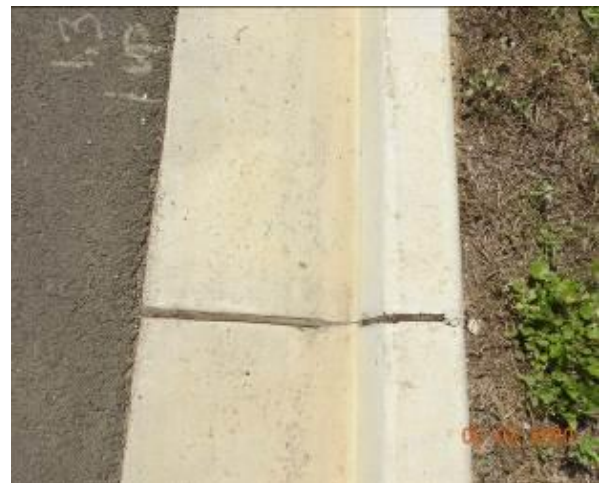
Figure 486 – Crack propagation through kerb and gutter

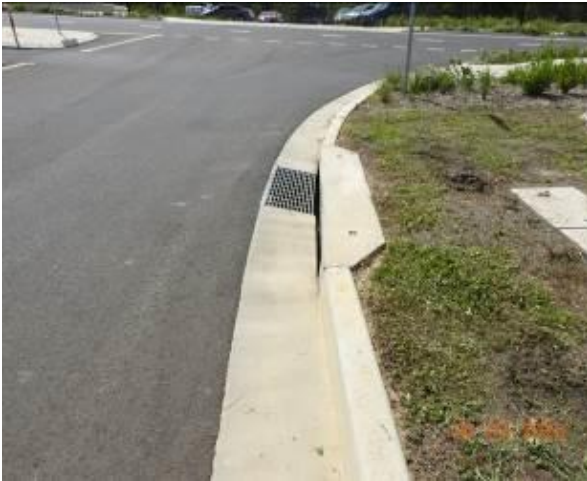
Figure 487 – General Condition of kerb and gutter

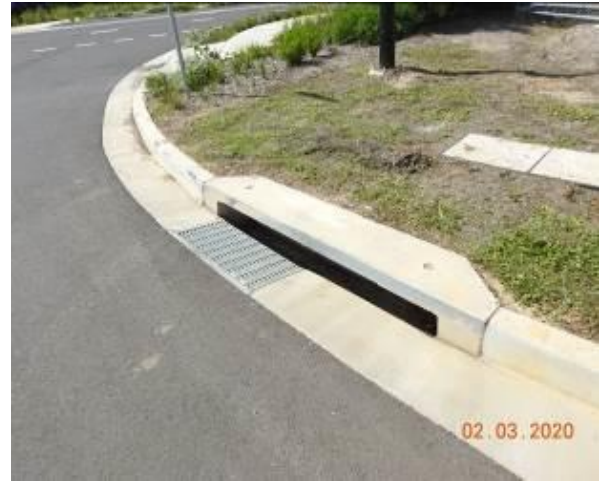
Figure 488 – General Condition of stormwater inlet pit

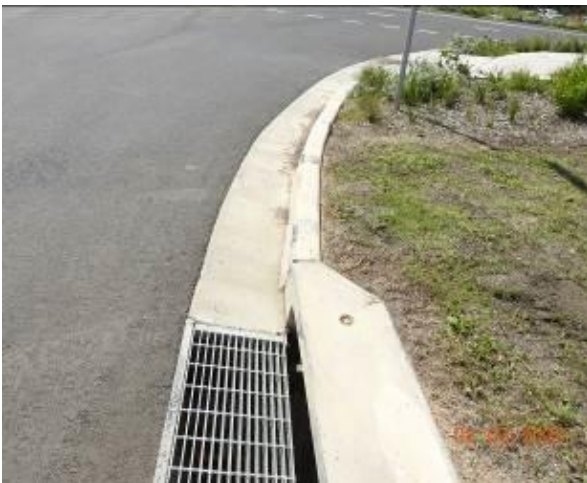
Figure 489 – General Condition of stormwater inlet pit

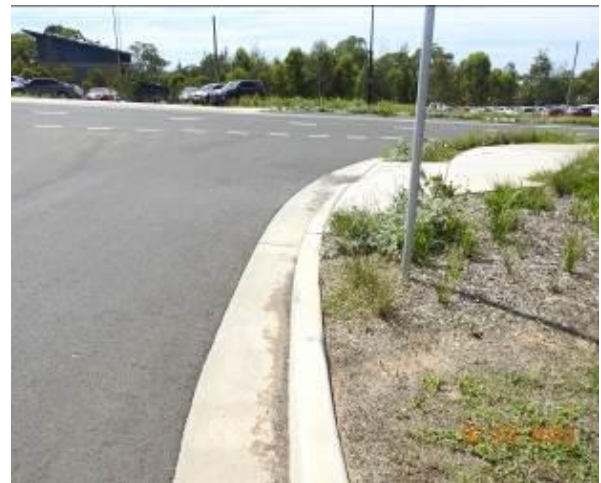
Figure 490 – General Condition of kerb and gutter

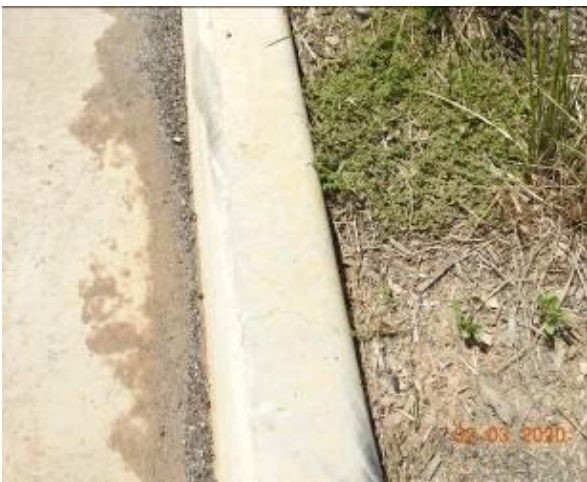
Figure 491 – Crack propagation through kerb

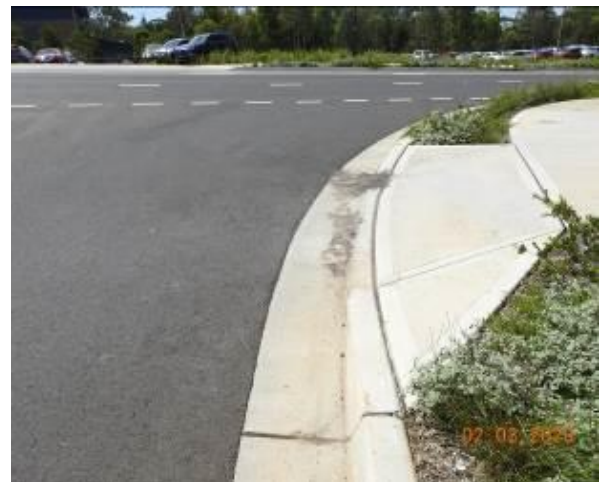
Figure 492 – General Condition of layback and gutter

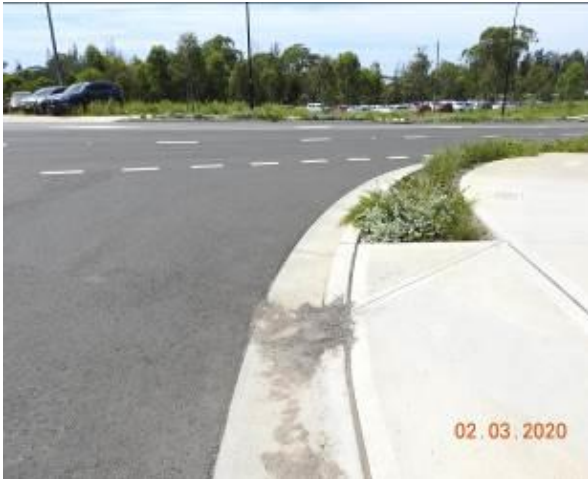
Figure 493 – General Condition of layback and gutter

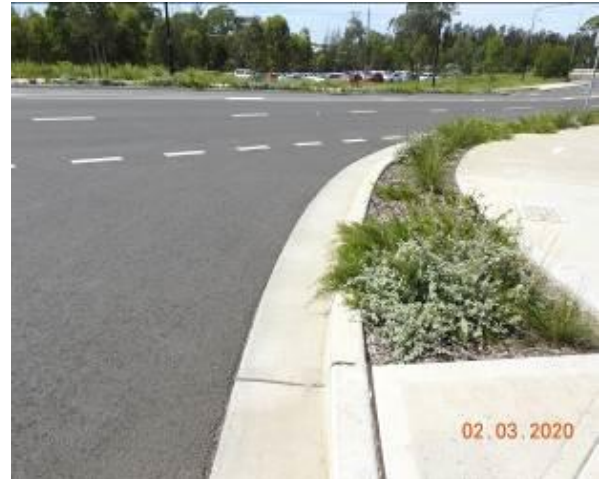
Figure 494 – General Condition of kerb and gutter
