**1-15 AND 2-12 CONFERTA AVENUE,  
ROUSE HILL NSW 2155  
TALLAWONG STATION PRECINCT SOUTH  
PRE-DILAPIDATION REPORT**

**DEICORP PROJECTS  
(TALLAWONG STATION) PTY LTD**

Job No. 191294.0  
05/07/2021

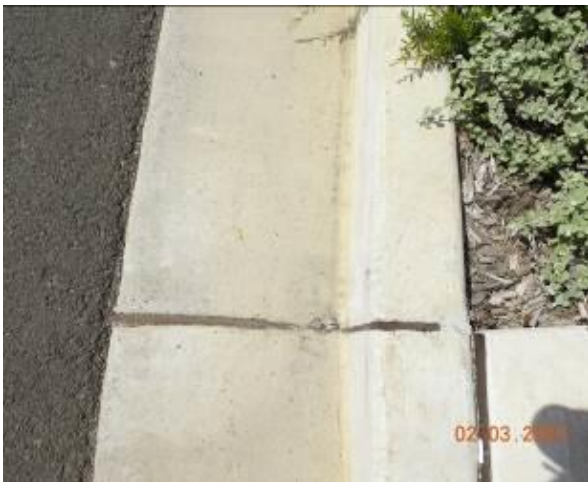
Figure 495 – Crack propagation through kerb and gutter

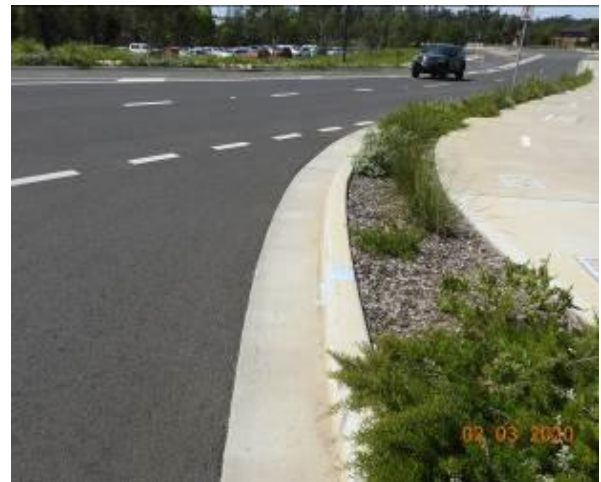
Figure 496 – General Condition of kerb and gutter

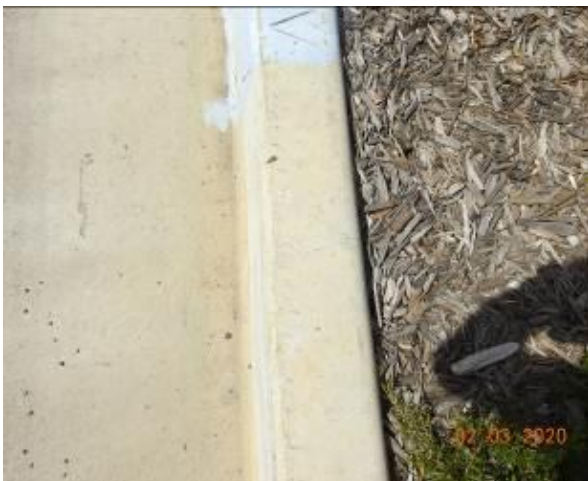
Figure 497 – Crack propagation through kerb and gutter

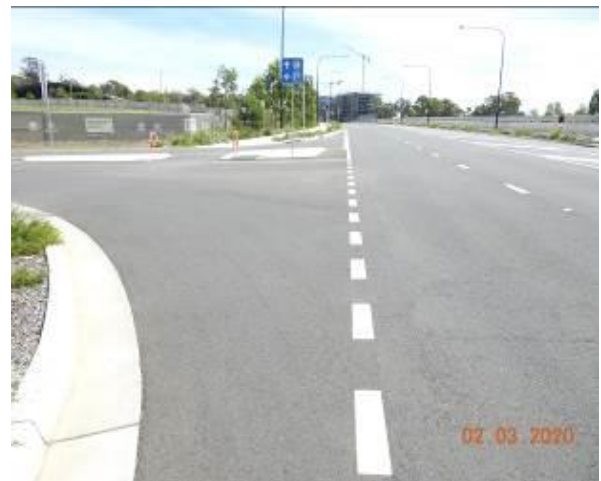
Figure 498 – General Condition of road surface

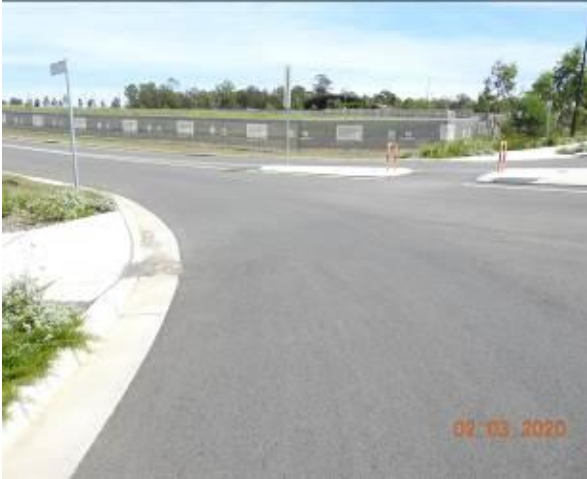
Figure 499 – General Condition of road surface

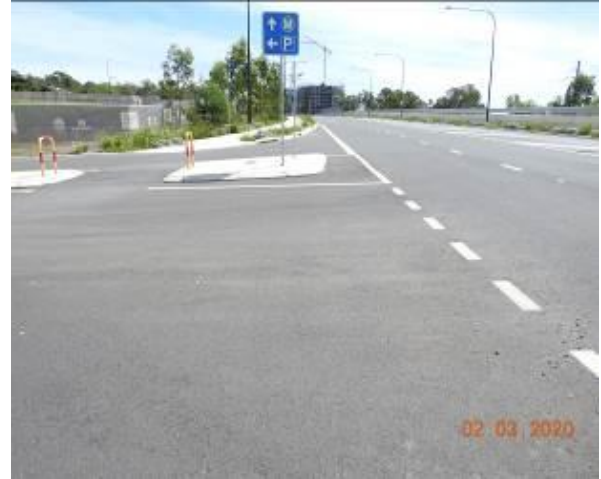
Figure 500 – General Condition of road surface

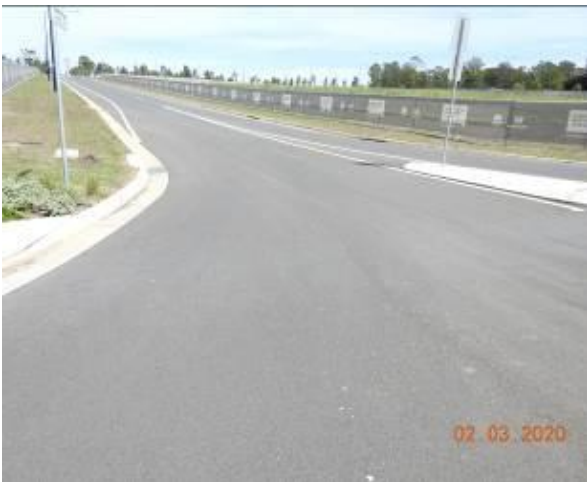
Figure 501 – General Condition of road surface

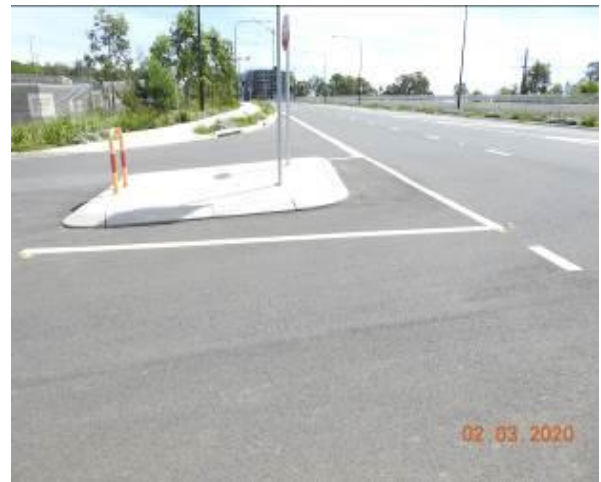
Figure 502 – General Condition of traffic island

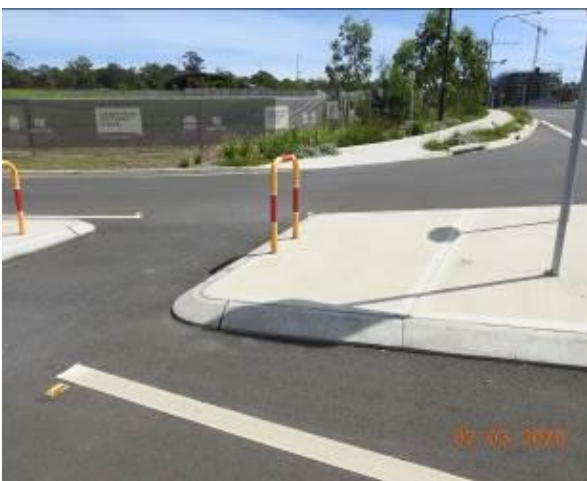
Figure 503 – General Condition of traffic island

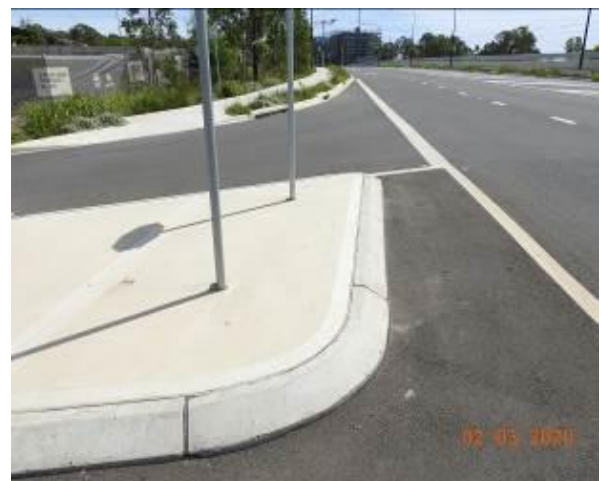
Figure 504 – General Condition of traffic island

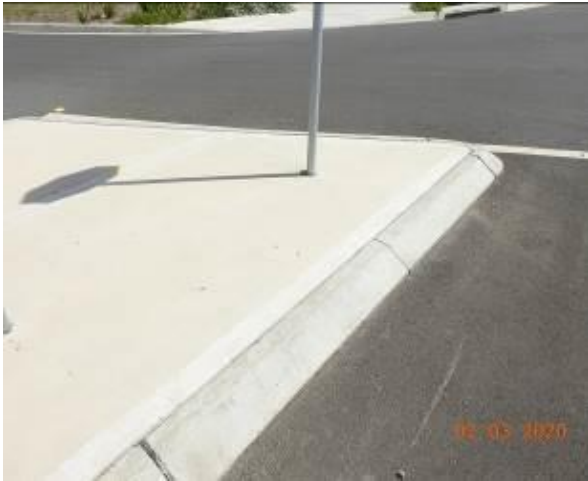
Figure 505 – General Condition of traffic island

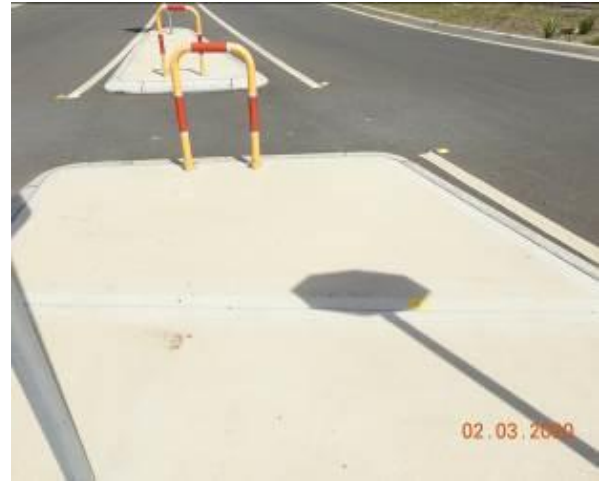
Figure 506 – General Condition of traffic island

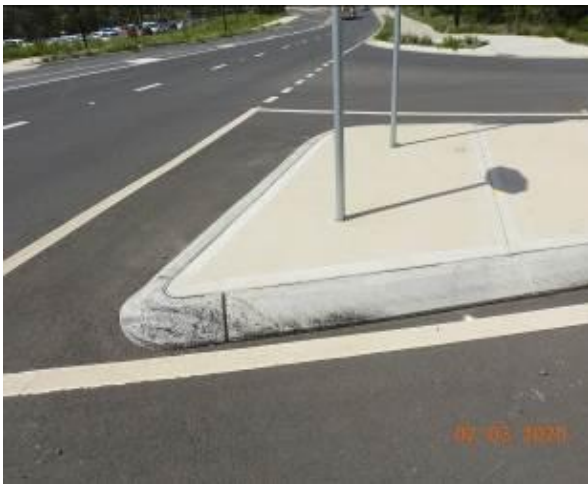
Figure 507 – General Condition of traffic island

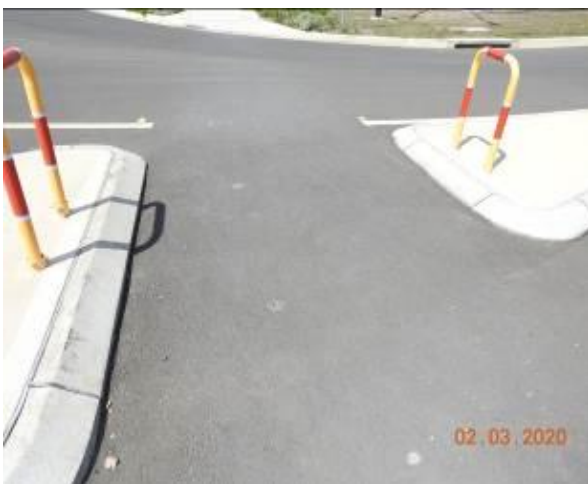
Figure 509 – General Condition of traffic island

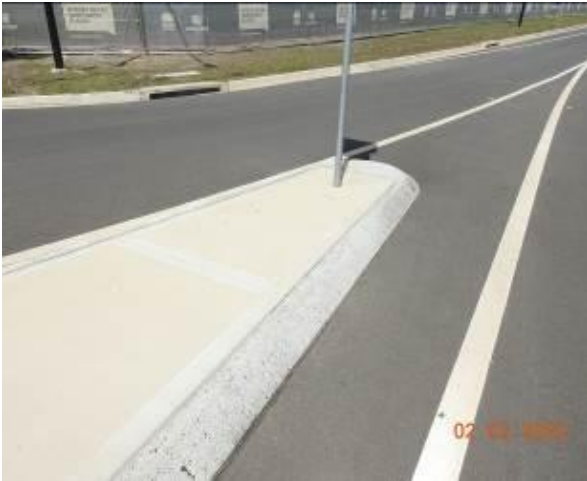
Figure 511 – General Condition of traffic island

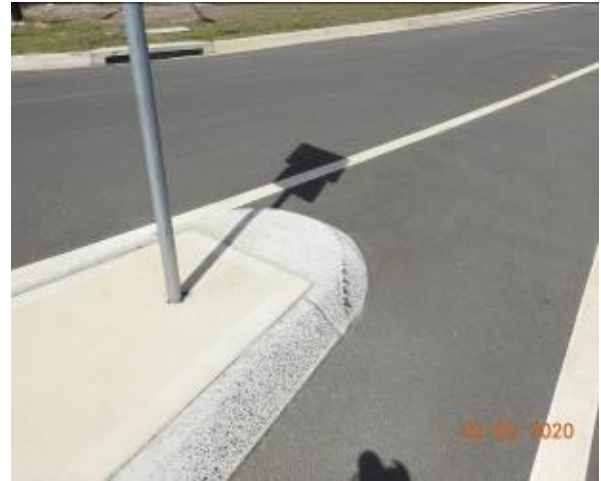
Figure 512 – General Condition of traffic island

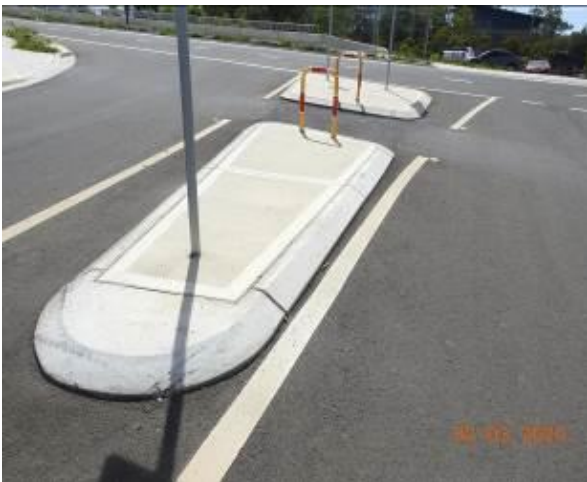
Figure 513 – General Condition of traffic island

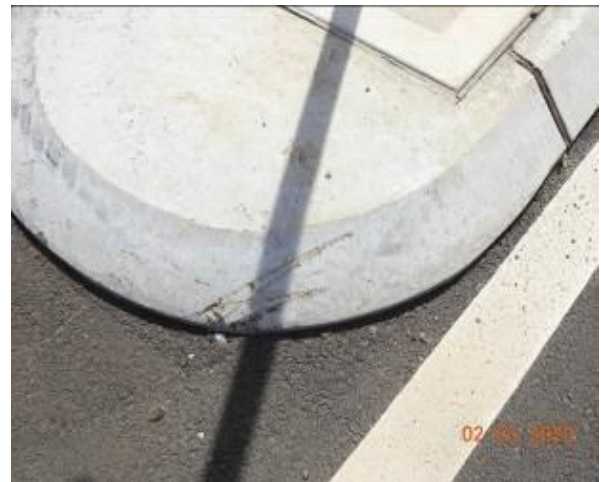
Figure 514 – Crack propagation through traffic island kerb

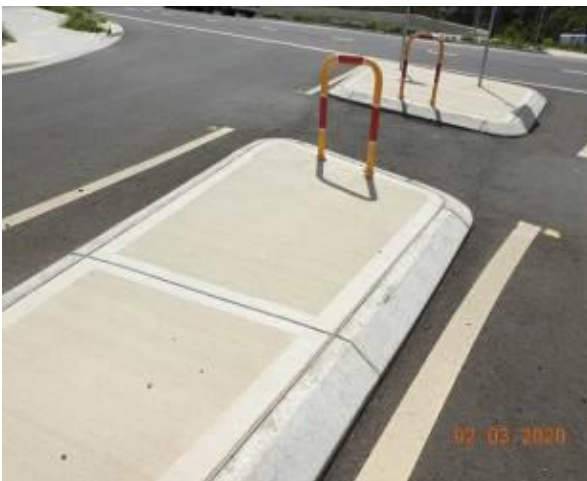
Figure 515 – General Condition of traffic island

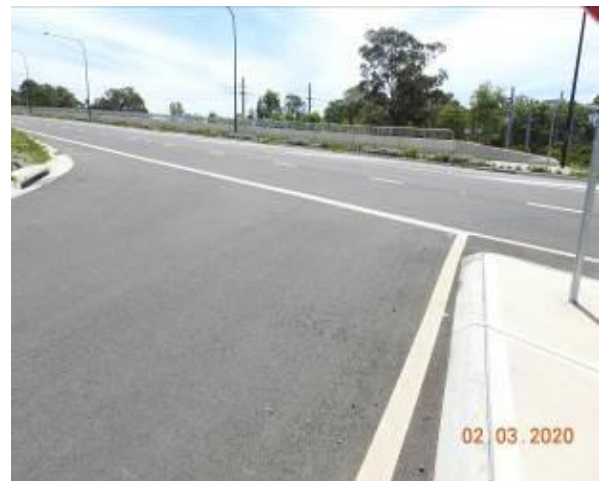
Figure 516 – General Condition of road surface

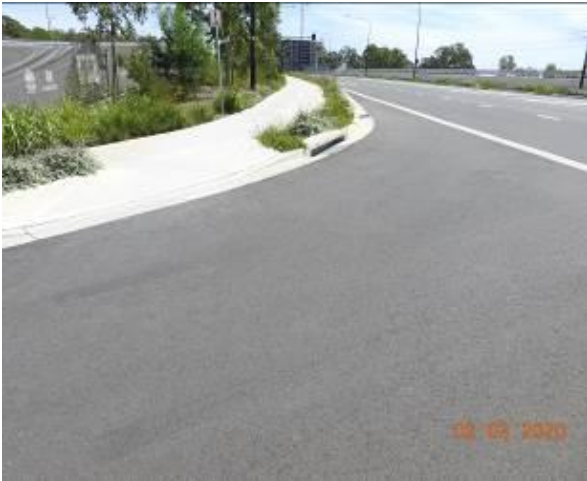
Figure 517 – General Condition of road surface

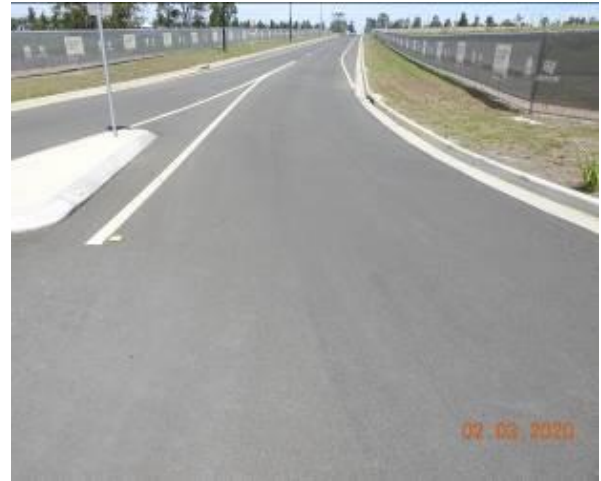
Figure 518 – General Condition of road surface

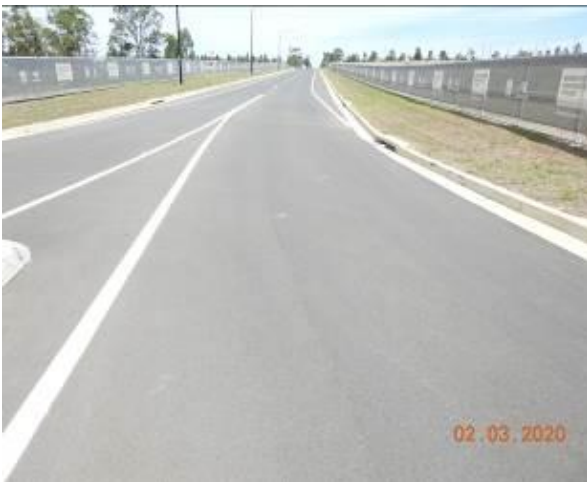
Figure 519 – General Condition of road surface

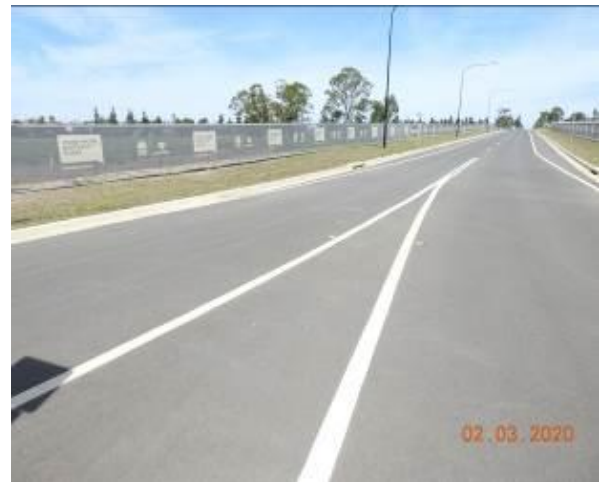
Figure 520 – General Condition of road surface

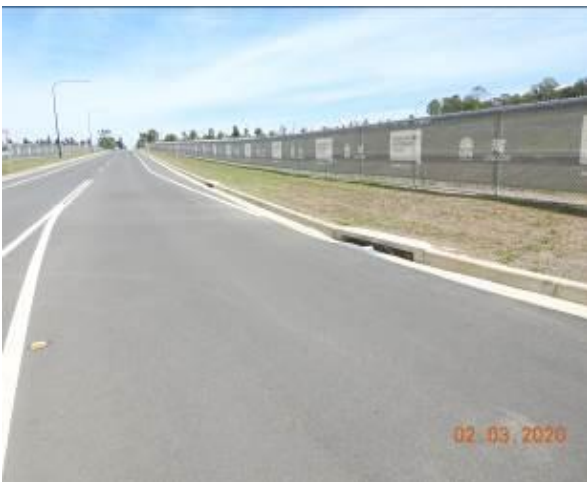
Figure 521 – General Condition of road surface

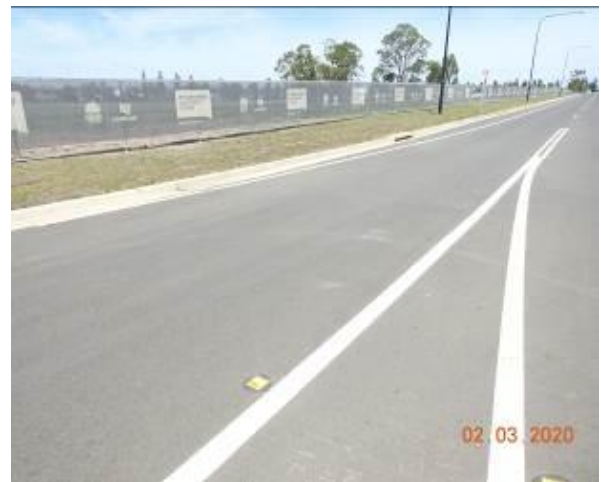
Figure 522 – General Condition of road surface

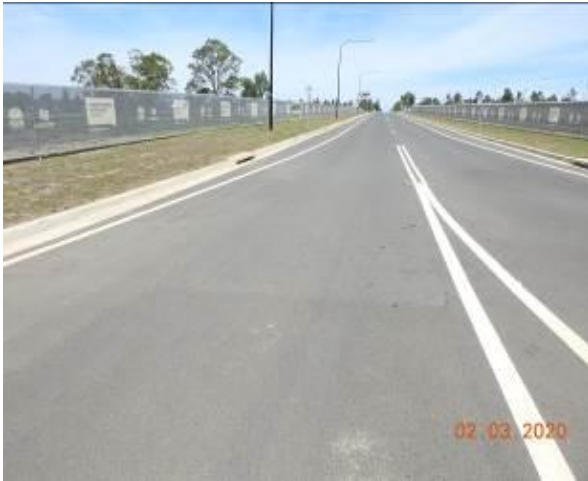
Figure 523 – General Condition of road surface

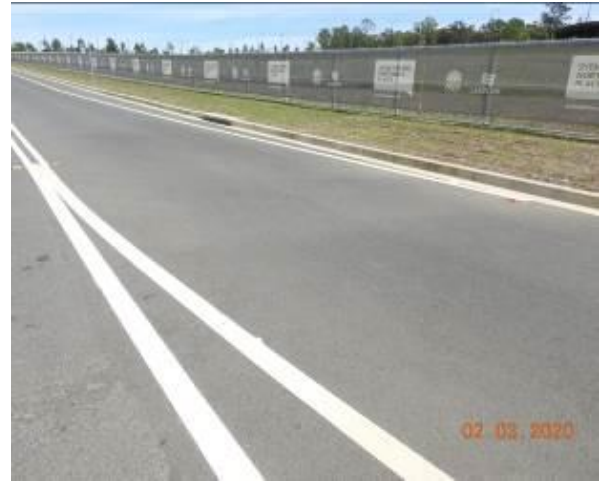
Figure 524 – General Condition of road surface

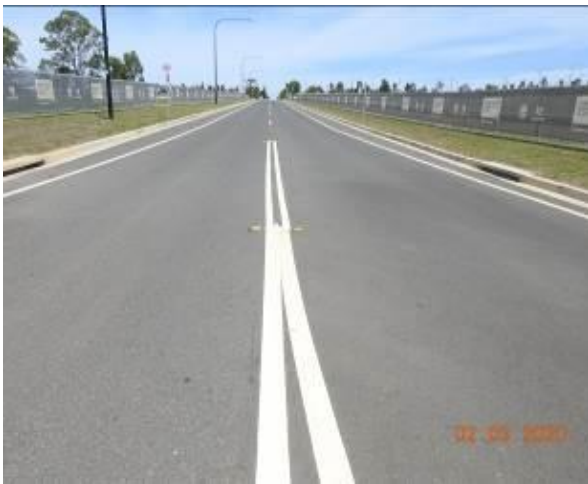
Figure 525 – General Condition of road surface

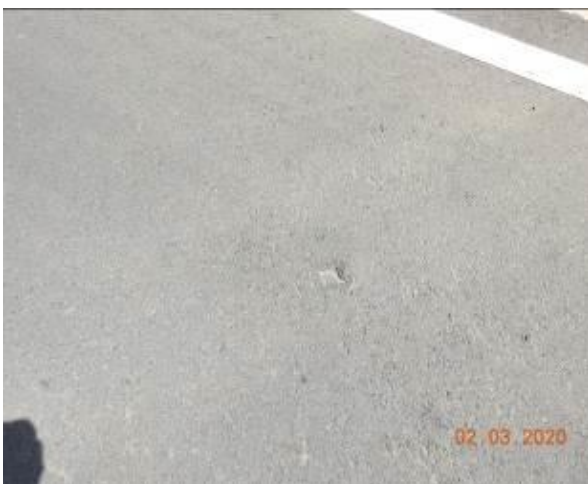
Figure 527 – Loss of material through road surface

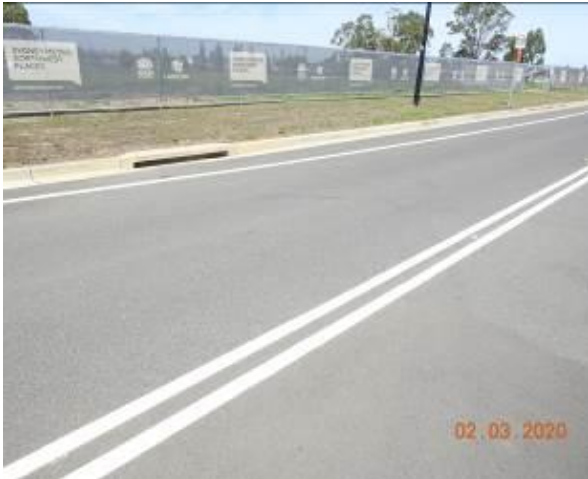
Figure 529 – General Condition of road surface

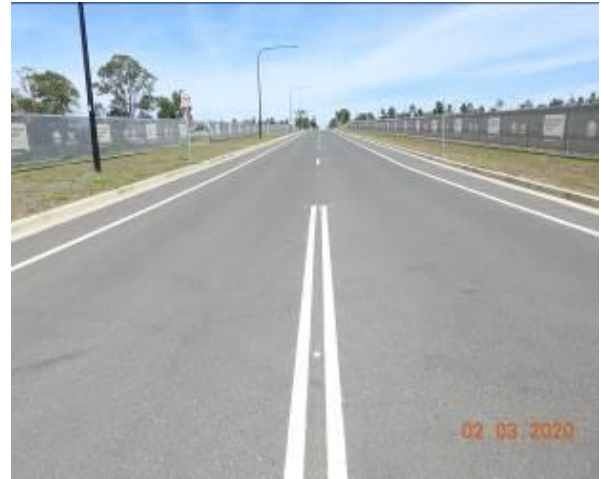
Figure 530 – General Condition of road surface

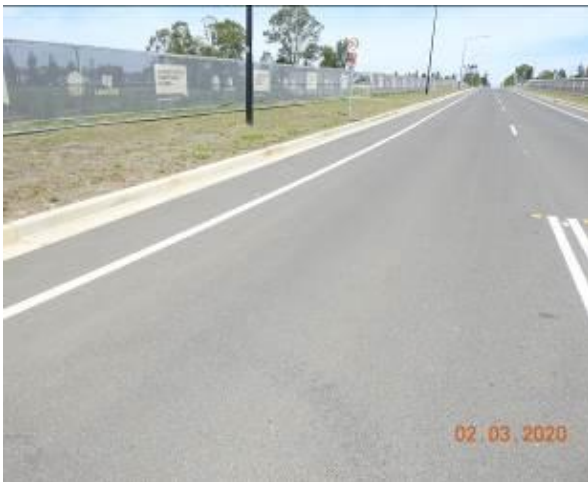
Figure 531 – General Condition of road surface

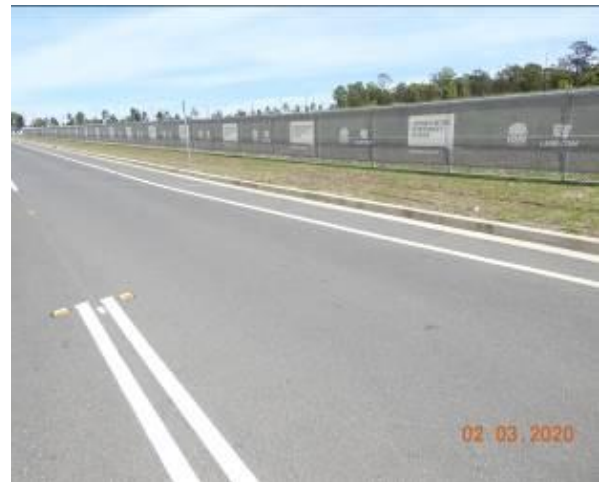
Figure 532 – General Condition of road surface

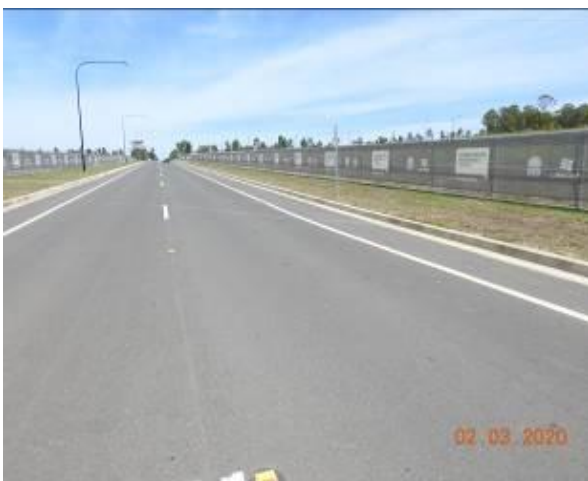
Figure 533 – General Condition of road surface

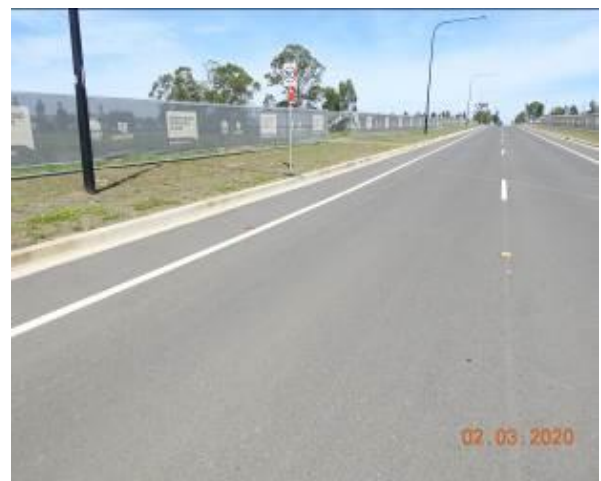
Figure 534 – General Condition of road surface

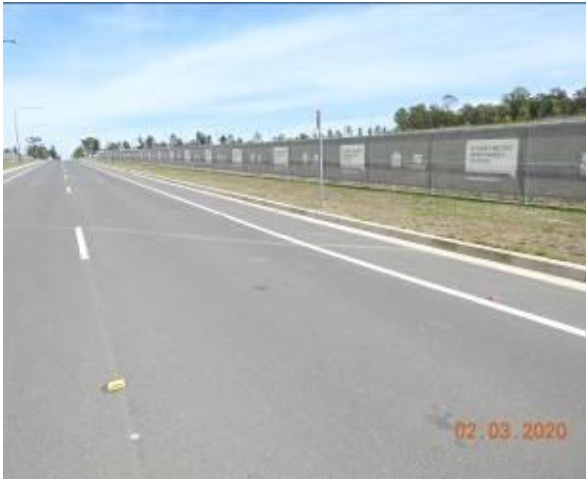
Figure 535 – General Condition of road surface

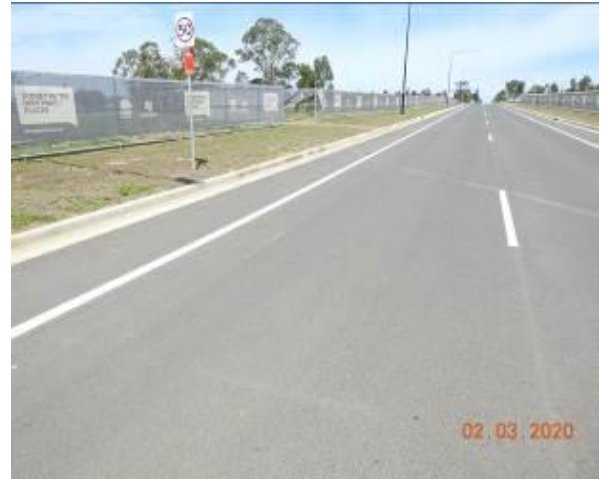
Figure 536 – General Condition of road surface

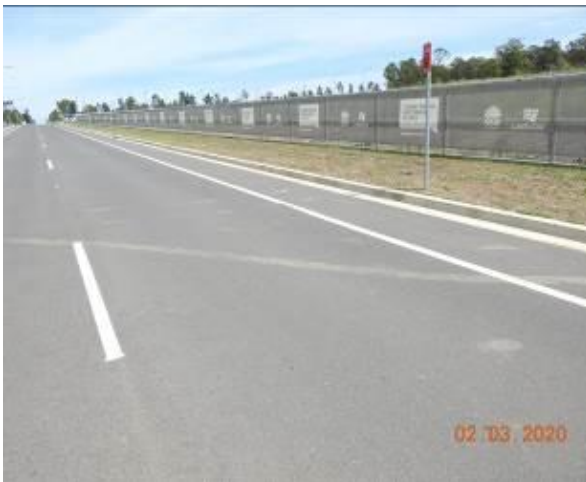
Figure 537 – General Condition of road surface

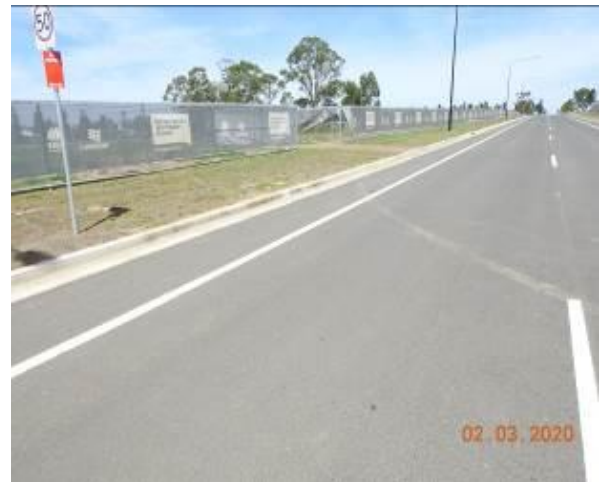
Figure 538 – General Condition of road surface

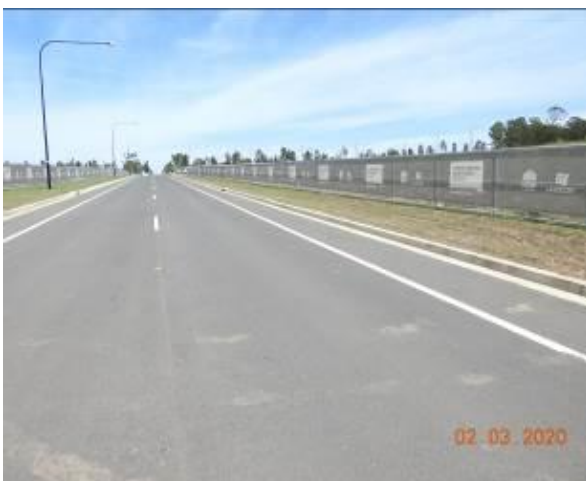
Figure 539 – General Condition of road surface

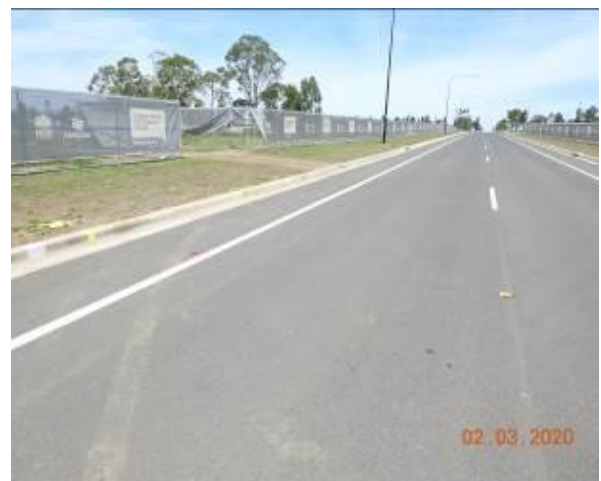
Figure 540 – General Condition of road surface

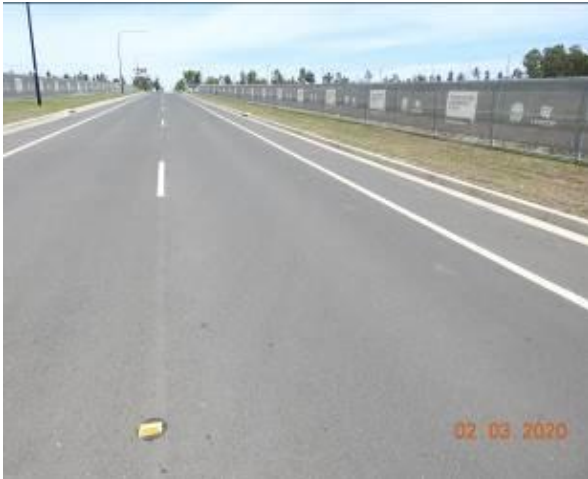
Figure 541 – General Condition of road surface

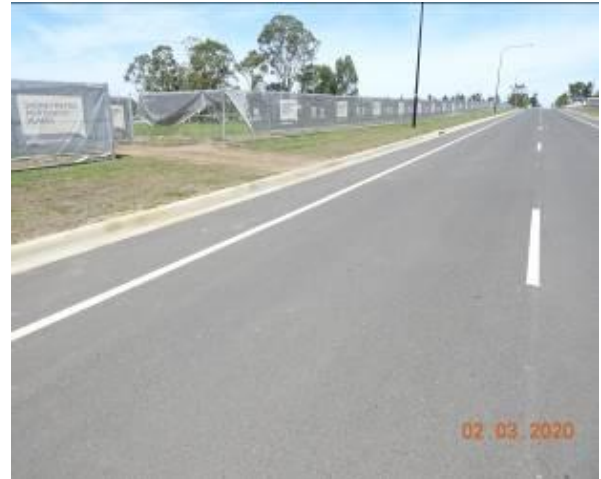
Figure 542 – General Condition of road surface

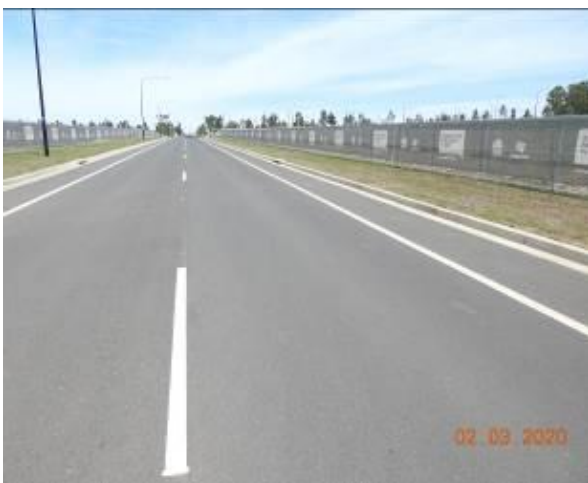
Figure 543 – General Condition of road surface

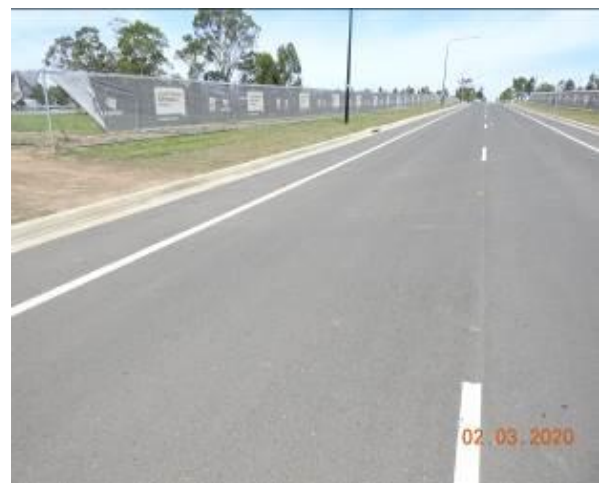
Figure 544 – General Condition of road surface

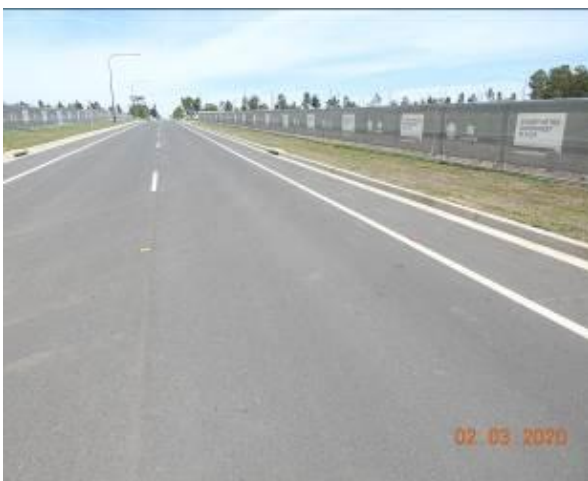
Figure 545 – General Condition of road surface

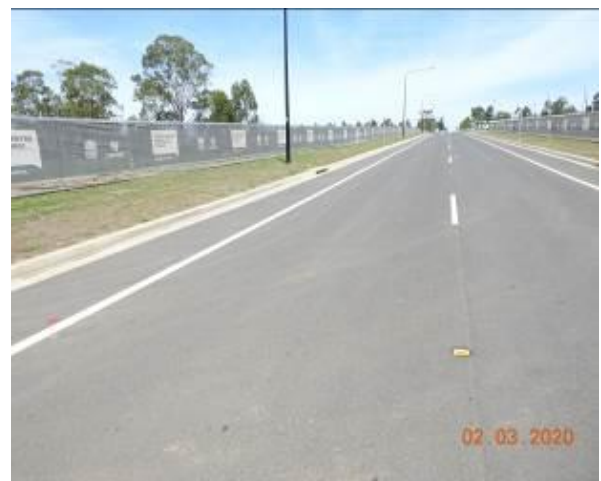
Figure 546 – General Condition of road surface

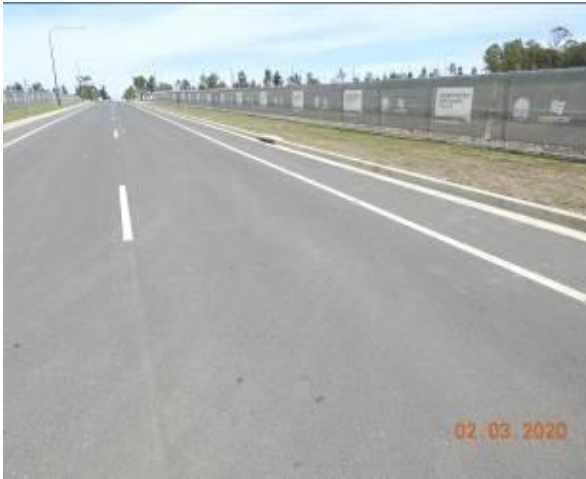
Figure 547 – General Condition of road surface

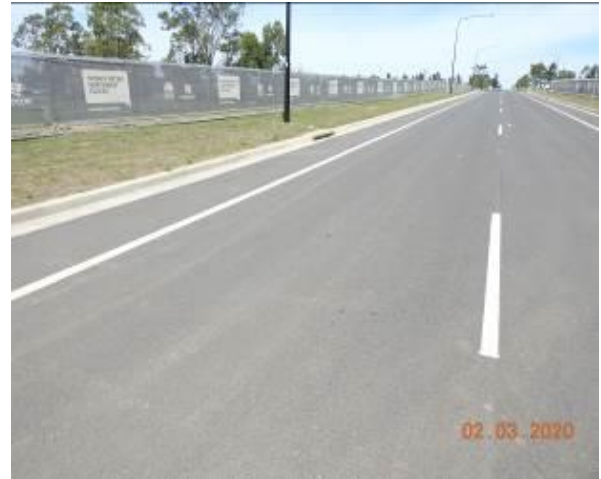
Figure 548 – General Condition of road surface

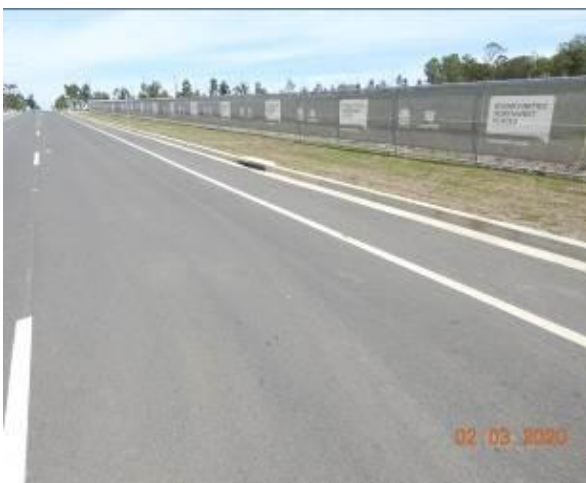
Figure 549 – General Condition of road surface

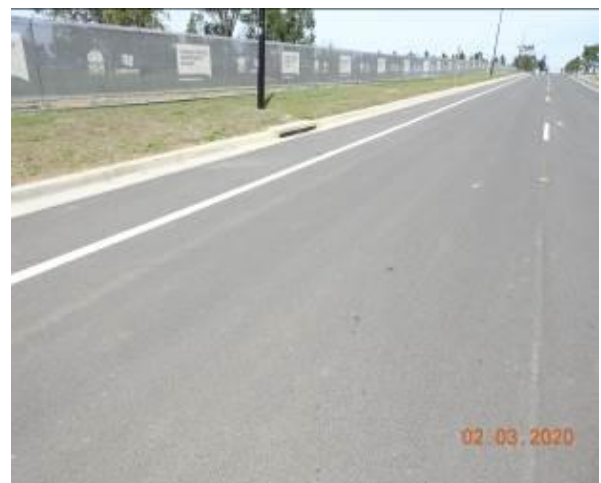
Figure 550 – General Condition of road surface

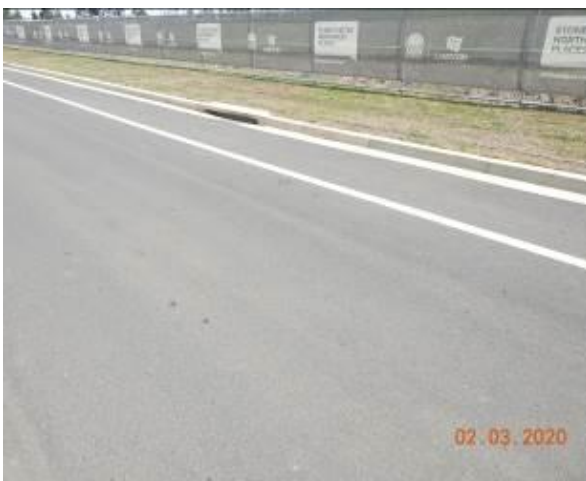
Figure 551 – General Condition of road surface

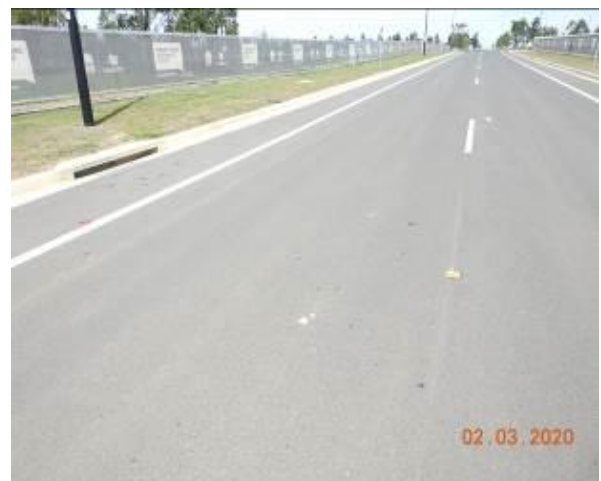
Figure 552 – General Condition of road surface

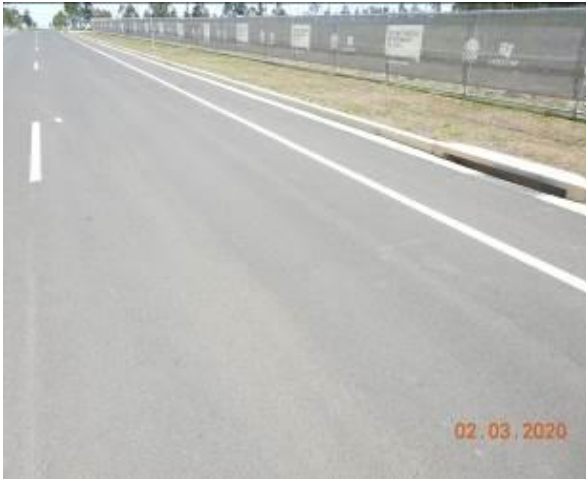
Figure 553 – General Condition of road surface

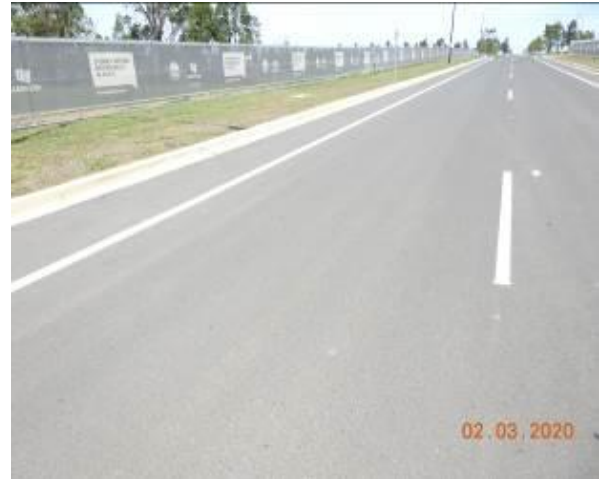
Figure 554 – General Condition of road surface

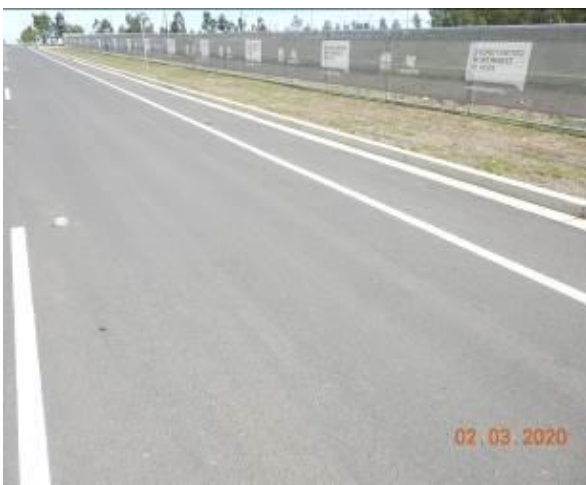
Figure 555 – General Condition of road surface

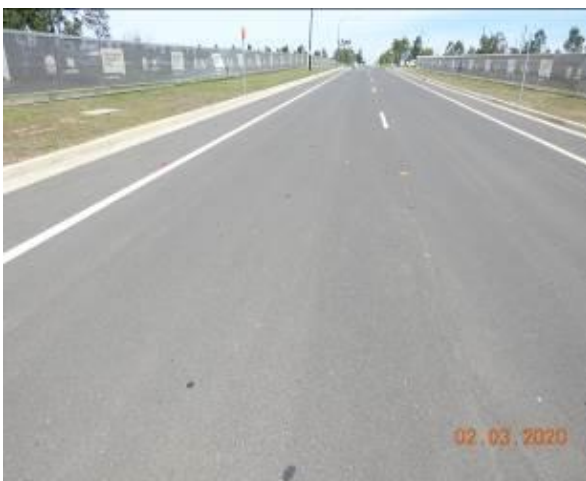
Figure 557 – General Condition of road surface

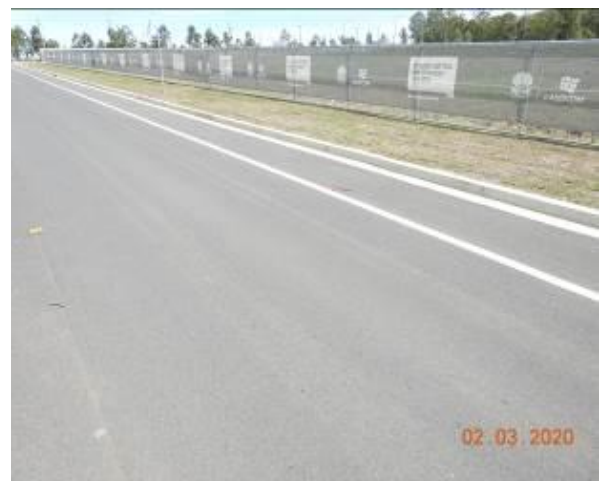
Figure 558 – General Condition of road surface

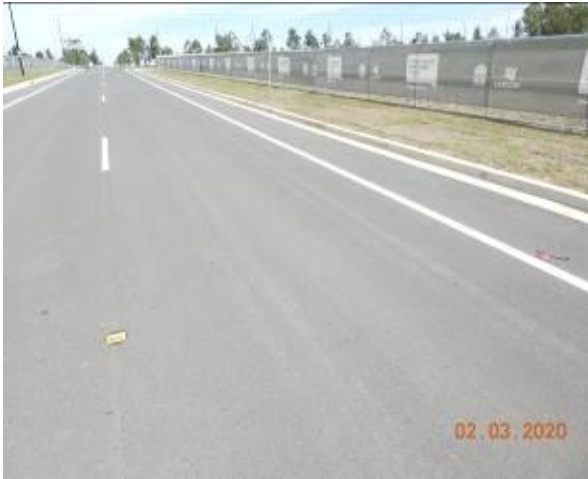
Figure 559 – General Condition of road surface

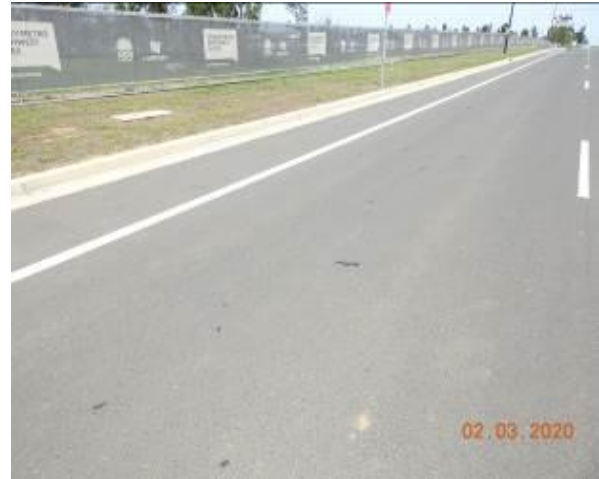
Figure 560 – General Condition of road surface

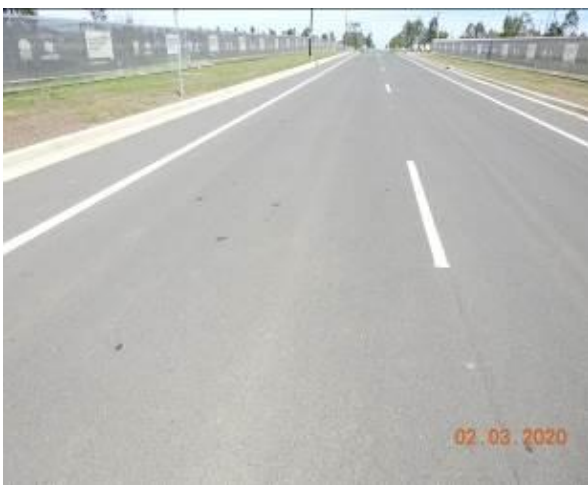
Figure 561 – General Condition of road surface

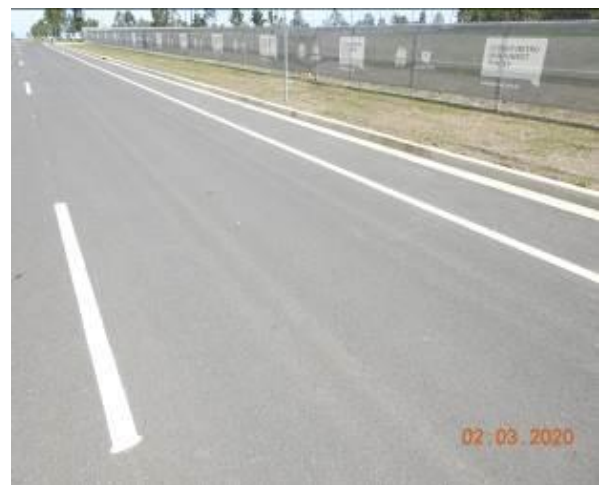
Figure 562 – General Condition of road surface

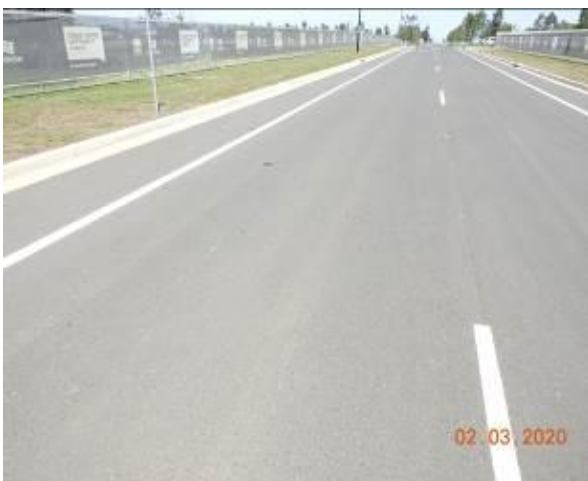
Figure 563 – General Condition of road surface

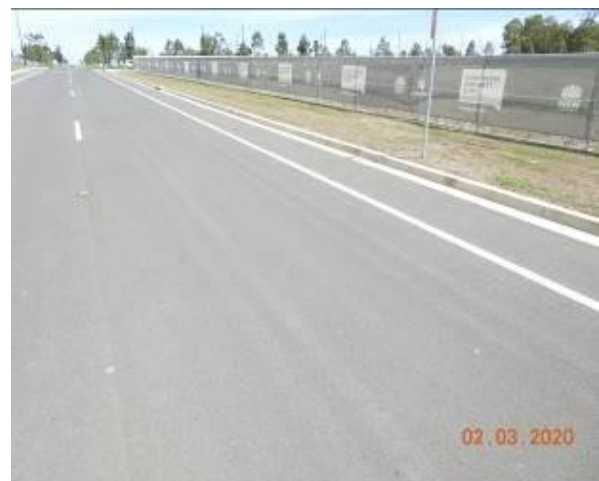
Figure 564 – General Condition of road surface

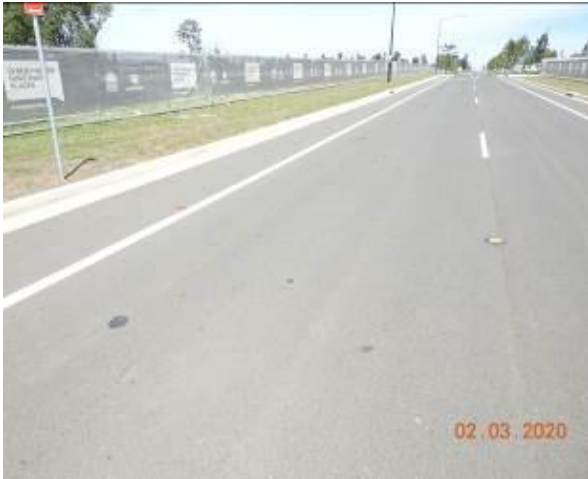
Figure 565 – General Condition of road surface

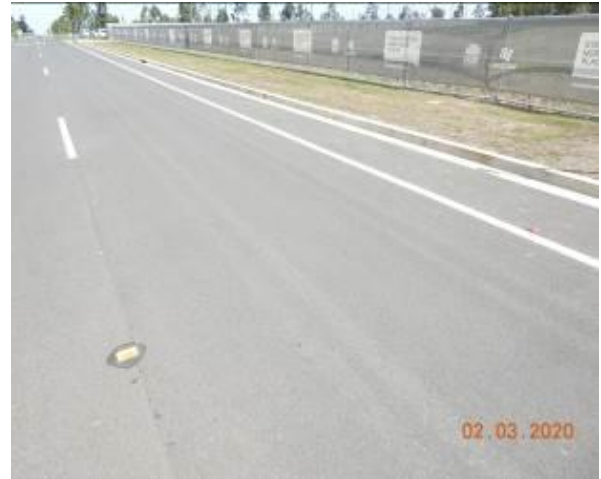
Figure 566 – General Condition of road surface

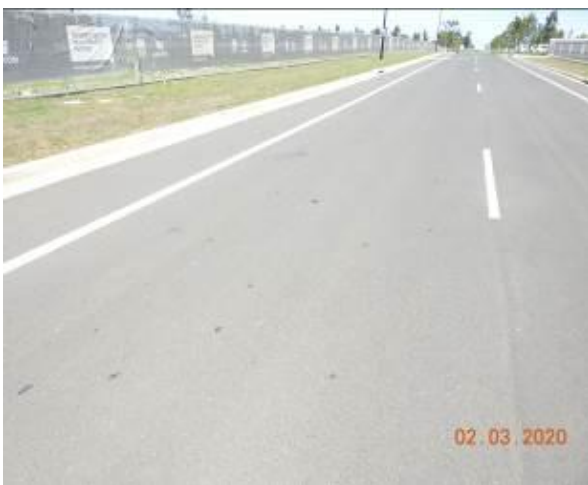
Figure 567 – General Condition of road surface

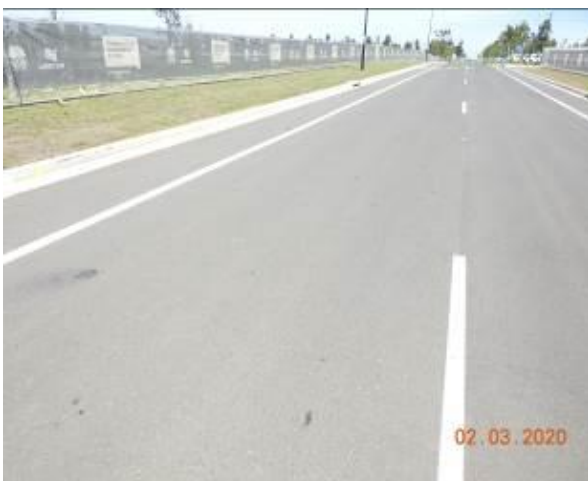
Figure 569 – General Condition of road surface

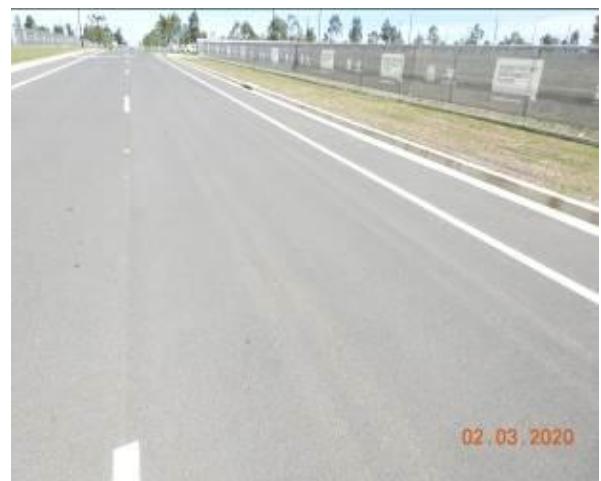
Figure 570 – General Condition of road surface

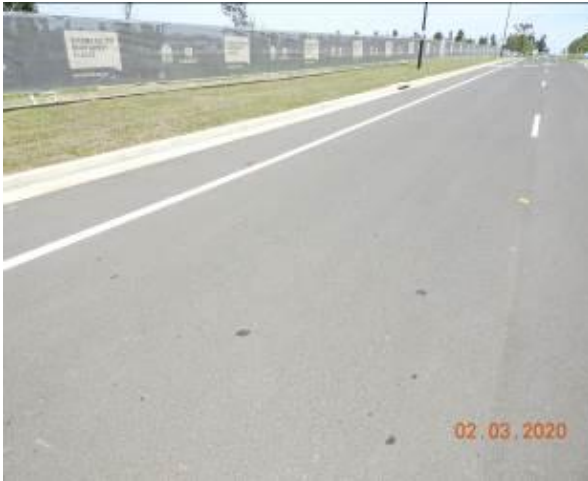
Figure 571 – General Condition of road surface

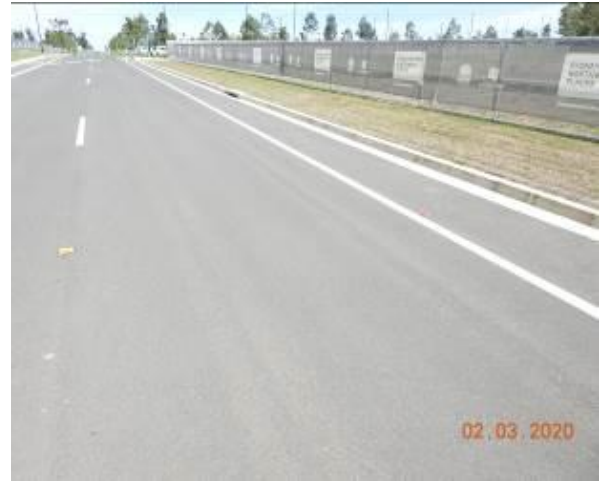
Figure 572 – General Condition of road surface

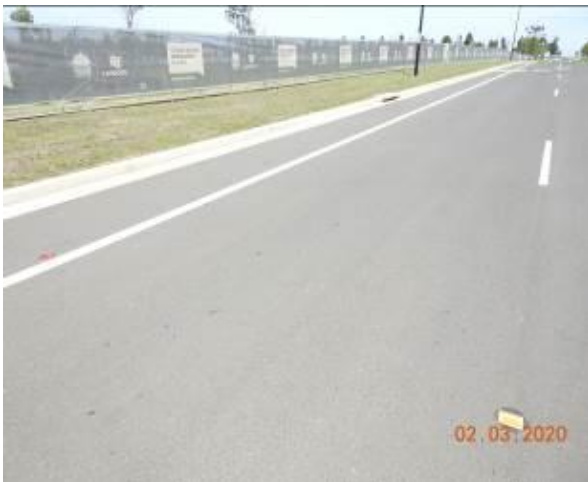
Figure 573 – General Condition of road surface

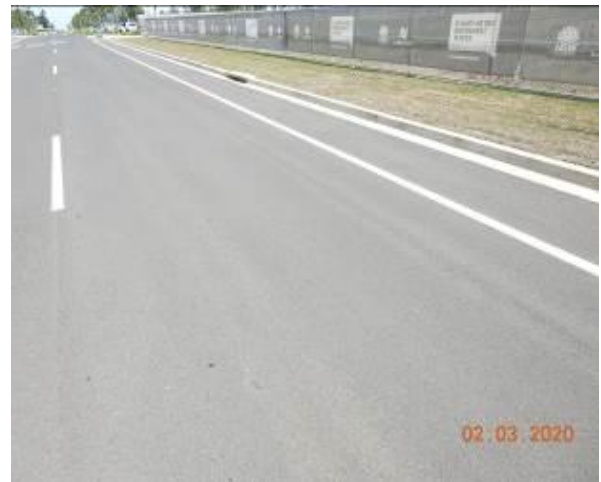
Figure 574 – General Condition of road surface

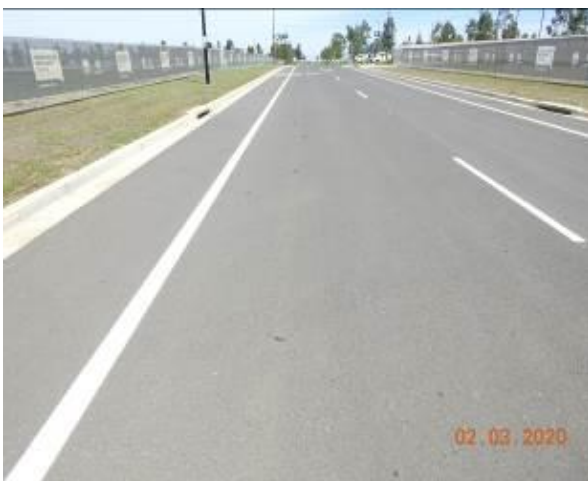
Figure 575 – General Condition of road surface

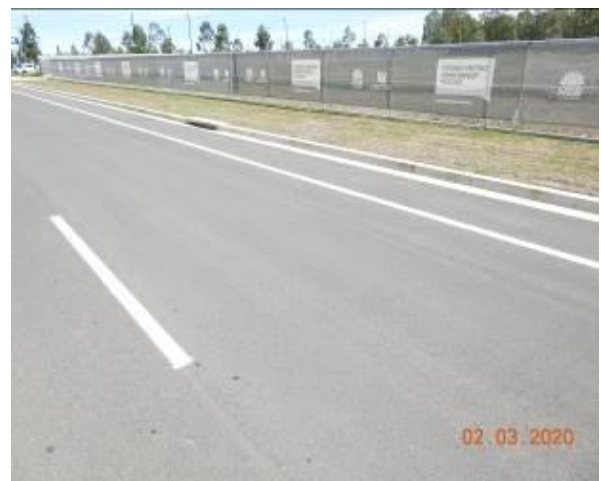
Figure 576 – General Condition of road surface

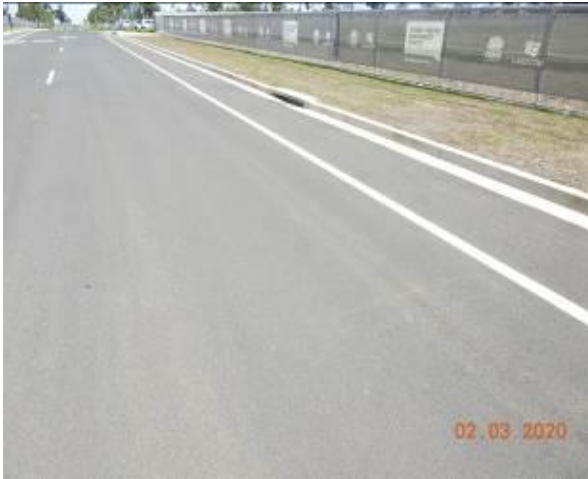
Figure 577 – General Condition of road surface
