**1-15 AND 2-12 CONFERTA AVENUE,  
ROUSE HILL NSW 2155  
TALLAWONG STATION PRECINCT SOUTH  
PRE-DILAPIDATION REPORT**

**DEICORP PROJECTS  
(TALLAWONG STATION) PTY LTD**

Job No. 191294.0  
05/07/2021

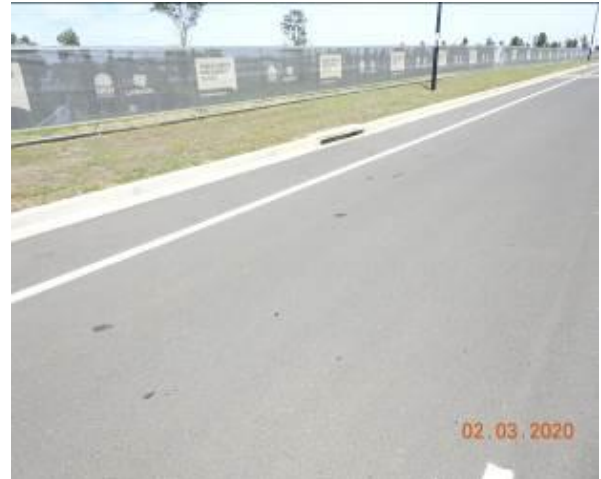
Figure 578 – General Condition of road surface

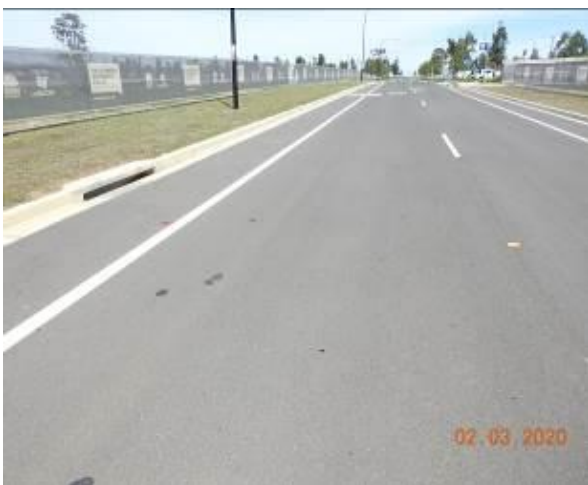
Figure 579 – General Condition of road surface

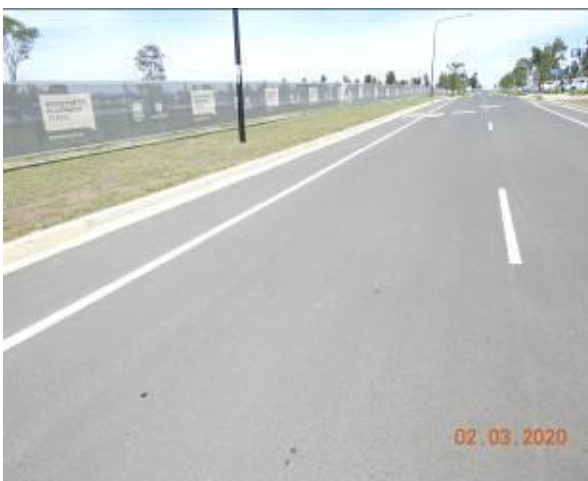
Figure 581 – General Condition of road surface

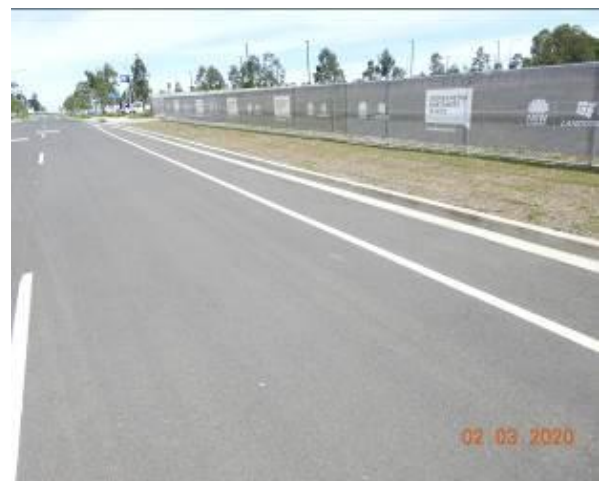
Figure 582 – General Condition of road surface

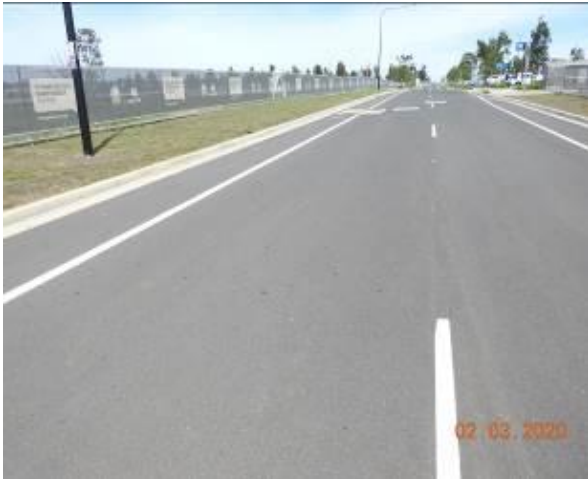
Figure 583 – General Condition of road surface

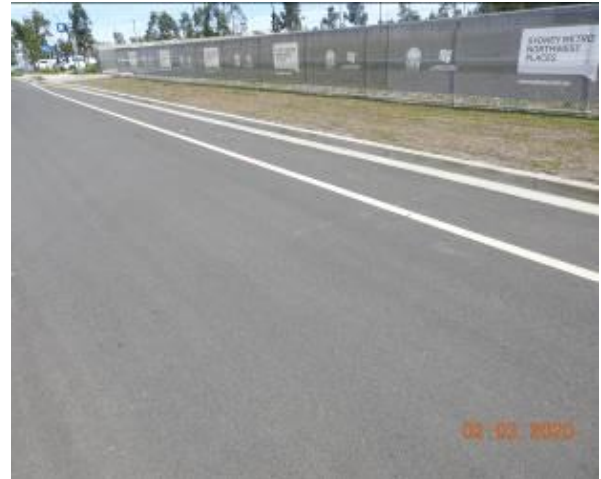
Figure 584 – General Condition of road surface

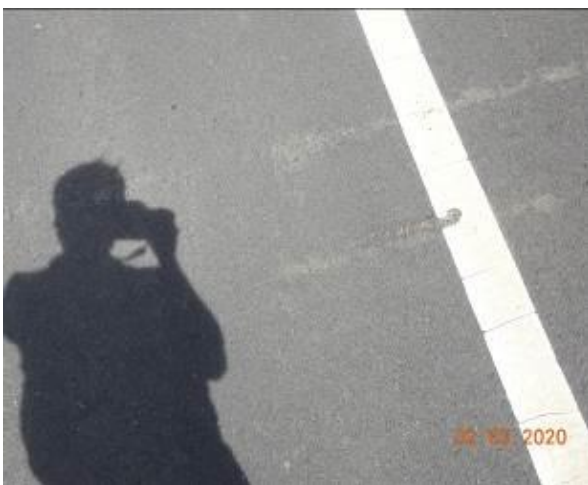
Figure 585 – Loss of material through road surface

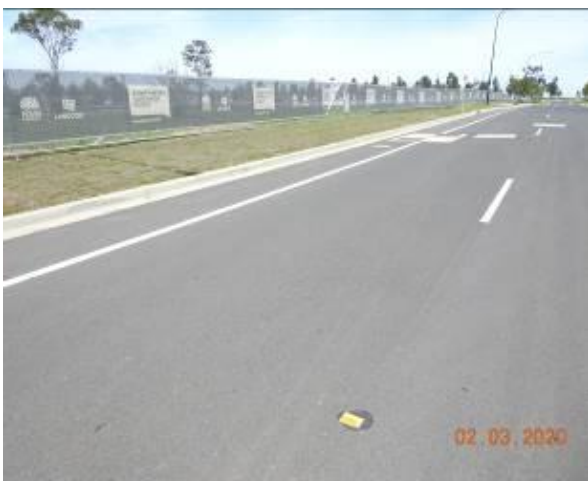
Figure 587 – General Condition of road surface

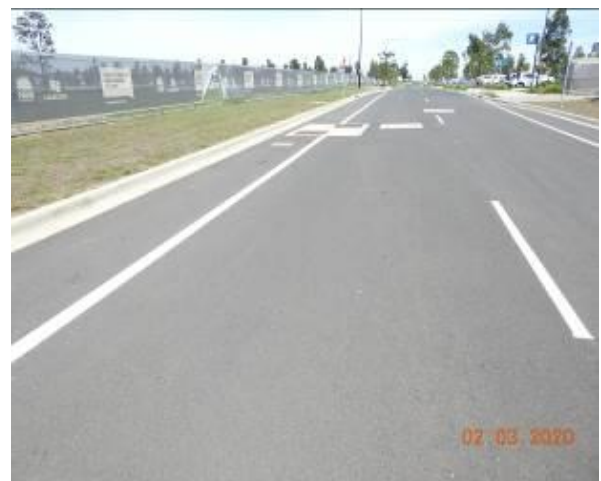
Figure 588 – General Condition of road surface

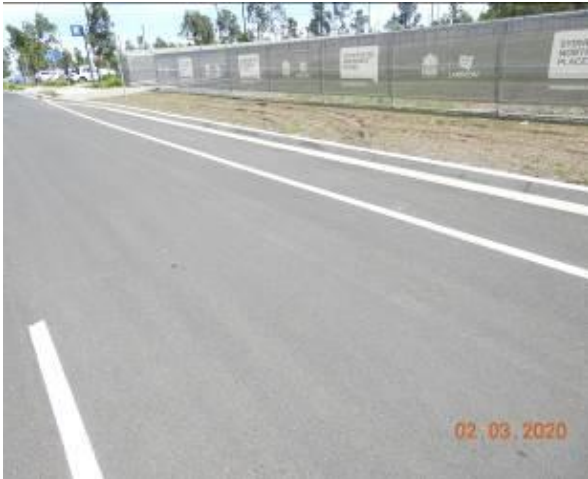
Figure 589 – General Condition of road surface

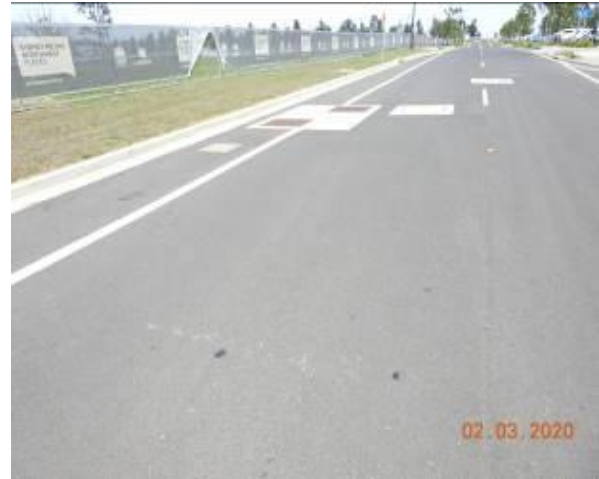
Figure 590 – General Condition of road surface

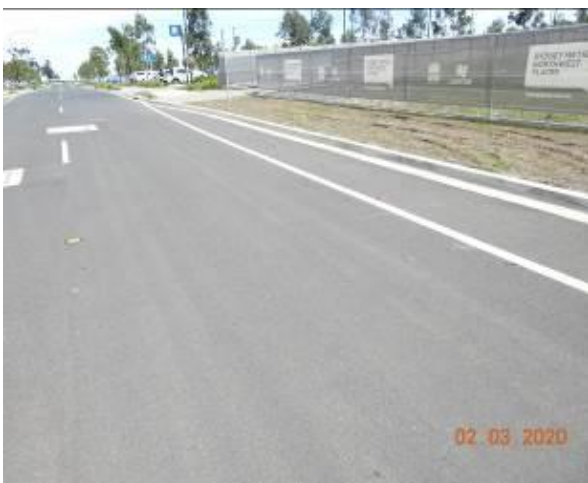
Figure 591 – General Condition of road surface

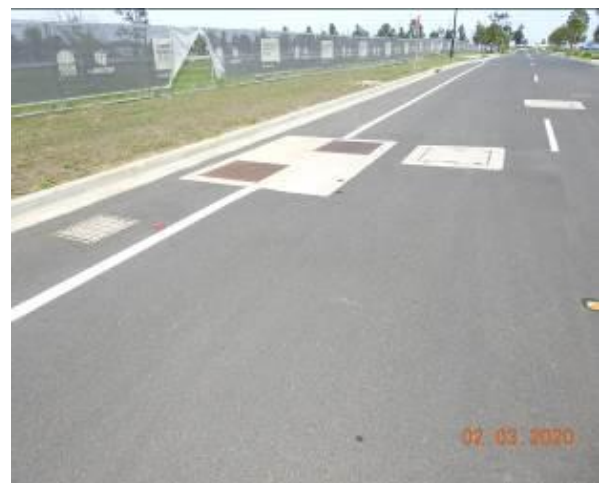
Figure 592 – General Condition of road surface

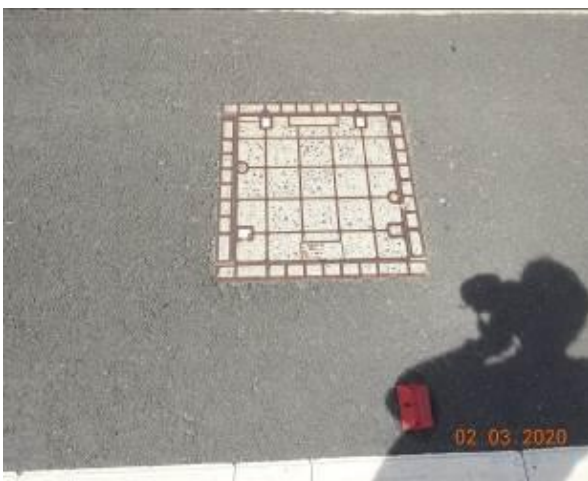
Figure 593 – General Condition of service pit

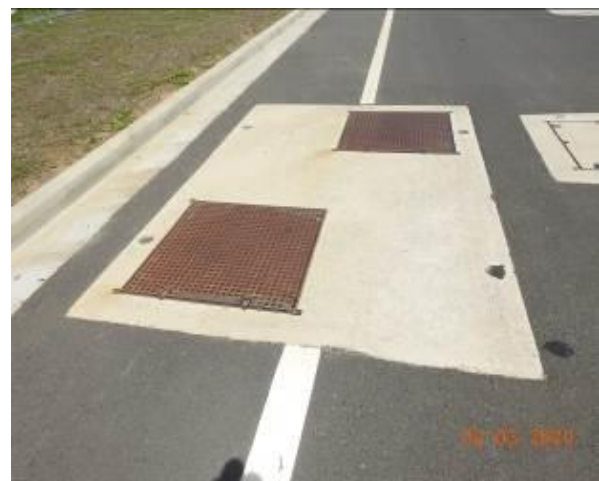
Figure 594 – General Condition of service pit

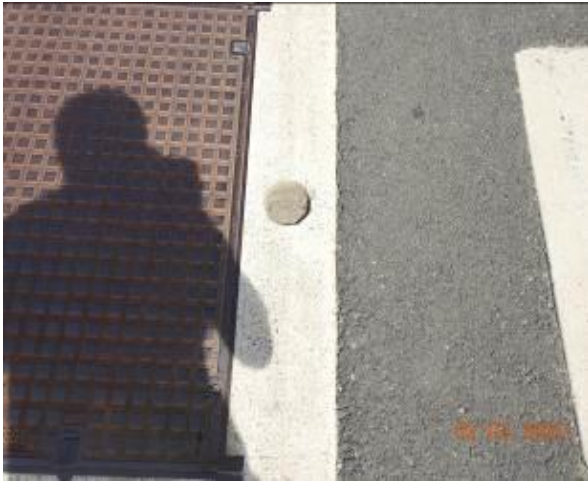
Figure 595 – Loss of material through service pit

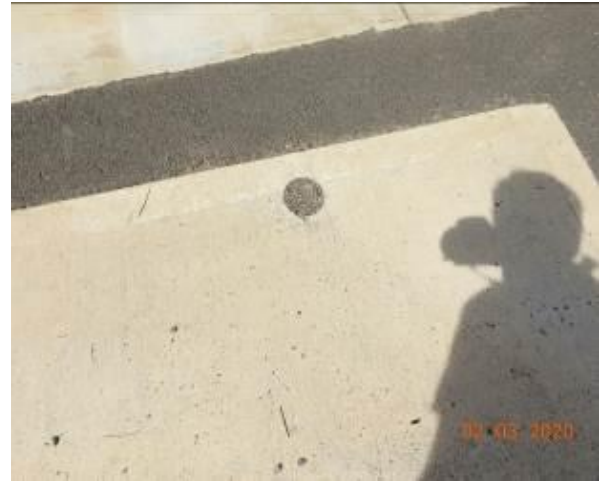
Figure 596 – Loss of material through service pit

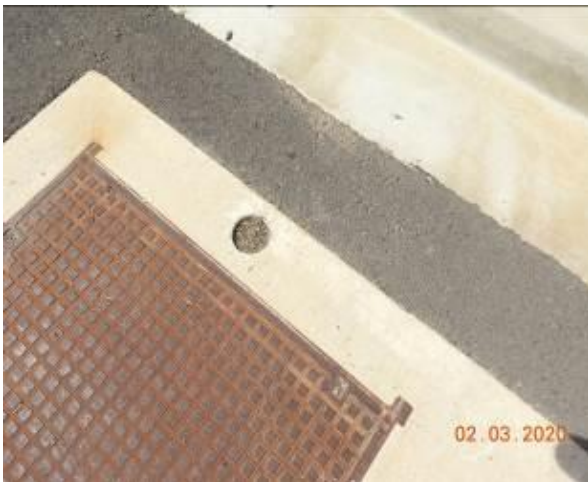
Figure 597 – Loss of material through service pit

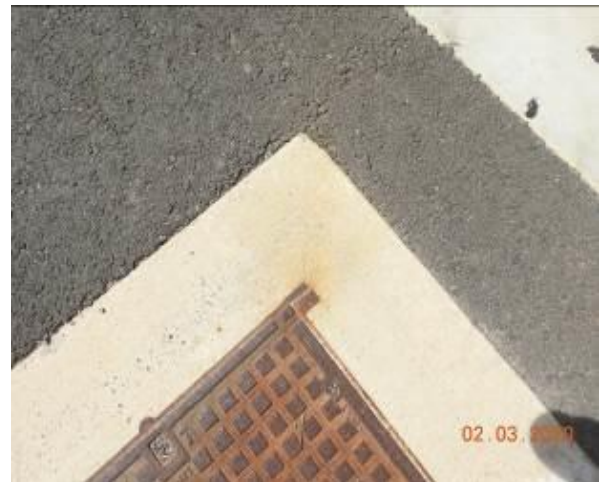
Figure 598 – Crack propagation through service pit

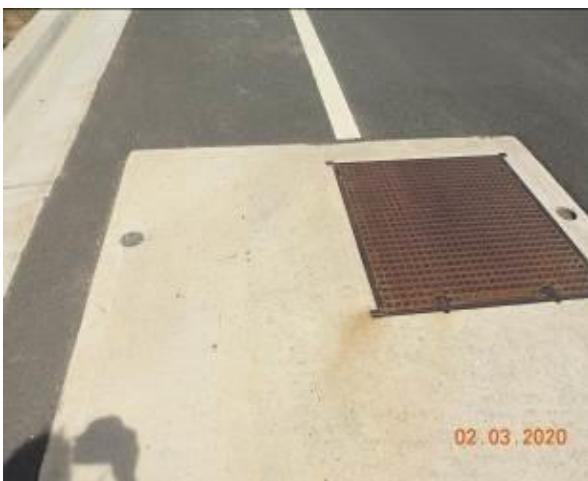
Figure 599 – General Condition of service pit

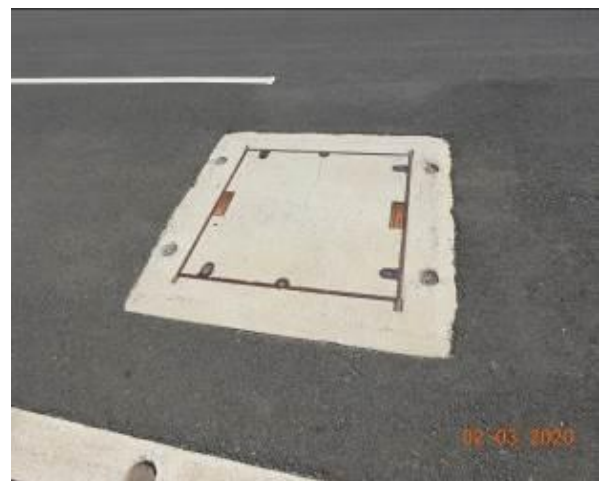
Figure 600 – General Condition of service pit

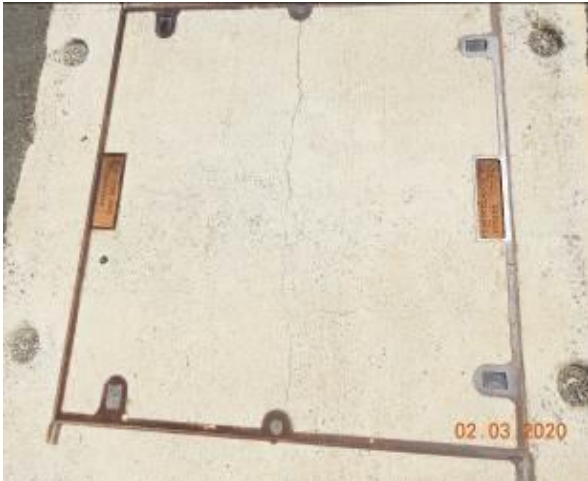
Figure 601 – Crack propagation through service pit

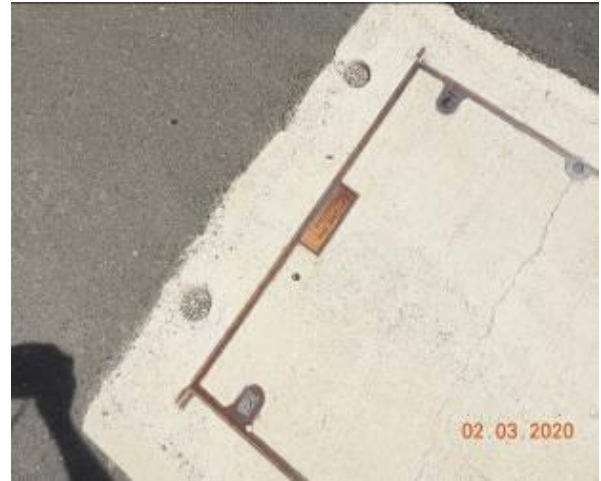
Figure 602 – Loss of material through service pit

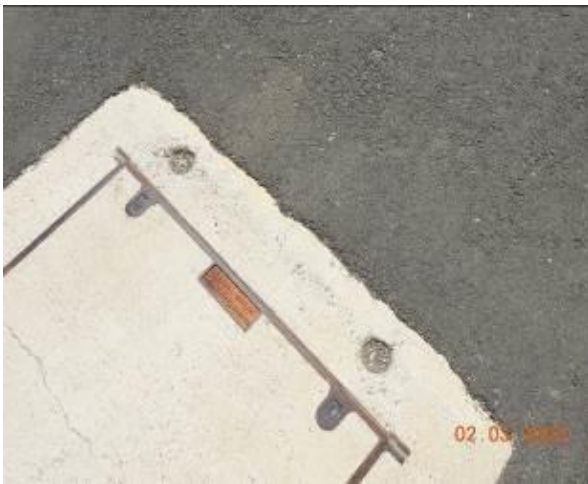
Figure 603 – Loss of material through service pit

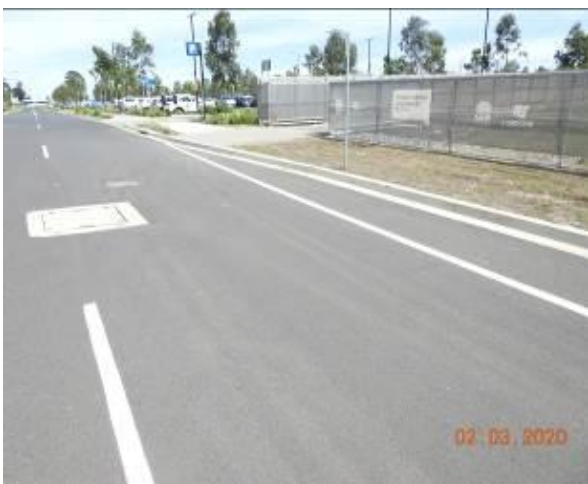
Figure 605 – General Condition of road surface

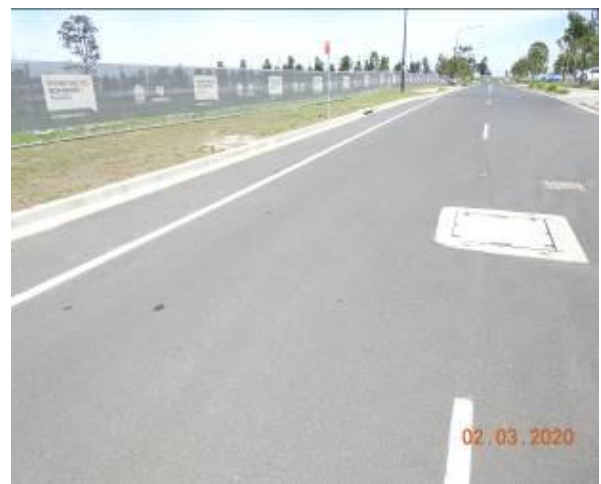
Figure 606 – General Condition of road surface

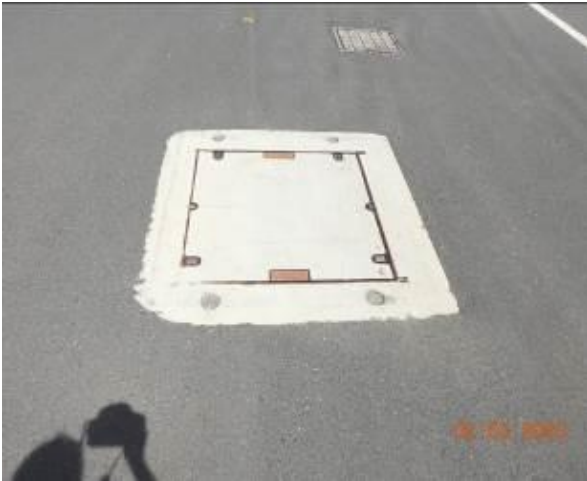
Figure 607 – General Condition of service pit

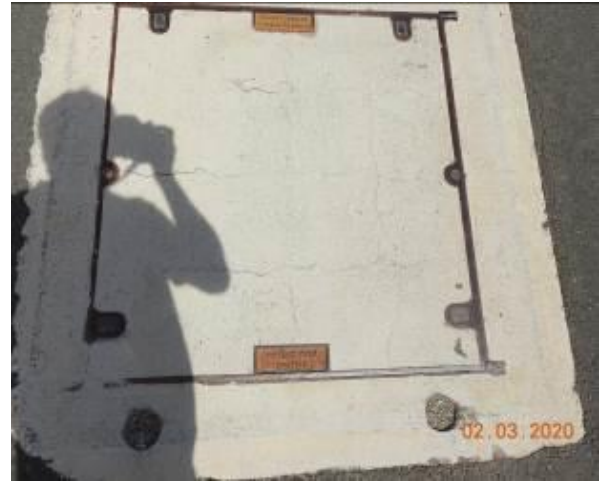
Figure 608 – Crack propagation through service pit

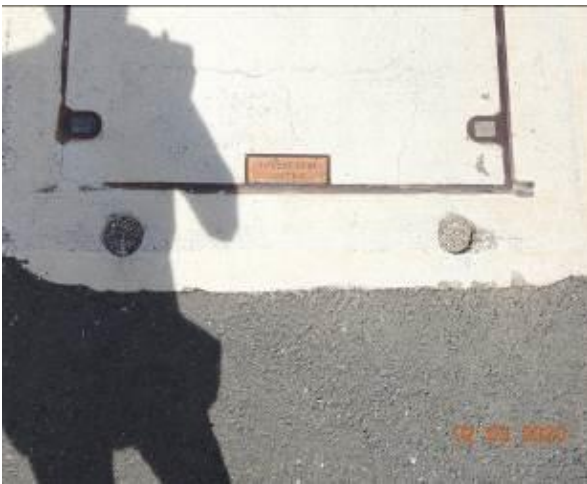
Figure 609 – Loss of material through service pit

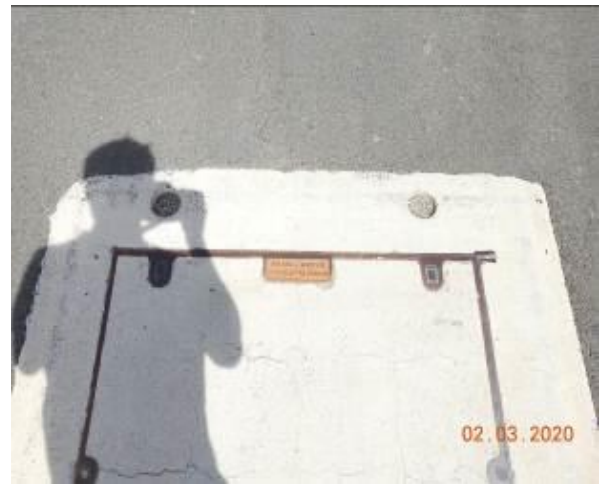
Figure 610 – Loss of material through service pit

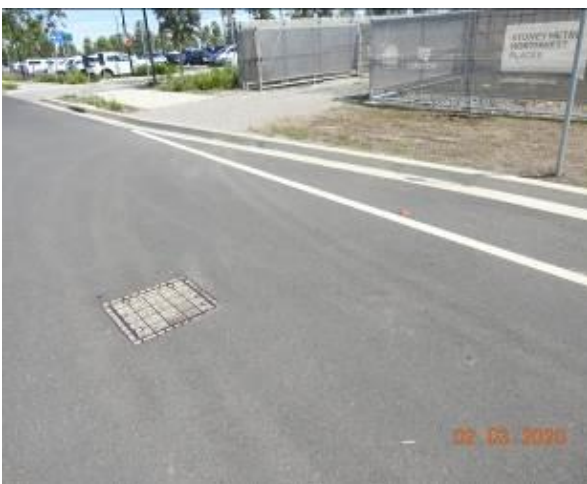
Figure 611 – General Condition of service pit

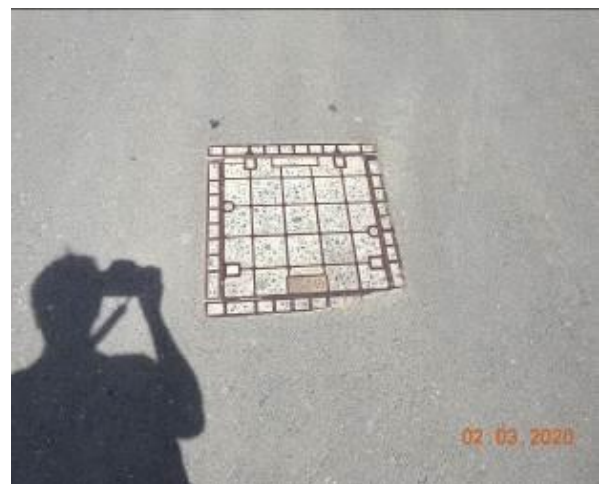
Figure 612 – General Condition of service pit

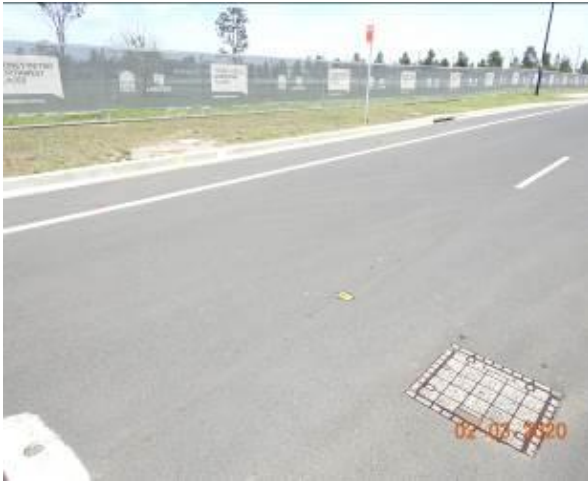
Figure 613 – General Condition of road surface

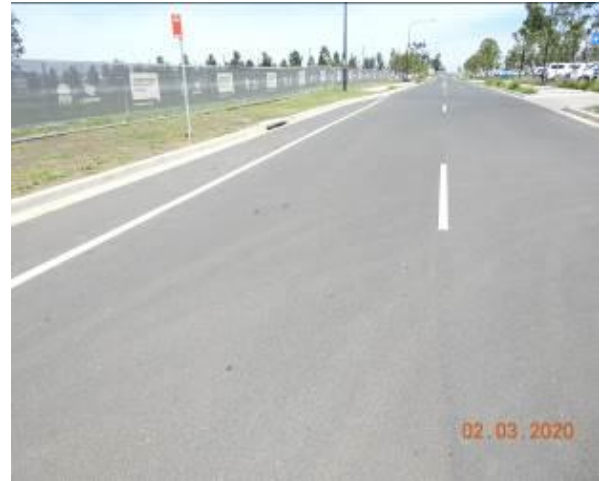
Figure 614 – General Condition of road surface

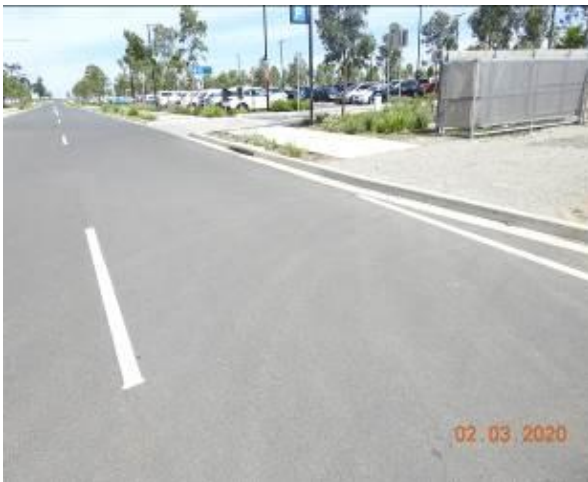
Figure 615 – General Condition of road surface

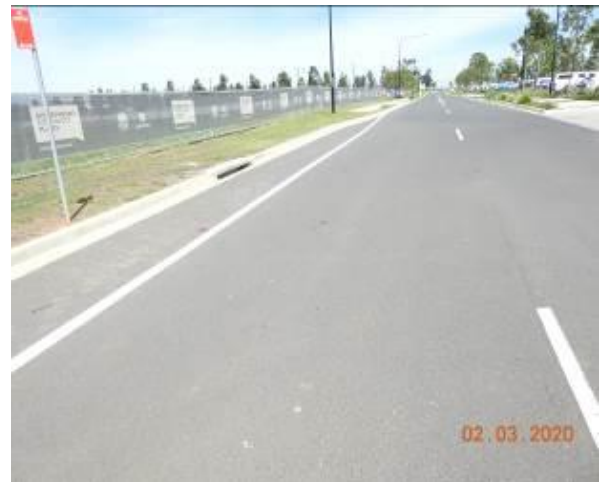
Figure 616 – General Condition of road surface

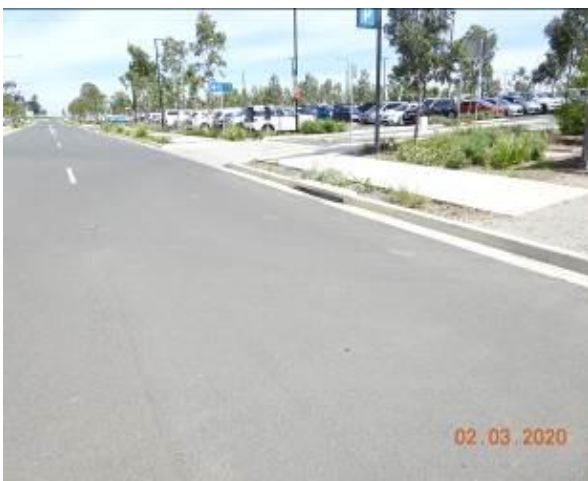
Figure 617 – General Condition of road surface

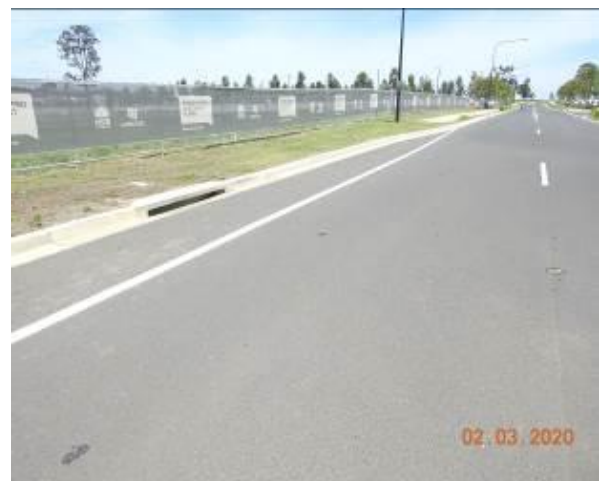
Figure 618 – General Condition of road surface

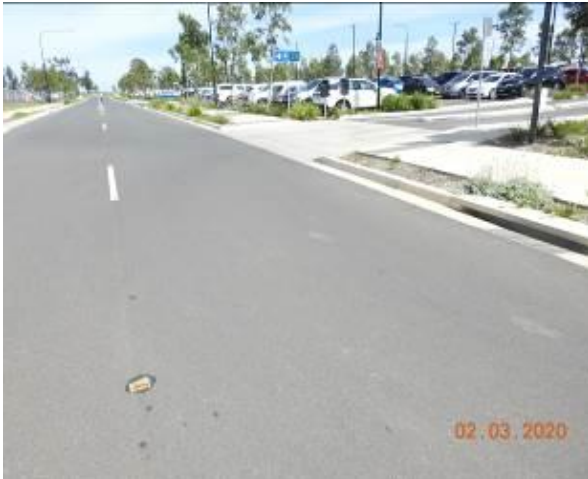
Figure 619 – General Condition of road surface

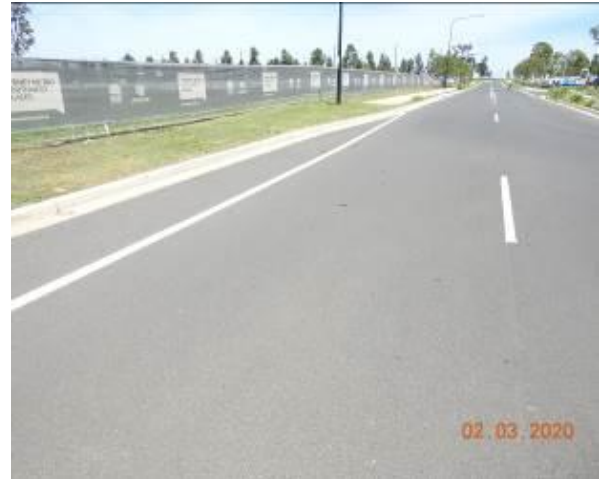
Figure 620 – General Condition of road surface

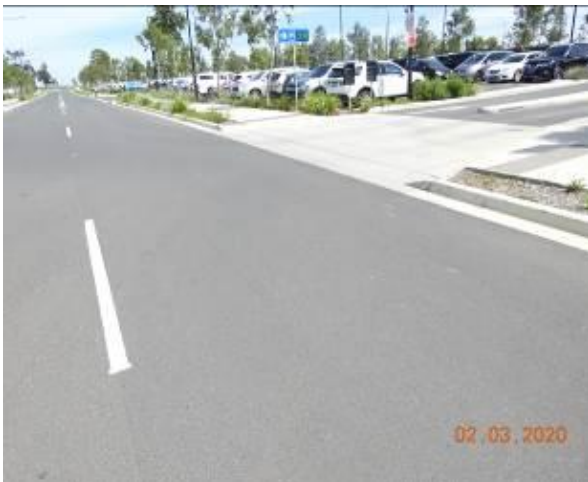
Figure 621 – General Condition of road surface

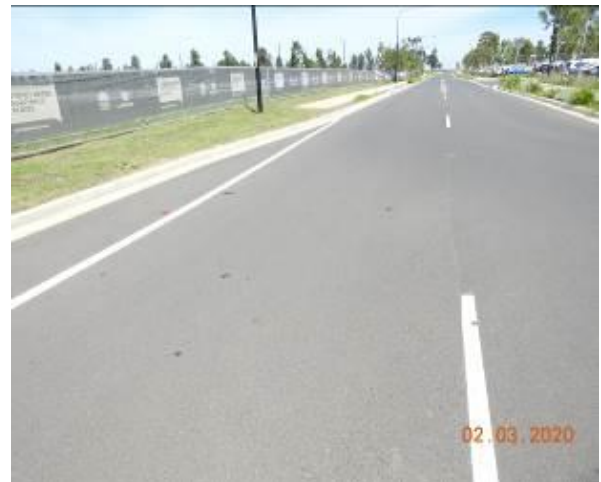
Figure 622 – General Condition of road surface

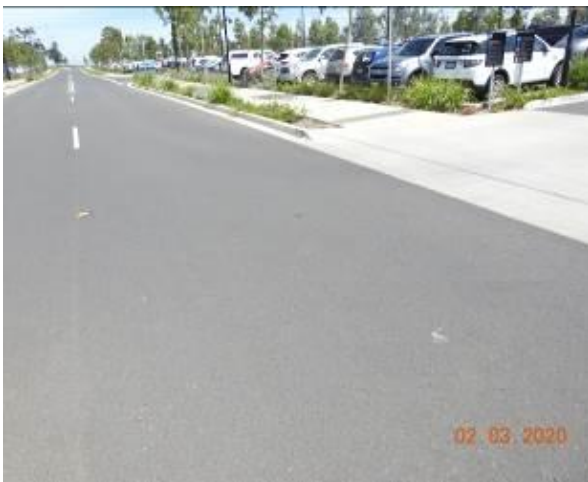
Figure 623 – General Condition of road surface

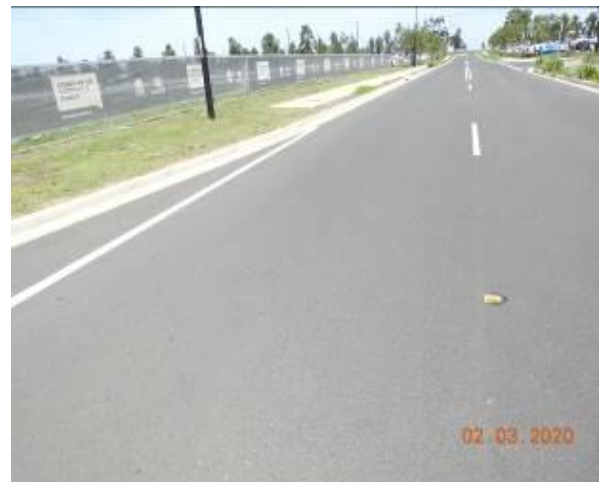
Figure 624 – General Condition of road surface

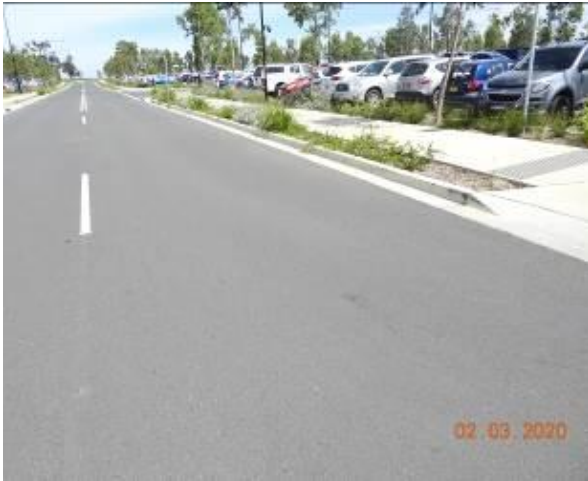
Figure 625 – General Condition of road surface

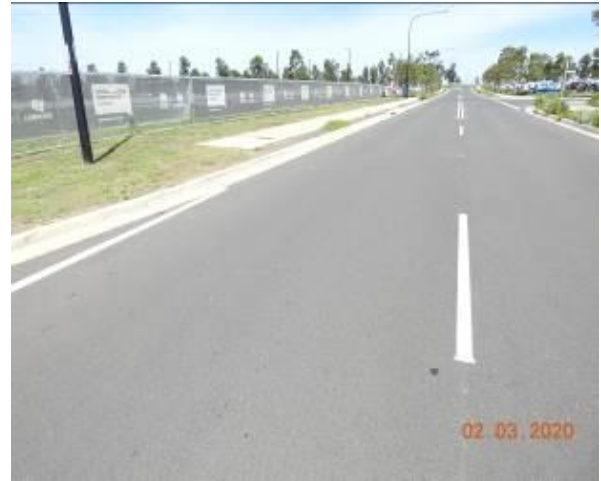
Figure 626 – General Condition of road surface

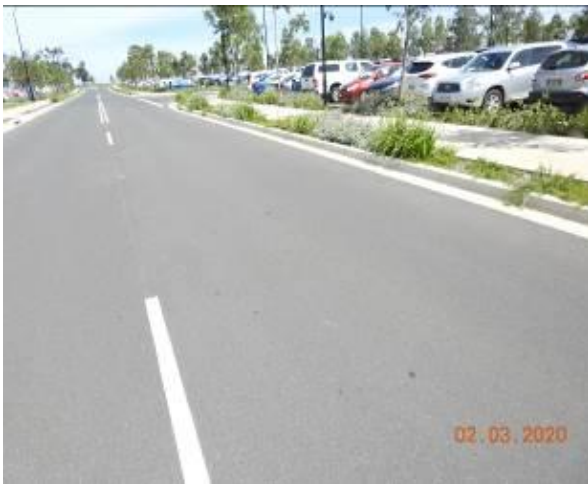
Figure 627 – General Condition of road surface

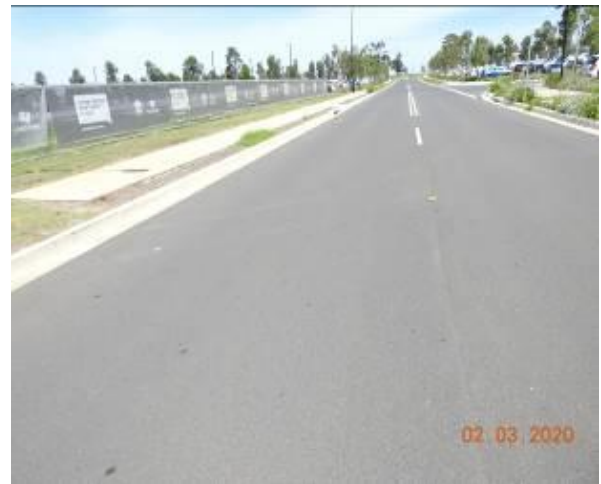
Figure 628 – General Condition of road surface

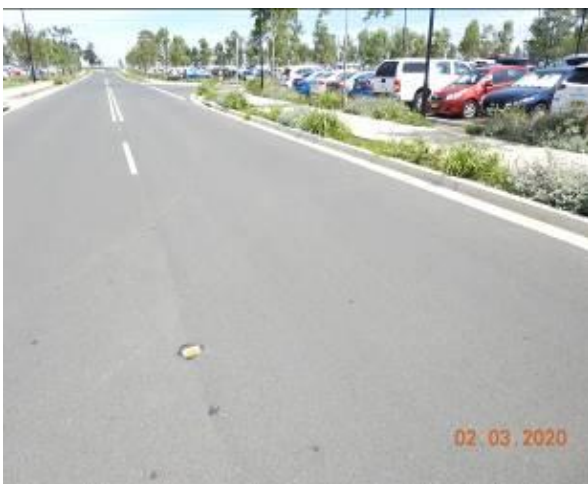
Figure 629 – General Condition of road surface

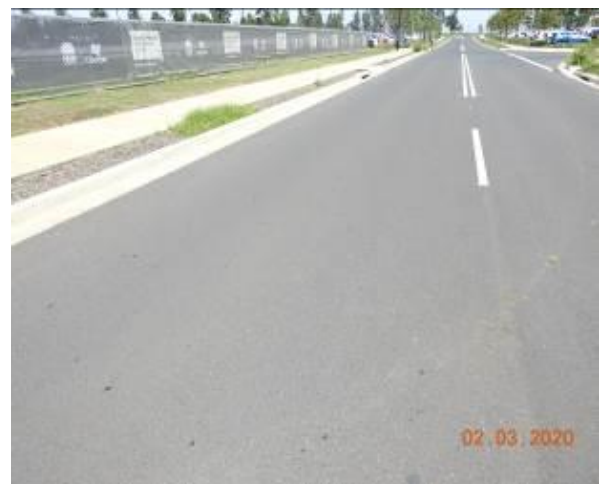
Figure 630 – General Condition of road surface

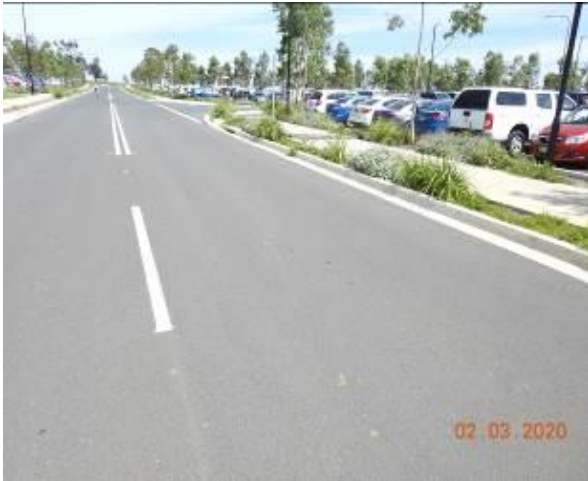
Figure 631 – General Condition of road surface

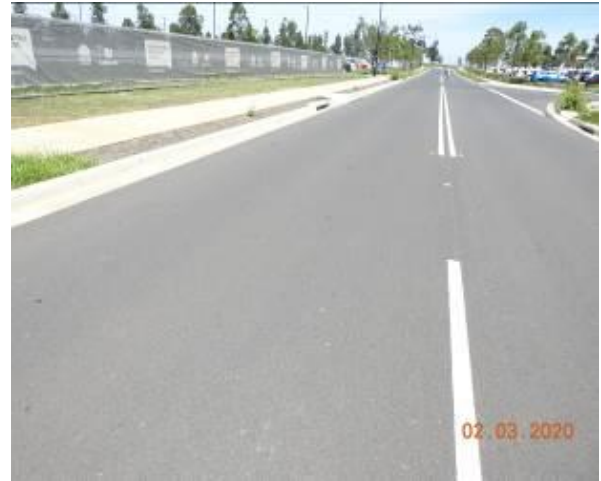
Figure 632 – General Condition of road surface

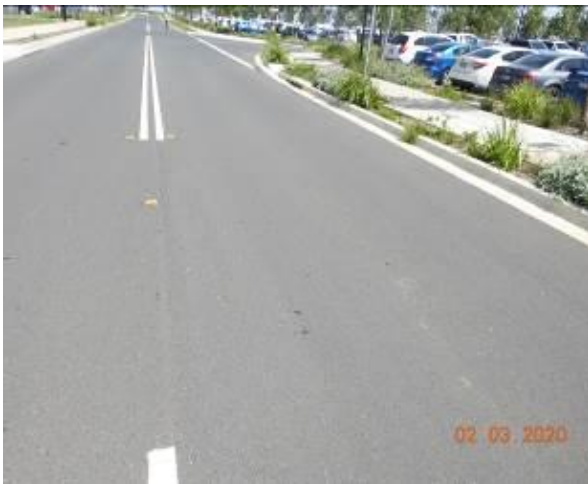
Figure 633 – General Condition of road surface

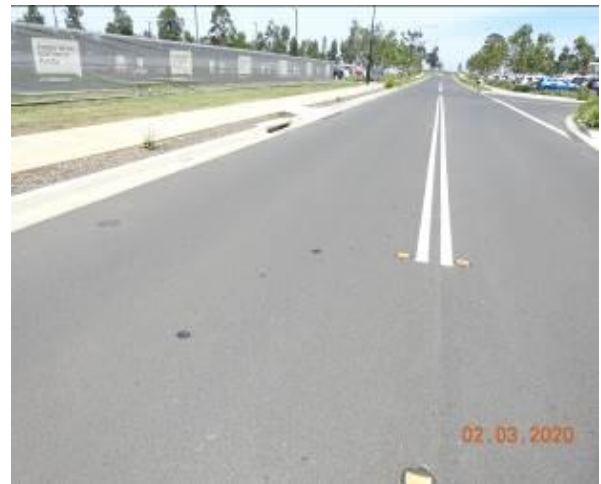
Figure 634 – General Condition of road surface

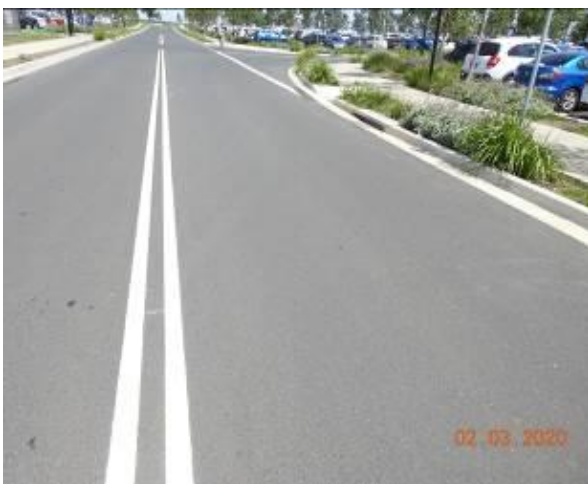
Figure 635 – General Condition of road surface

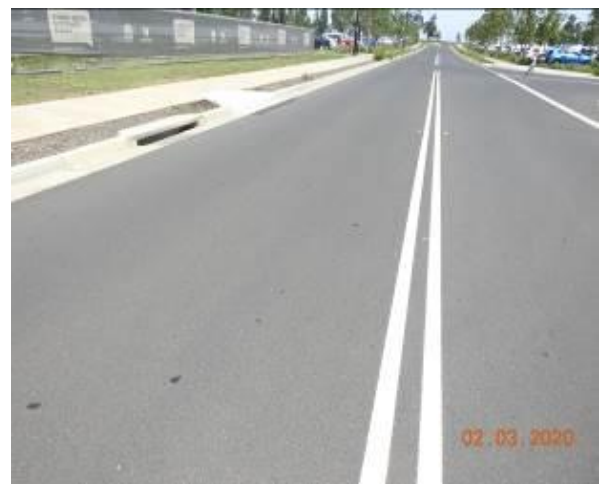
Figure 636 – General Condition of road surface

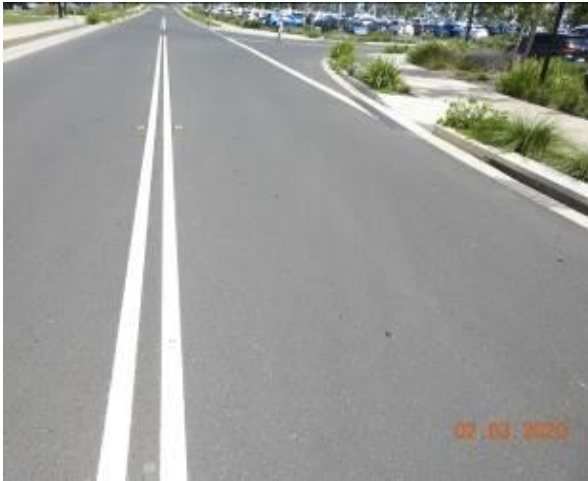
Figure 637 – General Condition of road surface

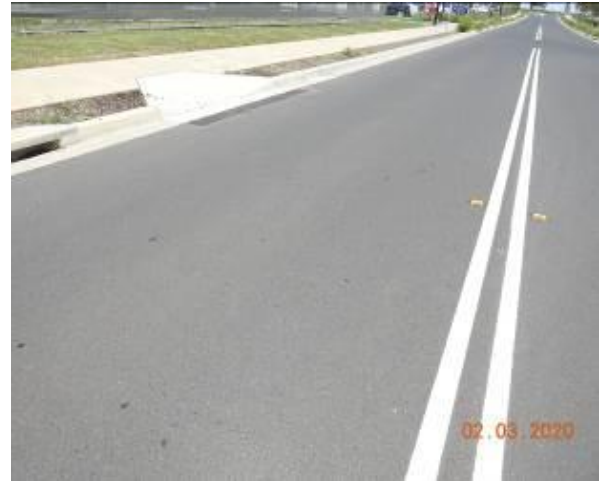
Figure 638 – General Condition of road surface

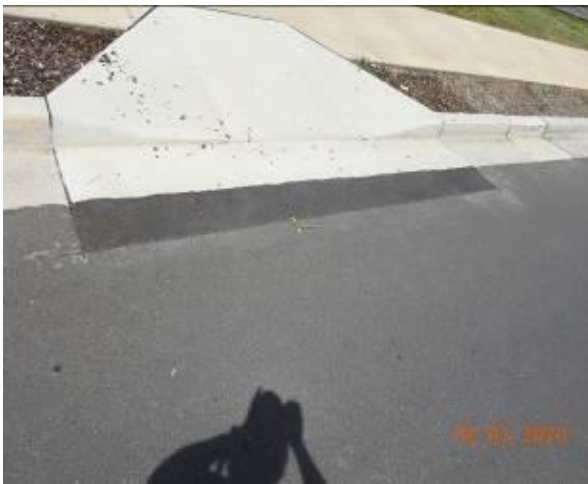
Figure 639 – Evidence of patchwork through road surface

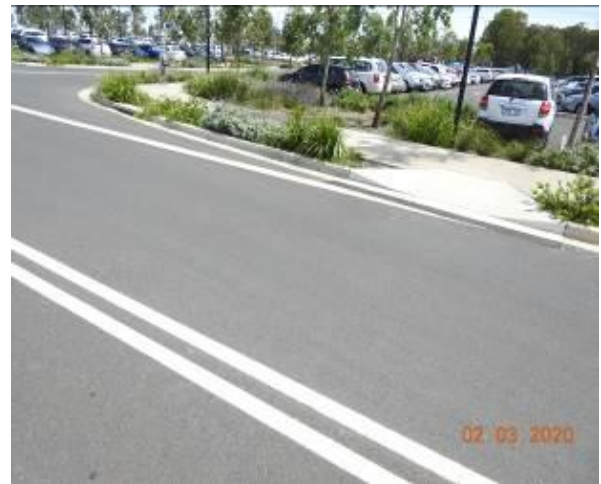
Figure 640 – General Condition of road surface

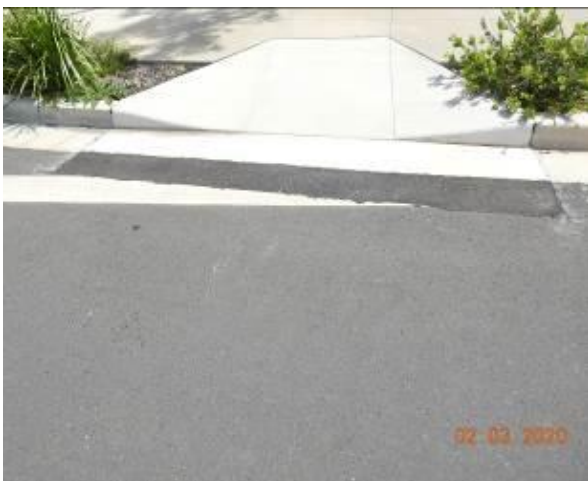
Figure 641 – Evidence of patchwork through road surface

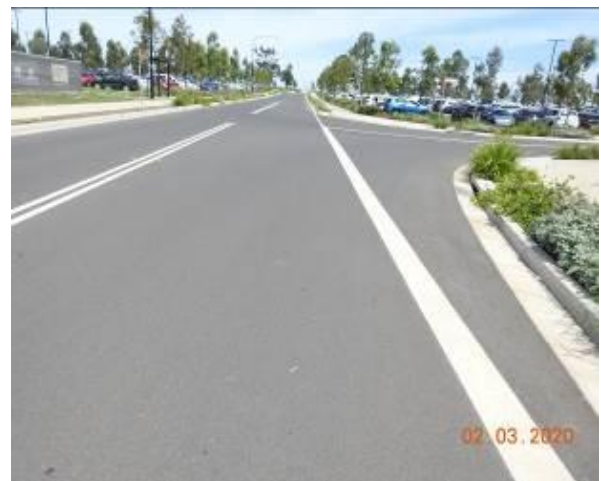
Figure 642 – General Condition of road surface

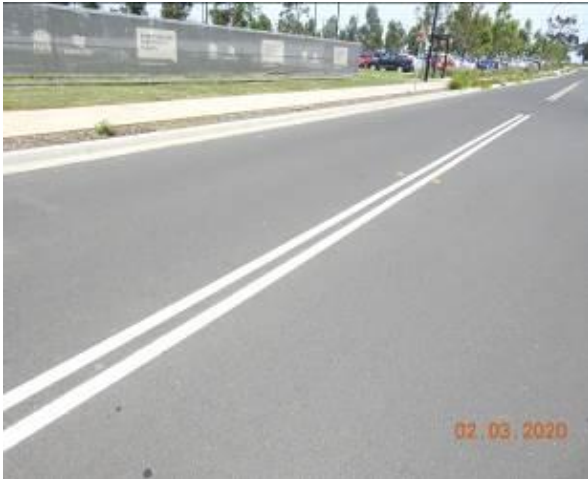
Figure 643 – General Condition of road surface

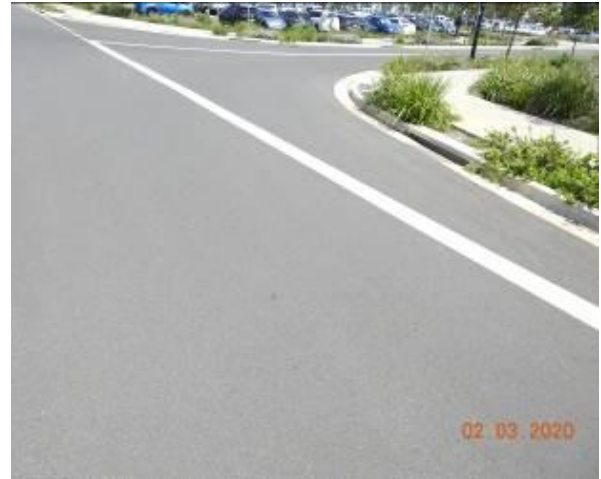
Figure 644 – General Condition of road surface

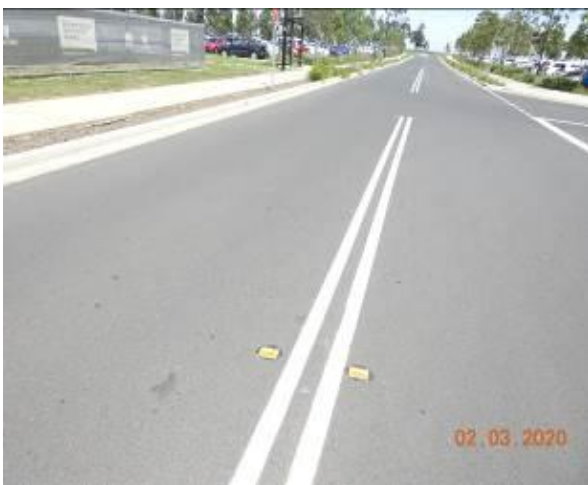
Figure 645 – General Condition of road surface

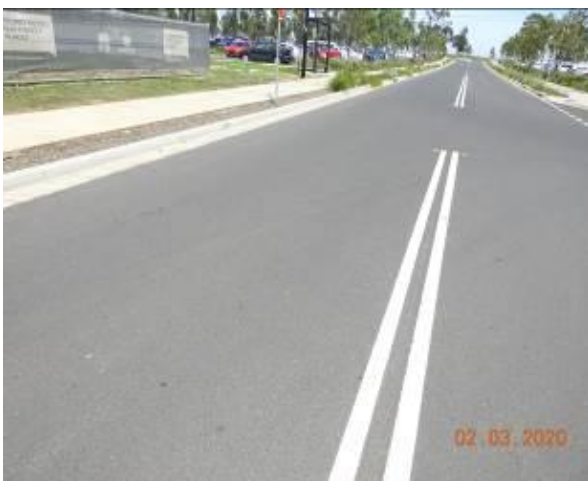
Figure 647 – General Condition of road surface

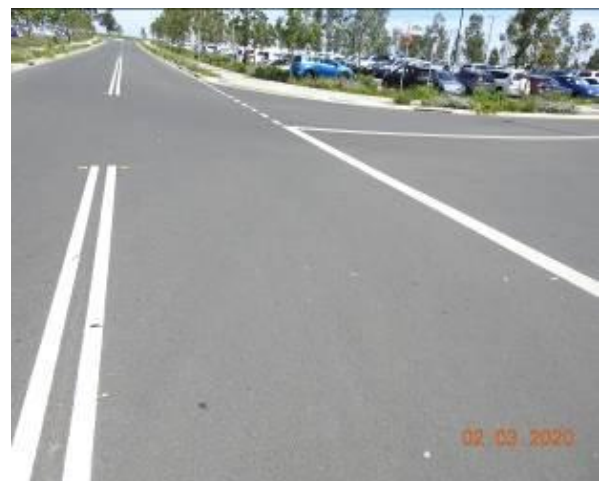
Figure 648 – General Condition of road surface

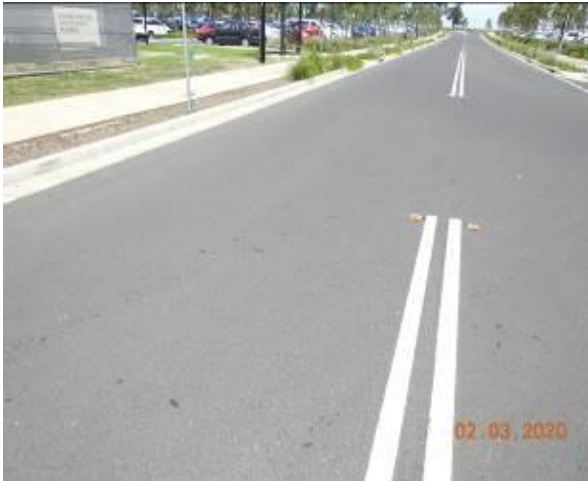
Figure 649 – General Condition of road surface

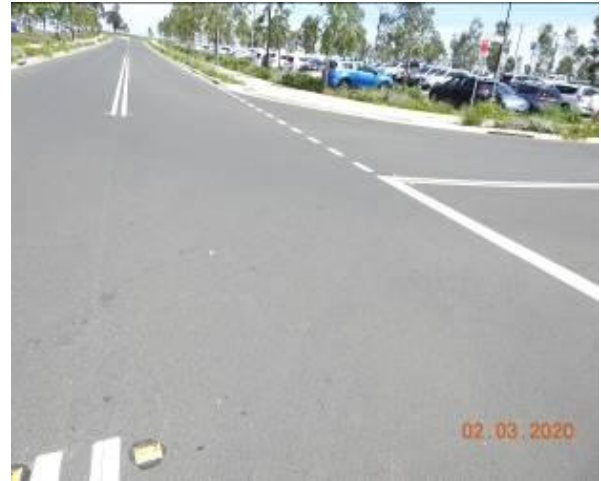
Figure 650 – General Condition of road surface

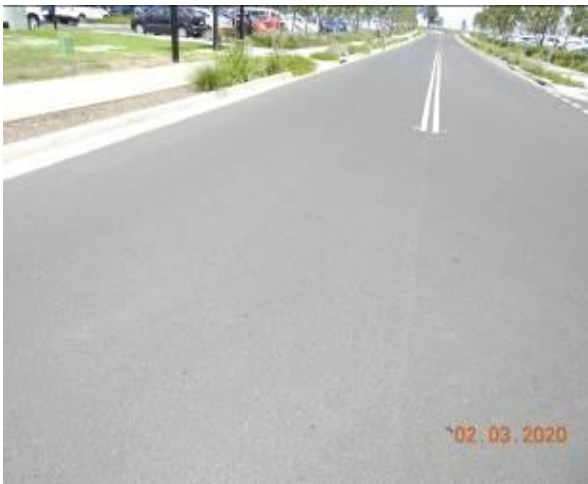
Figure 651 – General Condition of road surface

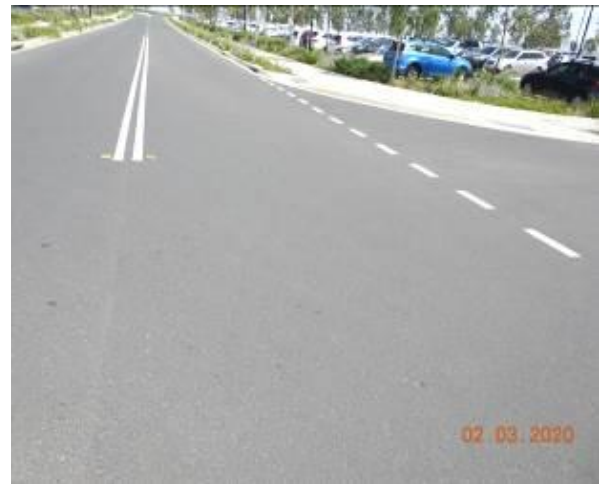
Figure 652 – General Condition of road surface

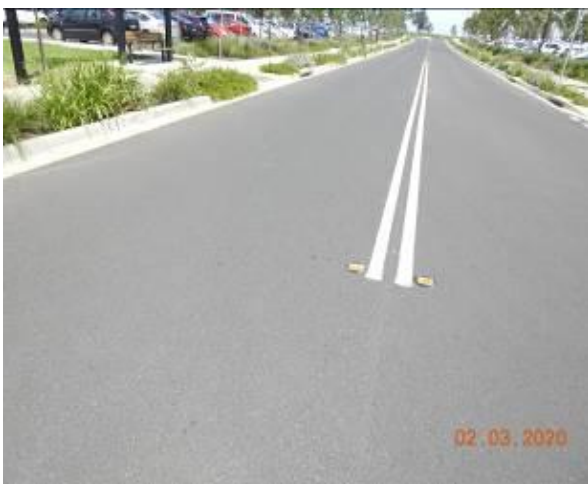
Figure 653 – General Condition of road surface

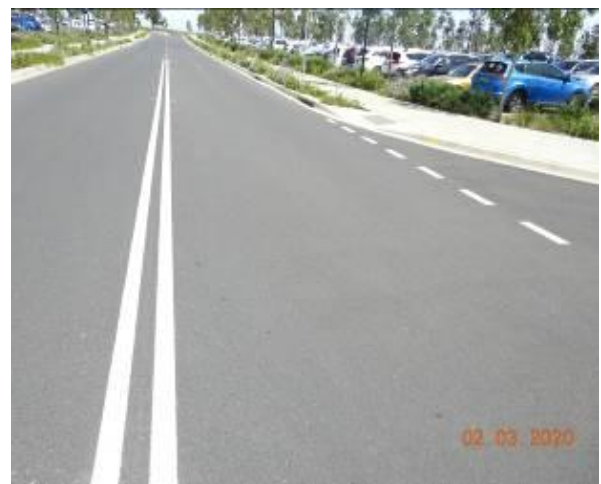
Figure 654 – General Condition of road surface

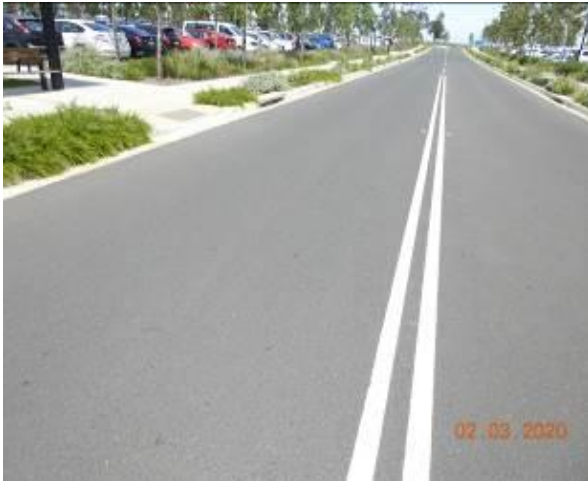
Figure 655 – General Condition of road surface

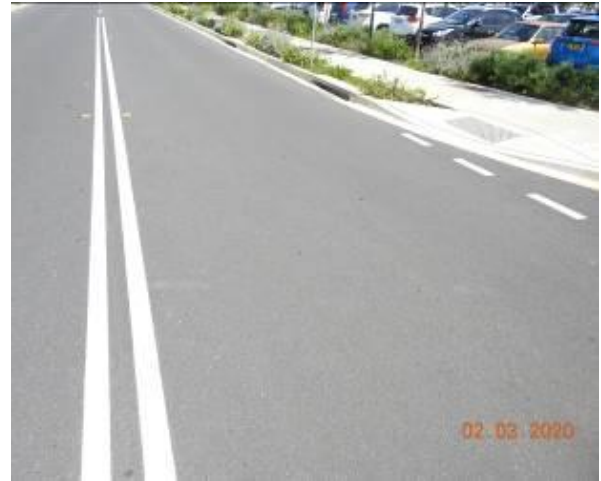
Figure 656 – General Condition of road surface

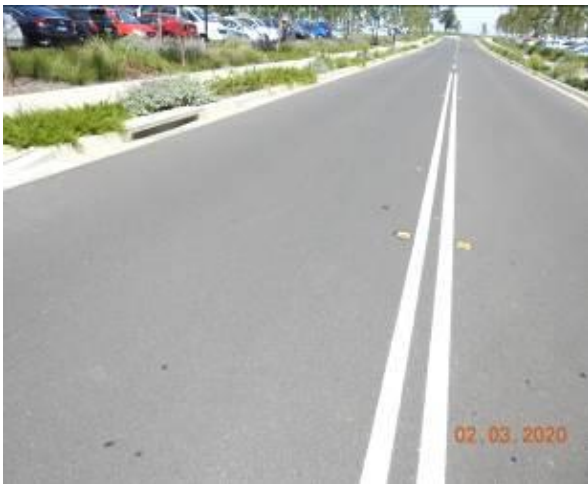
Figure 657 – General Condition of road surface

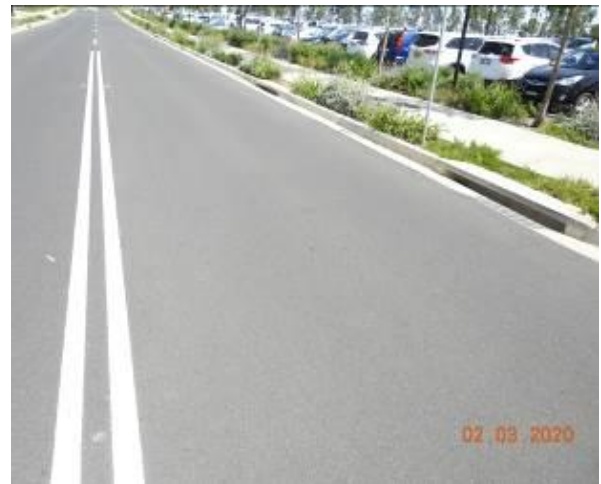
Figure 658 – General Condition of road surface
