**1-15 AND 2-12 CONFERTA AVENUE,  
ROUSE HILL NSW 2155  
TALLAWONG STATION PRECINCT SOUTH  
PRE-DILAPIDATION REPORT**

**DEICORP PROJECTS  
(TALLAWONG STATION) PTY LTD**

Job No. 191294.0  
05/07/2021

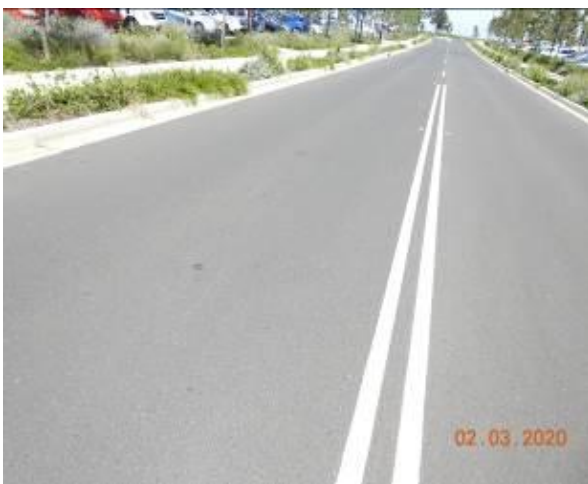
Figure 659 – General Condition of road surface

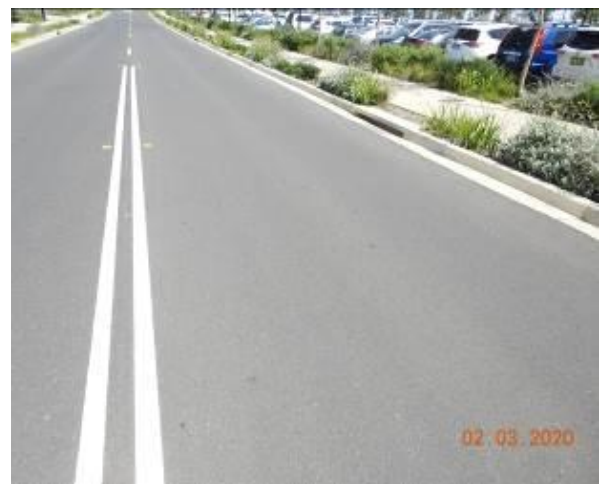
Figure 660 – General Condition of road surface

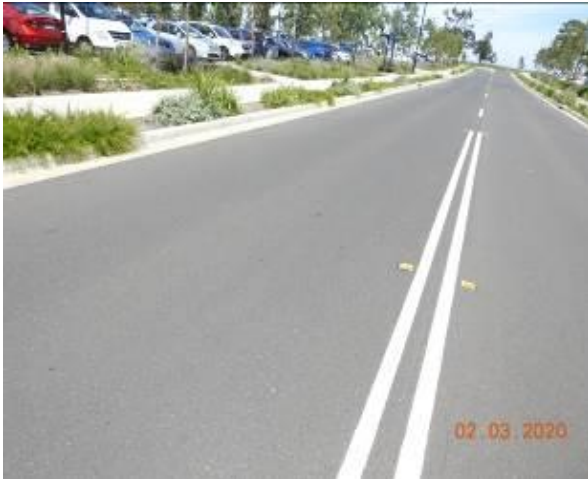
Figure 661 – General Condition of road surface

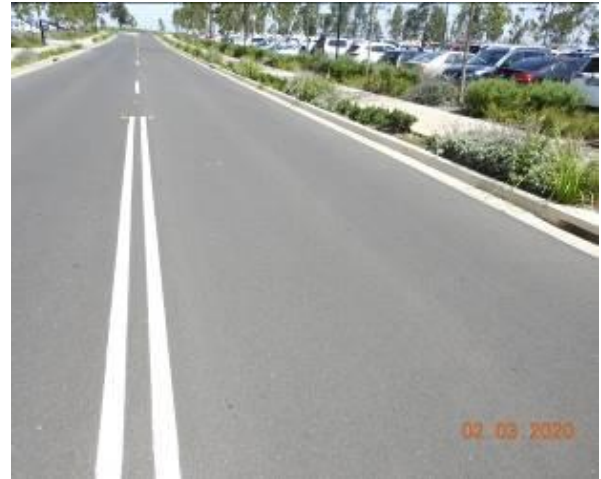
Figure 662 – General Condition of road surface

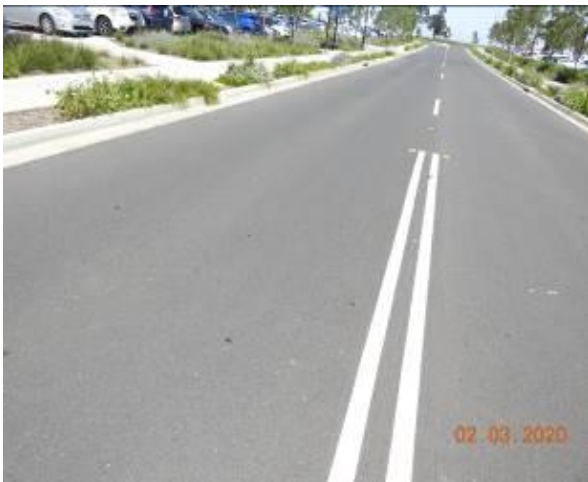
Figure 663 – General Condition of road surface

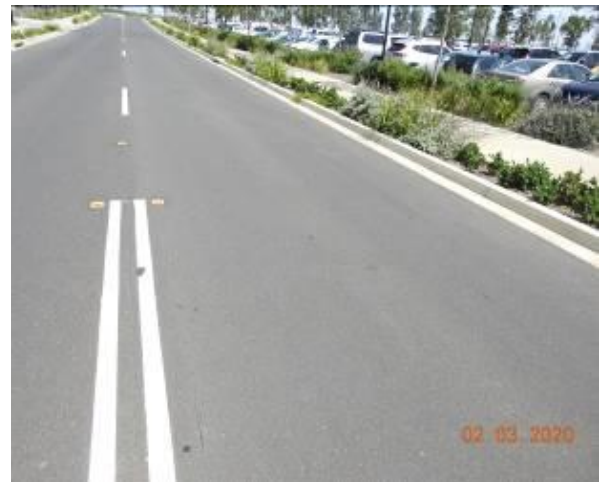
Figure 664 – General Condition of road surface

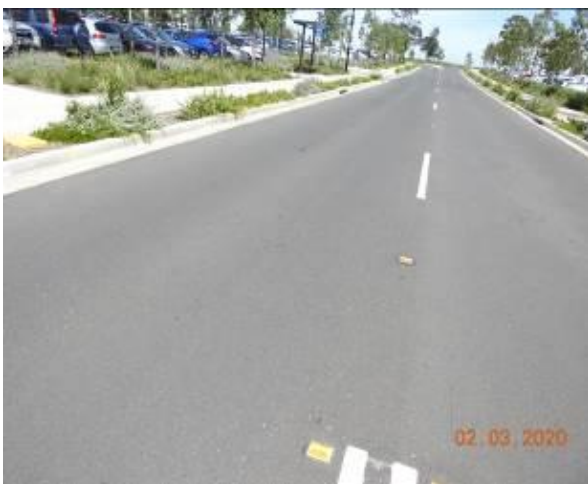
Figure 665 – General Condition of road surface

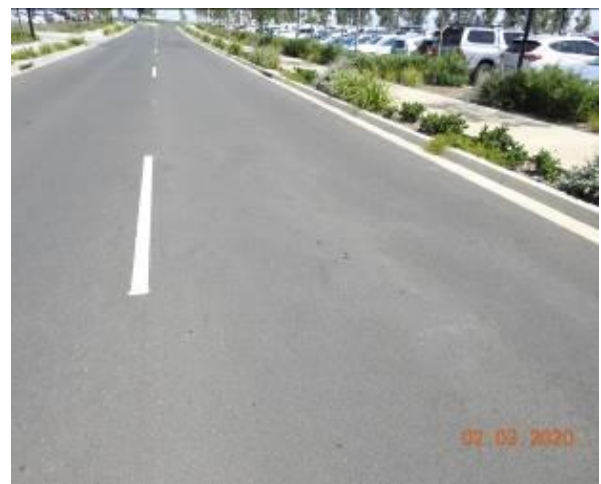
Figure 666 – General Condition of road surface

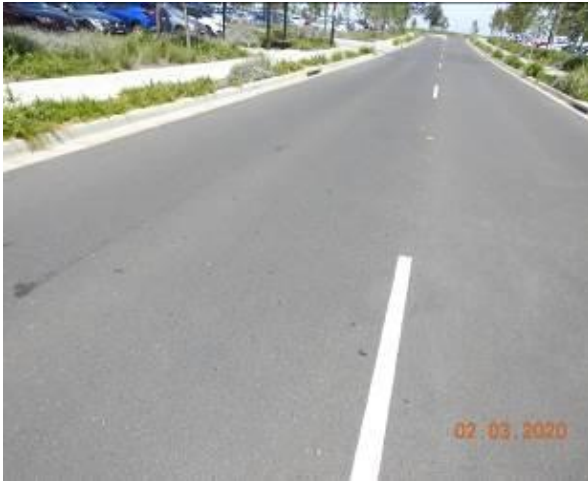
Figure 667 – General Condition of road surface

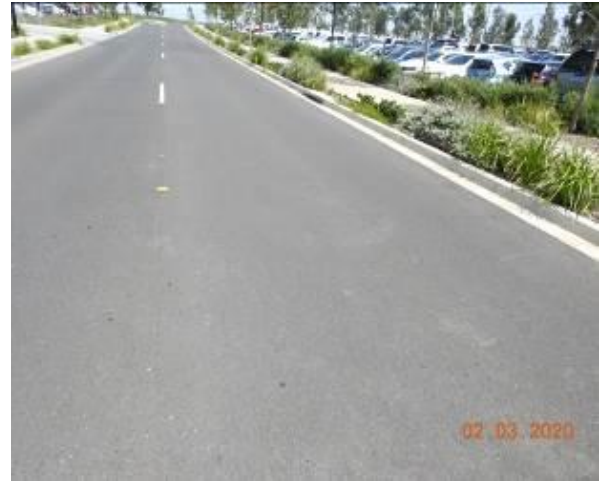
Figure 668 – General Condition of road surface

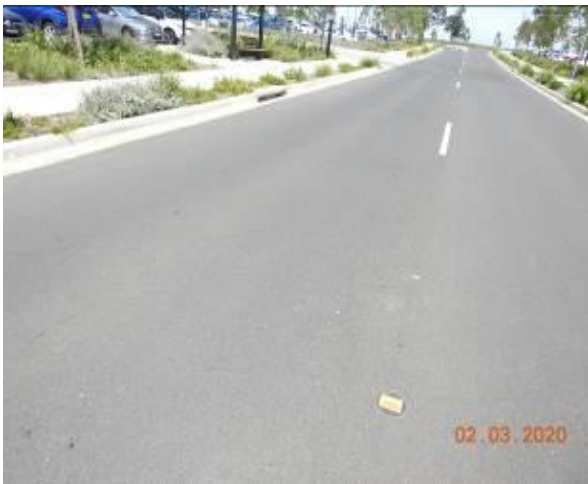
Figure 669 – General Condition of road surface

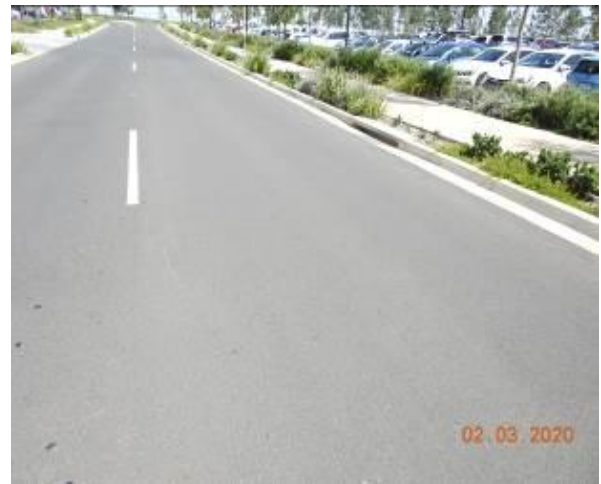
Figure 670 – General Condition of road surface

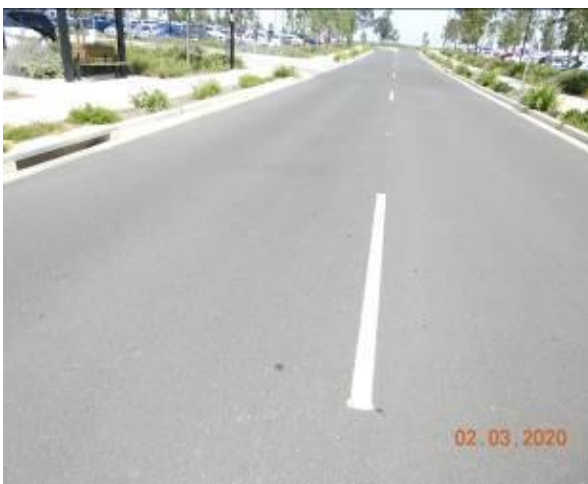
Figure 671 – General Condition of road surface

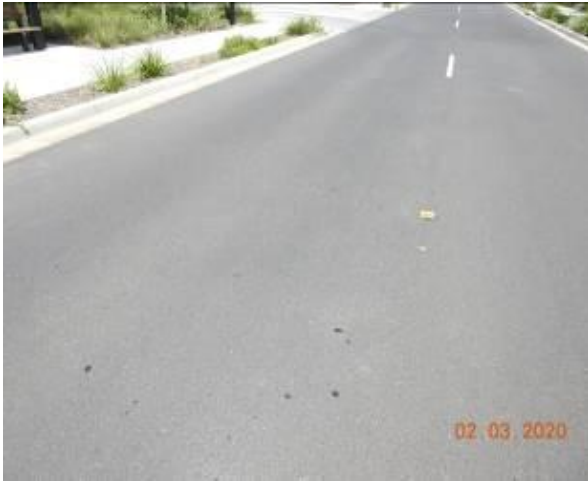
Figure 672 – General Condition of road surface

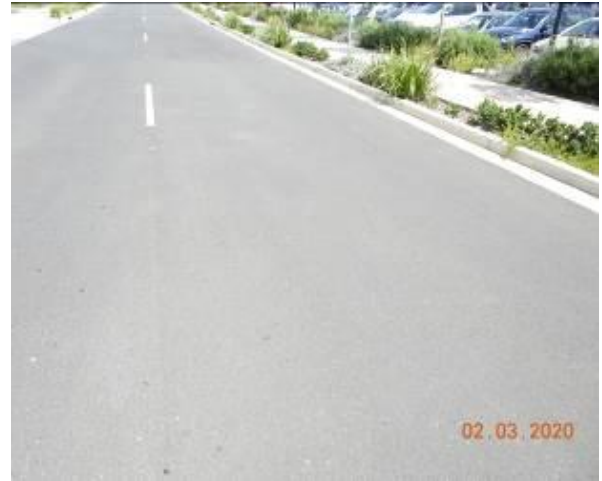
Figure 673 – General Condition of road surface

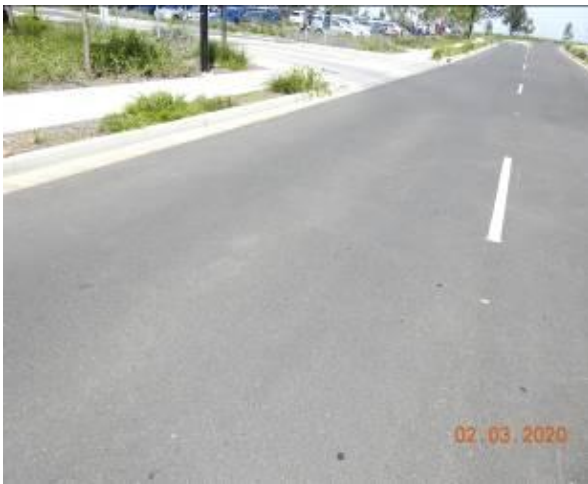
Figure 674 – General Condition of road surface

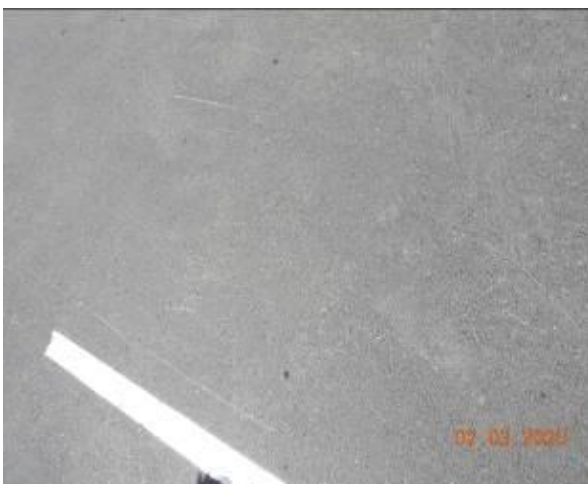
Figure 676 – General Condition of road surface

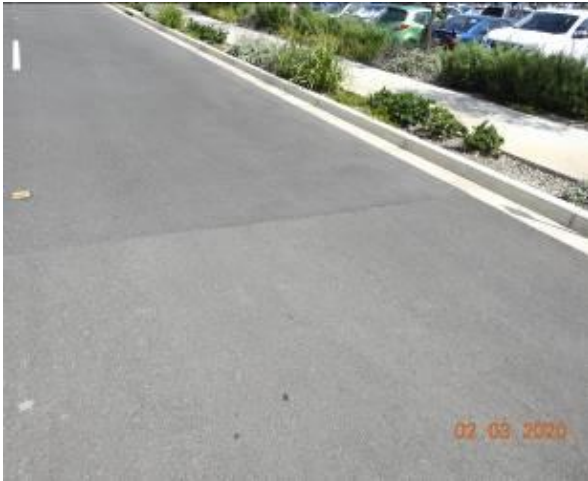
Figure 678 – General Condition of road surface

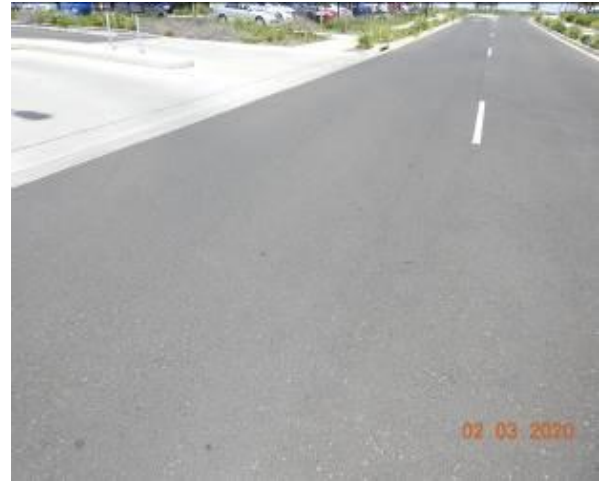
Figure 679 – General Condition of road surface

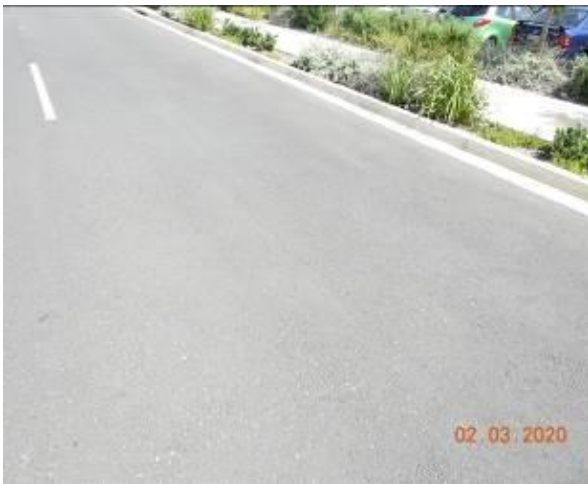
Figure 680 – General Condition of road surface

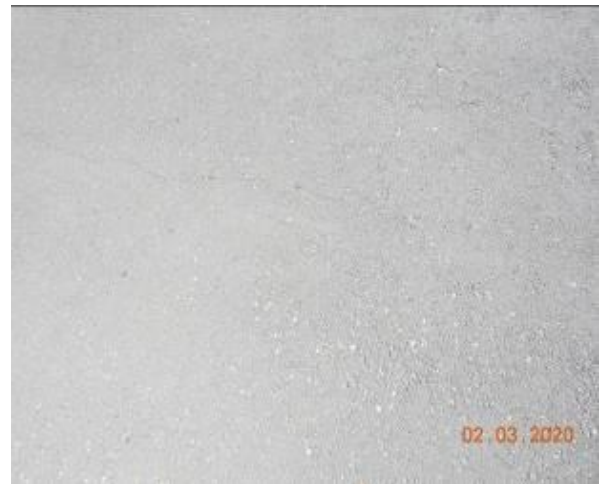
Figure 681 – General Condition of road surface

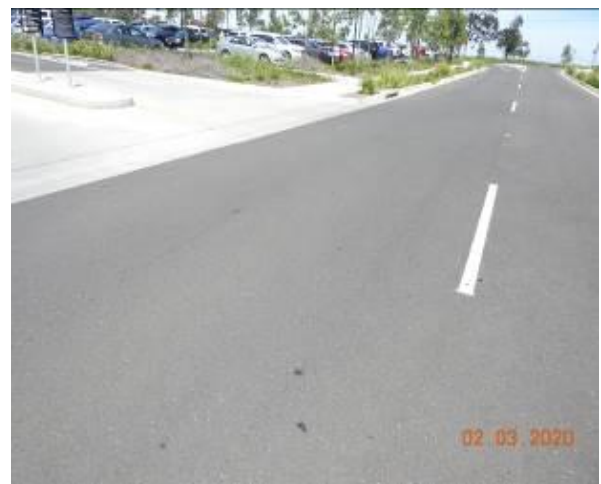
Figure 683 – Crack propagation through road surface

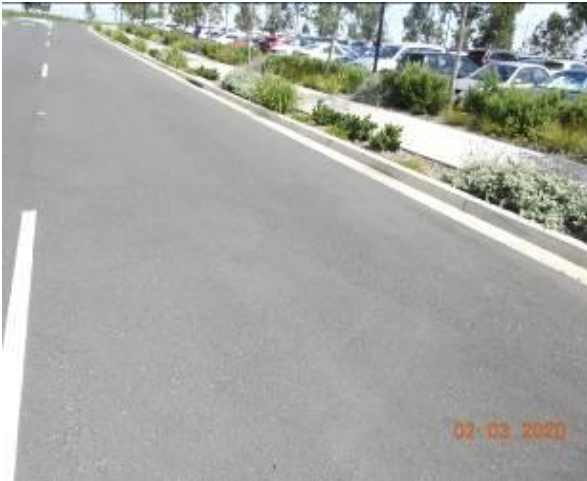
Figure 684 – General Condition of road surface

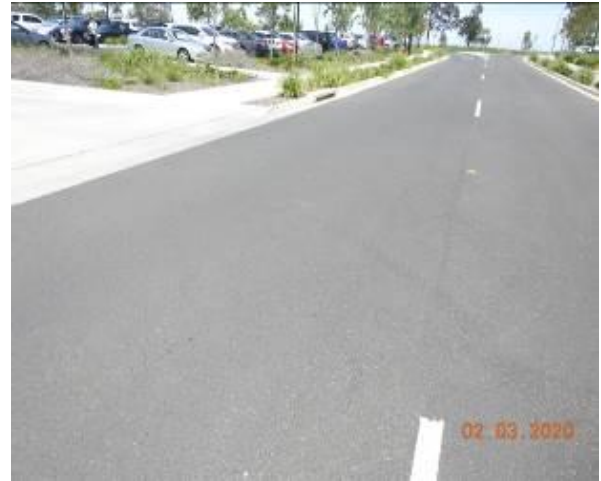
Figure 685 – General Condition of road surface

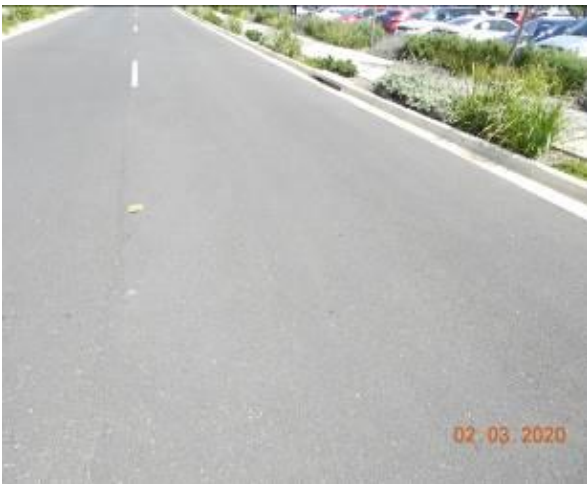
Figure 686 – General Condition of road surface

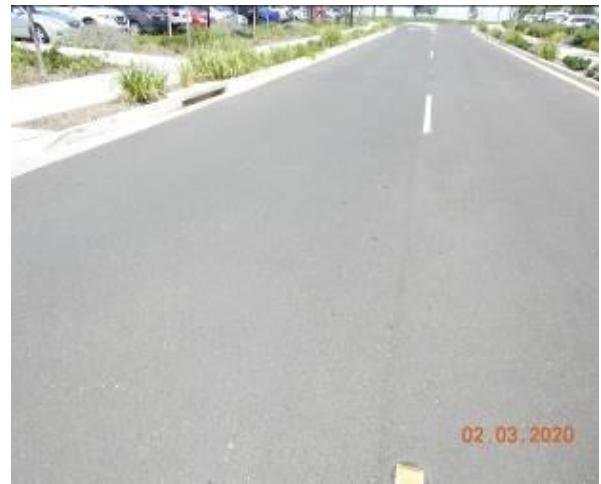
Figure 687 – General Condition of road surface

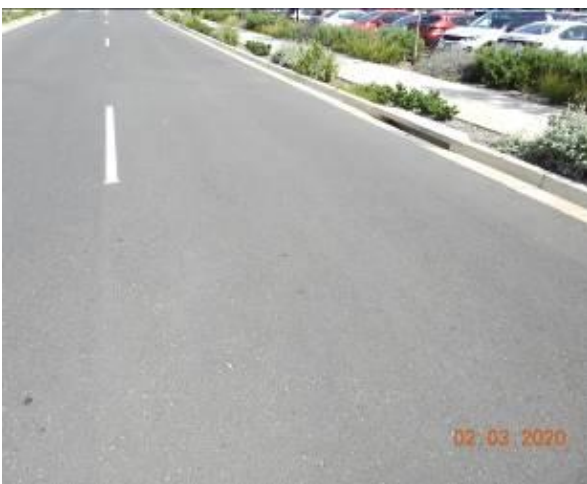
Figure 688 – General Condition of road surface

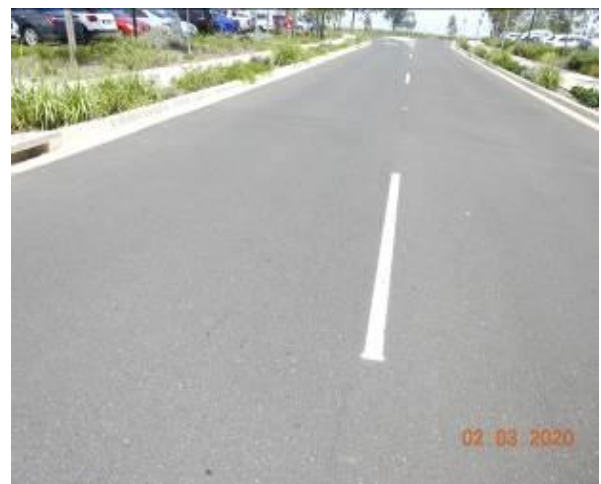
Figure 689 – General Condition of road surface

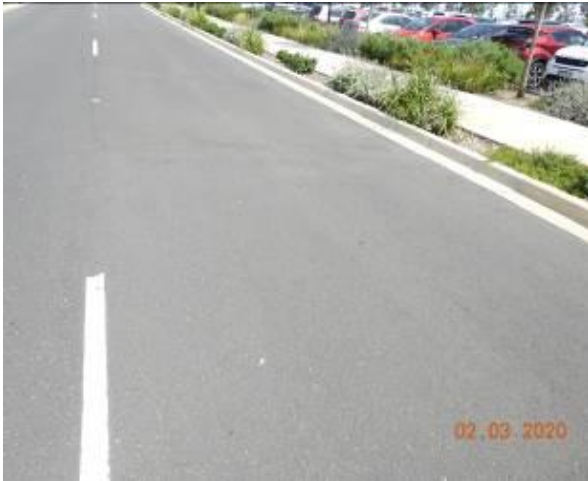
Figure 690 – General Condition of road surface

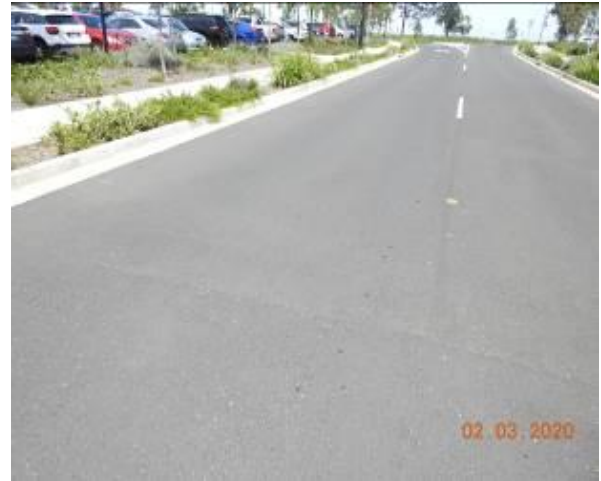
Figure 691 – General Condition of road surface

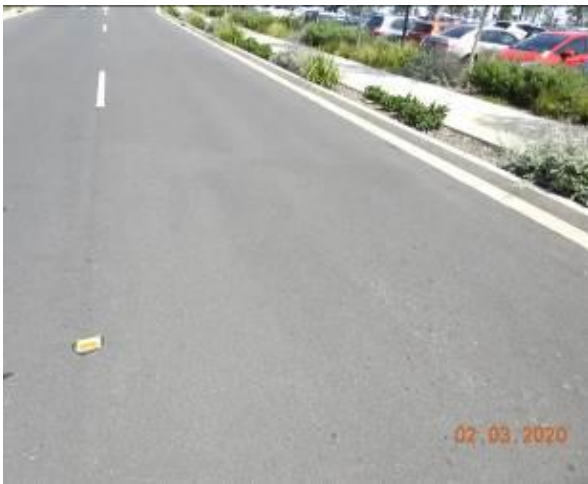
Figure 692 – General Condition of road surface

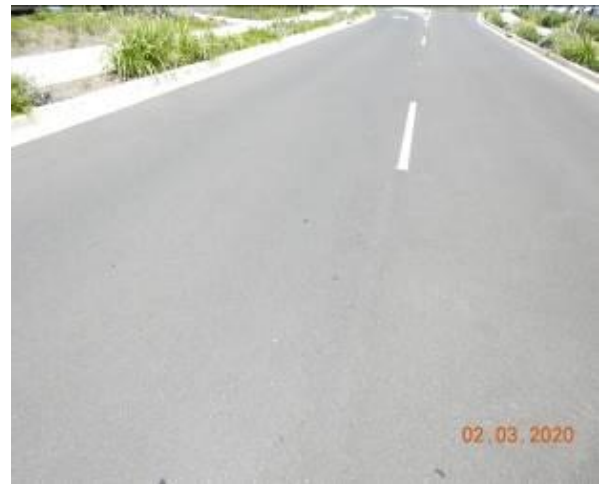
Figure 693 – General Condition of road surface

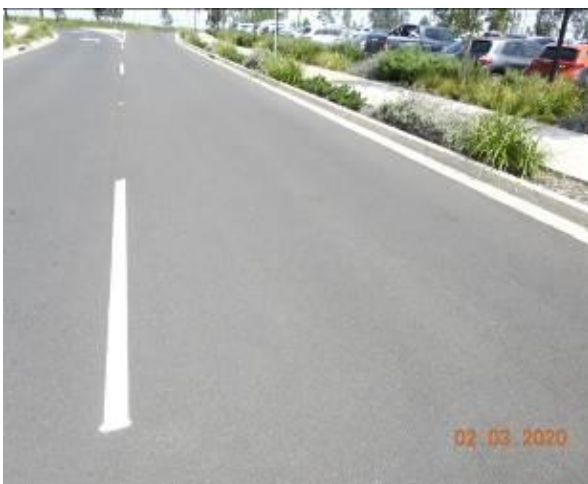
Figure 694 – General Condition of road surface

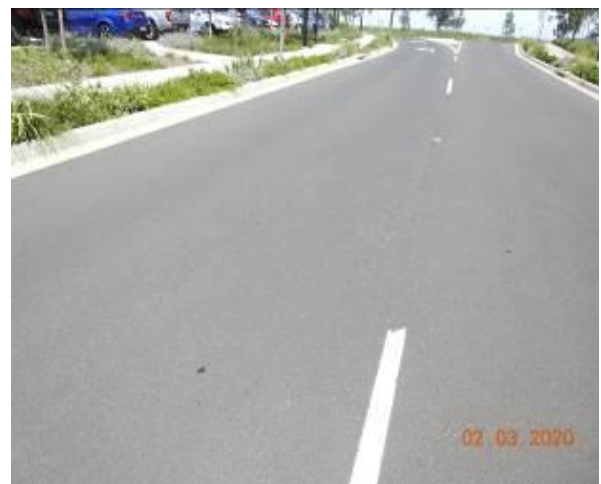
Figure 695 – General Condition of road surface

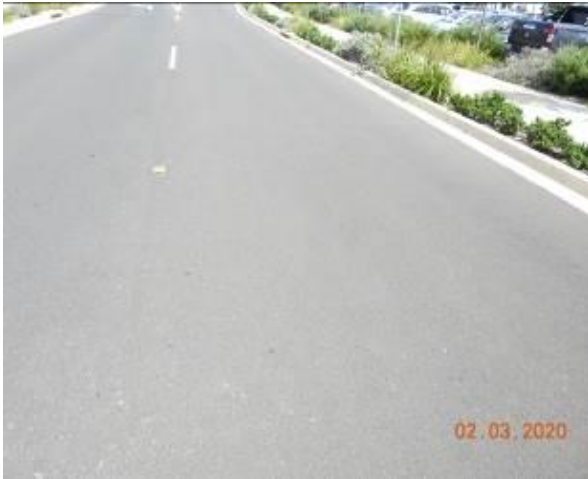
Figure 696 – General Condition of road surface

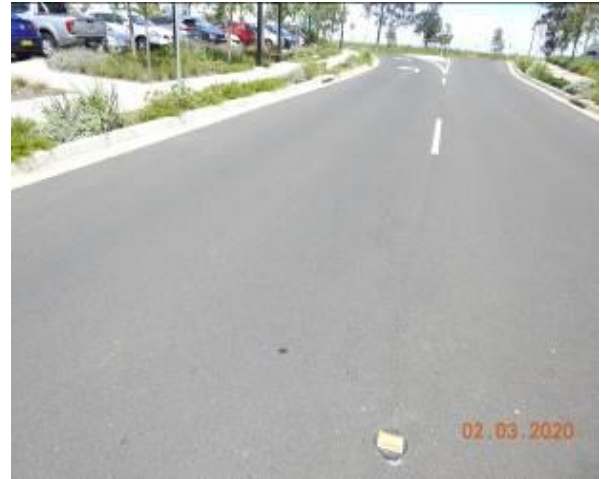
Figure 697 – General Condition of road surface

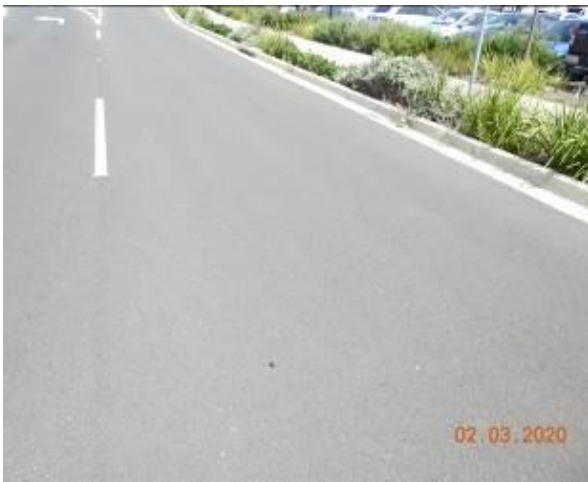
Figure 698 – General Condition of road surface

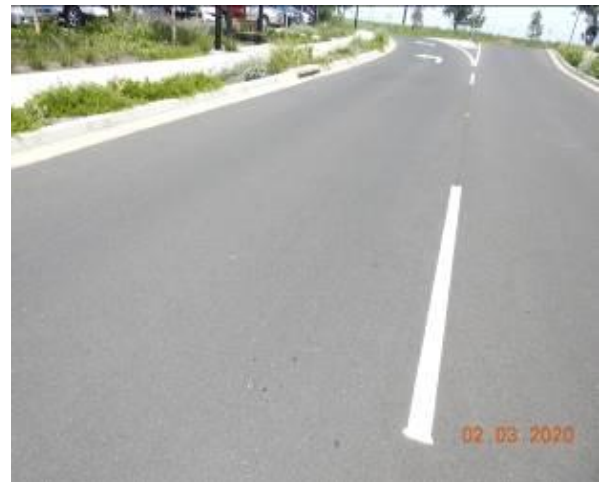
Figure 699 – General Condition of road surface

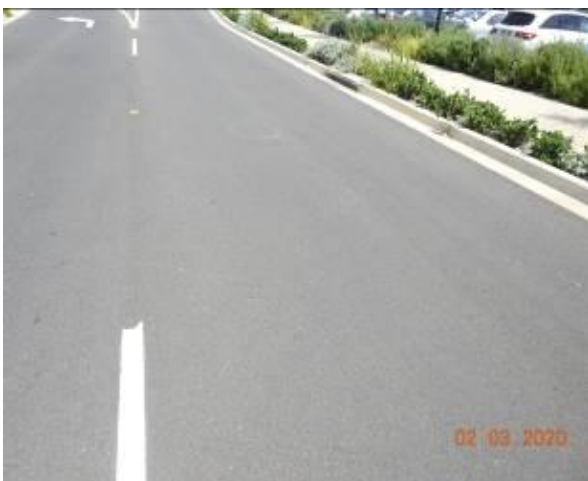
Figure 700 – General Condition of road surface

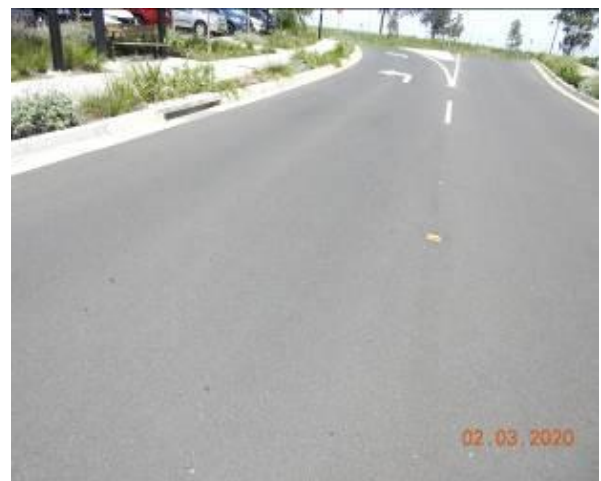
Figure 701 – General Condition of road surface

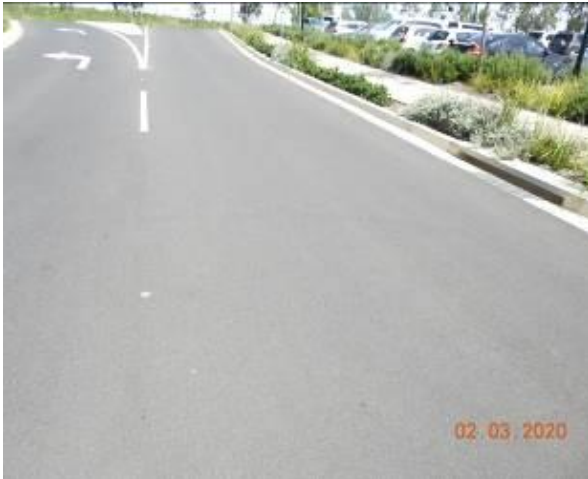
Figure 702 – General Condition of road surface

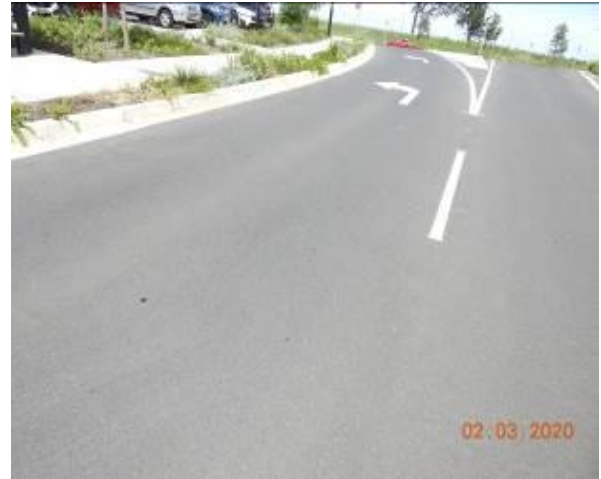
Figure 703 – General Condition of road surface

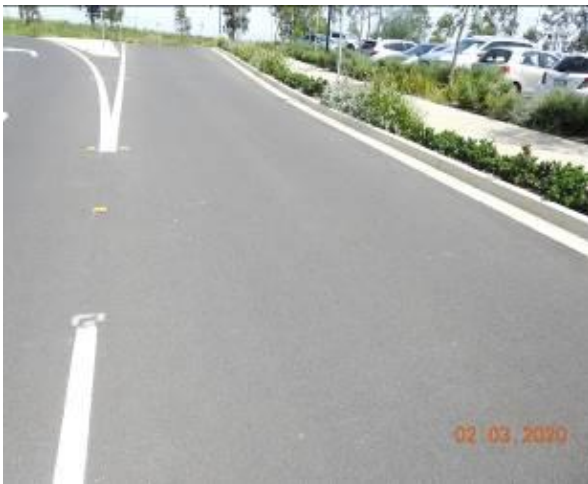
Figure 704 – General Condition of road surface

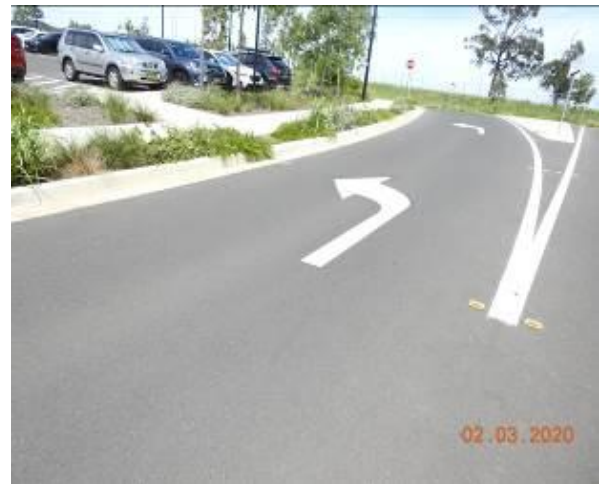
Figure 705 – General Condition of road surface

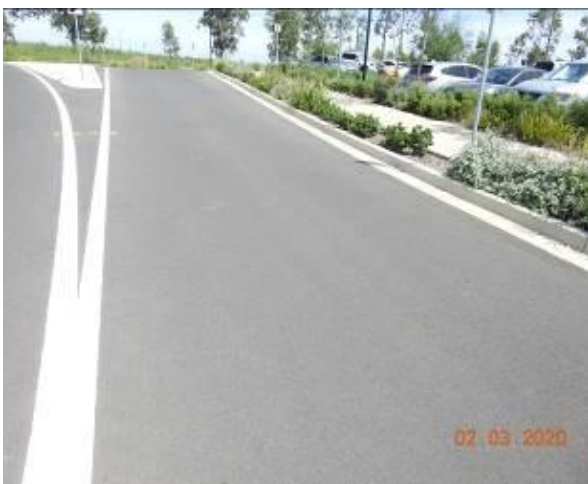
Figure 706 – General Condition of road surface

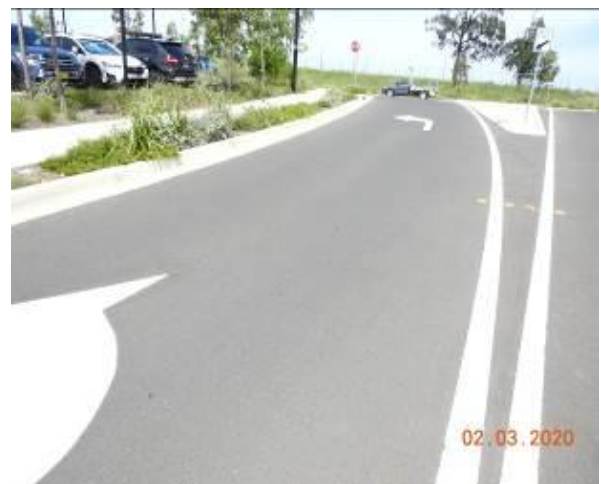
Figure 707 – General Condition of road surface

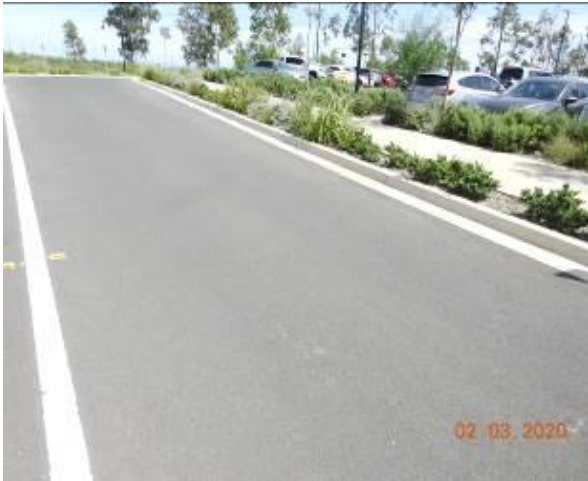
Figure 708 – General Condition of road surface

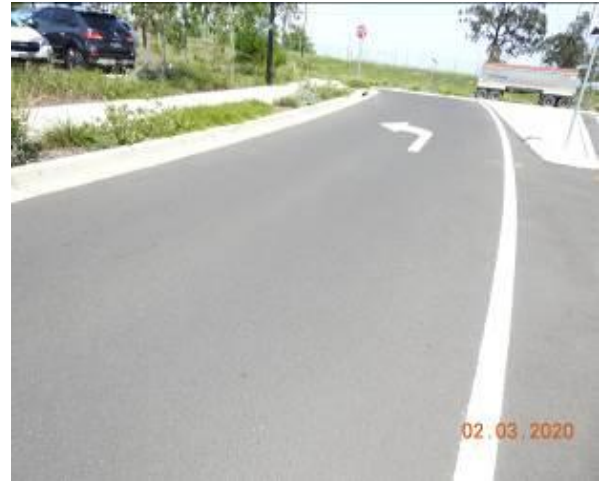
Figure 709 – General Condition of road surface

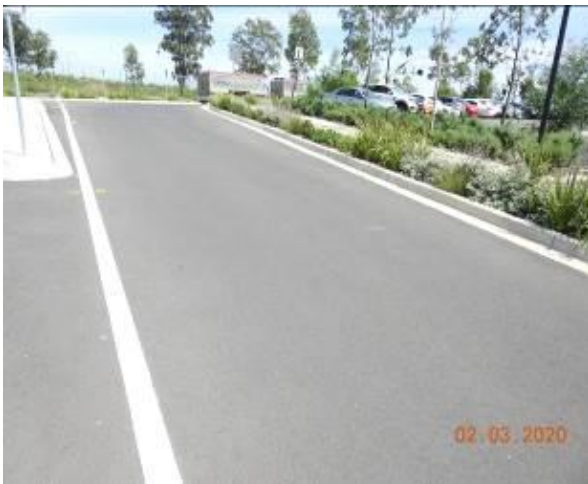
Figure 710 – General Condition of road surface

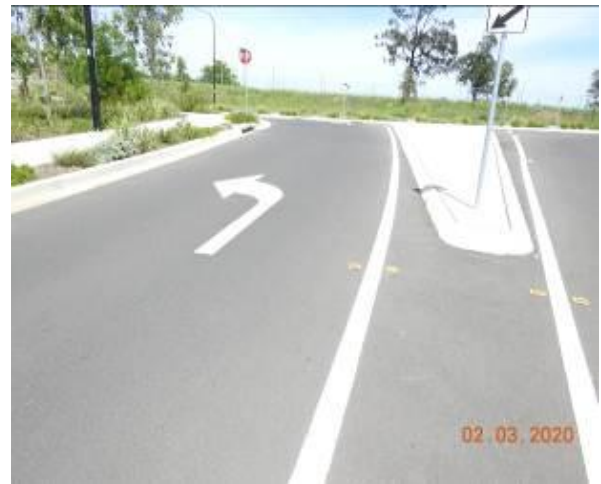
Figure 711 – General Condition of road surface

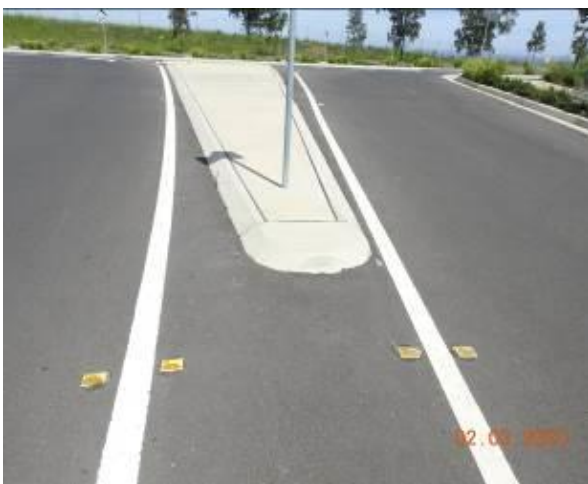
Figure 712 – General Condition of road surface

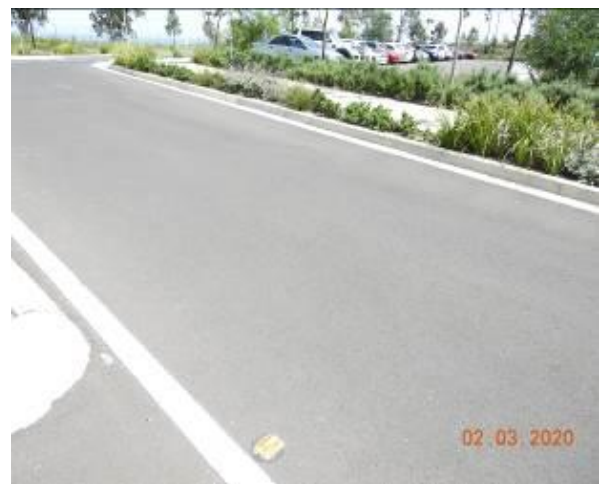
Figure 714 – General Condition of road surface

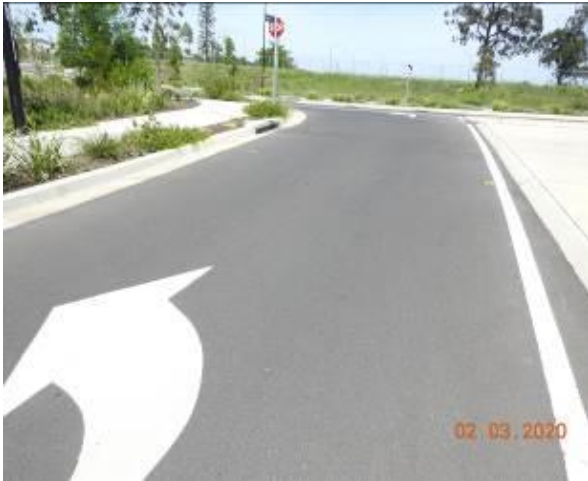
Figure 715 – General Condition of road surface

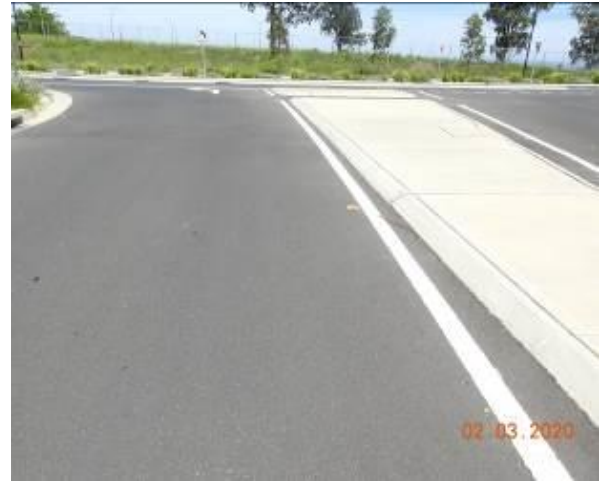
Figure 716 – General Condition of road surface

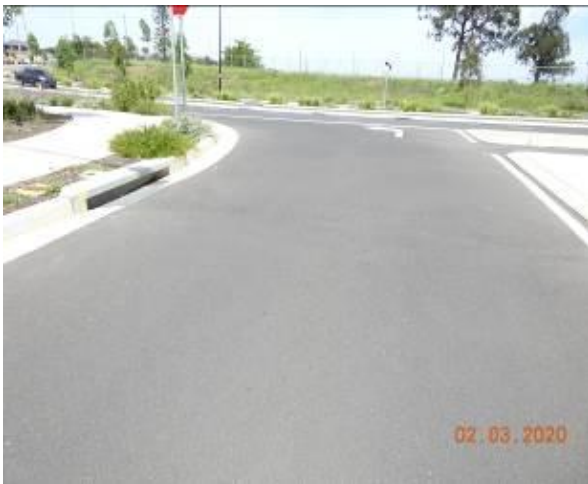
Figure 717 – General Condition of road surface

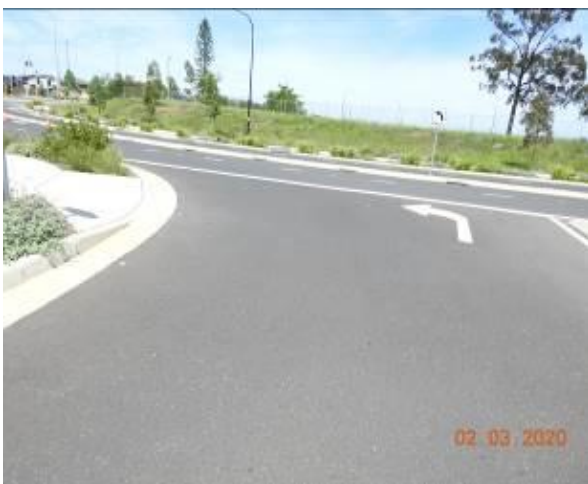
Figure 719 – General Condition of road surface

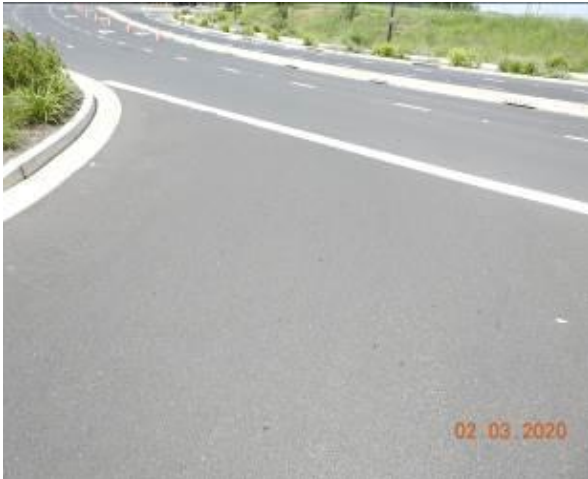
Figure 721 – General Condition of road surface

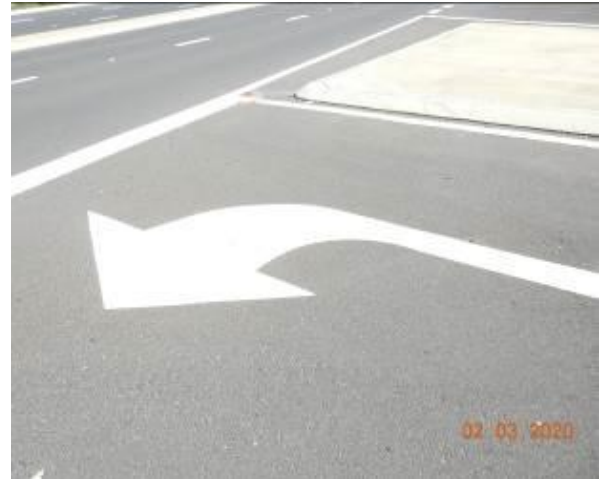
Figure 722 – General Condition of road surface

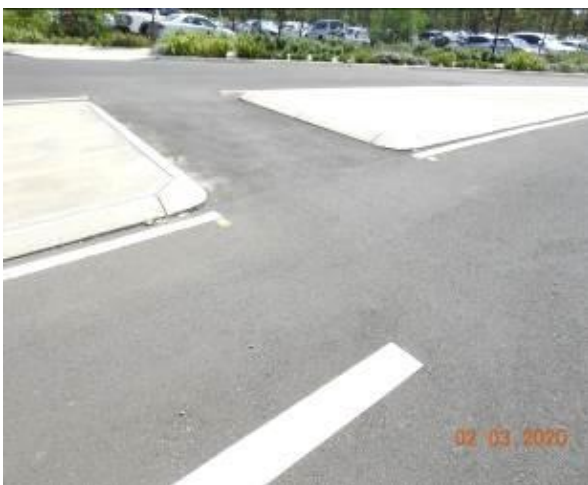
Figure 723 – General Condition of road surface

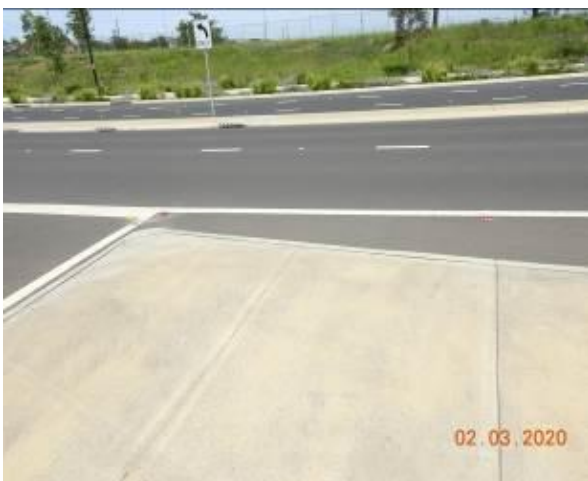
Figure 725 – General Condition of road surface

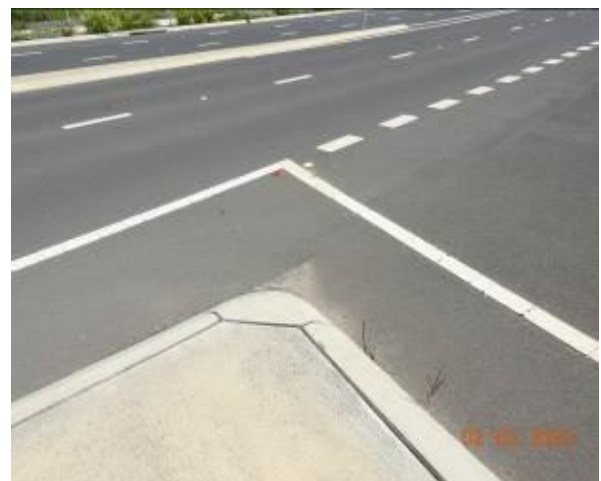
Figure 726 – General Condition of road surface

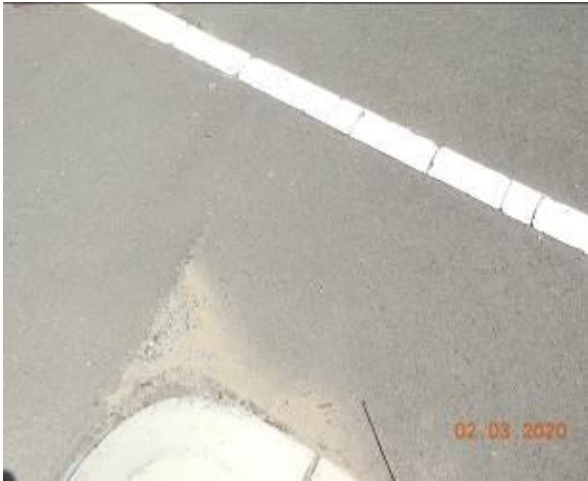
Figure 727 – Crack propagation through road surface

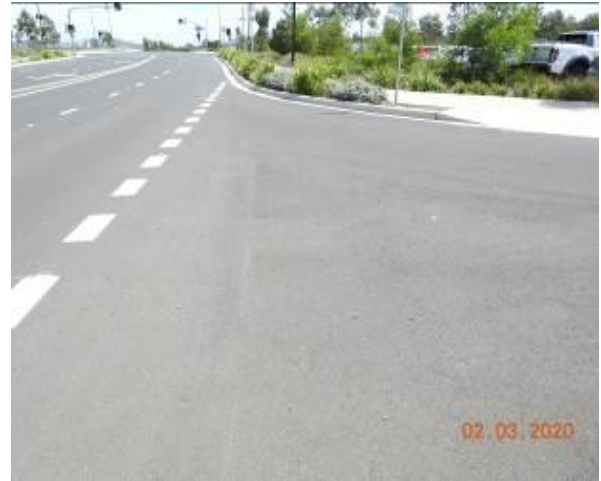
Figure 728 – General Condition of road surface

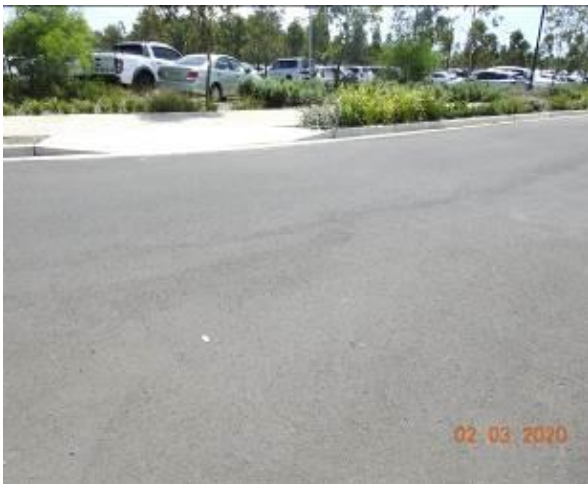
Figure 729 – General Condition of road surface

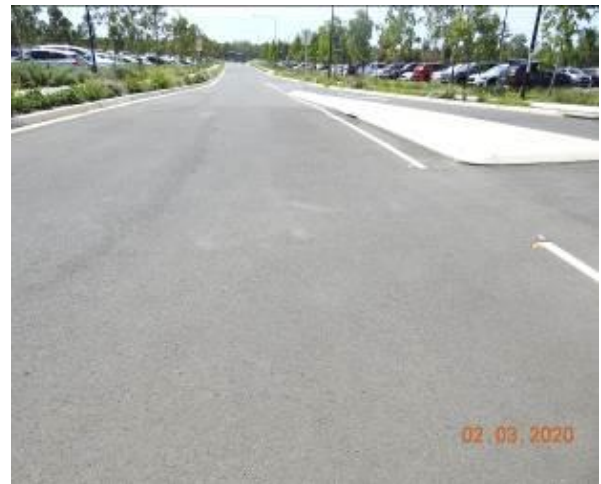
Figure 730 – General Condition of road surface

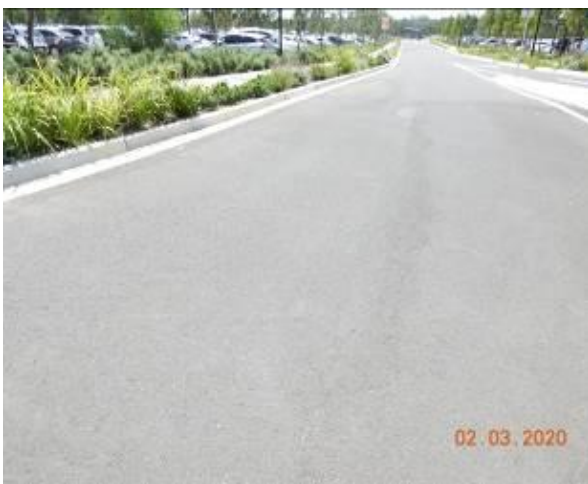
Figure 731 – General Condition of road surface

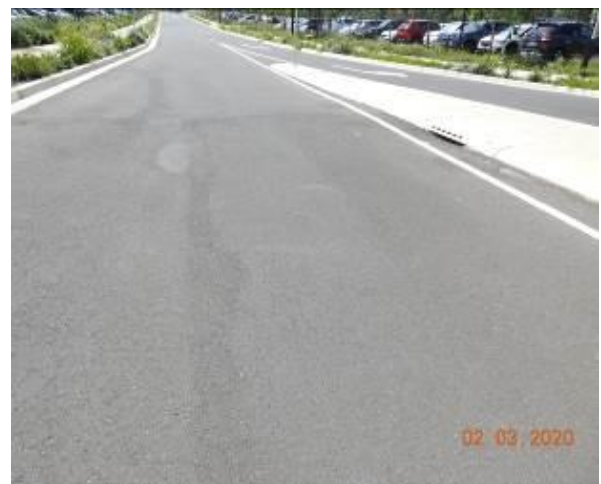
Figure 732 – General Condition of road surface

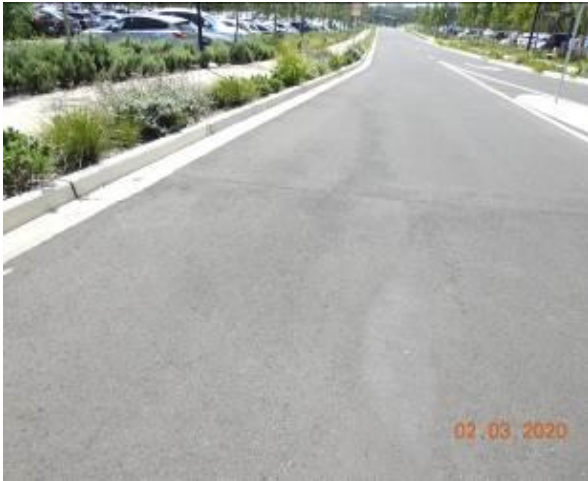
Figure 733 – General Condition of road surface

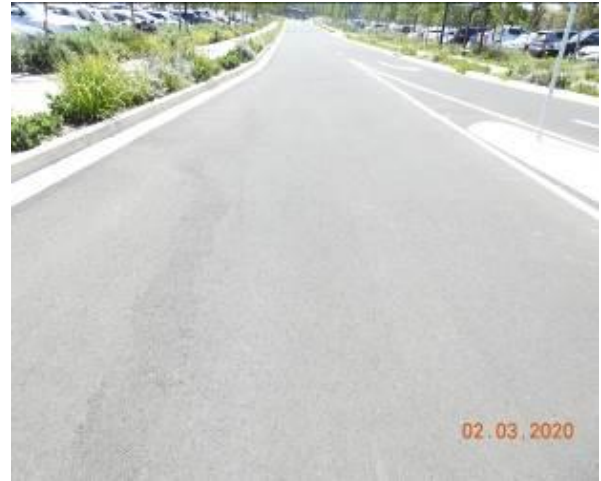
Figure 734 – General Condition of road surface

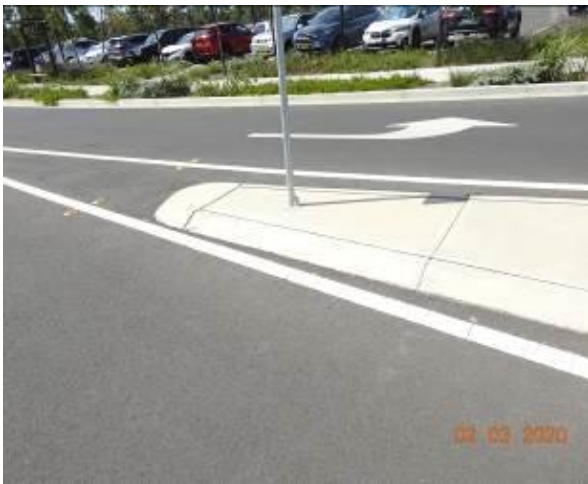
Figure 735 – General Condition of traffic island

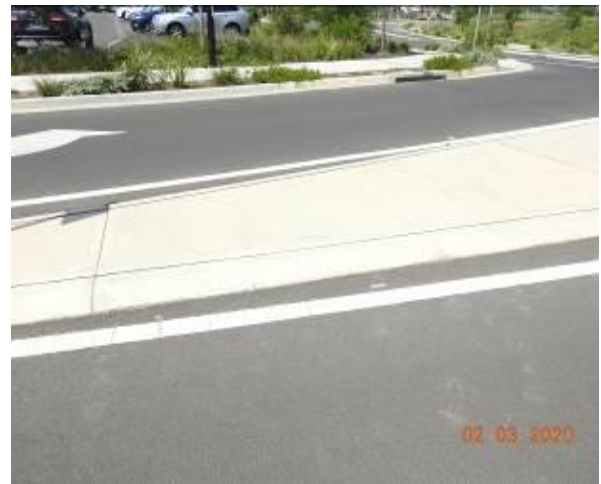
Figure 736 – General Condition of traffic island

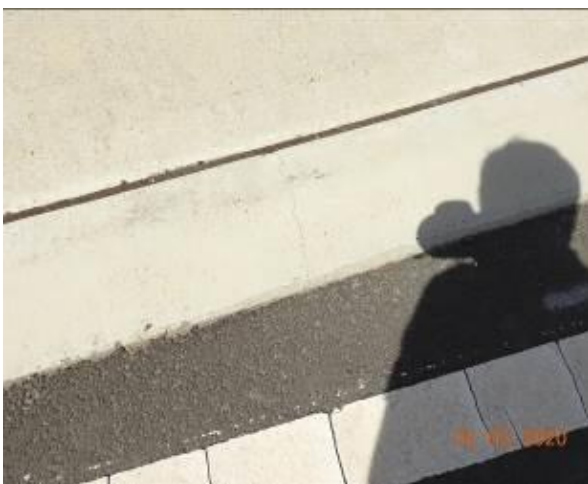
Figure 737 – Crack propagation through traffic island

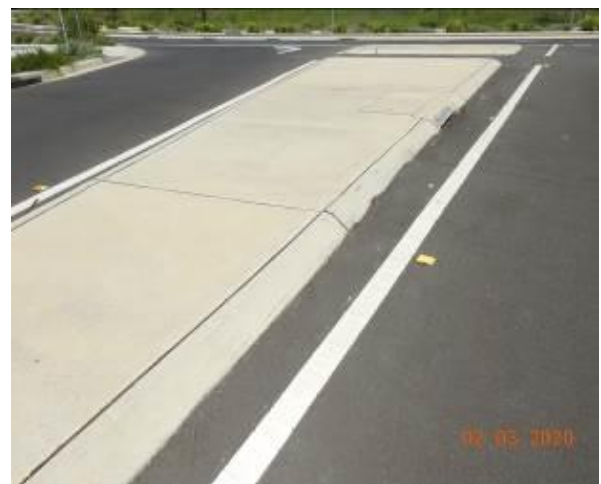
Figure 738 – General Condition of traffic island

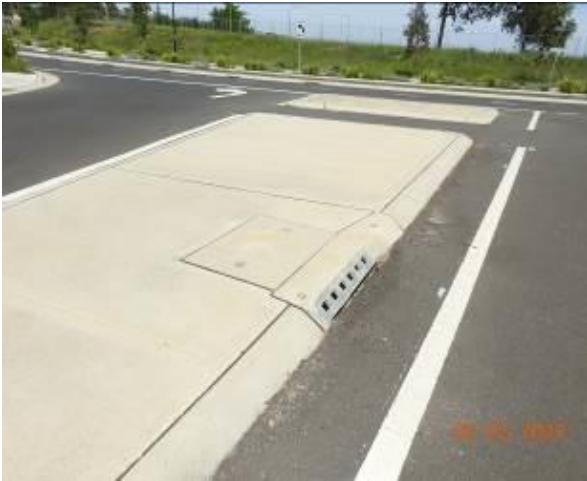
Figure 739 – General Condition of stormwater inlet pit

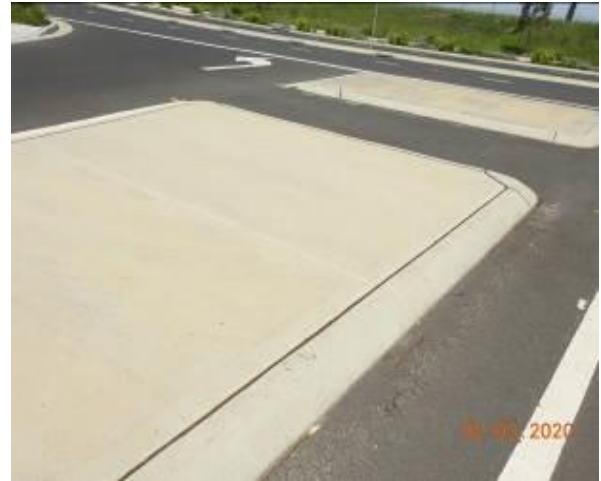
Figure 740 – General Condition of traffic island

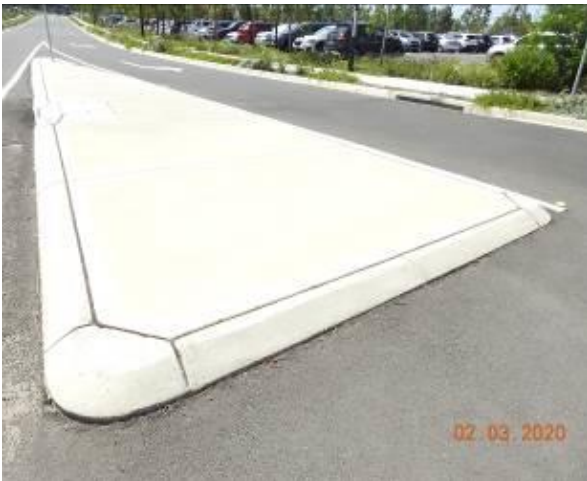
Figure 741 – General Condition of traffic island

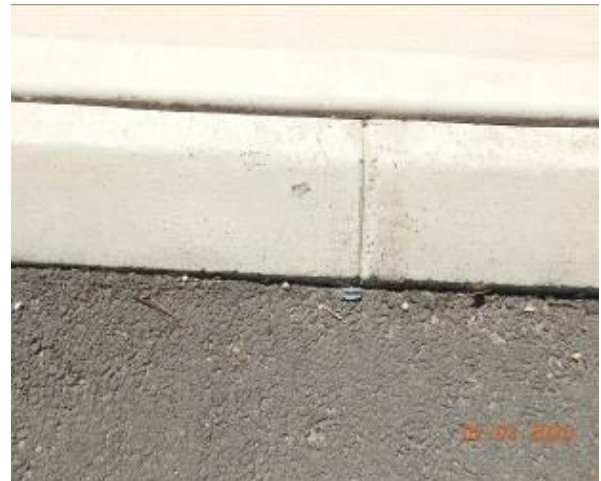
Figure 742 – Crack propagation through traffic island
