**1-15 AND 2-12 CONFERTA AVENUE,  
ROUSE HILL NSW 2155  
TALLAWONG STATION PRECINCT SOUTH  
PRE-DILAPIDATION REPORT**

**DEICORP PROJECTS  
(TALLAWONG STATION) PTY LTD**

Job No. 191294.0  
05/07/2021

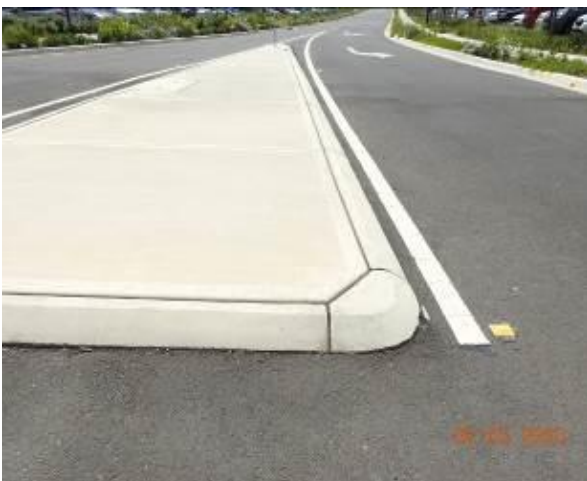
Figure 743 – General Condition of traffic island

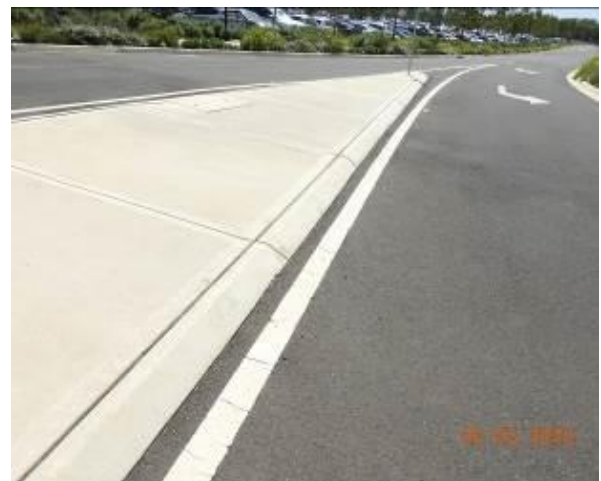
Figure 744 – General Condition of traffic island

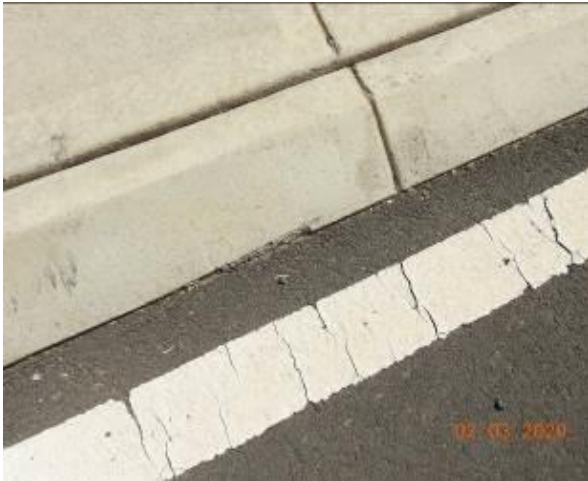
Figure 745 – Loss of material through traffic island kerb

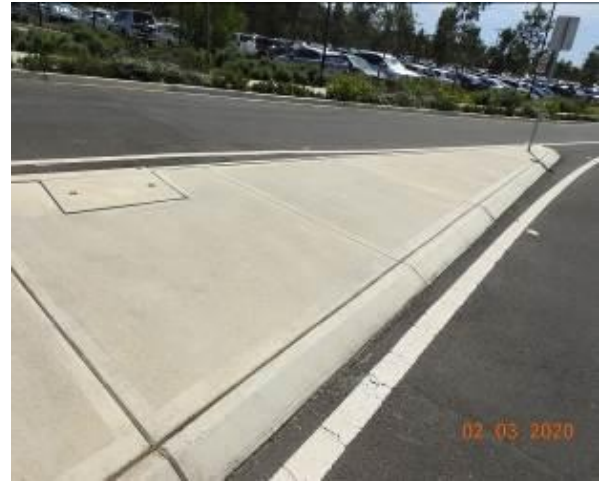
Figure 746 – General Condition of traffic island

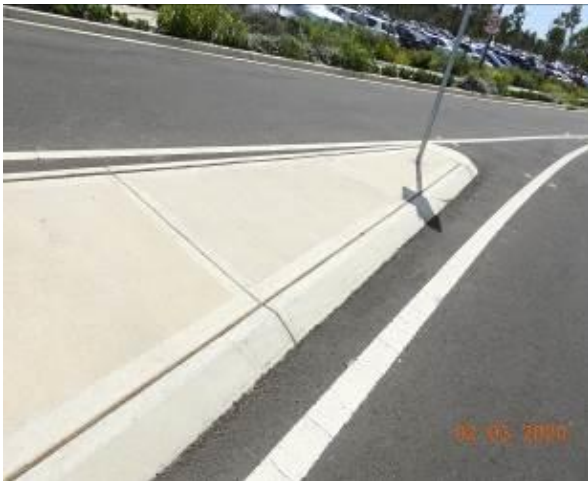
Figure 747 – General Condition of traffic island

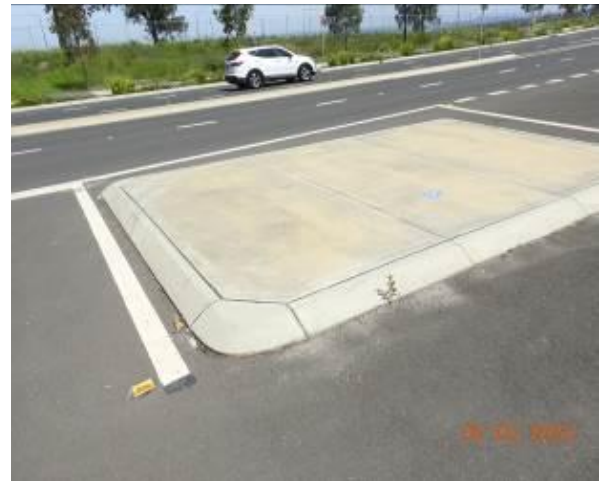
Figure 748 – General Condition of traffic island

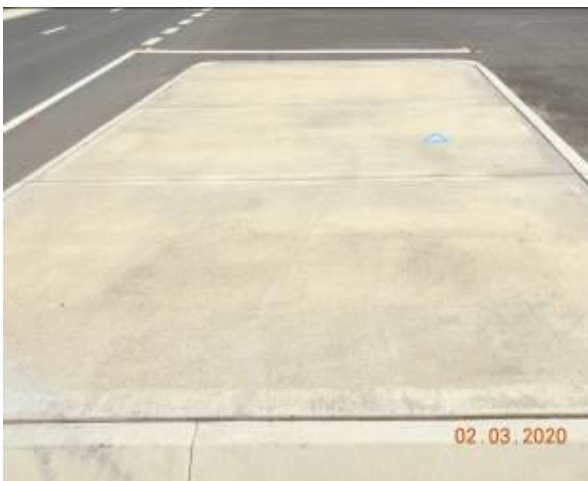
Figure 749 – General Condition of traffic island

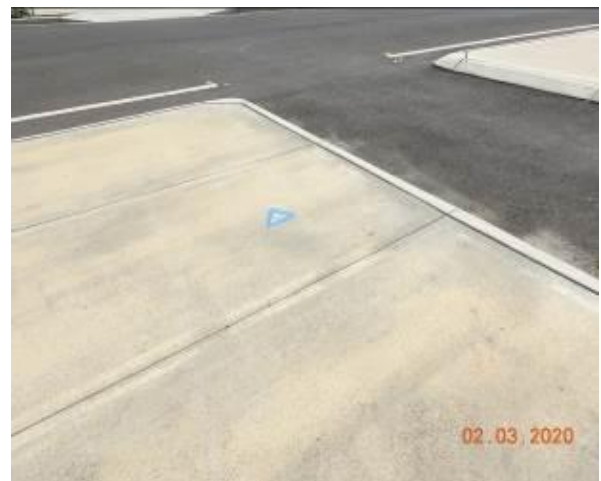
Figure 750 – General Condition of traffic island

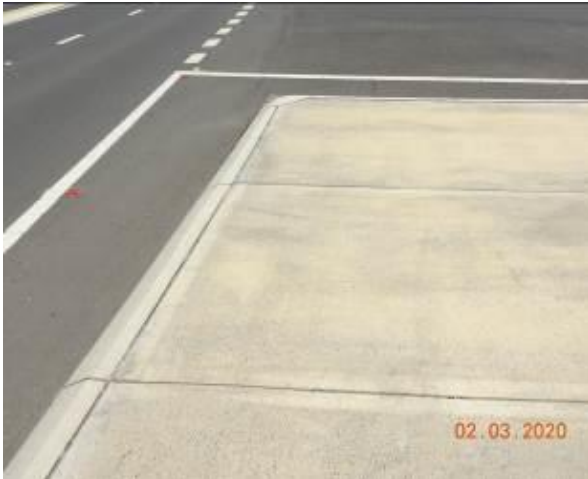
Figure 751 – General Condition of traffic island

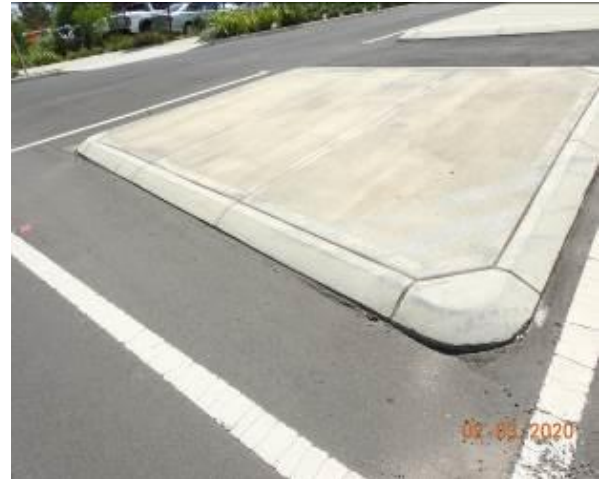
Figure 752 – General Condition of traffic island

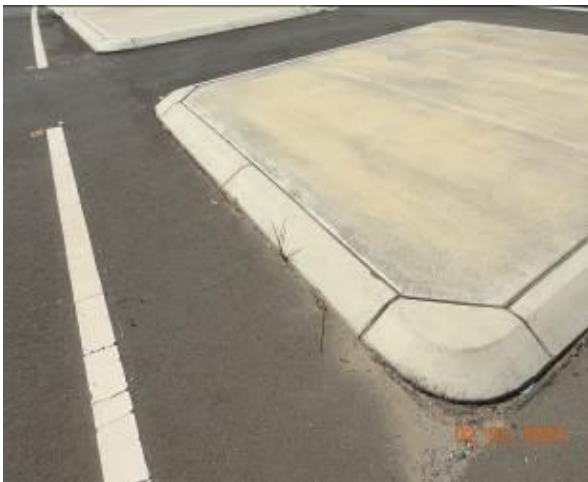
Figure 753 – General Condition of traffic island

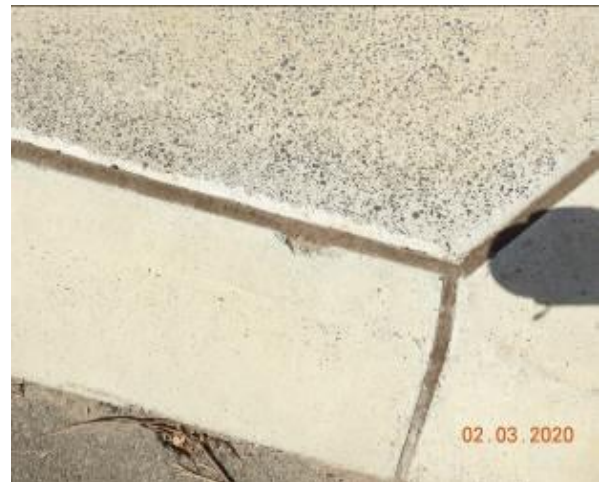
Figure 754 – Loss of material through traffic island kerb

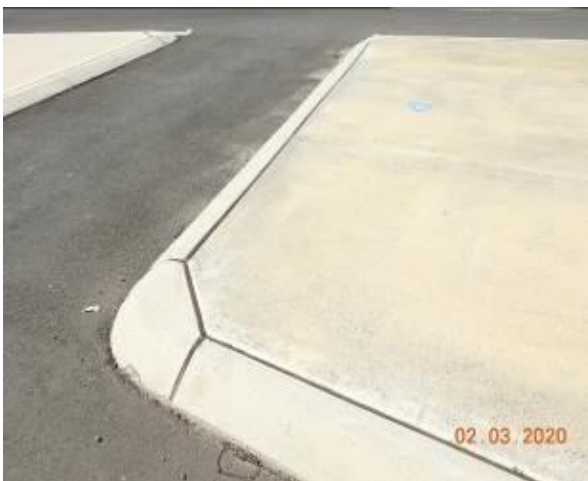
Figure 755 – General Condition of traffic island

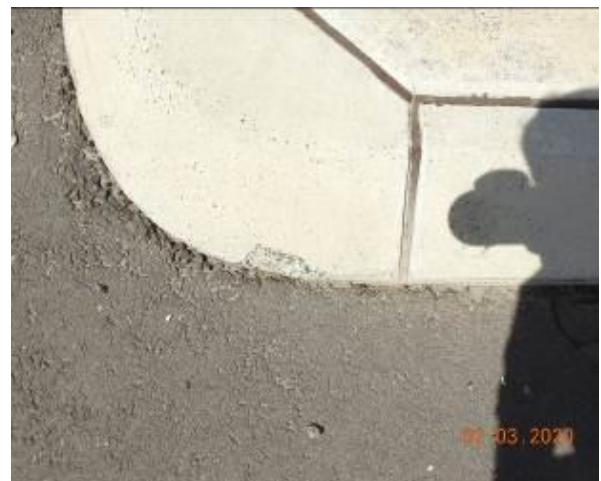
Figure 756 – Loss of material through traffic island

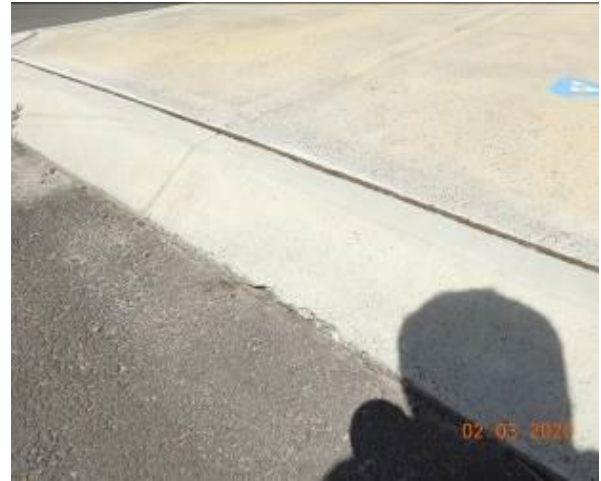
Figure 757 – General Condition of traffic island

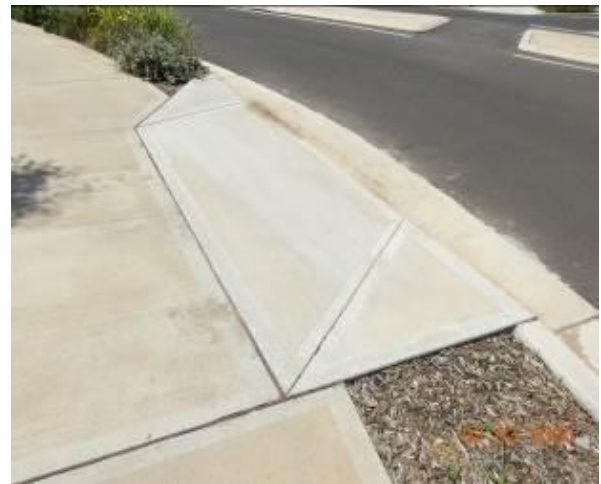
Figure 759 – General Condition of footpath pavement

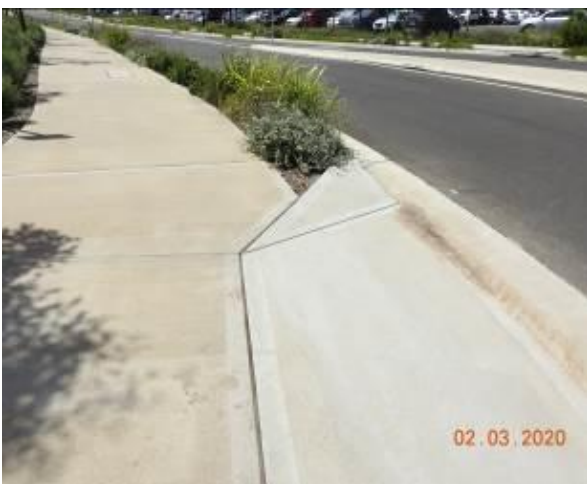
Figure 760 – General Condition of footpath pavement

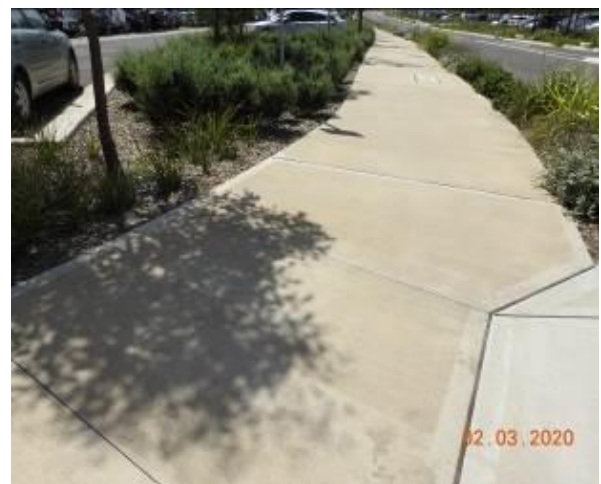
Figure 761 – General Condition of footpath pavement

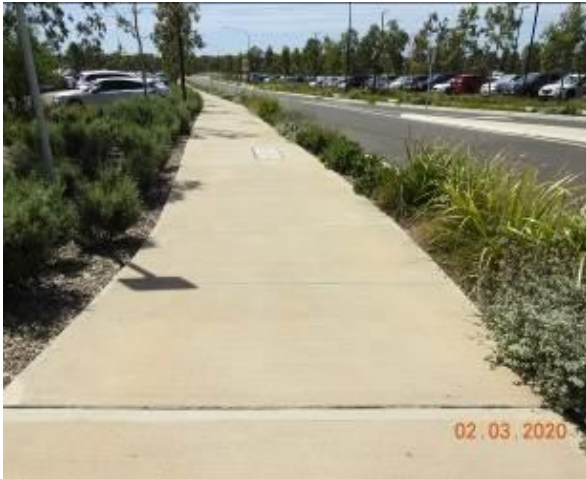
Figure 762 – General Condition of footpath pavement

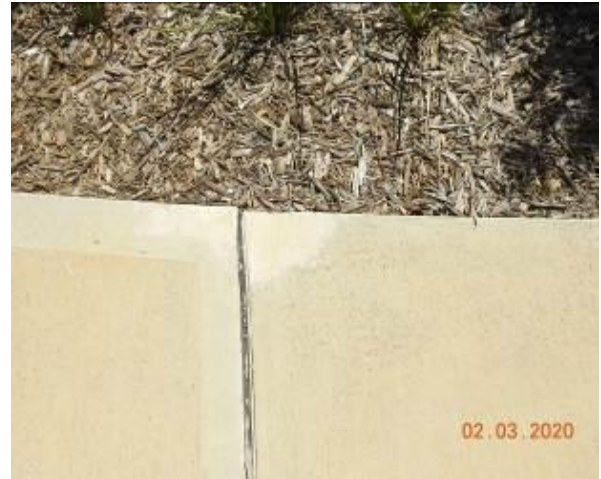
Figure 763 – General Condition of footpath pavement

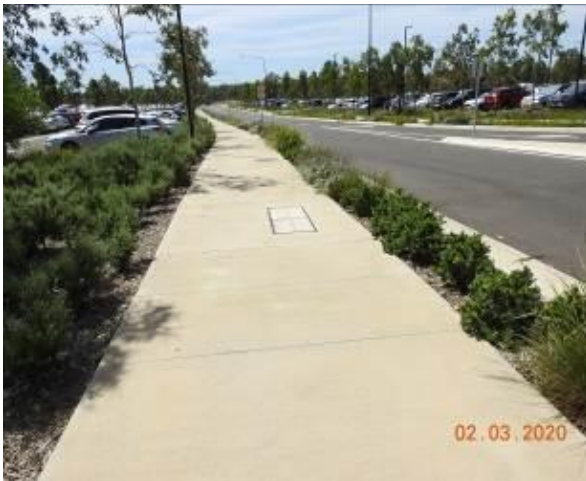
Figure 764 – Crack propagation through footpath pavement

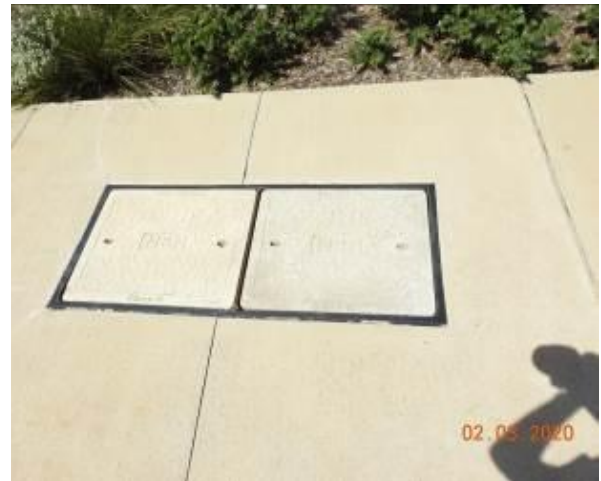
Figure 765 – General Condition of footpath pavement

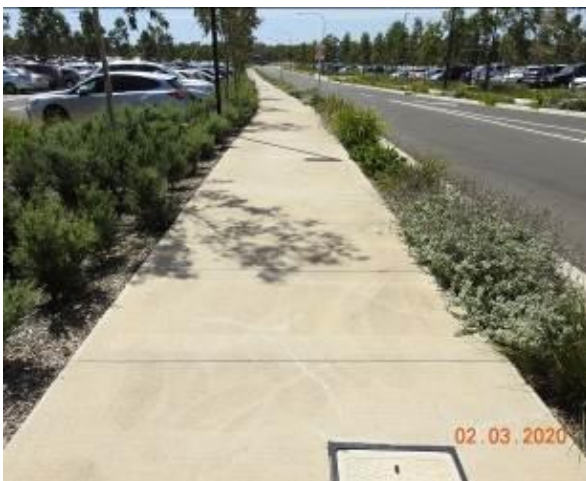
Figure 766 – General Condition of service pit

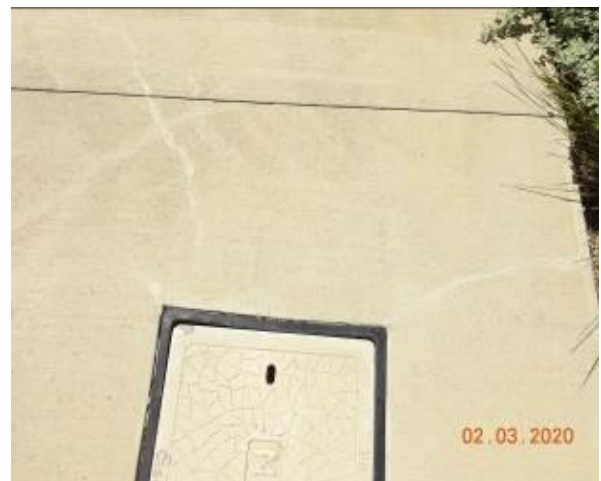
Figure 767 – General Condition of footpath pavement

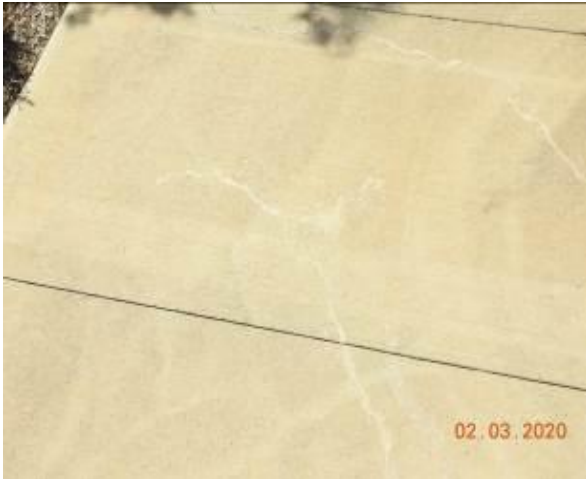
Figure 768 – Loss of material through service pit

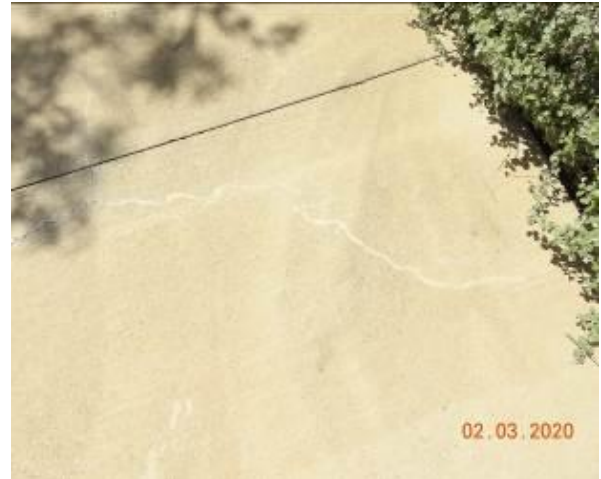
Figure 769 – Crack propagation through footpath pavement

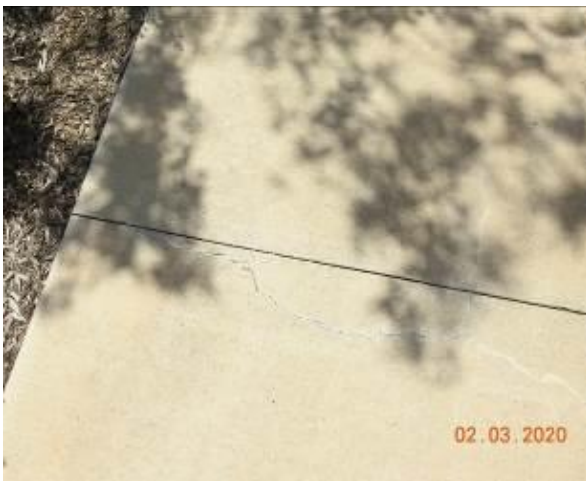
Figure 770 – Crack propagation through footpath pavement

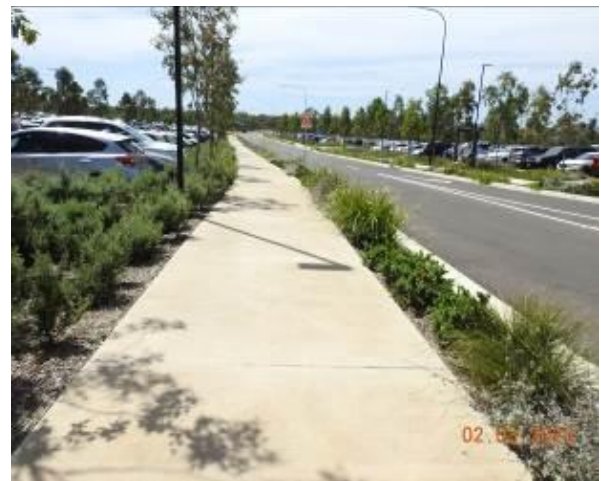
Figure 771 – Crack propagation through footpath pavement

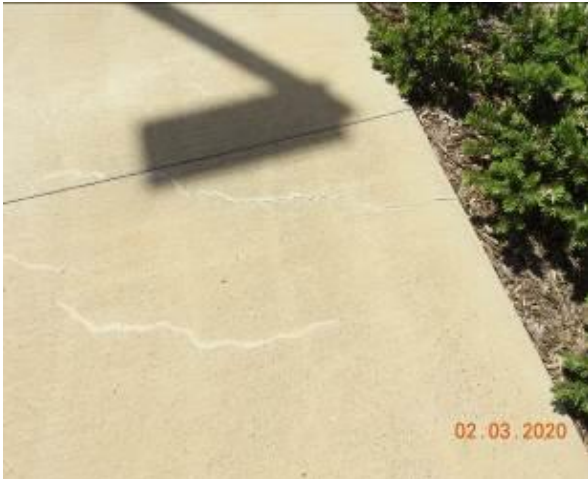
Figure 774 – Crack propagation through footpath pavement

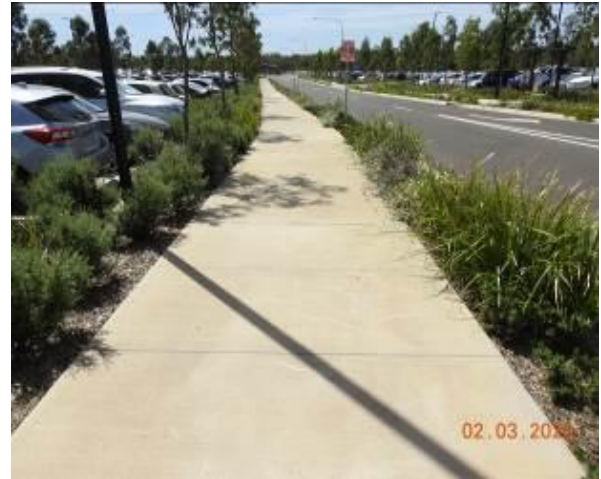
Figure 775 – Crack propagation through footpath pavement

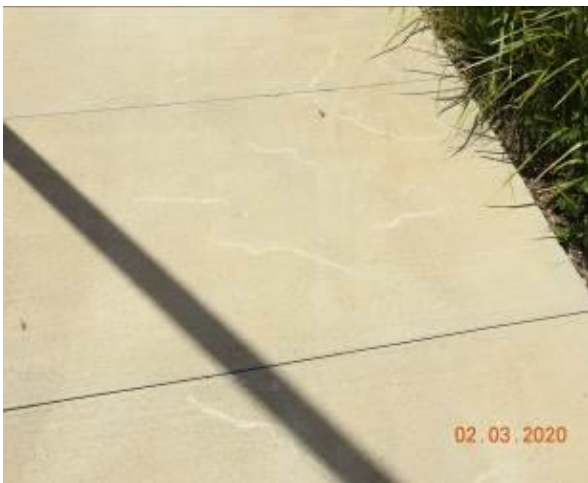
Figure 776 – General Condition of footpath pavement

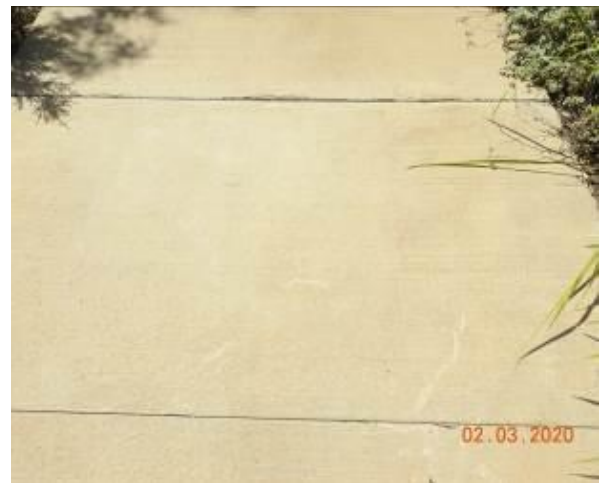
Figure 777 – Crack propagation through footpath pavement

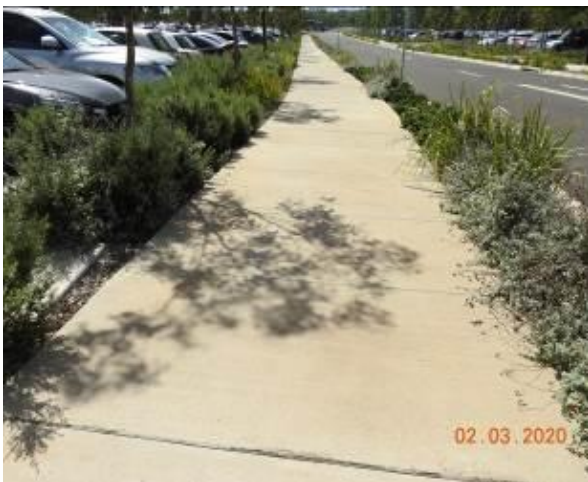
Figure 778 – Crack propagation through footpath pavement

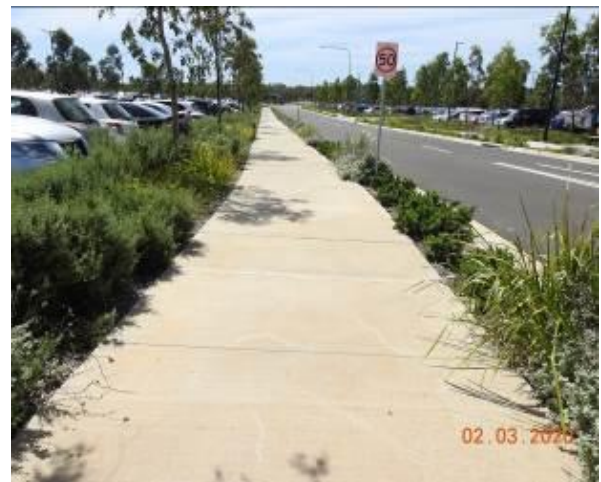
Figure 779 – General Condition of footpath pavement

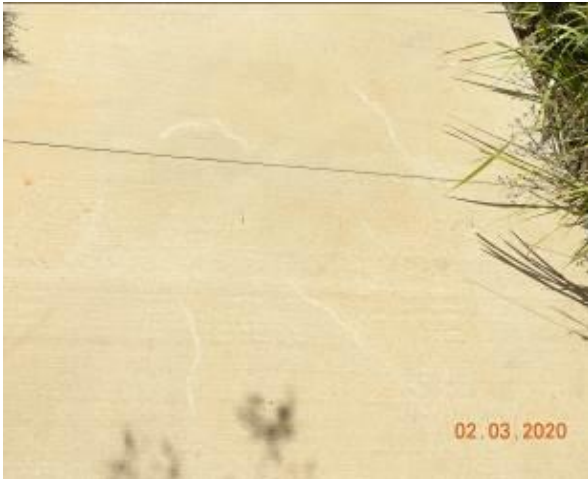
Figure 780 – General Condition of footpath pavement

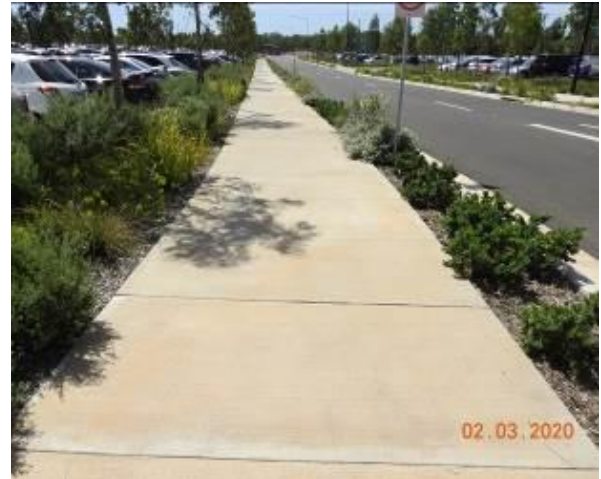
Figure 781 – Crack propagation through footpath pavement

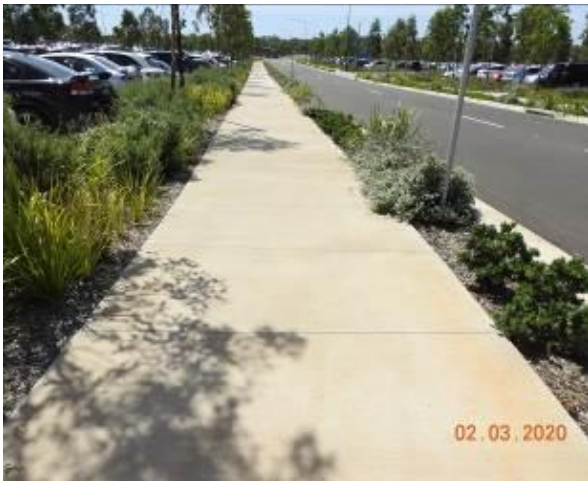
Figure 782 – General Condition of footpath pavement

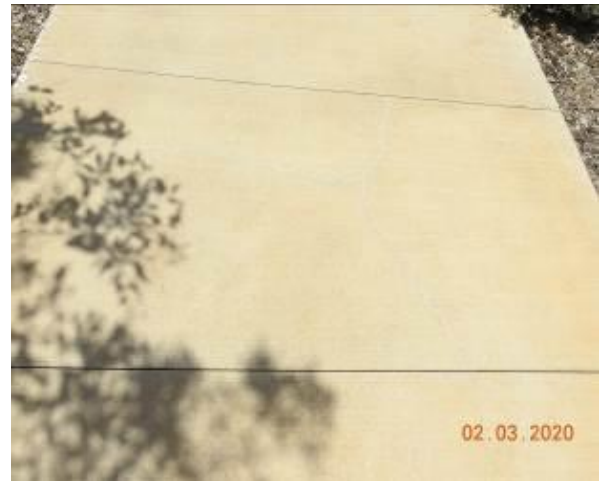
Figure 783 – General Condition of footpath pavement

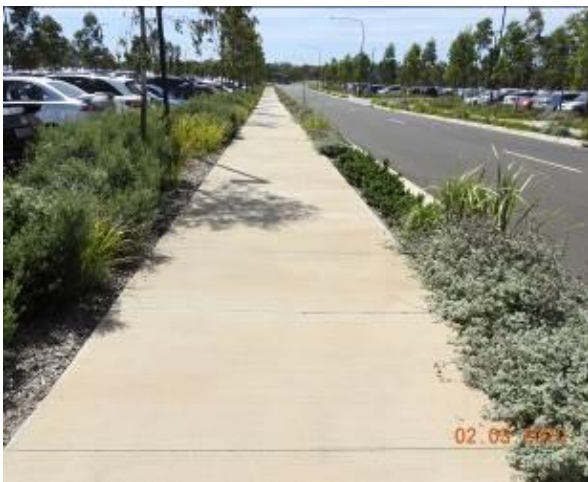
Figure 784 – Crack propagation through footpath pavement

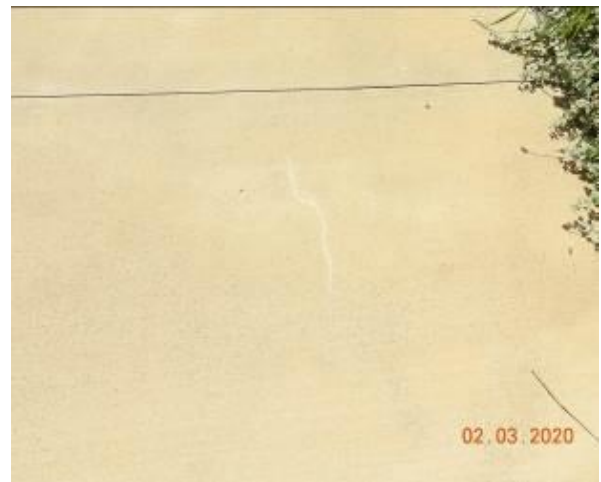
Figure 785 – General Condition of footpath pavement

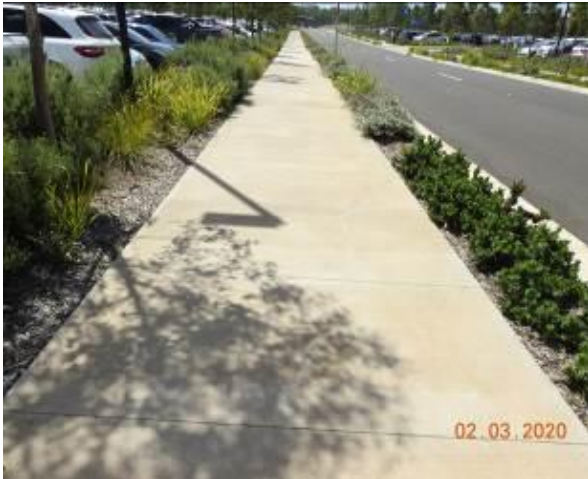
Figure 786 – Crack propagation through footpath pavement

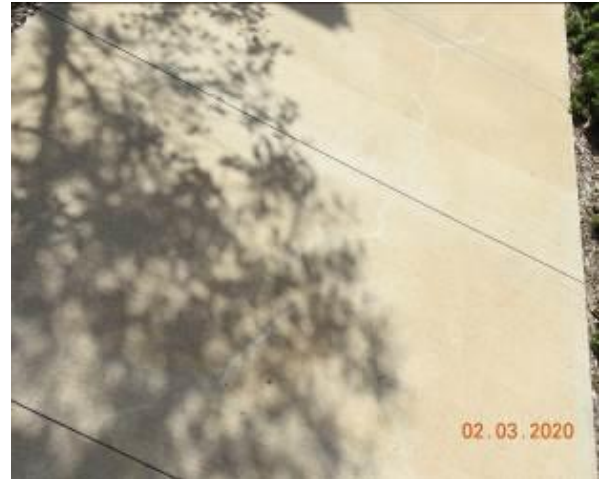
Figure 787 – General Condition of footpath pavement

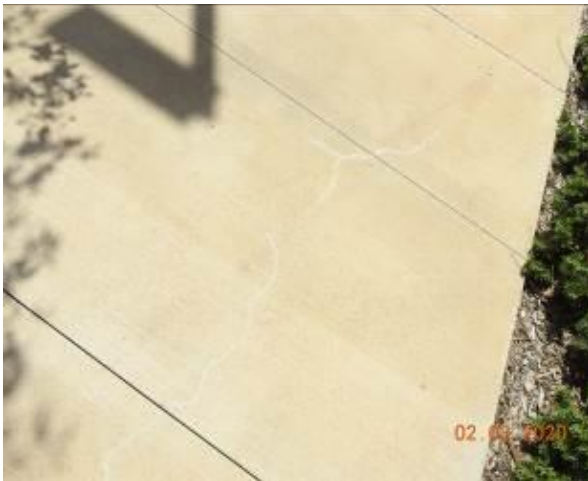
Figure 788 – Crack propagation through footpath pavement

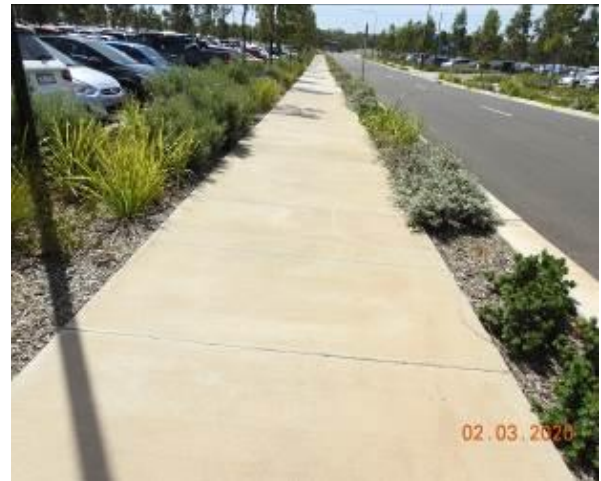
Figure 789 – Crack propagation through footpath pavement

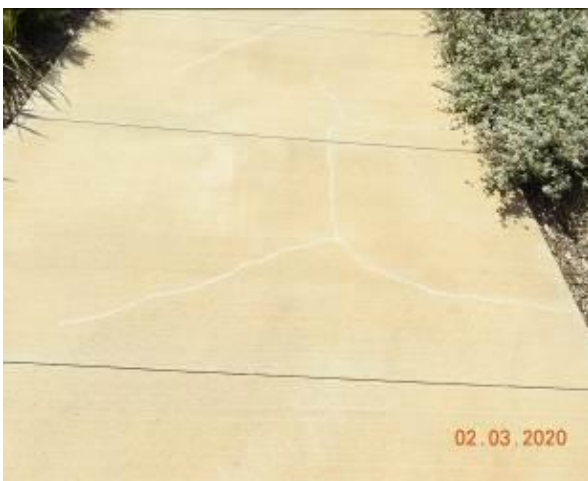
Figure 790 – General Condition of footpath pavement

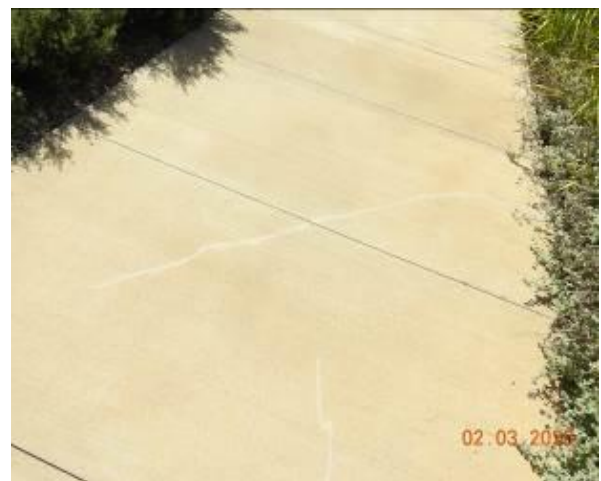
Figure 791 – Crack propagation through footpath pavement

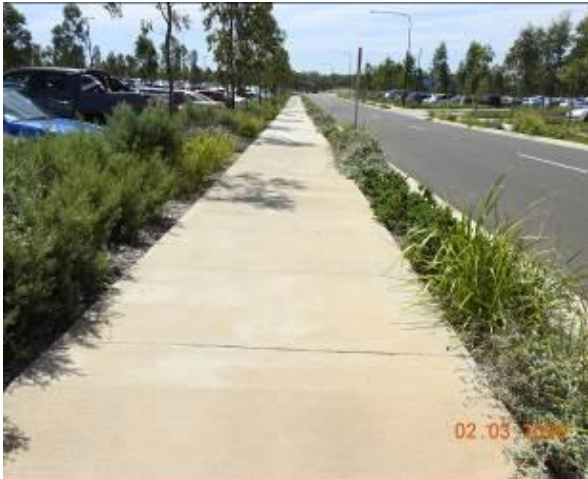
Figure 792 – Crack propagation through footpath pavement

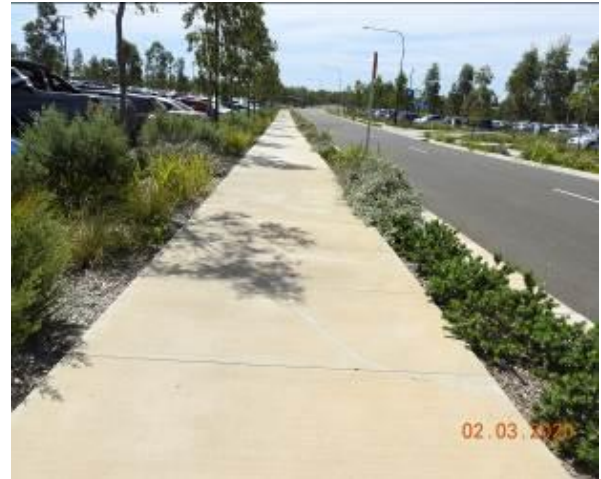
Figure 793 – General Condition of footpath pavement

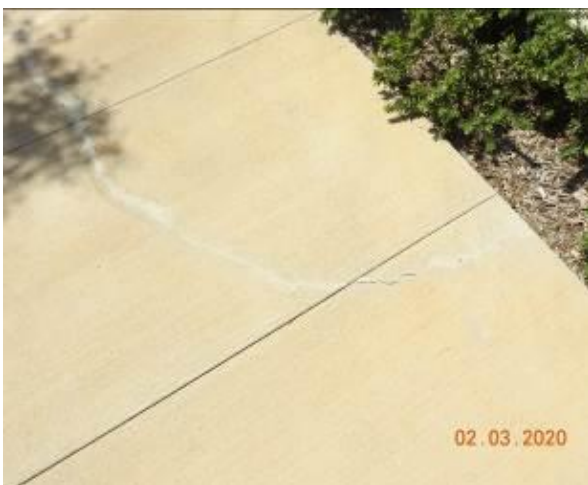
Figure 794 – General Condition of footpath pavement

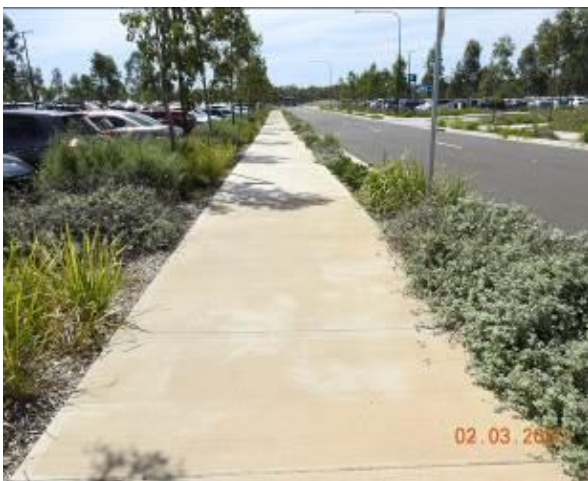
Figure 796 – Crack propagation through footpath pavement

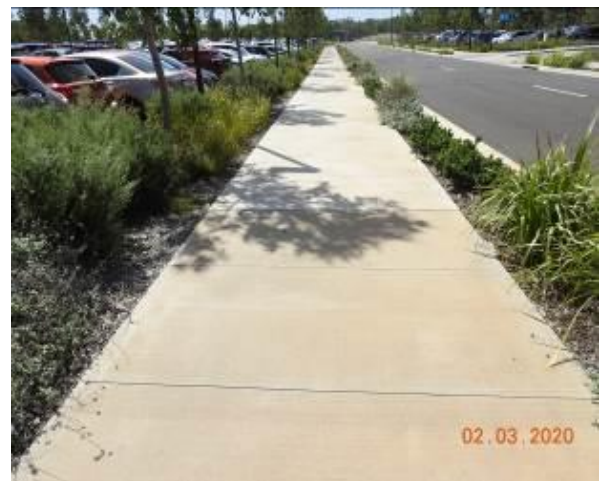
Figure 797 – General Condition of footpath pavement

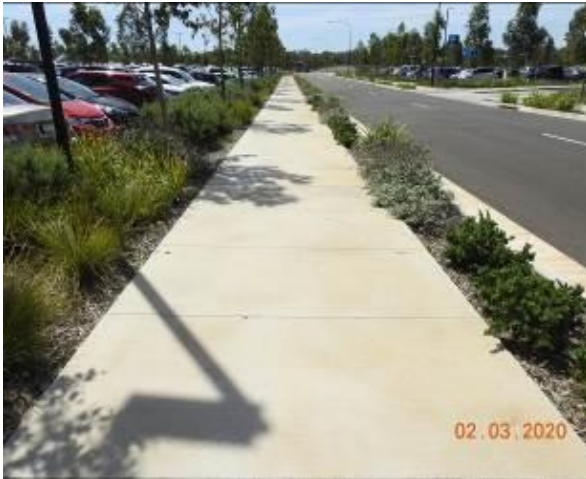
Figure 798 – General Condition of footpath pavement

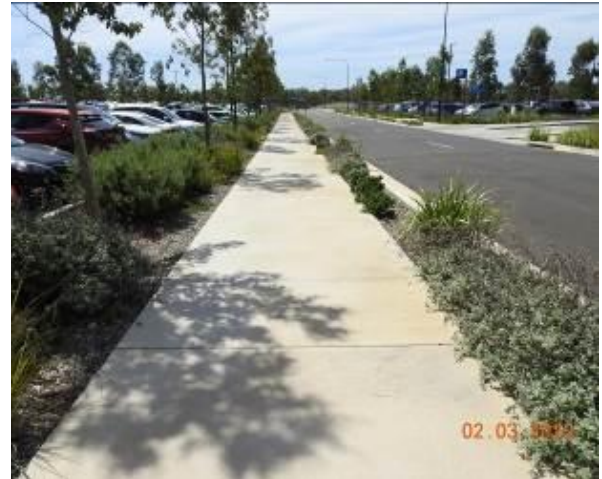
Figure 799 – General Condition of footpath pavement

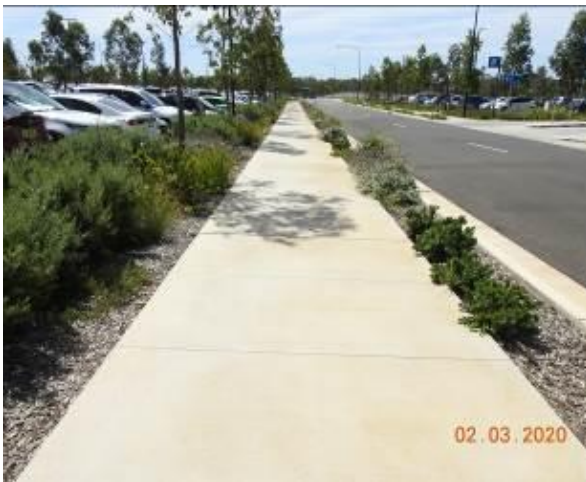
Figure 800 – General Condition of footpath pavement

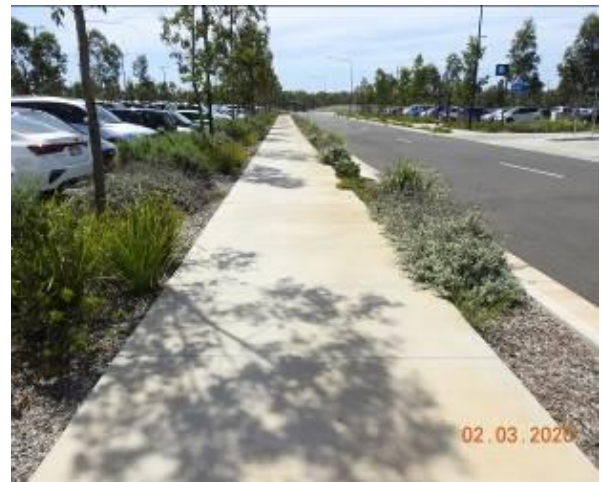
Figure 801 – General Condition of footpath pavement

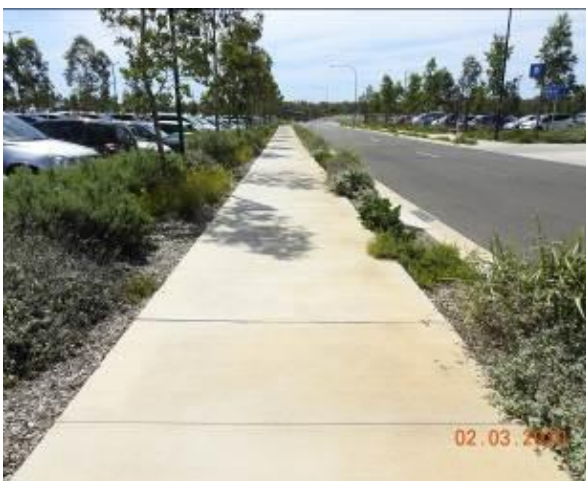
Figure 802 – General Condition of footpath pavement

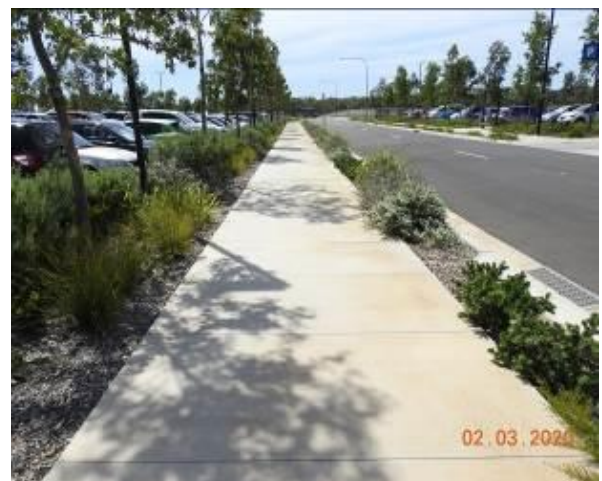
Figure 803 – General Condition of footpath pavement

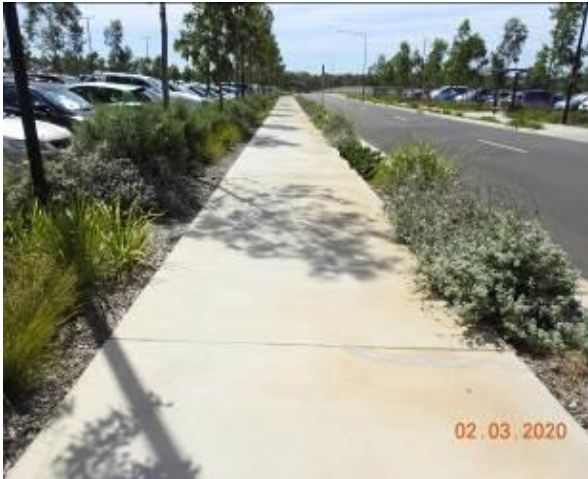
Figure 804 – General Condition of footpath pavement

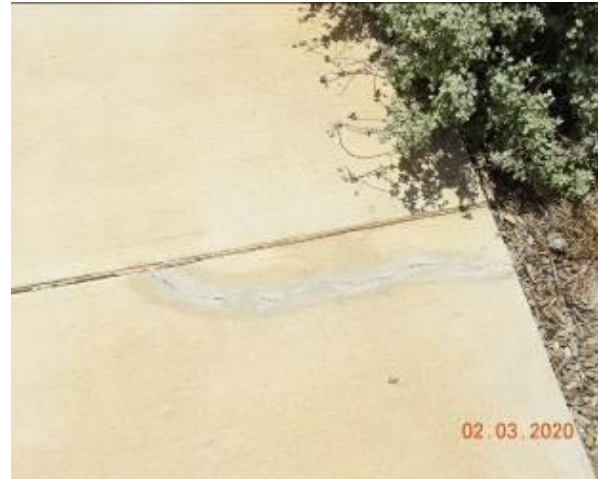
Figure 805 – General Condition of footpath pavement

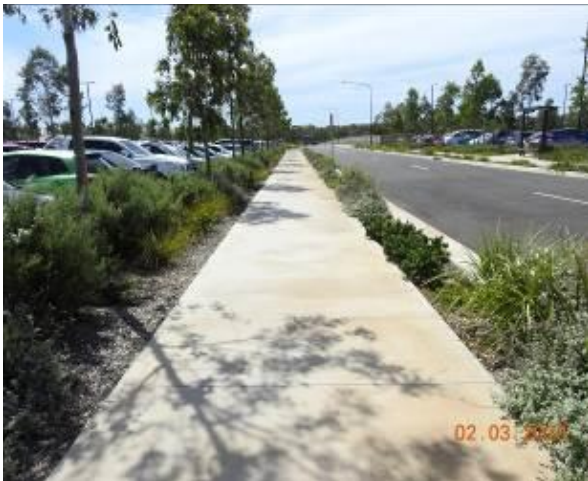
Figure 806 – Crack propagation through footpath pavement

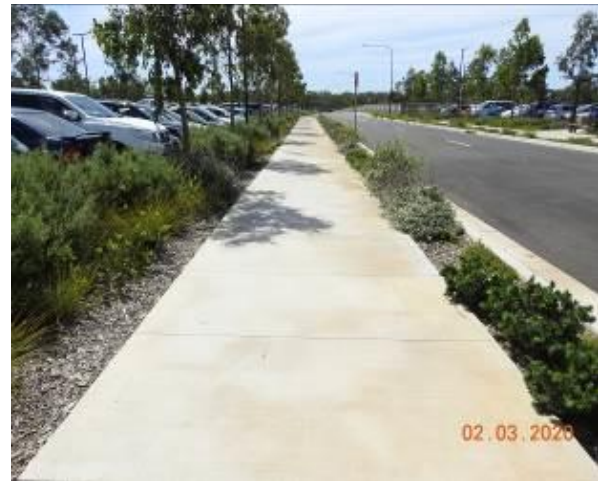
Figure 807 – General Condition of footpath pavement

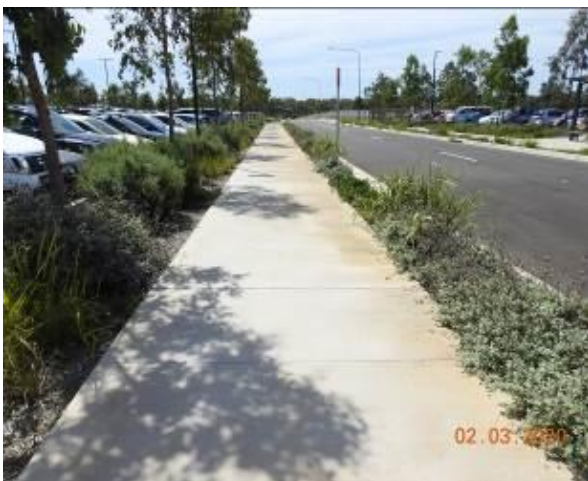
Figure 808 – General Condition of footpath pavement

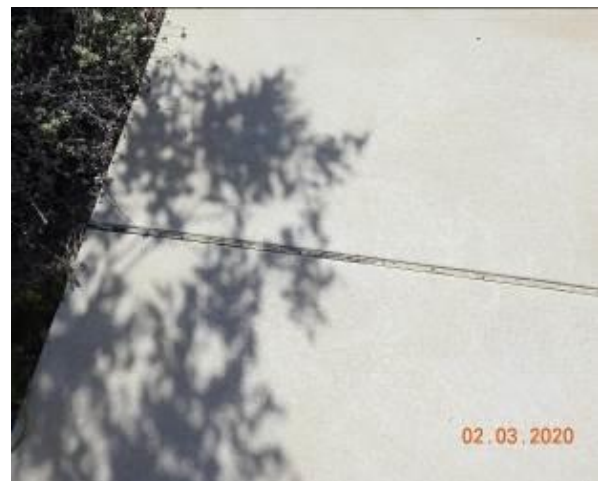
Figure 809 – General Condition of footpath pavement

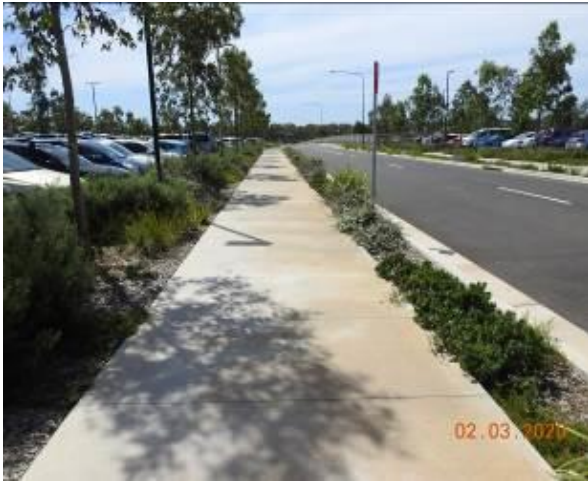
Figure 810 – Crack propagation through footpath pavement

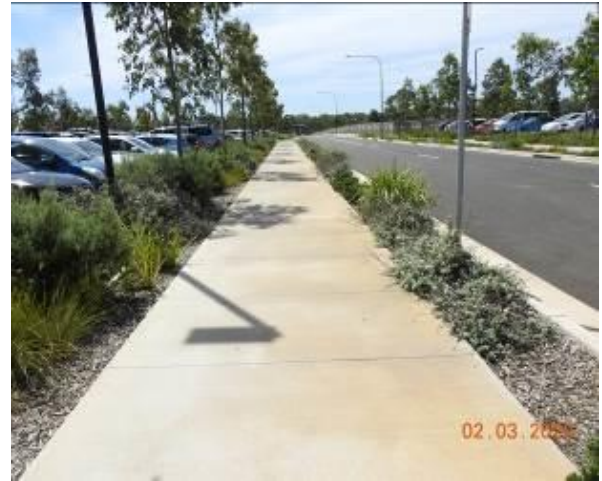
Figure 811 – General Condition of footpath pavement

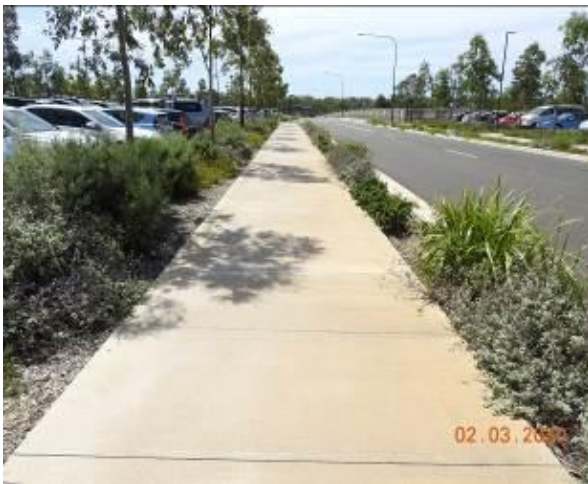
Figure 812 – General Condition of footpath pavement

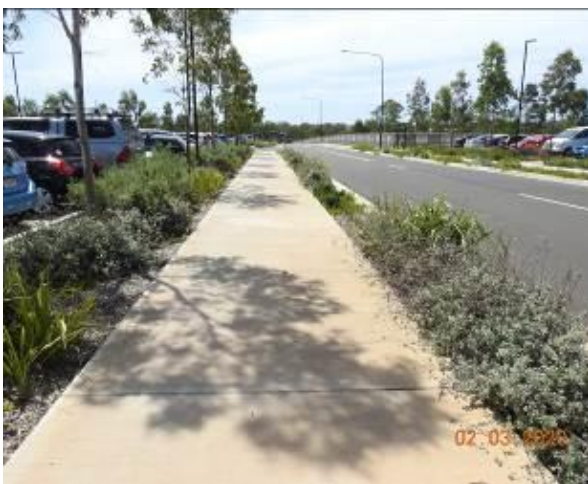
Figure 814 – General Condition of footpath pavement

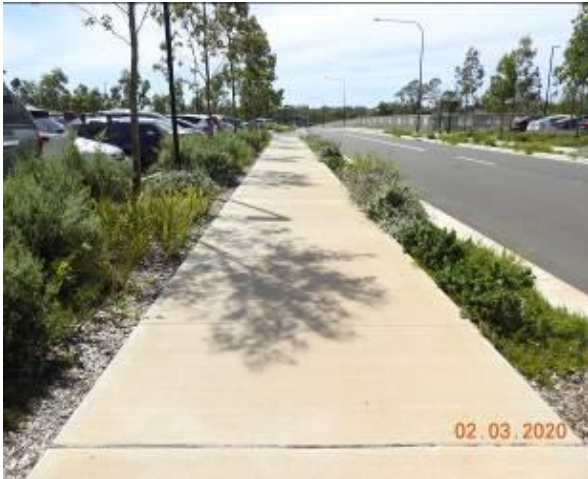
Figure 816 – General Condition of footpath pavement

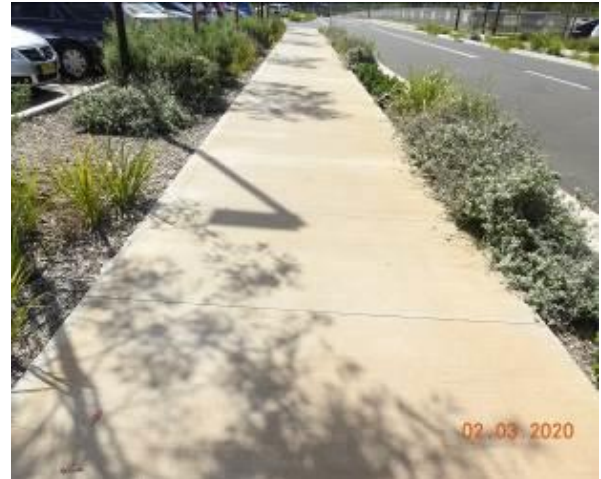
Figure 817 – General Condition of footpath pavement

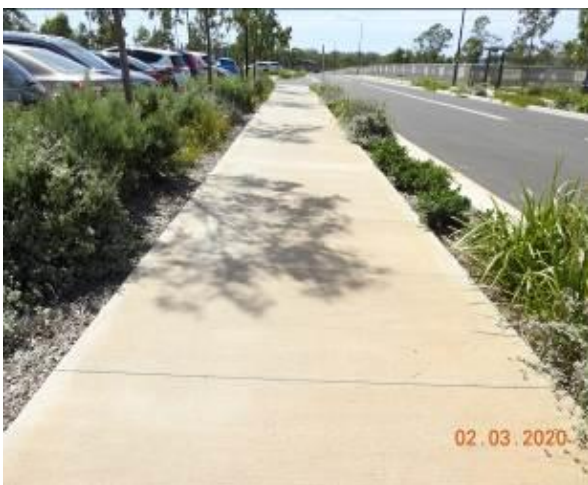
Figure 818 – General Condition of footpath pavement

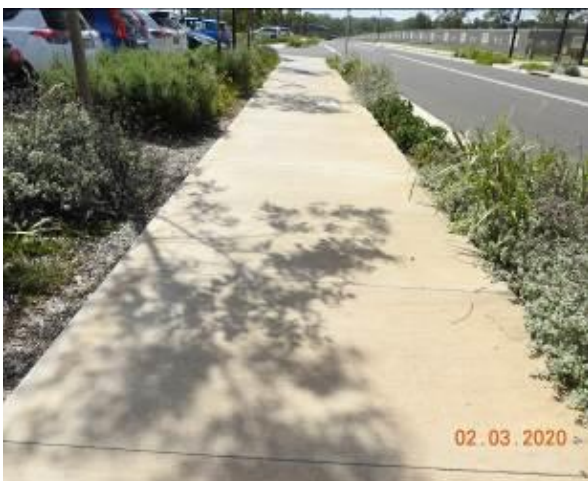
Figure 820 – General Condition of footpath pavement

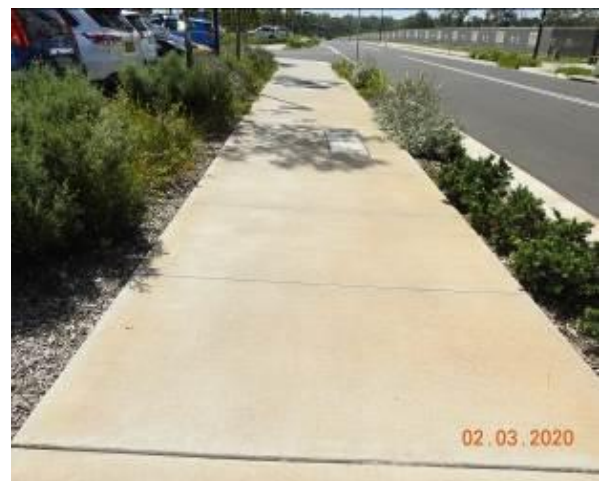
Figure 821 – General Condition of footpath pavement

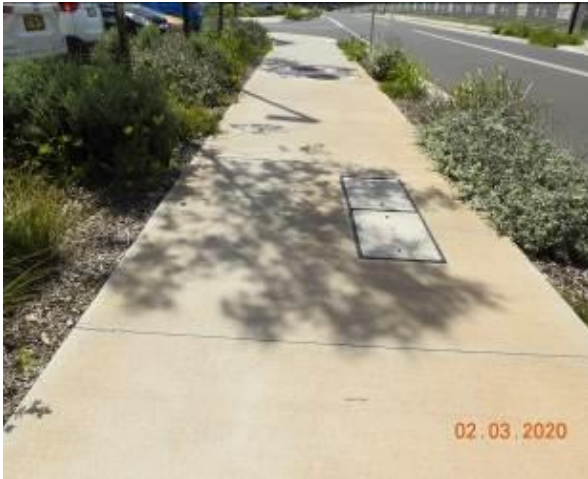
Figure 822 – General Condition of footpath pavement

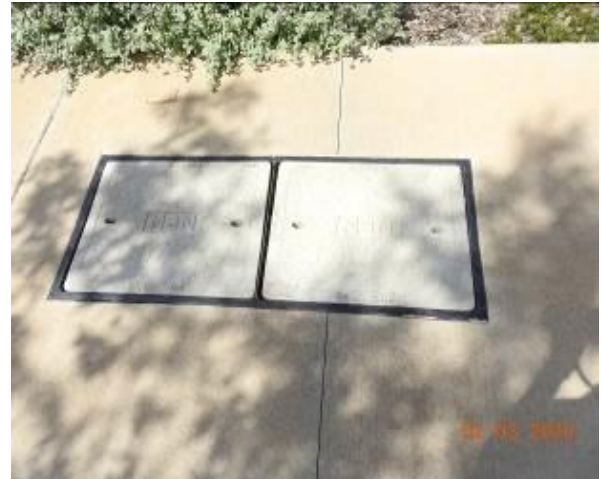
Figure 823 – General Condition of footpath pavement

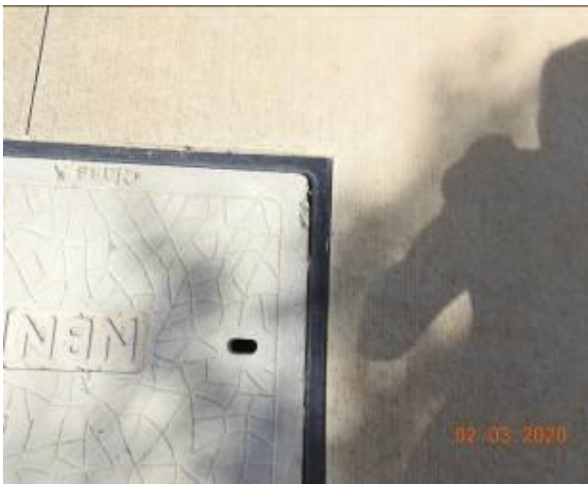
Figure 824 – General Condition of service pit

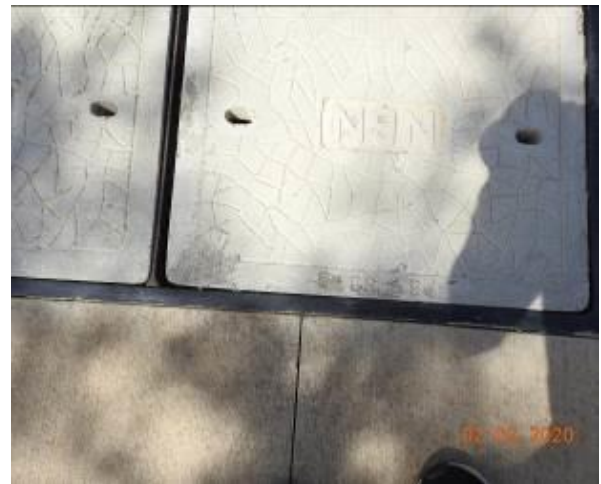
Figure 825 – Loss of material through service pit

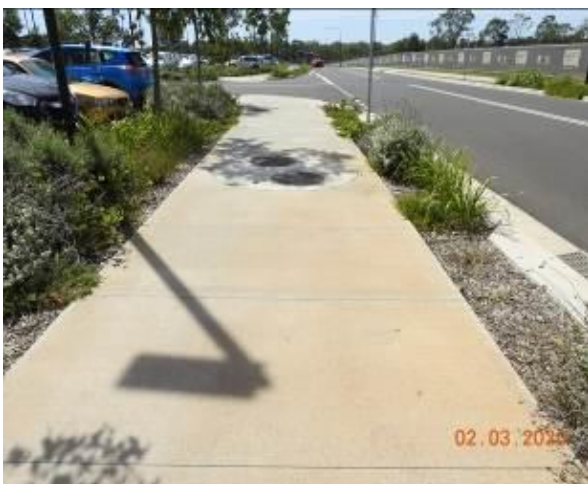
Figure 826 – Crack propagation through service pit
