**1-15 AND 2-12 CONFERTA AVENUE,  
ROUSE HILL NSW 2155  
TALLAWONG STATION PRECINCT SOUTH  
PRE-DILAPIDATION REPORT**

**DEICORP PROJECTS  
(TALLAWONG STATION) PTY LTD**

Job No. 191294.0  
05/07/2021

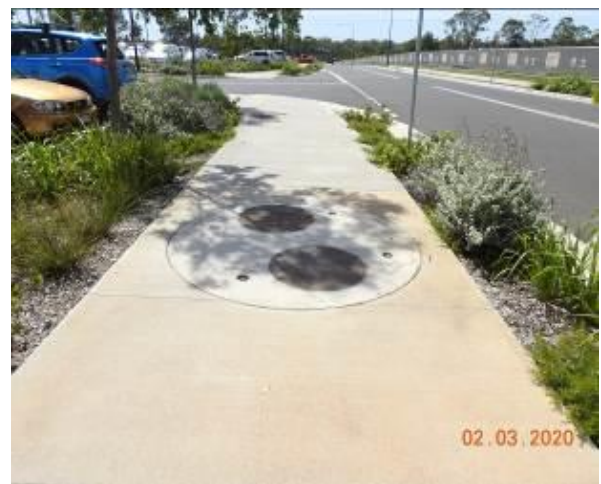
Figure 827 – General Condition of footpath pavement

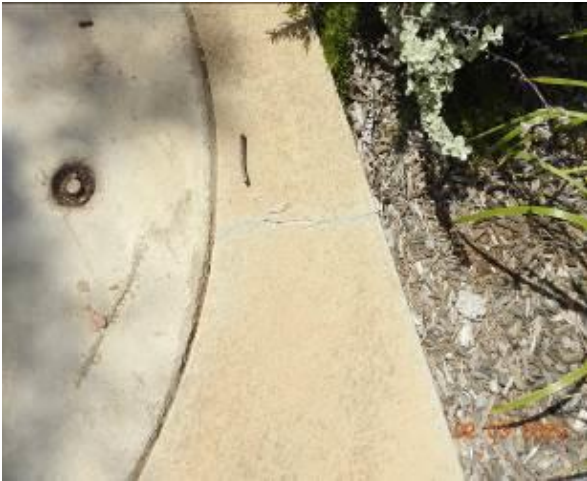
Figure 828 – General Condition of footpath pavement

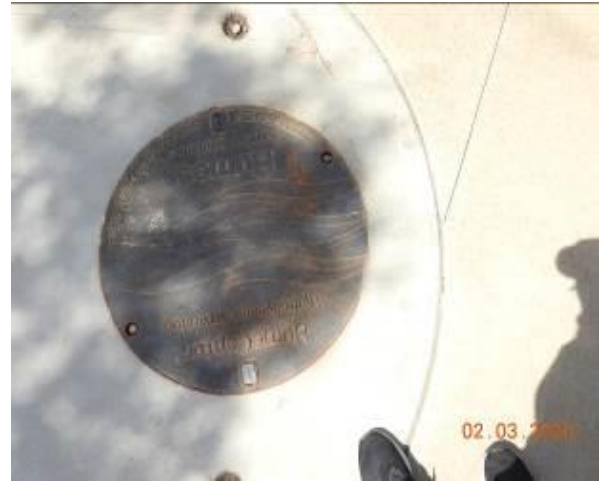
Figure 829 – Crack propagation through footpath pavement

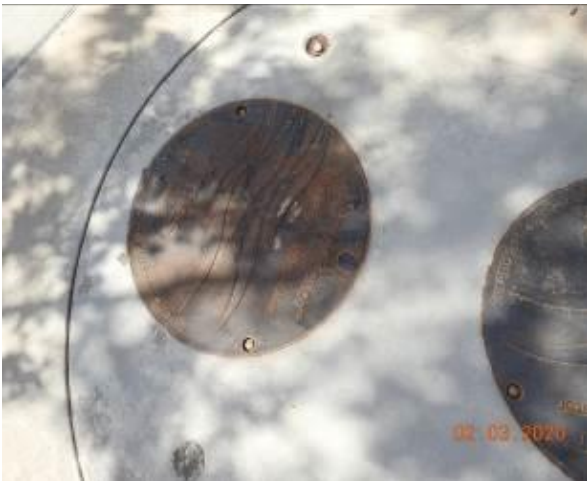
Figure 830 – General Condition of service pit

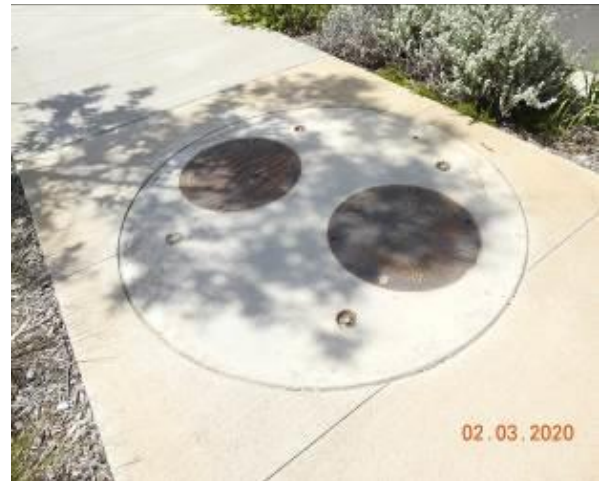
Figure 831 – General Condition of service pit

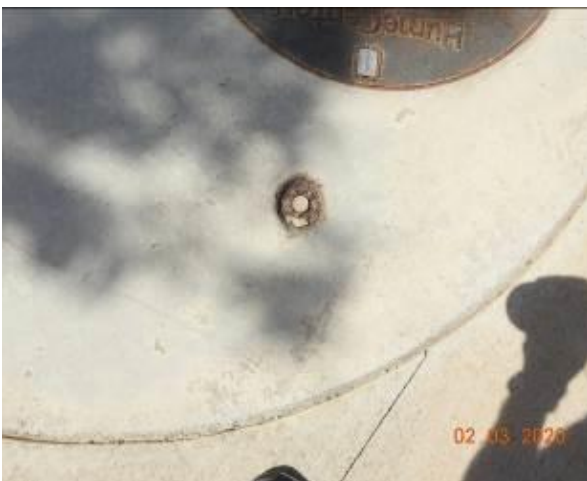
Figure 832 – General Condition of service pit

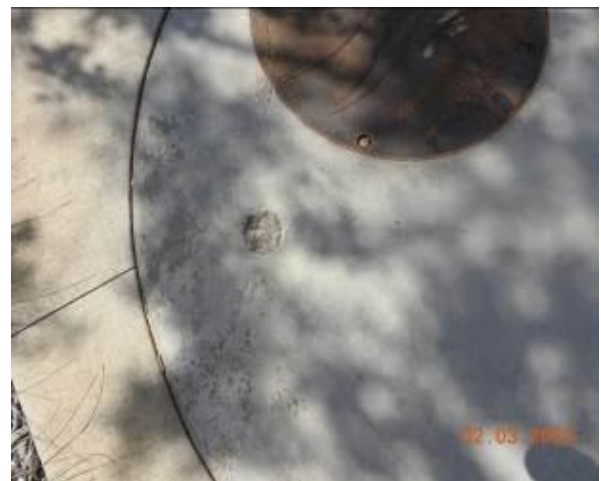
Figure 833 – Loss of material through service pit

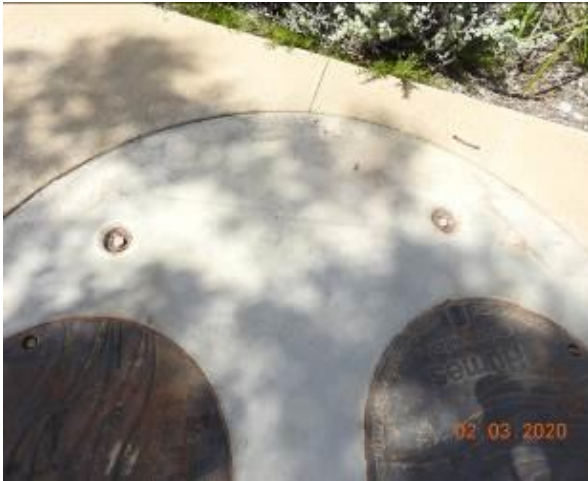
Figure 834 – Loss of material through service pit

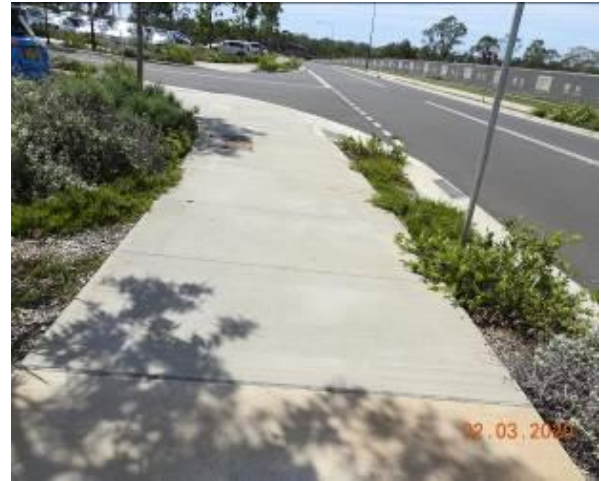
Figure 835 – General Condition of service pit

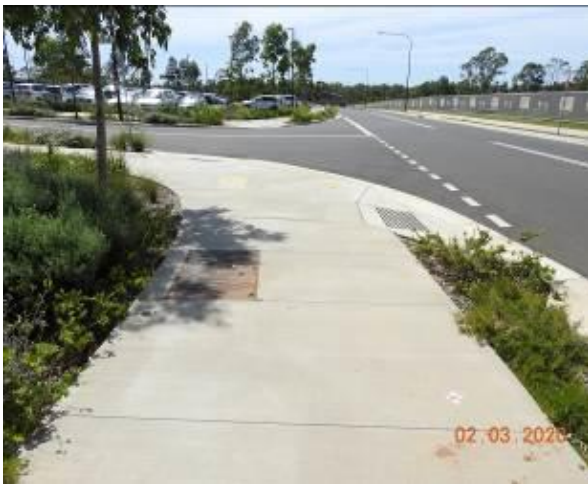
Figure 836 – General Condition of footpath pavement

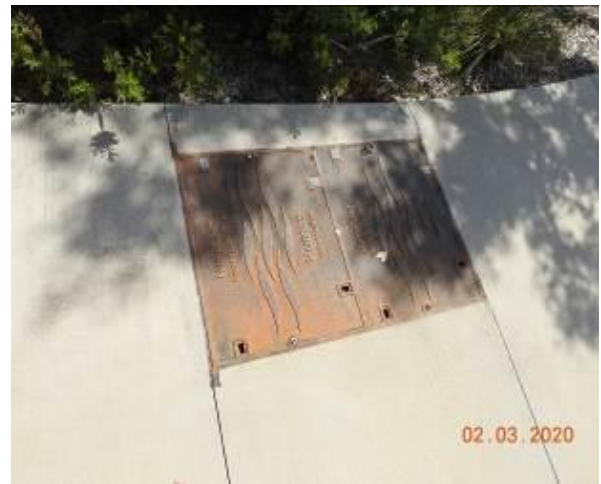
Figure 837 – General Condition of footpath pavement

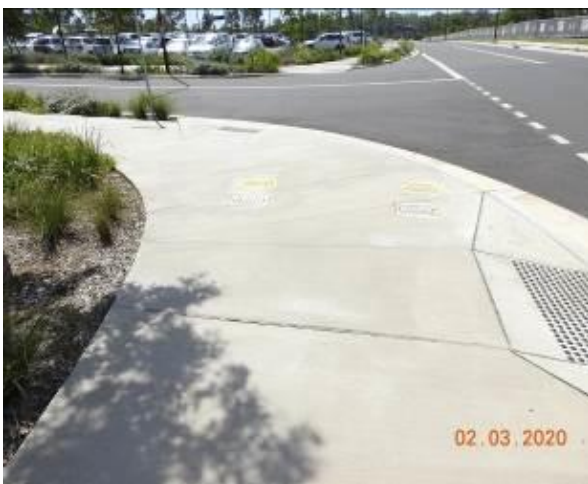
Figure 838 – General Condition of service pit

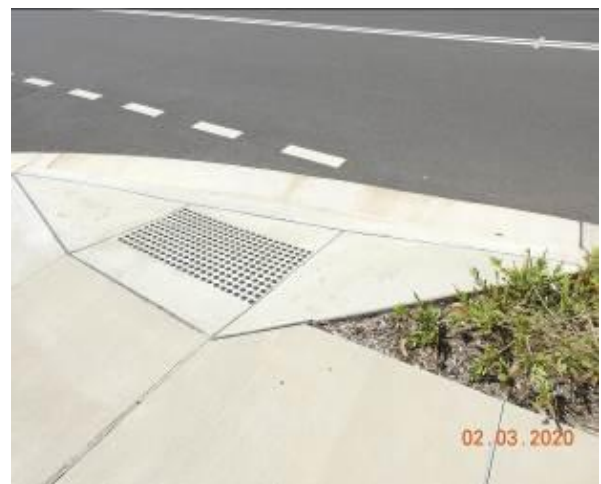
Figure 839 – General Condition of footpath pavement

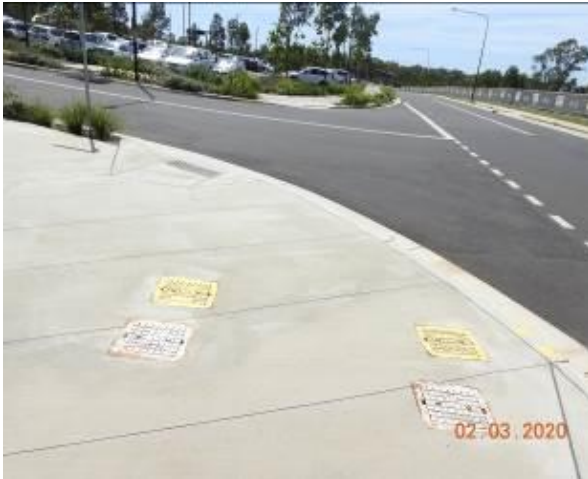
Figure 840 – General Condition of footpath pavement

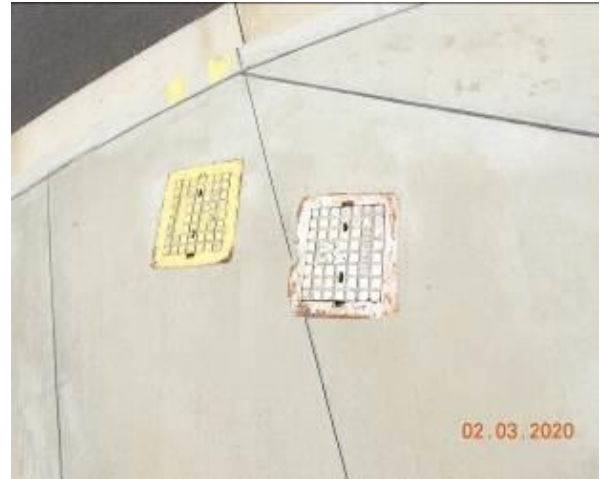
Figure 841 – General Condition of footpath pavement

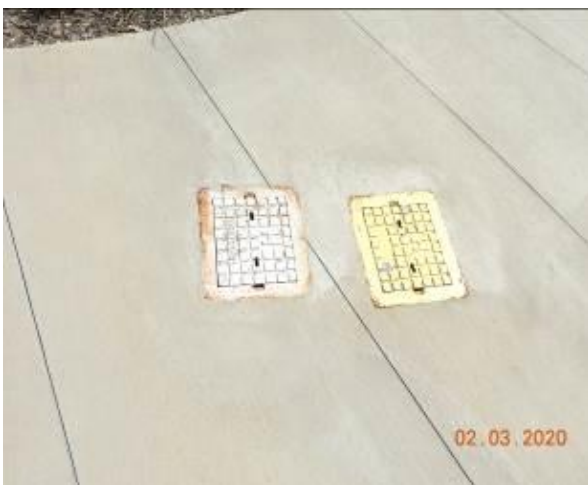
Figure 842 – General Condition of service pit

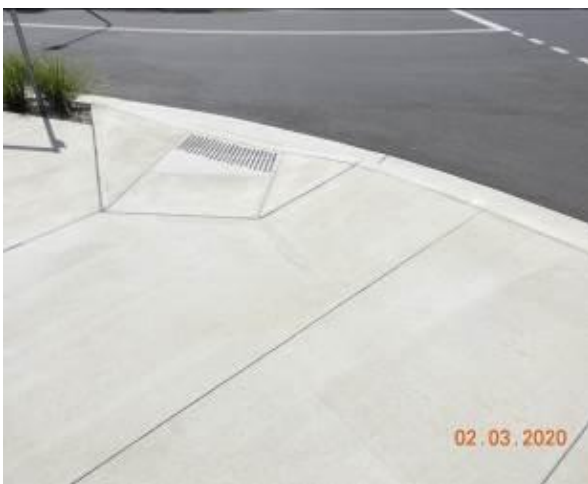
Figure 844 – General Condition of footpath pavement

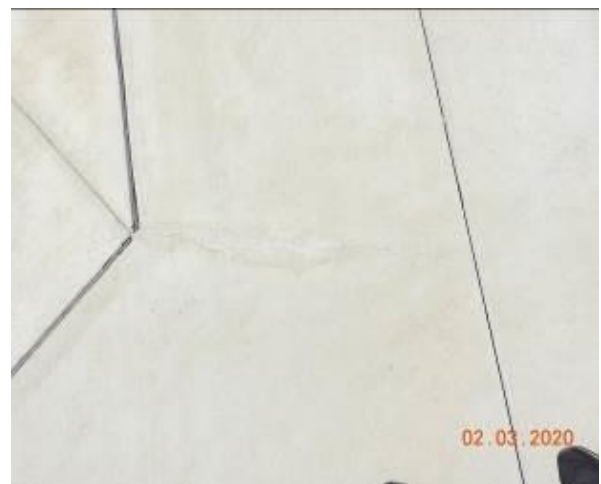
Figure 845 – General Condition of footpath pavement

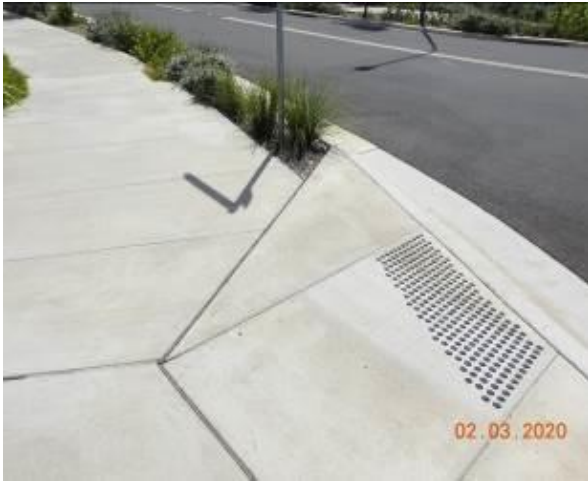
Figure 846 – Crack propagation through footpath pavement

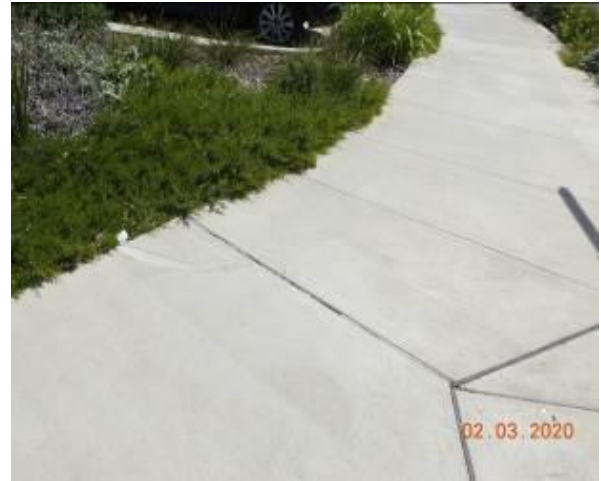
Figure 847 – General Condition of footpath pavement

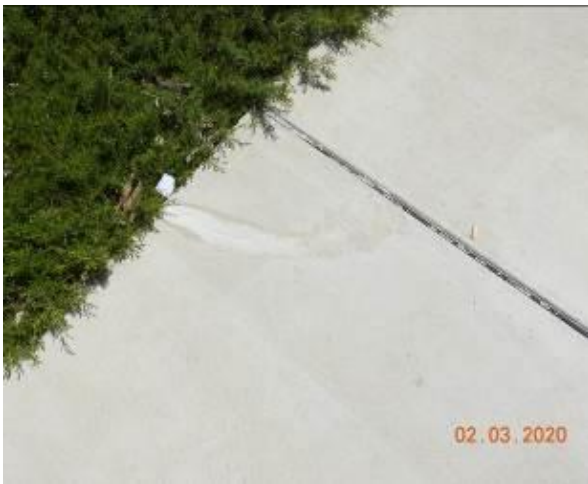
Figure 848 – General Condition of footpath pavement

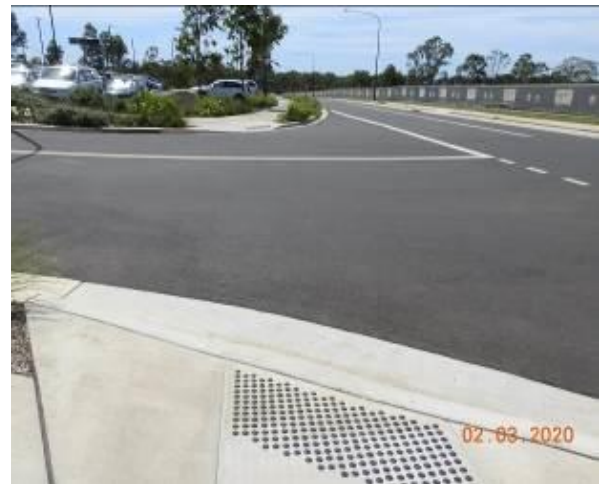
Figure 849 – Crack propagation through footpath pavement

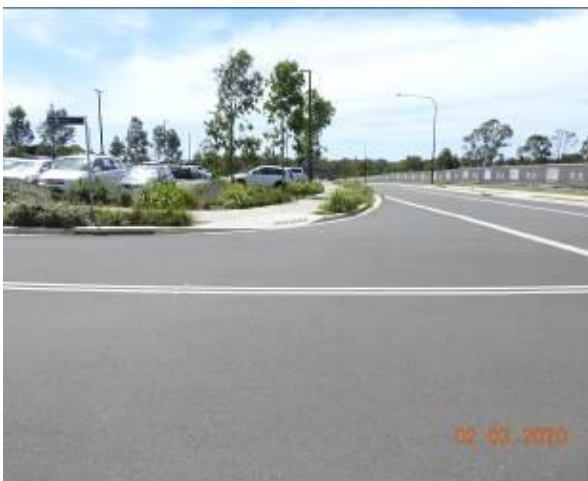
Figure 850 – General Condition of footpath pavement

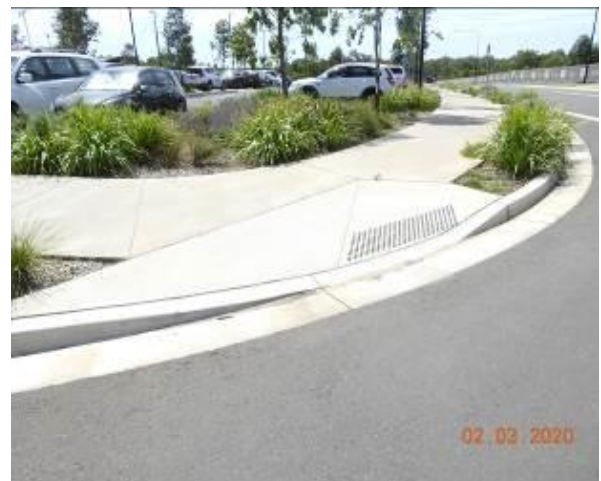
Figure 851 – General Condition of footpath pavement

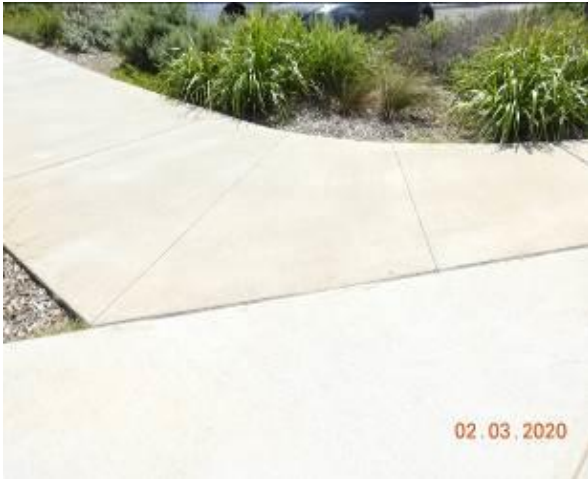
Figure 852 – General Condition of footpath pavement

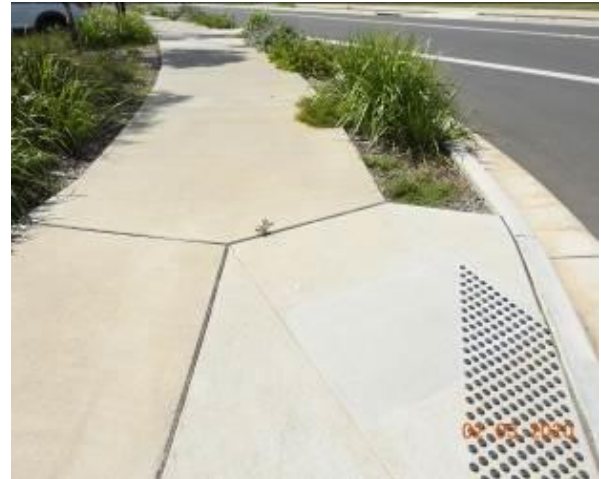
Figure 853 – General Condition of footpath pavement

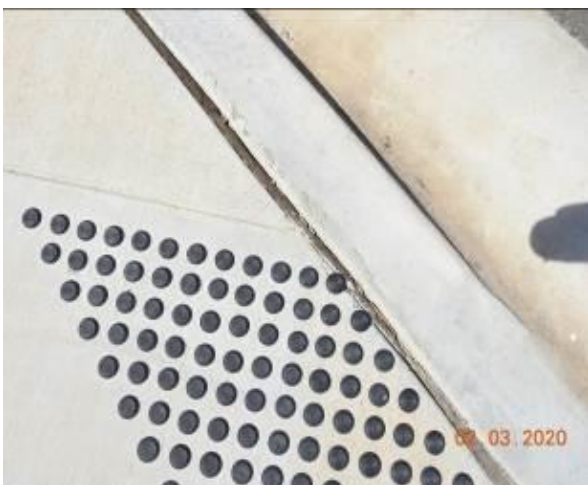
Figure 854 – General Condition of footpath pavement

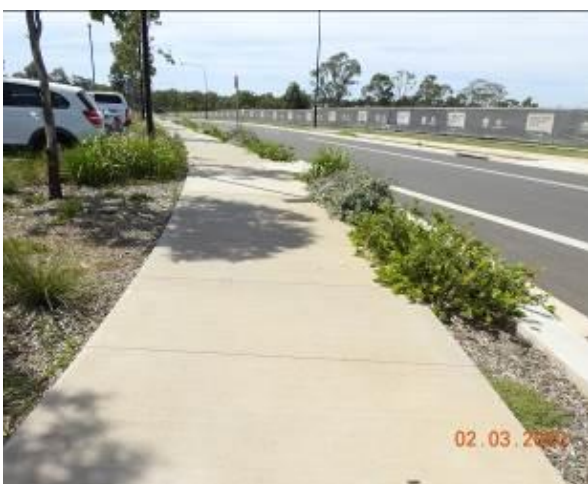
Figure 856 – General Condition of footpath pavement

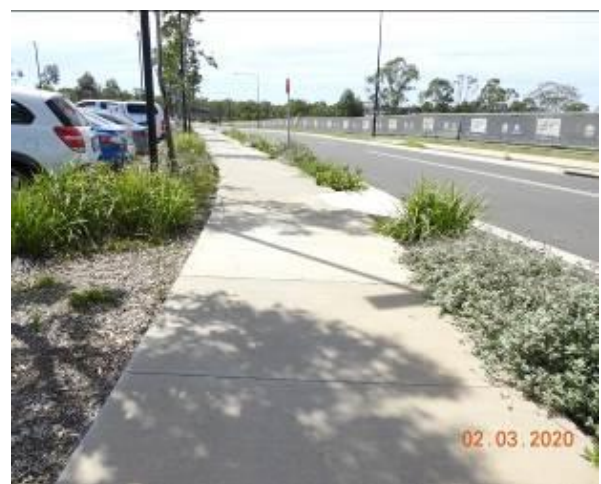
Figure 857 – General Condition of footpath pavement

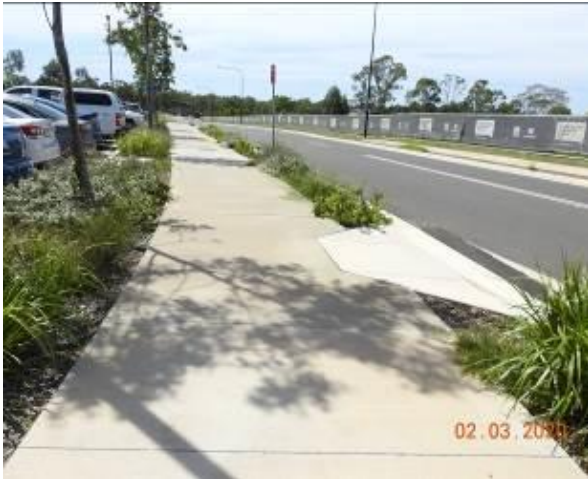
Figure 858 – General Condition of footpath pavement

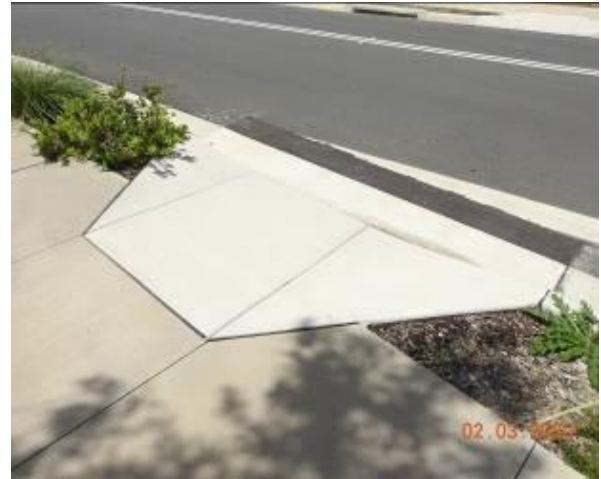
Figure 859 – General Condition of footpath pavement

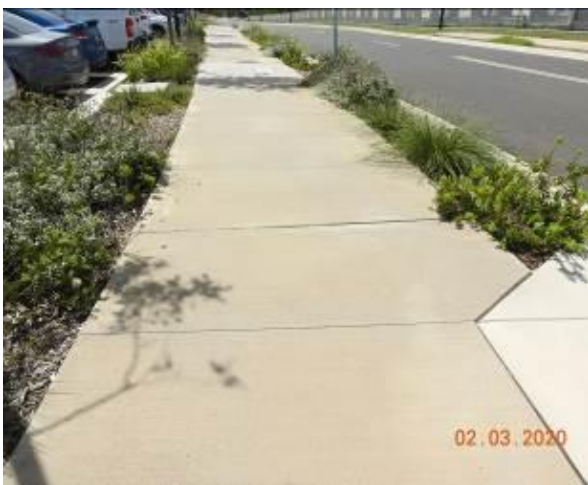
Figure 860 – General Condition of footpath pavement

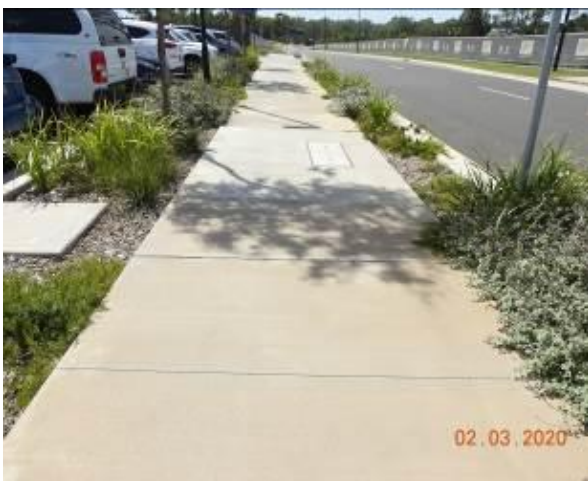
Figure 862 – General Condition of footpath pavement

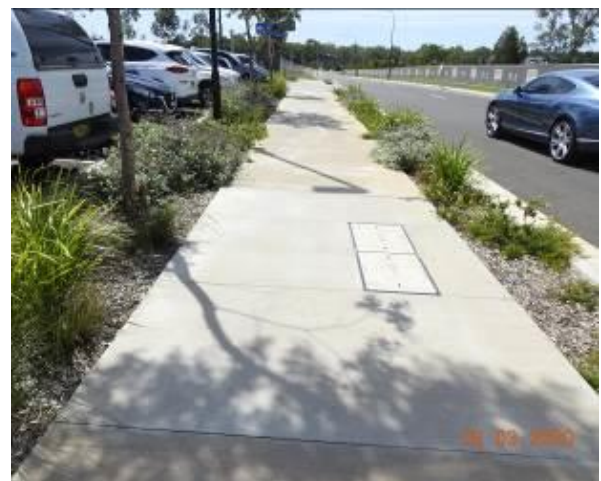
Figure 863 – General Condition of footpath pavement

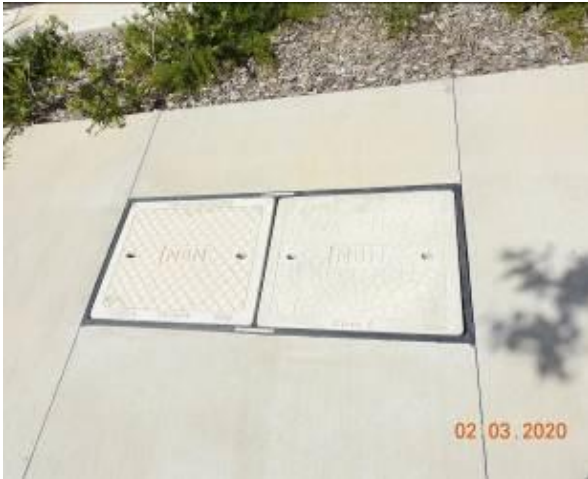
Figure 864 – General Condition of footpath pavement

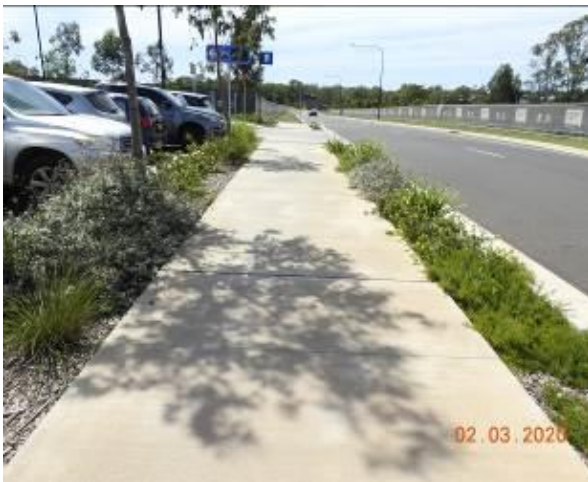
Figure 866 – General Condition of footpath pavement

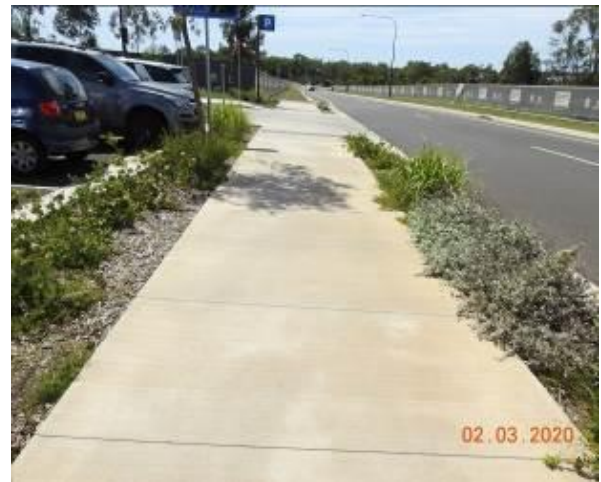
Figure 867 – General Condition of footpath pavement

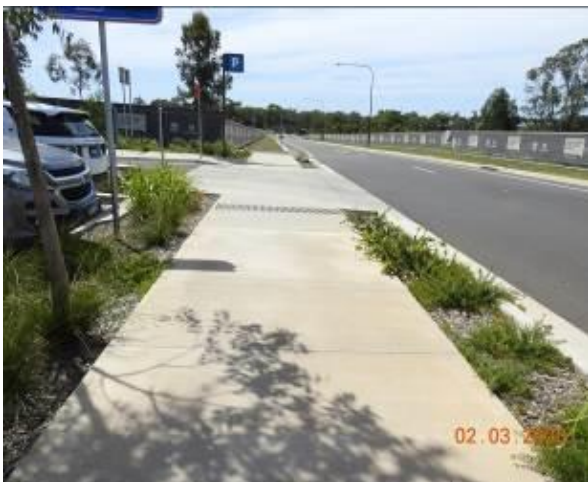
Figure 868 – General Condition of footpath pavement

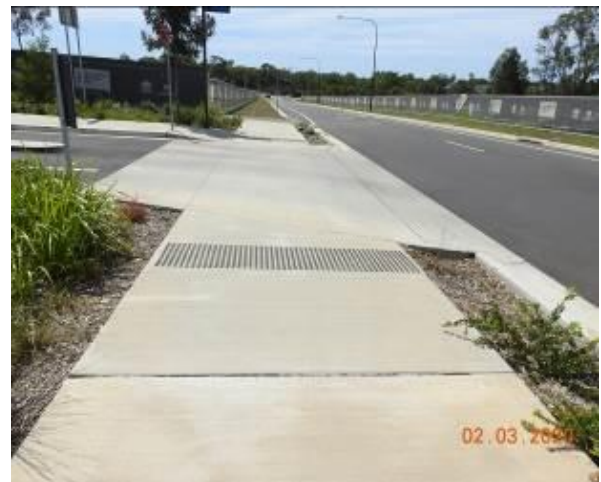
Figure 869 – General Condition of footpath pavement

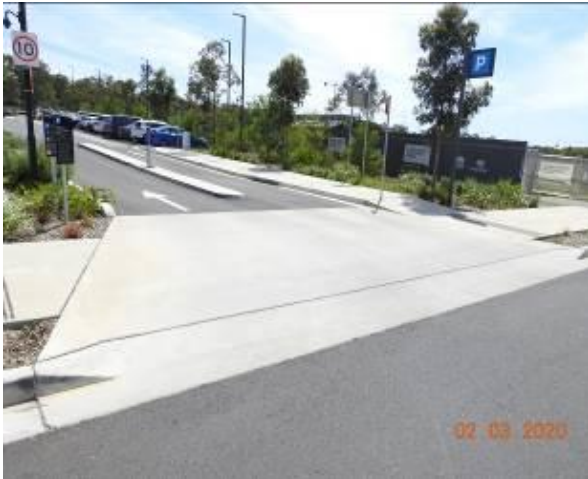
Figure 870 – General Condition of footpath pavement

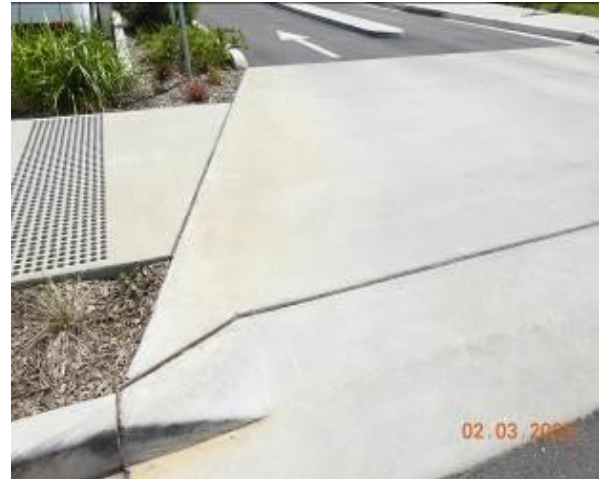
Figure 871 – General Condition of driveway ramp

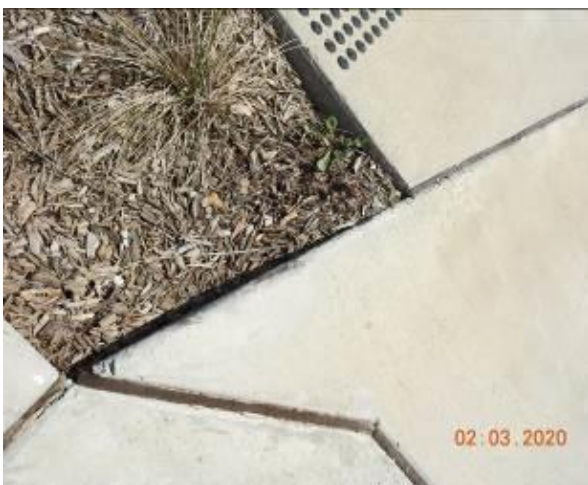
Figure 872 – General Condition of driveway ramp

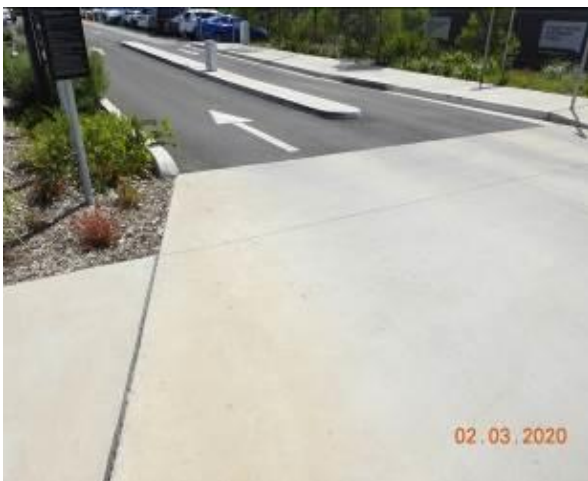
Figure 874 – Crack propagation through driveway ramp

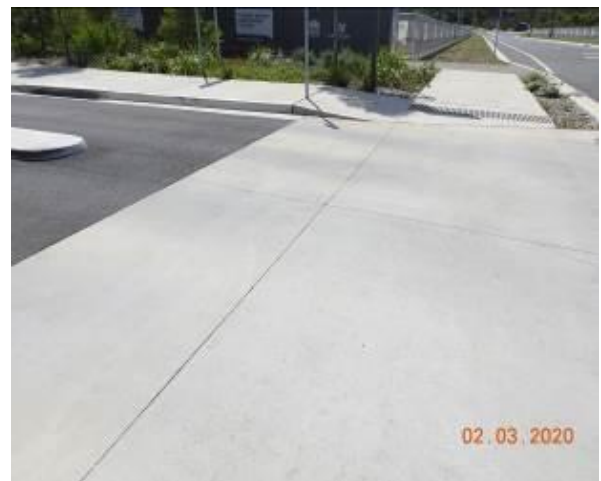
Figure 875 – General Condition of driveway ramp

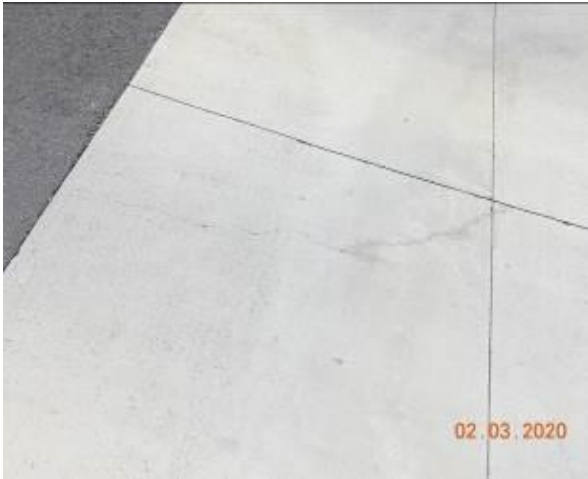
Figure 876 – General Condition of driveway ramp

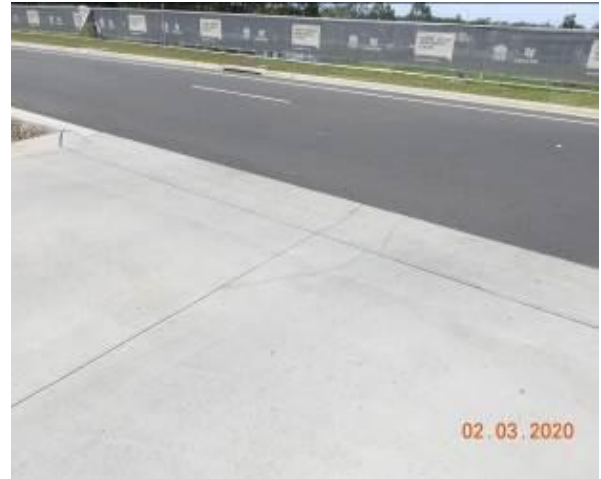
Figure 877 – Crack propagation through driveway ramp

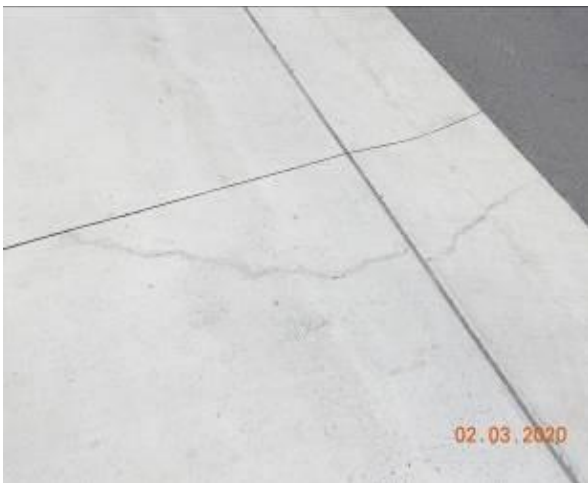
Figure 878 – General Condition of driveway ramp

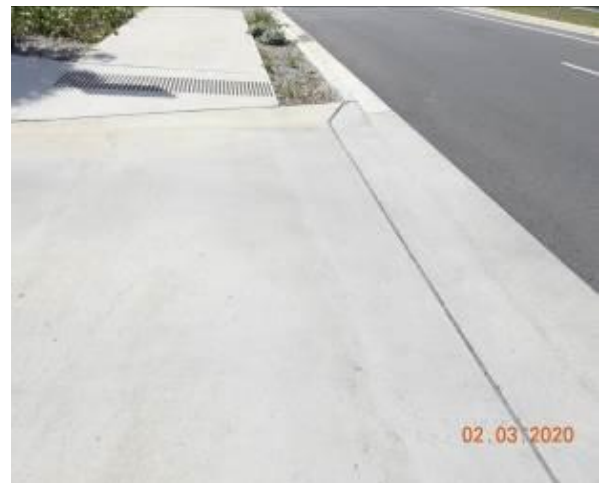
Figure 879 – Crack propagation through driveway ramp

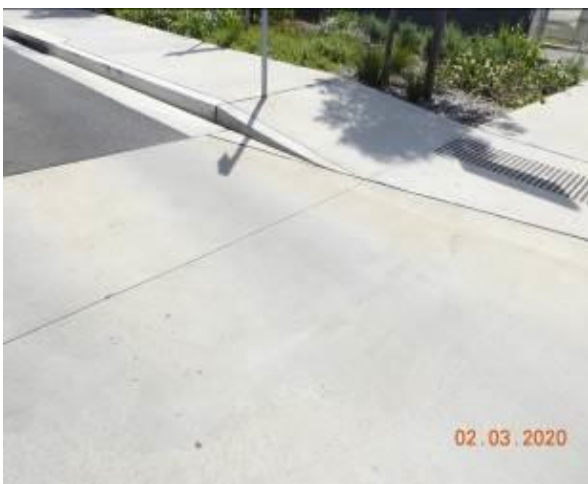
Figure 880 – General Condition of driveway ramp

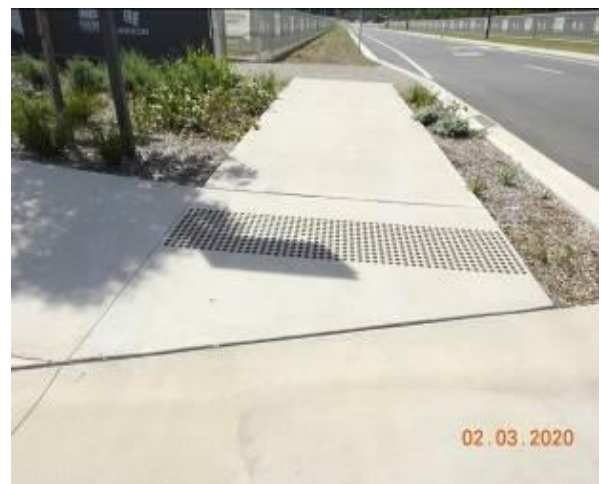
Figure 881 – General Condition of driveway ramp

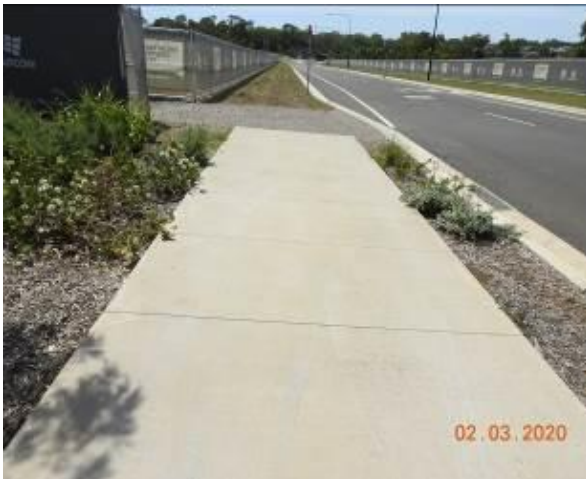
Figure 882 – General Condition of footpath pavement

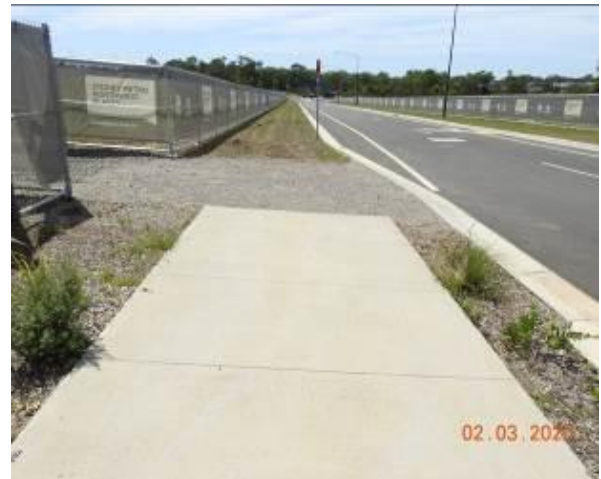
Figure 883 – General Condition of footpath pavement

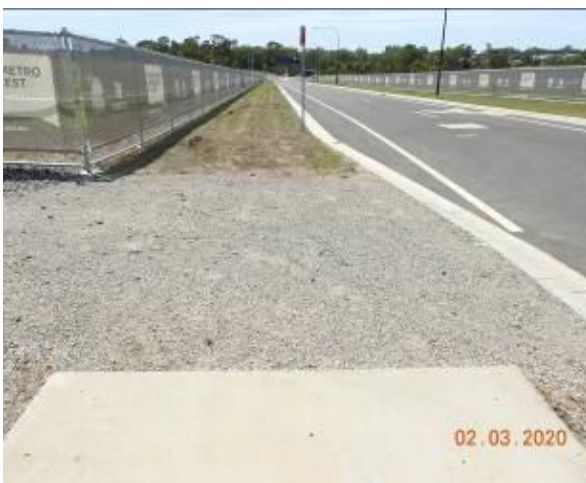
Figure 884 – General Condition of footpath pavement

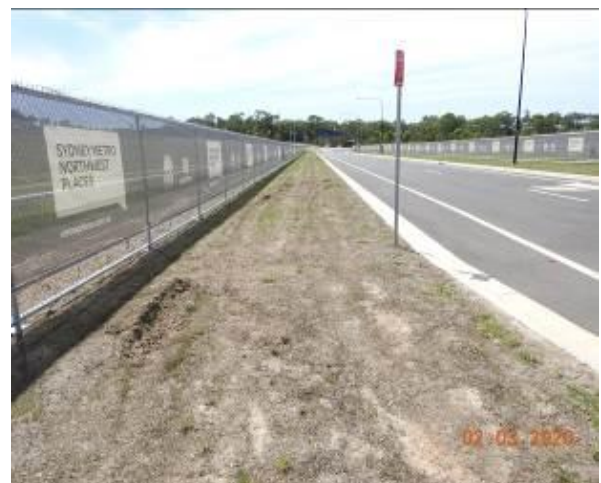
Figure 885 – Loss of material through footpath pavement

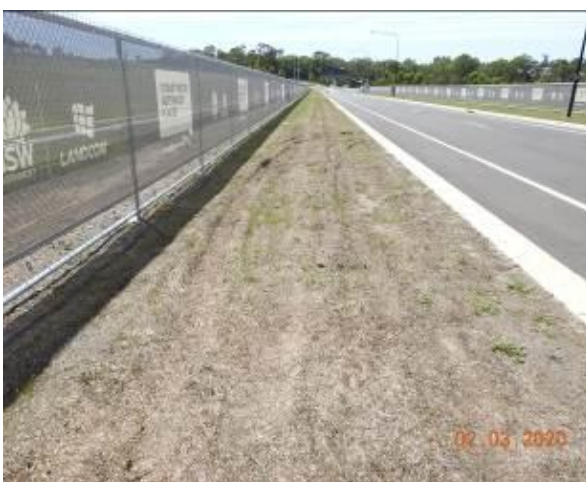
Figure 886 – General Condition of nature strip

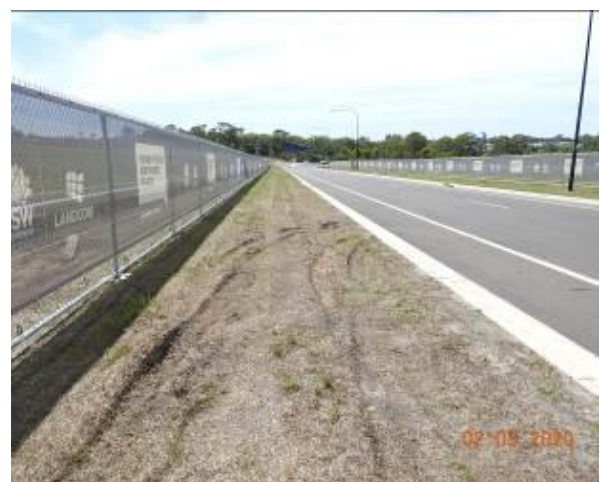
Figure 887 – General Condition of nature strip

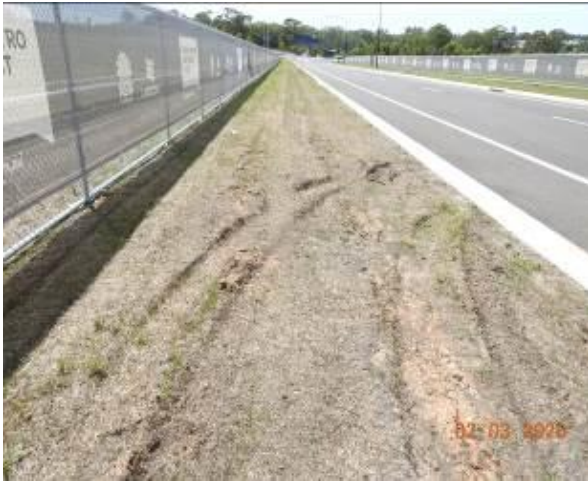
Figure 888 – General Condition of nature strip

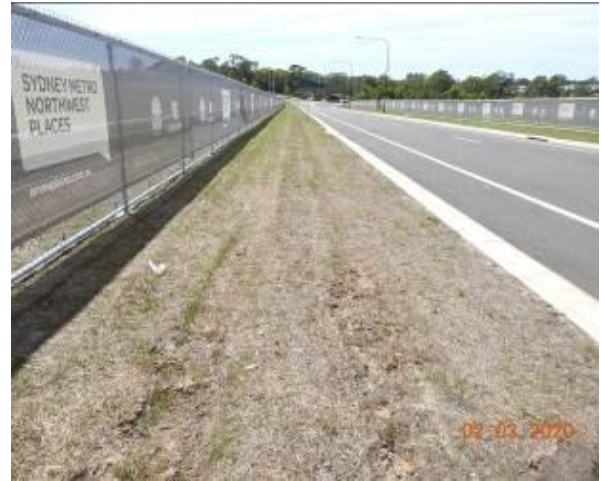
Figure 889 – General Condition of nature strip

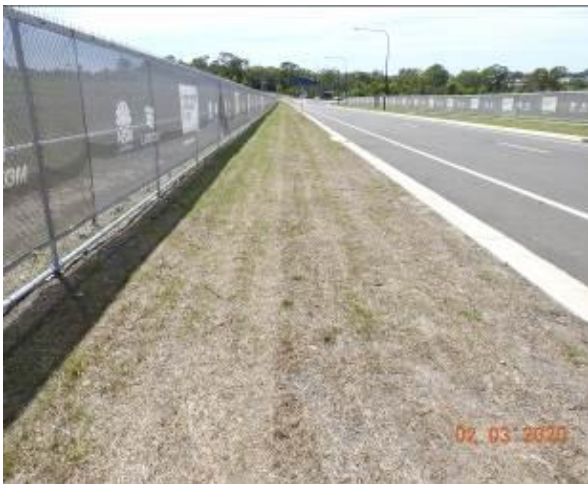
Figure 890 – General Condition of nature strip

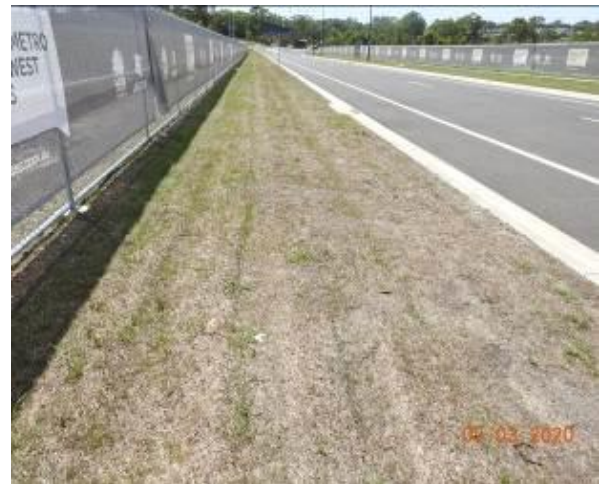
Figure 891 – General Condition of nature strip

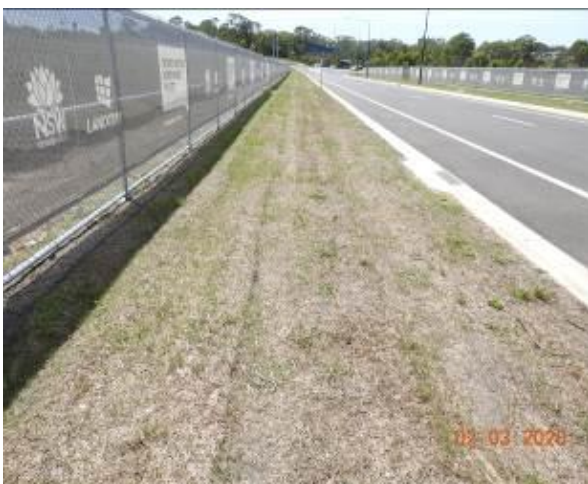
Figure 892 – General Condition of nature strip

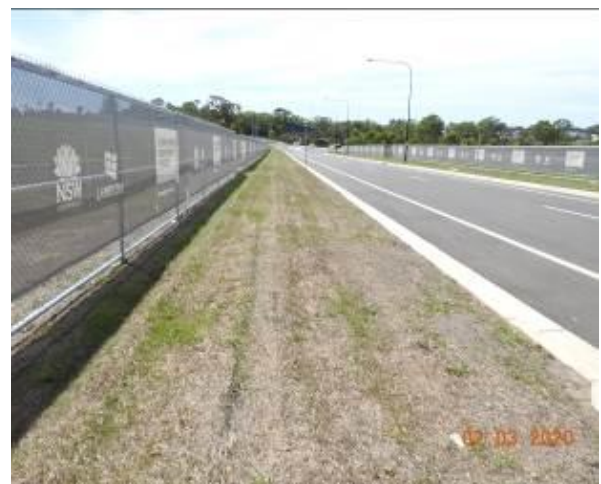
Figure 893 – General Condition of nature strip

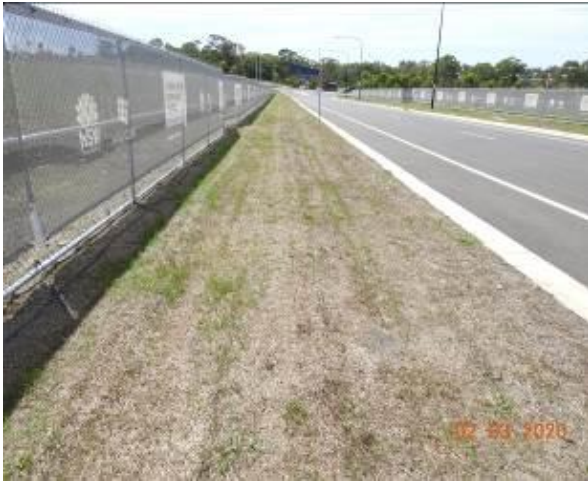
Figure 894 – General Condition of nature strip

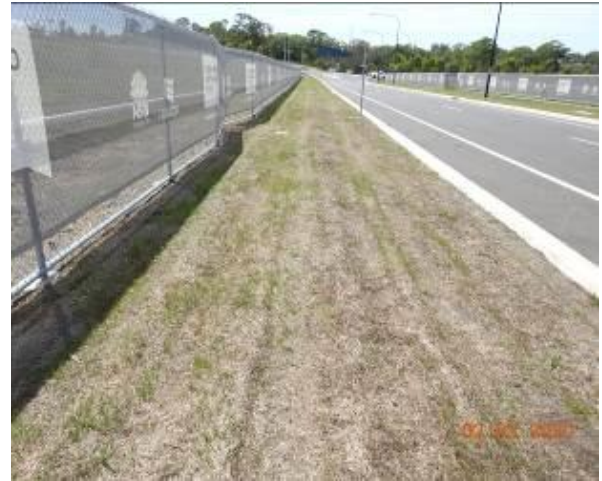
Figure 895 – General Condition of nature strip

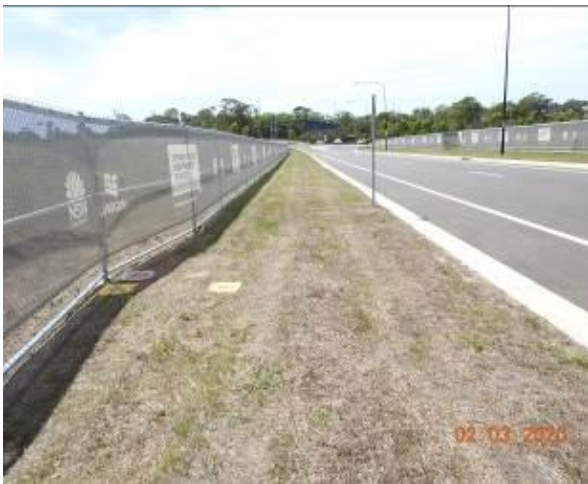
Figure 896 – General Condition of nature strip

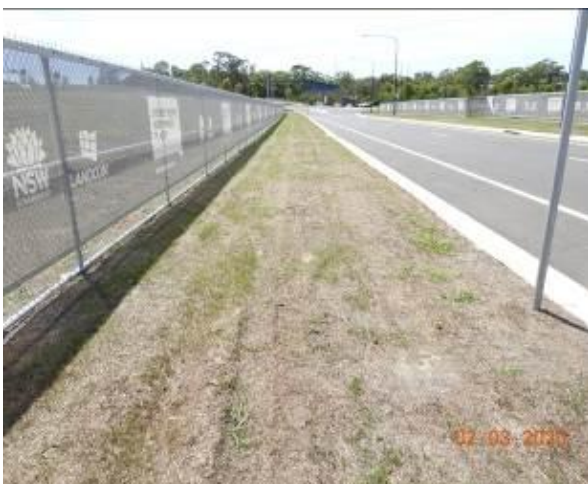
Figure 898 – General Condition of service pit

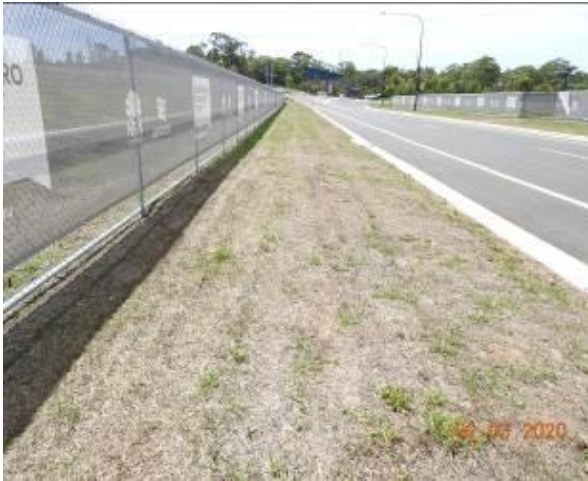
Figure 900 – General Condition of nature strip

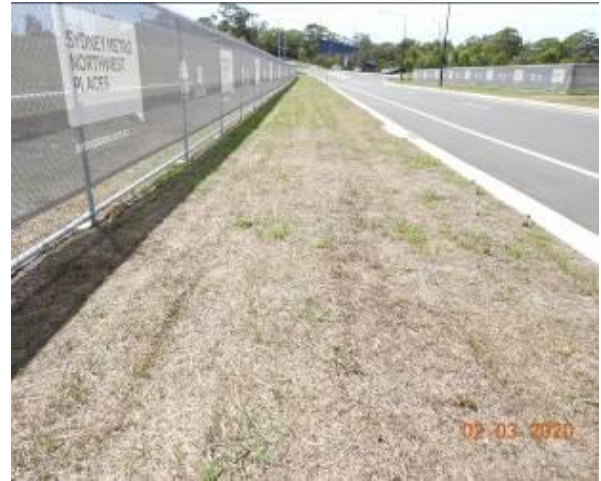
Figure 901 – General Condition of nature strip

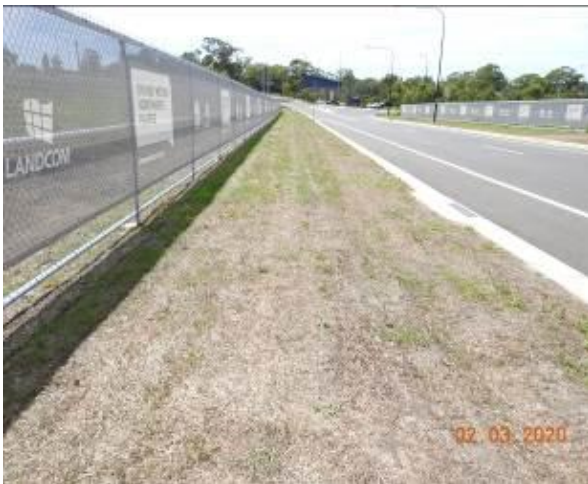
Figure 902 – General Condition of nature strip

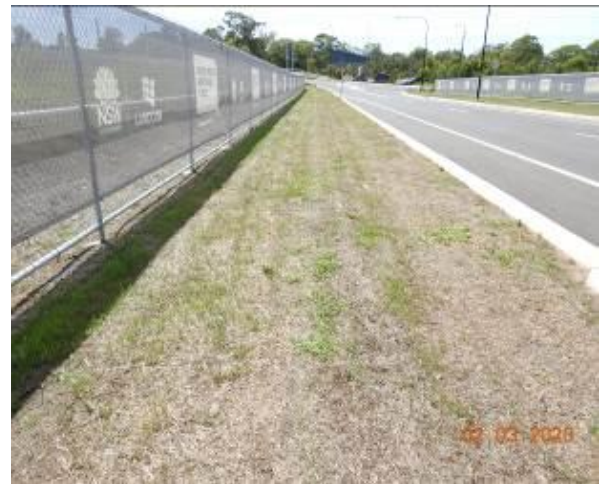
Figure 903 – General Condition of nature strip

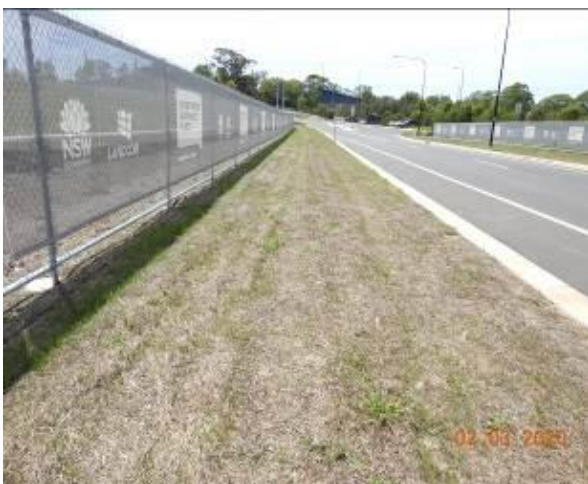
Figure 904 – General Condition of nature strip

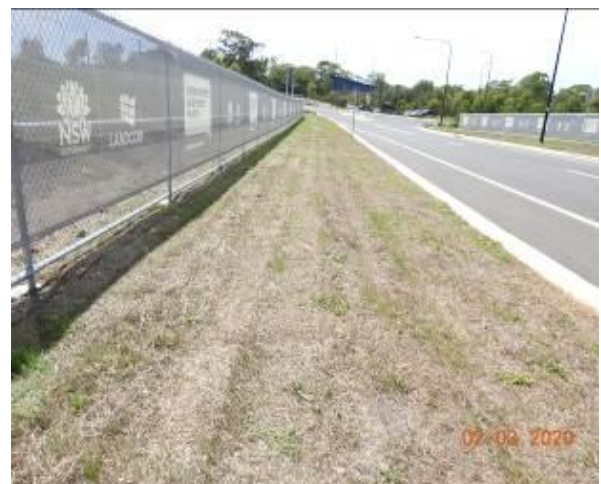
Figure 905 – General Condition of nature strip

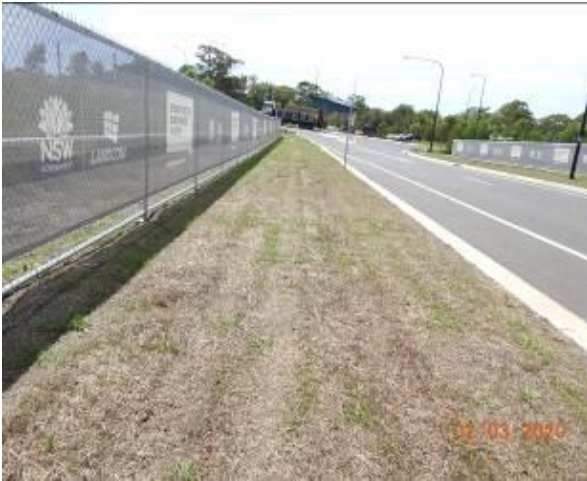
Figure 906 – General Condition of nature strip

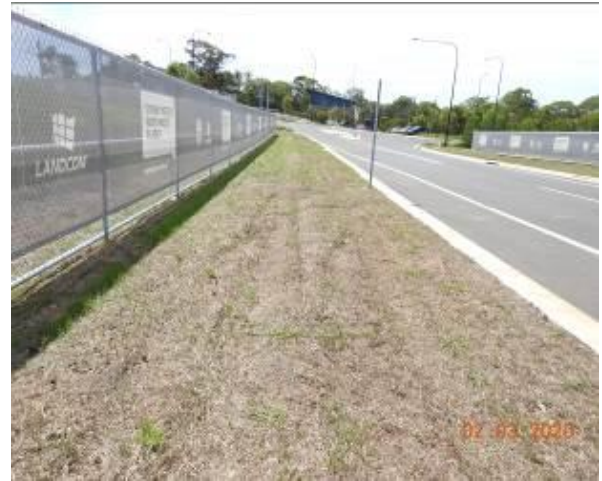
Figure 907 – General Condition of nature strip

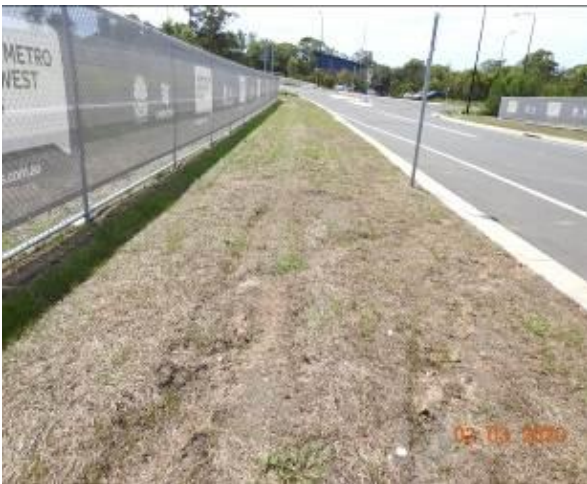
Figure 908 – General Condition of nature strip

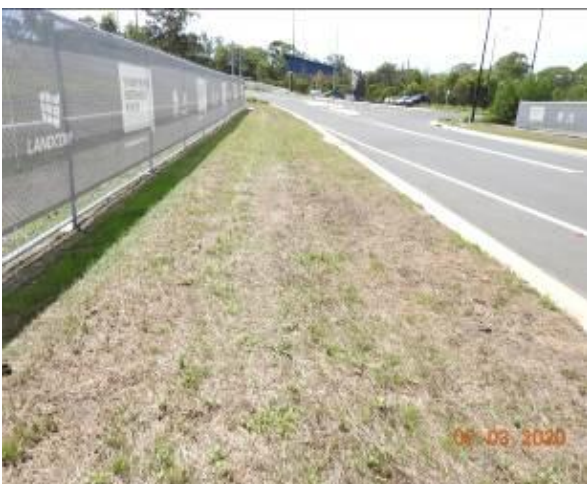
Figure 910 – General Condition of nature strip

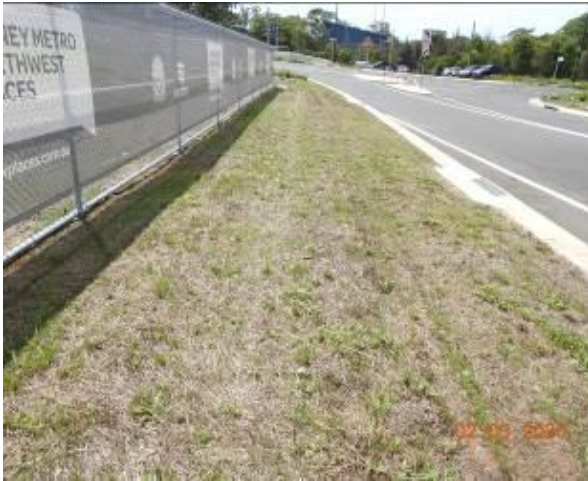
Figure 912 – General Condition of nature strip
