**1-15 AND 2-12 CONFERTA AVENUE,  
ROUSE HILL NSW 2155  
TALLAWONG STATION PRECINCT SOUTH  
PRE-DILAPIDATION REPORT**

**DEICORP PROJECTS  
(TALLAWONG STATION) PTY LTD**

Job No. 191294.0  
05/07/2021

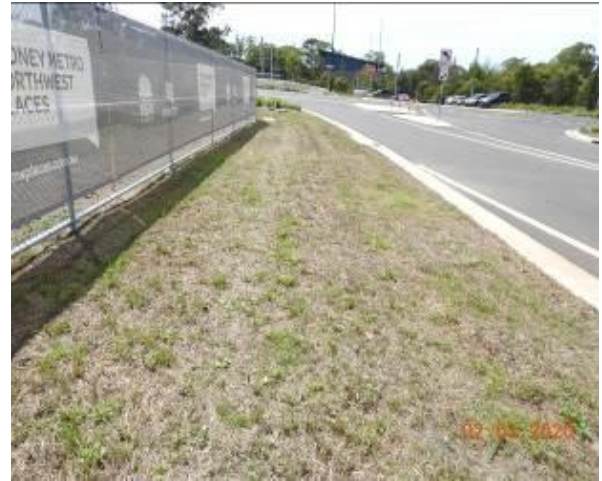
Figure 913 – General Condition of nature strip

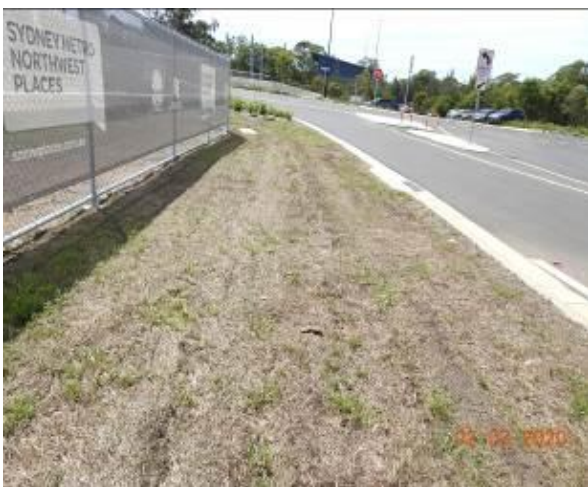
Figure 914 – General Condition of nature strip

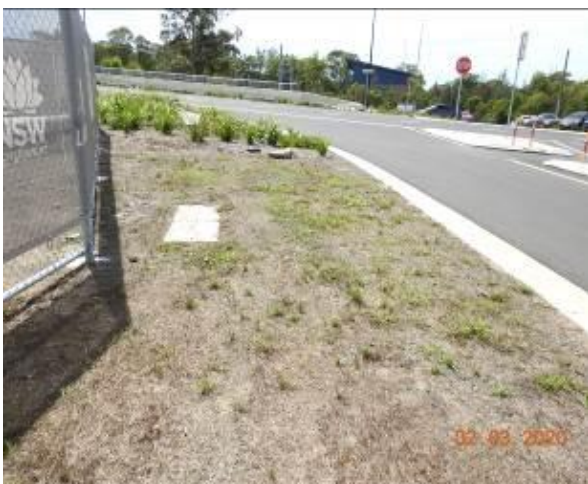
Figure 916 – General Condition of nature strip

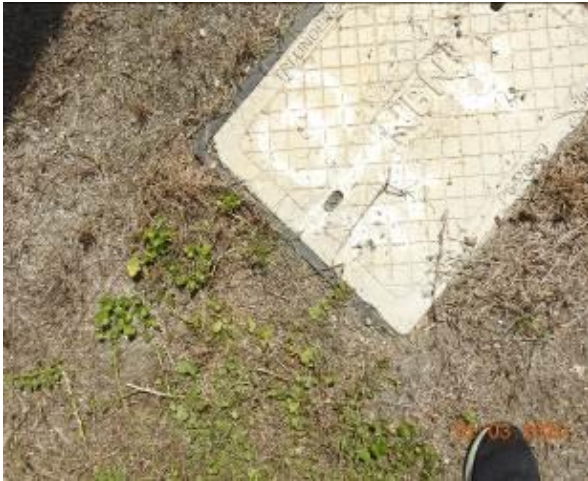
Figure 918 – General Condition of service pit

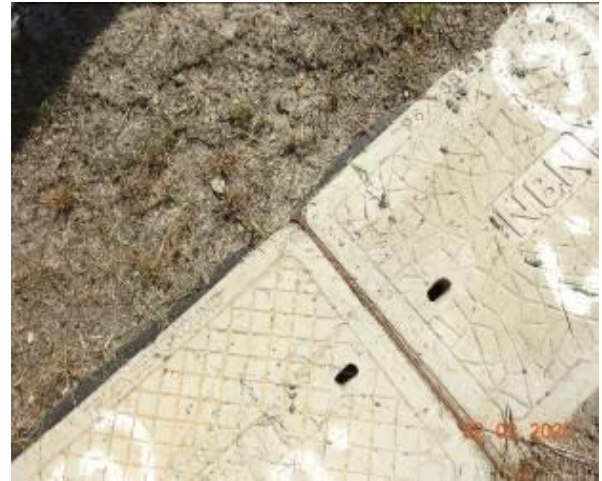
Figure 919 – Crack propagation through service pit

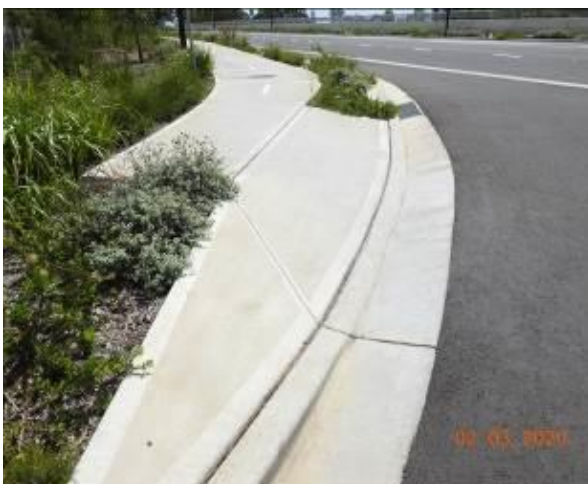
Figure 922 – General Condition of nature strip

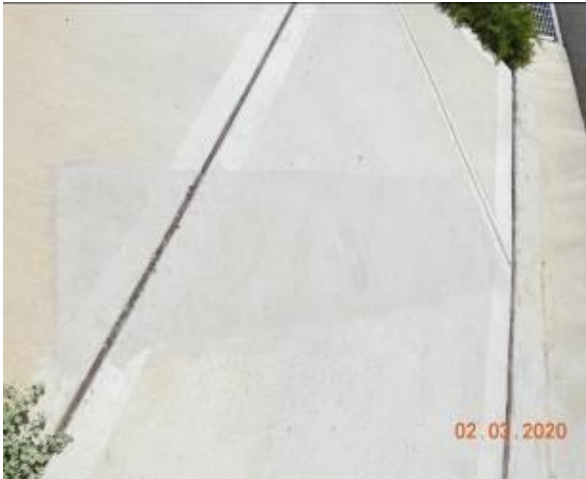
Figure 924 – General Condition of footpath pavement

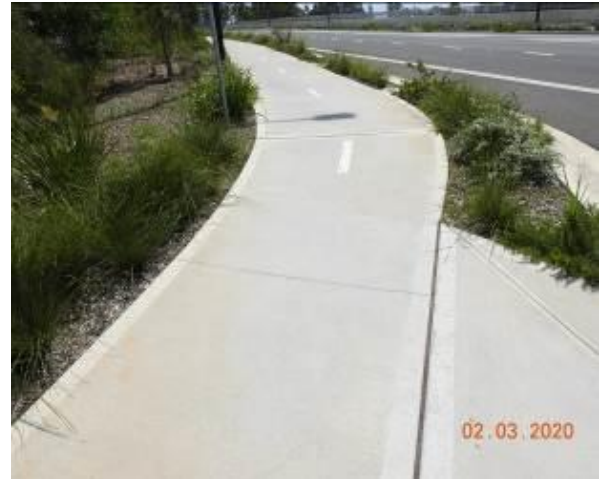
Figure 925 – General Condition of footpath pavement

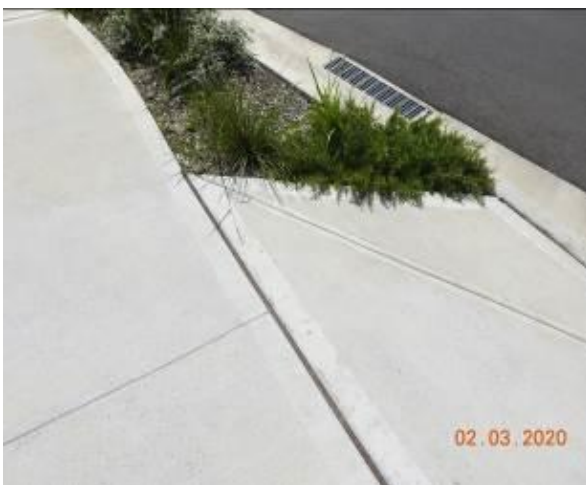
Figure 926 – General Condition of footpath pavement

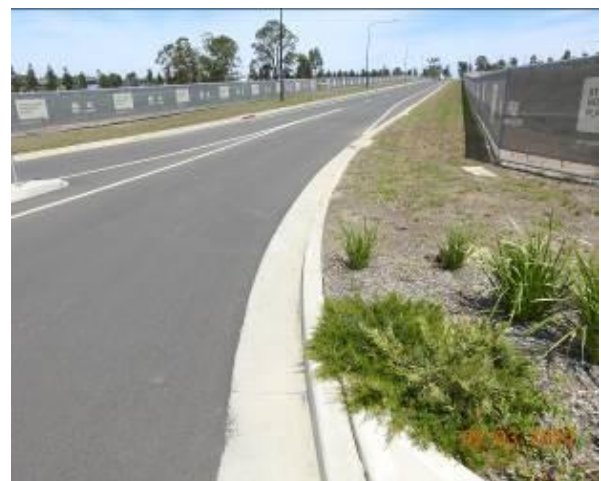
Figure 929 – General Condition of kerb and gutter

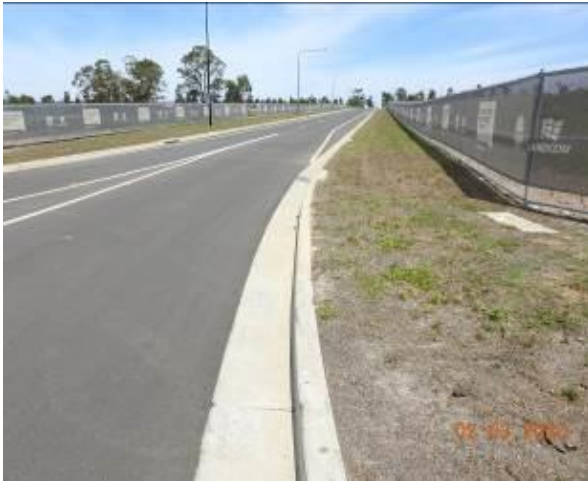
Figure 930 – General Condition of kerb and gutter

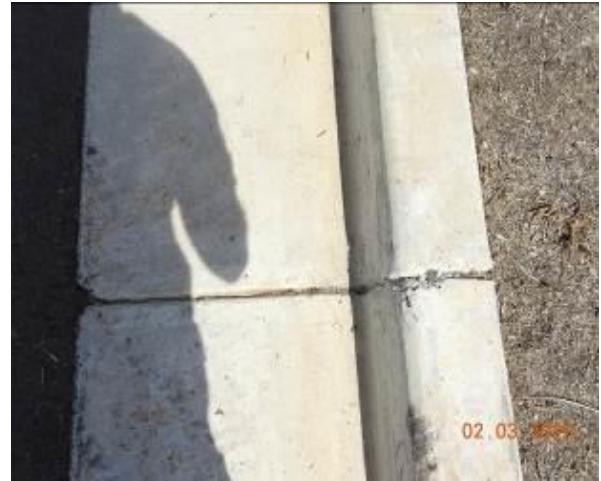
Figure 931 – General Condition of kerb and gutter

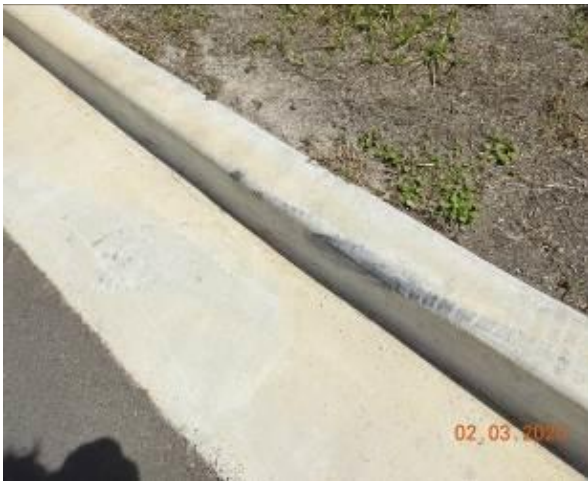
Figure 932 – Crack propagation and loss of material through kerb and gutter

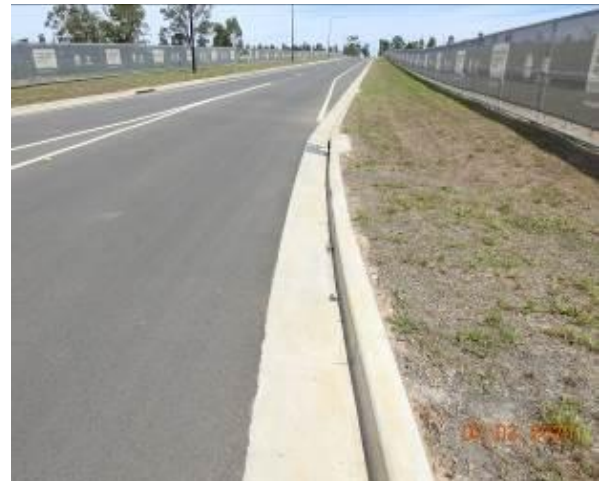
Figure 934 – General Condition of kerb and gutter

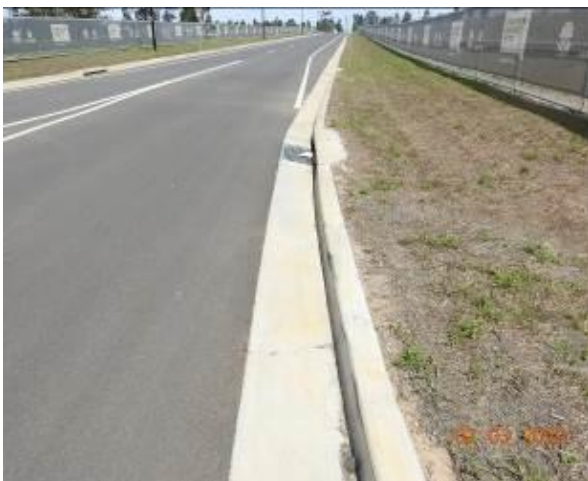
Figure 935 – General Condition of kerb and gutter

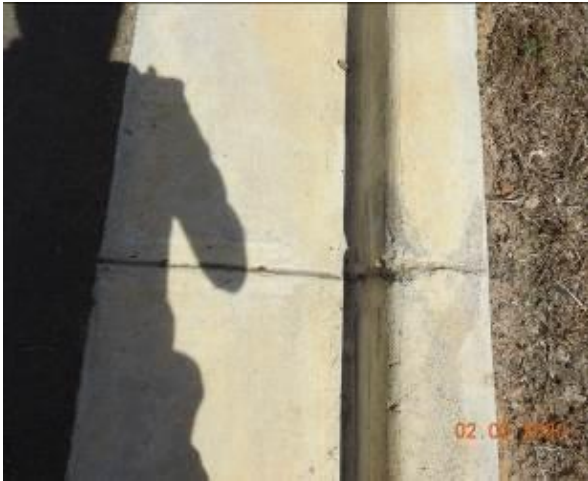
Figure 937 – Loss of material through kerb

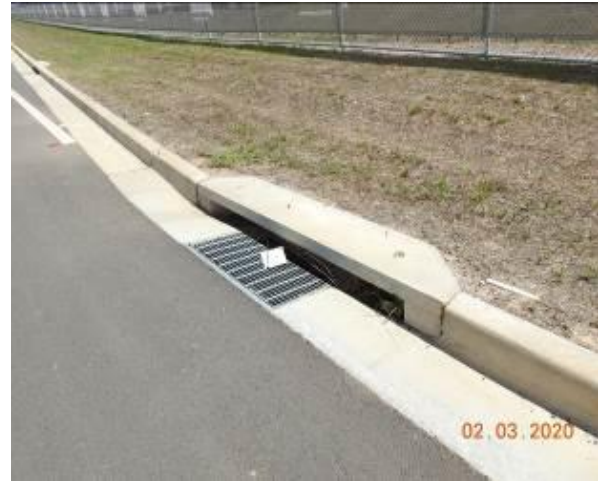
Figure 938 – General Condition of stormwater inlet pit

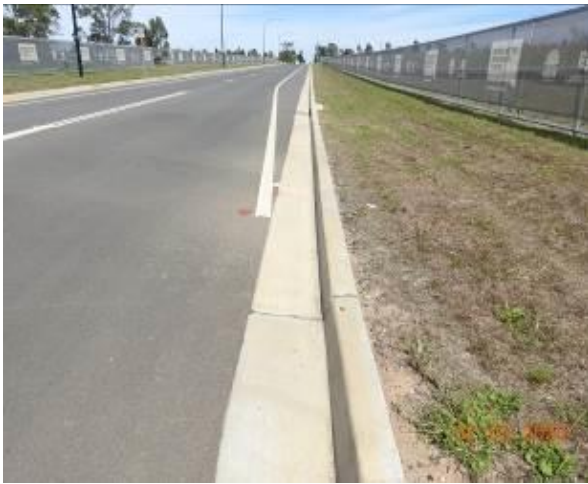
Figure 939 – General Condition of kerb and gutter

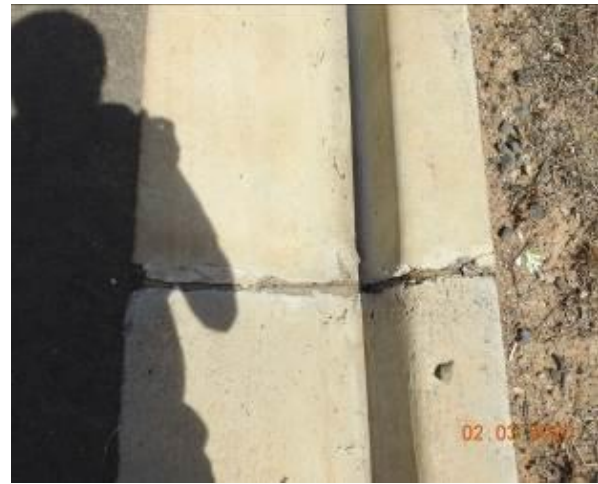
Figure 940 – Crack propagation and loss of material through kerb and gutter

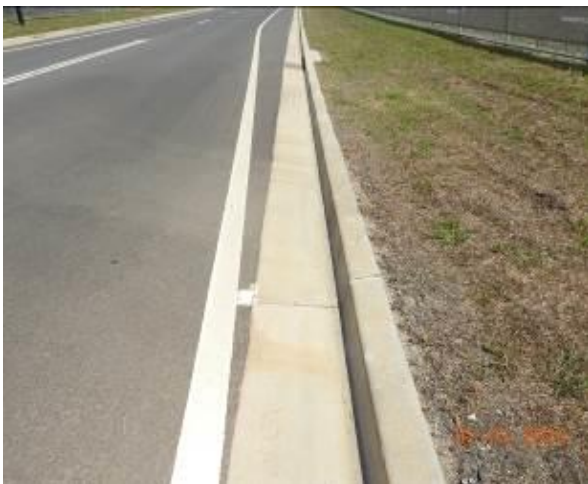
Figure 941 – General Condition of kerb and gutter

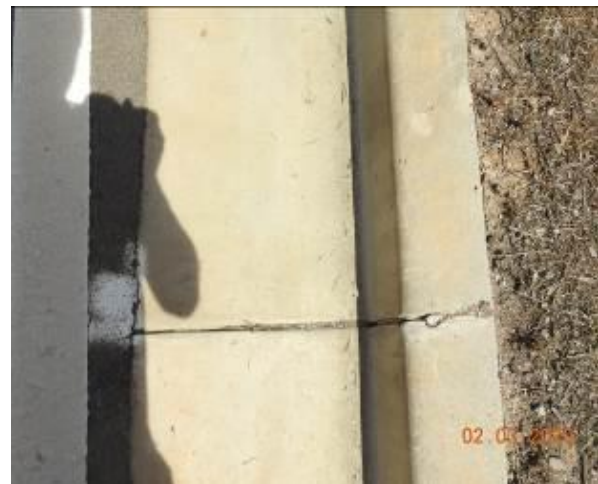
Figure 942 – Crack propagation and loss of material through kerb and gutter

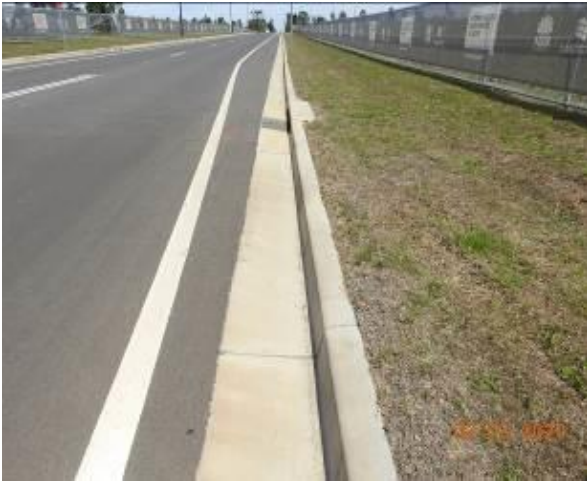
Figure 943 – General Condition of kerb and gutter

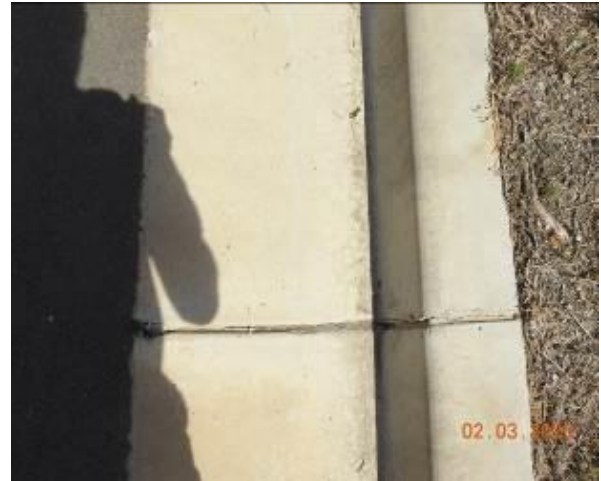
Figure 944 – Loss of material through gutter

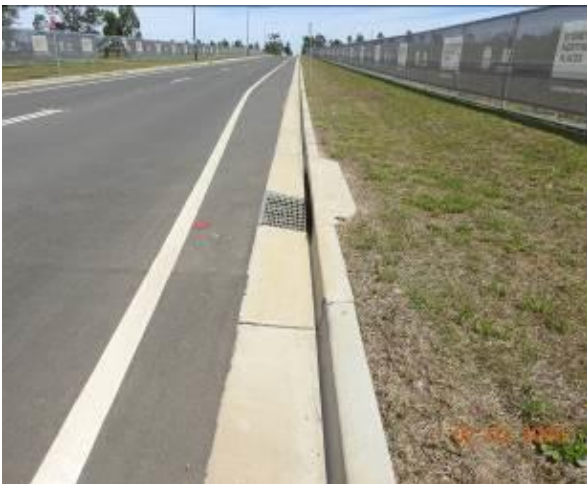
Figure 945 – General Condition of kerb and gutter

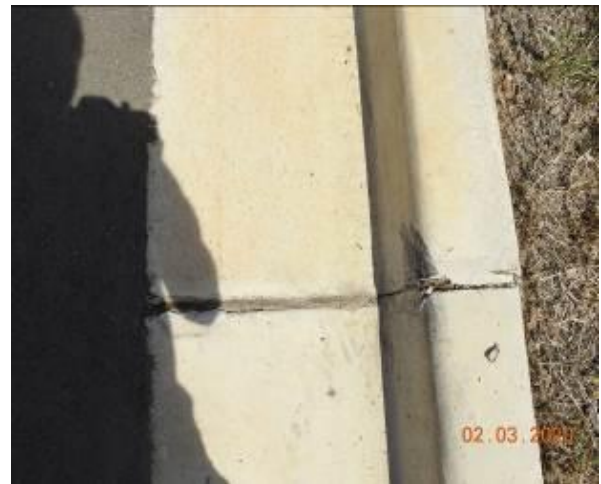
Figure 946 – Crack propagation and loss of material through kerb and gutter

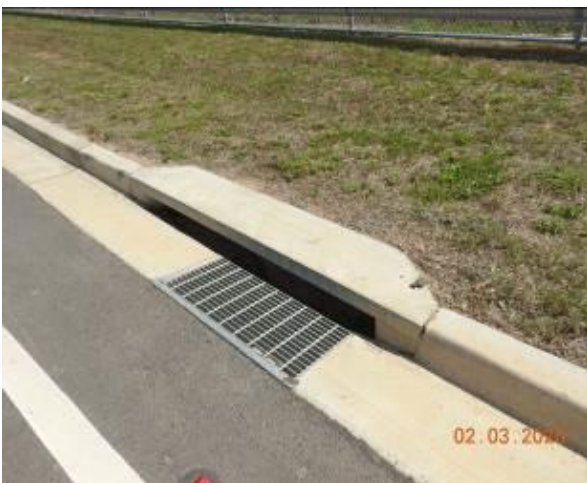
Figure 947 – General Condition of stormwater inlet pit

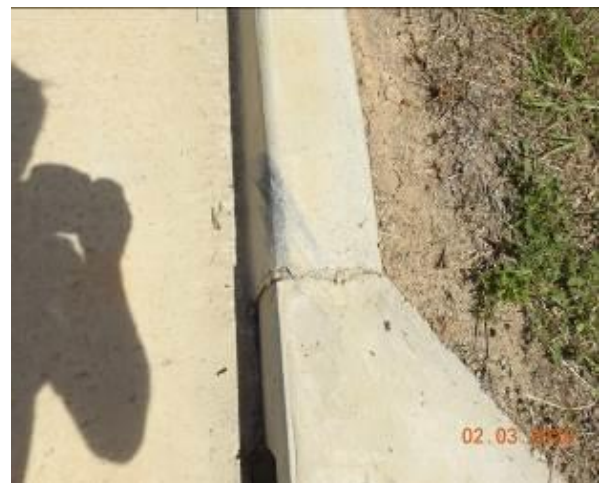
Figure 948 – Crack propagation through stormwater inlet pit

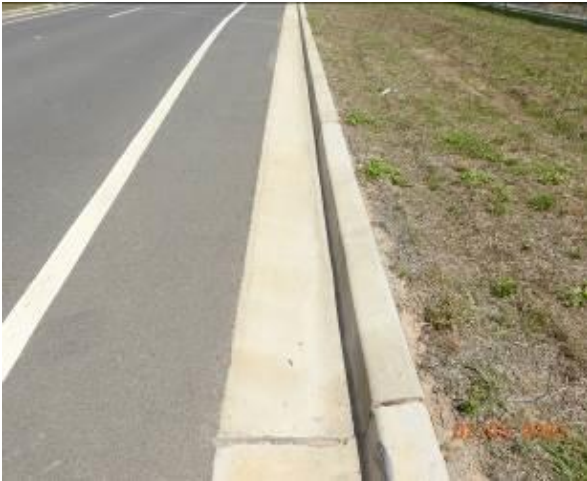
Figure 949 – General Condition of kerb and gutter

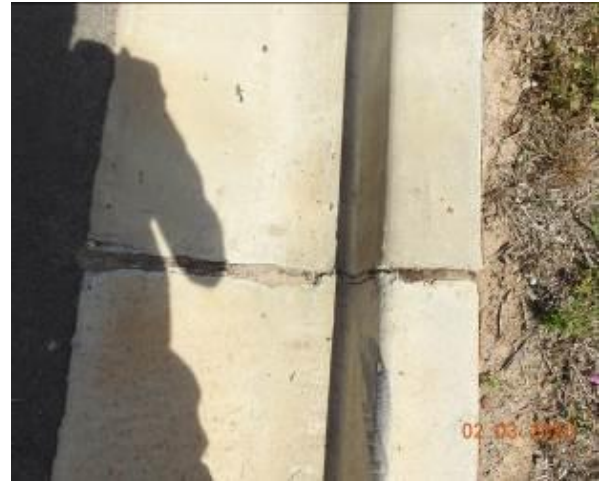
Figure 950 – Crack propagation through kerb and gutter

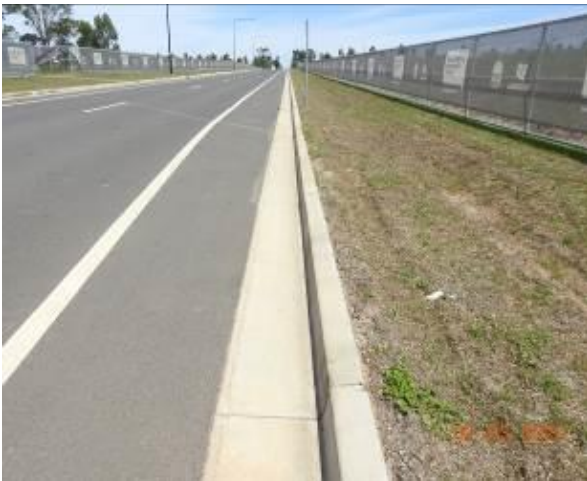
Figure 951 – General Condition of kerb and gutter

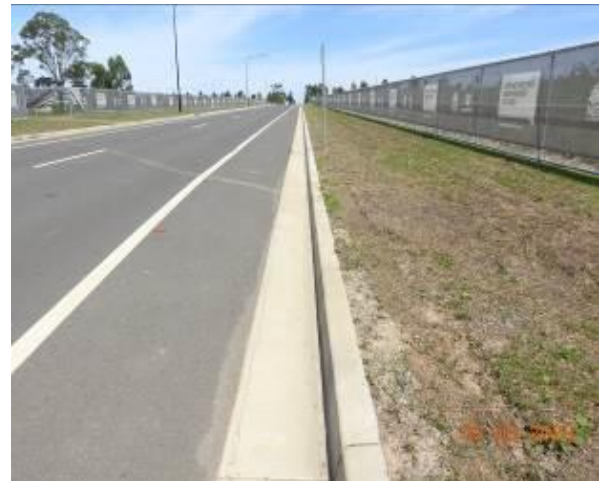
Figure 952 – General Condition of kerb and gutter

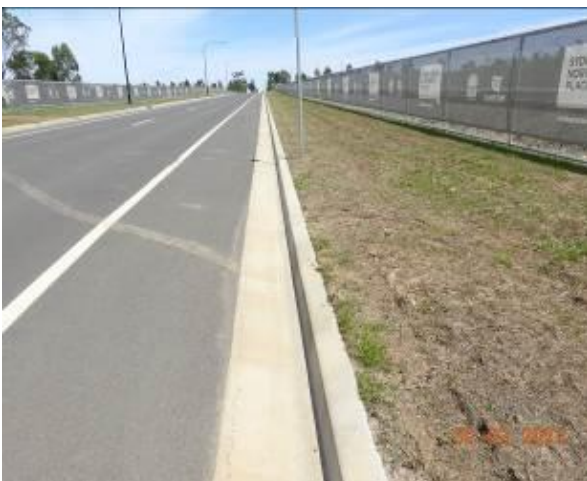
Figure 953 – General Condition of kerb and gutter

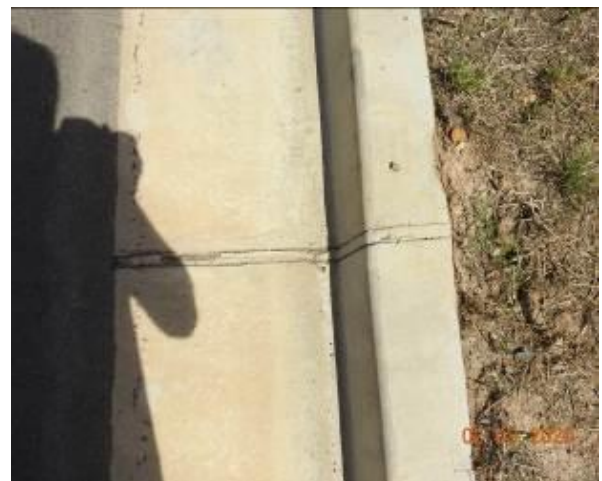
Figure 954 – Crack propagation through kerb and gutter

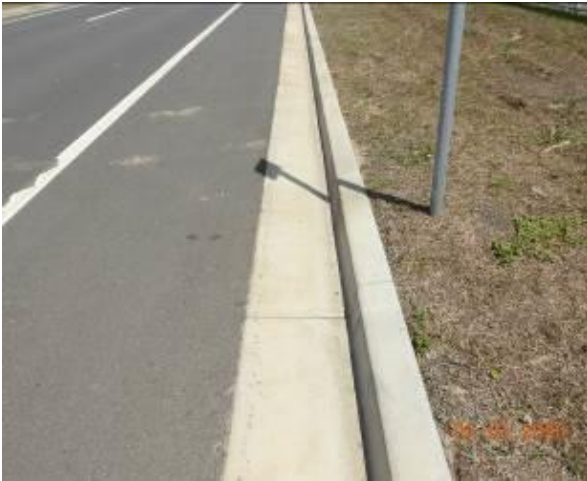
Figure 955 – General Condition of kerb and gutter

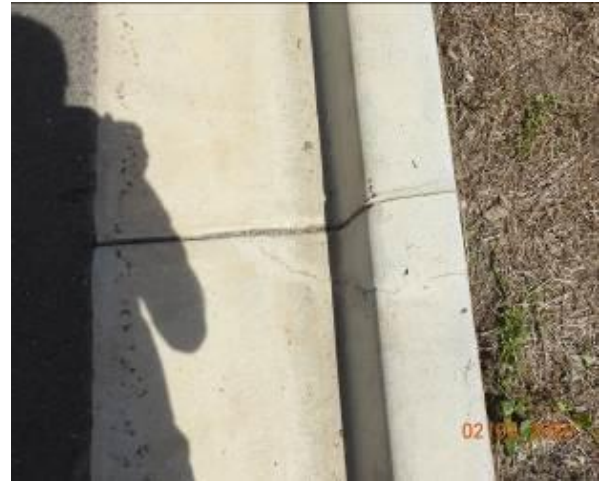
Figure 956 – Crack propagation through kerb and gutter

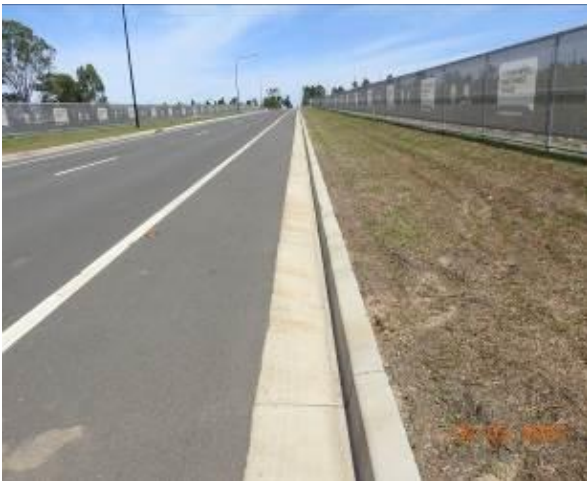
Figure 957 – General Condition of kerb and gutter

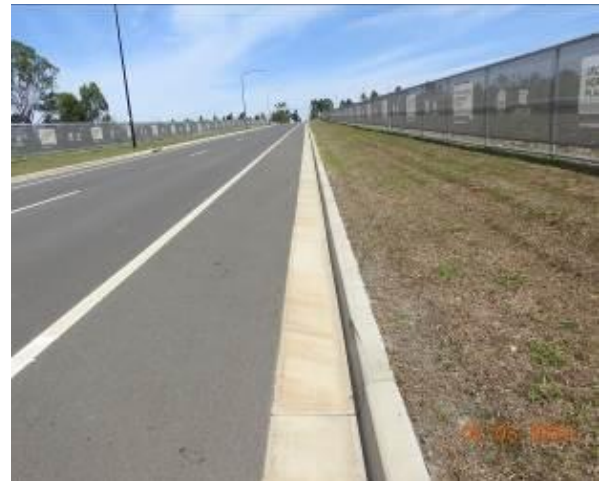
Figure 958 – General Condition of kerb and gutter

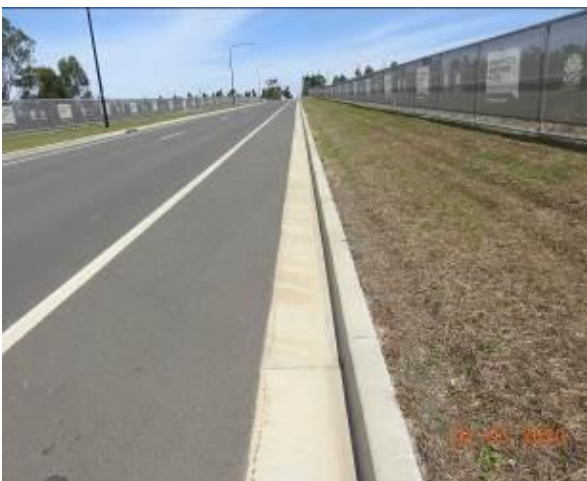
Figure 959 – General Condition of kerb and gutter

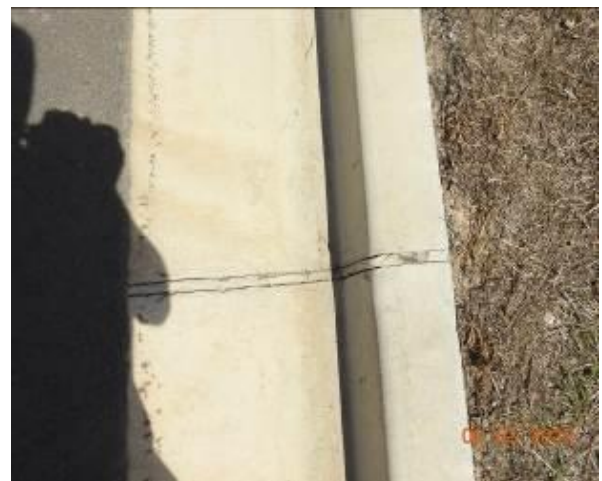
Figure 960 – Crack propagation through kerb and gutter

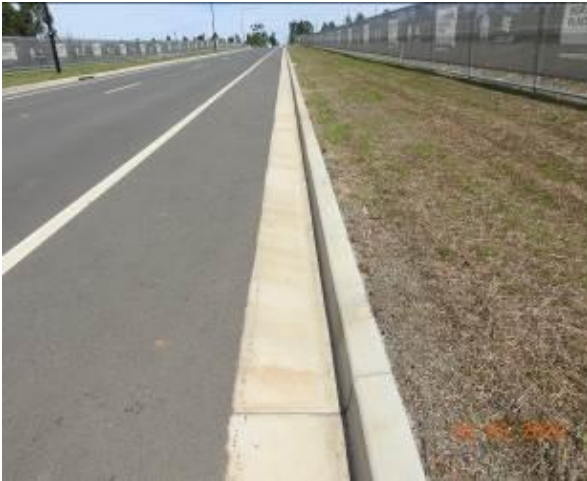
Figure 961 – General Condition of kerb and gutter

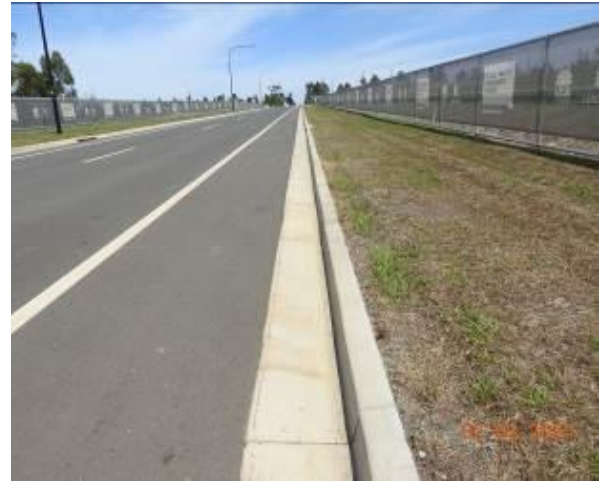
Figure 962 – General Condition of kerb and gutter

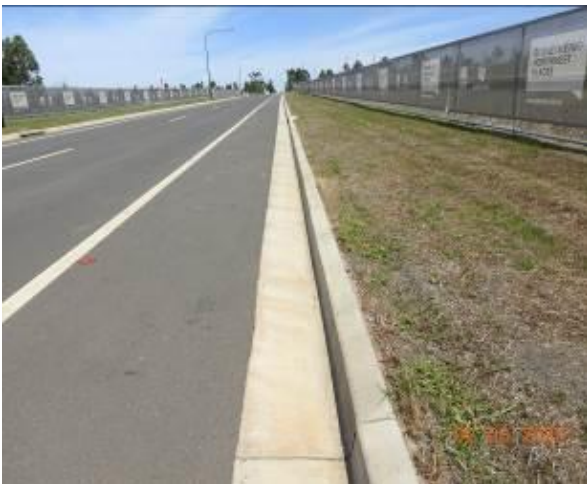
Figure 963 – General Condition of kerb and gutter

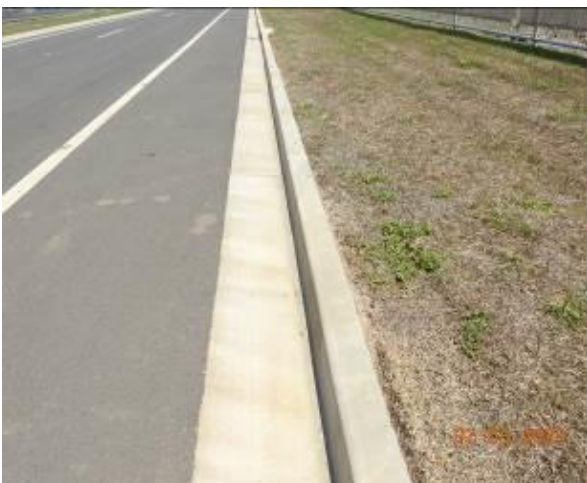
Figure 965 – General Condition of kerb and gutter

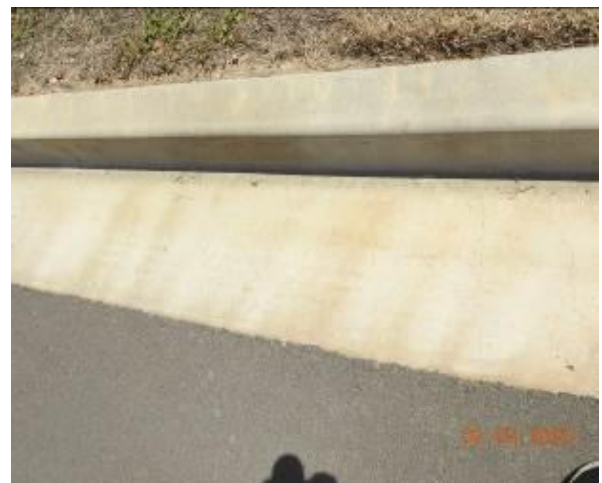
Figure 966 – Crack propagation through gutter

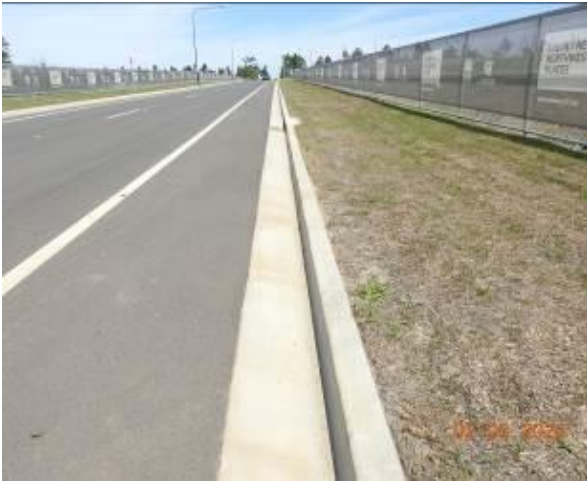
Figure 967 – General Condition of kerb and gutter

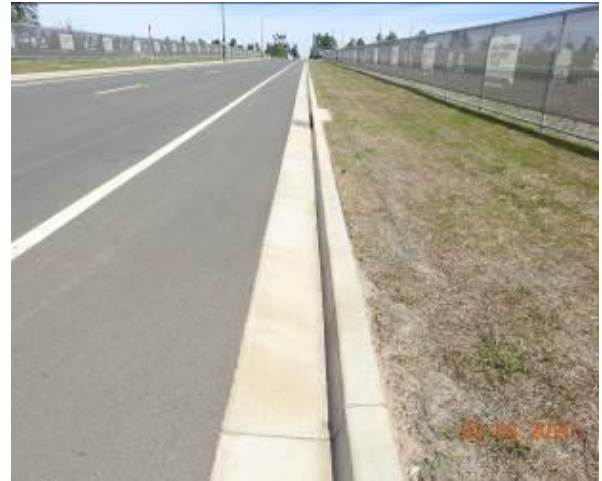
Figure 968 – General Condition of kerb and gutter

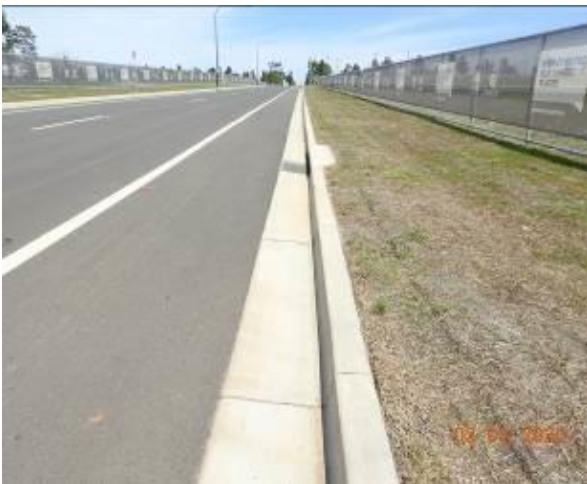
Figure 969 – General Condition of kerb and gutter

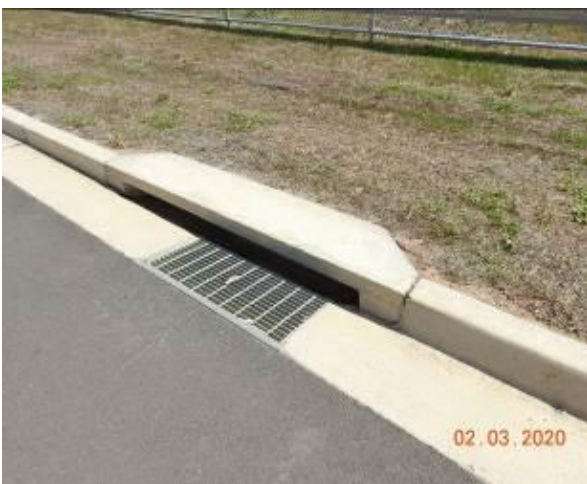
Figure 971 – General Condition of stormwater inlet pit

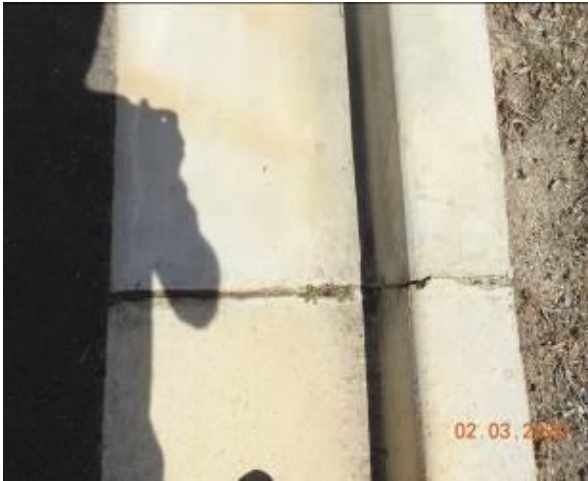
Figure 973 – Crack propagation through kerb and gutter

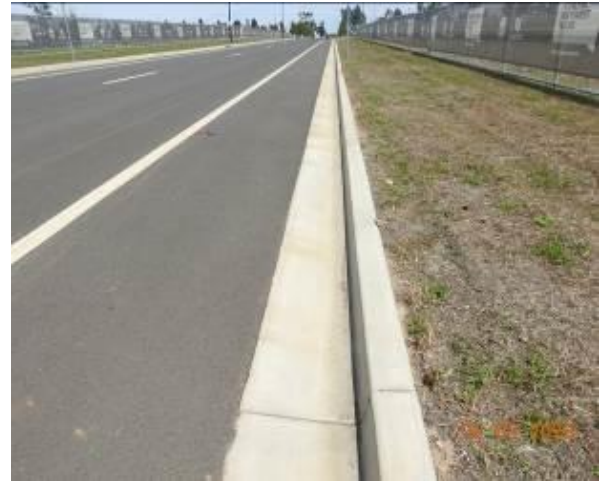
Figure 974 – General Condition of kerb and gutter

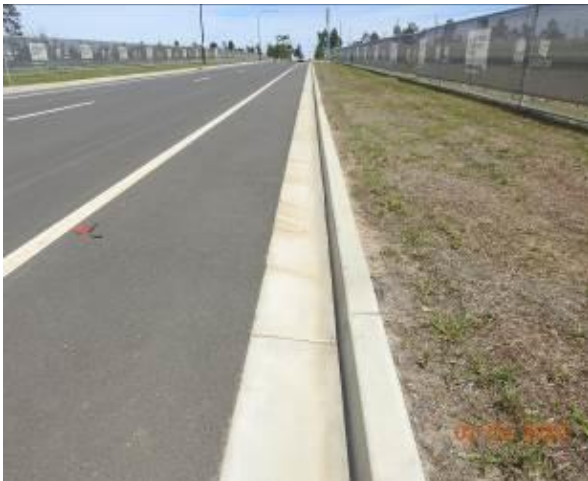
Figure 975 – General Condition of kerb and gutter

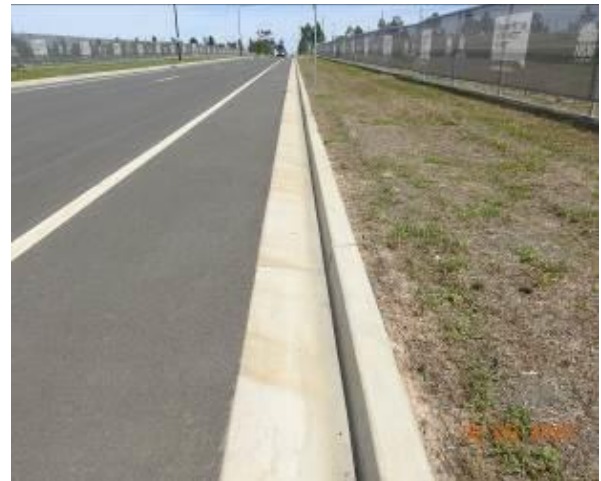
Figure 976 – General Condition of kerb and gutter

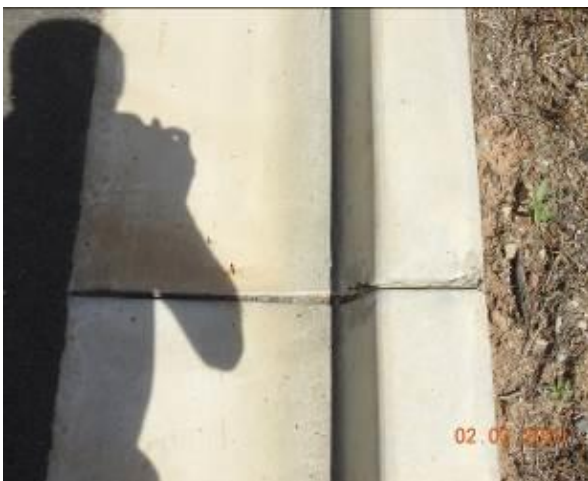
Figure 977 – Crack propagation through kerb and gutter

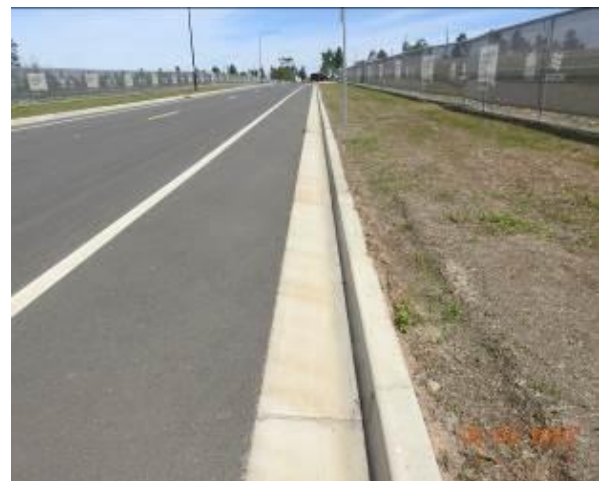
Figure 978 – General Condition of kerb and gutter

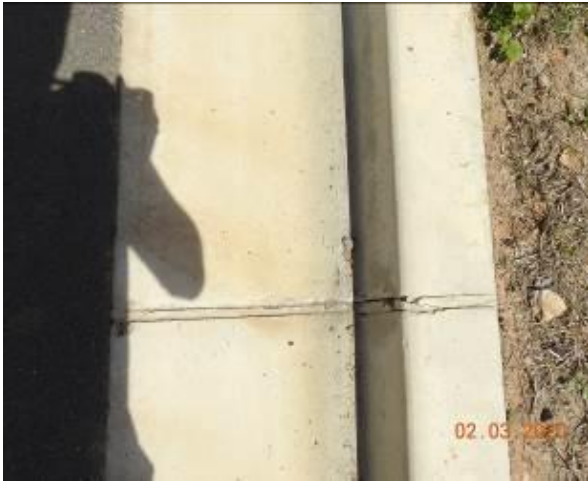
Figure 979 – Crack propagation through kerb and gutter

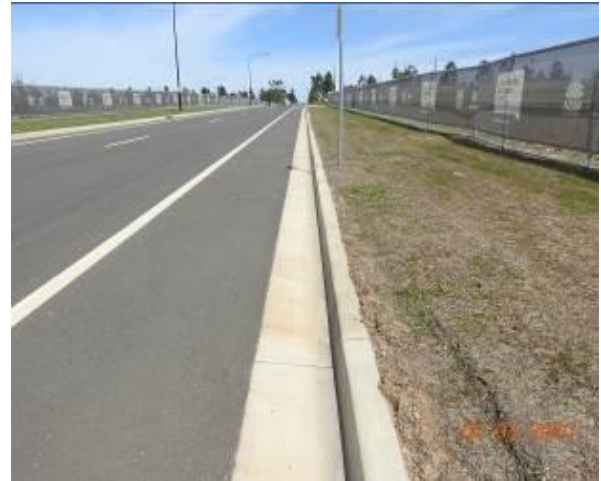
Figure 980 – General Condition of kerb and gutter

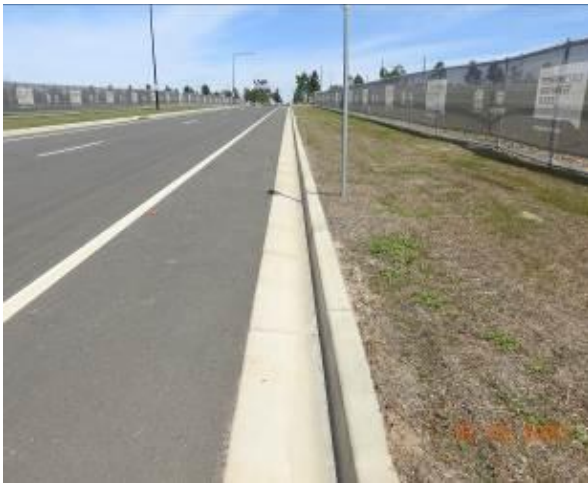
Figure 981 – General Condition of kerb and gutter

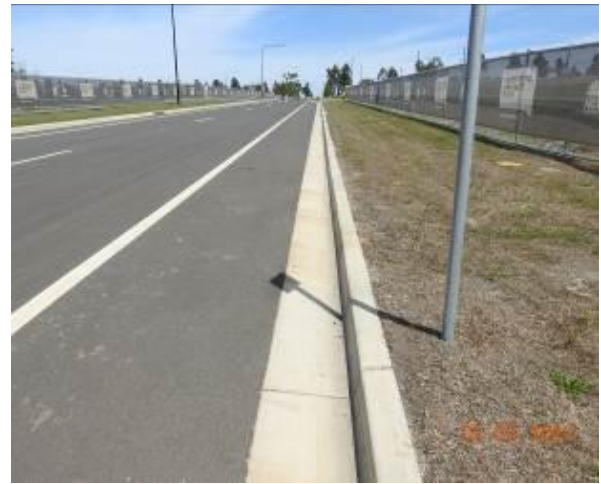
Figure 982 – General Condition of kerb and gutter

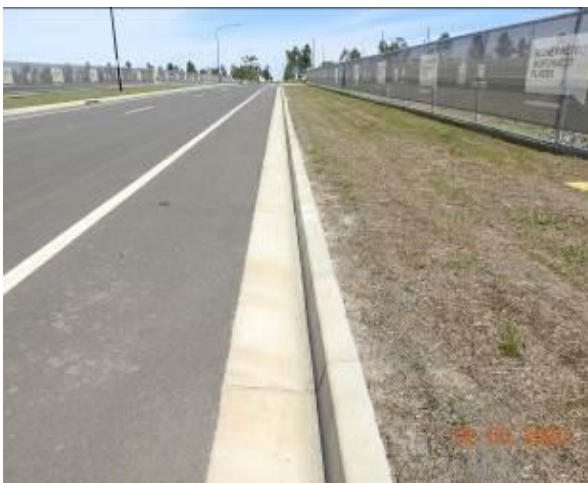
Figure 983 – General Condition of kerb and gutter

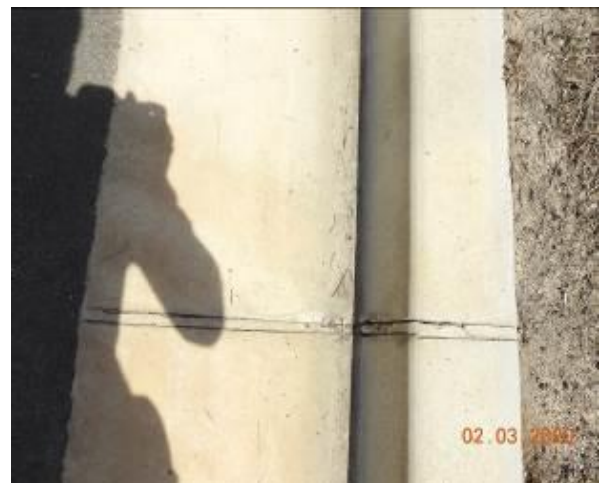
Figure 984 – Crack propagation through kerb and gutter

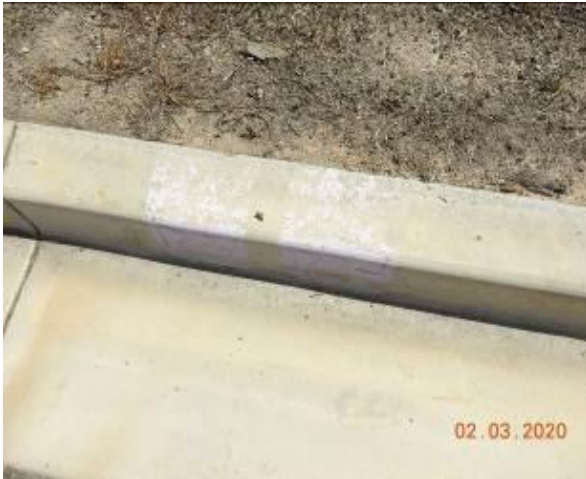
Figure 985 – General Condition of kerb and gutter

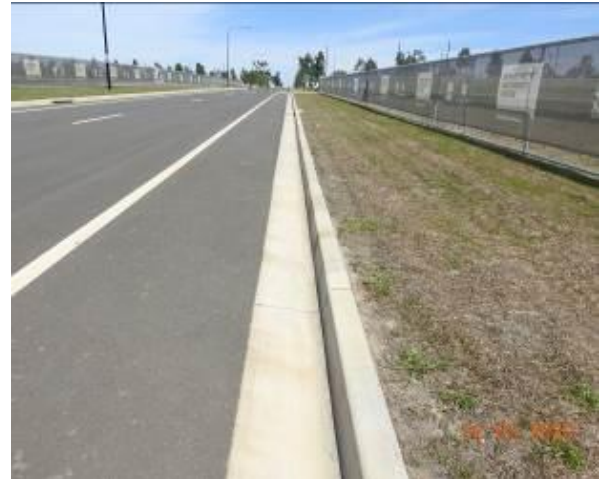
Figure 986 – General Condition of kerb and gutter

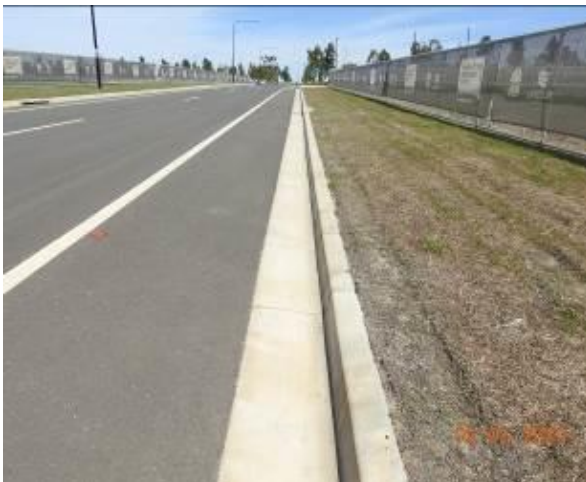
Figure 987 – General Condition of kerb and gutter

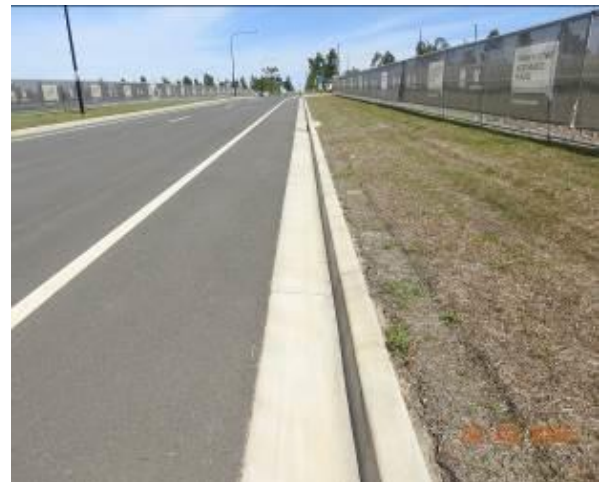
Figure 988 – General Condition of kerb and gutter

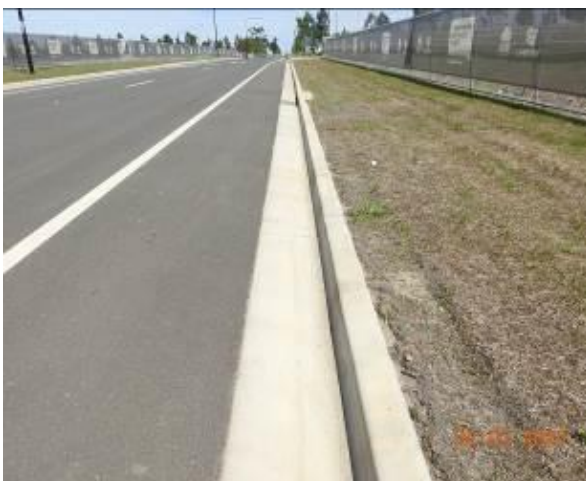
Figure 989 – General Condition of kerb and gutter

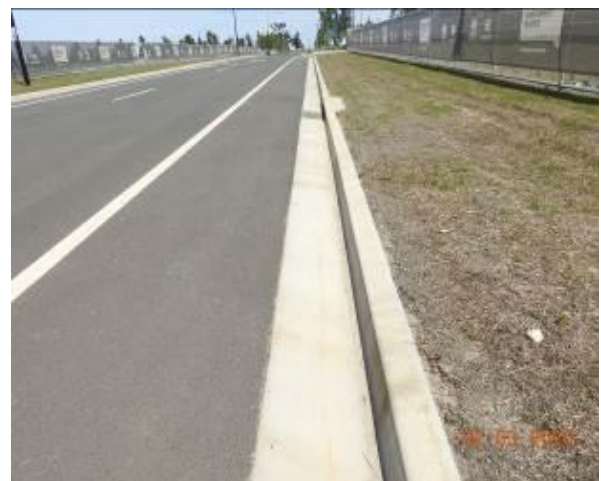
Figure 990 – General Condition of kerb and gutter

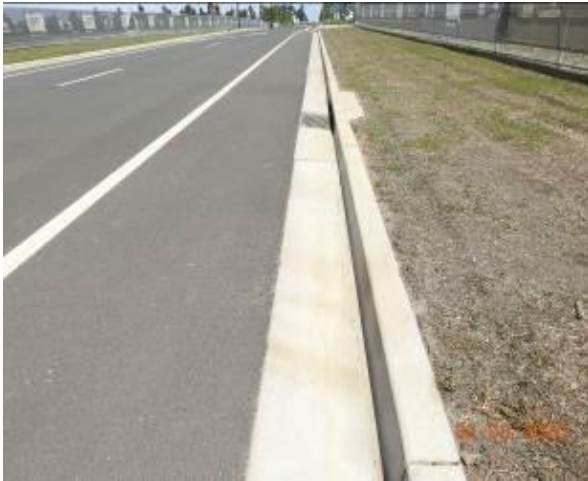
Figure 991 – General Condition of kerb and gutter

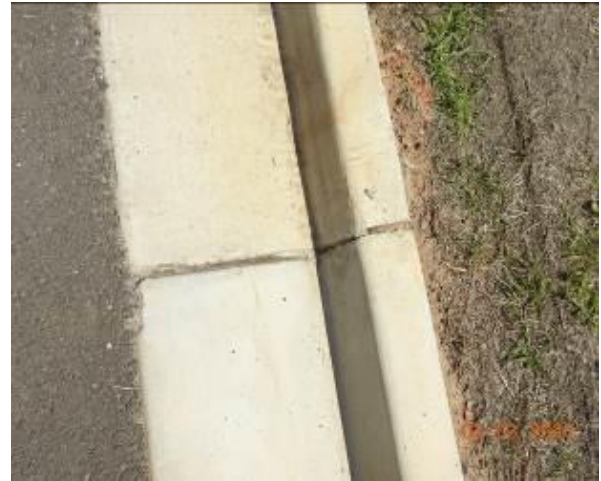
Figure 992 – Crack propagation and loss of material through kerb and gutter

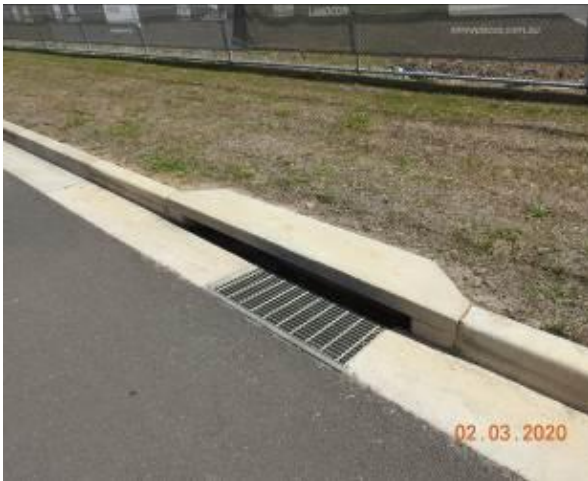
Figure 993 – General Condition of stormwater inlet pit

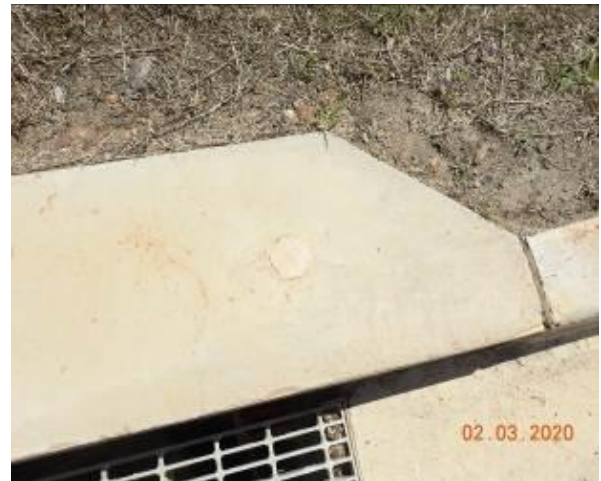
Figure 994 – Crack propagation and Evidence of patchwork through stormwater inlet pit

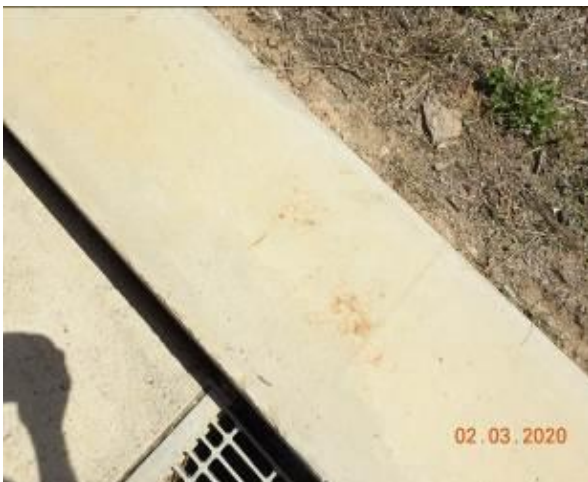
Figure 995 – Crack propagation through stormwater inlet pit

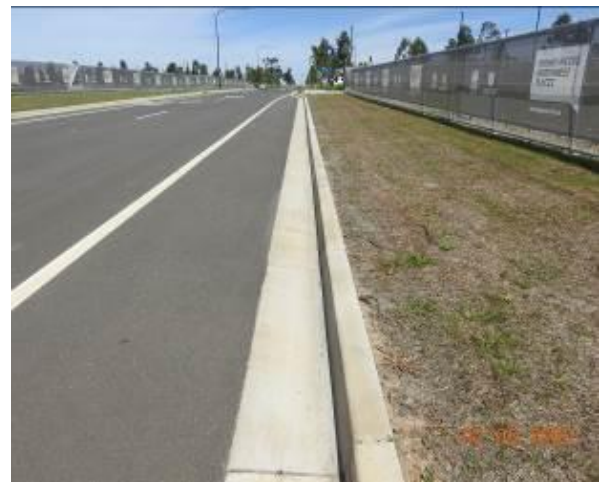
Figure 996 – General Condition of kerb and gutter

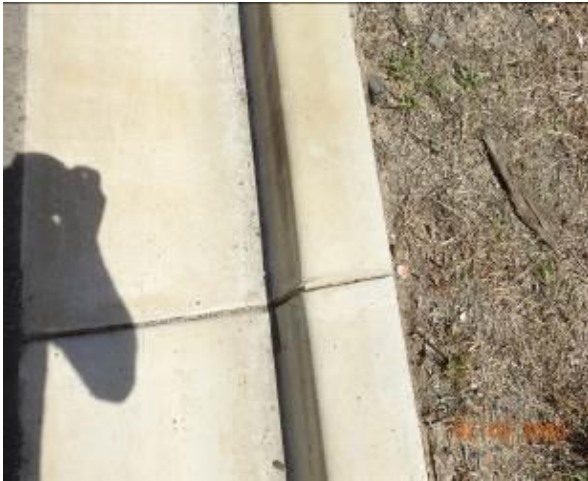
Figure 997 – General Condition of kerb and gutter

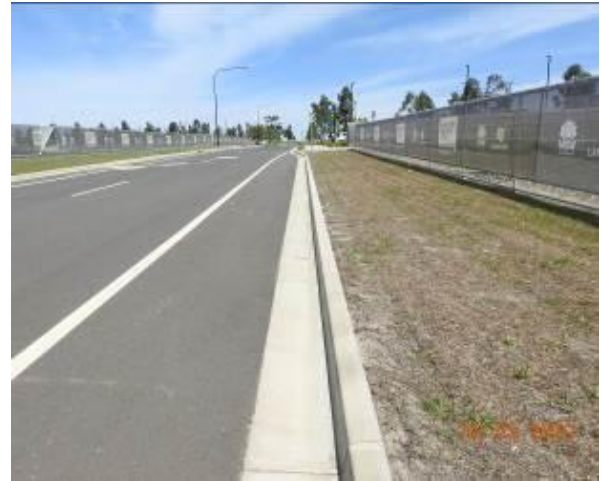
Figure 998 – General Condition of kerb and gutter

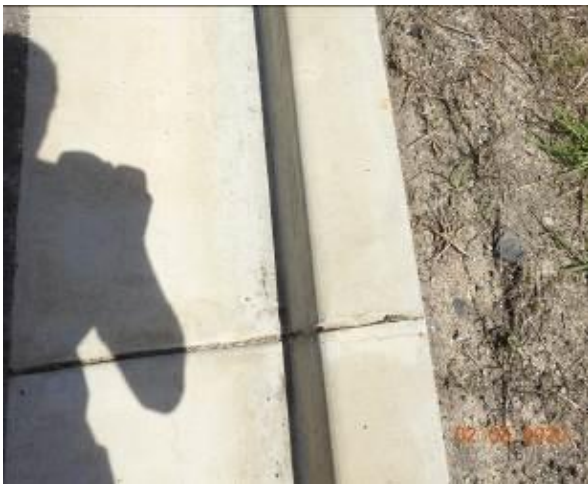
Figure 999 – Crack propagation through kerb and gutter

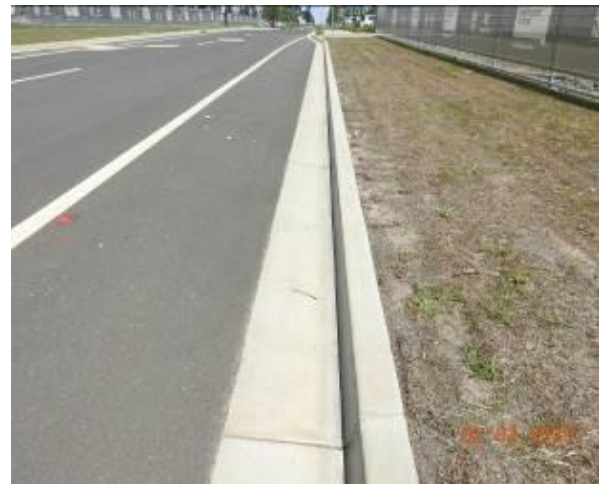
Figure 1000 – General Condition of kerb and gutter

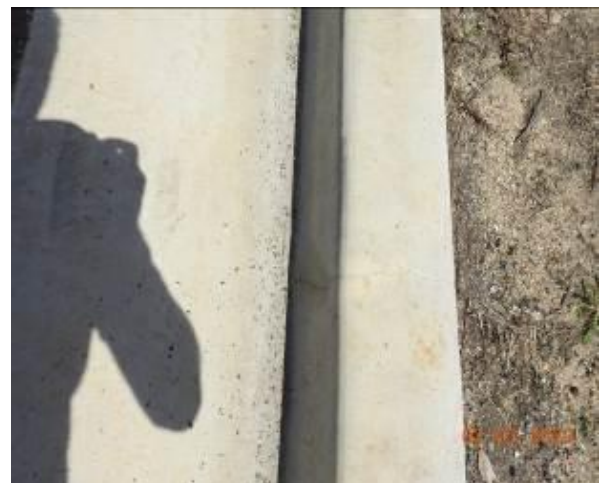
Figure 1002 – Crack propagation through kerb and gutter
