**1-15 AND 2-12 CONFERTA AVENUE,  
ROUSE HILL NSW 2155  
TALLAWONG STATION PRECINCT SOUTH  
PRE-DILAPIDATION REPORT**

**DEICORP PROJECTS  
(TALLAWONG STATION) PTY LTD**

Job No. 191294.0  
05/07/2021

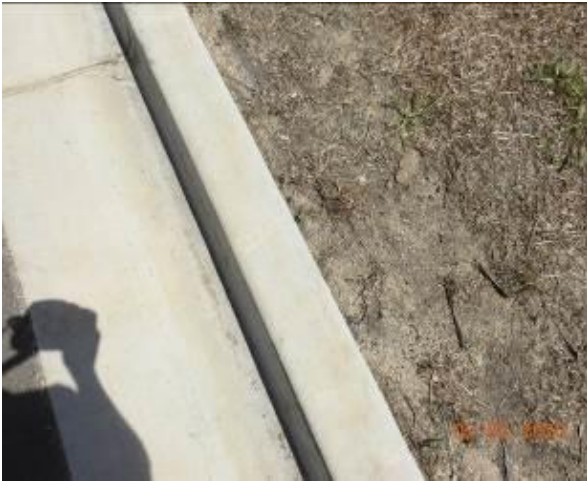
Figure 1003 – General Condition of kerb and gutter

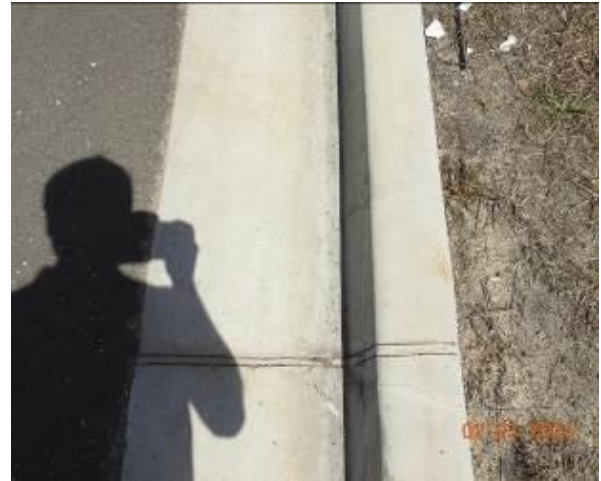
Figure 1004 – Crack propagation through kerb and gutter

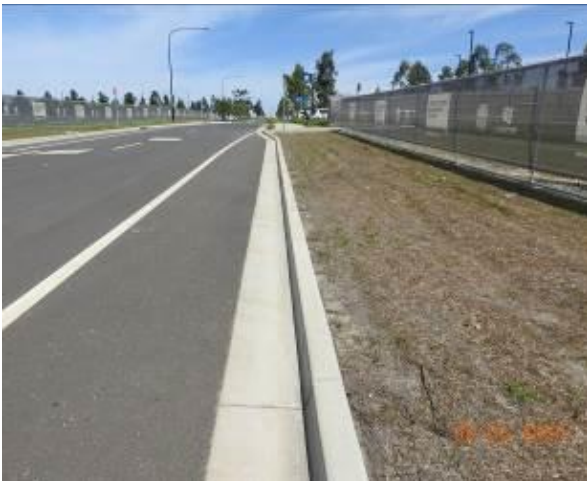
Figure 1005 – General Condition of kerb and gutter

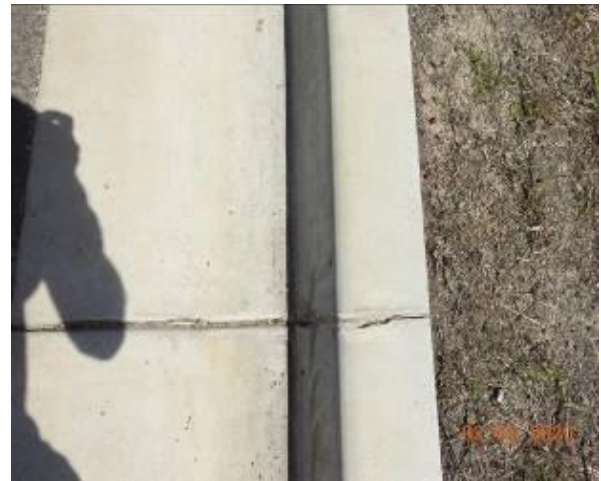
Figure 1006 – Loss of material through kerb

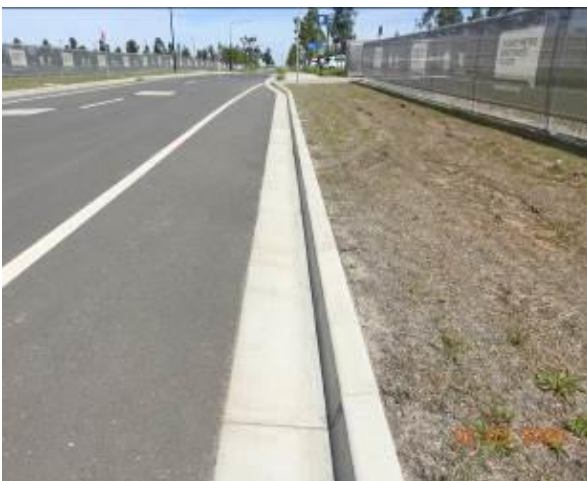
Figure 1007 – General Condition of kerb and gutter

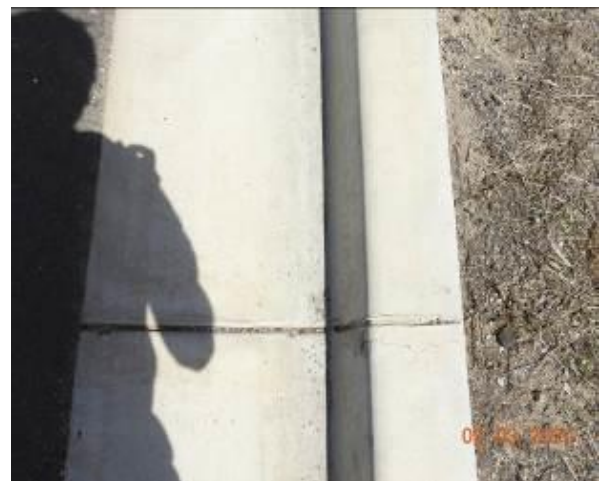
Figure 1008 – Crack propagation through kerb

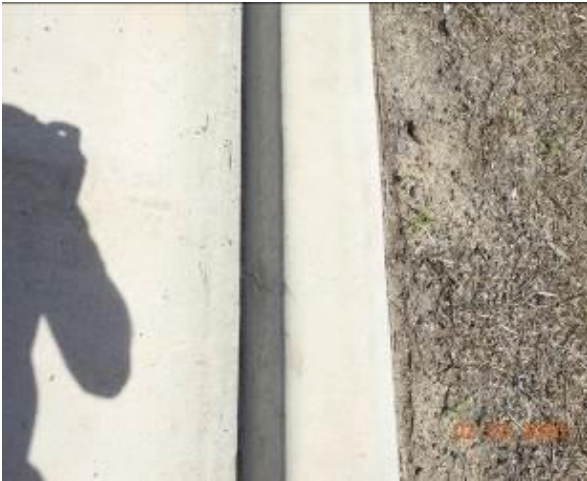
Figure 1009 – Crack propagation through kerb

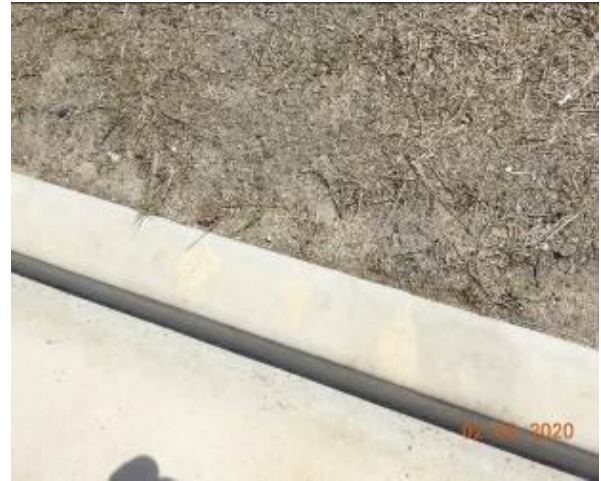
Figure 1010 – Crack propagation through kerb

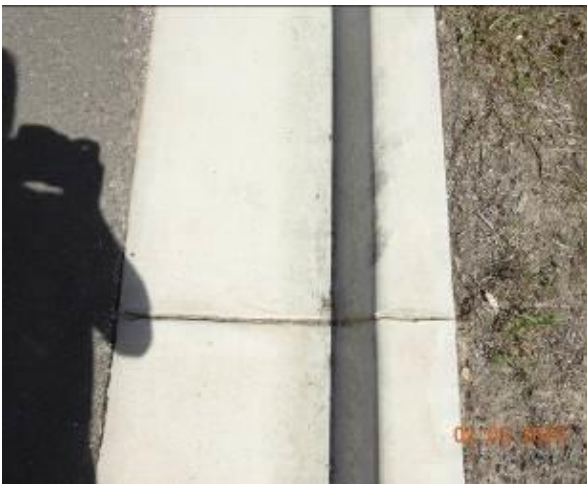
Figure 1011 – Crack propagation through kerb and gutter

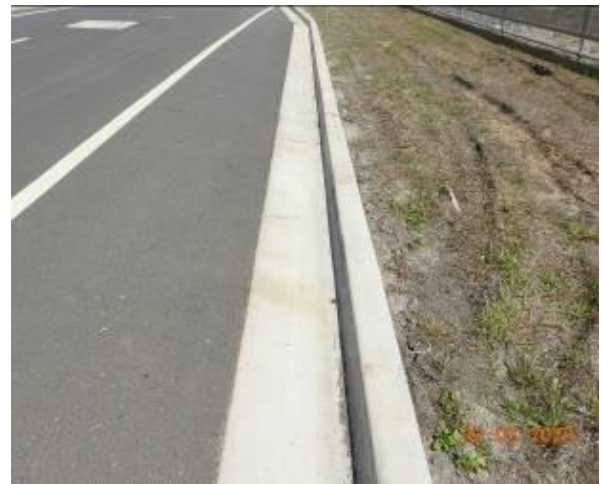
Figure 1012 – General Condition of kerb and gutter

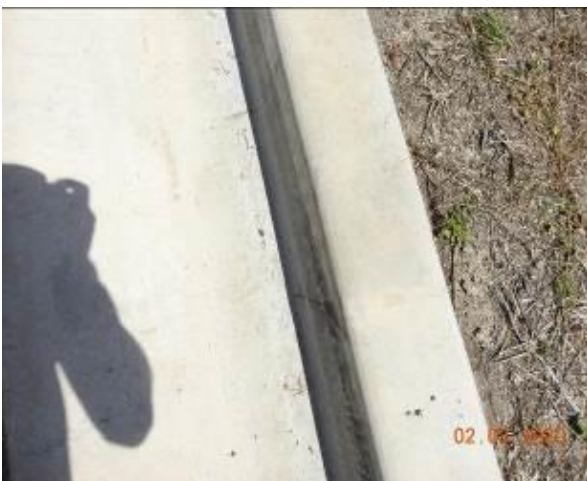
Figure 1013 – Crack propagation through kerb and gutter

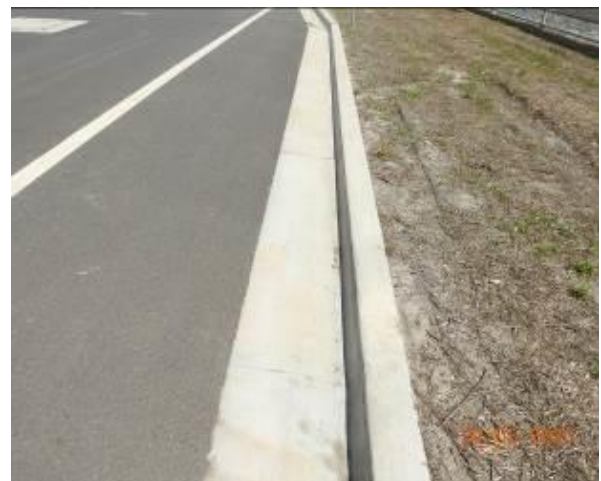
Figure 1014 – General Condition of kerb and gutter

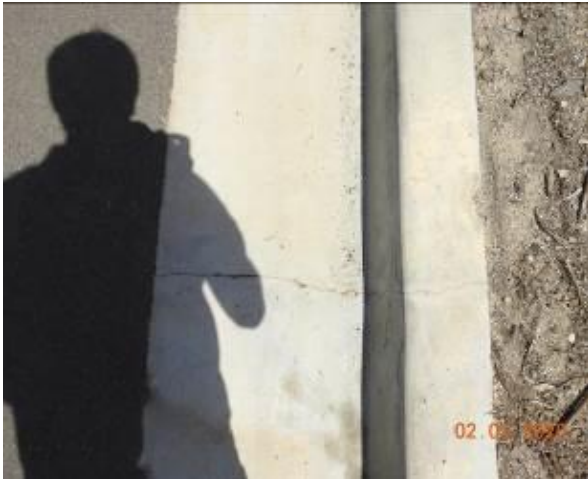
Figure 1015 – Crack propagation through kerb and gutter

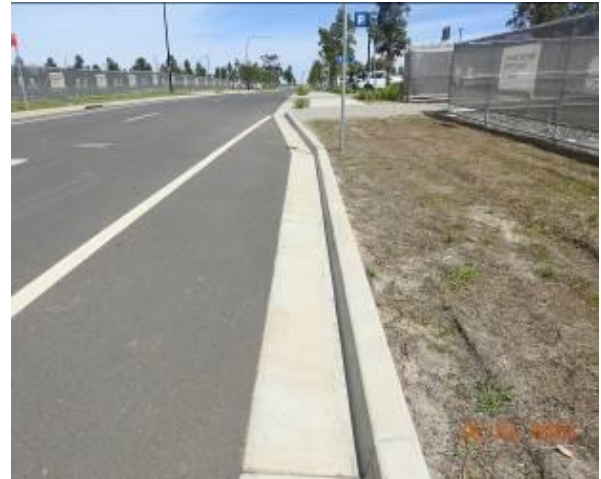
Figure 1016 – General Condition of kerb and gutter

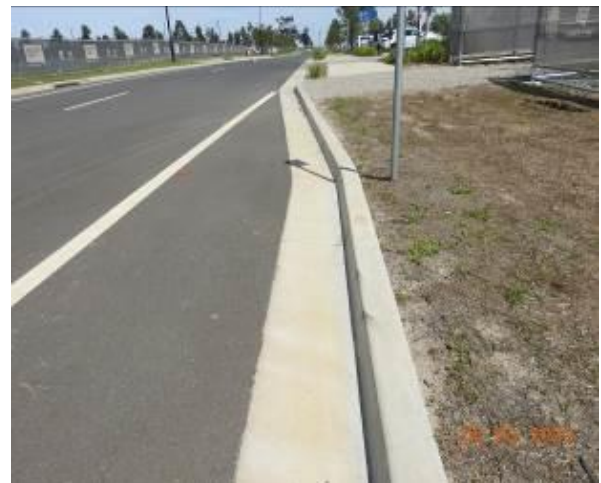
Figure 1017 – Crack propagation through kerb and gutter

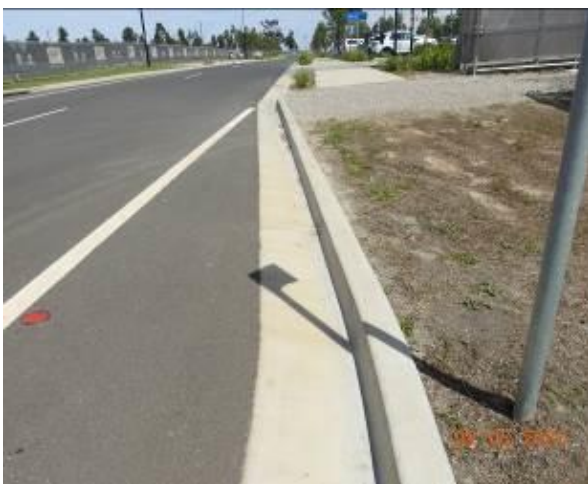
Figure 1018 – General Condition of kerb and gutter

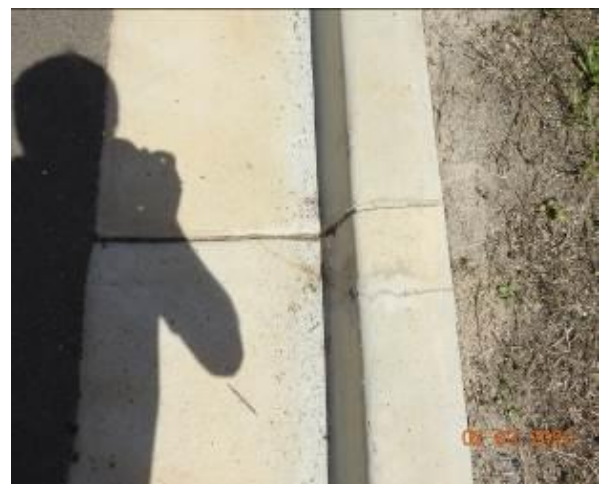
Figure 1019 – General Condition of kerb and gutter

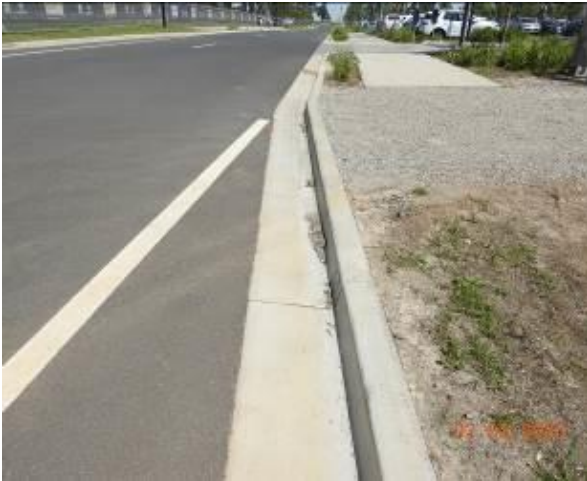
Figure 1020 – Crack propagation through kerb and gutter

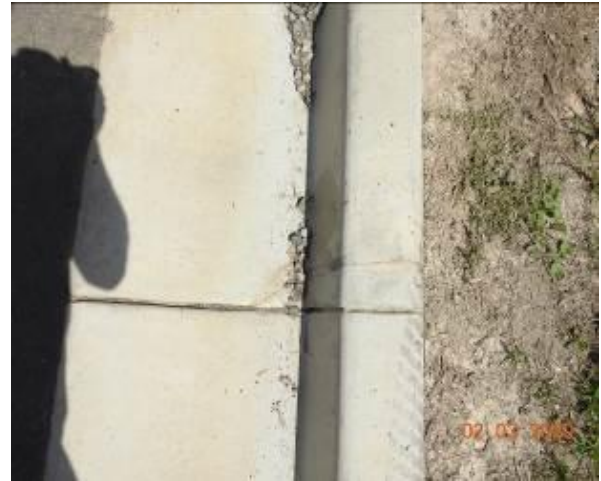
Figure 1021 – General Condition of kerb and gutter

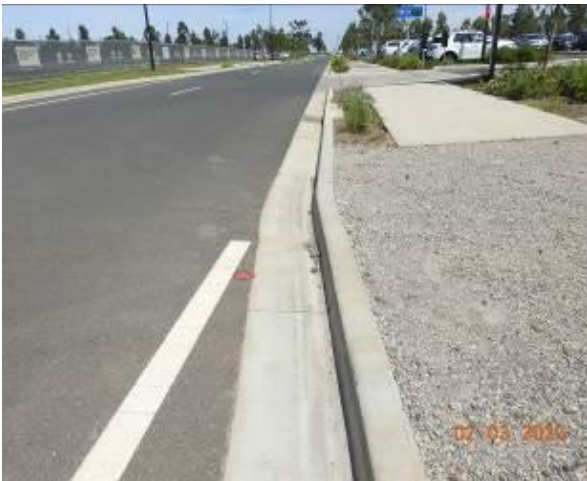
Figure 1022 – Crack propagation through kerb and gutter

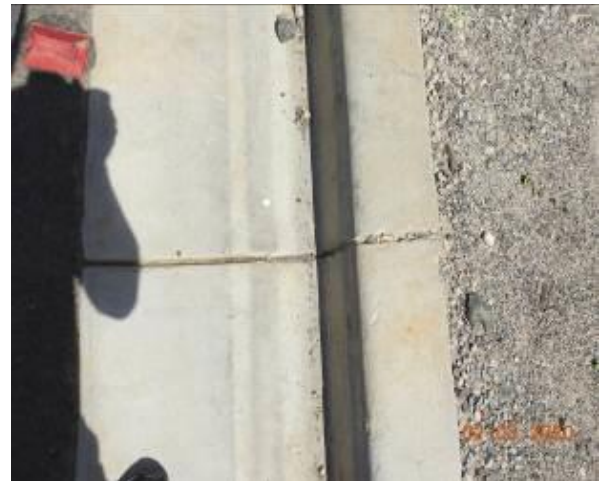
Figure 1023 – General Condition of kerb and gutter

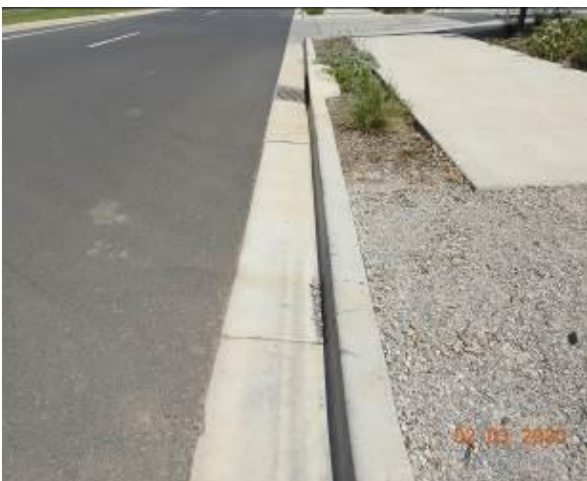
Figure 1024 – Loss of material through kerb

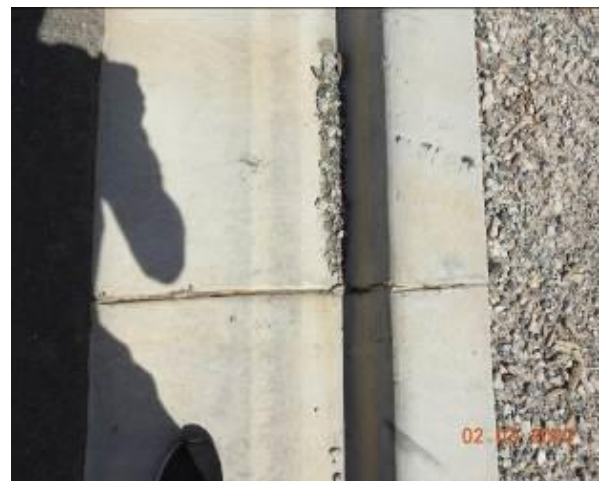
Figure 1025 – General Condition of kerb and gutter

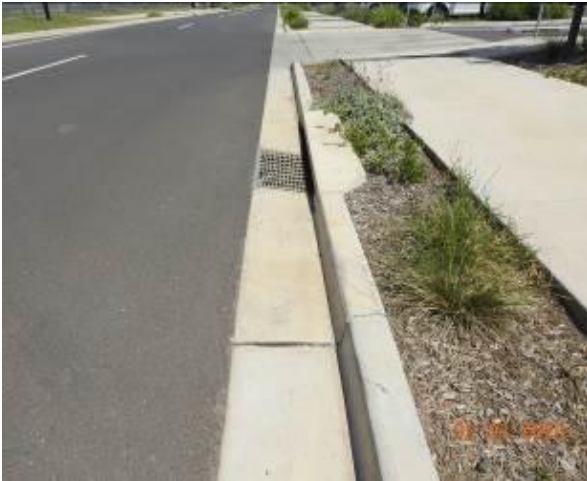
Figure 1026 – Crack propagation through kerb and gutter

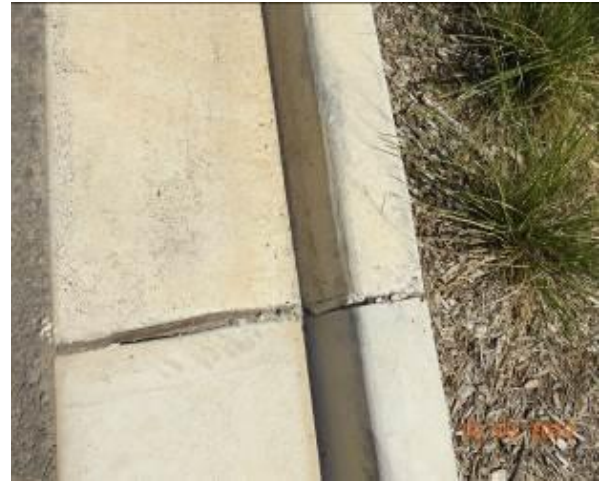
Figure 1027 – General Condition of kerb and gutter

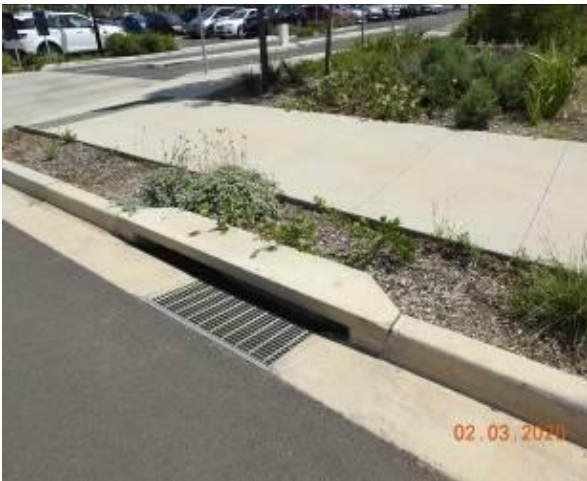
Figure 1028 – Loss of material through kerb and gutter

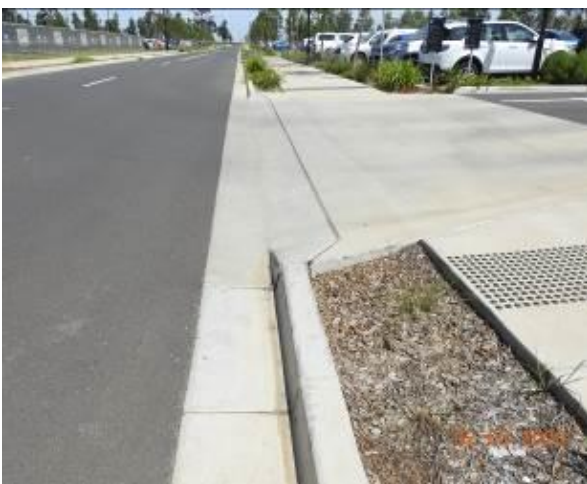
Figure 1030 – General Condition of kerb and gutter

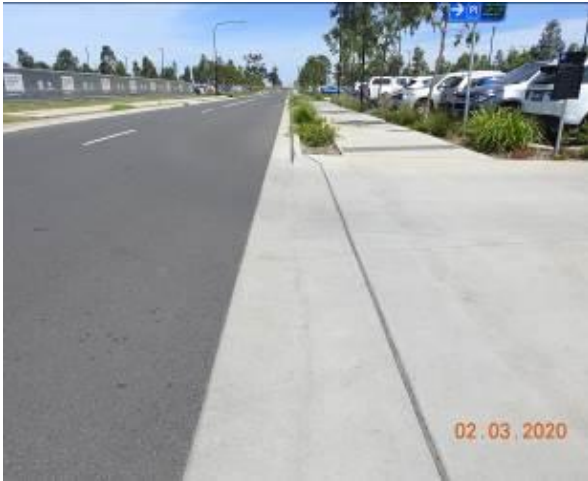
Figure 1032 – Loss of material through kerb and gutter

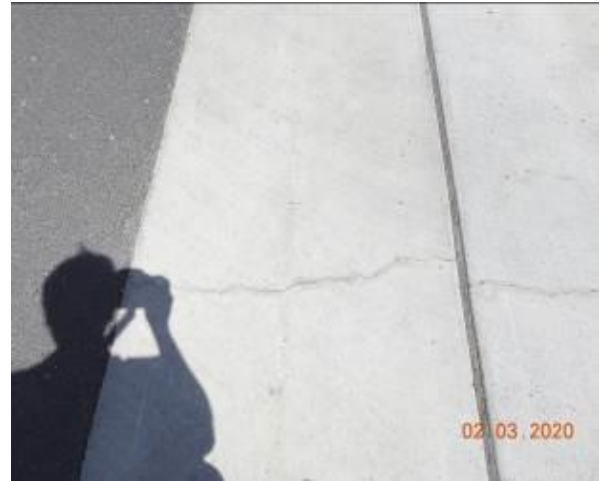
Figure 1033 – General Condition of gutter

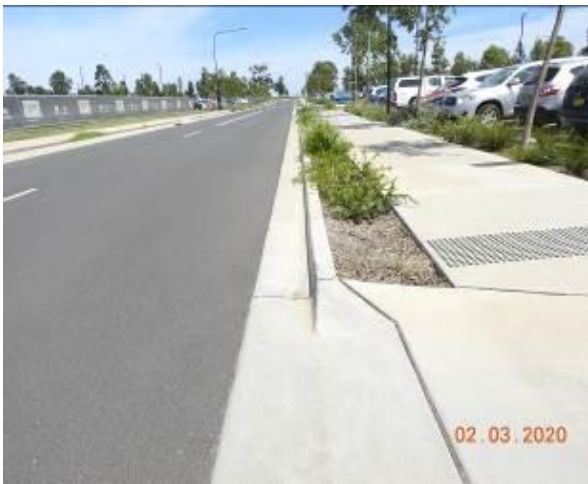
Figure 1034 – Crack propagation through gutter

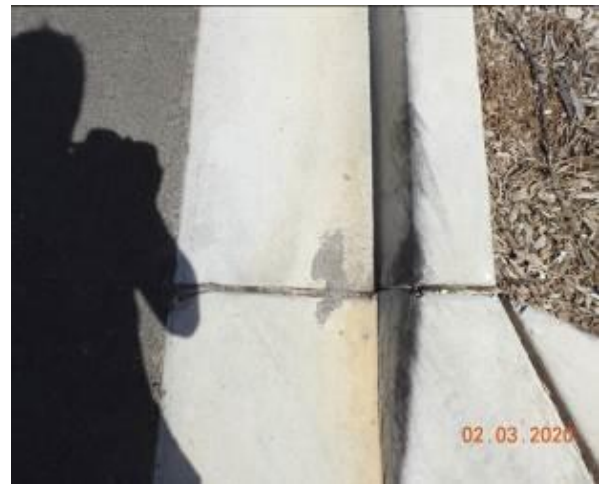
Figure 1035 – General Condition of gutter

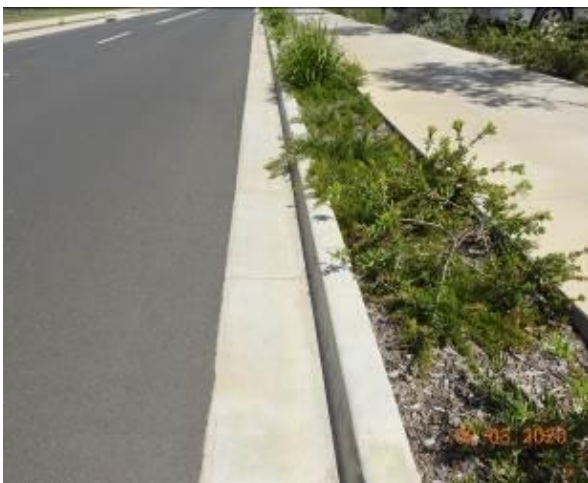
Figure 1036 – Crack propagation through kerb and gutter

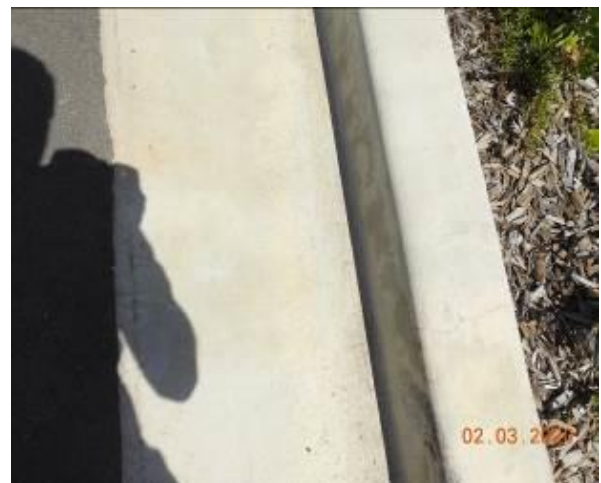
Figure 1037 – General Condition of kerb and gutter

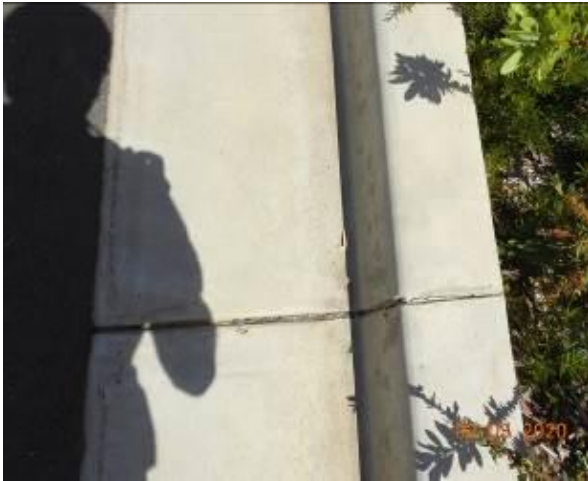
Figure 1038 – Crack propagation through kerb and gutter

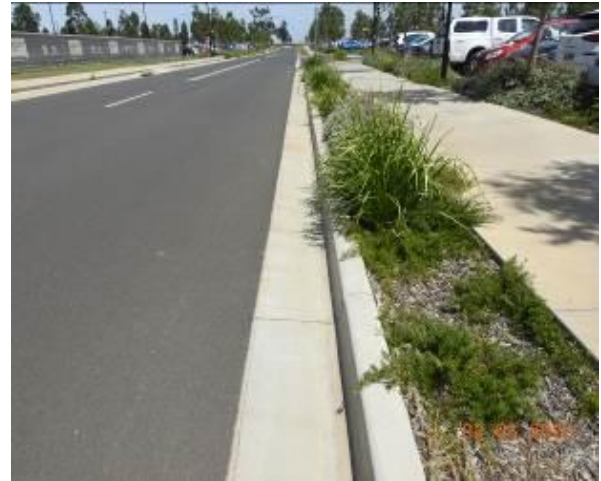
Figure 1039 – Crack propagation through kerb and gutter

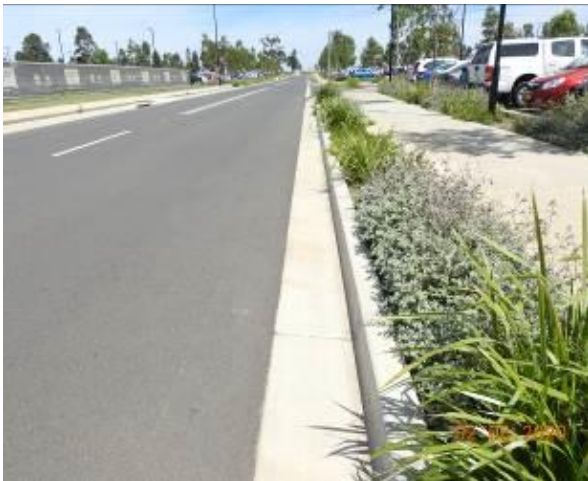
Figure 1040 – General Condition of kerb and gutter

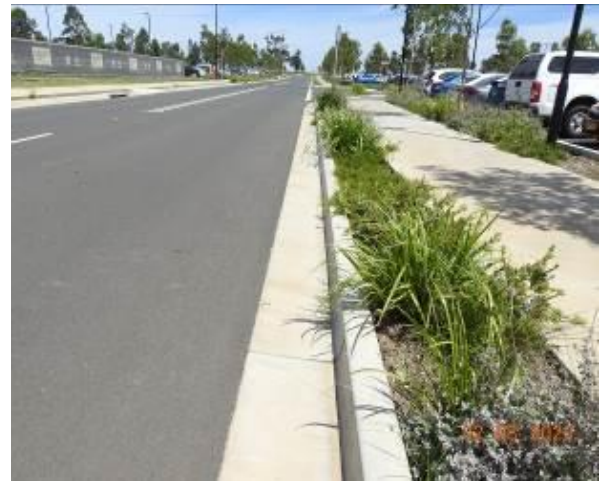
Figure 1041 – General Condition of kerb and gutter

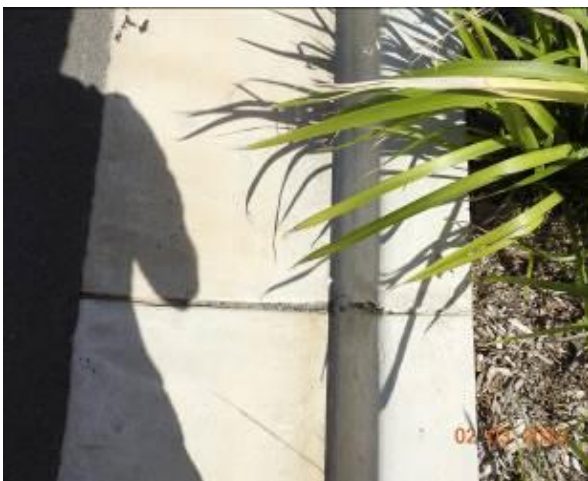
Figure 1042 – General Condition of kerb and gutter

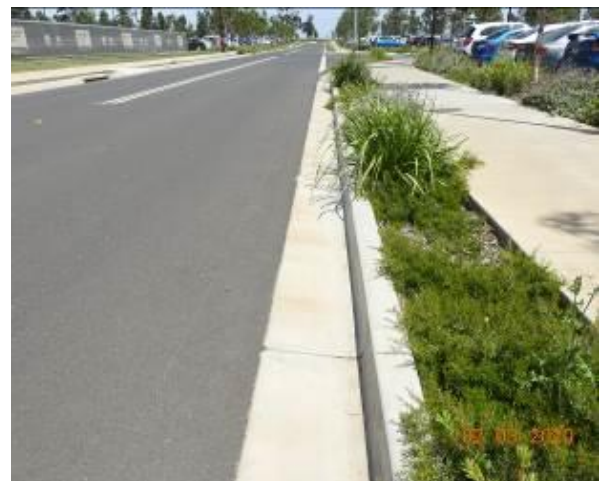
Figure 1043 – Crack propagation through kerb and gutter

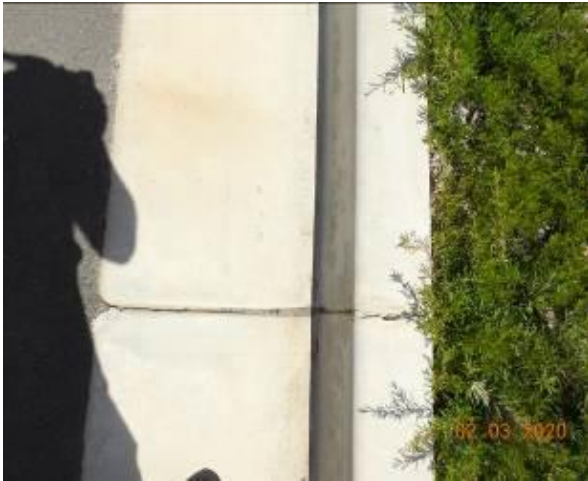
Figure 1044 – General Condition of kerb and gutter

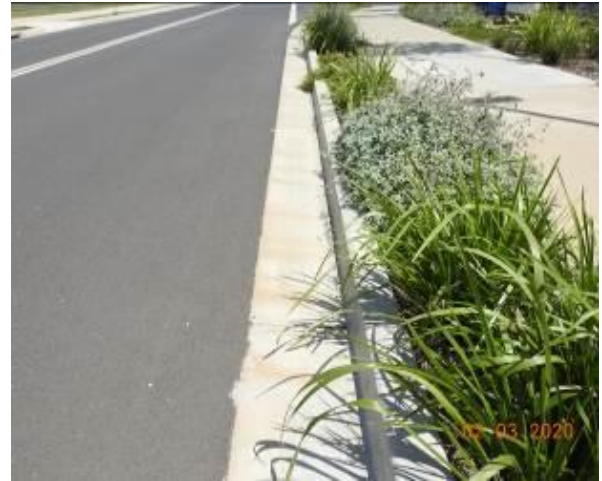
Figure 1045 – Crack propagation through kerb and gutter

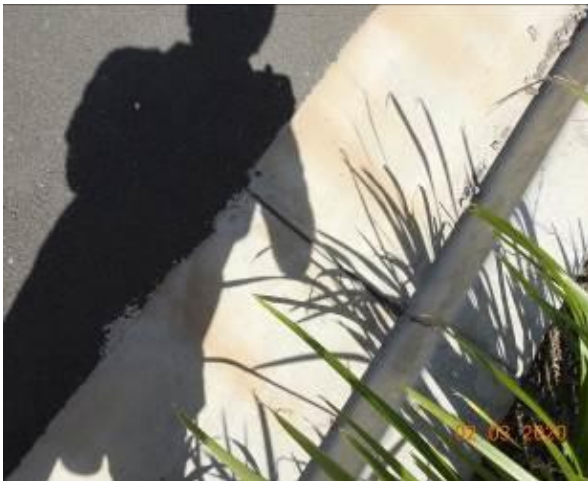
Figure 1046 – General Condition of kerb and gutter

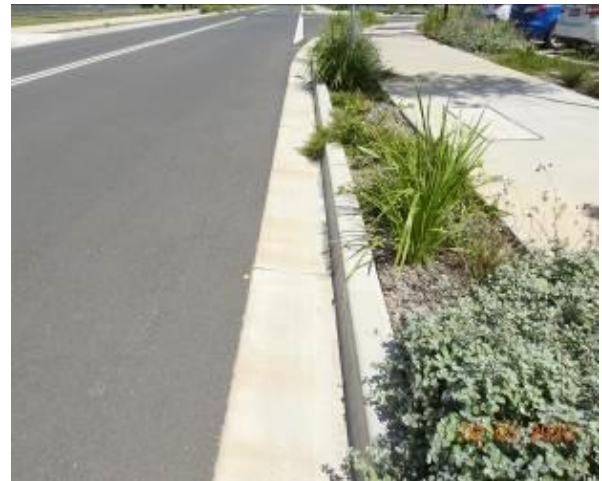
Figure 1047 – Crack propagation through kerb and gutter

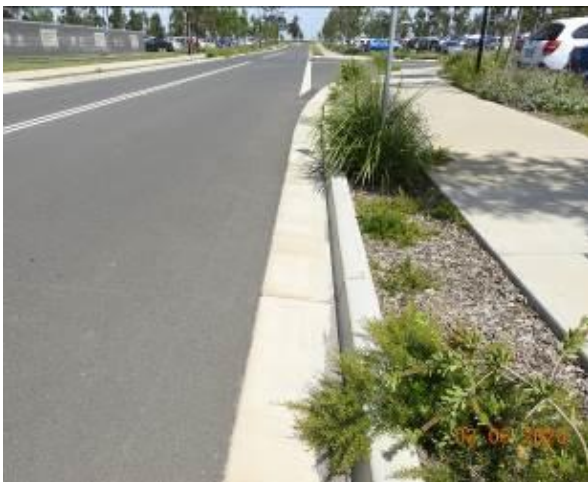
Figure 1048 – General Condition of kerb and gutter

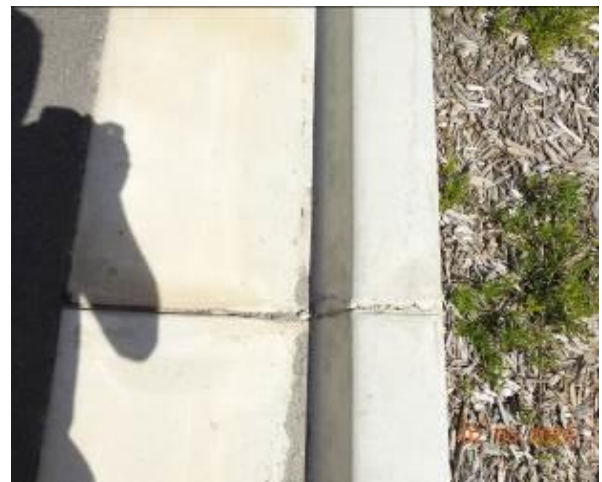
Figure 1049 – General Condition of kerb and gutter

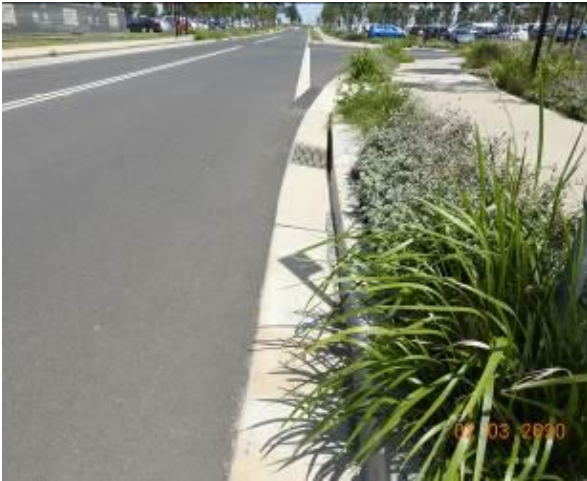
Figure 1050 – Crack propagation and loss of material through kerb and gutter

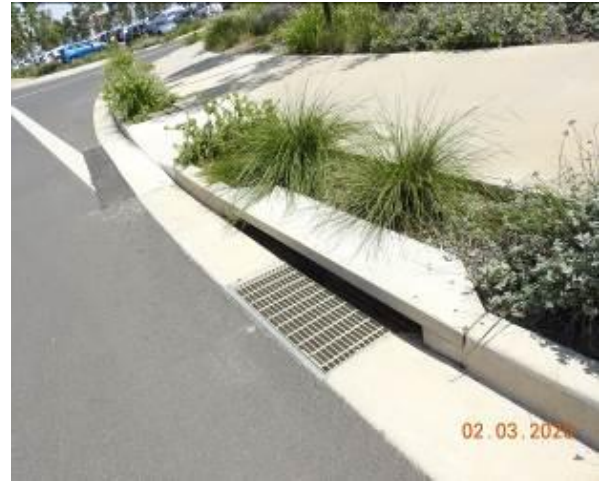
Figure 1051 – General Condition of kerb and gutter

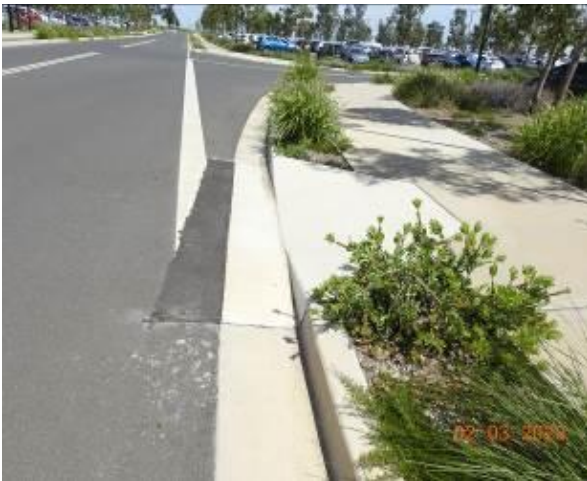
Figure 1052 – General Condition of stormwater inlet pit

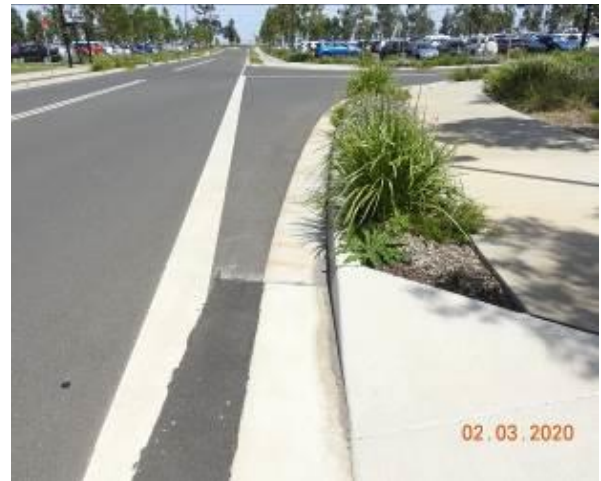
Figure 1053 – General Condition of kerb and gutter

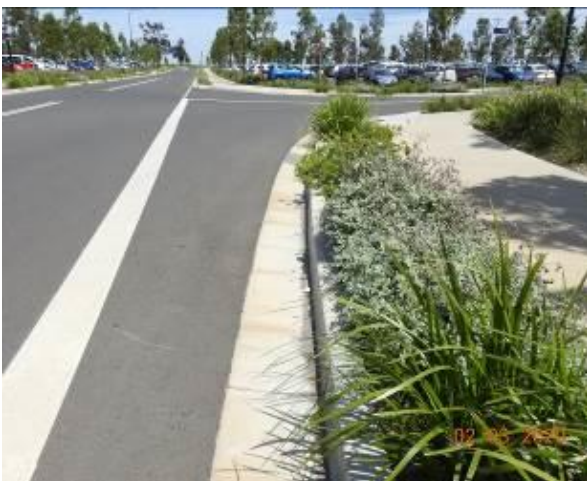
Figure 1054 – General Condition of kerb and gutter

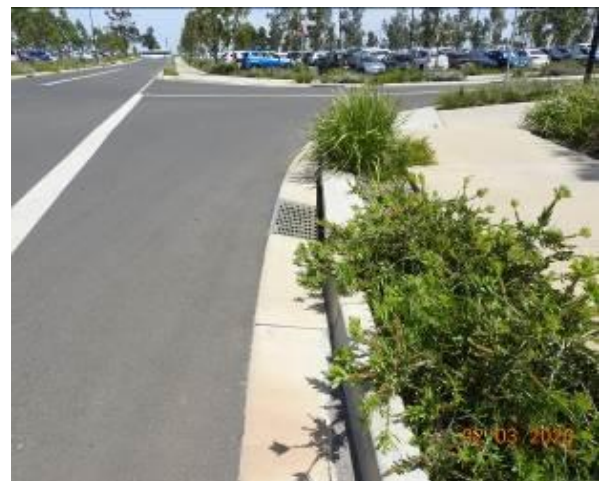
Figure 1055 – General Condition of kerb and gutter

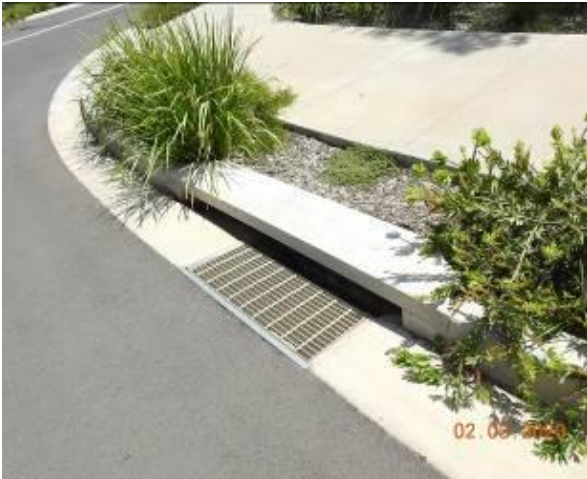
Figure 1056 – General Condition of kerb and gutter

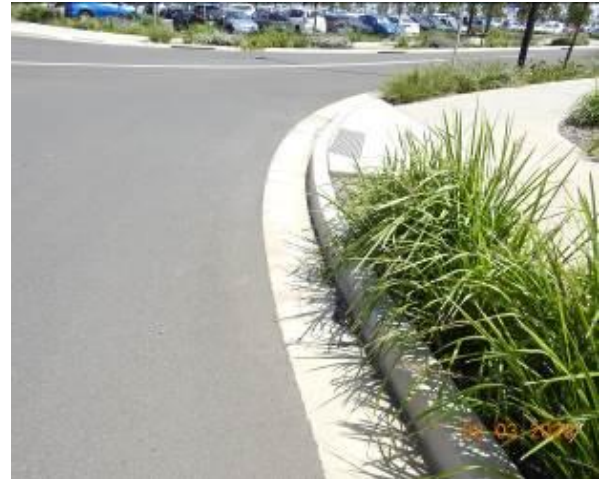
Figure 1057 – General Condition of stormwater inlet pit

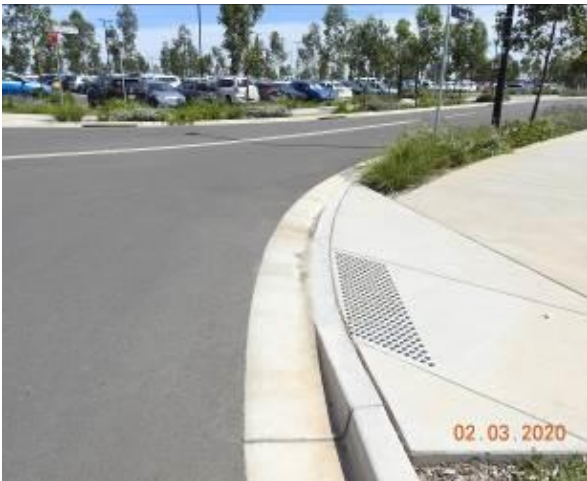
Figure 1058 – General Condition of kerb and gutter

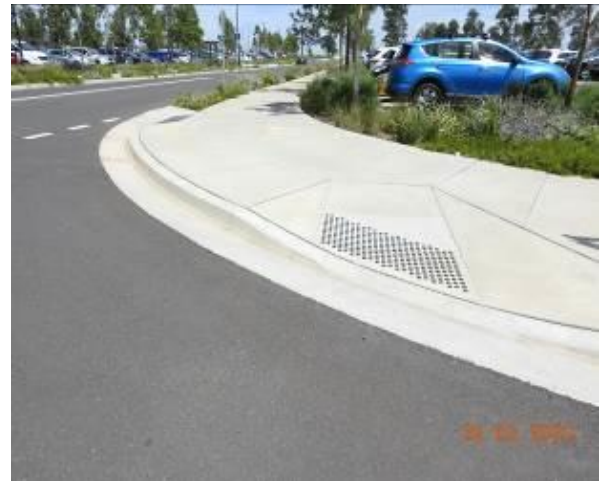
Figure 1059 – General Condition of kerb and gutter

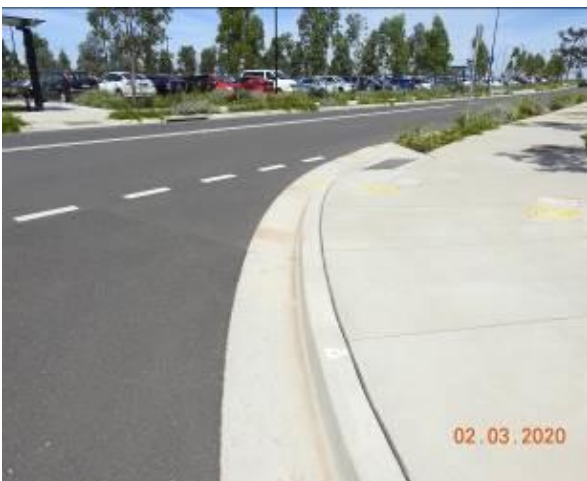
Figure 1060 – General Condition of kerb and gutter

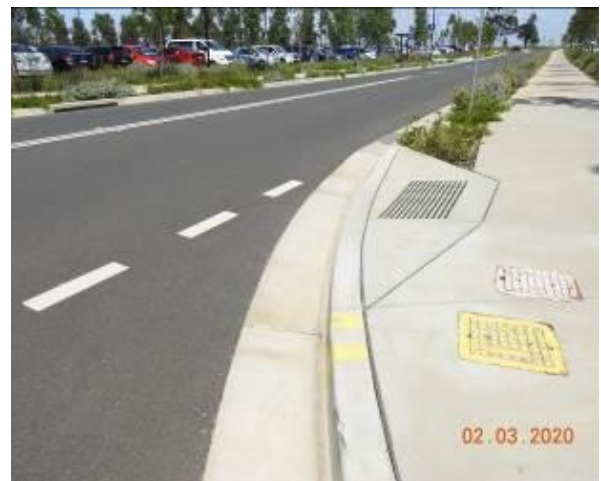
Figure 1061 – General Condition of kerb and gutter

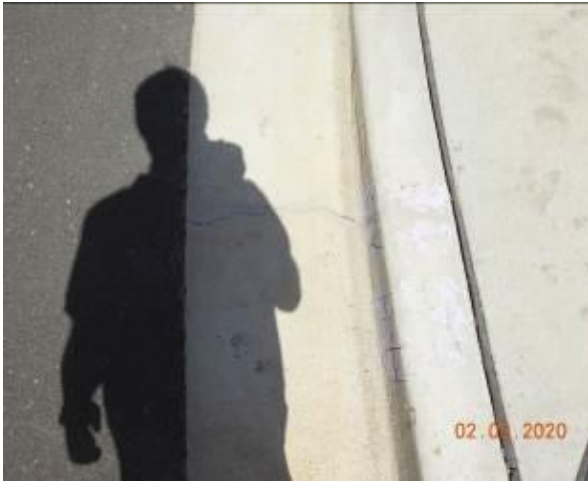
Figure 1062 – General Condition of kerb and gutter

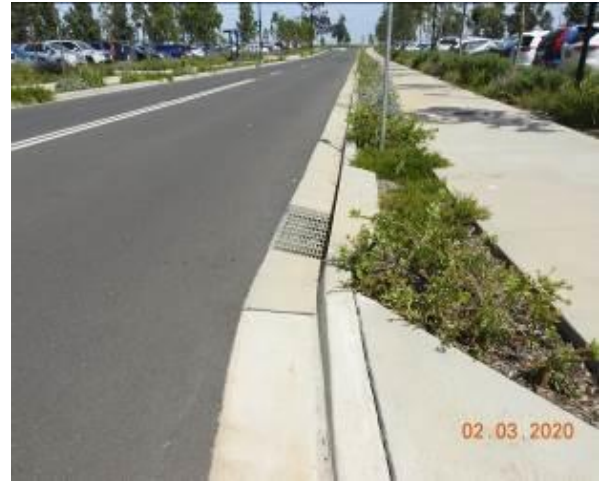
Figure 1063 – Crack propagation through gutter

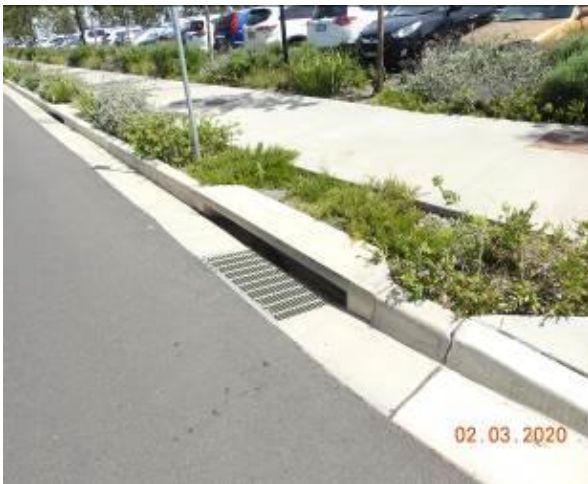
Figure 1064 – General Condition of kerb and gutter

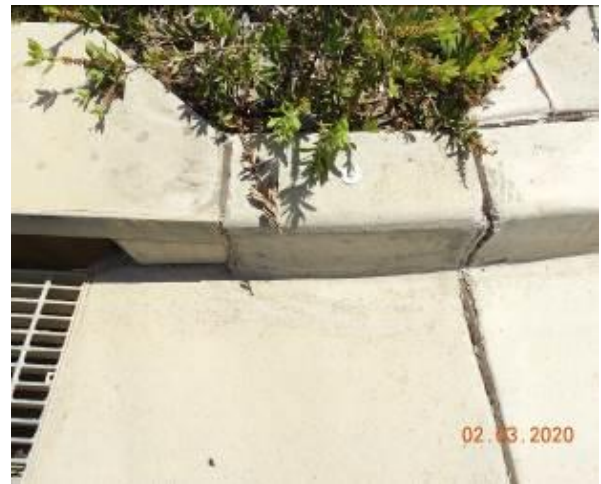
Figure 1065 – General Condition of stormwater inlet pit

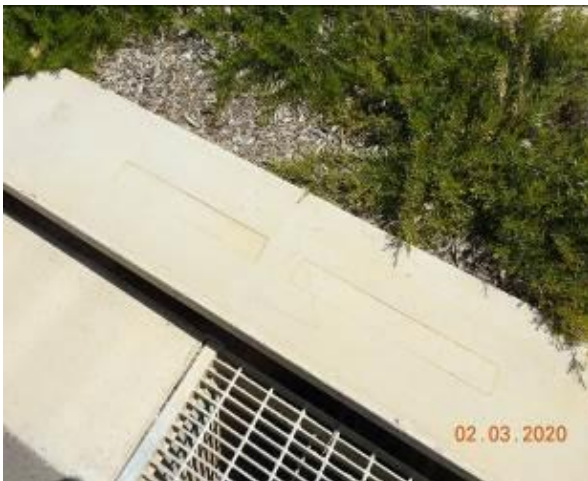
Figure 1066 – Crack propagation through stormwater inlet pit

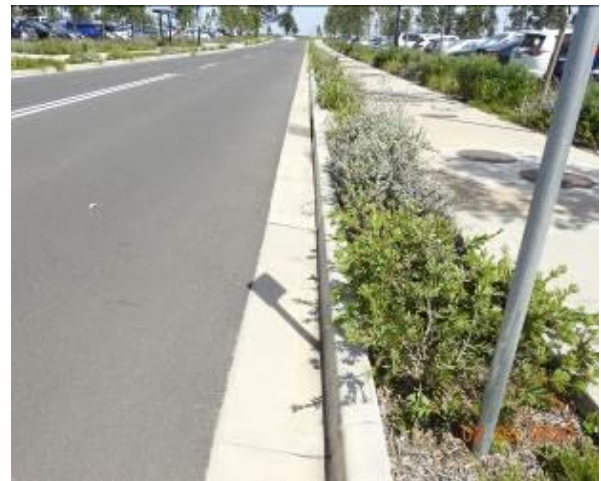
Figure 1067 – Loss of material through stormwater inlet pit

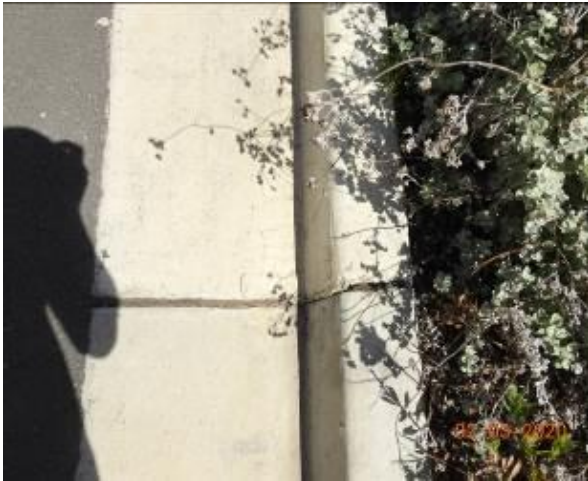
Figure 1068 – General Condition of kerb and gutter

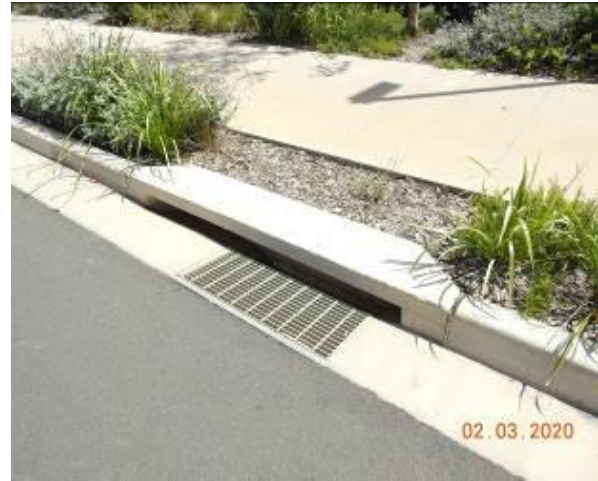
Figure 1069 – Crack propagation through kerb and gutter

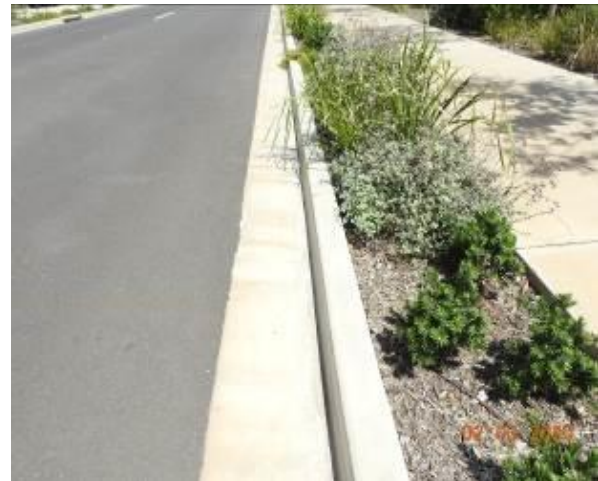
Figure 1071 – General Condition of kerb and gutter

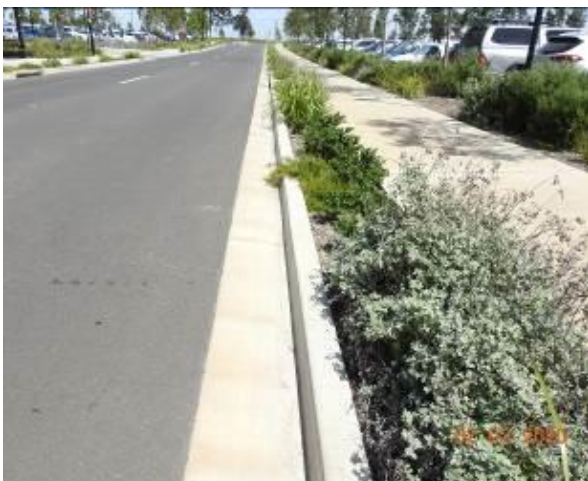
Figure 1072 – General Condition of kerb and gutter

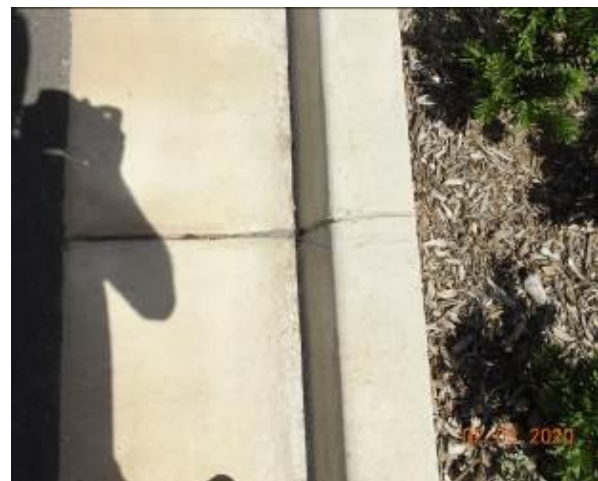
Figure 1073 – General Condition of kerb and gutter

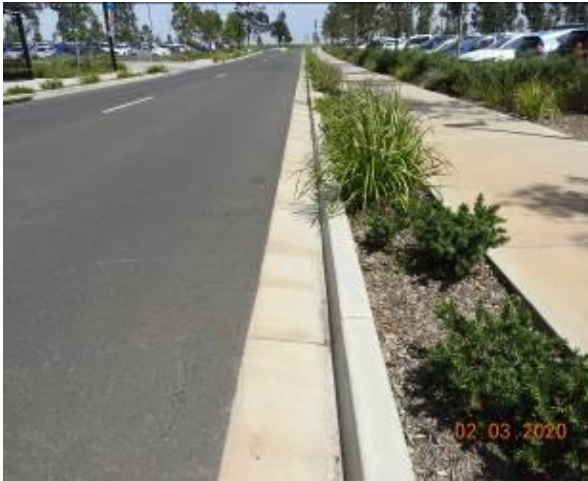
Figure 1074 – Crack propagation through kerb

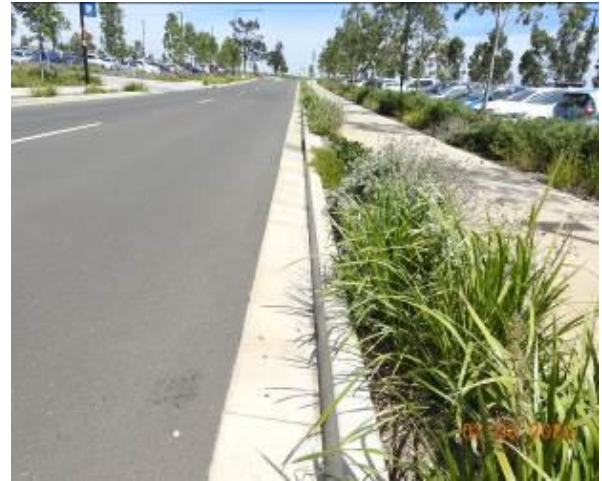
Figure 1075 – General Condition of kerb and gutter

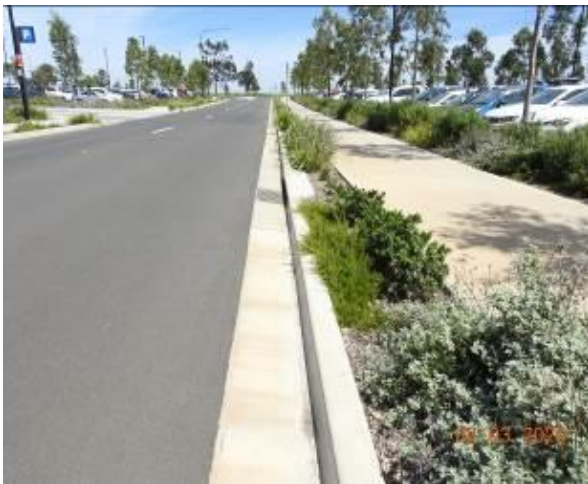
Figure 1076 – General Condition of kerb and gutter

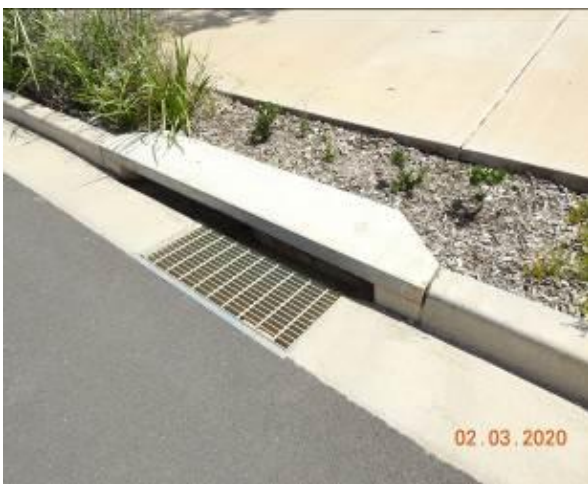
Figure 1078 – General Condition of kerb and gutter

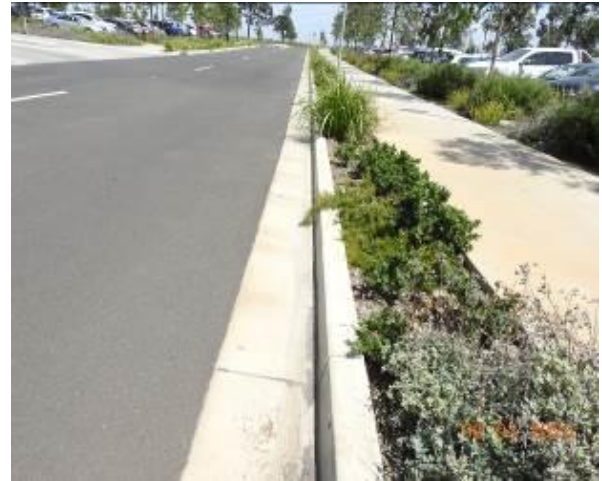
Figure 1081 – Loss of material through kerb

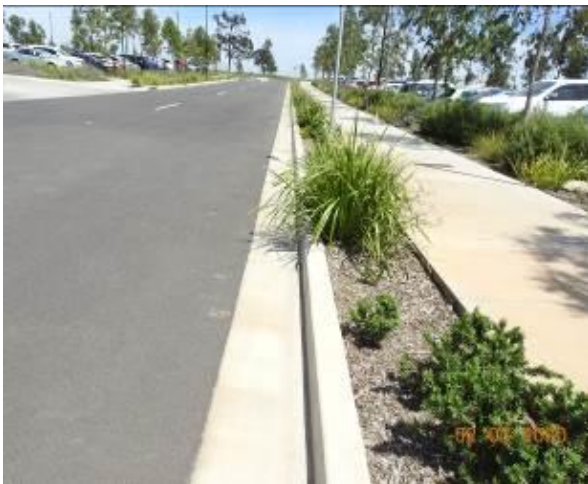
Figure 1082 – General Condition of kerb and gutter

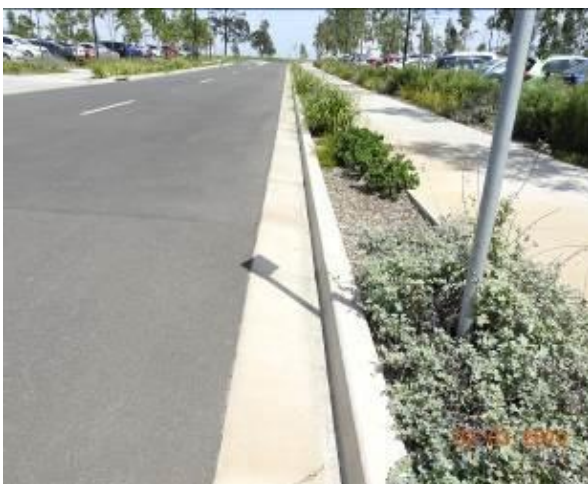
Figure 1084 – General Condition of kerb and gutter

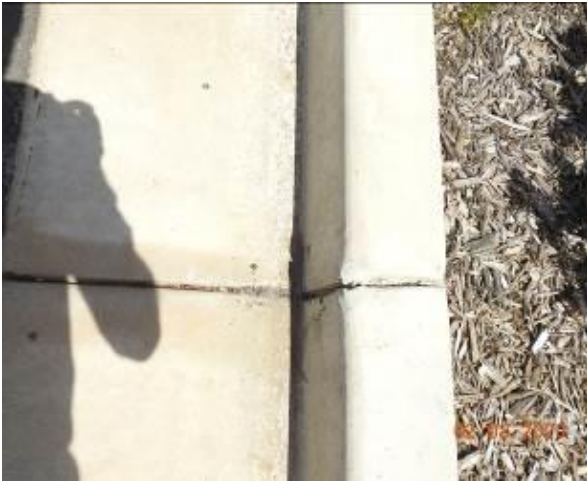
Figure 1086 – General Condition of kerb and gutter

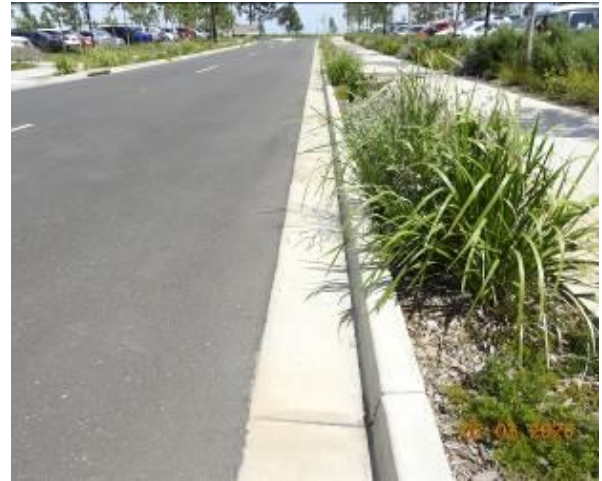
Figure 1087 – Crack propagation through kerb
