**1-15 AND 2-12 CONFERTA AVENUE,  
ROUSE HILL NSW 2155  
TALLAWONG STATION PRECINCT SOUTH  
PRE-DILAPIDATION REPORT**

**DEICORP PROJECTS  
(TALLAWONG STATION) PTY LTD**

Job No. 191294.0  
05/07/2021

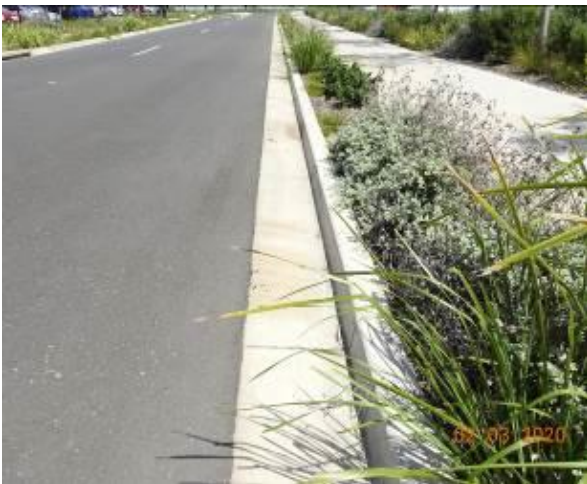
Figure 1088 – General Condition of kerb and gutter

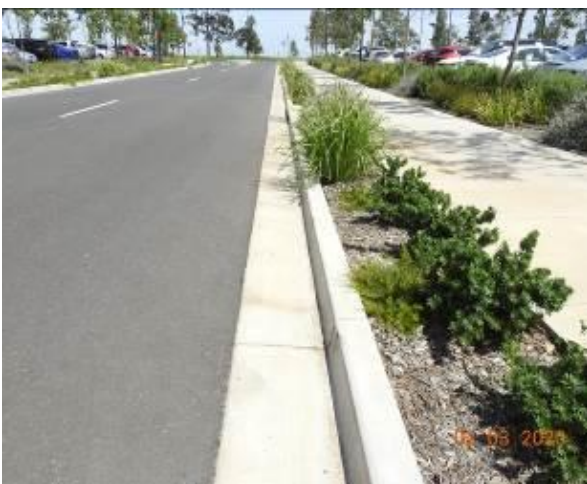
Figure 1090 – General Condition of kerb and gutter

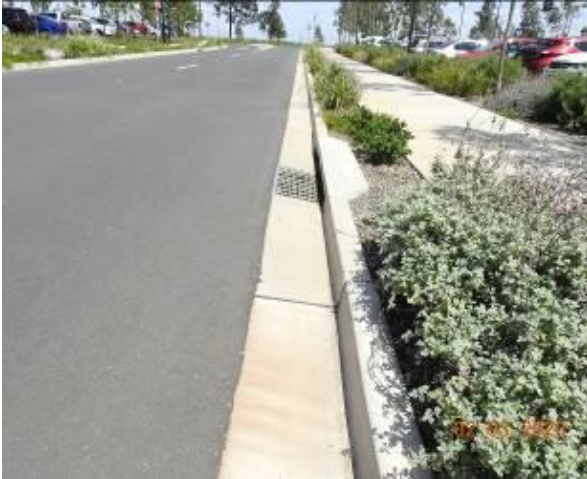
Figure 1092 – General Condition of kerb and gutter

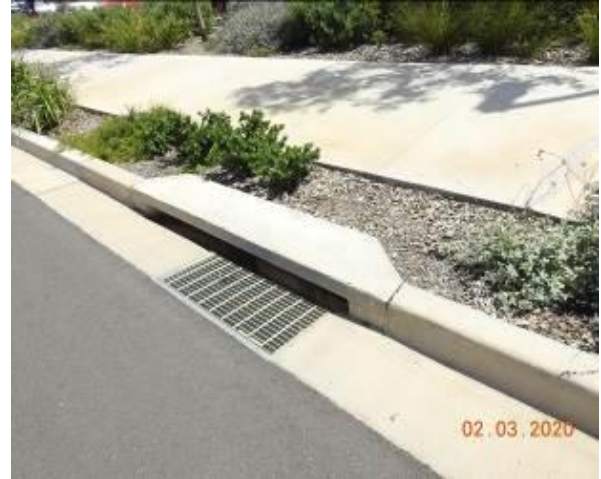
Figure 1093 – General Condition of kerb and gutter

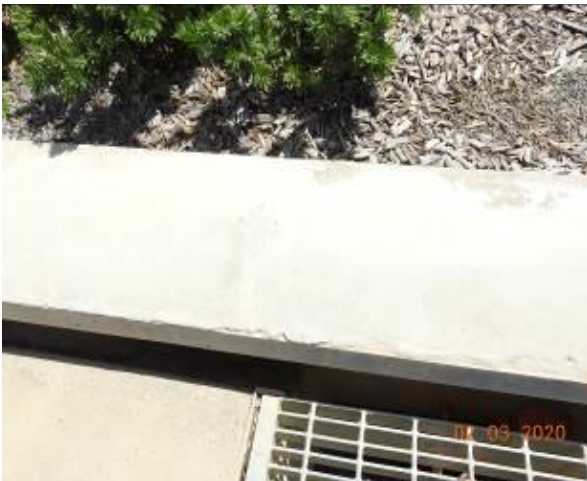
Figure 1094 – General Condition of stormwater inlet pit

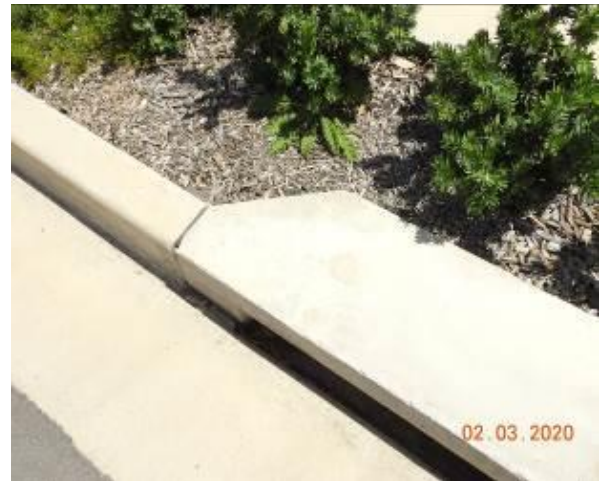
Figure 1095 – Crack propagation through stormwater inlet pit

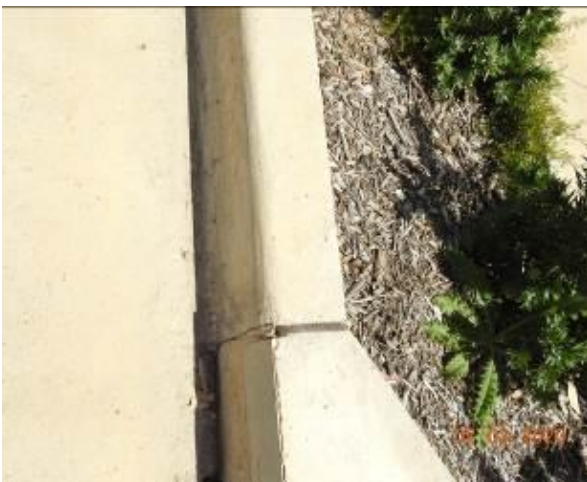
Figure 1096 – Crack propagation through stormwater inlet pit

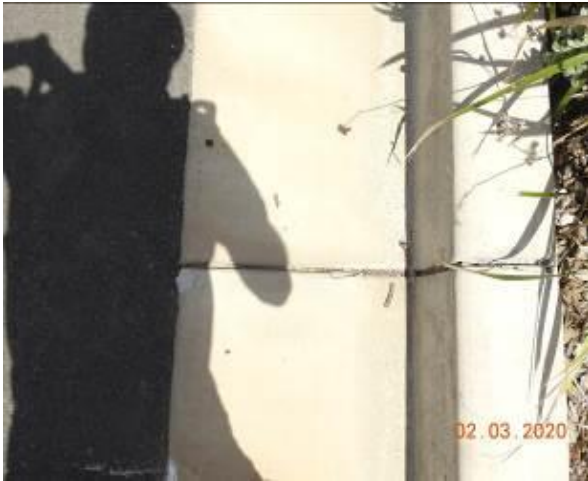
Figure 1098 – General Condition of kerb and gutter

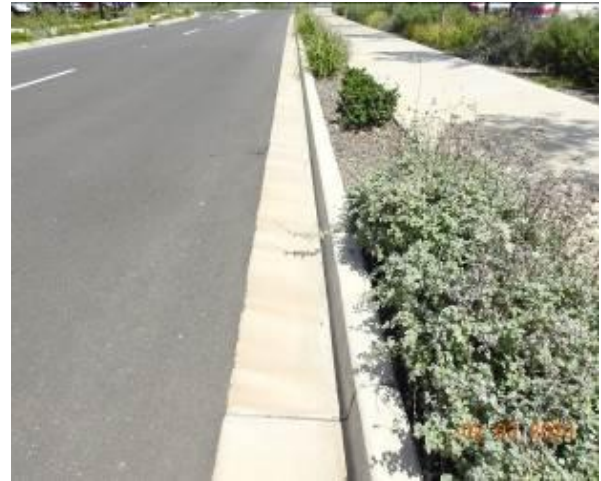
Figure 1099 – Crack propagation through kerb and gutter

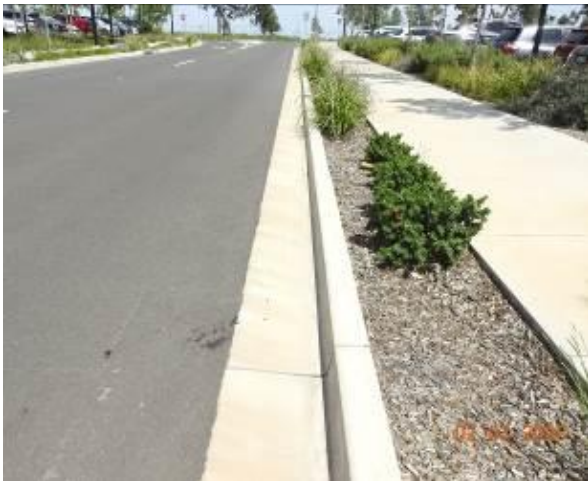
Figure 1100 – General Condition of kerb and gutter

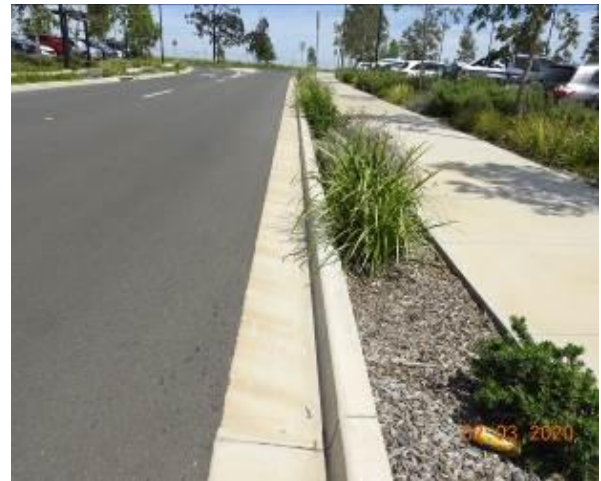
Figure 1101 – General Condition of kerb and gutter

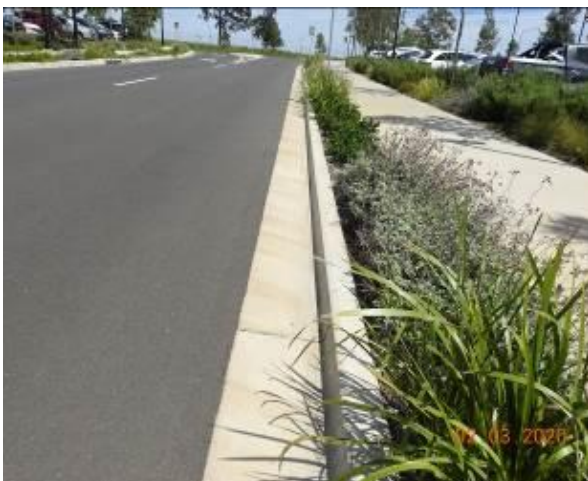
Figure 1102 – General Condition of kerb and gutter

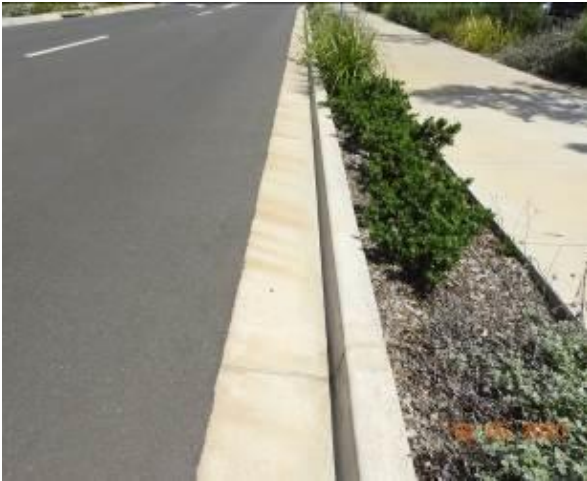
Figure 1104 – Crack propagation through kerb and gutter

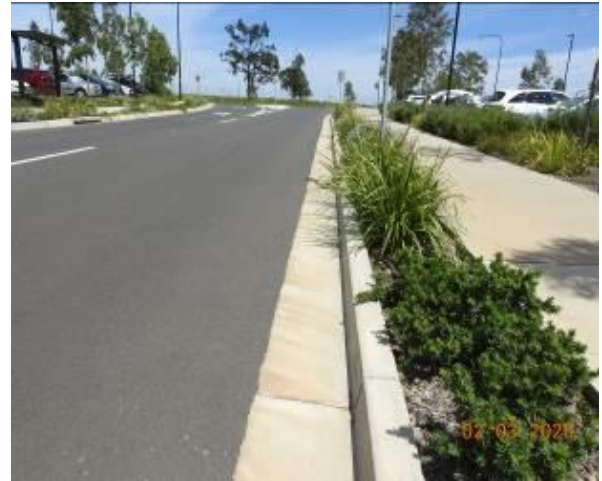
Figure 1105 – General Condition of kerb and gutter

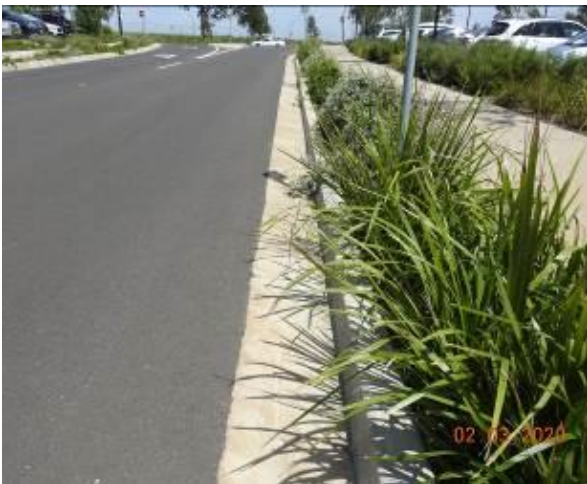
Figure 1106 – General Condition of kerb and gutter

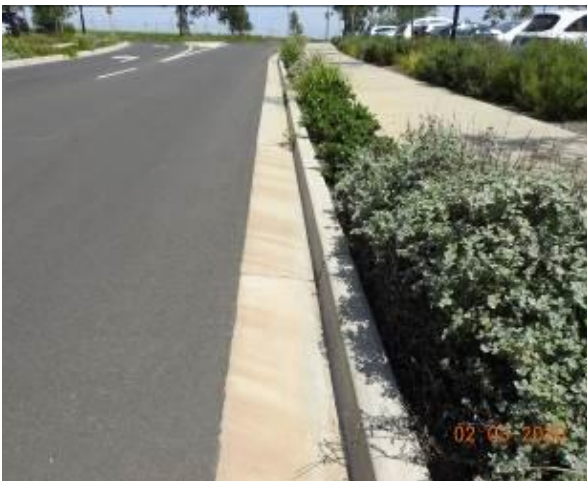
Figure 1108 – Crack propagation through kerb and gutter

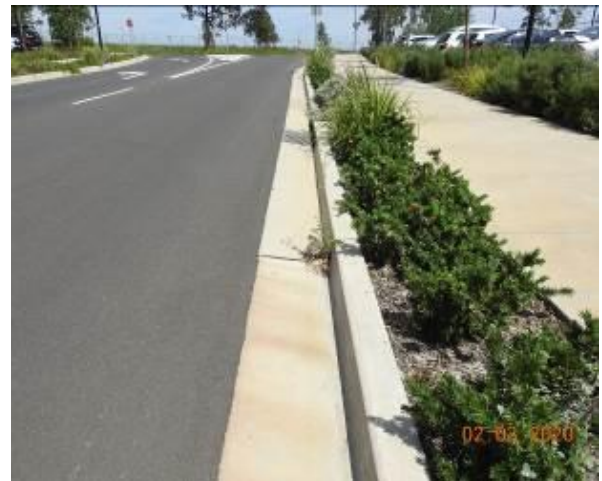
Figure 1109 – General Condition of kerb and gutter

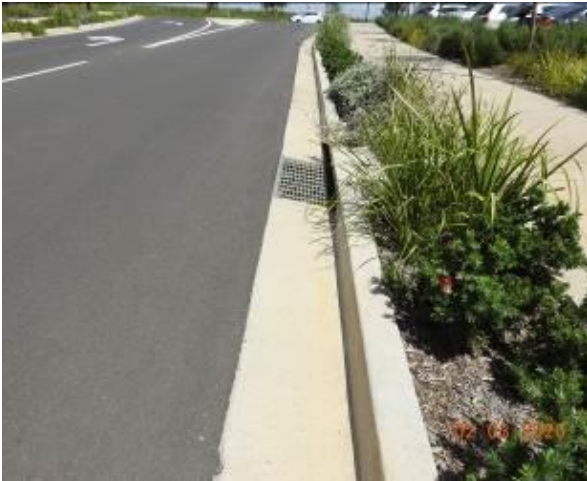
Figure 1110 – General Condition of kerb and gutter

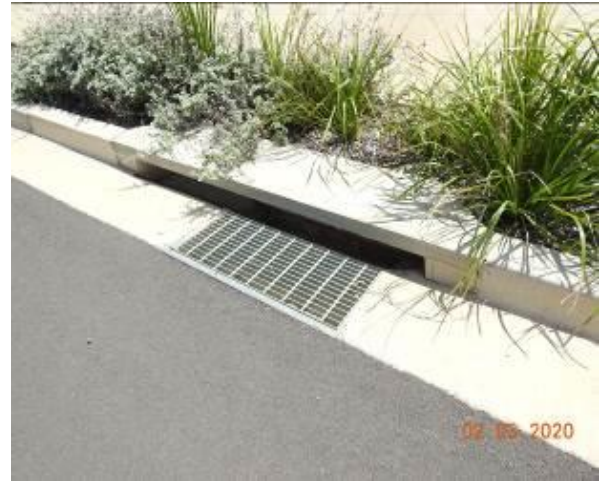
Figure 1111 – General Condition of kerb and gutter

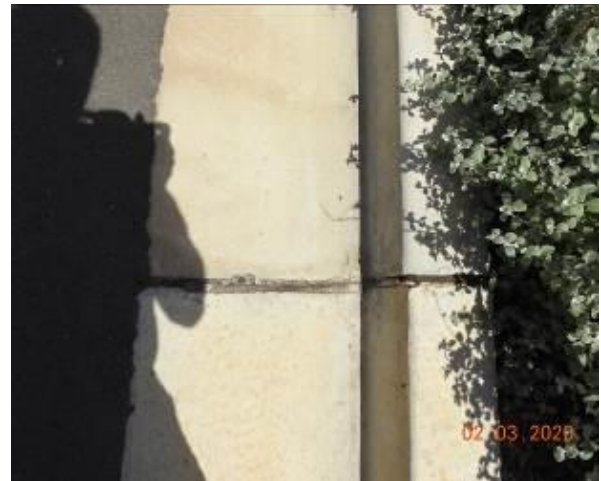
Figure 1113 – General Condition of kerb and gutter

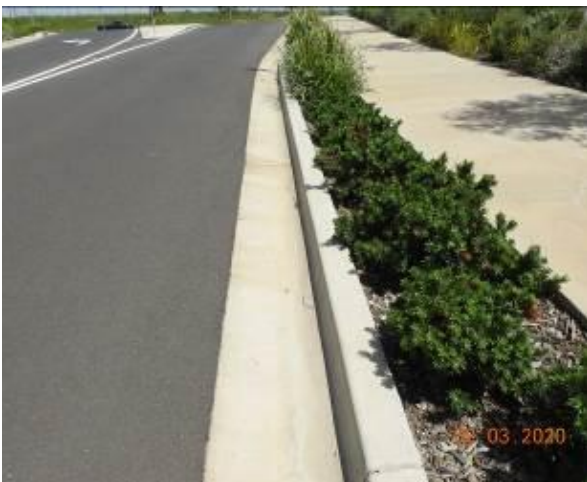
Figure 1114 – Crack propagation through kerb and gutter

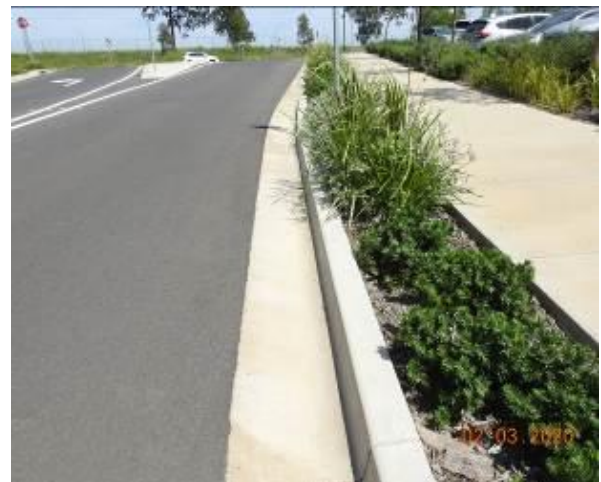
Figure 1115 – General Condition of kerb and gutter

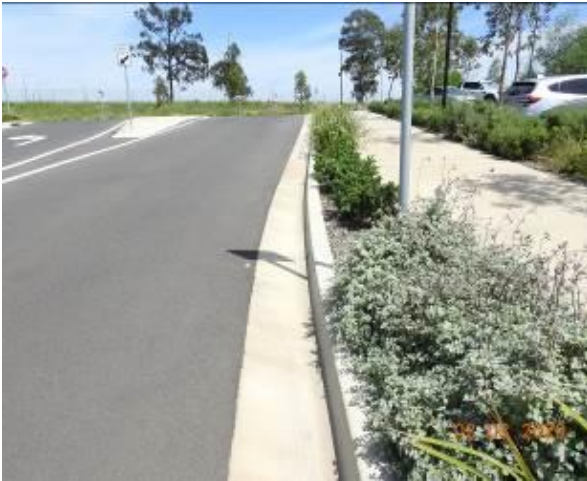
Figure 1116 – General Condition of kerb and gutter

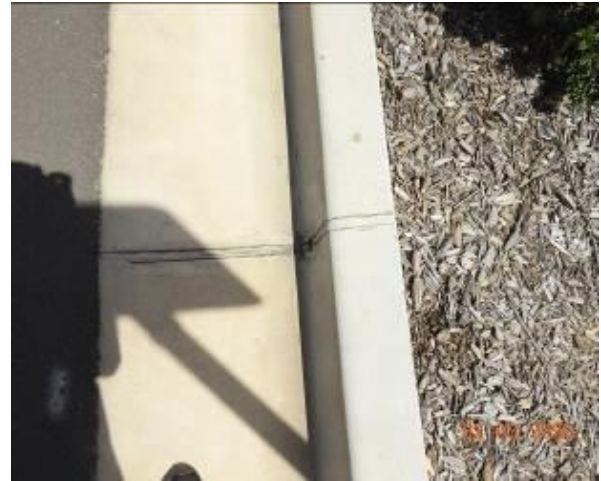
Figure 1117 – General Condition of kerb and gutter

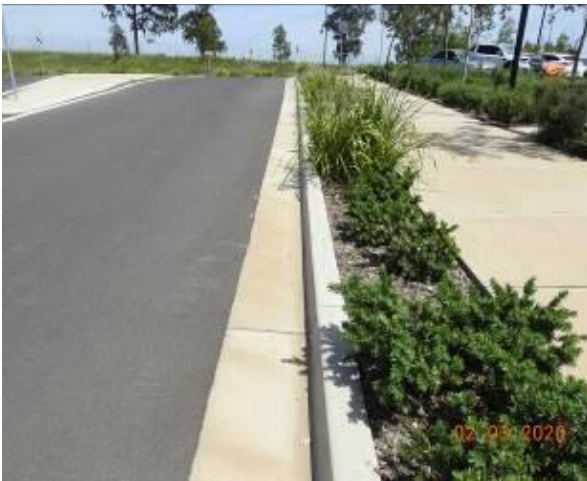
Figure 1118 – Crack propagation through kerb and gutter

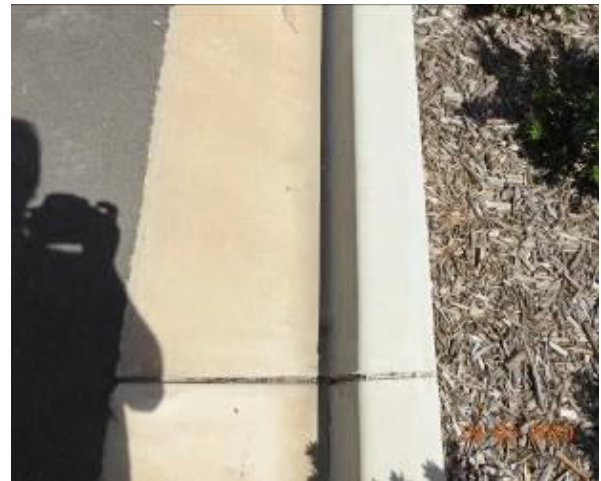
Figure 1119 – General Condition of kerb and gutter

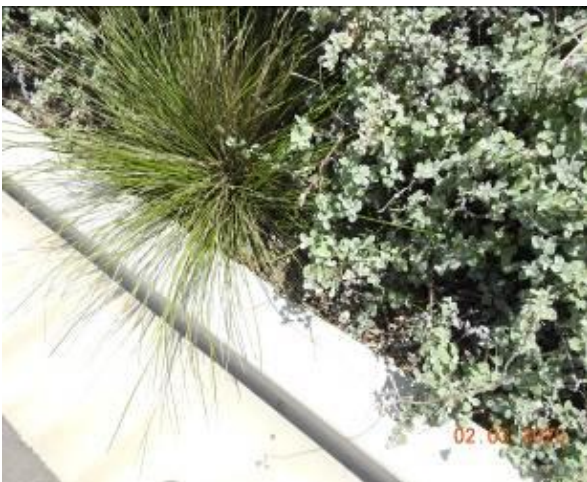
Figure 1120 – Crack propagation through kerb and gutter

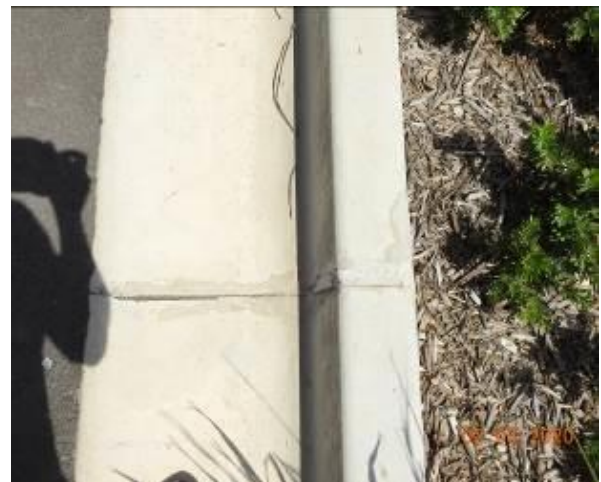
Figure 1121 – General Condition of kerb and gutter

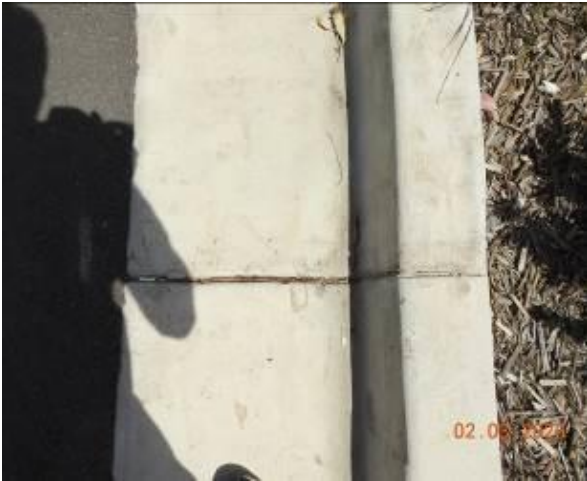
Figure 1122 – Crack propagation and loss of material through kerb and gutter

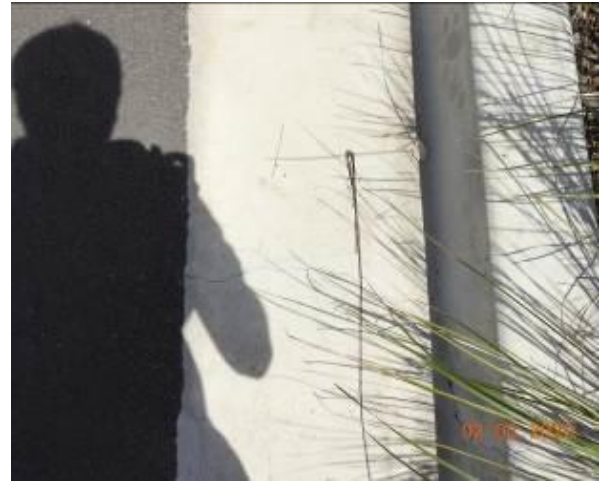
Figure 1123 – Crack propagation through kerb and gutter

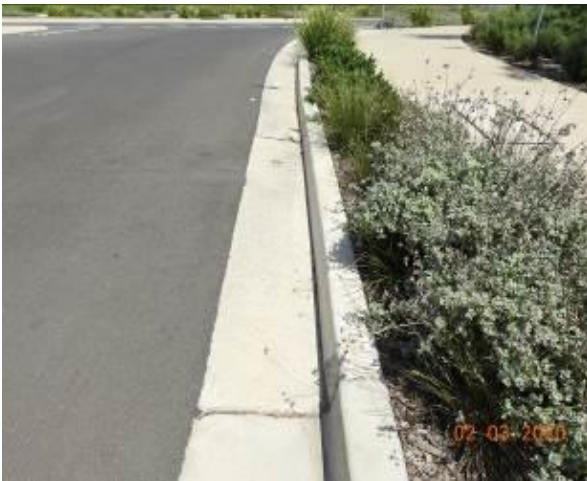
Figure 1124 – Crack propagation through kerb and gutter

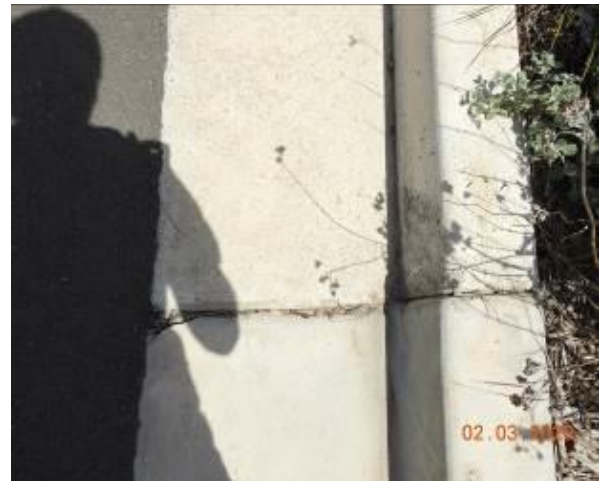
Figure 1125 – General Condition of kerb and gutter

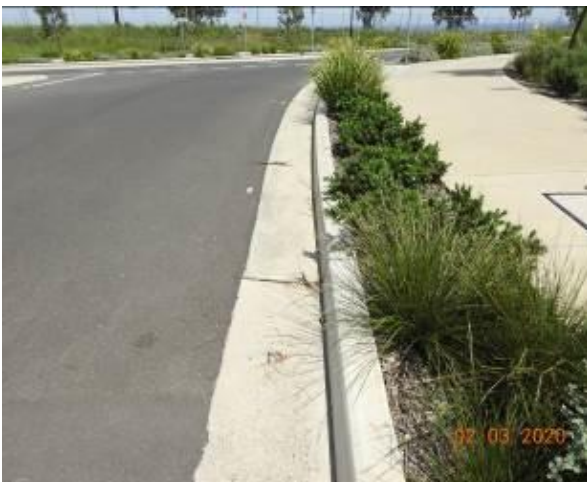
Figure 1126 – Crack propagation and loss of material through kerb and gutter

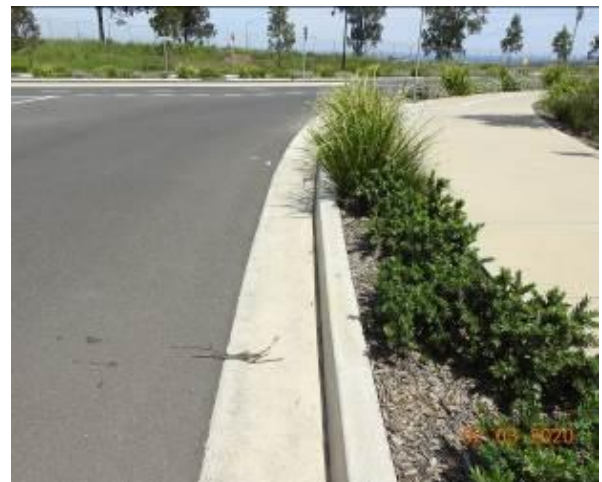
Figure 1127 – General Condition of kerb and gutter

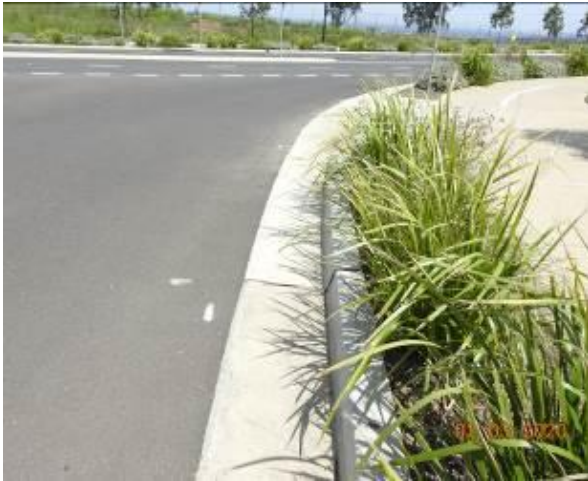
Figure 1128 – General Condition of kerb and gutter

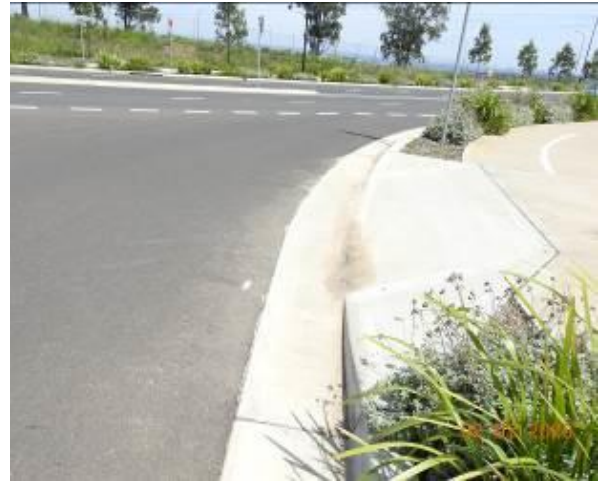
Figure 1129 – General Condition of kerb and gutter

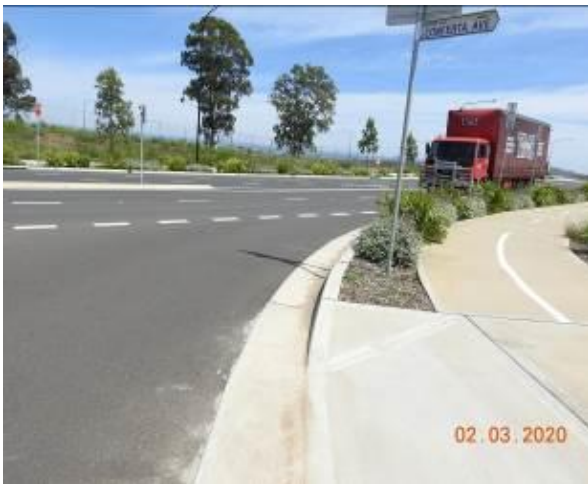
Figure 1130 – General Condition of kerb and gutter

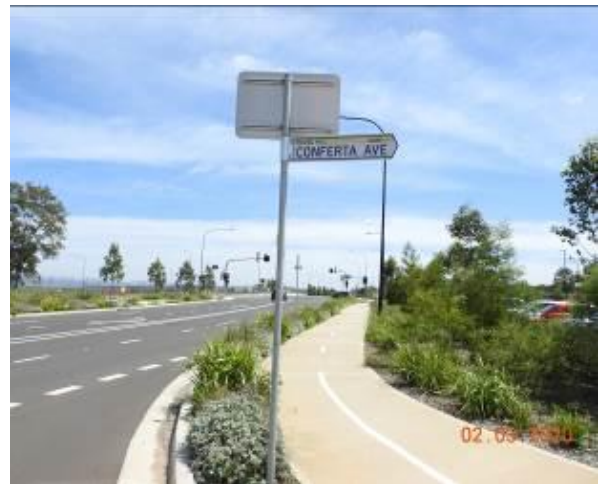
Figure 1131 – General Condition of kerb and gutter

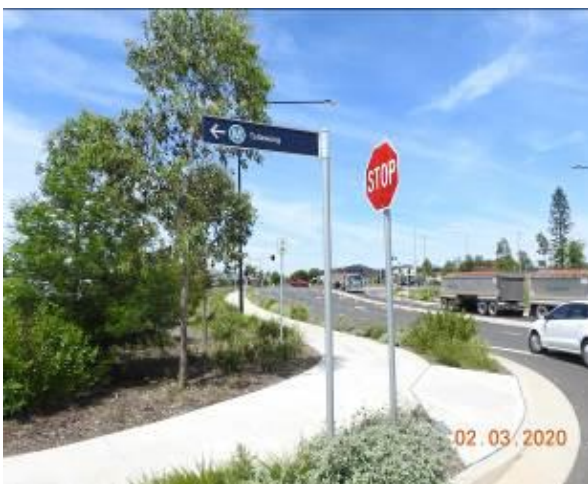
Figure 1132 – General Condition of street sign

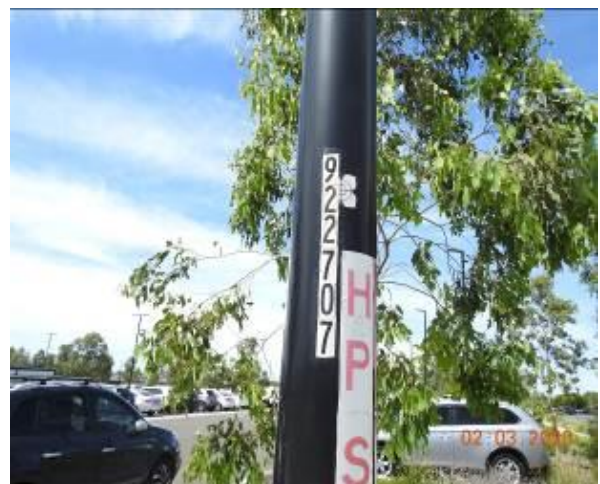
Figure 1133 – General Condition of street sign

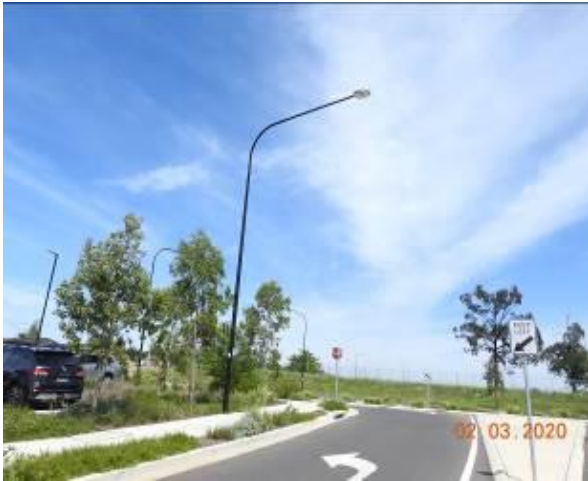
Figure 1134 – General Condition of lamp post  
Identification N.922707

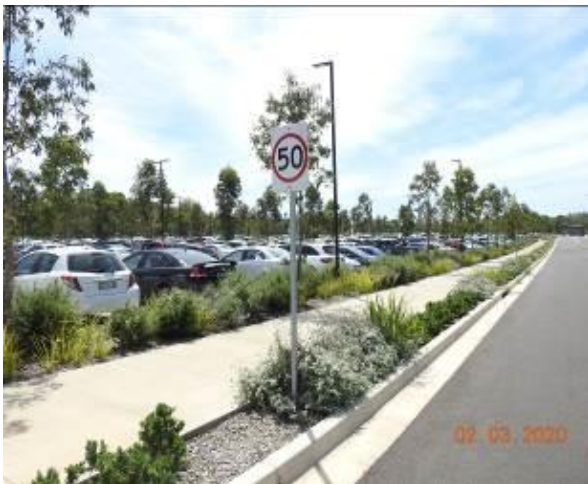
Figure 1136 – General Condition of street sign

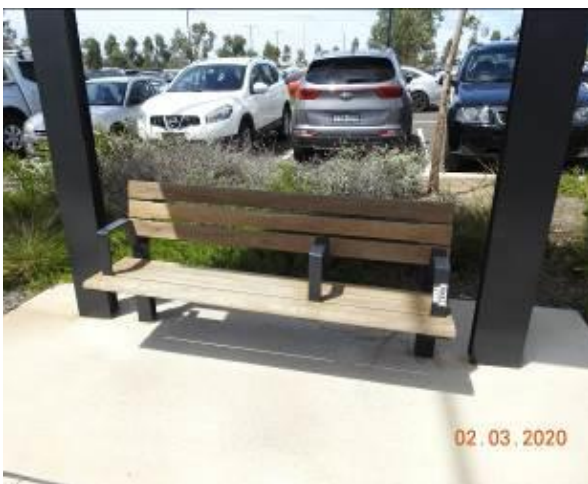
Figure 1138 – General Condition of public bench

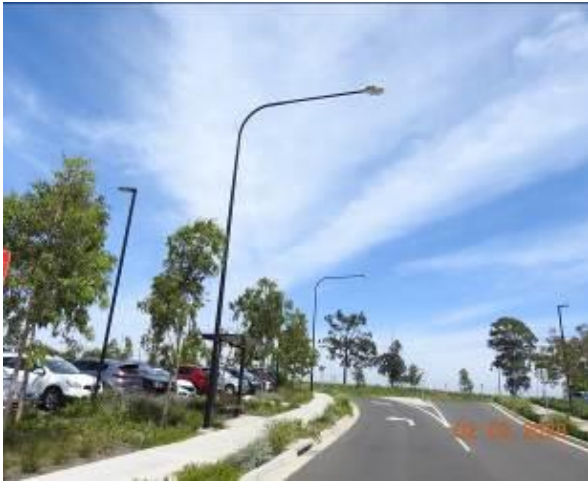
Figure 1140 – General Condition of lamp post  
Identification N.922706

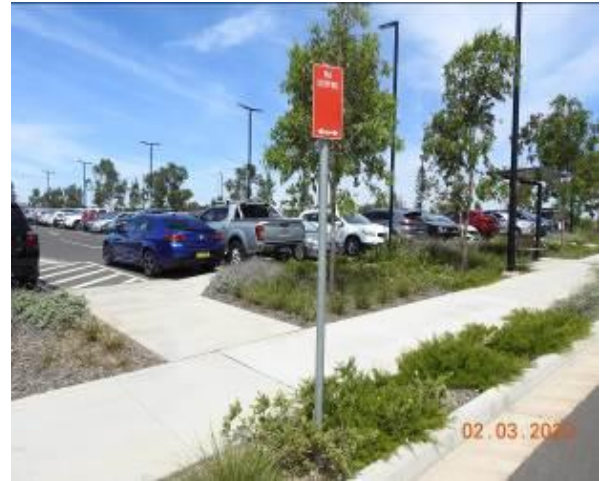
Figure 1141 – General Condition of lamp post

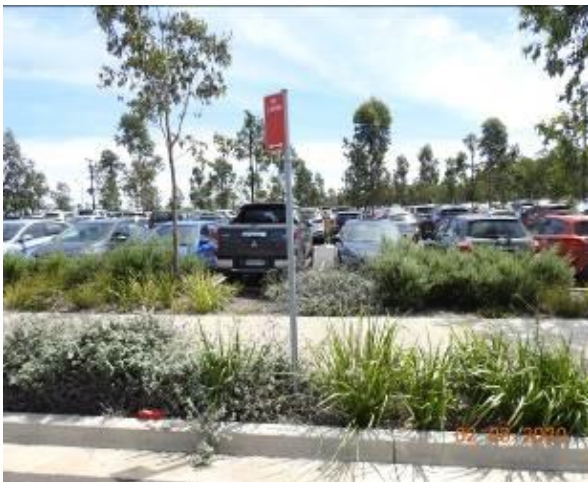
Figure 1142 – General Condition of street sign

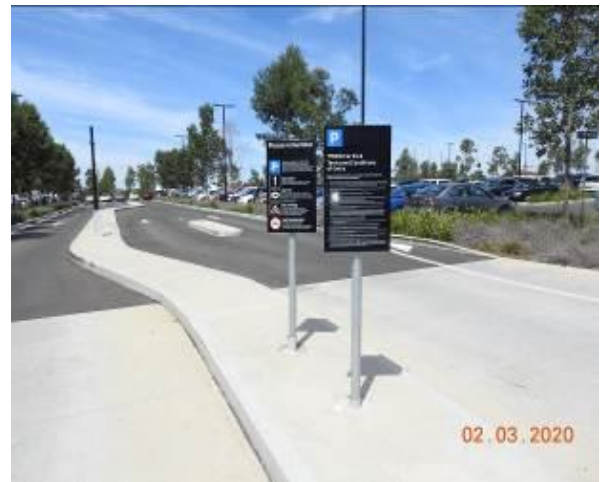
Figure 1143 – General Condition of street sign

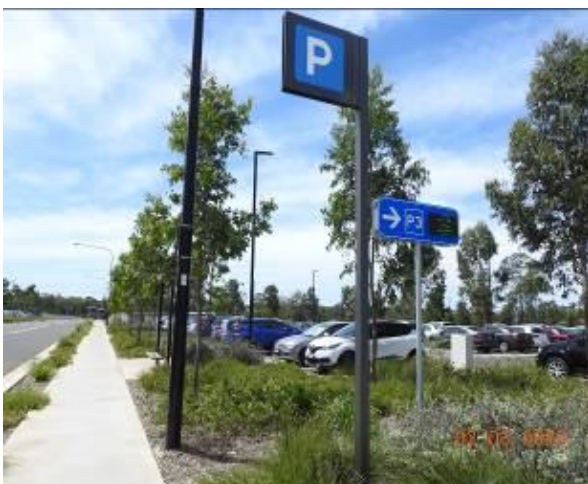
Figure 1144 – General Condition of street sign

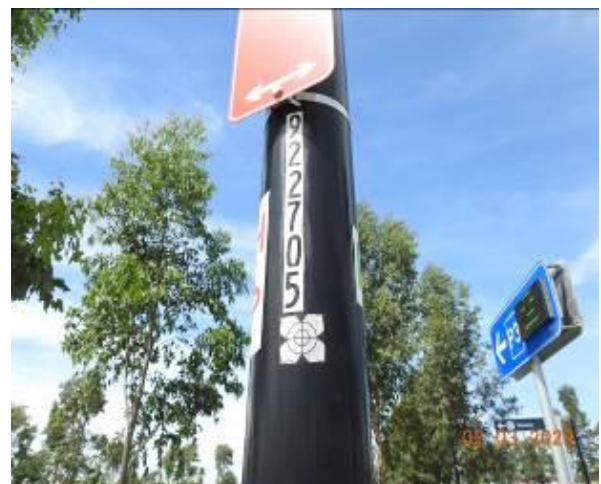
Figure 1145 – General Condition of street sign

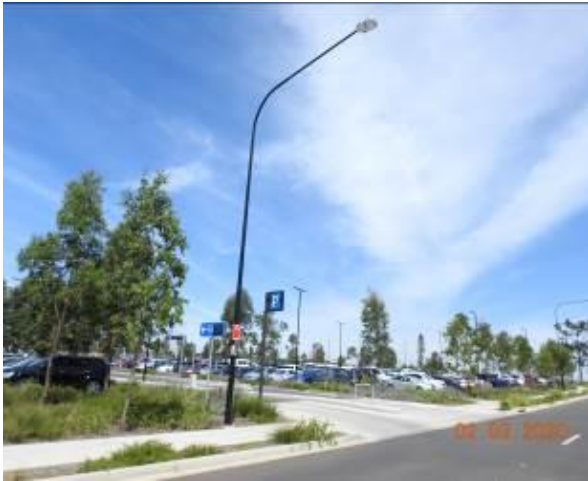
Figure 1146 – General Condition of lamp post  
Identification N.922705

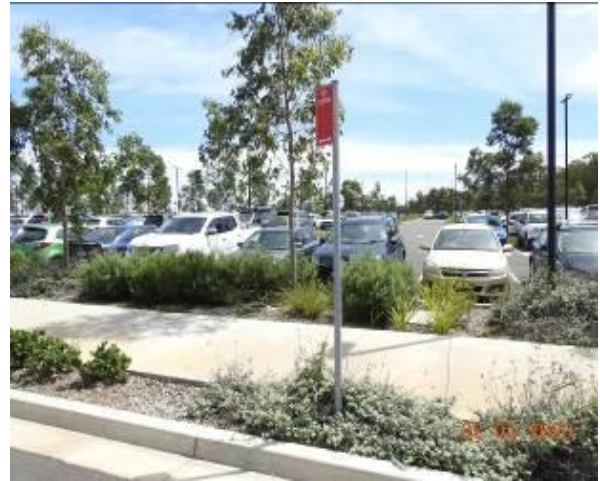
Figure 1147 – General Condition of lamp post

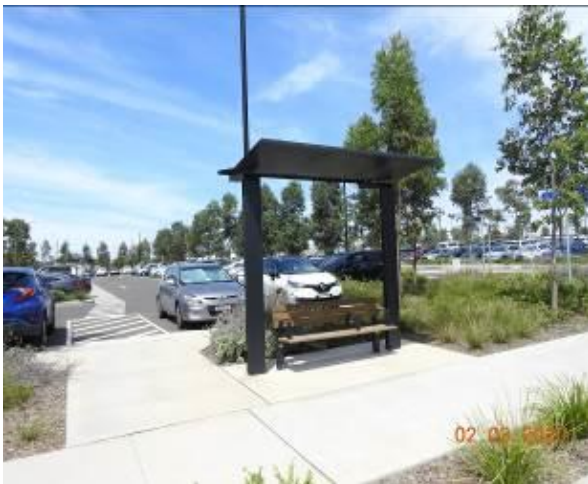
Figure 1148 – General Condition of street sign

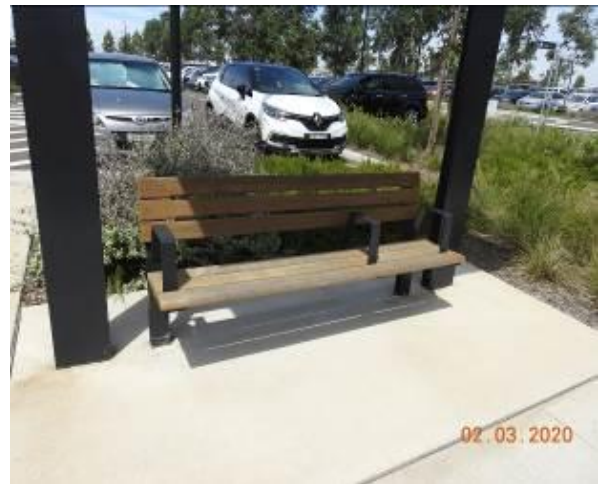
Figure 1149 – General Condition of public bench

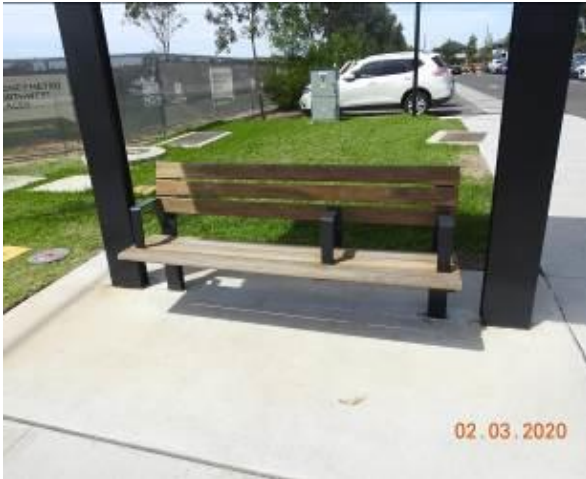
Figure 1152 – General Condition of public bench

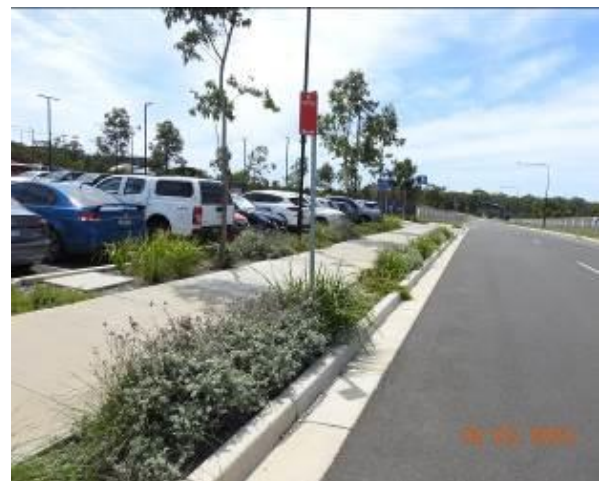
Figure 1157 – General Condition of street sign

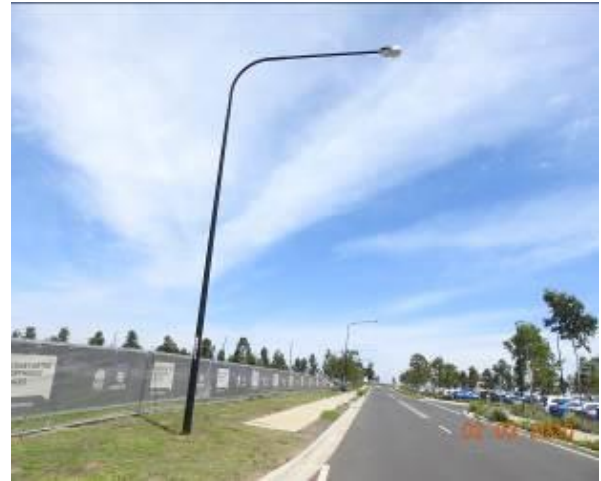
Figure 1159 – General Condition of lamp post  
Identification N.922708

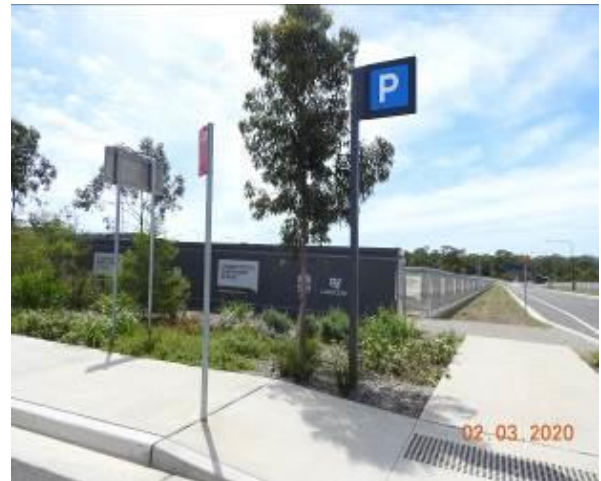
Figure 1161 – General Condition of street sign

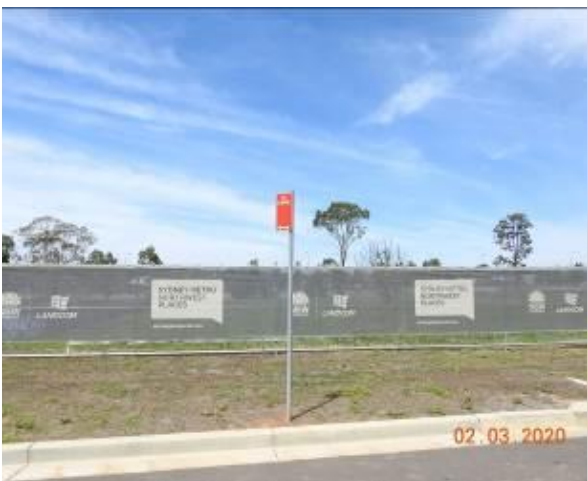
Figure 1162 – General Condition of street sign

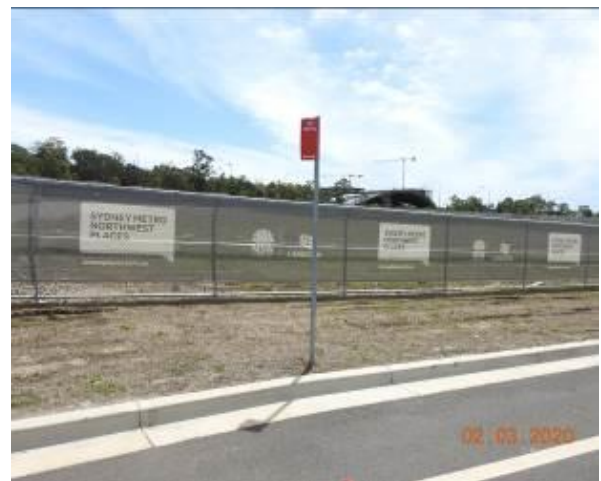
Figure 1163 – General Condition of street sign

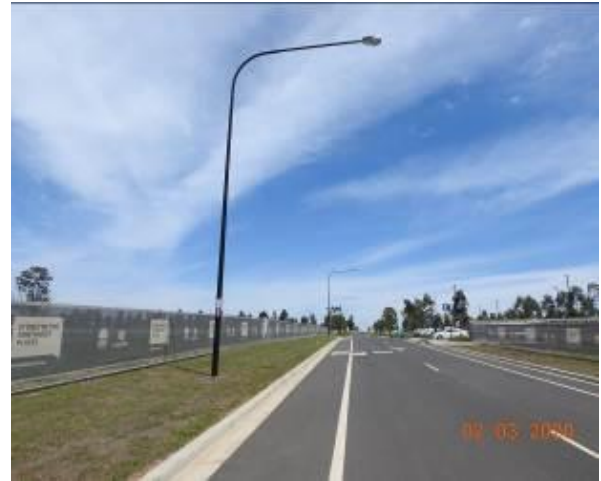
Figure 1165 – General Condition of lamp post  
Identification N.922709

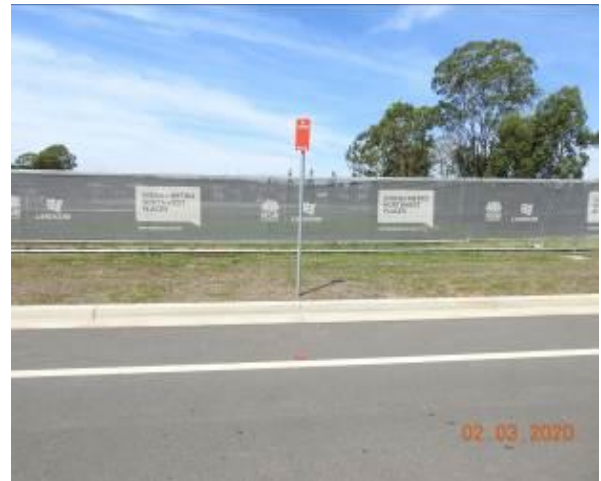
Figure 1167 – General Condition of street sign

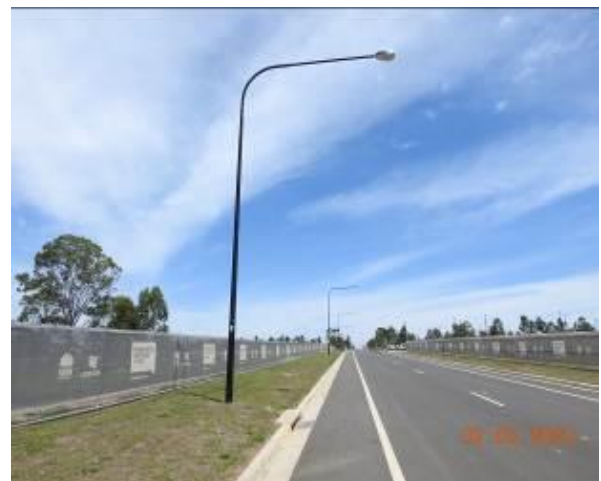
Figure 1169 – General Condition of lamp post  
Identification N.922710

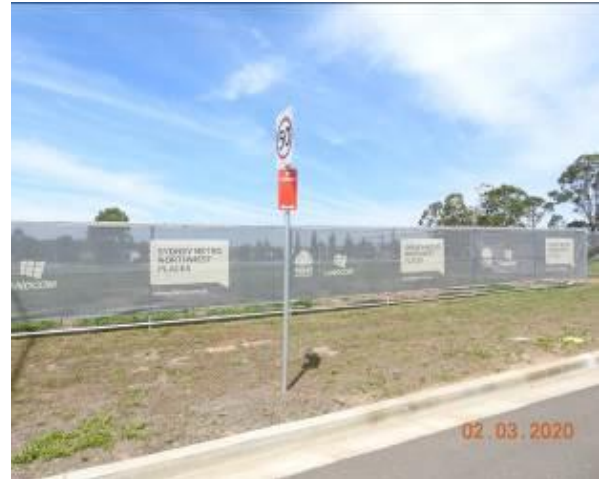
Figure 1171 – General Condition of street sign

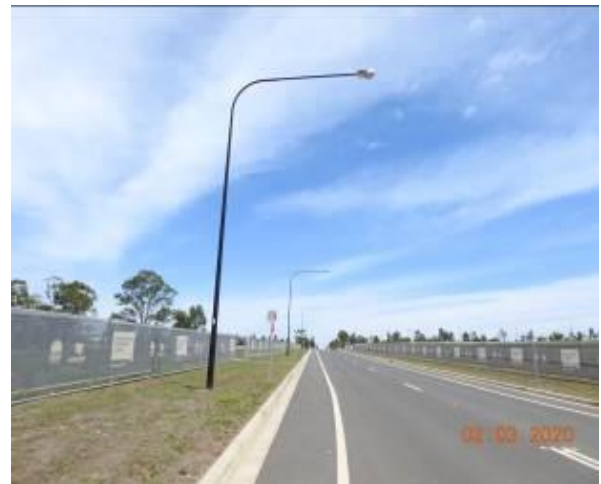
Figure 1173 – General Condition of lamp post  
Identification N.922711

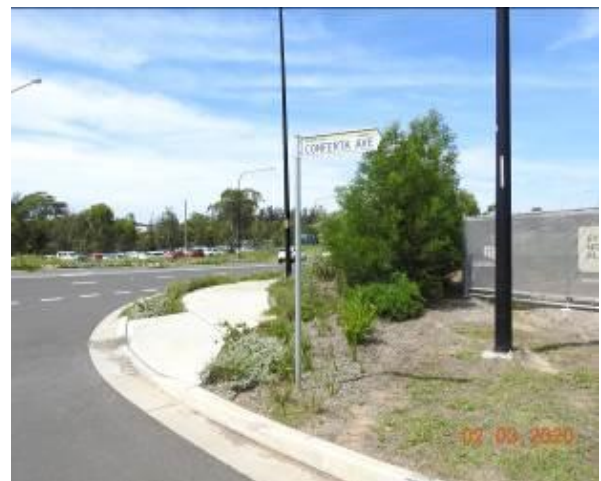
Figure 1175 – General Condition of street sign

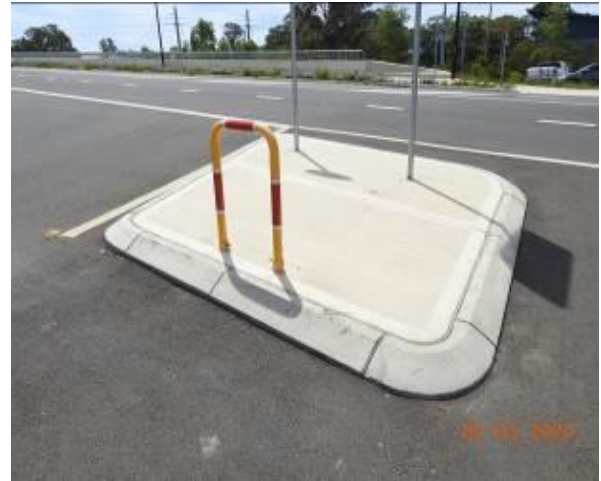
Figure 1177 – General Condition of traffic island bollard

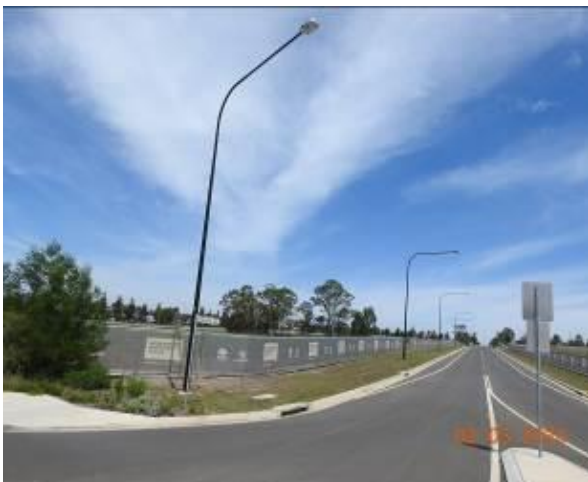
Figure 1180 – General Condition of lamp post  
Identification N.922623

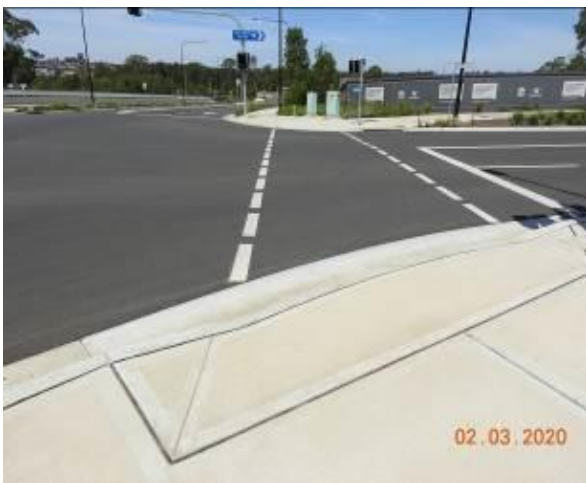
Figure 1183 – General Condition of footpath pavement

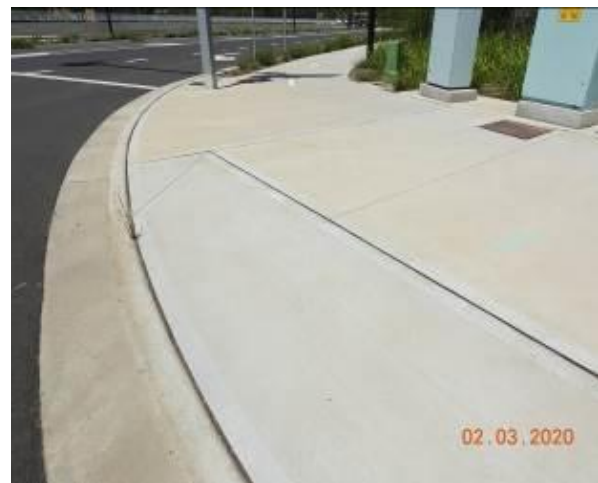
Figure 1184 – General Condition of footpath pavement

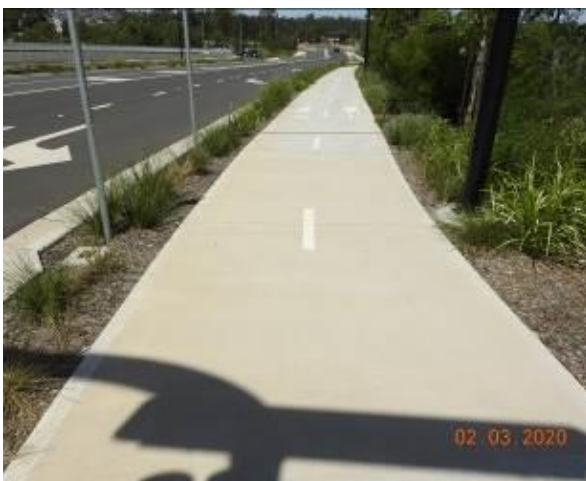
Figure 1185 – General Condition of footpath pavement

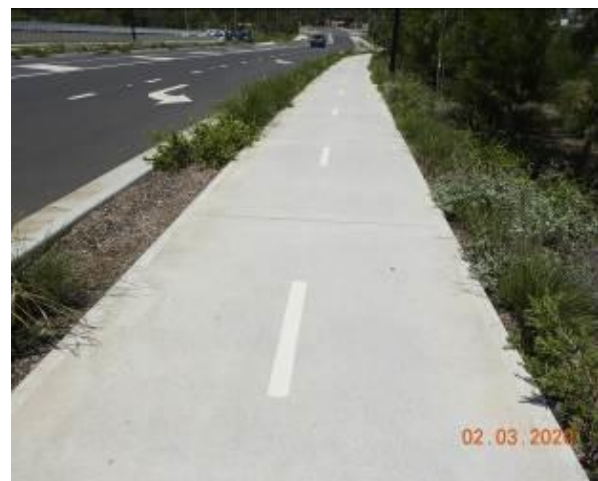
Figure 1186 – General Condition of footpath pavement

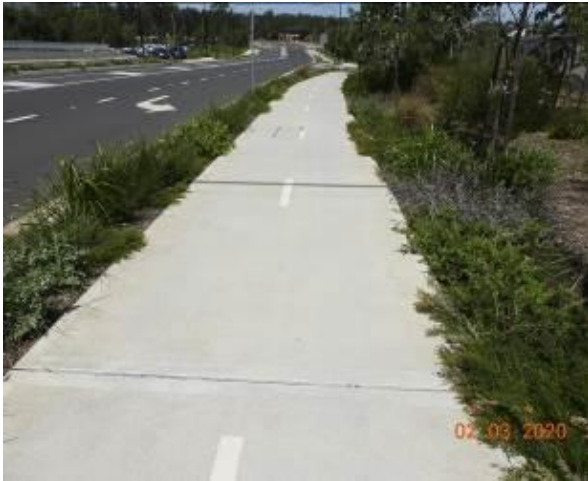
Figure 1187 – General Condition of footpath pavement

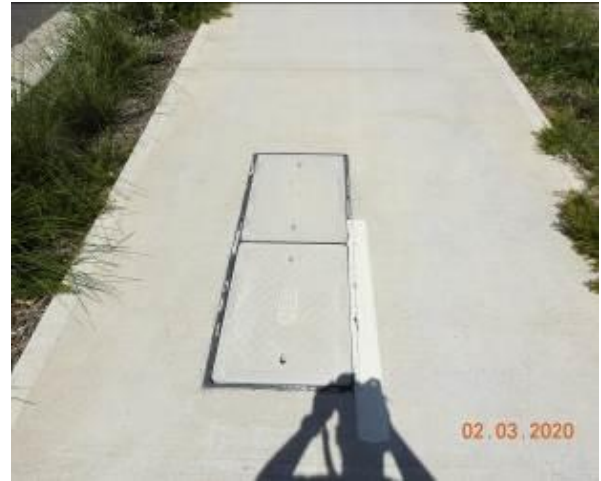
Figure 1188 – General Condition of footpath pavement

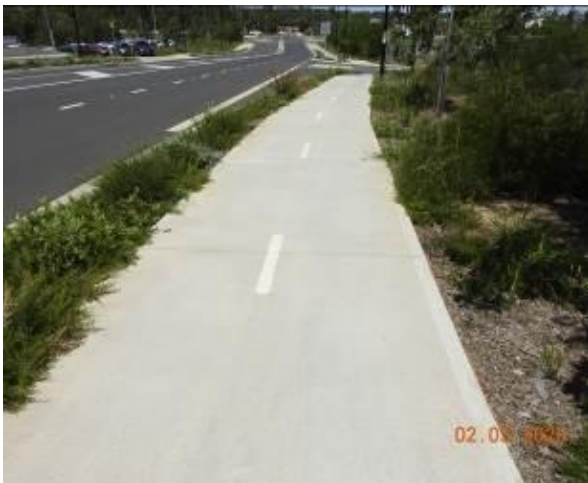
Figure 1189 – General Condition of service pit

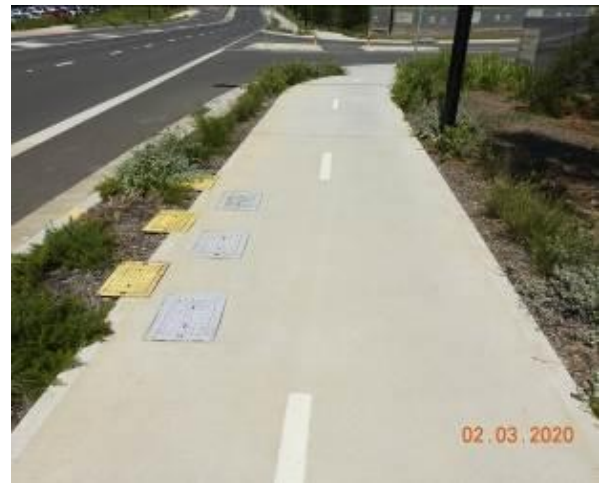
Figure 1190 – General Condition of footpath pavement

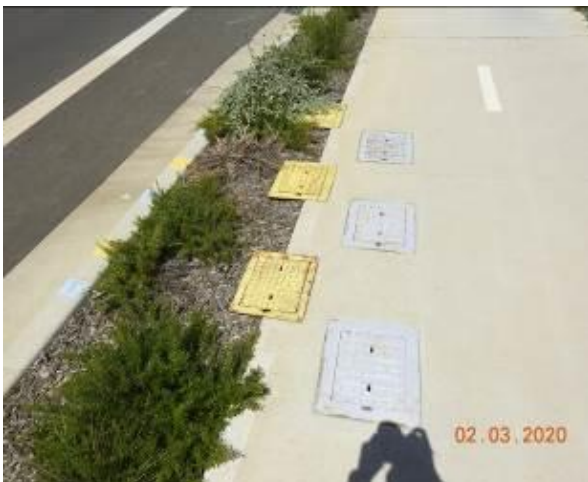
Figure 1191 – General Condition of footpath pavement

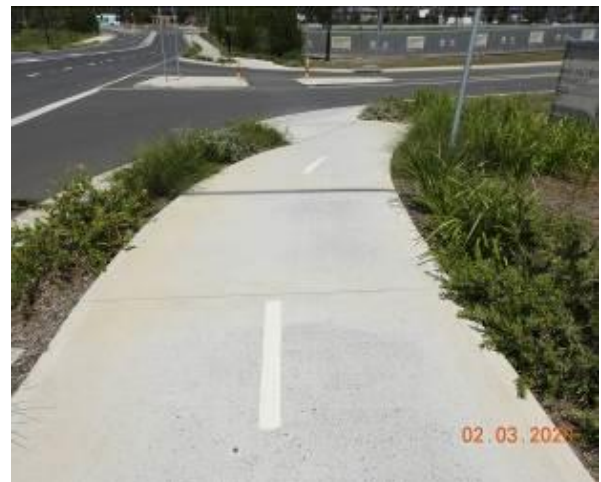
Figure 1192 – General Condition of service pit
