**1-15 AND 2-12 CONFERTA AVENUE,  
ROUSE HILL NSW 2155  
TALLAWONG STATION PRECINCT SOUTH  
PRE-DILAPIDATION REPORT**

**DEICORP PROJECTS  
(TALLAWONG STATION) PTY LTD**

Job No. 191294.0  
05/07/2021

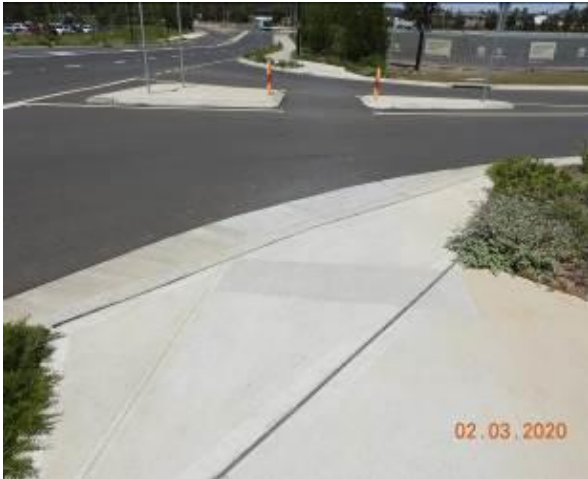
Figure 1193 – General Condition of footpath pavement

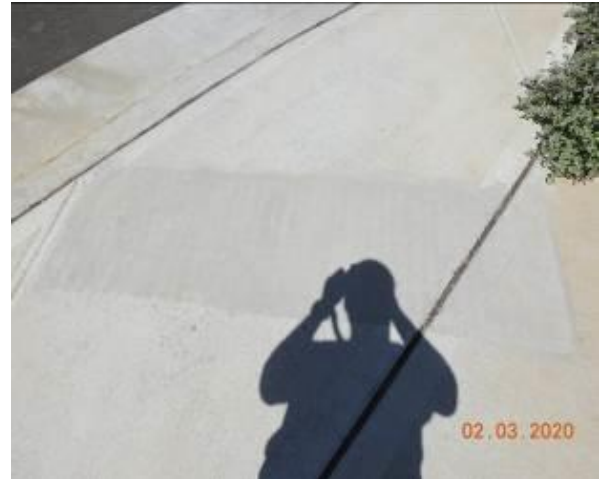
Figure 1194 – General Condition of footpath pavement

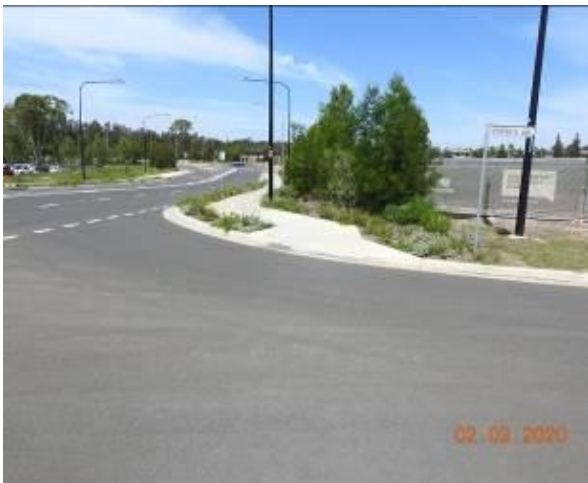
Figure 1195 – General Condition of footpath pavement

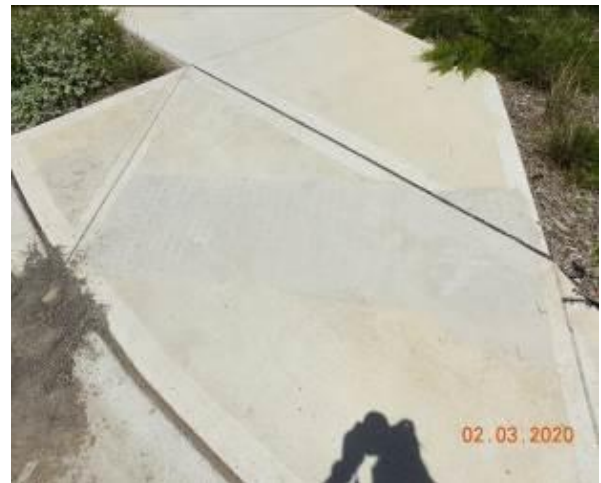
Figure 1196 – General Condition of footpath pavement

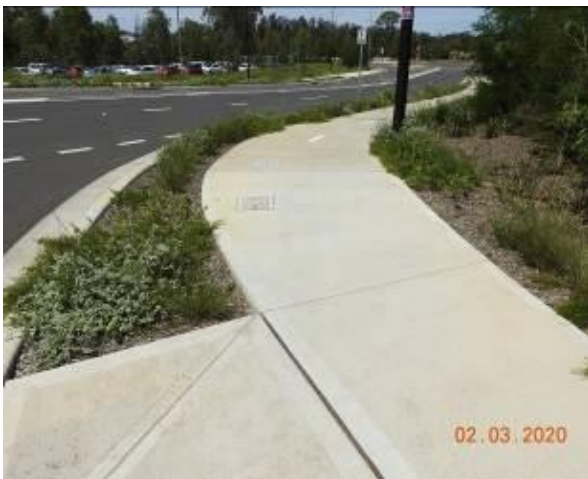
Figure 1197 – General Condition of footpath pavement

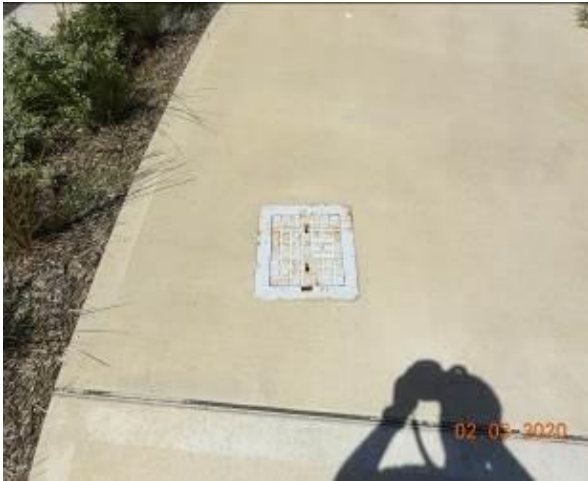
Figure 1199 – General Condition of service pit

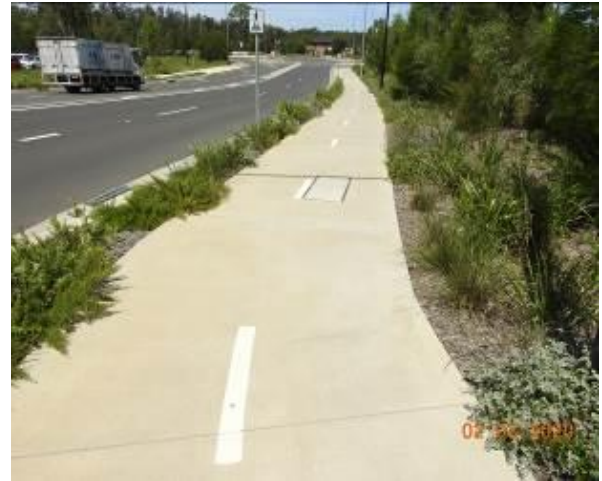
Figure 1200 – General Condition of service pit

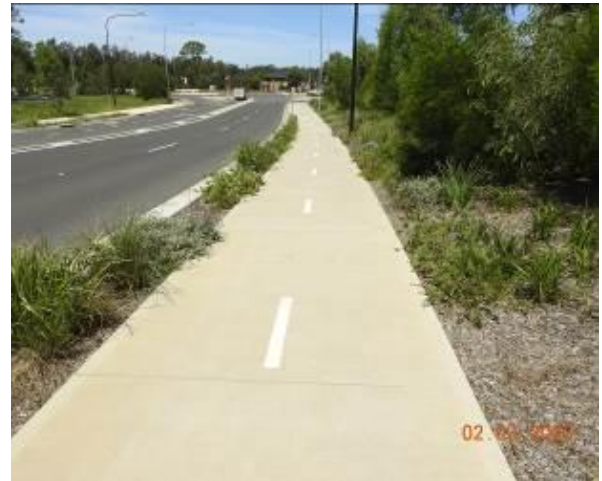
Figure 1202 – General Condition of service pit

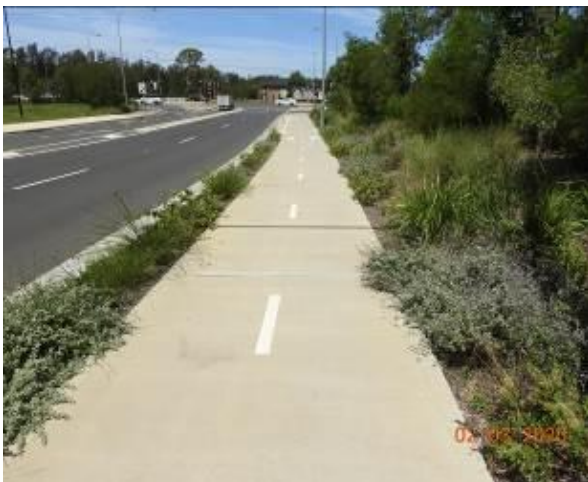
Figure 1203 – General Condition of footpath pavement

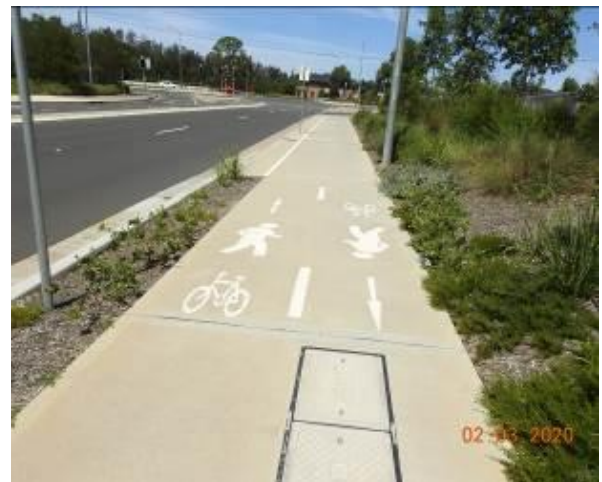
Figure 1204 – General Condition of footpath pavement

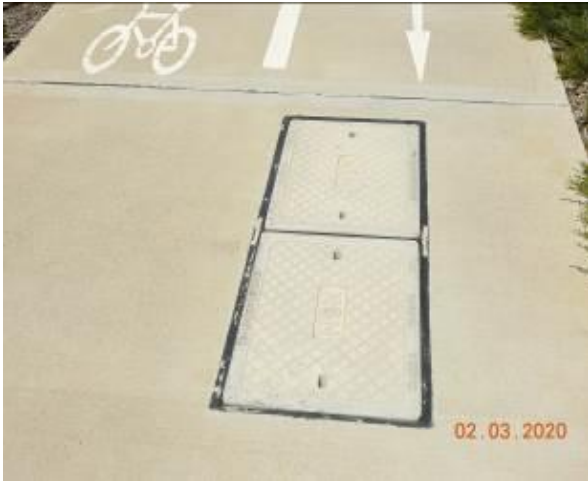
Figure 1205 – General Condition of service pit

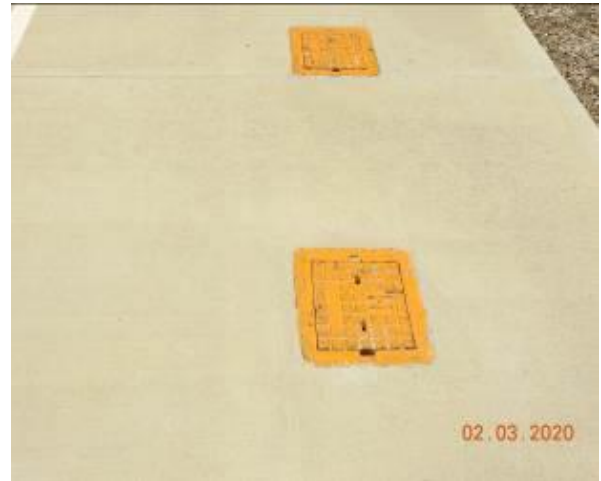
Figure 1208 – General Condition of footpath pavement

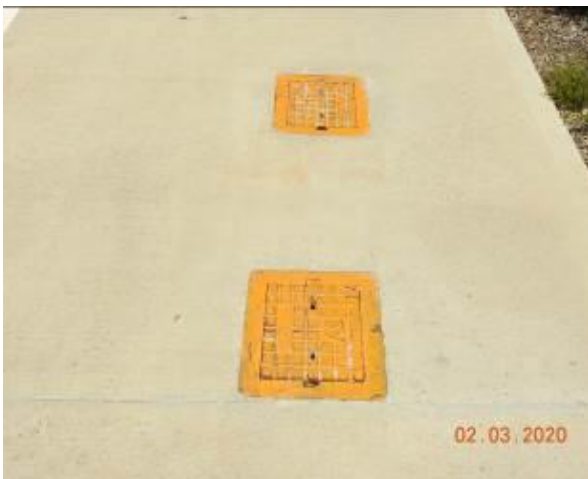
Figure 1209 – General Condition of service pit

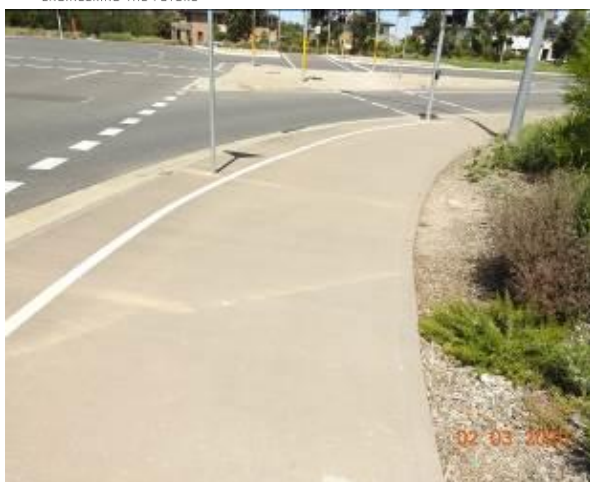
Figure 1211 – General Condition of footpath pavement

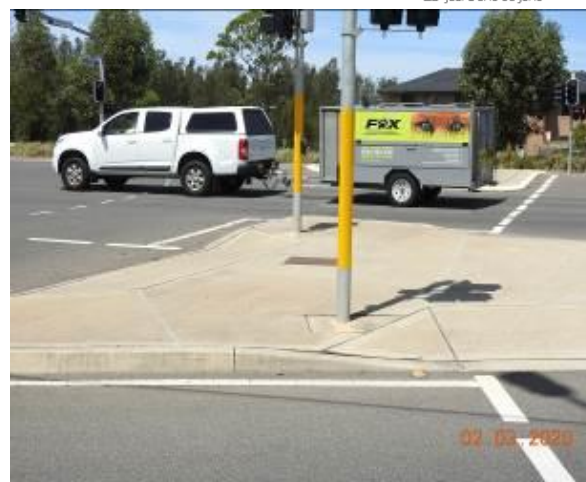
Figure 1212 – General Condition of footpath pavement

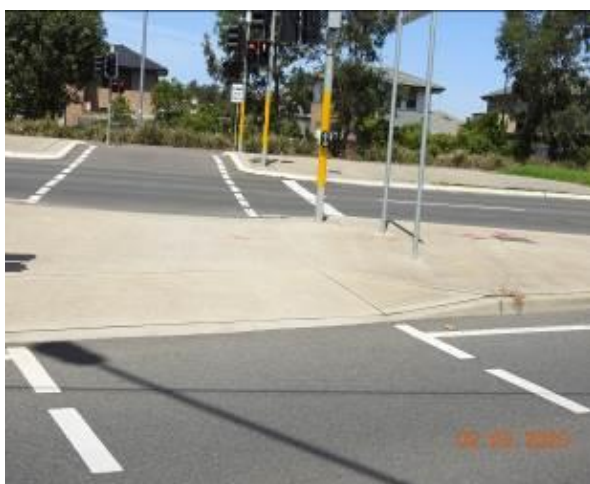
Figure 1213 – General Condition of footpath pavement

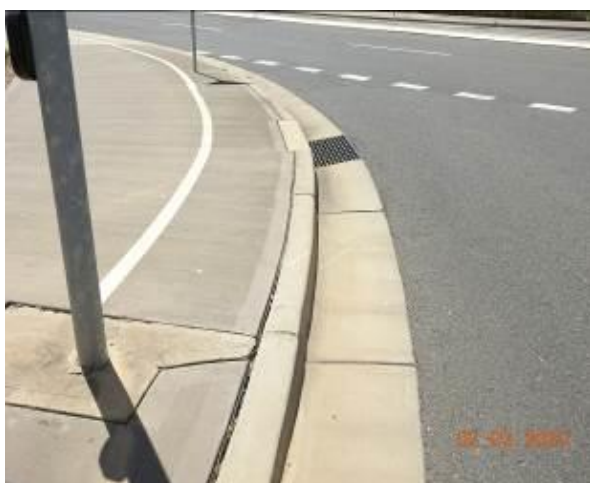
Figure 1215 – General Condition of kerb and gutter

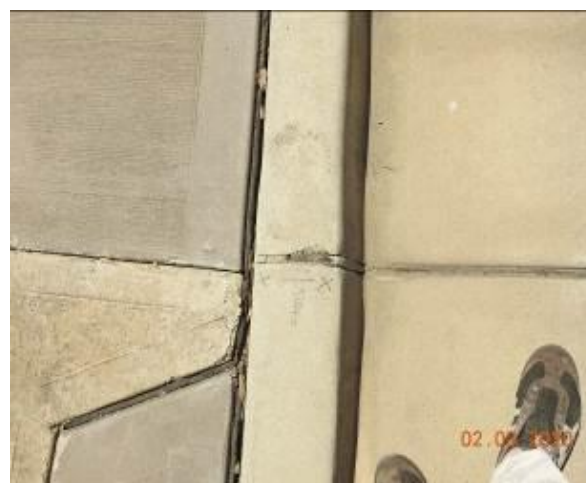
Figure 1216 – General Condition of kerb and gutter

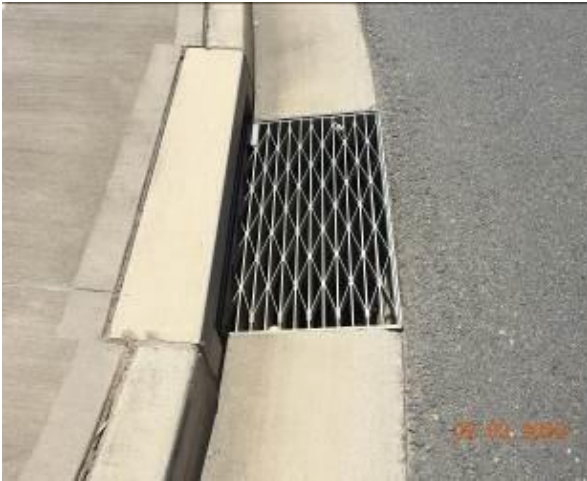
Figure 1217 – Loss of material through kerb and gutter

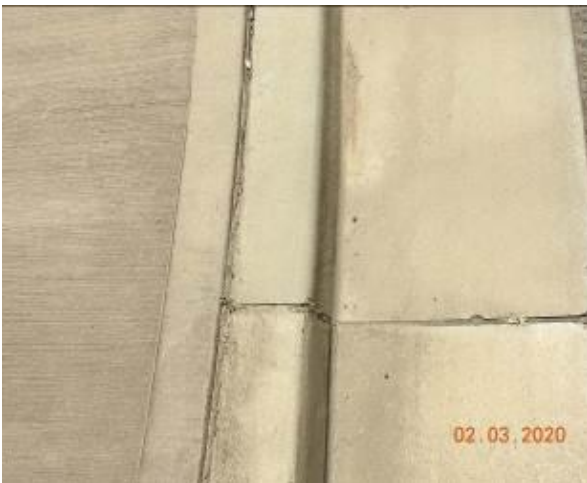
Figure 1219 – General Condition of kerb and gutter

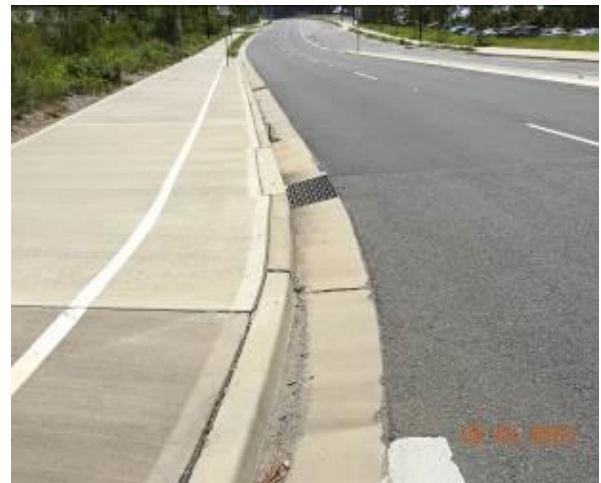
Figure 1220 – Loss of material through kerb and gutter

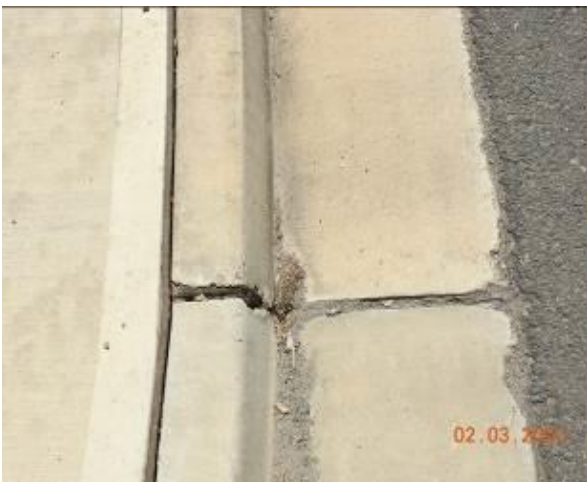
Figure 1221 – General Condition of kerb and gutter

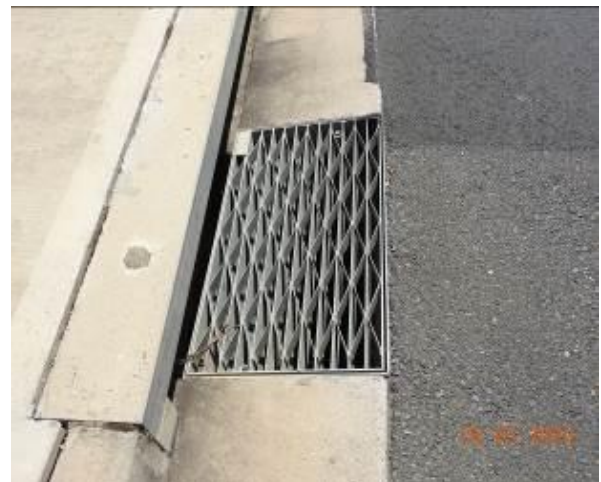
Figure 1222 – Loss of material through kerb and gutter

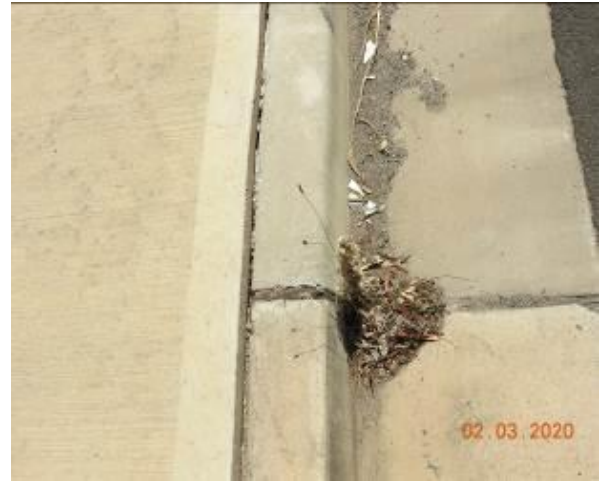
Figure 1224 – General Condition of kerb and gutter

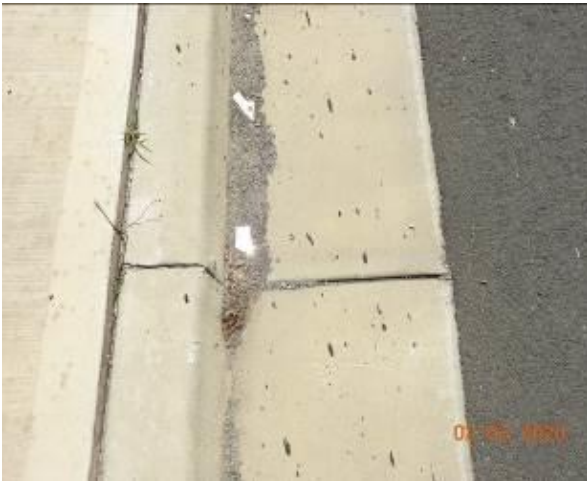
Figure 1225 – Crack propagation through kerb and gutter

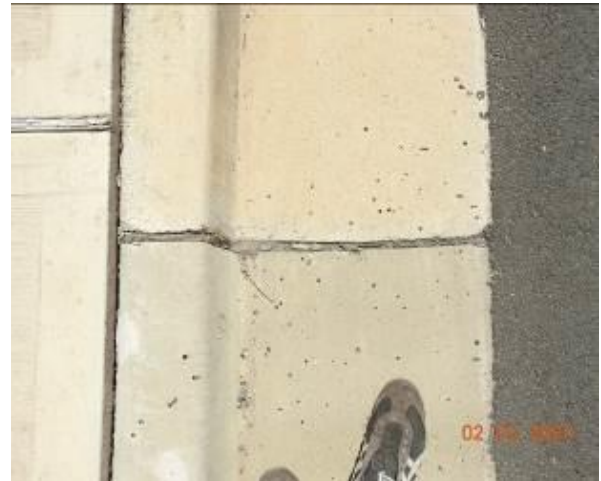
Figure 1226 – Crack propagation through kerb and gutter

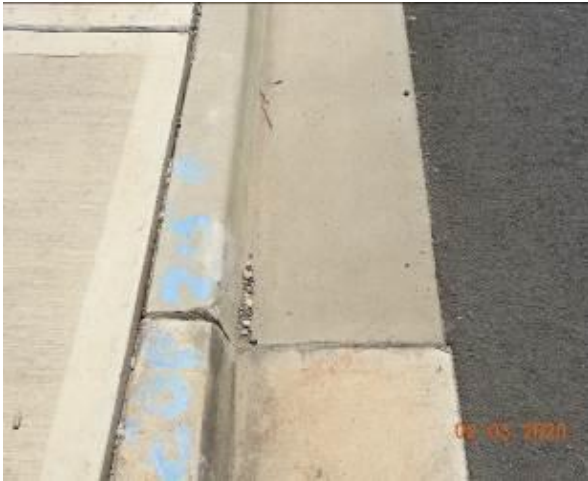
Figure 1229 – General Condition of kerb and gutter

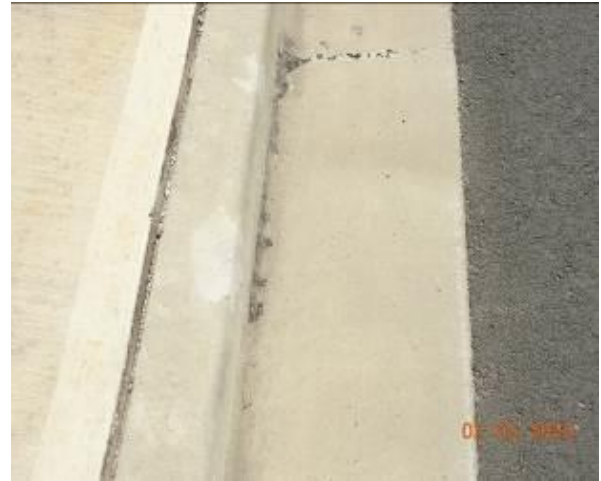
Figure 1230 – Loss of material through kerb and gutter

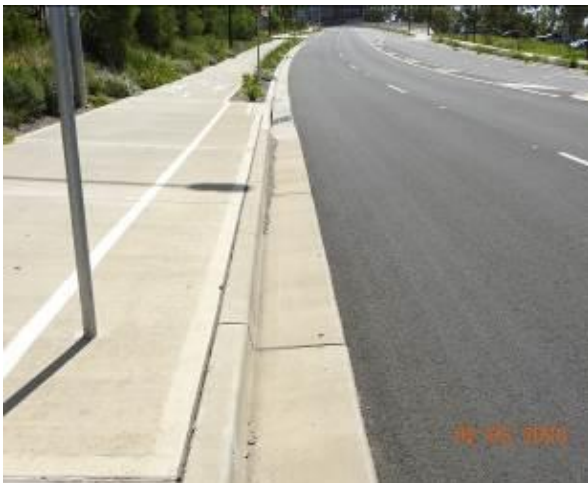
Figure 1231 – Crack propagation through kerb

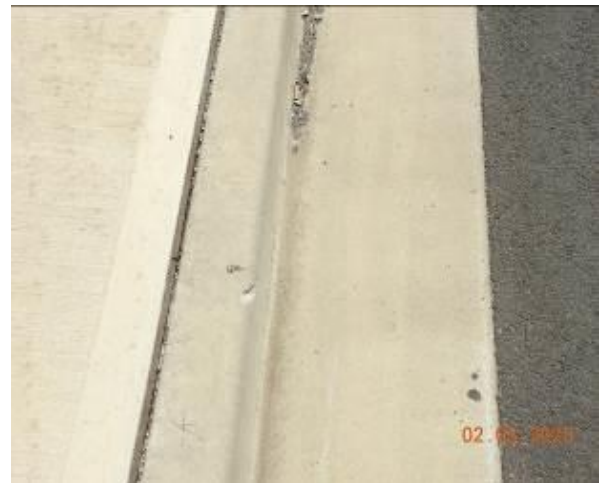
Figure 1232 – General Condition of kerb and gutter

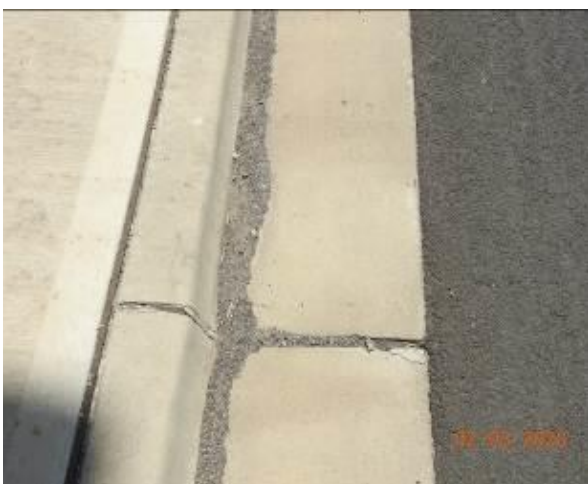
Figure 1233 – Crack propagation through kerb

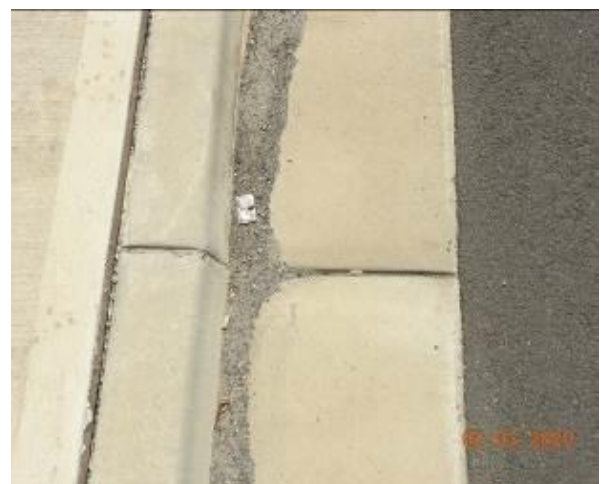
Figure 1234 – Crack propagation through kerb and gutter

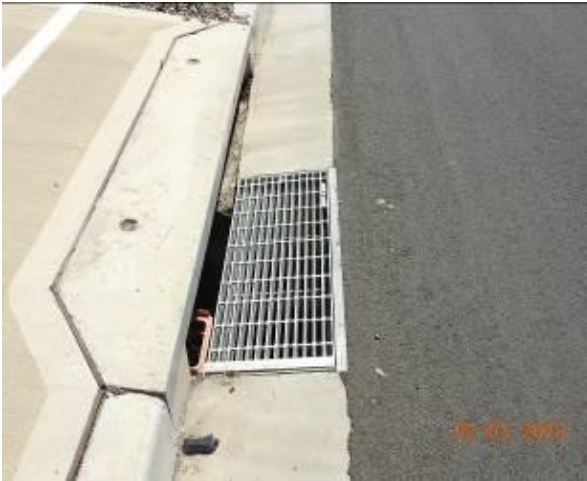
Figure 1235 – Crack propagation through kerb and gutter

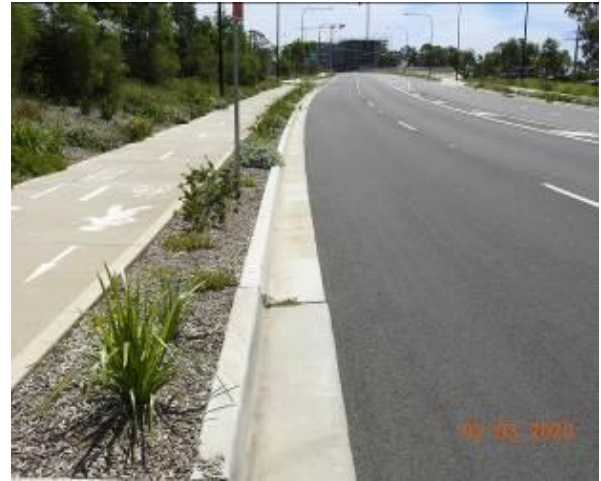
Figure 1236 – General Condition of stormwater inlet pit

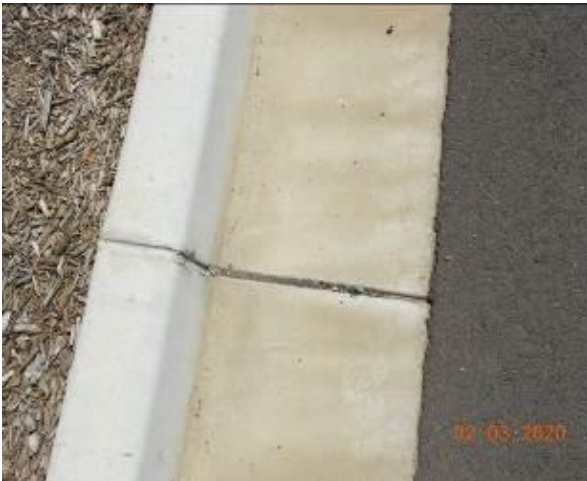
Figure 1237 – General Condition of kerb and gutter

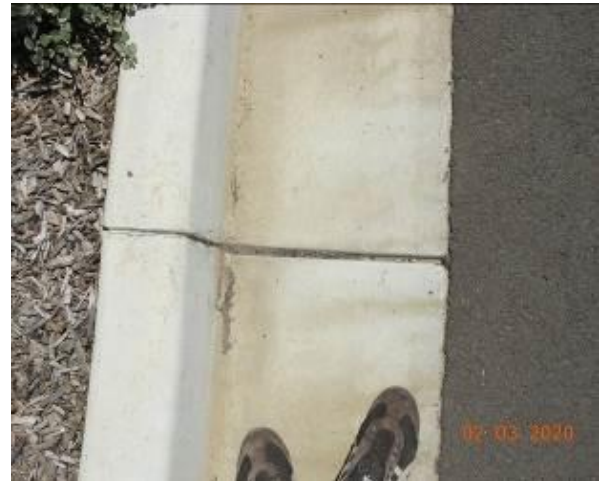
Figure 1238 – Crack propagation through kerb and gutter

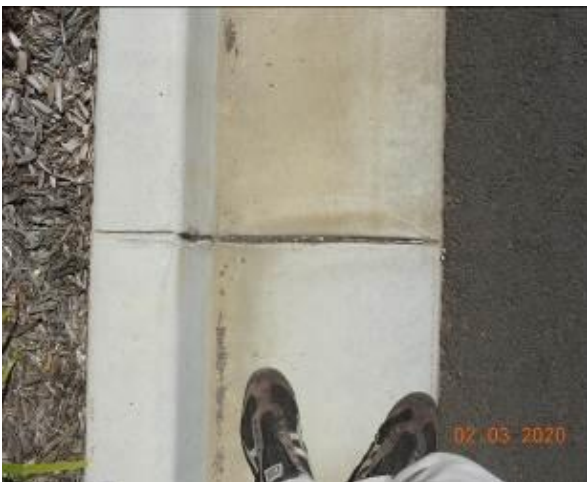
Figure 1239 – Crack propagation through kerb and gutter

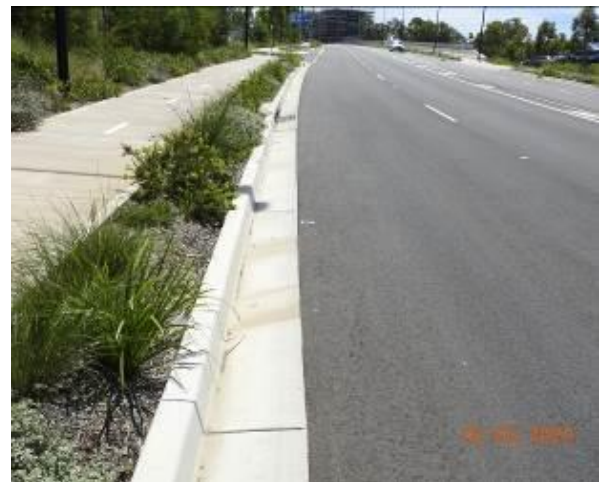
Figure 1240 – Crack propagation through kerb and gutter

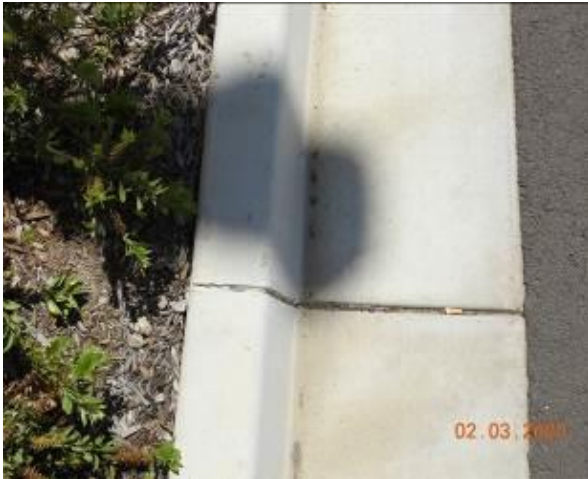
Figure 1241 – General Condition of kerb and gutter

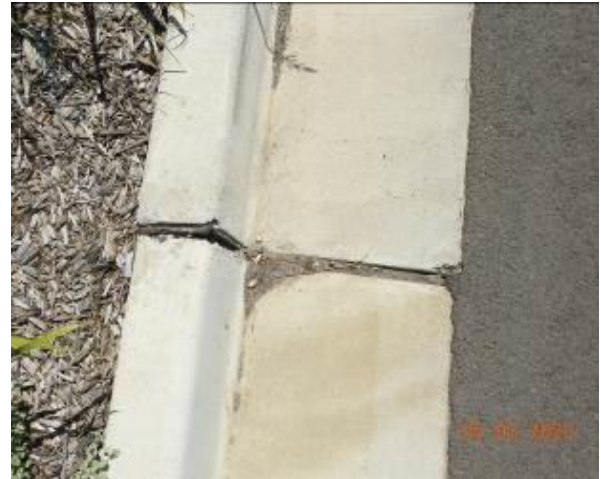
Figure 1242 – Crack propagation through kerb and gutter

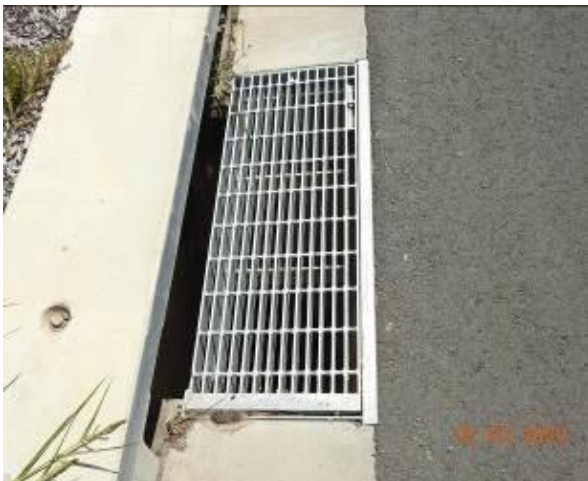
Figure 1243 – Crack propagation through kerb and gutter

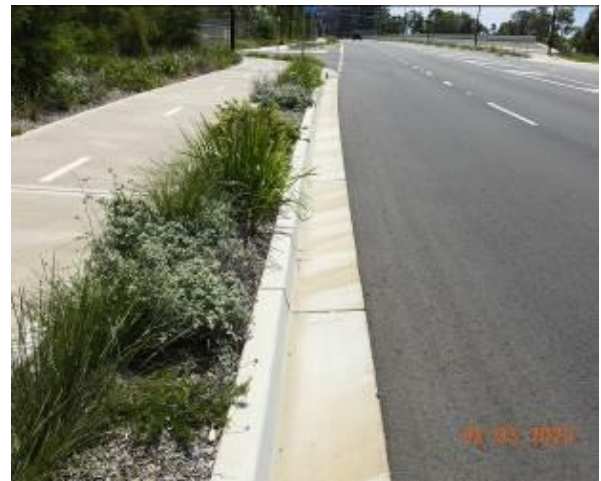
Figure 1244 – General Condition of stormwater inlet pit

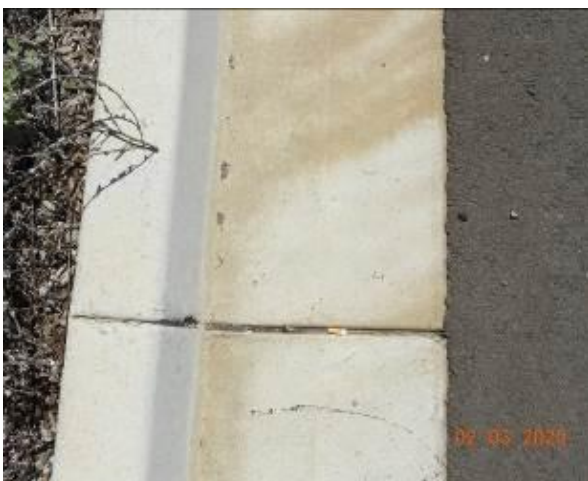
Figure 1245 – General Condition of kerb and gutter

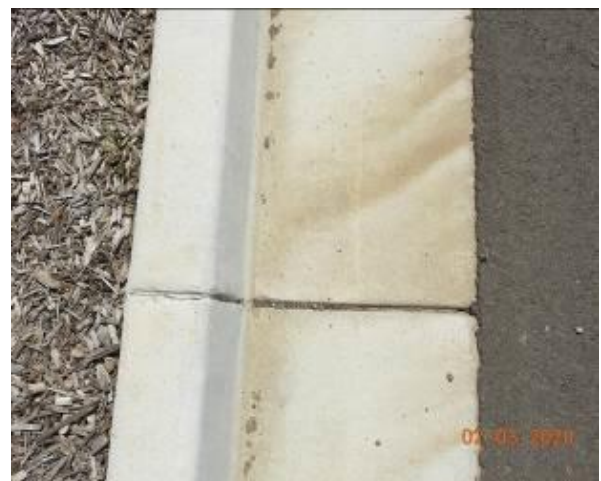
Figure 1246 – Crack propagation through kerb

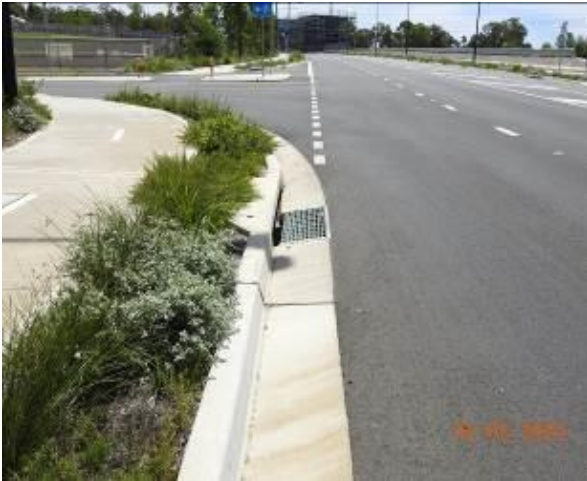
Figure 1247 – Crack propagation through kerb

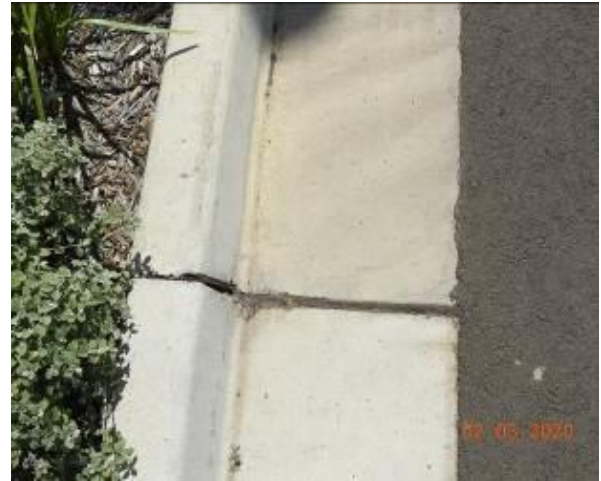
Figure 1248 – General Condition of kerb and gutter

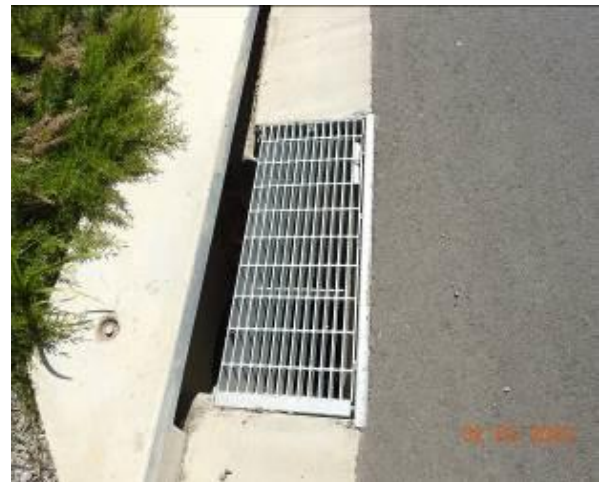
Figure 1250 – Crack propagation through kerb

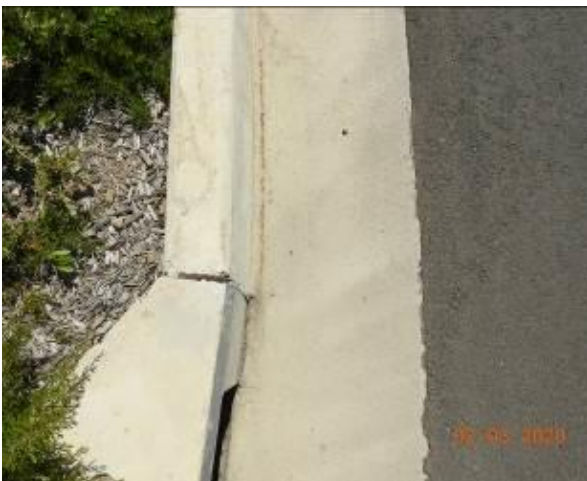
Figure 1251 – General Condition of stormwater inlet pit

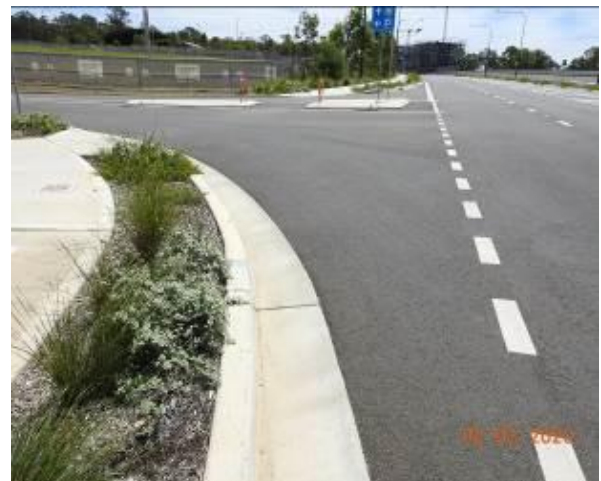
Figure 1252 – Crack propagation through kerb

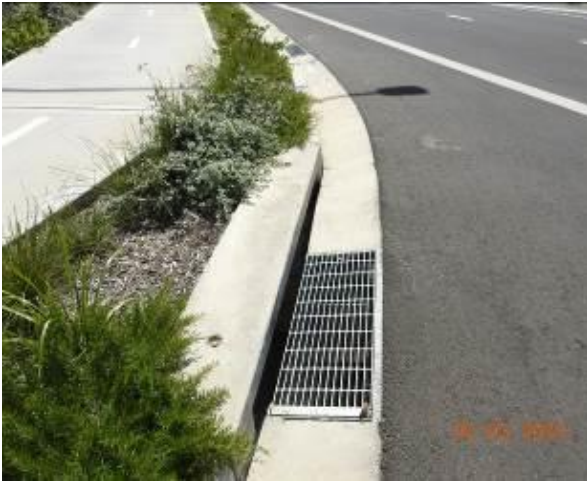
Figure 1253 – General Condition of kerb and gutter

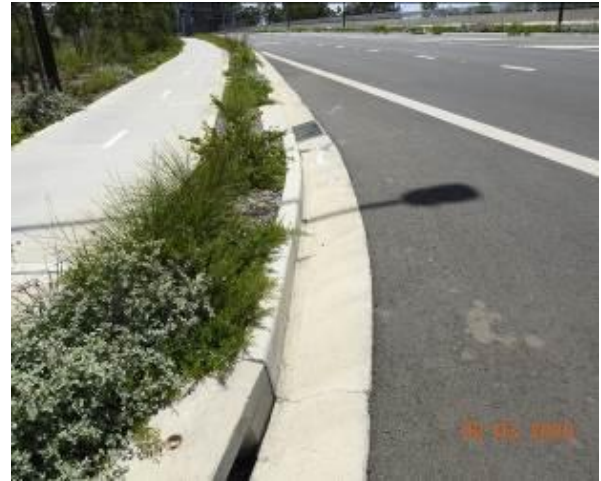
Figure 1254 – General Condition of stormwater inlet pit

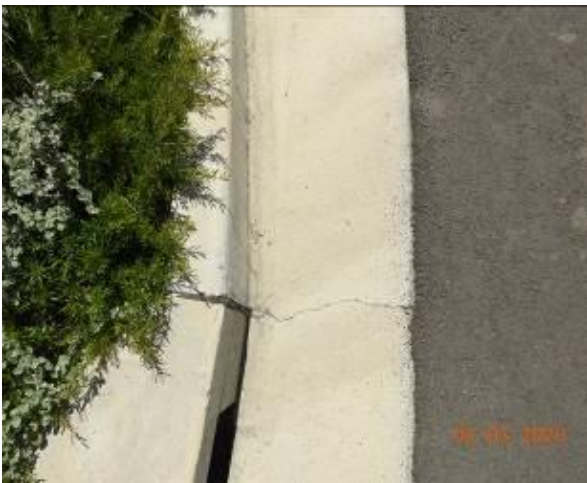
Figure 1255 – General Condition of kerb and gutter

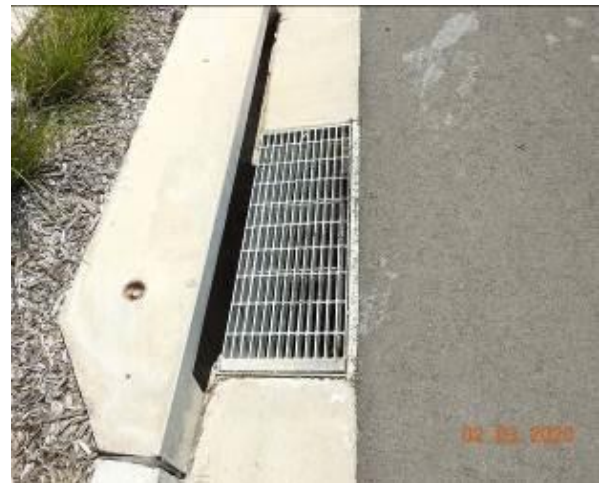
Figure 1256 – Crack propagation through kerb and gutter

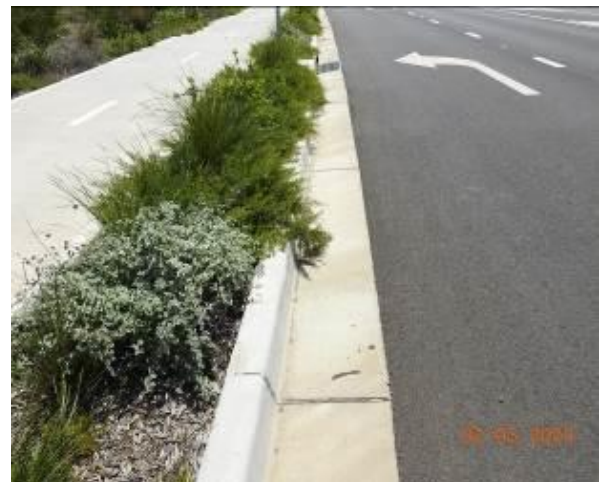
Figure 1258 – General Condition of kerb and gutter

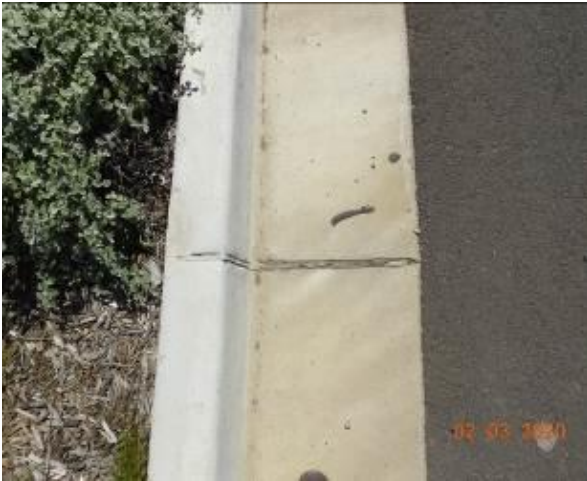
Figure 1259 – General Condition of kerb and gutter

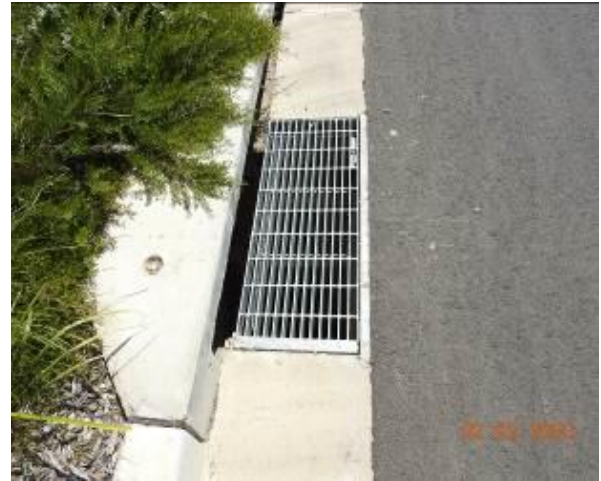
Figure 1260 – Crack propagation through kerb and gutter

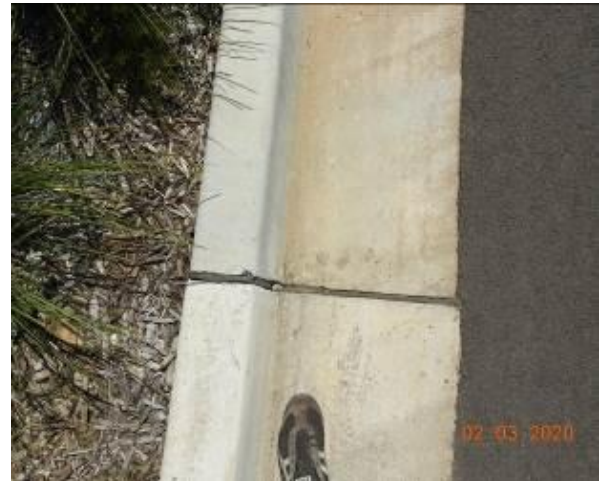
Figure 1262 – General Condition of kerb and gutter

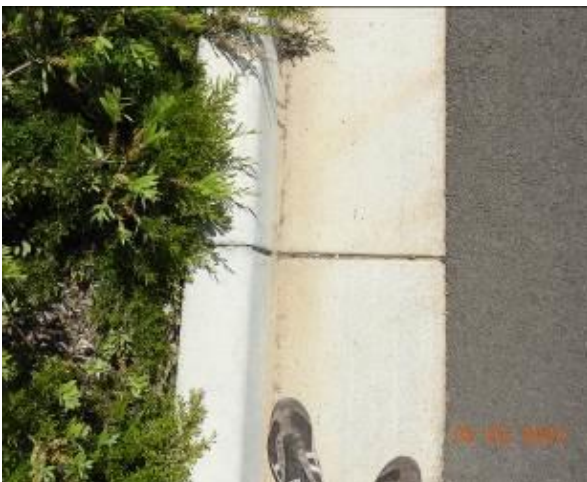
Figure 1263 – Crack propagation through kerb and gutter

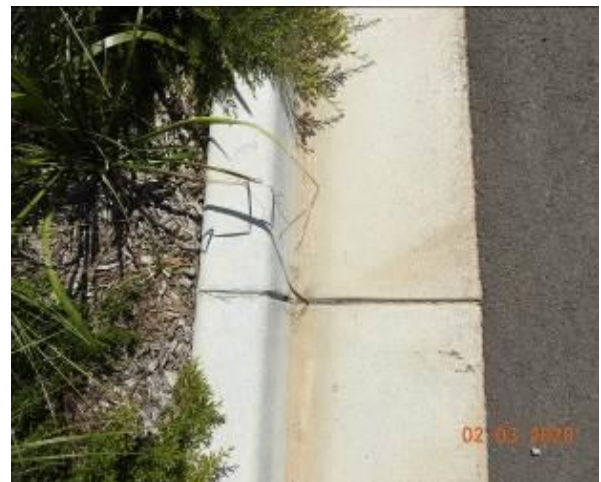
Figure 1264 – Crack propagation through kerb and gutter

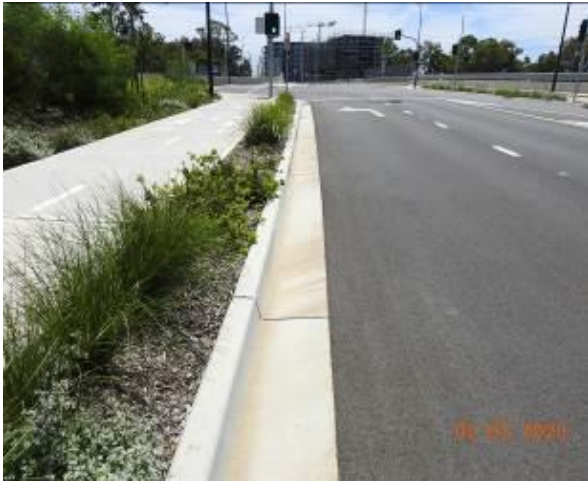
Figure 1265 – Crack propagation through kerb and gutter

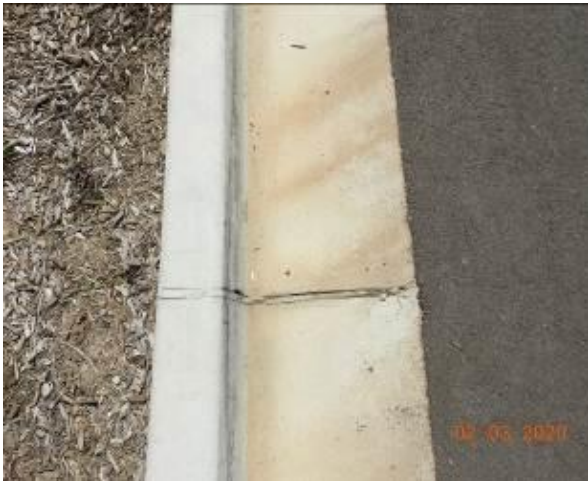
Figure 1267 – Crack propagation through kerb and gutter

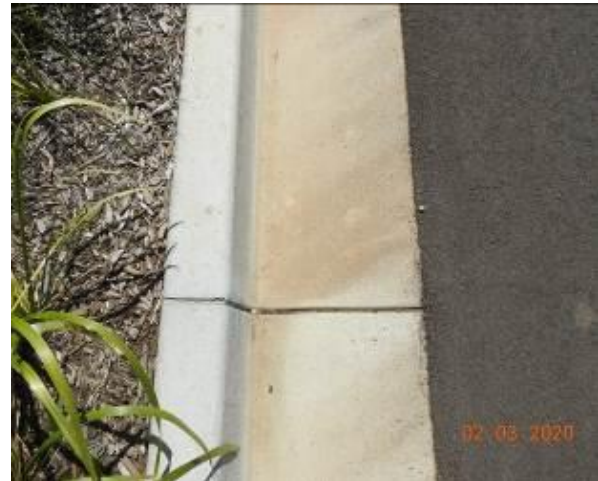
Figure 1268 – Crack propagation through kerb and gutter

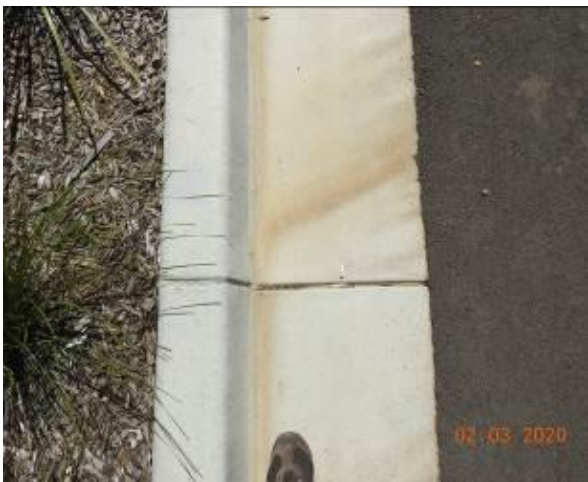
Figure 1269 – Crack propagation through kerb and gutter

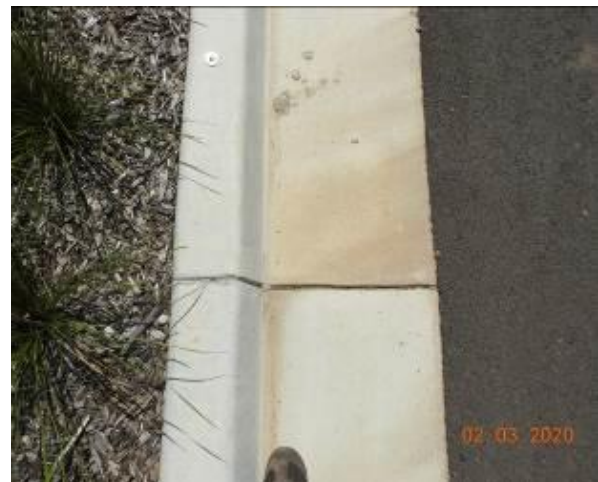
Figure 1270 – Crack propagation through kerb and gutter

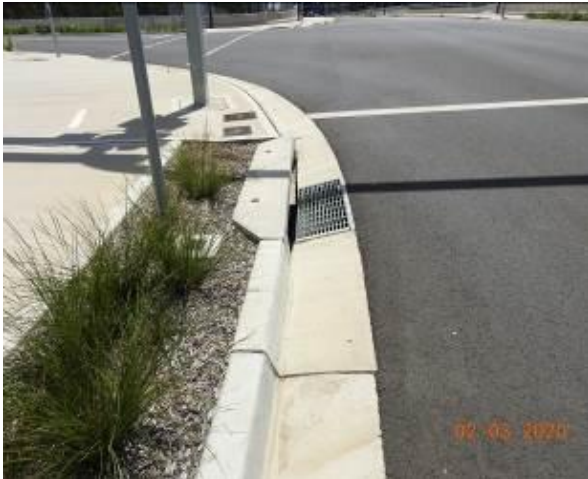
Figure 1271 – Crack propagation through kerb and gutter

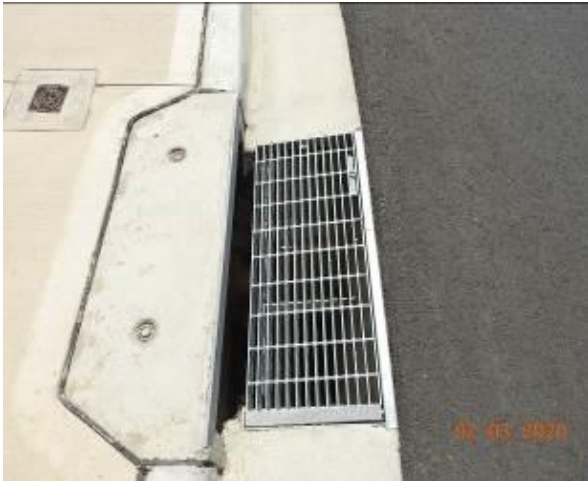
Figure 1277 – Crack propagation through stormwater inlet pit

The condition of the lamp posts, stormwater inlet pits, street signs and service pits was also inspected and were determined to be in a reasonable condition. With cases of crack propagation through stormwater inlet pit

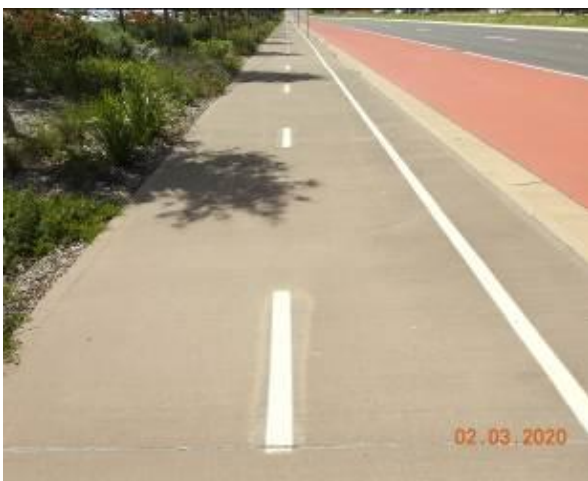
Figure 1345 – General Condition of footpath pavement

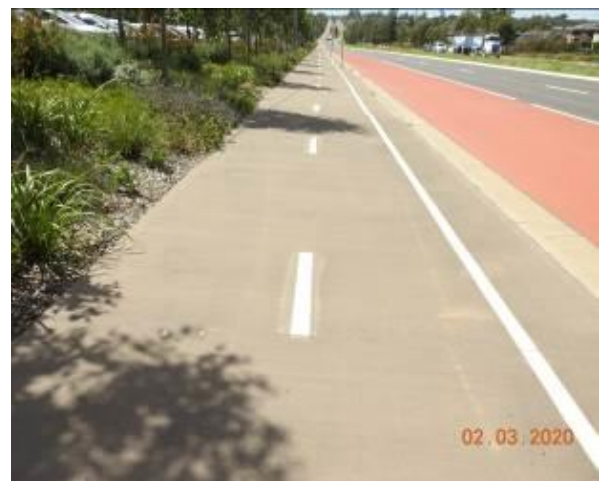
Figure 1346 – General Condition of footpath pavement

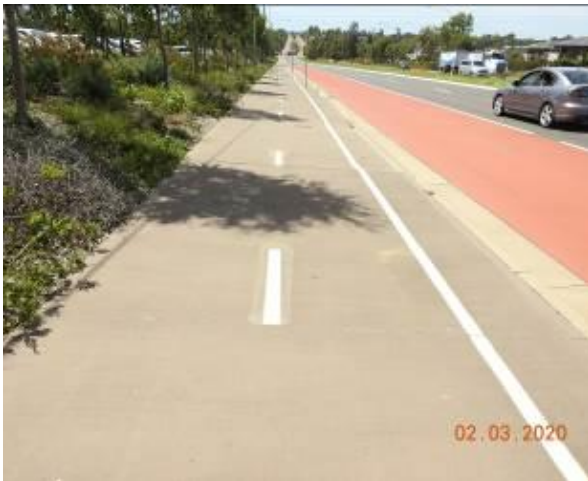
Figure 1347 – General Condition of footpath pavement

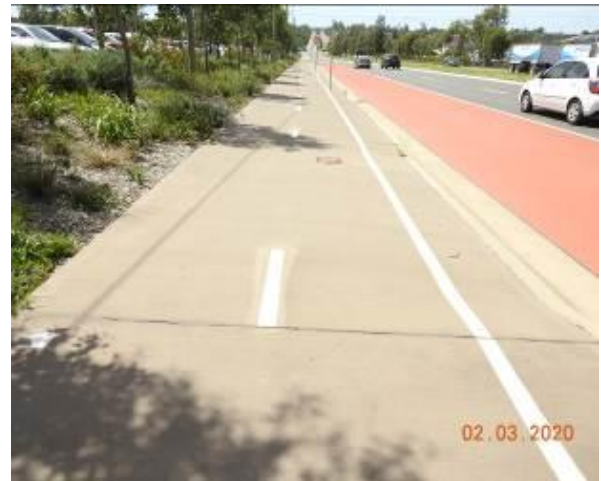
Figure 1348 – General Condition of footpath pavement

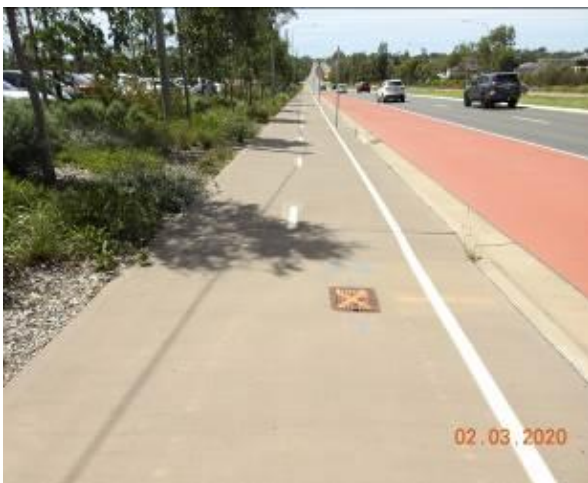
Figure 1349 – General Condition of footpath pavement

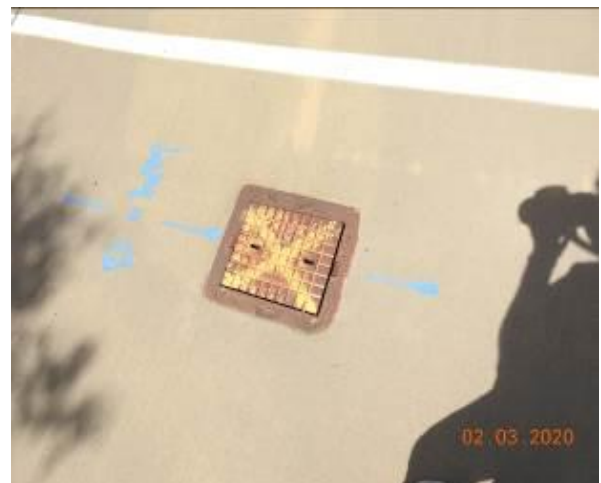
Figure 1350 – General Condition of footpath pavement

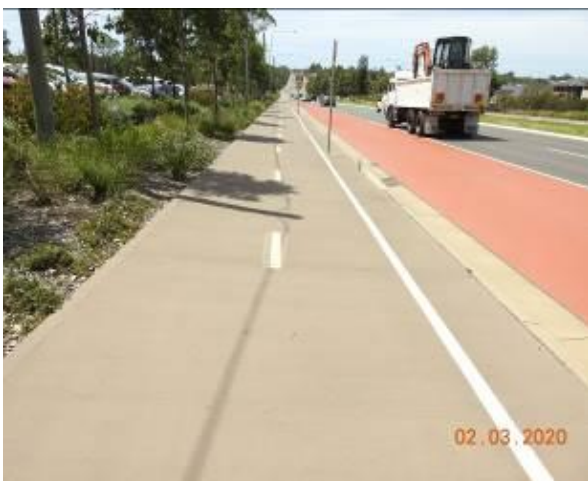
Figure 1351 – General Condition of service pit

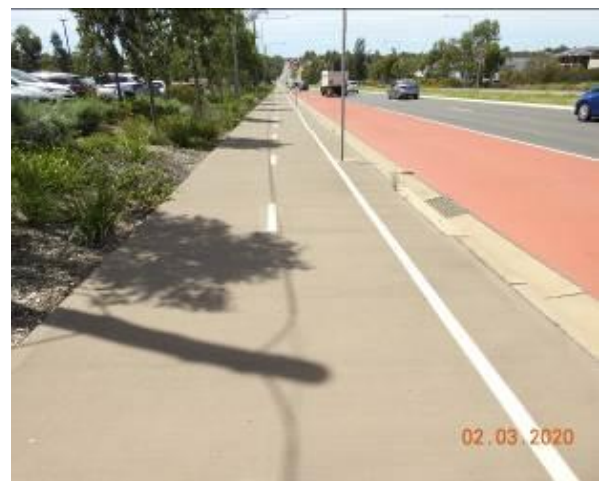
Figure 1352 – General Condition of footpath pavement

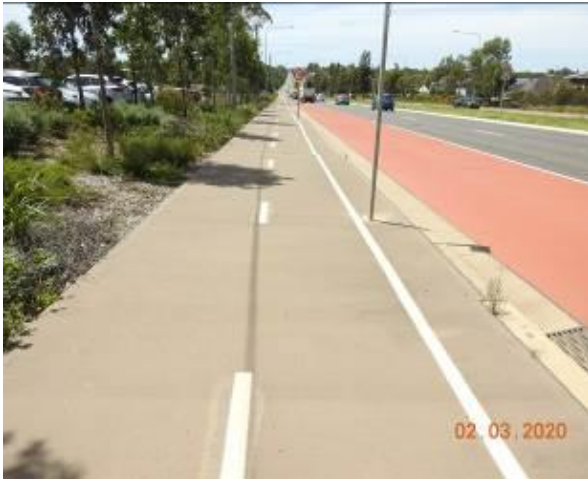
Figure 1353 – General Condition of footpath pavement

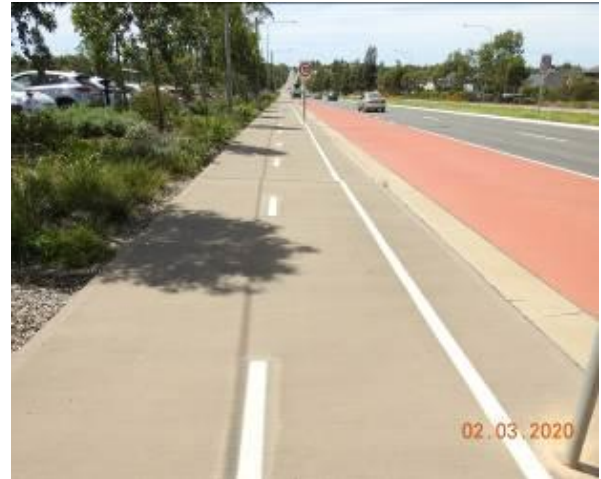
Figure 1354 – General Condition of footpath pavement

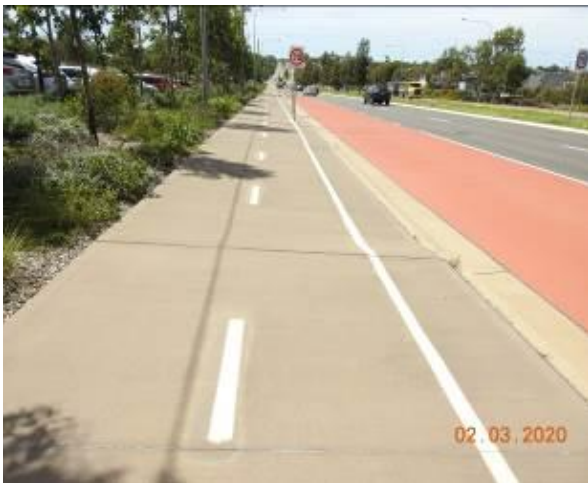
Figure 1355 – General Condition of footpath pavement
