**1-15 AND 2-12 CONFERTA AVENUE,  
ROUSE HILL NSW 2155  
TALLAWONG STATION PRECINCT SOUTH  
PRE-DILAPIDATION REPORT**

**DEICORP PROJECTS  
(TALLAWONG STATION) PTY LTD**

Job No. 191294.0  
05/07/2021

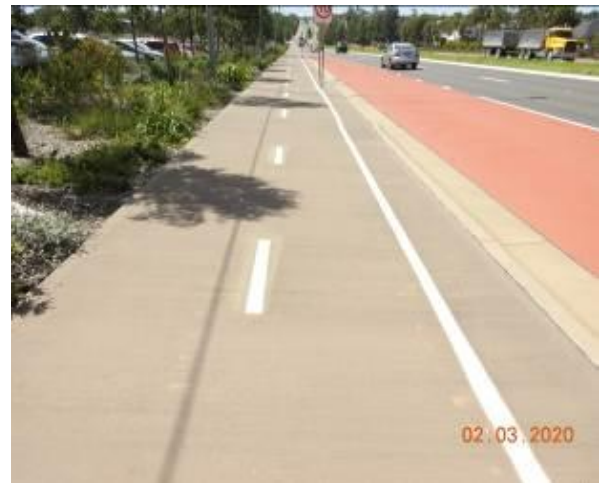
Figure 1356 – General Condition of footpath pavement

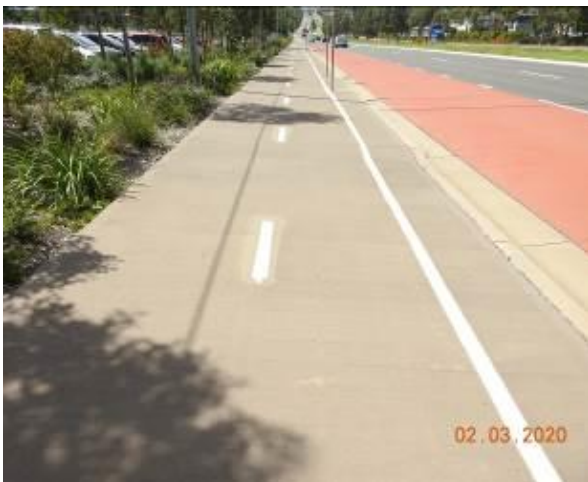
Figure 1357 – General Condition of footpath pavement

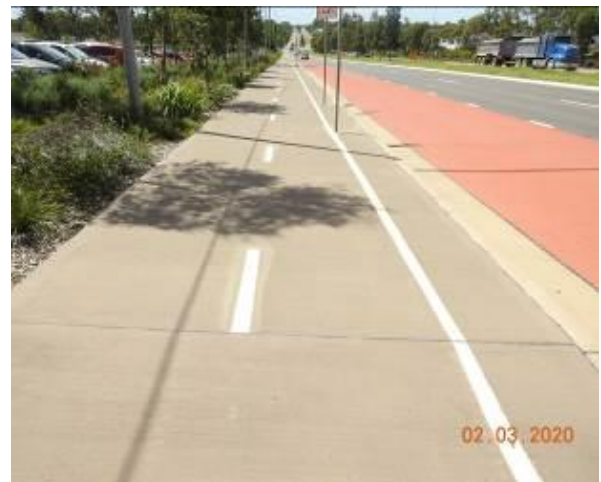
Figure 1358 – General Condition of footpath pavement

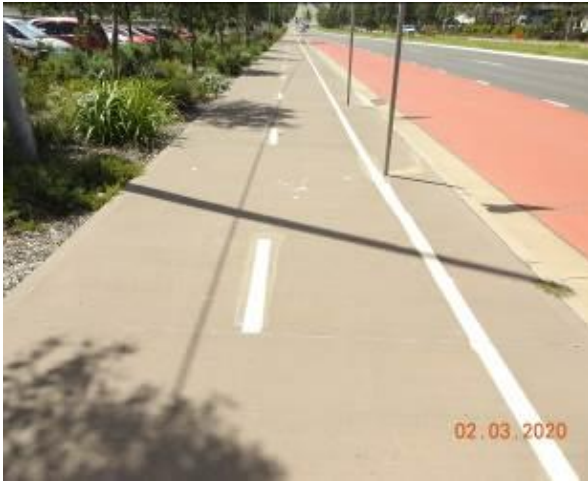
Figure 1359 – General Condition of footpath pavement

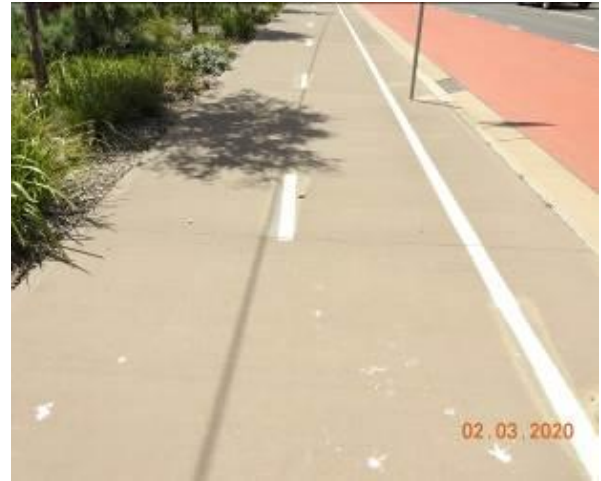
Figure 1360 – General Condition of footpath pavement

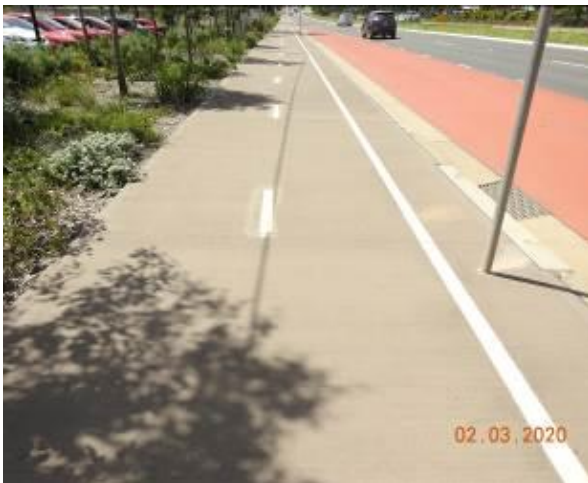
Figure 1361 – General Condition of footpath pavement

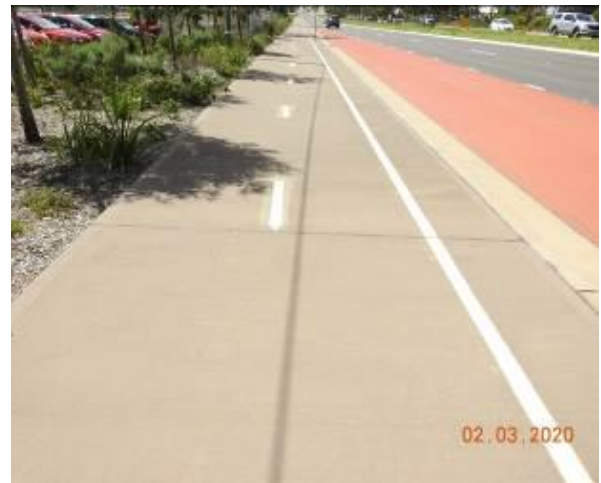
Figure 1362 – General Condition of footpath pavement

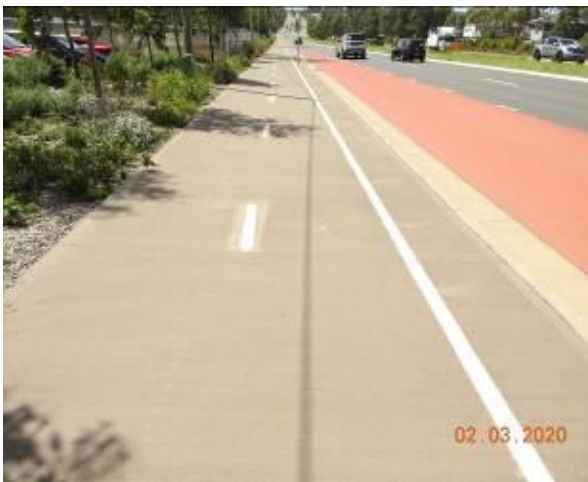
Figure 1363 – General Condition of footpath pavement

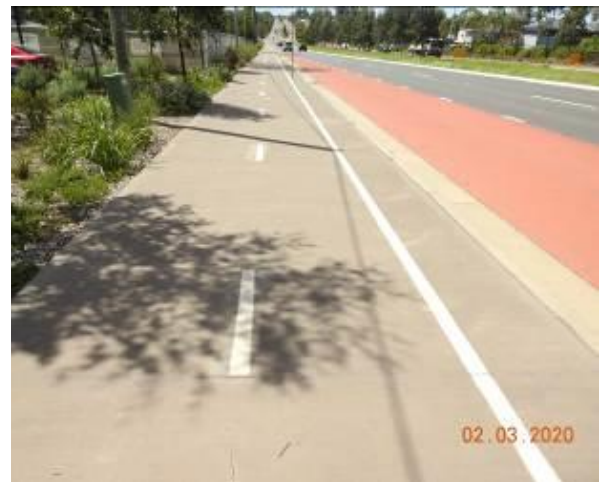
Figure 1364 – General Condition of footpath pavement

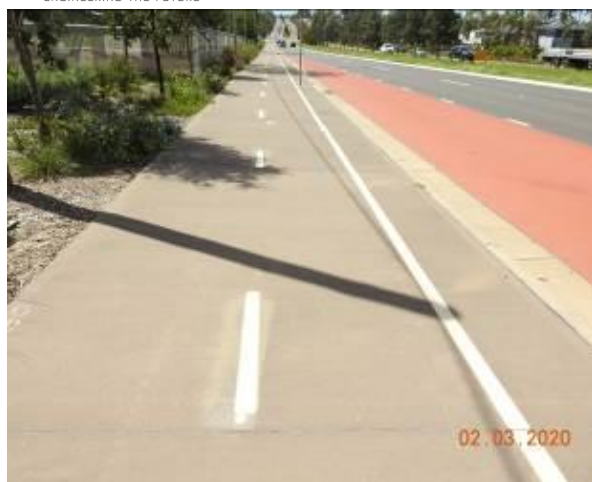
Figure 1365 – General Condition of footpath pavement

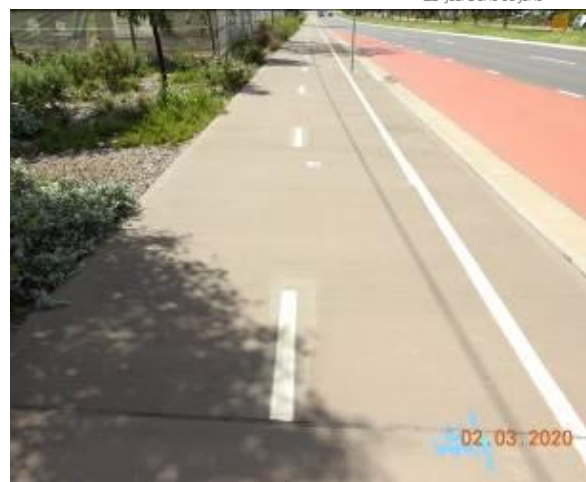
Figure 1366 – General Condition of footpath pavement

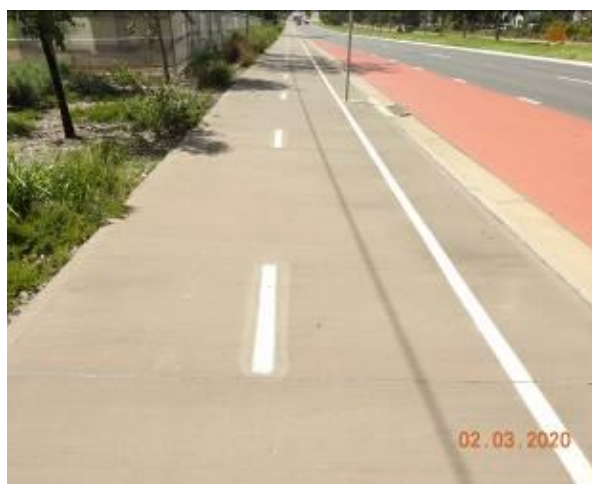
Figure 1367 – General Condition of footpath pavement

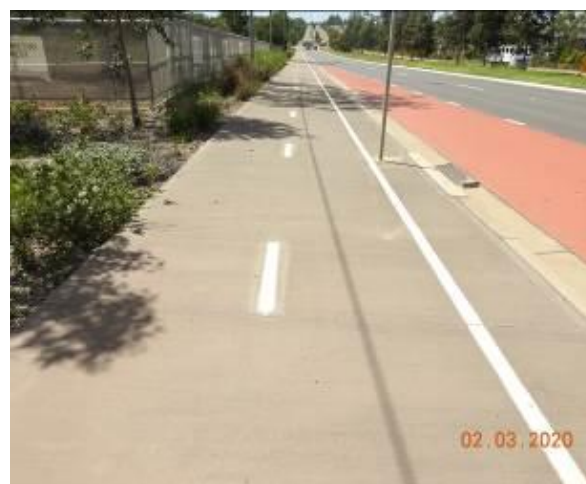
Figure 1368 – General Condition of footpath pavement

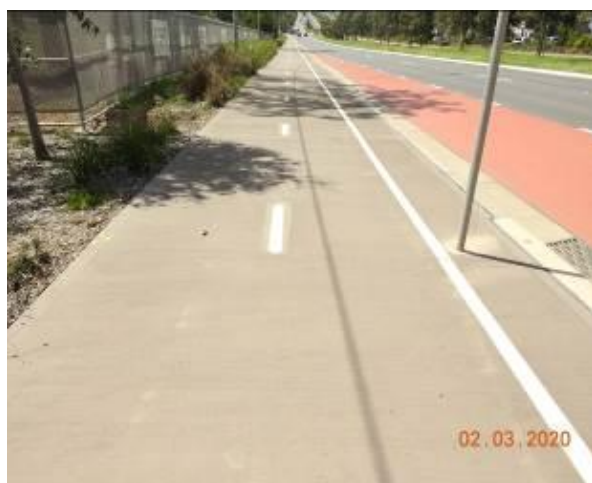
Figure 1369 – General Condition of footpath pavement

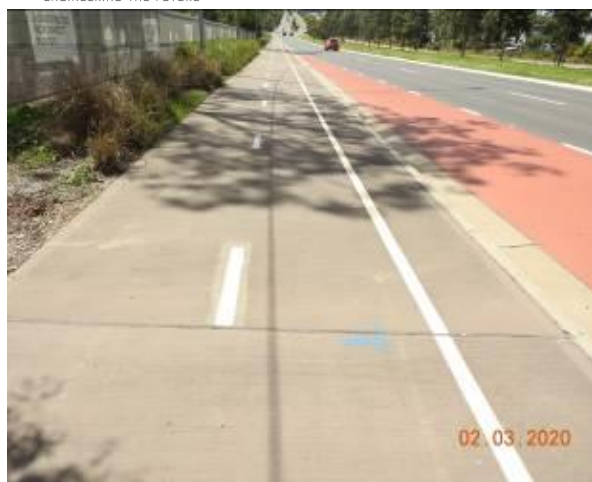
Figure 1371 – Evidence of patchwork through footpath pavement

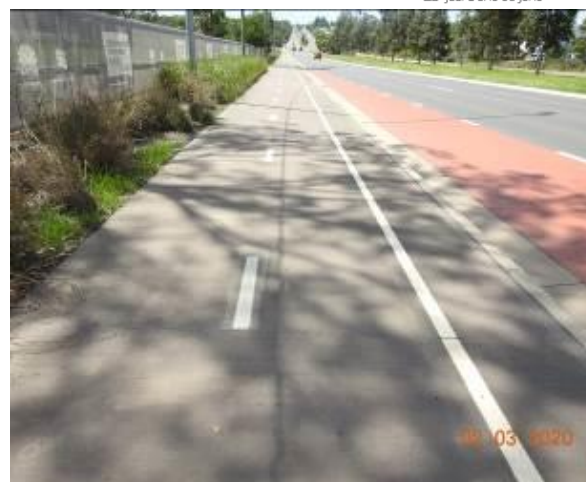
Figure 1372 – General Condition of footpath pavement

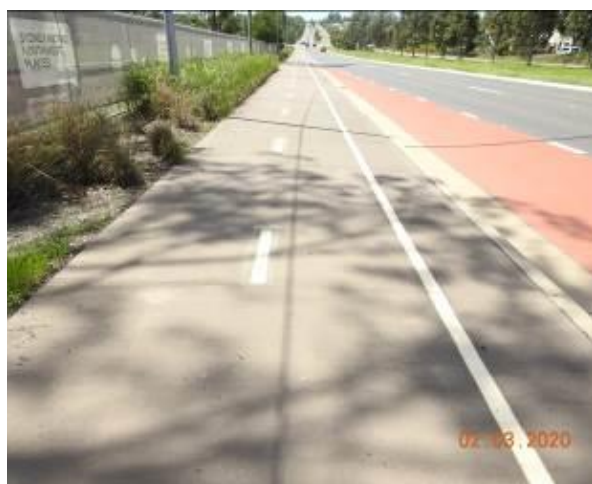
Figure 1373 – General Condition of footpath pavement

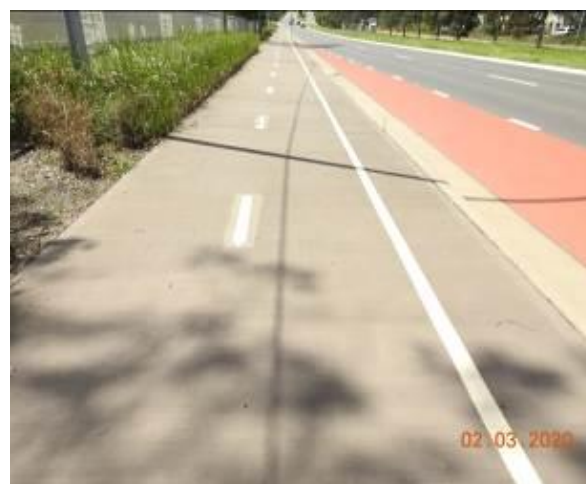
Figure 1374 – General Condition of footpath pavement

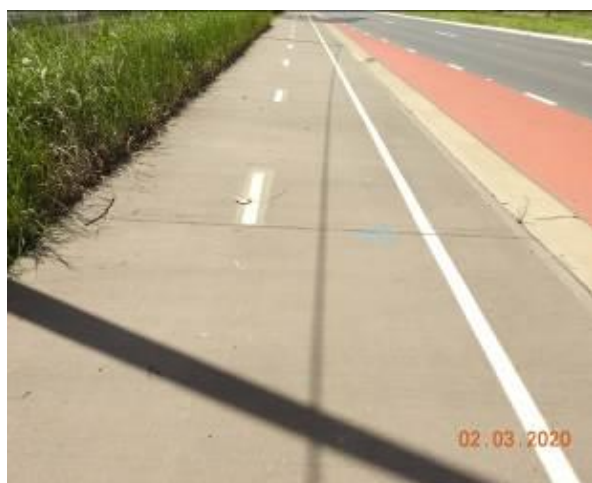
Figure 1375 – General Condition of footpath pavement

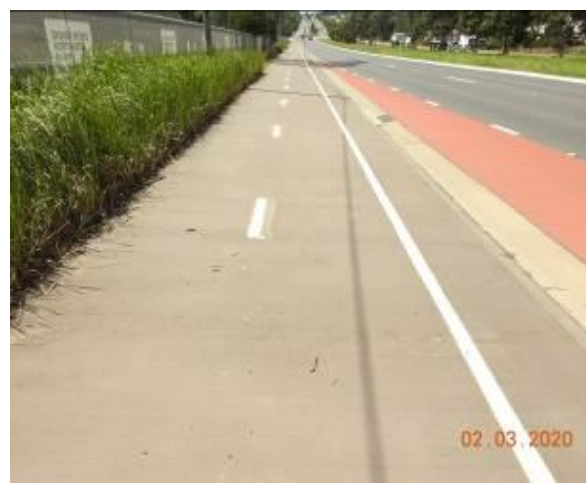
Figure 1376 – General Condition of footpath pavement

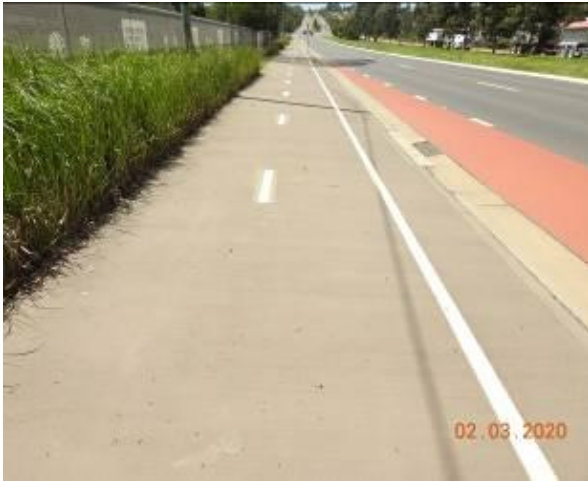
Figure 1377 – General Condition of footpath pavement

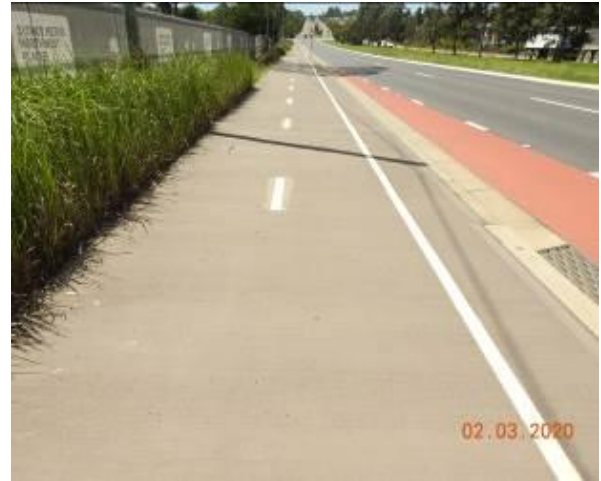
Figure 1378 – General Condition of footpath pavement

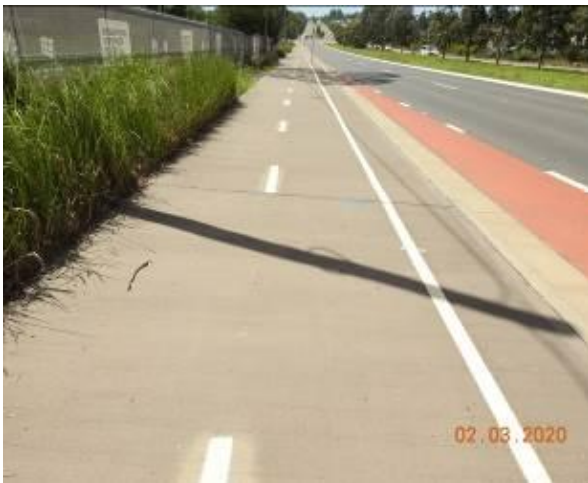
Figure 1379 – General Condition of footpath pavement

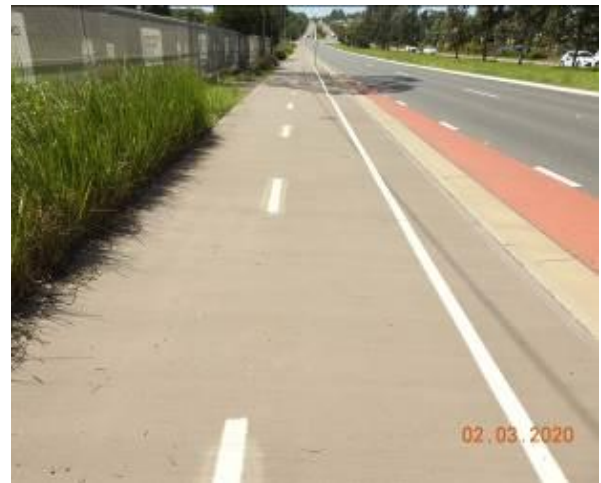
Figure 1380 – General Condition of footpath pavement

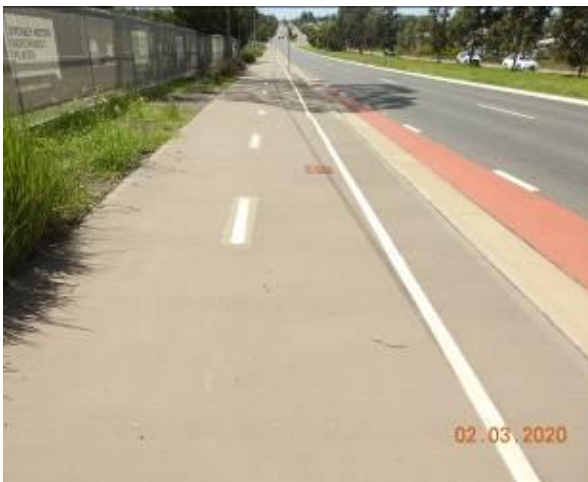
Figure 1381 – General Condition of footpath pavement

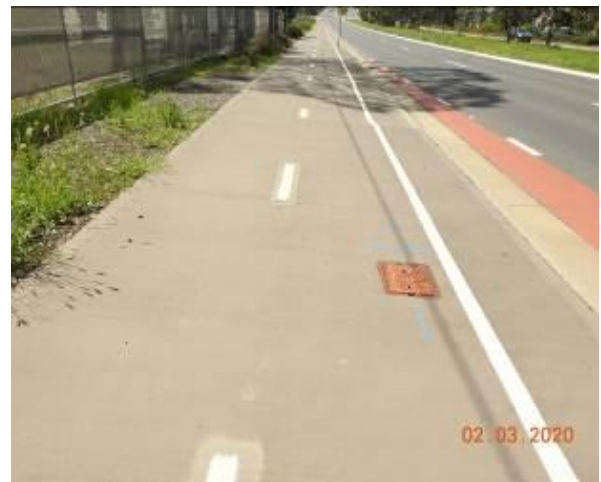
Figure 1382 – General Condition of footpath pavement

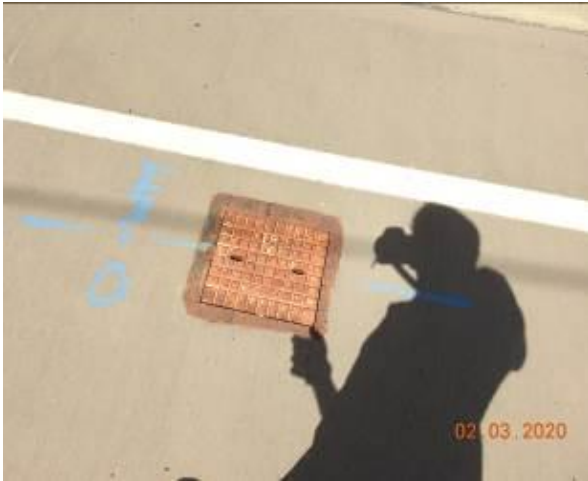
Figure 1383 – General Condition of footpath pavement

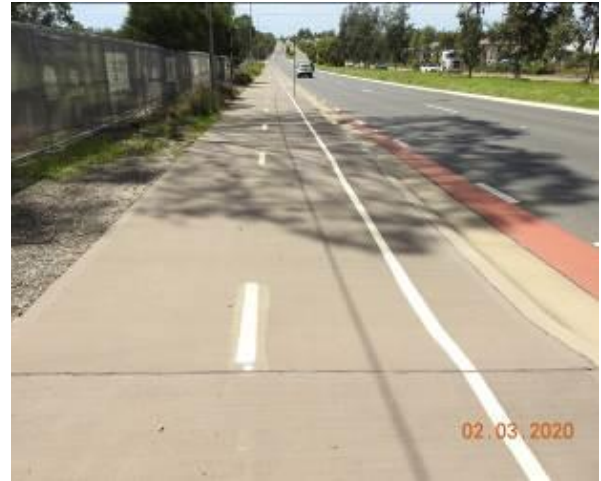
Figure 1384 – General Condition of service pit

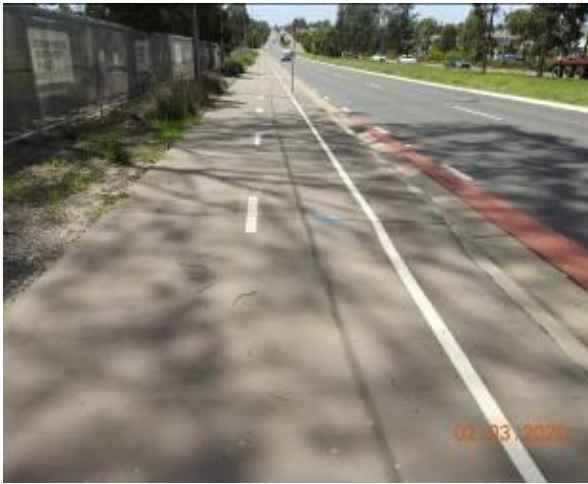
Figure 1385 – General Condition of footpath pavement

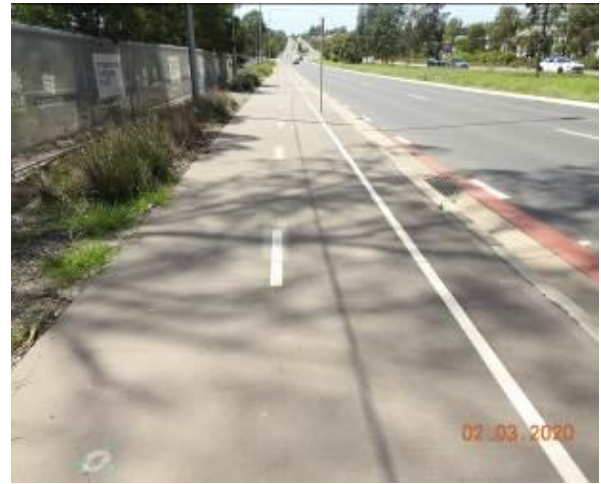
Figure 1386 – General Condition of footpath pavement

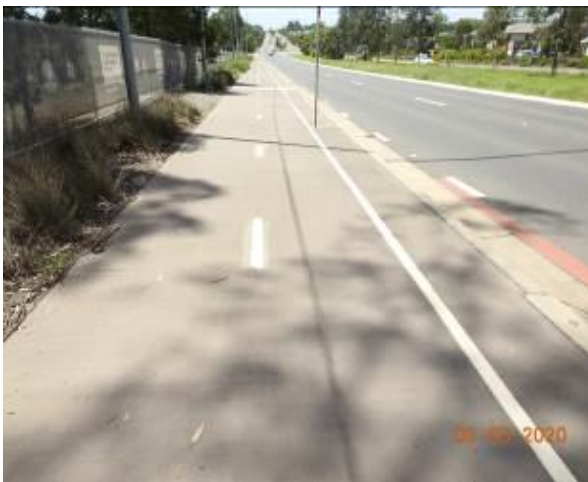
Figure 1387 – General Condition of footpath pavement

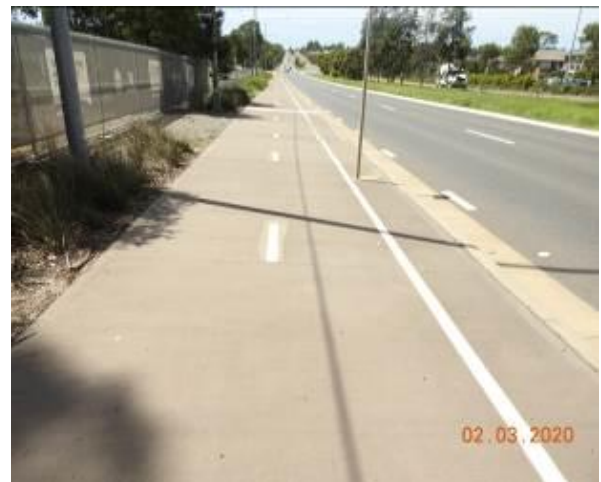
Figure 1388 – General Condition of footpath pavement

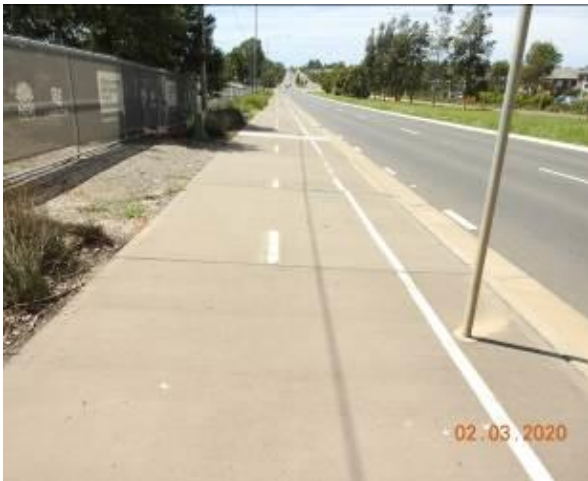
Figure 1389 – General Condition of footpath pavement

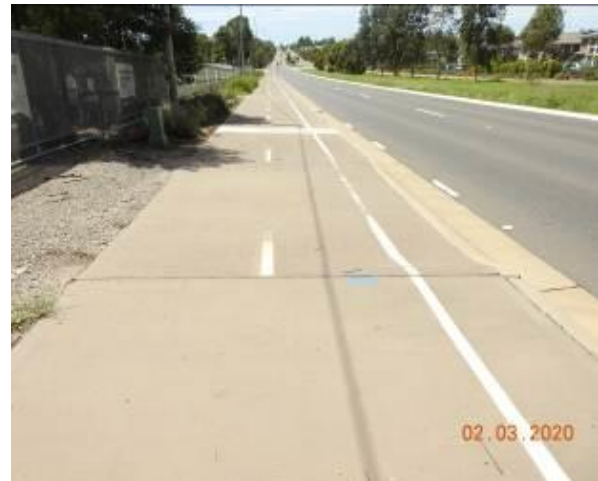
Figure 1390 – General Condition of footpath pavement

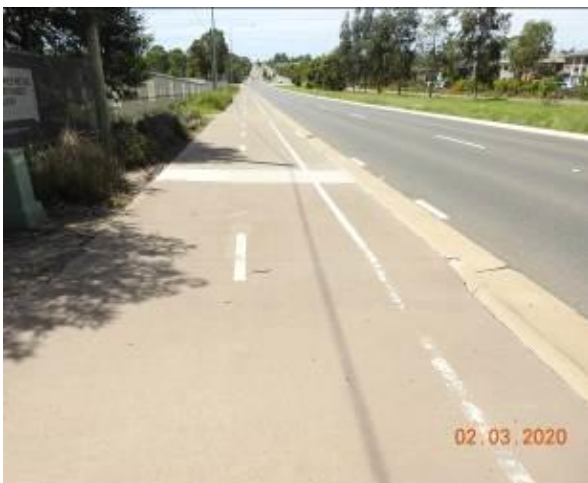
Figure 1391 – General Condition of footpath pavement

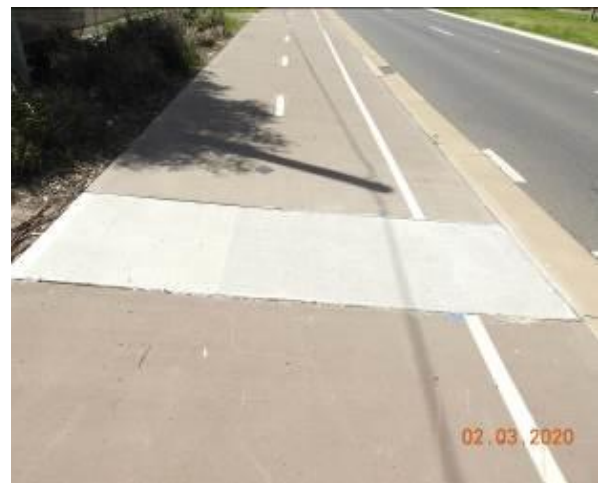
Figure 1392 – General Condition of footpath pavement

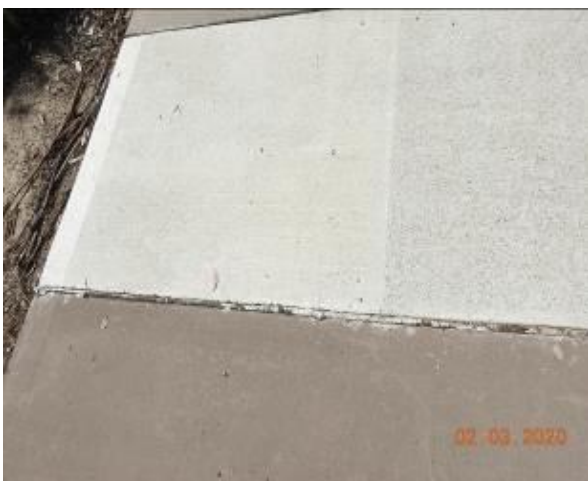
Figure 1393 – Evidence of patchwork through footpath pavement

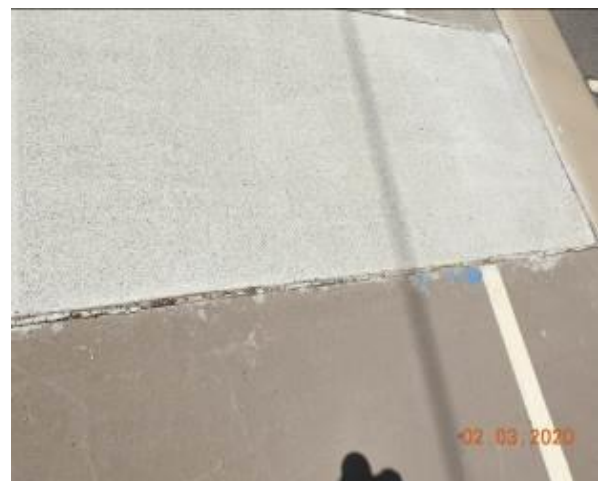
Figure 1394 – Crack propagation through footpath pavement

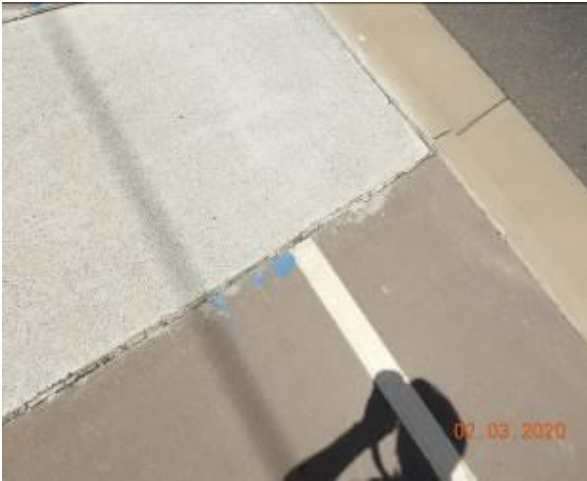
Figure 1395 – Crack propagation through footpath pavement

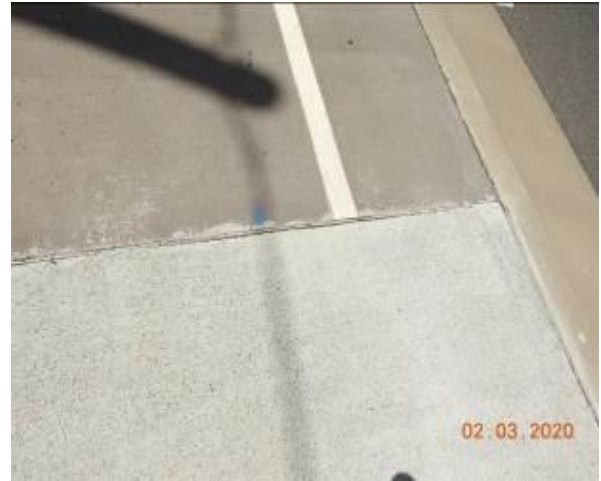
Figure 1396 – Crack propagation through footpath pavement

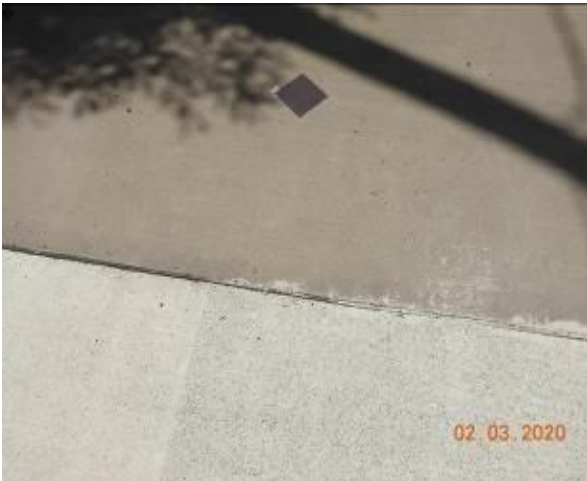
Figure 1397 – Crack propagation through footpath pavement

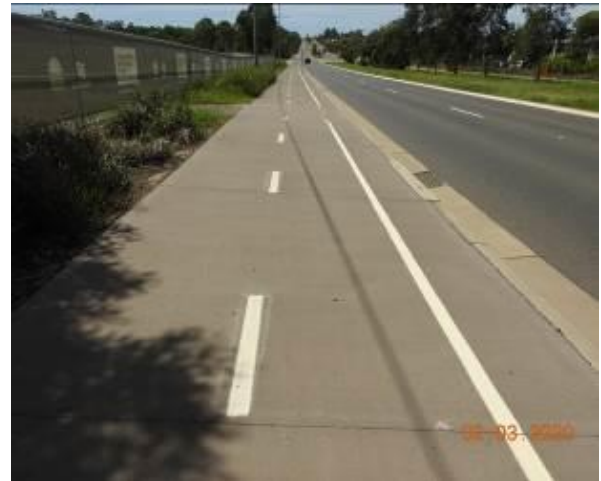
Figure 1398 – Crack propagation through footpath pavement

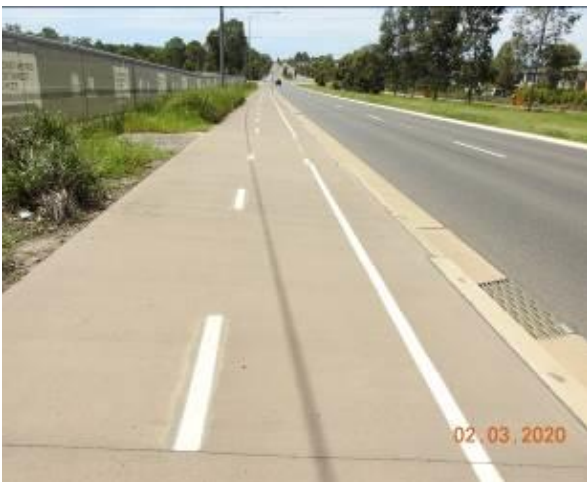
Figure 1399 – General Condition of footpath pavement

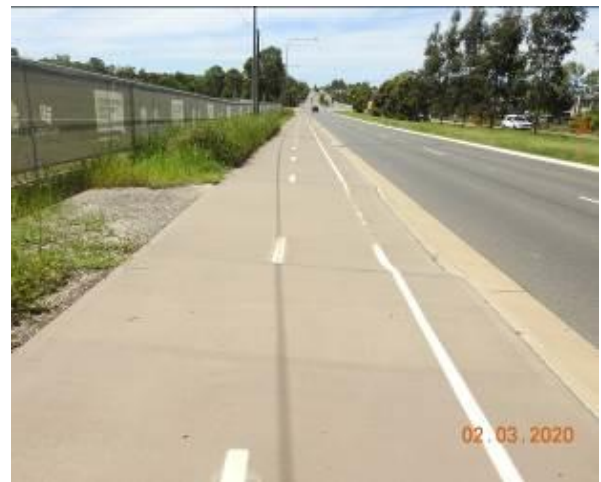
Figure 1400 – General Condition of footpath pavement

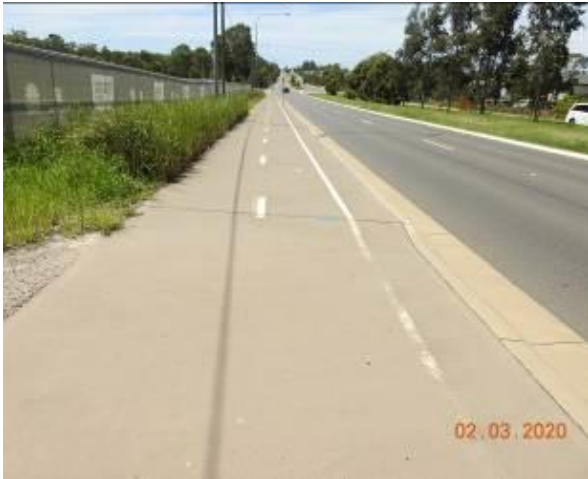
Figure 1401 – General Condition of footpath pavement

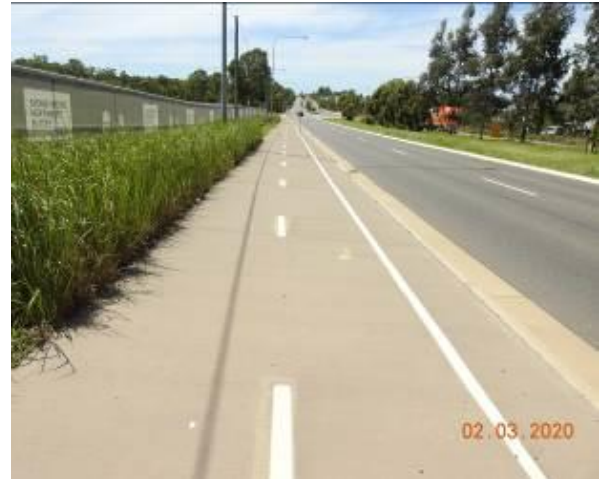
Figure 1402 – General Condition of footpath pavement

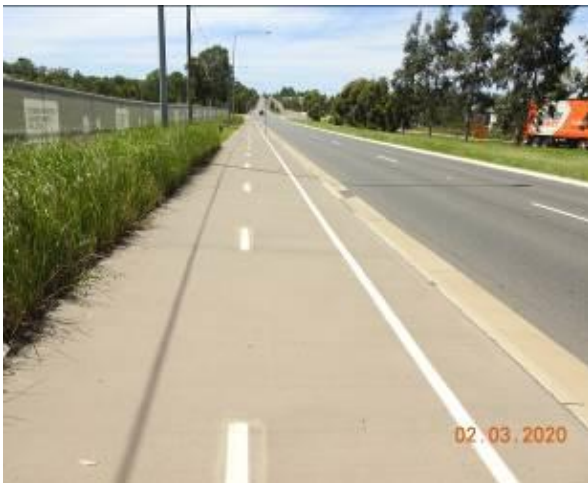
Figure 1403 – General Condition of footpath pavement

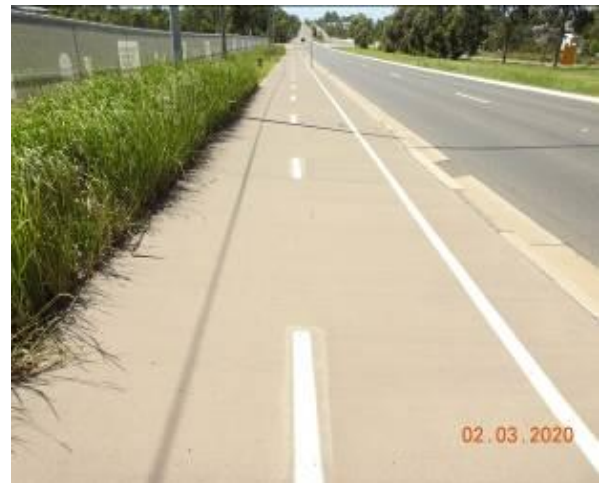
Figure 1404 – General Condition of footpath pavement

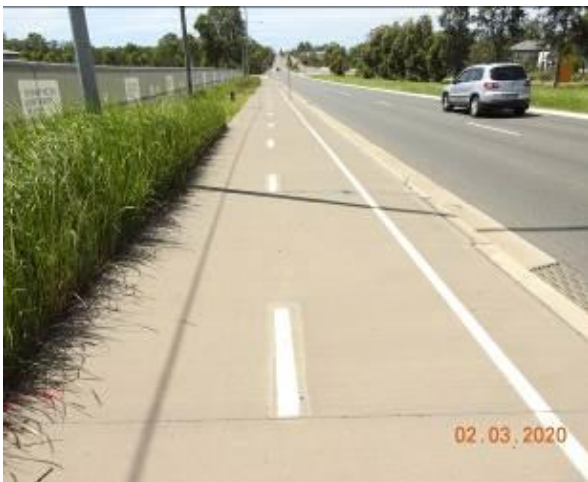
Figure 1405 – General Condition of footpath pavement

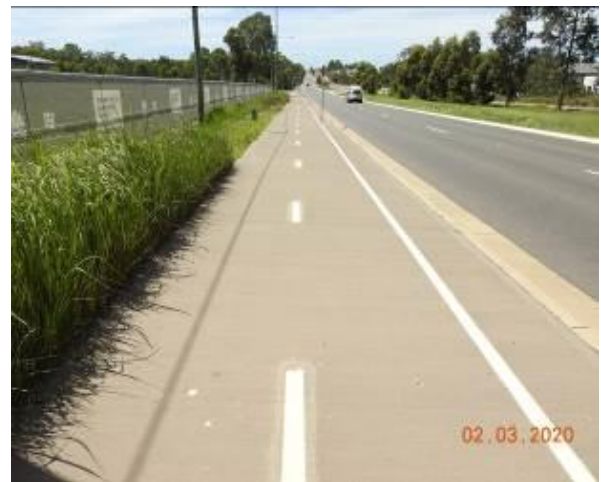
Figure 1406 – General Condition of footpath pavement

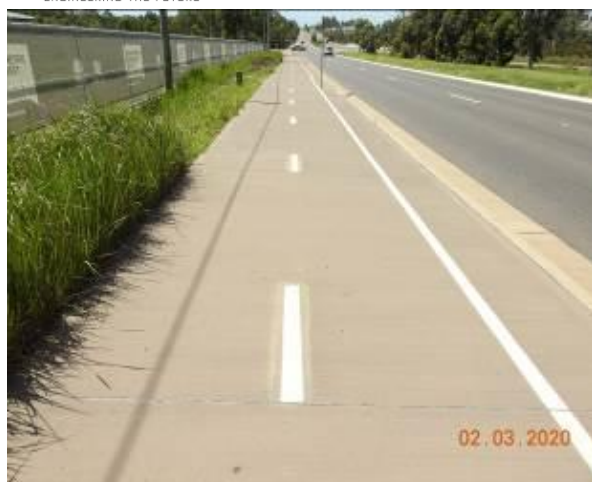
Figure 1407 – General Condition of footpath pavement

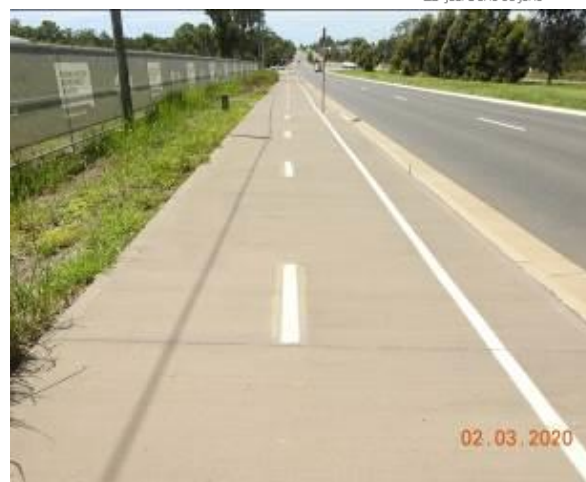
Figure 1408 – General Condition of footpath pavement

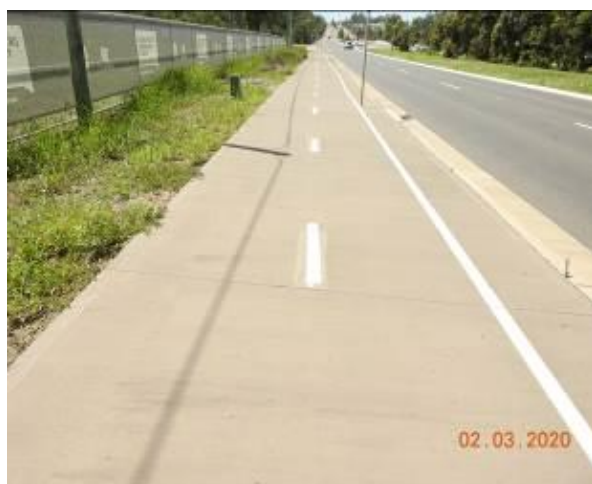
Figure 1409 – General Condition of footpath pavement

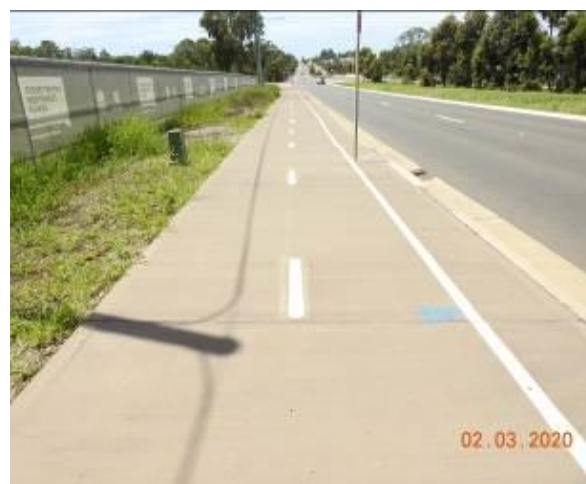
Figure 1410 – General Condition of footpath pavement

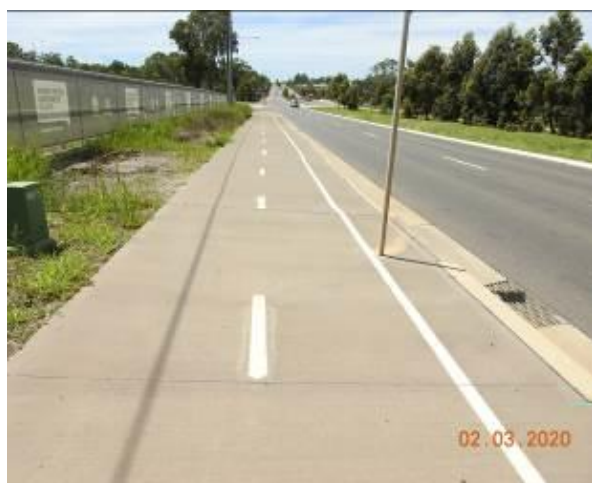
Figure 1411 – General Condition of footpath pavement

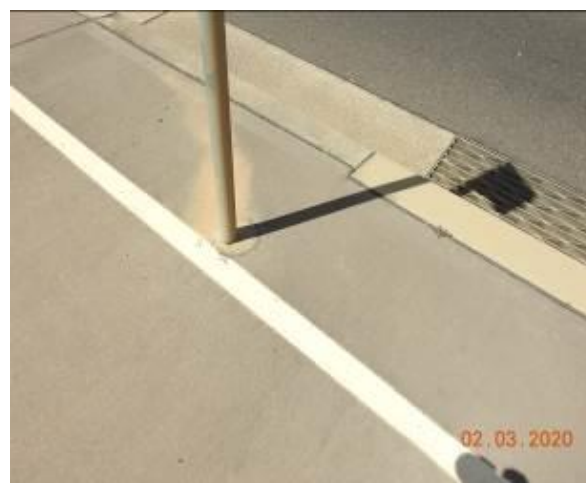
Figure 1412 – General Condition of footpath pavement

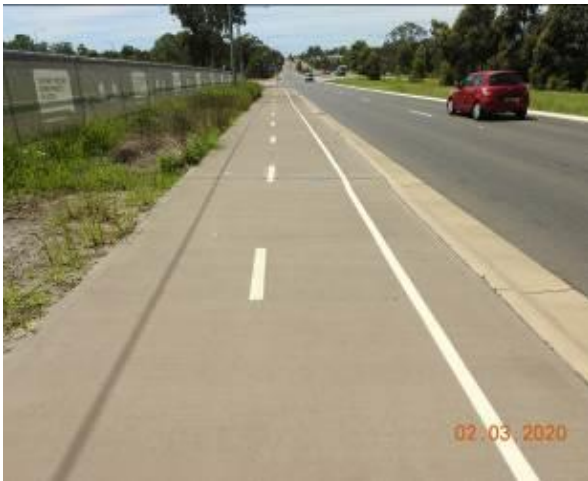
Figure 1413 – Evidence of patchwork through footpath pavement

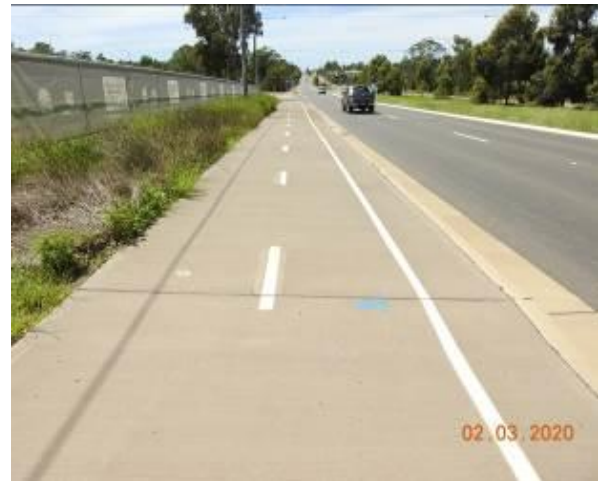
Figure 1414 – General Condition of footpath pavement

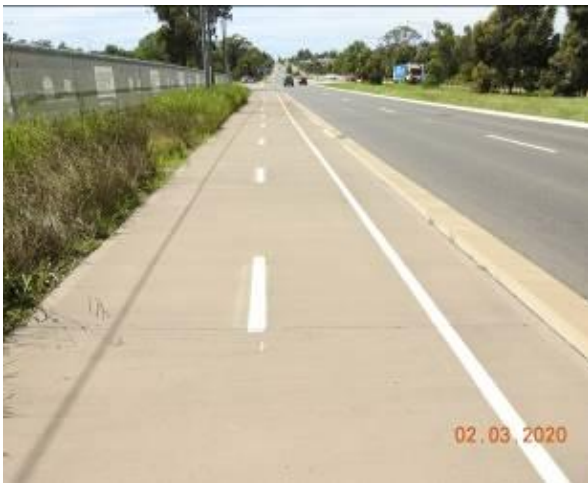
Figure 1415 – General Condition of footpath pavement

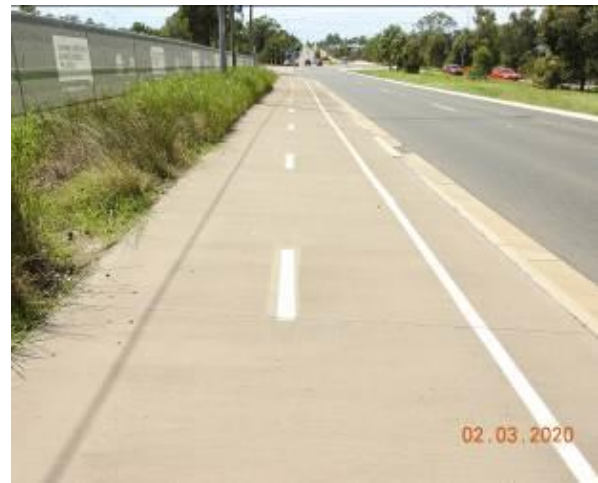
Figure 1416 – General Condition of footpath pavement

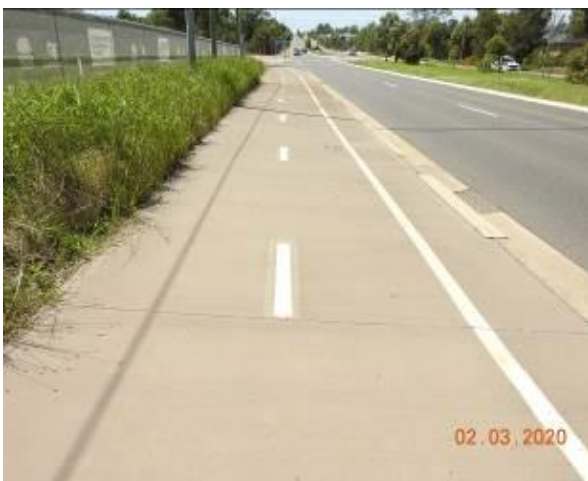
Figure 1417 – General Condition of footpath pavement

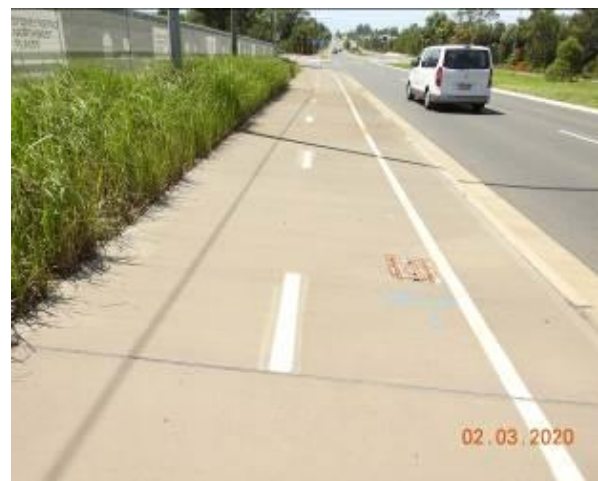
Figure 1418 – General Condition of footpath pavement

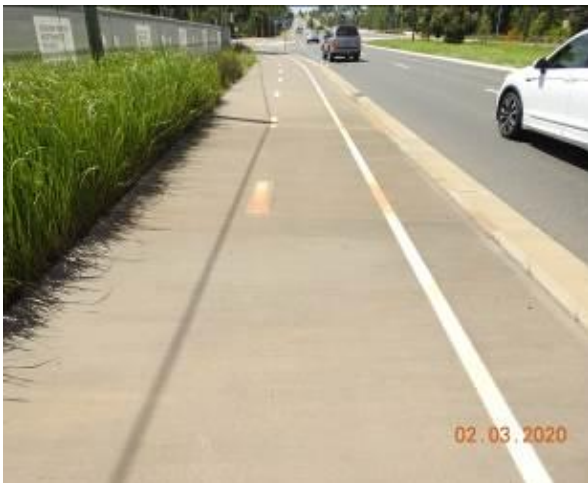
Figure 1421 – General Condition of footpath pavement

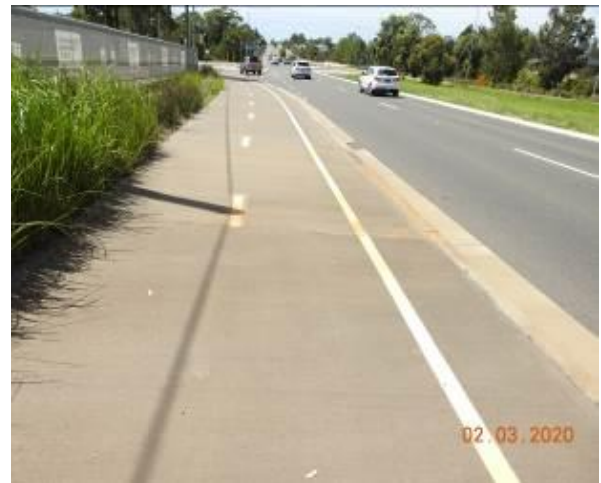
Figure 1422 – General Condition of footpath pavement

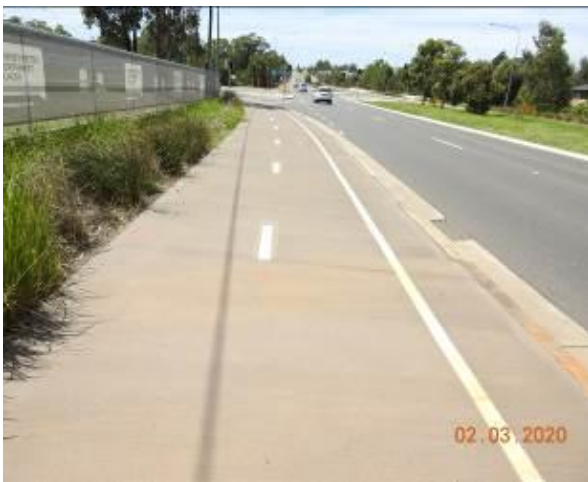
Figure 1423 – General Condition of footpath pavement

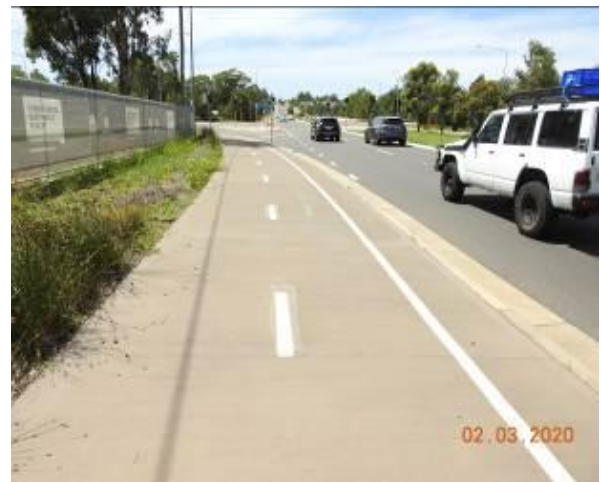
Figure 1424 – General Condition of footpath pavement

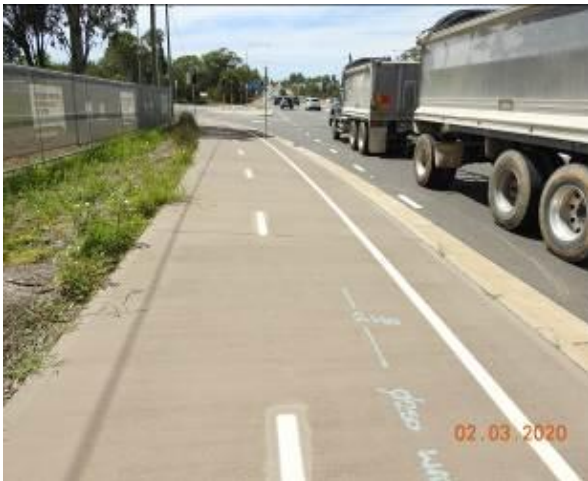
Figure 1426 – General Condition of footpath pavement

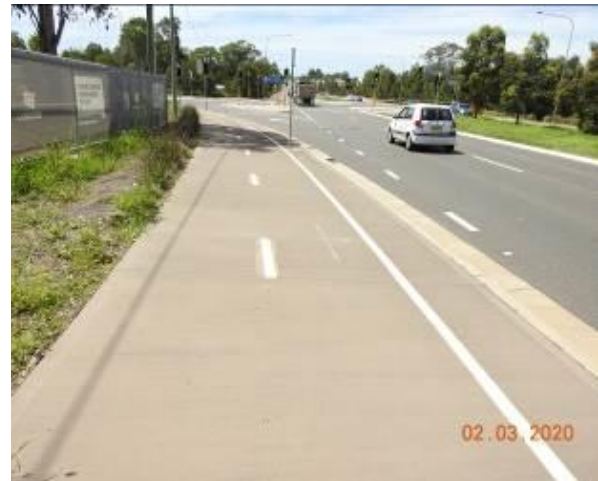
Figure 1427 – General Condition of footpath pavement

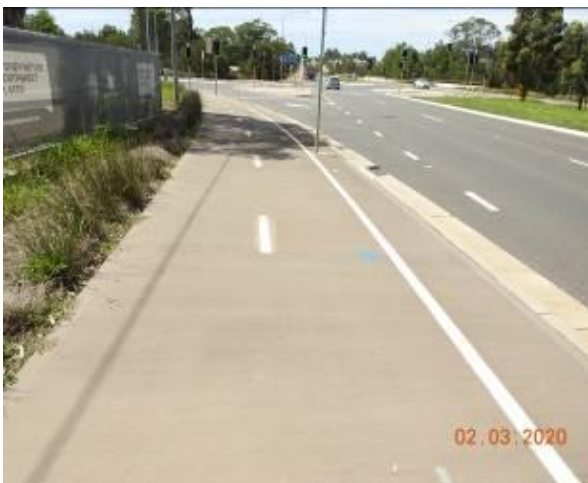
Figure 1428 – General Condition of footpath pavement

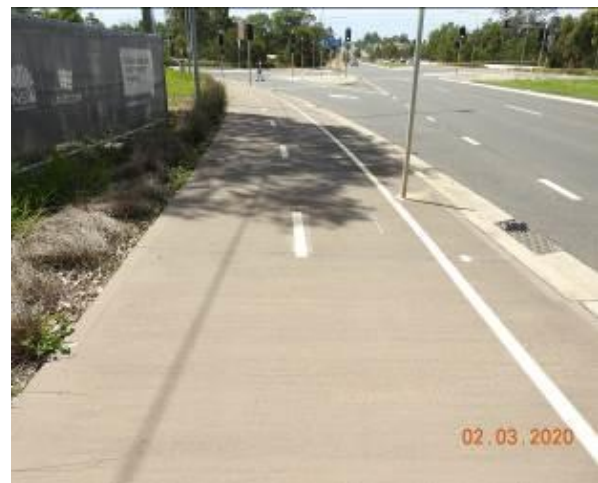
Figure 1429 – General Condition of footpath pavement

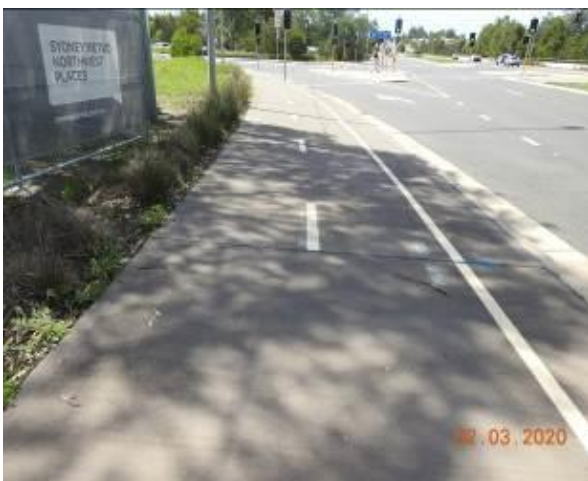
Figure 1430 – General Condition of footpath pavement

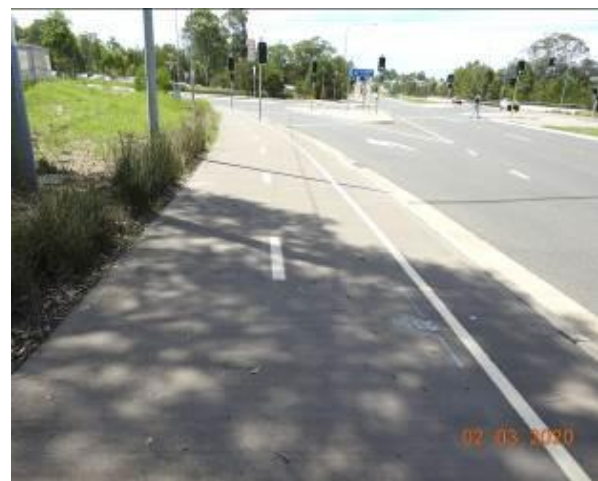
Figure 1431 – General Condition of footpath pavement

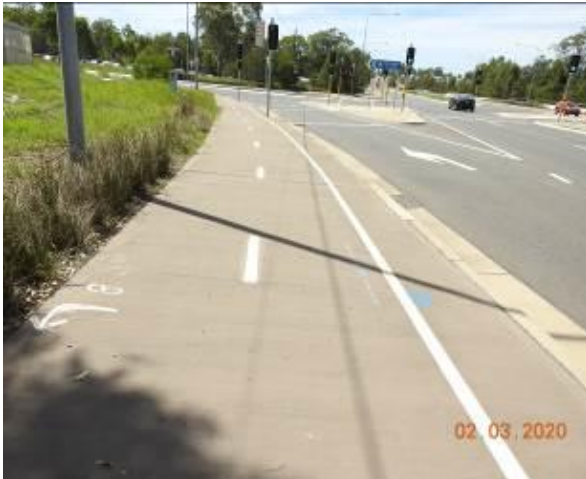
Figure 1432 – General Condition of footpath pavement

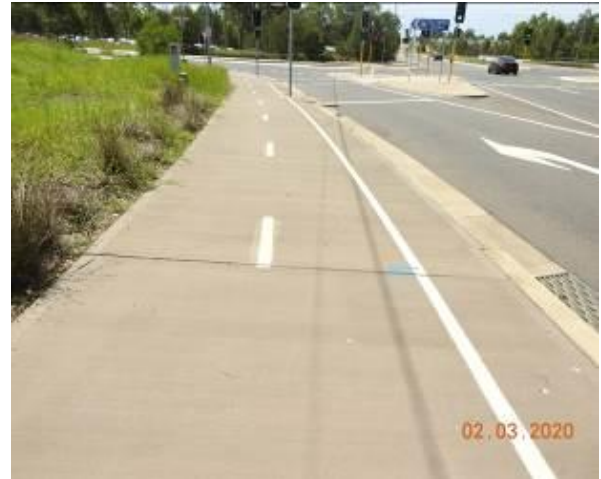
Figure 1433 – General Condition of footpath pavement

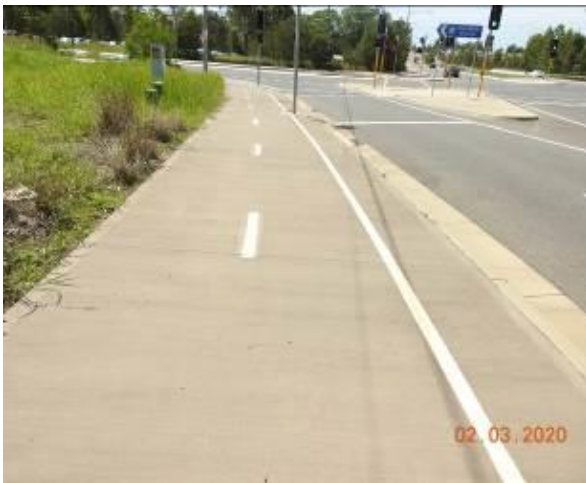
Figure 1434 – General Condition of footpath pavement

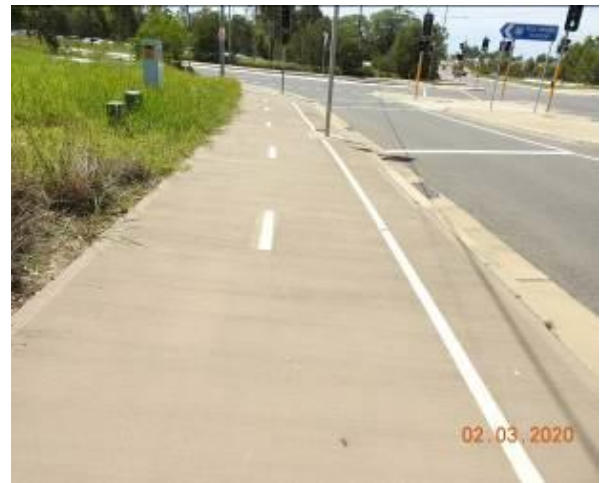
Figure 1435 – General Condition of footpath pavement

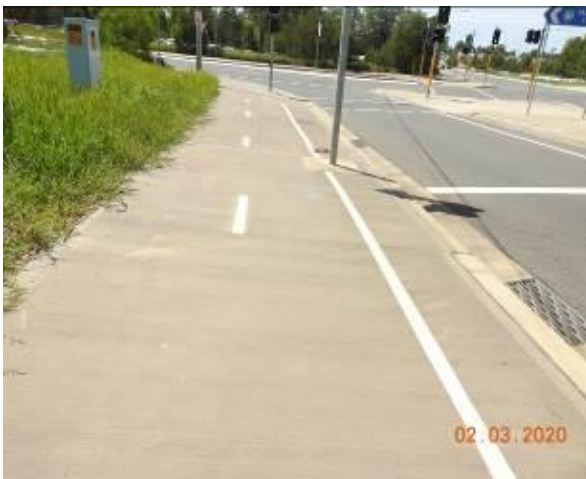
Figure 1436 – General Condition of footpath pavement
