**1-15 AND 2-12 CONFERTA AVENUE,  
ROUSE HILL NSW 2155  
TALLAWONG STATION PRECINCT SOUTH  
PRE-DILAPIDATION REPORT**

**DEICORP PROJECTS  
(TALLAWONG STATION) PTY LTD**

Job No. 191294.0  
05/07/2021

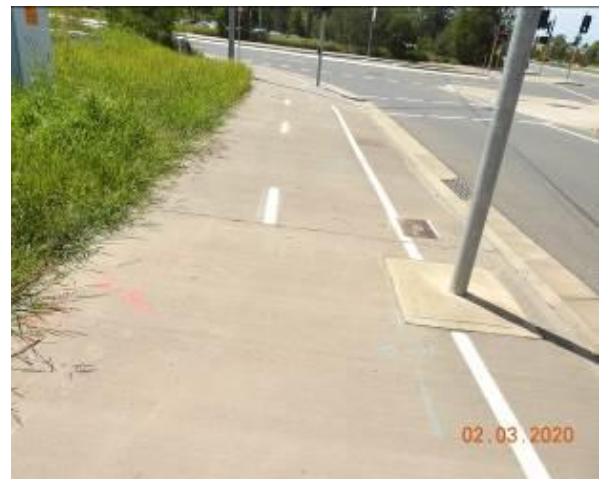
Figure 1437 – General Condition of footpath pavement

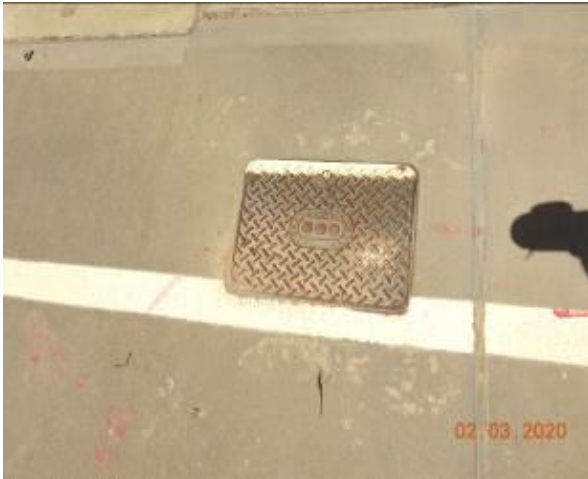
Figure 1438 – General Condition of service pit

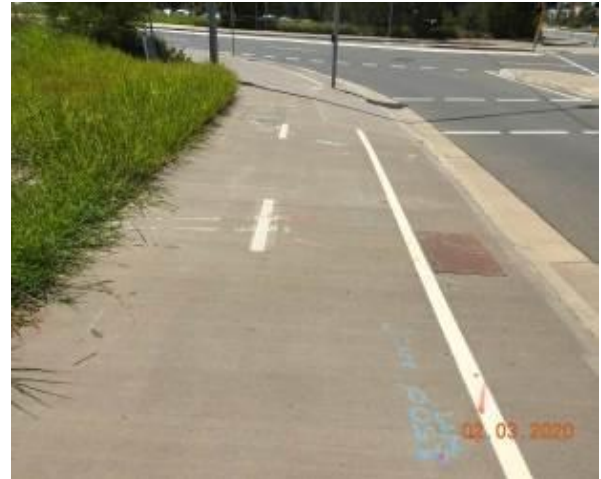
Figure 1439 – General Condition of footpath pavement

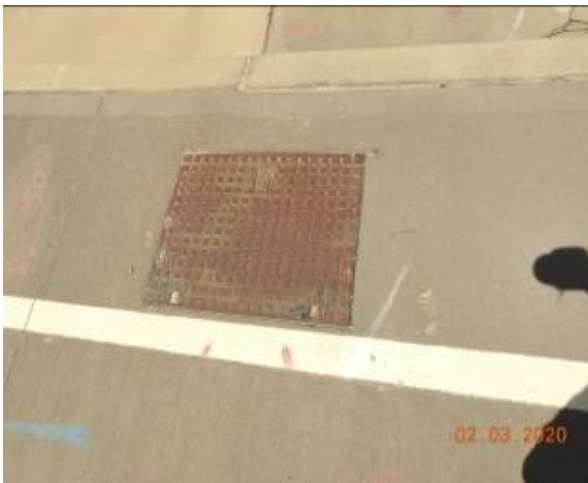
Figure 1440 – General Condition of service pit

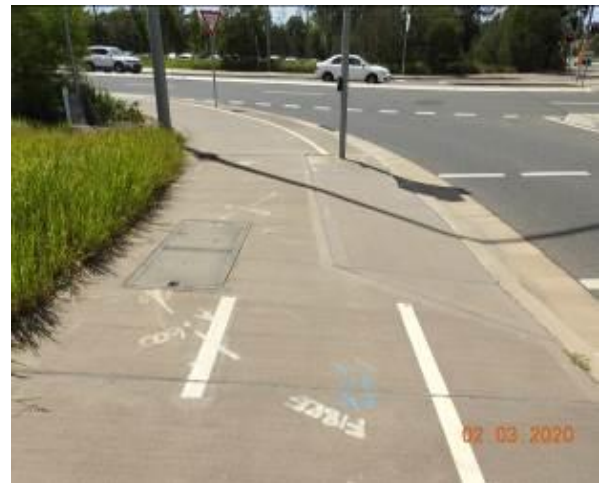
Figure 1441 – General Condition of footpath pavement

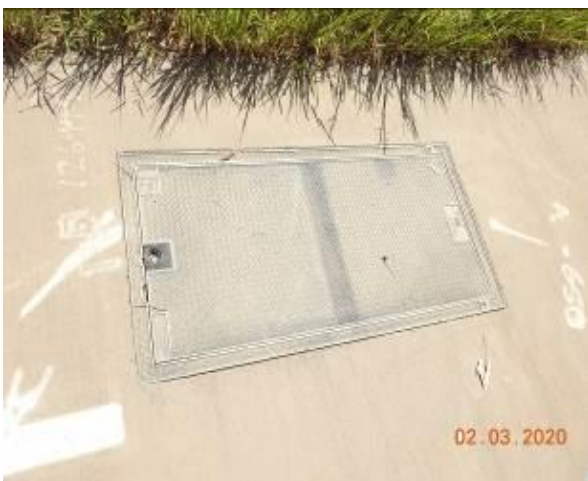
Figure 1442 – General Condition of service pit

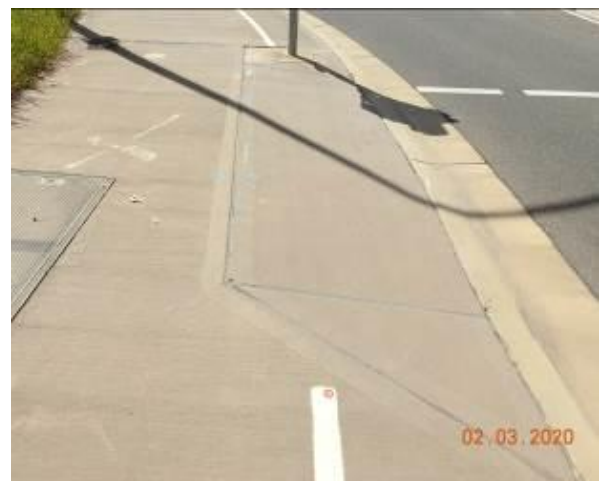
Figure 1443 – General Condition of footpath pavement

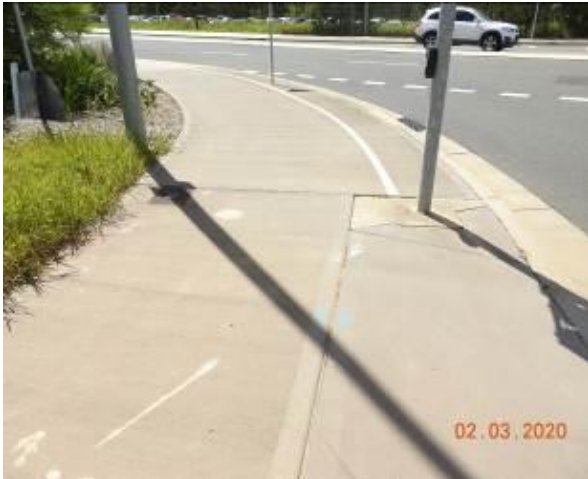
Figure 1444 – General Condition of footpath pavement

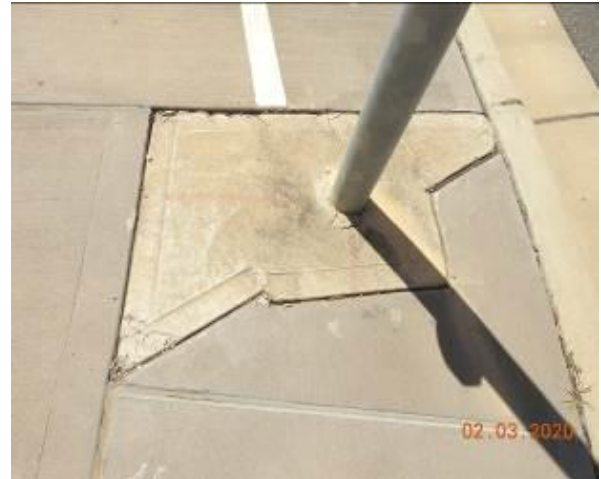
Figure 1445 – Crack propagation and loss of material through footpath pavement

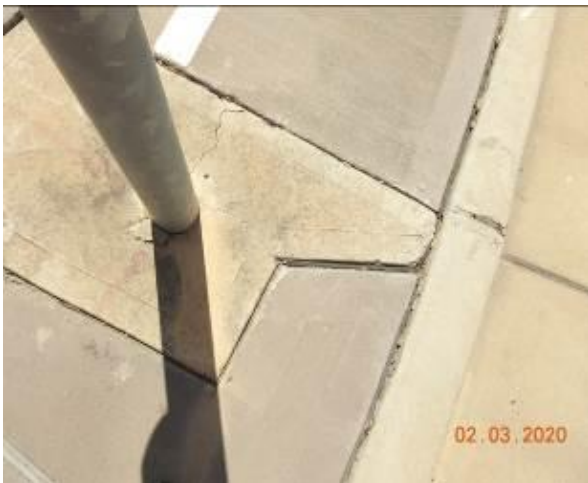
Figure 1446 – Crack propagation through footpath pavement

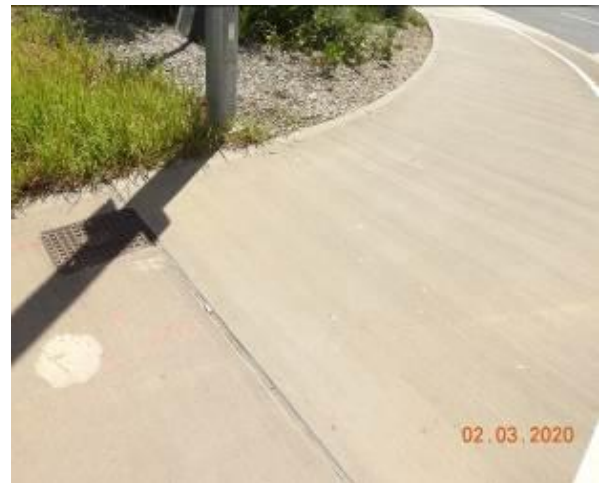
Figure 1447 – General Condition of footpath pavement

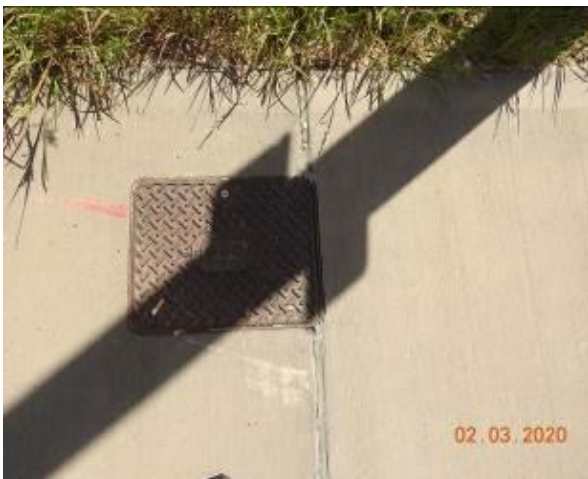
Figure 1448 – General Condition of service pit

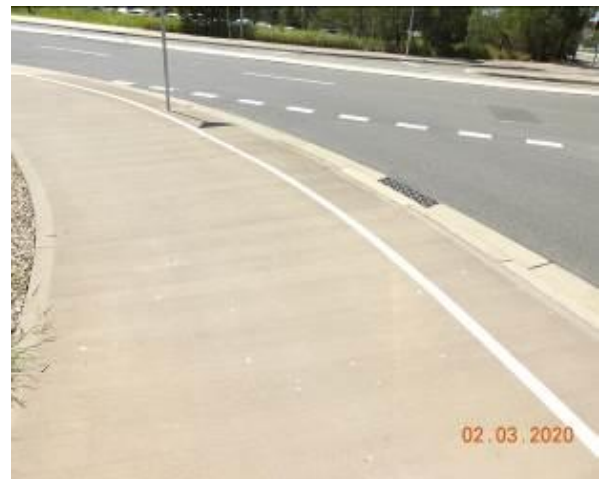
Figure 1449 – General Condition of footpath pavement

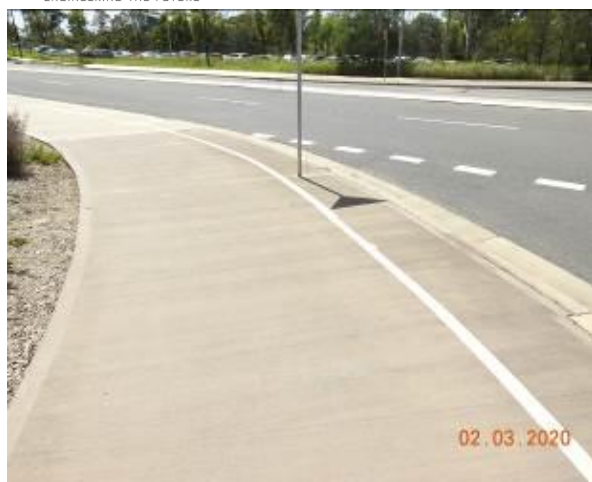
Figure 1450 – General Condition of footpath pavement

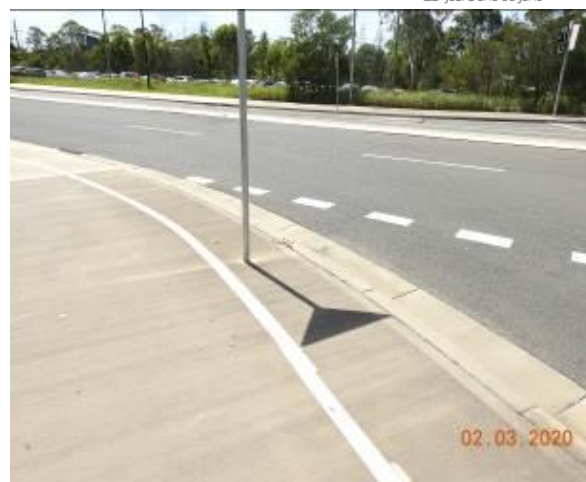
Figure 1451 – General Condition of footpath pavement

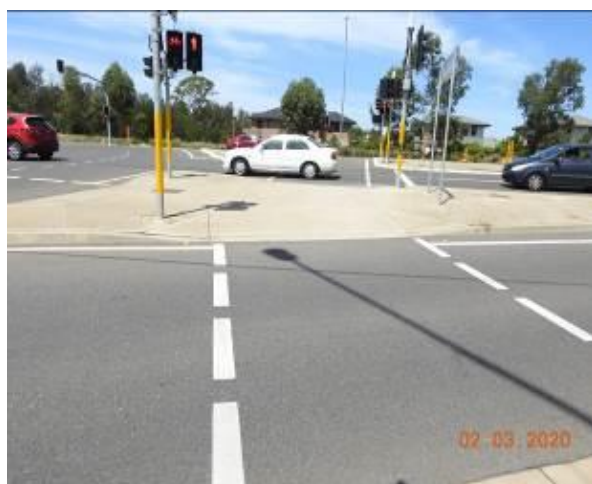
Figure 1452 – General Condition of footpath pavement

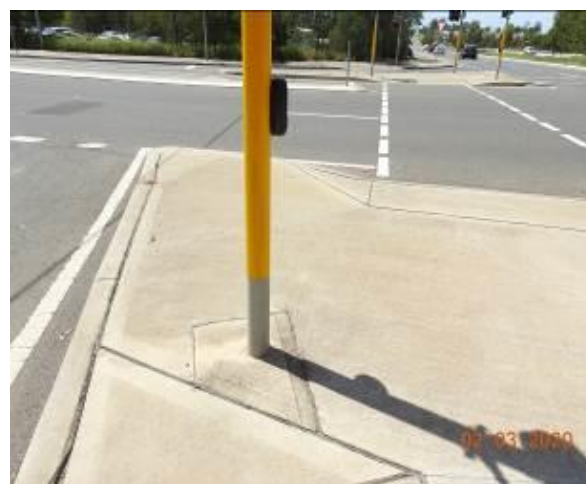
Figure 1453 – General Condition of footpath pavement

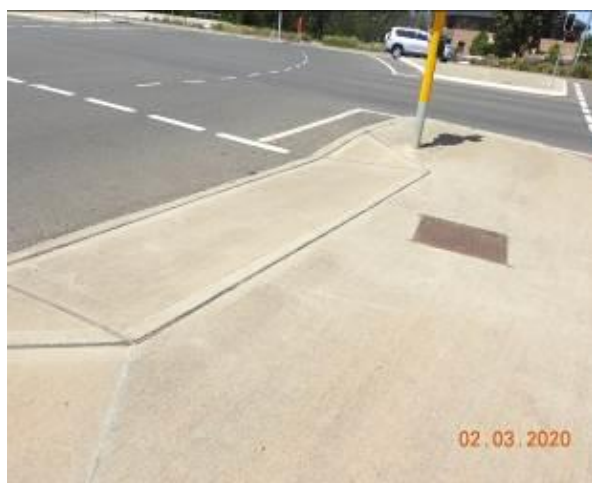
Figure 1454 – General Condition of footpath pavement

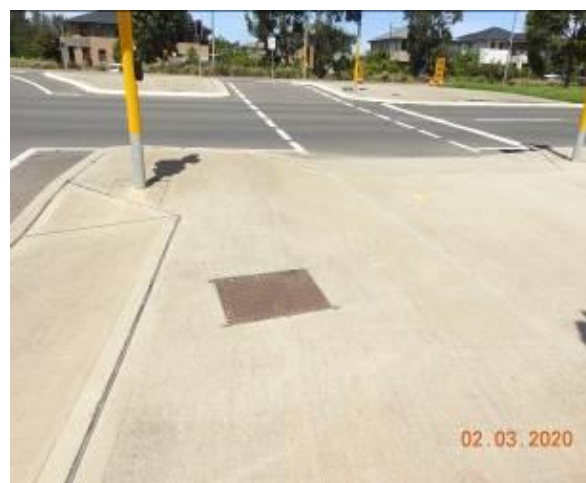
Figure 1455 – General Condition of footpath pavement

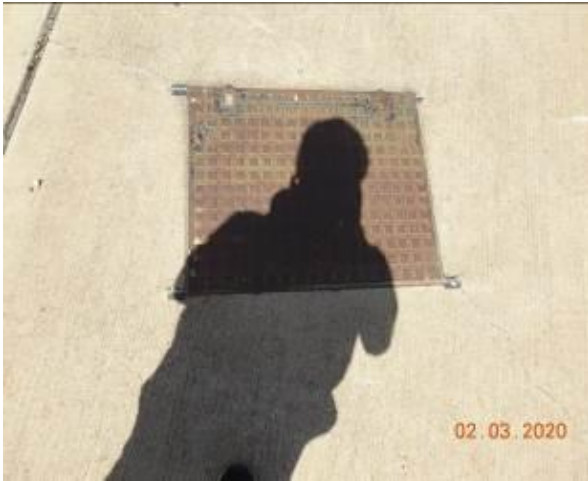
Figure 1456 – Crack propagation through service pit

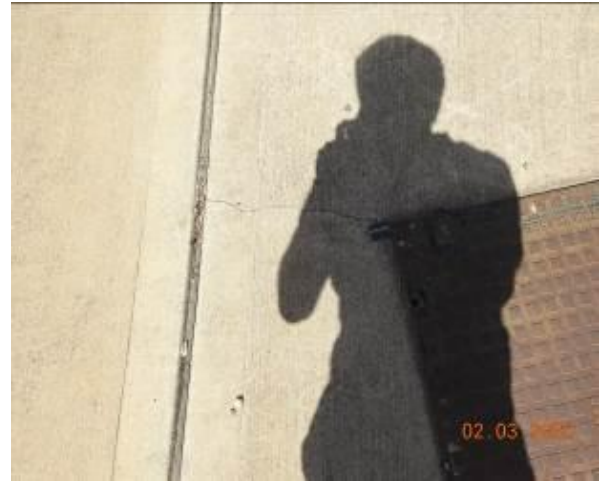
Figure 1457 – Crack propagation through footpath pavement

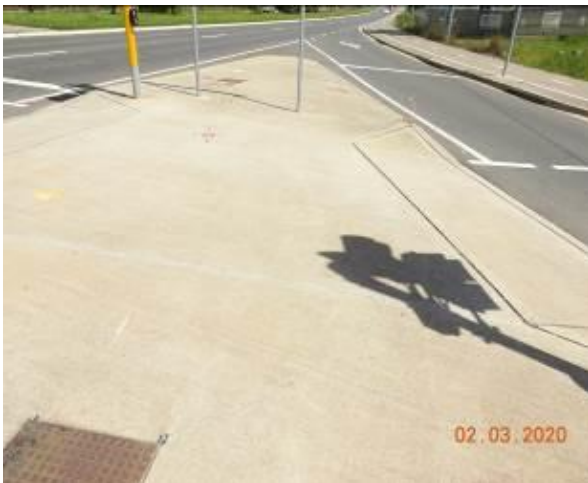
Figure 1458 – General Condition of footpath pavement

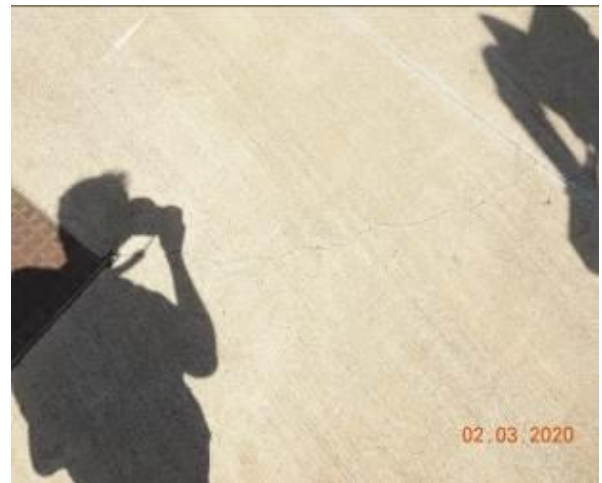
Figure 1459 – Crack propagation through footpath pavement

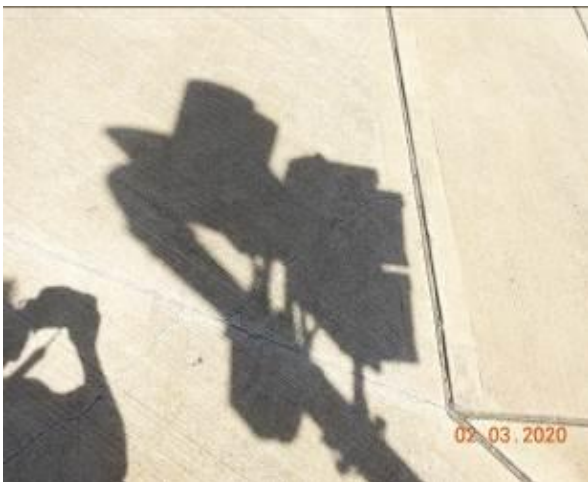
Figure 1460 – Crack propagation through footpath pavement

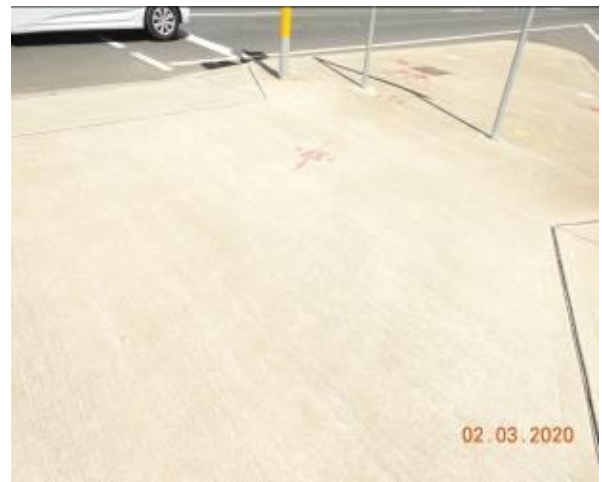
Figure 1461 – General Condition of footpath pavement

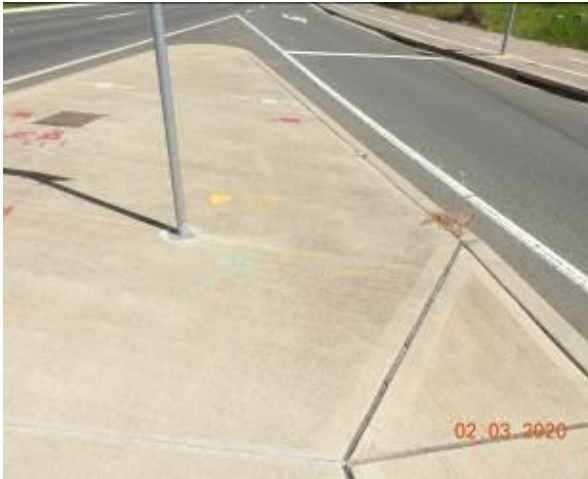
Figure 1462 – General Condition of footpath pavement

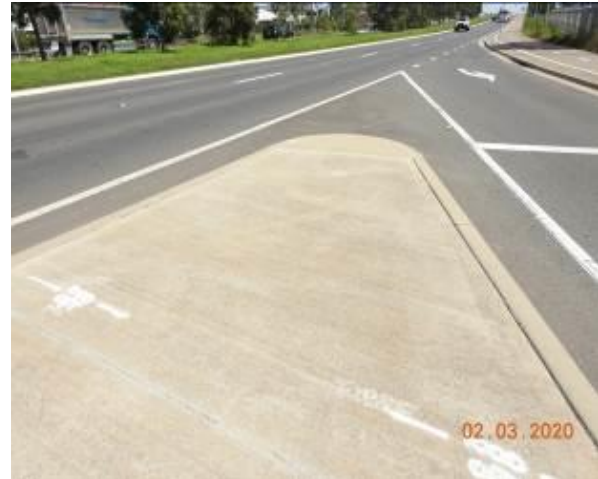
Figure 1463 – General Condition of footpath pavement

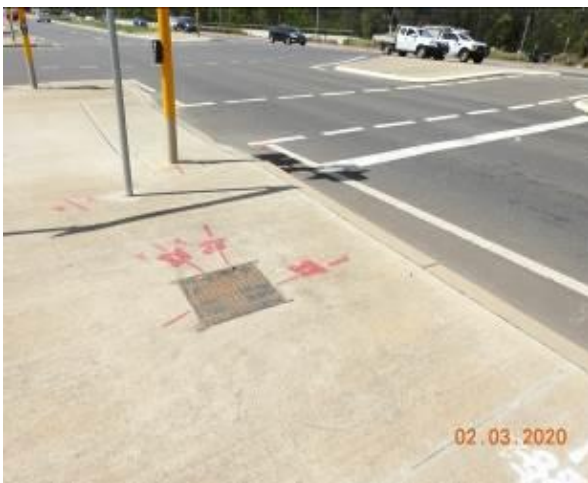
Figure 1464 – General Condition of footpath pavement

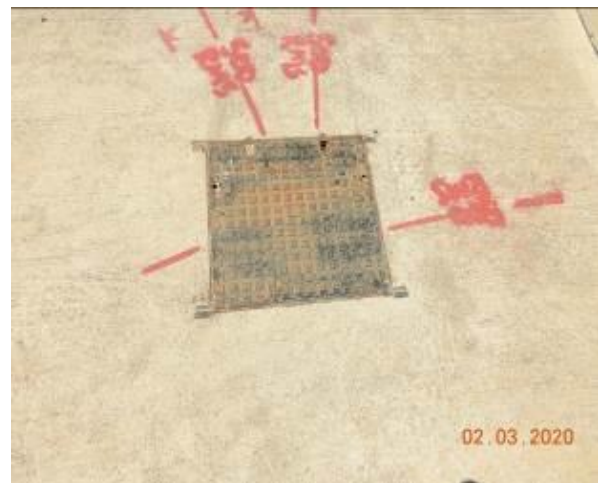
Figure 1465 – General Condition of General Condition of service pit

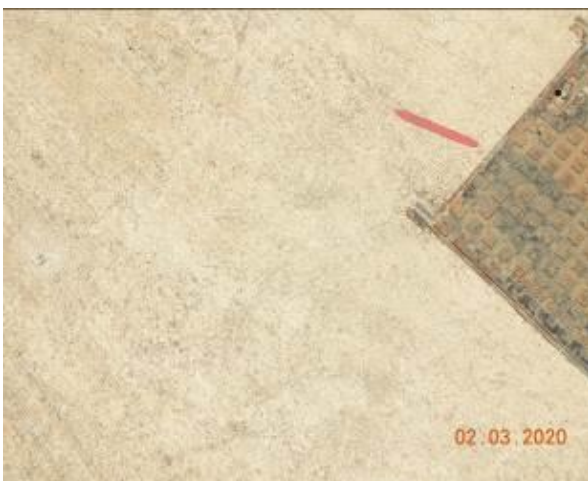
Figure 1466 – Crack propagation through footpath pavement

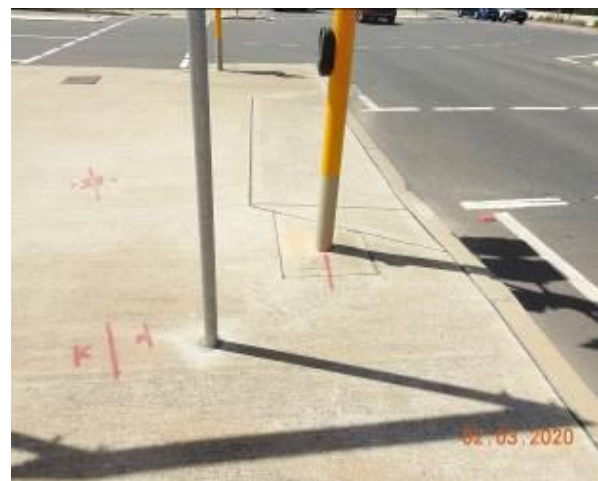
Figure 1467 – General Condition of footpath pavement
