The property Tallawong station – P2 Car Park, is the neighbouring property to our client’s site. It was photographed and inspected prior to any construction works on the subject site and was found to be in a reasonable condition. The property serves as a car park.

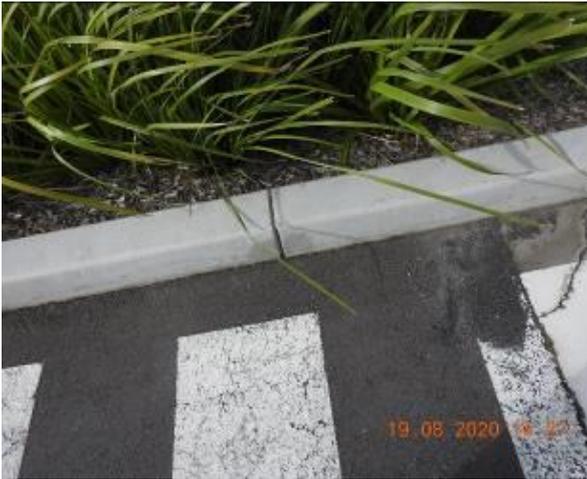
Figure 1197 – Crack propagation through car park kerb

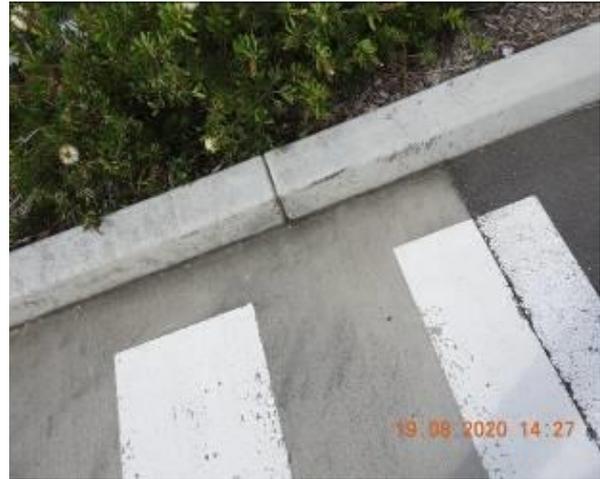
Figure 1198 – Crack propagation through car park kerb

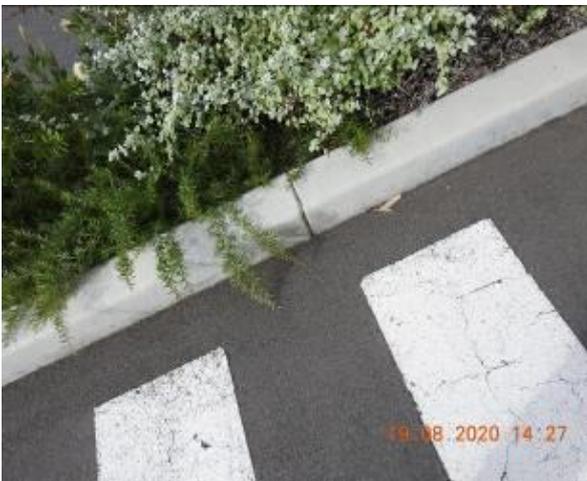
Figure 1199 – Crack propagation through car park kerb

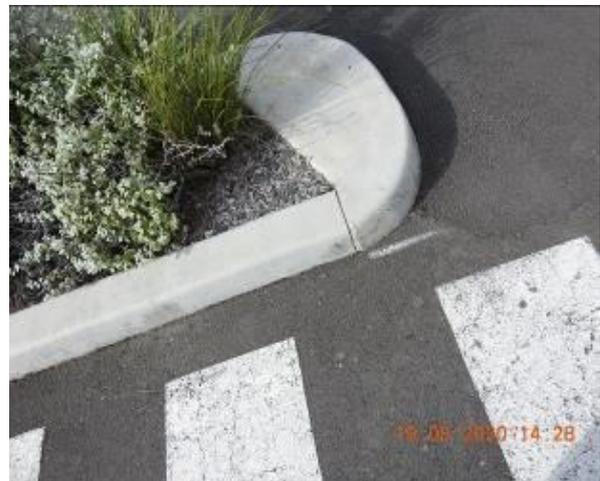
Figure 1200 – General condition of car park kerb

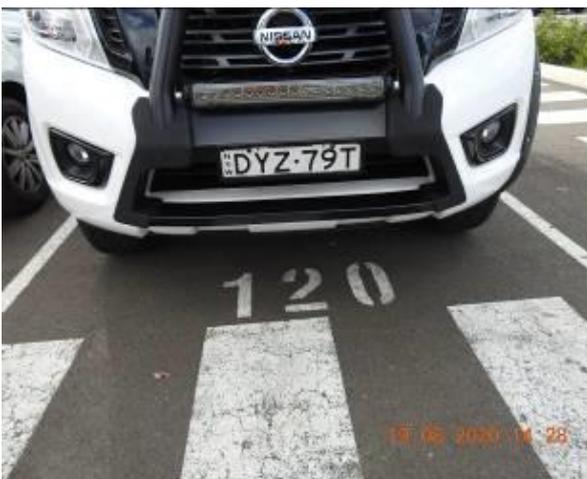
Figure 1201 – General condition of car park pavement

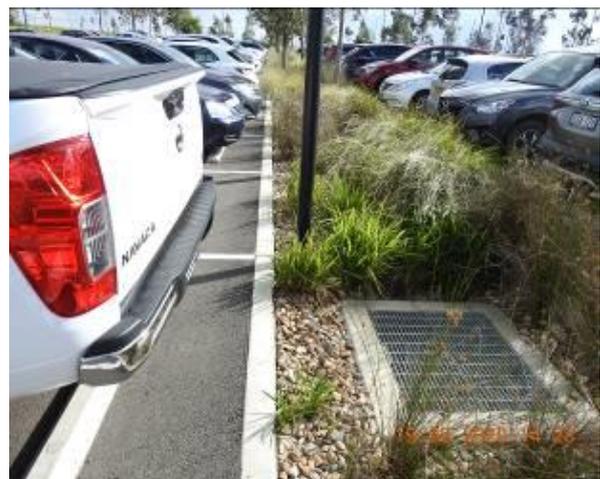
Figure 1202 – General condition of stormwater inlet pit

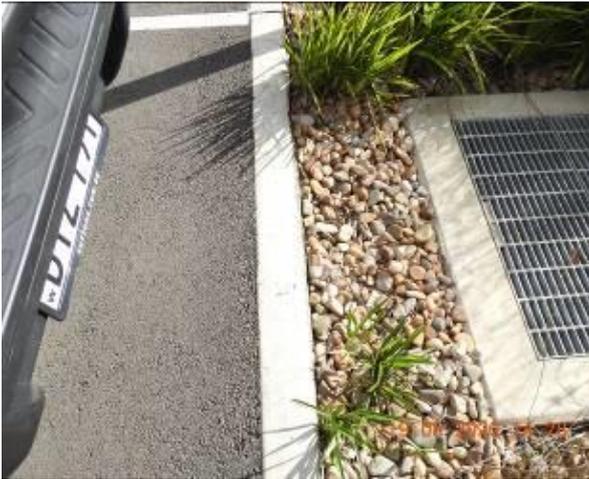
Figure 1203 – General condition of car park kerb

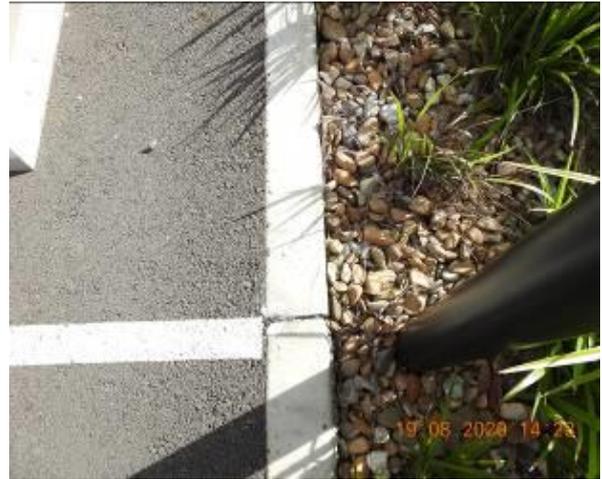
Figure 1204 – Crack propagation through car park kerb

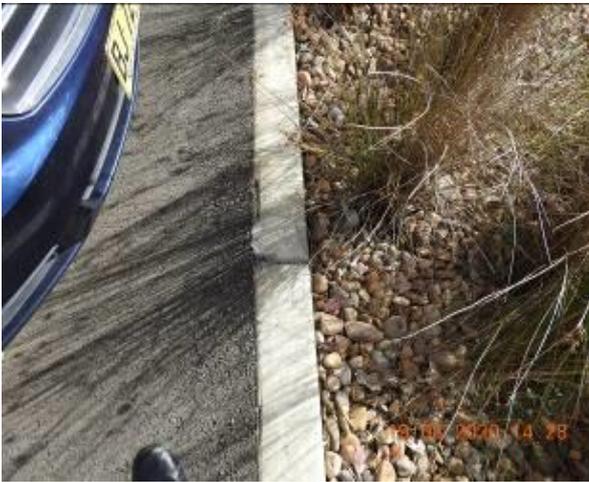
Figure 1205 – Crack propagation and loss of material through car park kerb

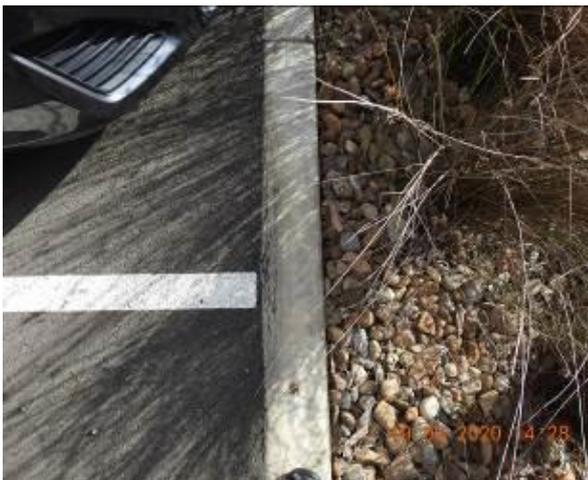
Figure 1207 – Crack propagation and loss of material through car park kerb

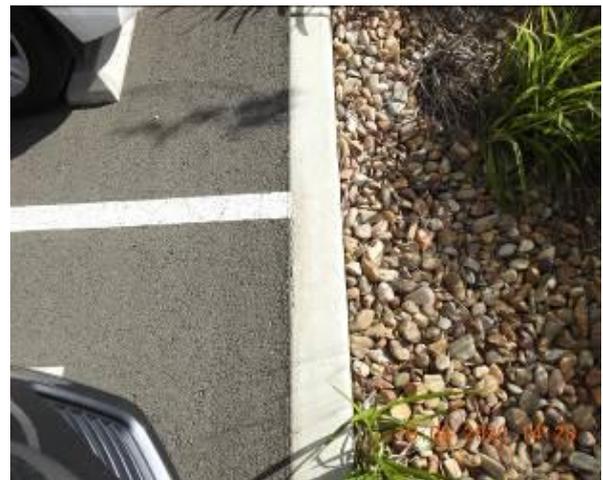
Figure 1208 – Crack propagation through car park kerb

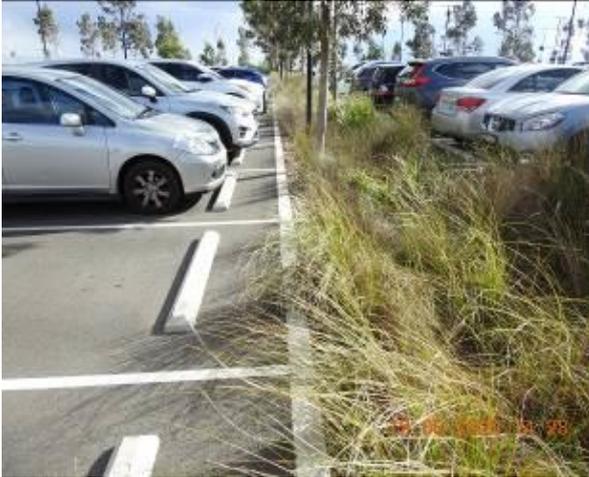
Figure 1209 – General condition of car park kerb

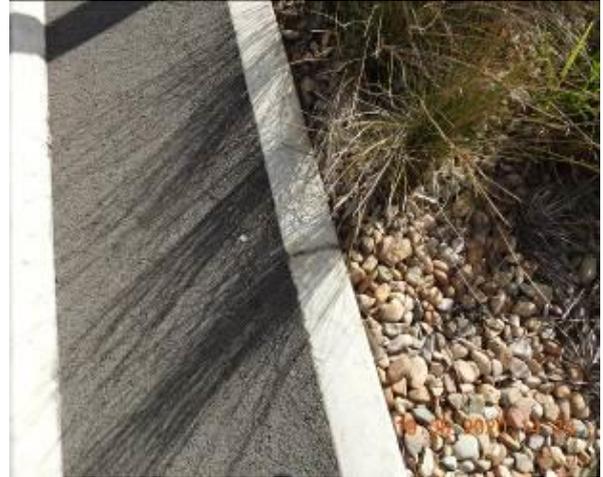
Figure 1210 – Crack propagation through car park kerb

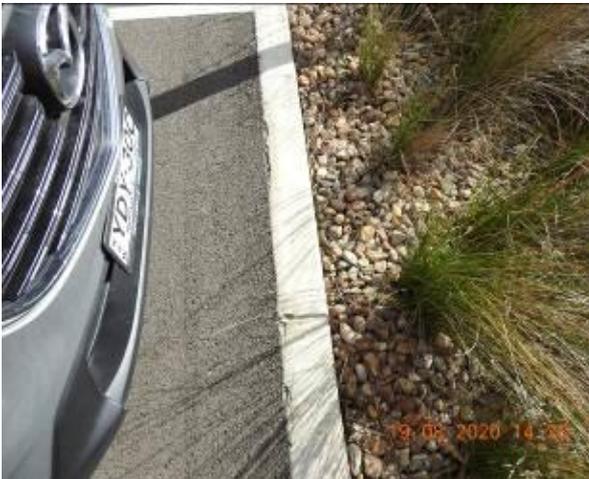
Figure 1211 – Crack propagation and loss of material through car park kerb

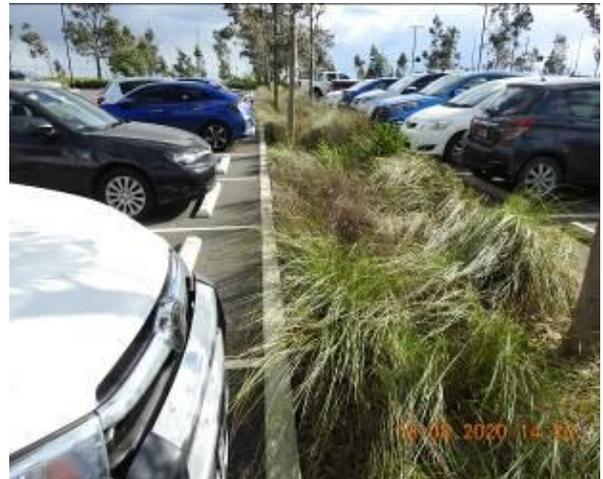
Figure 1212 – General condition of car park kerb

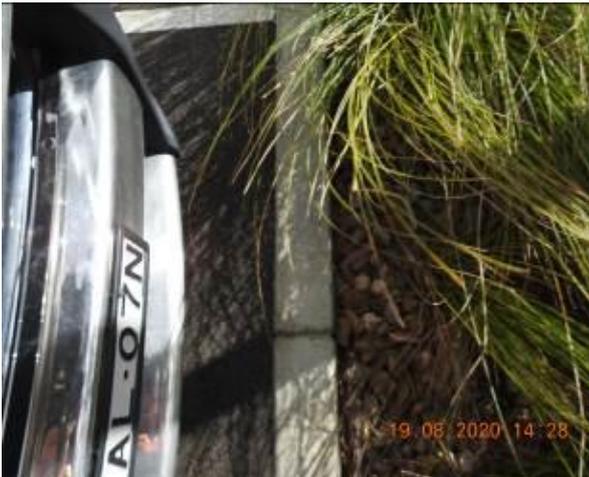
Figure 1213 – Crack propagation through car park kerb

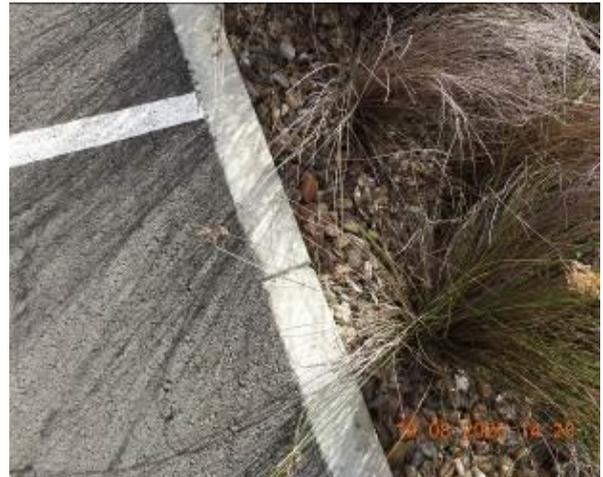
Figure 1214 – Crack propagation through car park kerb

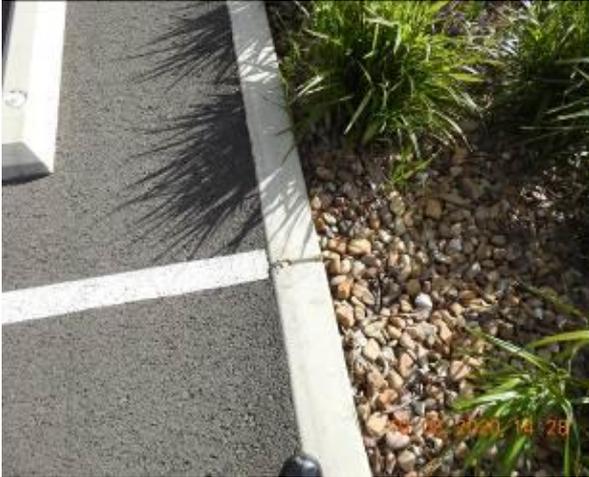
Figure 1215 – Crack propagation through car park kerb

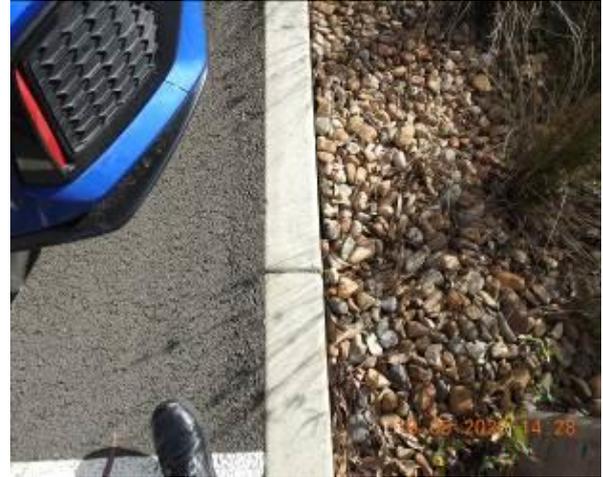
Figure 1216 – Crack propagation through car park kerb

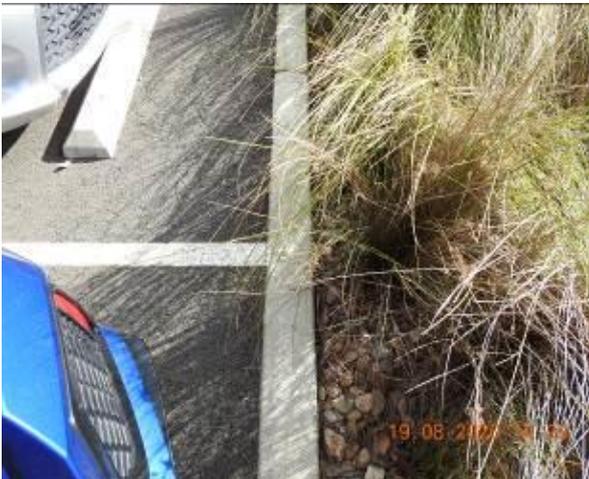
Figure 1217 – General condition of car park kerb

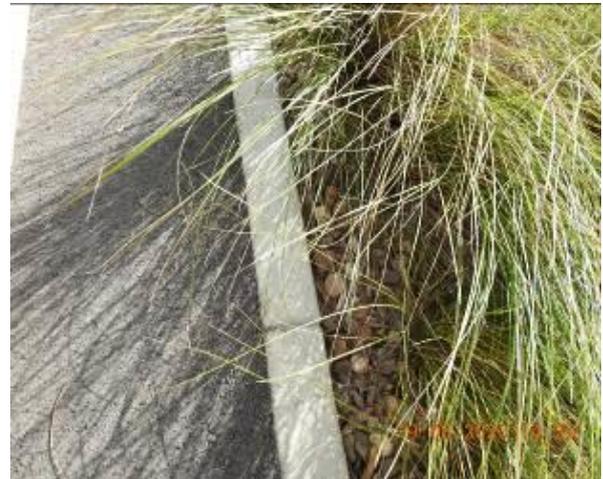
Figure 1218 – Crack propagation through car park kerb

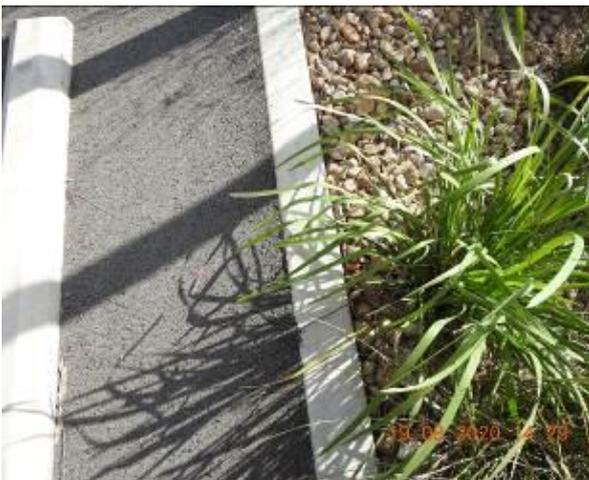
Figure 1219 – General condition of car park kerb

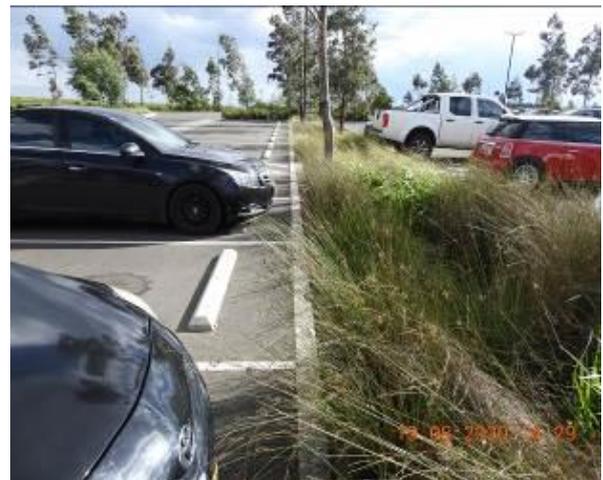
Figure 1220 – General condition of car park kerb

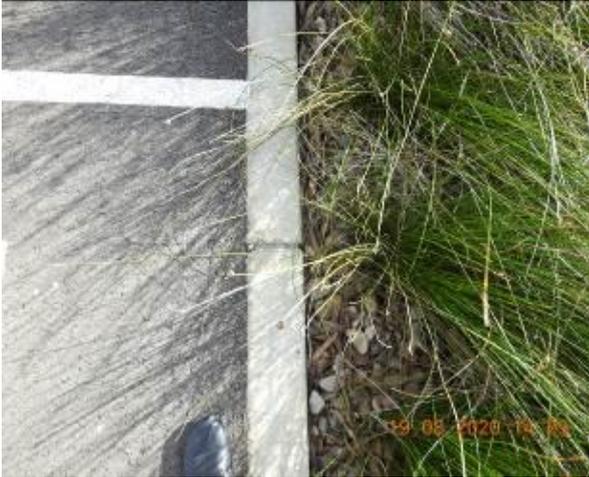
Figure 1221 – Crack propagation through car park kerb

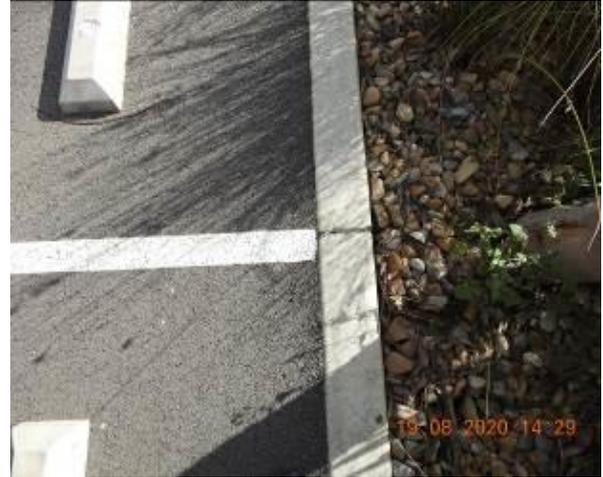
Figure 1222 – Crack propagation through car park kerb

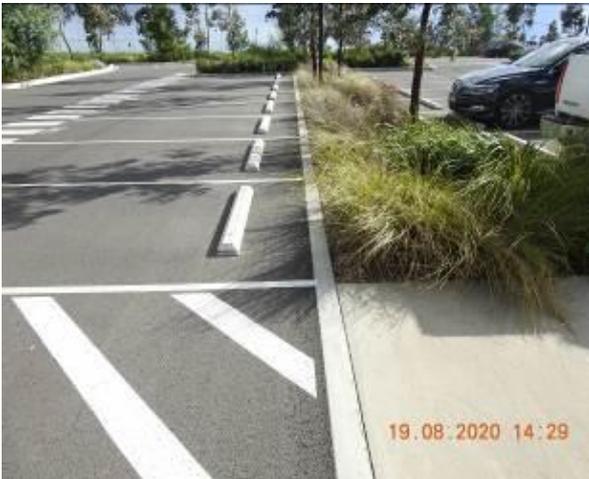
Figure 1223 – General condition of car park kerb

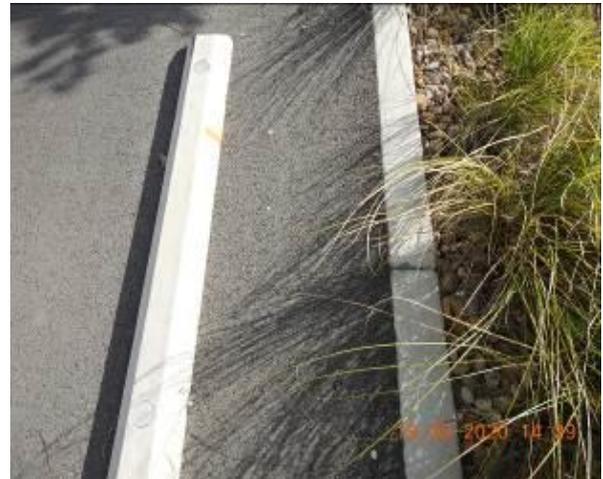
Figure 1224 – General condition of car park kerb

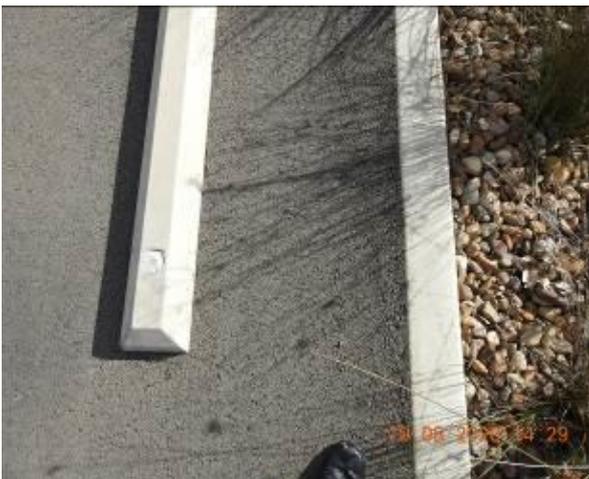
Figure 1225 – General condition of car park kerb

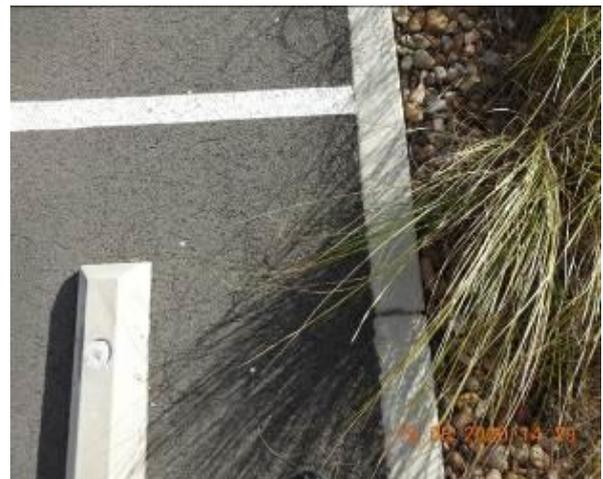
Figure 1226 – Crack propagation through car park kerb

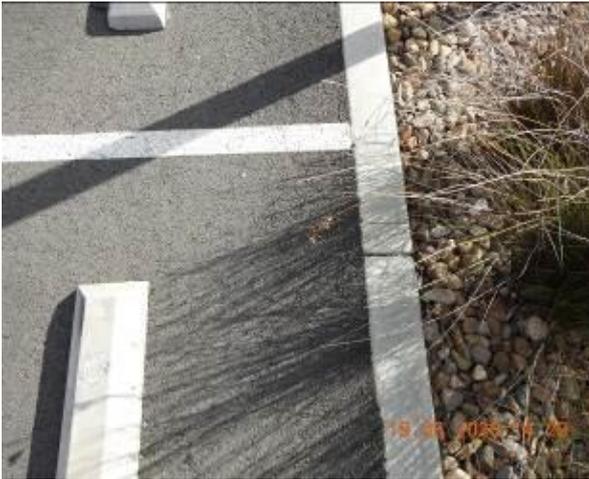
Figure 1227 – Crack propagation through car park kerb

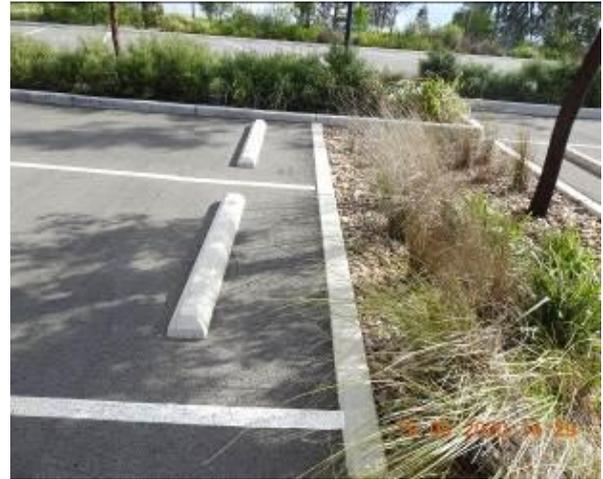
Figure 1228 – General condition of car park kerb

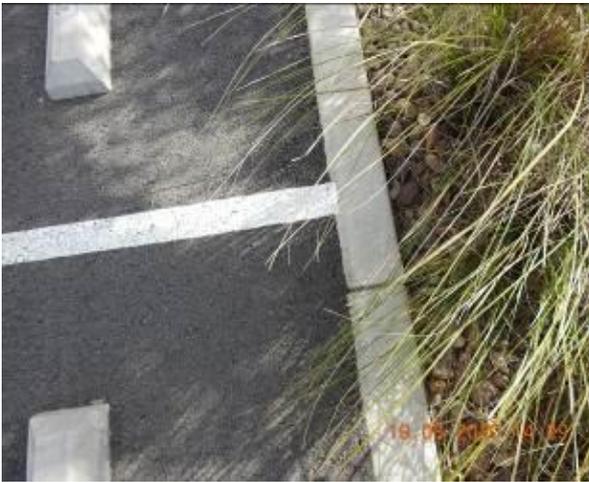
Figure 1229 – Crack propagation through car park kerb

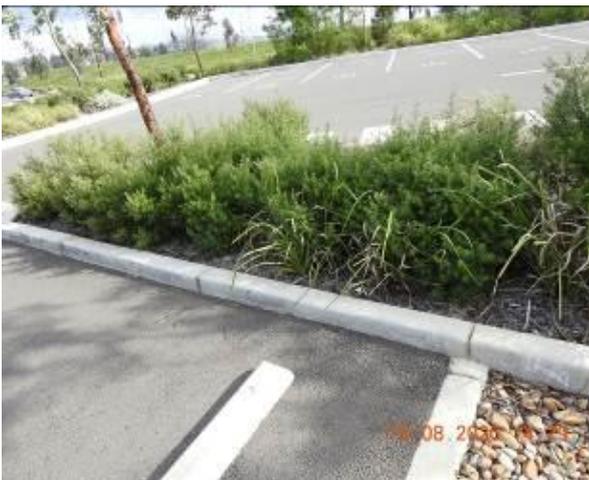
Figure 1231 – Hairline cracking through car park kerb

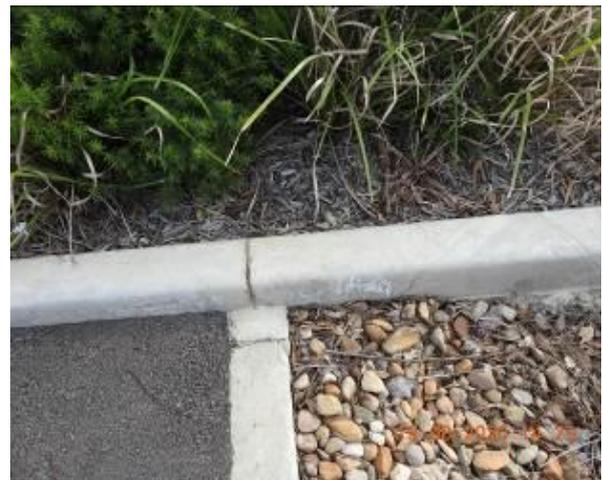
Figure 1232 – Hairline cracking through car park kerb

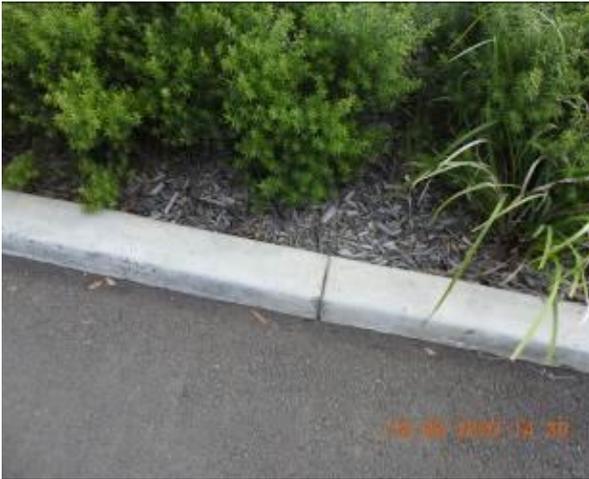
Figure 1233 – Hairline cracking through car park kerb

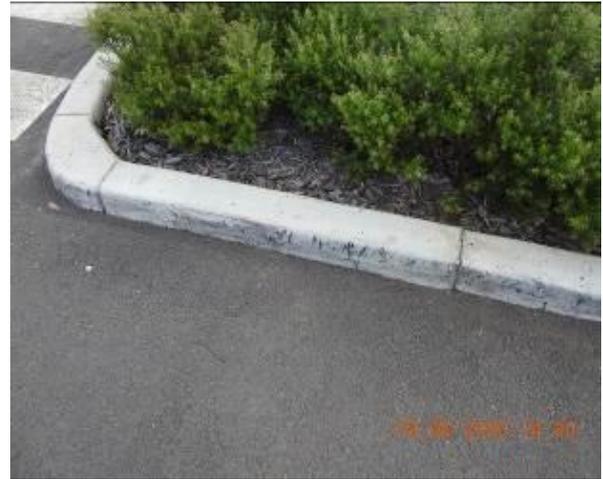
Figure 1234 – Crack propagation through car park kerb

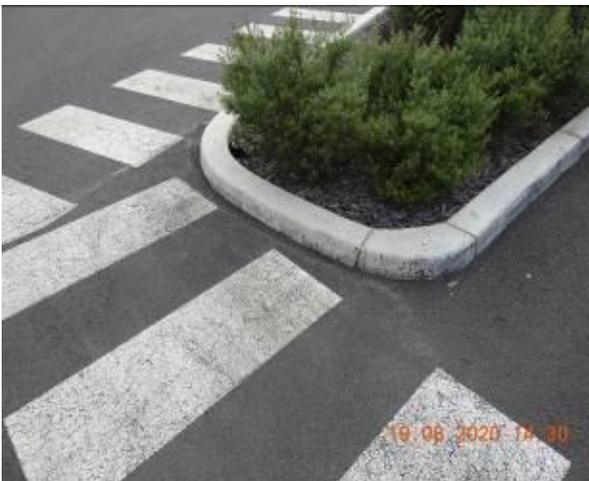
Figure 1235 – General condition of car park kerb

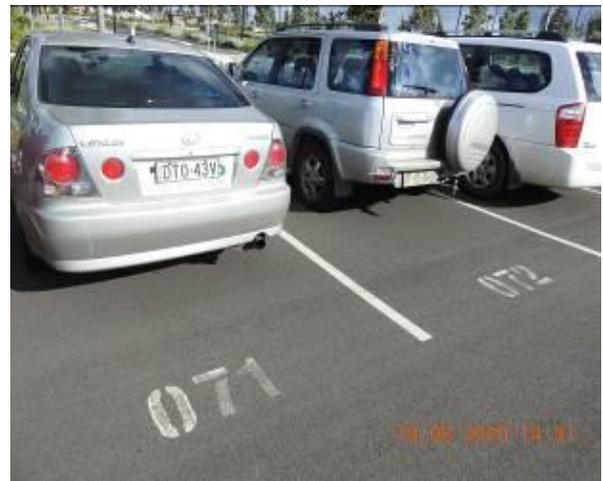
Figure 1236 – General condition of car park pavement

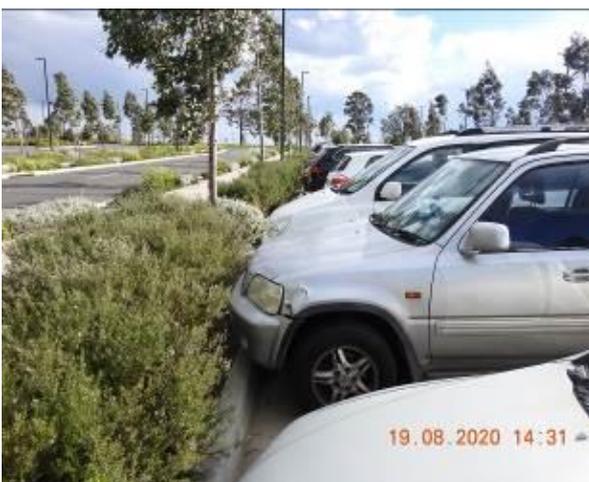
Figure 1237 – General condition of car park kerb and gutter

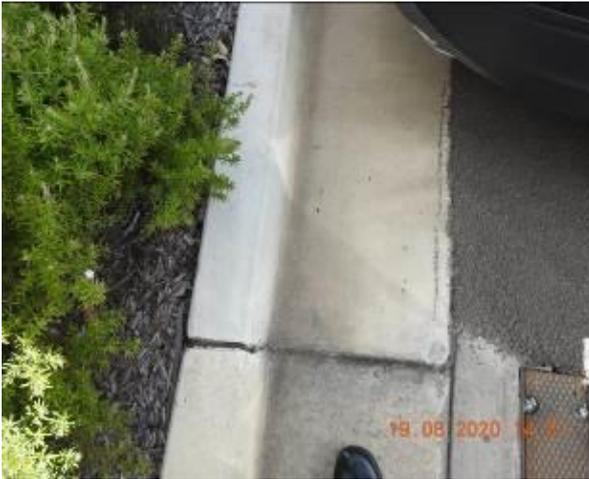
Figure 1239 – General condition of car park kerb and gutter

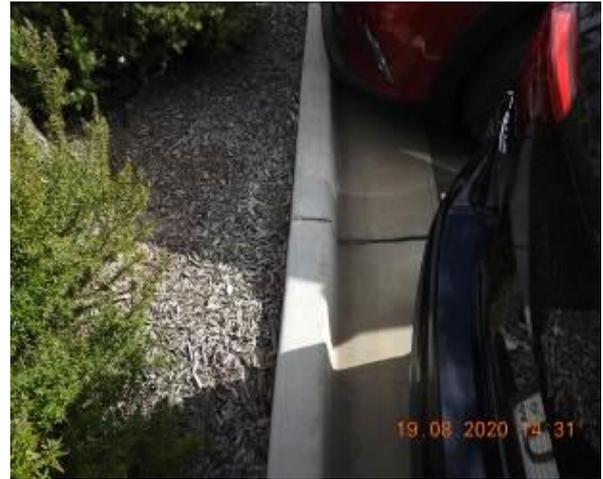
Figure 1240 – General condition of car park kerb and gutter

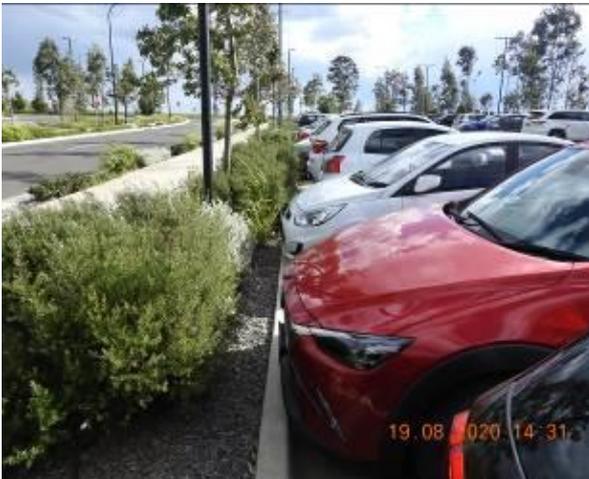
Figure 1241 – General condition of car park kerb and gutter

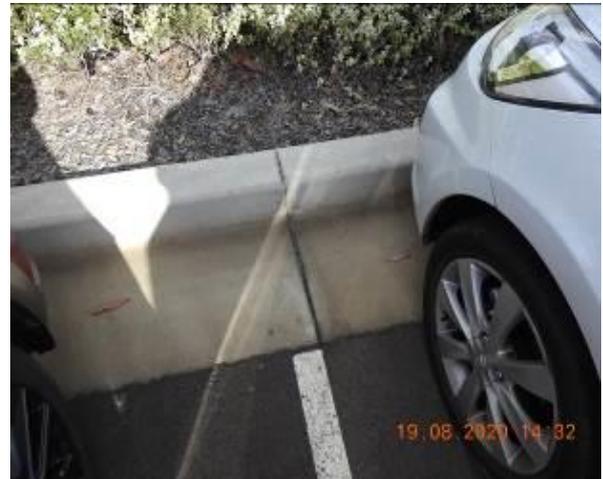
Figure 1242 – Crack propagation through car park kerb

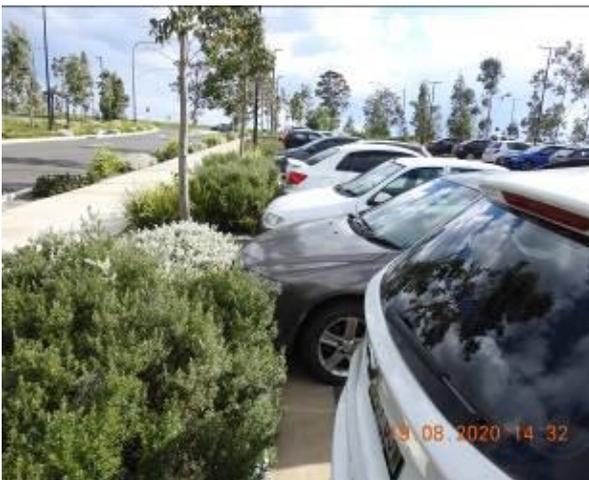
Figure 1243 – General condition of car park kerb and gutter

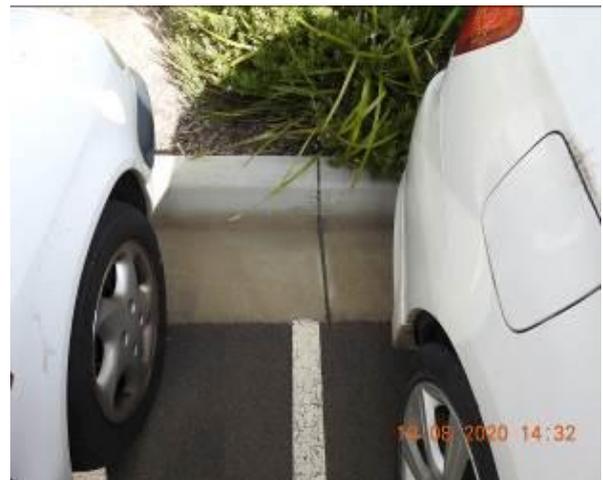
Figure 1244 – Crack propagation through car park kerb

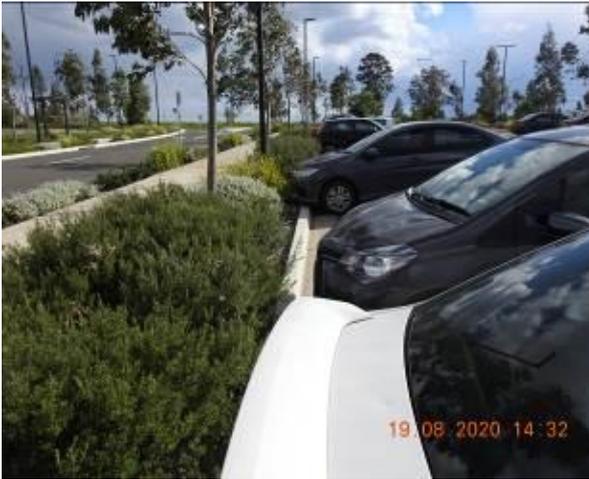
Figure 1245 – General condition of car park kerb and gutter

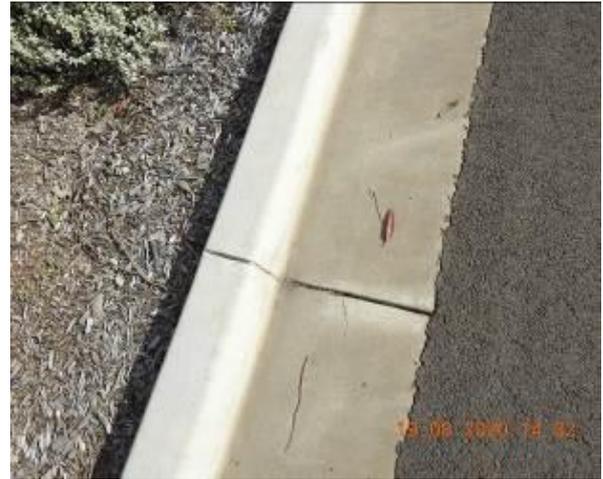
Figure 1246 – Crack propagation through car park kerb

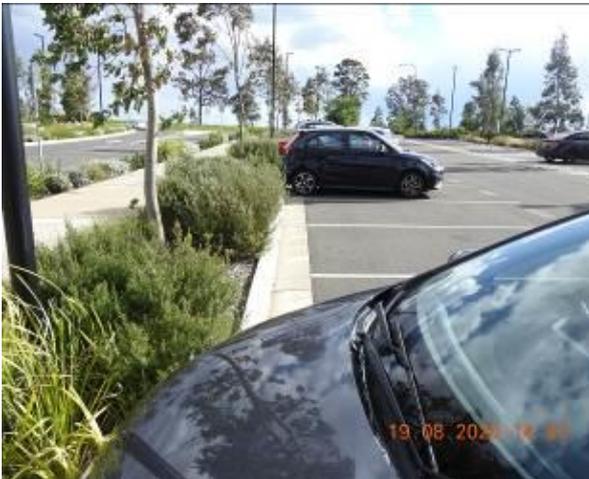
Figure 1247 – General condition of car park kerb and gutter

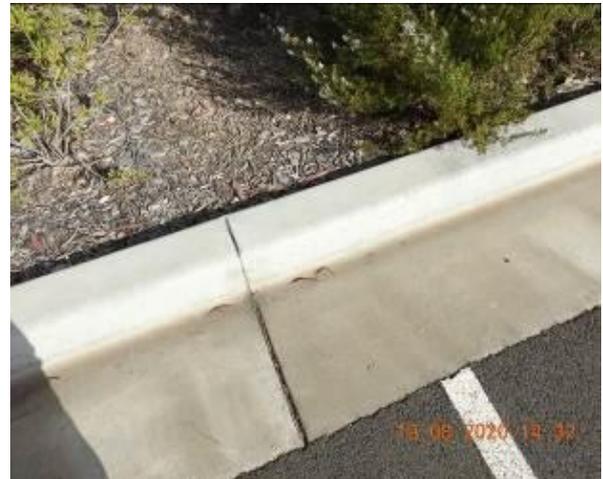
Figure 1248 – Crack propagation through car park kerb

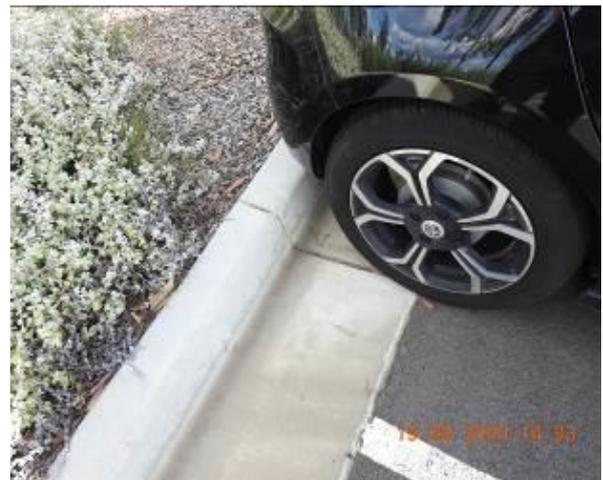
Figure 1250 – Crack propagation through car park kerb

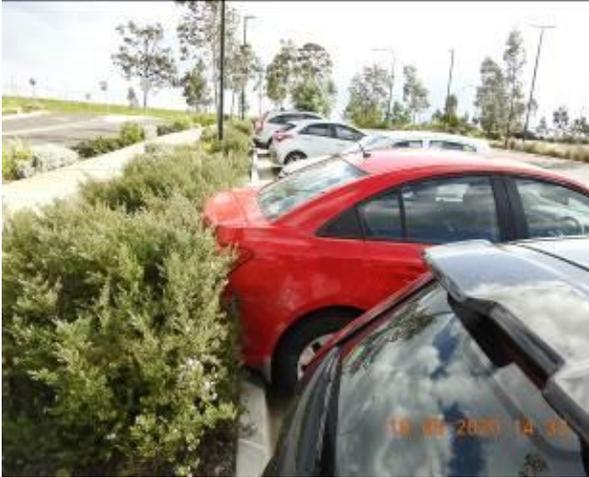
Figure 1251 – General condition of car park kerb and gutter

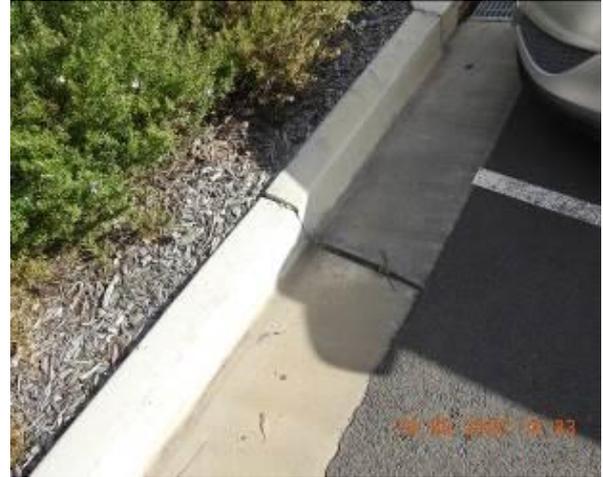
Figure 1252 – Crack propagation and loss of material through car park kerb

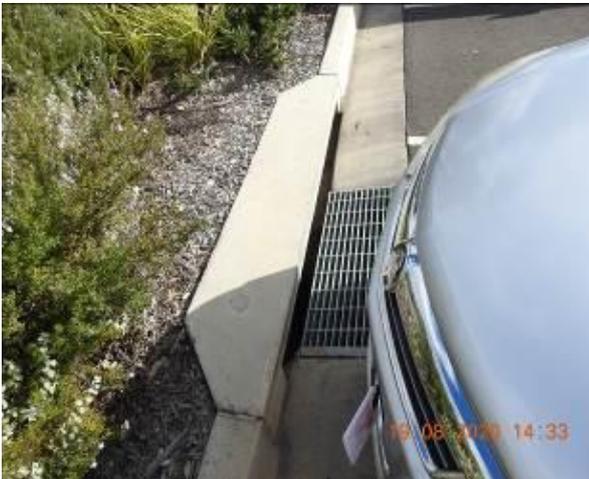
Figure 1253 – General condition of kerb inlet pit and stormwater inlet pit

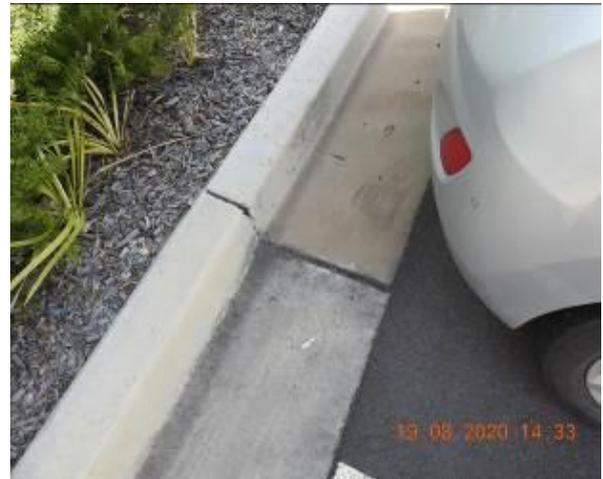
Figure 1254 – Crack propagation and loss of material through car park kerb

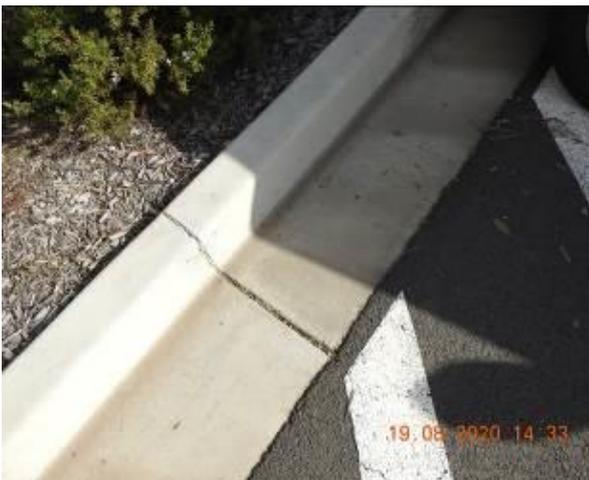
Figure 1255 – Crack propagation through car park kerb

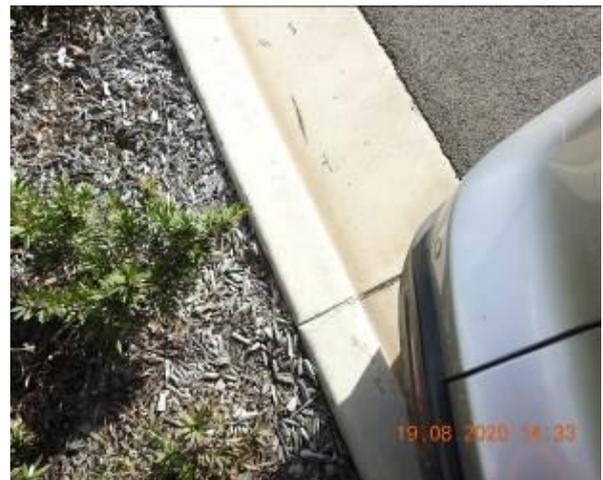
Figure 1256 – General condition of car park kerb and gutter

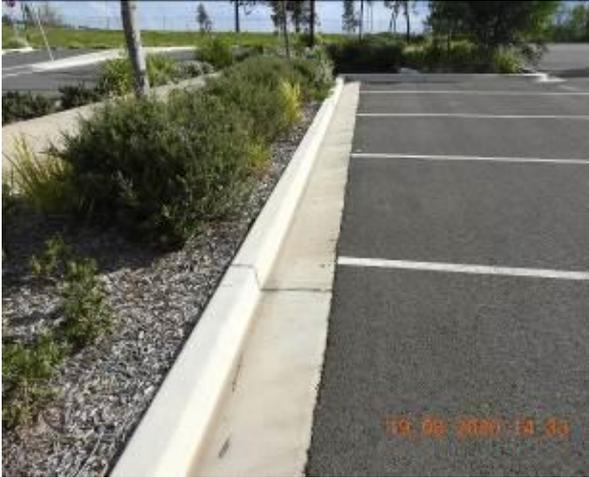
Figure 1257 – General condition of car park kerb and gutter

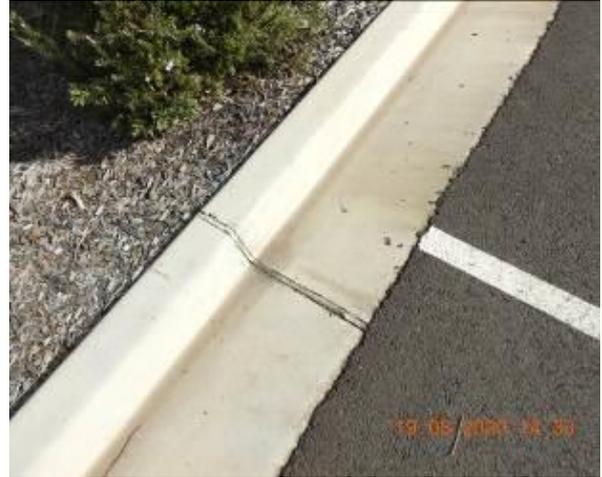
Figure 1258 – General condition of car park kerb and gutter

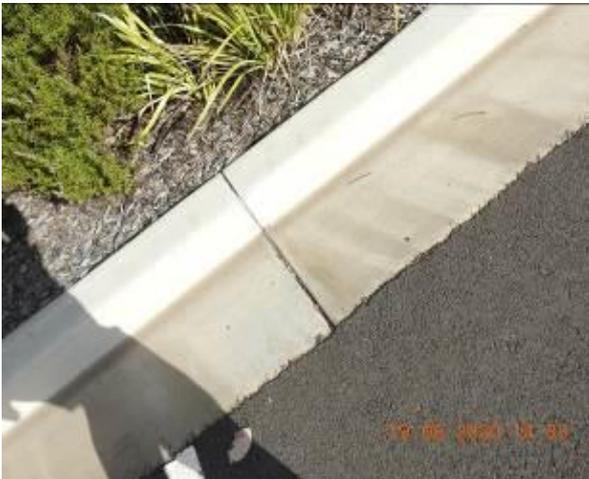
Figure 1259 – Crack propagation through car park kerb

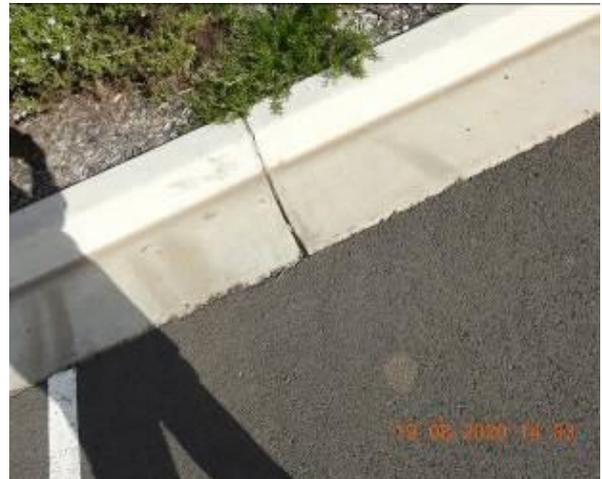
Figure 1260 – Crack propagation through car park kerb

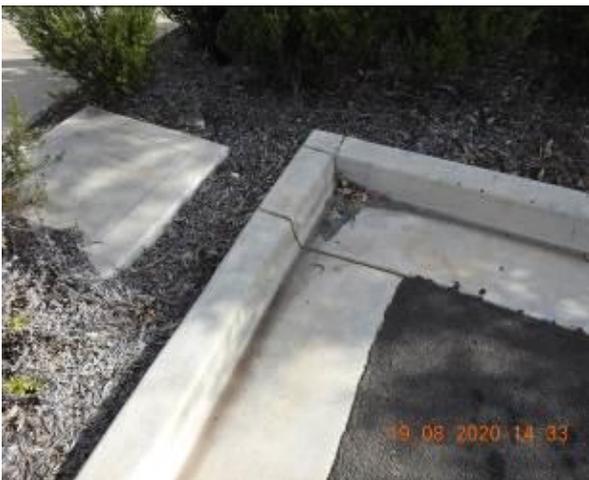
Figure 1261 – Crack propagation through car park kerb

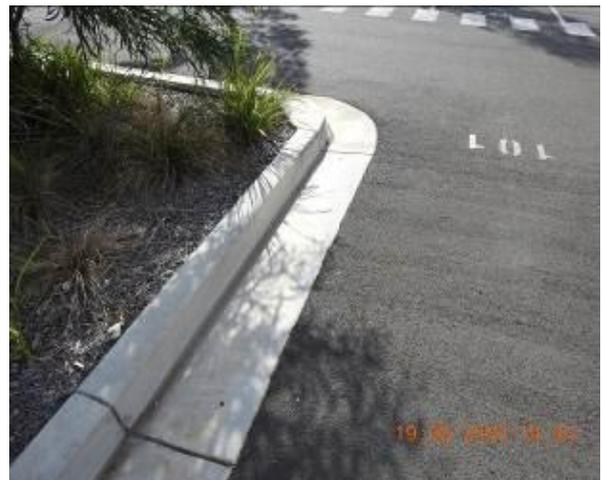
Figure 1262 – Crack propagation through car park kerb

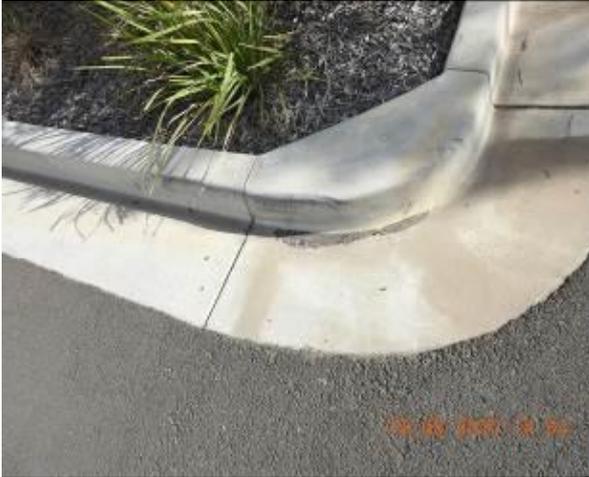
Figure 1263 – Hairline cracking through car park kerb and gutter

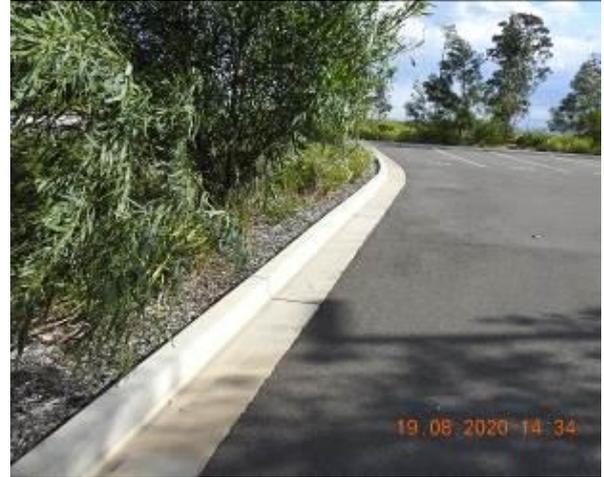
Figure 1264 – General condition of car park kerb and gutter

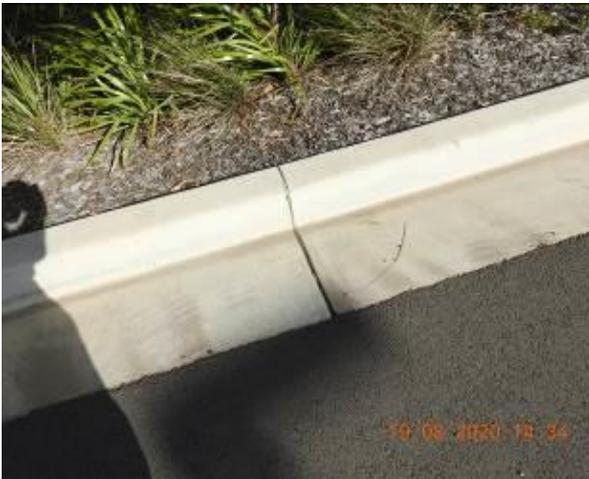
Figure 1265 – Crack propagation through car park kerb

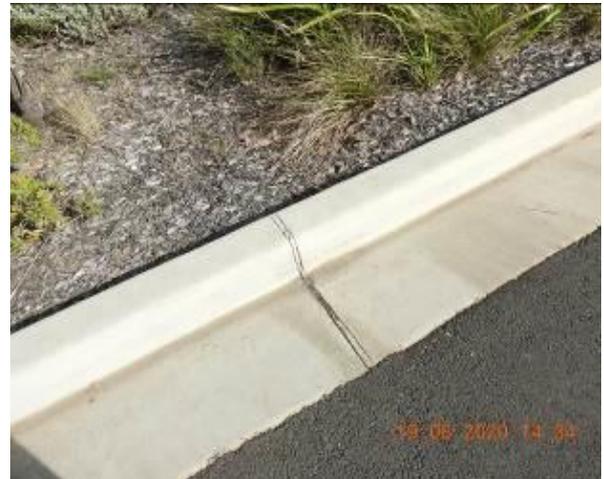
Figure 1266 – Crack propagation through car park kerb

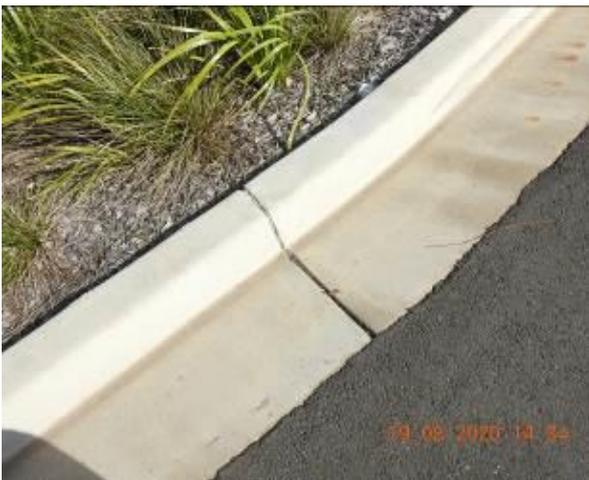
Figure 1267 – Crack propagation through car park kerb

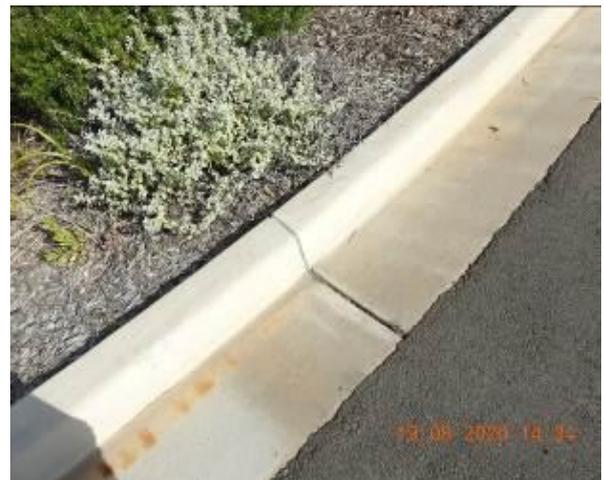
Figure 1268 – Crack propagation through car park kerb

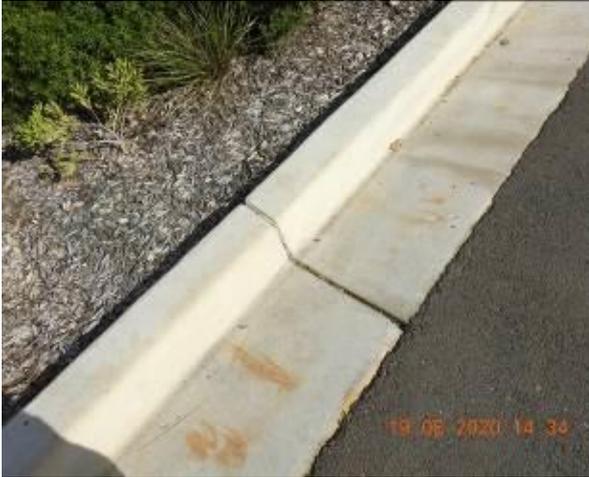
Figure 1269 – Crack propagation through car park kerb

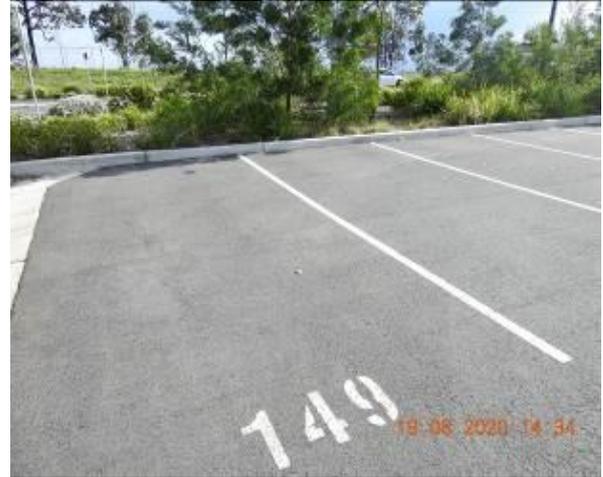
Figure 1270 – General condition of car park kerb

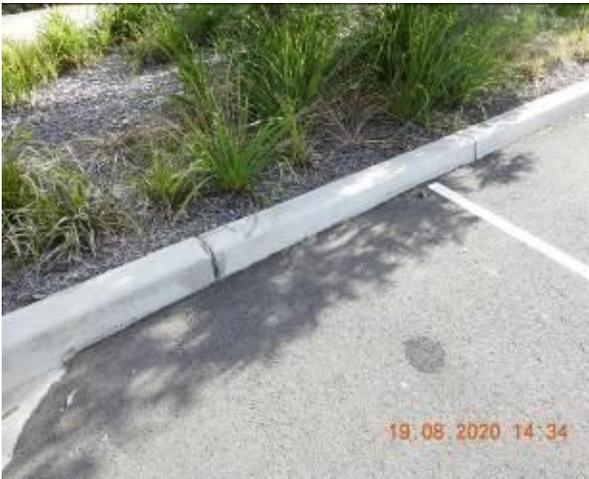
Figure 1271 – Crack propagation through car park kerb

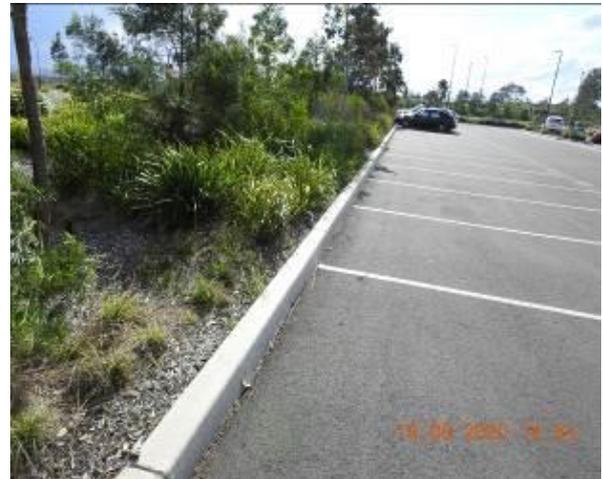
Figure 1272 – General condition of car park kerb

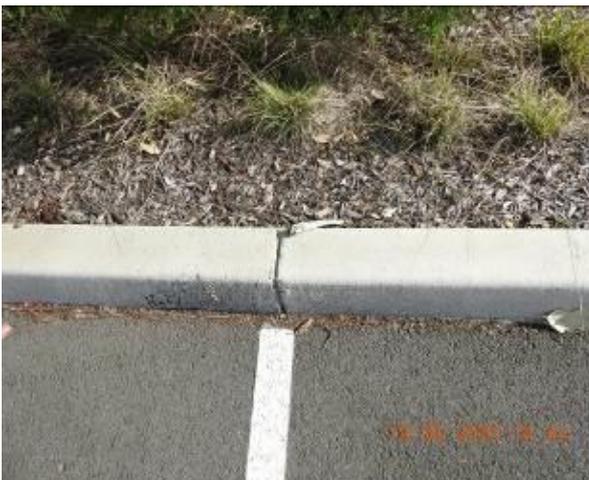
Figure 1273 – Crack propagation through car park kerb

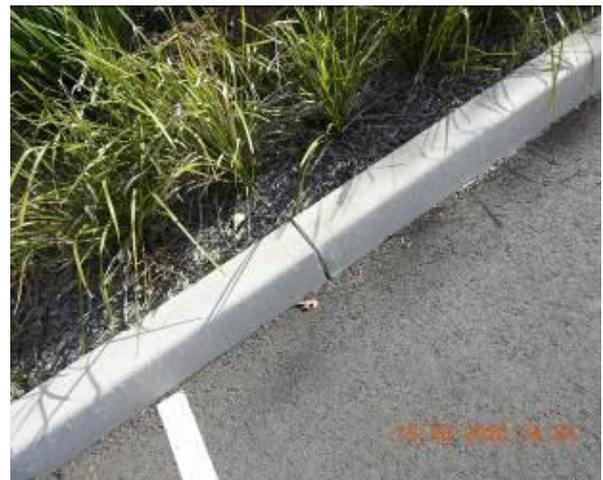
Figure 1274 – Crack propagation through car park kerb

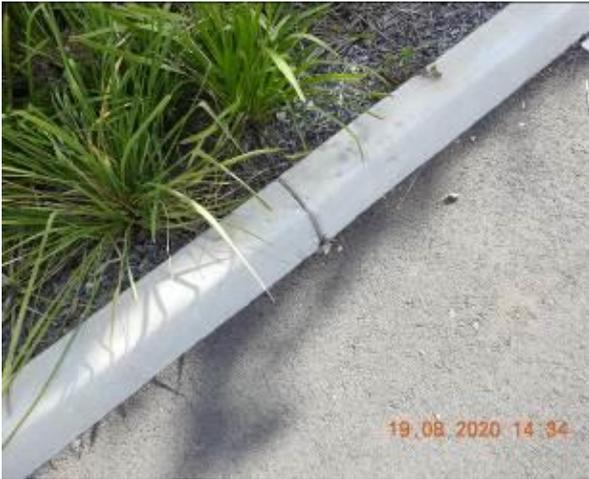
Figure 1275 – Crack propagation through car park kerb

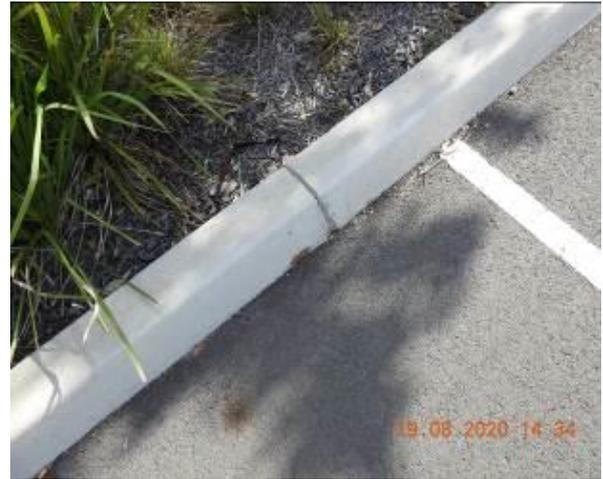
Figure 1276 – Crack propagation through car park kerb

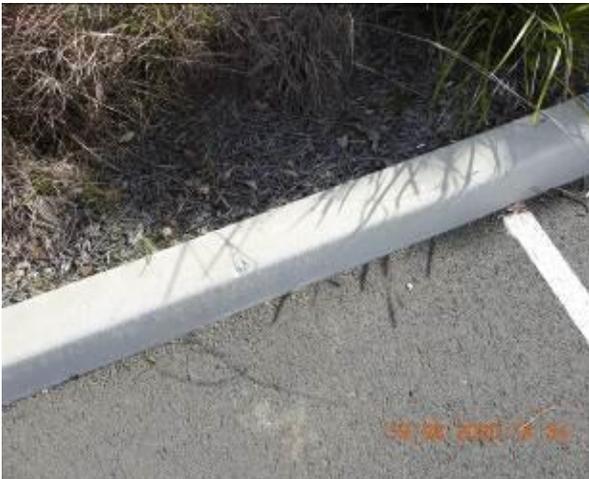
Figure 1277 – Loss of material through car park kerb
