The property Tallawong station – P2 Car Park, is the neighbouring property to our client’s site. It was photographed and inspected prior to any construction works on the subject site and was found to be in a reasonable condition. The property serves as a car park.

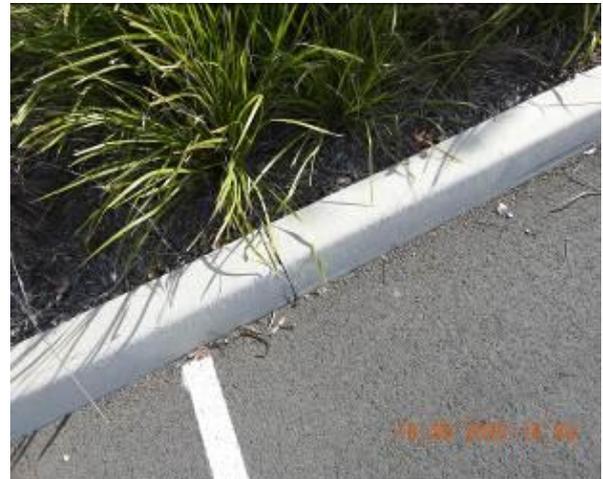
Figure 1278 – Crack propagation through car park kerb

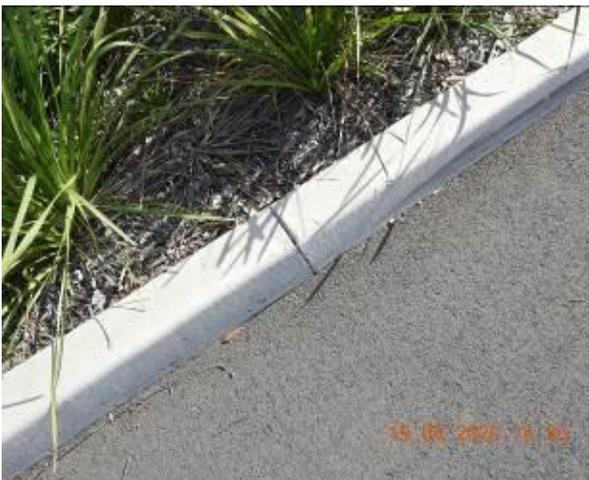
Figure 1279 – Crack propagation through car park kerb

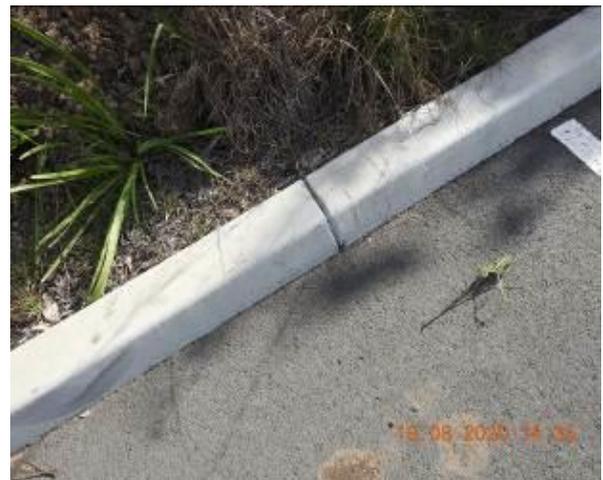
Figure 1280 – Crack propagation through car park kerb

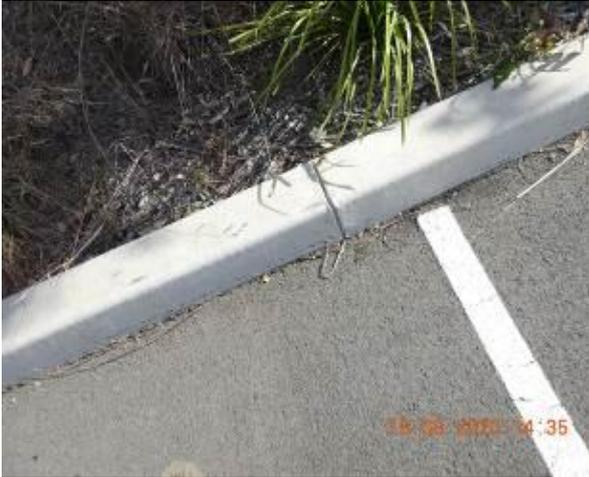
Figure 1281 – Crack propagation through car park kerb

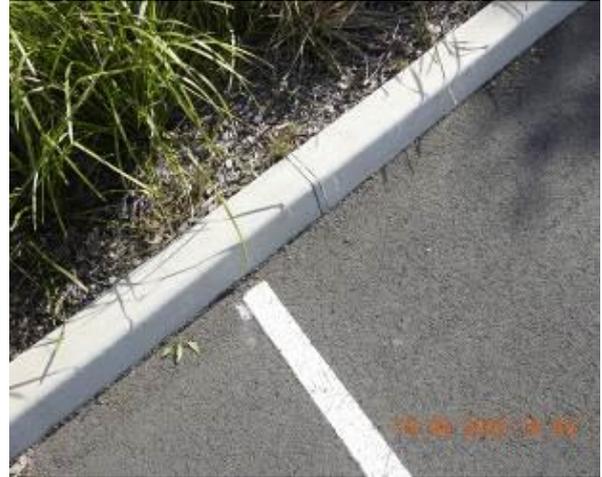
Figure 1282 – General condition of car park kerb

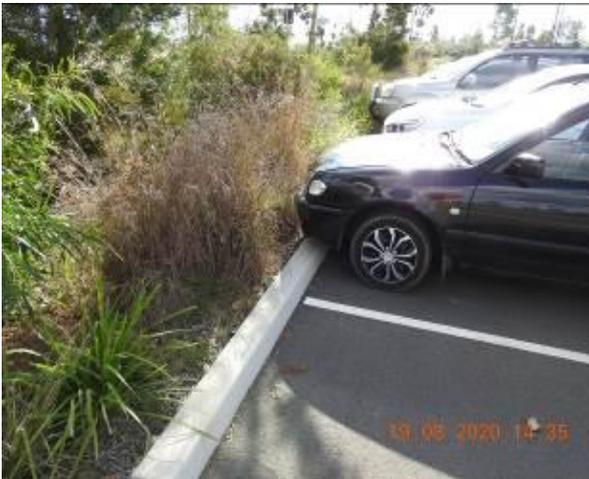
Figure 1283 – General condition of car park kerb

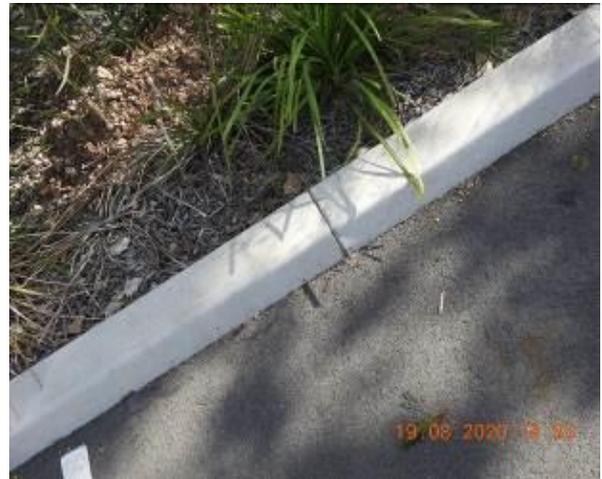
Figure 1284 – Crack propagation through car park kerb

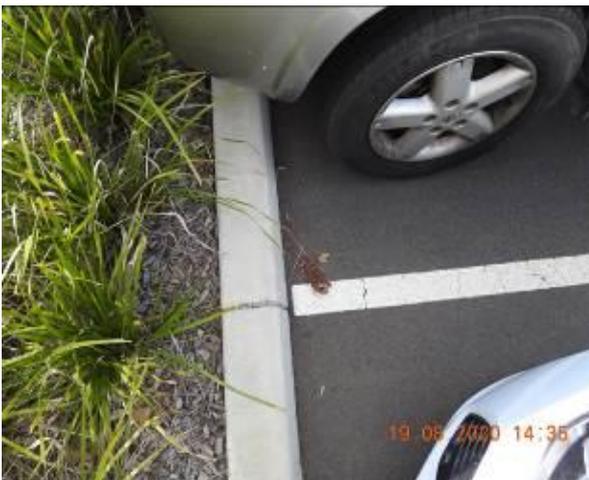
Figure 1285 – Crack propagation through car park kerb

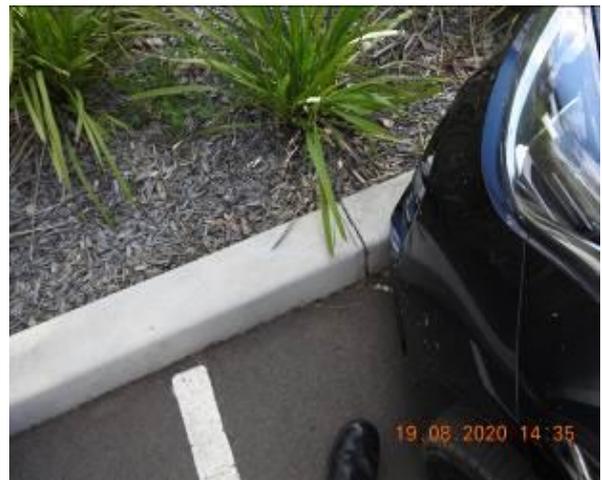
Figure 1286 – Crack propagation through car park kerb

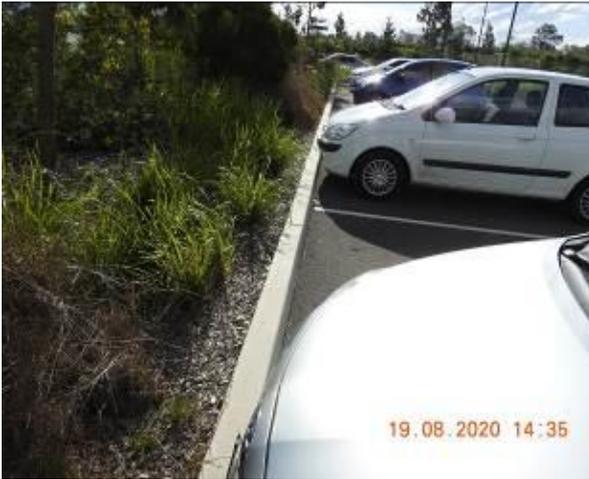
Figure 1287 – General condition of car park kerb

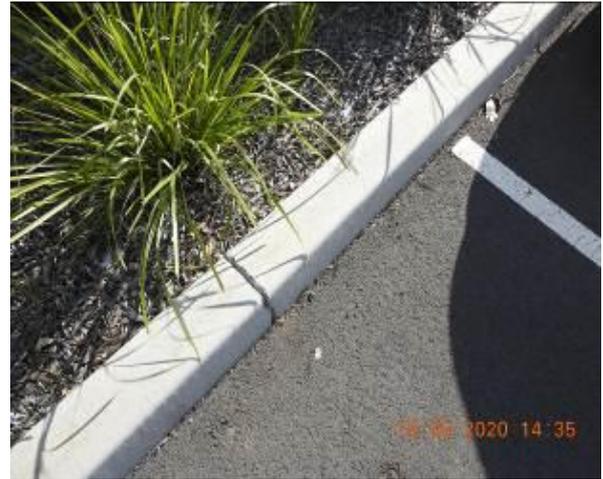
Figure 1288 – Crack propagation through car park kerb

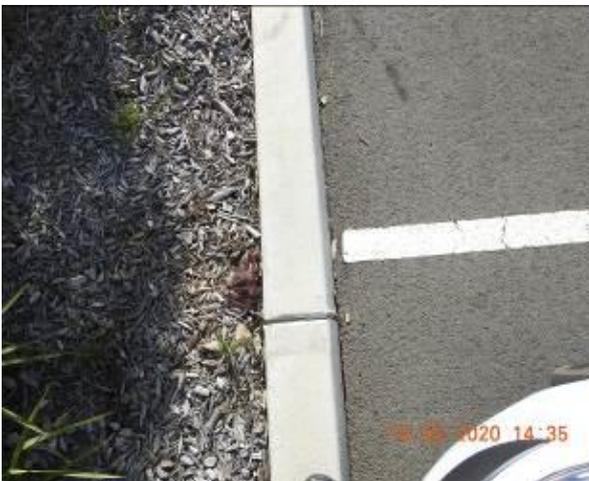
Figure 1289 – Crack propagation through car park kerb

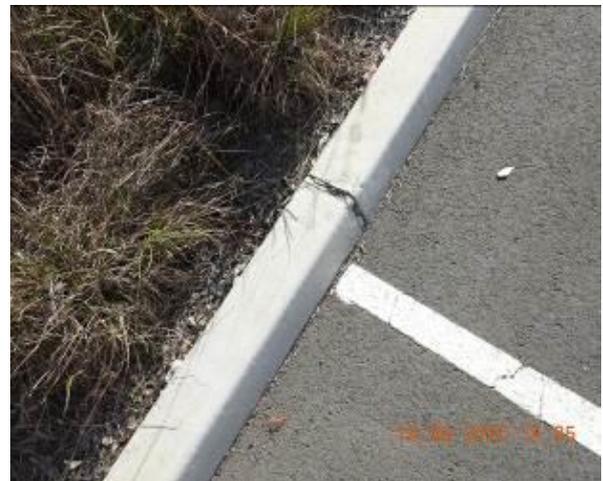
Figure 1290 – Crack propagation and loss of material through car park kerb

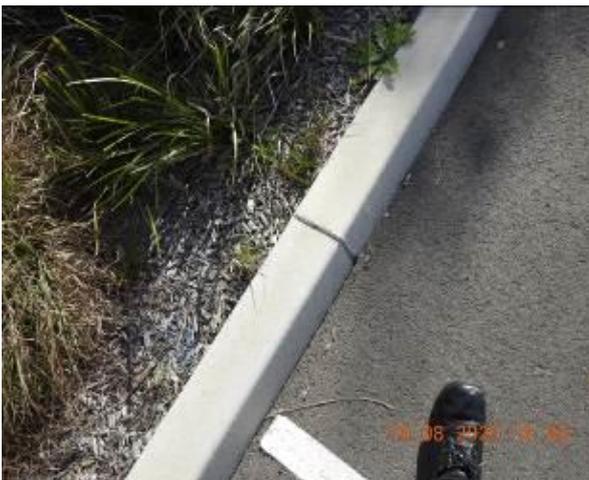
Figure 1291 – Crack propagation through car park kerb

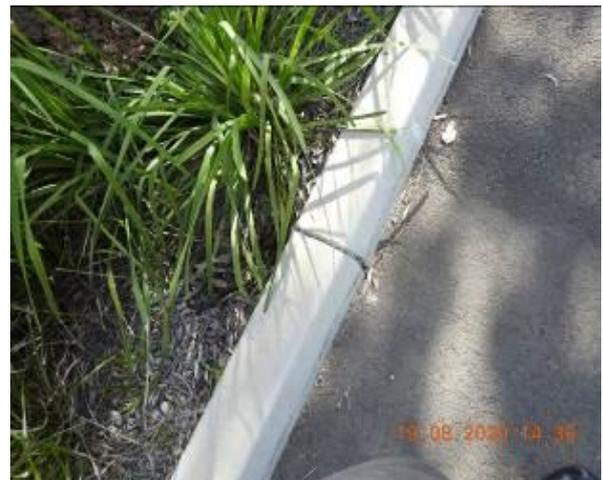
Figure 1292 – Crack propagation through car park kerb

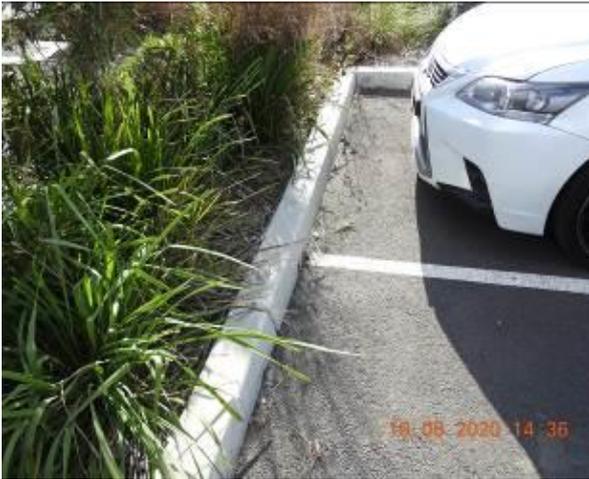
Figure 1293 – General condition of car park kerb

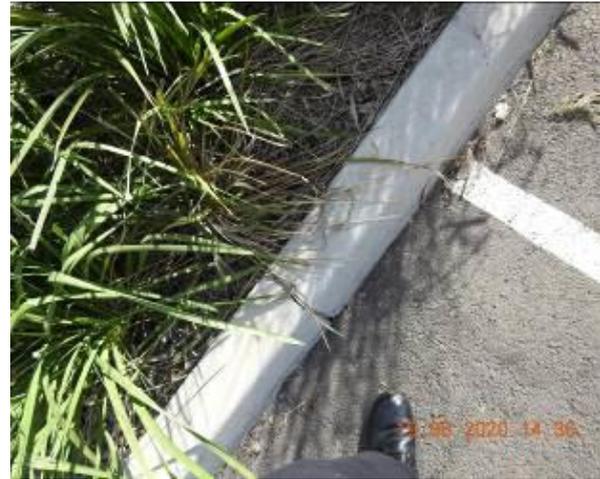
Figure 1294 – Crack propagation through car park kerb

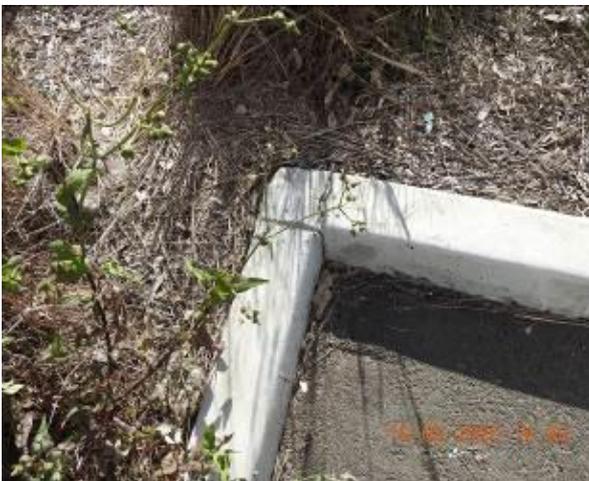
Figure 1295 – Crack propagation through car park kerb

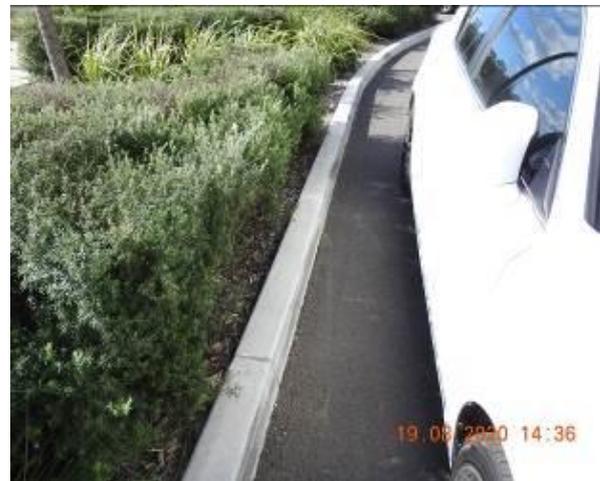
Figure 1296 – General condition of car park kerb

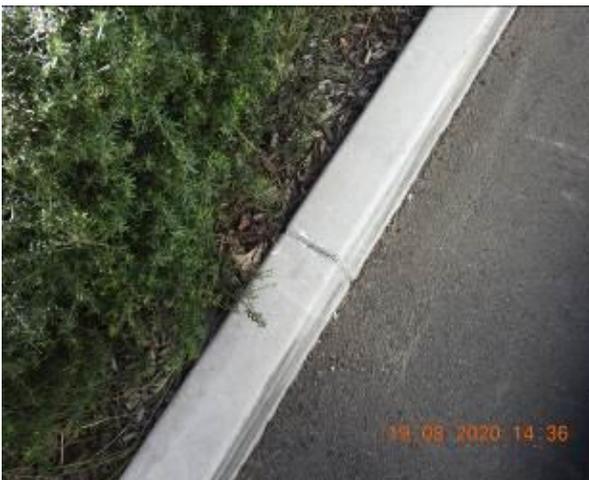
Figure 1297 – Crack propagation through car park kerb

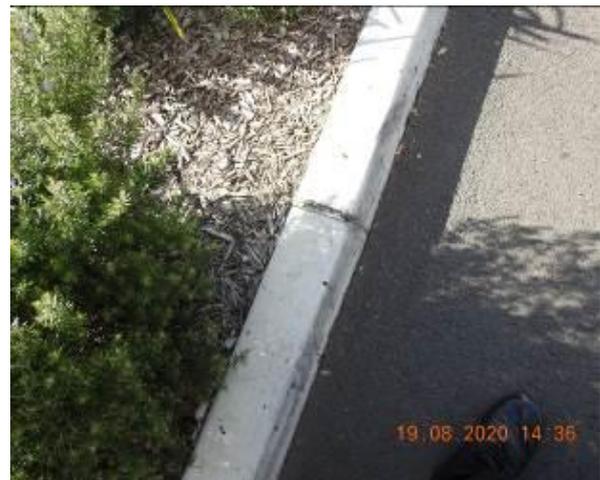
Figure 1298 – Crack propagation and loss of material through car park kerb

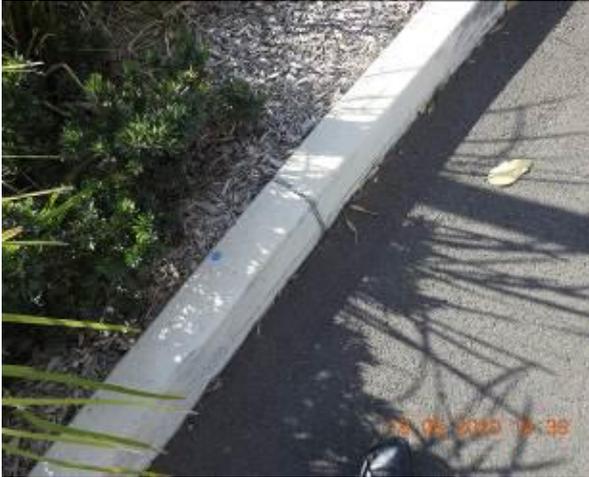
Figure 1299 – Crack propagation through car park kerb

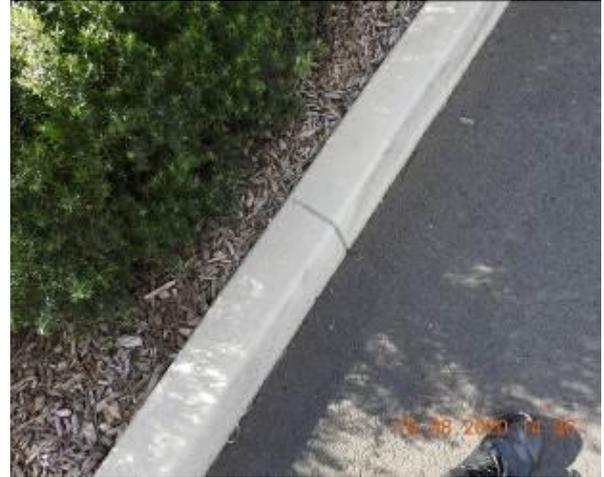
Figure 1300 – Crack propagation through car park kerb

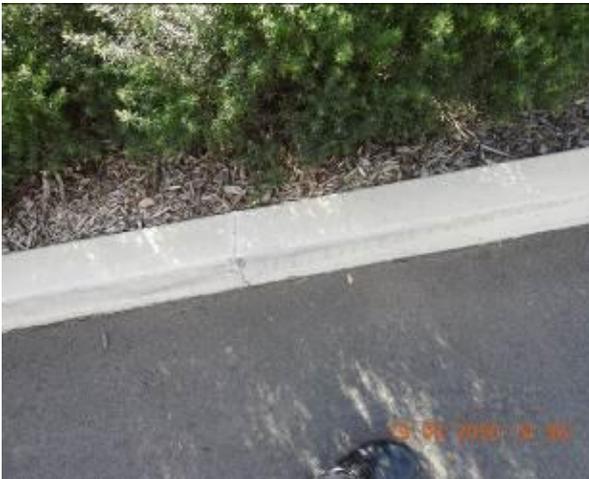
Figure 1301 – Crack propagation through car park kerb

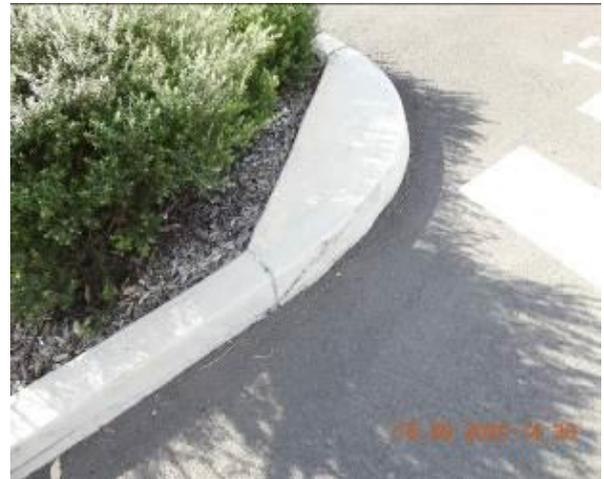
Figure 1302 – General condition of car park kerb

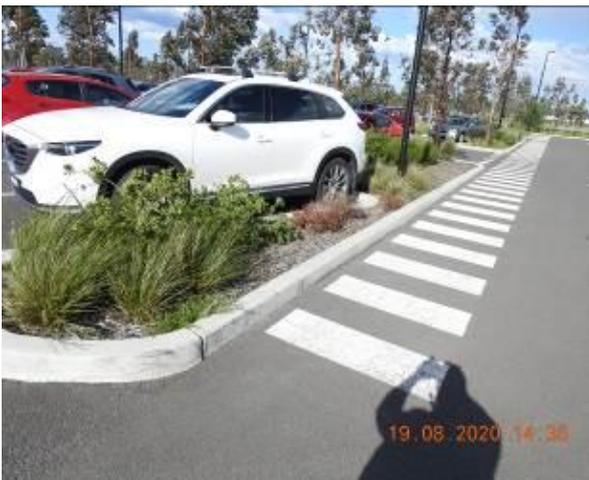
Figure 1303 – General condition of car park kerb

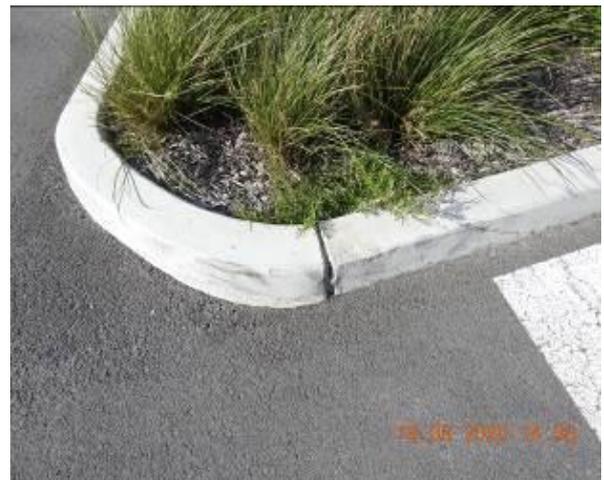
Figure 1304 – Crack propagation and loss of material through car park kerb

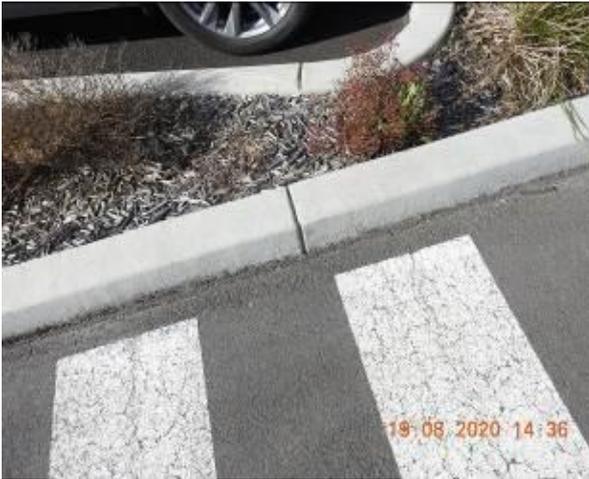
Figure 1305 – Crack propagation through car park kerb

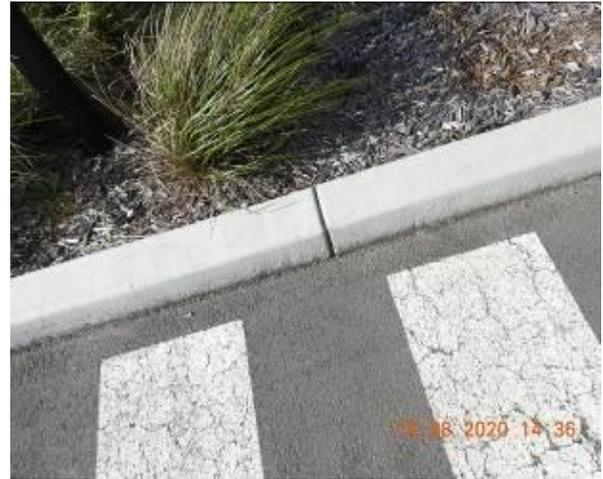
Figure 1306 – Crack propagation through car park kerb

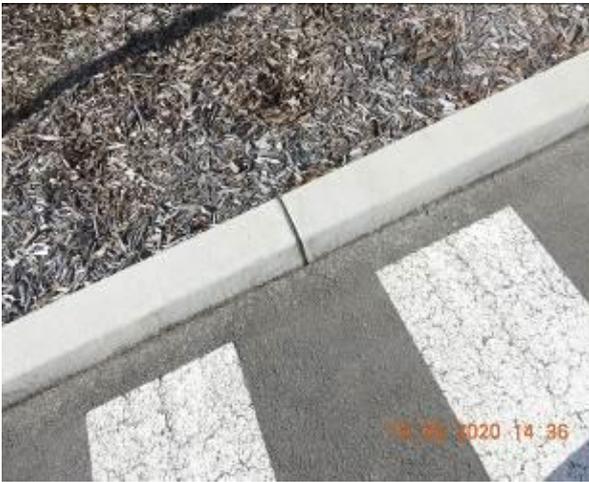
Figure 1307 – Crack propagation through car park kerb

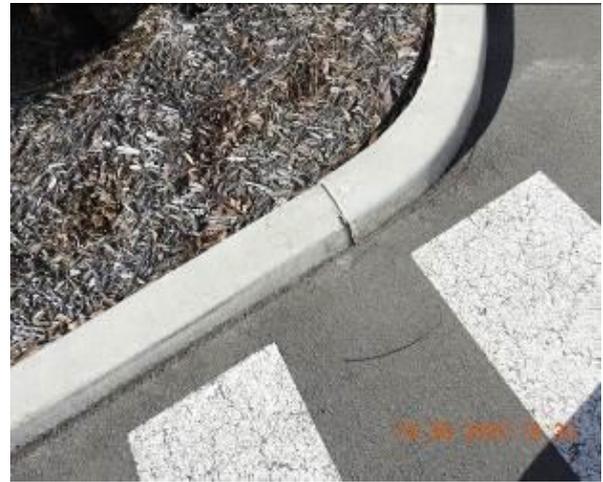
Figure 1308 – Crack propagation through car park kerb

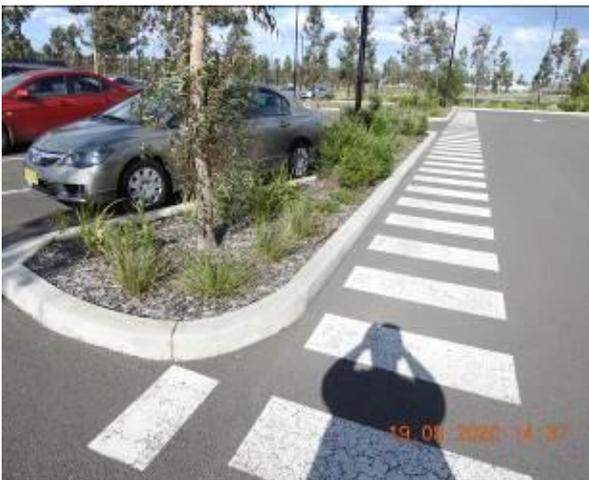
Figure 1309 – General condition of car park kerb

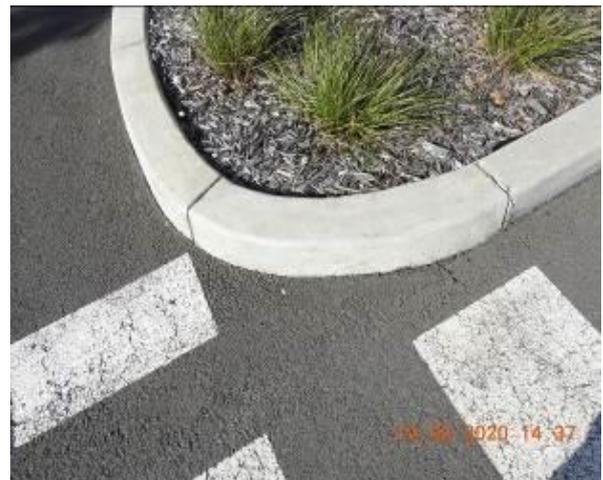
Figure 1310 – Crack propagation through car park kerb

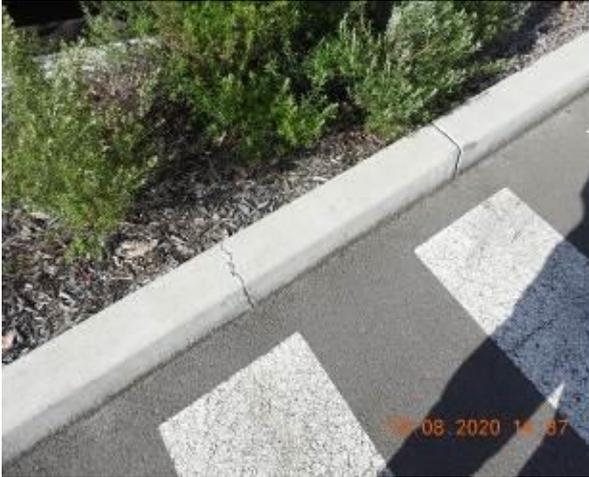
Figure 1311 – Crack propagation through car park kerb

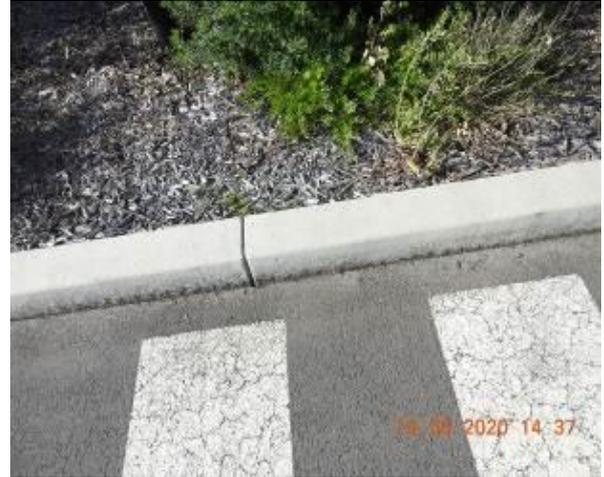
Figure 1312 – Crack propagation through car park kerb

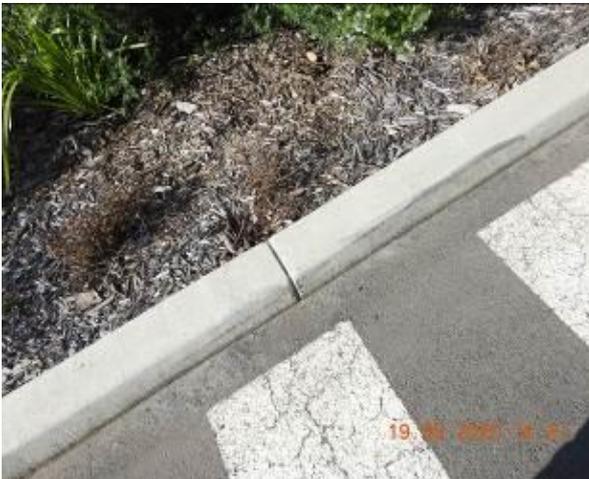
Figure 1313 – Crack propagation through car park kerb

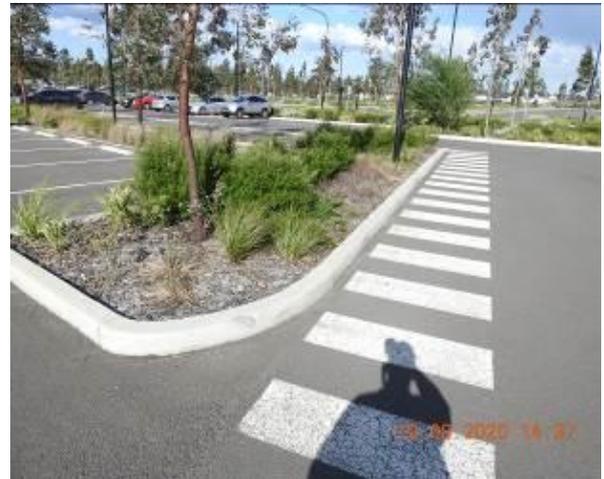
Figure 1314 – General condition of car park kerb

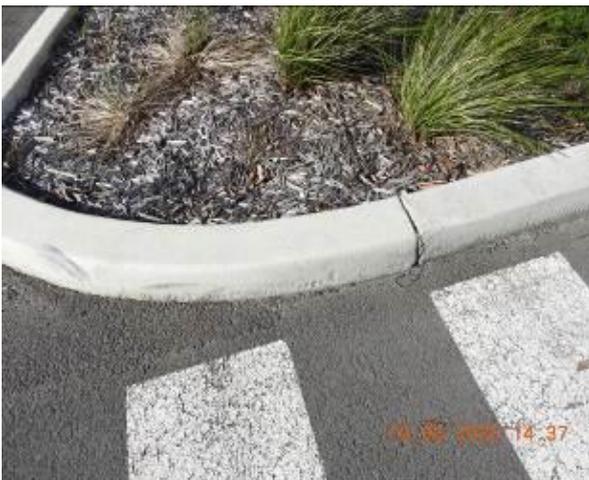
Figure 1315 – Crack propagation through car park kerb

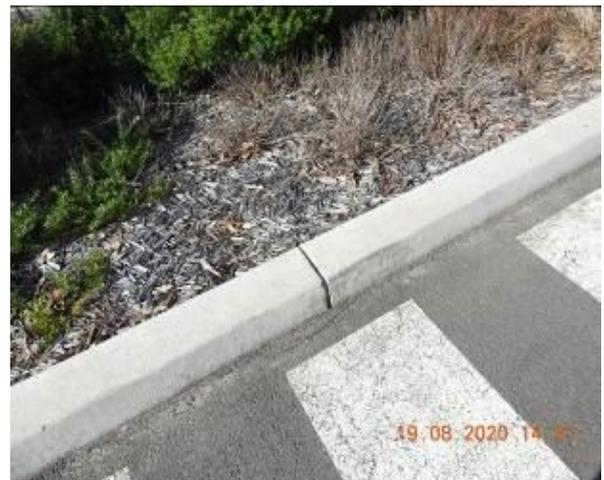
Figure 1316 – Crack propagation through car park kerb

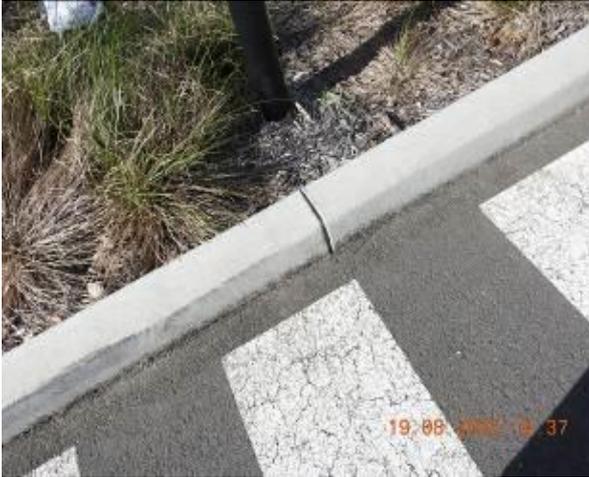
Figure 1317 – Crack propagation through car park kerb

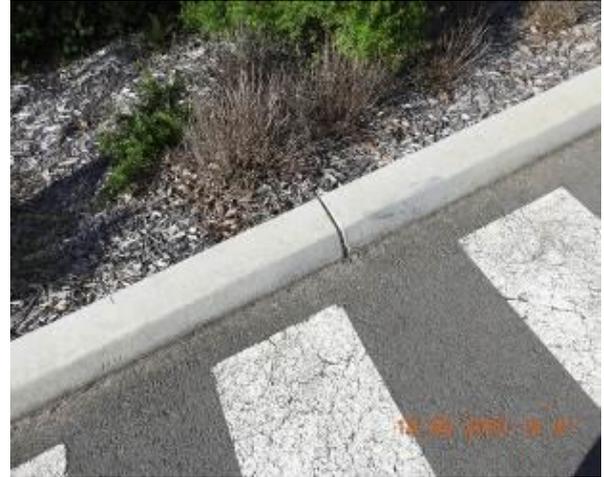
Figure 1318 – Crack propagation through car park kerb

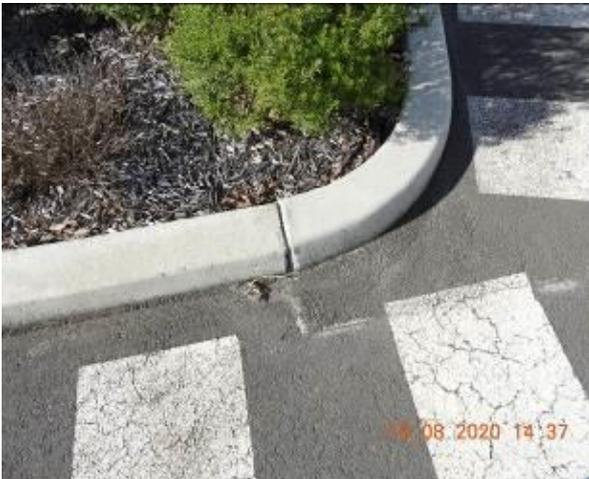
Figure 1319 – Crack propagation through car park kerb

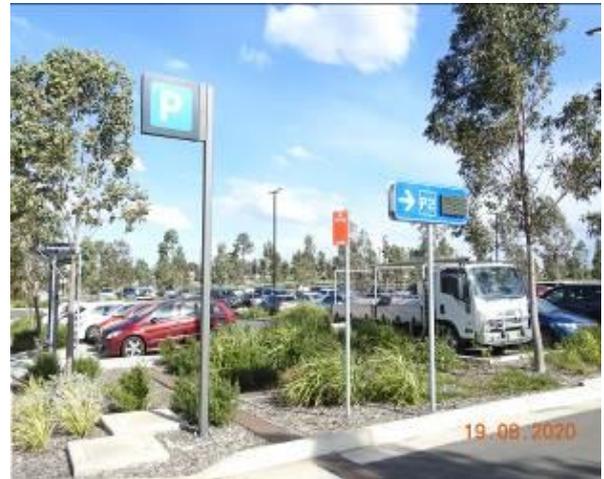
Figure 1320 – General condition of street sign

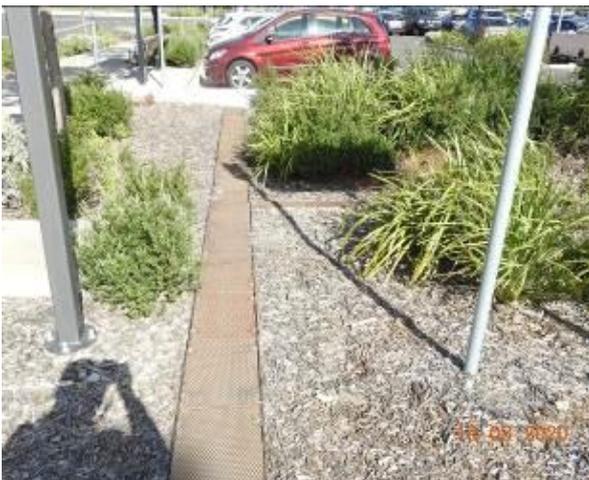
Figure 1321 – General condition of plantation and service pit

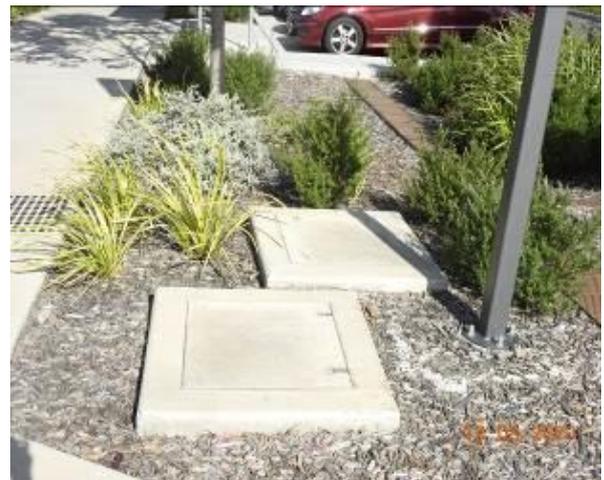
Figure 1322 – General condition of service pits

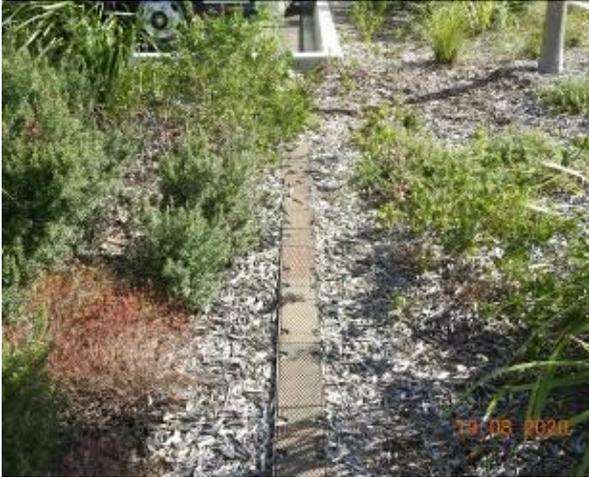
Figure 1323 – General condition of plantation and service pit

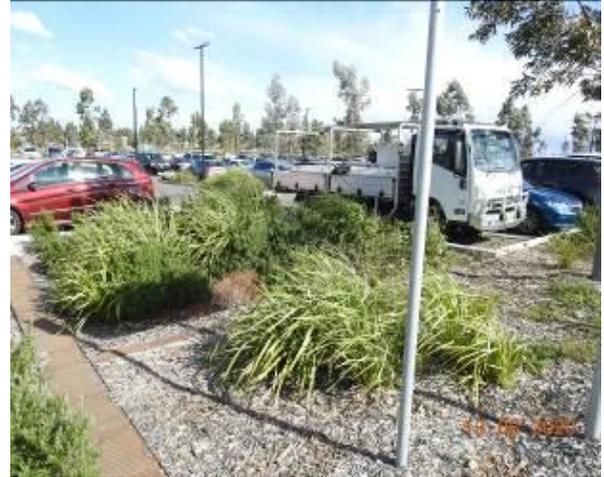
Figure 1324 – General condition of plantation and service pit

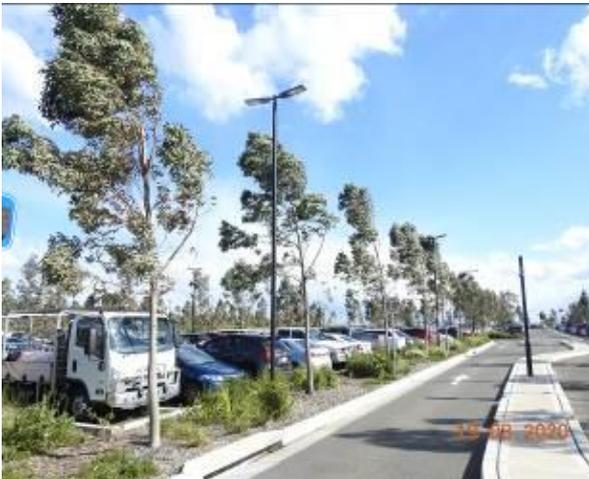
Figure 1325 – General condition of plantation and lamp post

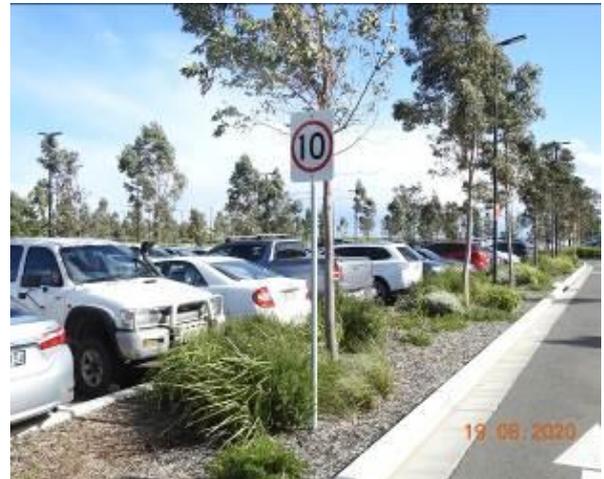
Figure 1326 – General condition of street sign

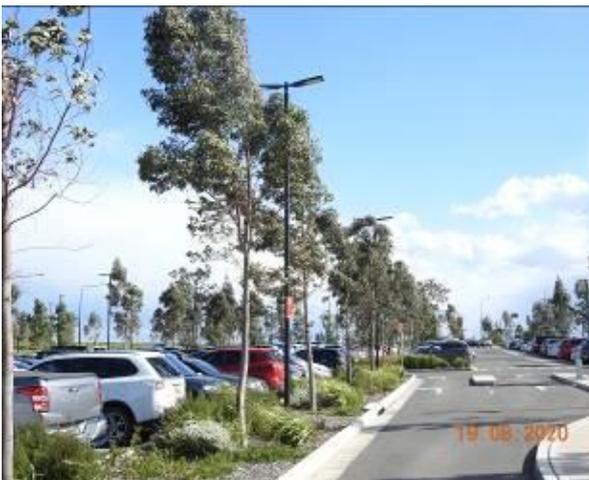
Figure 1327 – General condition of plantation and lamp post

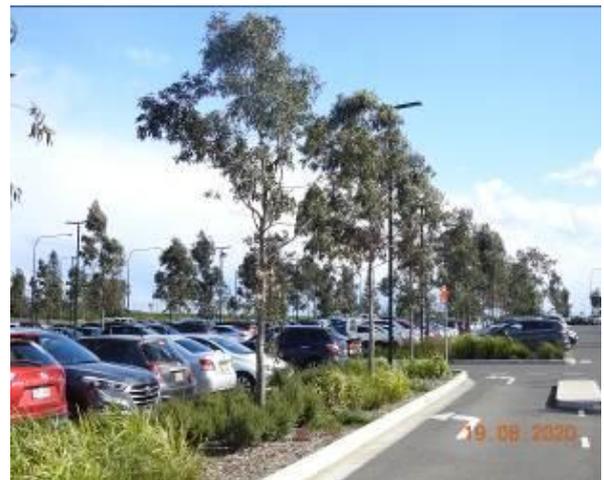
Figure 1328 – General condition of plantation and lamp post

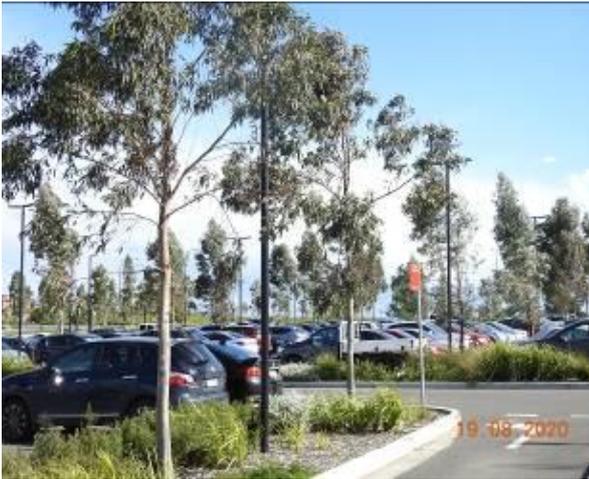
Figure 1329 – General condition of plantation and lamp post

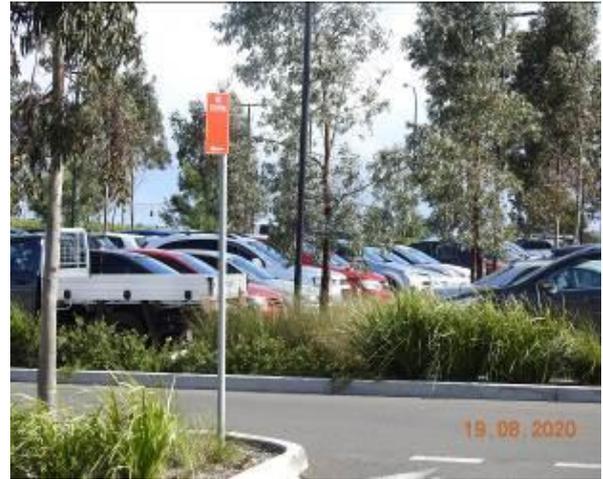
Figure 1330 – General condition of street sign

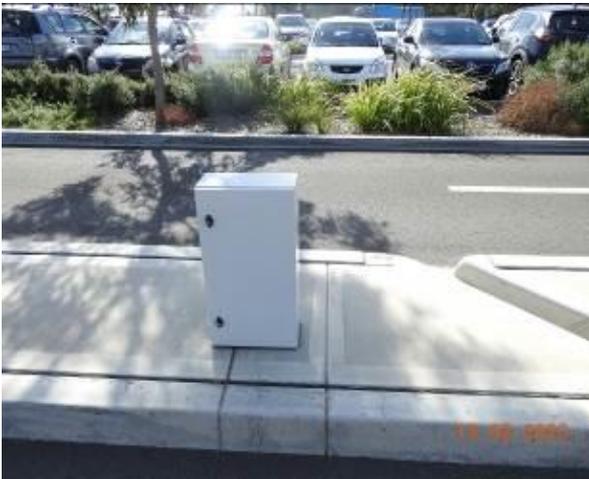
Figure 1331 – General condition of electricity box

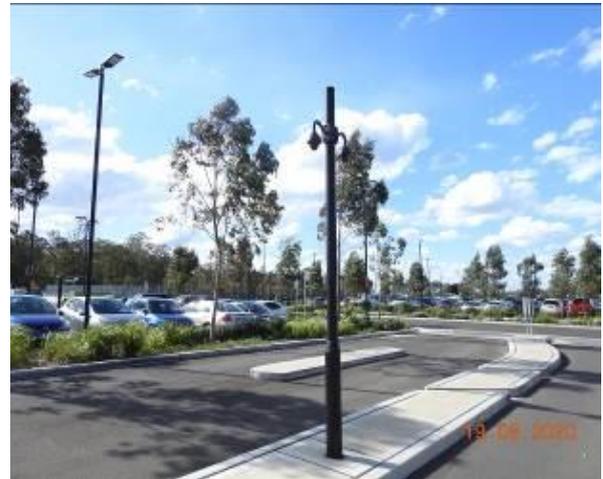
Figure 1332 – General condition of security camera pole

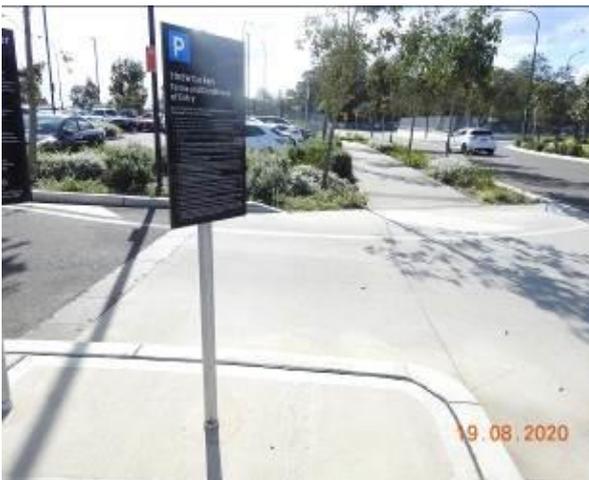
Figure 1333 – General condition of street sign

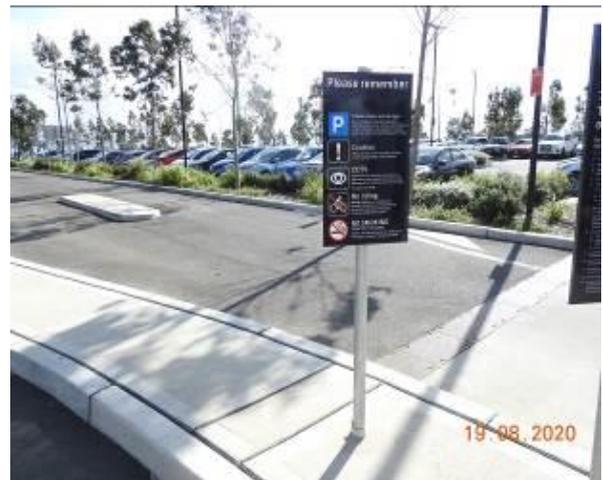
Figure 1334 – General condition of street sign

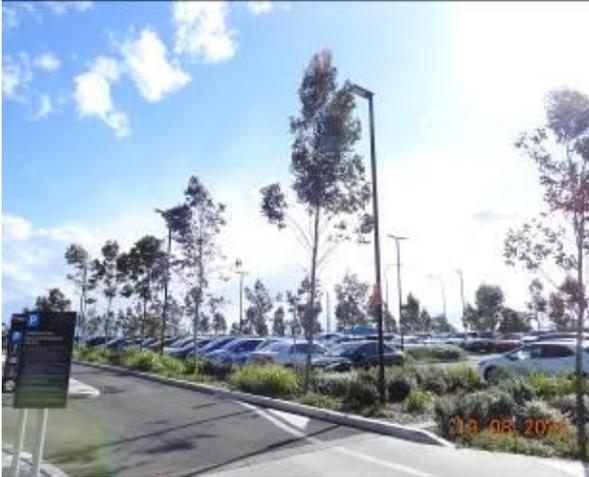
Figure 1335 – General condition of plantation and lamp post

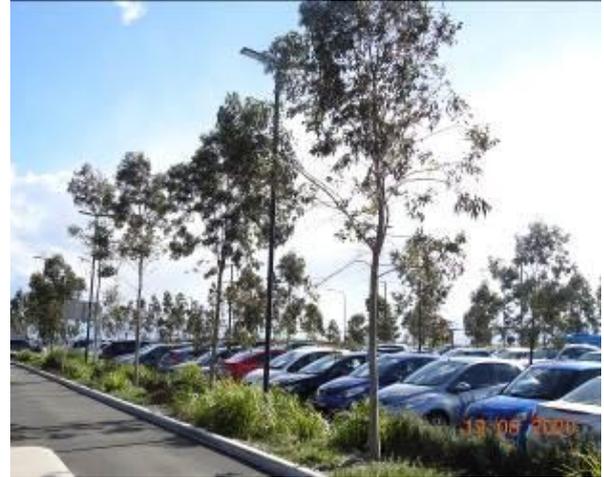
Figure 1336 – General condition of plantation and lamp post

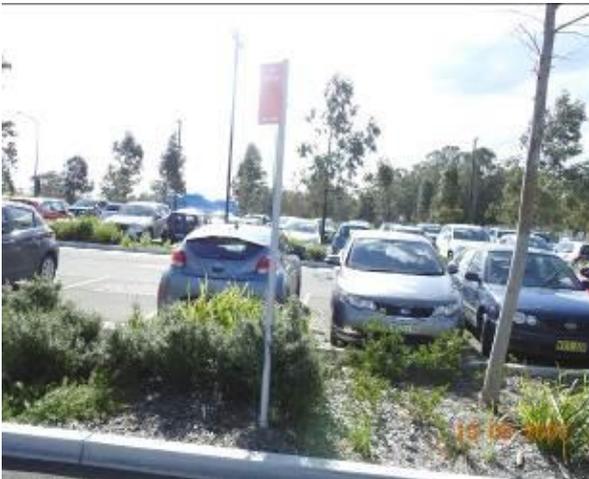
Figure 1337 – General condition of street sign

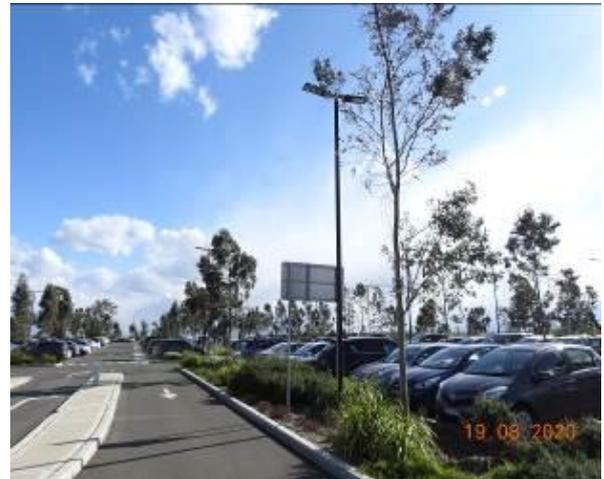
Figure 1338 – General condition of plantation and lamp post

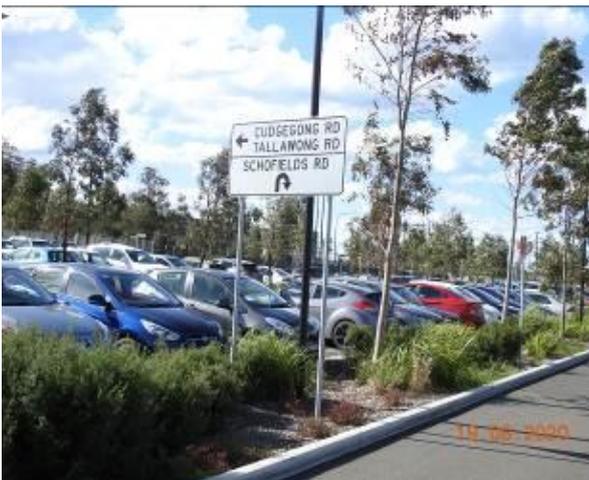
Figure 1339 – General condition of street sign

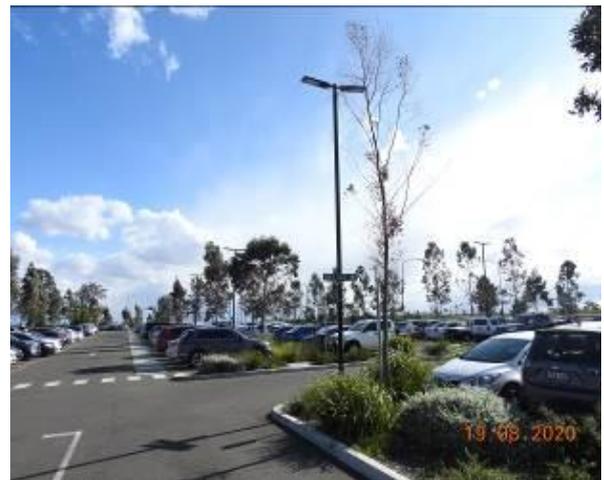
Figure 1340 – General condition of plantation and lamp post

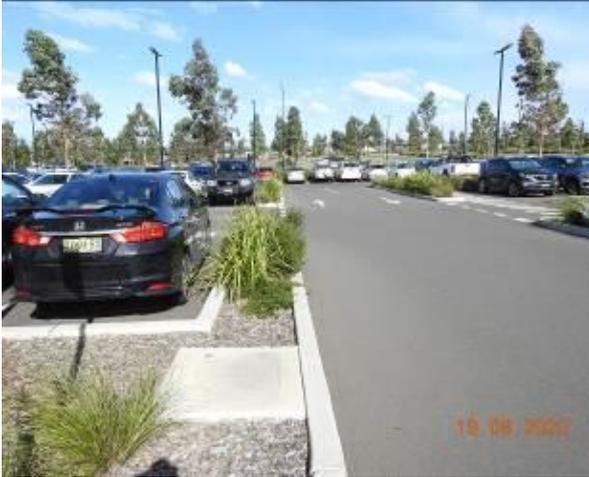
Figure 1341 – General condition of plantation

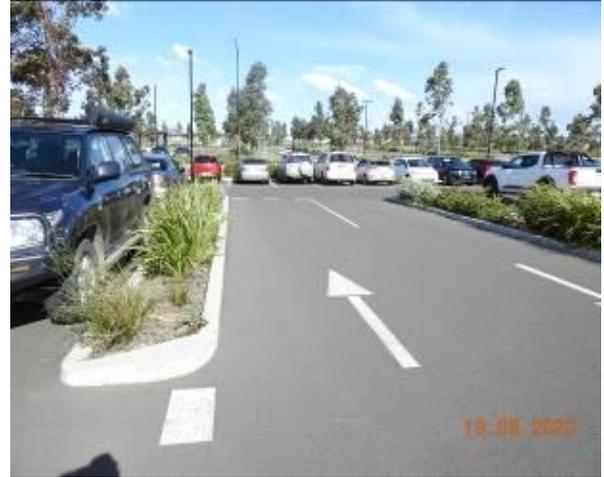
Figure 1342 – General condition of plantation

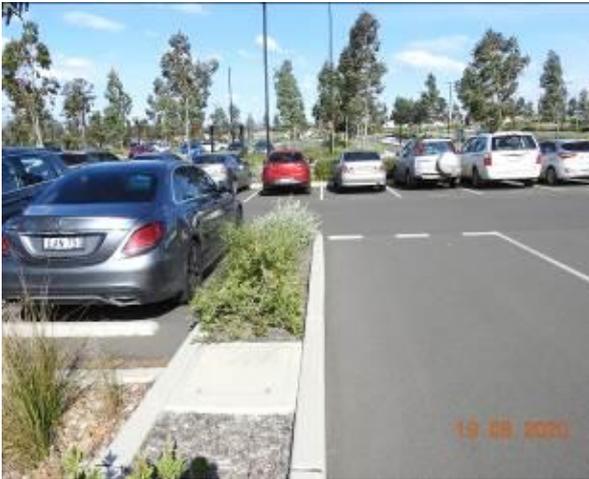
Figure 1343 – General condition of plantation

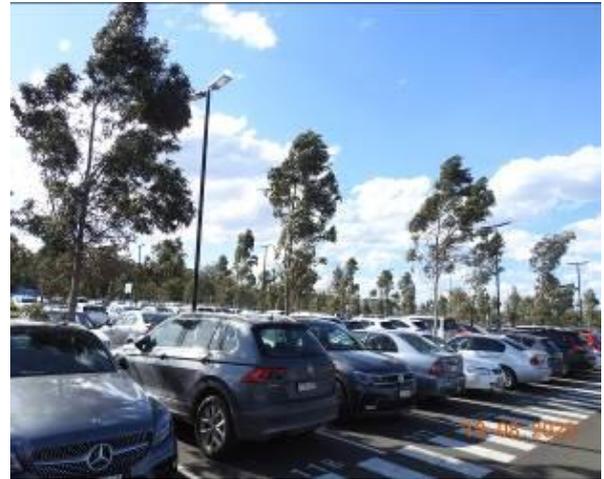
Figure 1344 – General condition of plantation and lamp post

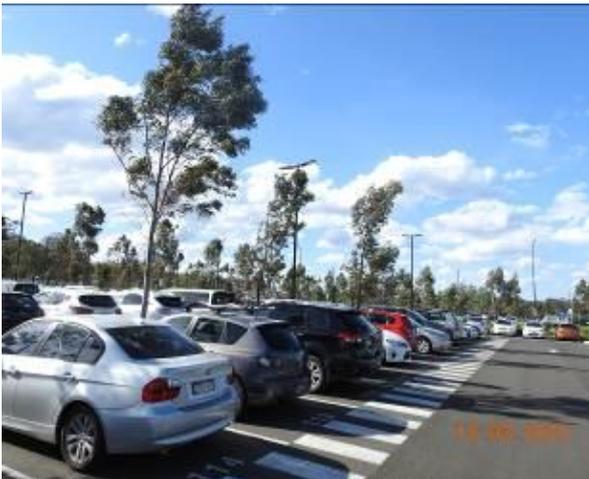
Figure 1345 – General condition of plantation and lamp post

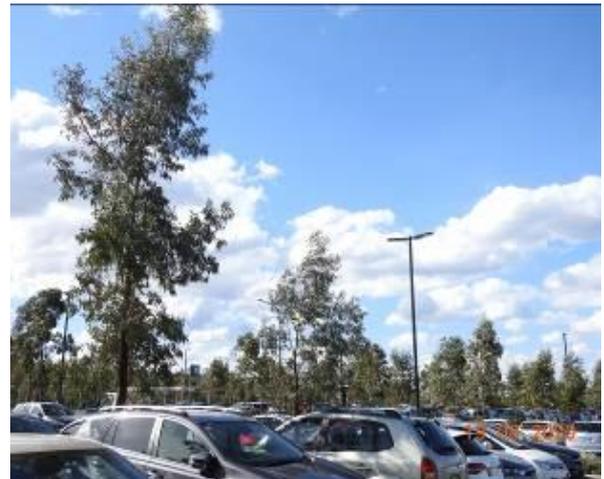
Figure 1346 – General condition of plantation and lamp post

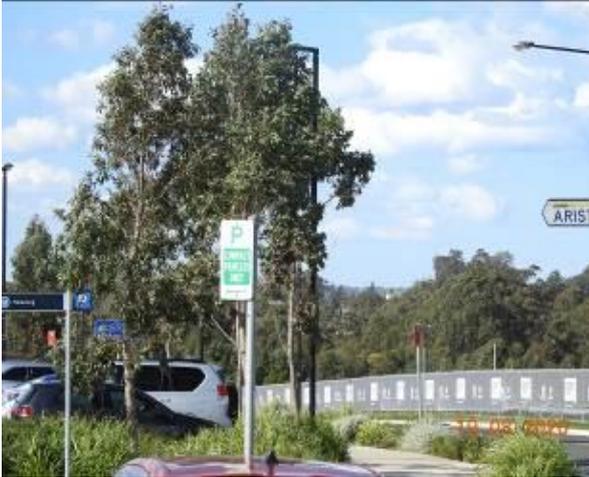
Figure 1347 – General condition of street sign

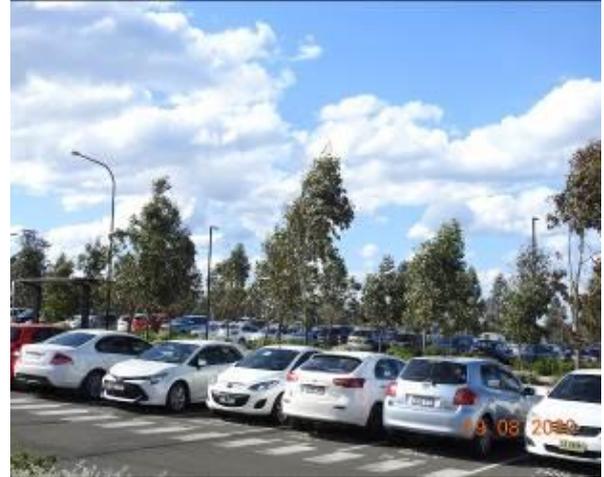
Figure 1348 – General condition of plantation and lamp post

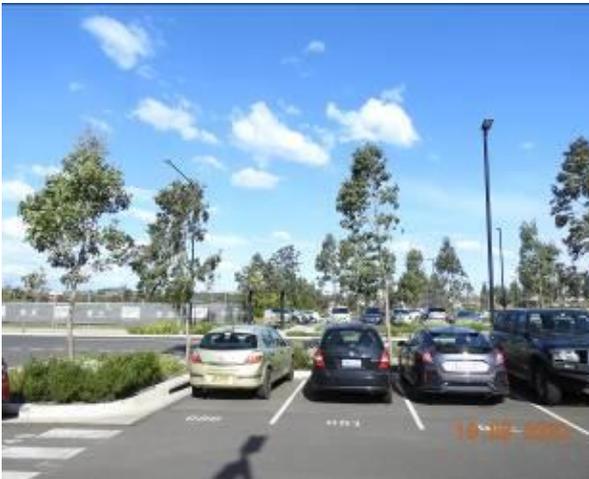
Figure 1349 – General condition of plantation and lamp post

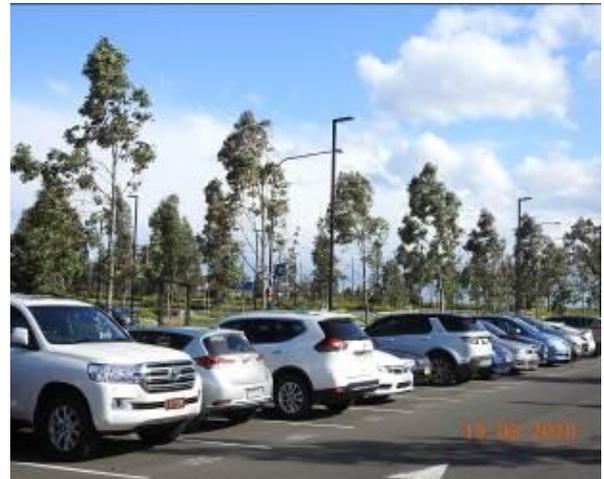
Figure 1350 – General condition of plantation and lamp post

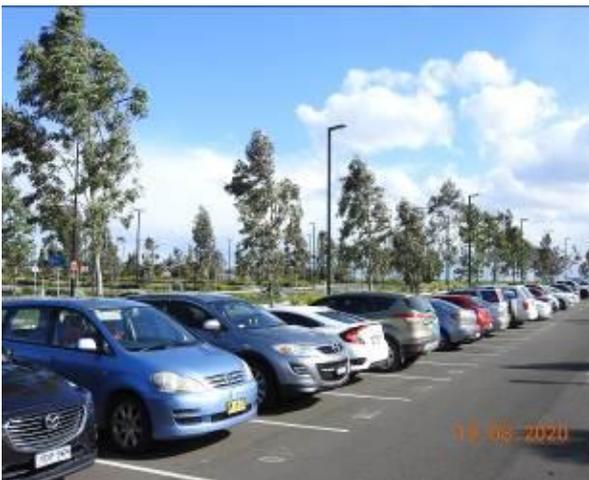
Figure 1351 – General condition of plantation and lamp post

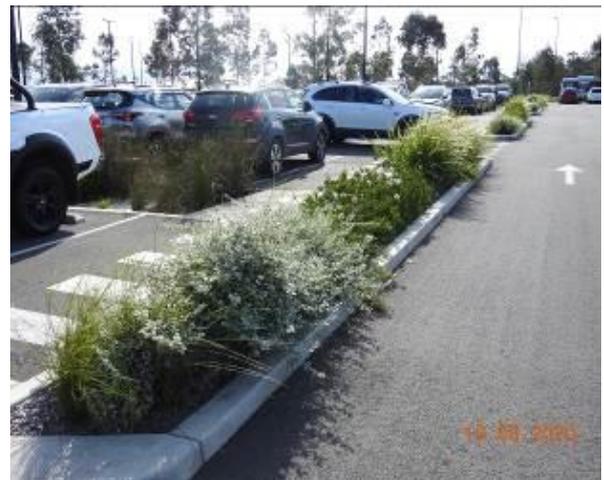
Figure 1352 – General condition of plantation

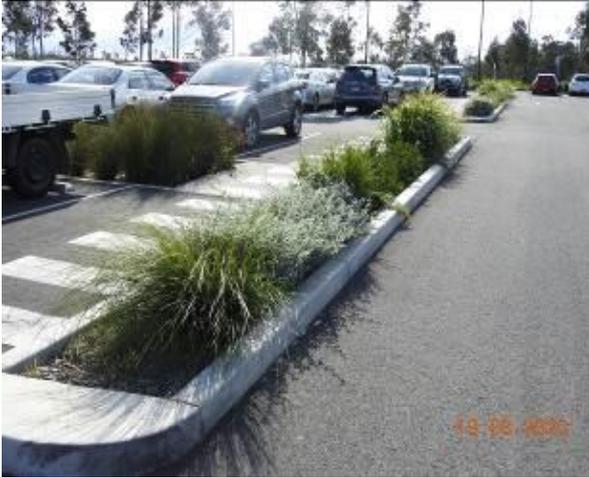
Figure 1353 – General condition of plantation

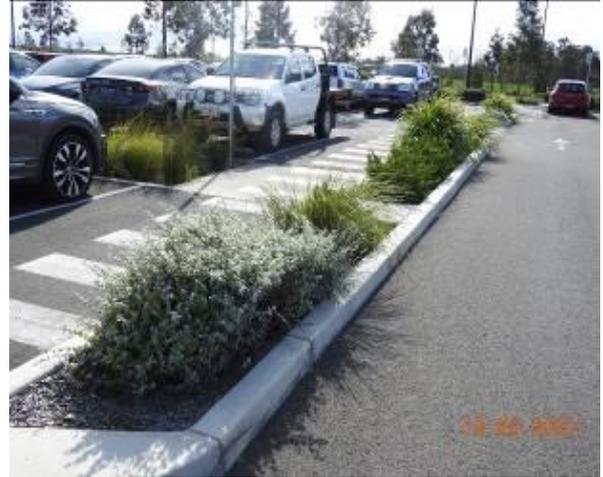
Figure 1354 – General condition of plantation
