The property Tallawong station – P2 Car Park, is the neighbouring property to our client’s site. It was photographed and inspected prior to any construction works on the subject site and was found to be in a reasonable condition. The property serves as a car park.

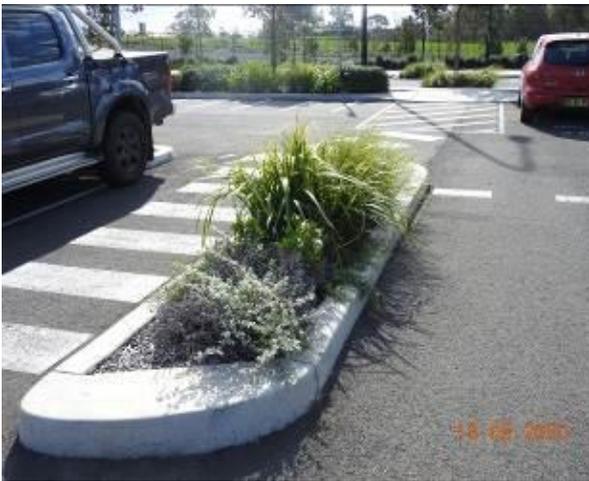
Figure 1355 – General condition of plantation

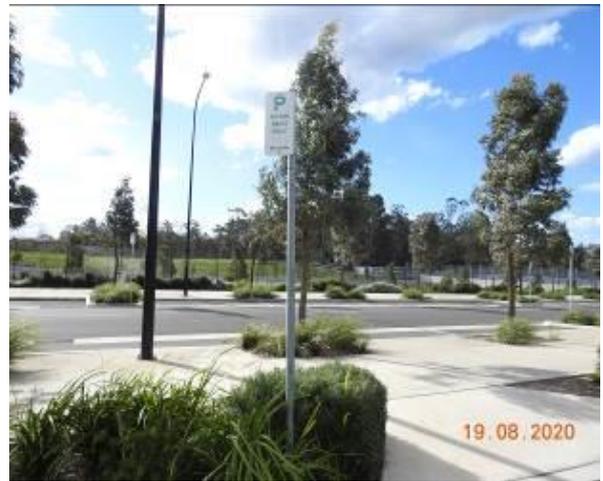
Figure 1356 – General condition of street sign

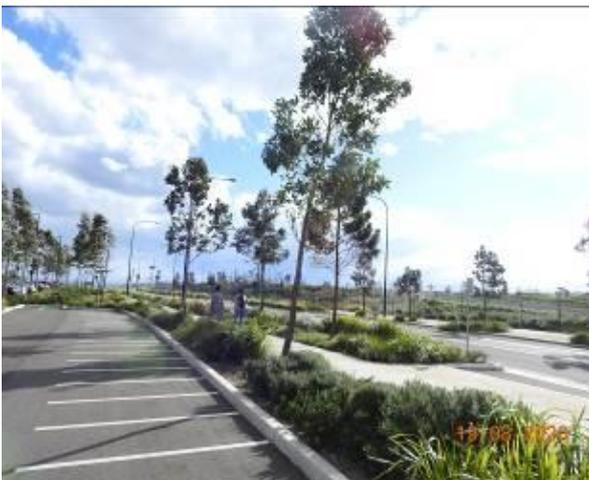
Figure 1357 – General condition of plantation and lamp post

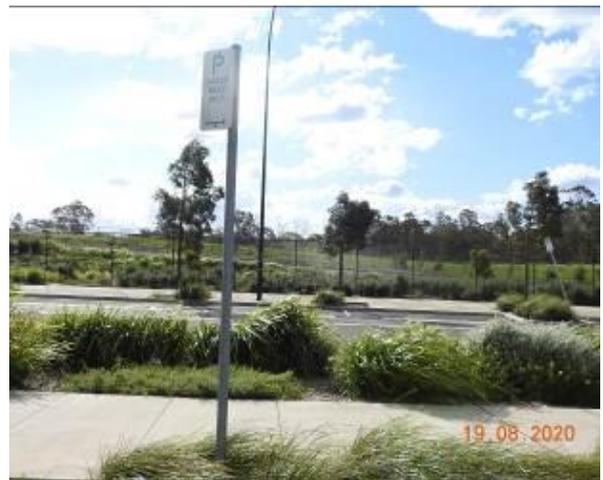
Figure 1358 – General condition of street sign

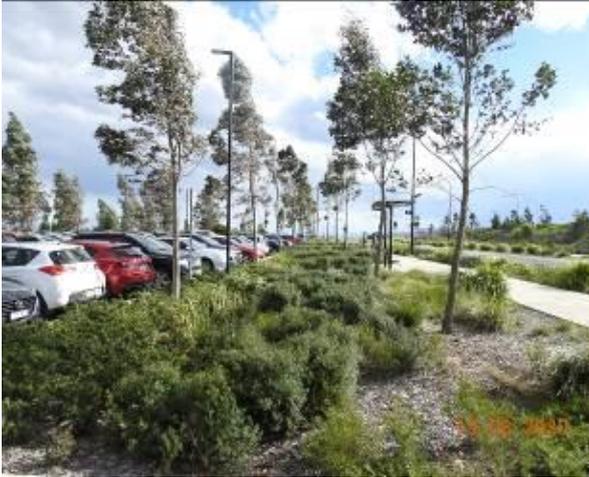
Figure 1359 – General condition of plantation and lamp post

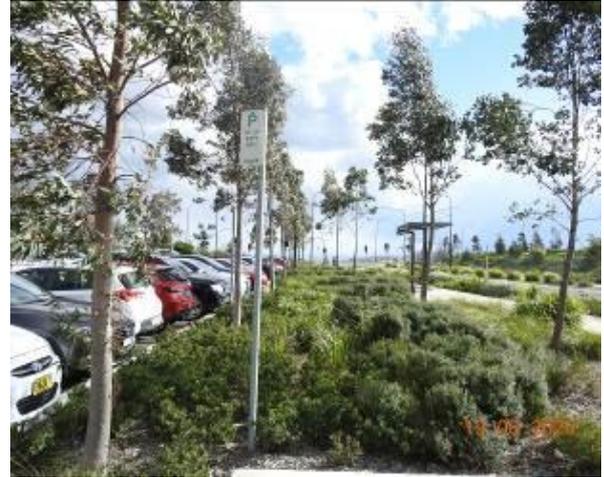
Figure 1360 – General condition of street sign and plantation

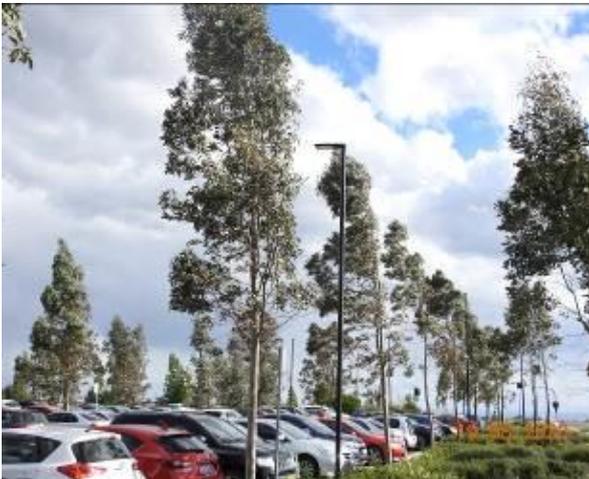
Figure 1361 – General condition of plantation and lamp post

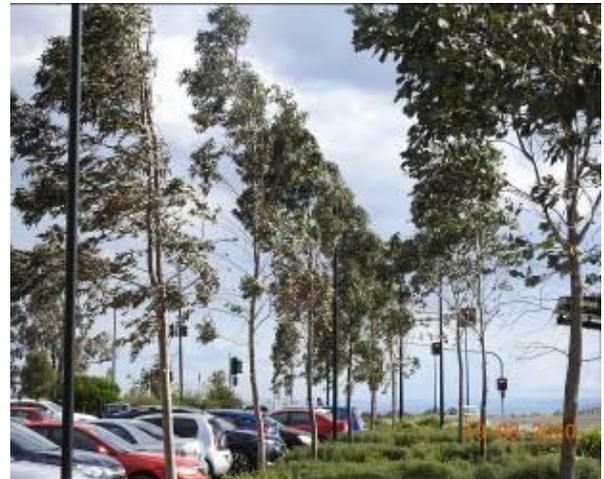
Figure 1362 – General condition of plantation and lamp post

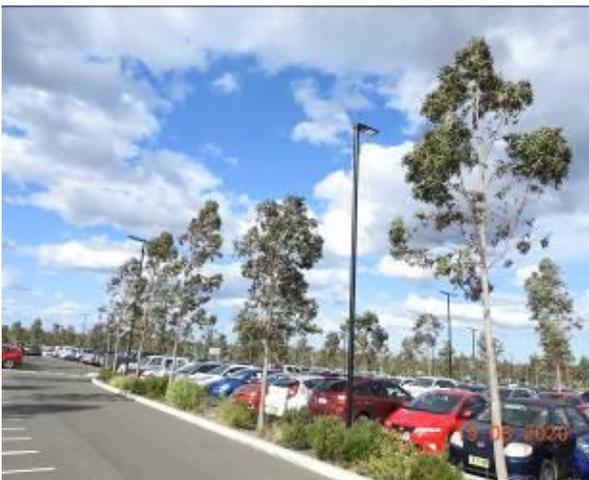
Figure 1363 – General condition of plantation and lamp post

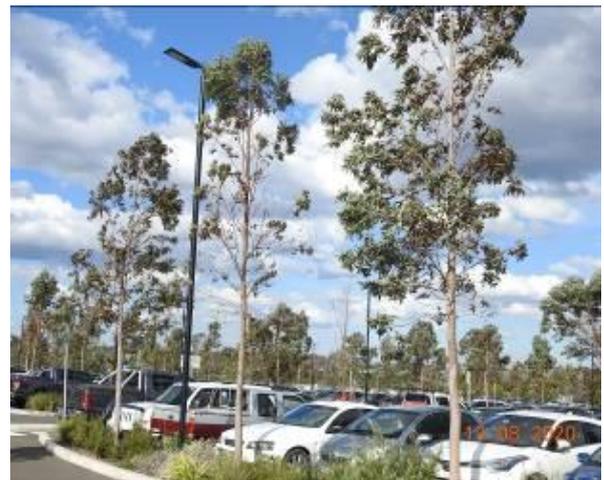
Figure 1364 – General condition of plantation and lamp post

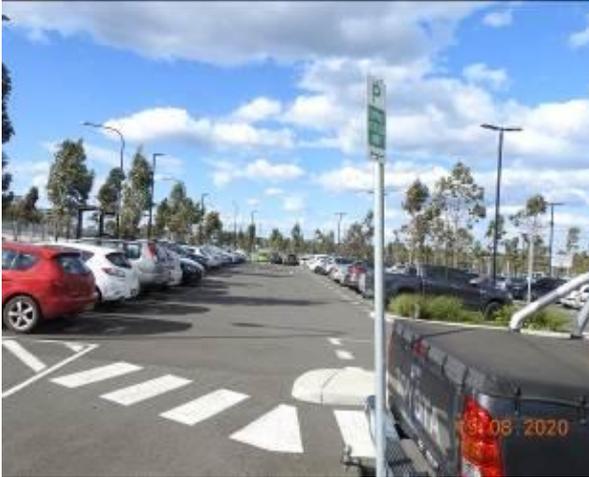
Figure 1365 – General condition of street sign

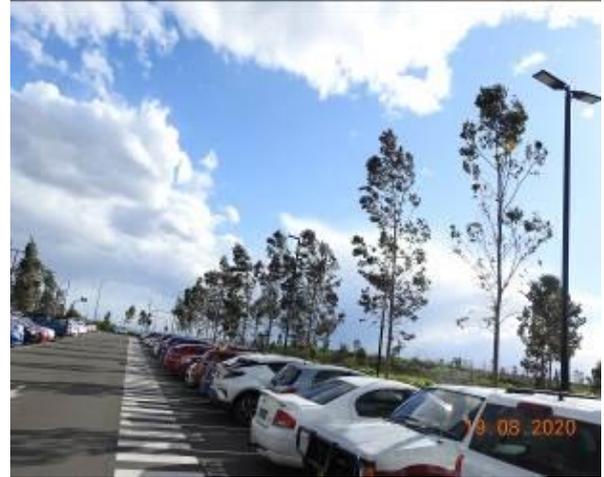
Figure 1366 – General condition of plantation and lamp post

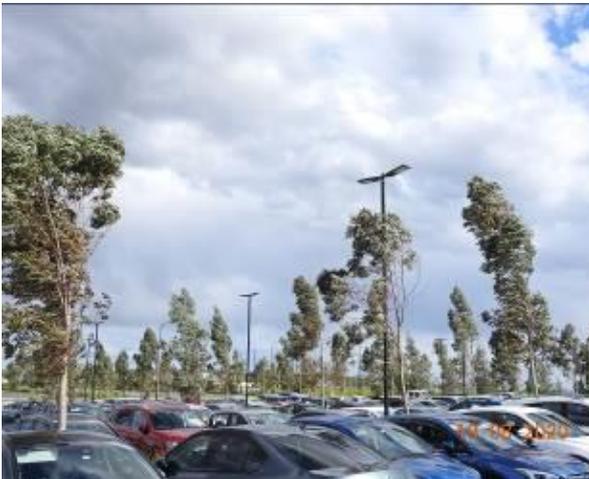
Figure 1367 – General condition of plantation and lamp post

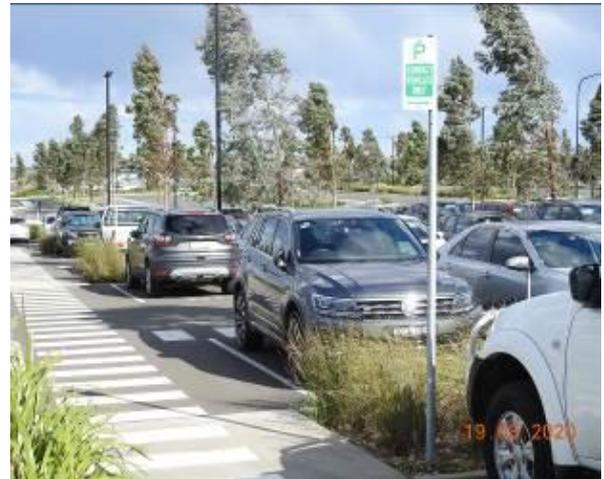
Figure 1368 – General condition of street sign

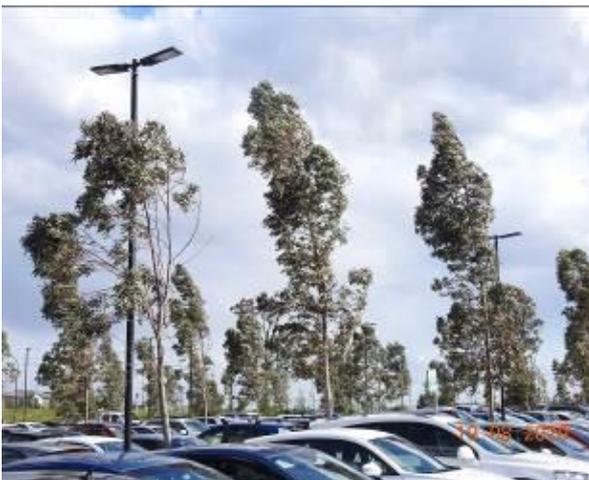
Figure 1369 – General condition of plantation and lamp post

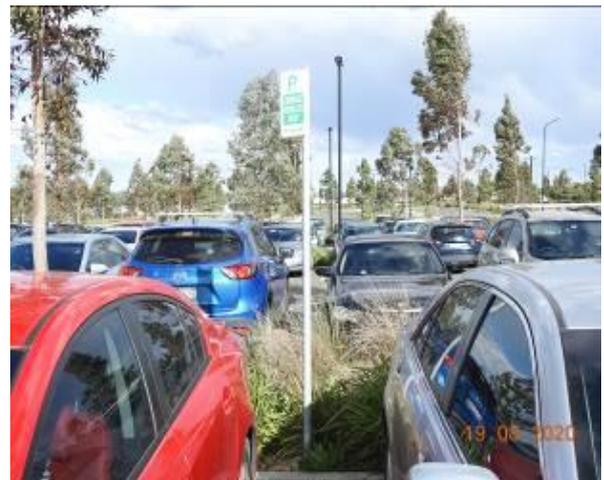
Figure 1370 – General condition of street sign

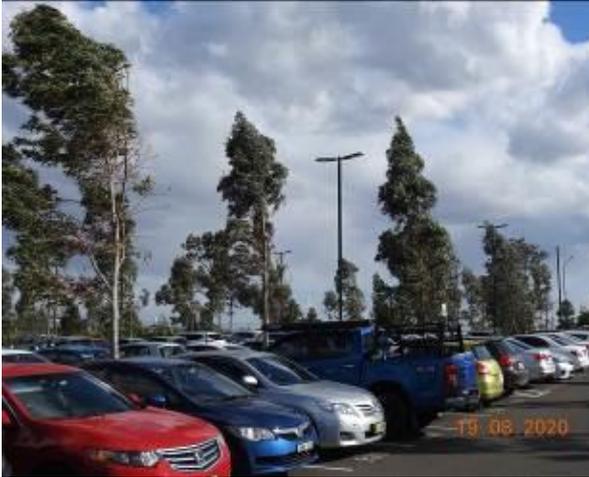
Figure 1371 – General condition of plantation and lamp post

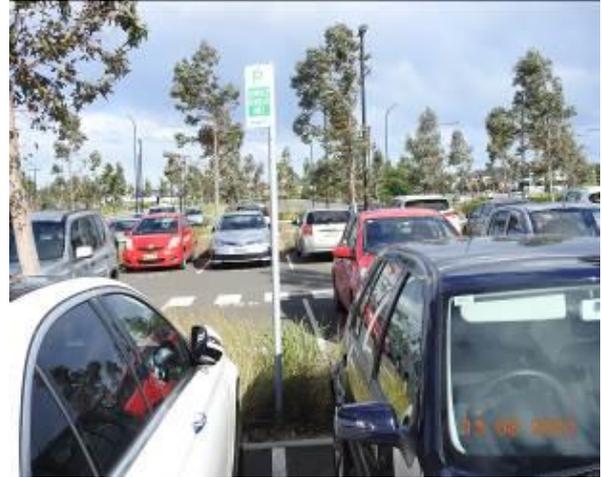
Figure 1372 – General condition of street sign

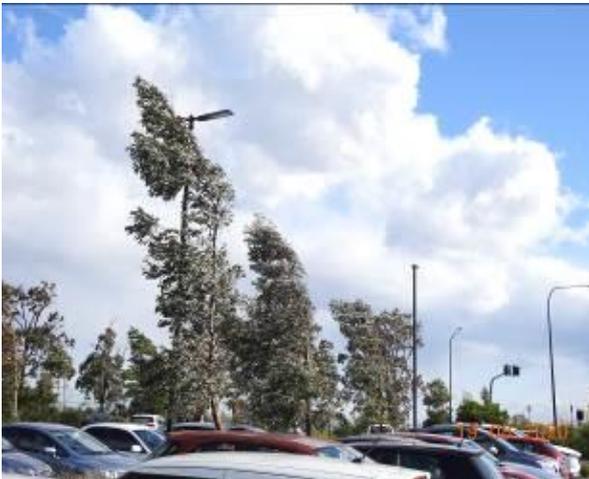
Figure 1373 – General condition of plantation and lamp post

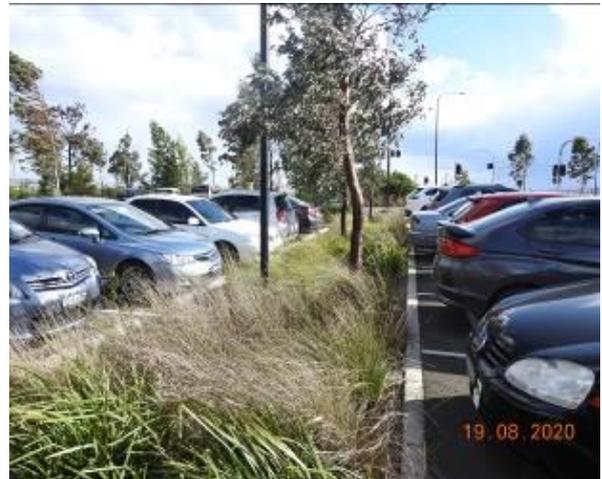
Figure 1374 – General condition of plantation

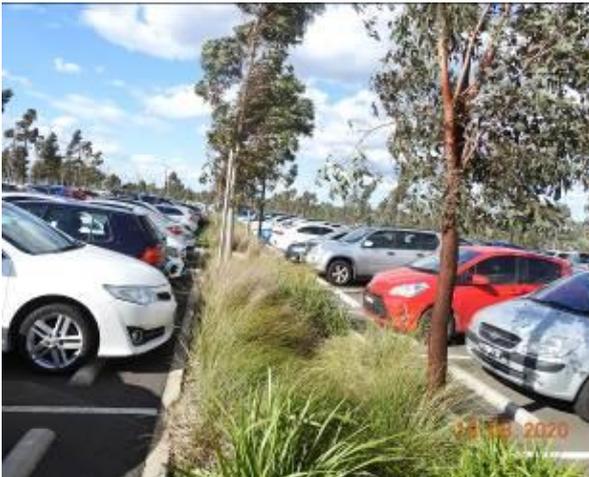
Figure 1375 – General condition of plantation

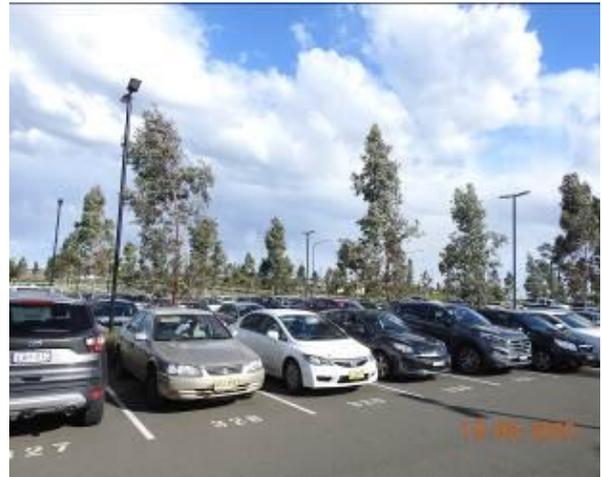
Figure 1376 – General condition of plantation and lamp post

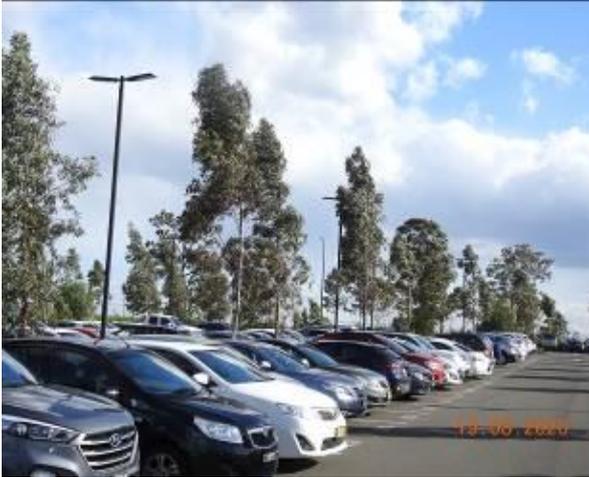
Figure 1377 – General condition of plantation and lamp post

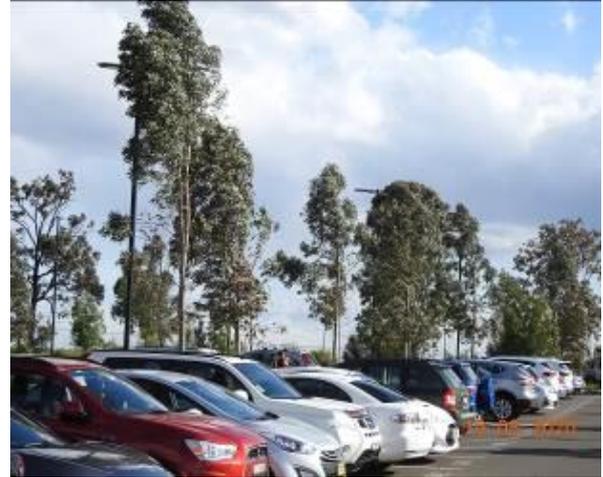
Figure 1378 – General condition of plantation and lamp post

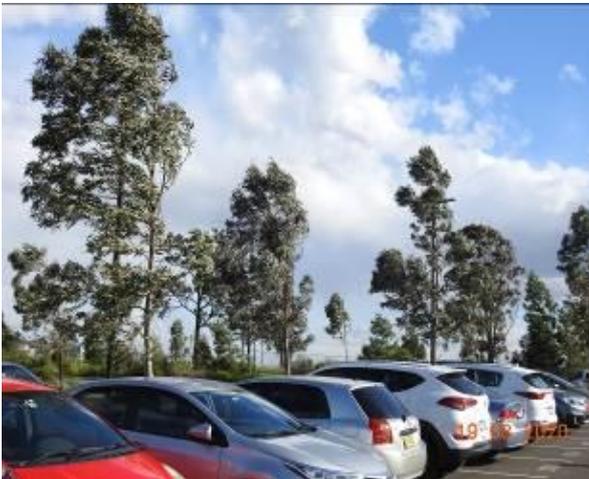
Figure 1379 – General condition of plantation and lamp post

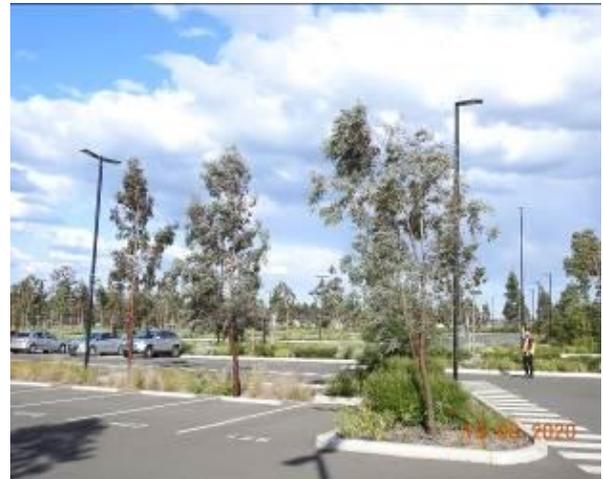
Figure 1380 – General condition of plantation and lamp post

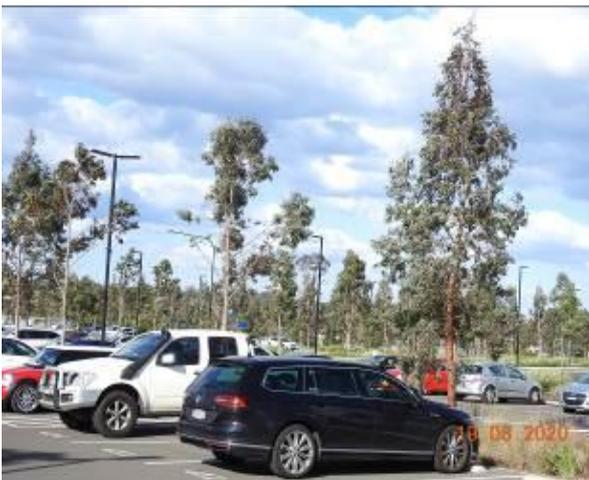
Figure 1381 – General condition of plantation and lamp post

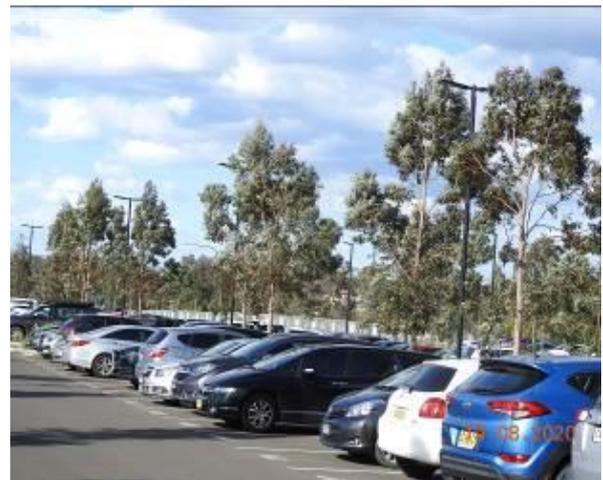
Figure 1382 – General condition of plantation and lamp post

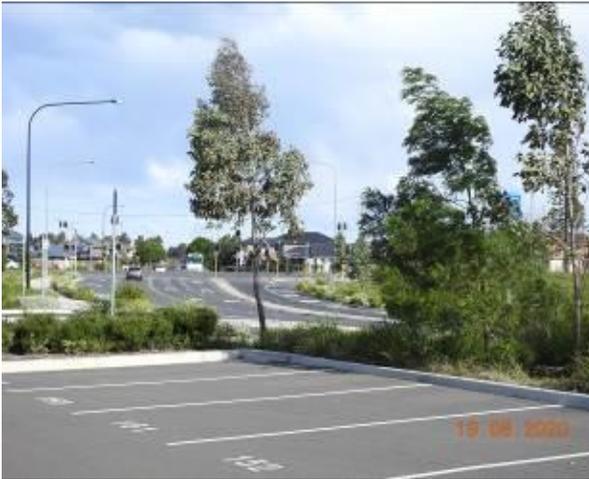
Figure 1383 – General condition of plantation and lamp post

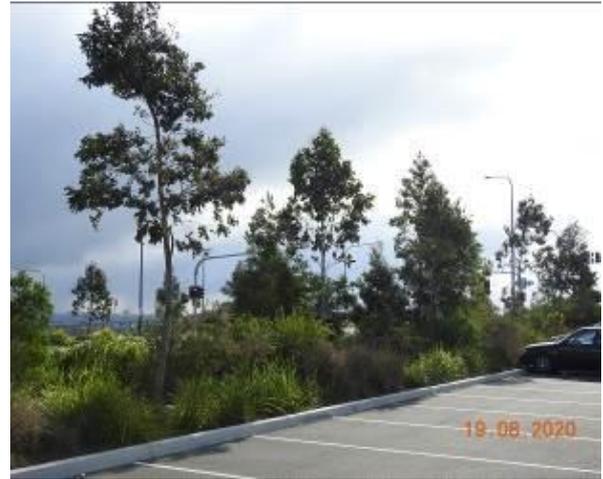
Figure 1384 – General condition of plantation and lamp post

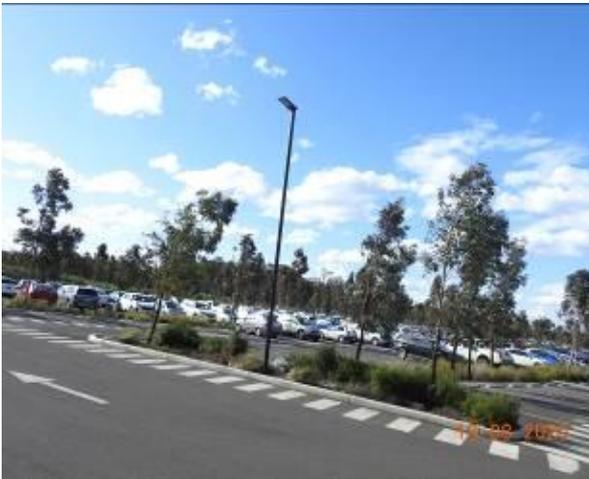
Figure 1385 – General condition of plantation and lamp post

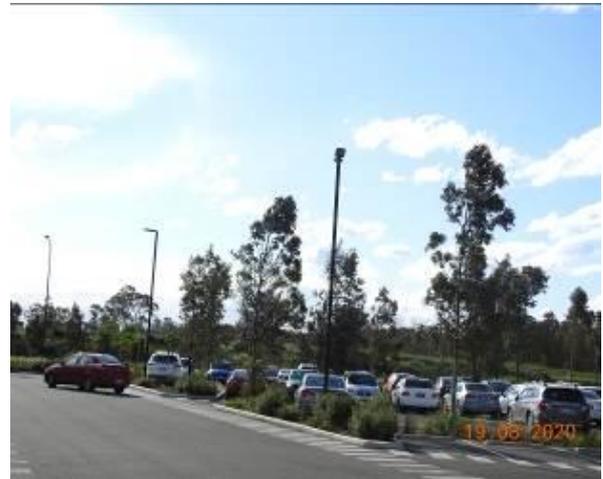
Figure 1386 – General condition of plantation and lamp post

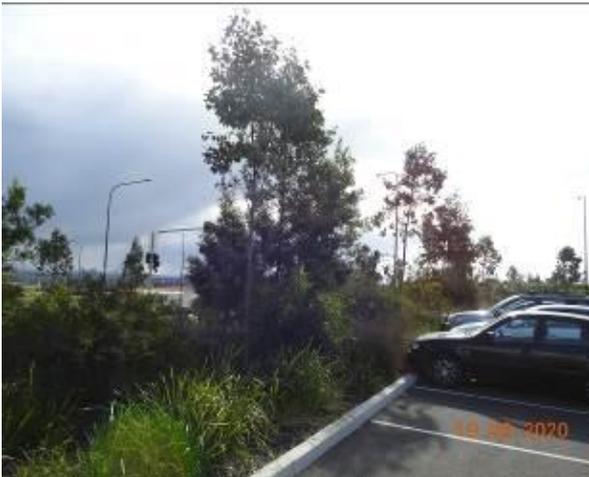
Figure 1387 – General condition of plantation and lamp post

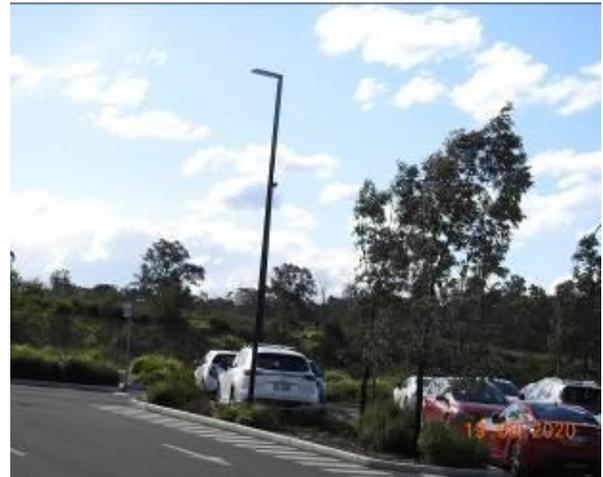
Figure 1388 – General condition of plantation and lamp post

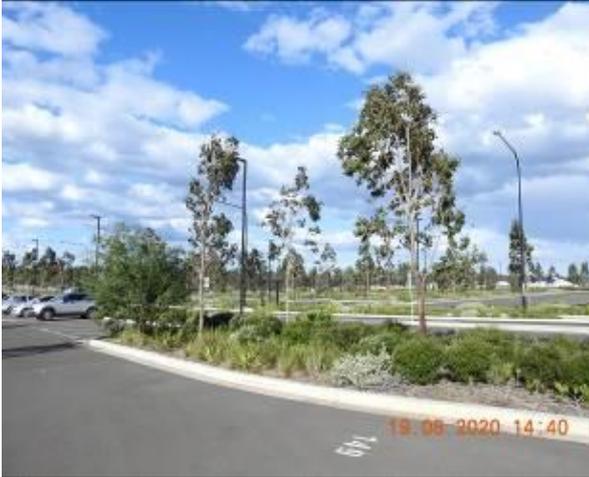
Figure 1389 – General condition of plantation and lamp post

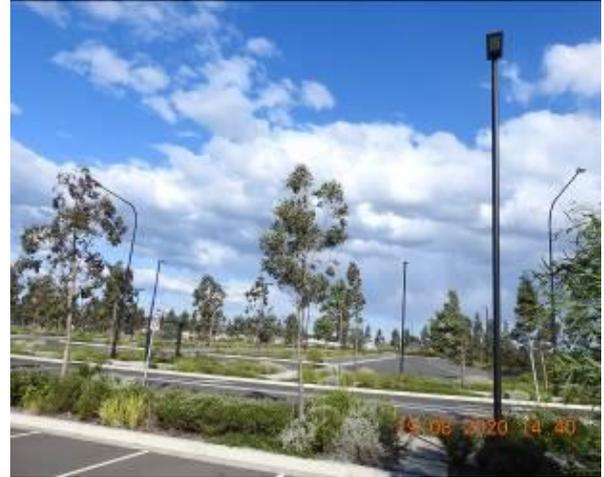
Figure 1390 – General condition of plantation and lamp post

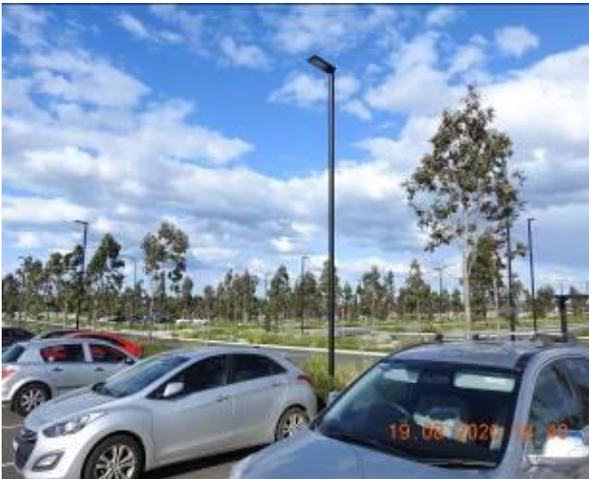
Figure 1391 – General condition of plantation and lamp post

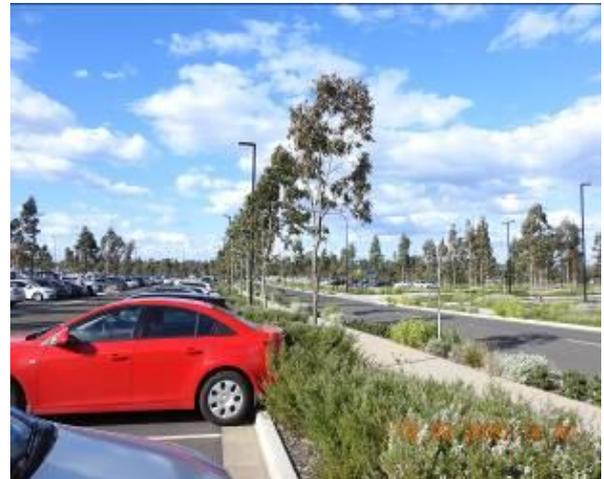
Figure 1392 – General condition of plantation and lamp post

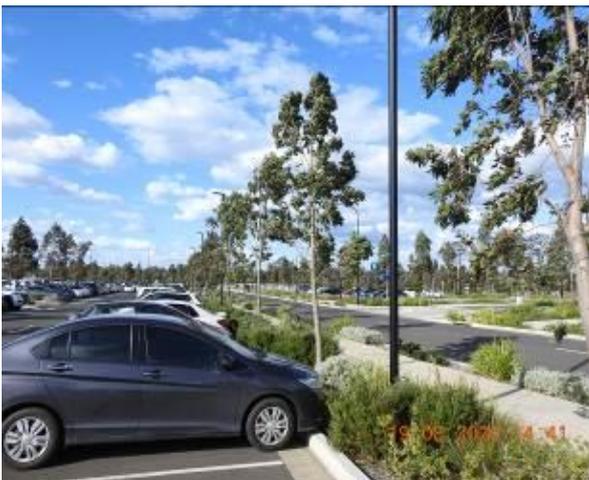
Figure 1393 – General condition of plantation and lamp post

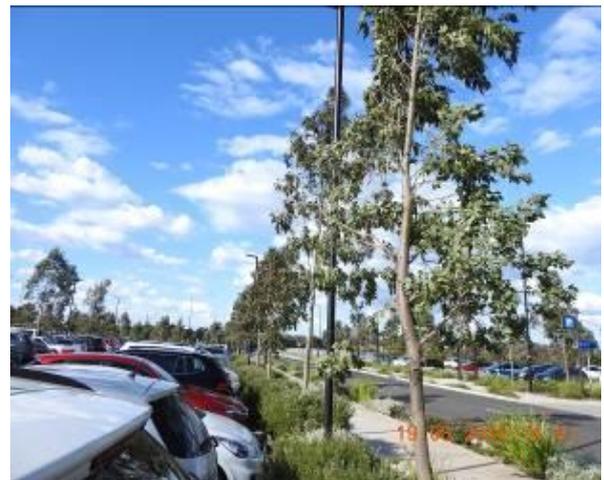
Figure 1394 – General condition of plantation and lamp post

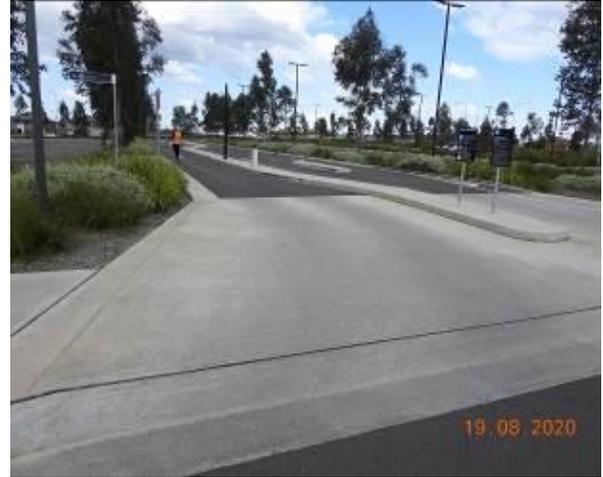
Figure 1396 – General condition of car park pavement

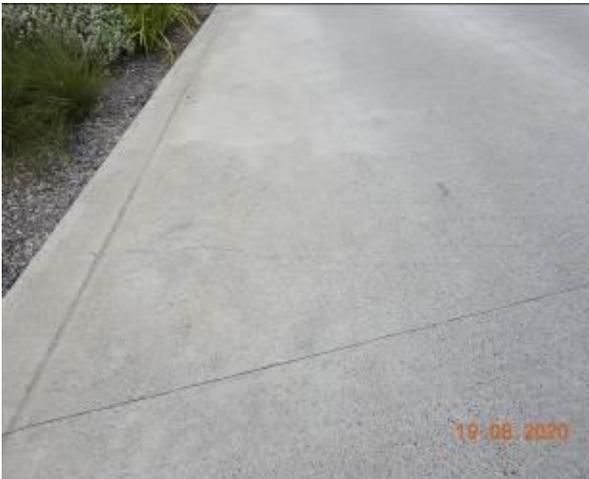
Figure 1397 – Crack propagation through car park pavement

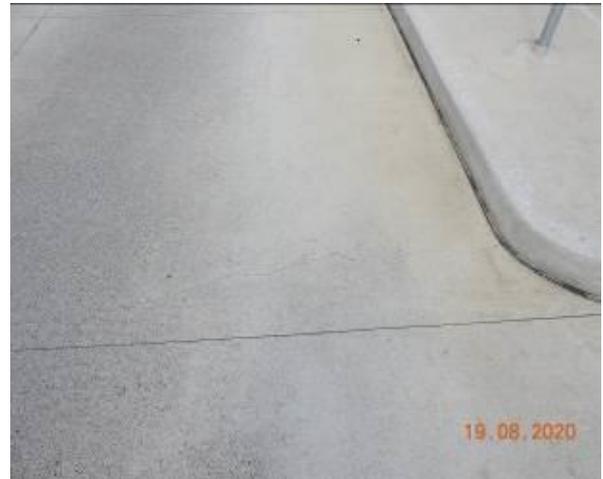
Figure 1398 – Crack propagation through car park pavement

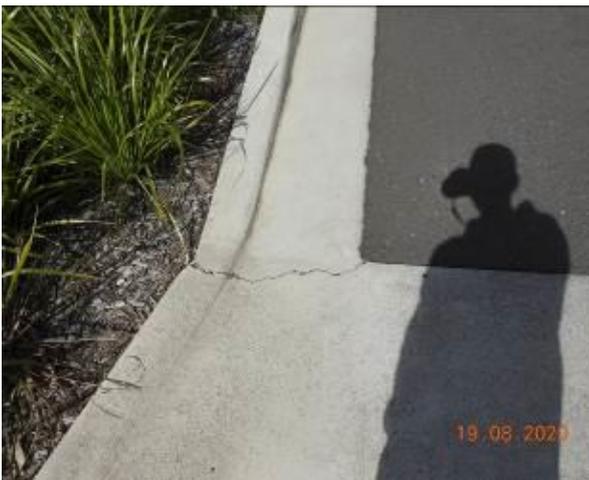
Figure 1399 – Crack propagation through car park pavement

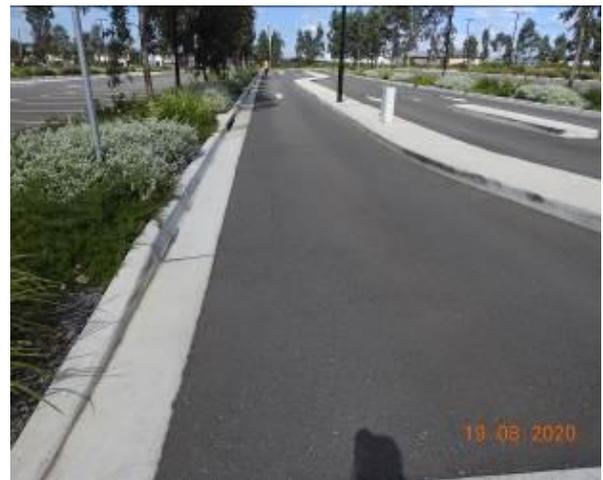
Figure 1400 – Crack propagation through car park pavement

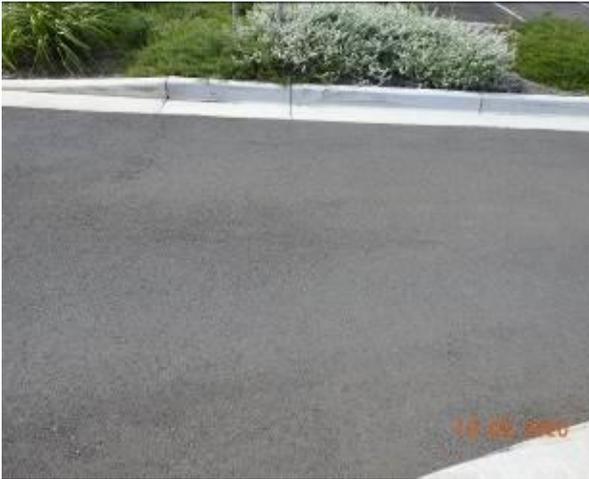
Figure 1401 – Crack propagation through car park pavement

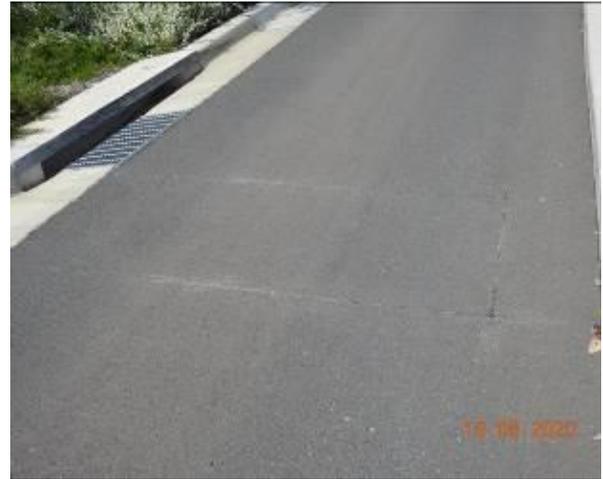
Figure 1402 – Crack propagation through car park pavement

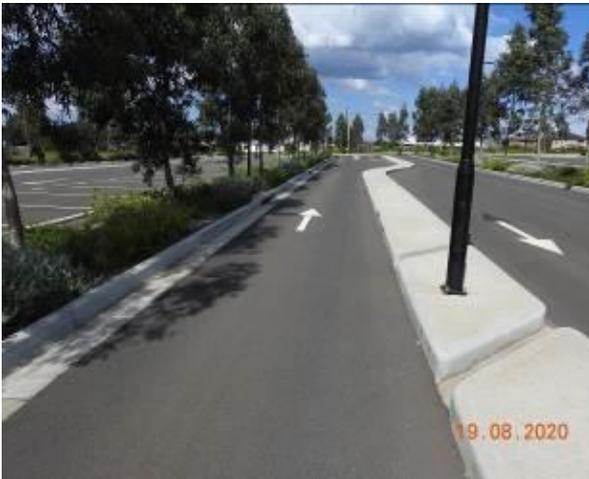
Figure 1403 – General condition of car park pavement

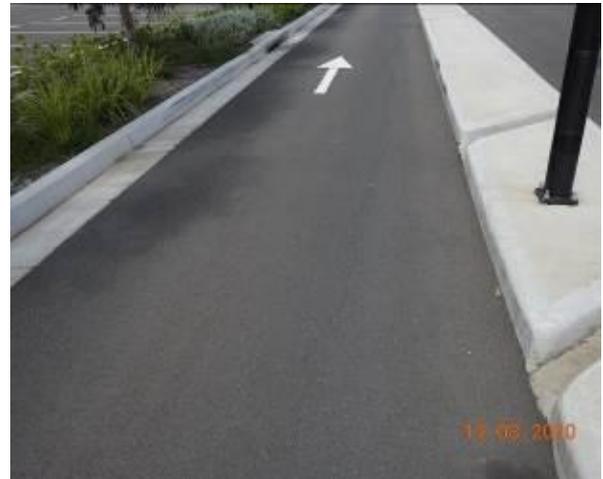
Figure 1404 – Crack propagation through car park pavement

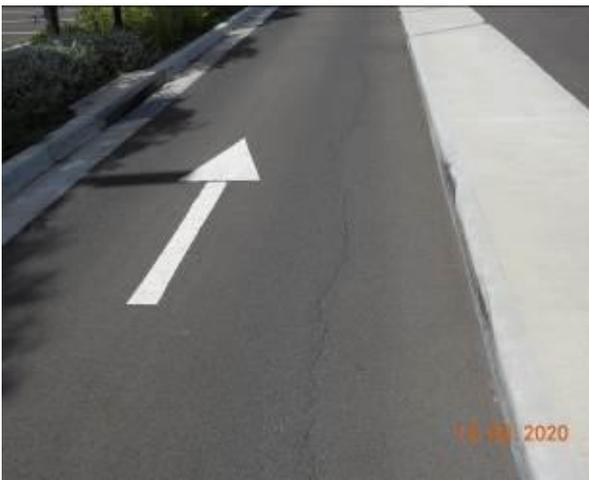
Figure 1405 – Crack propagation through car park pavement

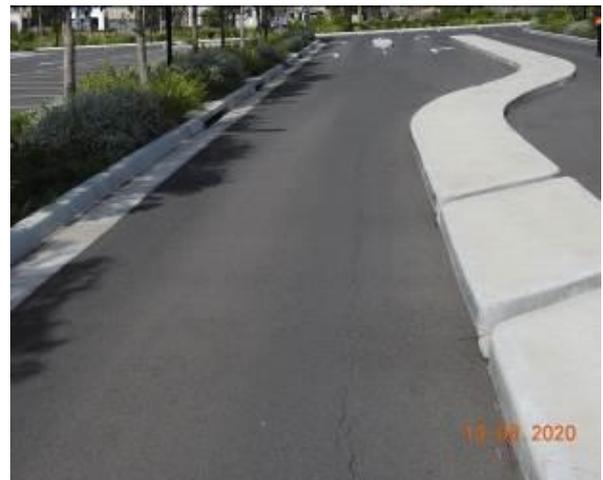
Figure 1406 – Crack propagation through car park pavement

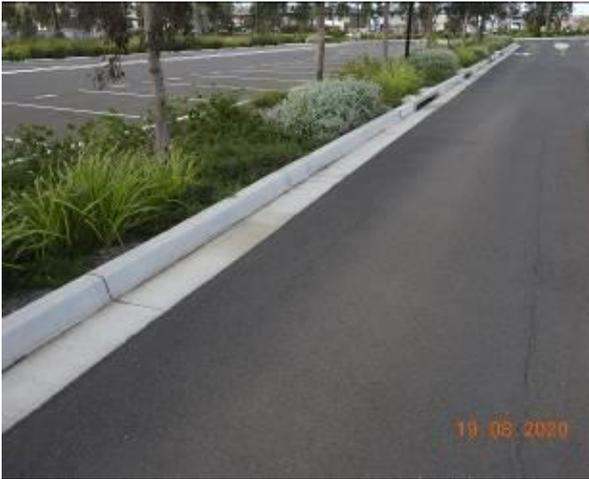
Figure 1407 – Crack propagation through car park pavement

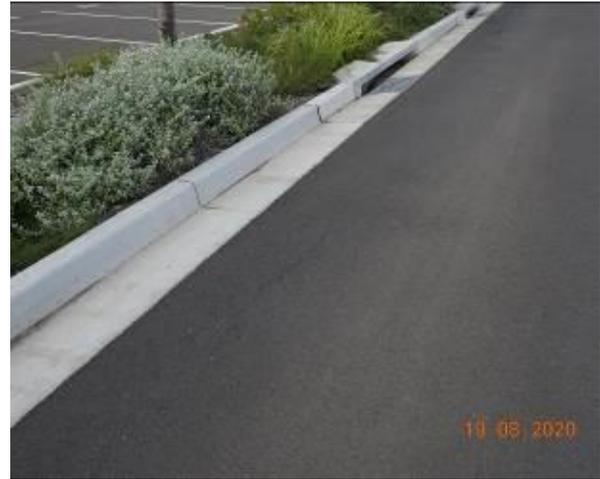
Figure 1408 – Crack propagation through car park pavement

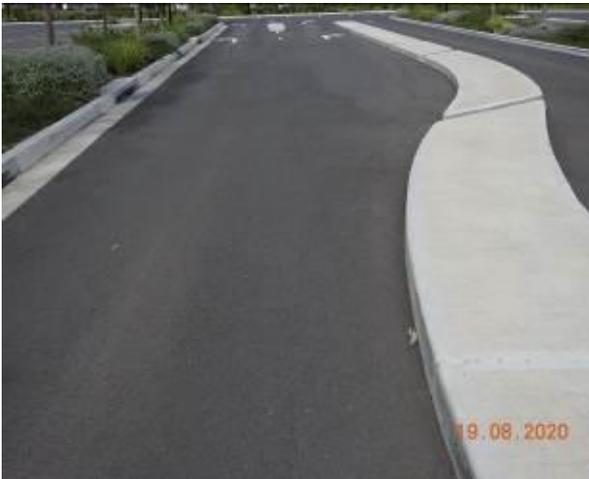
Figure 1409 – Crack propagation through car park pavement

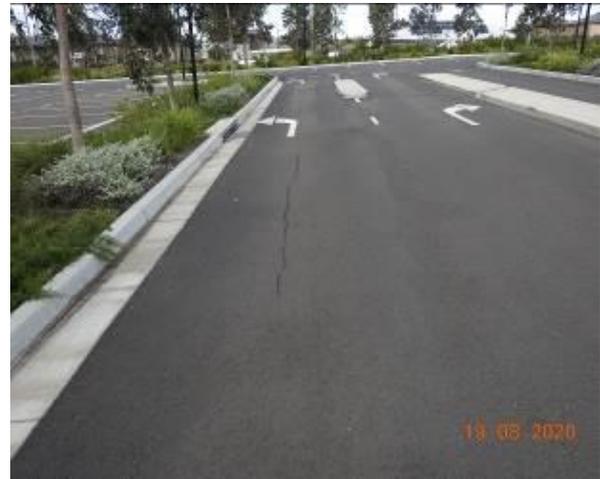
Figure 1410 – Crack propagation through car park pavement

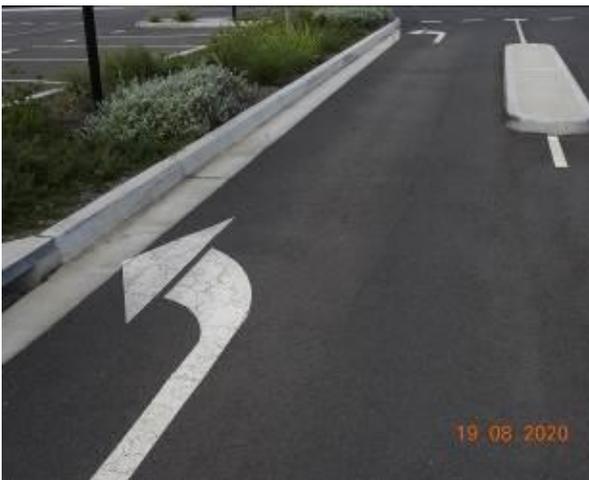
Figure 1411 – Crack propagation through car park pavement

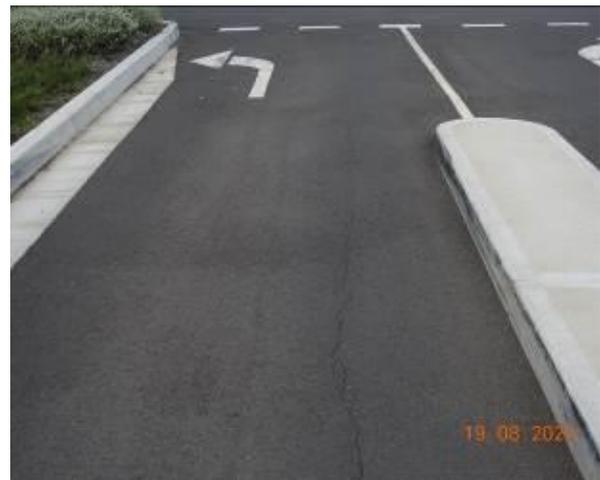
Figure 1412 – Crack propagation through car park pavement

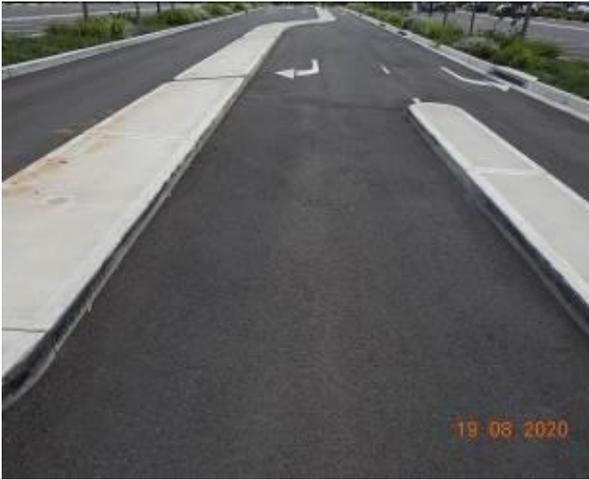
Figure 1413 – General condition of car park pavement

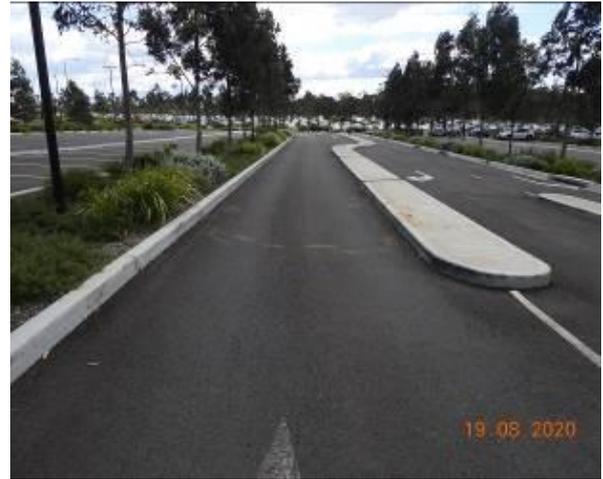
Figure 1414 – General condition of car park pavement

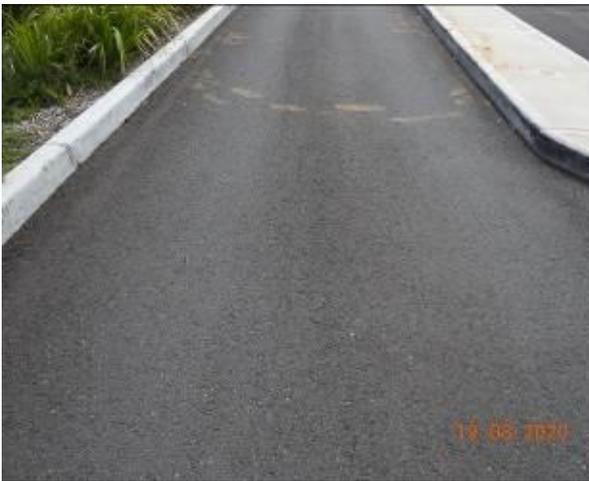
Figure 1415 – Crack propagation through car park pavement

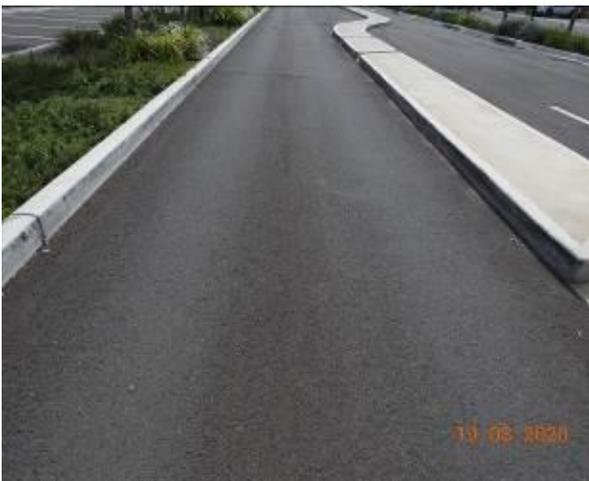
Figure 1417 – Crack propagation through car park pavement

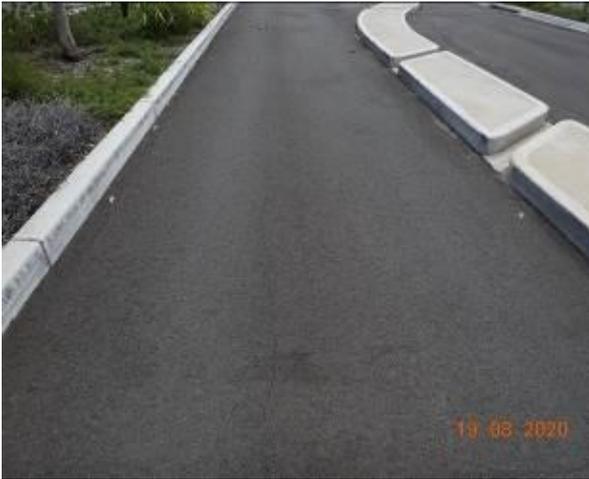
Figure 1419 – Crack propagation through car park pavement

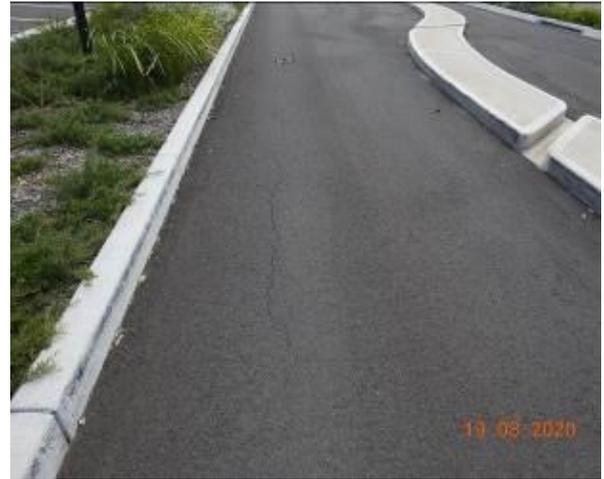
Figure 1420 – Crack propagation through car park pavement

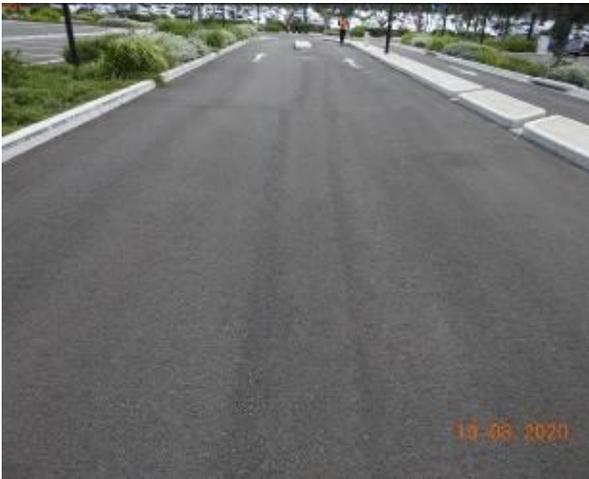
Figure 1421 – General condition of car park pavement

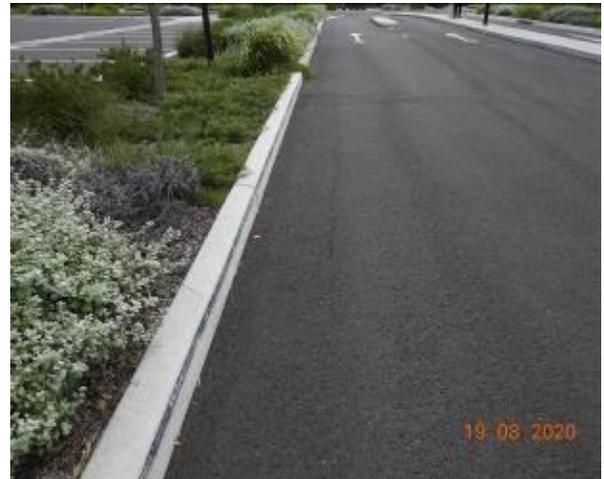
Figure 1422 – Crack propagation through car park pavement

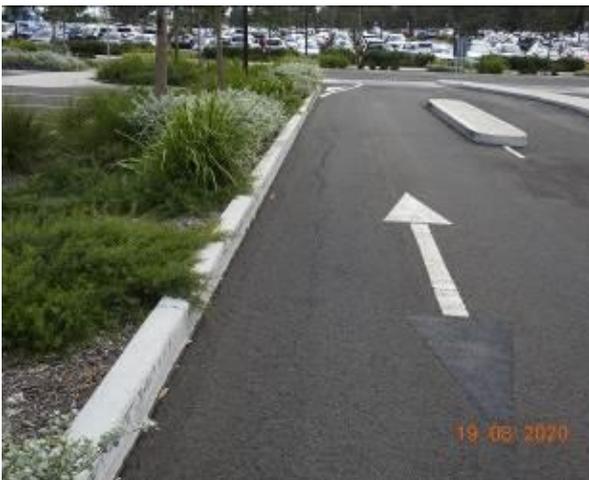
Figure 1423 – Crack propagation through car park pavement

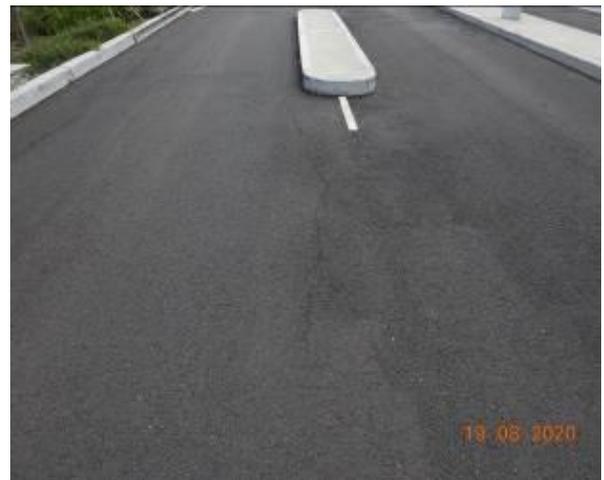
Figure 1424 – Crack propagation through car park pavement

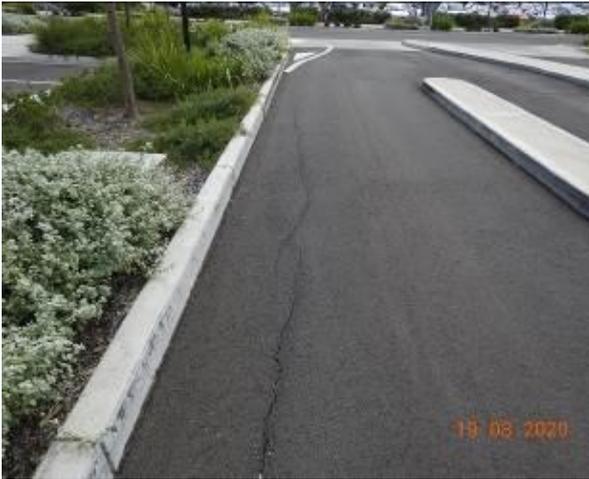
Figure 1425 – Crack propagation through car park pavement

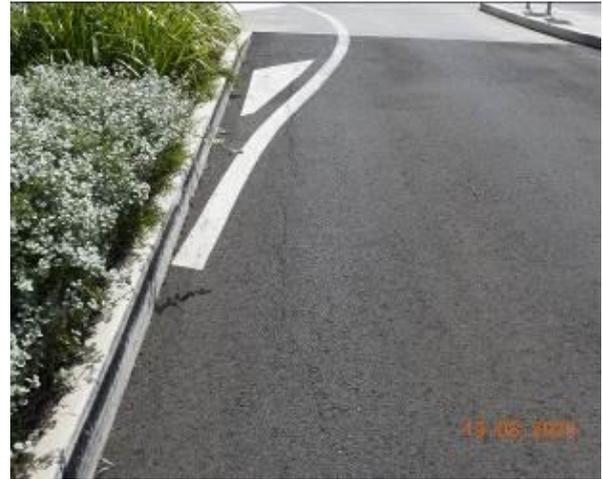
Figure 1426 – Crack propagation through car park pavement

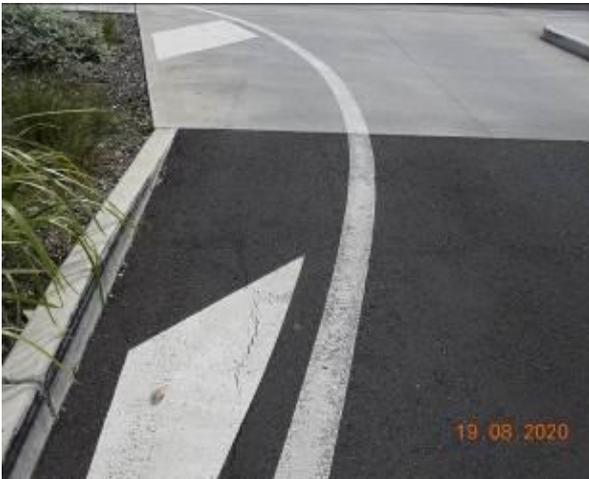
Figure 1427 – Crack propagation through car park pavement

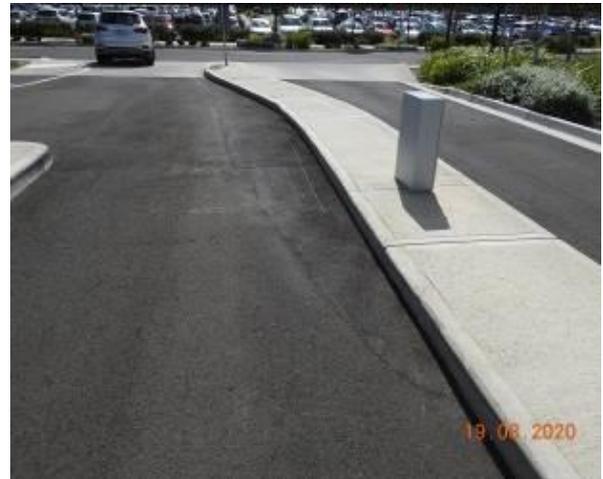
Figure 1428 – Evidence of patchwork through car park pavement

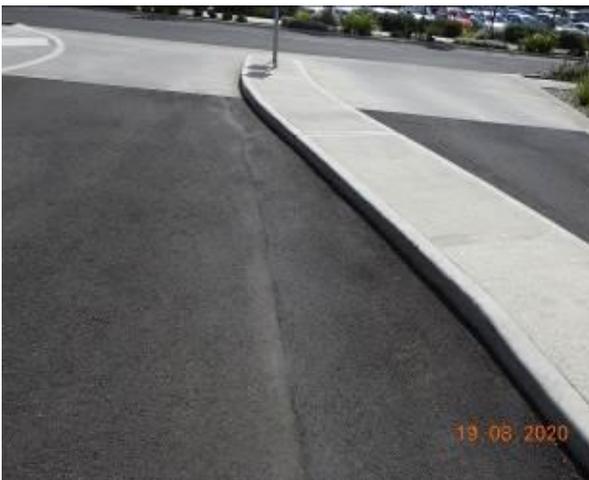
Figure 1429 – Evidence of patchwork through car park pavement

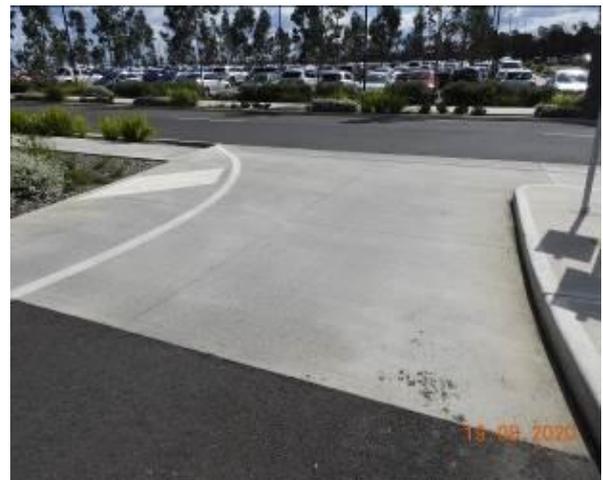
Figure 1430 – General condition of car park pavement

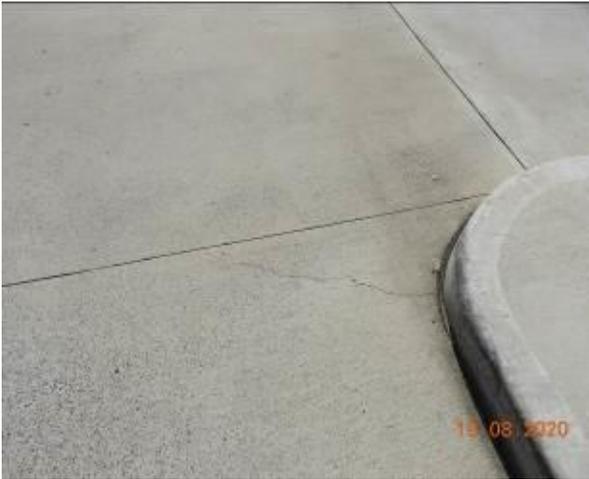
Figure 1431 – Crack propagation through car park pavement

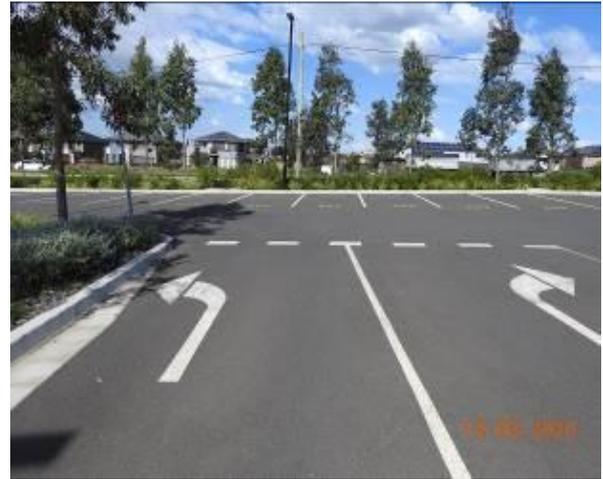
Figure 1432 – General condition of car park pavement

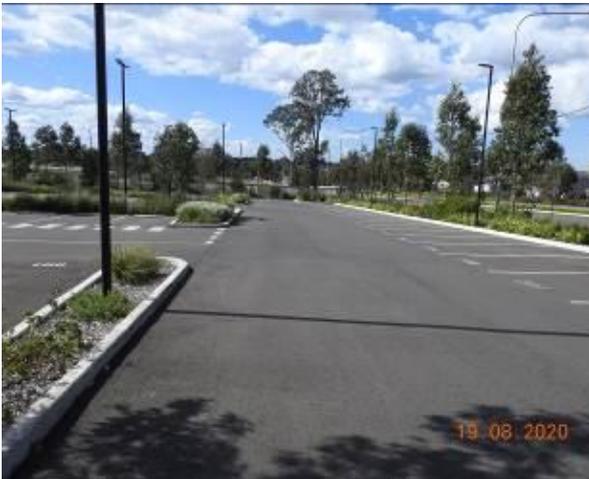
Figure 1433 – General condition of car park pavement

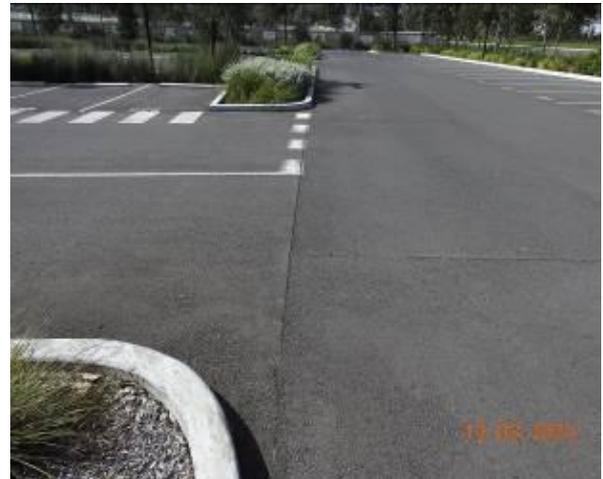
Figure 1434 – Crack propagation through car park pavement
