The property Tallawong station – P2 Car Park, is the neighbouring property to our client’s site. It was photographed and inspected prior to any construction works on the subject site and was found to be in a reasonable condition. The property serves as a car park.

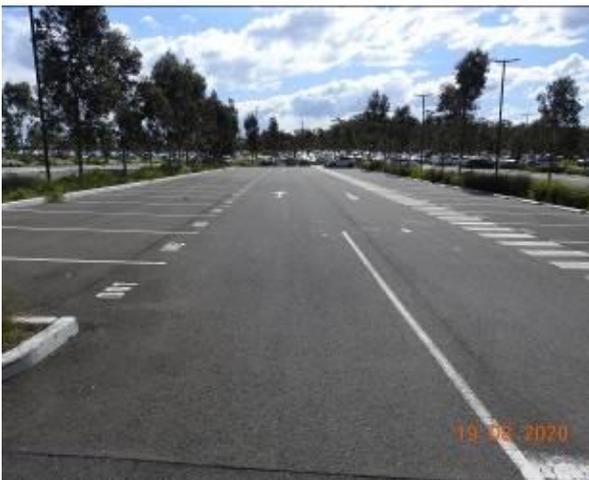
Figure 1435 – General condition of car park pavement

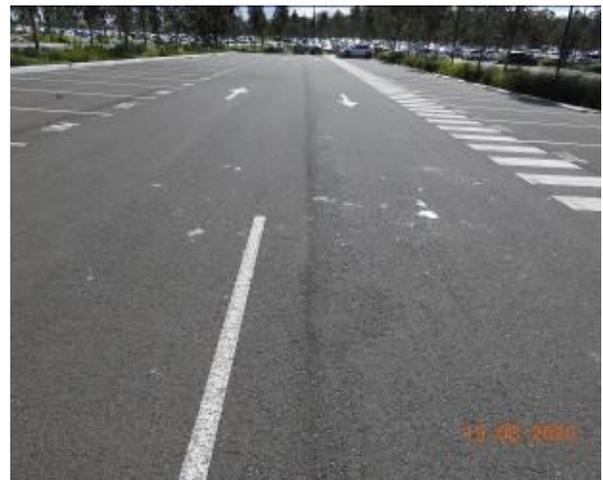
Figure 1436 – General condition of car park pavement

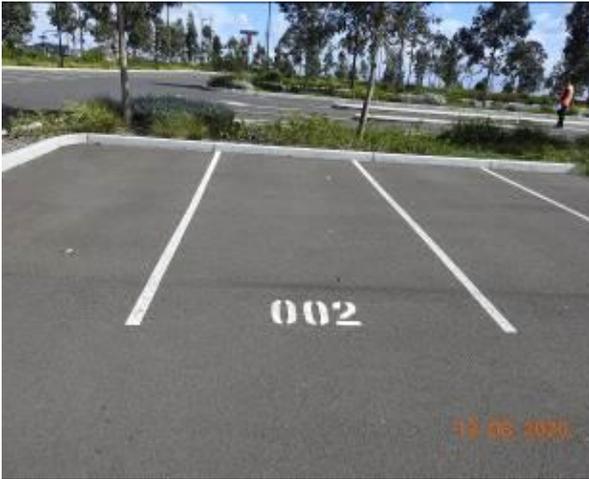
Figure 1437 – General condition of car park pavement

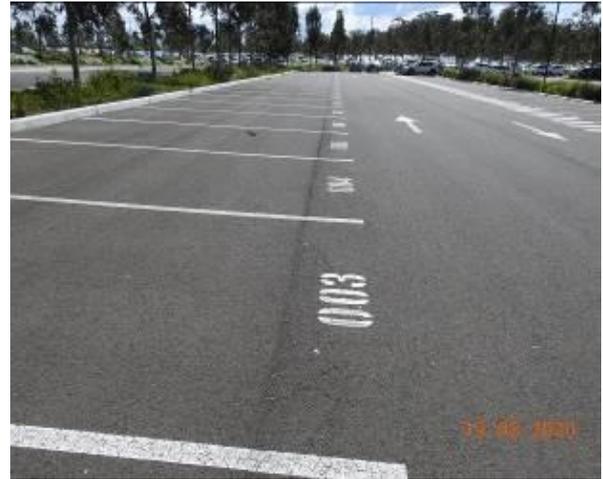
Figure 1438 – General condition of car park pavement

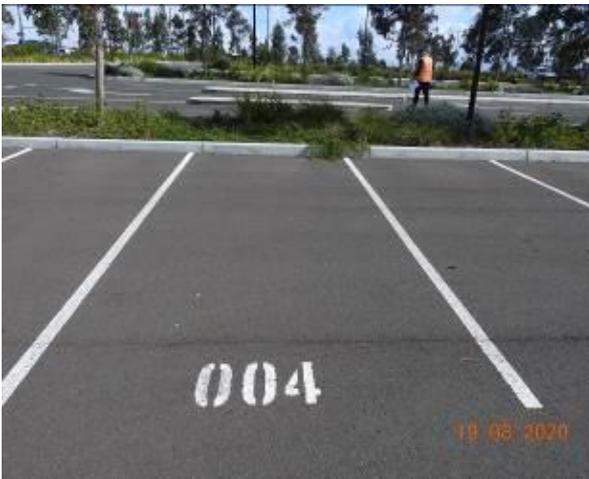
Figure 1439 – General condition of car park pavement

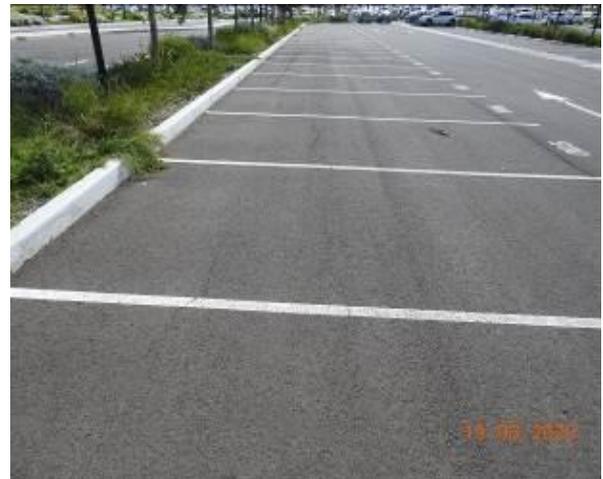
Figure 1440 – Crack propagation through car park pavement

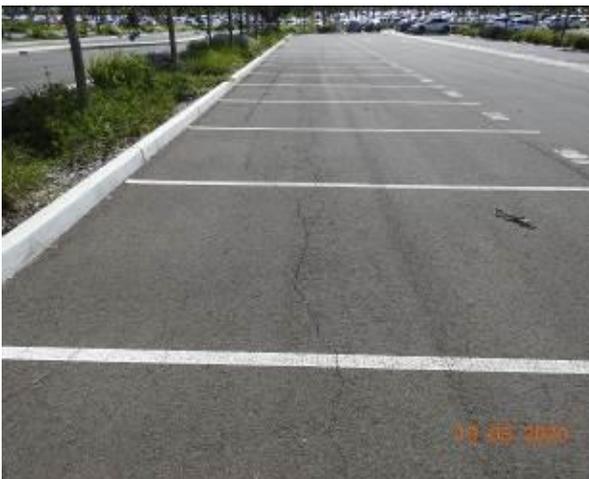
Figure 1441 – Crack propagation through car park pavement

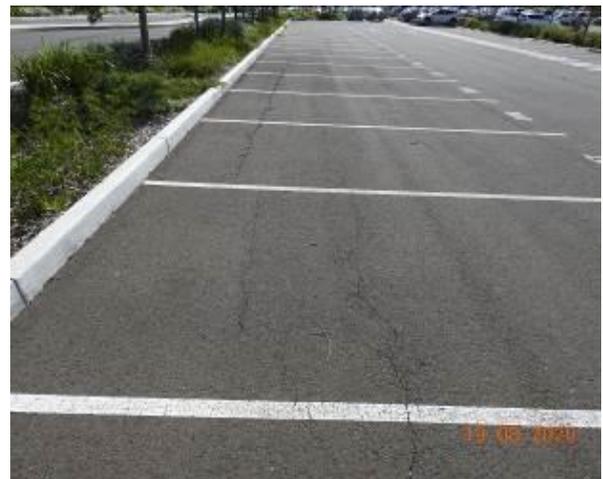
Figure 1442 – Crack propagation through car park pavement

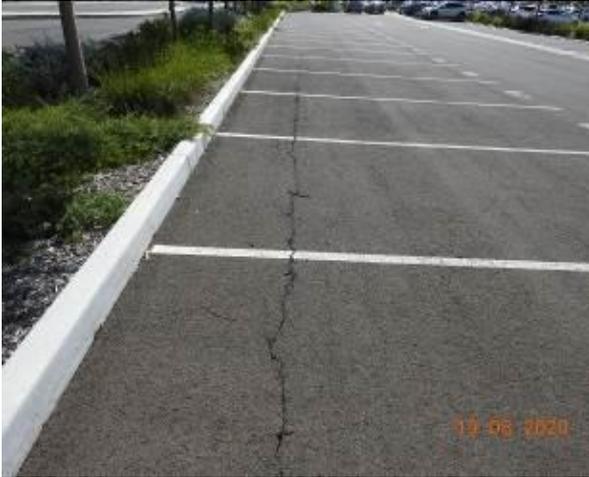
Figure 1443 – Crack propagation and evidence of patchwork through car park pavement

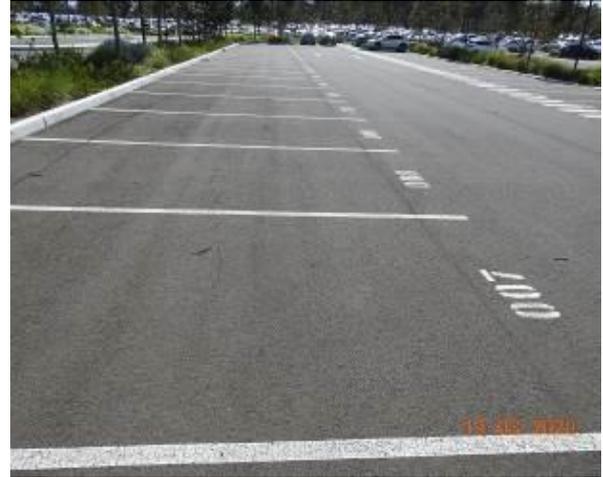
Figure 1444 – Crack propagation through car park pavement

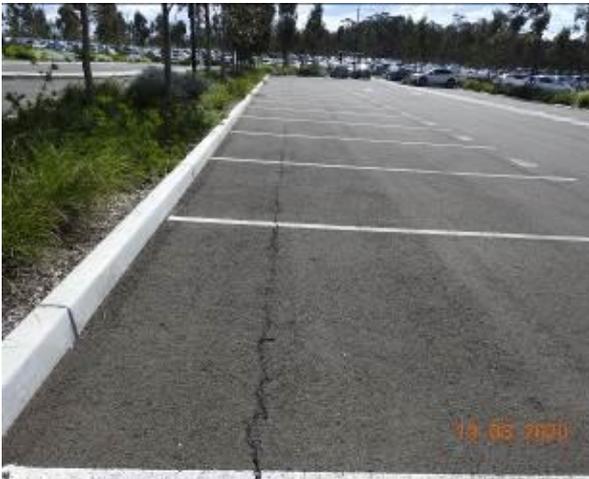
Figure 1445 – Crack propagation and evidence of patchwork through car park pavement

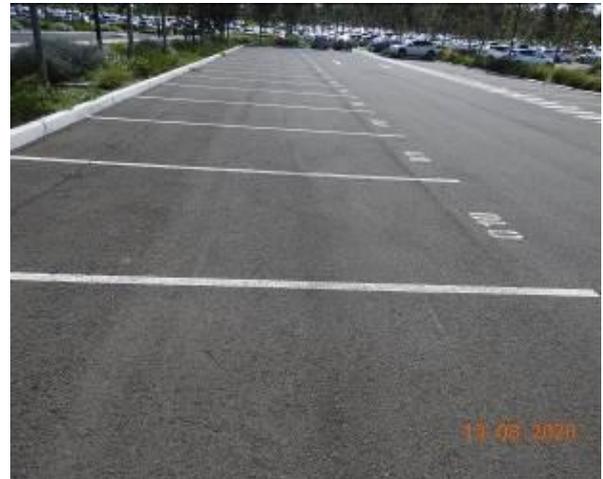
Figure 1446 – General condition of car park pavement

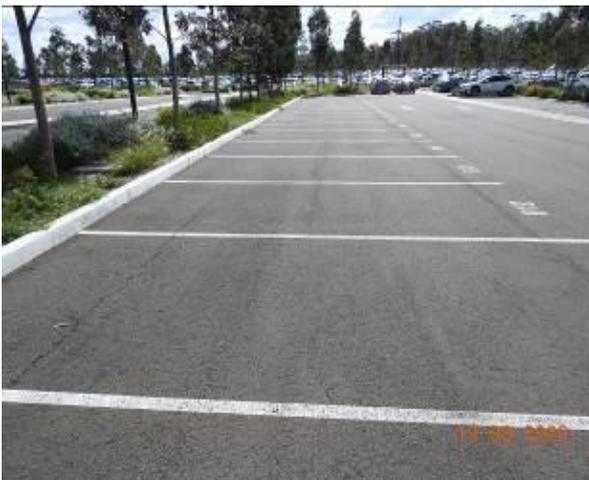
Figure 1447 – Crack propagation through car park pavement

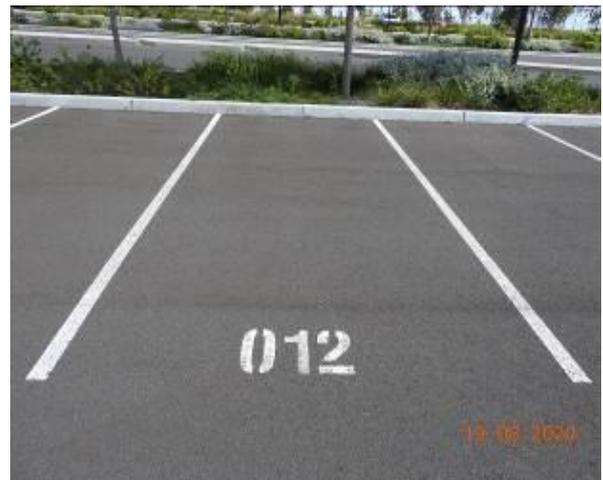
Figure 1448 – General condition of car park pavement

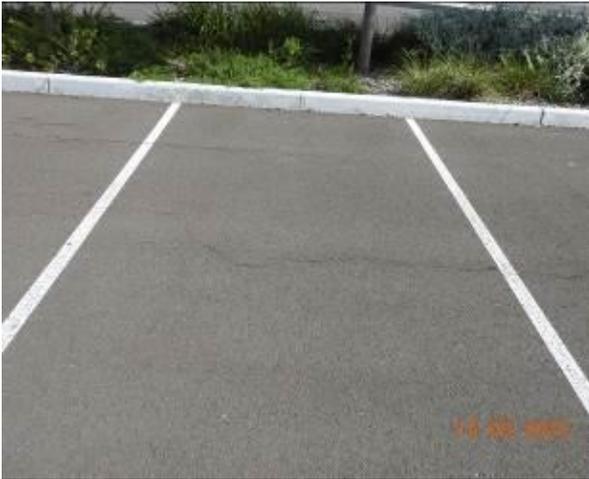
Figure 1449 – Crack propagation through car park pavement

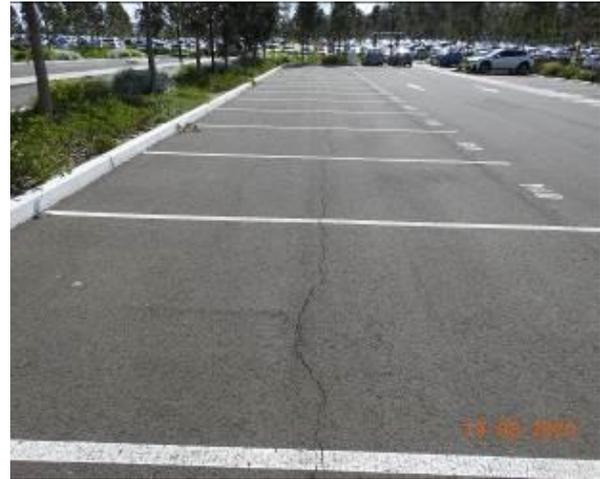
Figure 1450 – Crack propagation through car park pavement

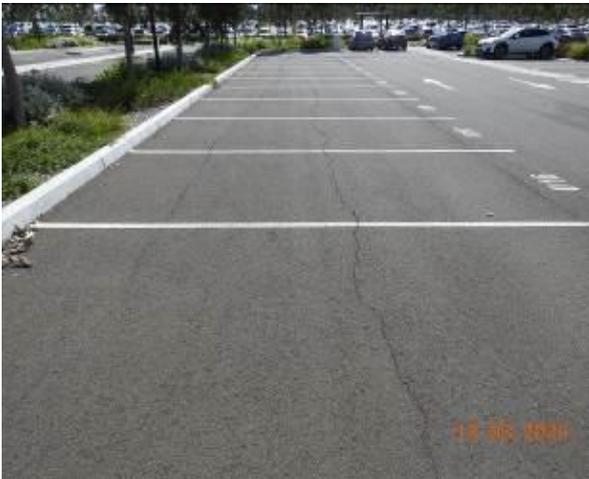
Figure 1451 – Crack propagation through car park pavement

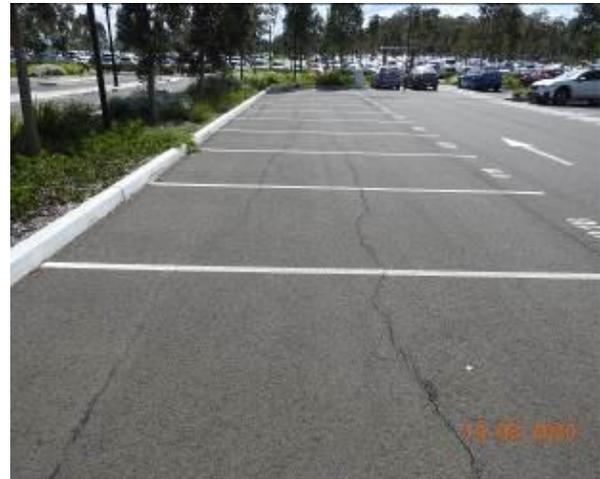
Figure 1452 – Crack propagation through car park pavement t

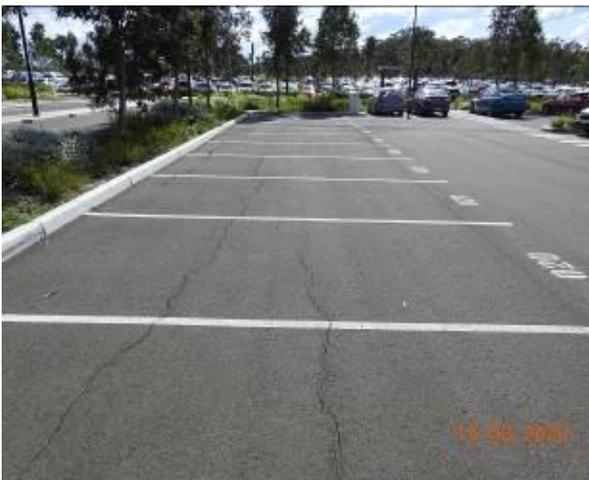
Figure 1453 – Crack propagation through car park pavement

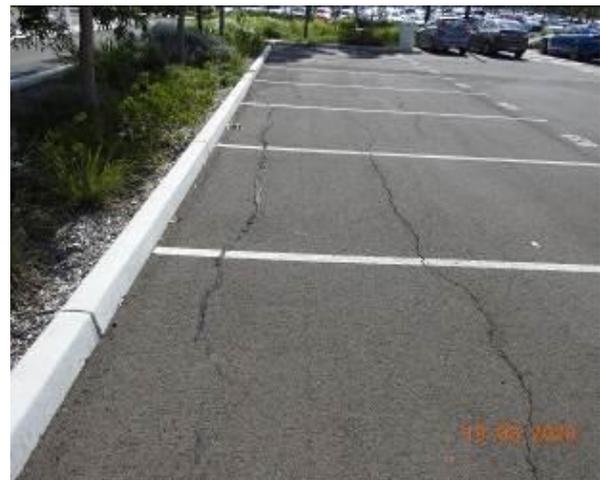
Figure 1454 – Crack propagation and evidence of patchwork through car park pavement

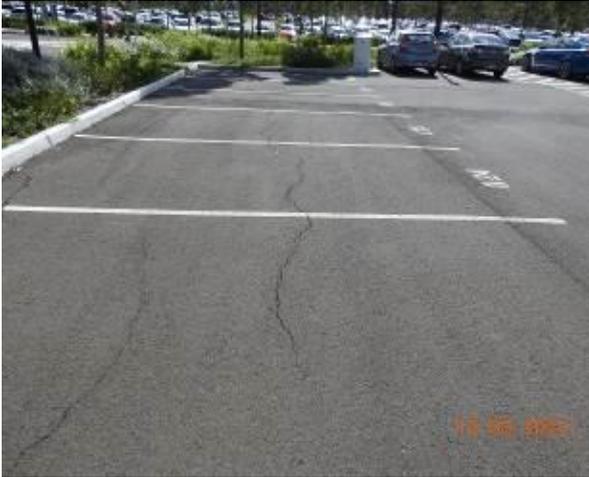
Figure 1455 – Crack propagation through car park pavement

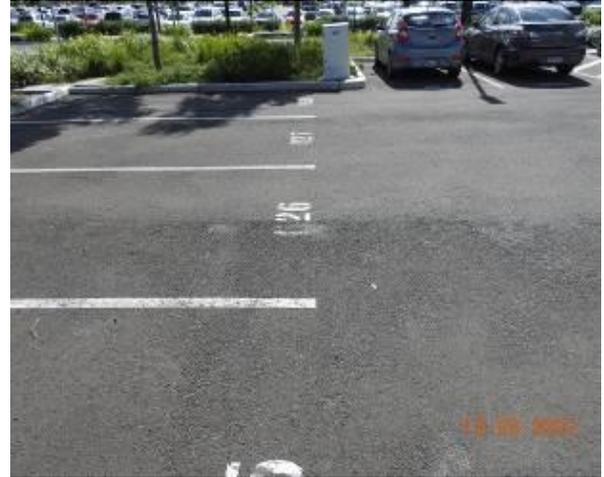
Figure 1456 – Loss of material through car park pavement

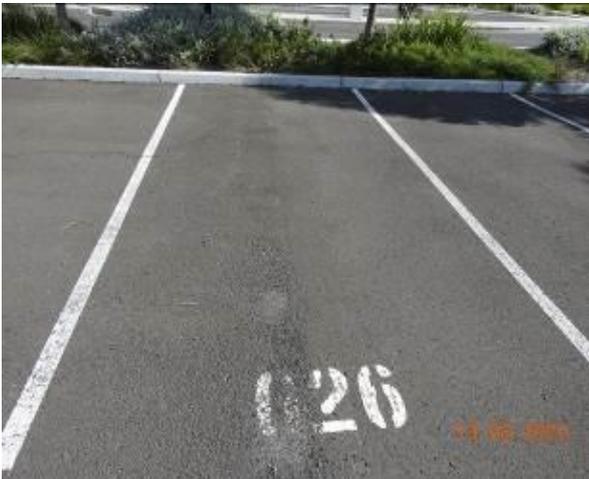
Figure 1457 – Loss of material through car park pavement

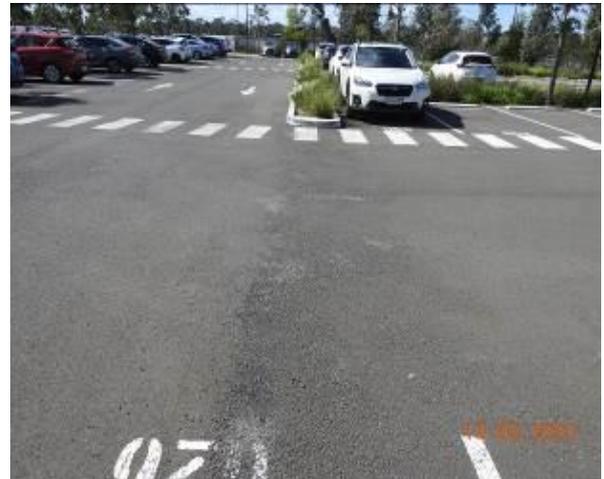
Figure 1458 – Loss of material through car park pavement

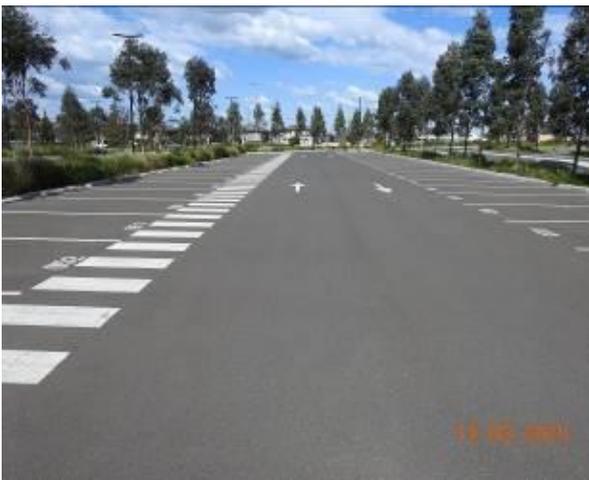
Figure 1459 – General condition of car park pavement

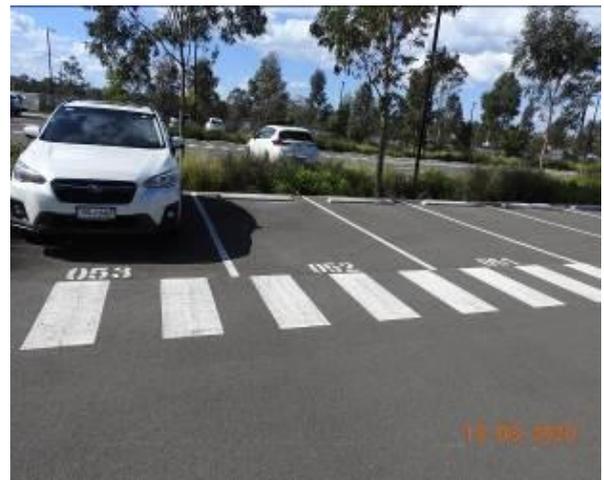
Figure 1460 – General condition of car park pavement

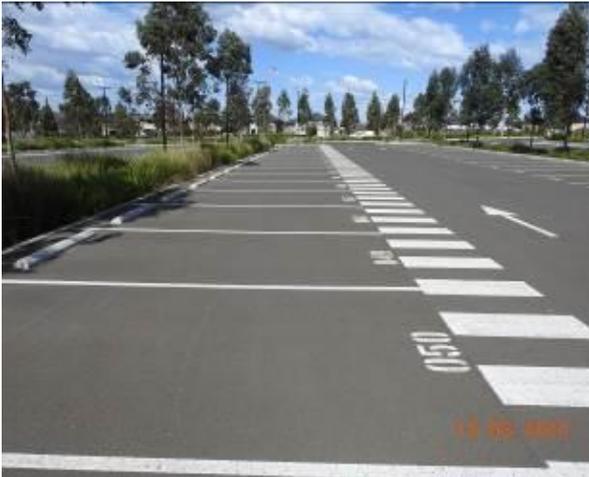
Figure 1461 – General condition of car park pavement

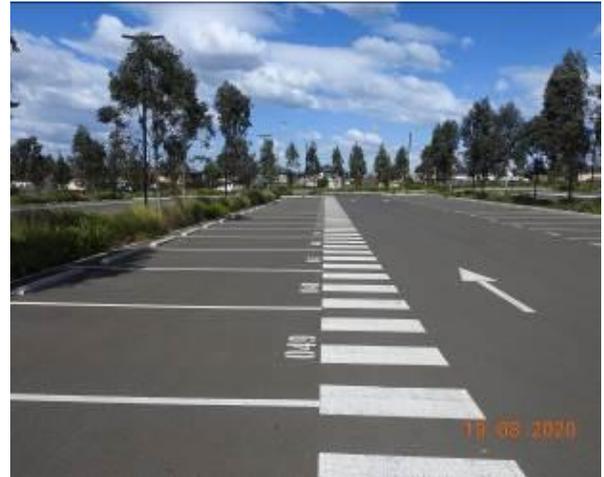
Figure 1462 – General condition of car park pavement

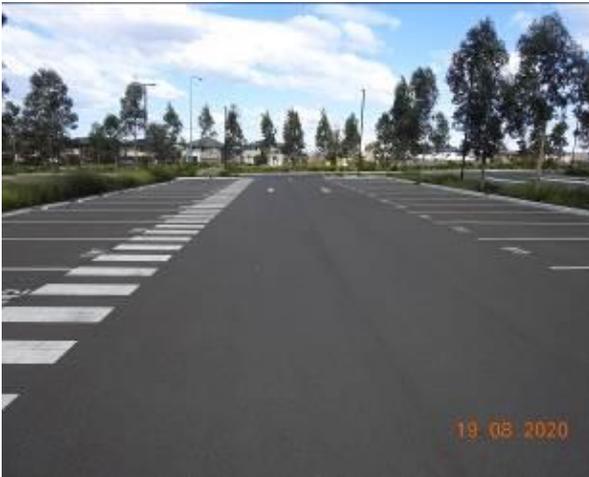
Figure 1463 – General condition of car park pavement

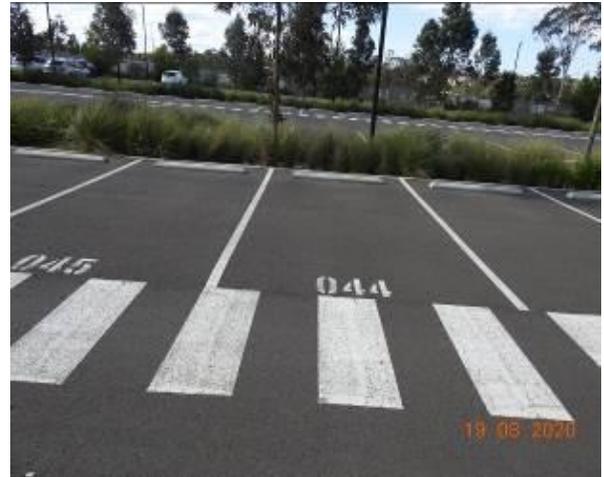
Figure 1464 – General condition of car park pavement

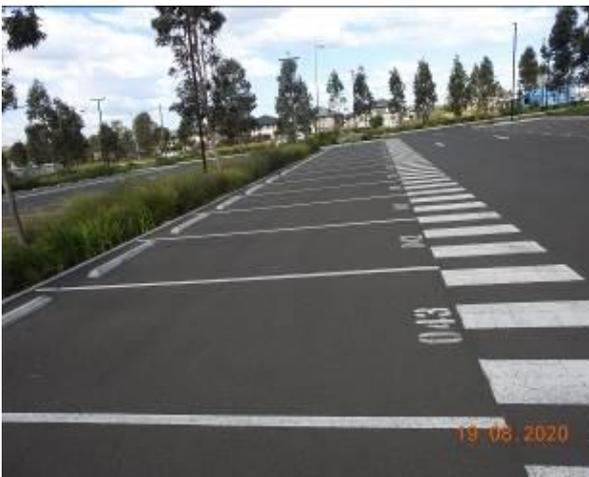
Figure 1465 – General condition of car park pavement

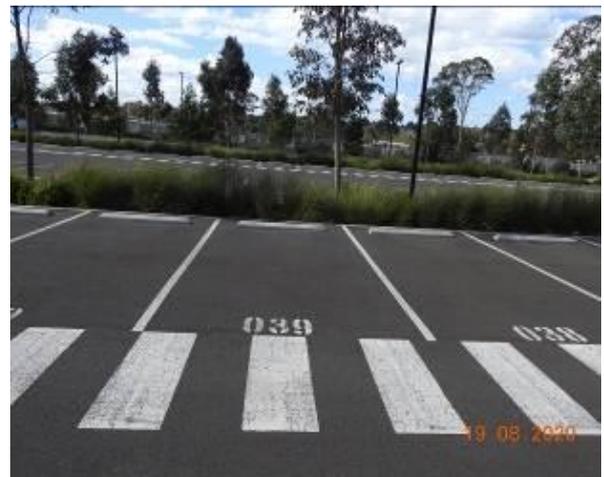
Figure 1466 – General condition of car park pavement

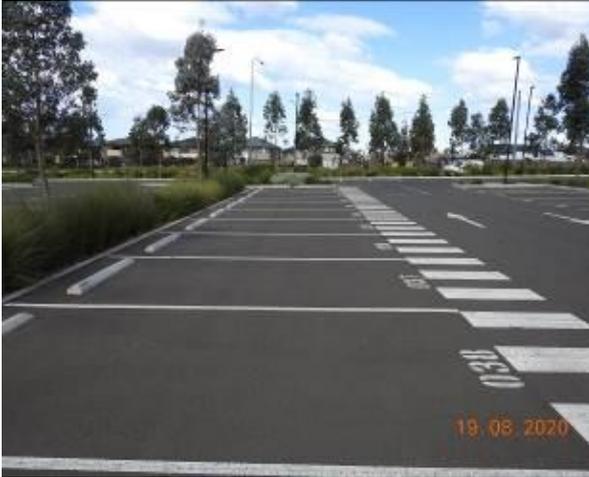
Figure 1467 – General condition of car park pavement

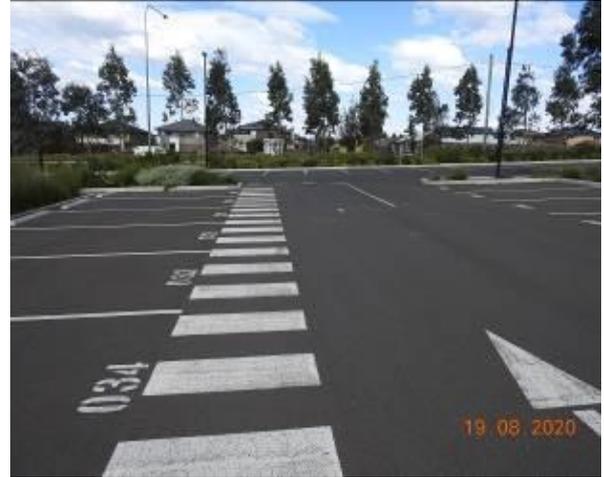
Figure 1468 – General condition of car park pavement

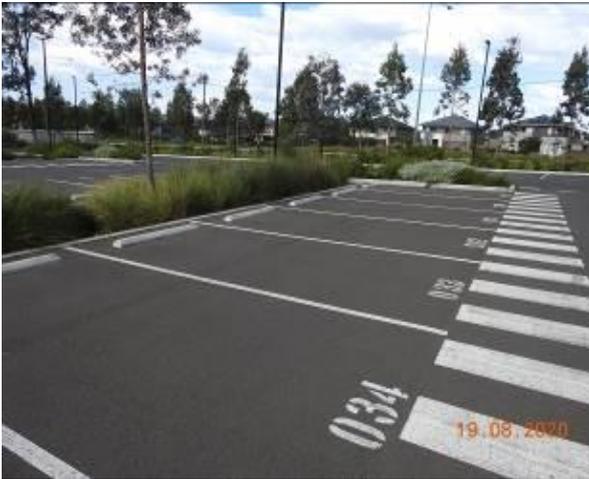
Figure 1469 – General condition of car park pavement

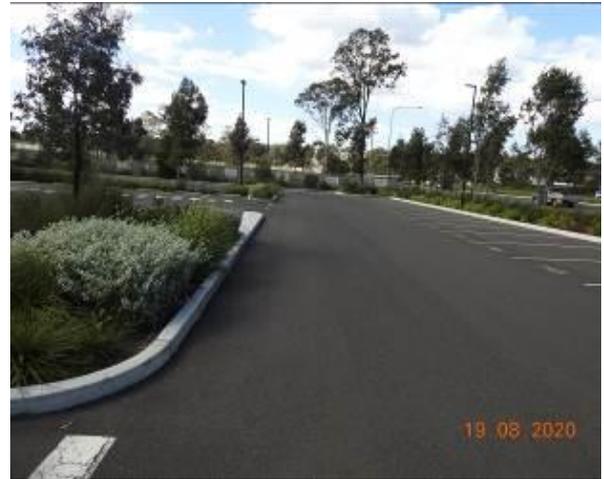
Figure 1470 – General condition of car park pavement

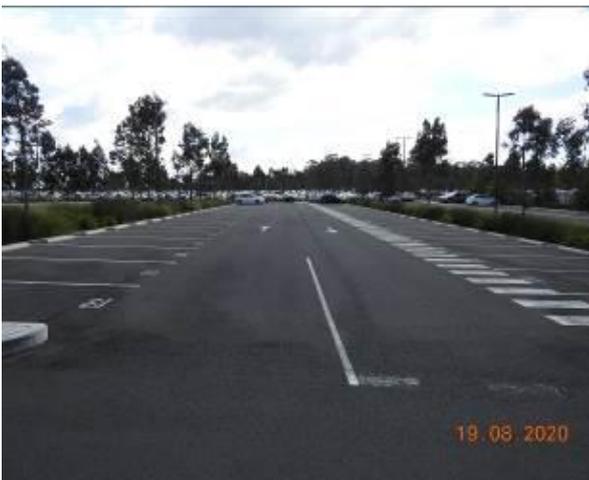
Figure 1471 – General condition of car park pavement

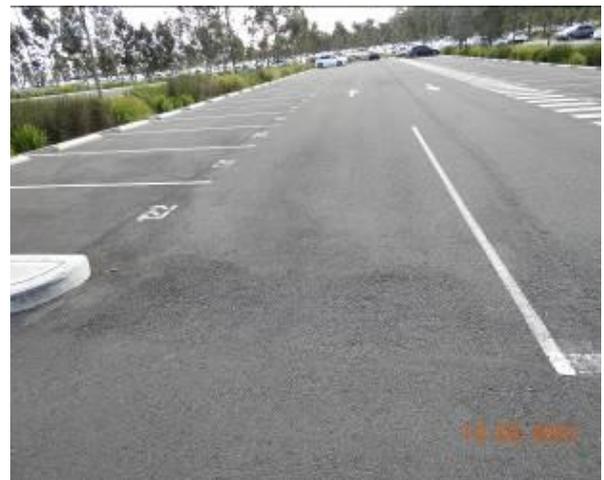
Figure 1472 – General condition of car park pavement

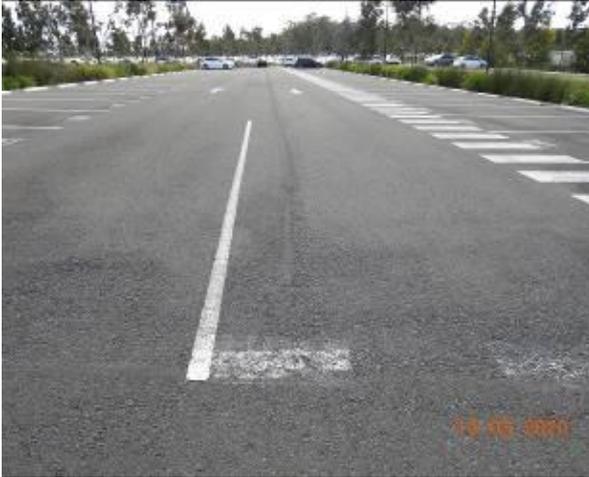
Figure 1473 – General condition of car park pavement

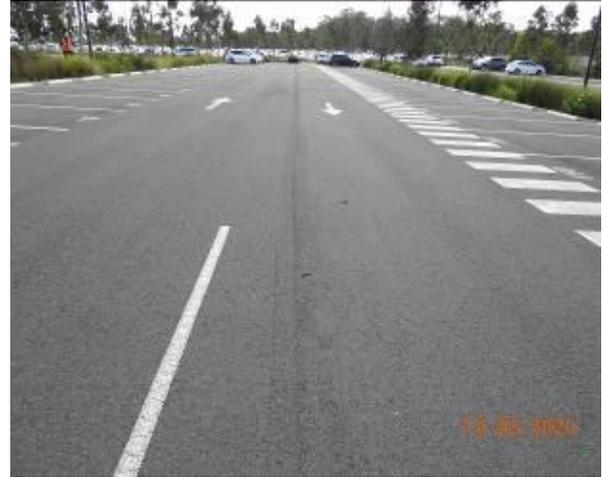
Figure 1474 – General condition of car park pavement

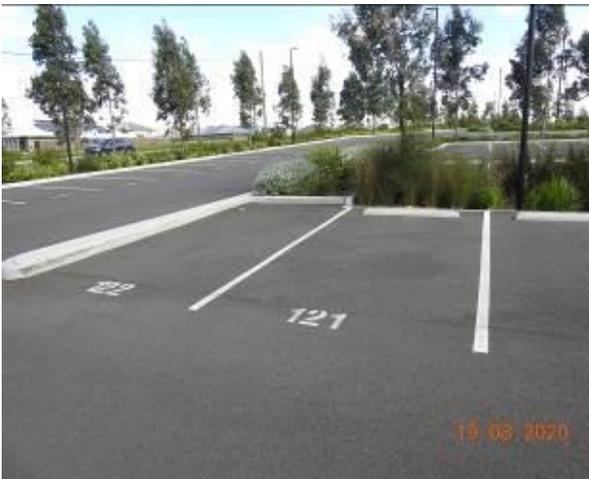
Figure 1475 – General condition of car park pavement

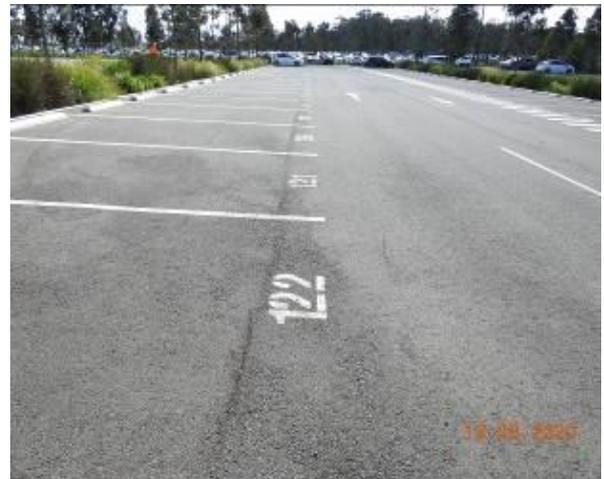
Figure 1476 – General condition of car park pavement

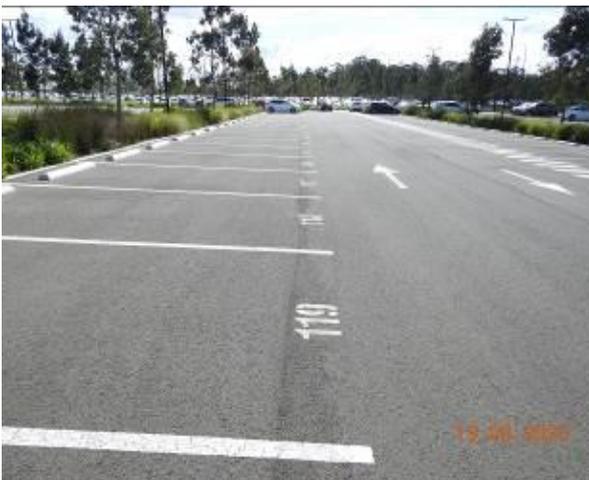
Figure 1477 – General condition of car park pavement

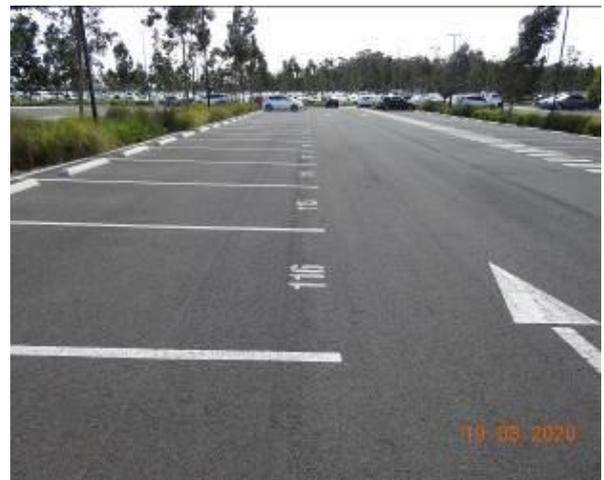
Figure 1478 – General condition of car park pavement

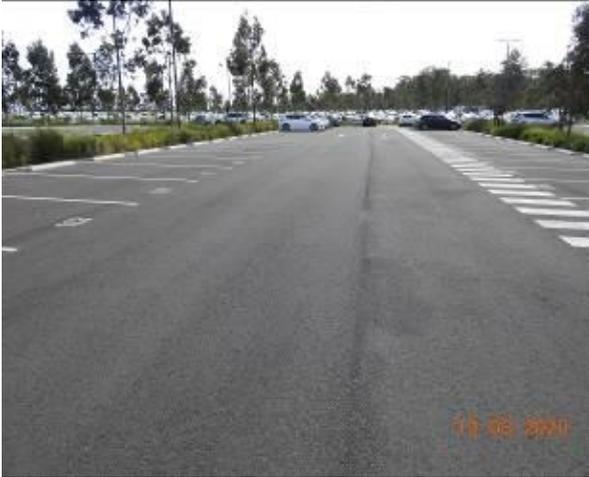
Figure 1479 – General condition of car park pavement

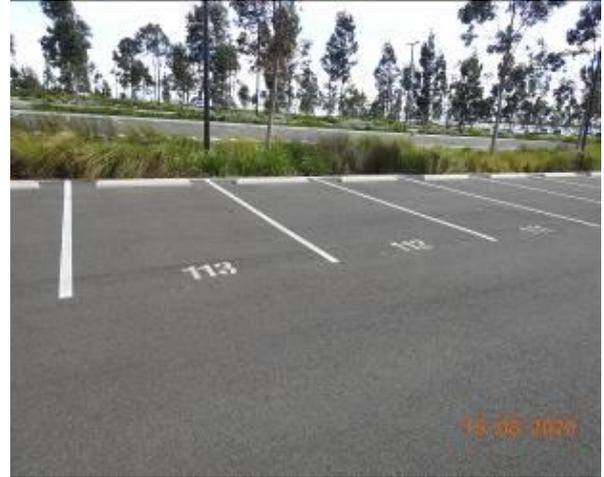
Figure 1481 – General condition of car park pavement

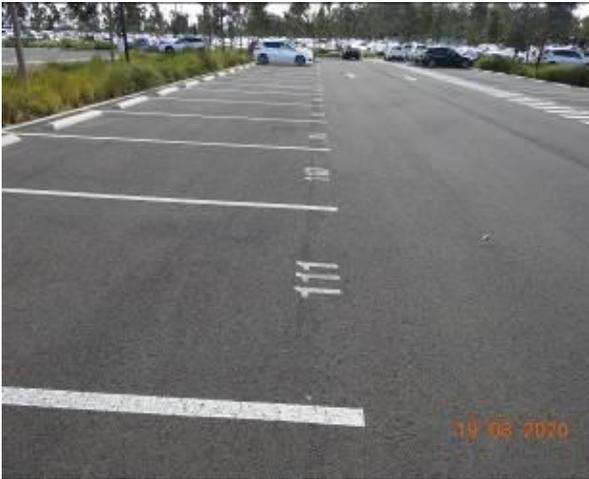
Figure 1482 – General condition of car park pavement

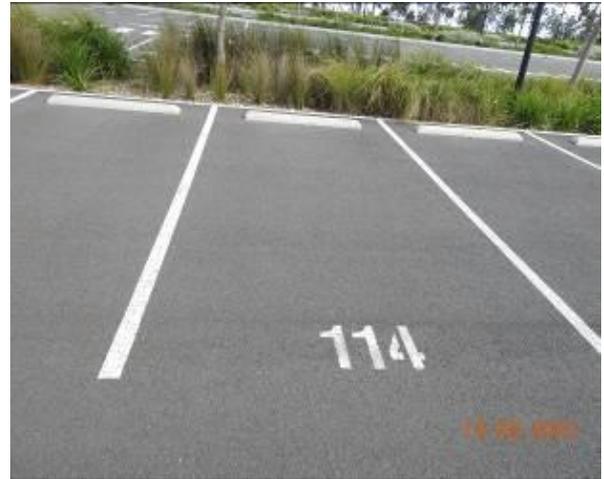
Figure 1483 – Crack propagation through car park pavement

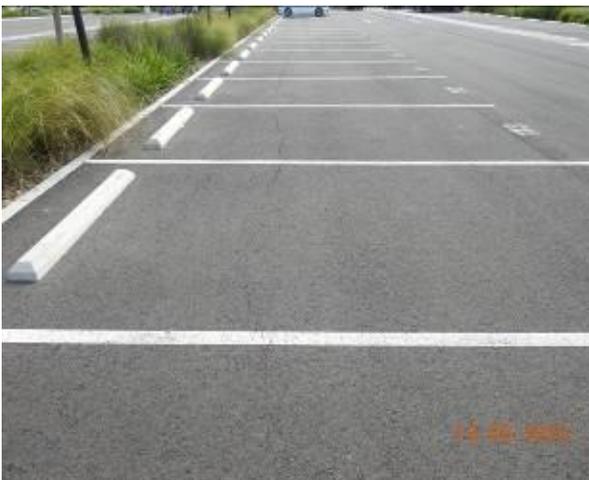
Figure 1484 – Crack propagation through car park pavement

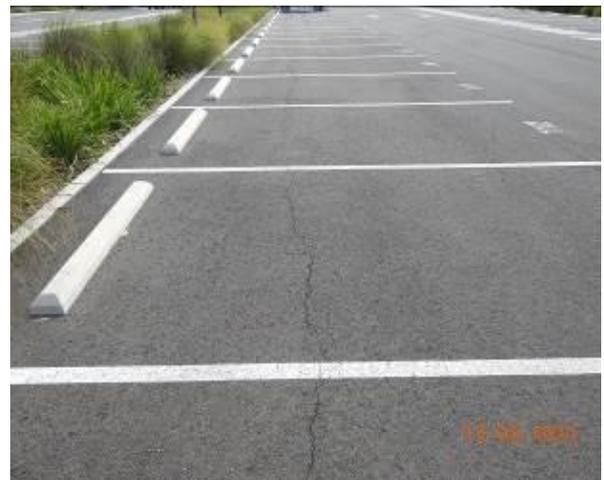
Figure 1485 – Crack propagation through car park pavement

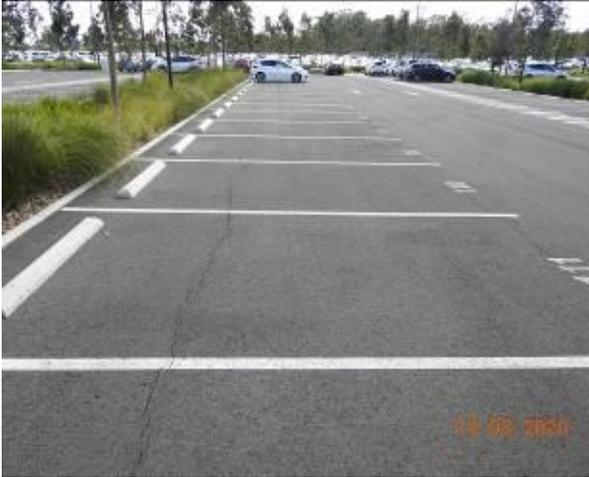
Figure 1486 – Crack propagation through car park pavement

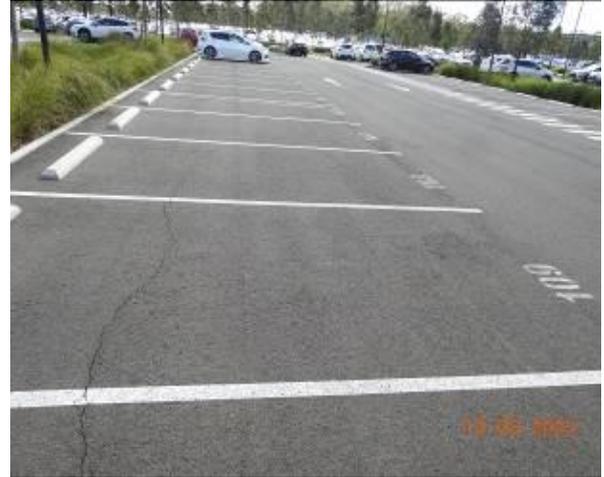
Figure 1487 – Crack propagation through car park pavement

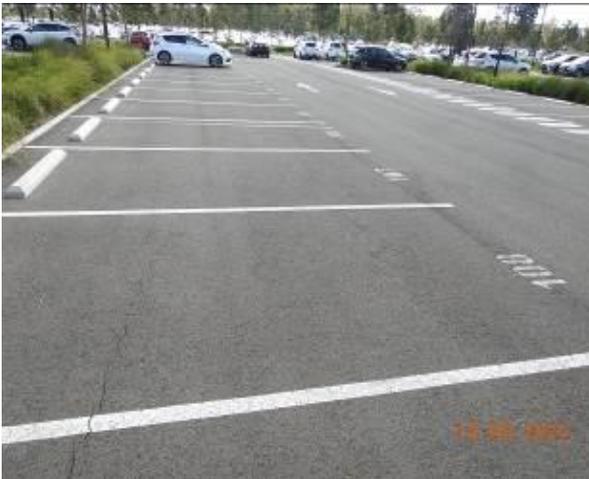
Figure 1488 – General condition of car park pavement

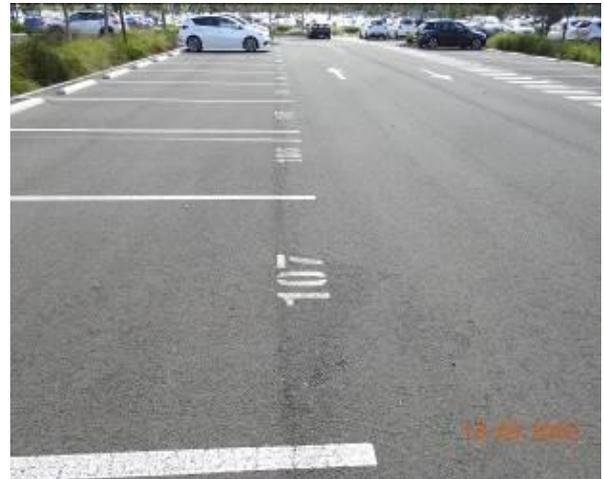
Figure 1489 – General condition of car park pavement

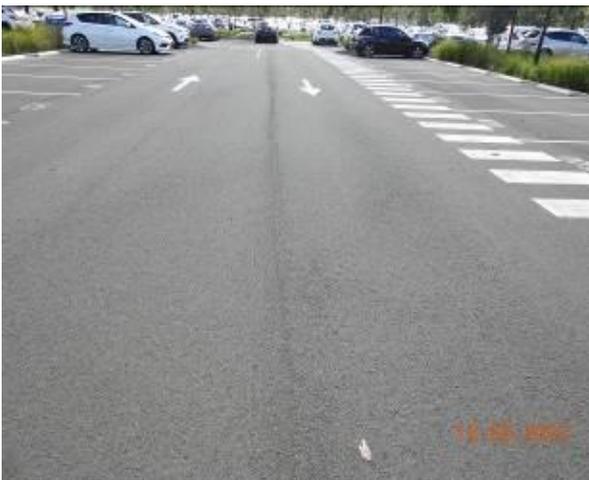
Figure 1490 – General condition of car park pavement

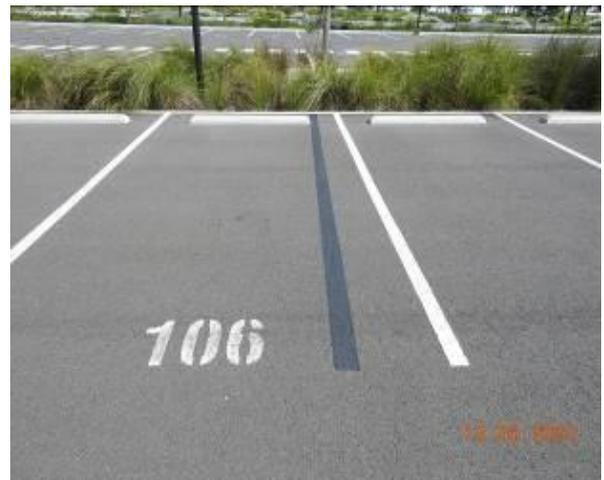
Figure 1491 – General condition of car park pavement

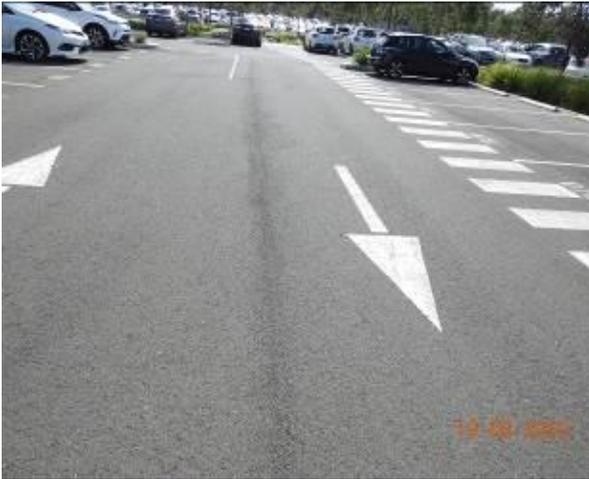
Figure 1492 – General condition of car park pavement

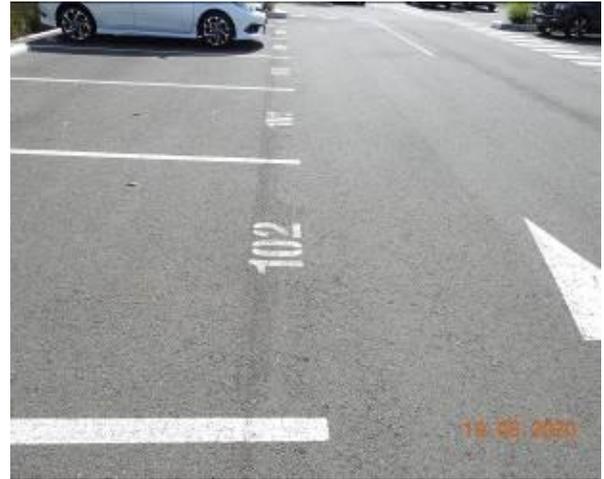
Figure 1493 – General condition of car park pavement

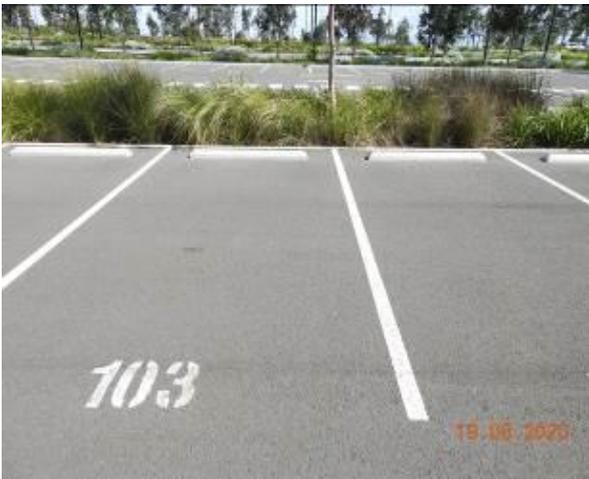
Figure 1494 – Crack propagation through car park pavement

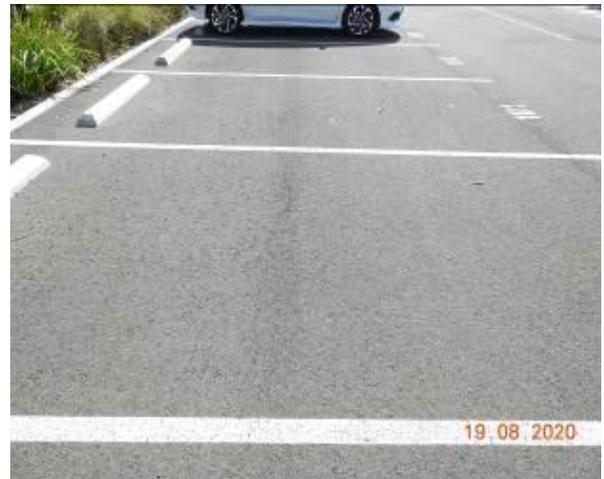
Figure 1495 – General condition of car park pavement

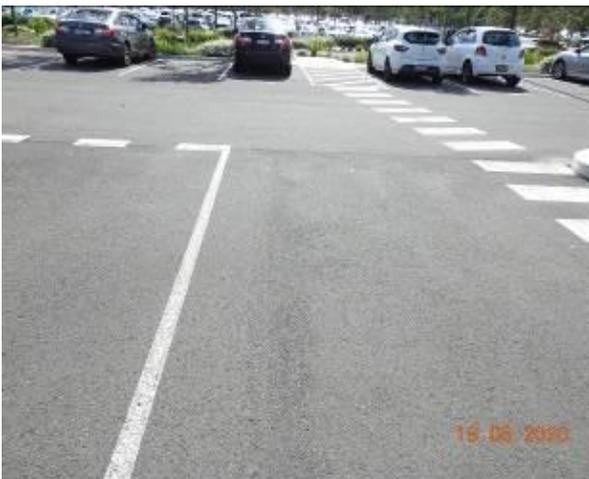
Figure 1496 – General condition of car park pavement

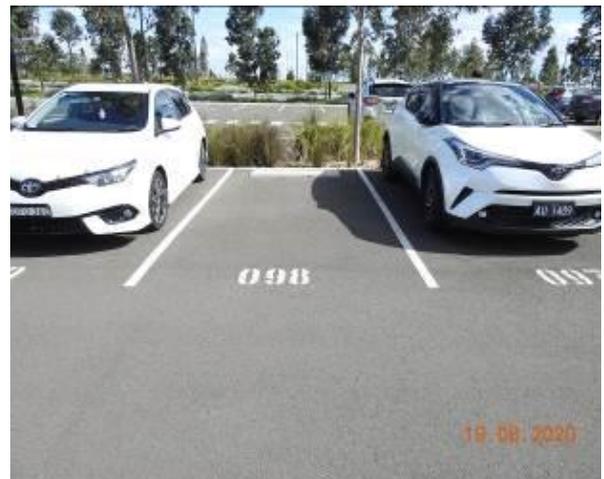
Figure 1497 – Crack propagation through car park pavement

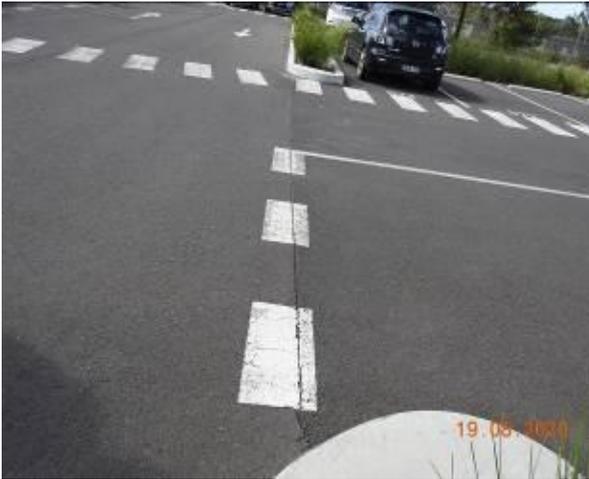
Figure 1498 – General condition of car park pavement

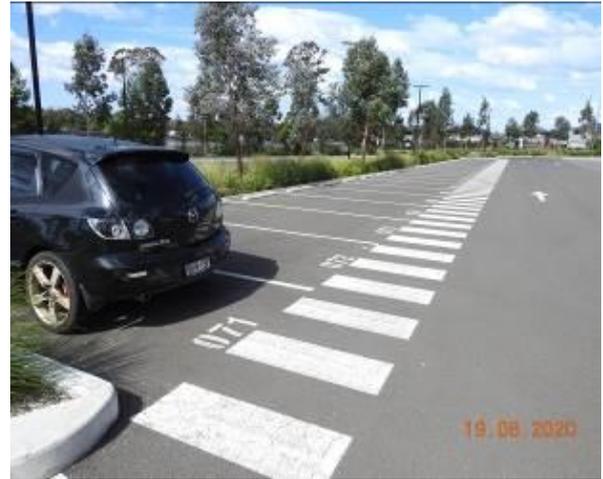
Figure 1499 – General condition of car park pavement

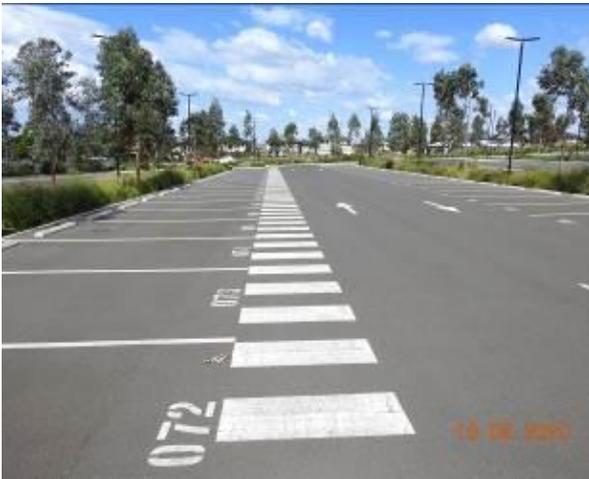
Figure 1500 – General condition of car park pavement

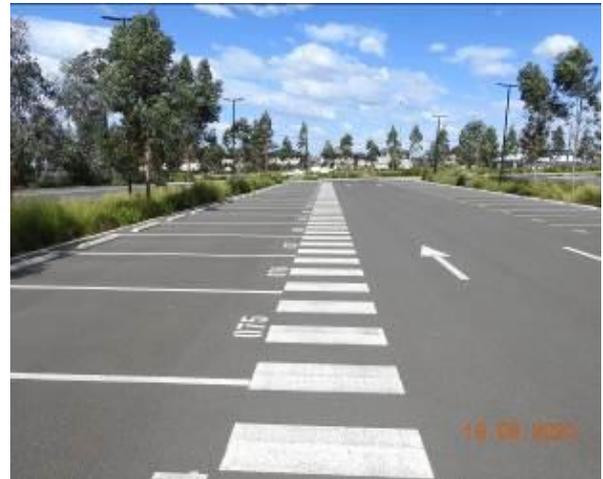
Figure 1501 – General condition of car park pavement

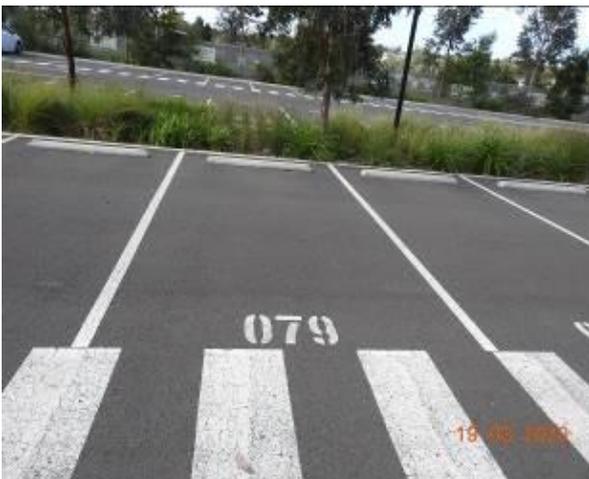
Figure 1502 – Crack propagation through car park pavement

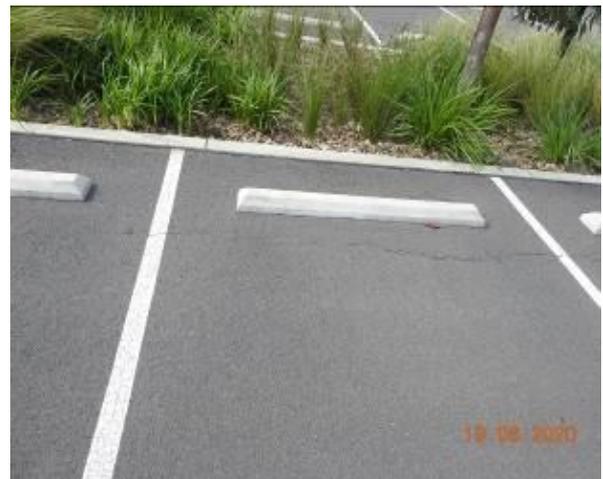
Figure 1503 – Crack propagation through car park pavement

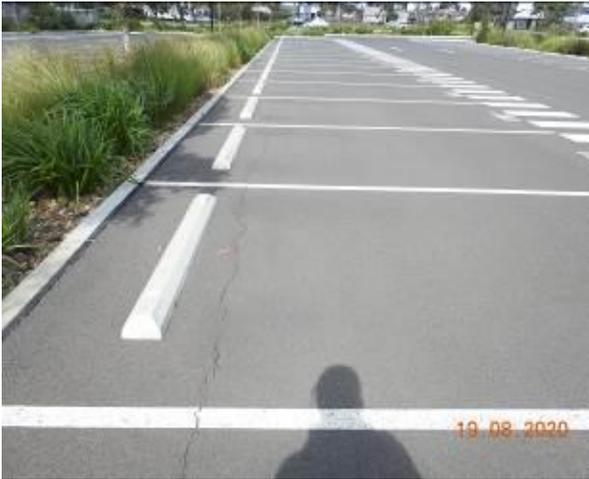
Figure 1504 – Crack propagation through car park pavement

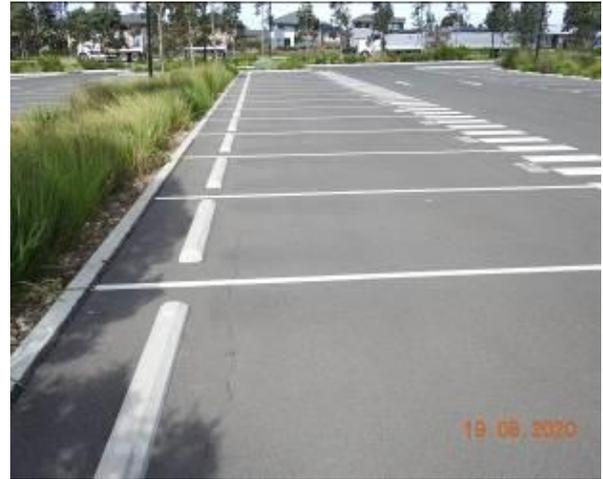
Figure 1505 – General condition of car park pavement

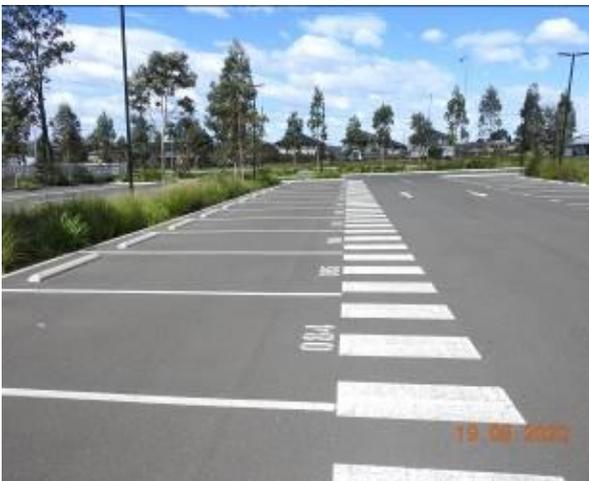
Figure 1506 – General condition of car park pavement

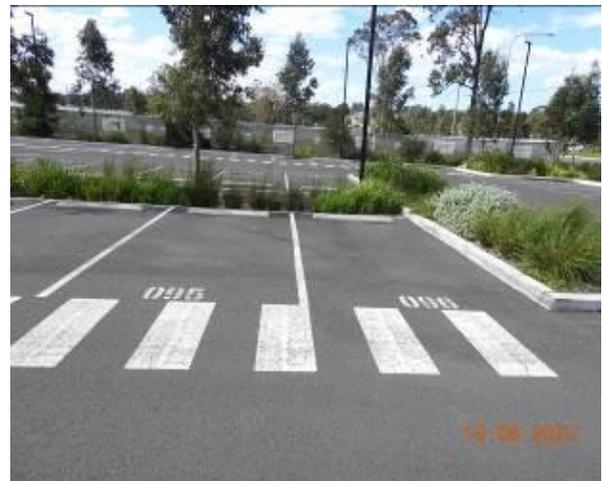
Figure 1507 – General condition of car park pavement

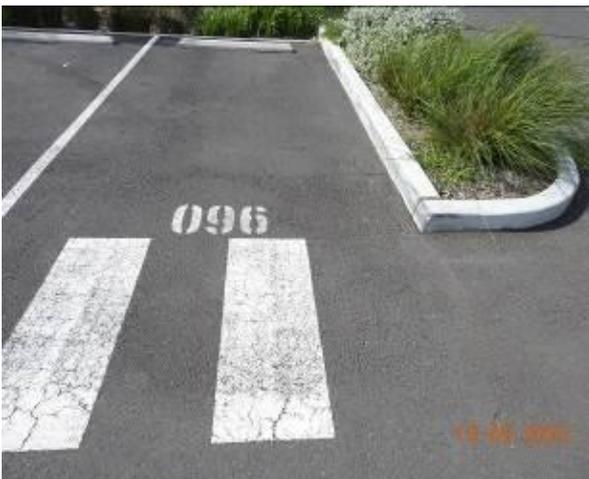
Figure 1508 – General condition of car park pavement

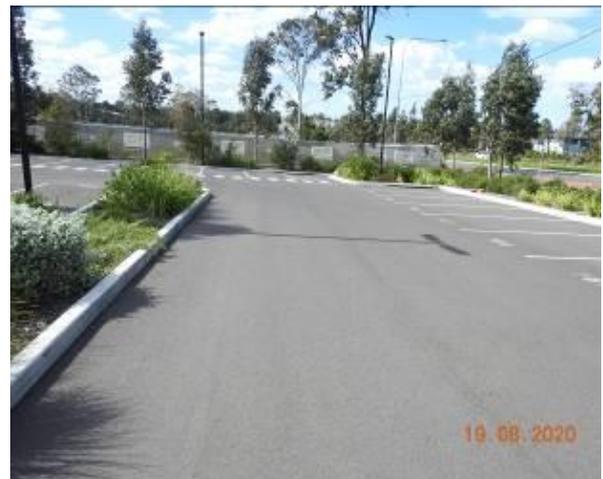
Figure 1509 – General condition of car park pavement

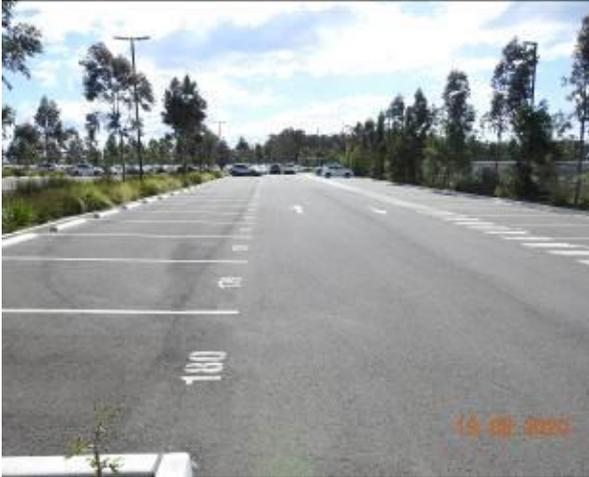
Figure 1510 – General condition of car park pavement

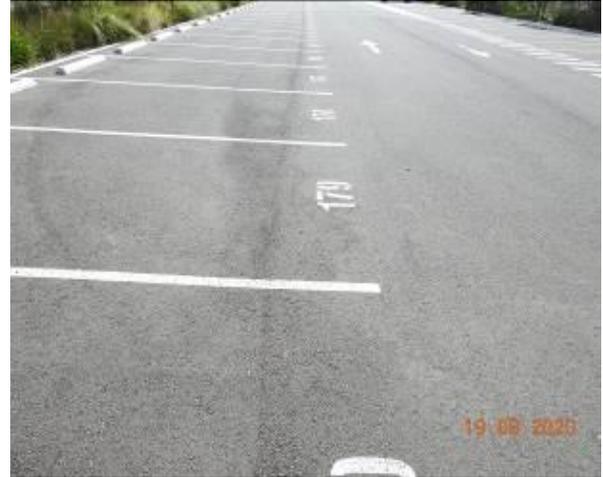
Figure 1511 – General condition of car park pavement

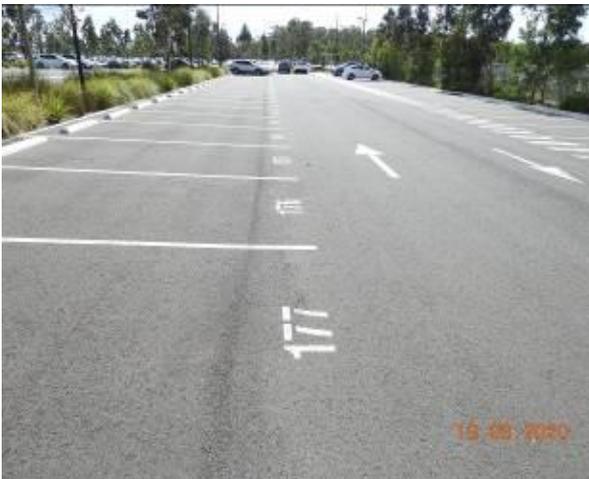
Figure 1512 – General condition of car park pavement
