The property Tallawong station – P2 Car Park, is the neighbouring property to our client’s site. It was photographed and inspected prior to any construction works on the subject site and was found to be in a reasonable condition. The property serves as a car park.

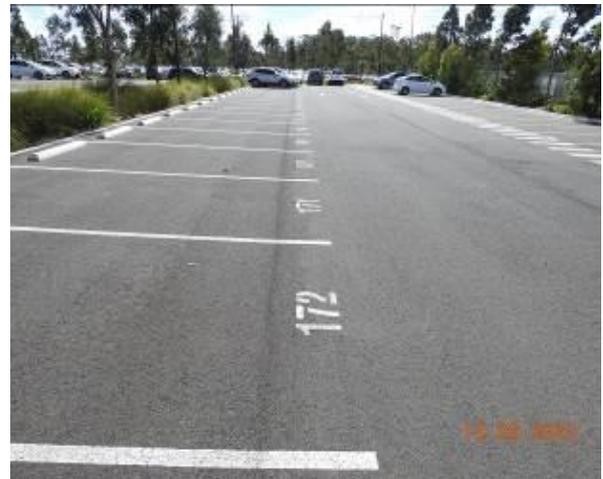
Figure 1513 – General condition of car park pavement

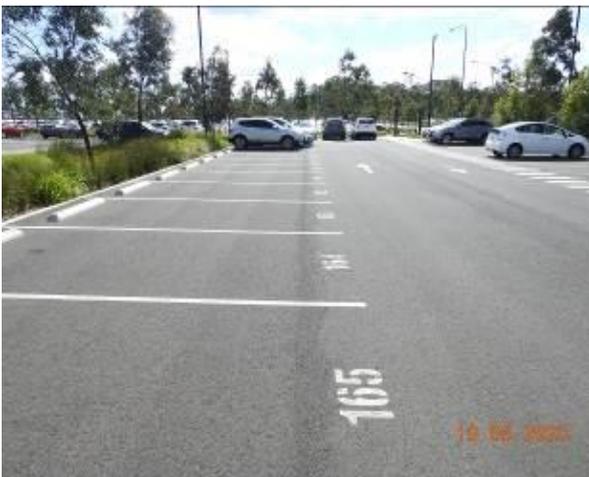
Figure 1514 – General condition of car park pavement

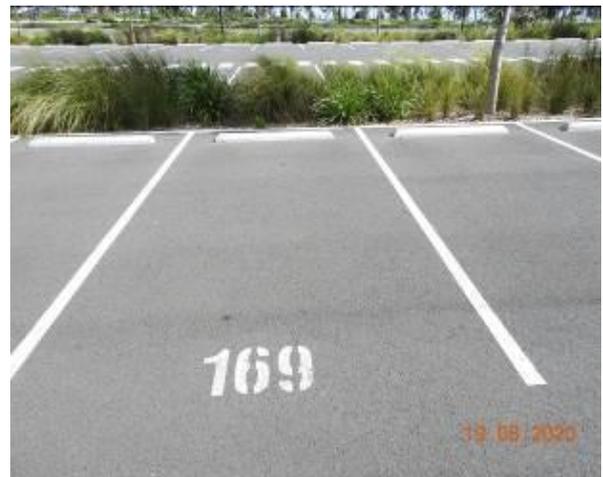
Figure 1515 – Crack propagation through car park pavement

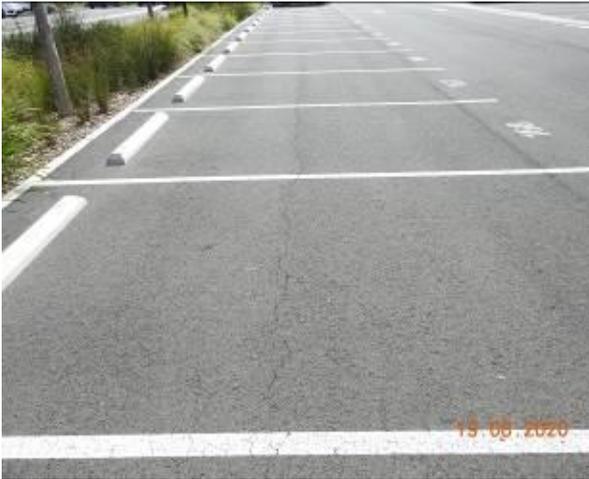
Figure 1516 – Crack propagation through car park pavement

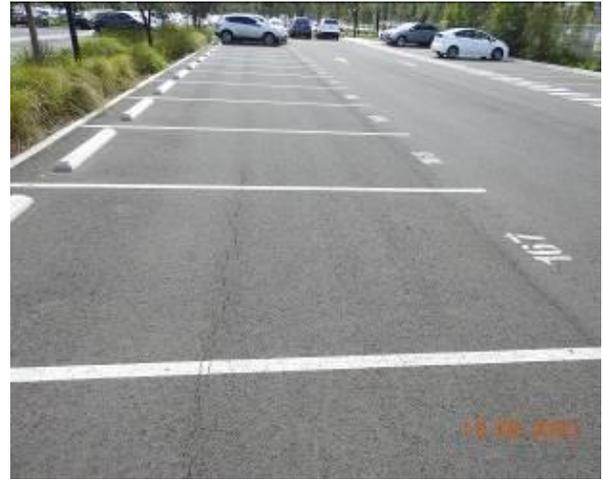
Figure 1517 – General condition of car park pavement

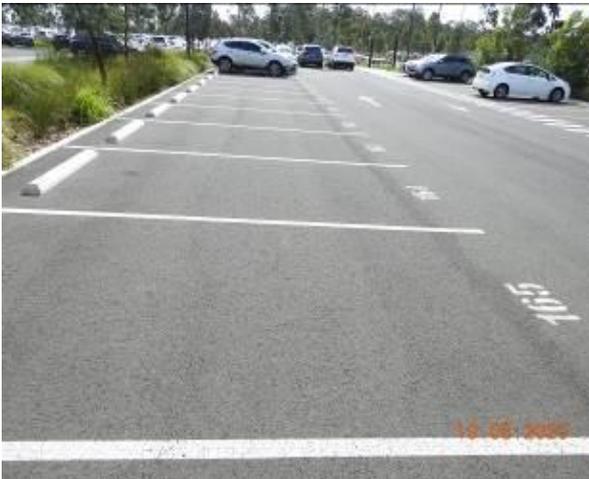
Figure 1518 – Crack propagation through car park pavement

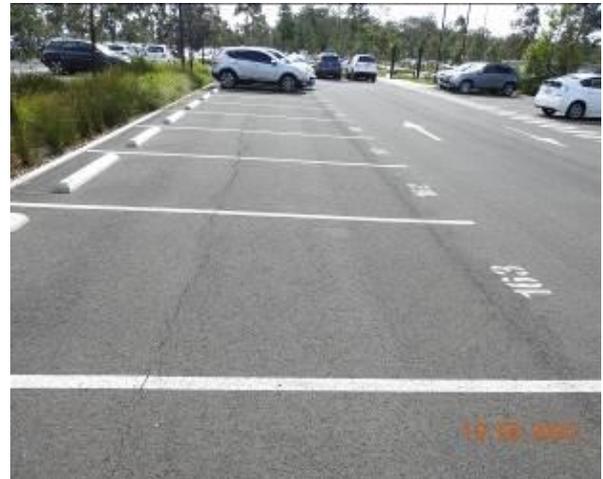
Figure 1519 – Crack propagation through car park pavement

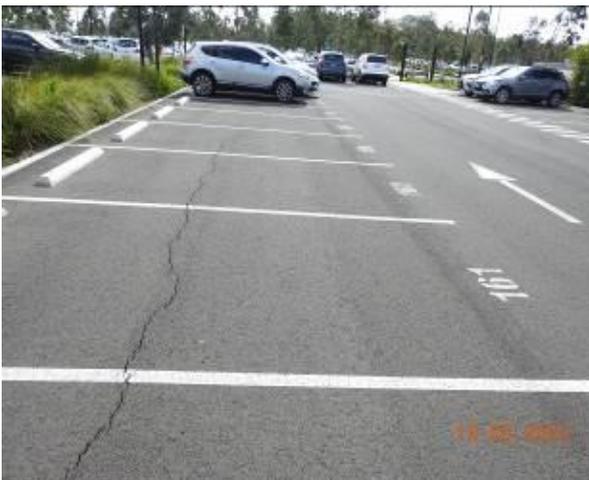
Figure 1520 – Crack propagation through car park pavement

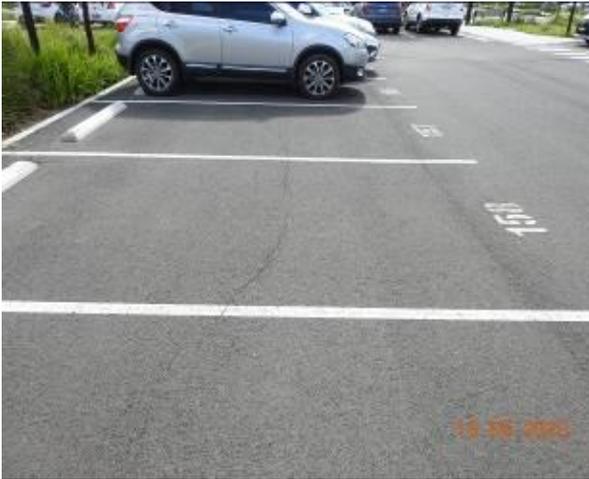
Figure 1521 – Crack propagation through car park pavement

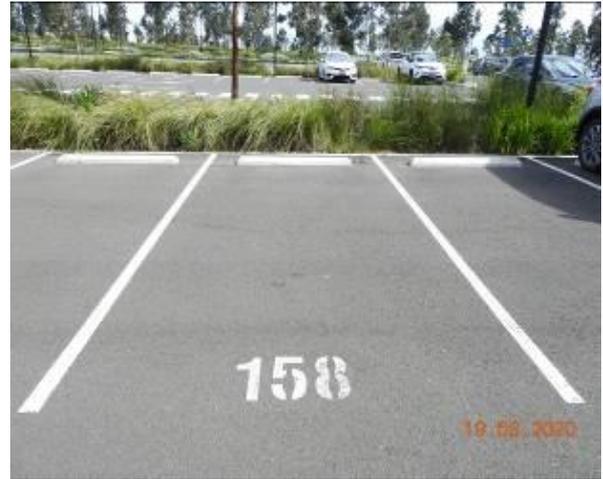
Figure 1522 – General condition of car park pavement

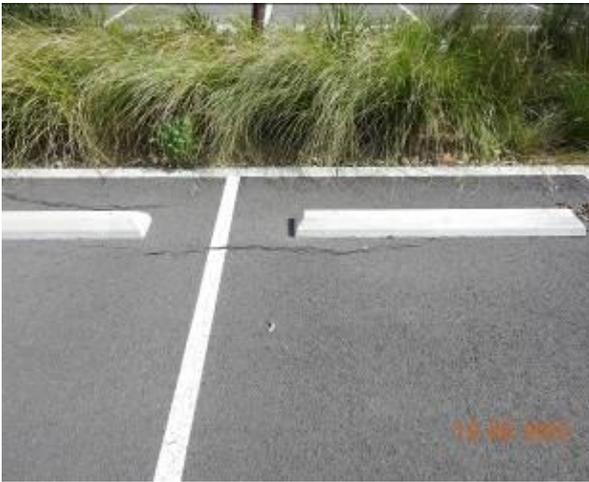
Figure 1523 – Evidence of patchwork through car park pavement

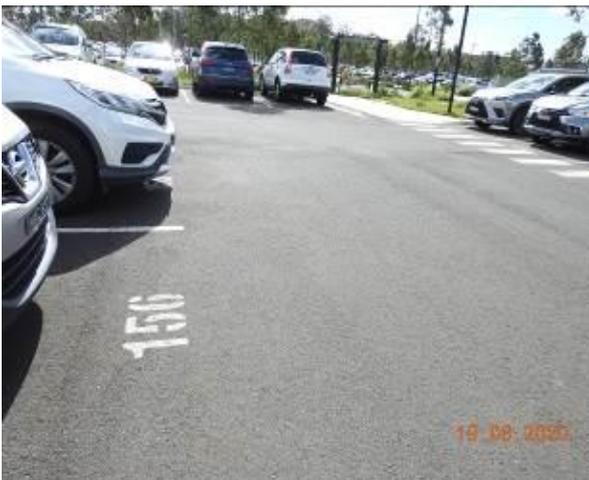
Figure 1525 – General condition of car park pavement

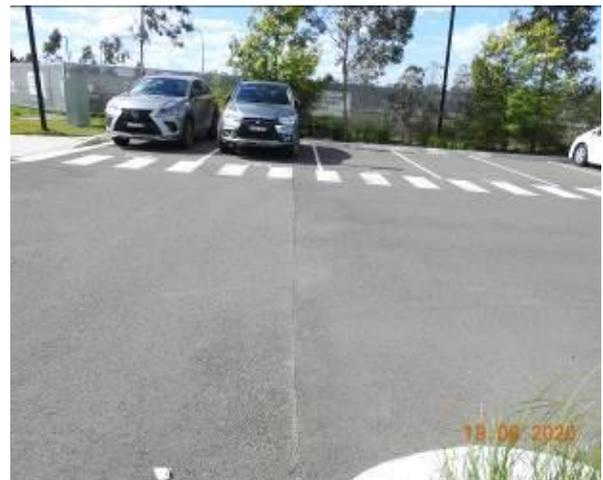
Figure 1526 – Crack propagation through car park pavement

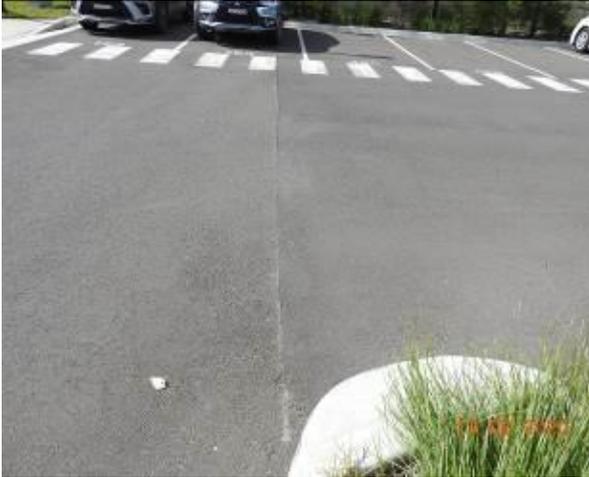
Figure 1527 – Crack propagation through car park pavement

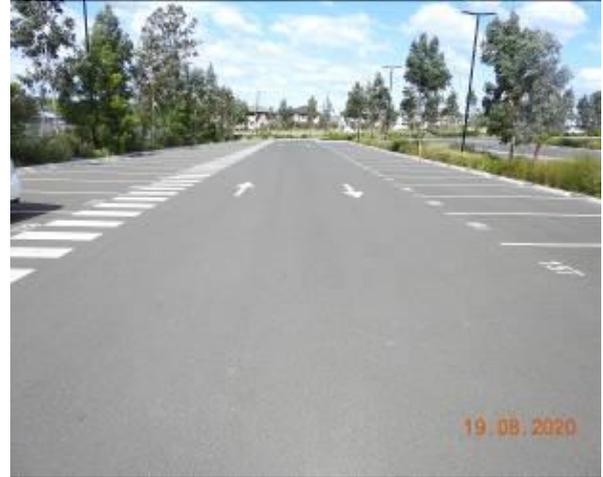
Figure 1528 – General condition of car park pavement

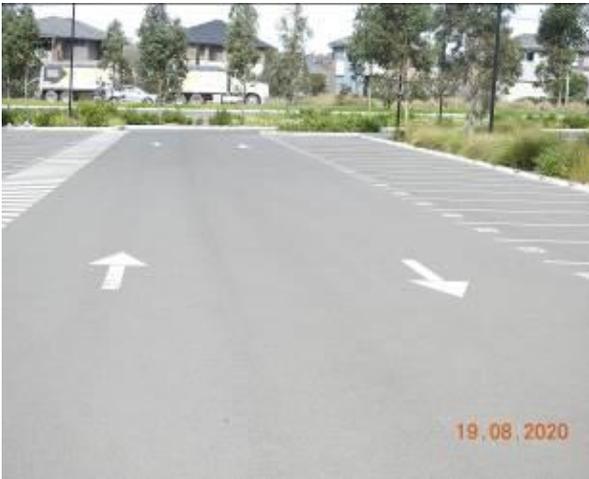
Figure 1529 – General condition of car park pavement

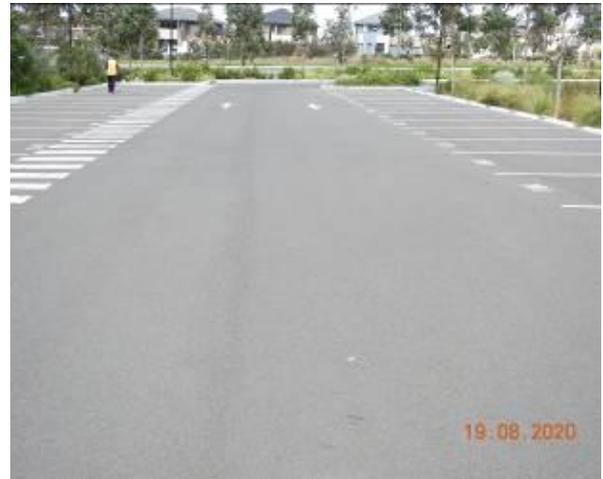
Figure 1530 – General condition of car park pavement

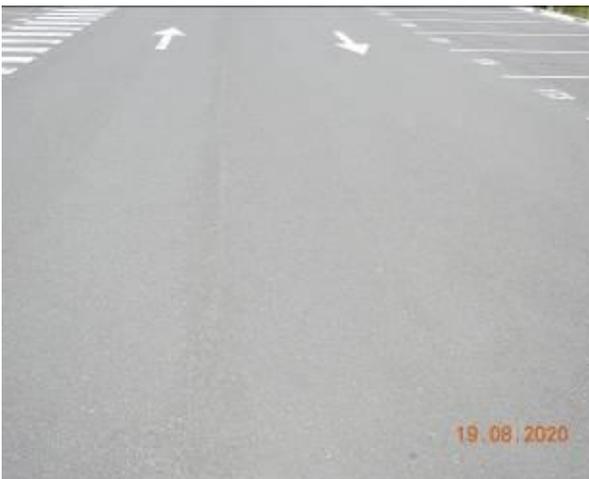
Figure 1531 – General condition of car park pavement

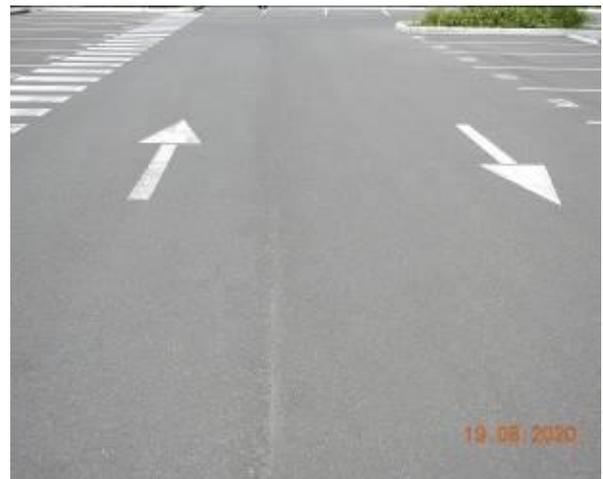
Figure 1532 – General condition of car park pavement

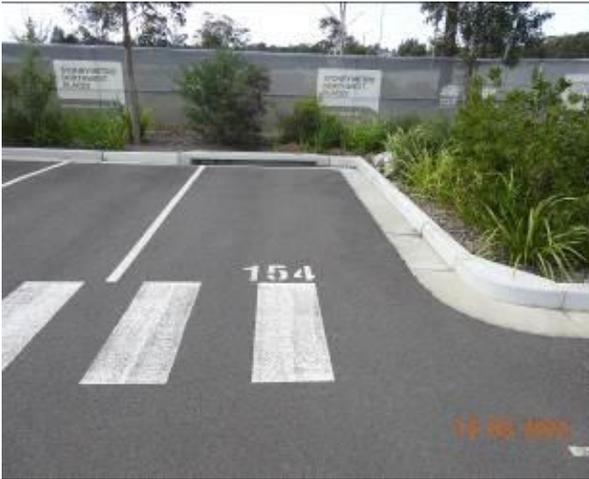
Figure 1533 – General condition of car park pavement

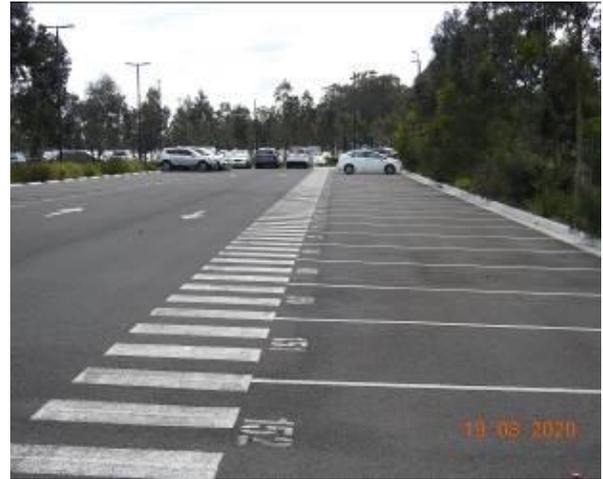
Figure 1534 – General condition of car park pavement

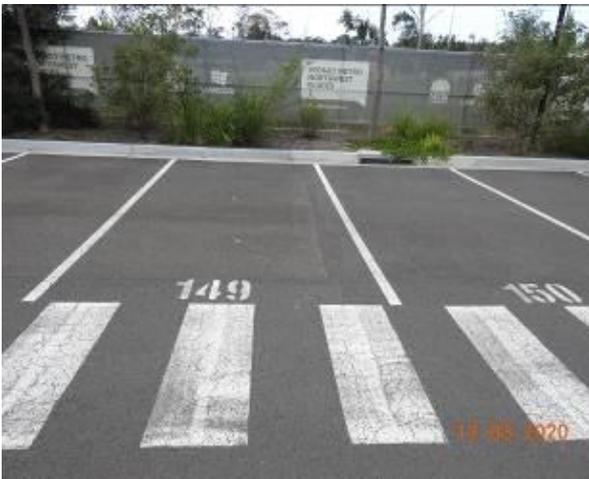
Figure 1535 – General condition of car park pavement

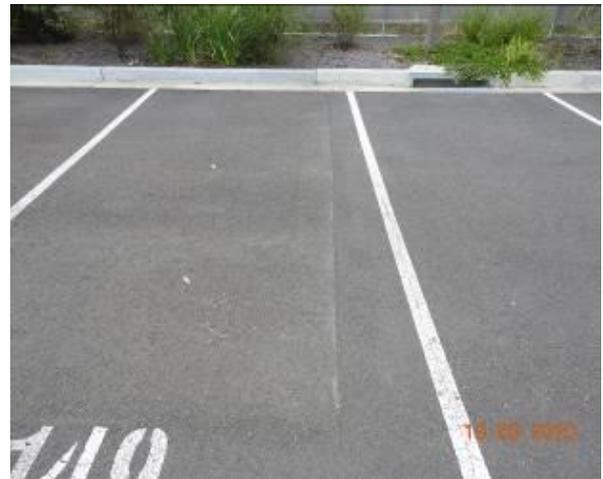
Figure 1536 – General condition of car park pavement

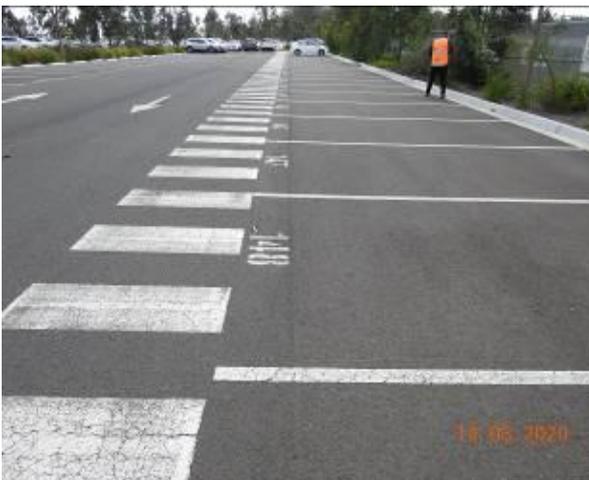
Figure 1537 – General condition of car park pavement

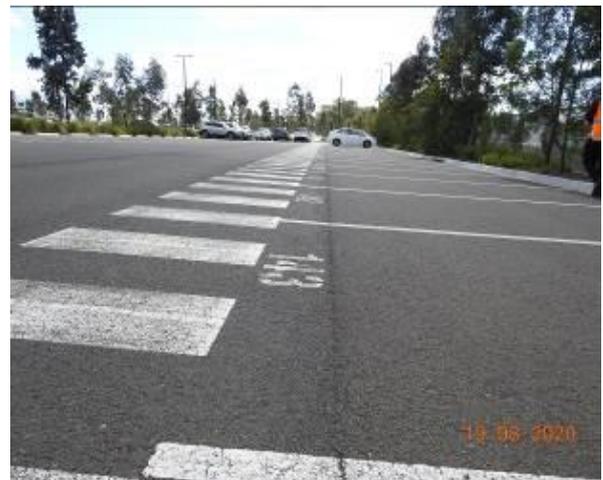
Figure 1538 – General condition of car park pavement

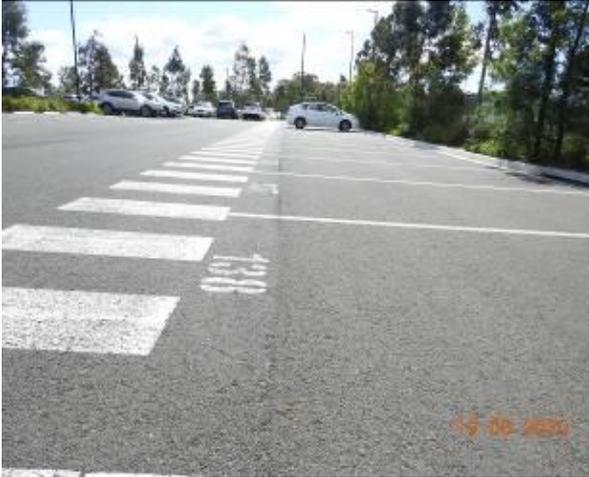
Figure 1539 – General condition of car park pavement

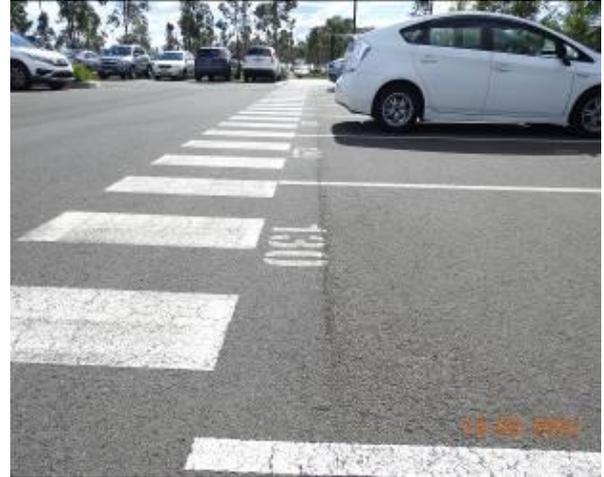
Figure 1540 – General condition of car park pavement

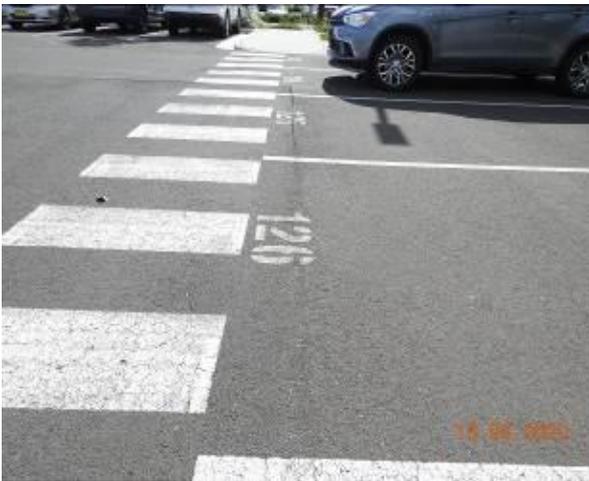
Figure 1541 – Crack propagation through car park pavement

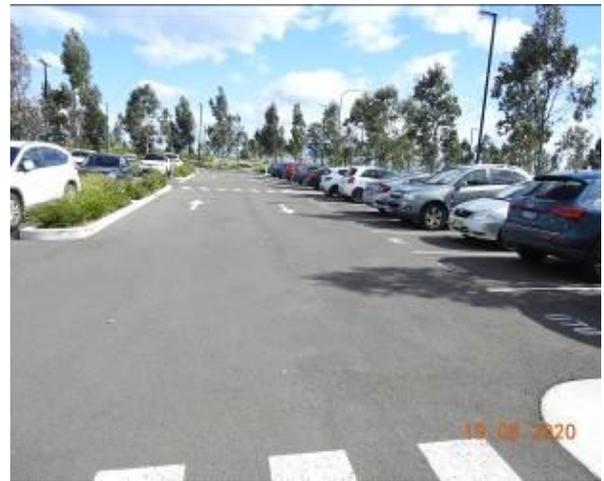
Figure 1542 – General condition of car park pavement

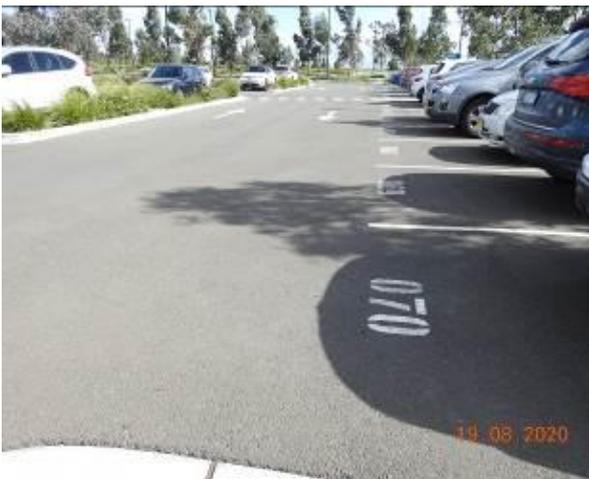
Figure 1543 – General condition of car park pavement

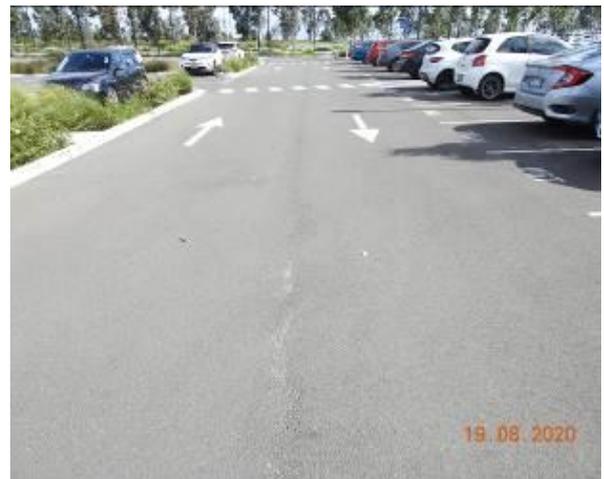
Figure 1544 – Loss of material through car park pavement

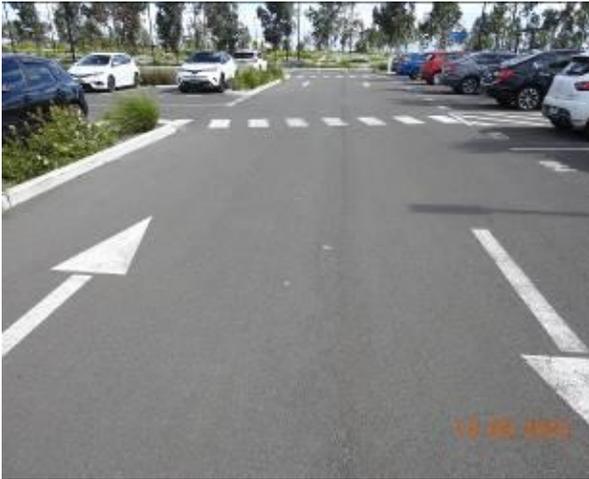
Figure 1545 – General condition of car park pavement

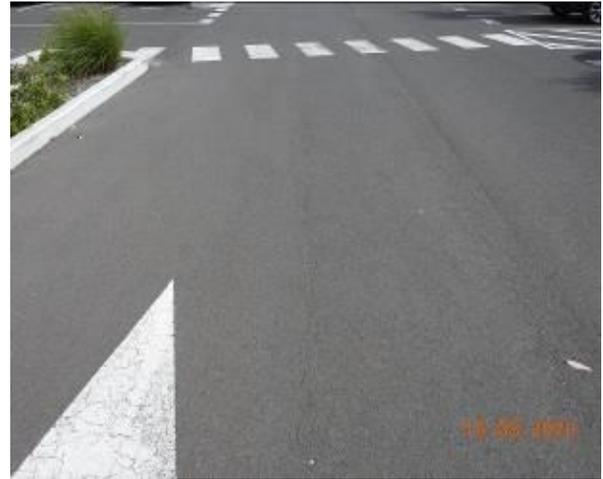
Figure 1546 – Crack propagation through car park pavement

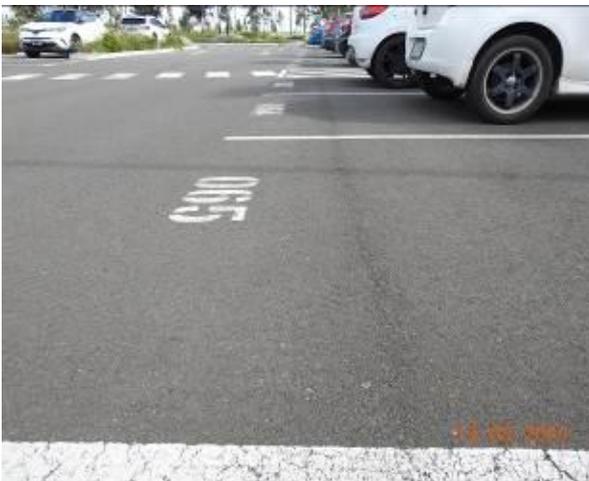
Figure 1547 – General condition of car park pavement

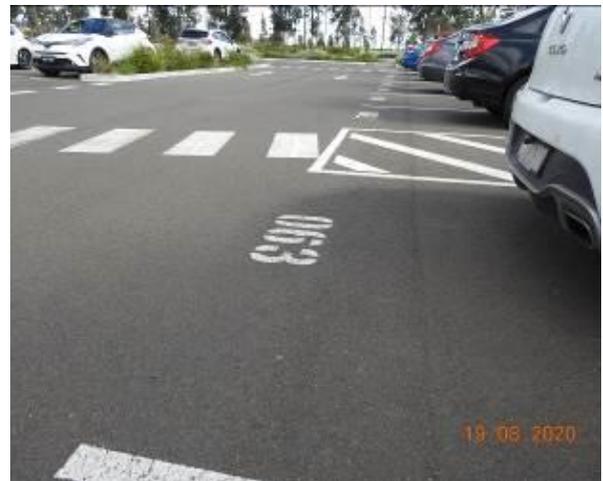
Figure 1548 – General condition of car park pavement

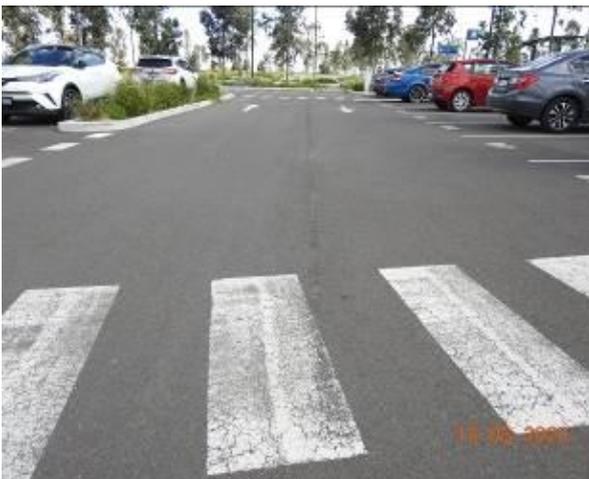
Figure 1549 – General condition of car park pavement

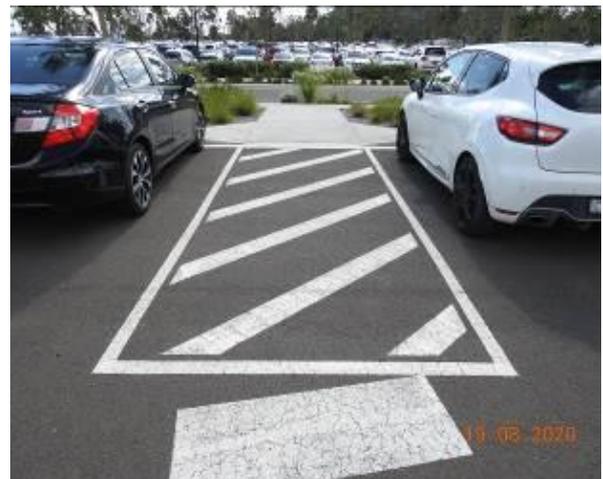
Figure 1550 – General condition of car park pavement

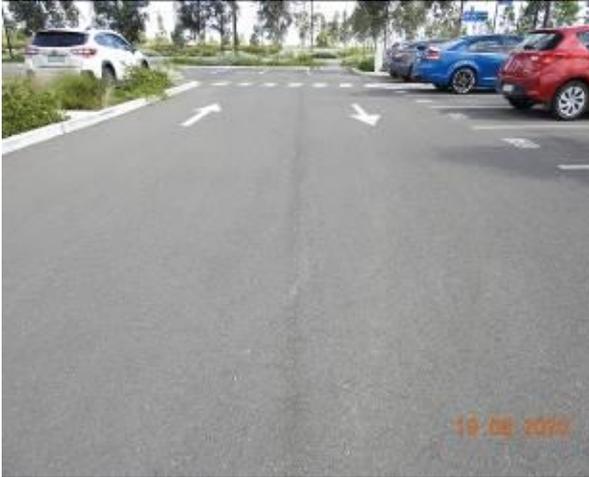
Figure 1551 – General condition of car park pavement

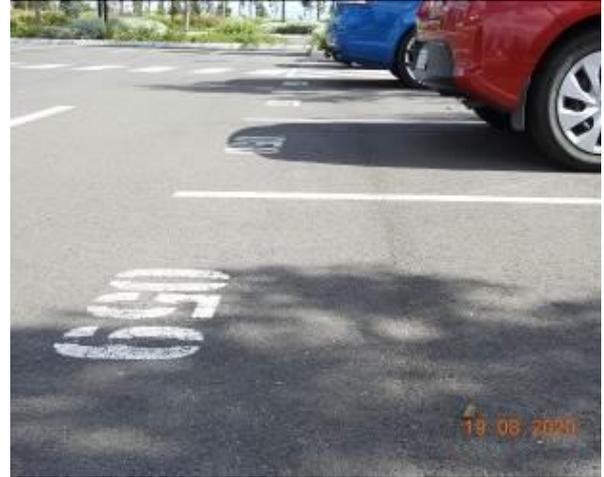
Figure 1552 – General condition of car park pavement

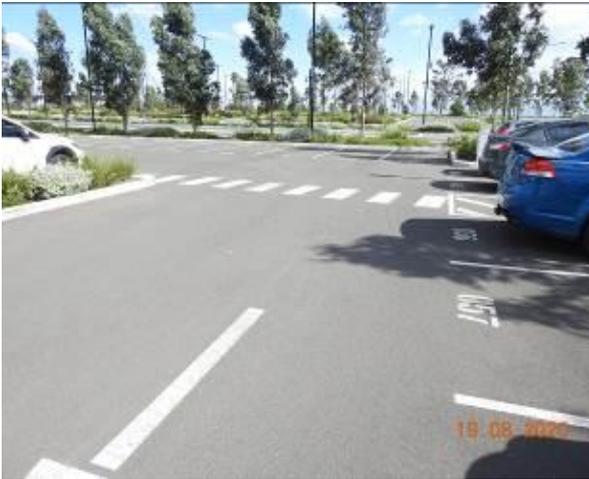
Figure 1553 – General condition of car park pavement

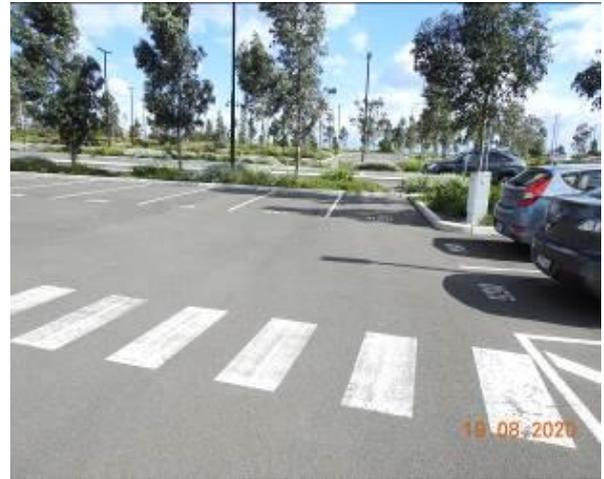
Figure 1554 – General condition of car park pavement

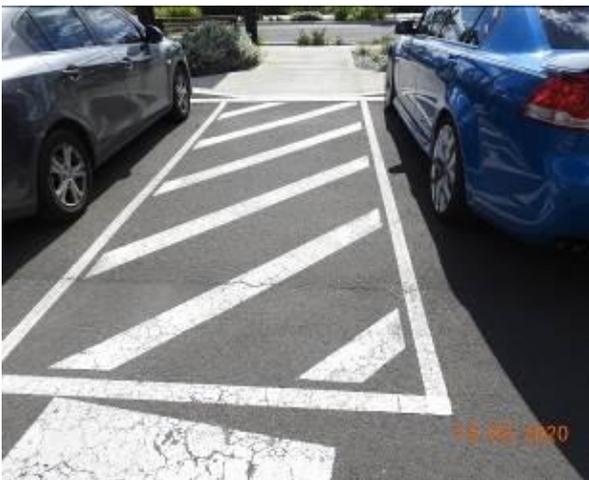
Figure 1555 – General condition of car park pavement

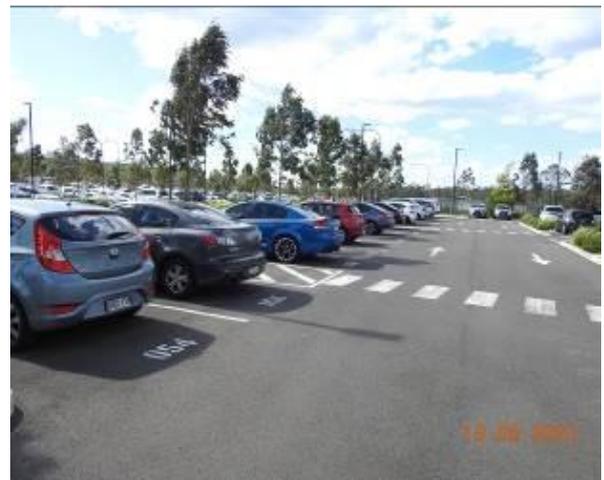
Figure 1556 – General condition of car park pavement

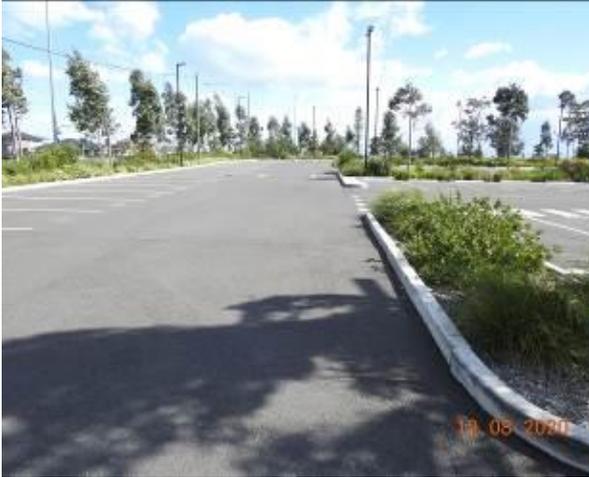
Figure 1557 – General condition of car park pavement

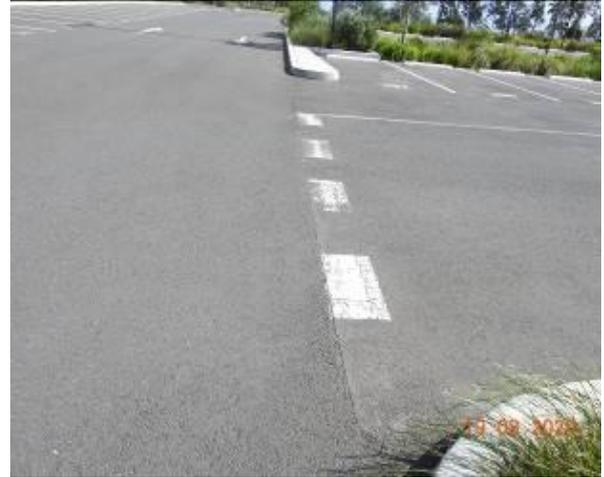
Figure 1558 – Crack propagation through car park pavement

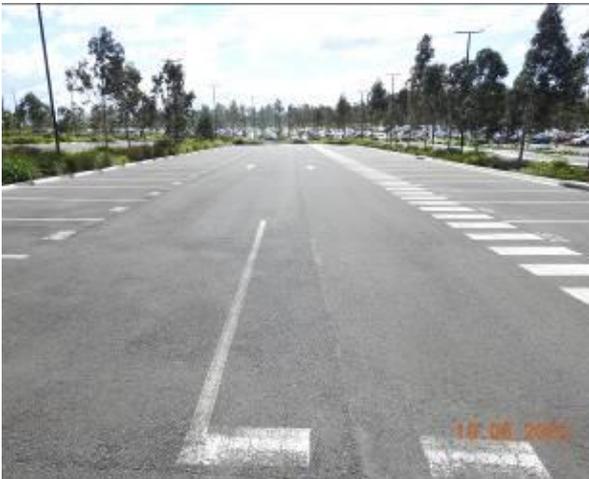
Figure 1559 – Evidence of patchwork through car park pavement

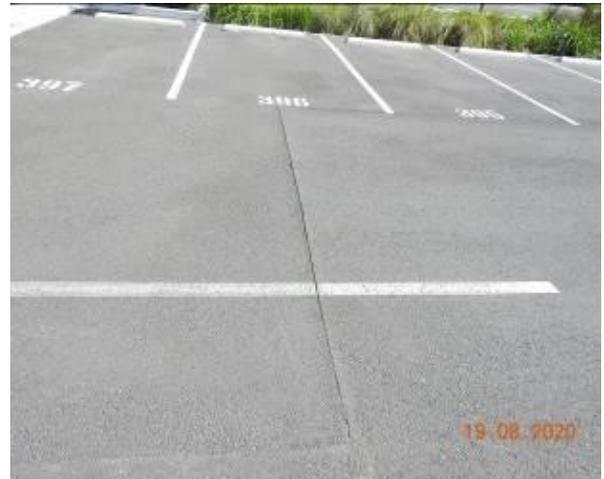
Figure 1560 – Evidence of patchwork through car park pavement

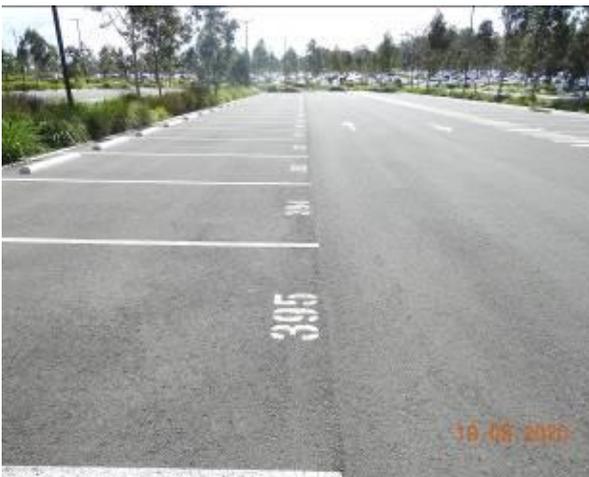
Figure 1561 – General condition of car park pavement

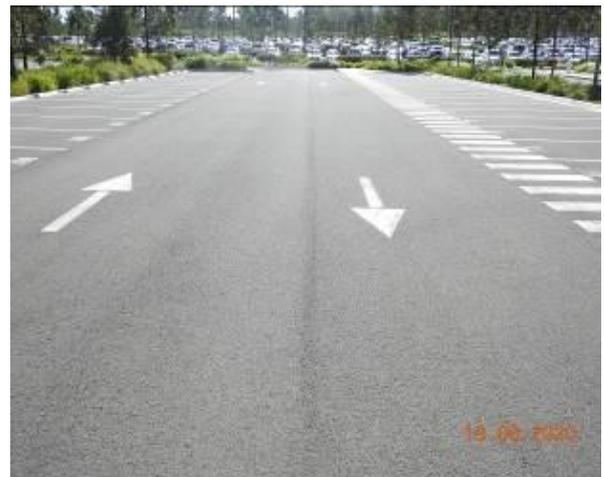
Figure 1562 – General condition of car park pavement

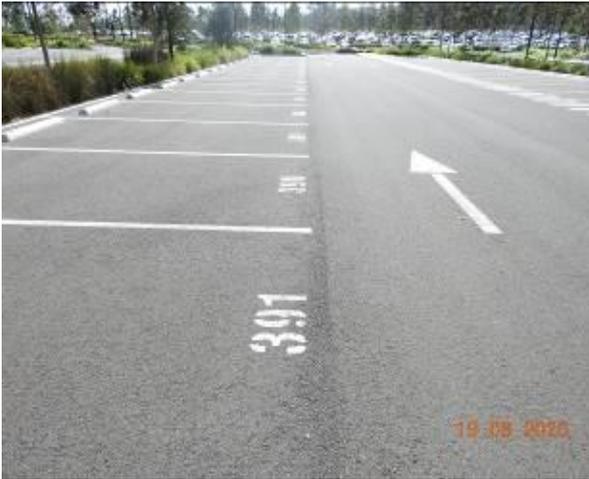
Figure 1563 – General condition of car park pavement

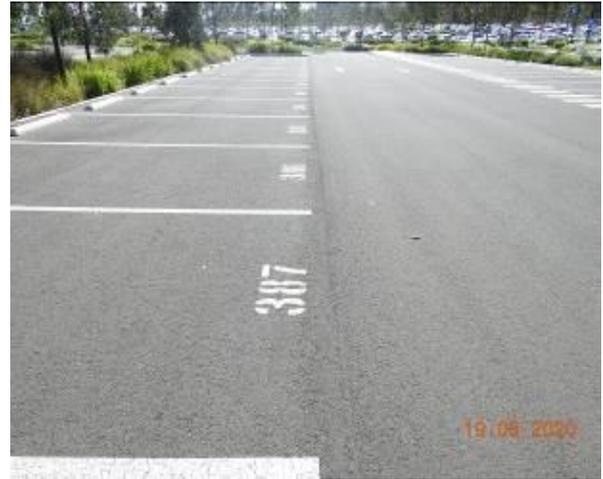
Figure 1564 – General condition of car park pavement

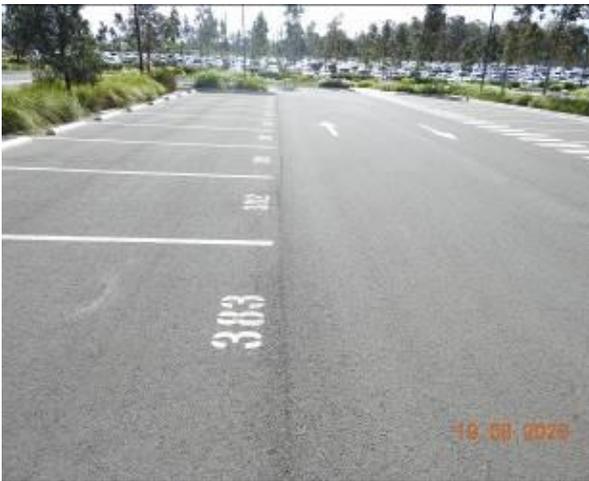
Figure 1565 – General condition of car park pavement

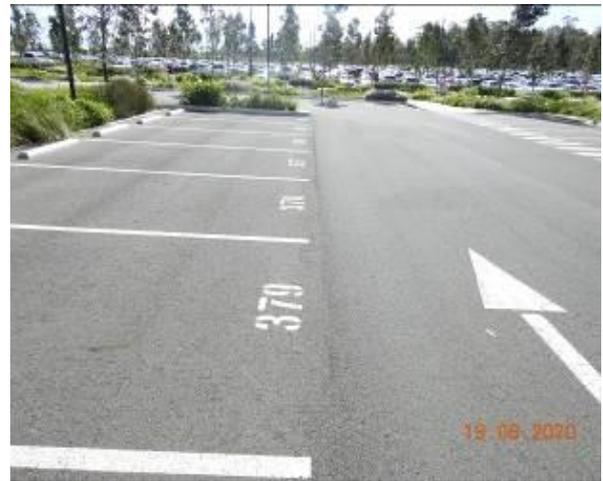
Figure 1566 – General condition of car park pavement

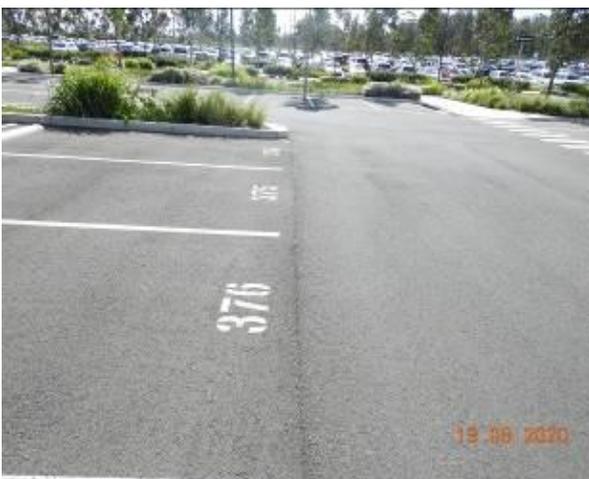
Figure 1567 – General condition of car park pavement

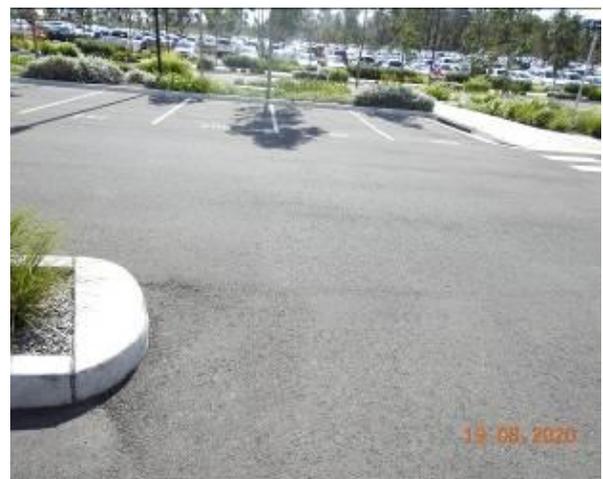
Figure 1568 – General condition of car park pavement

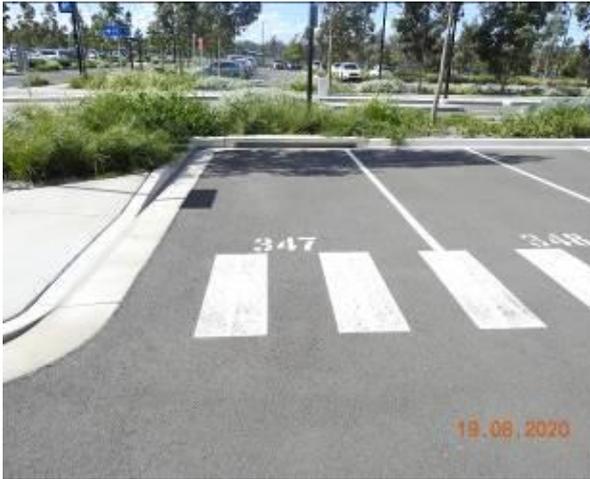
Figure 1569 – General condition of car park pavement

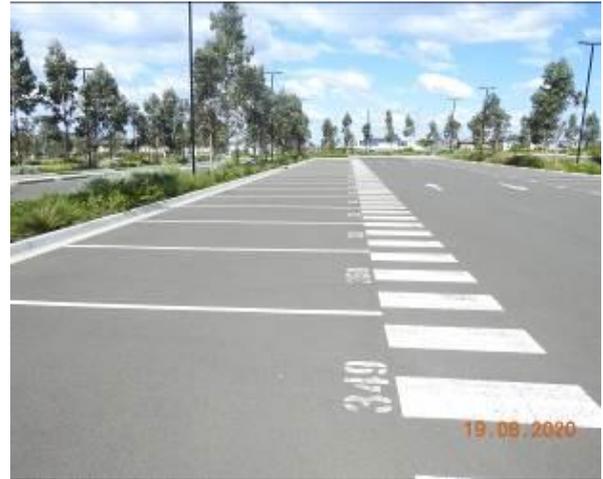
Figure 1570 – General condition of car park pavement

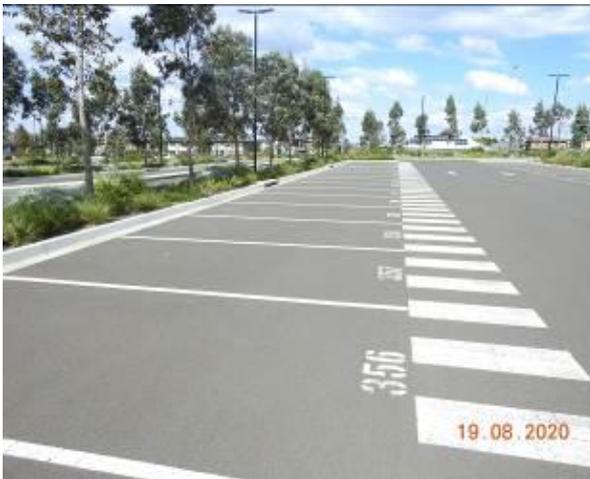
Figure 1571 – General condition of car park pavement

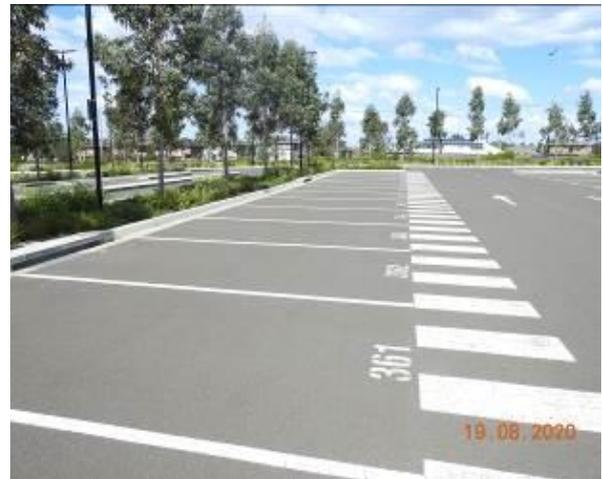
Figure 1572 – General condition of car park pavement

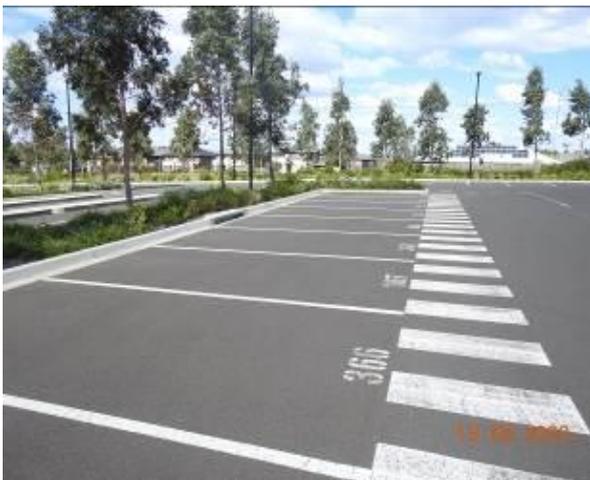
Figure 1573 – General condition of car park pavement

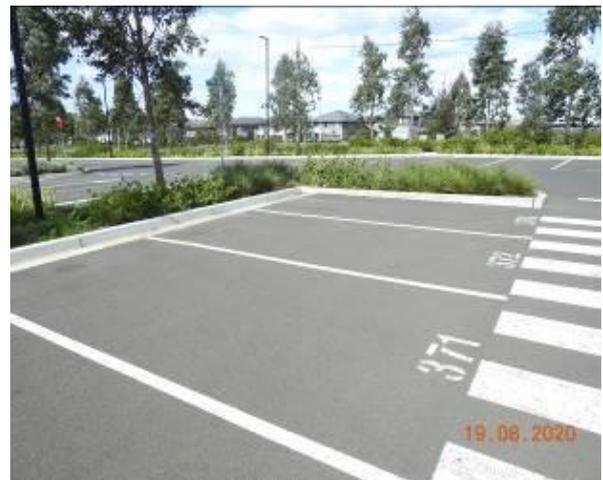
Figure 1574 – General condition of car park pavement

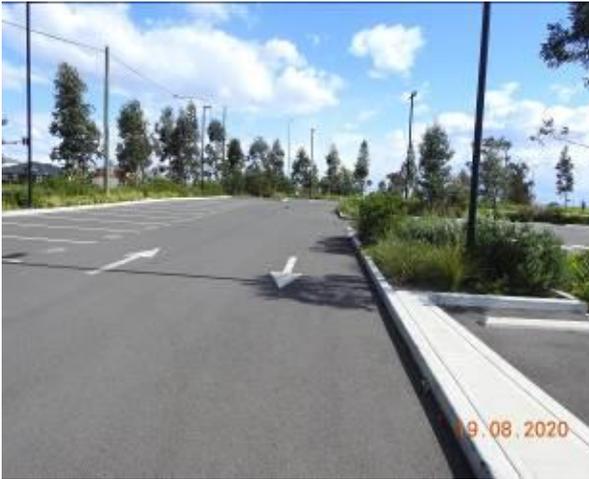
Figure 1575 – General condition of car park pavement

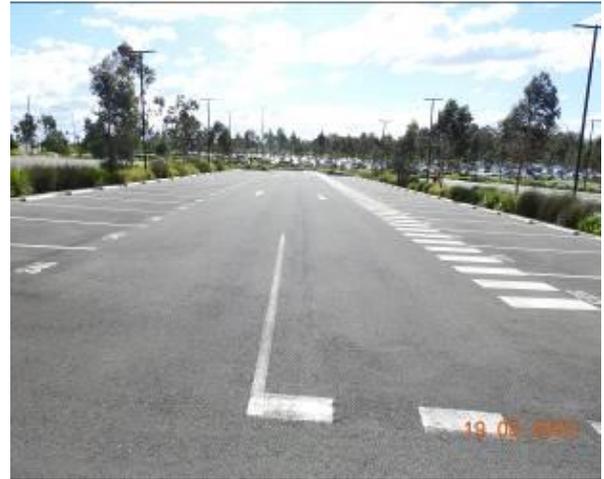
Figure 1576 – General condition of car park pavement

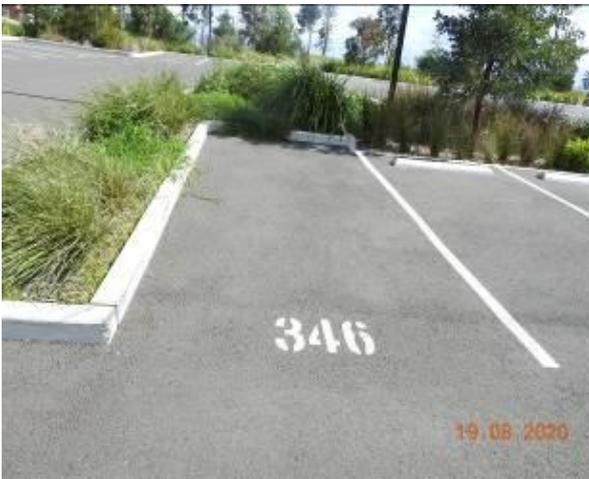
Figure 1577 – General condition of car park pavement

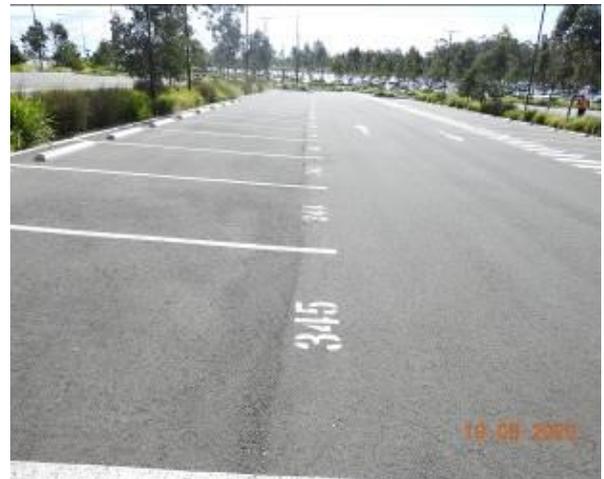
Figure 1578 – General condition of car park pavement

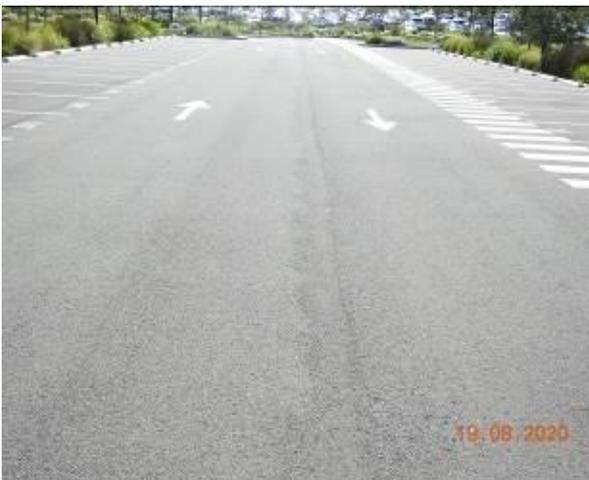
Figure 1579 – General condition of car park pavement

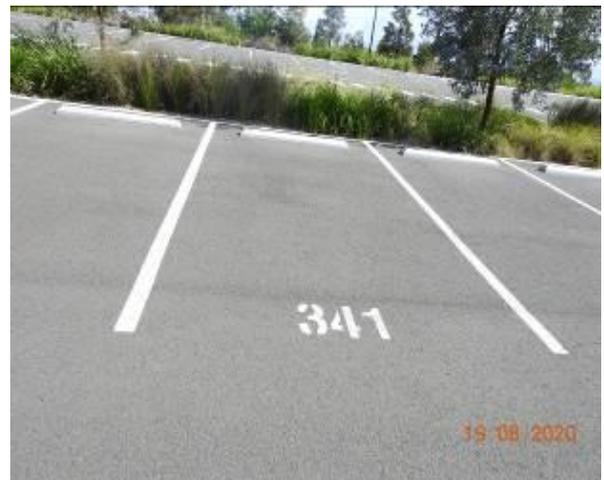
Figure 1580 – General condition of car park pavement

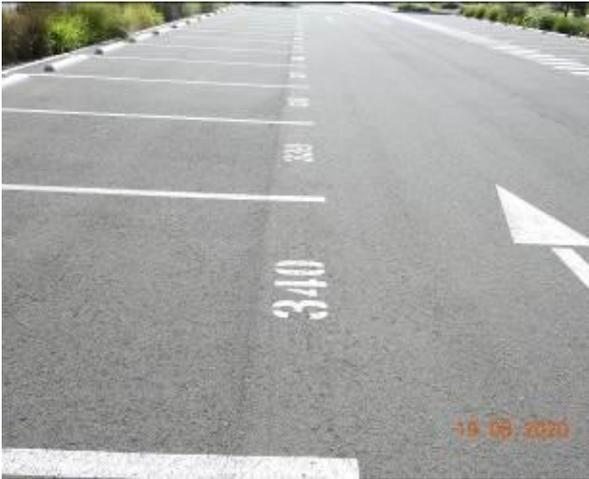
Figure 1581 – General condition of car park pavement

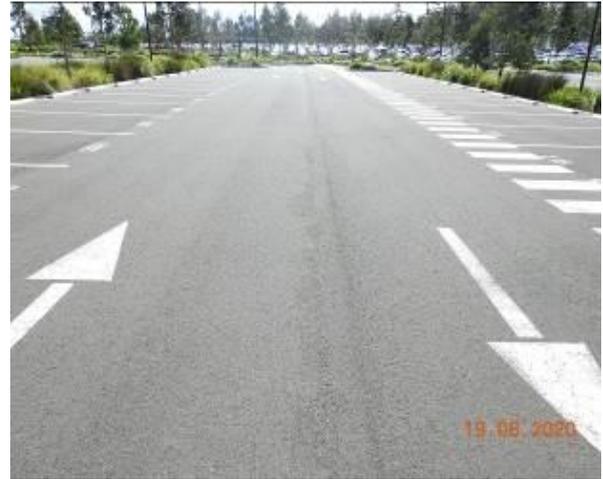
Figure 1582 – General condition of car park pavement

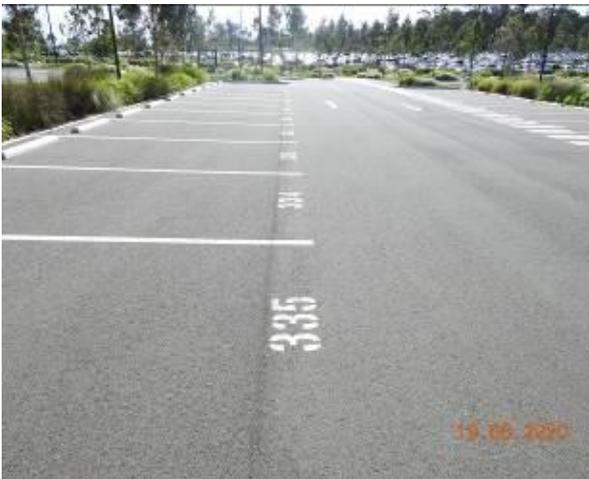
Figure 1583 – General condition of car park pavement

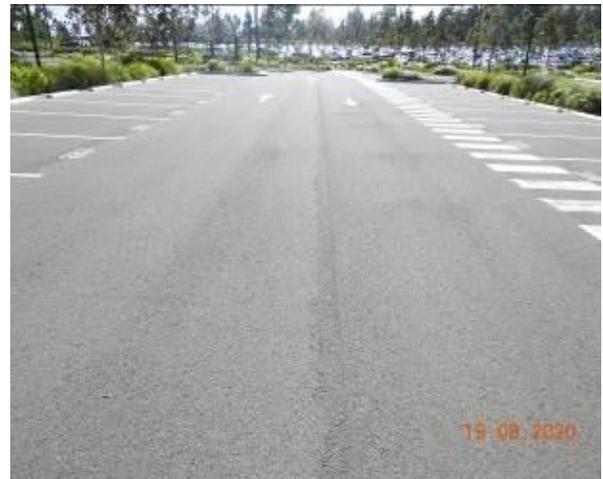
Figure 1584 – General condition of car park pavement

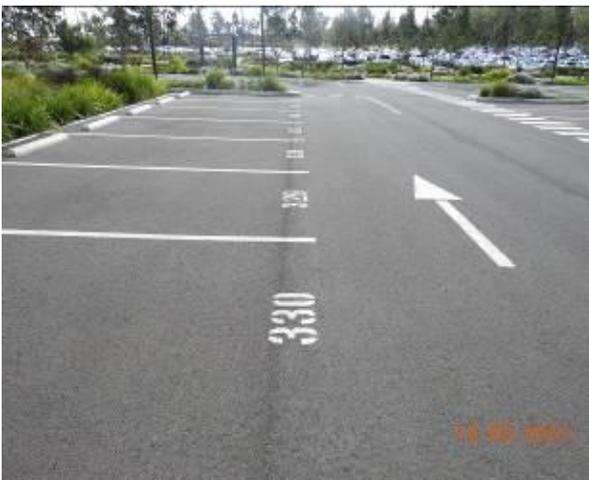
Figure 1585 – General condition of car park pavement

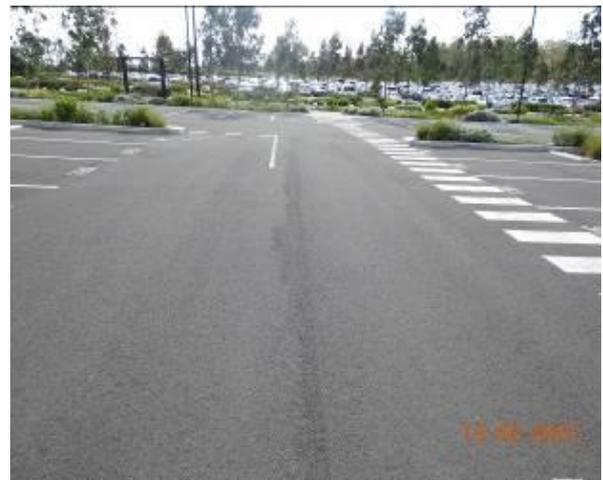
Figure 1586 – General condition of car park pavement

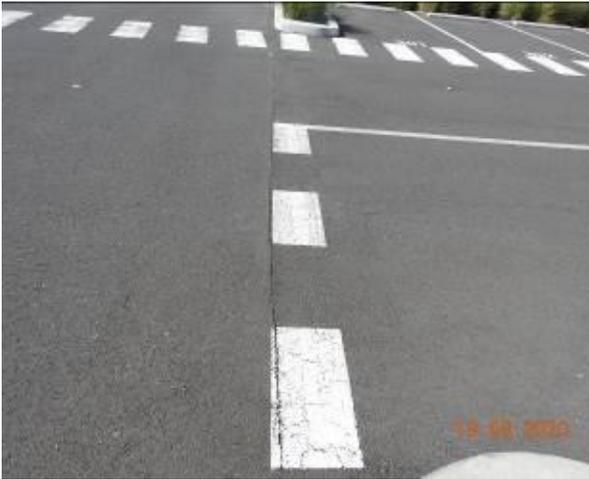
Figure 1587 – Crack propagation through car park pavement

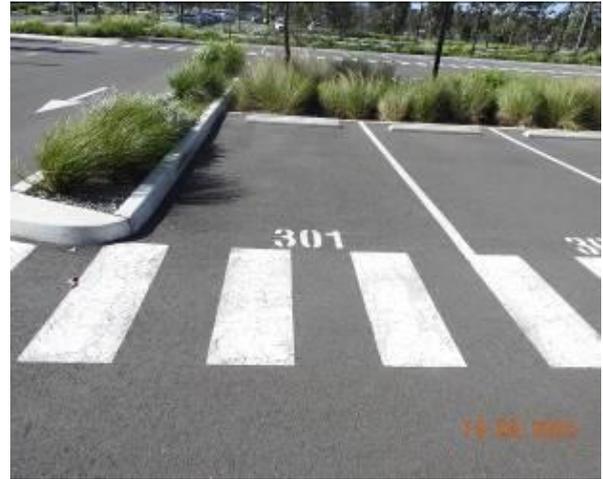
Figure 1588 – General condition of car park pavement

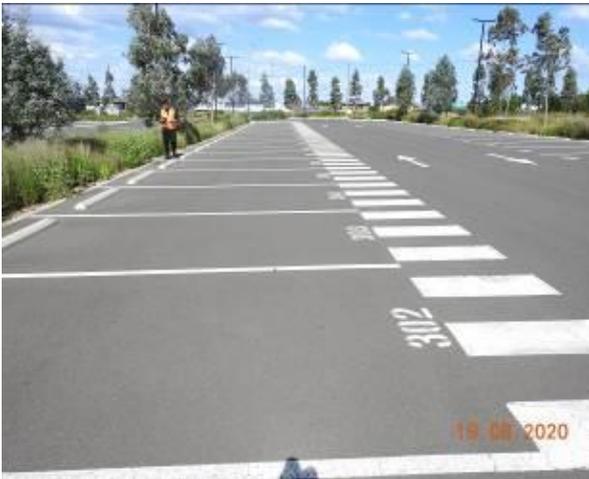
Figure 1589 – General condition of car park pavement

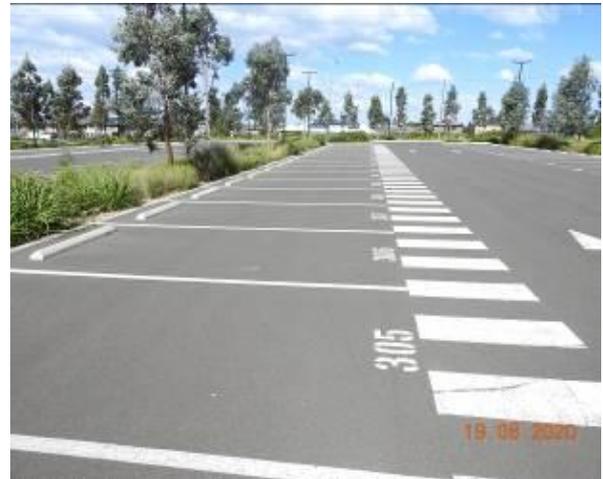
Figure 1590 – General condition of car park pavement
