The property Tallawong station – P2 Car Park, is the neighbouring property to our client’s site. It was photographed and inspected prior to any construction works on the subject site and was found to be in a reasonable condition. The property serves as a car park.

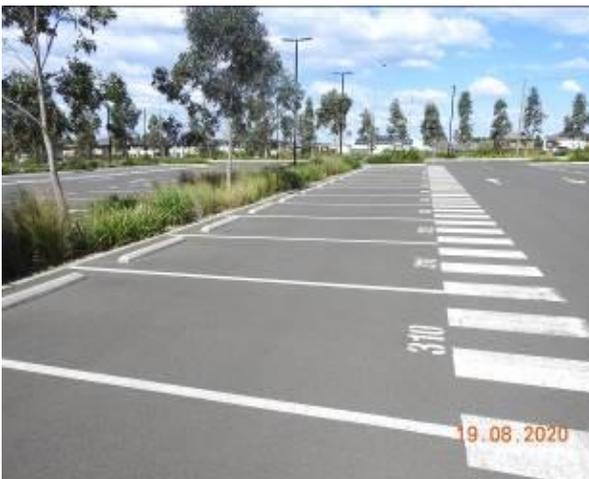
Figure 1591 – General condition of car park pavement

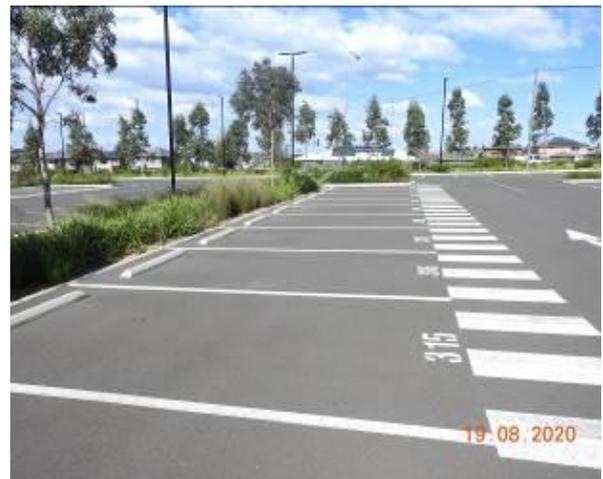
Figure 1592 – General condition of car park pavement

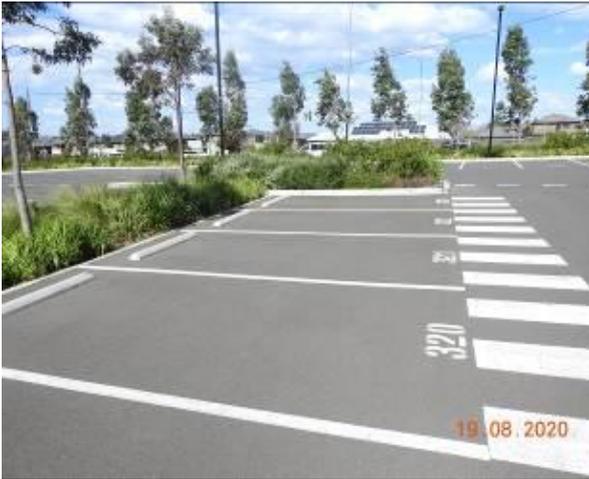
Figure 1593 – General condition of car park pavement

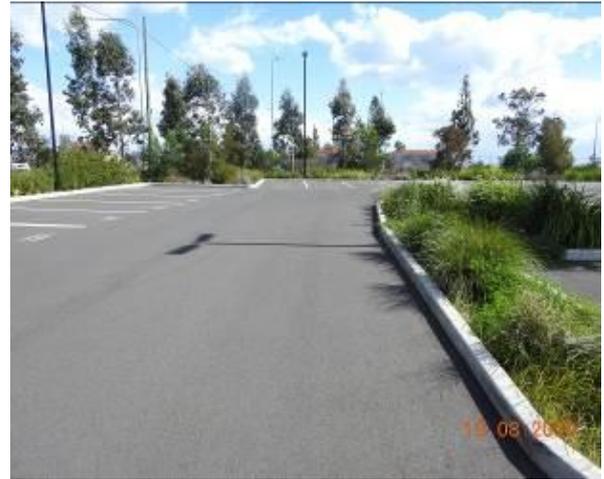
Figure 1594 – General condition of car park pavement

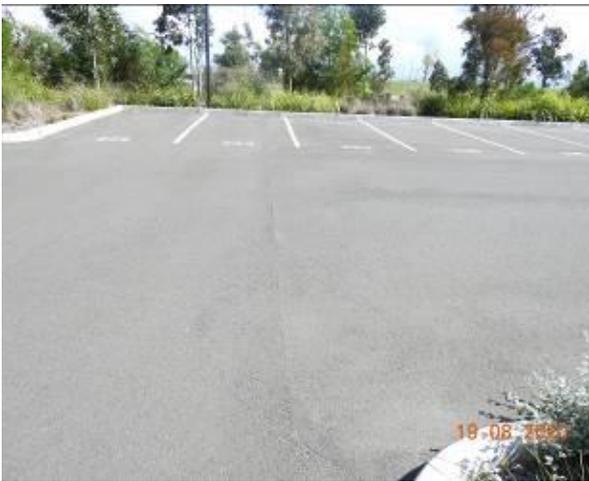
Figure 1595 – General condition of car park pavement

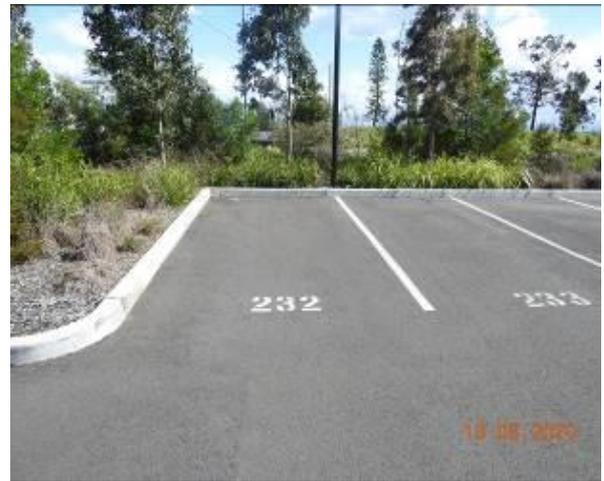
Figure 1596 – General condition of car park pavement

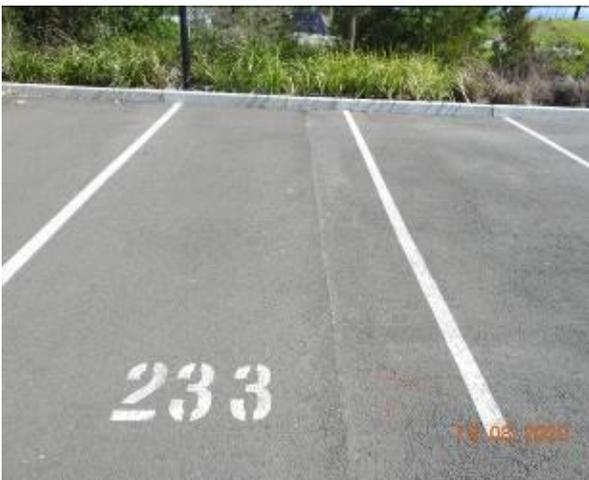
Figure 1597 – General condition of car park pavement

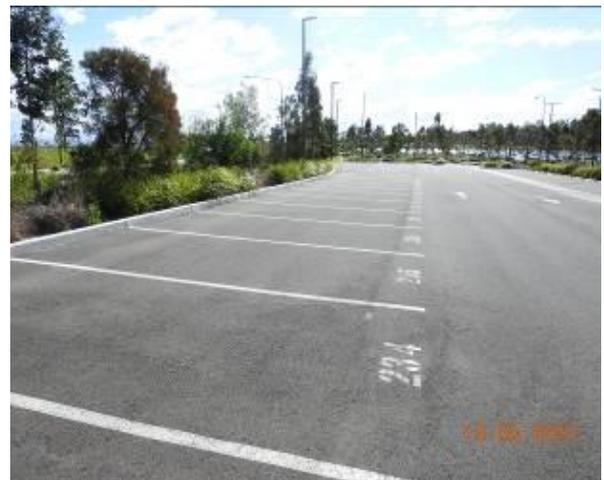
Figure 1598 – General condition of car park pavement

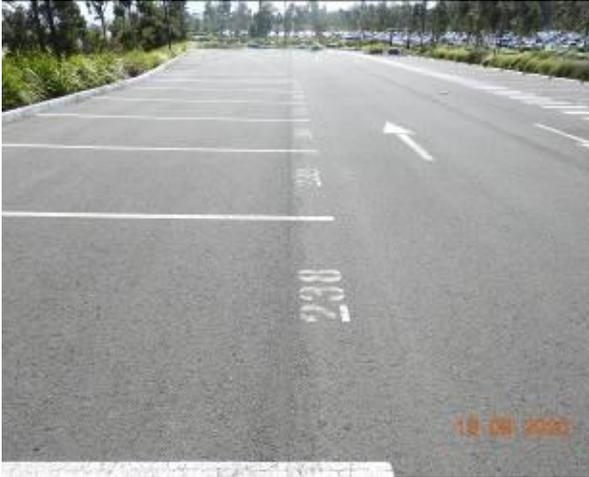
Figure 1599 – General condition of car park pavement

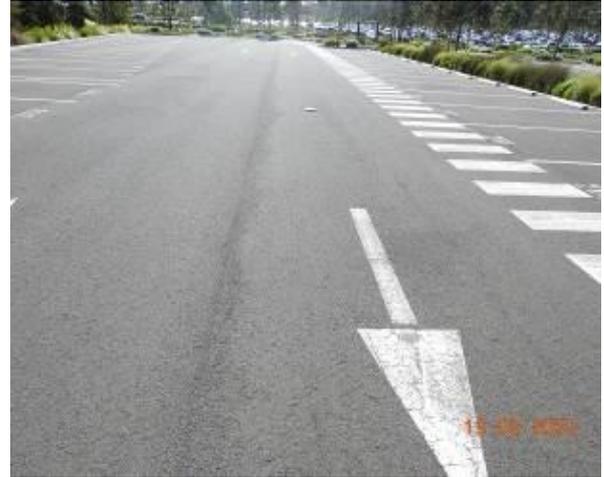
Figure 1600 – General condition of car park pavement

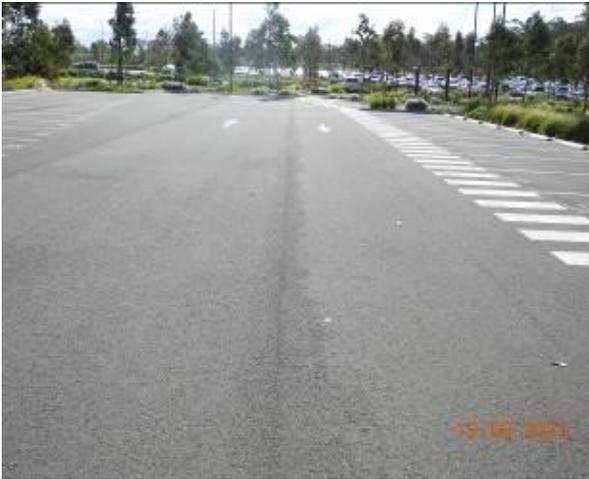
Figure 1601 – General condition of car park pavement

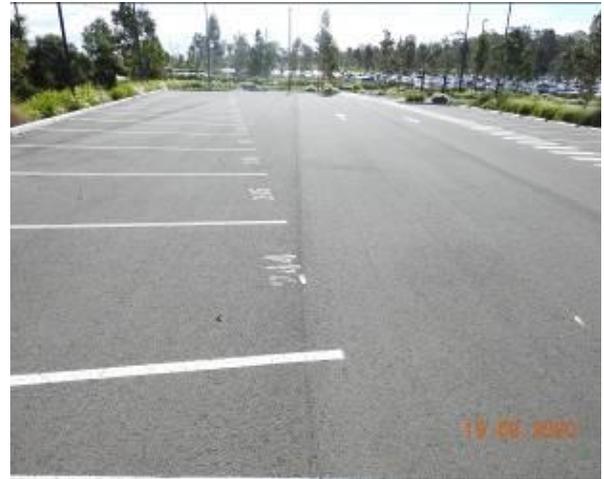
Figure 1602 – General condition of car park pavement

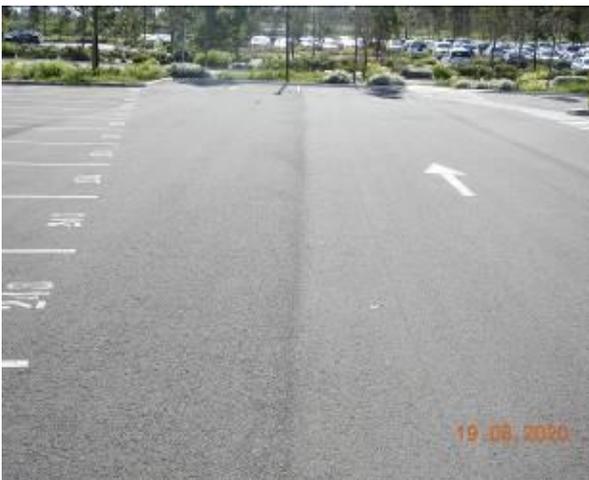
Figure 1603 – General condition of car park pavement

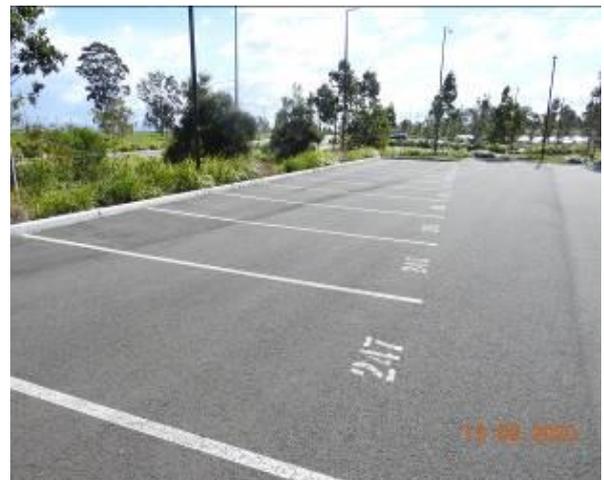
Figure 1604 – General condition of car park pavement

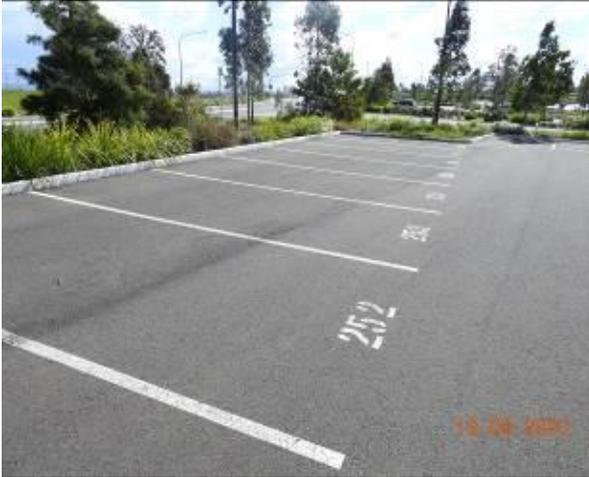
Figure 1605 – General condition of car park pavement

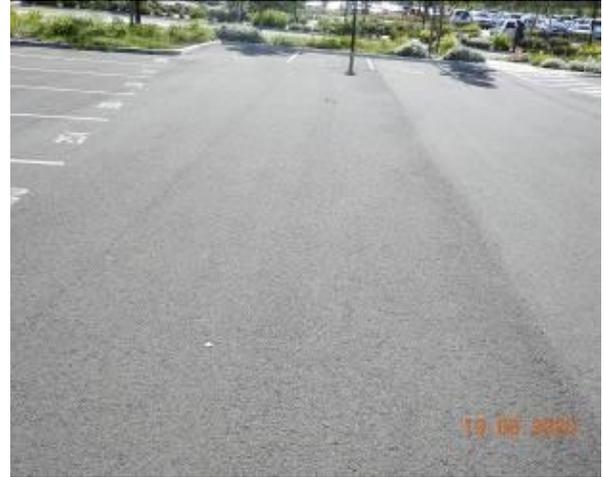
Figure 1606 – General condition of car park pavement

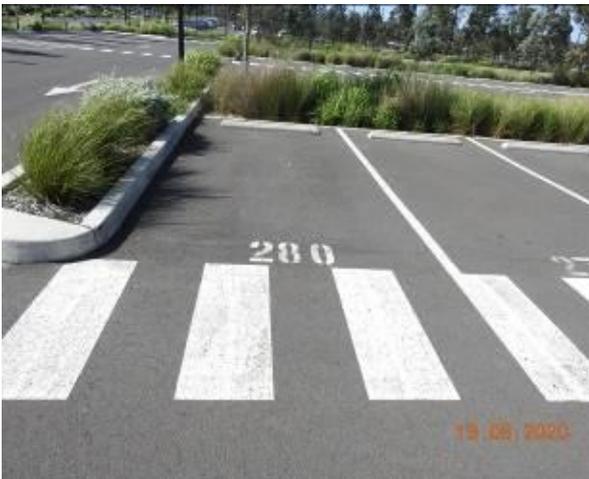
Figure 1607 – General condition of car park pavement

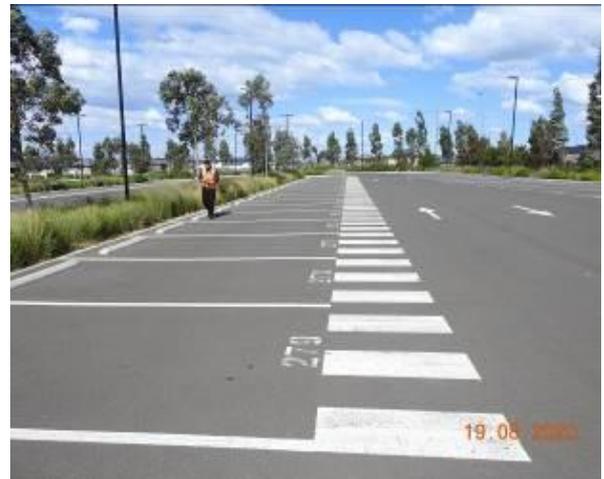
Figure 1608 – General condition of car park pavement

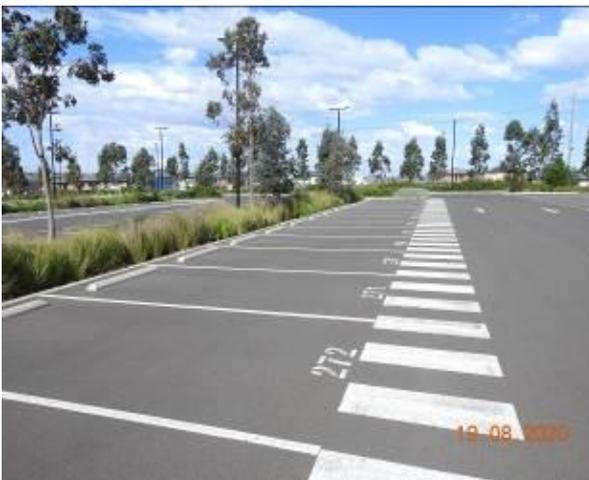
Figure 1609 – General condition of car park pavement

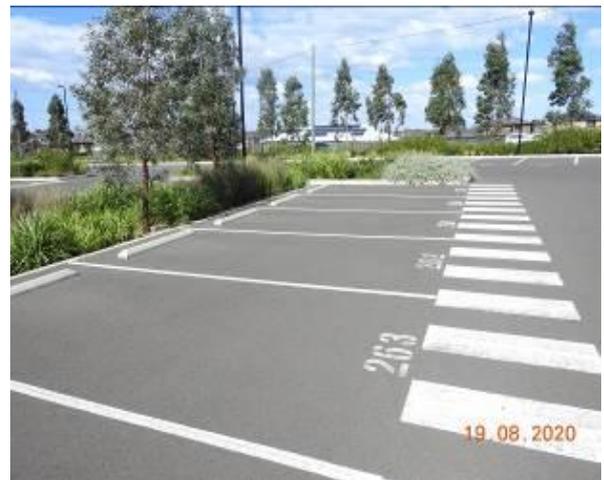
Figure 1610 – General condition of car park pavement

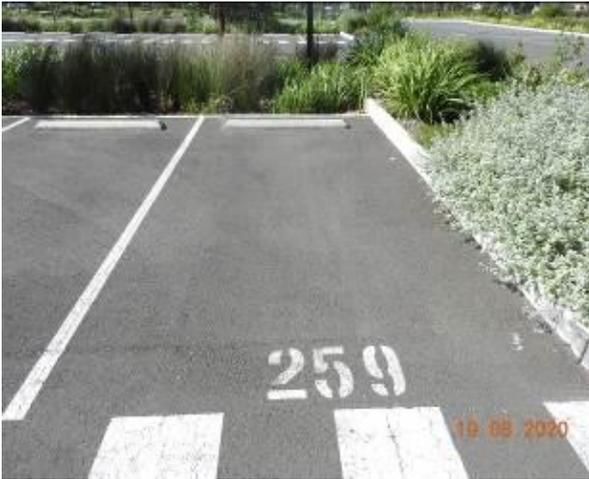
Figure 1611 – General condition of car park pavement

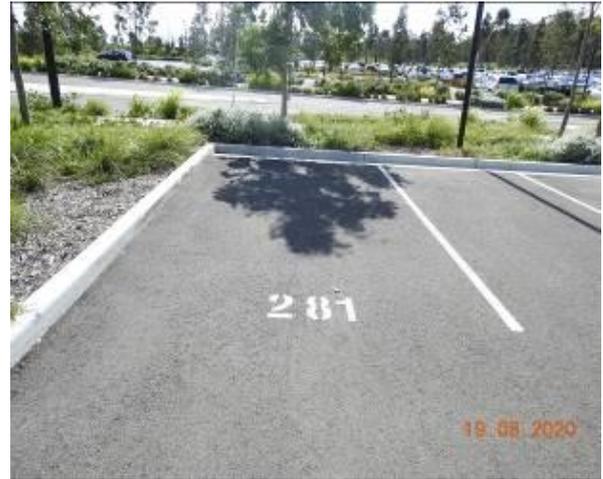
Figure 1612 – General condition of car park pavement

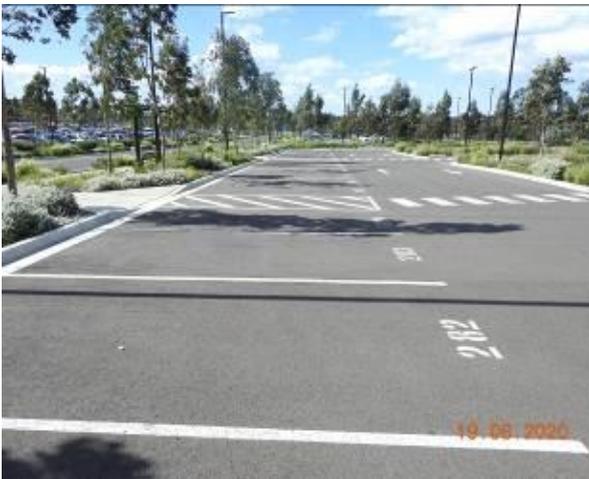
Figure 1613 – General condition of car park pavement

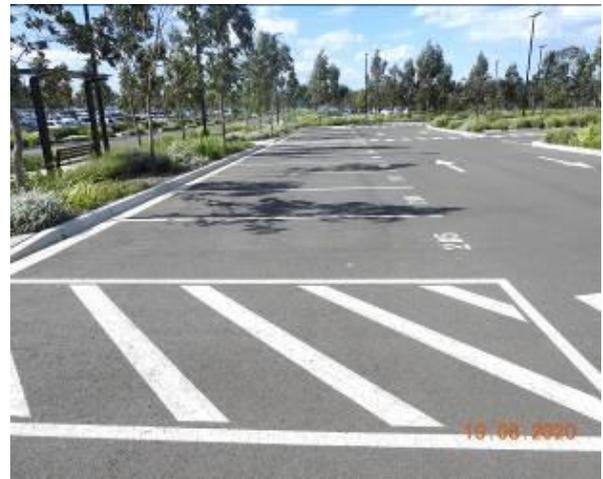
Figure 1614 – General condition of car park pavement

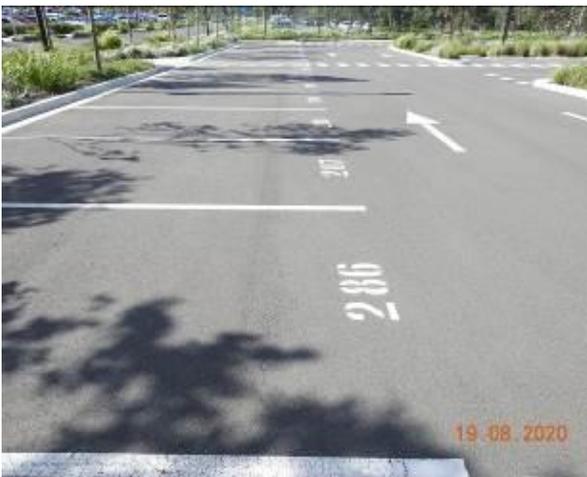
Figure 1615 – General condition of car park pavement

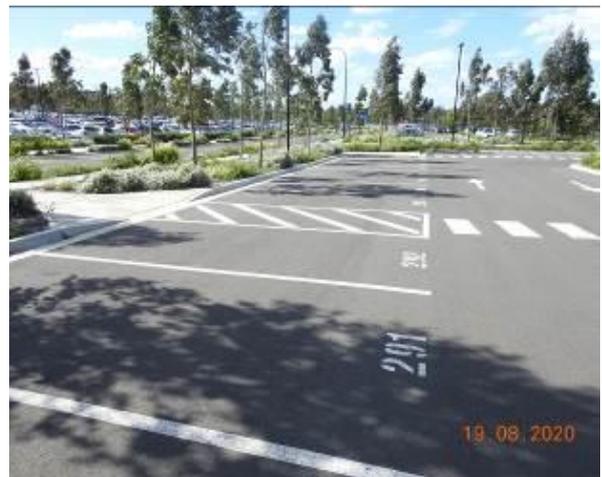
Figure 1616 – General condition of car park pavement

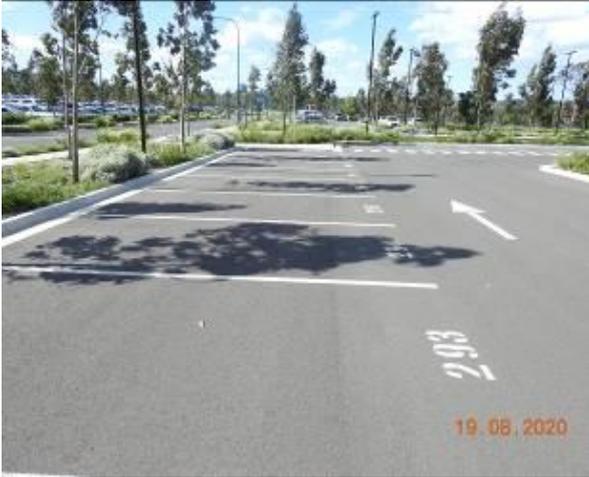
Figure 1617 – General condition of car park pavement

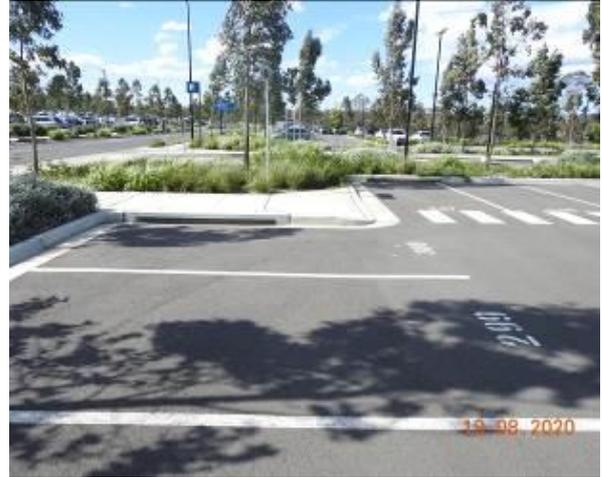
Figure 1618 – General condition of car park pavement

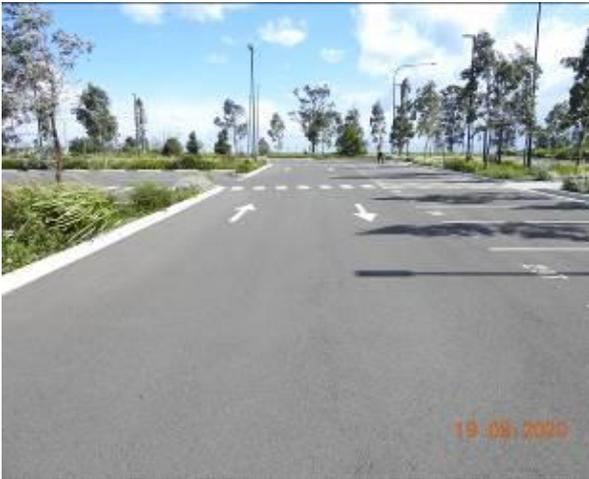
Figure 1619 – General condition of car park pavement

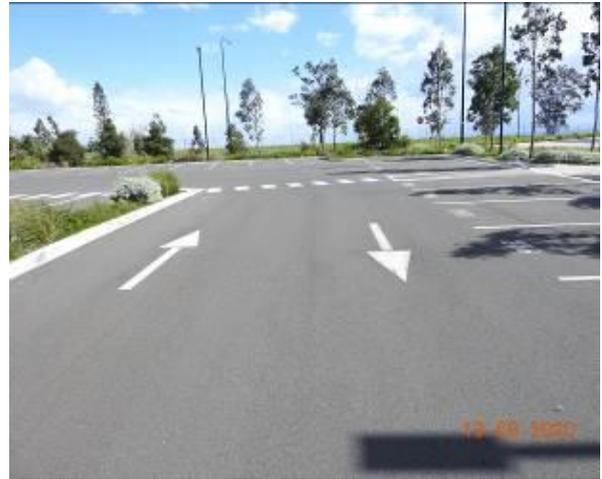
Figure 1620 – General condition of car park pavement

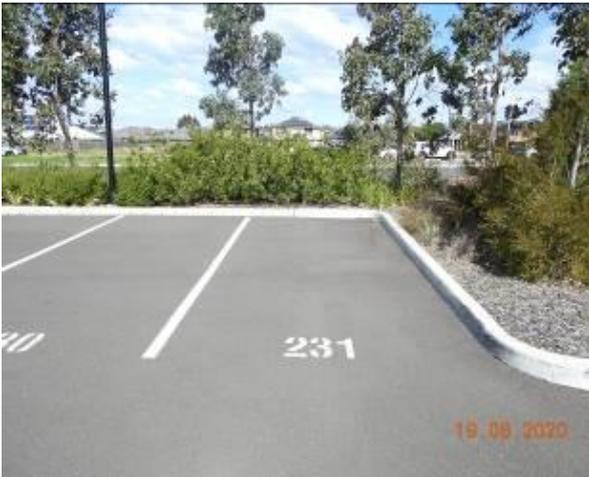
Figure 1621 – General condition of car park pavement

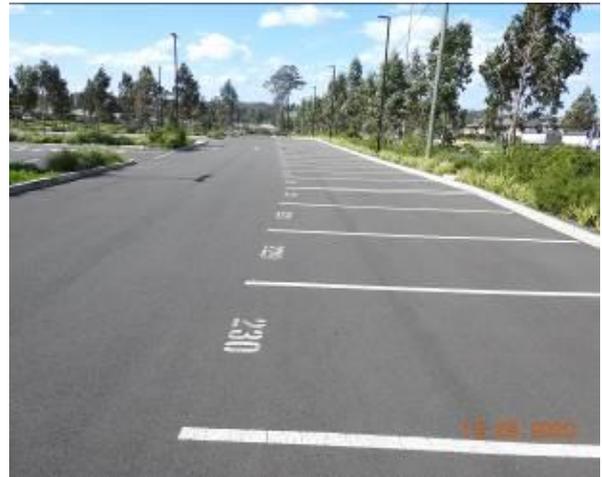
Figure 1622 – General condition of car park pavement

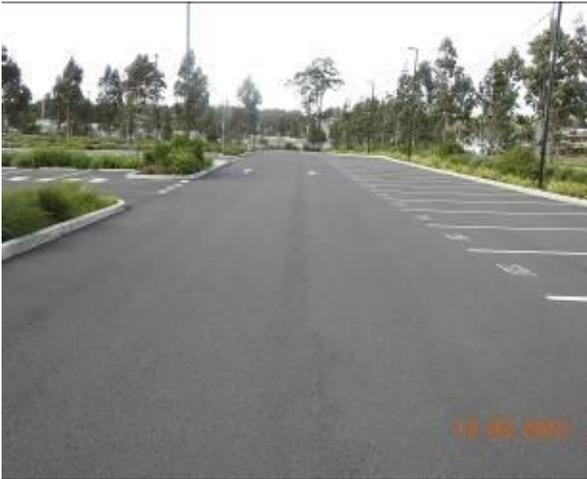
Figure 1623 – General condition of car park pavement

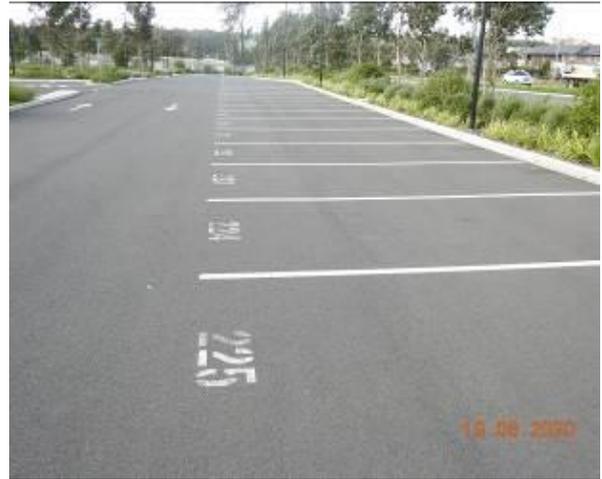
Figure 1624 – General condition of car park pavement

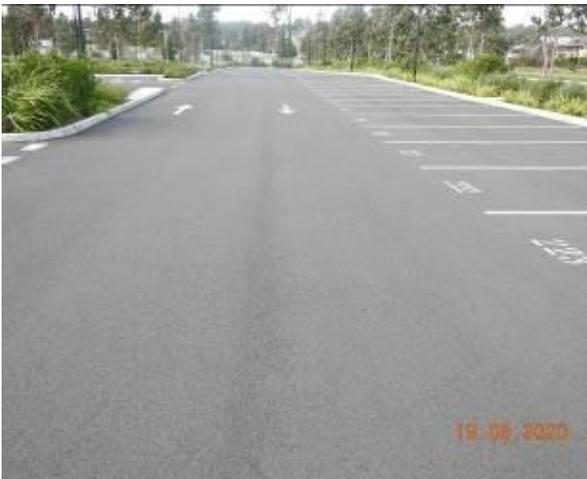
Figure 1625 – General condition of car park pavement

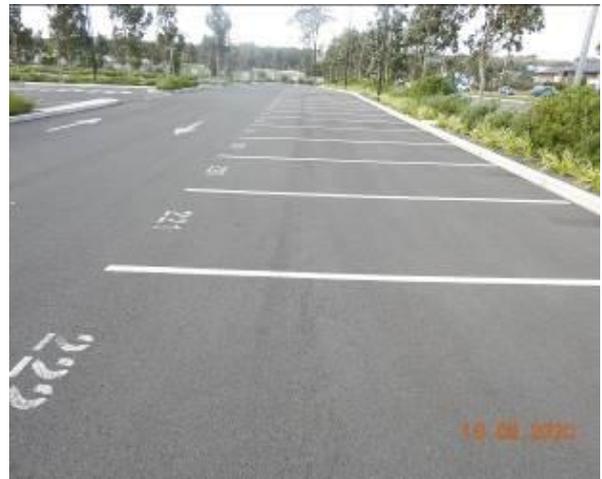
Figure 1626 – General condition of car park pavement

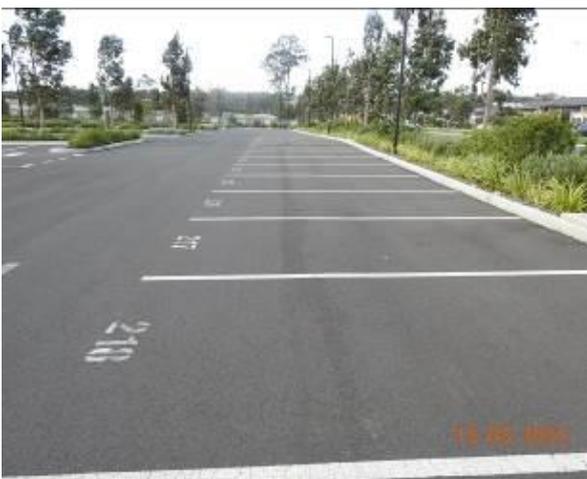
Figure 1627 – General condition of car park pavement

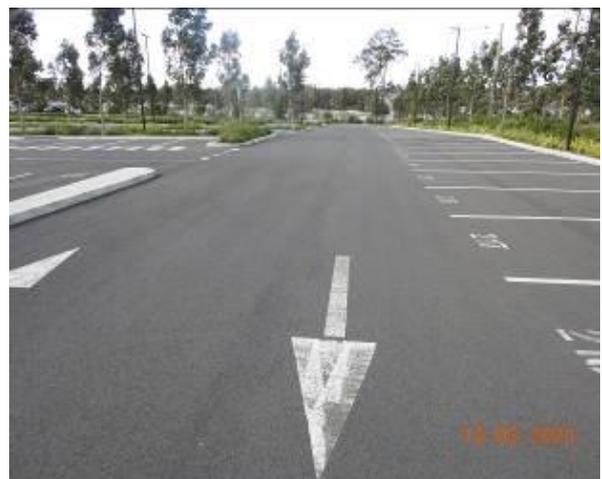
Figure 1628 – General condition of car park pavement

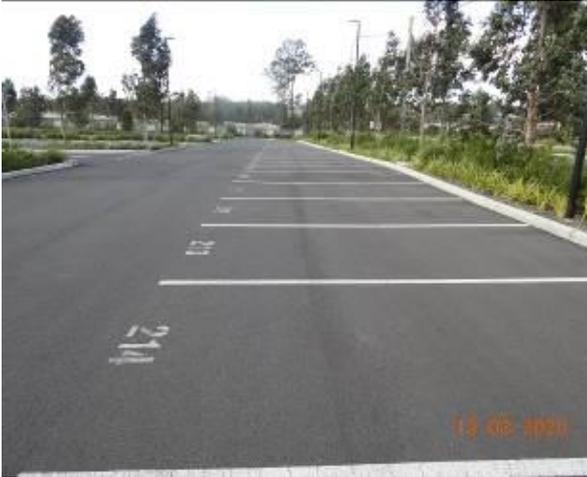
Figure 1629 – General condition of car park pavement

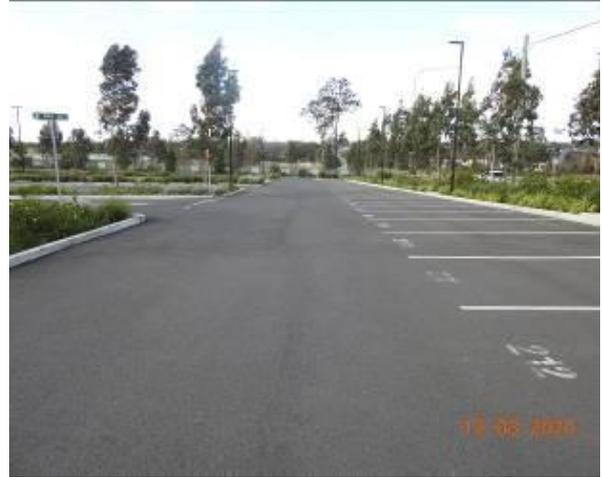
Figure 1630 – General condition of car park pavement

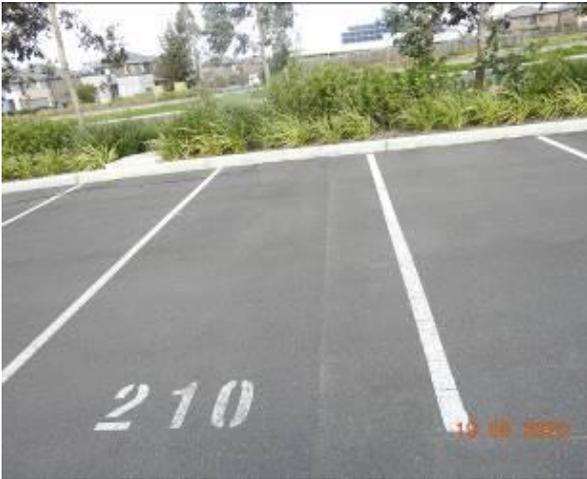
Figure 1631 – General condition of car park pavement

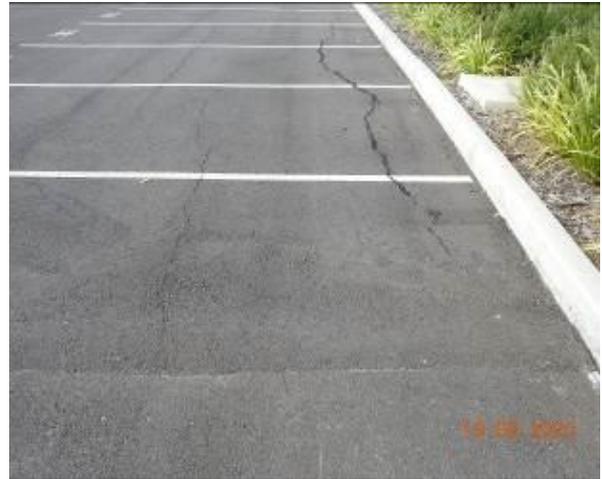
Figure 1632 – Crack propagation and Evidence of patchwork through car park pavement

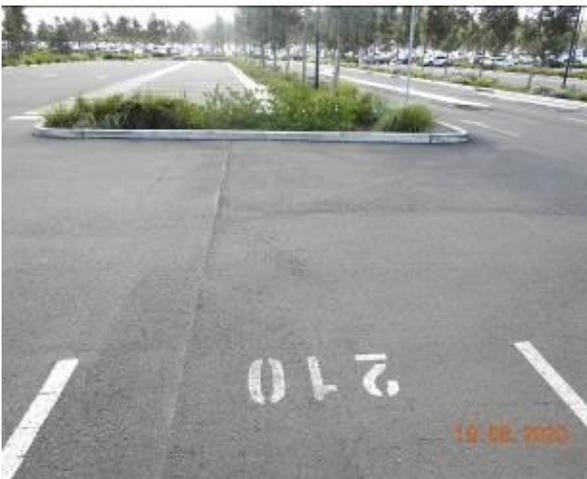
Figure 1633 – General condition of car park pavement

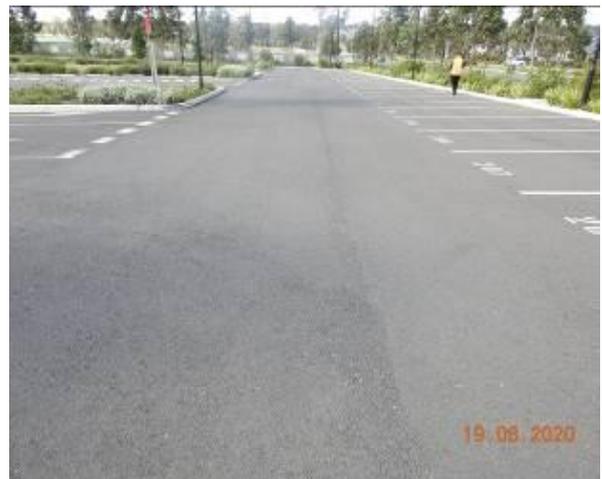
Figure 1634 – General condition of car park pavement

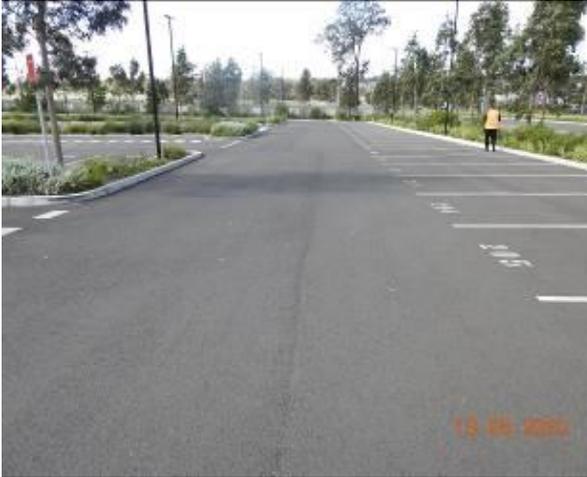
Figure 1635 – General condition of car park pavement

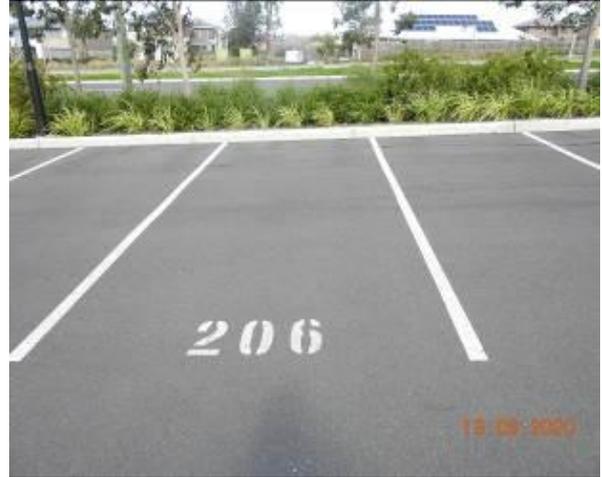
Figure 1636 – General condition of car park pavement

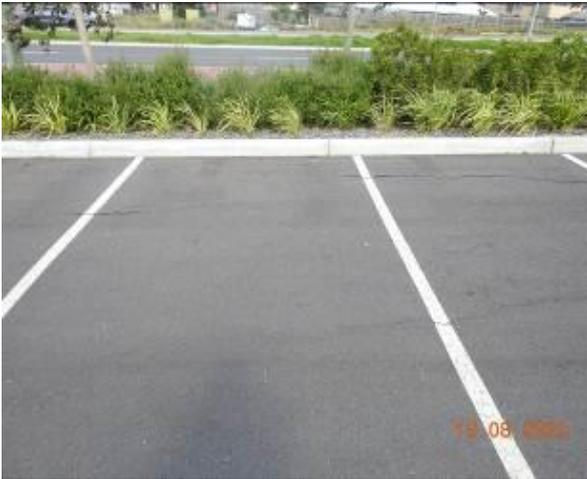
Figure 1637 – Crack propagation through car park pavement

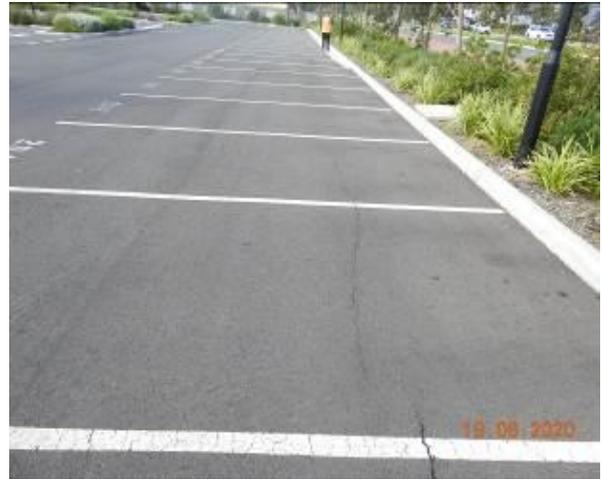
Figure 1638 – Crack propagation through car park pavement

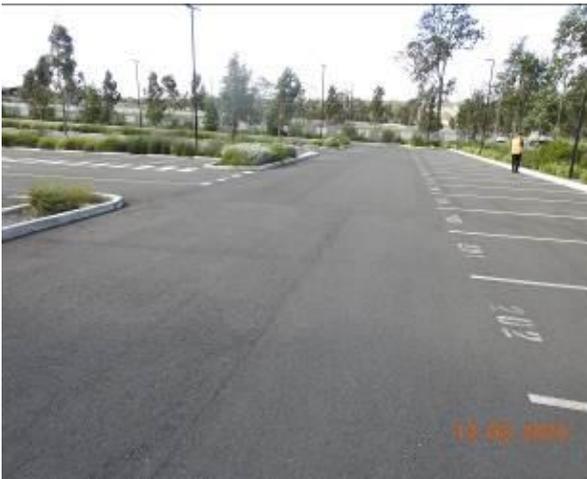
Figure 1639 – General condition of car park pavement

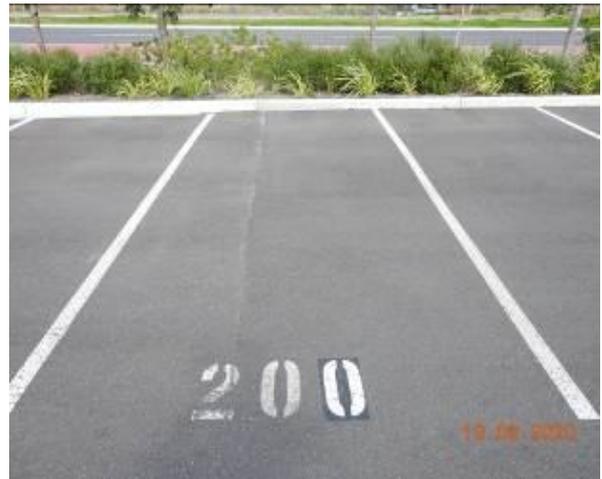
Figure 1640 – General condition of car park pavement

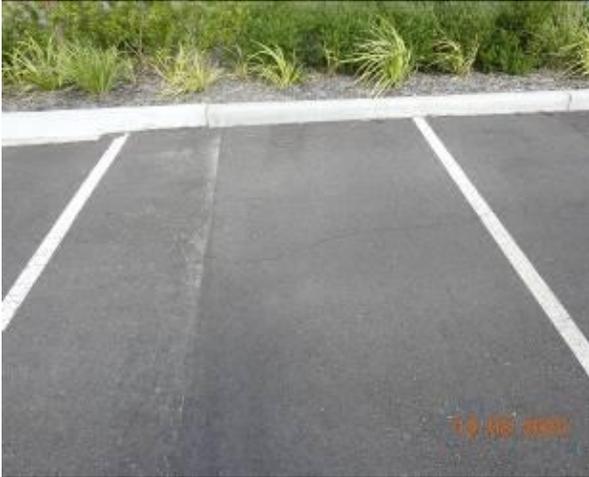
Figure 1641 – Crack propagation through car park pavement

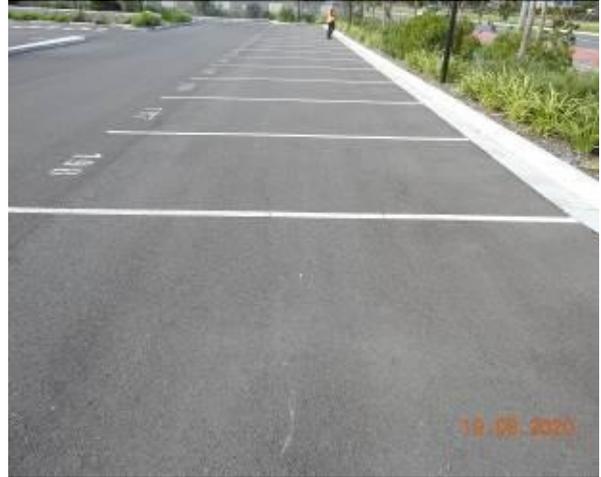
Figure 1642 – Crack propagation through car park pavement

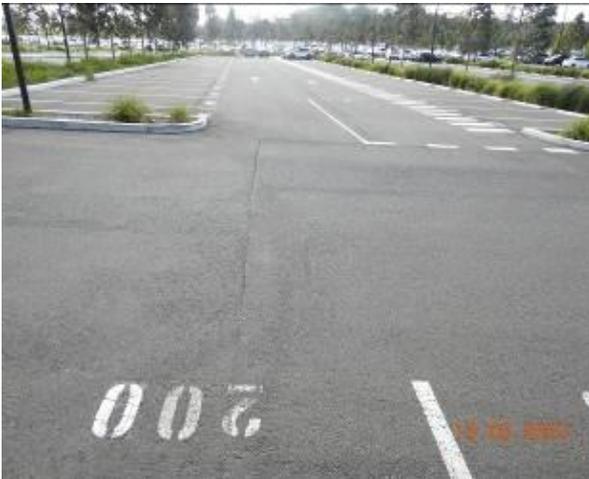
Figure 1643 – Crack propagation through car park pavement

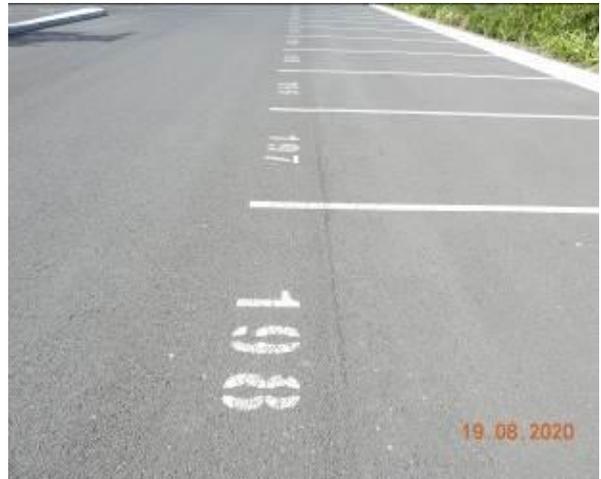
Figure 1644 – Crack propagation through car park pavement

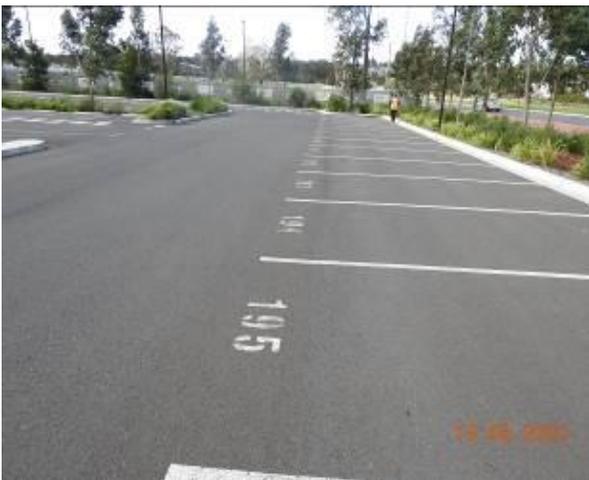
Figure 1645 – General condition of car park pavement

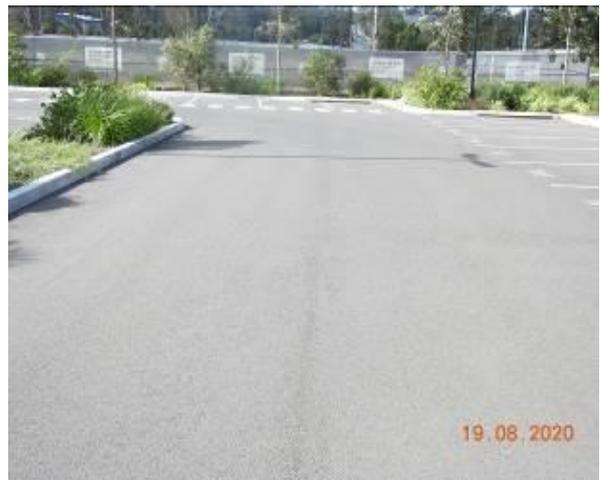
Figure 1646 – General condition of car park pavement

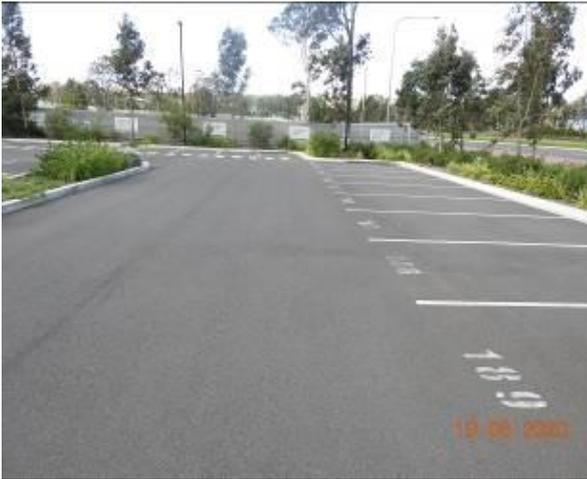
Figure 1647 – General condition of car park pavement

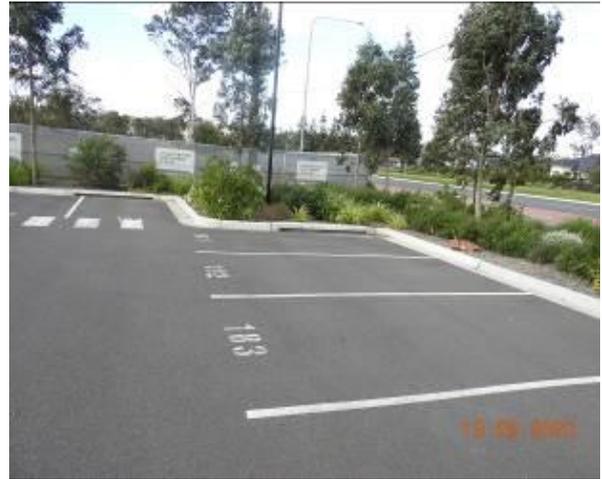
Figure 1648 – General condition of car park pavement

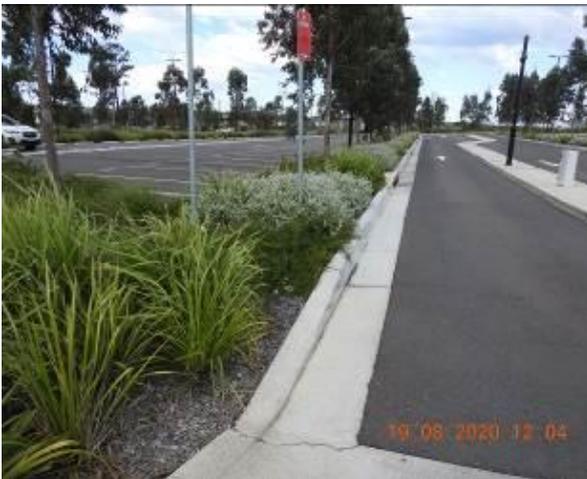
Figure 1649 – General condition of car park kerb and gutter

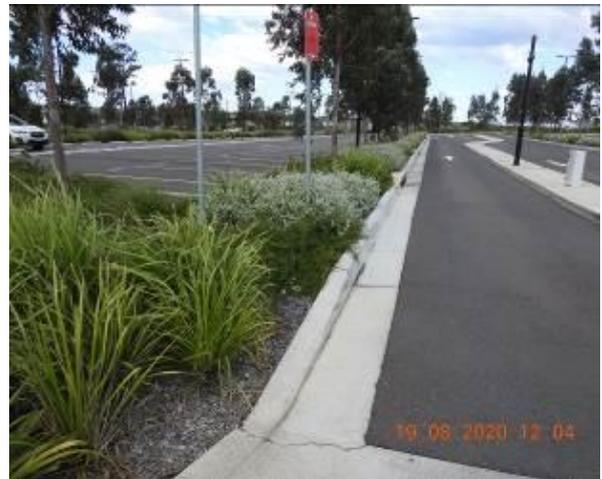
Figure 1650 – General condition of car park kerb and gutter

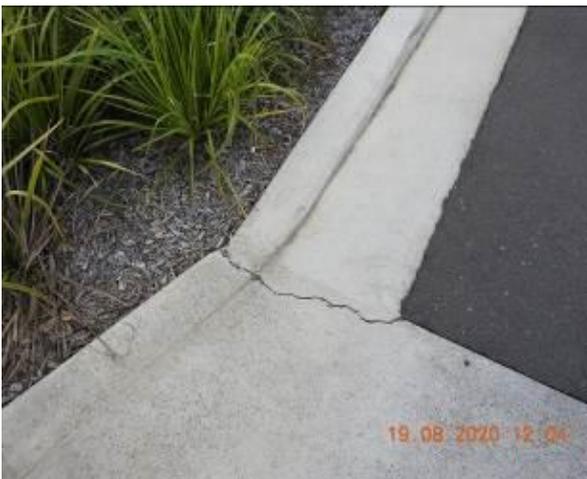
Figure 1651 – Crack propagation through car park kerb and gutter

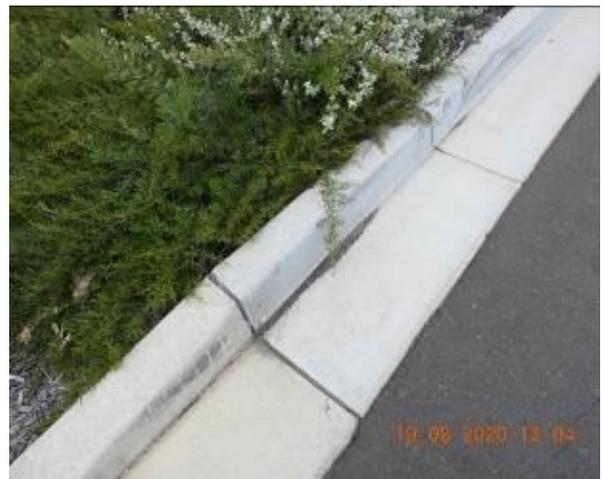
Figure 1652 – General condition of car park kerb and gutter

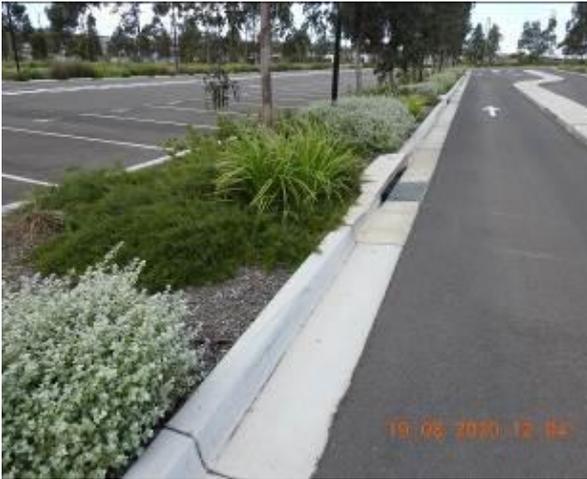
Figure 1653 – General condition of car park kerb and gutter

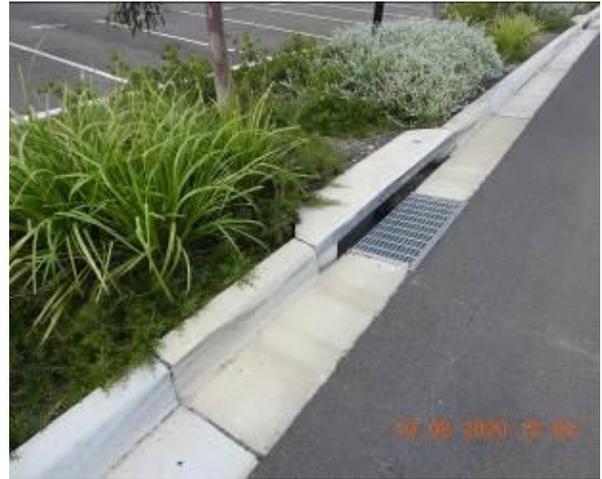
Figure 1654 – General condition of kerb inlet pit and stormwater inlet pit

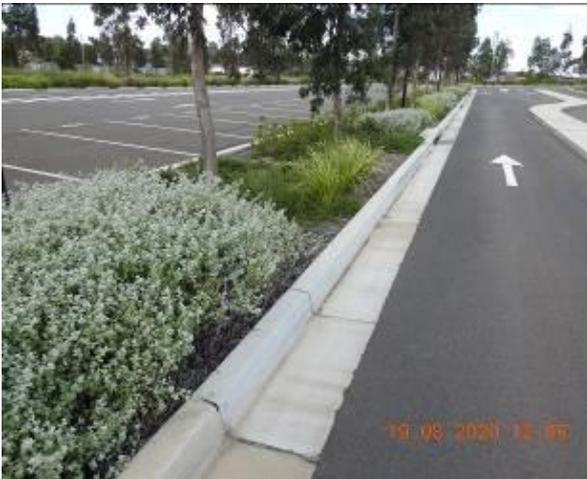
Figure 1655 – General condition of car park kerb and gutter

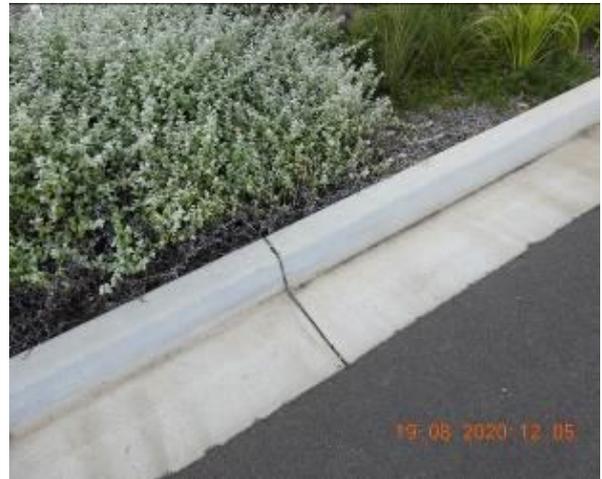
Figure 1656 – Crack propagation through car park kerb

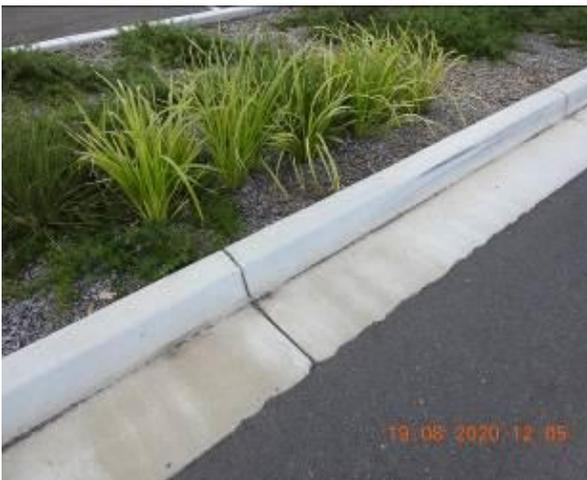
Figure 1657 – Crack propagation through car park kerb

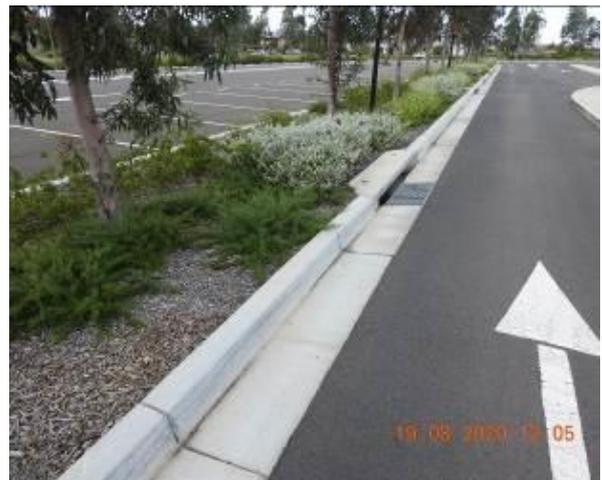
Figure 1658 – General condition of car park kerb and gutter

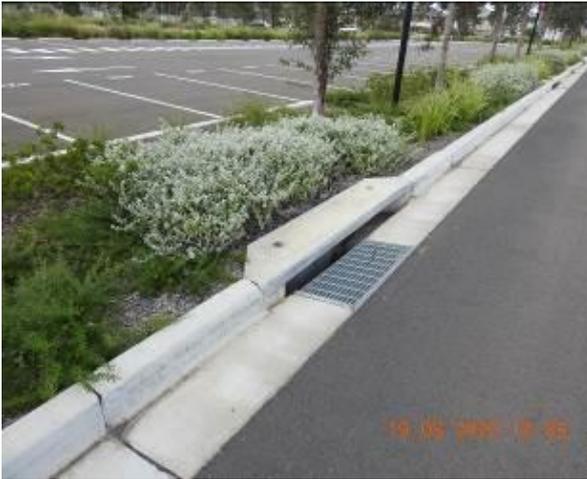
Figure 1659 – General condition of kerb inlet pit and stormwater inlet pit

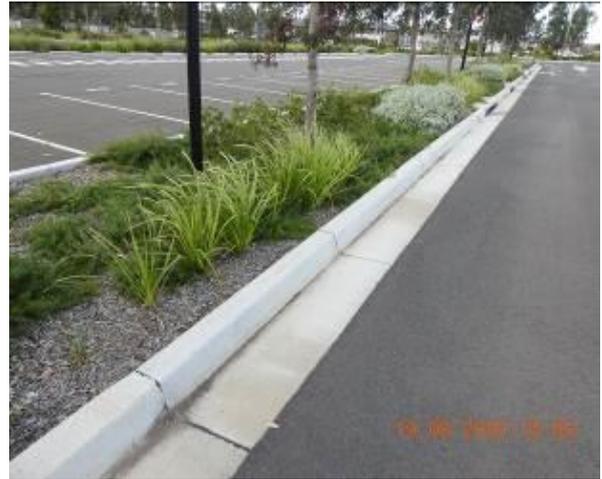
Figure 1660 – General condition of car park kerb and gutter

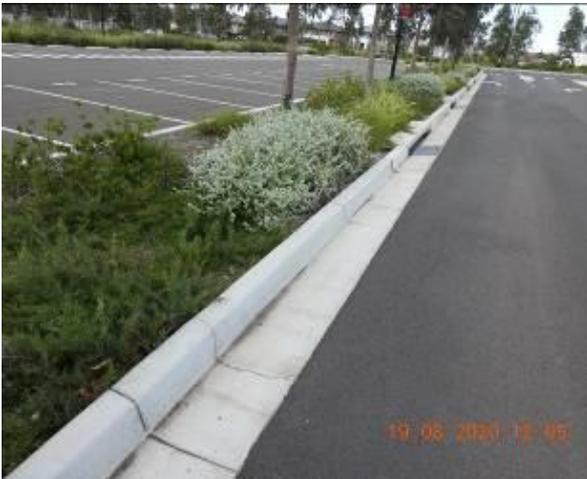
Figure 1661 – Crack propagation through car park kerb and gutter

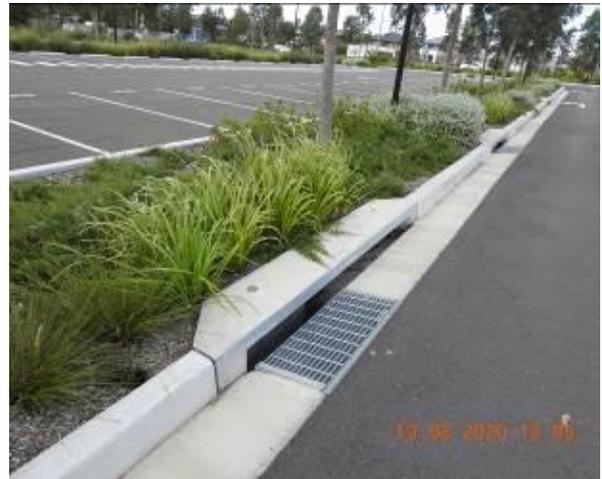
Figure 1662 – General condition of kerb inlet pit and stormwater inlet pit

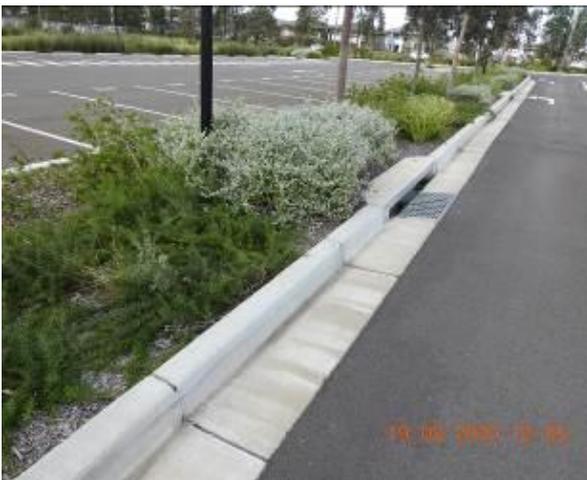
Figure 1663 – Crack propagation through car park kerb

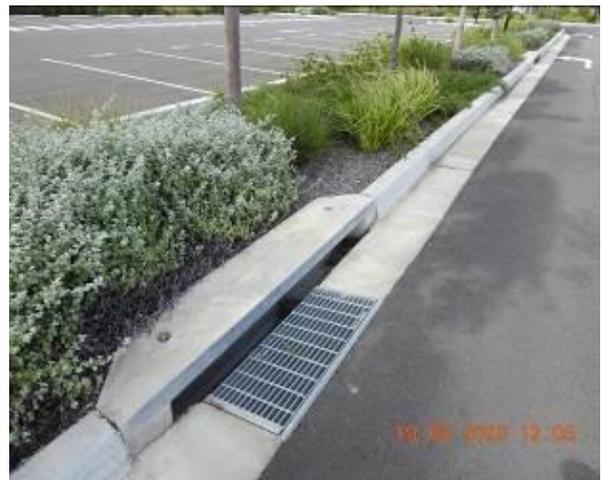
Figure 1664 – General condition of kerb inlet pit and stormwater inlet pit

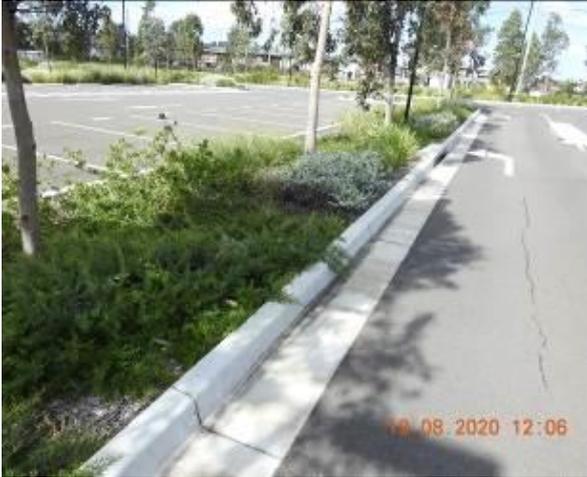
Figure 1665 – General condition of car park kerb and gutter

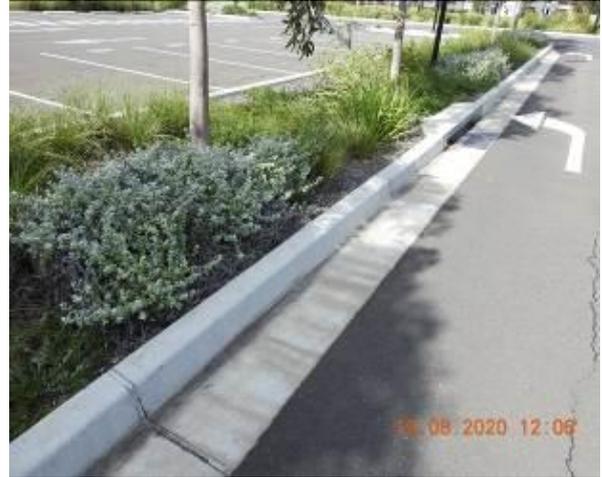
Figure 1666 – Crack propagation through car park kerb

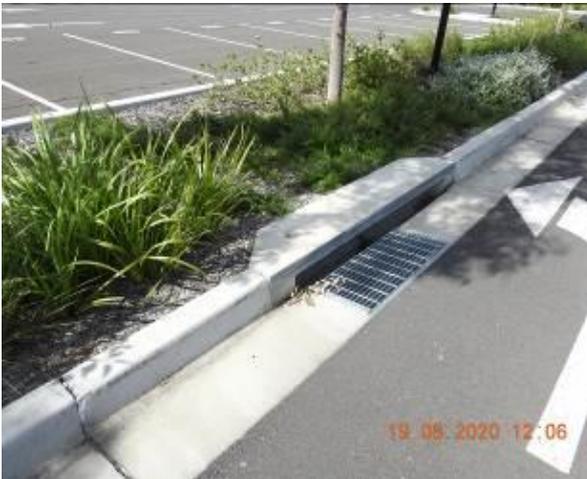
Figure 1667 – Crack propagation and loss of material through car park kerb and general condition of stormwater inlet pit
