The property Tallawong station – P2 Car Park, is the neighbouring property to our client’s site. It was photographed and inspected prior to any construction works on the subject site and was found to be in a reasonable condition. The property serves as a car park.

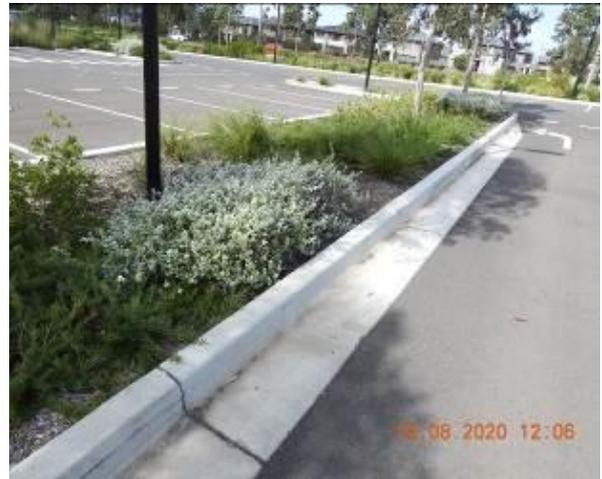
Figure 1668 – General condition of car park kerb and gutter

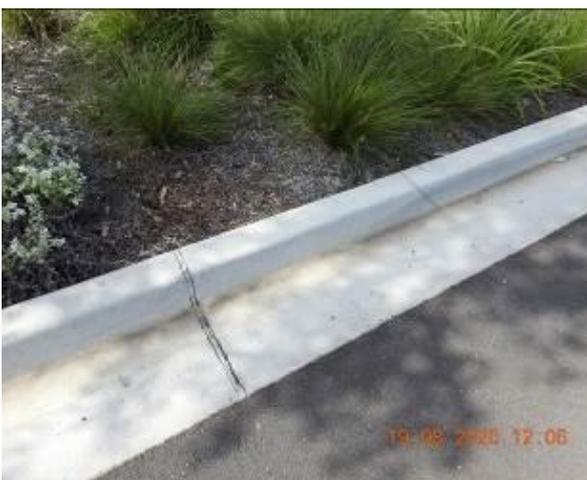
Figure 1669 – Crack propagation and loss of material through car park kerb and gutter

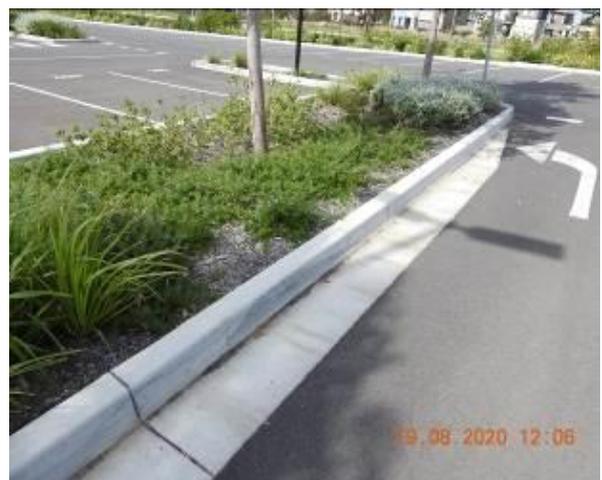
Figure 1670 – Crack propagation through car park kerb

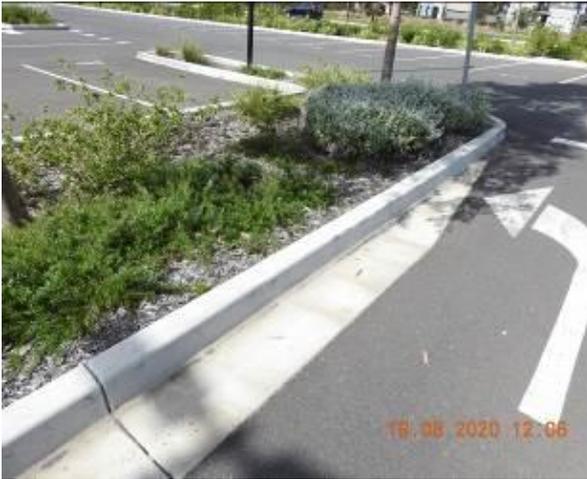
Figure 1671 – General condition of car park kerb

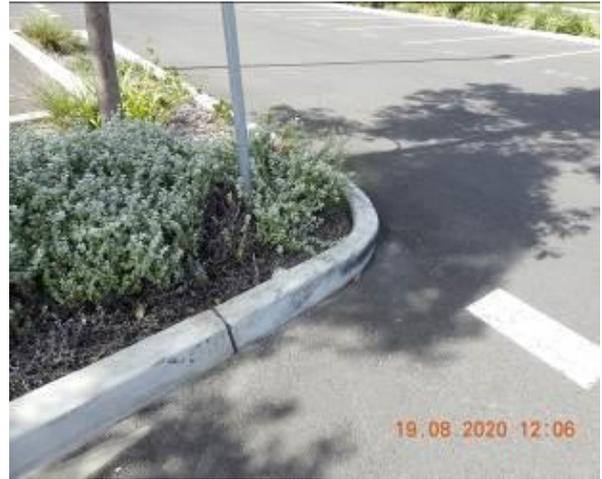
Figure 1672 – General condition of car park kerb

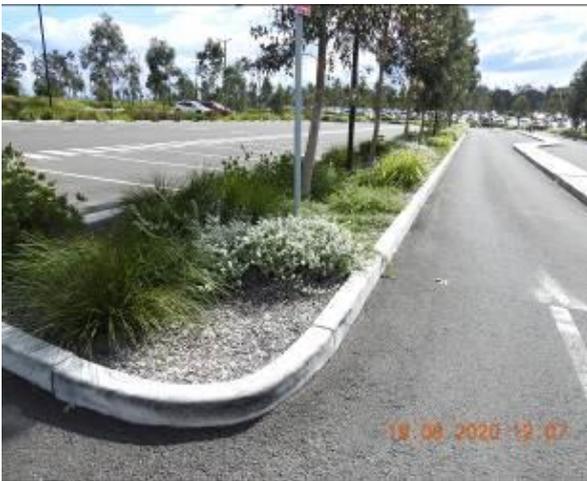
Figure 1673 – General condition of car park kerb

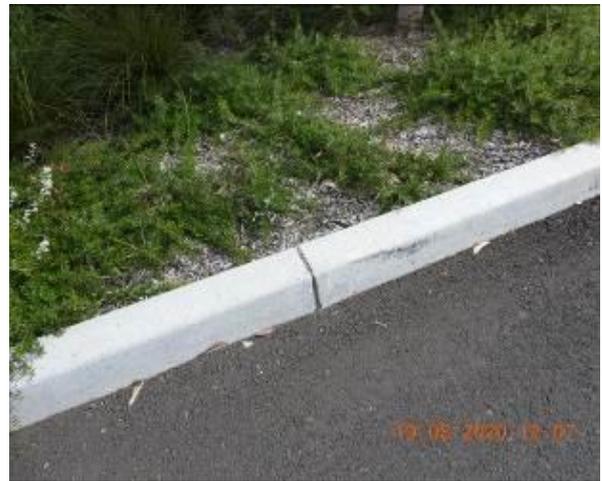
Figure 1674 – Crack propagation through car park kerb

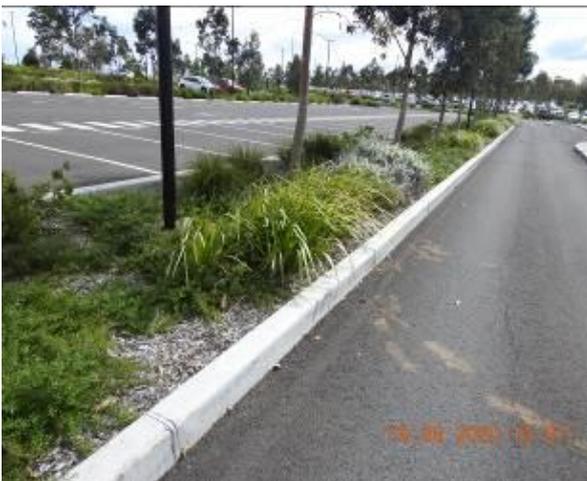
Figure 1675 – General condition of car park kerb

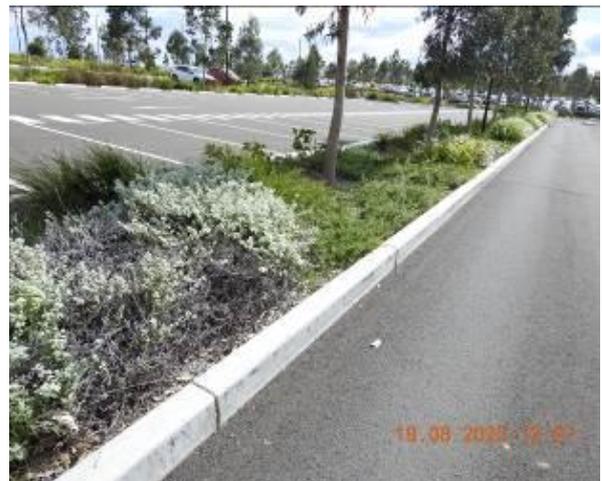
Figure 1676 – General condition of car park kerb

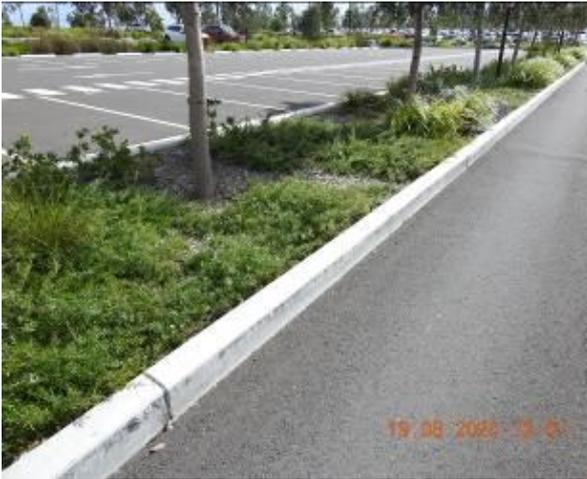
Figure 1677 – General condition of car park kerb

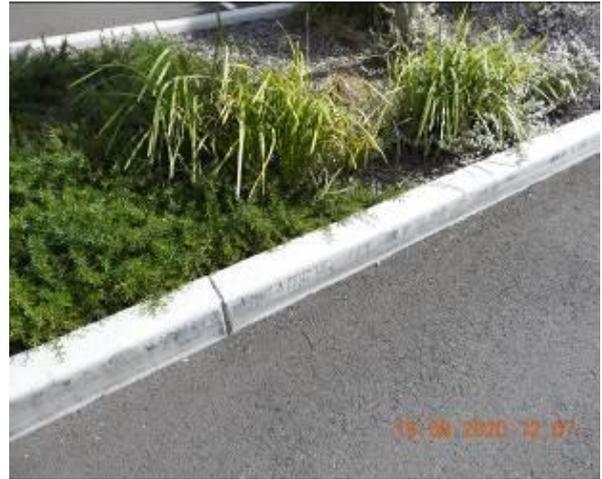
Figure 1678 – Crack propagation through car park kerb

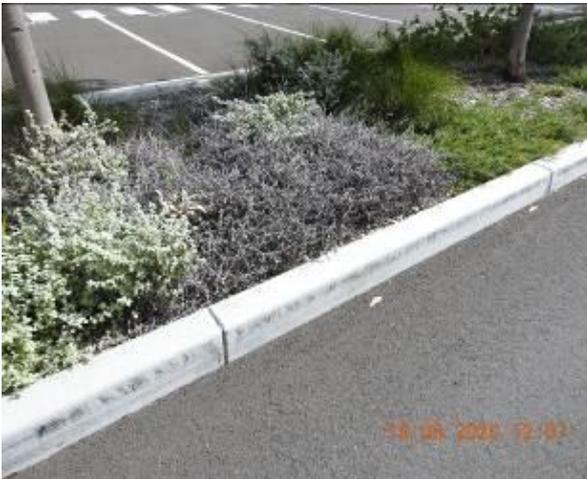
Figure 1679 – Crack propagation through car park kerb

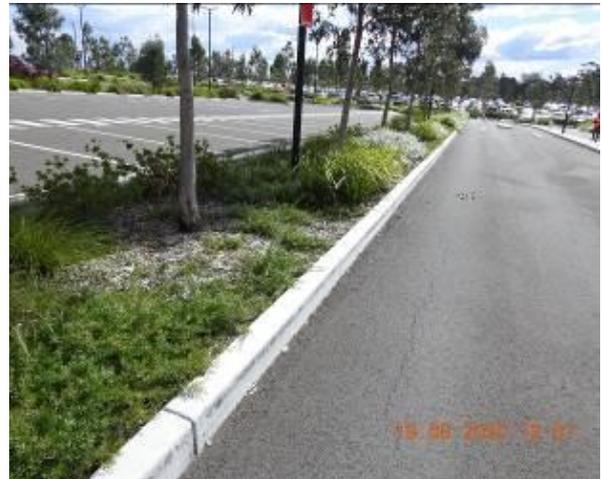
Figure 1680 – General condition of car park kerb

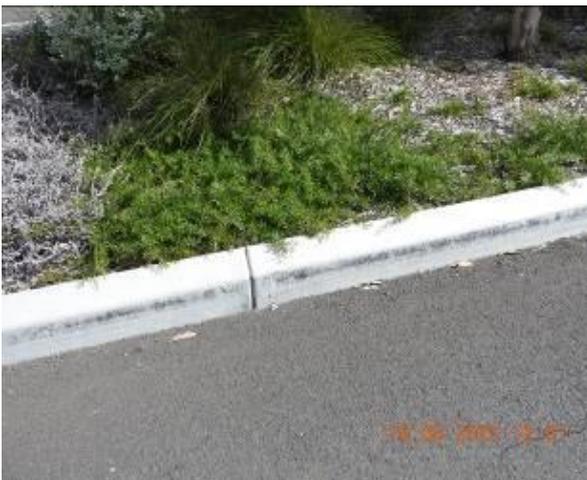
Figure 1681 – Crack propagation through car park kerb

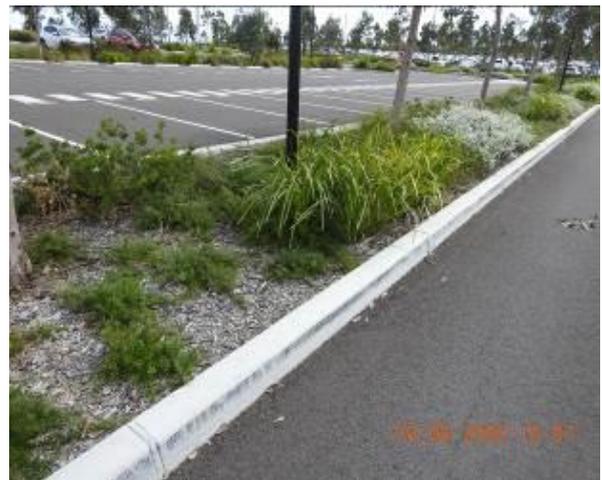
Figure 1682 – General condition of car park kerb

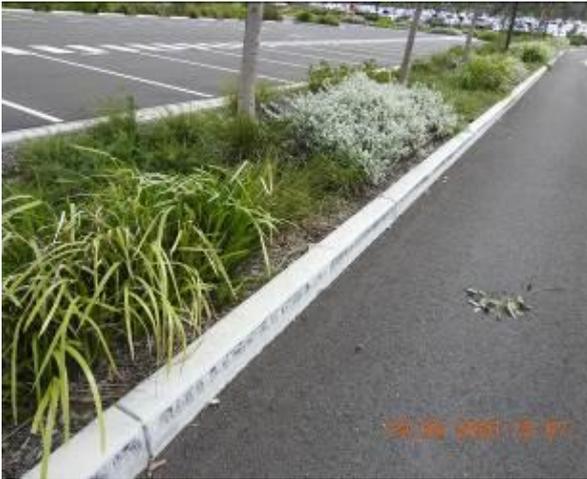
Figure 1683 – General condition of car park kerb

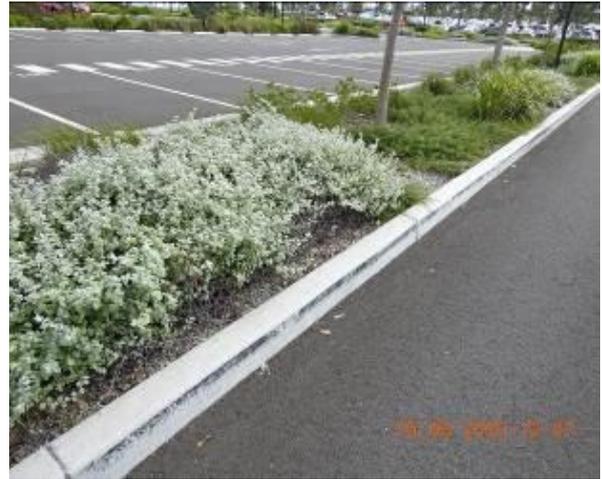
Figure 1684 – General condition of car park kerb

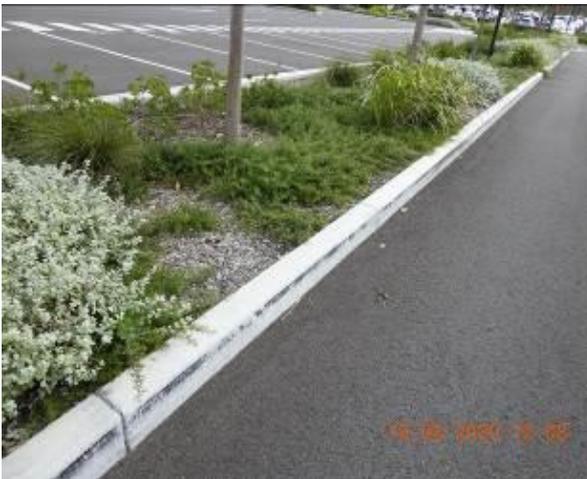
Figure 1685 – General condition of car park kerb

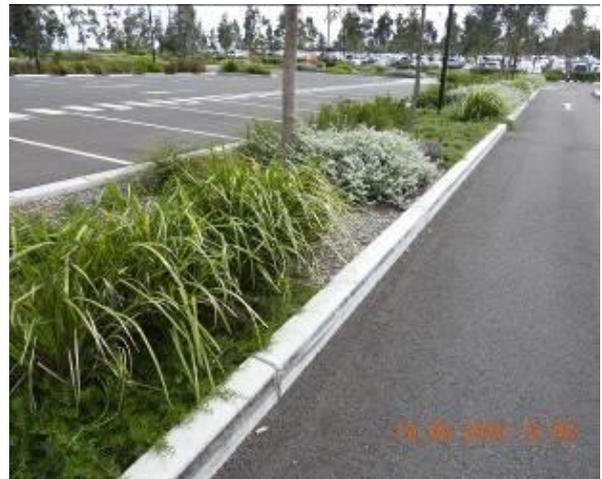
Figure 1686 – General condition of car park kerb

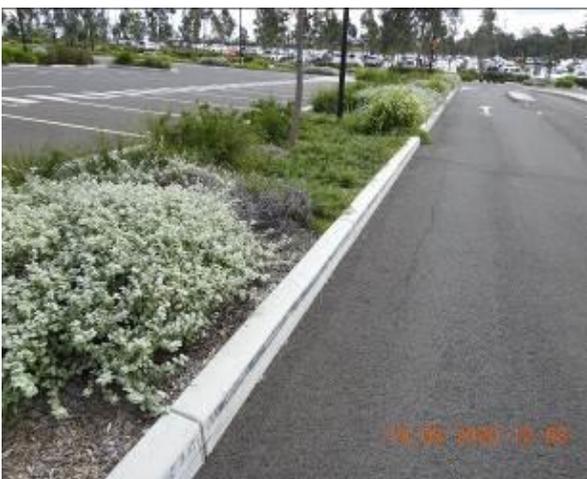
Figure 1687 – General condition of car park kerb

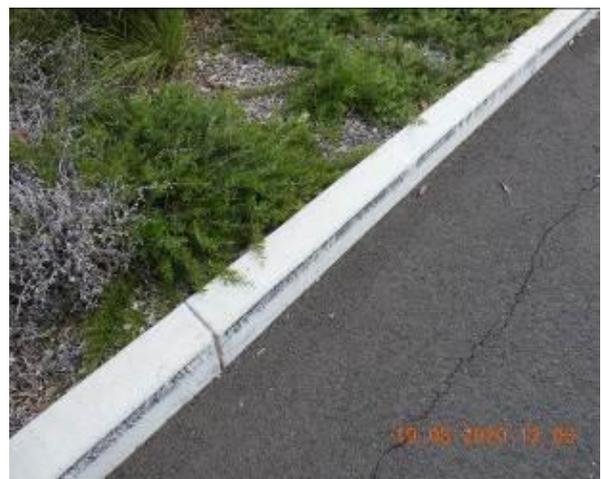
Figure 1688 – Crack propagation through car park kerb

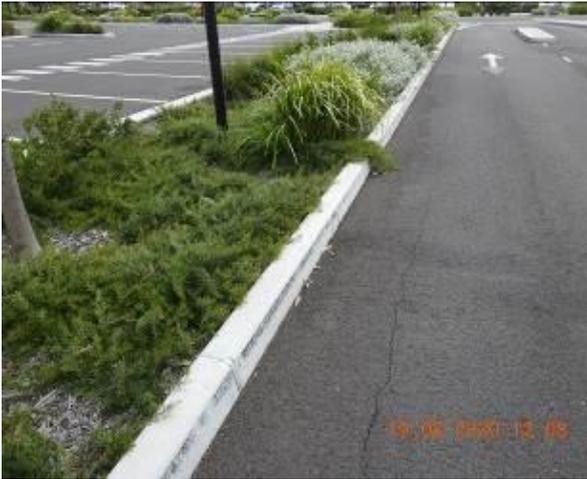
Figure 1689 – General condition of car park kerb

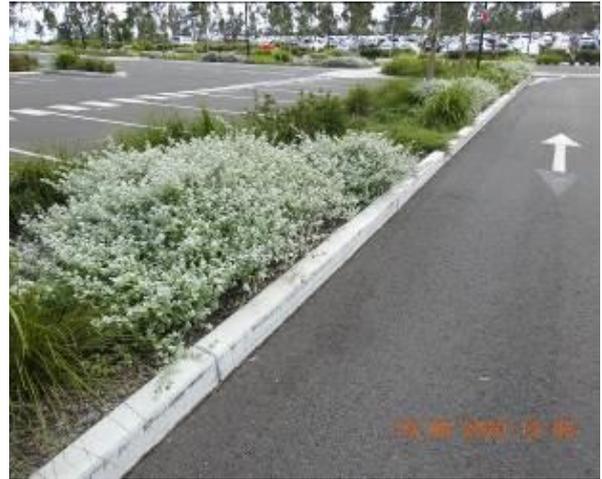
Figure 1690 – General condition of car park kerb

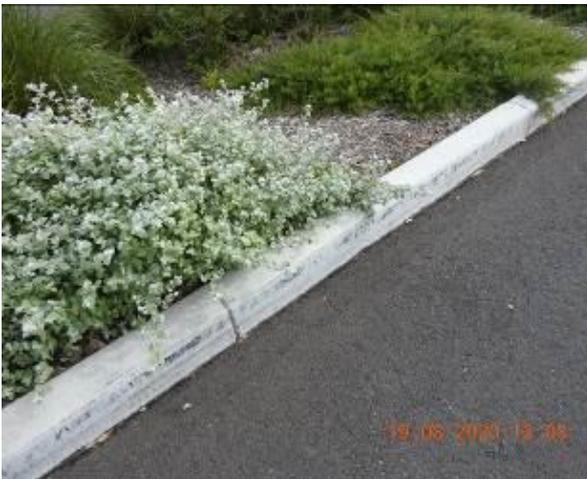
Figure 1691 – Crack propagation through car park kerb

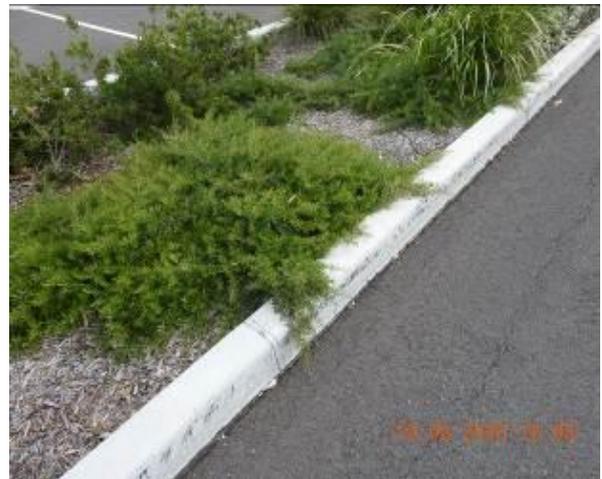
Figure 1692 – Crack propagation through car park kerb

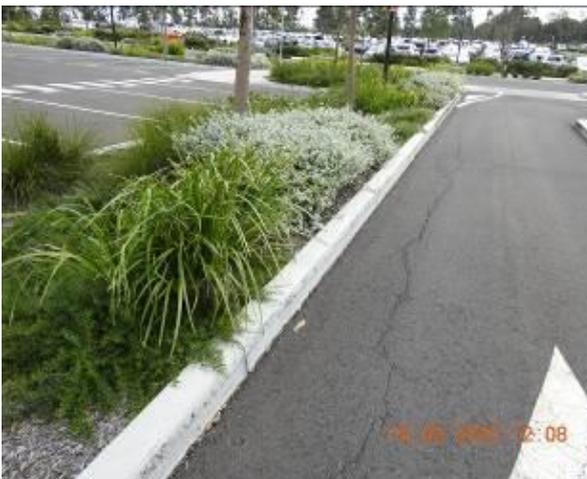
Figure 1693 – General condition of car park kerb

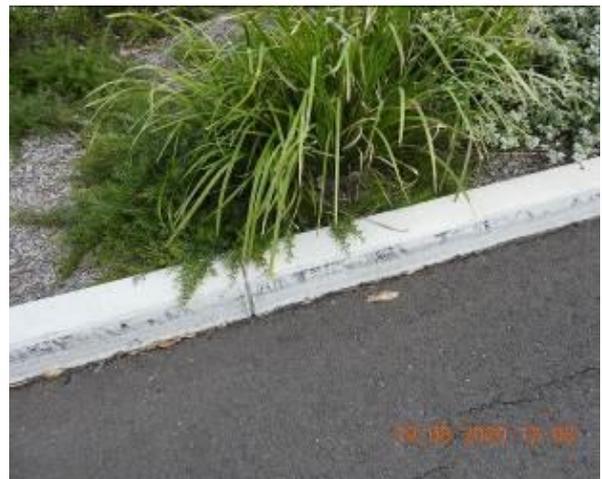
Figure 1694 – Crack propagation through car park kerb

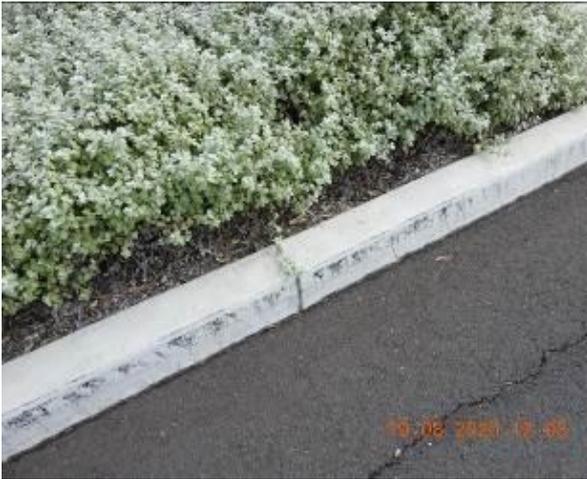
Figure 1695 – Crack propagation through car park kerb

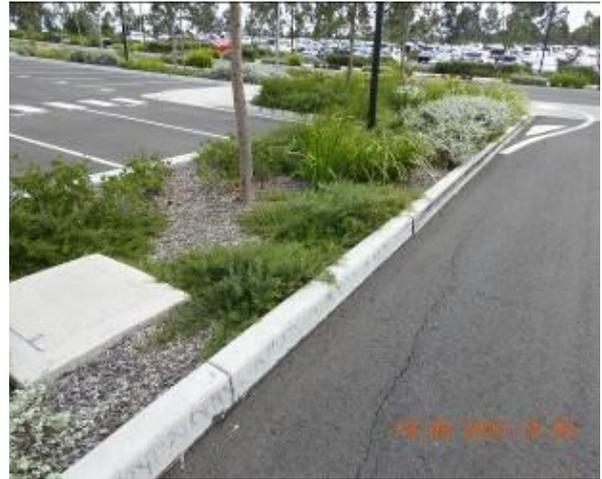
Figure 1696 – General condition of car park kerb

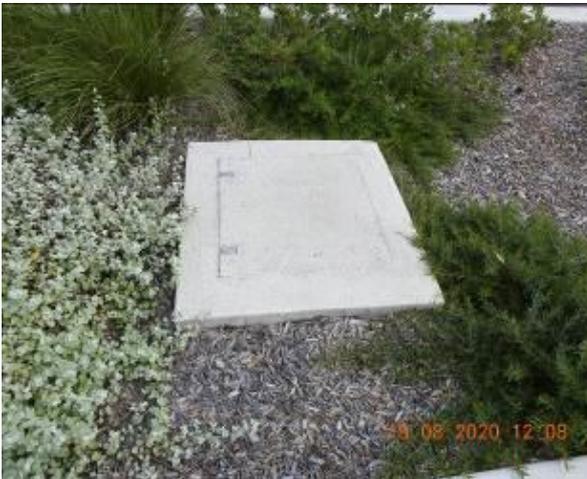
Figure 1697 – General condition of service pit

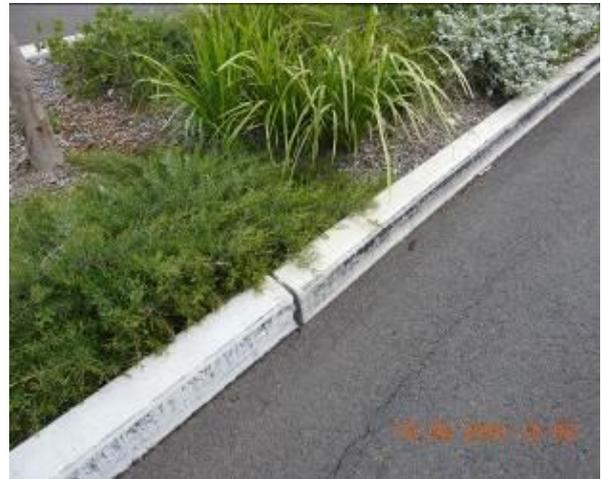
Figure 1698 – General condition of car park kerb

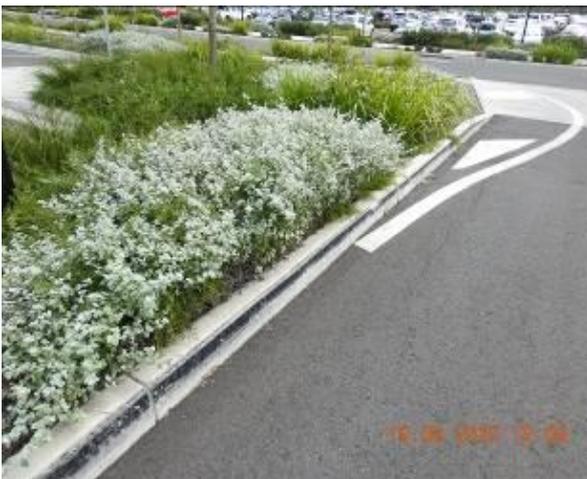
Figure 1699 – General condition of car park kerb

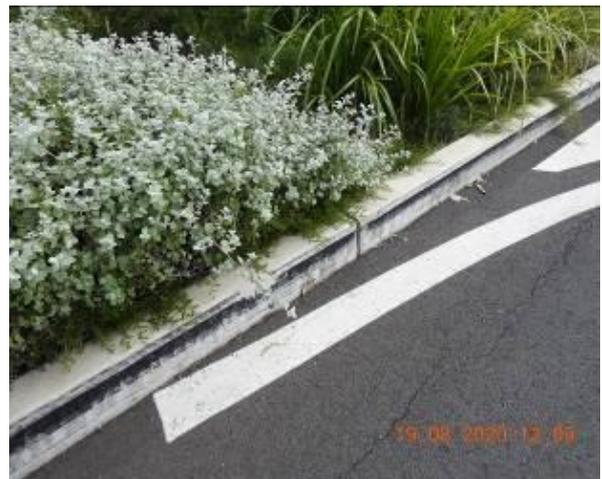
Figure 1700 – General condition of car park kerb

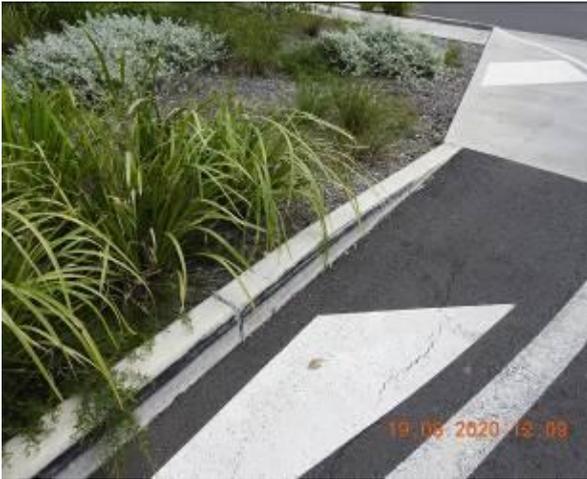
Figure 1701 – Crack propagation through car park kerb

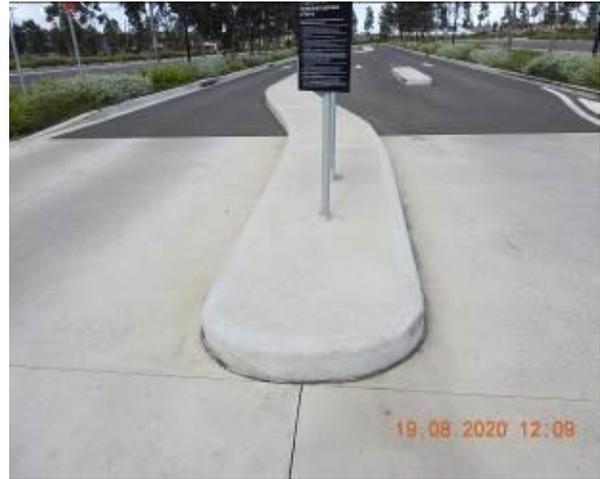
Figure 1702 – General condition of traffic island

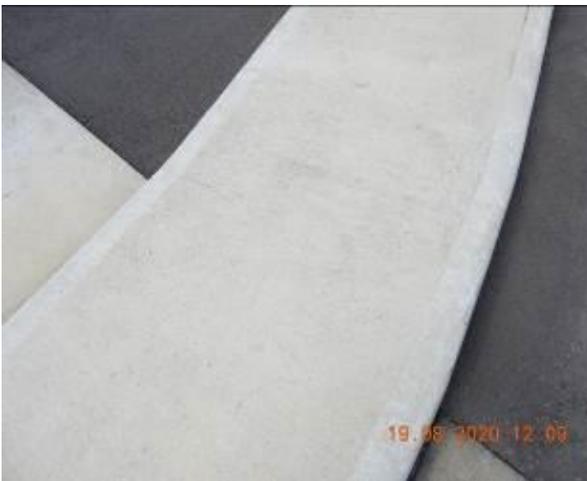
Figure 1703 – Hairline cracking through traffic island

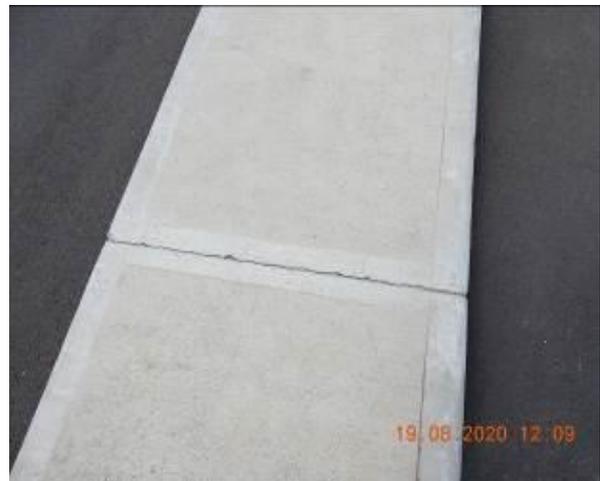
Figure 1704 – Crack propagation through traffic island

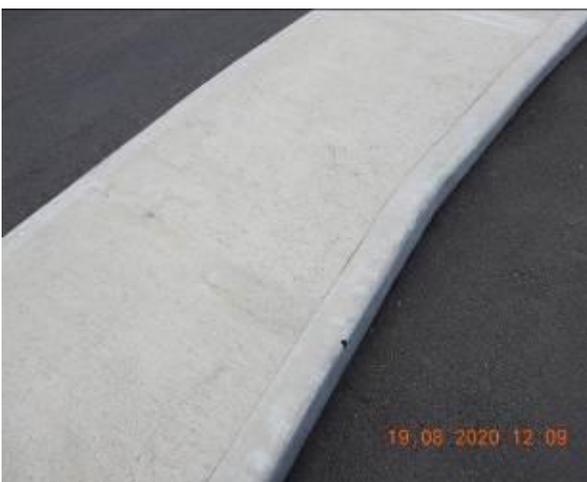
Figure 1705 – General condition of traffic island

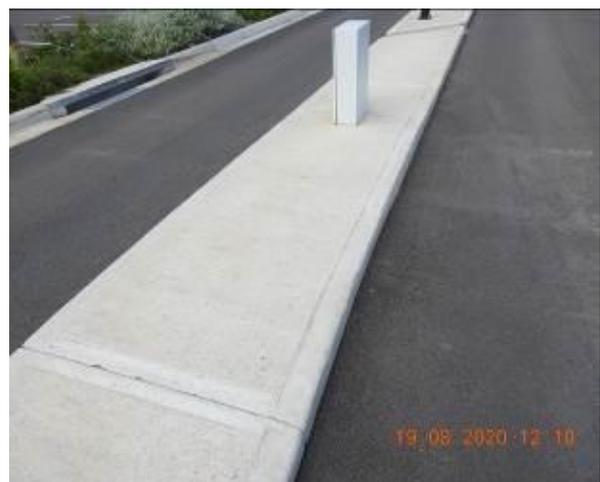
Figure 1706 – General condition of traffic island

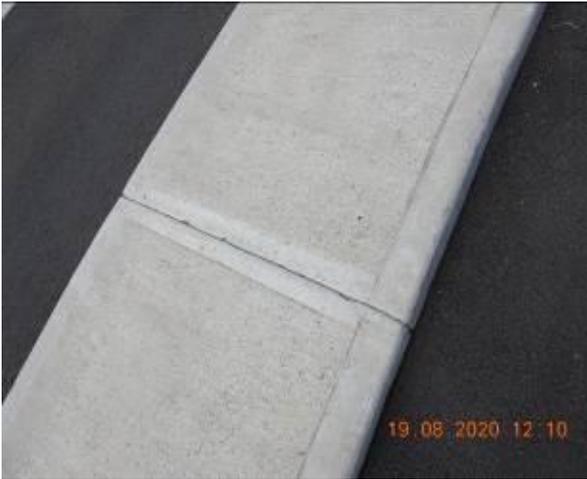
Figure 1707 – Crack propagation through traffic island

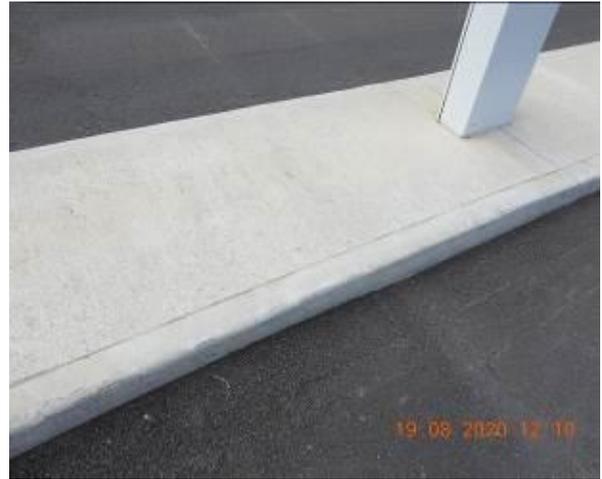
Figure 1708 – General condition of traffic island

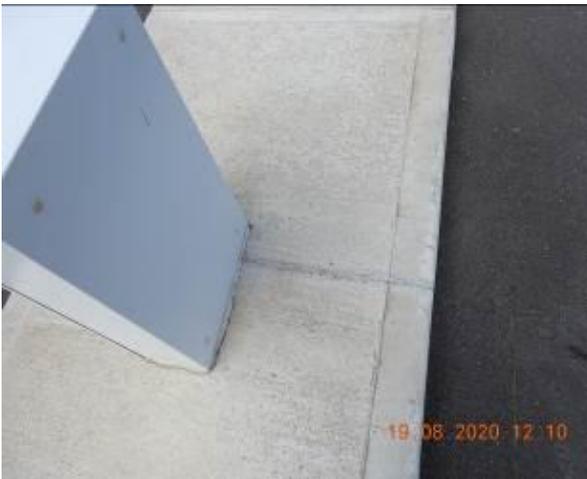
Figure 1709 – General condition of traffic island

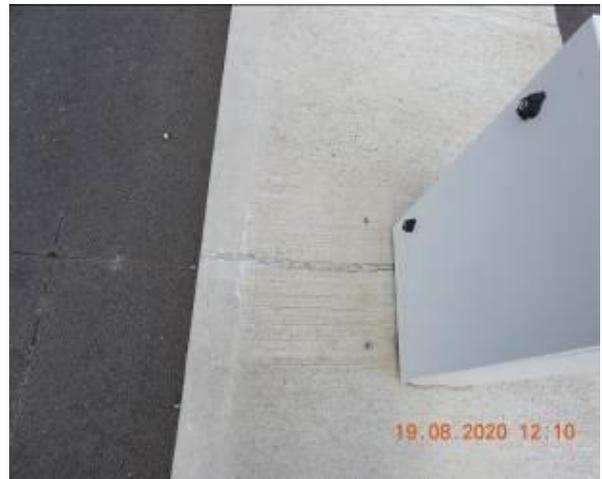
Figure 1710 – General condition of traffic island

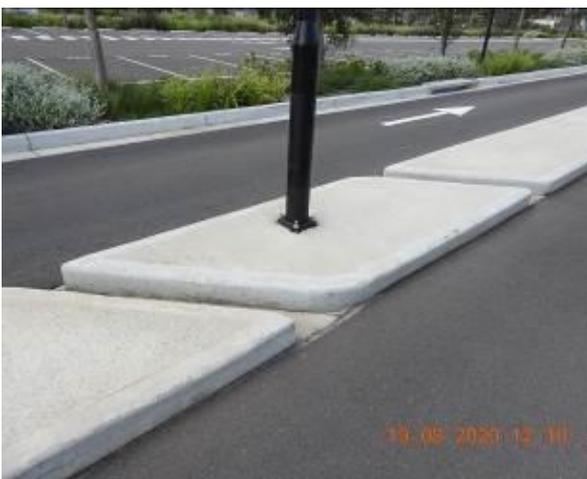
Figure 1711 – General condition of traffic island

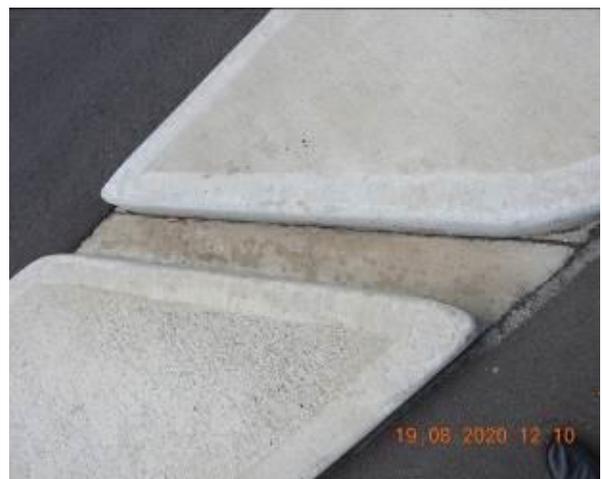
Figure 1712 – General condition of traffic island

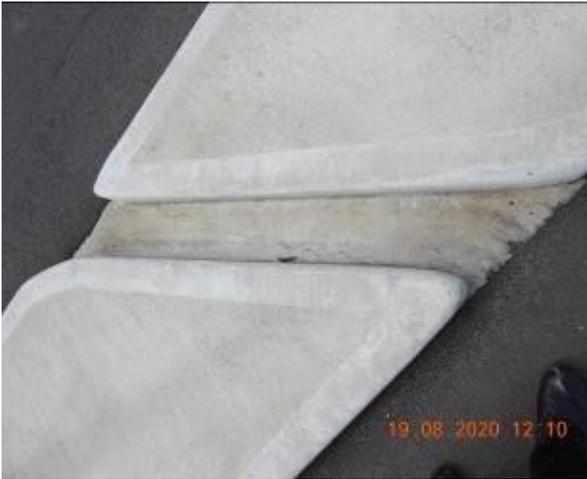
Figure 1713 – Crack propagation through traffic island

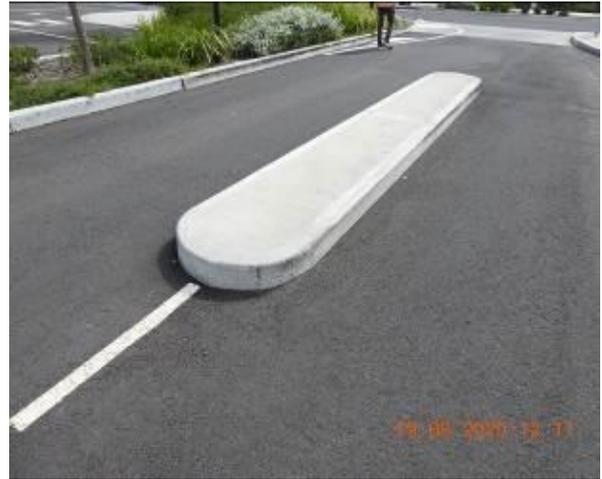
Figure 1714 – General condition of traffic island

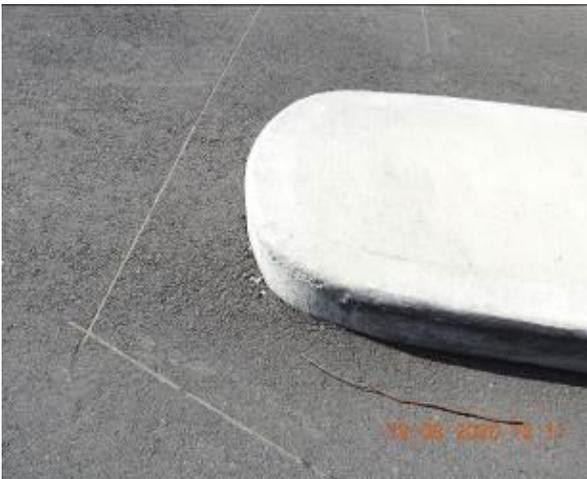
Figure 1715 – General condition of traffic island

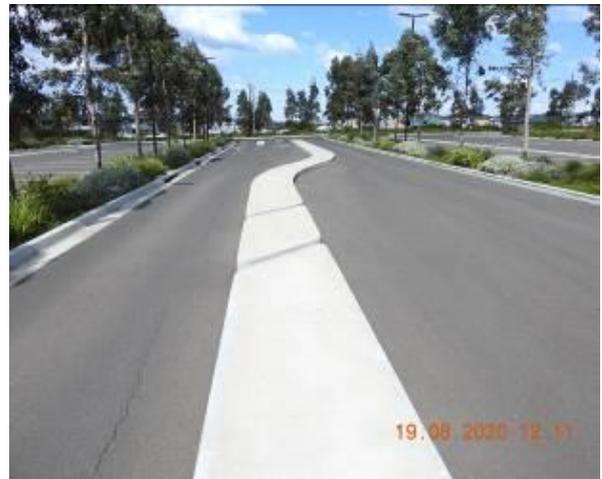
Figure 1716 – General condition of traffic island

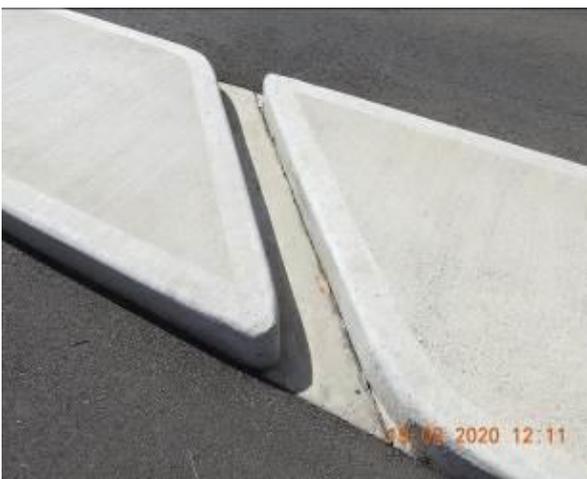
Figure 1717 – Crack propagation through traffic island

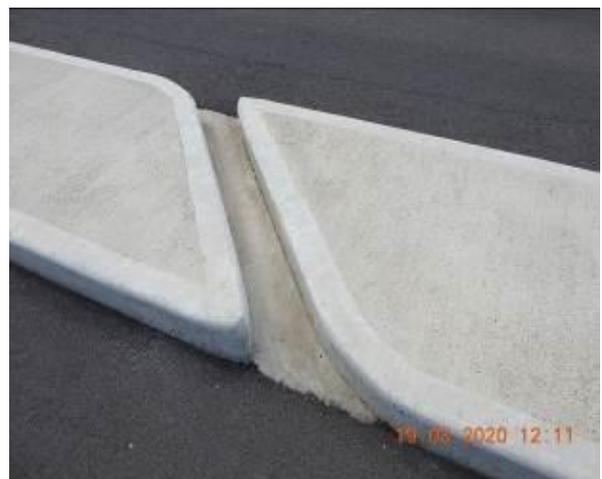
Figure 1718 – Crack propagation through traffic island

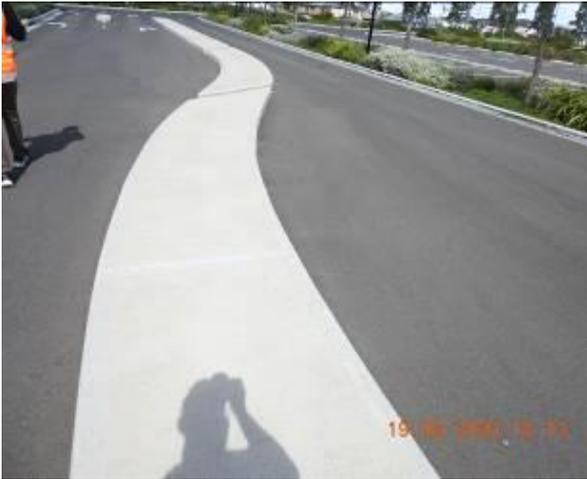
Figure 1719 – General condition of traffic island

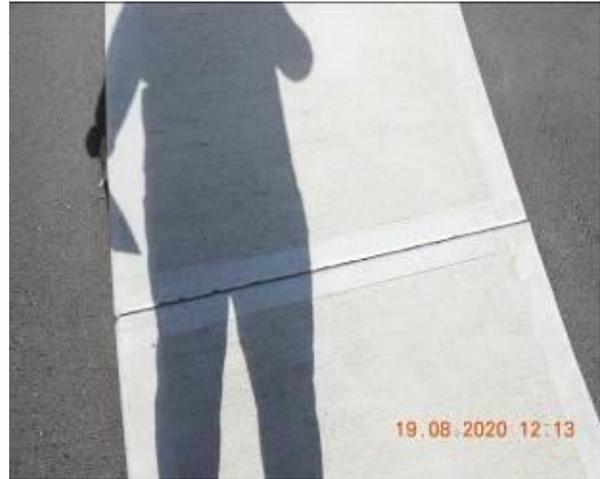
Figure 1720 – Crack propagation through traffic island

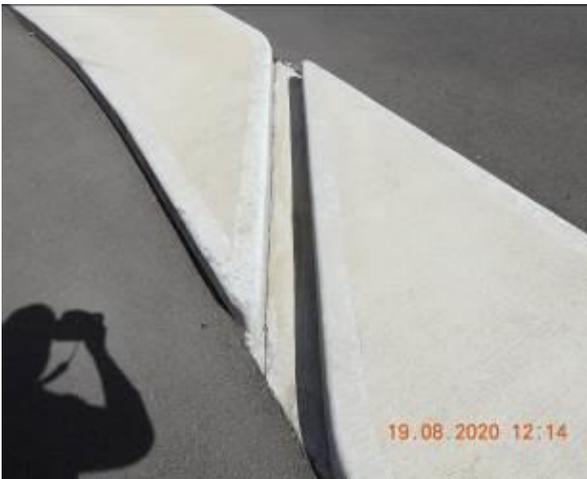
Figure 1721 – Crack propagation through traffic island

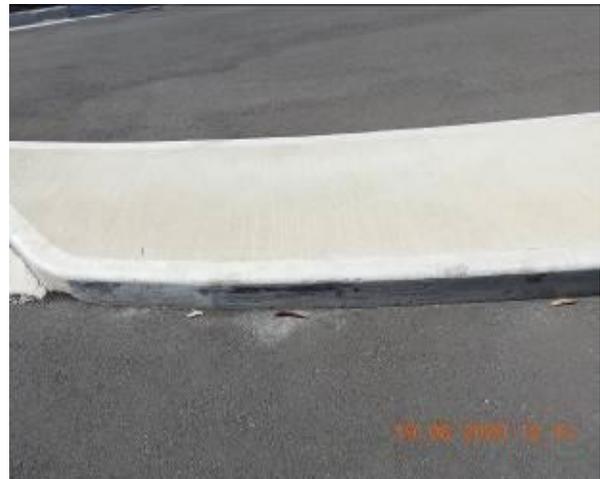
Figure 1722 – General condition of traffic island

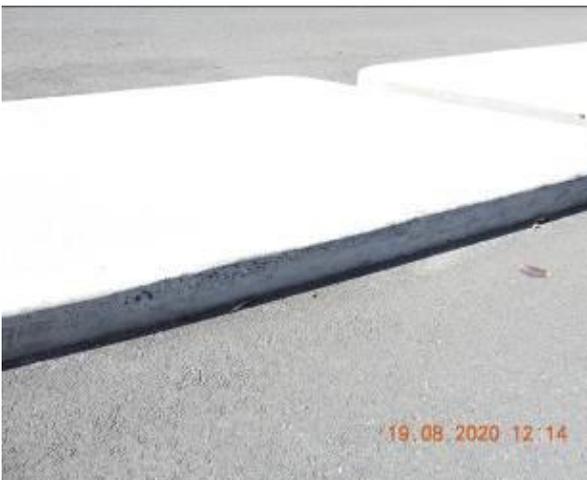
Figure 1723 – General condition of traffic island

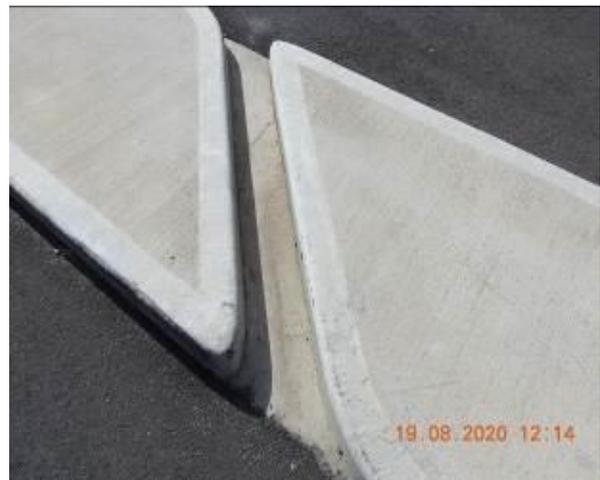
Figure 1724 – Crack propagation through traffic island

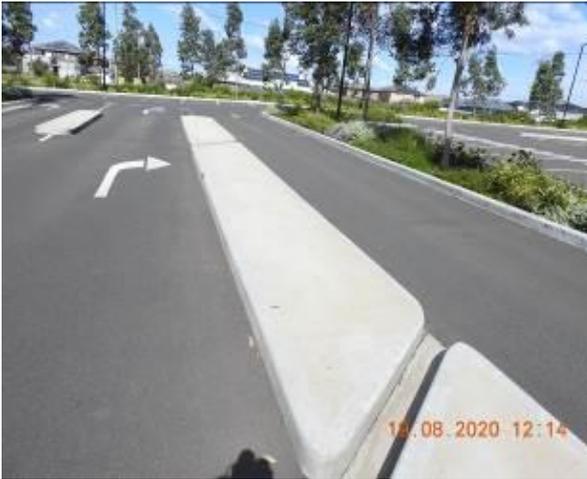
Figure 1725 – General condition of traffic island

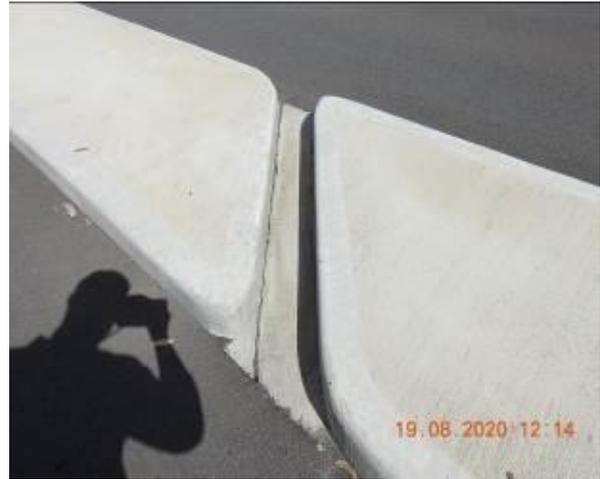
Figure 1726 – Crack propagation through traffic island

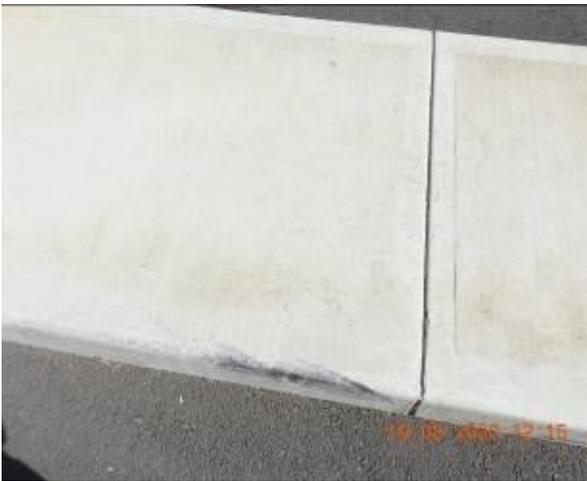
Figure 1727 – General condition of traffic island

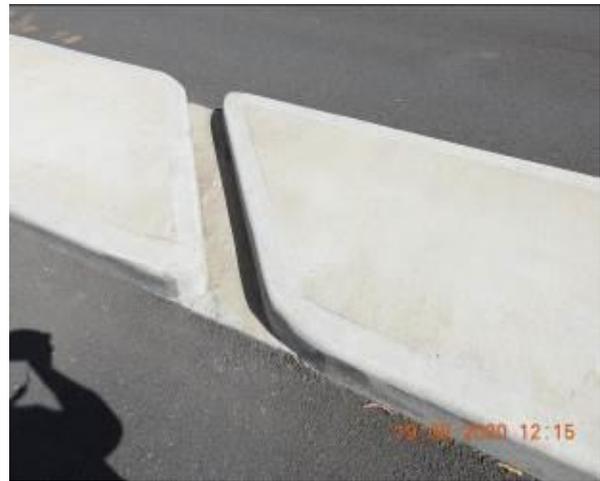
Figure 1728 – General condition of traffic island

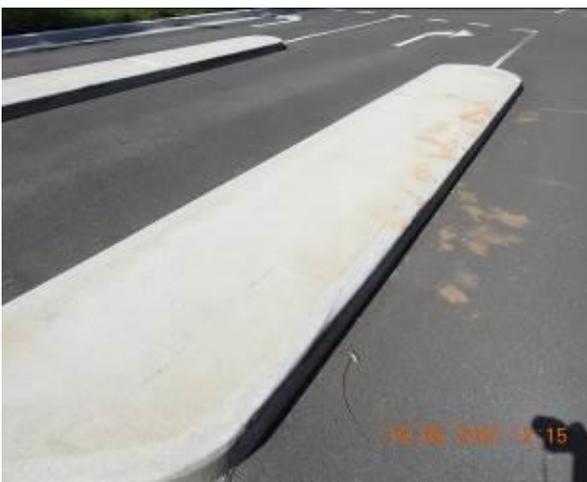
Figure 1729 – General condition of traffic island

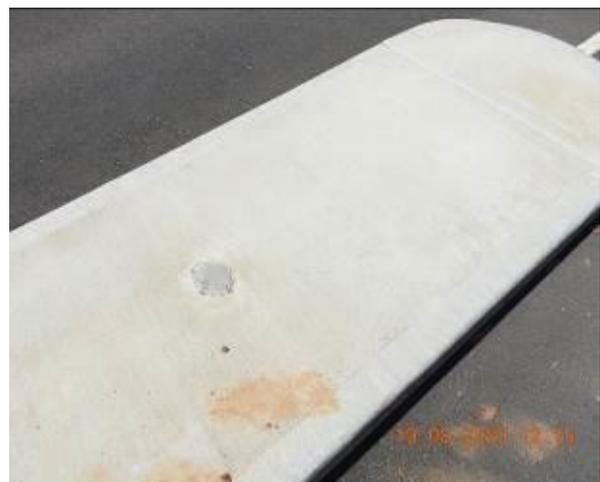
Figure 1730 – Evidence of patchwork through traffic island

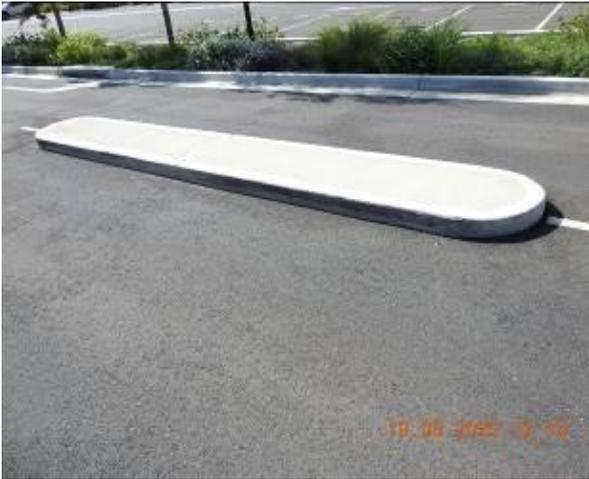
Figure 1731 – General condition of traffic island

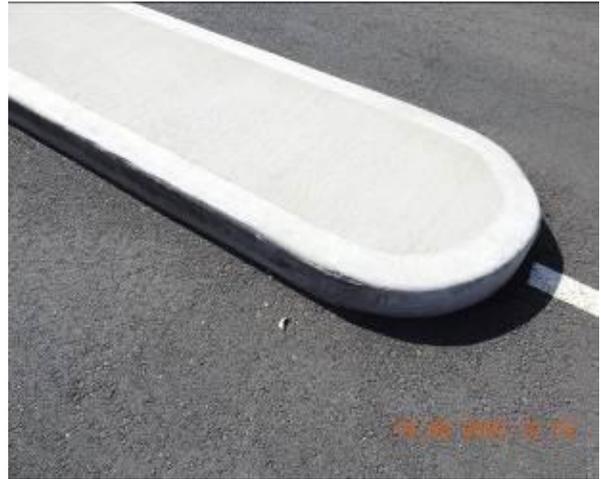
Figure 1732 – General condition of traffic island

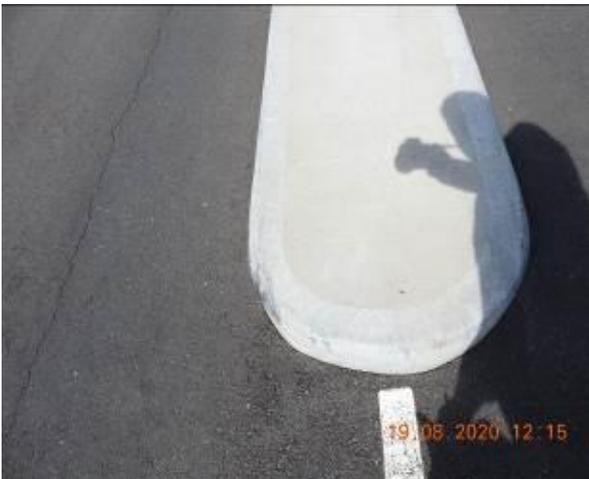
Figure 1733 – General condition of traffic island

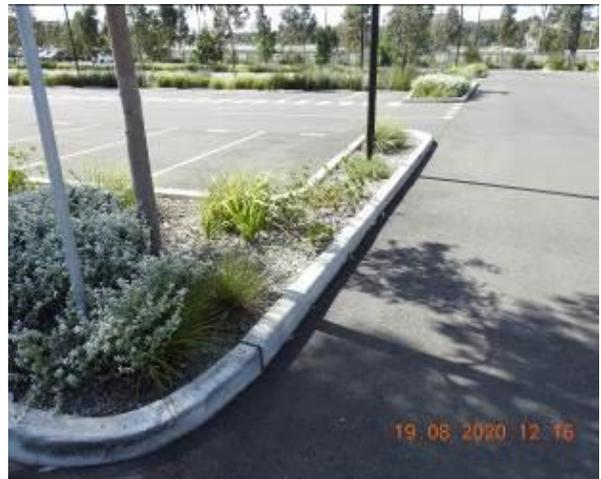
Figure 1734 – General condition of car park kerb

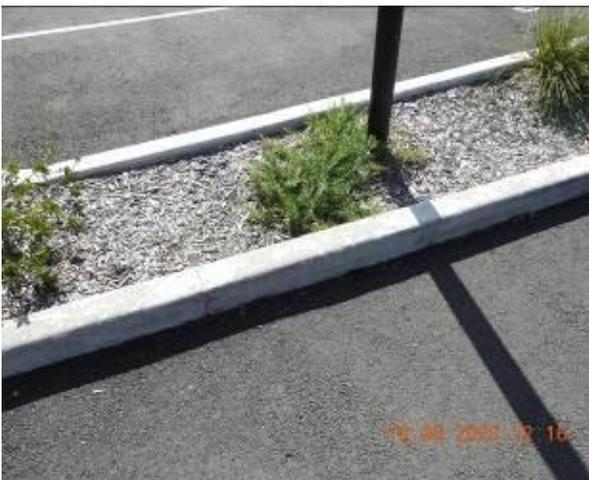
Figure 1735 – Crack propagation through car park kerb

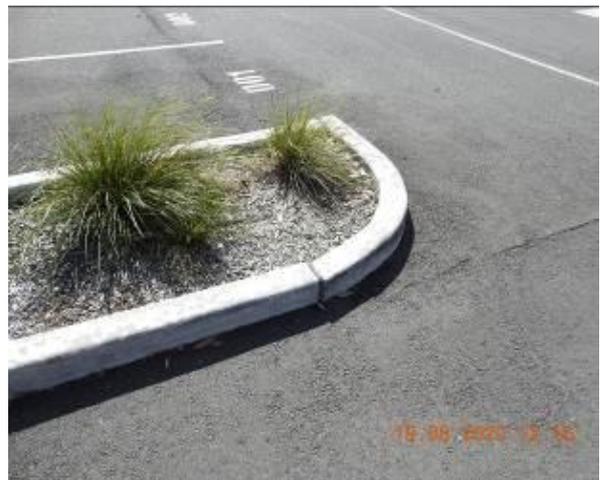
Figure 1736 – General condition of car park kerb

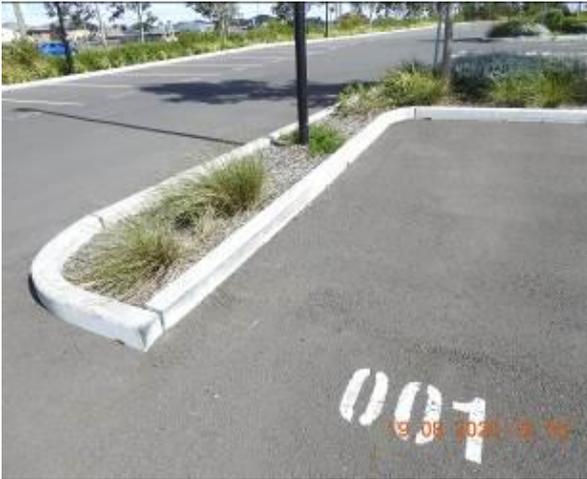
Figure 1737 – General condition of car park kerb

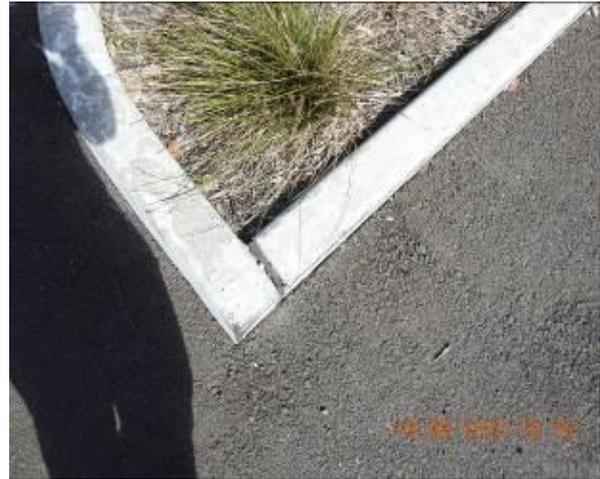
Figure 1738 – General condition of car park kerb

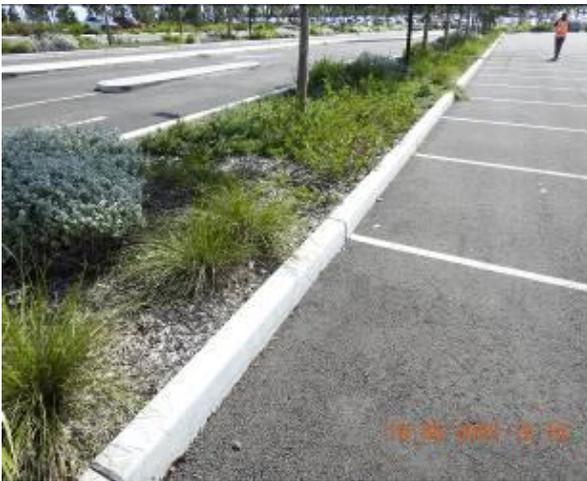
Figure 1739 – General condition of car park kerb

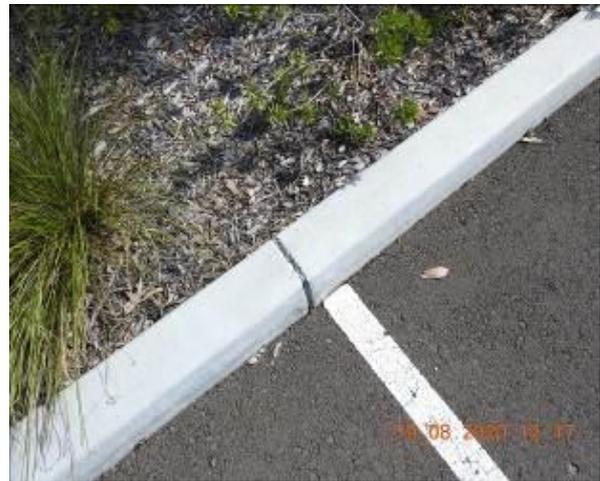
Figure 1740 – Crack propagation through car park kerb

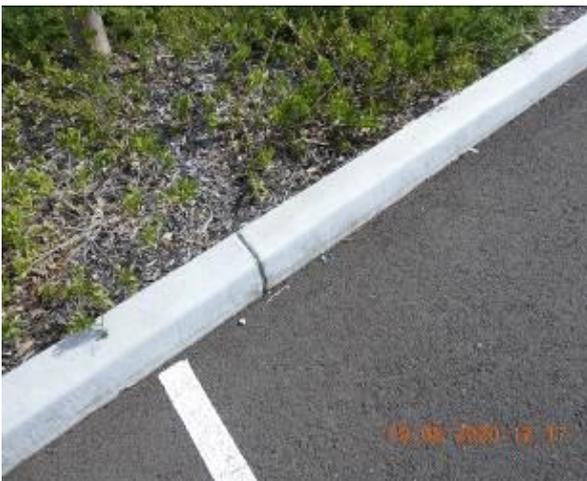
Figure 1741 – Crack propagation through car park kerb

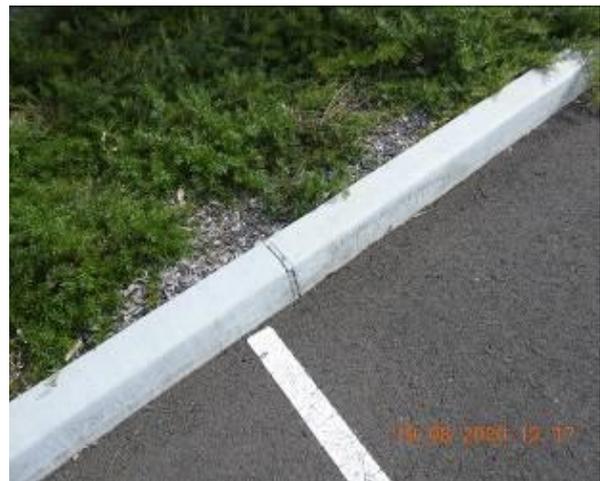
Figure 1742 – General condition of car park kerb

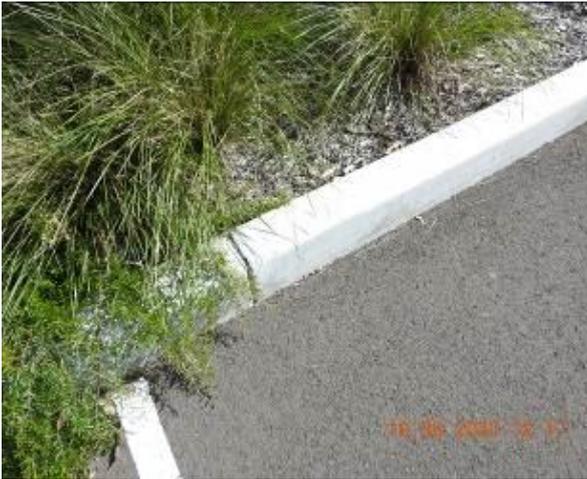
Figure 1743 – Crack propagation through car park kerb

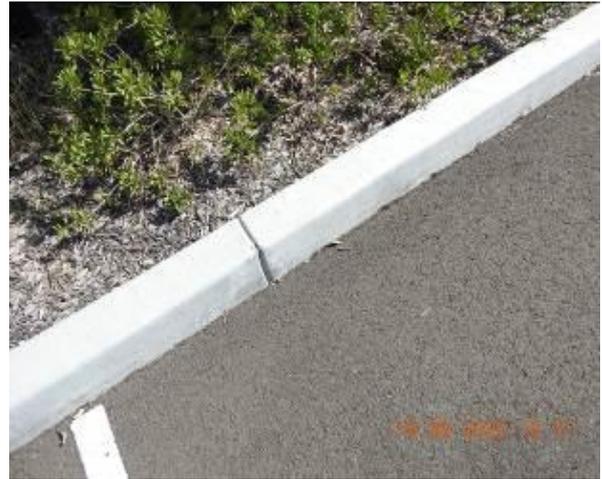
Figure 1744 – Crack propagation through car park kerb
