The property Tallawong station – P2 Car Park, is the neighbouring property to our client’s site. It was photographed and inspected prior to any construction works on the subject site and was found to be in a reasonable condition. The property serves as a car park.

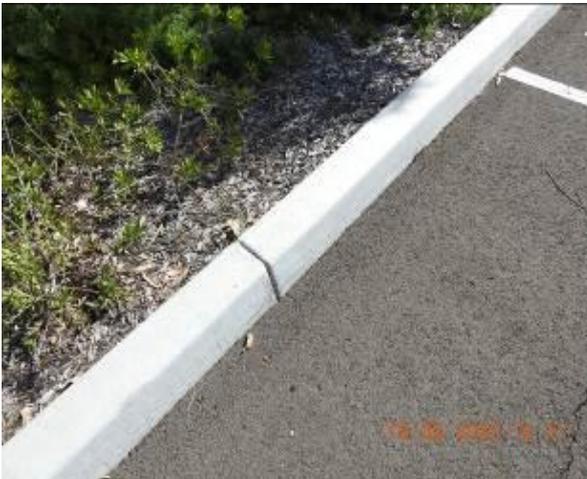
Figure 1745 – Crack propagation through car park kerb

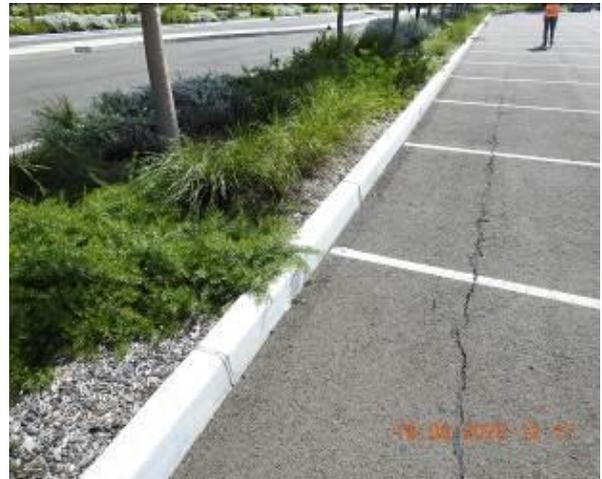
Figure 1746 – General condition of car park kerb

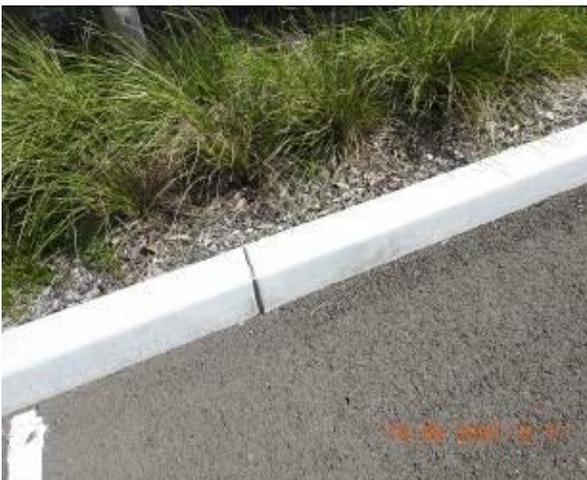
Figure 1747 – Crack propagation through car park kerb

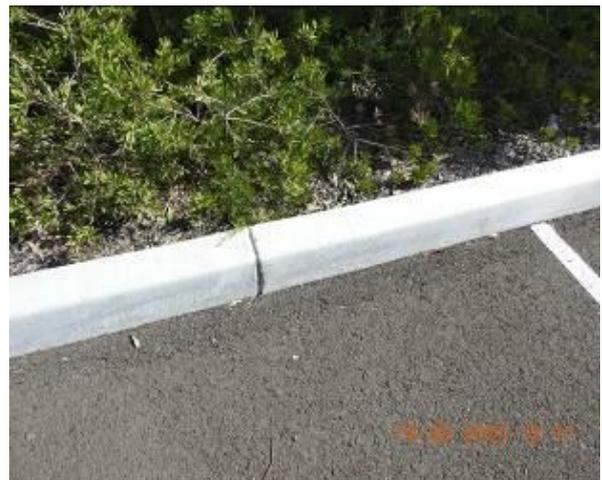
Figure 1748 – Crack propagation through car park kerb

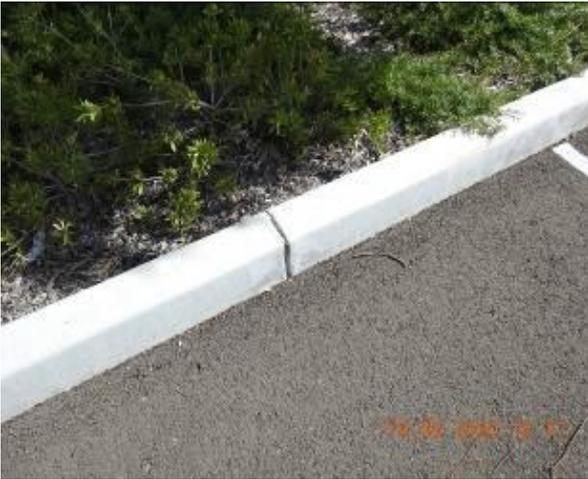
Figure 1749 – Crack propagation through car park kerb

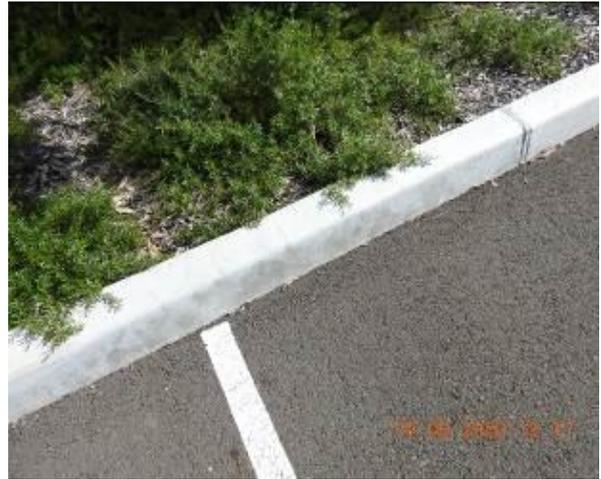
Figure 1750 – Crack propagation through car park kerb

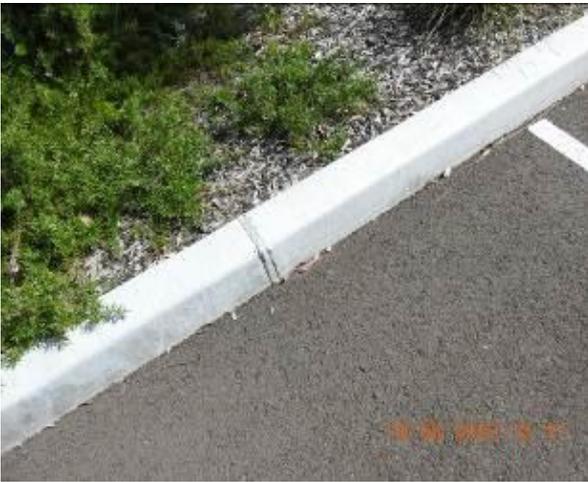
Figure 1751 – General condition of car park kerb

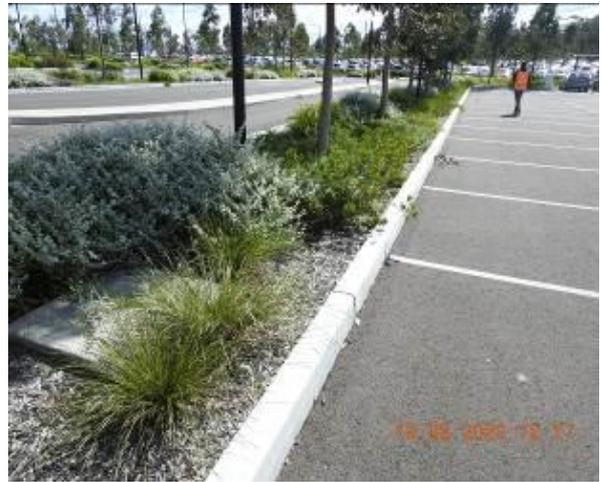
Figure 1752 – General condition of car park kerb

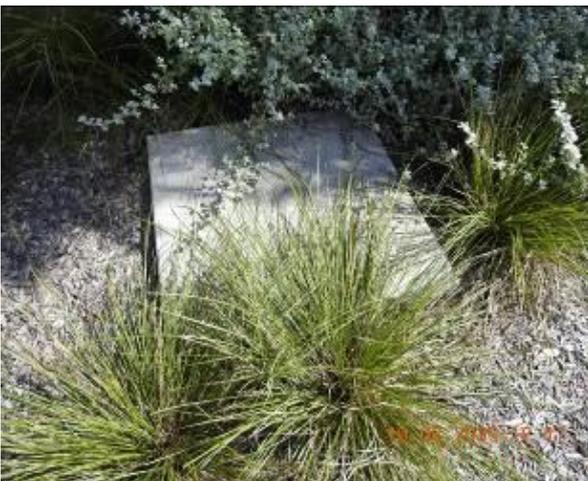
Figure 1753 – General condition of service pit

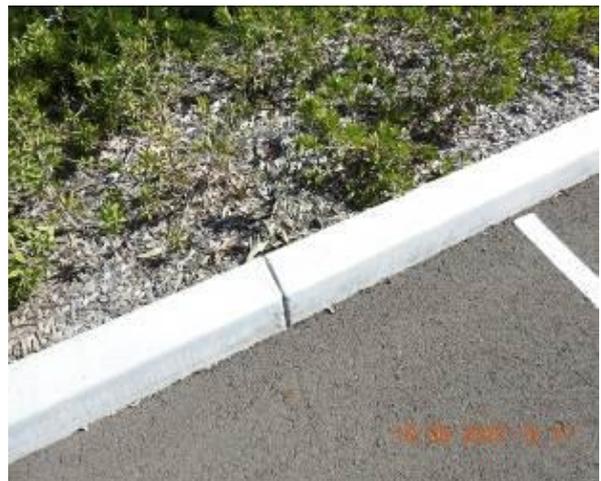
Figure 1754 – Crack propagation through car park kerb

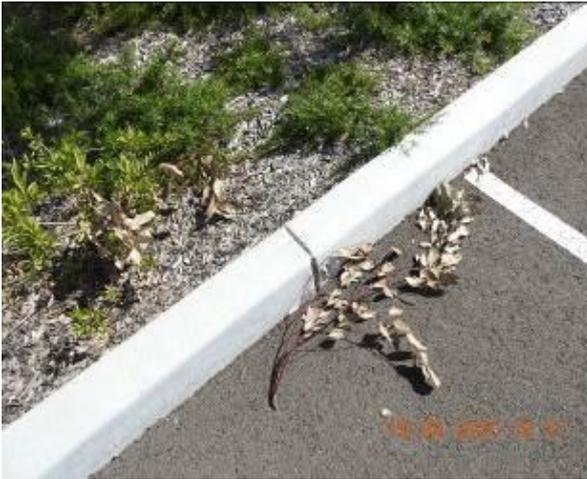
Figure 1755 – Crack propagation through car park kerb

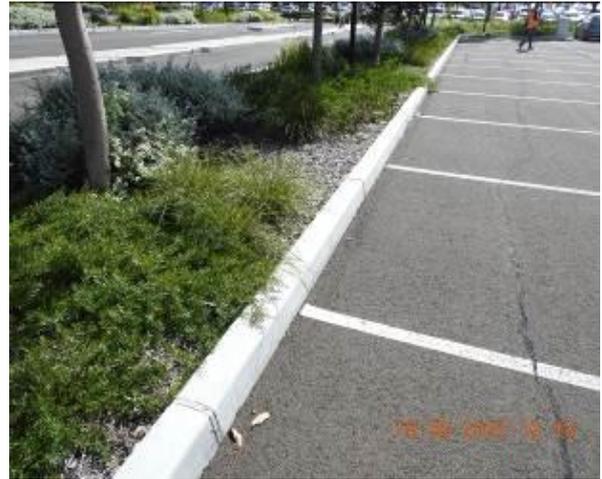
Figure 1756 – General condition of car park kerb

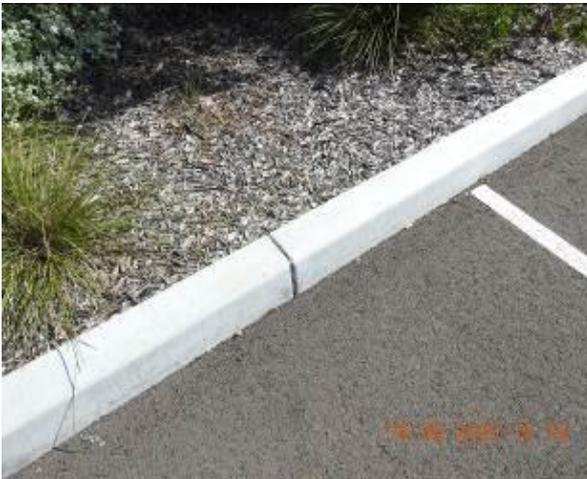
Figure 1757 – Crack propagation through car park kerb

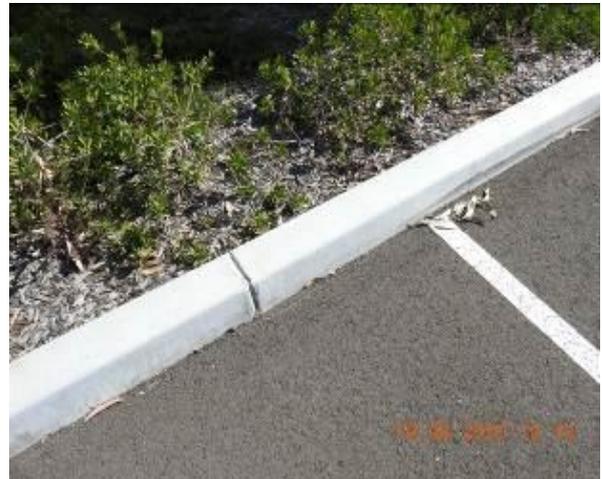
Figure 1758 – Crack propagation through car park kerb

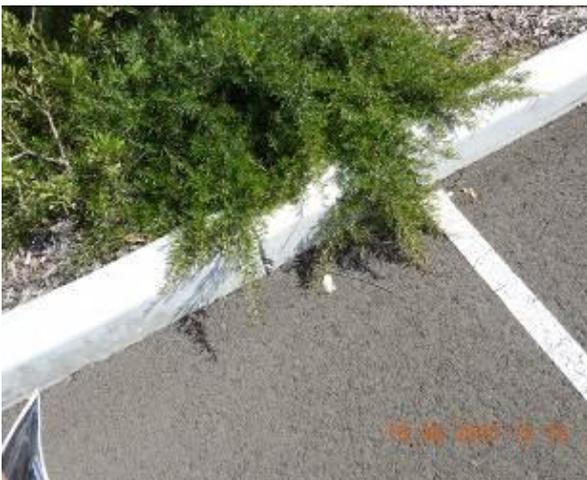
Figure 1759 – Crack propagation through car park kerb

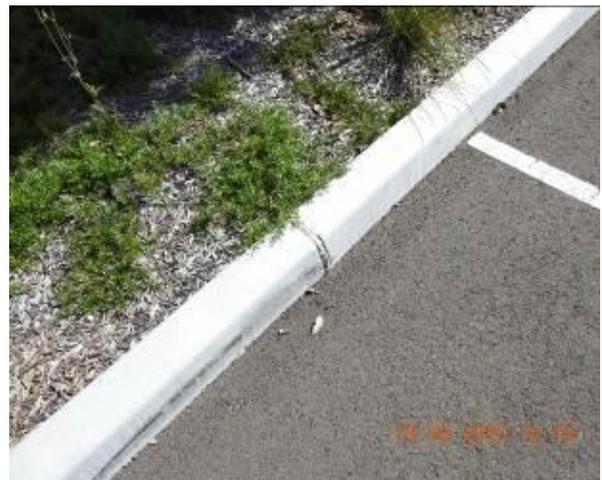
Figure 1760 – Crack propagation through car park kerb

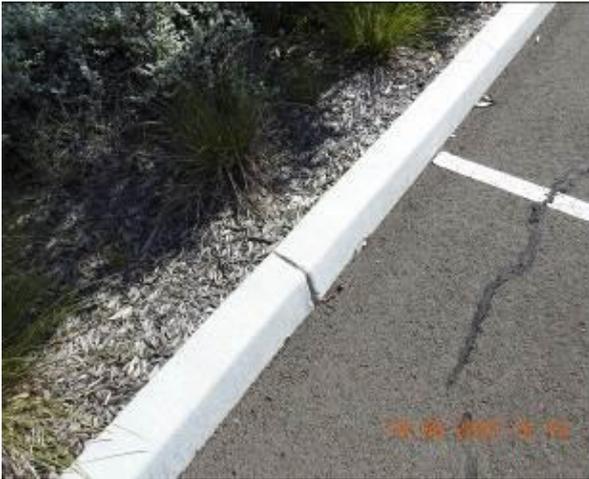
Figure 1761 – Crack propagation through car park kerb

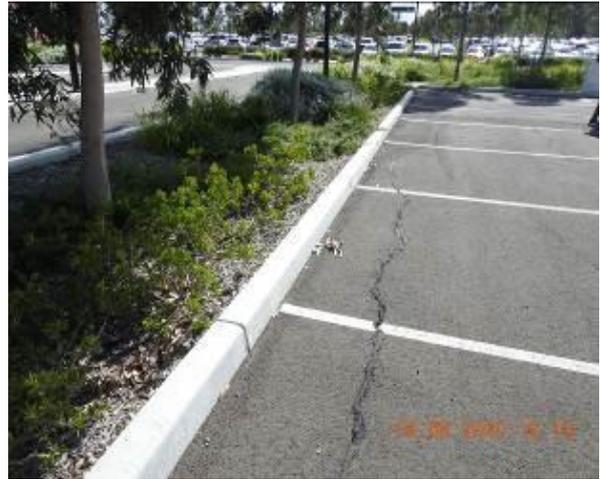
Figure 1762 – General condition of car park kerb

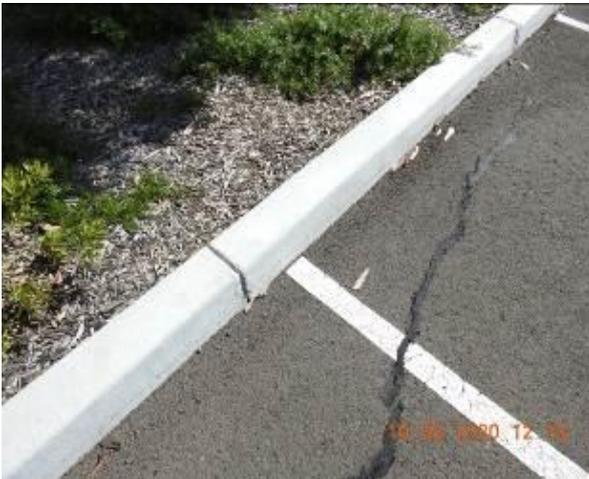
Figure 1763 – Crack propagation through car park kerb

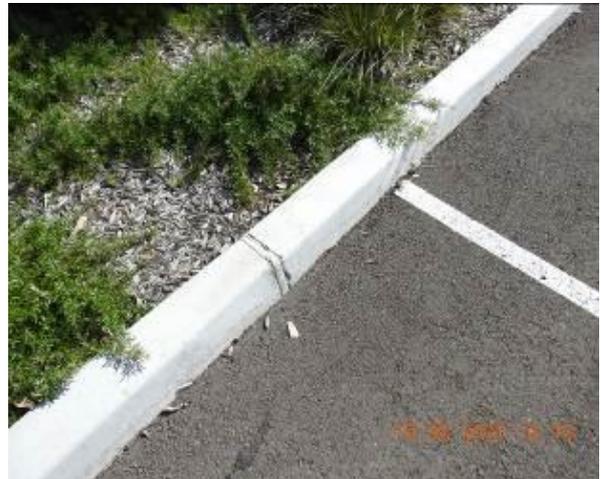
Figure 1764 – Crack propagation and loss of material through car park kerb

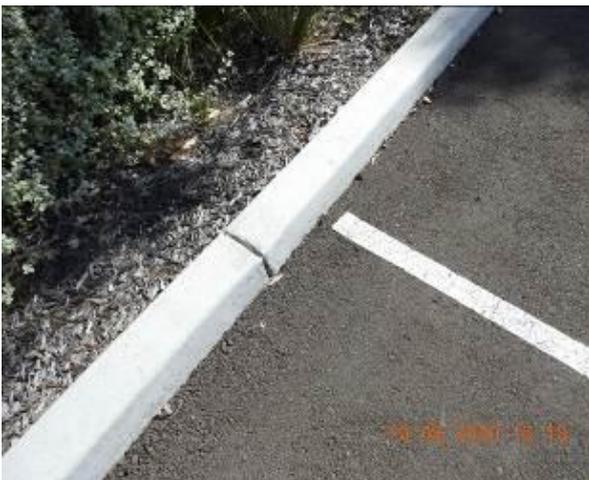
Figure 1765 – Crack propagation through car park kerb

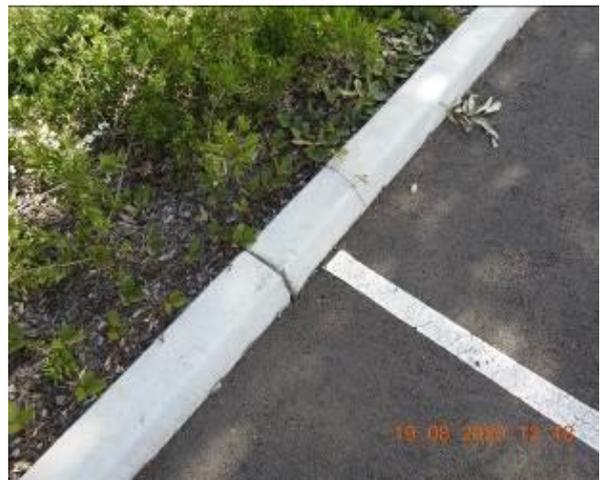
Figure 1766 – Crack propagation through car park kerb

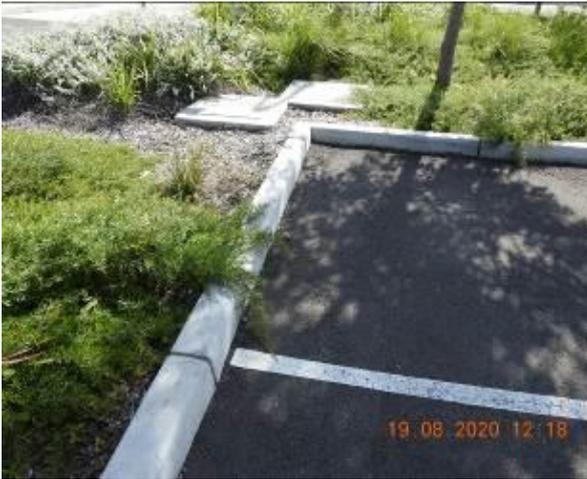
Figure 1767 – General condition of car park kerb

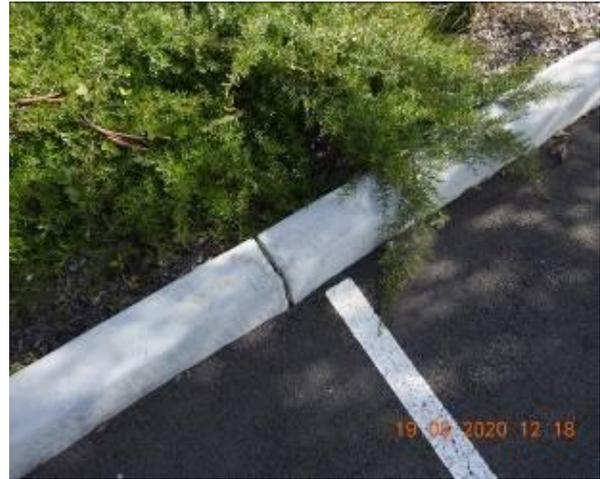
Figure 1768 – Crack propagation through car park kerb

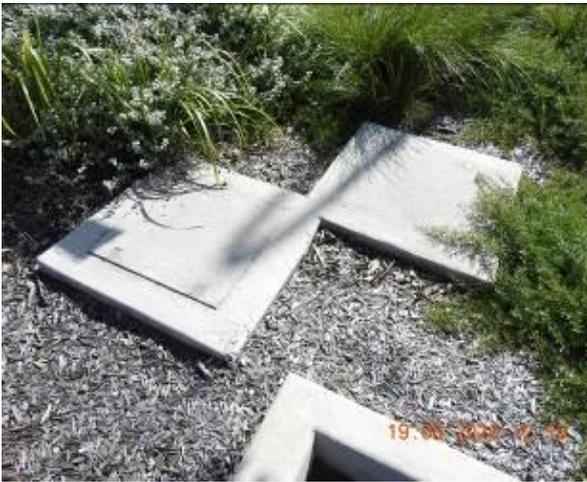
Figure 1769 – General condition of service pits

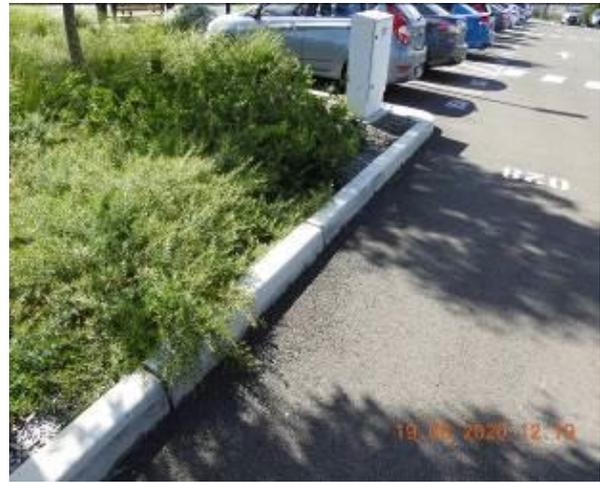
Figure 1770 – General condition of car park kerb

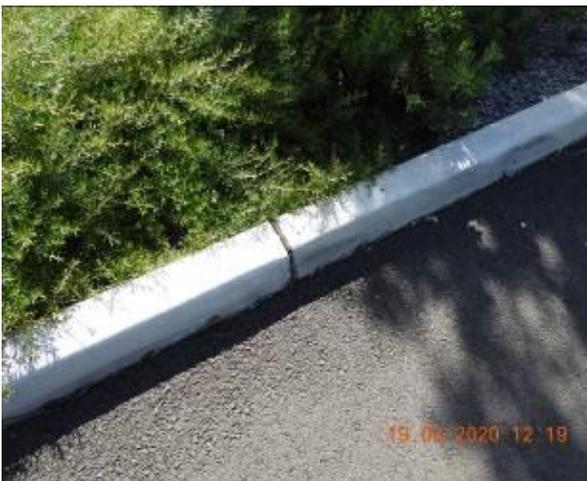
Figure 1771 – General condition of car park kerb

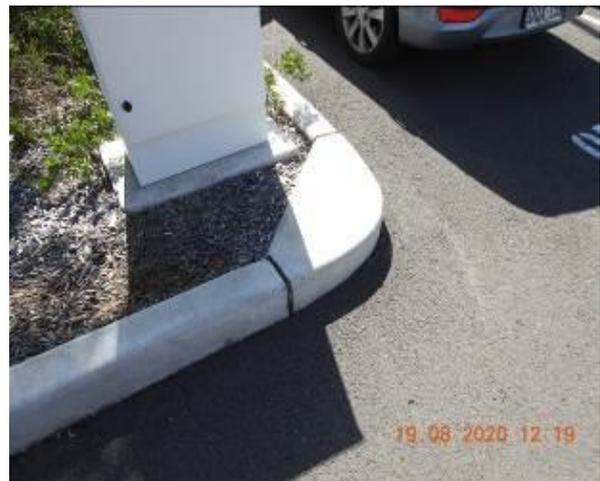
Figure 1772 – General condition of car park kerb

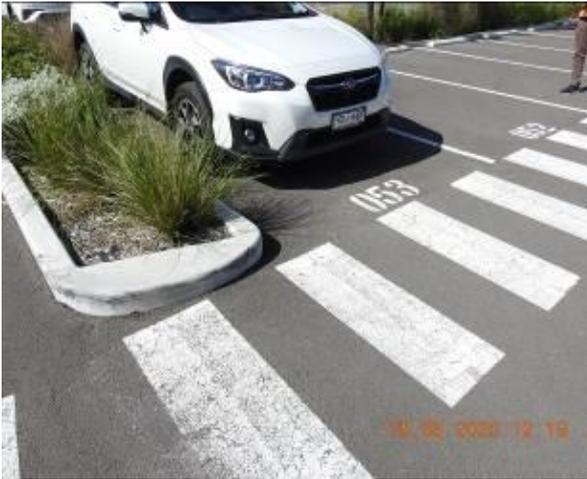
Figure 1773 – General condition of car park kerb

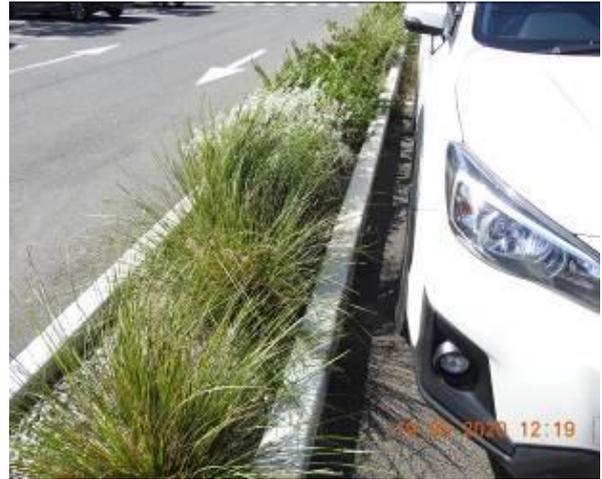
Figure 1774 – General condition of car park kerb

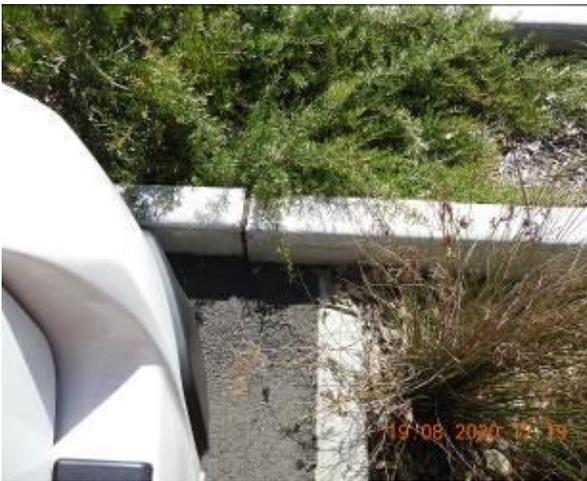
Figure 1775 – General condition of car park kerb

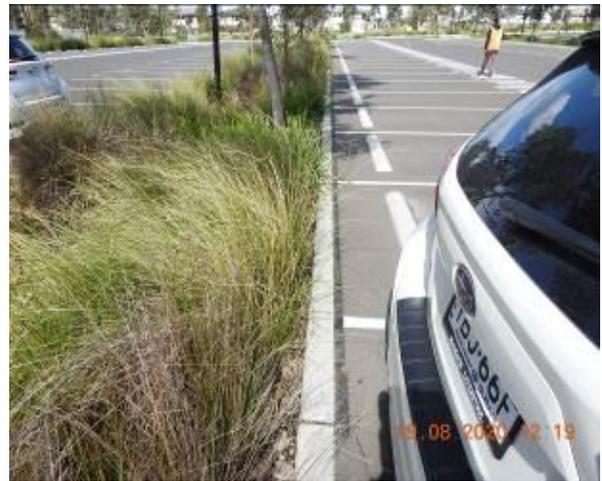
Figure 1776 – General condition of car park kerb

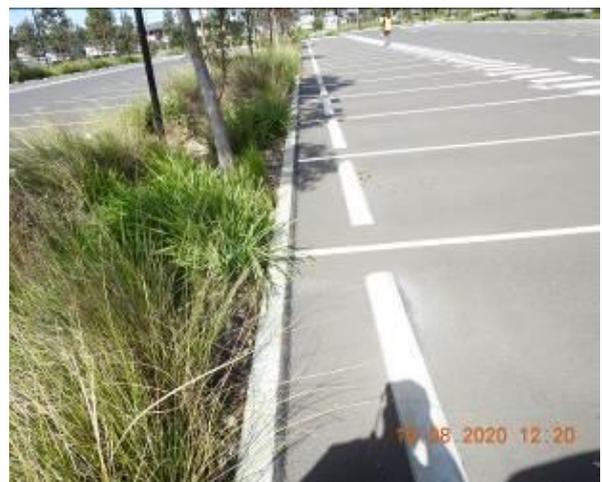
Figure 1778 – General condition of car park kerb

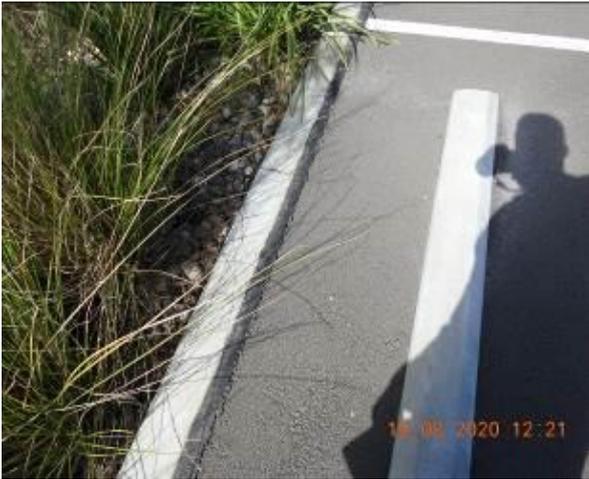
Figure 1779 – Crack propagation through car park kerb

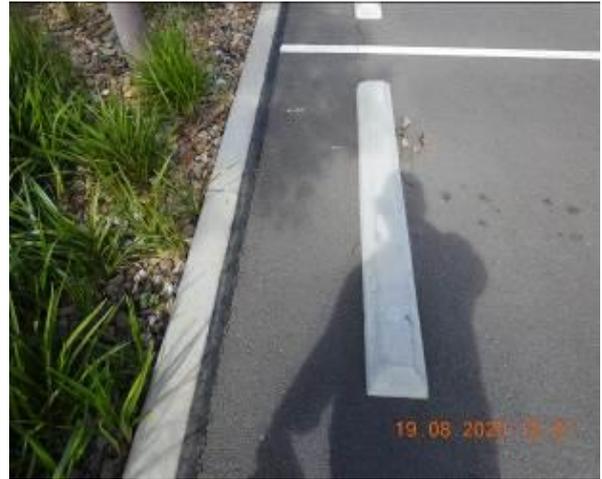
Figure 1780 – Crack propagation through car park kerb

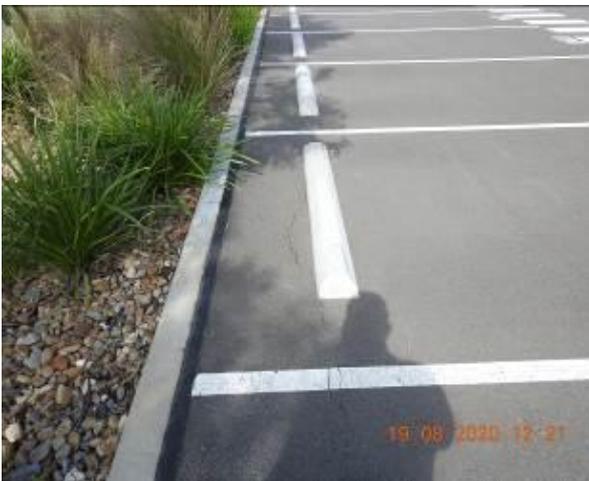
Figure 1781 – Crack propagation through car park kerb

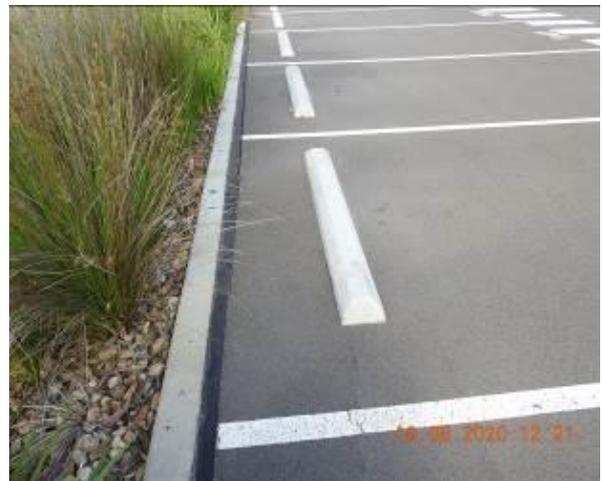
Figure 1782 – Crack propagation through car park kerb

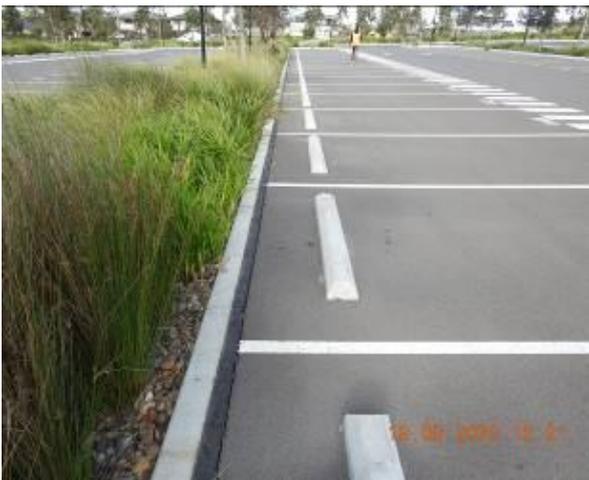
Figure 1783 – Crack propagation through car park kerb

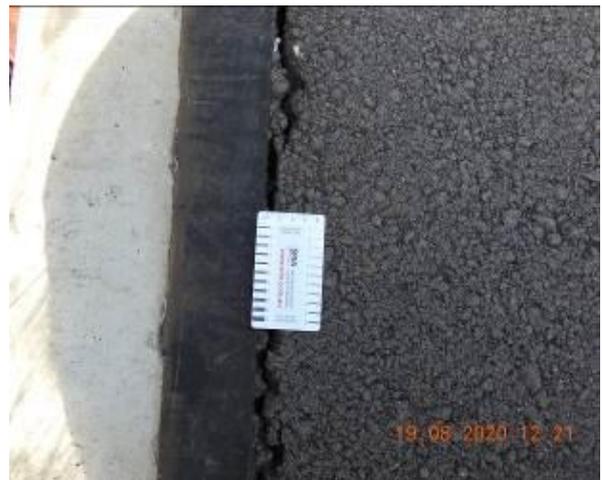
Figure 1784 – Crack propagation through car park kerb approx. 10 mm in width

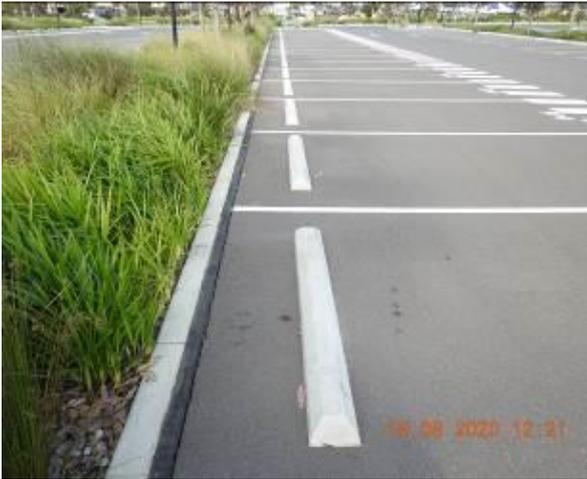
Figure 1785 – Crack propagation through car park kerb

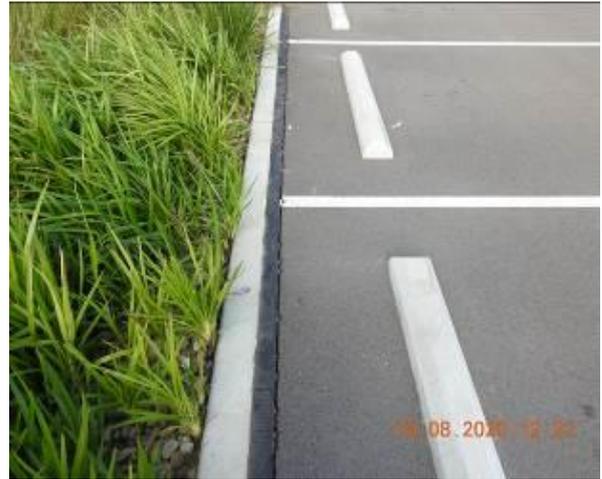
Figure 1786 – Crack propagation through car park kerb

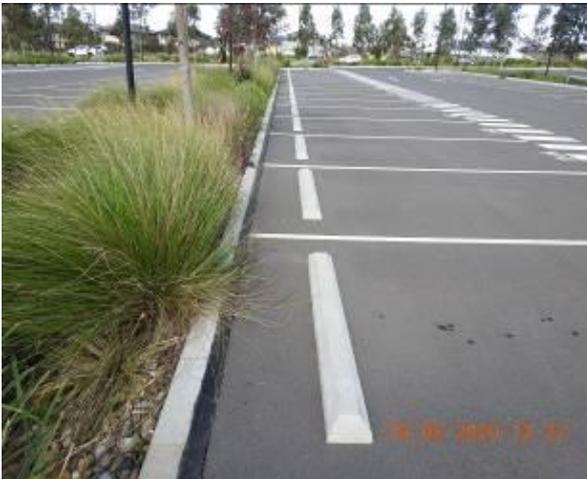
Figure 1787 – Crack propagation through car park kerb

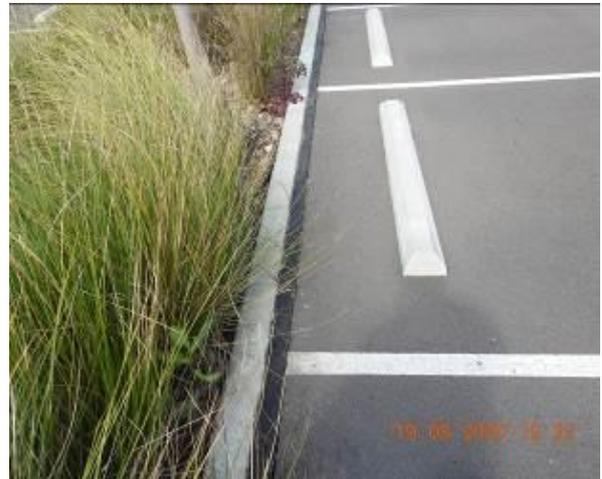
Figure 1788 – Crack propagation through car park kerb

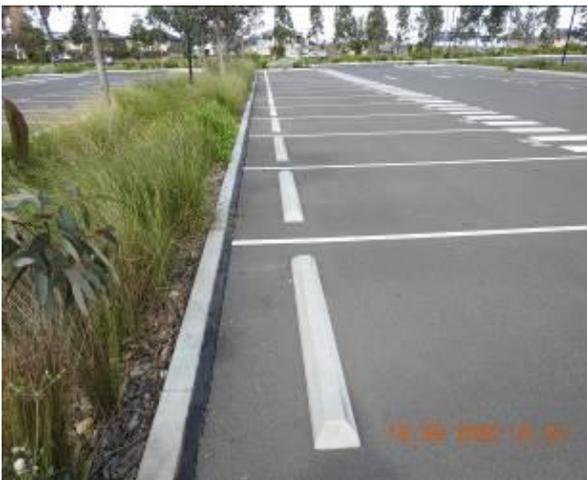
Figure 1789 – Crack propagation through car park kerb

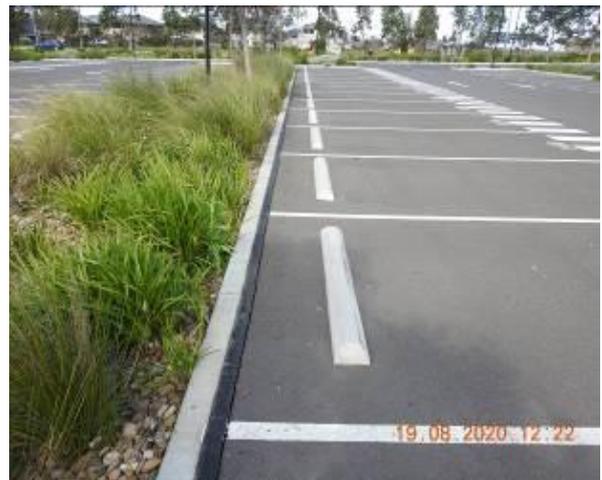
Figure 1790 – Crack propagation through car park kerb

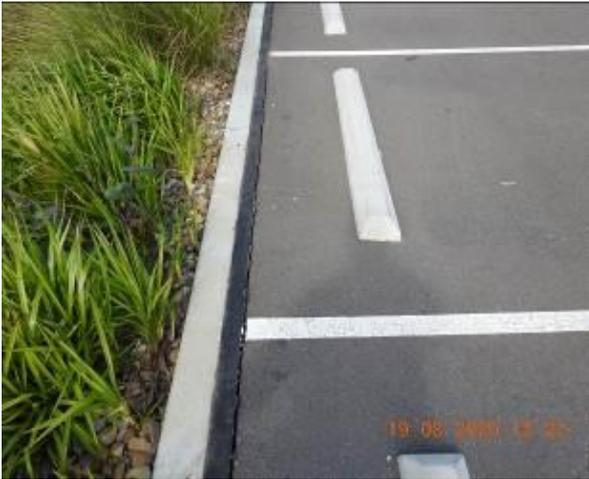
Figure 1791 – Crack propagation through car park kerb

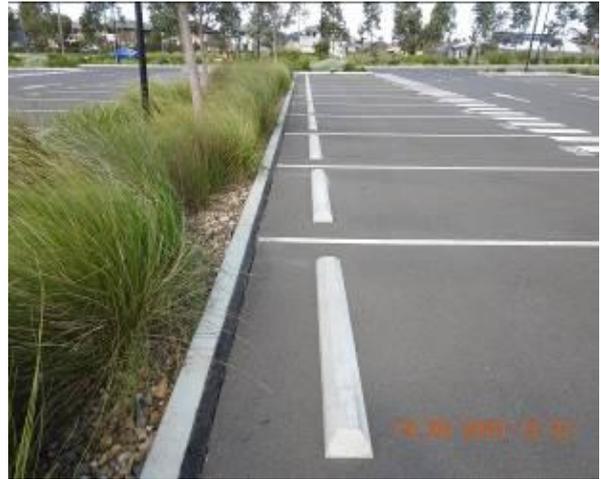
Figure 1792 – Crack propagation through car park kerb

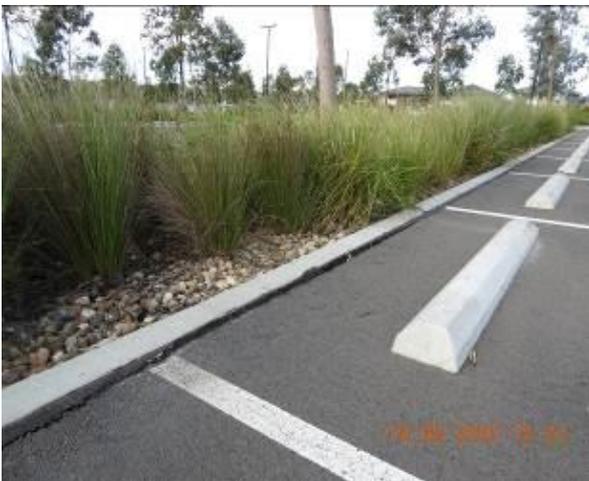
Figure 1793 – Crack propagation through car park kerb

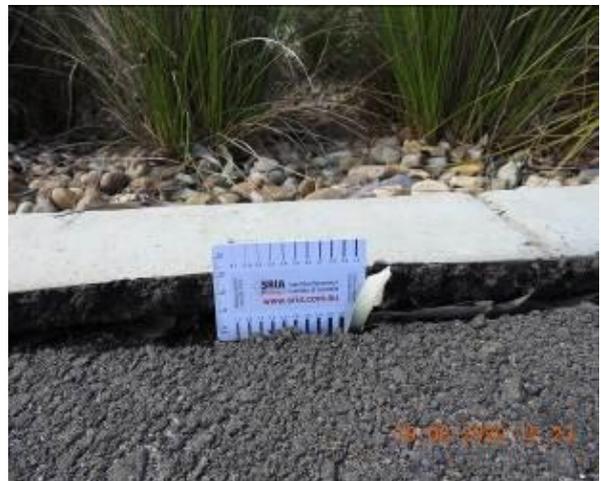
Figure 1794 – Separation through expansion joint approx. 30 mm in height

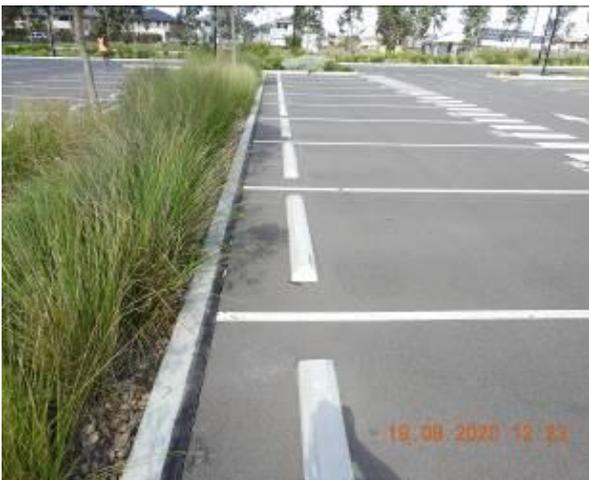
Figure 1795 – Crack propagation through car park kerb

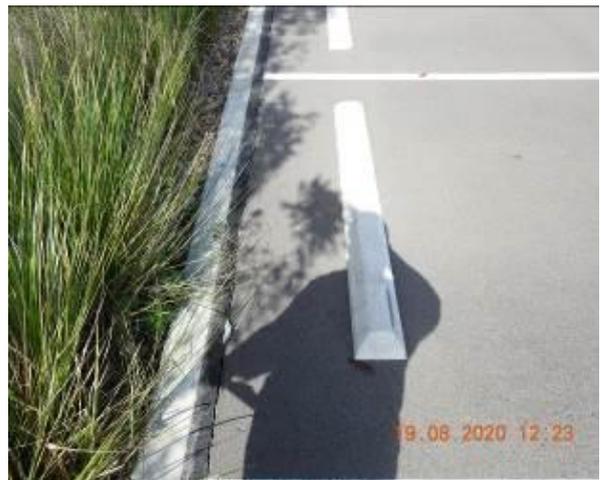
Figure 1796 – Crack propagation through car park kerb

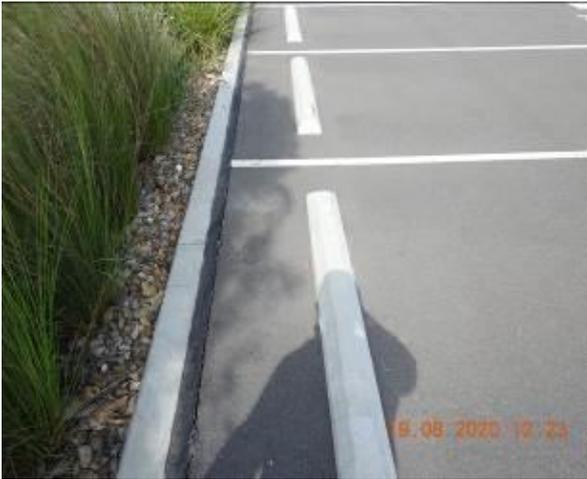
Figure 1797 – Crack propagation through car park kerb

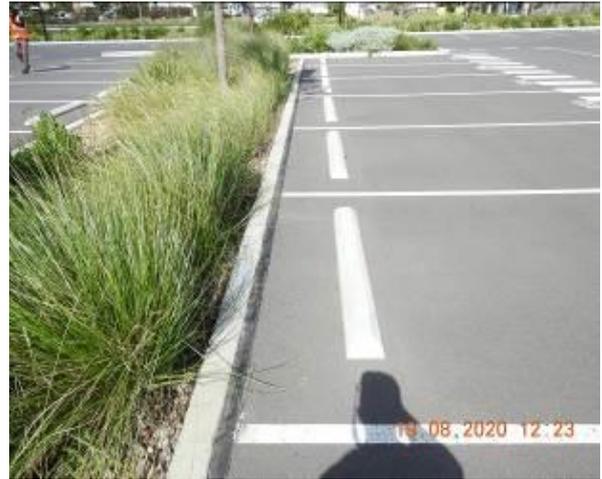
Figure 1798 – Crack propagation through car park kerb

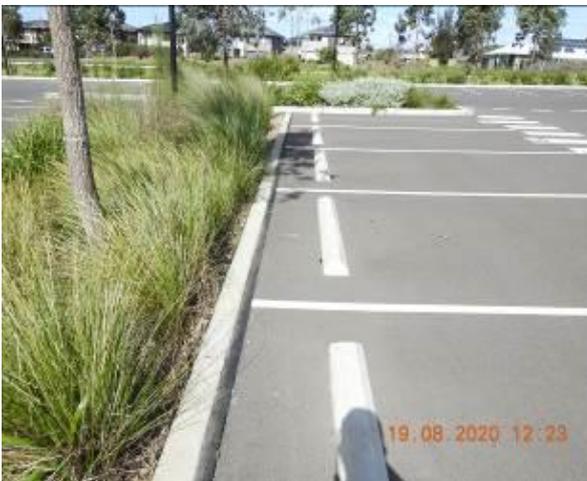
Figure 1799 – Crack propagation through car park kerb

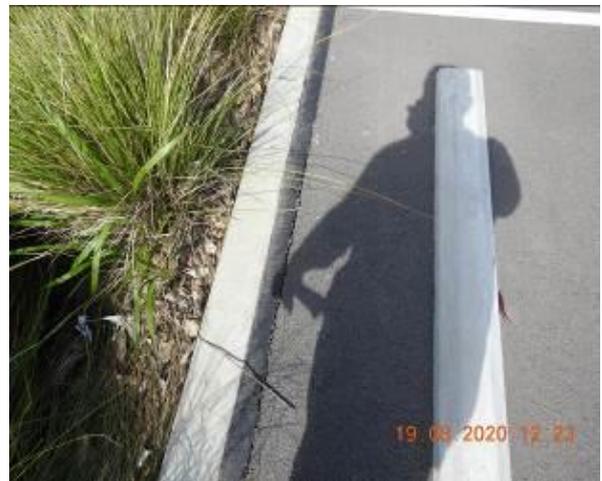
Figure 1800 – Crack propagation through car park kerb

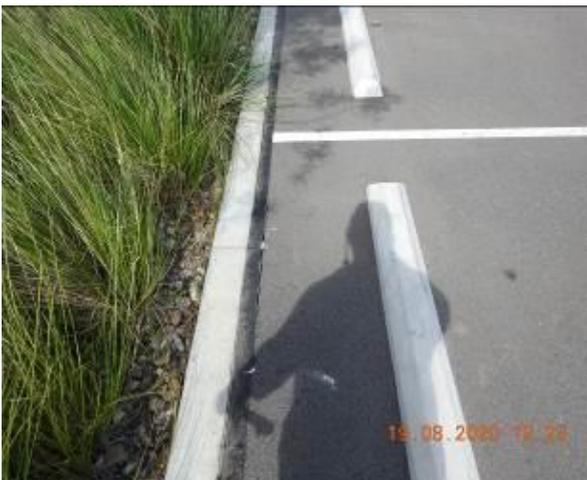
Figure 1801 – Crack propagation through car park kerb

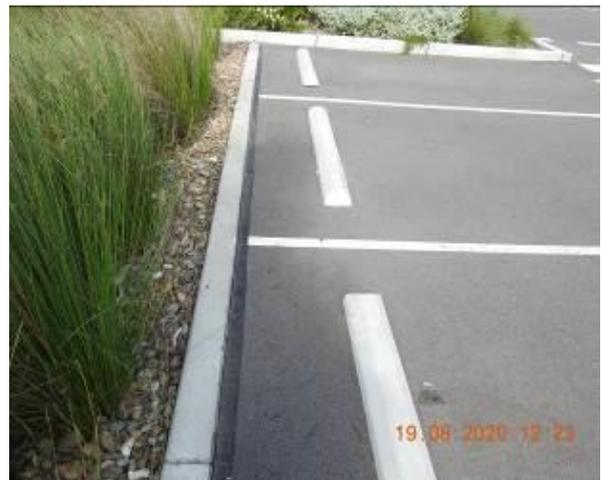
Figure 1802 – Crack propagation through car park kerb

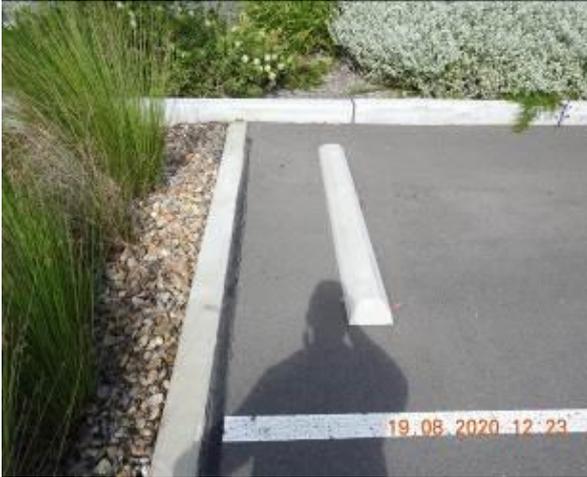
Figure 1803 – Crack propagation through car park kerb

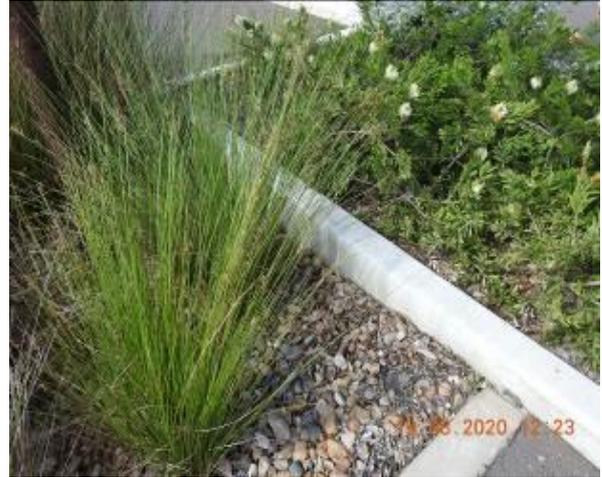
Figure 1804 – General condition of car park kerb

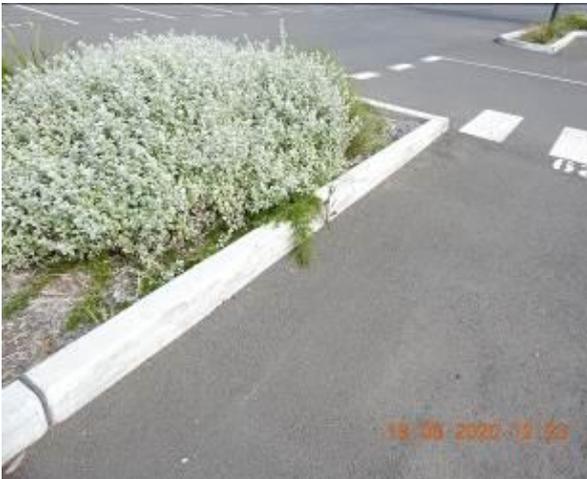
Figure 1805 – General condition of car park kerb

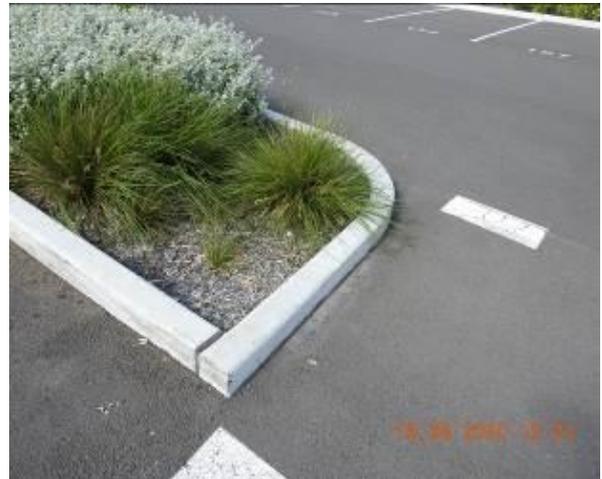
Figure 1806 – General condition of car park kerb

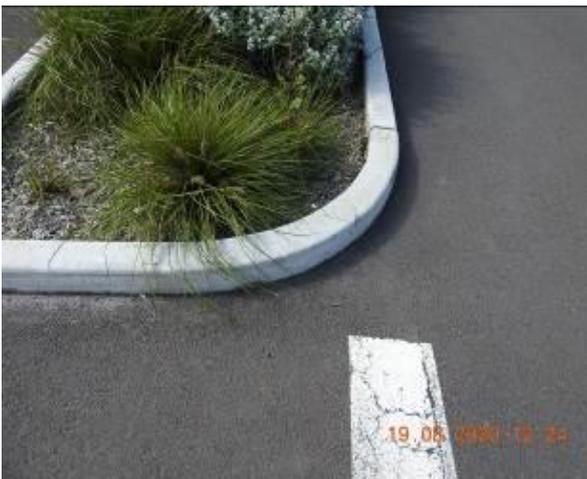
Figure 1807 – General condition of car park kerb

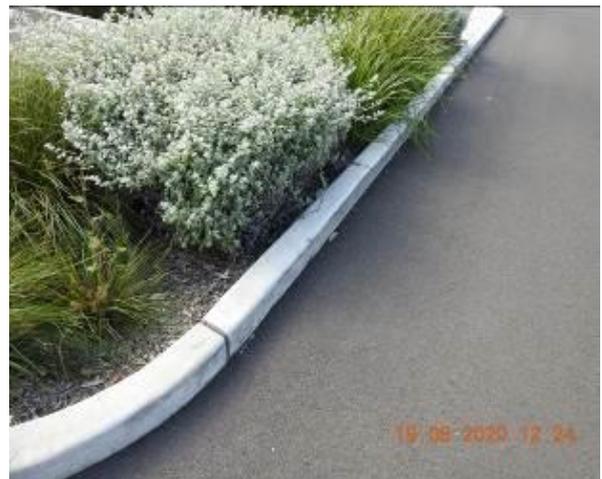
Figure 1808 – General condition of car park kerb

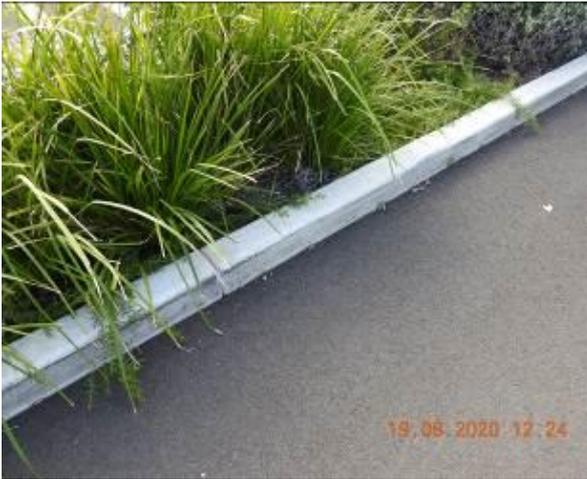
Figure 1809 – General condition of car park kerb

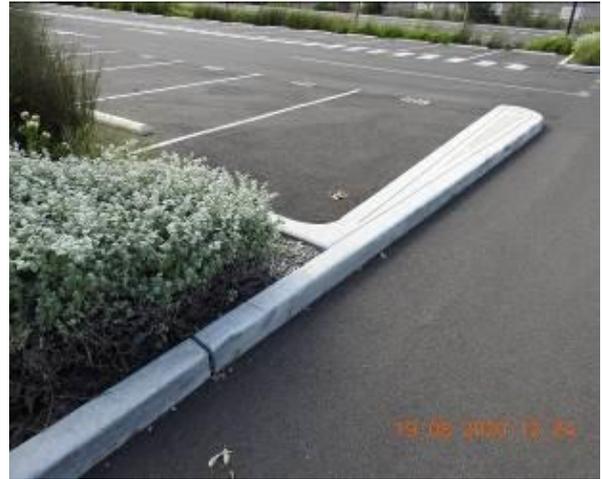
Figure 1810 – General condition of car park kerb

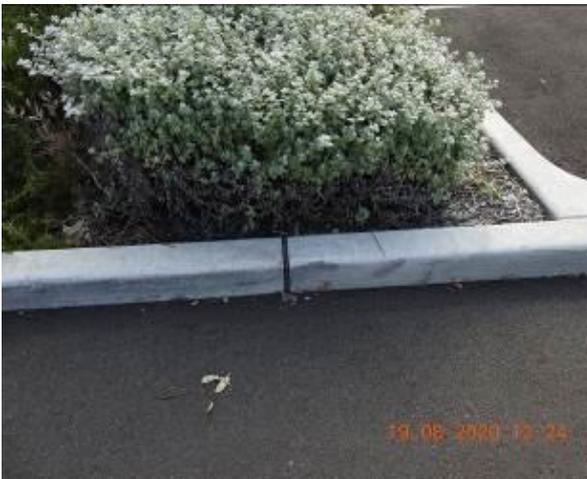
Figure 1811 – General condition of car park kerb

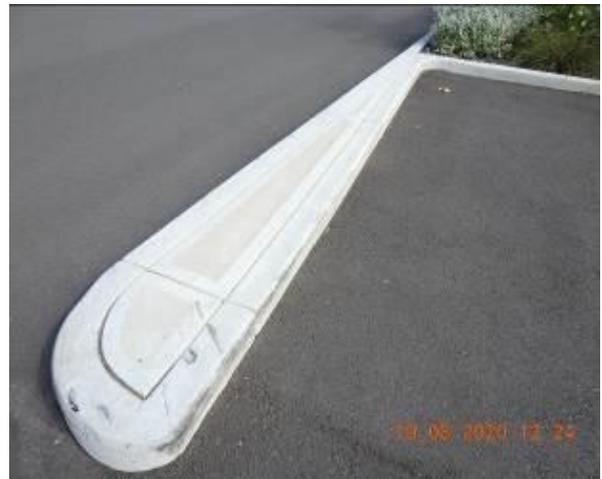
Figure 1812 – General condition of car park kerb

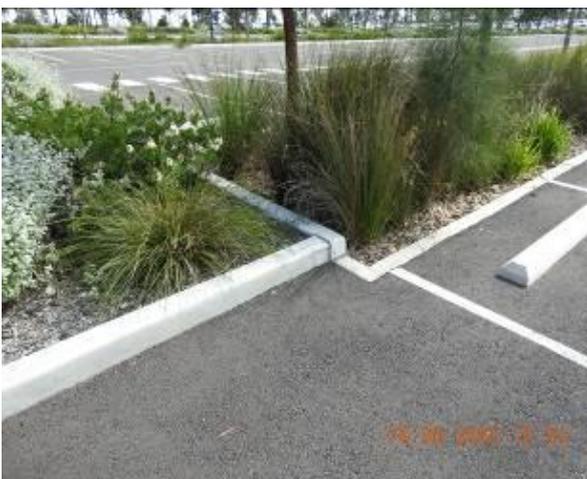
Figure 1813 – General condition of car park kerb

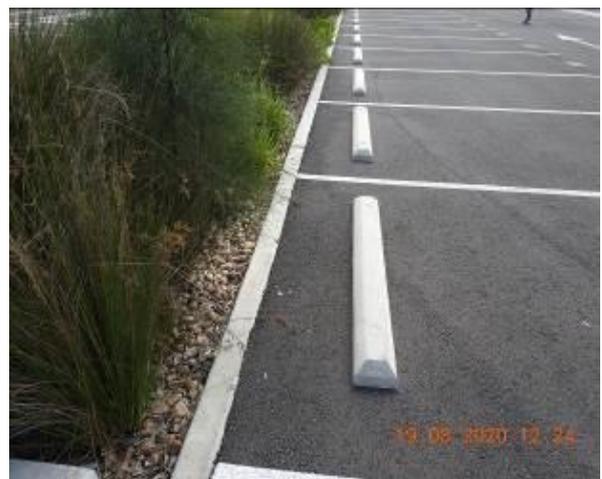
Figure 1814 – General condition of car park kerb

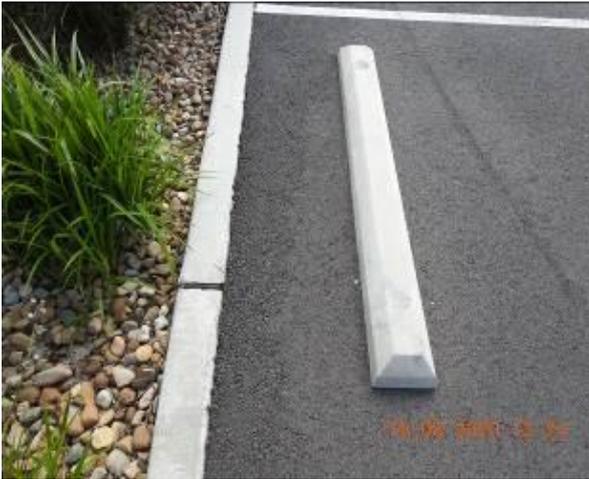
Figure 1815 – General condition of car park kerb

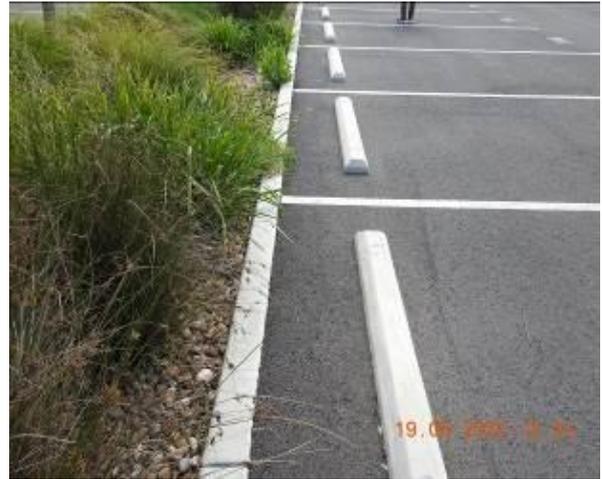
Figure 1816 – General condition of car park kerb

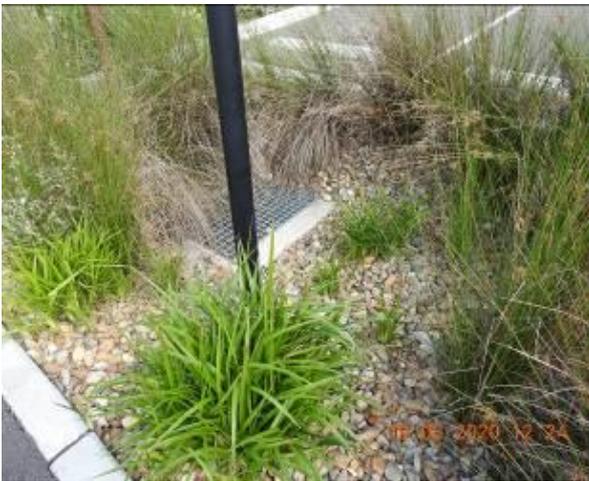
Figure 1817 – General condition of stormwater inlet pit

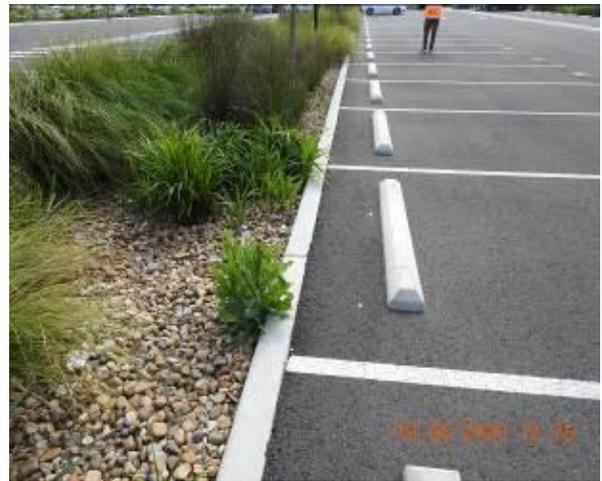
Figure 1818 – General condition of car park kerb

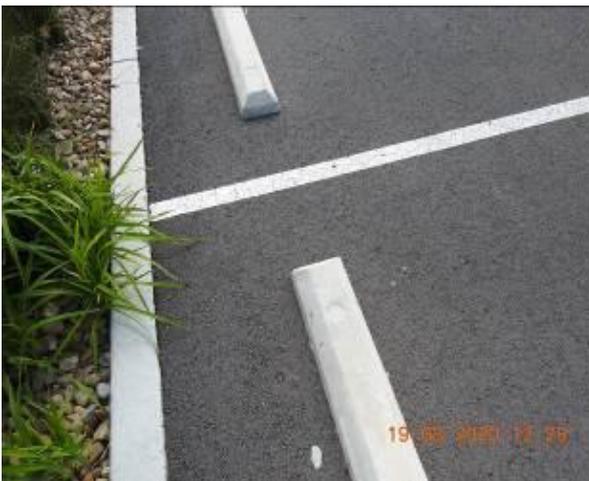
Figure 1819 – General condition of car park kerb

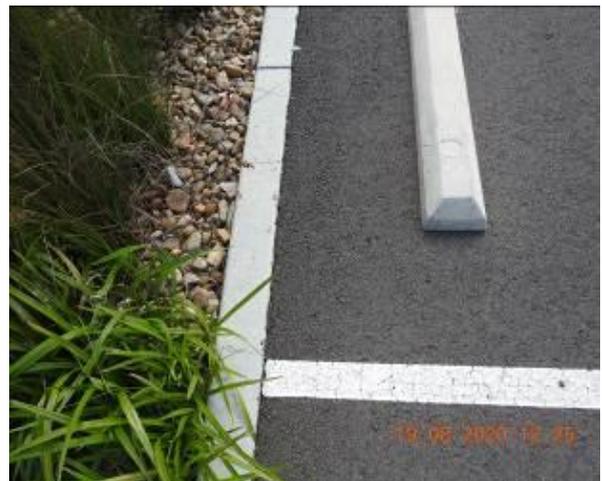
Figure 1820 – Crack propagation through car park kerb

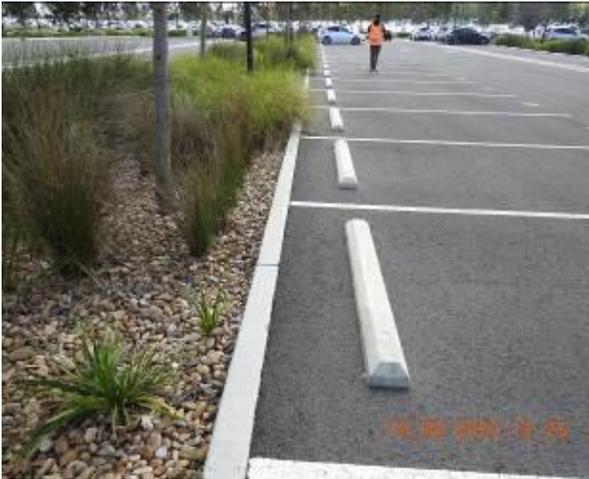
Figure 1821 – General condition of car park kerb

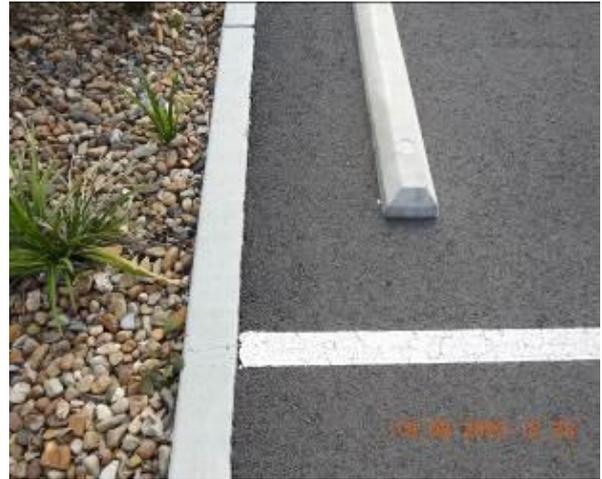
Figure 1822 – Crack propagation through car park kerb
