The property Tallawong station – P2 Car Park, is the neighbouring property to our client’s site. It was photographed and inspected prior to any construction works on the subject site and was found to be in a reasonable condition. The property serves as a car park.

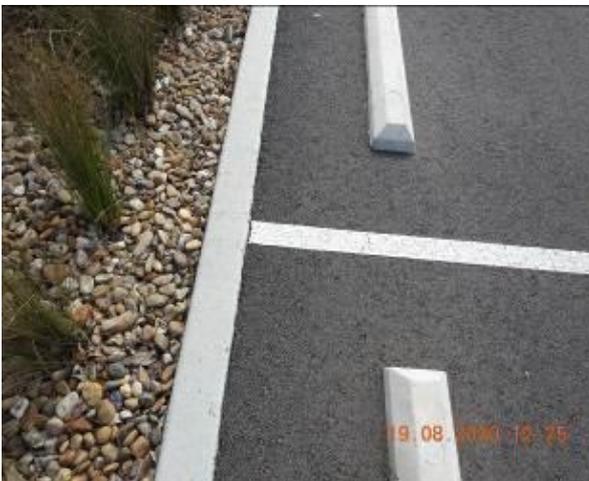
Figure 1823 – Crack propagation through car park kerb

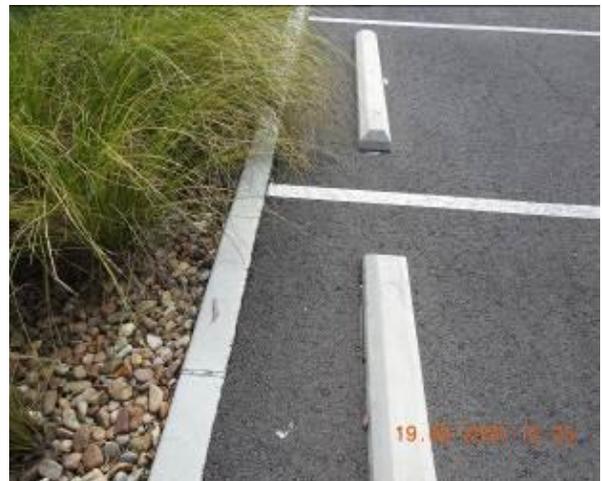
Figure 1824 – General condition of car park kerb

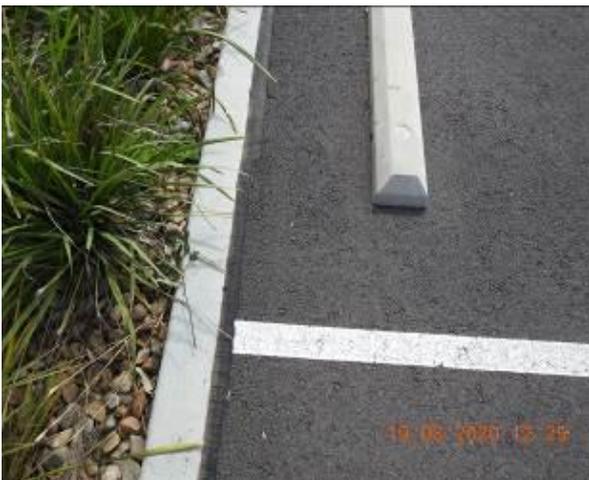
Figure 1825 – General condition of car park kerb

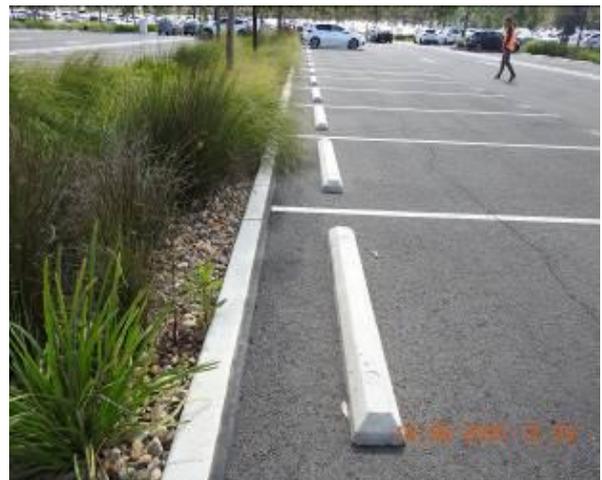
Figure 1826 – General condition of car park kerb

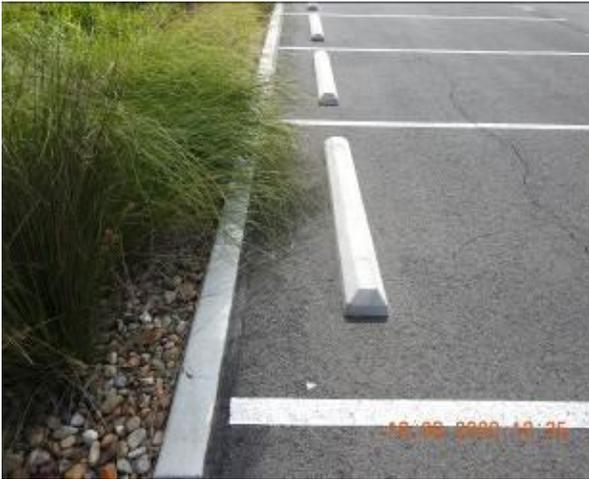
Figure 1827 – General condition of car park kerb

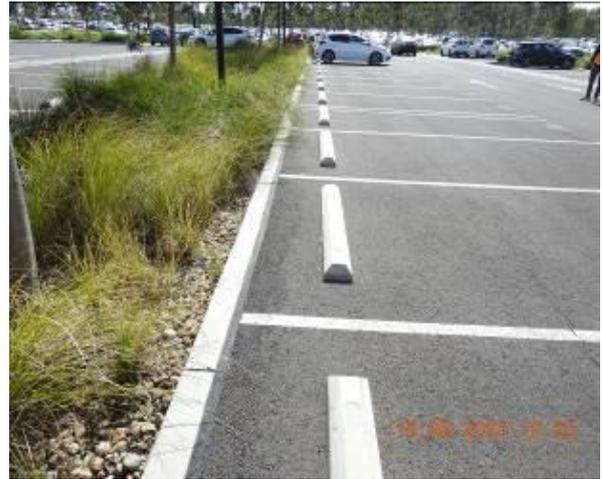
Figure 1828 – General condition of car park kerb

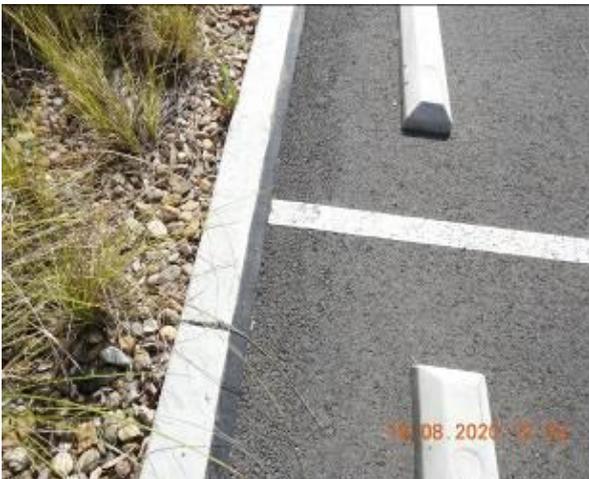
Figure 1829 – Crack propagation through car park kerb

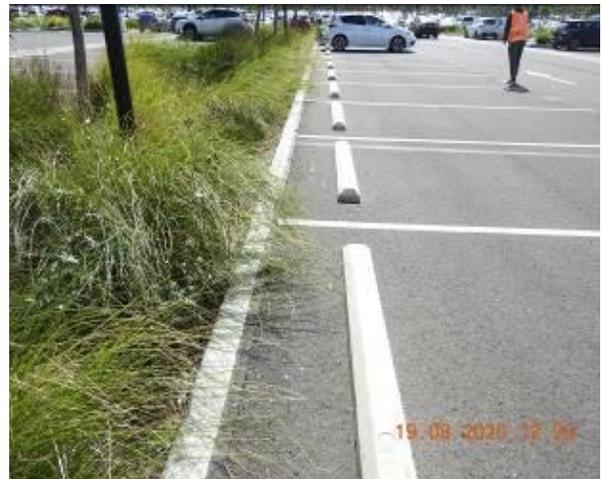
Figure 1830 – General condition of car park kerb

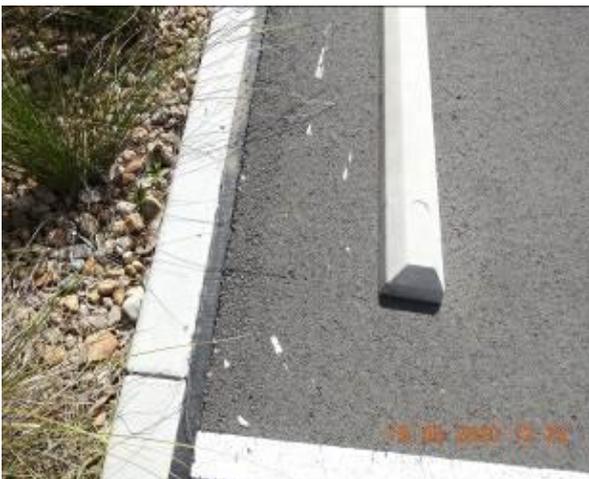
Figure 1831 – Crack propagation through car park kerb

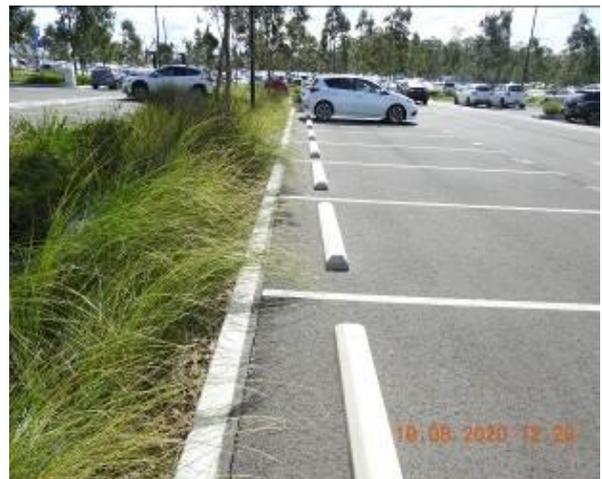
Figure 1832 – Crack propagation through car park kerb

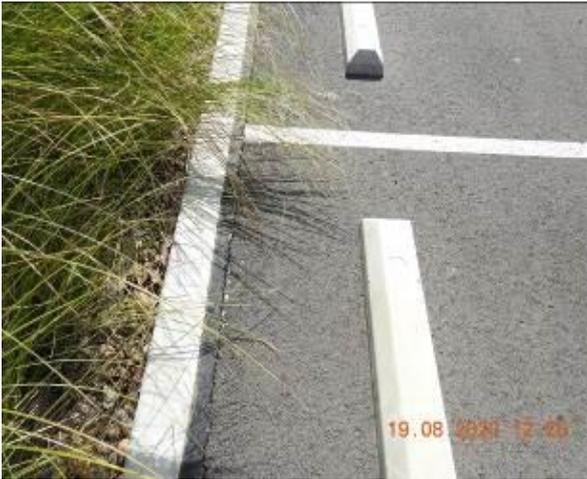
Figure 1833 – Crack propagation through car park kerb

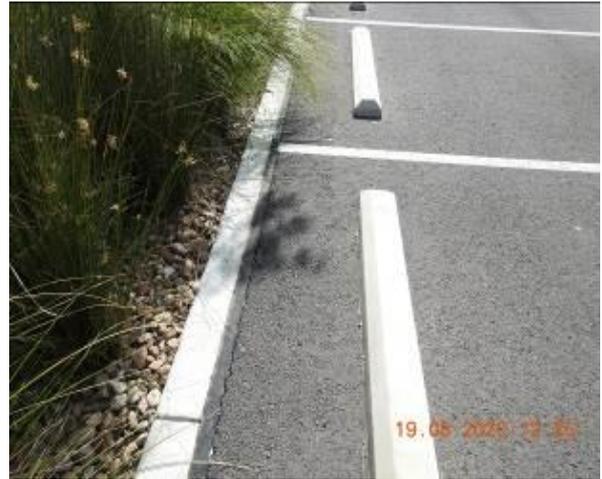
Figure 1834 – Crack propagation through car park kerb

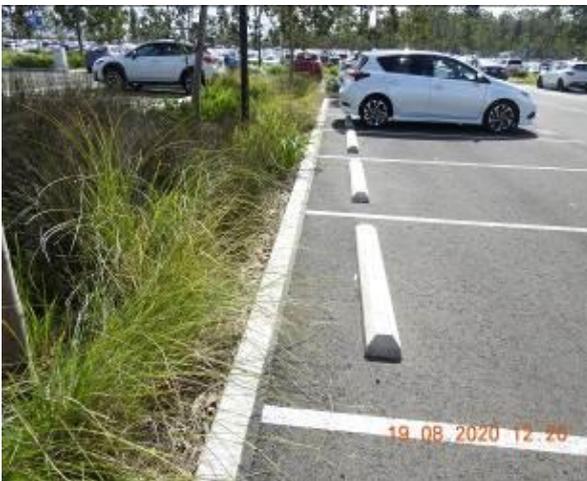
Figure 1835 – Crack propagation through car park kerb

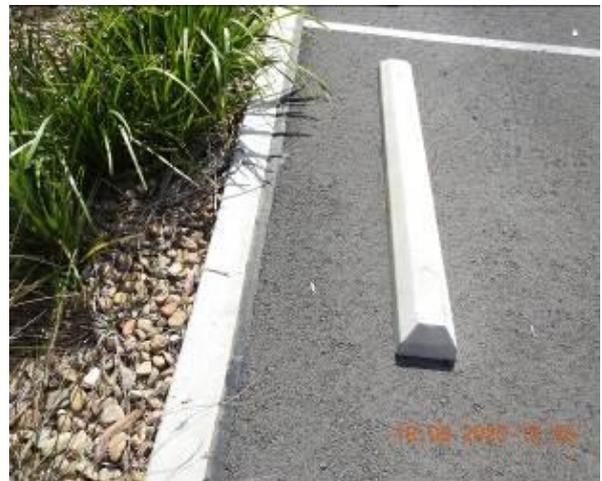
Figure 1836 – General condition of car park kerb

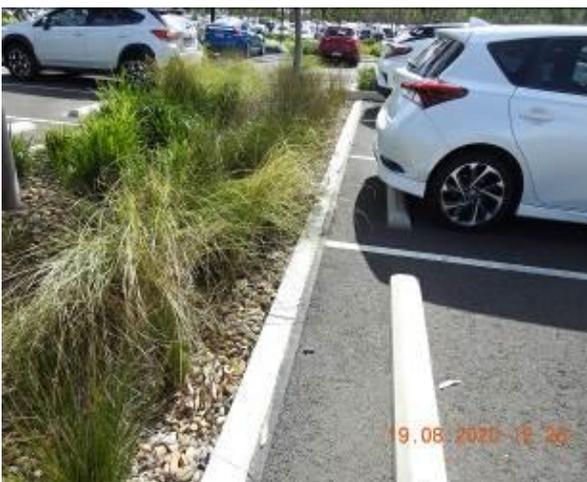
Figure 1837 – General condition of car park kerb

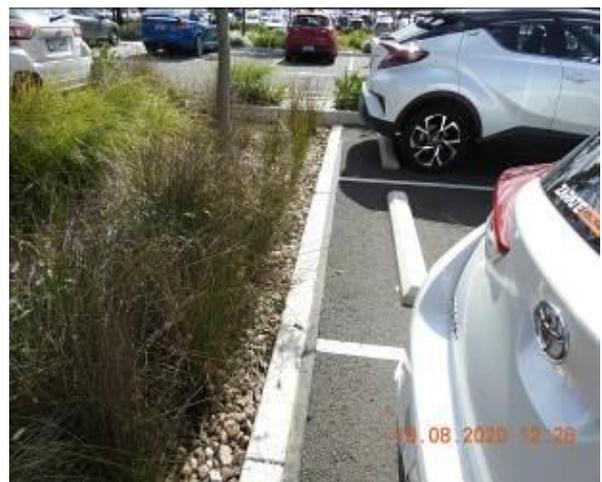
Figure 1838 – General condition of car park kerb

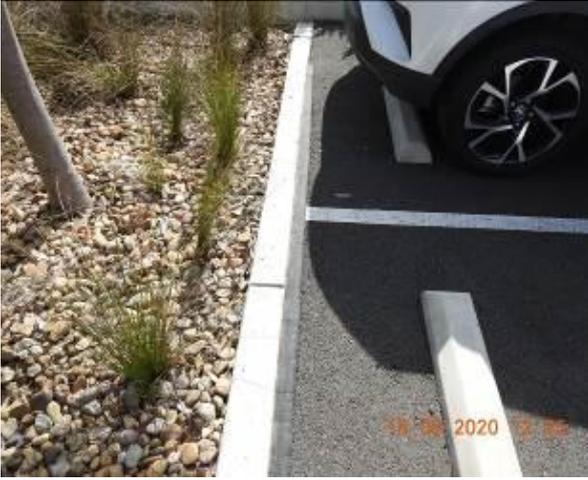
Figure 1839 – Crack propagation through car park kerb

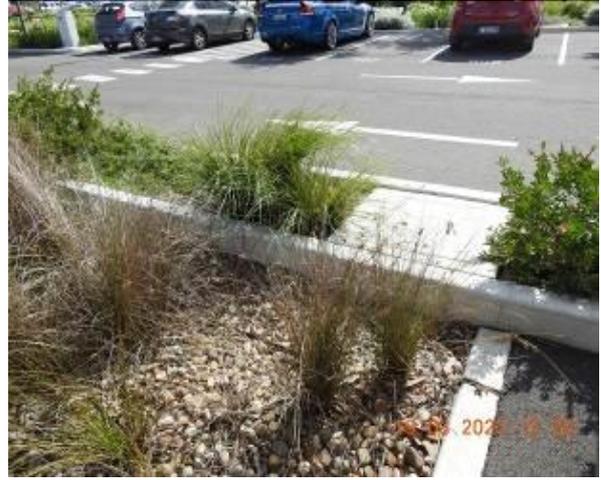
Figure 1840 – General condition of car park kerb

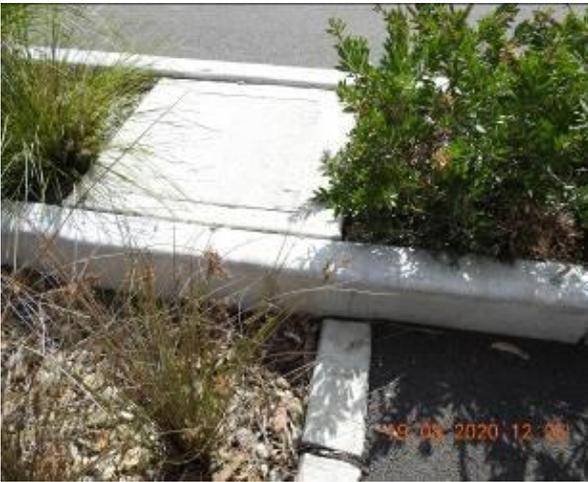
Figure 1841 – General condition of car park kerb

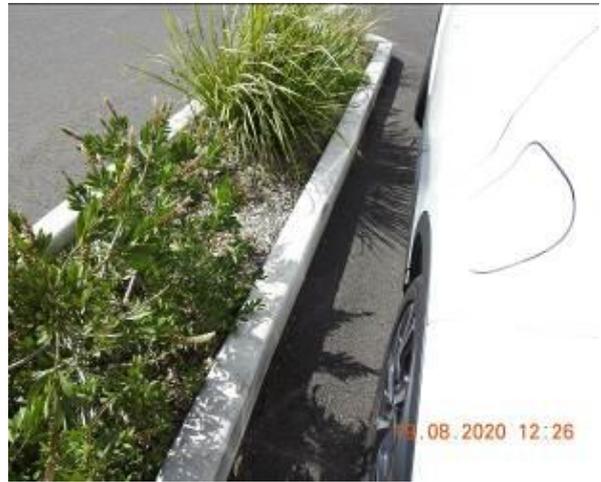
Figure 1842 – General condition of car park kerb

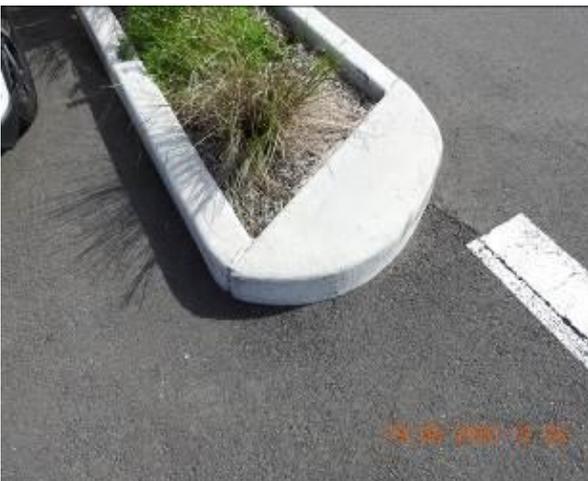
Figure 1843 – Crack propagation through car park kerb

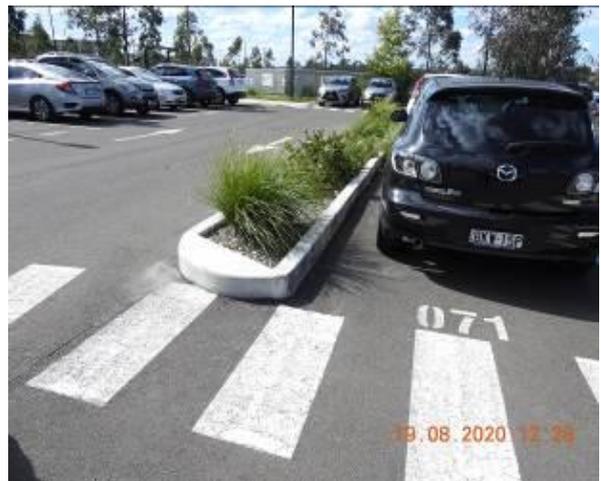
Figure 1844 – General condition of car park kerb

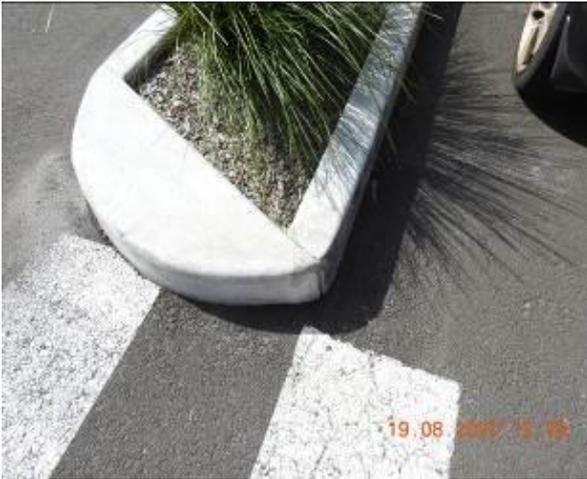
Figure 1845 – Crack propagation through car park kerb

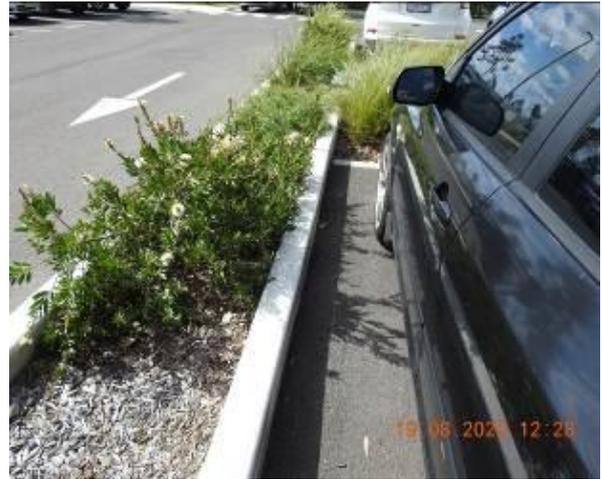
Figure 1846 – General condition of car park kerb

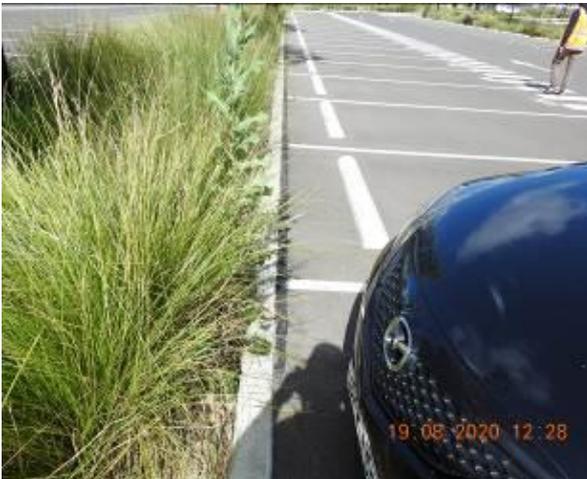
Figure 1847 – General condition of car park kerb

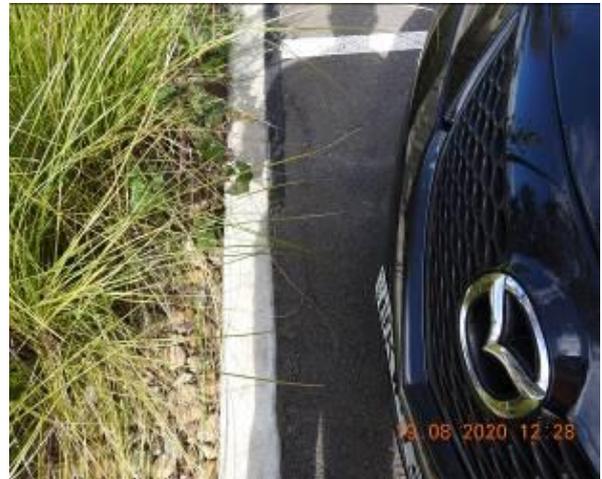
Figure 1848 – General condition of car park kerb and Crack propagation through car park pavement

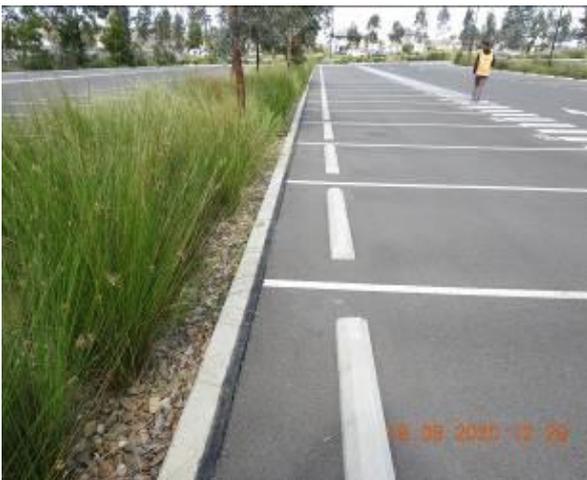
Figure 1849 – General condition of car park kerb

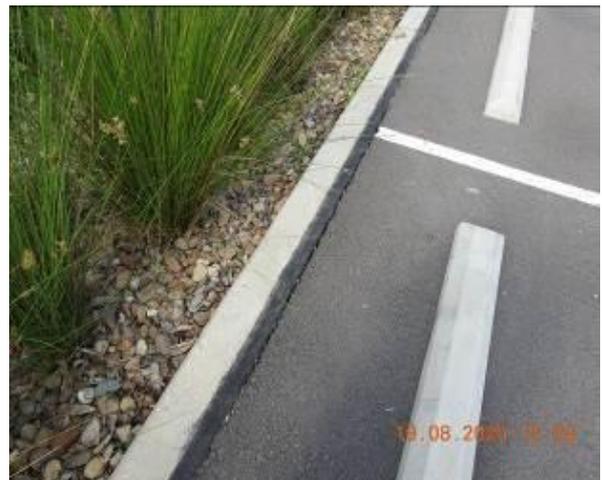
Figure 1850 – Crack propagation through car park kerb

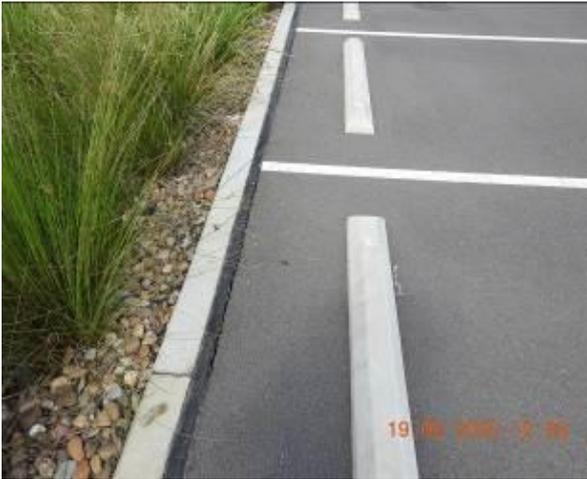
Figure 1851 – Crack propagation through car park kerb

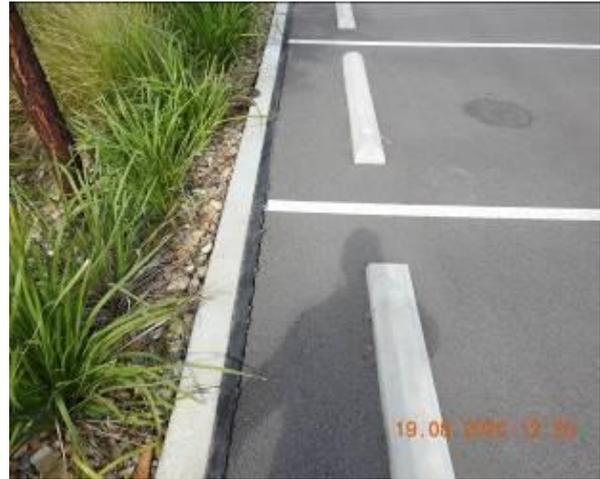
Figure 1852 – Crack propagation through car park kerb

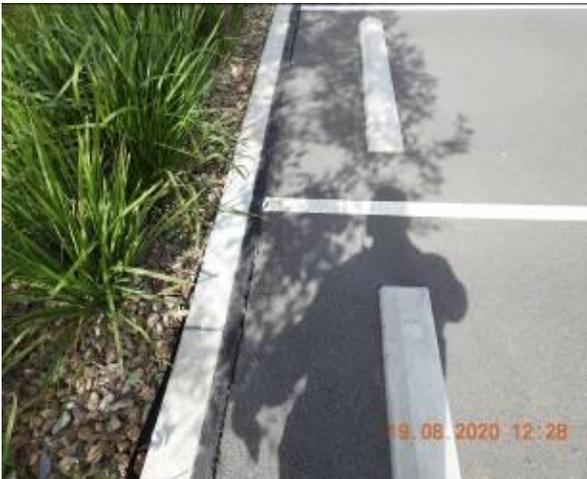
Figure 1853 – Crack propagation through car park kerb

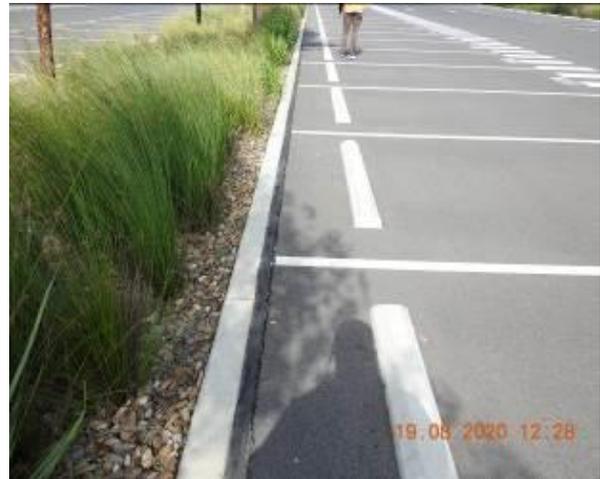
Figure 1854 – Crack propagation through car park kerb

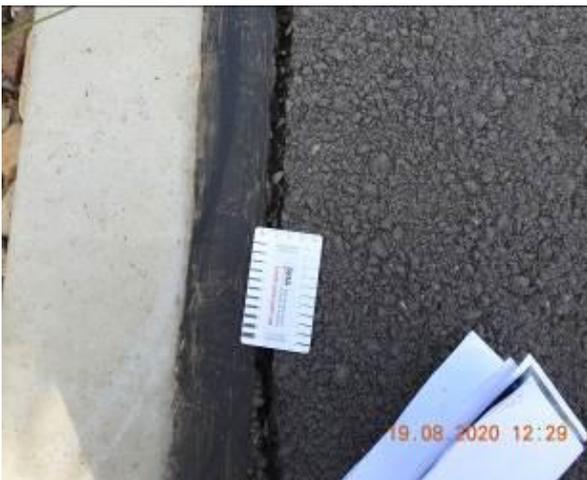
Figure 1855 – Separation through car park kerb approx. 15 mm

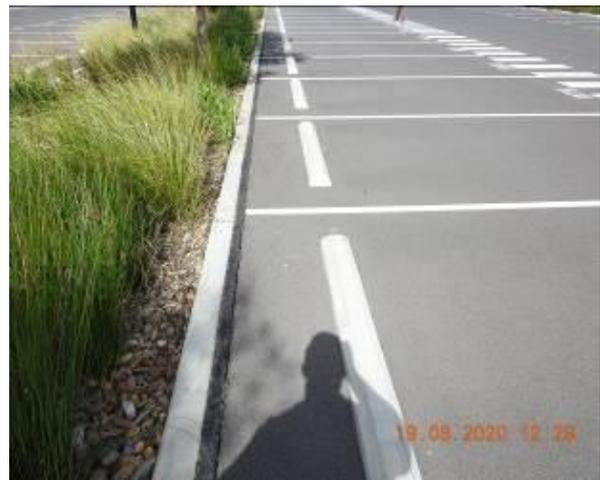
Figure 1856 – Crack propagation through car park kerb

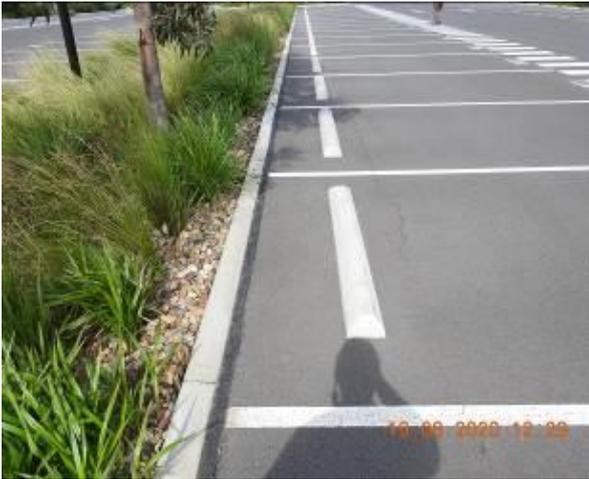
Figure 1857 – Crack propagation through car park kerb

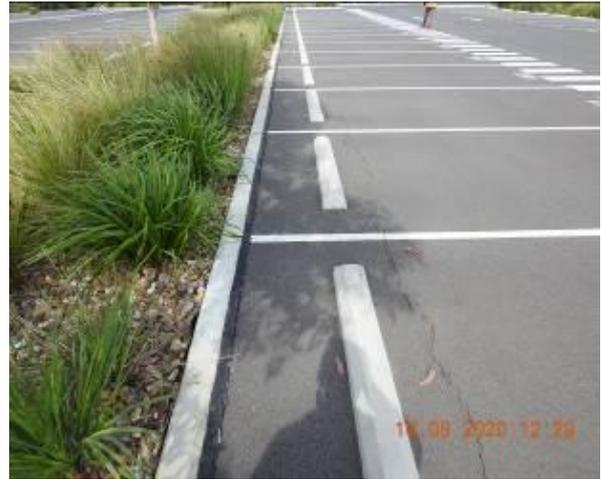
Figure 1858 – Crack propagation through car park kerb

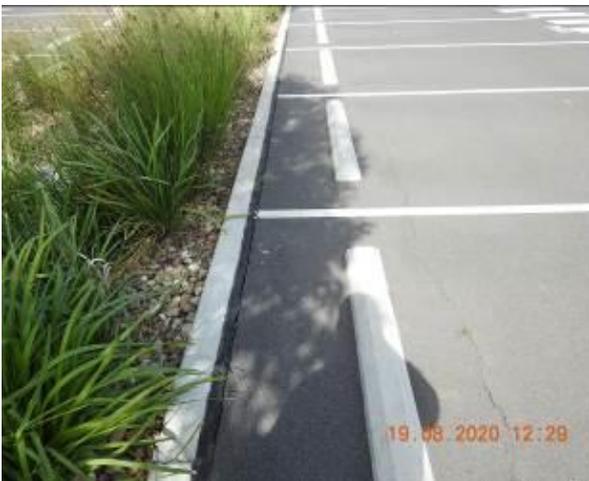
Figure 1859 – Crack propagation through car park kerb

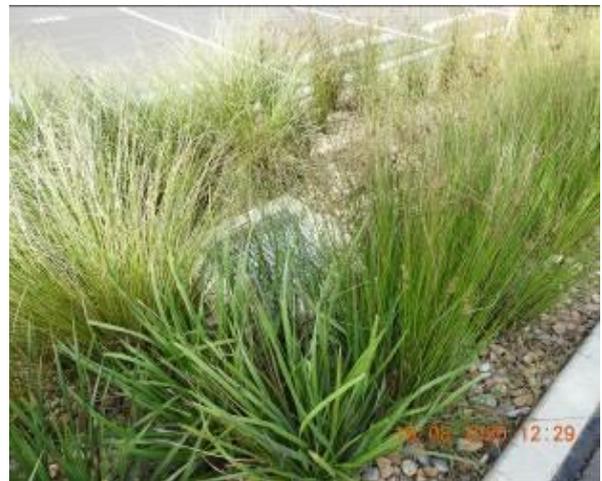
Figure 1860 – General condition of stormwater inlet pit

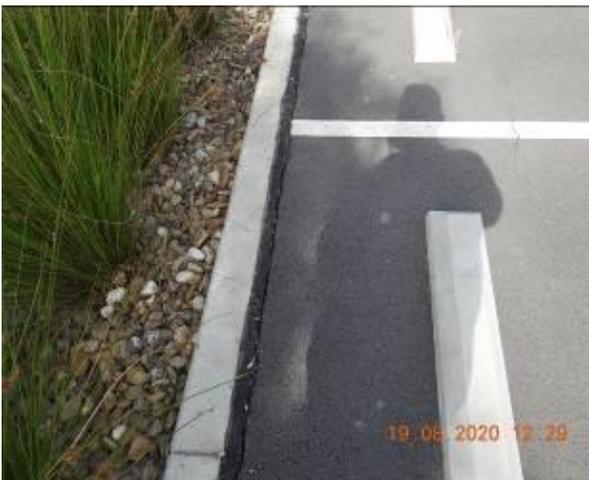
Figure 1861 – Crack propagation through car park kerb

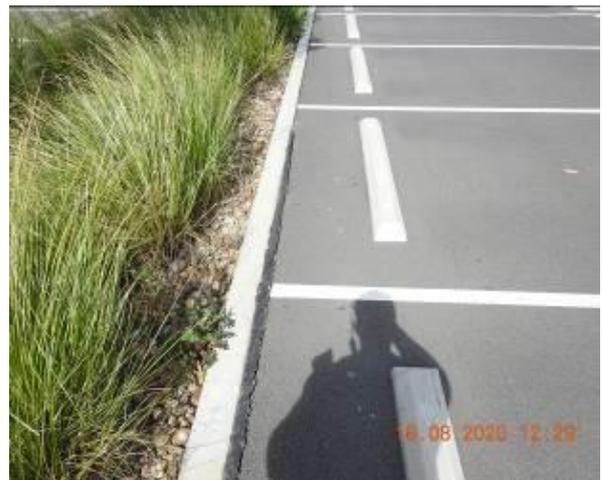
Figure 1862 – Crack propagation through car park kerb

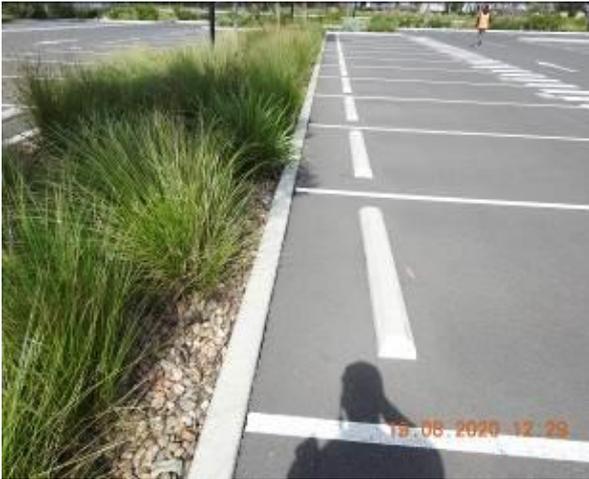
Figure 1863 – Crack propagation through car park kerb

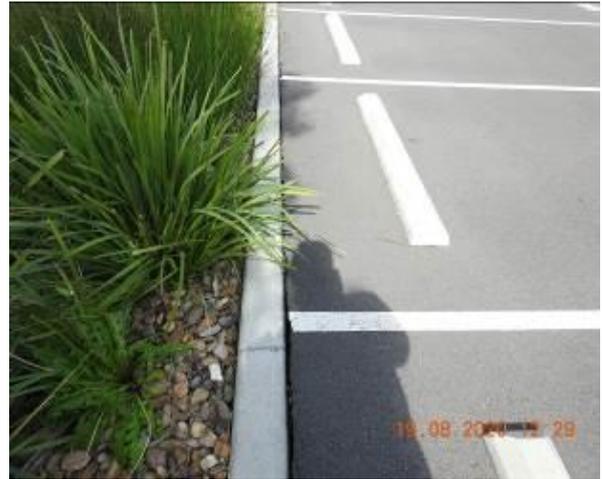
Figure 1864 – Crack propagation through car park kerb

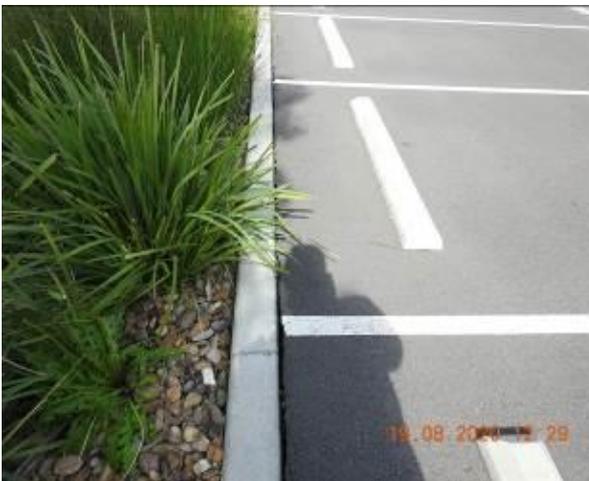
Figure 1865 – Crack propagation through car park kerb

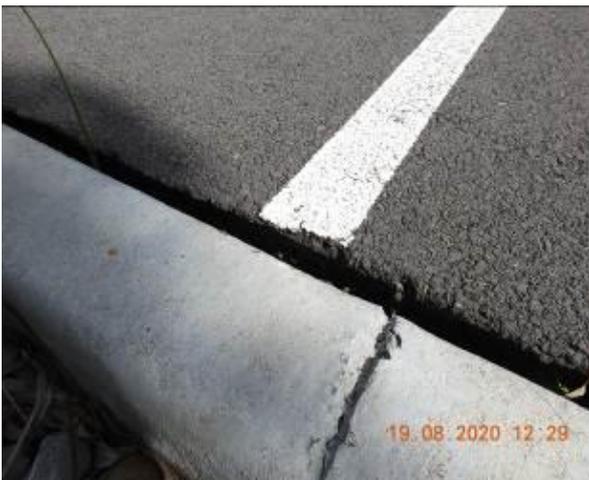
Figure 1867 – Separation through Crack propagation through car park kerb

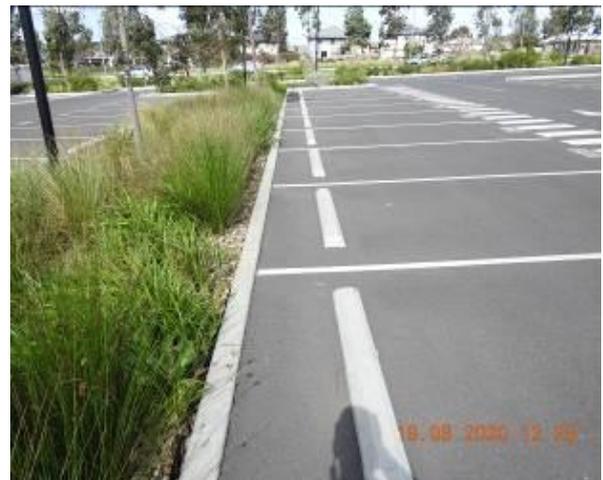
Figure 1868 – Crack propagation through car park kerb

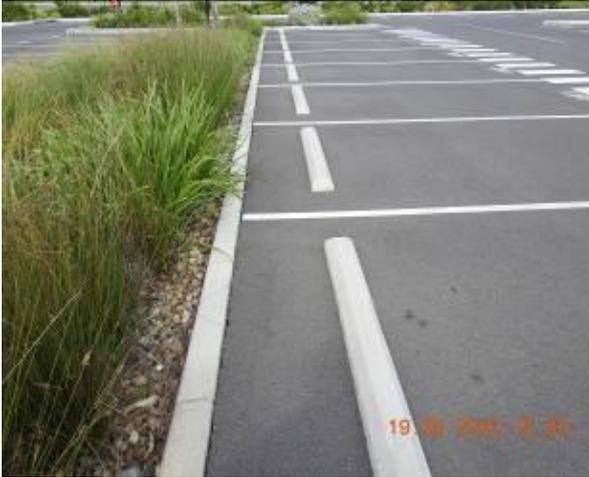
Figure 1869 – Crack propagation through car park kerb

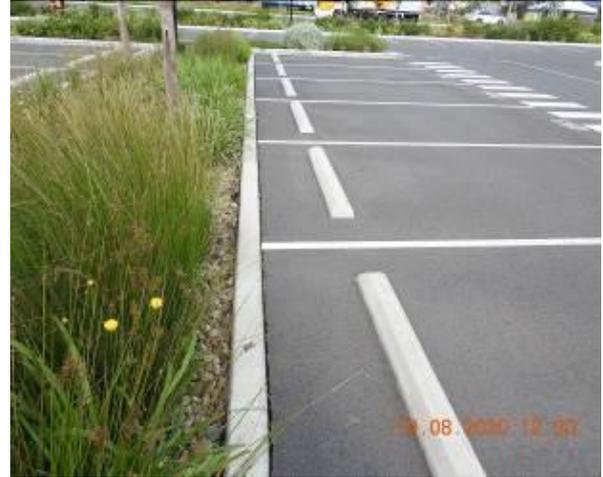
Figure 1870 – Crack propagation through car park kerb

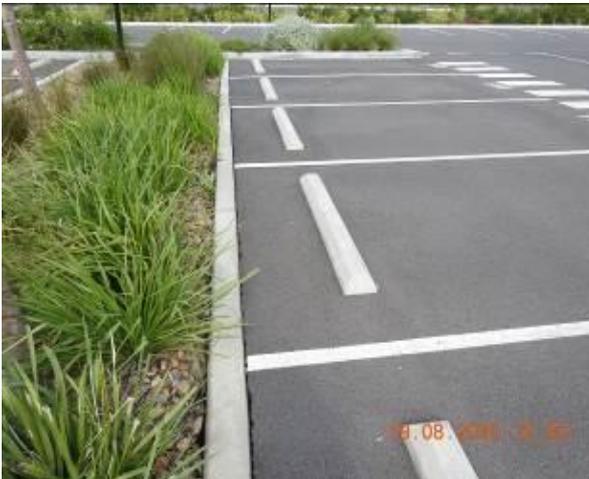
Figure 1871 – Crack propagation through car park kerb

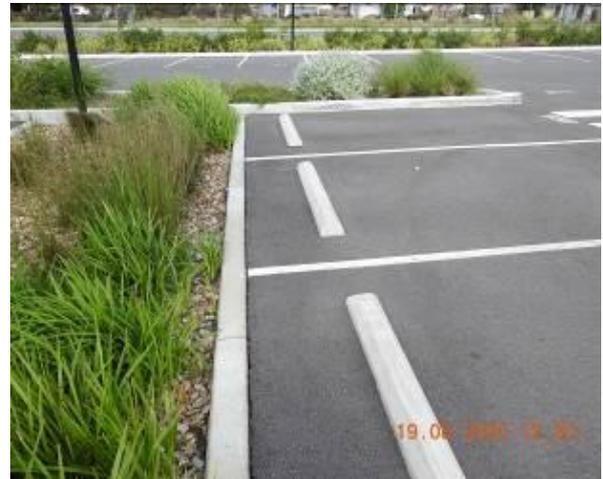
Figure 1872 – Crack propagation through car park kerb

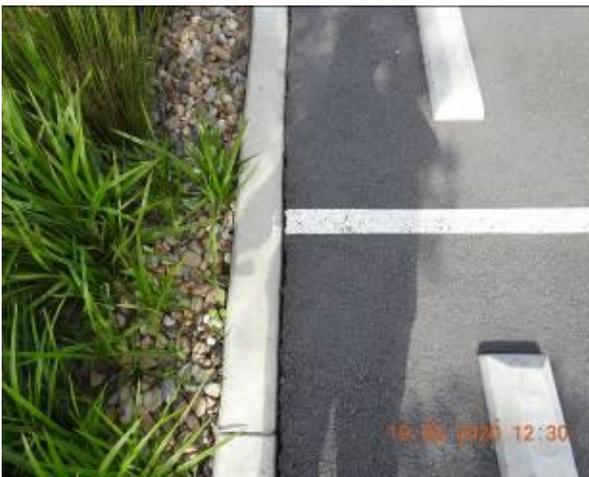
Figure 1873 – Crack propagation through car park kerb

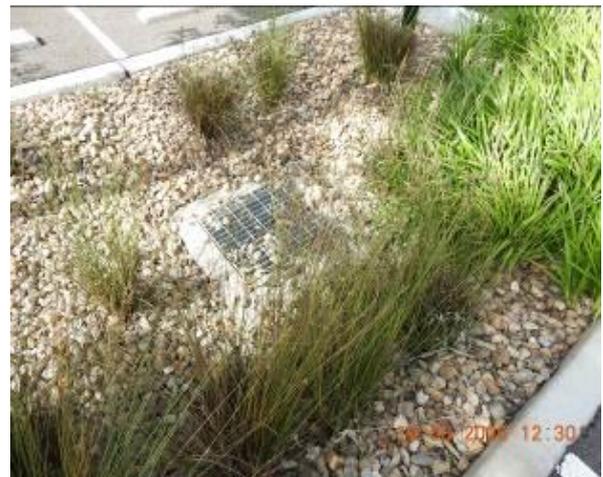
Figure 1874 – General condition of stormwater inlet pit

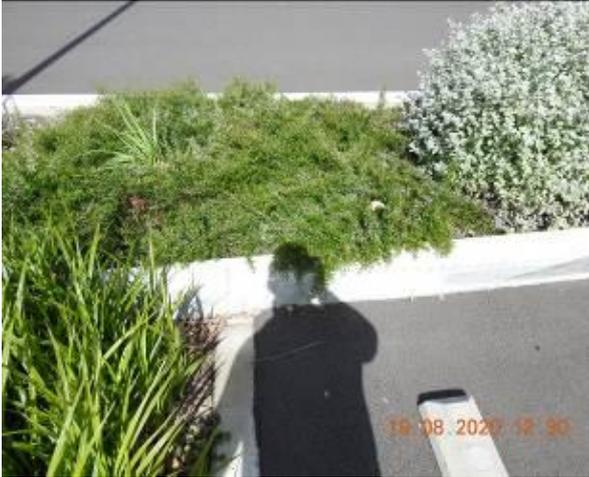
Figure 1875 – Crack propagation through car park kerb

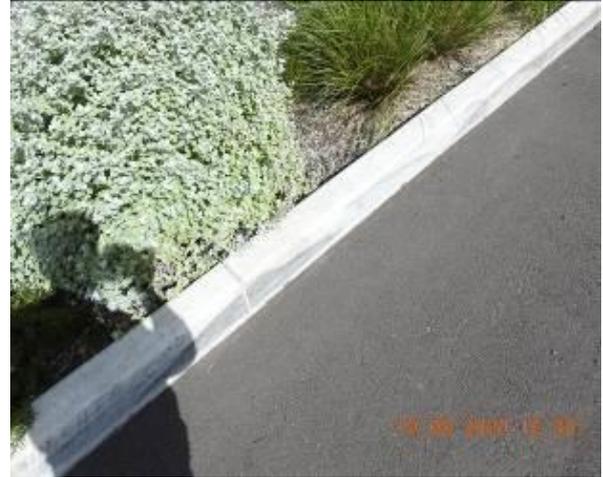
Figure 1876 – Crack propagation through car park kerb

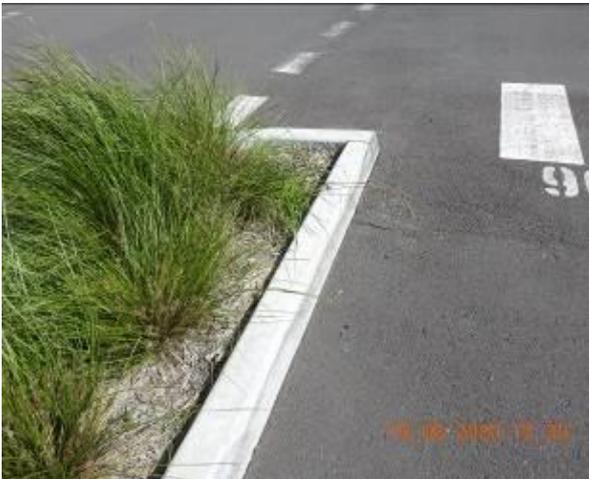
Figure 1877 – General condition of car park kerb

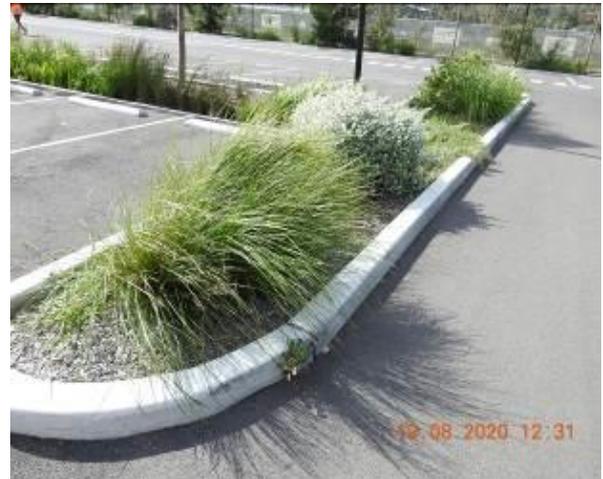
Figure 1878 – General condition of car park kerb

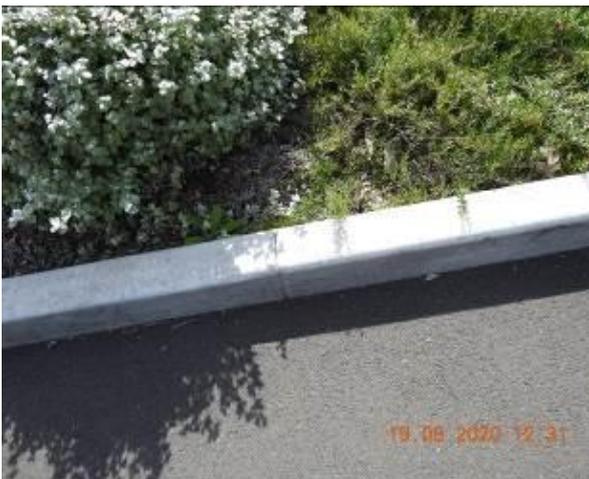
Figure 1879 – Crack propagation through car park kerb

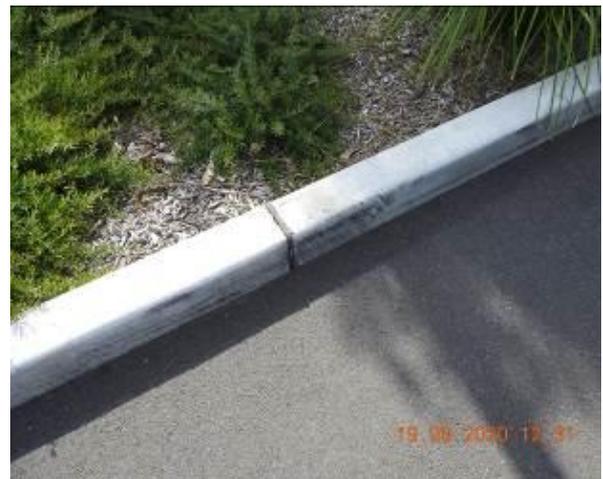
Figure 1880 – General condition of car park kerb

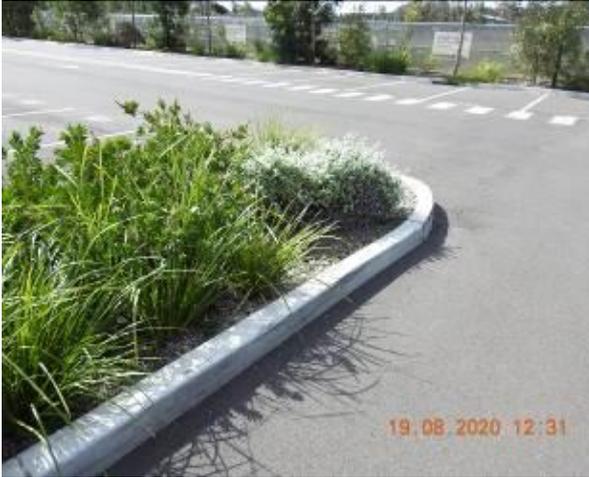
Figure 1881 – General condition of car park kerb

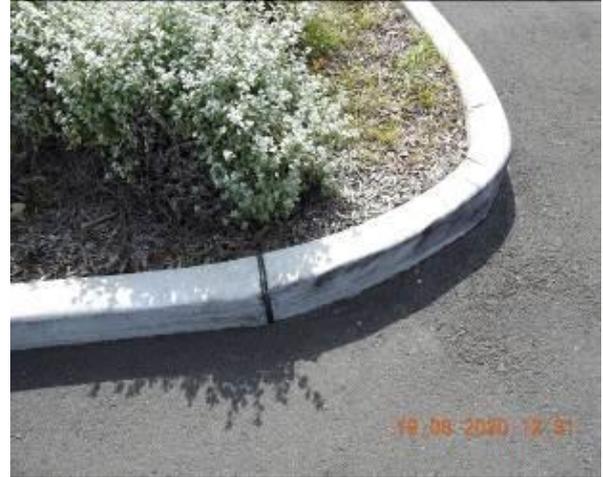
Figure 1882 – General condition of car park kerb

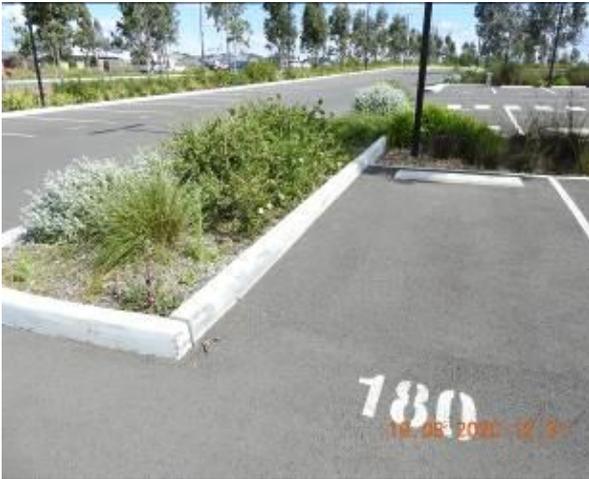
Figure 1883 – General condition of car park kerb

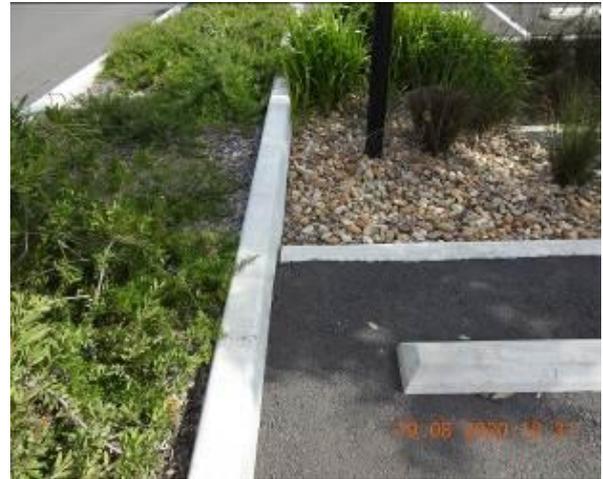
Figure 1884 – General condition of car park kerb

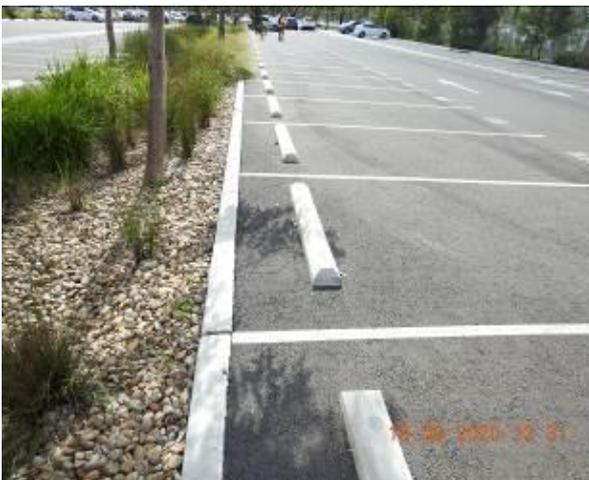
Figure 1885 – General condition of car park kerb

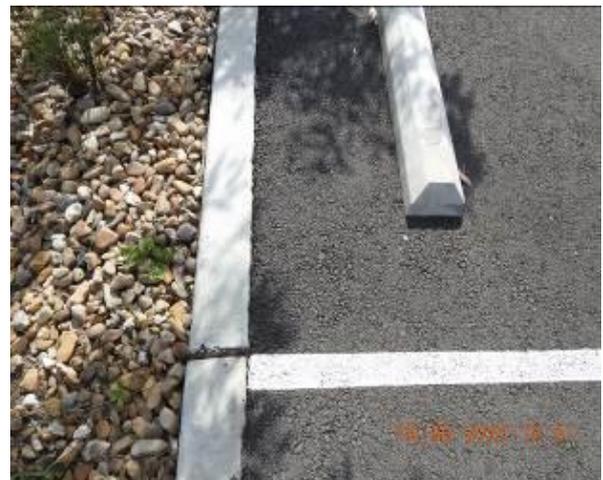
Figure 1886 – General condition of car park kerb

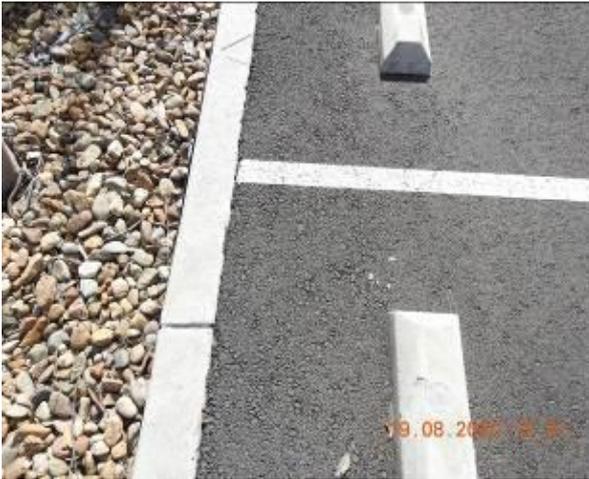
Figure 1887 – Crack propagation through car park kerb

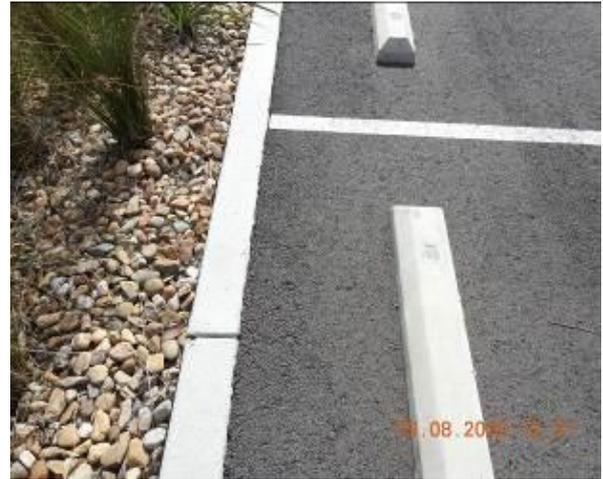
Figure 1888 – Crack propagation through car park kerb

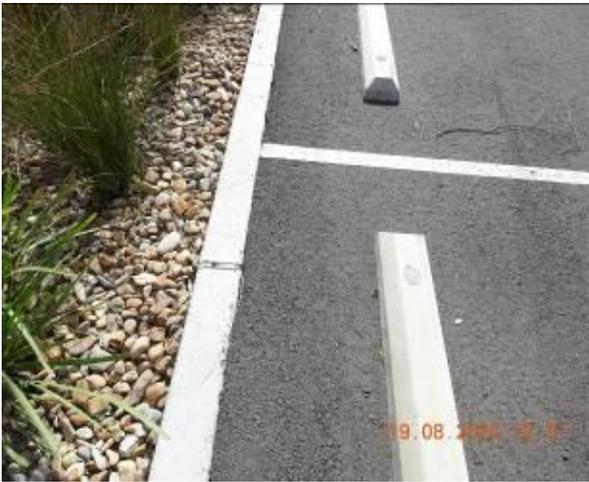
Figure 1889 – General condition of car park kerb

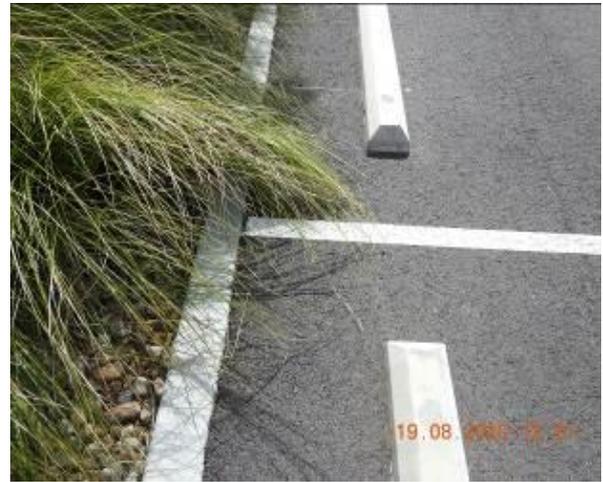
Figure 1890 – Crack propagation through car park kerb

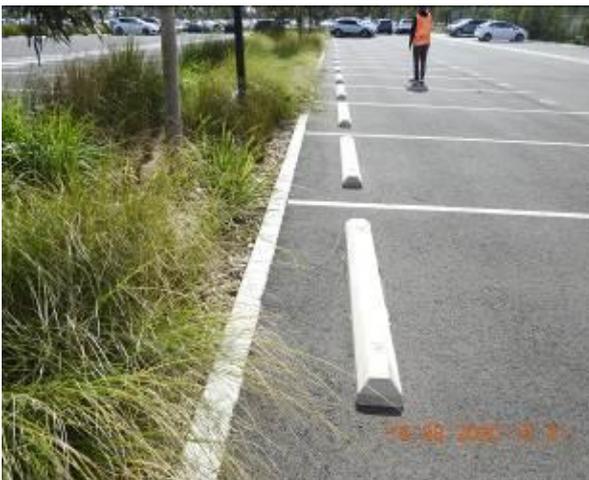
Figure 1891 – General condition of car park kerb

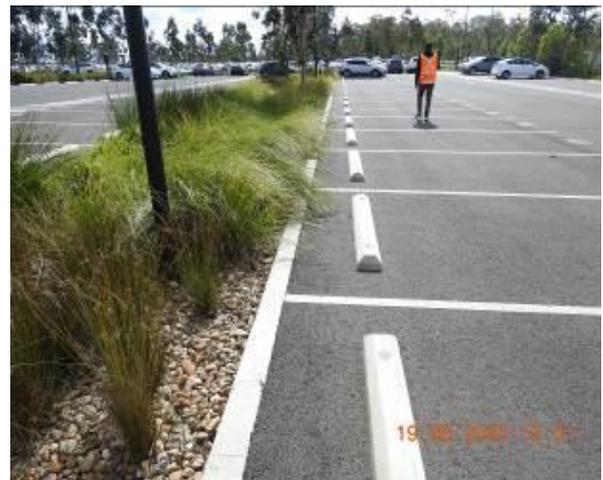
Figure 1892 – General condition of car park kerb

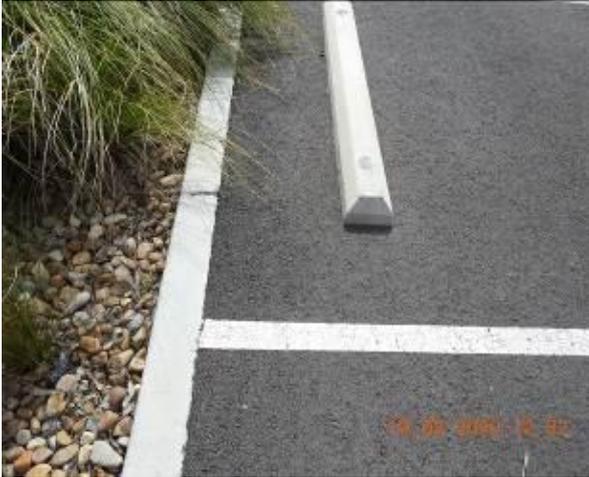
Figure 1893 – Loss of material through car park kerb

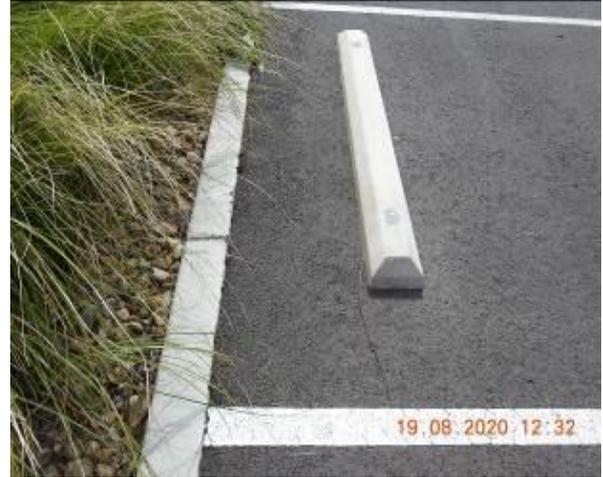
Figure 1894 – General condition of car park kerb

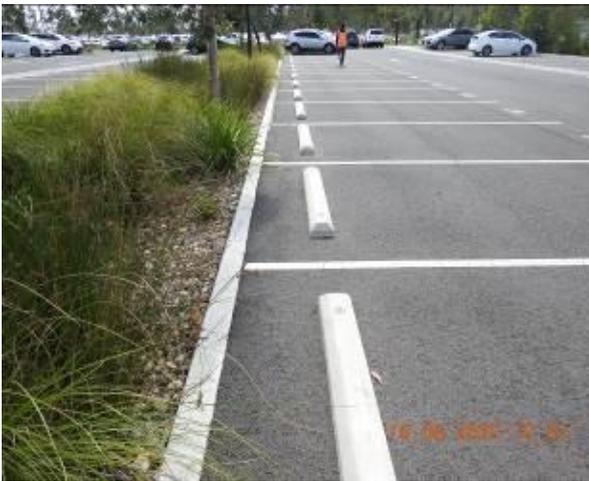
Figure 1895 – General condition of car park kerb

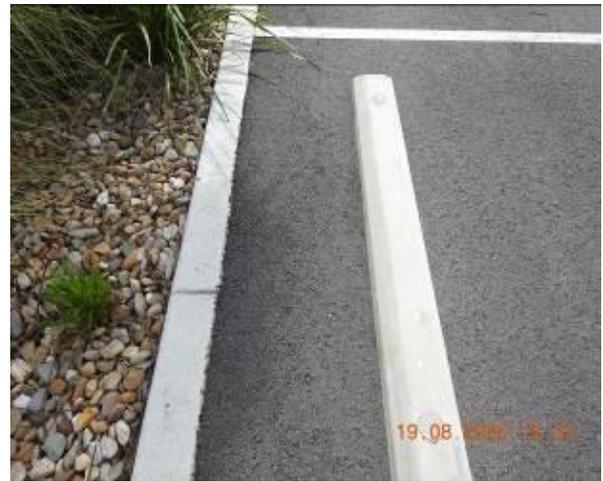
Figure 1896 – Crack propagation through car park kerb

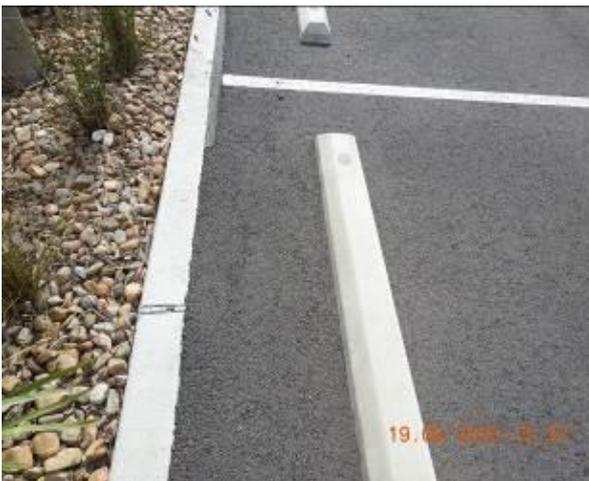
Figure 1897 – General condition of car park kerb

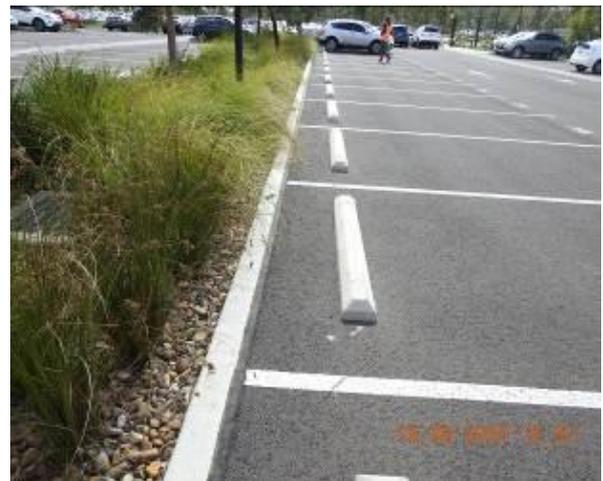
Figure 1898 – General condition of car park kerb

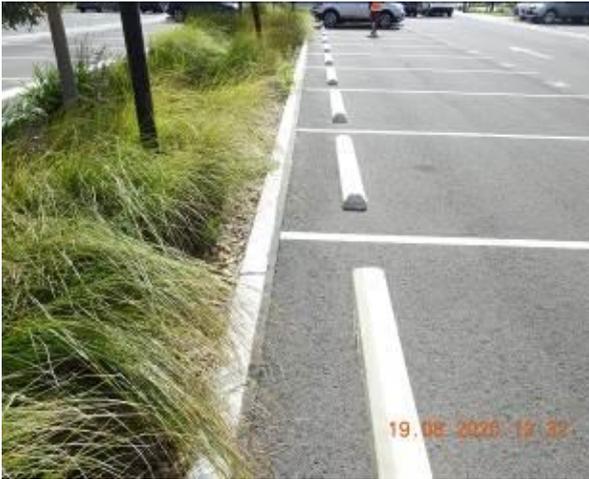
Figure 1899 – General condition of car park kerb

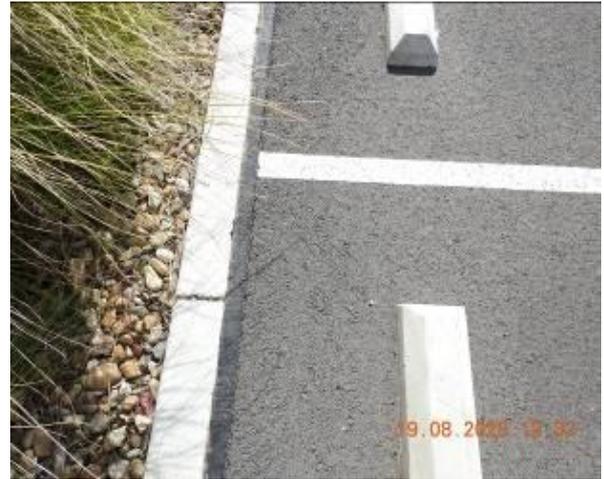
Figure 1900 – General condition of car park kerb
