The property Tallawong station – P2 Car Park, is the neighbouring property to our client’s site. It was photographed and inspected prior to any construction works on the subject site and was found to be in a reasonable condition. The property serves as a car park.

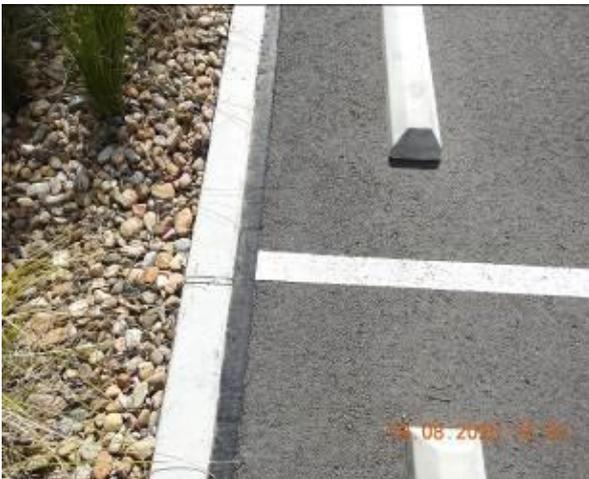
Figure 1901 – General condition of car park kerb

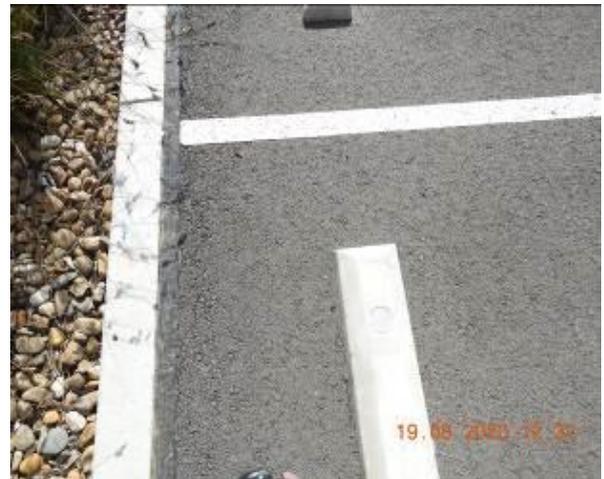
Figure 1902 – General condition of car park kerb

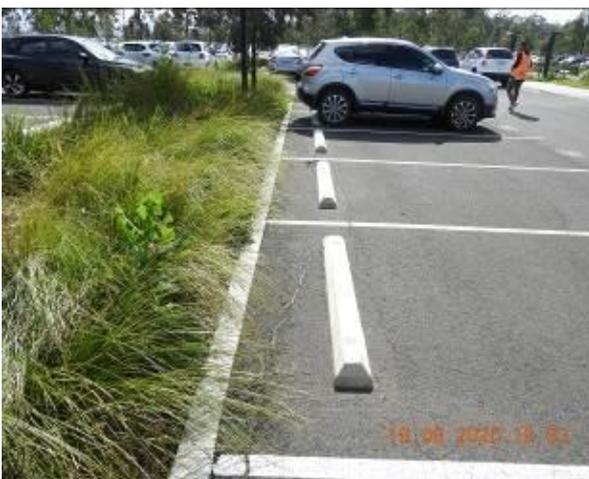
Figure 1903 – General condition of car park kerb

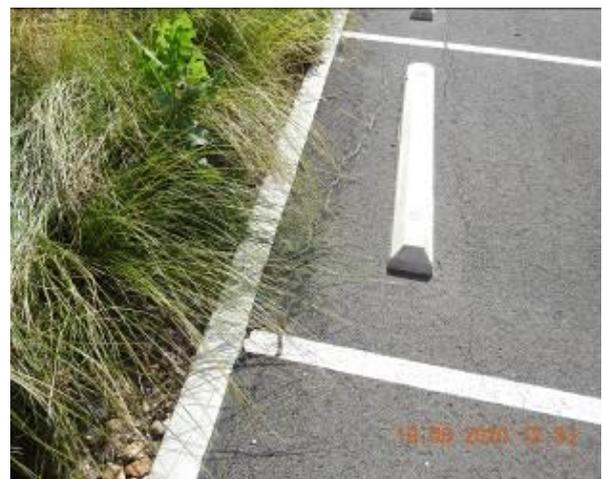
Figure 1904 – General condition of car park kerb and evidence of patchwork through carpark pavement

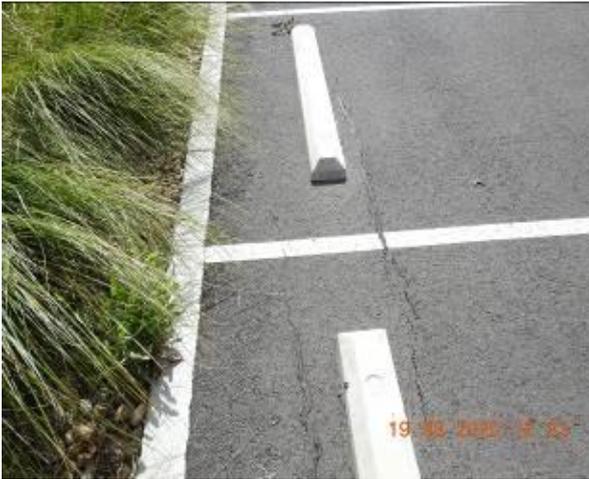
Figure 1905 – General condition of car park kerb

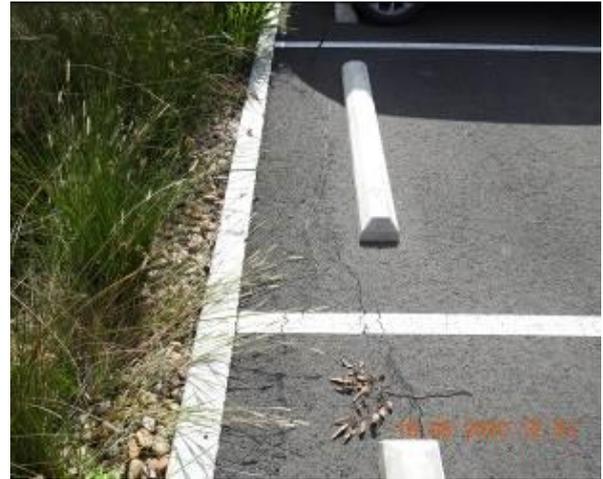
Figure 1906 – General condition of car park kerb and evidence of patchwork through carpark pavement

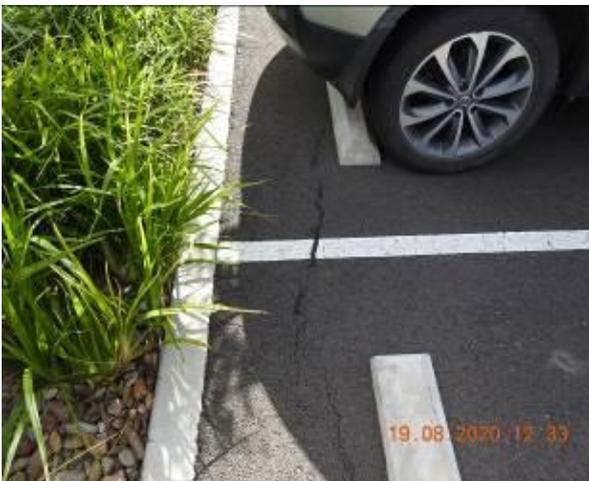
Figure 1907 – General condition of car park kerb and evidence of patchwork through carpark pavement

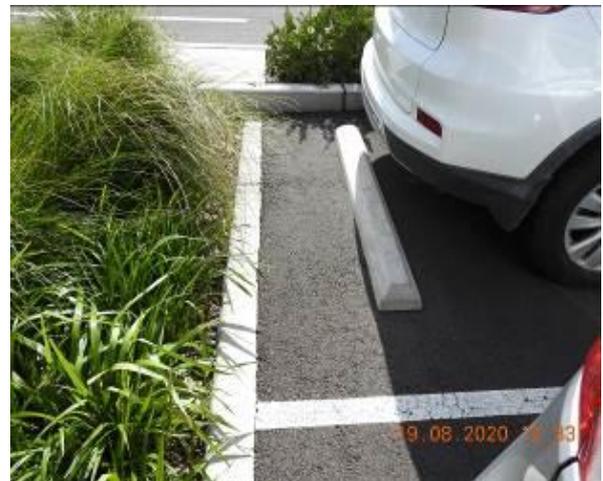
Figure 1908 – General condition of car park kerb

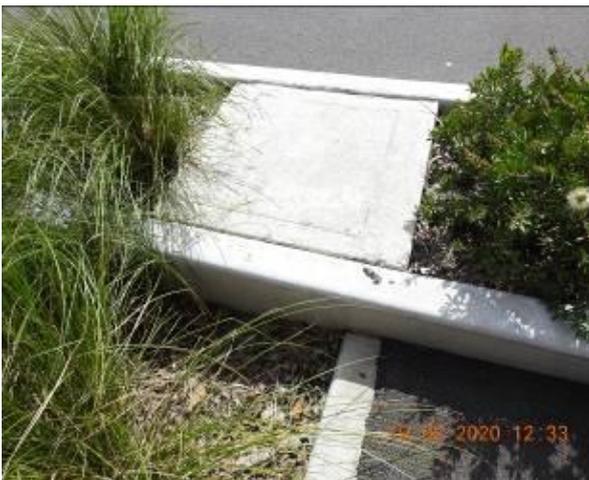
Figure 1909 – General condition of service pit

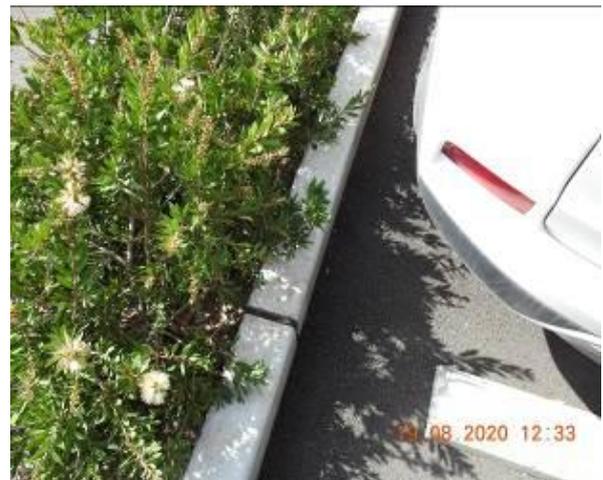
Figure 1910 – General condition of car park kerb

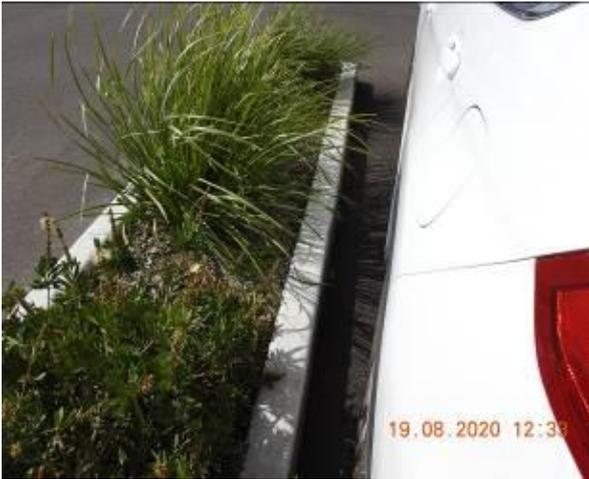
Figure 1911 – General condition of car park kerb

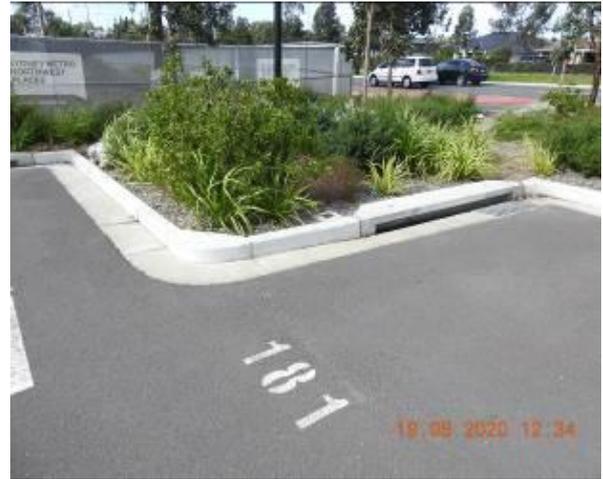
Figure 1912 – General condition of kerb inlet pit and stormwater inlet pit

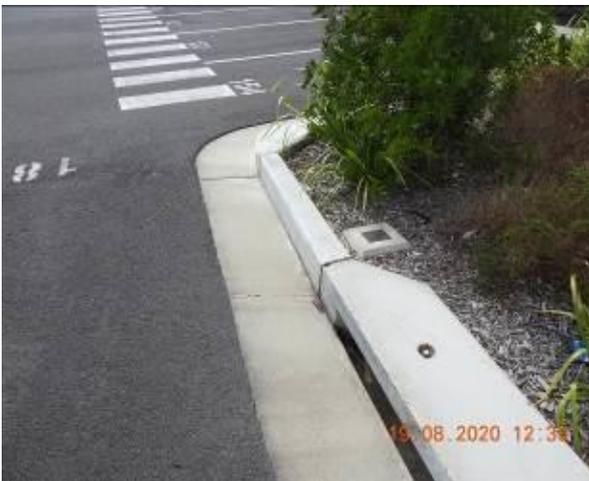
Figure 1913 – General condition of service pit and crack propagation through car park gutter

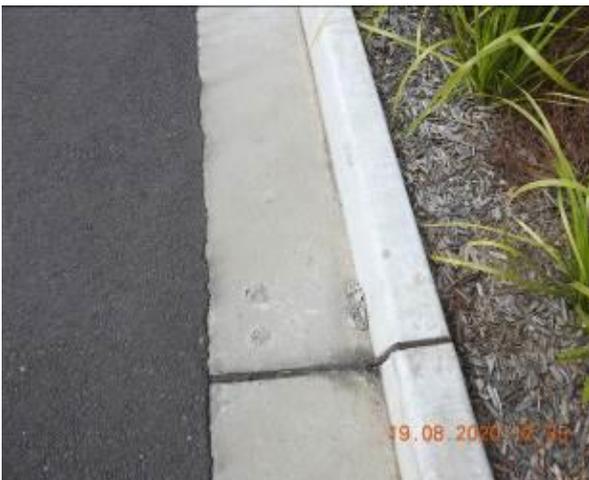
Figure 1915 – General condition of car park kerb and gutter

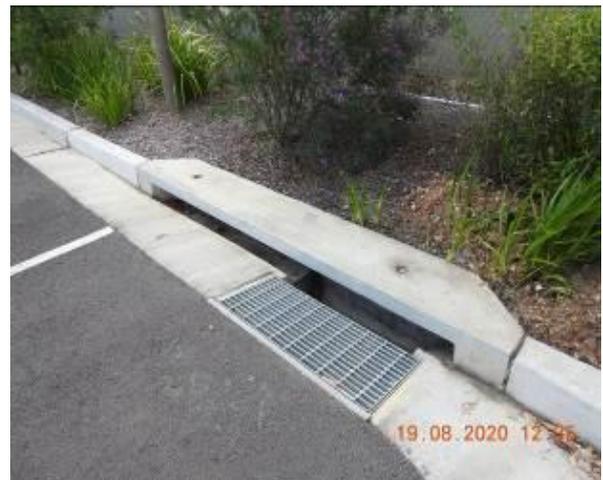
Figure 1916 – General condition of kerb inlet pit and stormwater inlet pit

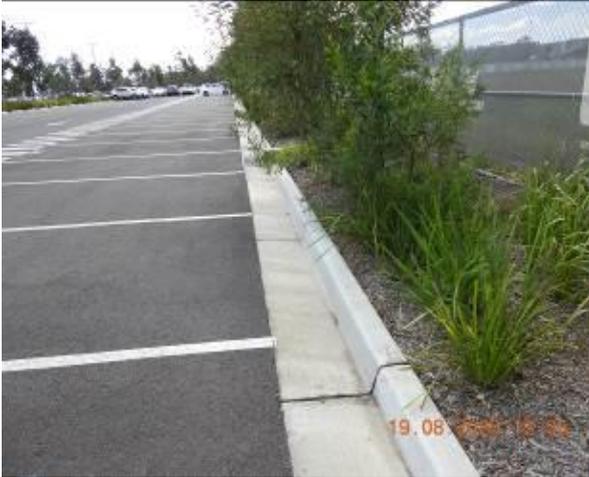
Figure 1917 – General condition of car park kerb and gutter

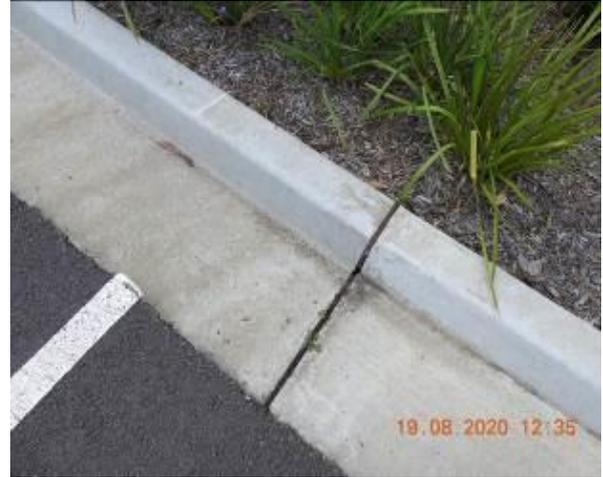
Figure 1918 – General condition of car park kerb

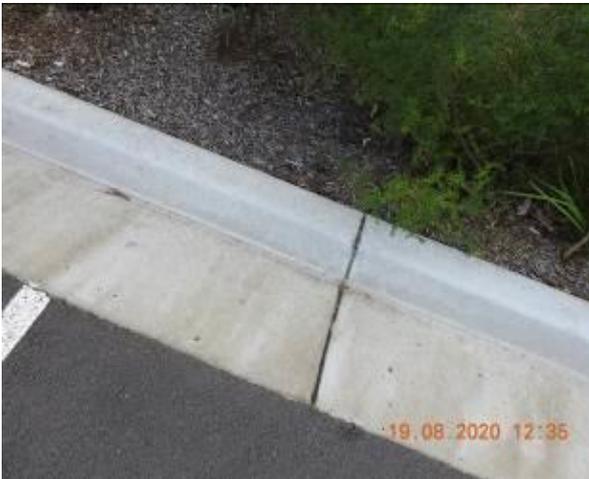
Figure 1919 – Crack propagation through car park kerb

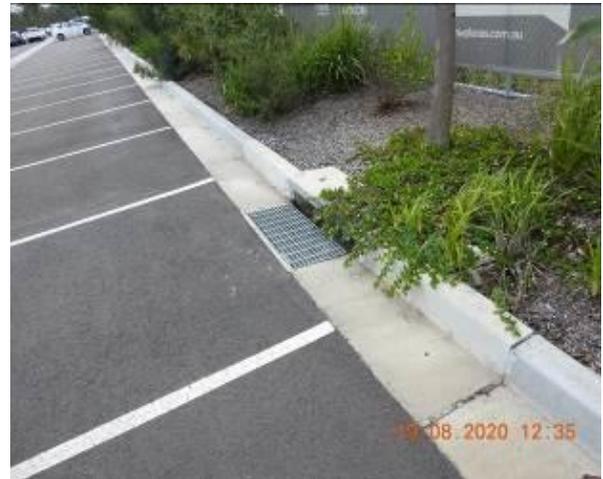
Figure 1920 – General condition of kerb inlet pit and stormwater inlet pit

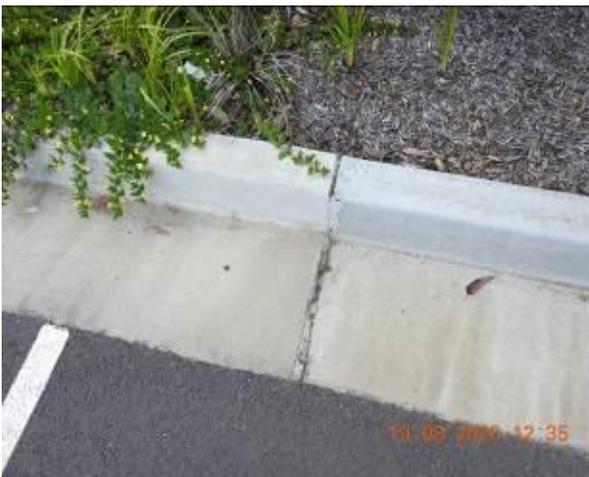
Figure 1921 – Crack propagation through car park kerb and gutter

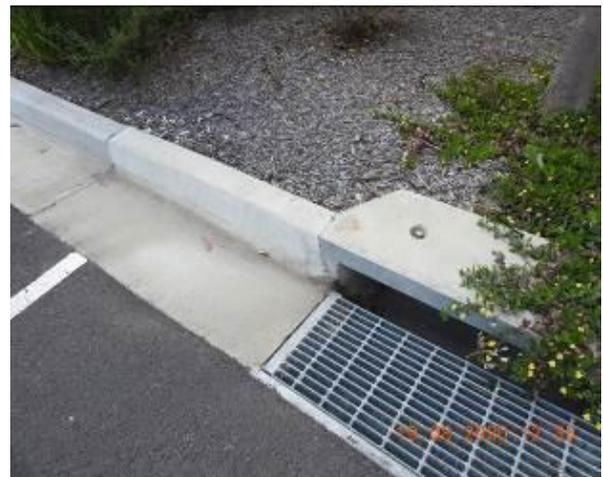
Figure 1922 – General condition of car park kerb and gutter

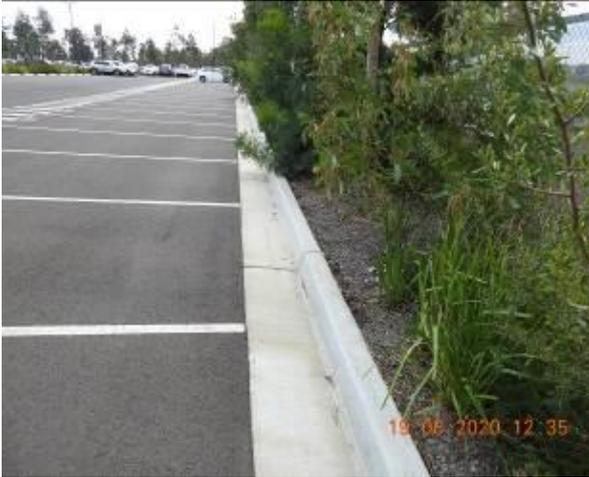
Figure 1923 – General condition of car park kerb and gutter

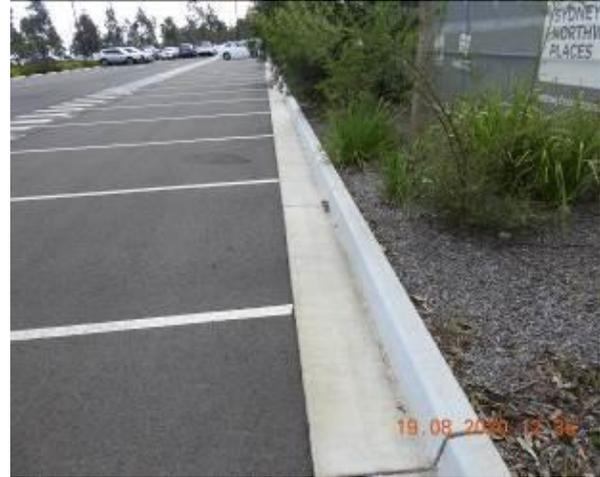
Figure 1924 – General condition of car park kerb and gutter

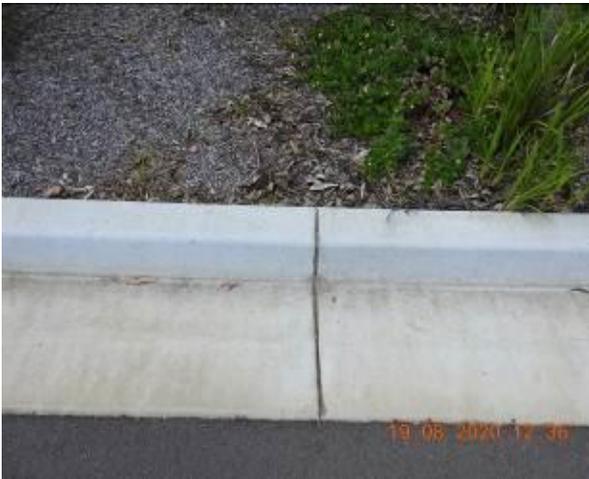
Figure 1925 – Crack propagation through car park kerb

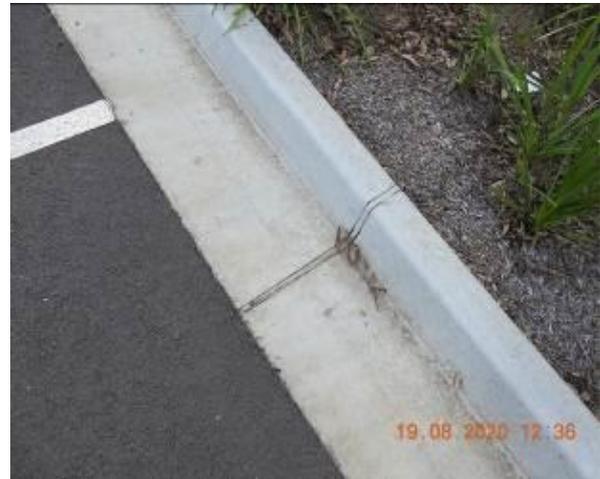
Figure 1926 – General condition of car park kerb and gutter

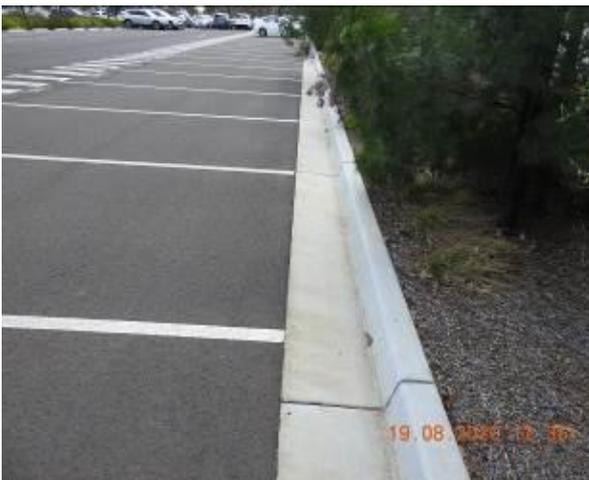
Figure 1927 – General condition of car park kerb and gutter

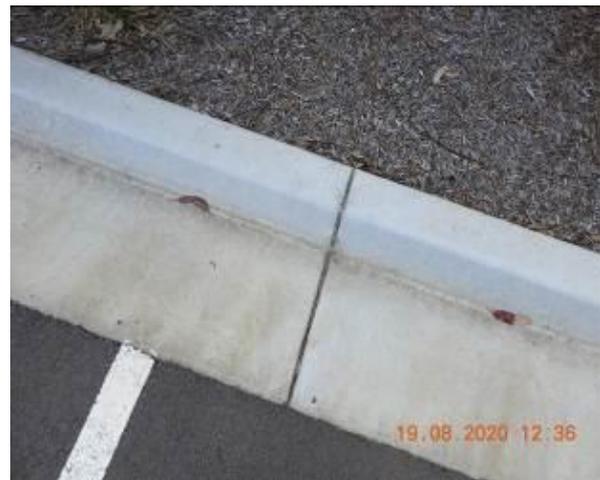
Figure 1928 – Crack propagation through car park kerb

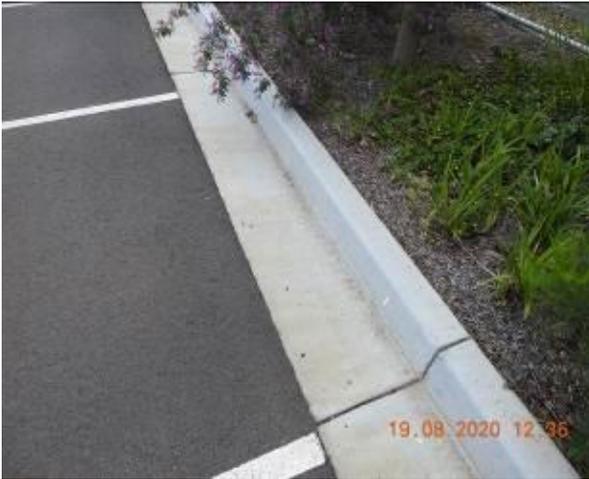
Figure 1929 – General condition of car park kerb and gutter

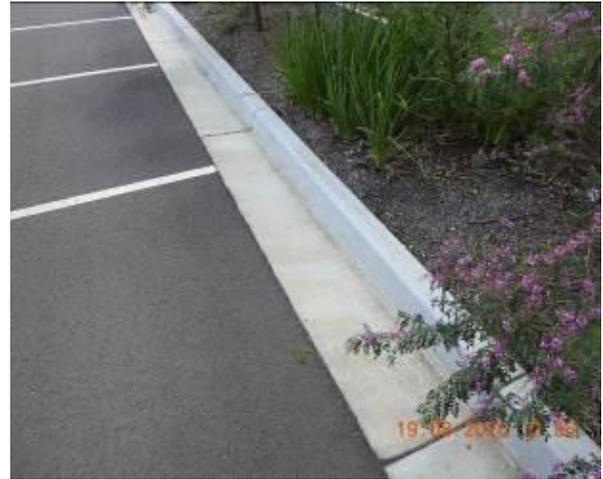
Figure 1930 – General condition of car park kerb and gutter

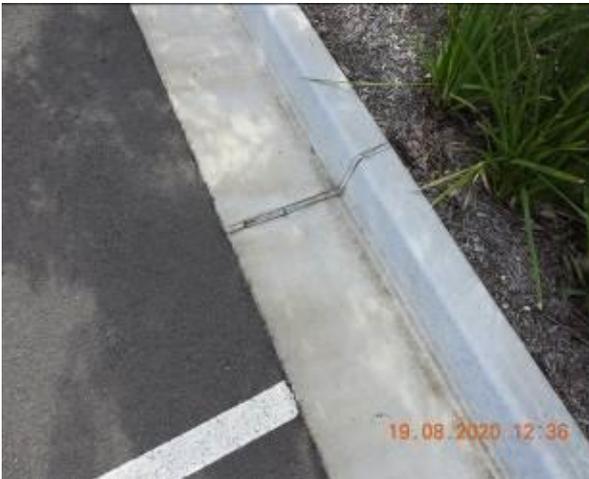
Figure 1931 – Crack propagation through car park kerb and gutter

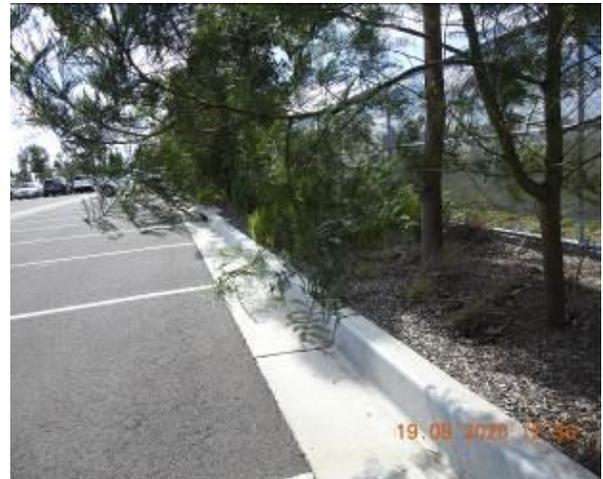
Figure 1932 – General condition of car park kerb and gutter

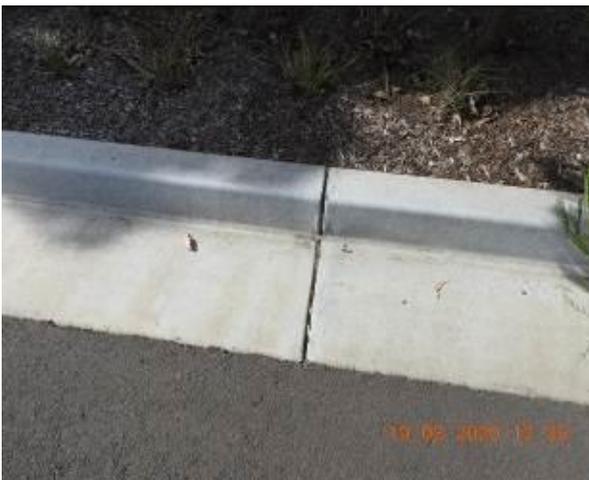
Figure 1933 – General condition of car park kerb and gutter

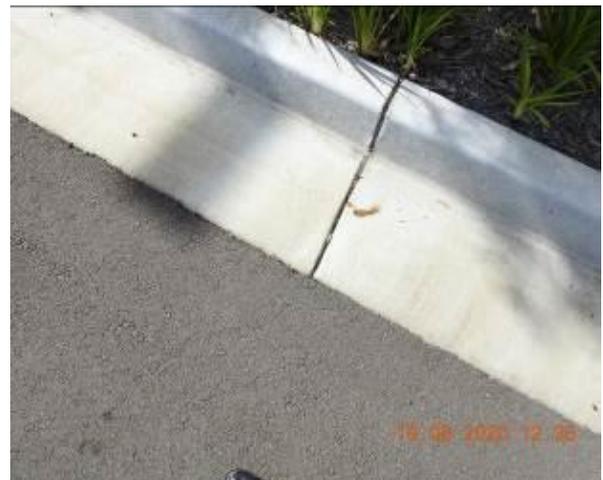
Figure 1934 – Crack propagation through car park kerb

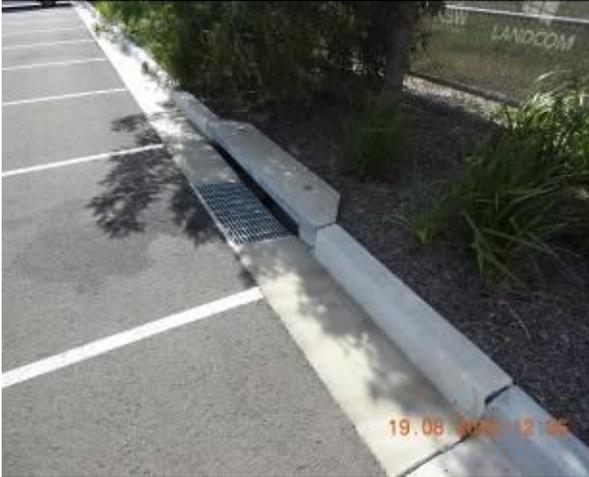
Figure 1935 – General condition of kerb inlet pit and stormwater inlet pit

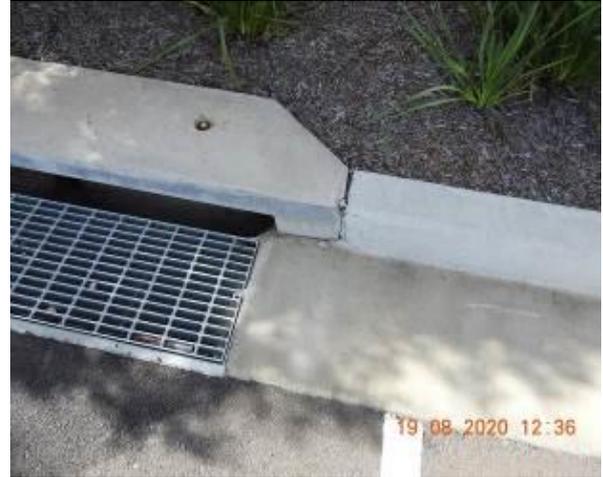
Figure 1936 – Crack propagation and loss of material through car park kerb

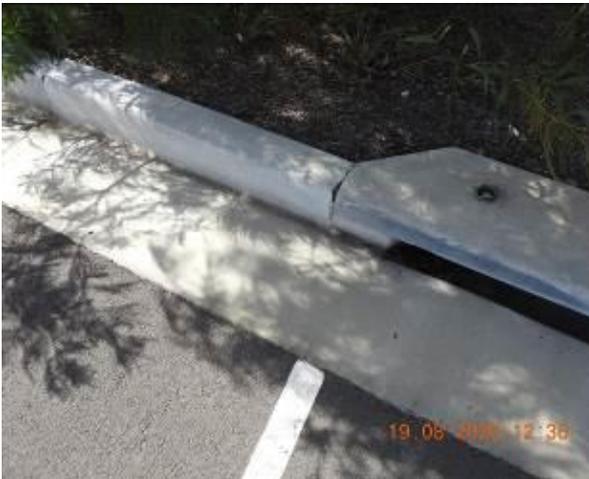
Figure 1937 – General condition of car park kerb and gutter

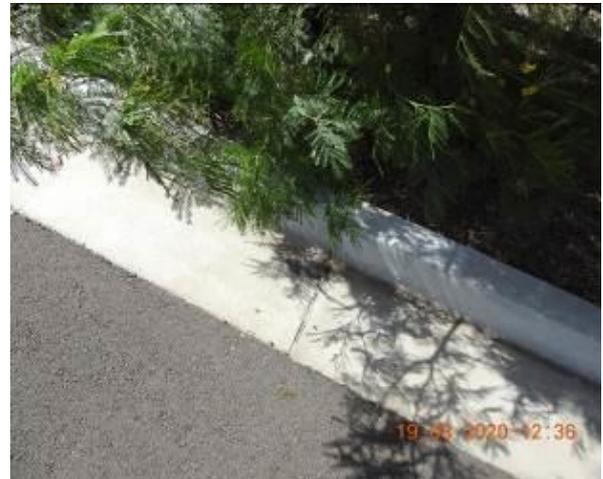
Figure 1938 – General condition of car park kerb and gutter

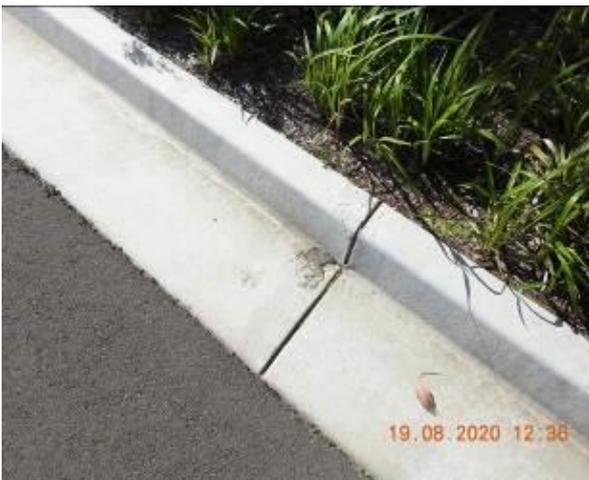
Figure 1939 – General condition of car park kerb and gutter

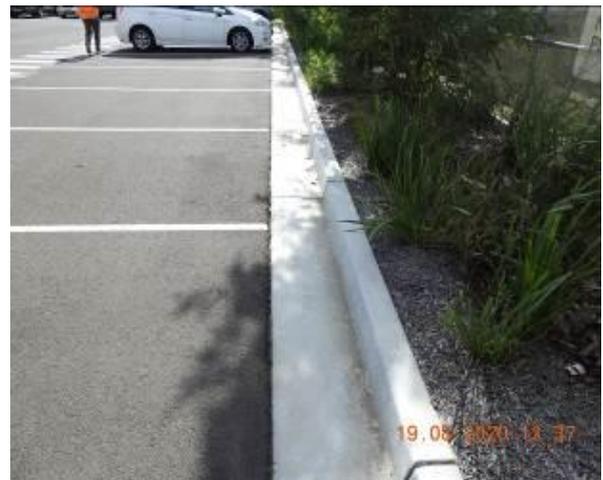
Figure 1940 – General condition of car park kerb and gutter

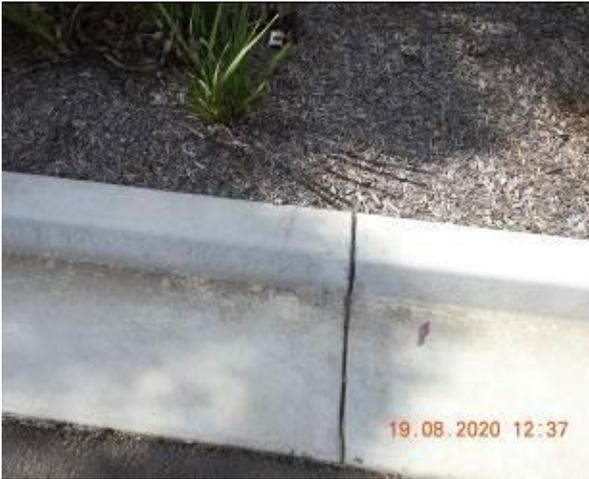
Figure 1941 – Crack propagation through car park kerb

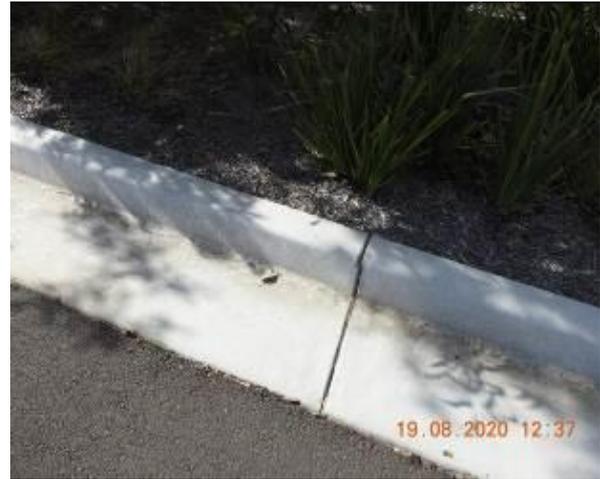
Figure 1942 – Crack propagation through car park kerb

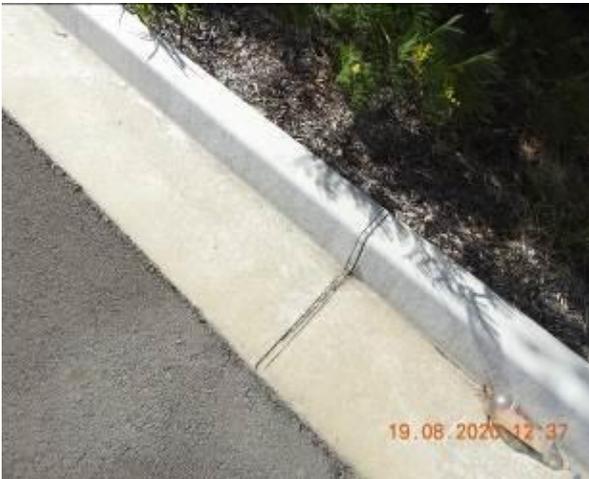
Figure 1943 – Crack propagation through car park gutter

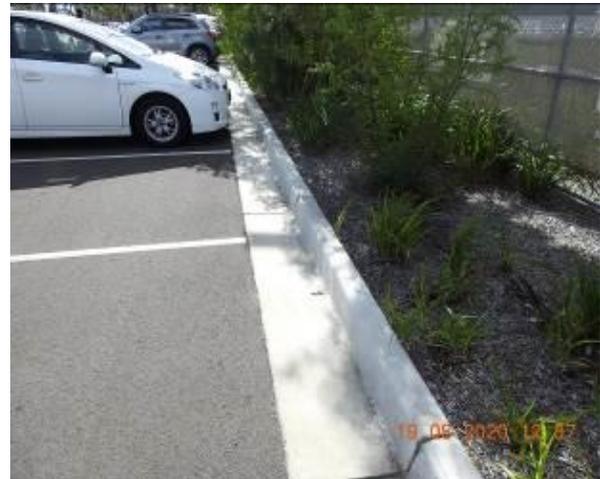
Figure 1944 – General condition of car park kerb and gutter

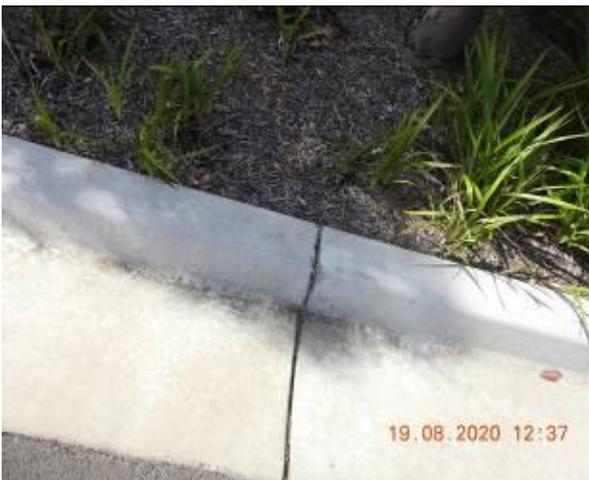
Figure 1945 – Crack propagation through car park gutter

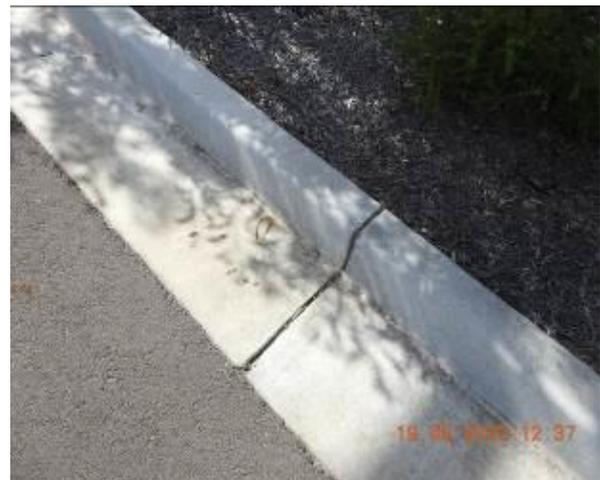
Figure 1946 – General condition of car park kerb and gutter

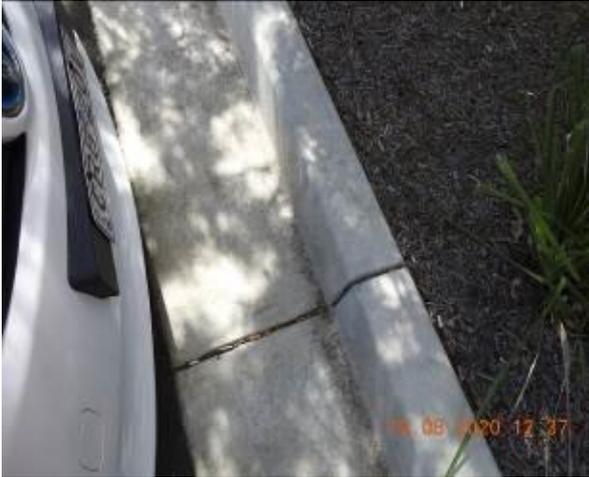
Figure 1947 – General condition of car park kerb and gutter

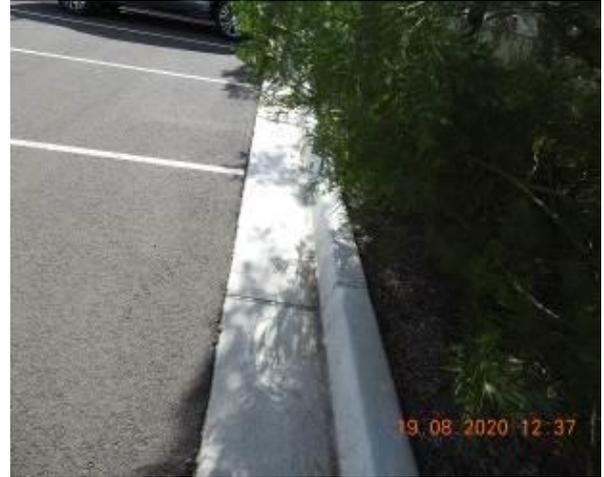
Figure 1948 – General condition of car park kerb and gutter

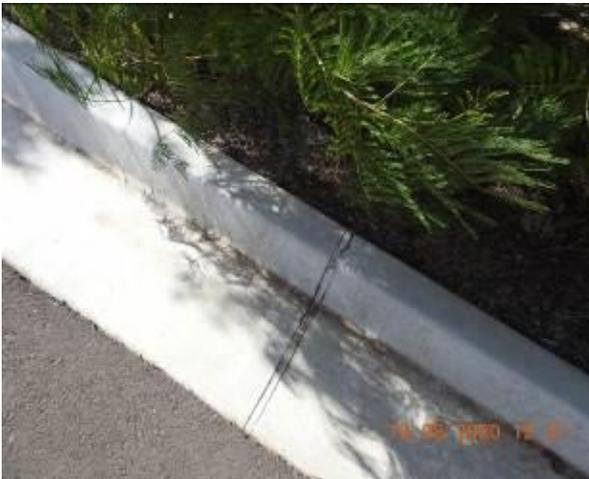
Figure 1949 – Crack propagation through car park kerb

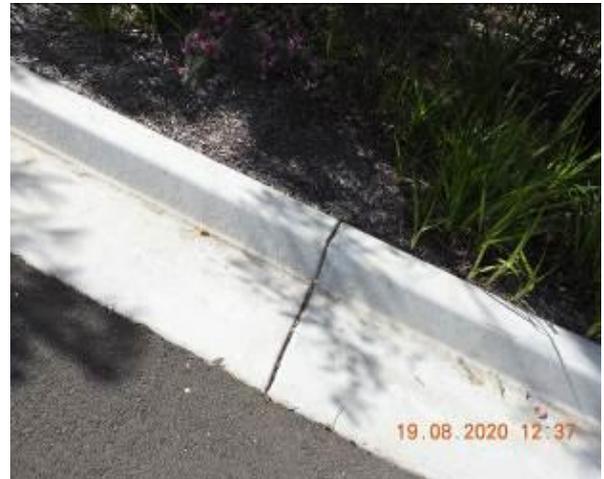
Figure 1950 – General condition of car park kerb and gutter

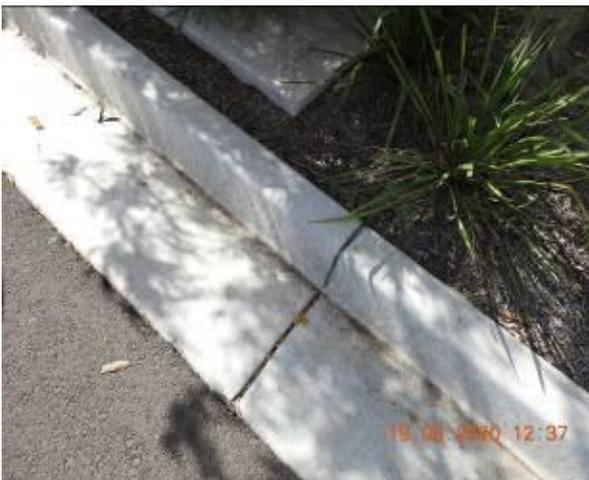
Figure 1951 – Crack propagation through car park kerb

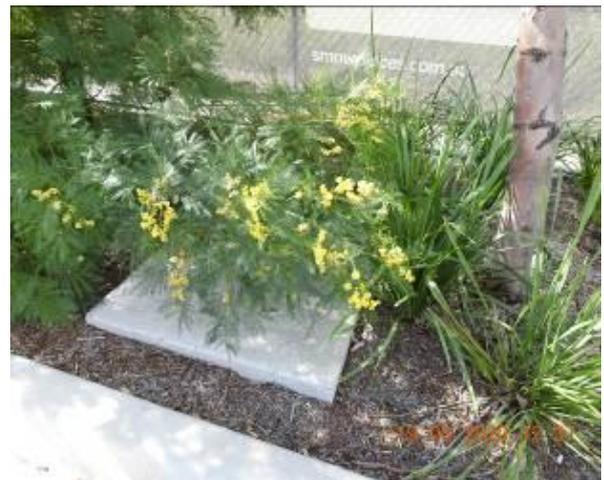
Figure 1952 – General condition of service pit

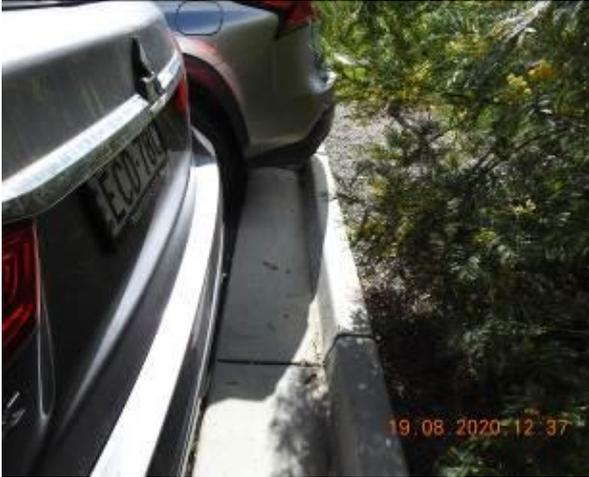
Figure 1953 – General condition of car park kerb and gutter

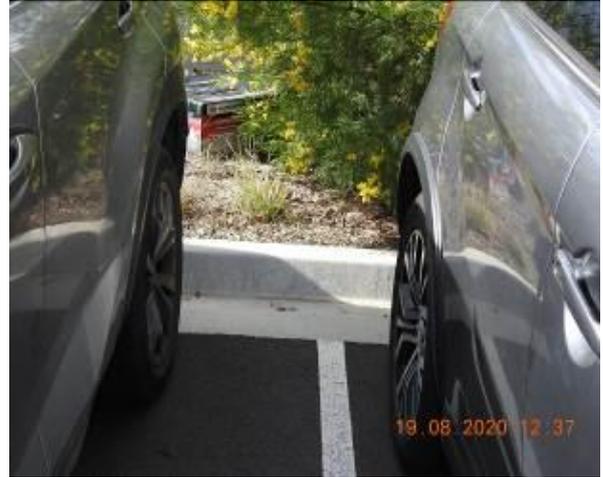
Figure 1954 – General condition of car park kerb and gutter

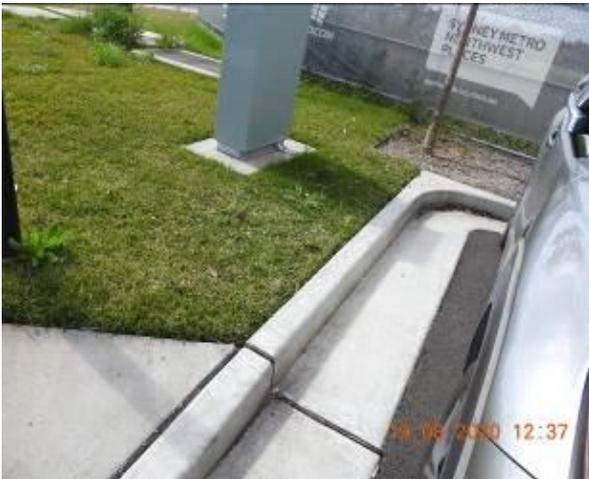
Figure 1955 – General condition of car park kerb and gutter

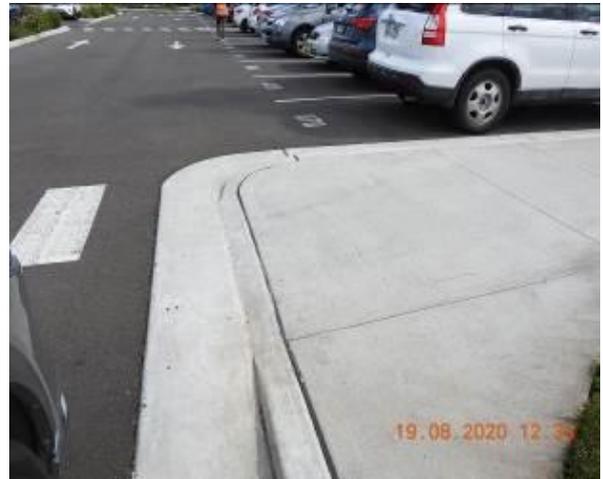
Figure 1956 – General condition of car park layback and gutter

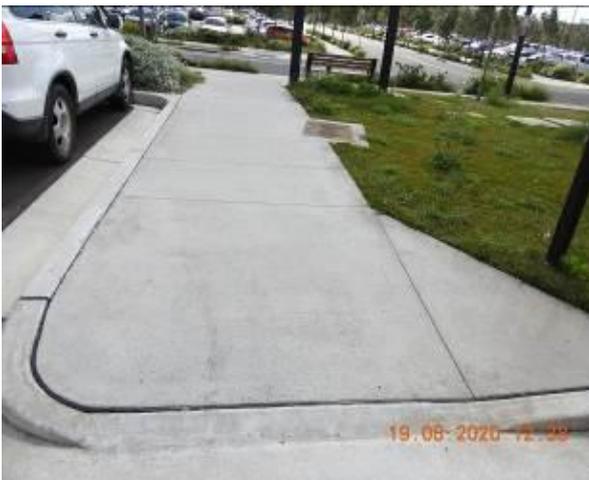
Figure 1957 – General condition of footpath pavement

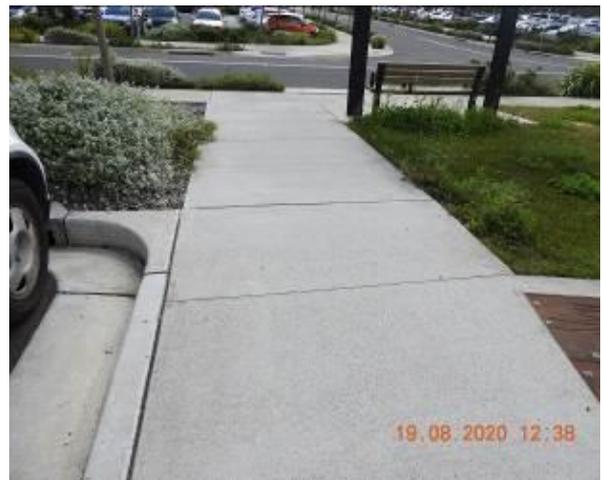
Figure 1958 – General condition of footpath pavement

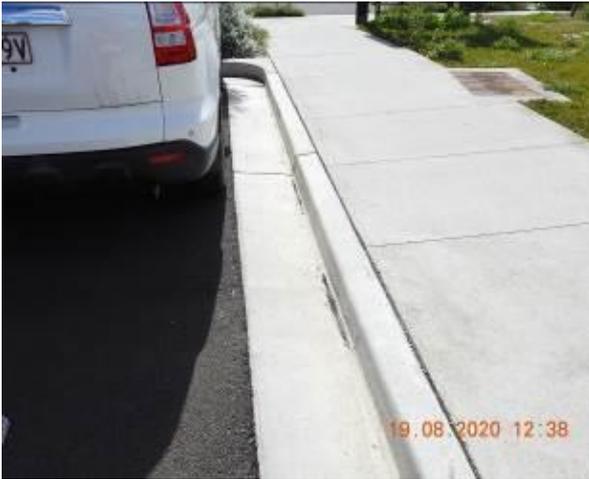
Figure 1959 – General condition of car park kerb and gutter

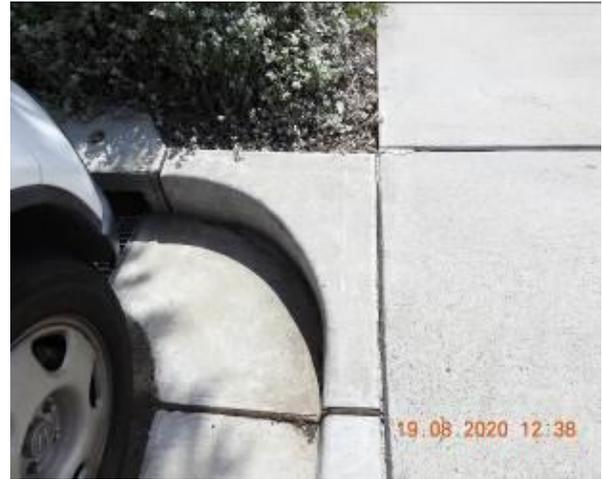
Figure 1960 – General condition of car park kerb and gutter

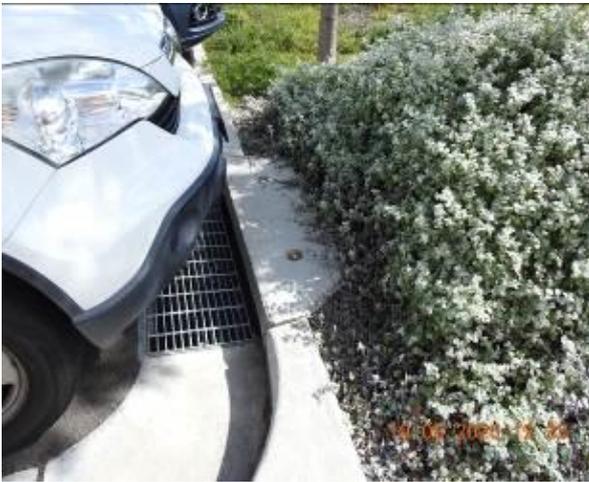
Figure 1961 – General condition of kerb inlet pit and stormwater inlet pit

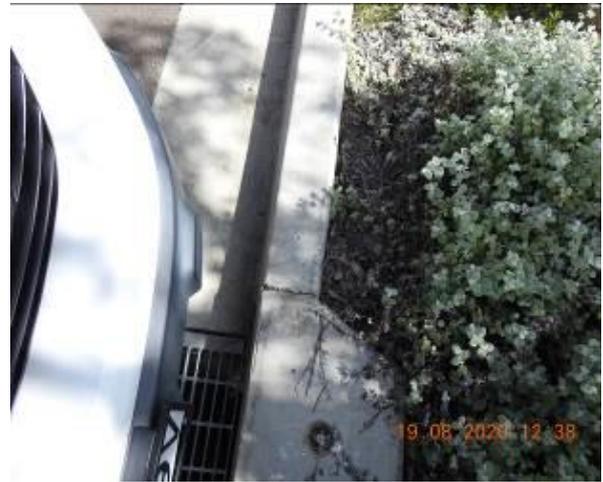
Figure 1962 – General condition of car park kerb and gutter

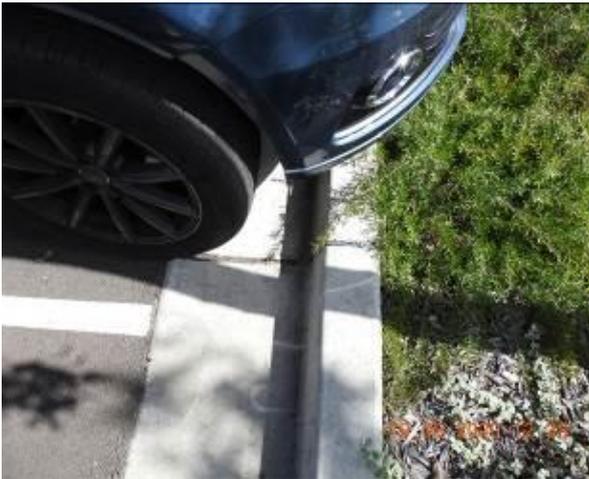
Figure 1963 – General condition of car park kerb and gutter

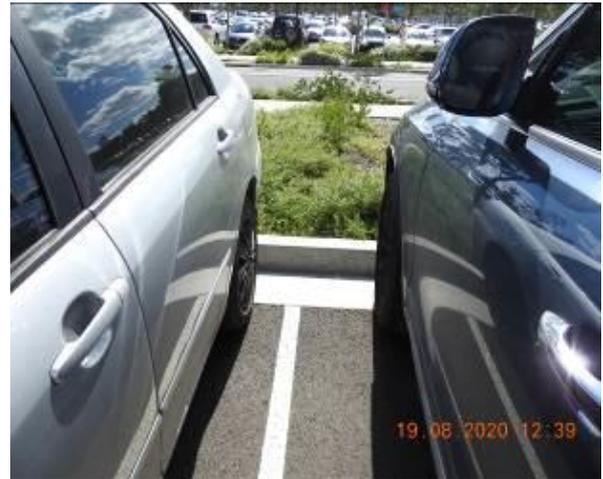
Figure 1964 – General condition of car park kerb and gutter

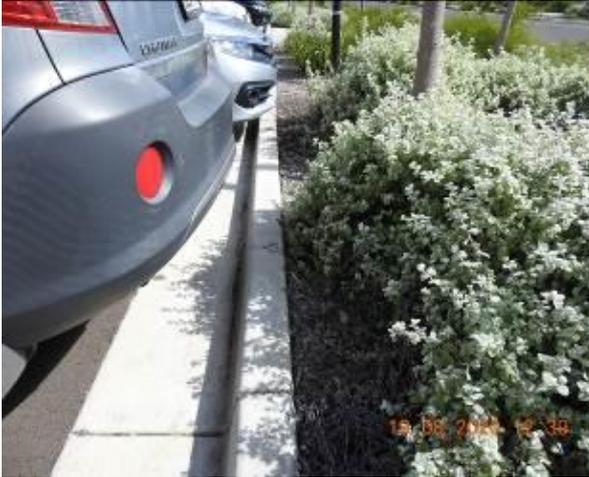
Figure 1965 – General condition of car park kerb and gutter

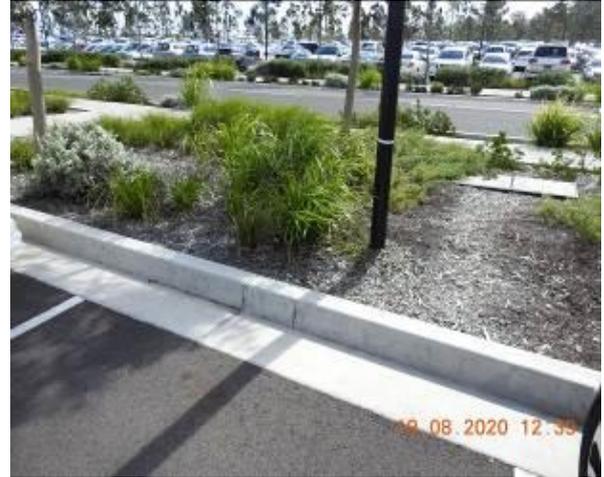
Figure 1966 – General condition of car park kerb and gutter

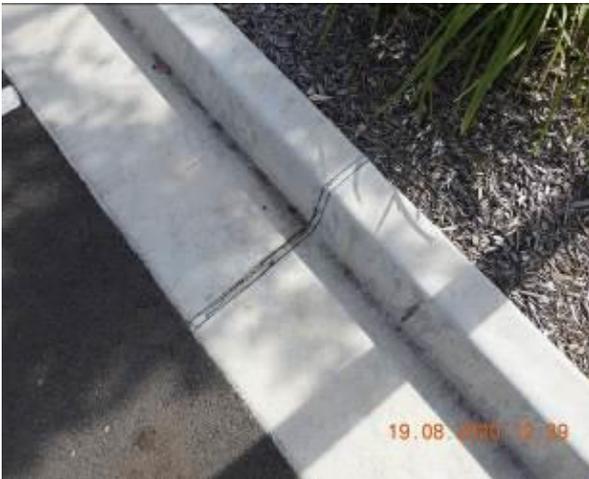
Figure 1967 – Crack propagation through car park kerb and gutter

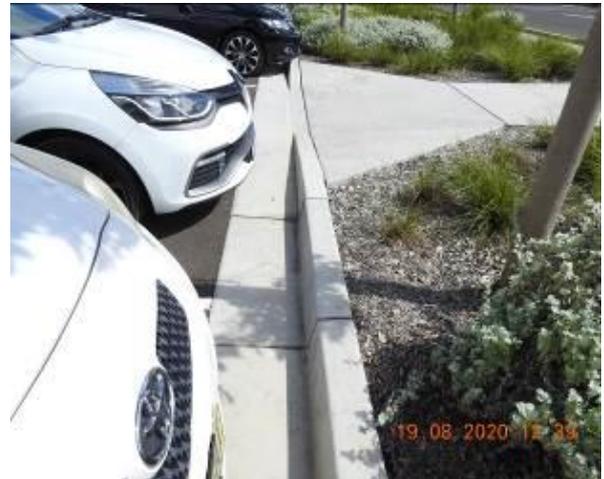
Figure 1968 – General condition of car park kerb and gutter

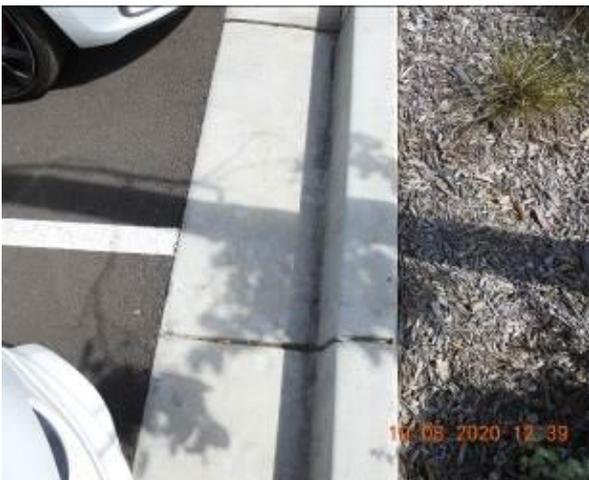
Figure 1969 – General condition of car park kerb and gutter

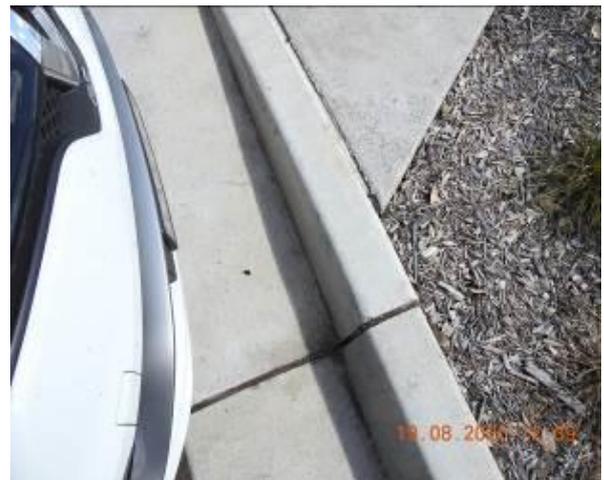
Figure 1970 – General condition of car park kerb and gutter

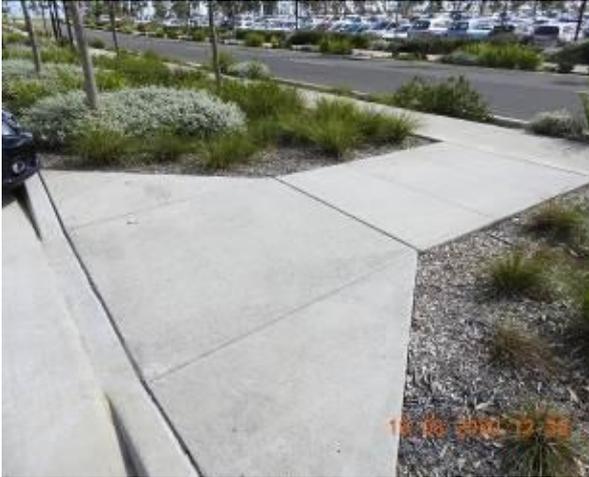
Figure 1971 – General condition of car park layback and gutter

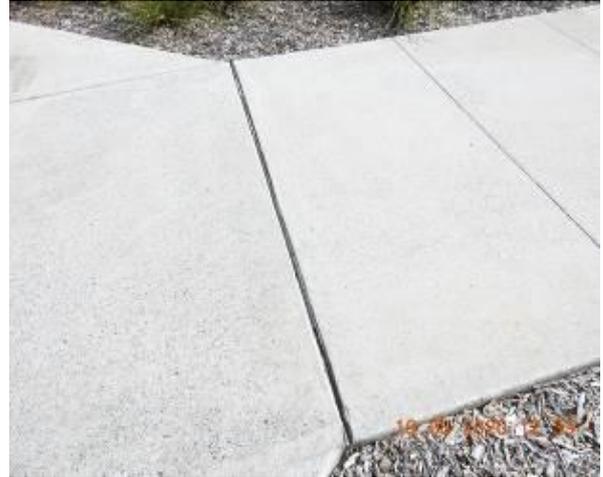
Figure 1972 – General condition of footpath pavement

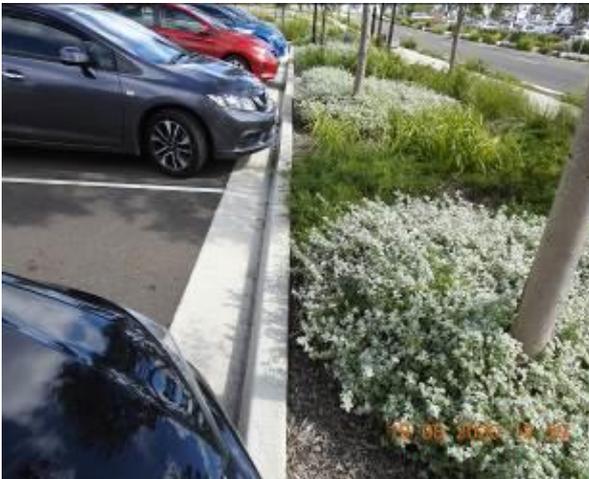
Figure 1973 – General condition of car park kerb and gutter

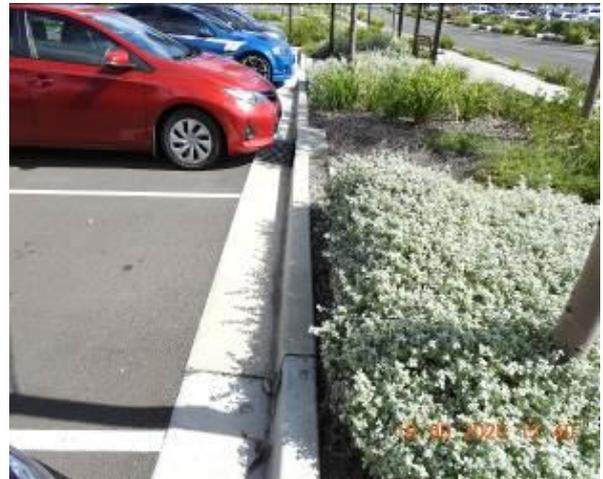
Figure 1974 – General condition of car park kerb and gutter

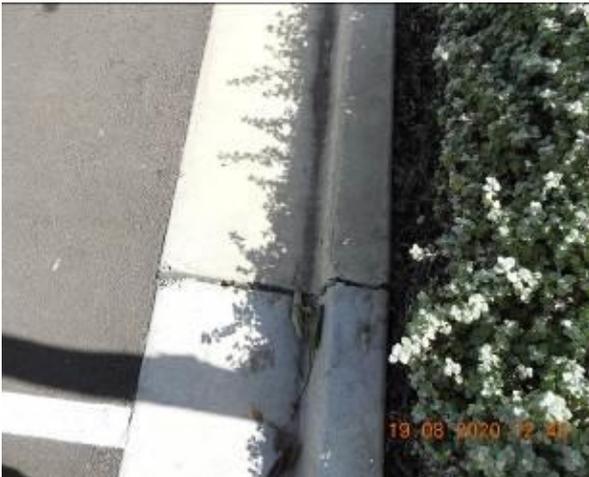
Figure 1975 – Crack propagation and loss of material through car park kerb and gutter

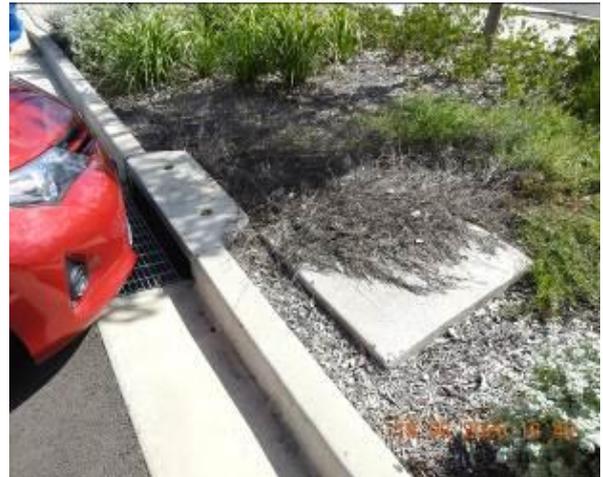
Figure 1976 – General condition of kerb inlet pit and stormwater inlet pit

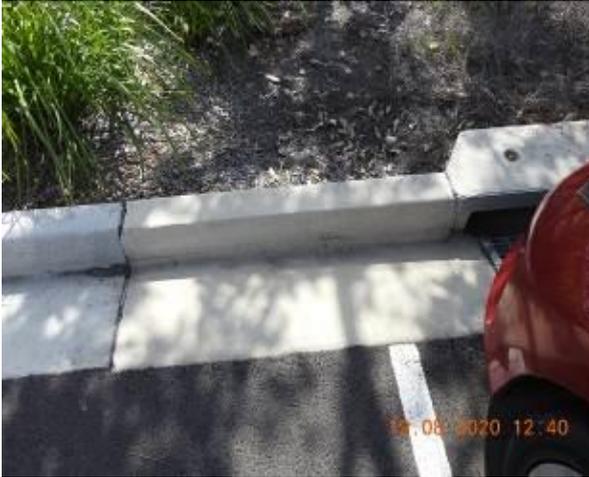
Figure 1977 – General condition of car park kerb and gutter
