The property Tallawong station – P2 Car Park, is the neighbouring property to our client’s site. It was photographed and inspected prior to any construction works on the subject site and was found to be in a reasonable condition. The property serves as a car park.

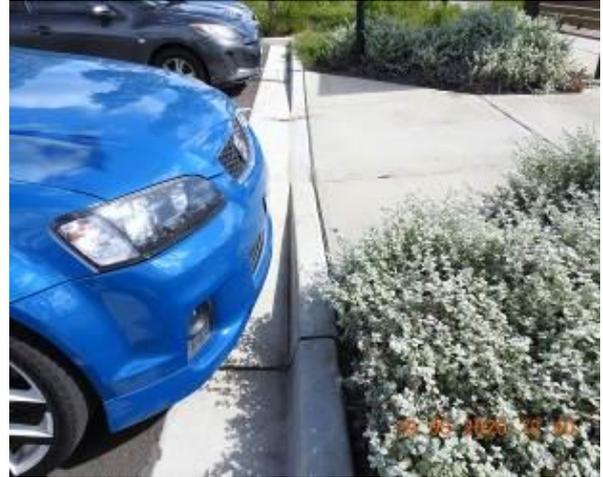
Figure 1978 – General condition of car park kerb and gutter

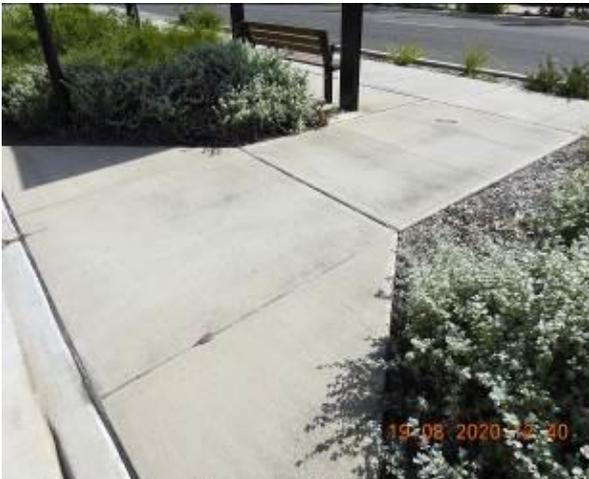
Figure 1979 – General condition of car park layback

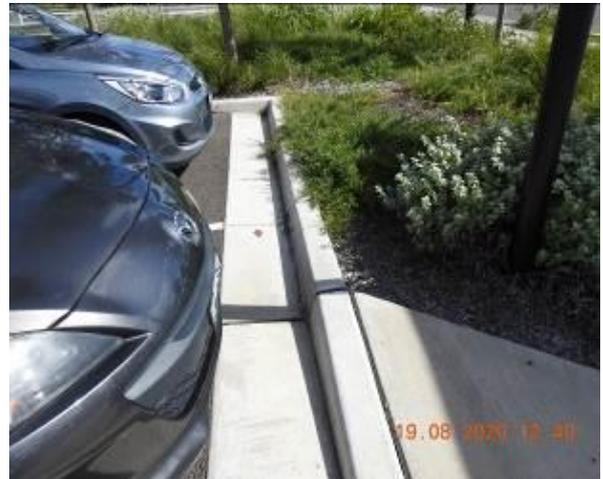
Figure 1980 – General condition of car park kerb and gutter

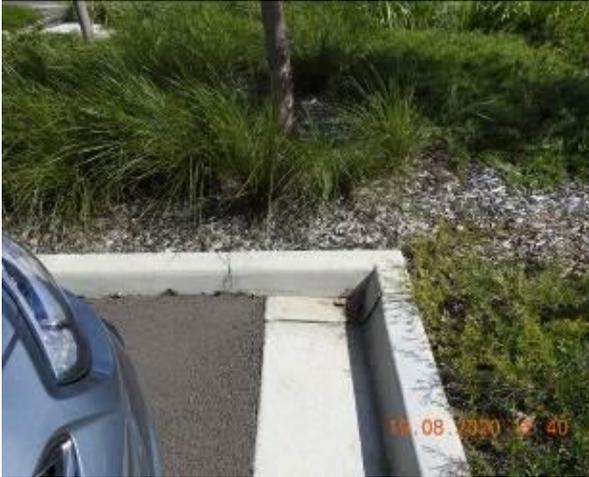
Figure 1983 – General condition of car park kerb and gutter

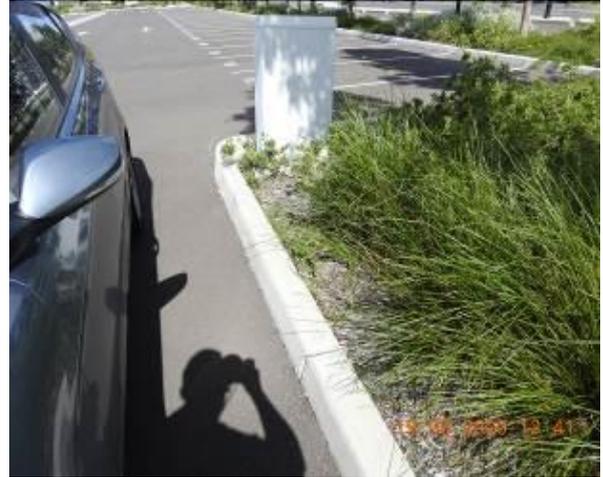
Figure 1984 – General condition of car park kerb

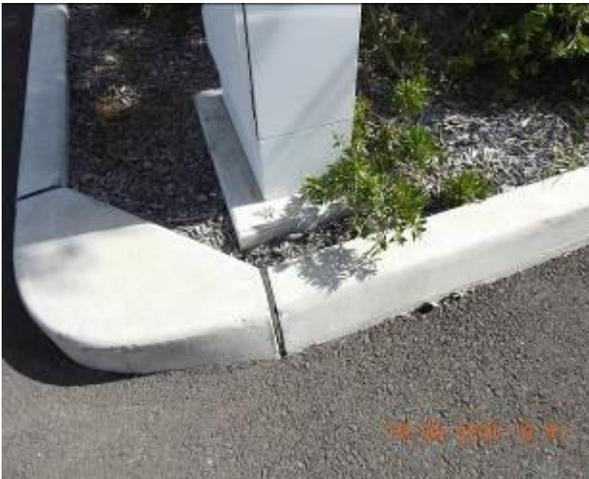
Figure 1985 – General condition of car park kerb

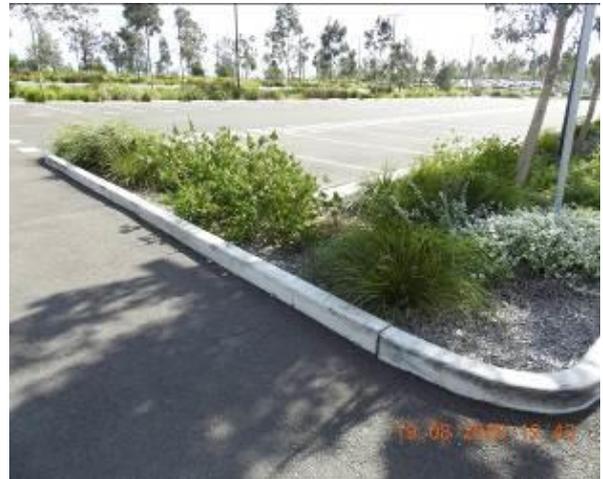
Figure 1986 – General condition of car park kerb

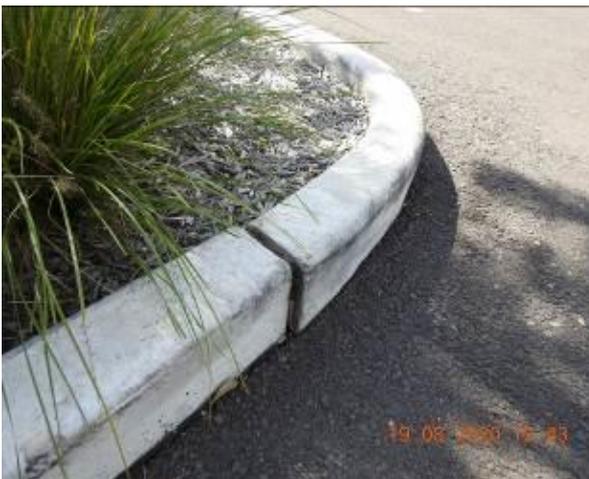
Figure 1987 – General condition of car park kerb

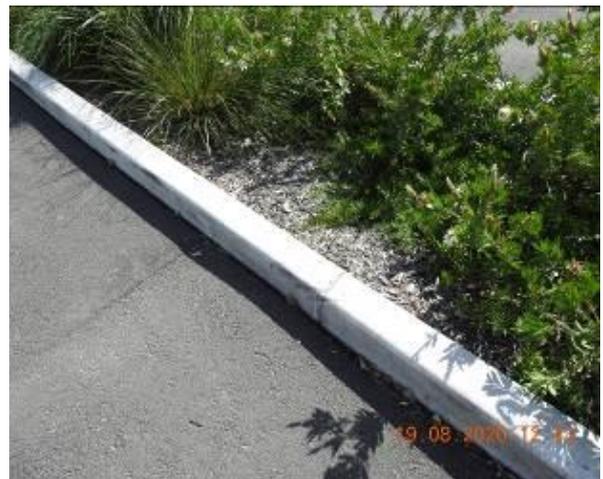
Figure 1988 – Crack propagation through car park kerb

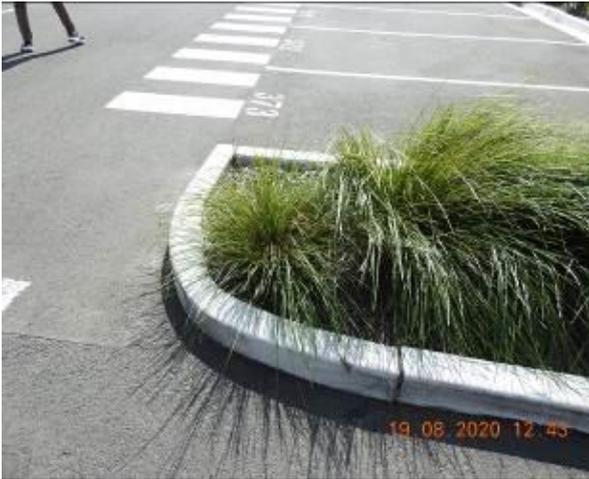
Figure 1989 – General condition of car park kerb

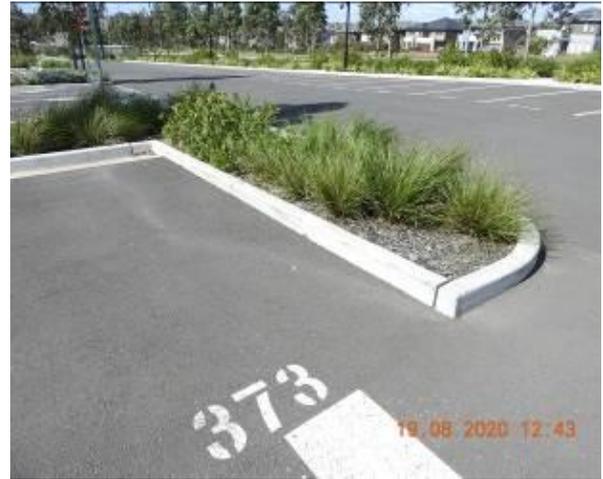
Figure 1990 – General condition of car park kerb

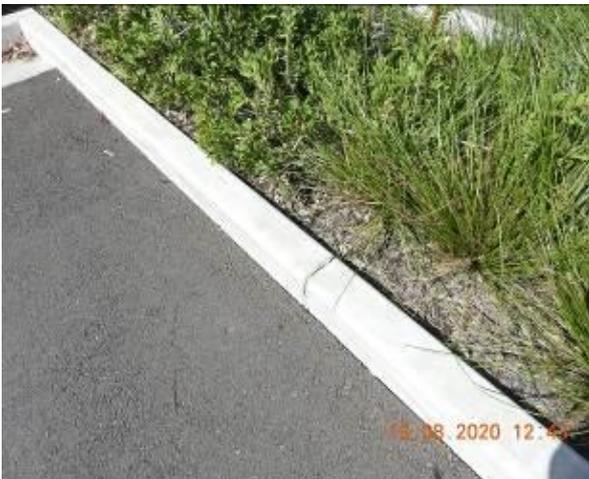
Figure 1991 – Crack propagation through car park kerb

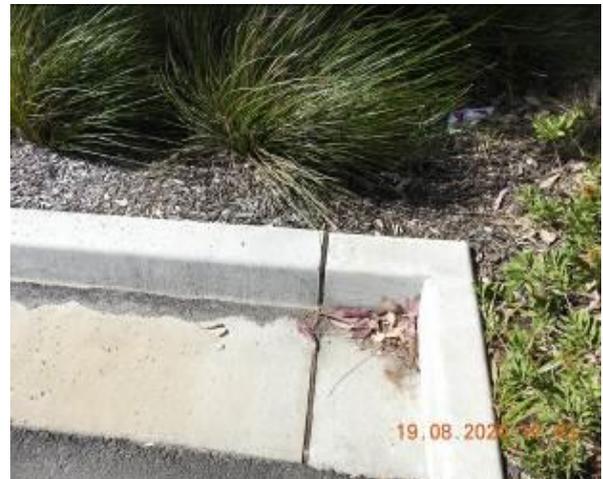
Figure 1992 – General condition of car park kerb

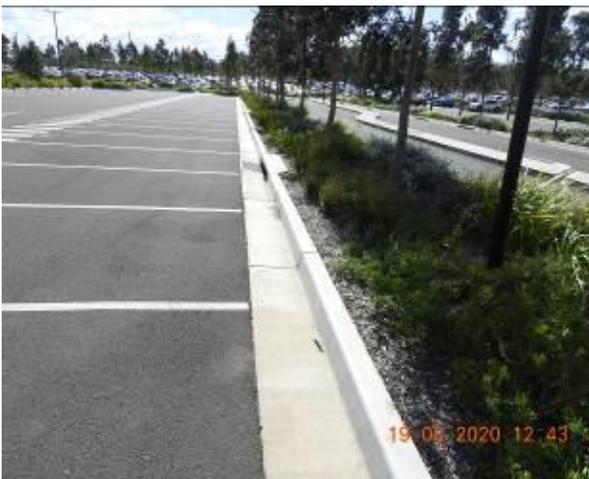
Figure 1993 – General condition of car park kerb

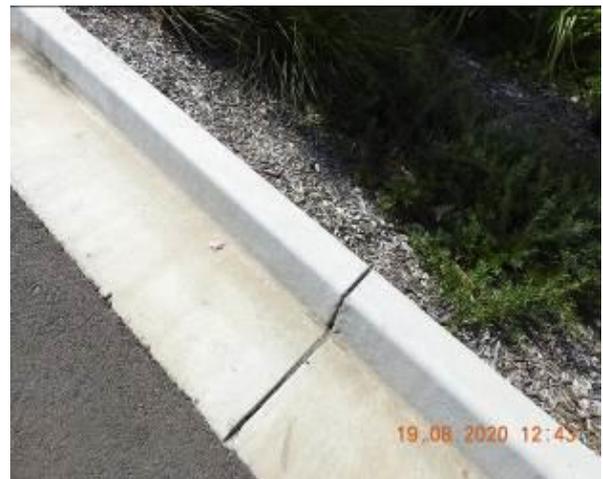
Figure 1994 – General condition of car park kerb

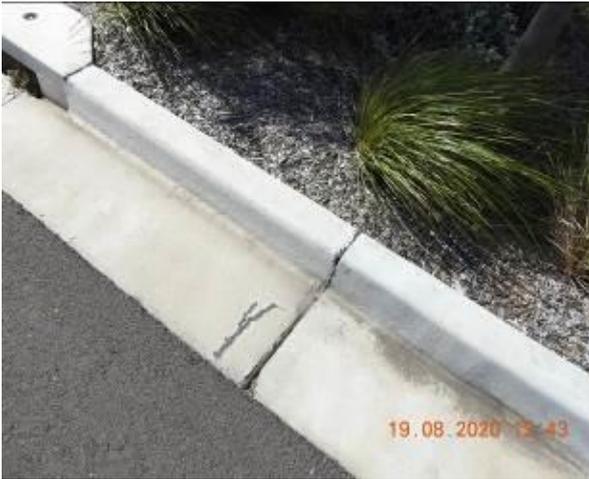
Figure 1995 – General condition of car park kerb

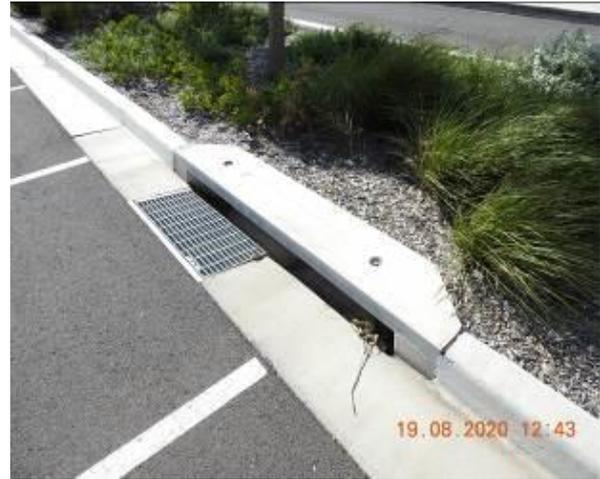
Figure 1996 – General condition of kerb inlet pit and stormwater inlet pit

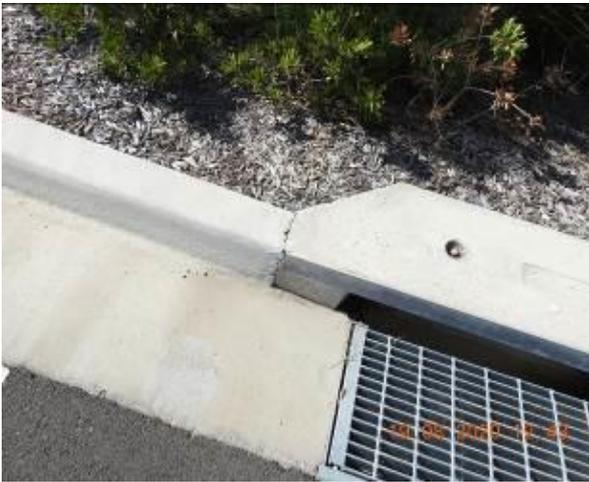
Figure 1997 – Crack propagation through car park kerb

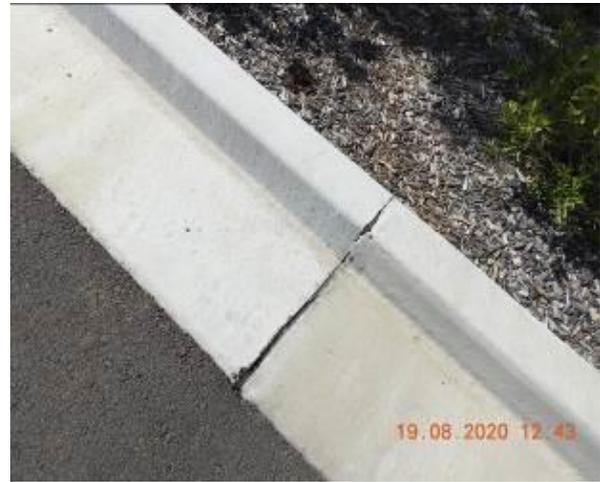
Figure 1998 – General condition of car park kerb

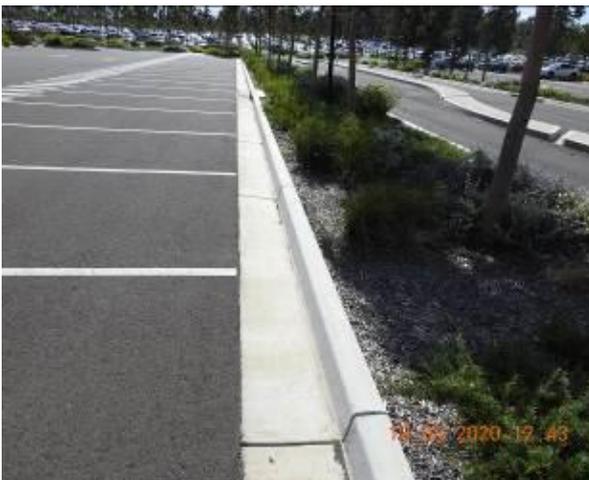
Figure 1999 – General condition of car park kerb

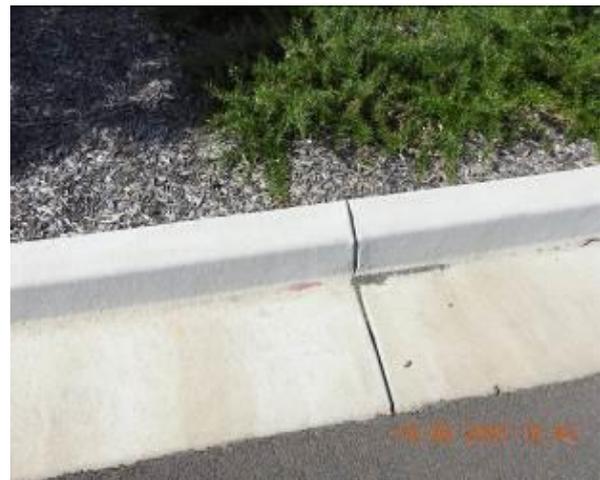
Figure 2000 – Crack propagation through car park kerb

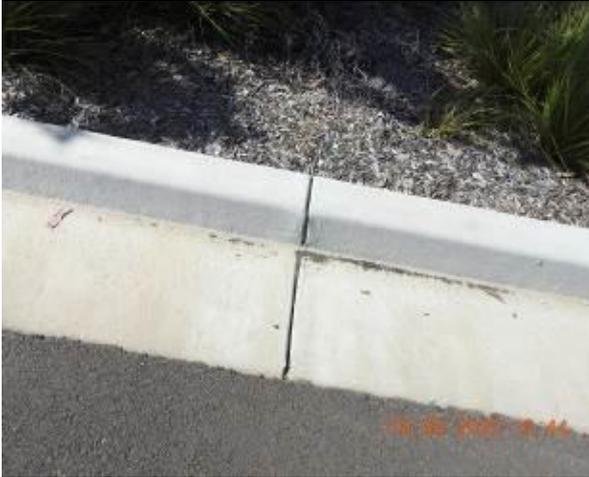
Figure 2001 – Crack propagation through car park kerb

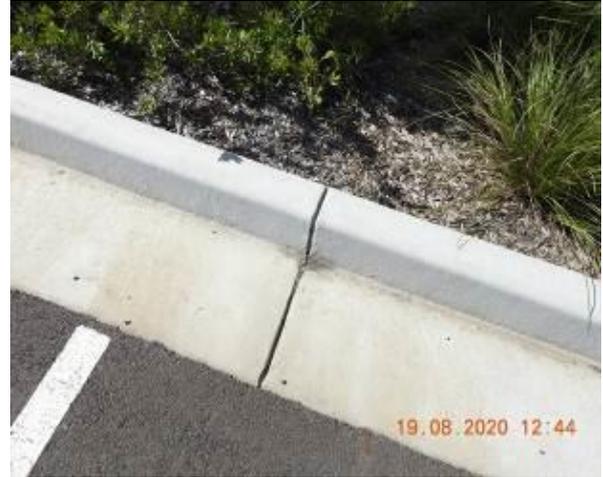
Figure 2002 – Crack propagation through car park kerb

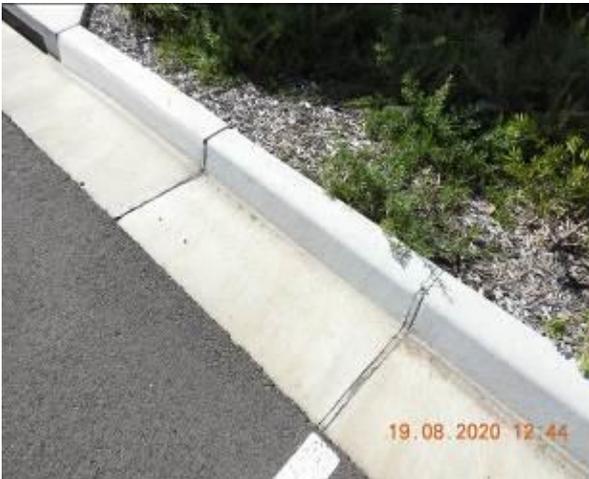
Figure 2003 – General condition of car park kerb

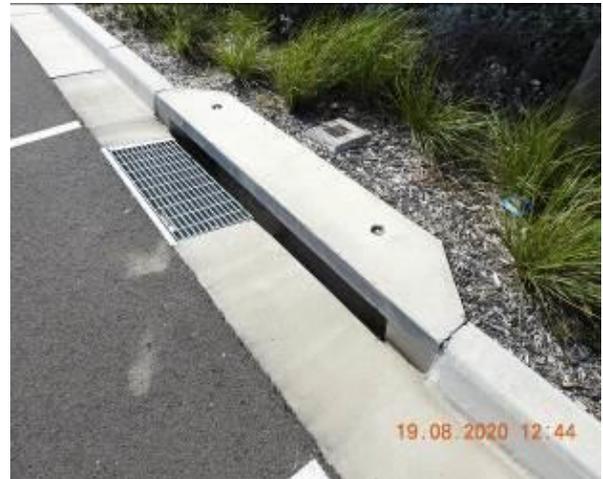
Figure 2004 – General condition of kerb inlet pit and stormwater inlet pit

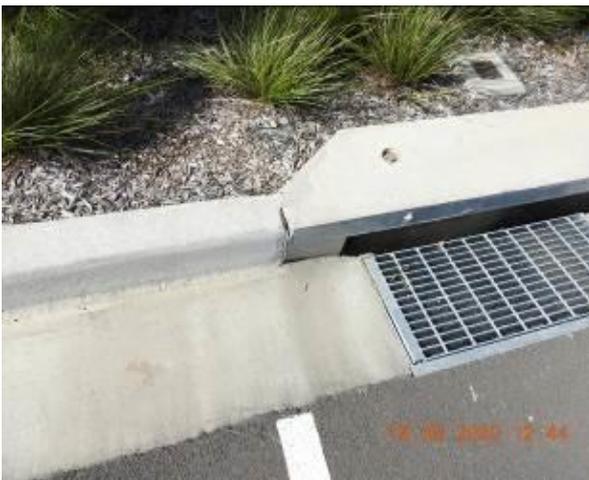
Figure 2005 – General condition of car park kerb and gutter

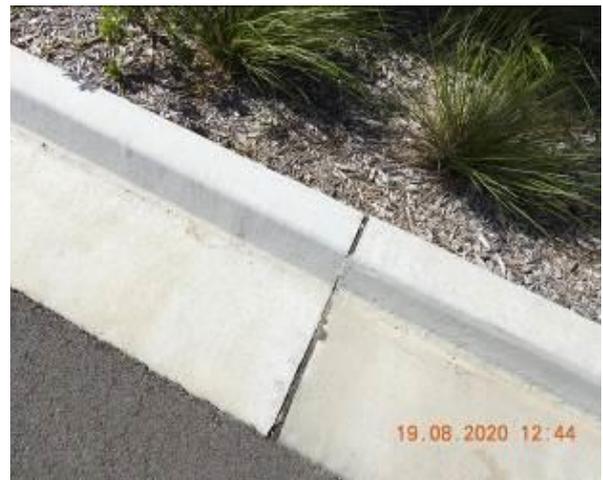
Figure 2006 – General condition of car park kerb and gutter

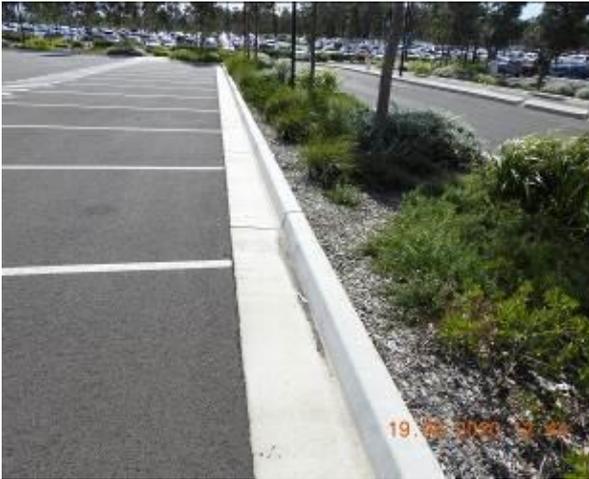
Figure 2007 – General condition of car park kerb and gutter

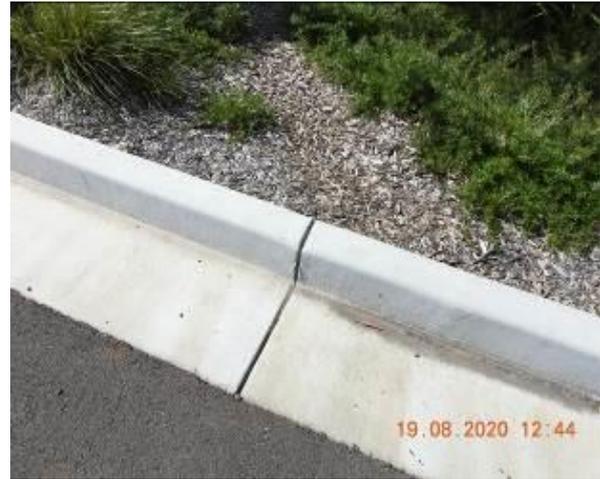
Figure 2008 – Crack propagation through car park kerb and gutter

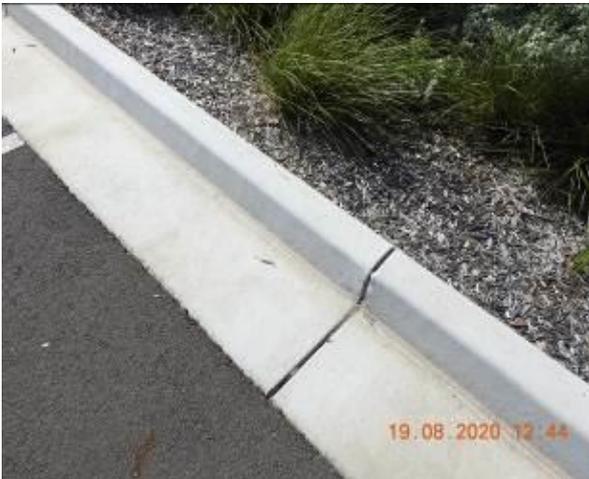
Figure 2009 – Crack propagation through car park kerb and gutter

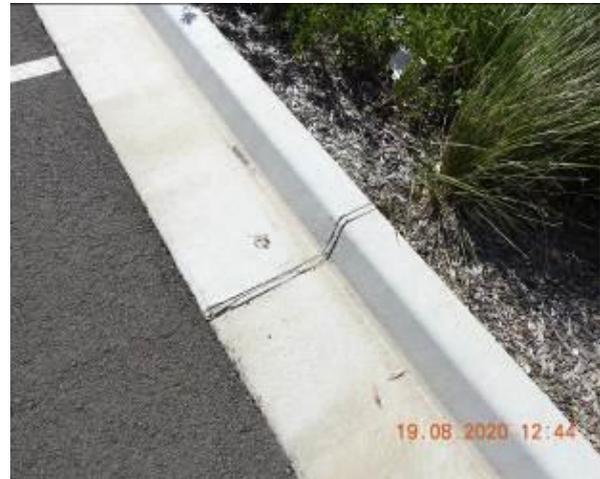
Figure 2010 – General condition of car park kerb and gutter

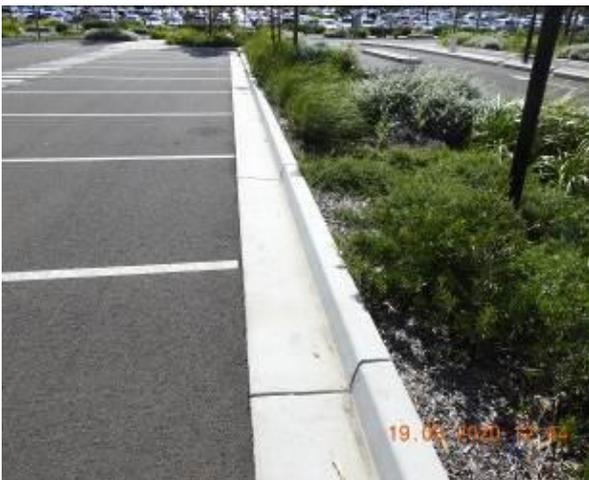
Figure 2011 – General condition of car park kerb and gutter

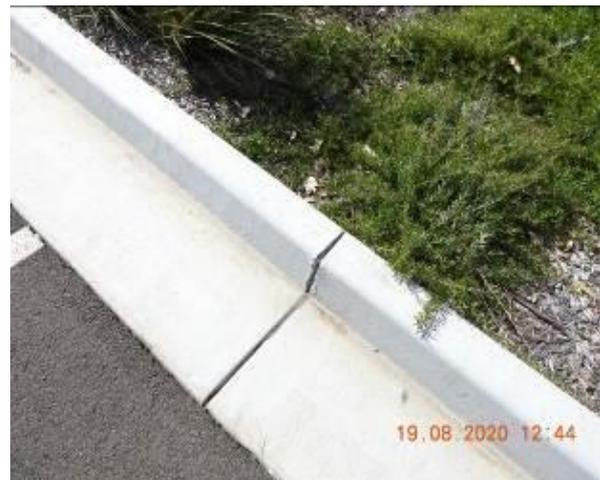
Figure 2012 General condition of car park kerb and gutter –

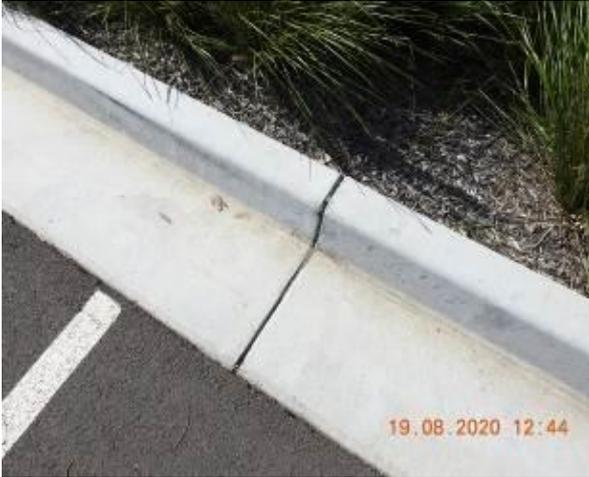
Figure 2013 – General condition of car park kerb and gutter

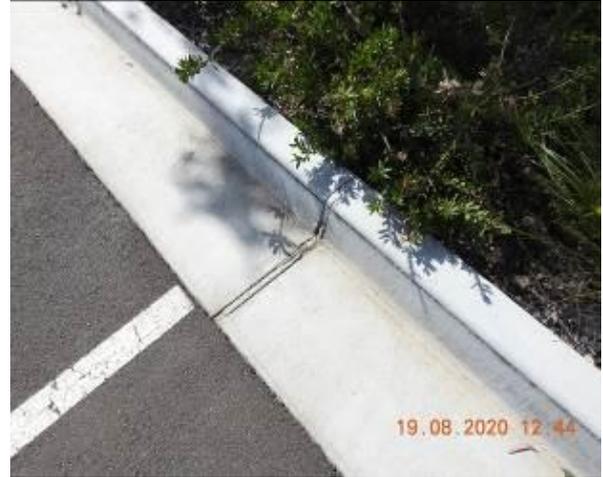
Figure 2014 – Crack propagation and loss of material through car park gutter

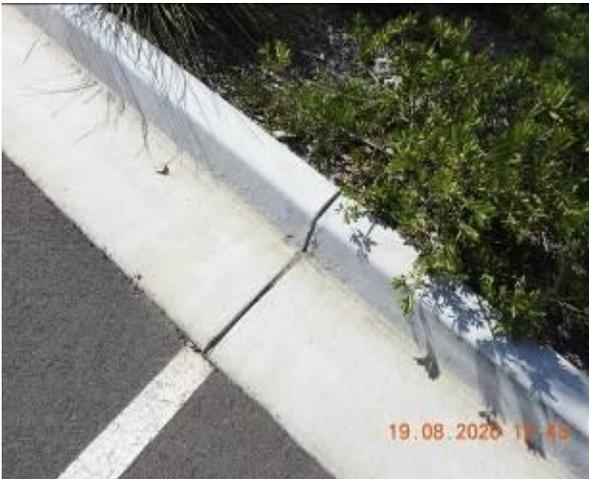
Figure 2015 – General condition of car park kerb and gutter

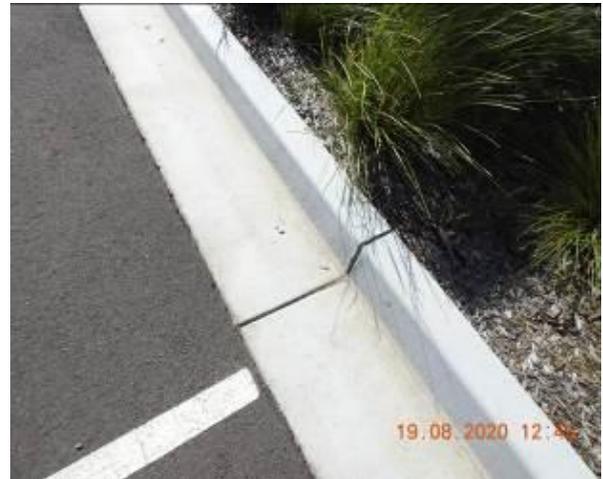
Figure 2016 – General condition of car park kerb and gutter

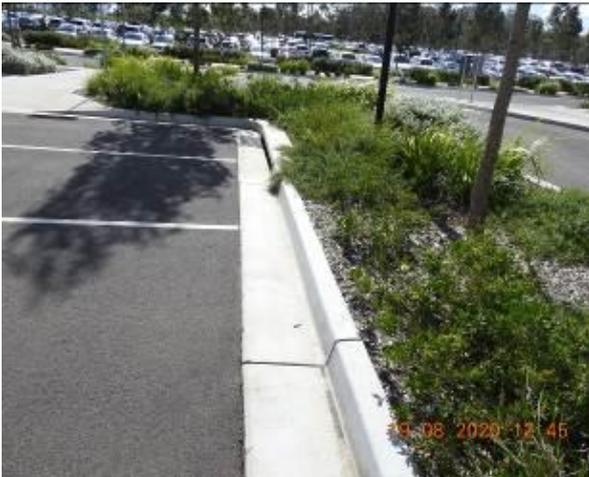
Figure 2017 – General condition of car park kerb and gutter

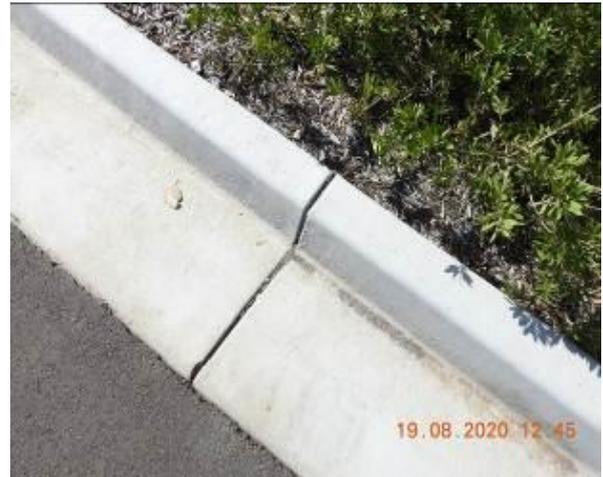
Figure 2018 – Crack propagation through car park kerb

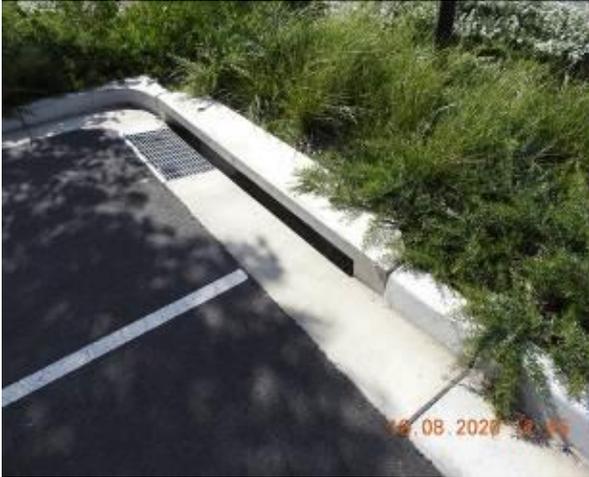
Figure 2019 – General condition of kerb inlet pit and stormwater inlet pit

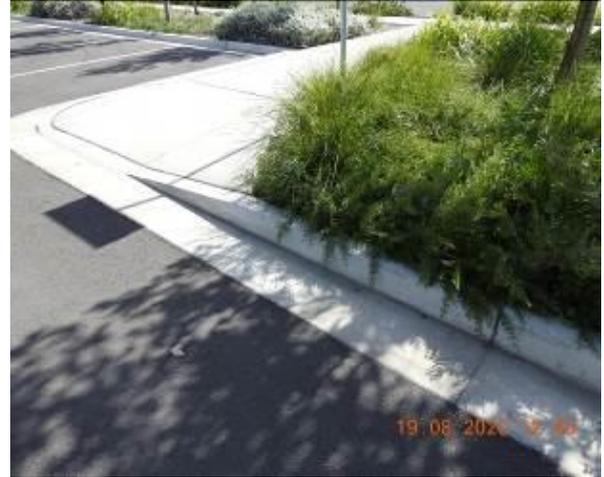
Figure 2020 – General condition of car park kerb and gutter

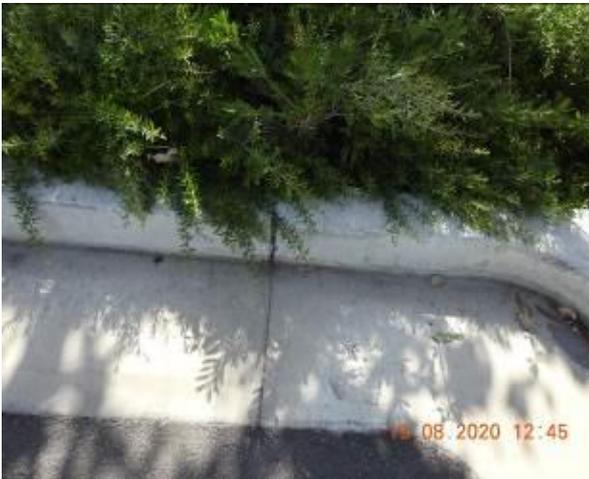
Figure 2021 – General condition of car park kerb and gutter

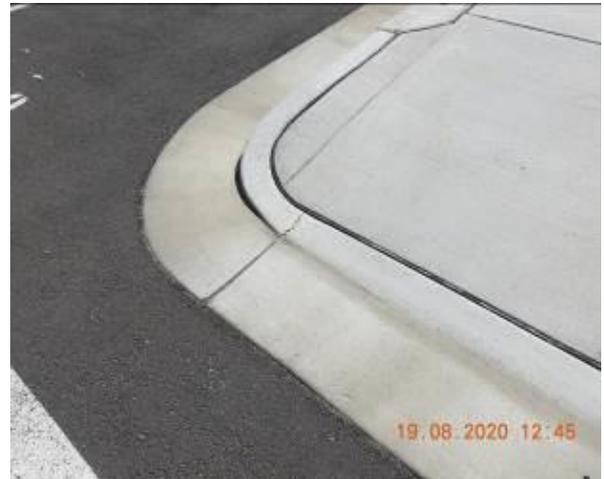
Figure 2022 – Crack propagation through car park kerb layback

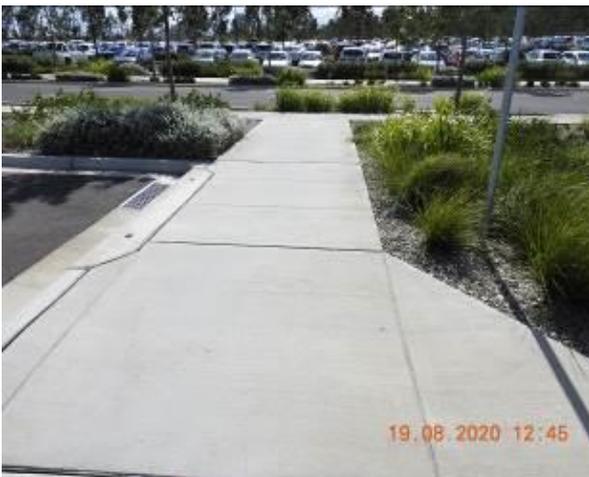
Figure 2023 – General condition of footpath pavement

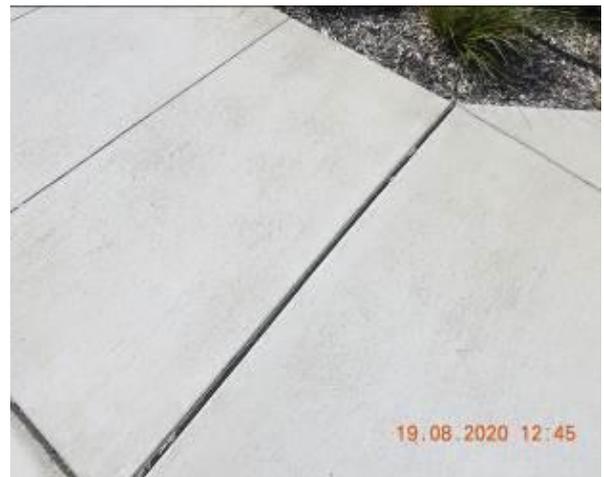
Figure 2024 – General condition of footpath pavement

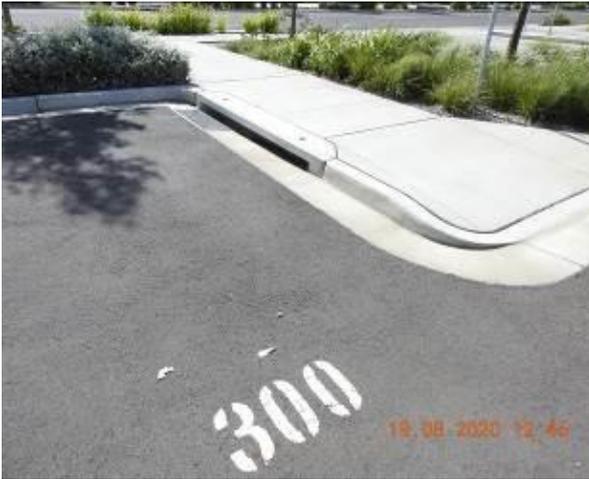
Figure 2025 – General condition of car park kerb and gutter

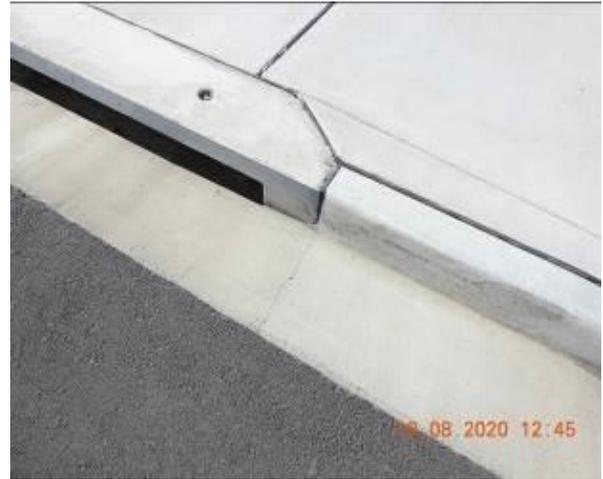
Figure 2026 – Crack propagation through car park gutter

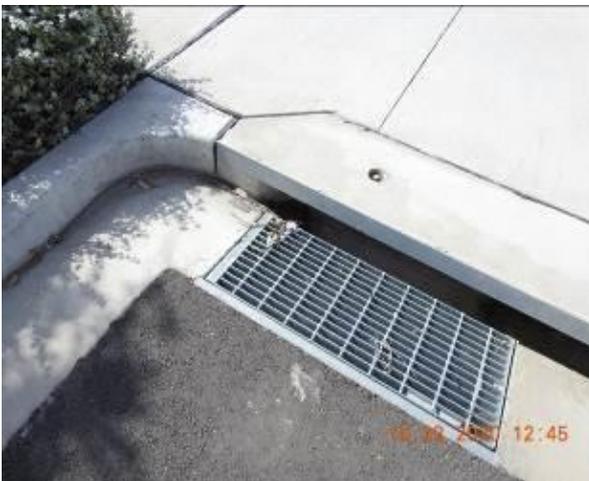
Figure 2027 – General condition of kerb inlet pit and stormwater inlet pit

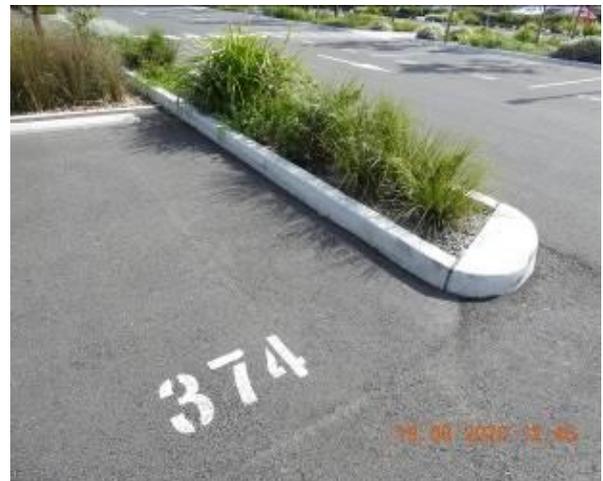
Figure 2028 – General condition of car park kerb

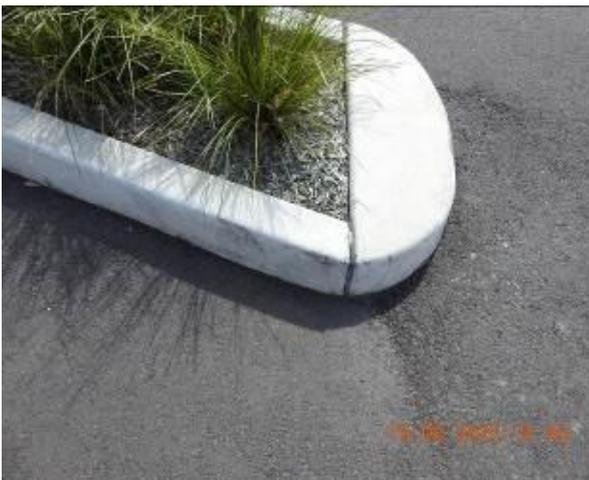
Figure 2029 – General condition of car park kerb

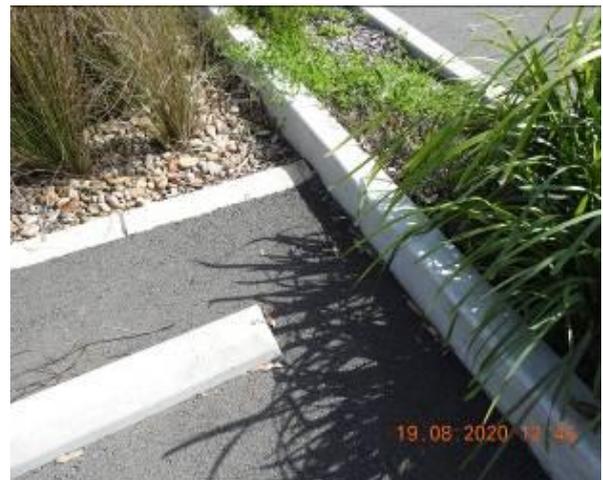
Figure 2030 – General condition of car park kerb

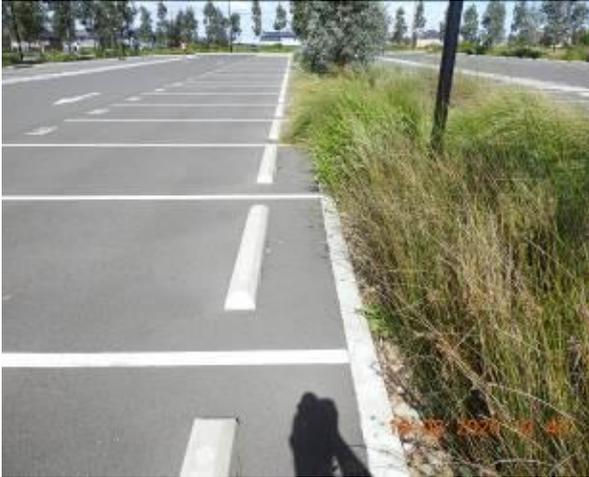
Figure 2031 – General condition of car park kerb

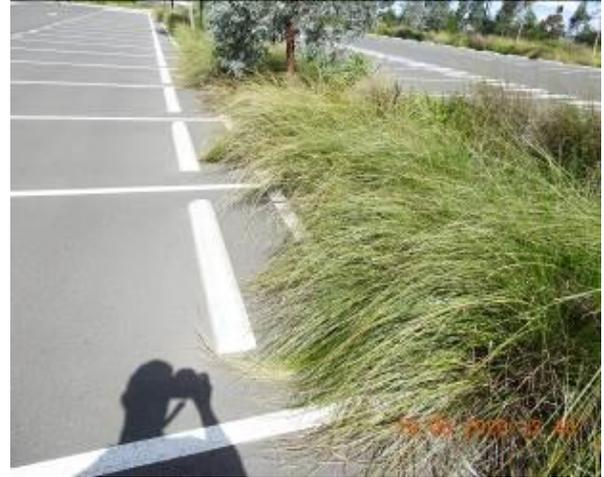
Figure 2032 – General condition of car park kerb

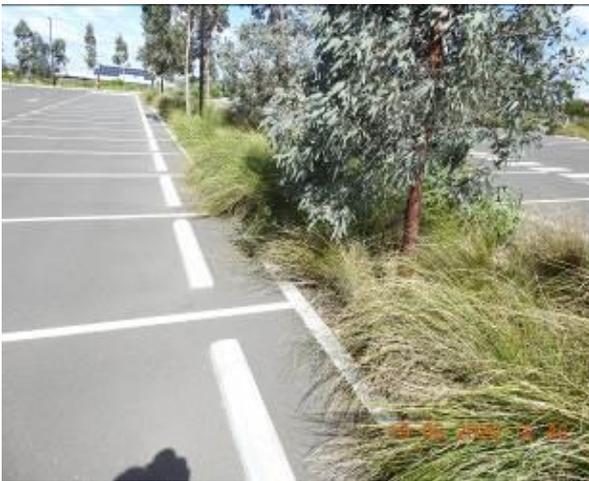
Figure 2033 – General condition of car park kerb

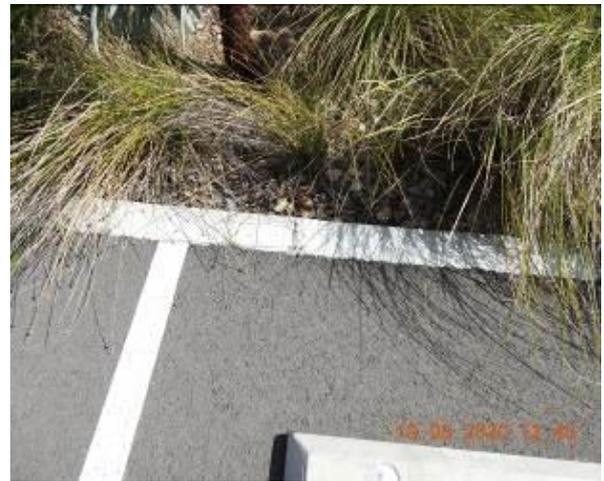
Figure 2034 – General condition of car park kerb

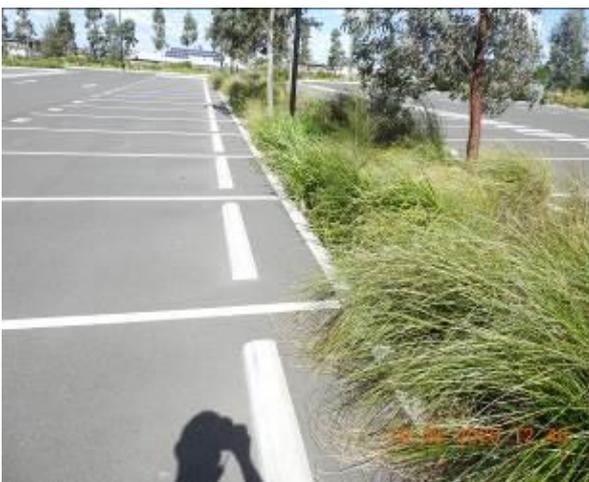
Figure 2035 – General condition of car park kerb

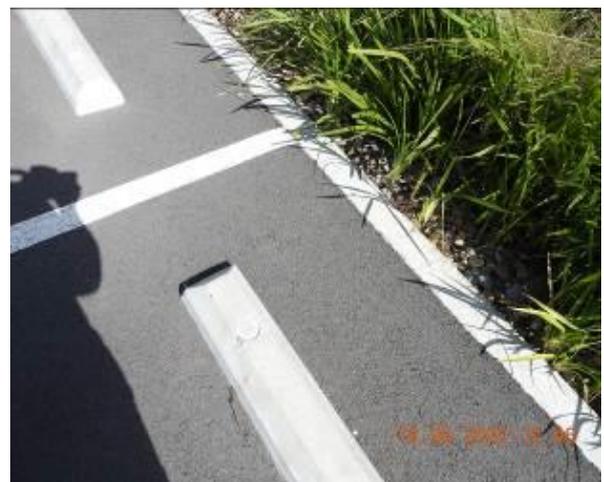
Figure 2036 – General condition of car park kerb

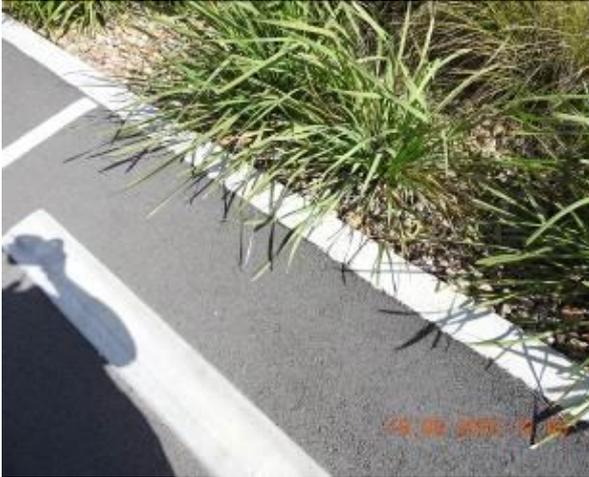
Figure 2037 – General condition of car park kerb

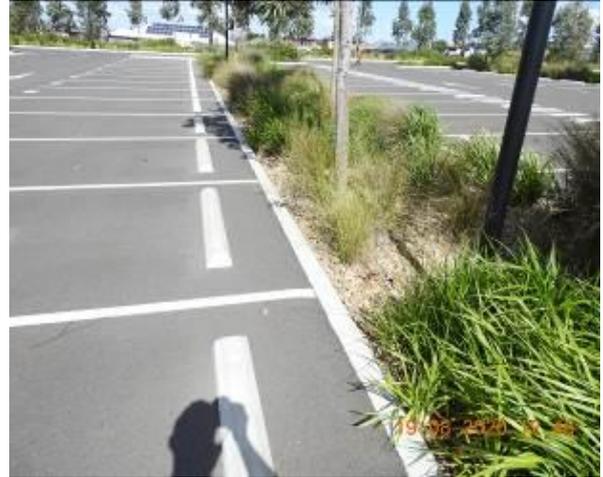
Figure 2038 – General condition of car park kerb

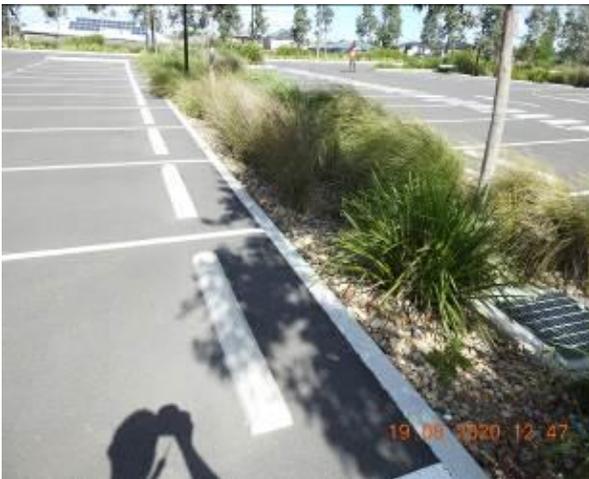
Figure 2039 – General condition of car park kerb

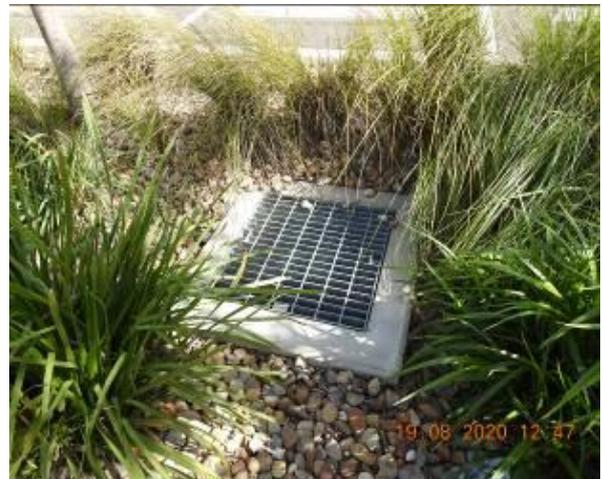
Figure 2040 – General condition of stormwater inlet pit

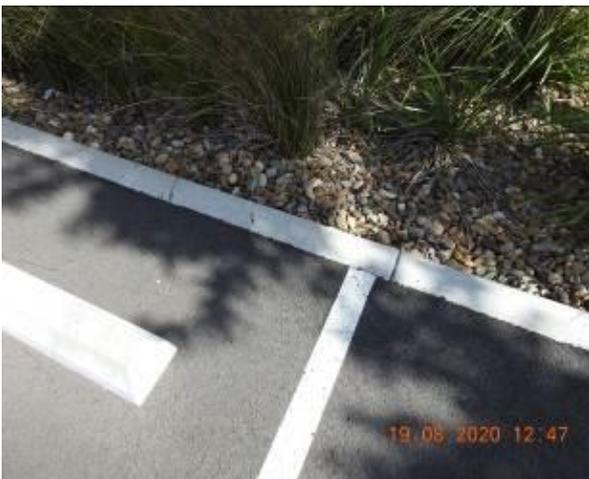
Figure 2041 – General condition of car park kerb

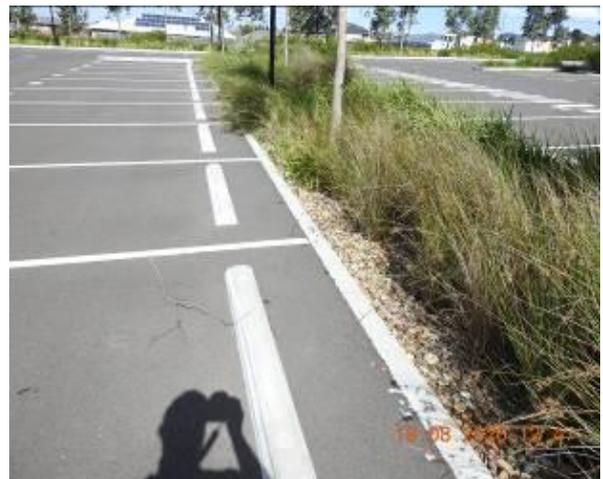
Figure 2042 – General condition of car park kerb

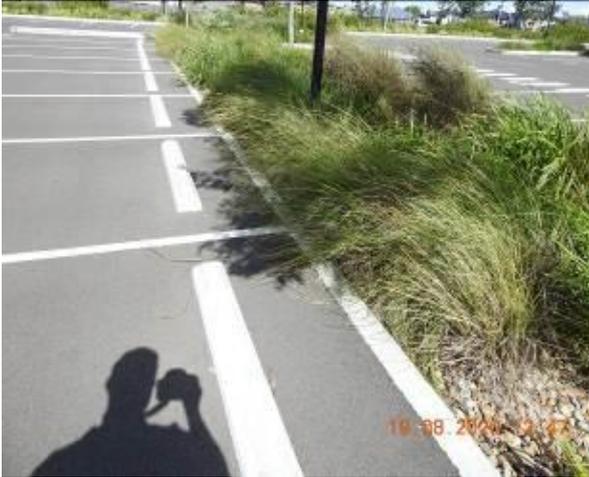
Figure 2044 – General condition of car park kerb

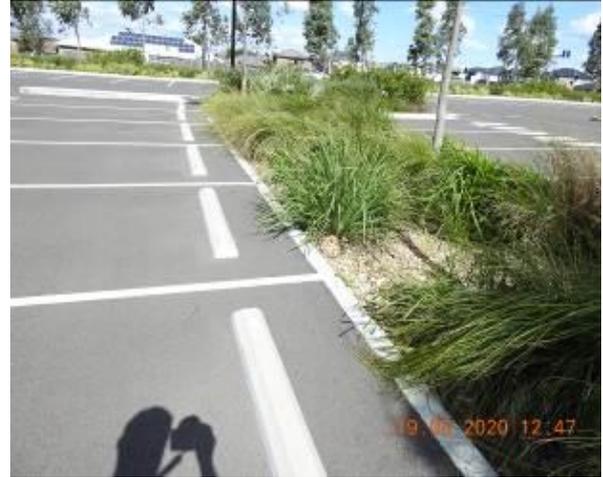
Figure 2045 – General condition of car park kerb

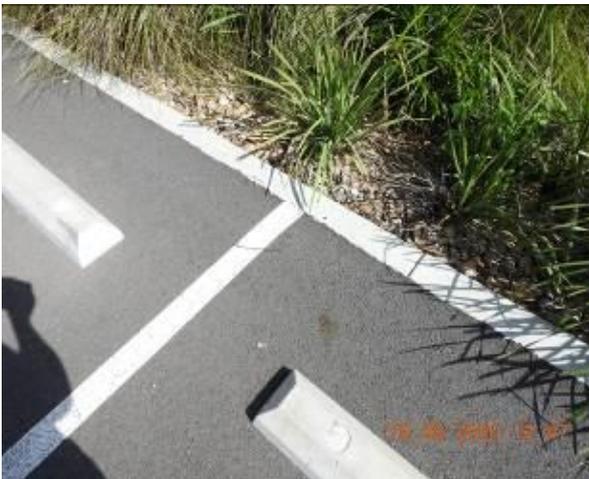
Figure 2046 – General condition of car park kerb

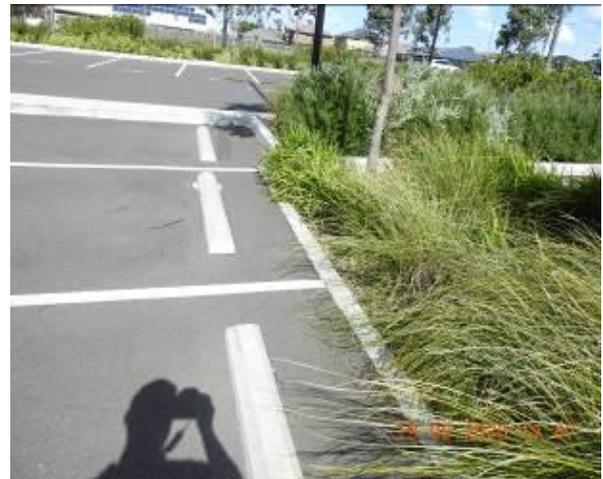
Figure 2047 – General condition of car park kerb

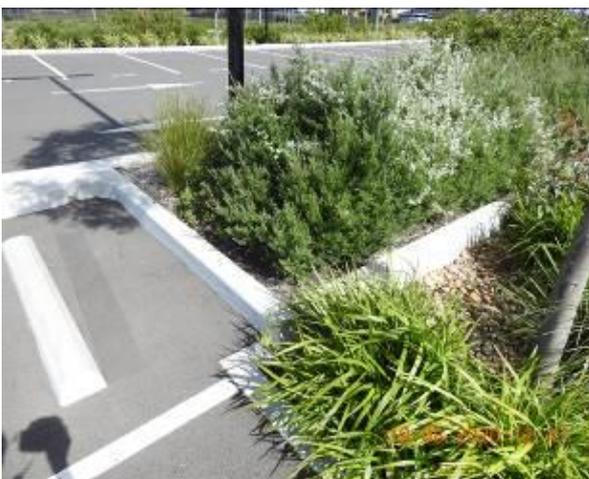
Figure 2048 – Crack propagation through car park kerb

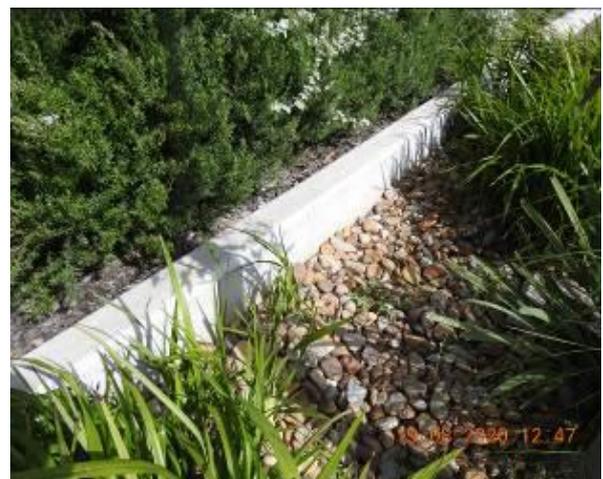
Figure 2049 – General condition of car park kerb

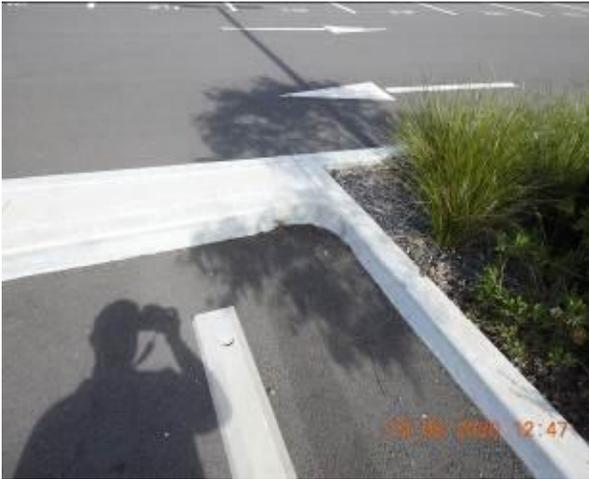
Figure 2050 – Crack propagation through car park kerb

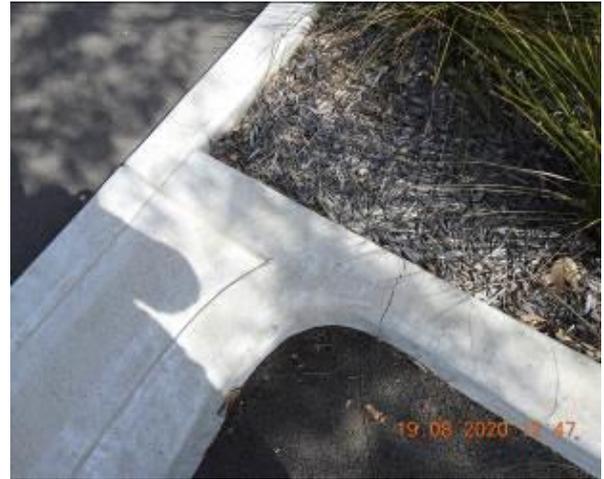
Figure 2051 – General condition of car park kerb

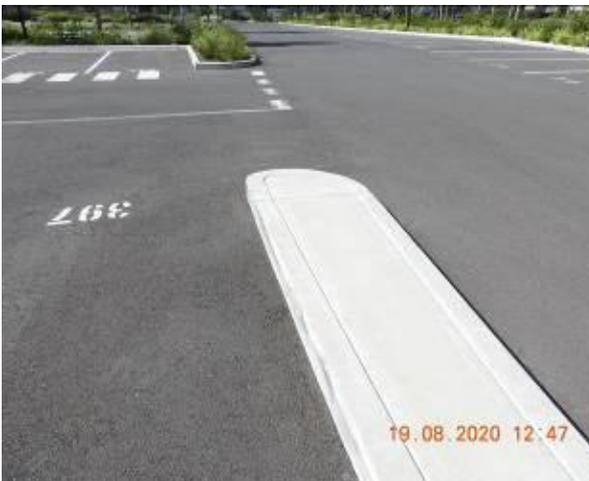
Figure 2052 – General condition of car park kerb

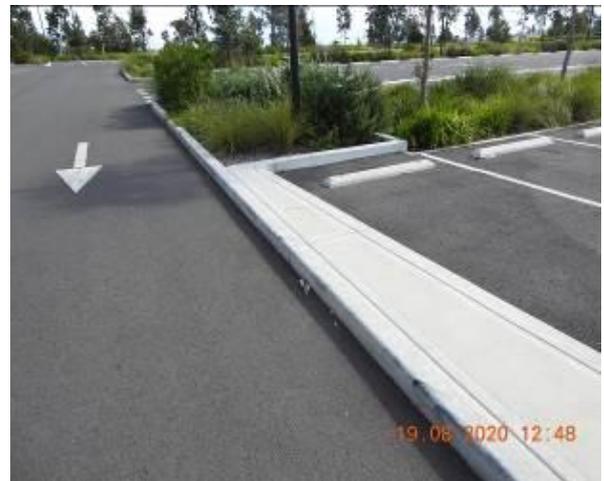
Figure 2053 – General condition of car park kerb

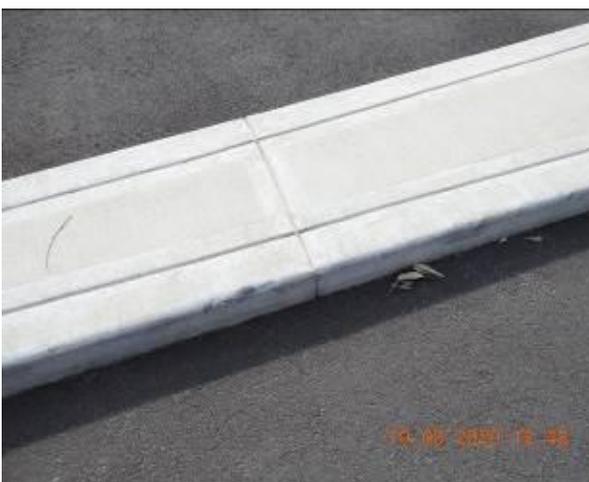
Figure 2054 – Crack propagation through car park kerb

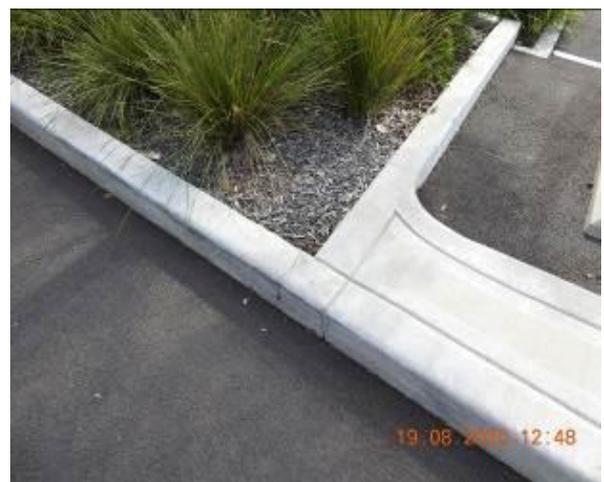
Figure 2055 – General condition of car park kerb

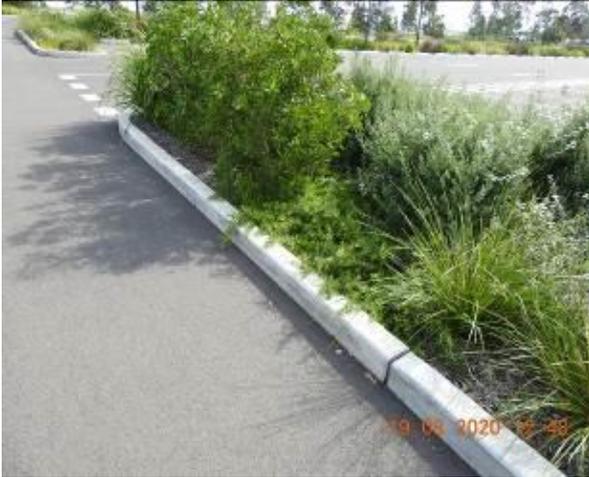
Figure 2056 – Crack propagation through car park kerb

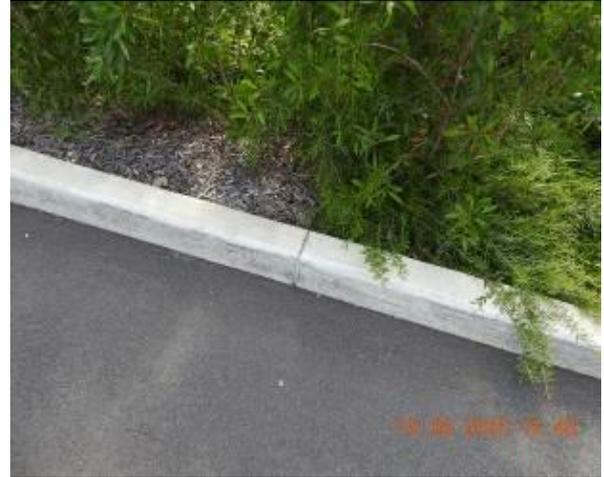
Figure 2057 – General condition of car park kerb
