The property Tallawong station – P2 Car Park, is the neighbouring property to our client’s site. It was photographed and inspected prior to any construction works on the subject site and was found to be in a reasonable condition. The property serves as a car park.

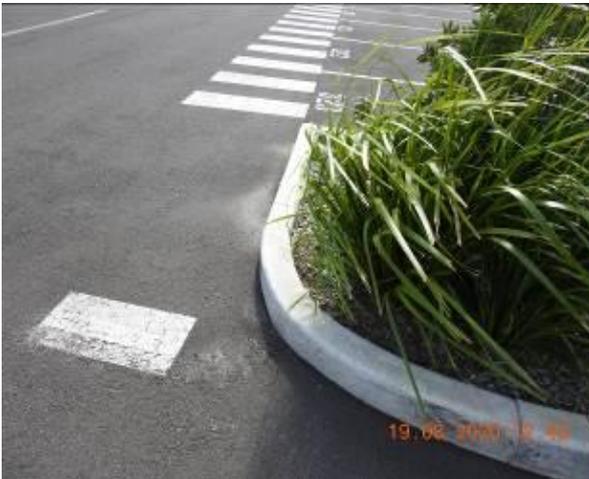
Figure 2058 – General condition of car park kerb

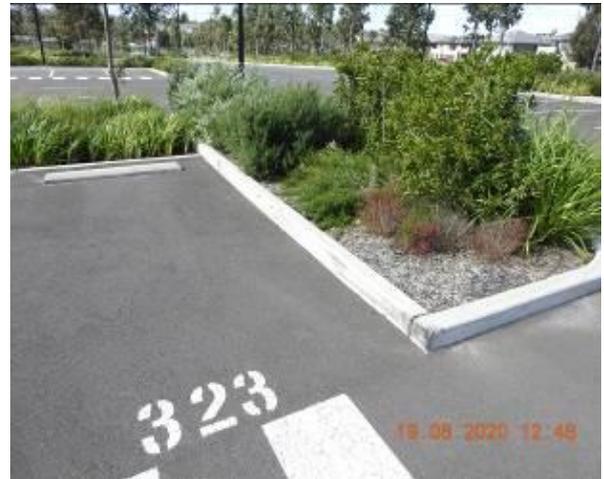
Figure 2059 – General condition of car park kerb

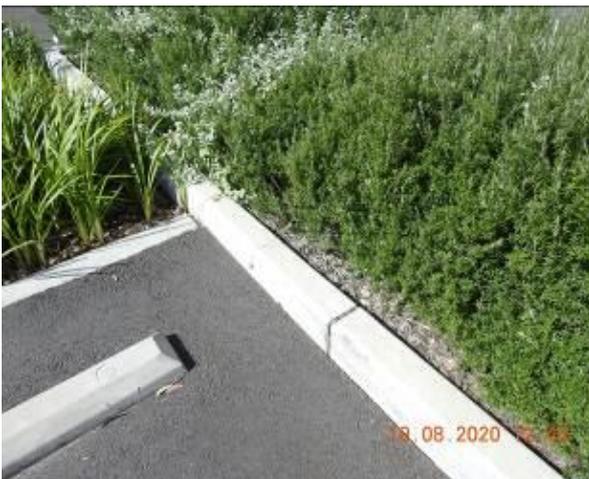
Figure 2060 – General condition of car park kerb

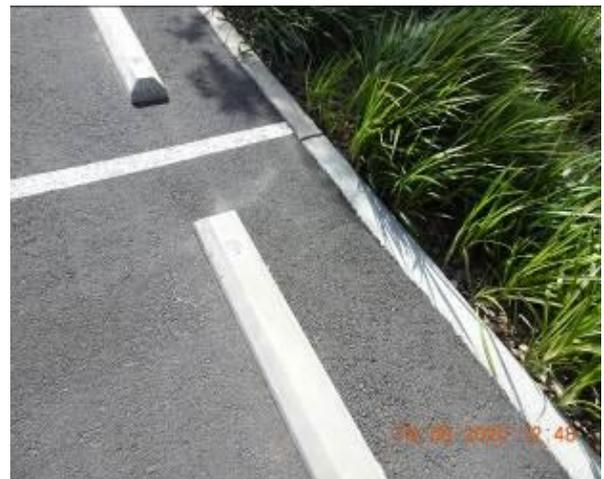
Figure 2061 – General condition of car park kerb

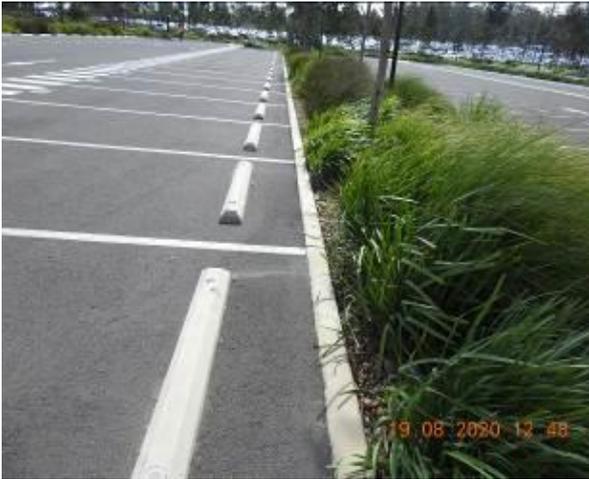
Figure 2062 – General condition of car park kerb

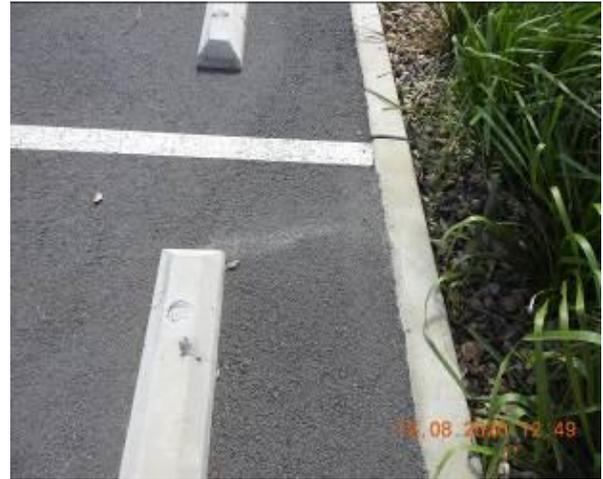
Figure 2063 – General condition of car park kerb

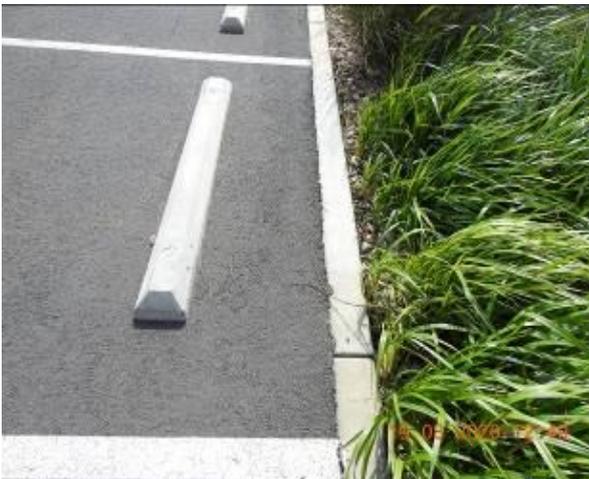
Figure 2064 – General condition of car park kerb

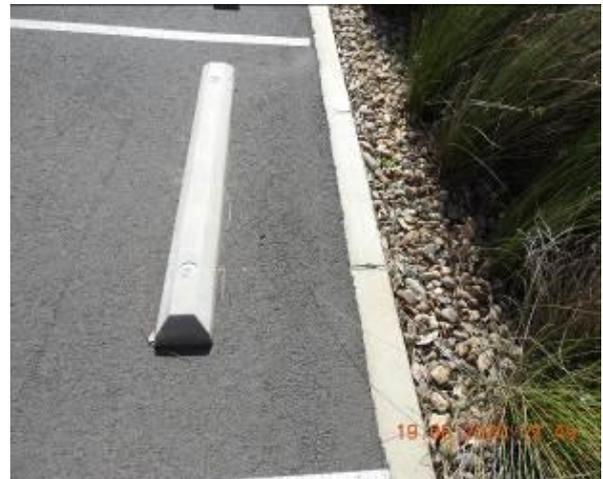
Figure 2065 – Loss of material through car park kerb

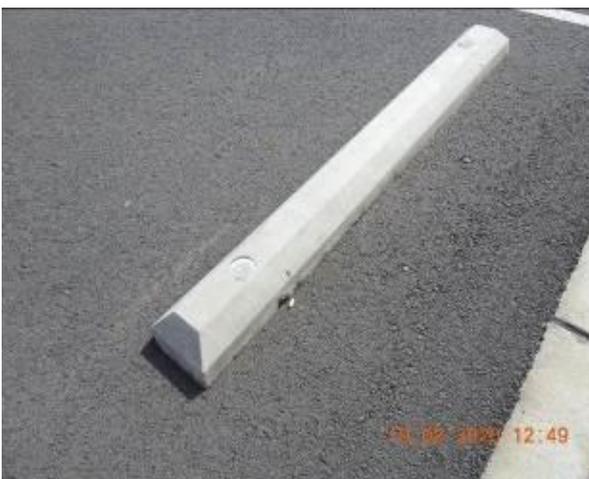
Figure 2066 – General condition of car park kerb

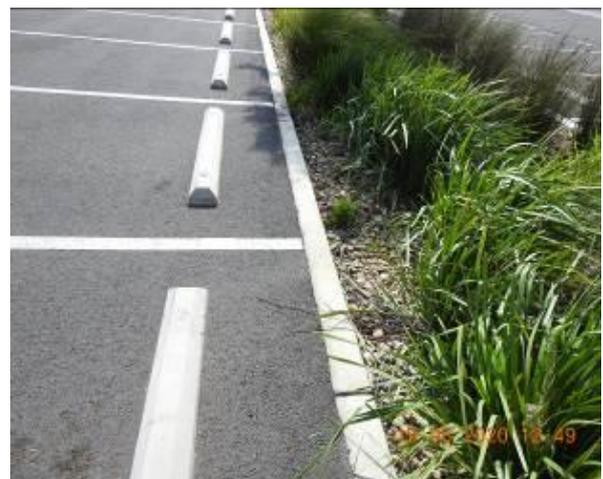
Figure 2067 – General condition of car park kerb

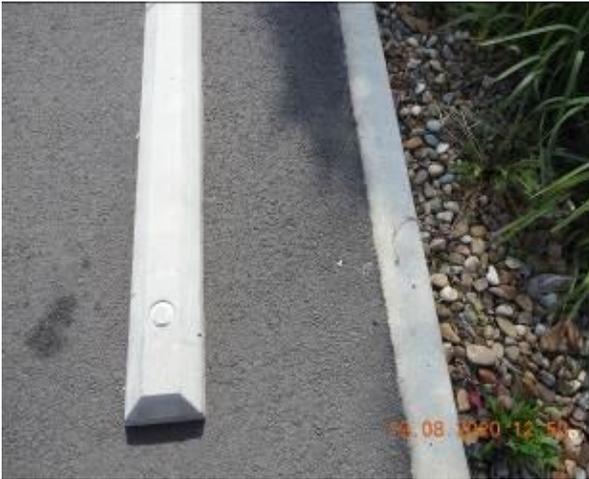
Figure 2068 – General condition of car park kerb

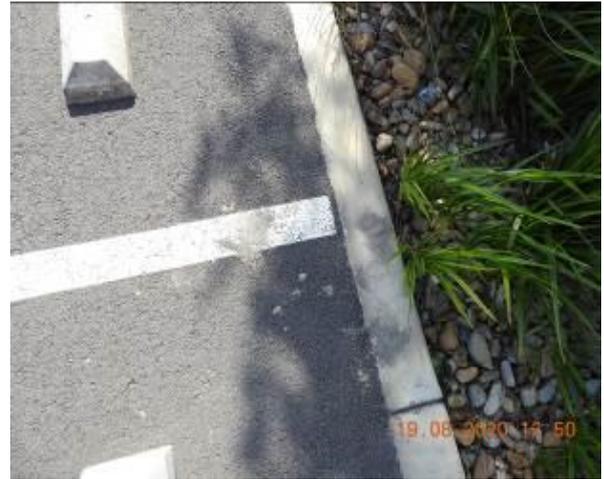
Figure 2069 – General condition of car park kerb

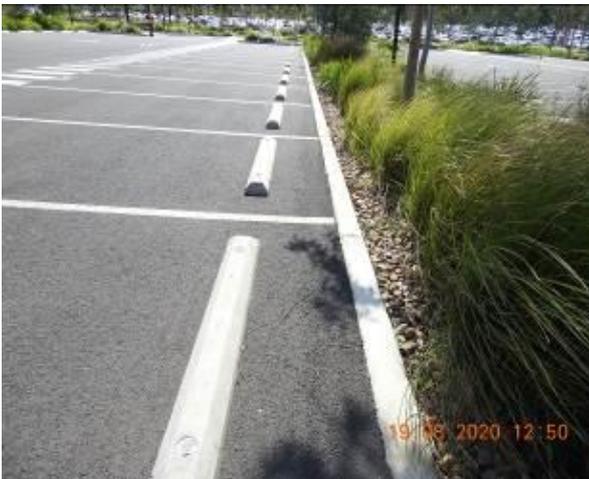
Figure 2070 – General condition of car park kerb

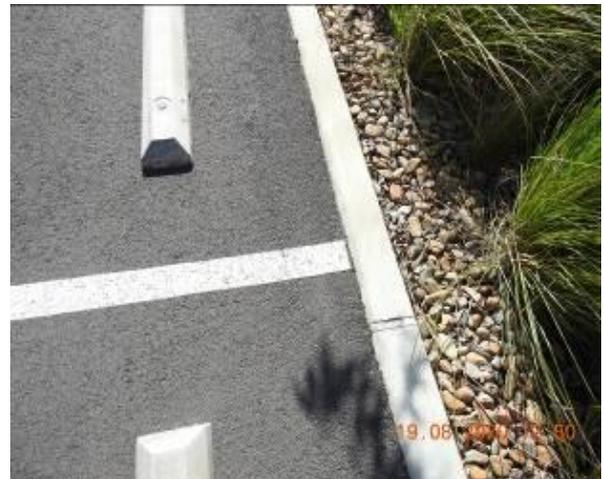
Figure 2071 – General condition of car park kerb

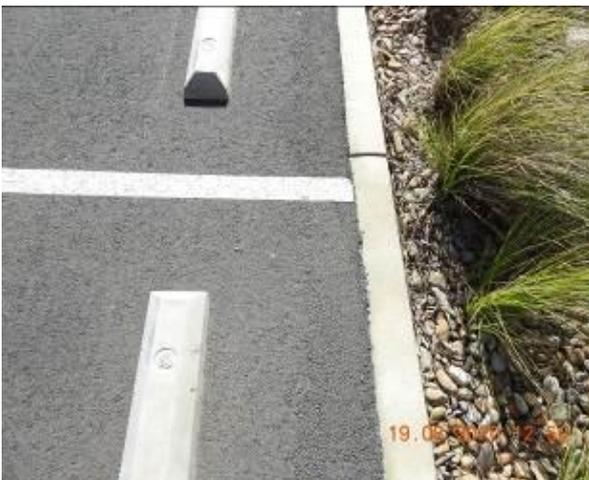
Figure 2072 – General condition of car park kerb

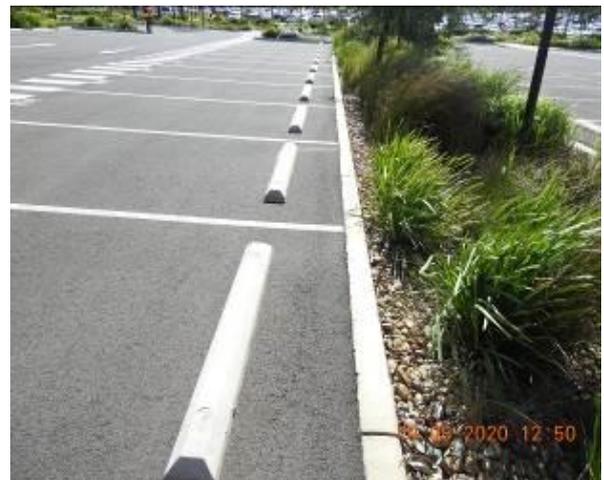
Figure 2073 – General condition of car park kerb

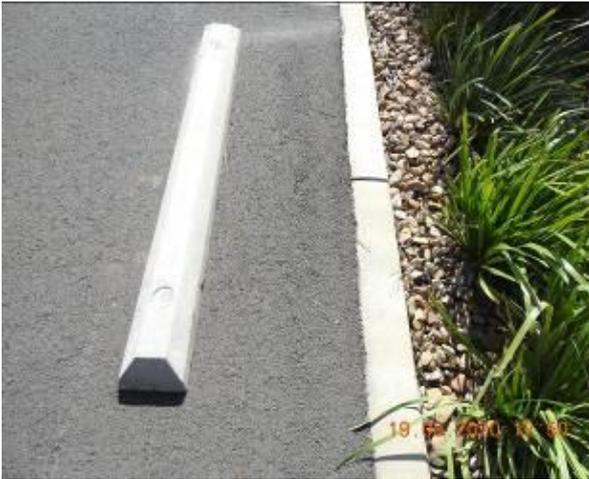
Figure 2074 – Loss of material through car park kerb

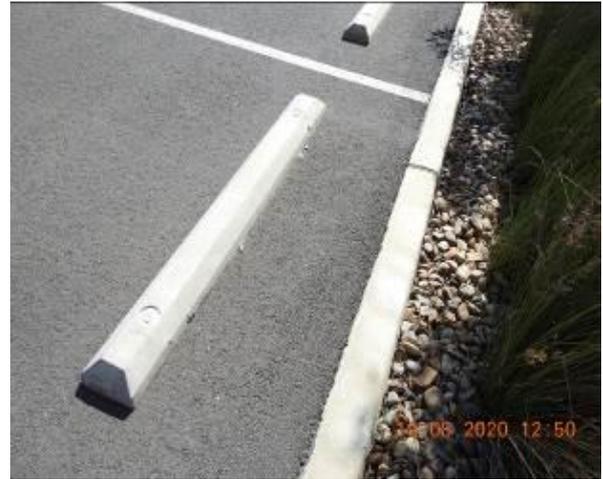
Figure 2075 – General condition of car park kerb

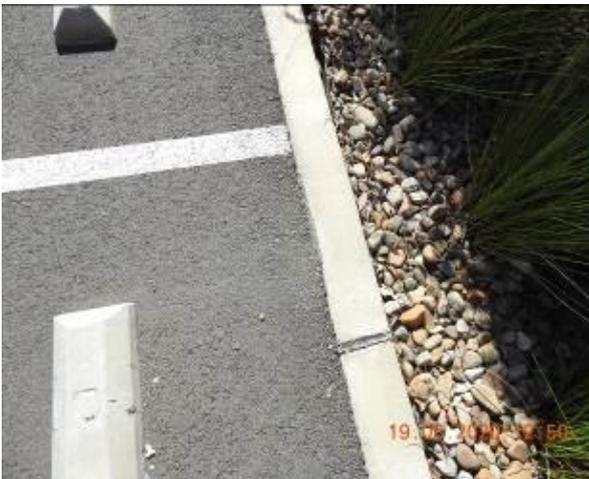
Figure 2076 – Loss of material through car park kerb

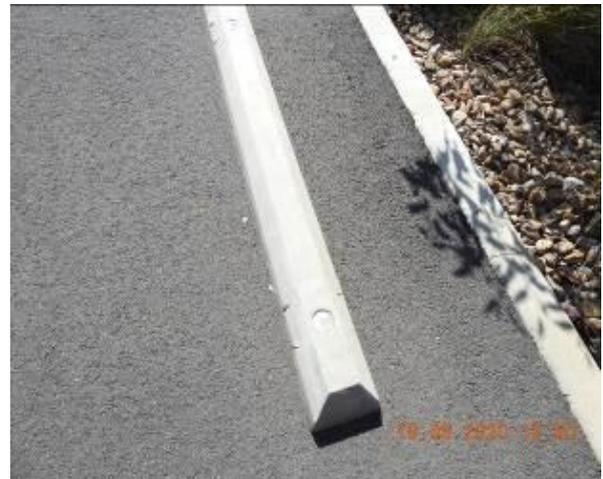
Figure 2077 – General condition of car park kerb

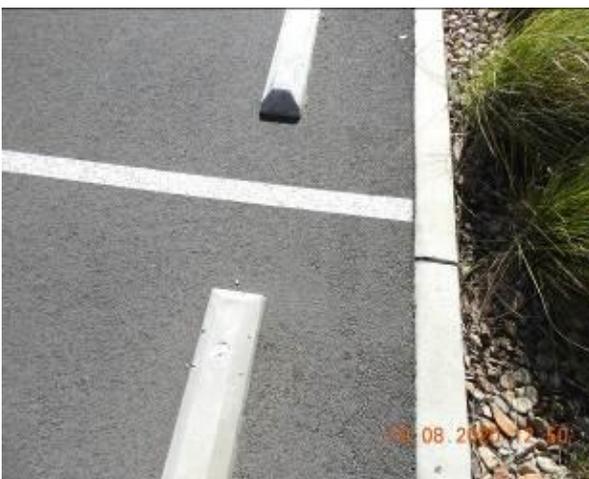
Figure 2078 – General condition of car park kerb

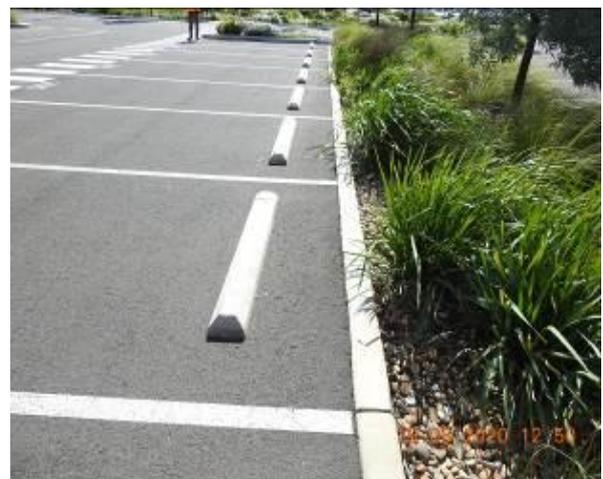
Figure 2079 – General condition of car park kerb

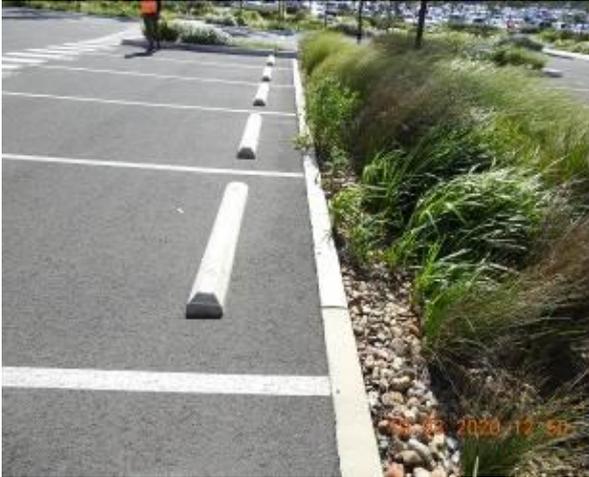
Figure 2080 – General condition of car park kerb

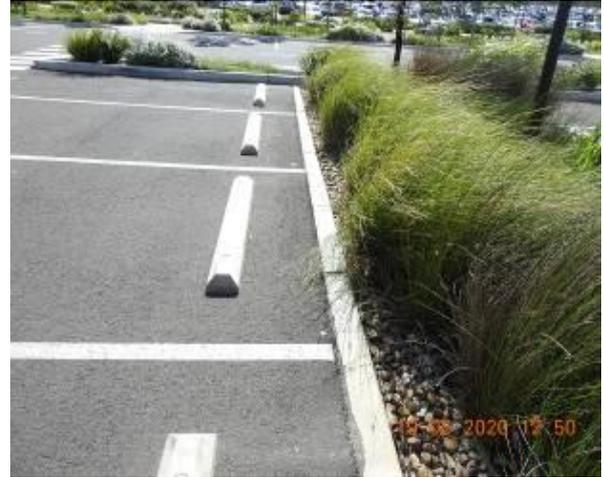
Figure 2081 – General condition of car park kerb

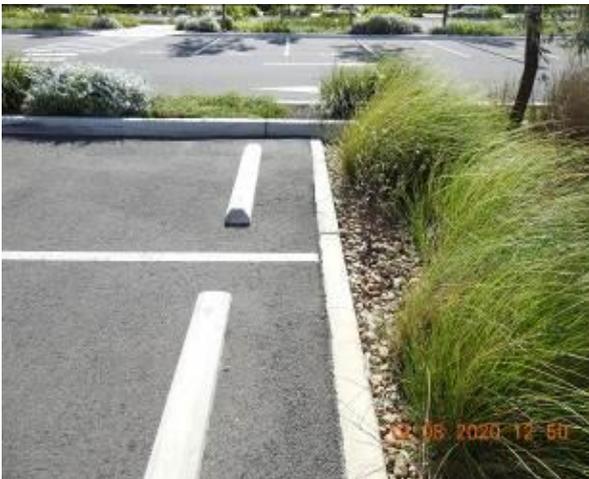
Figure 2082 – General condition of car park kerb

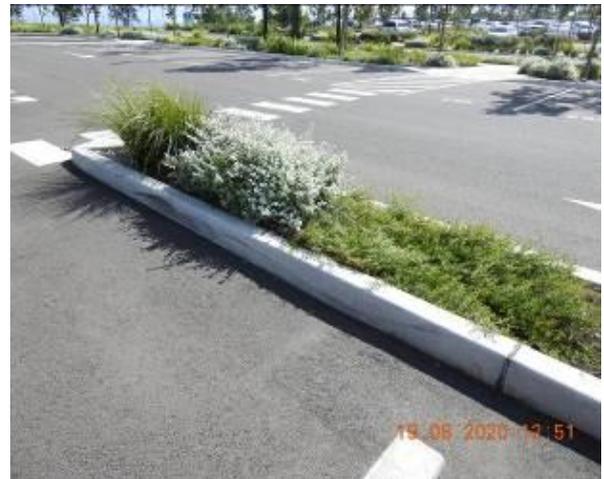
Figure 2083 – General condition of car park kerb

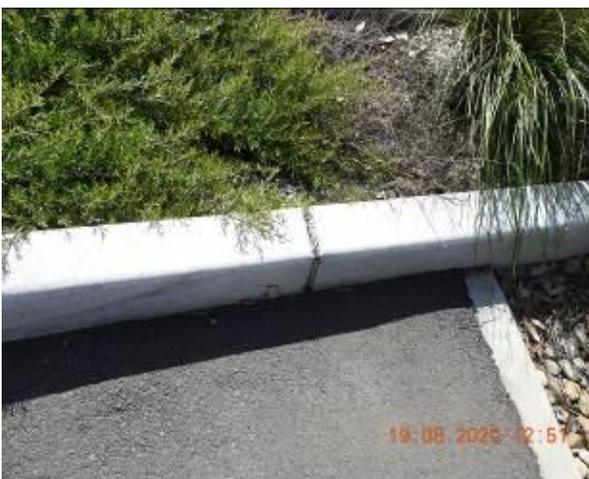
Figure 2084 – Crack propagation through car park kerb

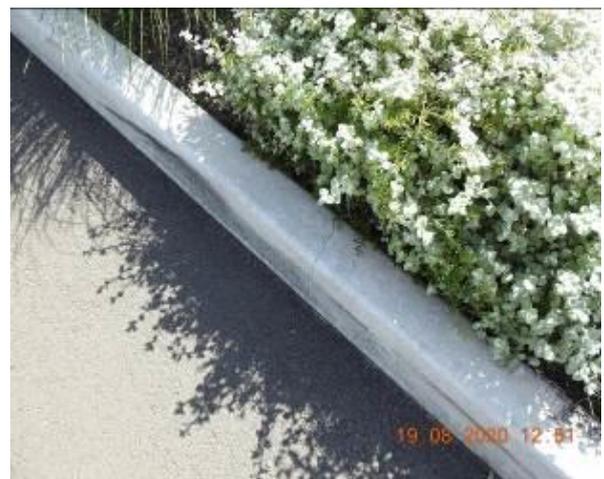
Figure 2085 – General condition of car park kerb

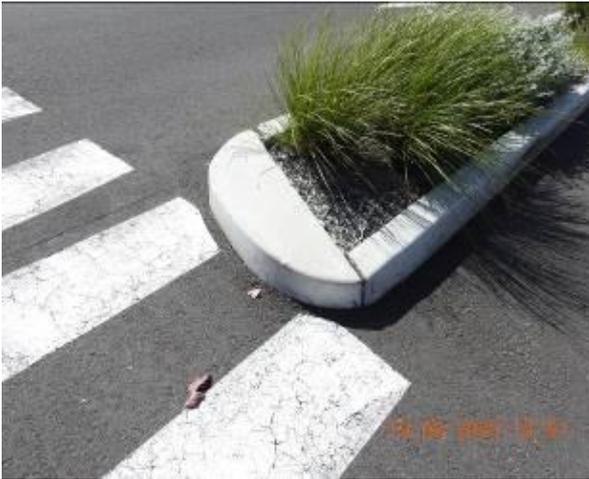
Figure 2086 – General condition of car park kerb

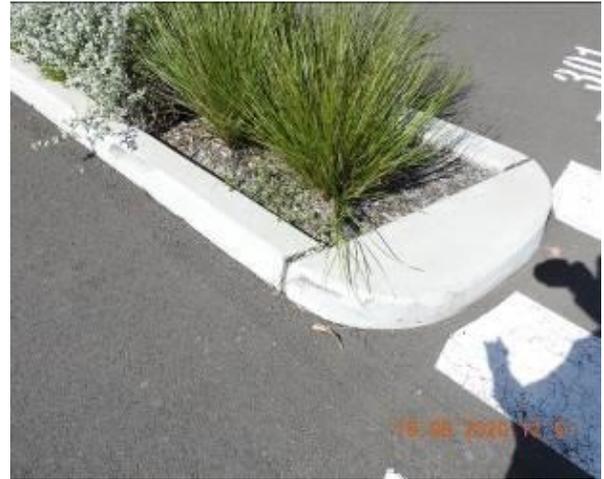
Figure 2087 – General condition of car park kerb

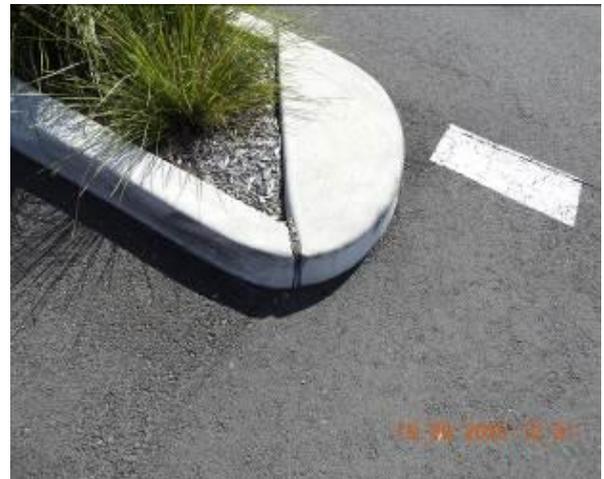
Figure 2089 – General condition of car park kerb

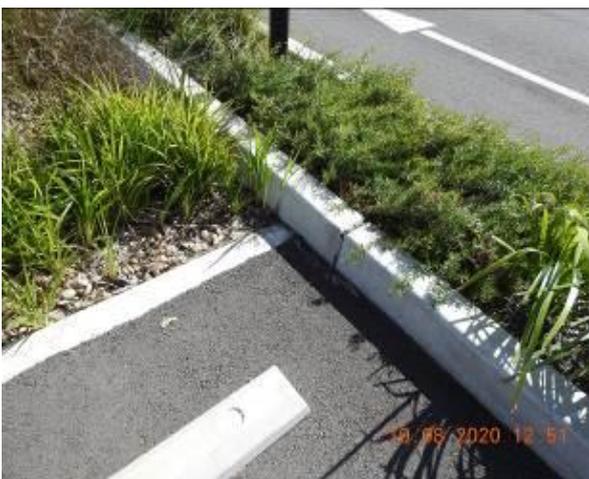
Figure 2090 – General condition of car park kerb

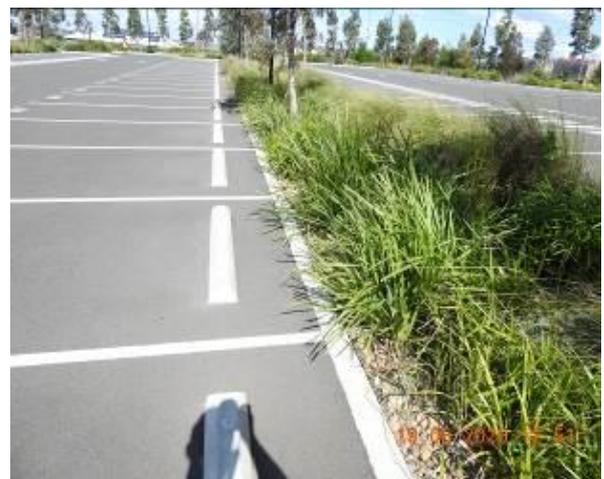
Figure 2091 – General condition of car park kerb

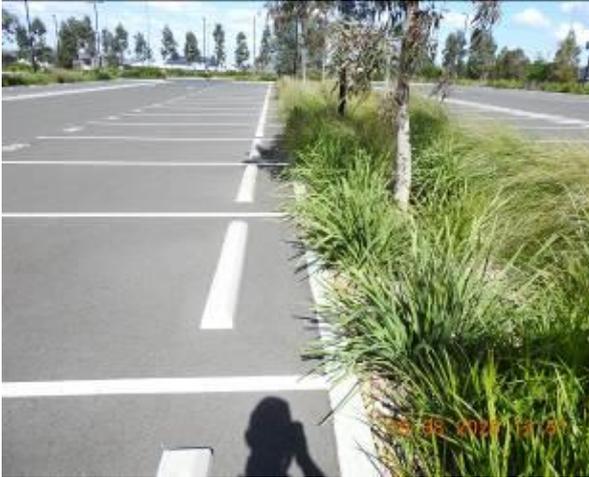
Figure 2092 – General condition of car park kerb

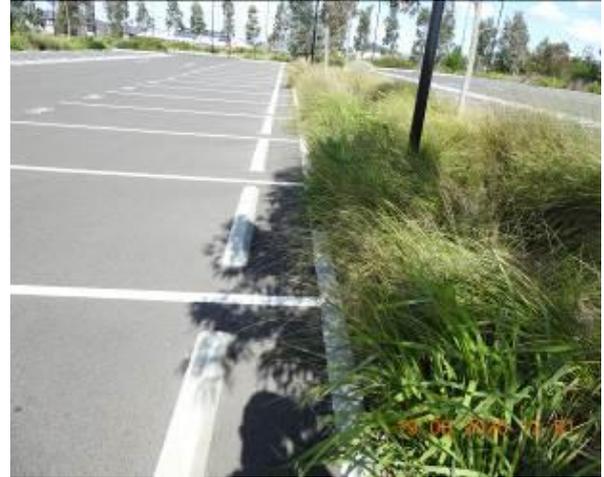
Figure 2093 – General condition of car park kerb

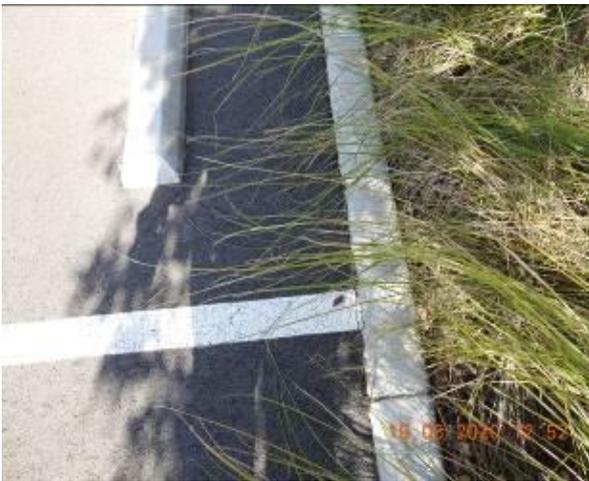
Figure 2094 – General condition of car park kerb

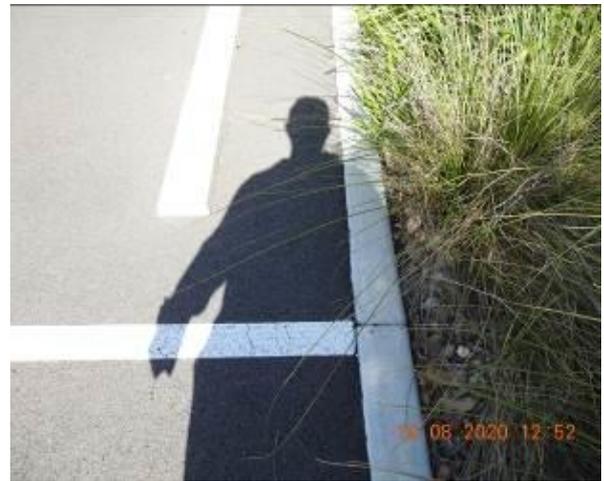
Figure 2095 – General condition of car park kerb

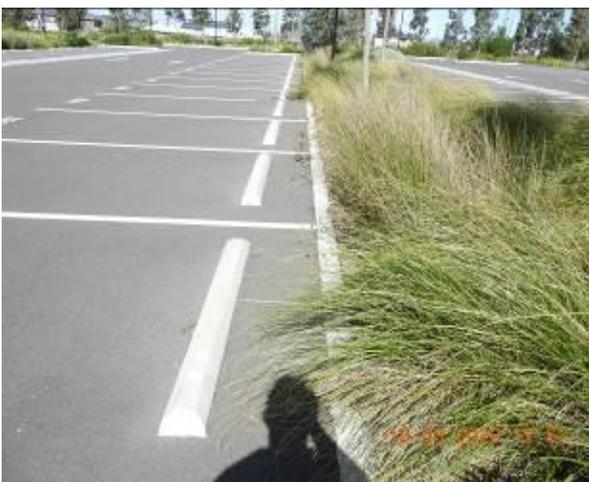
Figure 2096 – General condition of car park kerb

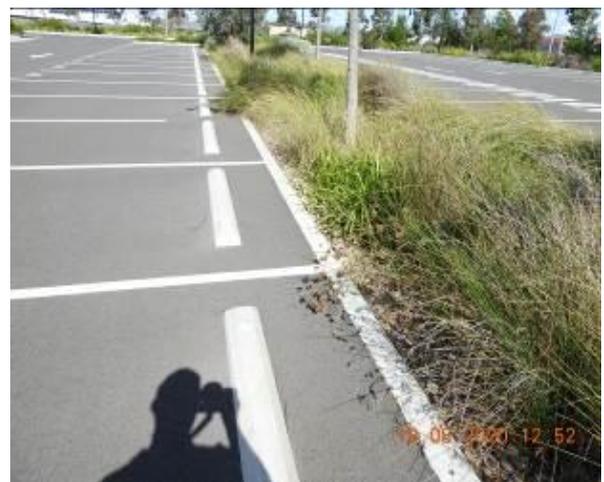
Figure 2097 – General condition of car park kerb

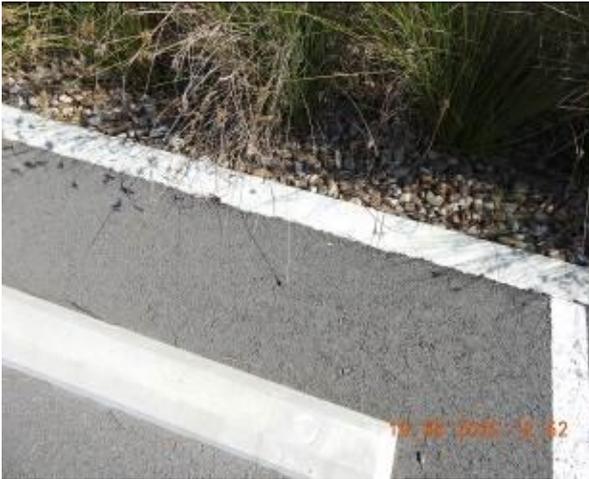
Figure 2098 – General condition of car park kerb

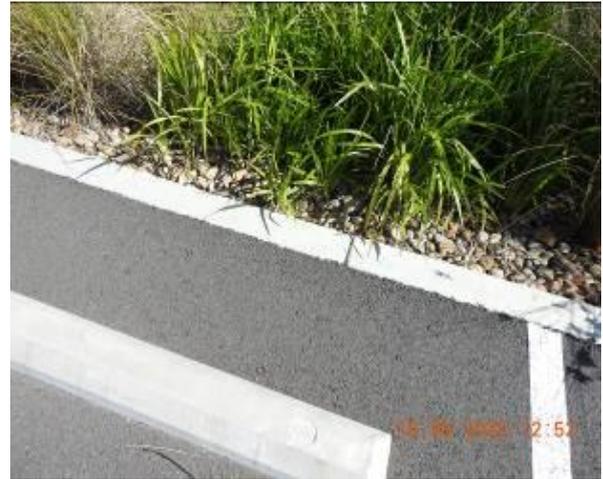
Figure 2099 – General condition of car park kerb

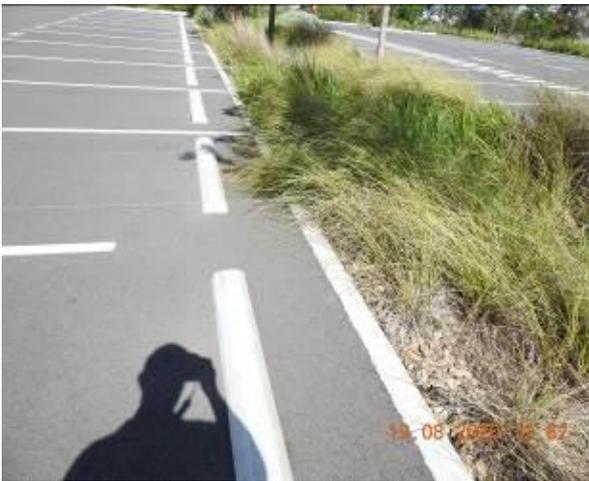
Figure 2100 – General condition of car park kerb

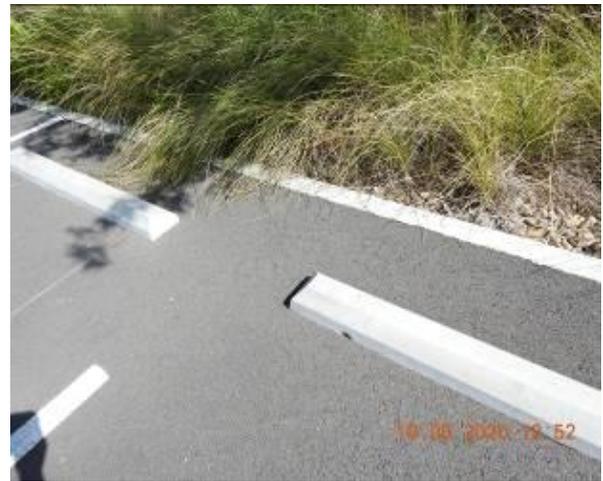
Figure 2101 – General condition of car park kerb

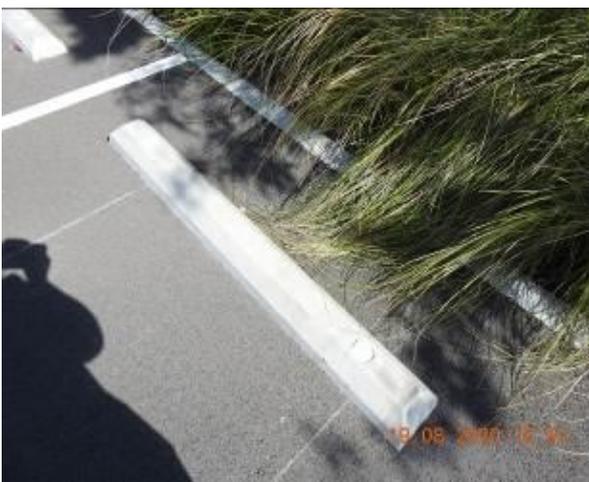
Figure 2102 – General condition of car park kerb

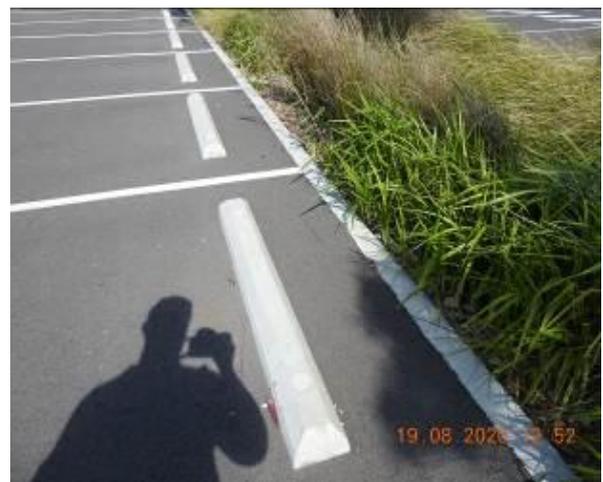
Figure 2103 – General condition of car park kerb

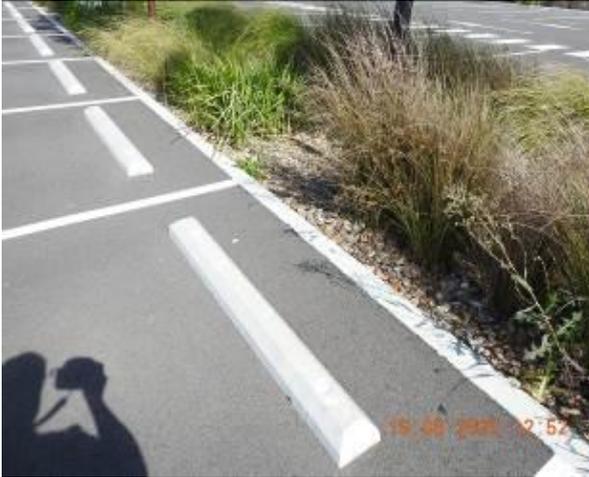
Figure 2104 – General condition of car park kerb

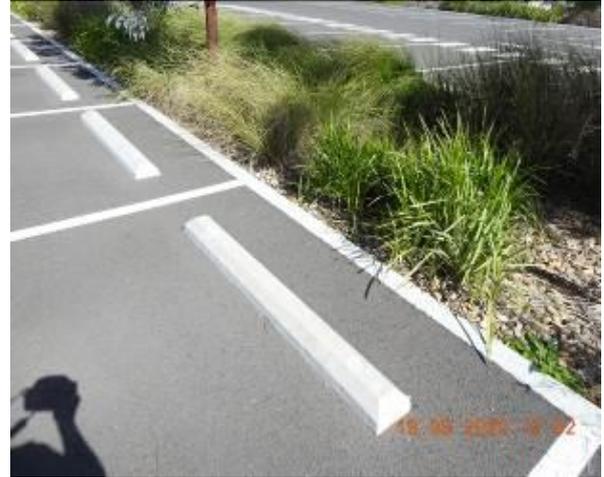
Figure 2105 – General condition of car park kerb

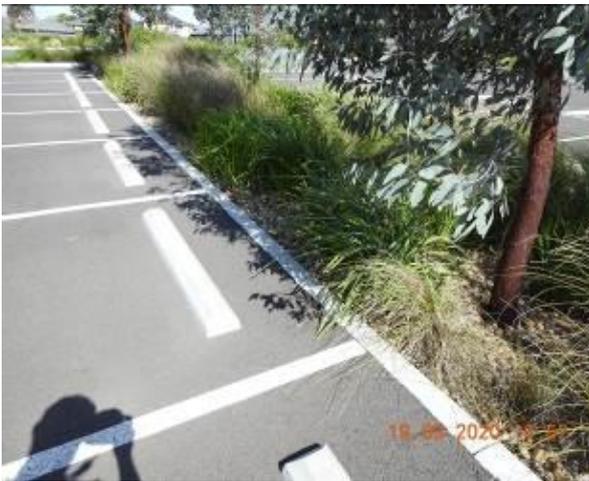
Figure 2106 – General condition of car park kerb

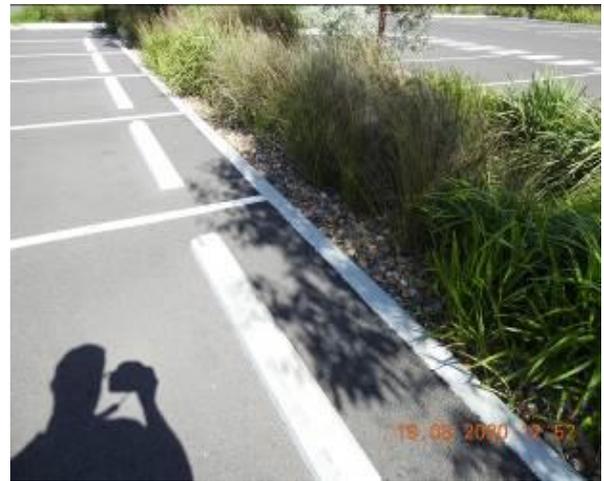
Figure 2107 – General condition of car park kerb

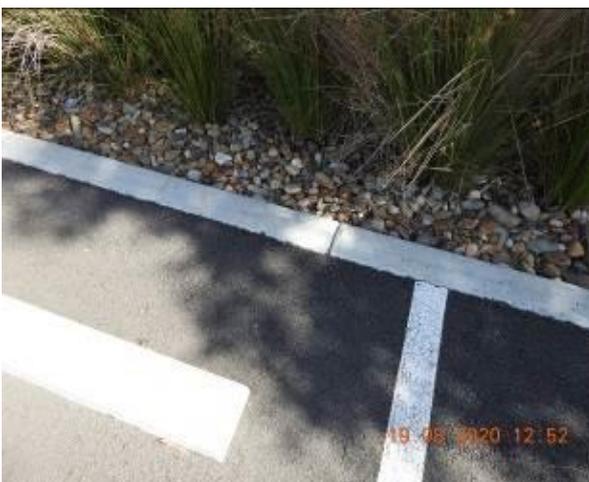
Figure 2108 – General condition of car park kerb

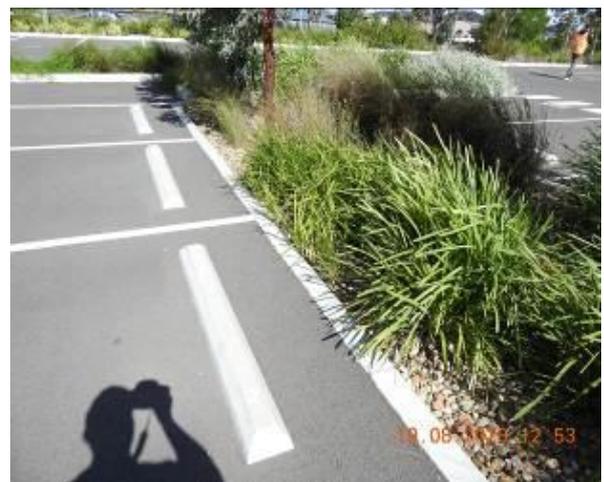
Figure 2109 – General condition of car park kerb

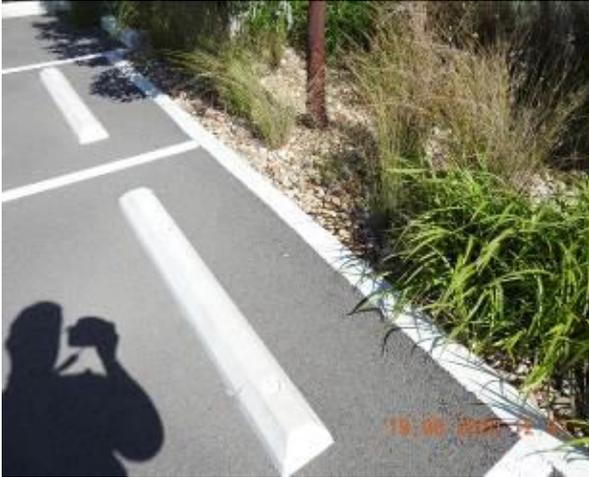
Figure 2110 – General condition of car park kerb

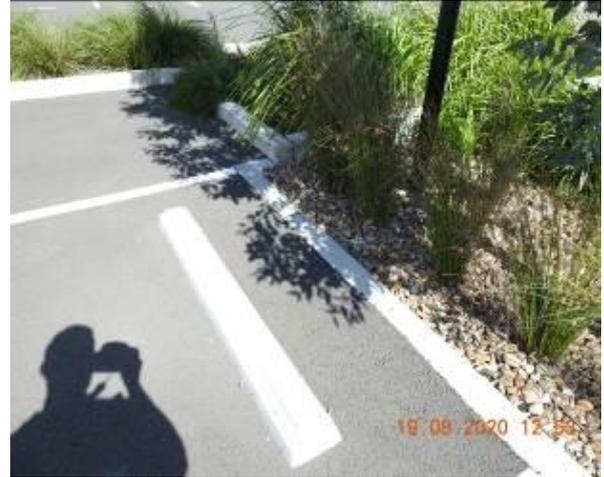
Figure 2111 – General condition of car park kerb

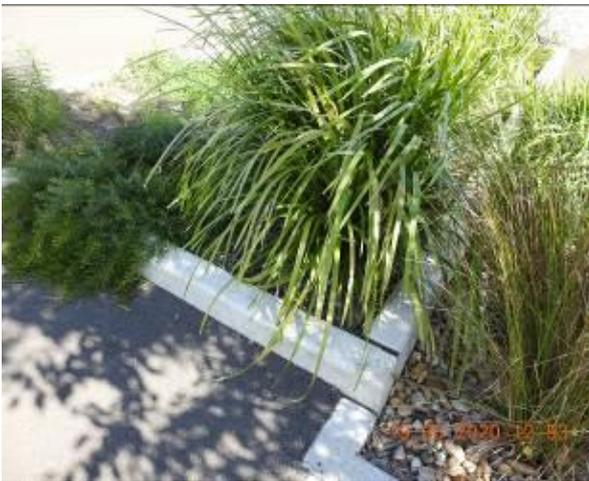
Figure 2112 – General condition of car park kerb

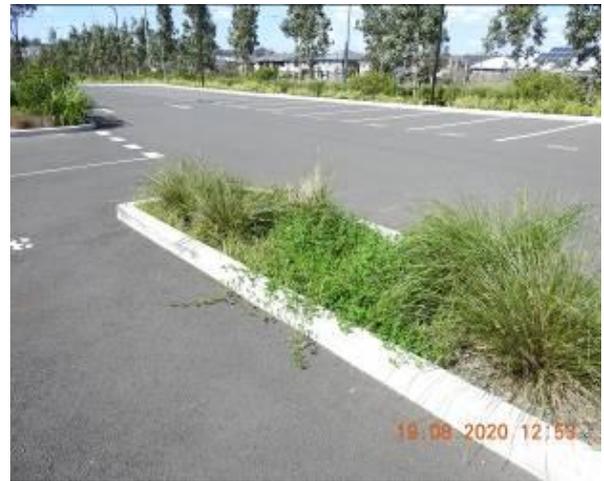
Figure 2113 – General condition of car park kerb

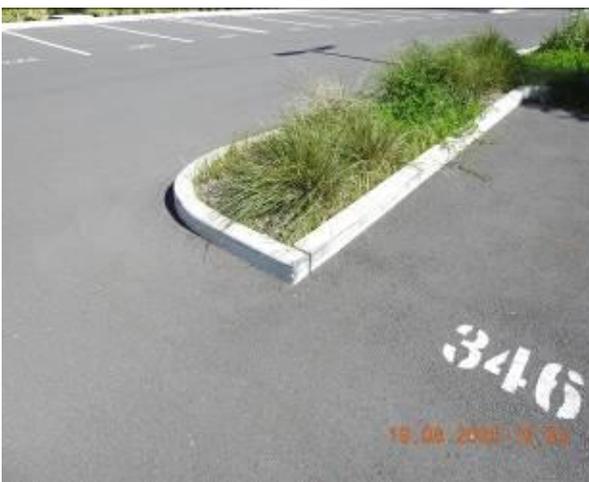
Figure 2114 – General condition of car park kerb

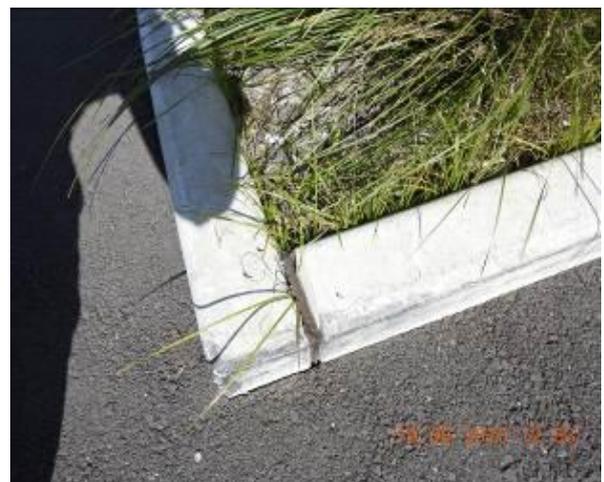
Figure 2115 – General condition of car park kerb

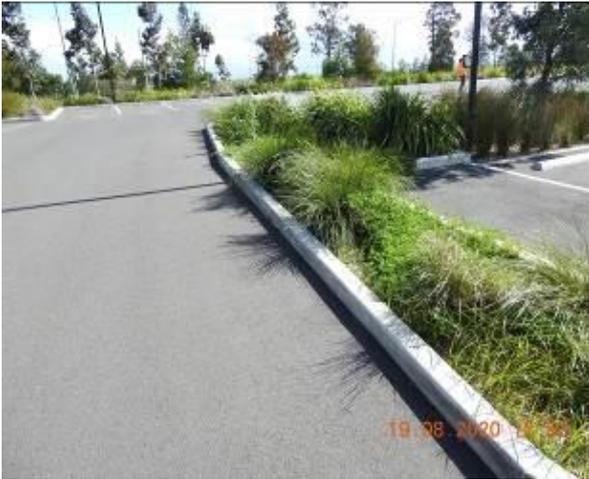
Figure 2116 – General condition of car park kerb

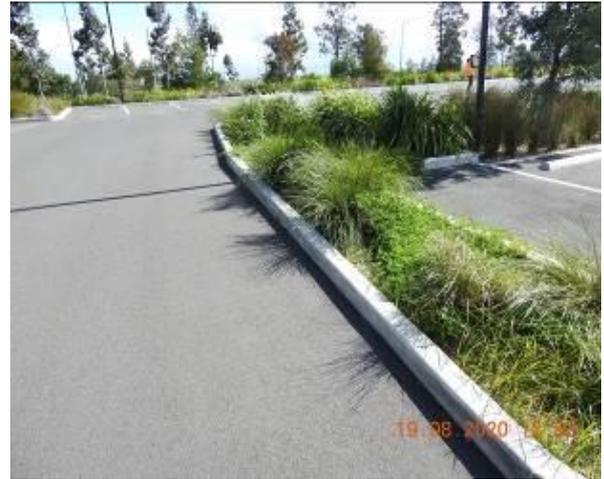
Figure 2117 – Crack propagation through car park kerb

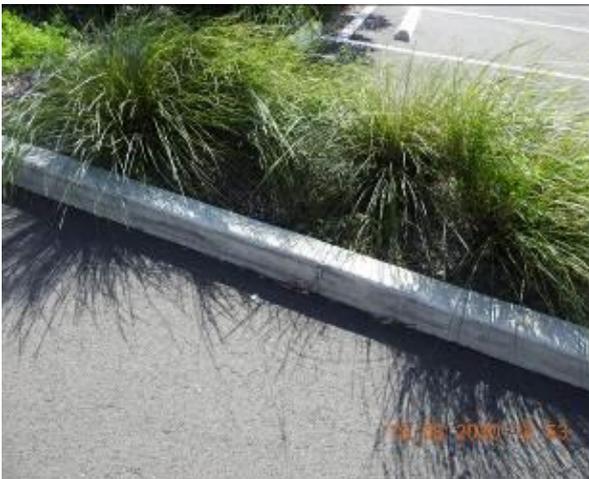
Figure 2118 – General condition of car park kerb

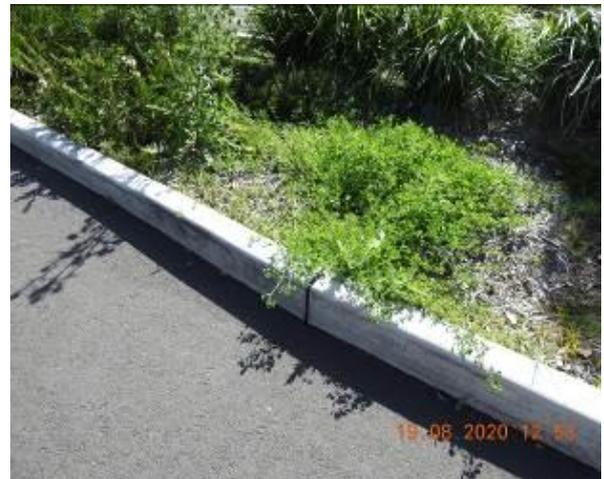
Figure 2119 – Crack propagation through car park kerb

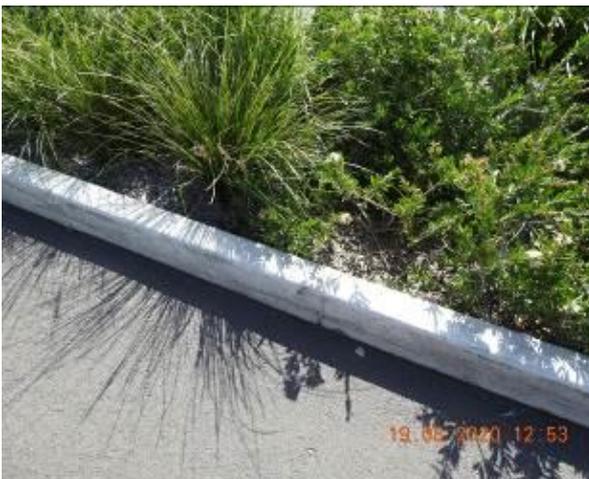
Figure 2120 – General condition of car park kerb

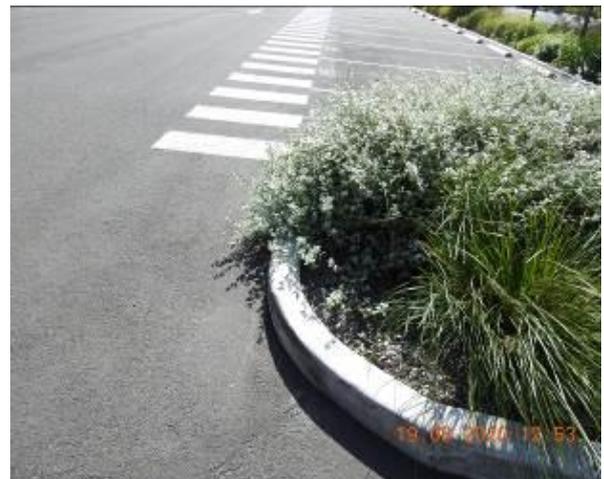
Figure 2121 – General condition of car park kerb

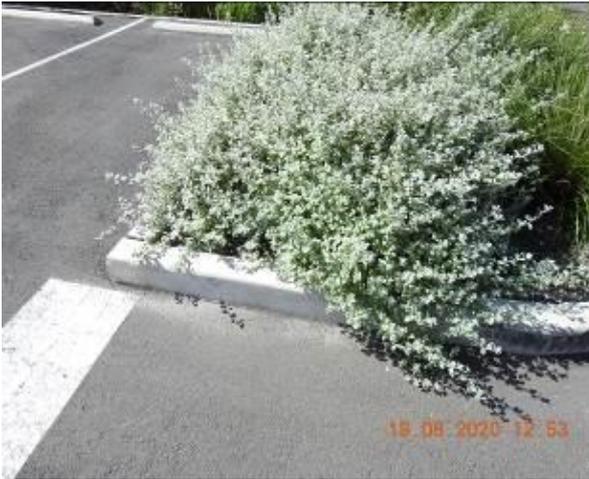
Figure 2122 – General condition of car park kerb

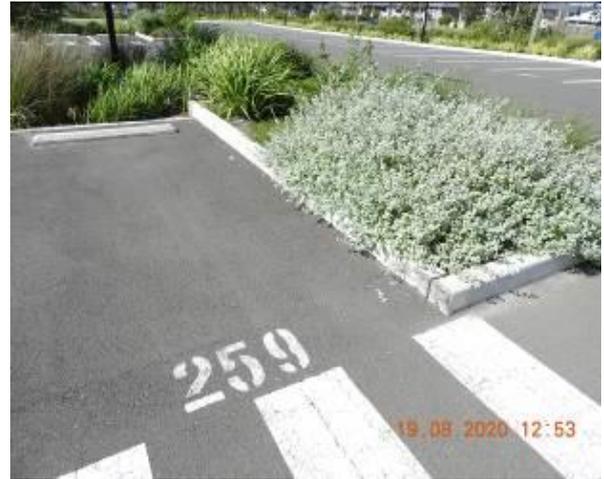
Figure 2123 – General condition of car park kerb

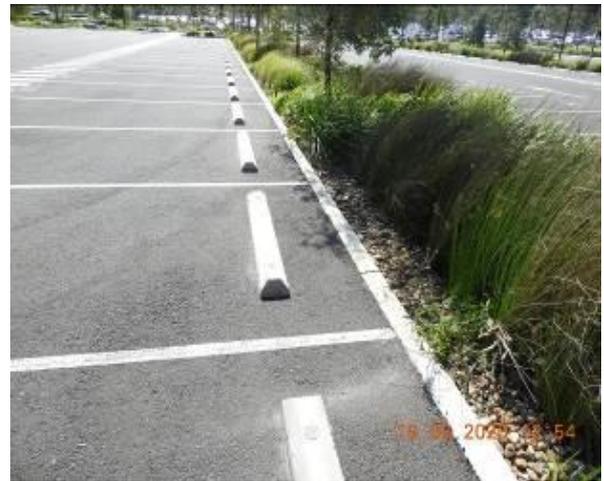
Figure 2124 – General condition of car park kerb

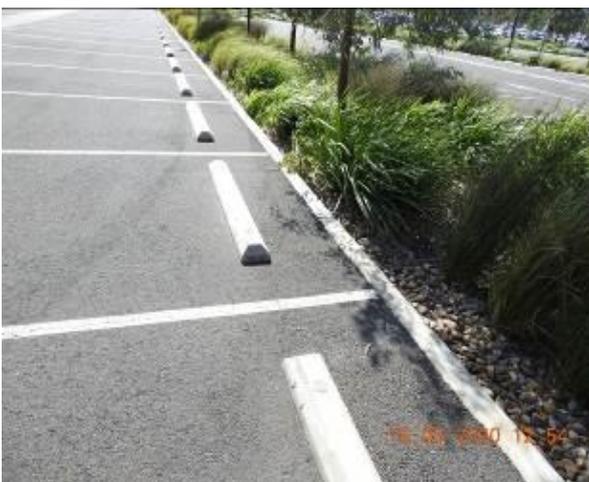
Figure 2125 – General condition of car park kerb

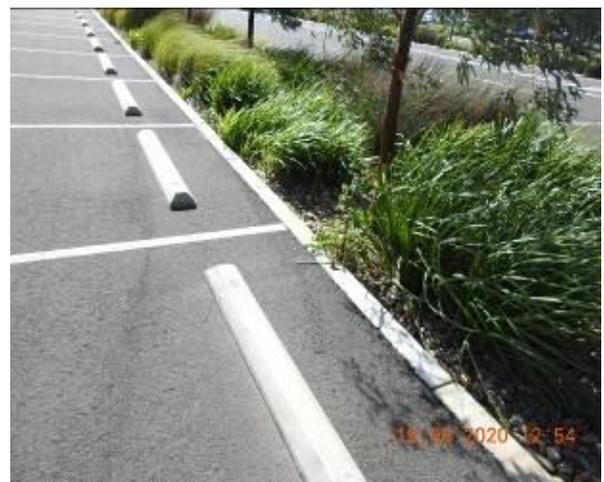
Figure 2126 – General condition of car park kerb

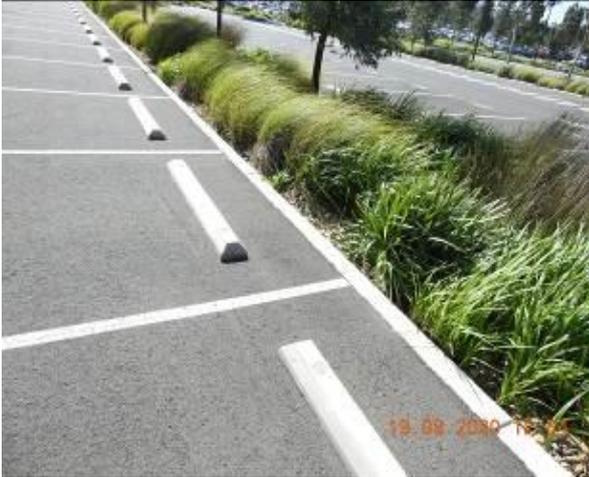
Figure 2127 – General condition of car park kerb

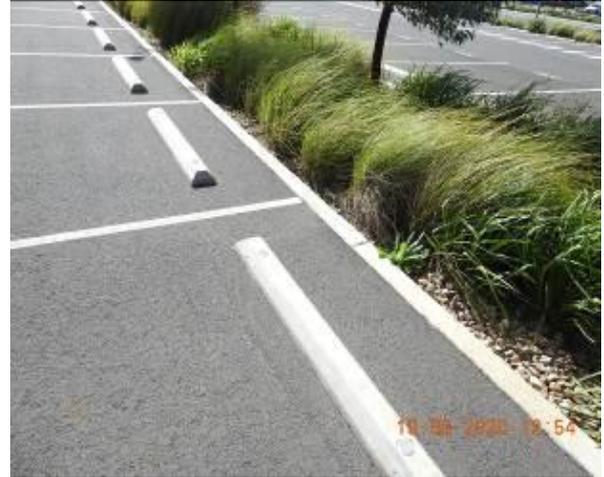
Figure 2128 – General condition of car park kerb

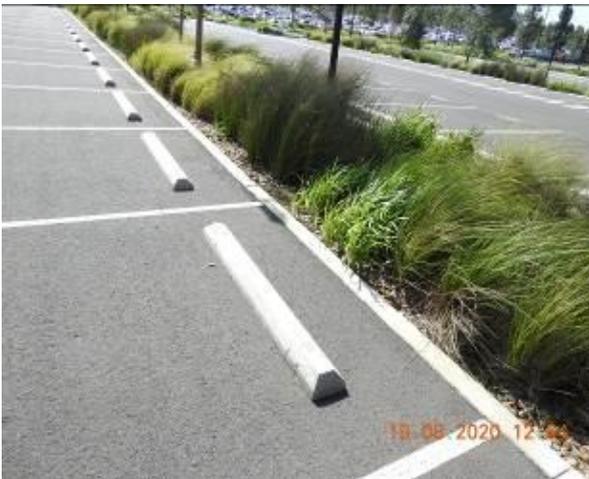
Figure 2129 – General condition of car park kerb

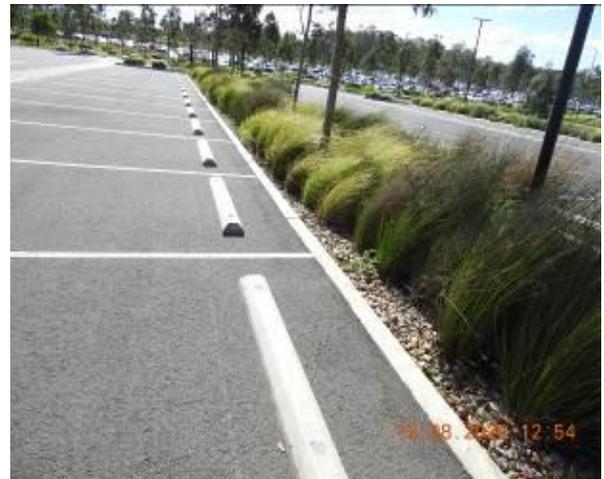
Figure 2130 – General condition of car park kerb

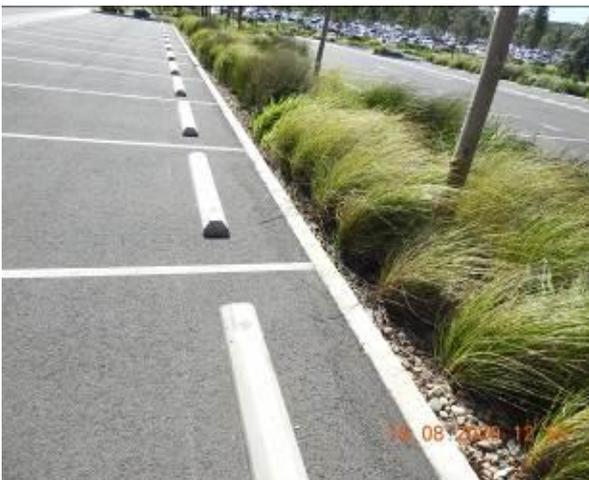
Figure 2131 – General condition of car park kerb

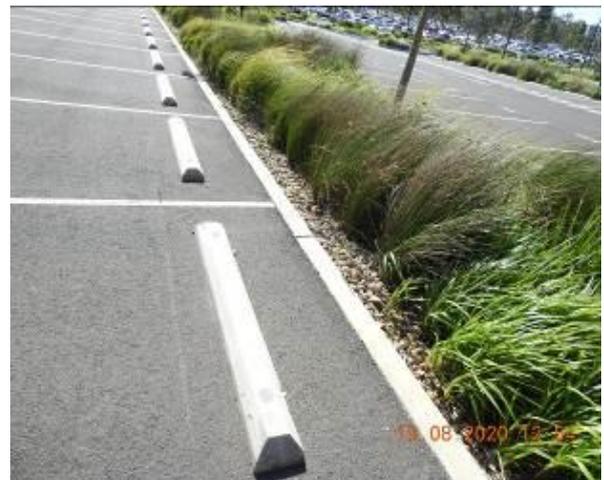
Figure 2132 – General condition of car park kerb

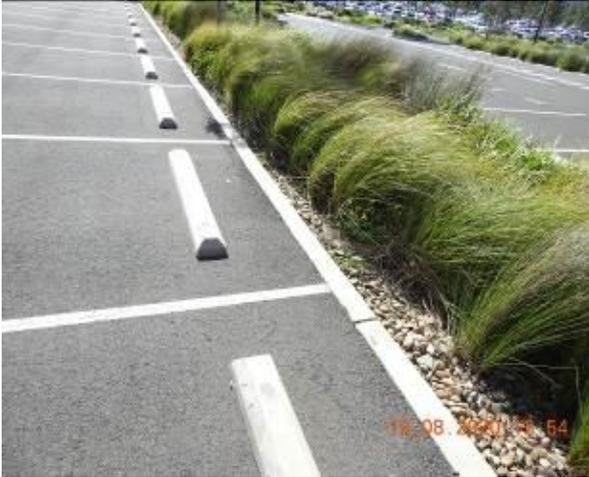
Figure 2133 – General condition of car park kerb

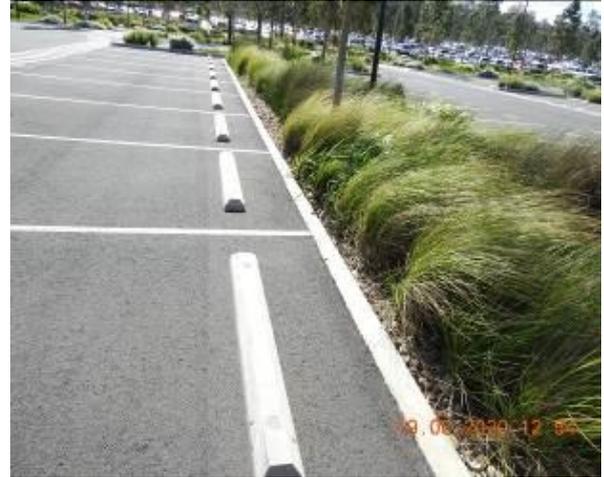
Figure 2134 – General condition of car park kerb

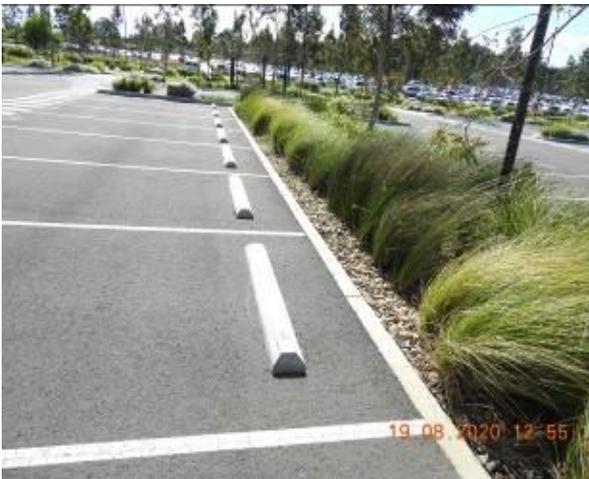
Figure 2135 – General condition of car park kerb
