The property Tallawong station – P2 Car Park, is the neighbouring property to our client’s site. It was photographed and inspected prior to any construction works on the subject site and was found to be in a reasonable condition. The property serves as a car park.

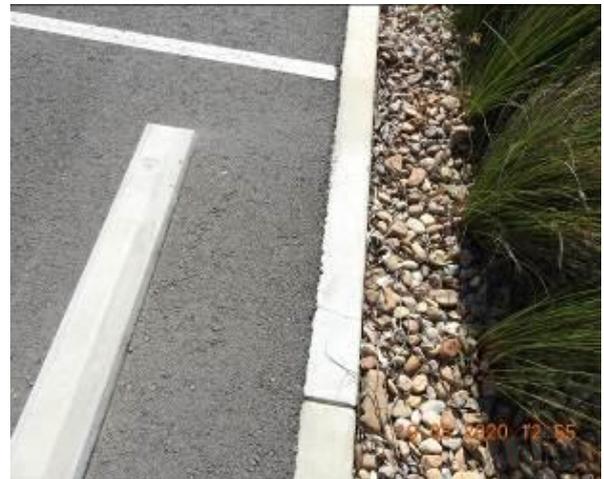
Figure 2136 – Crack propagation through car park kerb

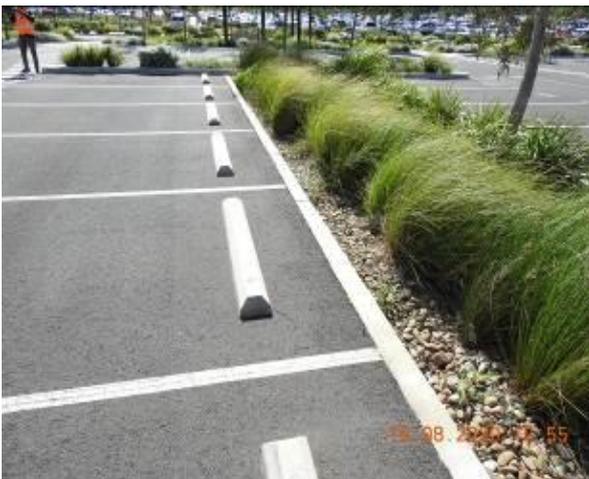
Figure 2137 – General condition of car park kerb

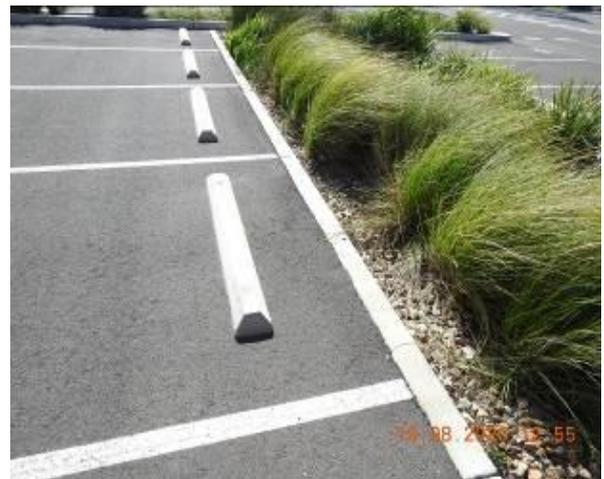
Figure 2138 – General condition of car park kerb

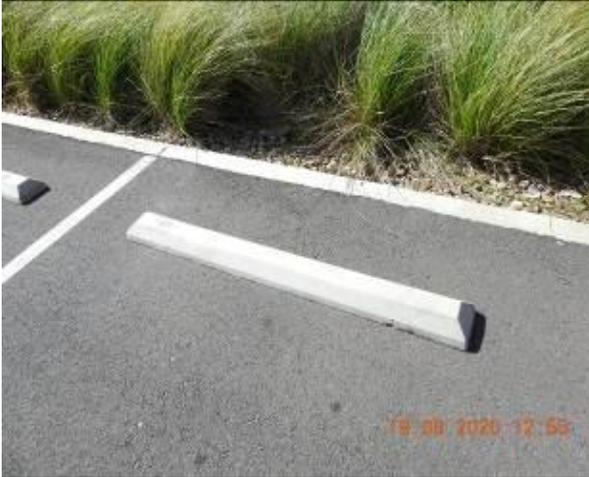
Figure 2139 – General condition of car park kerb

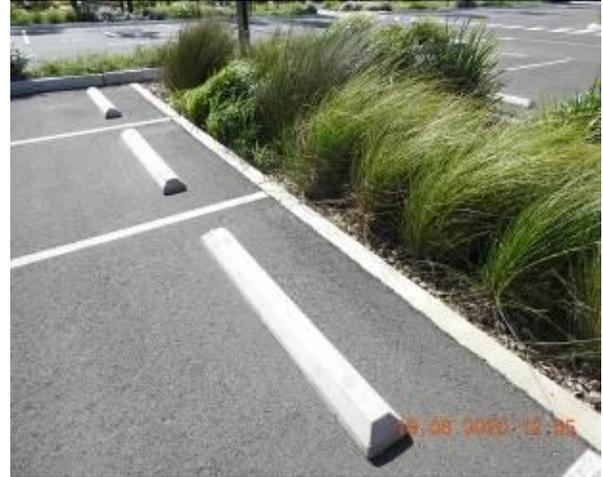
Figure 2140 – General condition of car park kerb

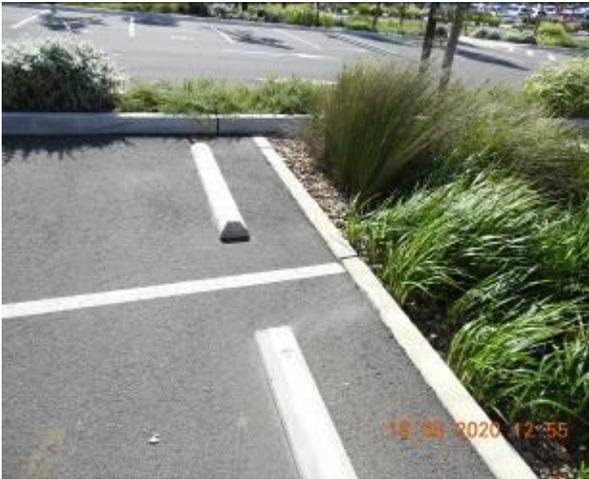
Figure 2141 – General condition of car park kerb

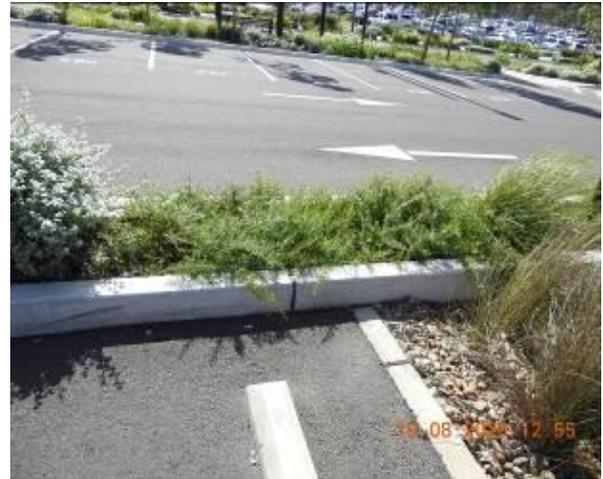
Figure 2142 – General condition of car park kerb

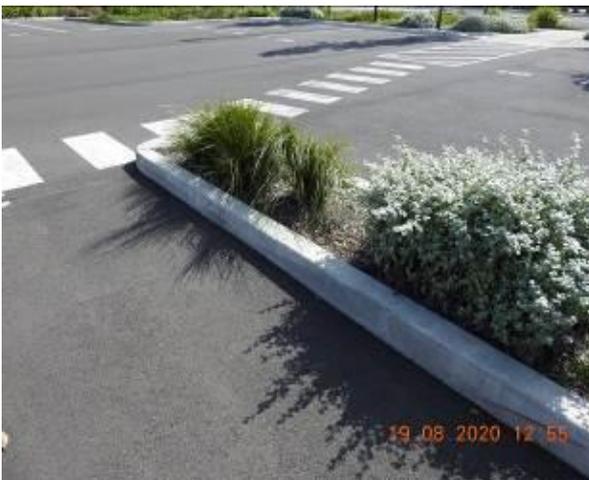
Figure 2143 – General condition of car park kerb

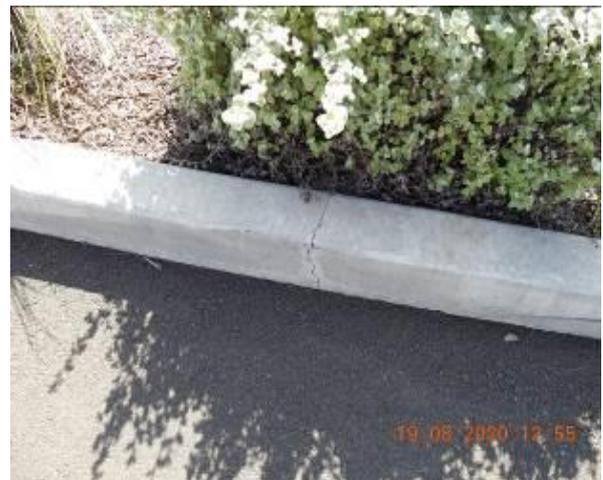
Figure 2144 – Crack propagation through car park kerb

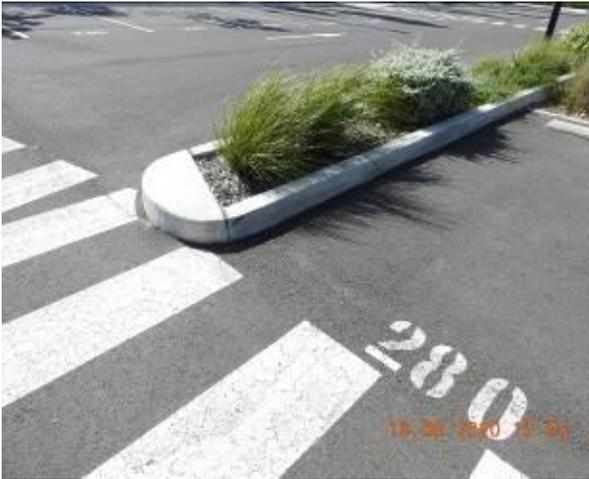
Figure 2145 – General condition of car park kerb

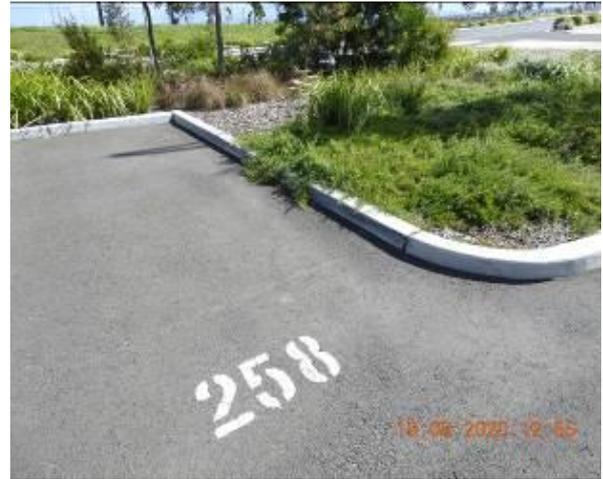
Figure 2146 – General condition of car park kerb

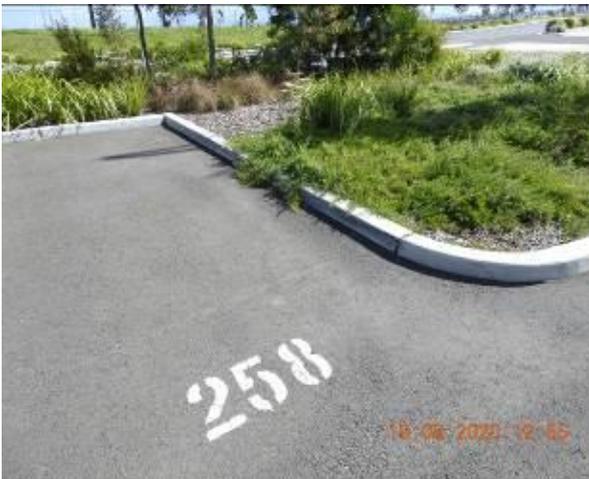
Figure 2147 – General condition of car park kerb

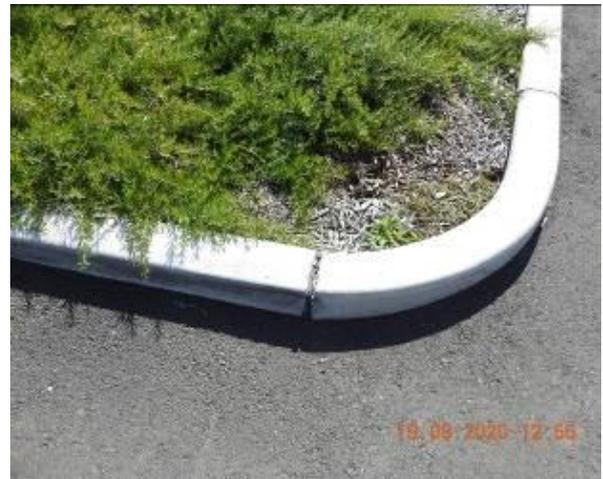
Figure 2148 – General condition of car park kerb

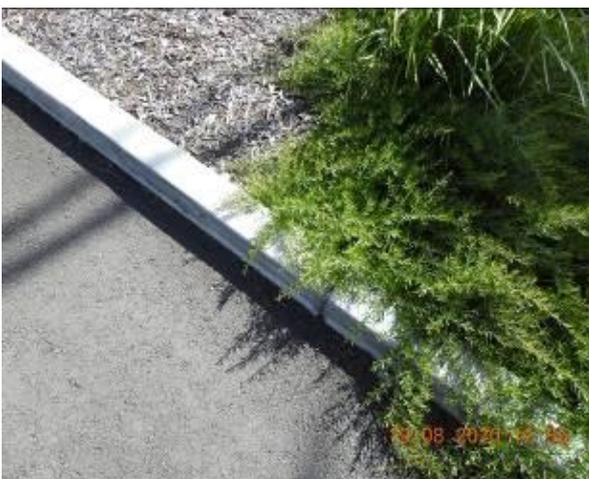
Figure 2149 – General condition of car park kerb

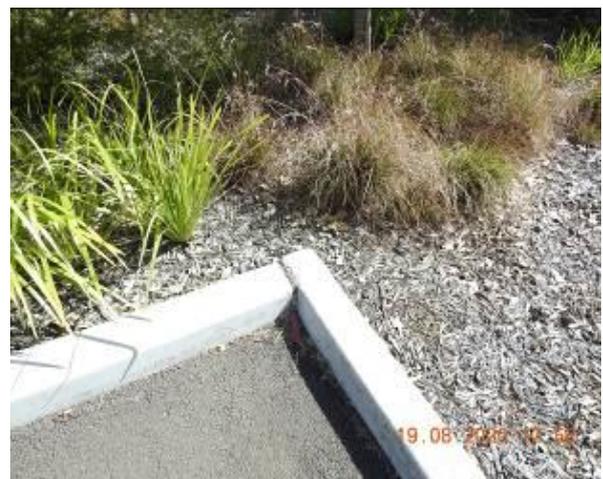
Figure 2150 – General condition of car park kerb

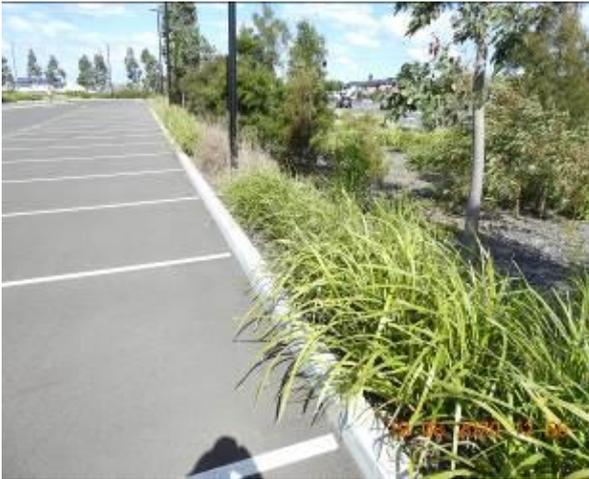
Figure 2151 – General condition of car park kerb

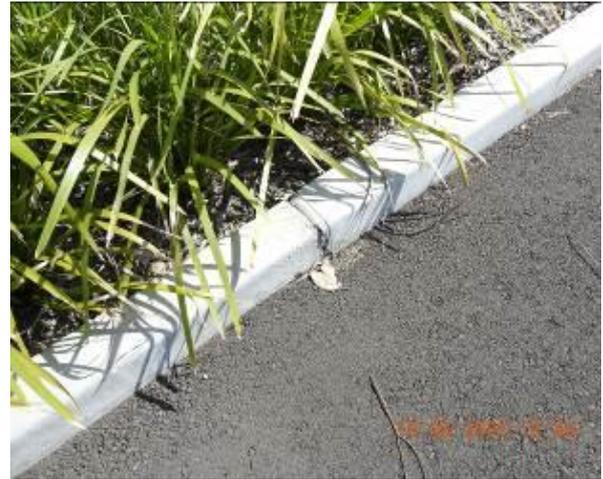
Figure 2152 – General condition of car park kerb

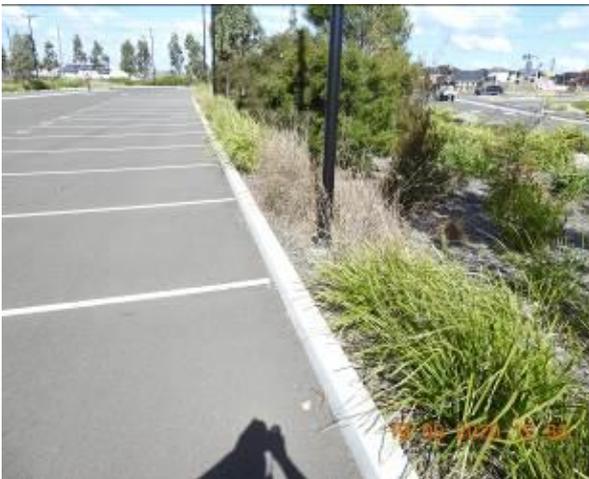
Figure 2153 – General condition of car park kerb

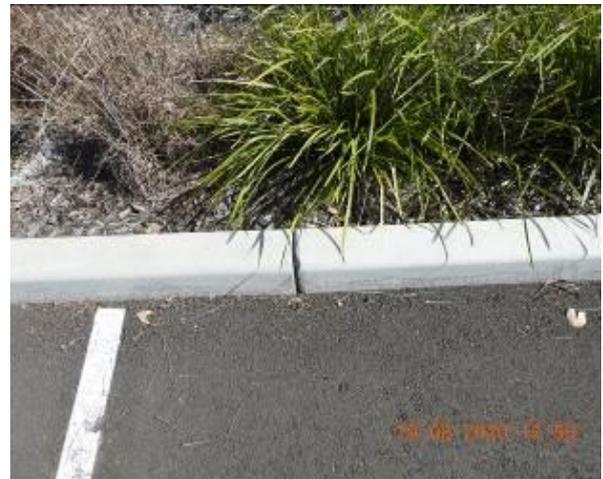
Figure 2154 – Crack propagation through car park kerb

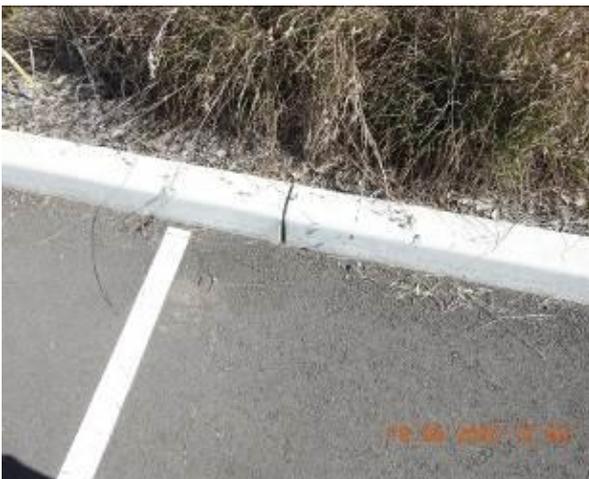
Figure 2155 – Crack propagation through car park kerb

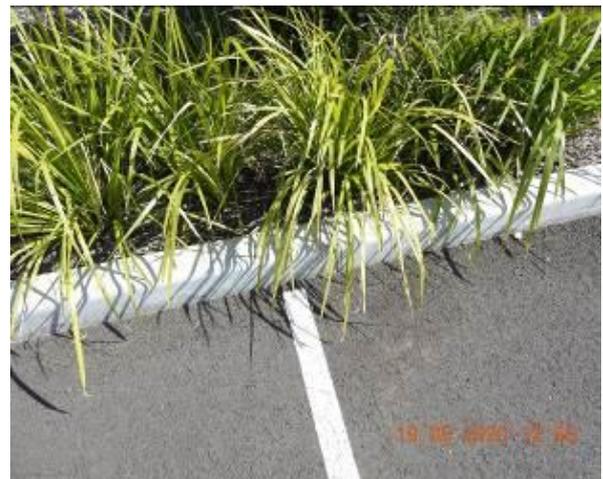
Figure 2156 – General condition of car park kerb

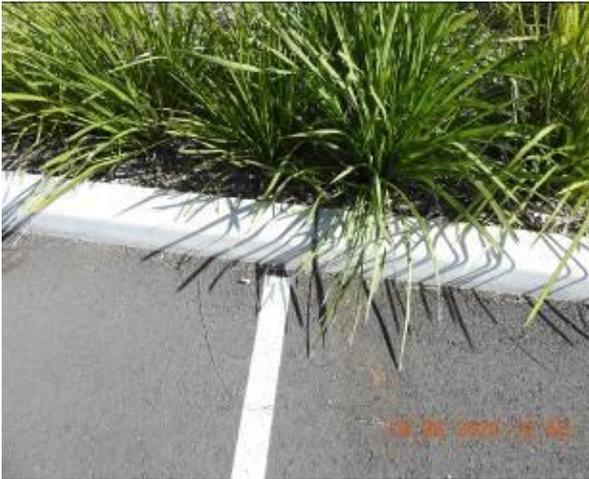
Figure 2157 – Crack propagation through car park kerb

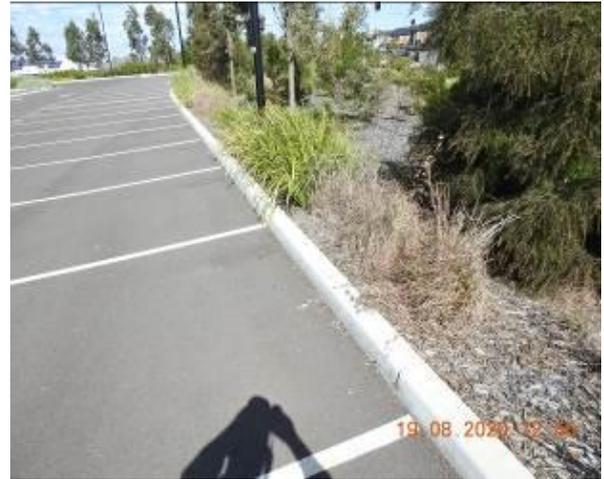
Figure 2158 – General condition of car park kerb

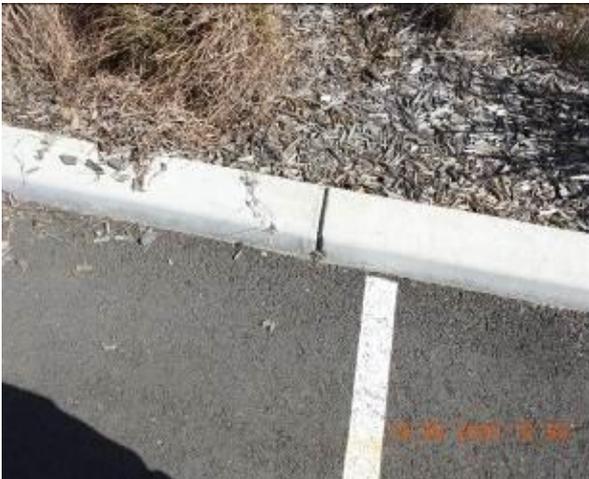
Figure 2159 – Crack propagation through car park kerb

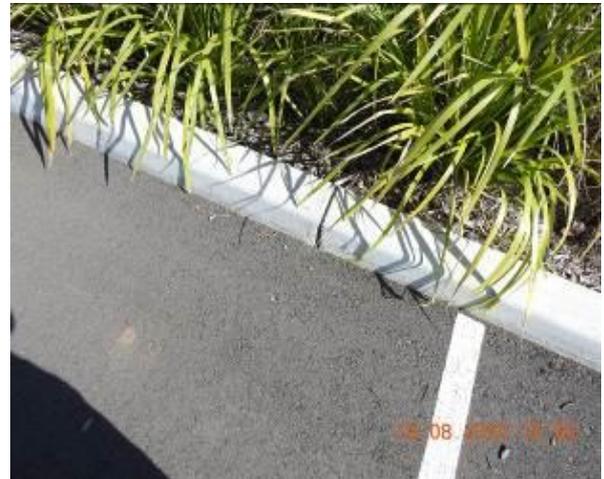
Figure 2160 – Crack propagation through car park kerb

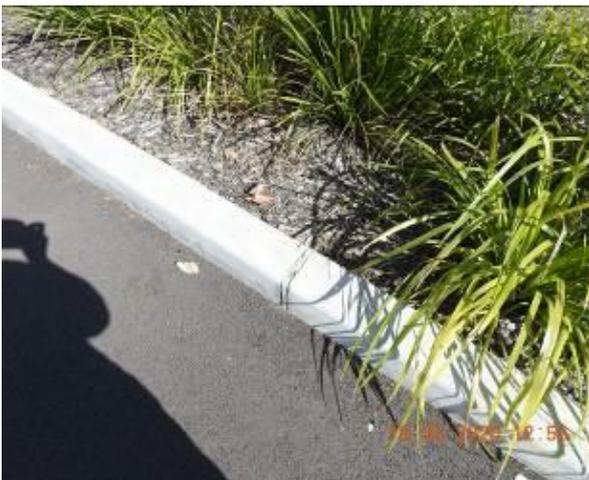
Figure 2161 – General condition of car park kerb

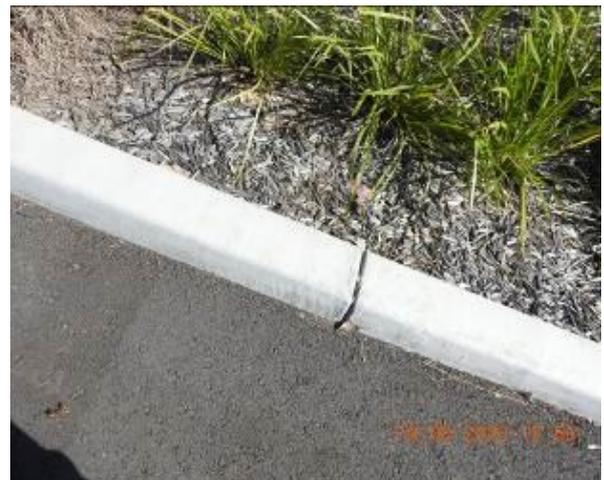
Figure 2162 – Crack propagation through car park kerb

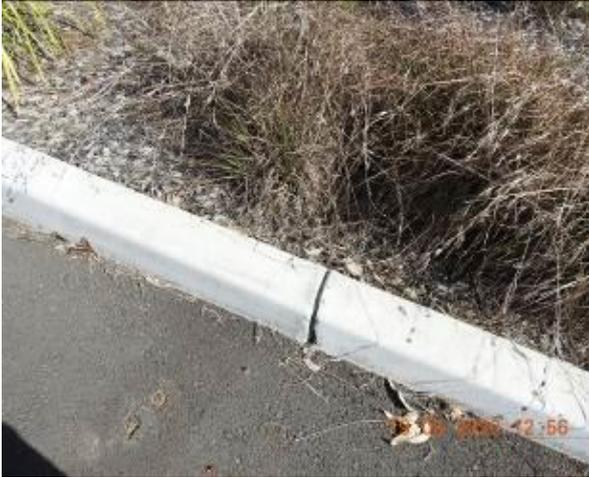
Figure 2163 – Crack propagation through car park kerb

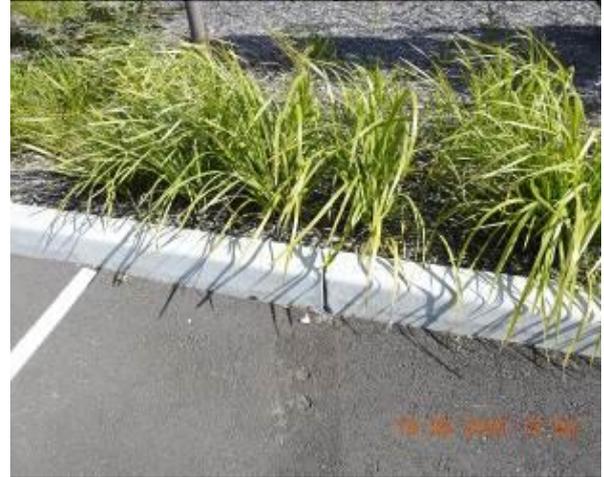
Figure 2164 – Crack propagation through car park kerb

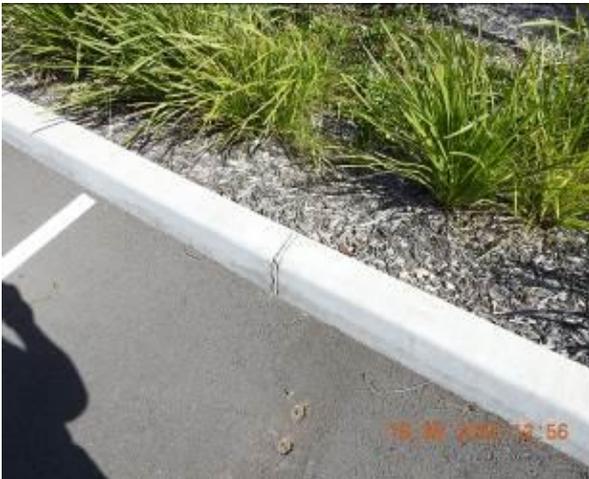
Figure 2165 – General condition of car park kerb

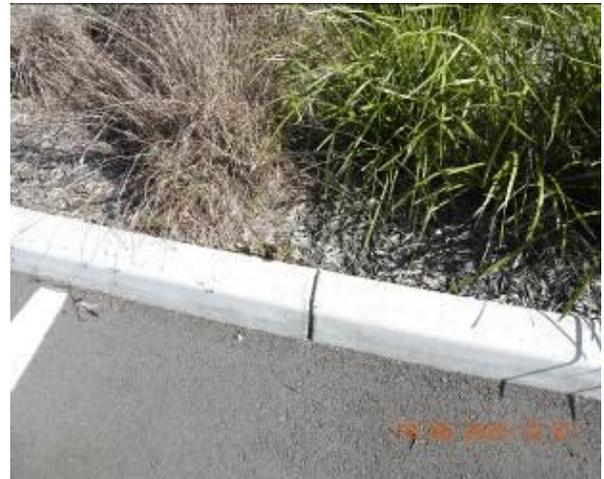
Figure 2166 – Crack propagation through car park kerb

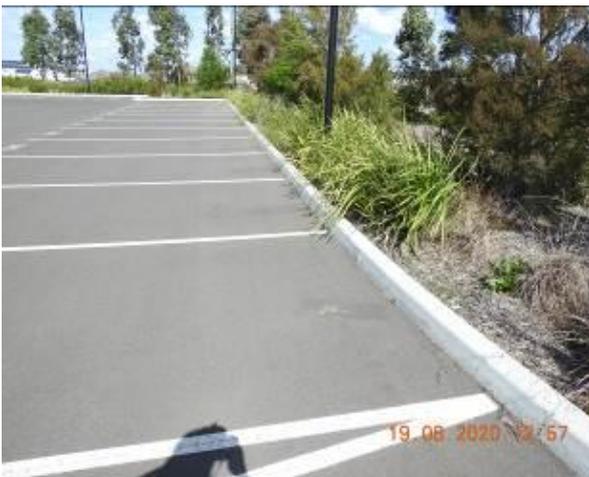
Figure 2167 – General condition of car park kerb

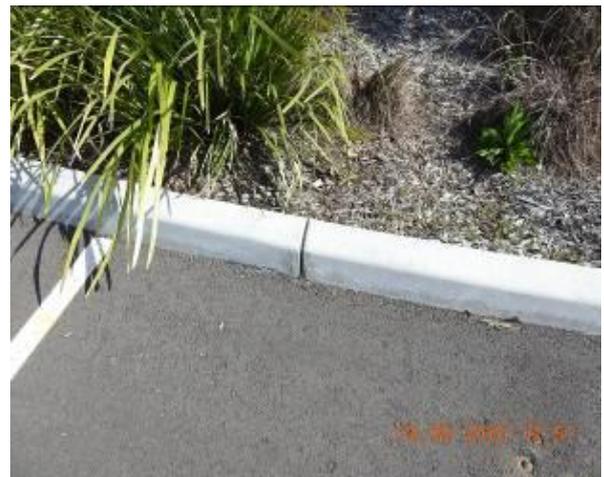
Figure 2168 – Crack propagation through car park kerb

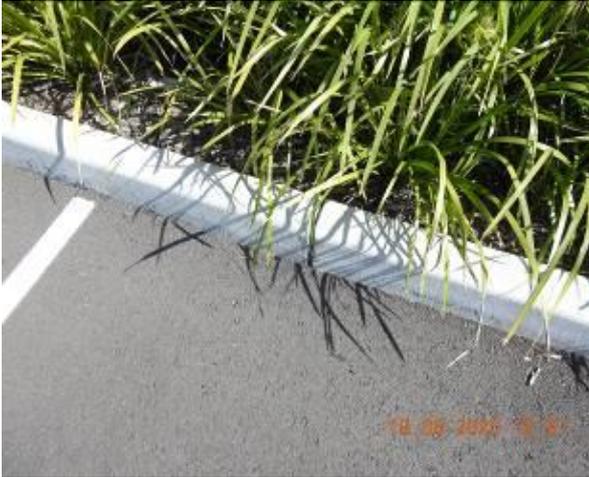
Figure 2169 – Crack propagation through car park kerb

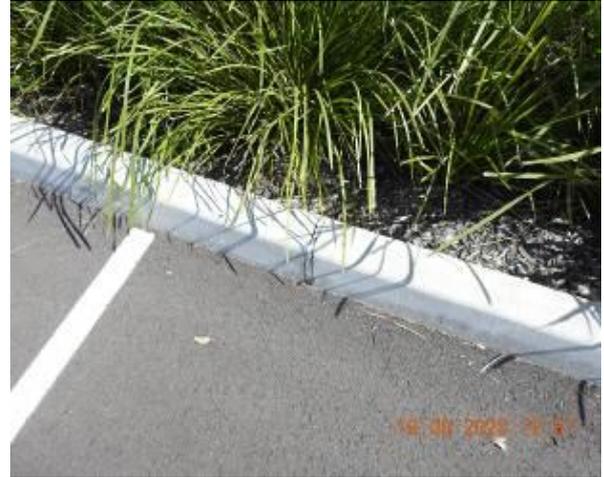
Figure 2170 – General condition of car park kerb

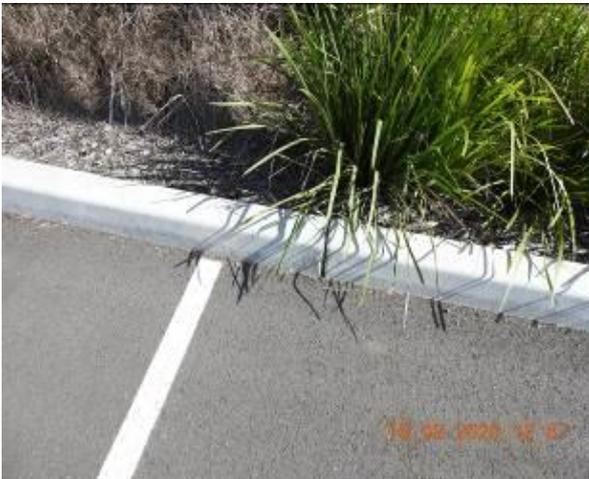
Figure 2171 – General condition of car park kerb

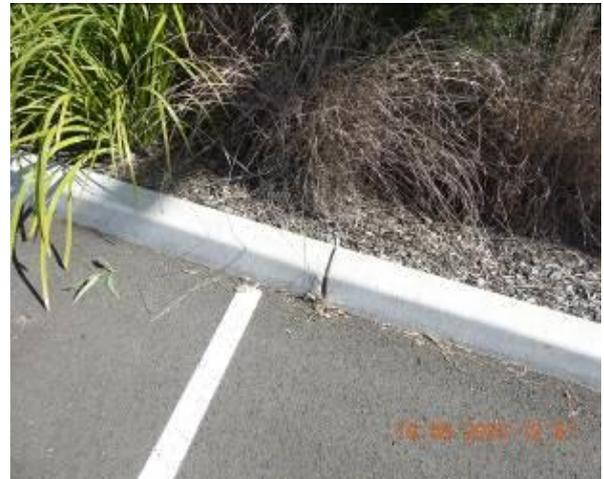
Figure 2172 – Crack propagation through car park kerb

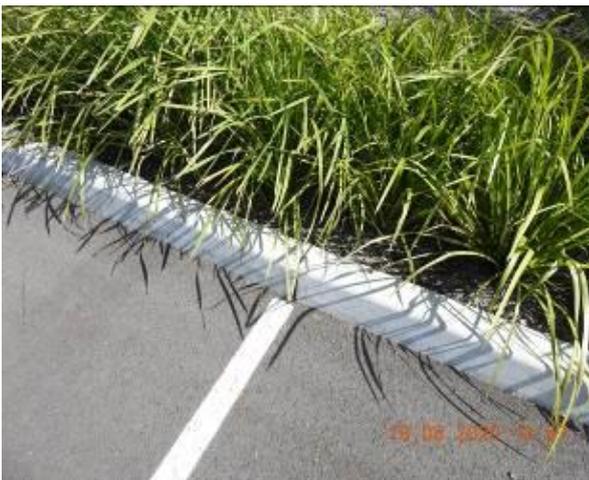
Figure 2173 – Crack propagation through car park kerb

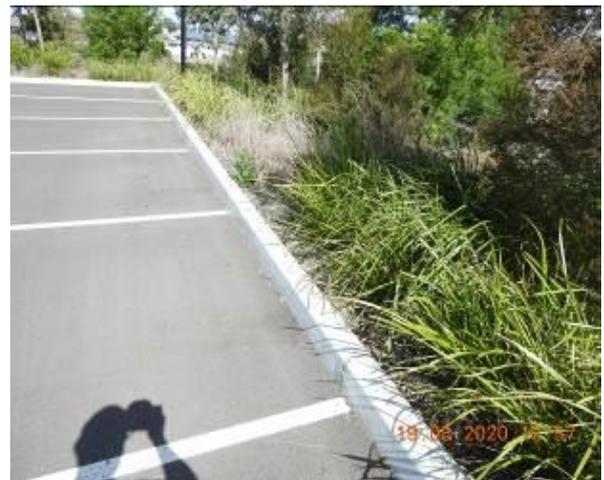
Figure 2174 – General condition of car park kerb

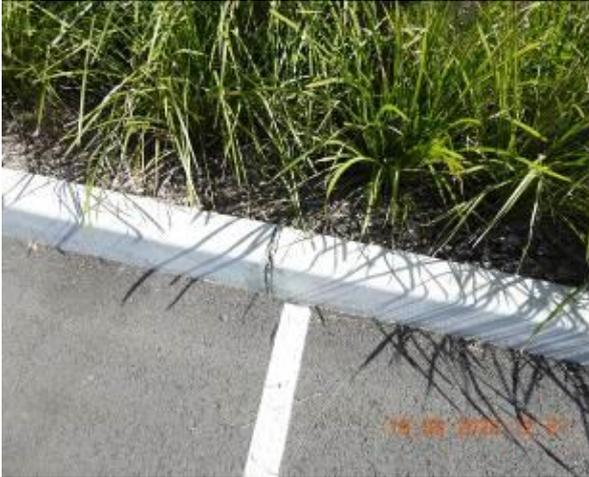
Figure 2175 – General condition of car park kerb

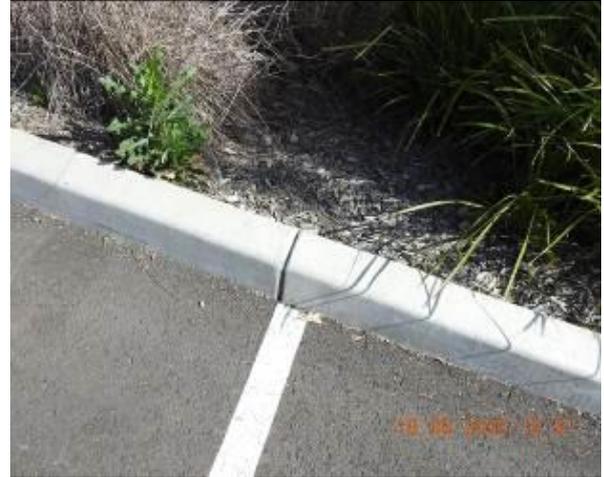
Figure 2176 – Crack propagation through car park kerb

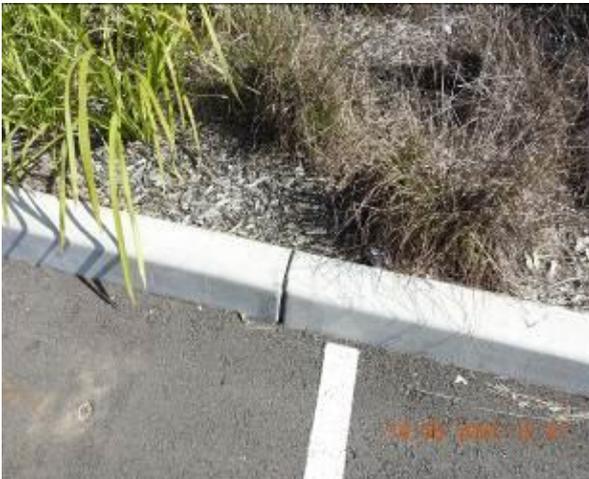
Figure 2177 – Crack propagation through car park kerb

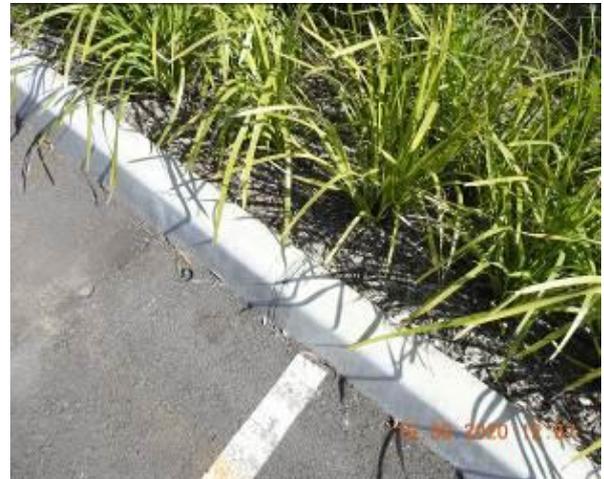
Figure 2178 – General condition of car park kerb

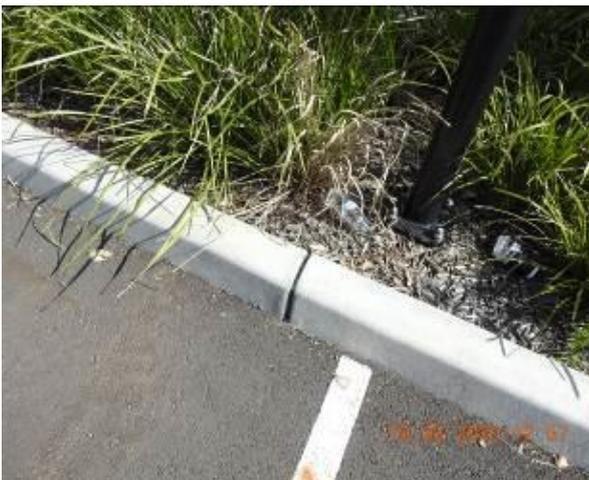
Figure 2179 – Crack propagation through car park kerb

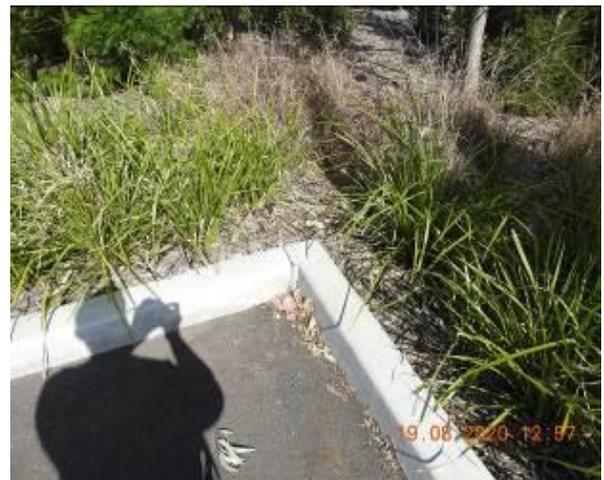
Figure 2180 – General condition of car park kerb

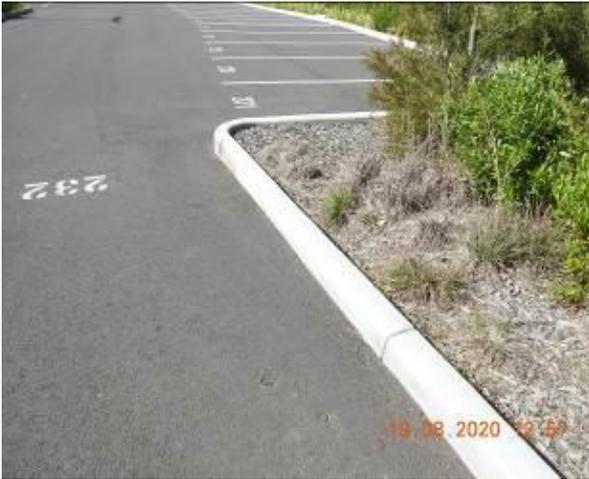
Figure 2181 – General condition of car park kerb

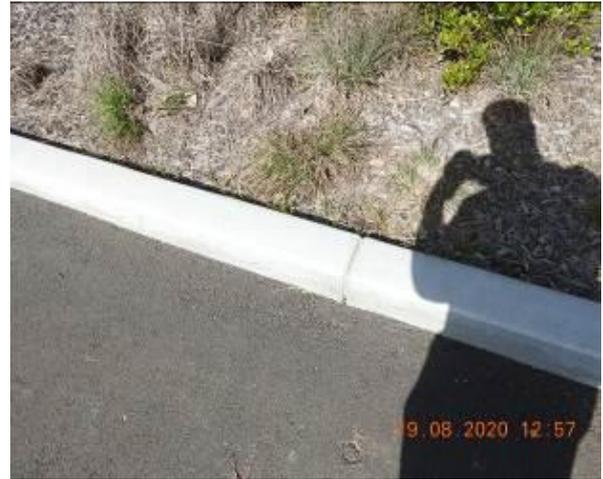
Figure 2182 – Crack propagation through car park kerb

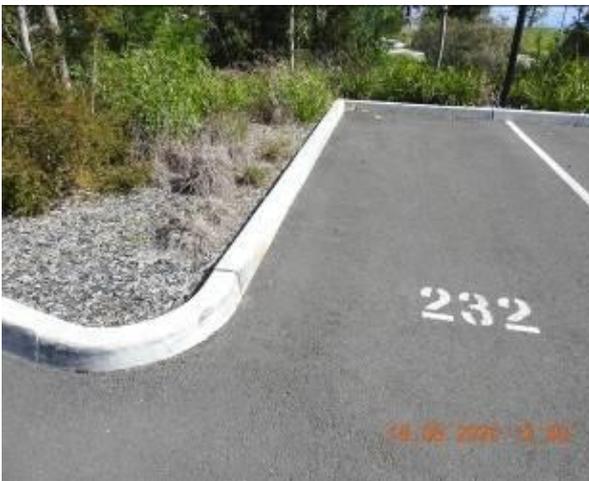
Figure 2183 – General condition of car park kerb

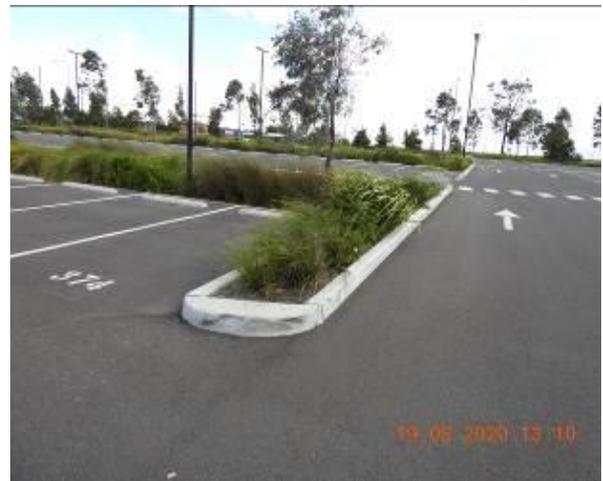
Figure 2184 – General condition of car park kerb

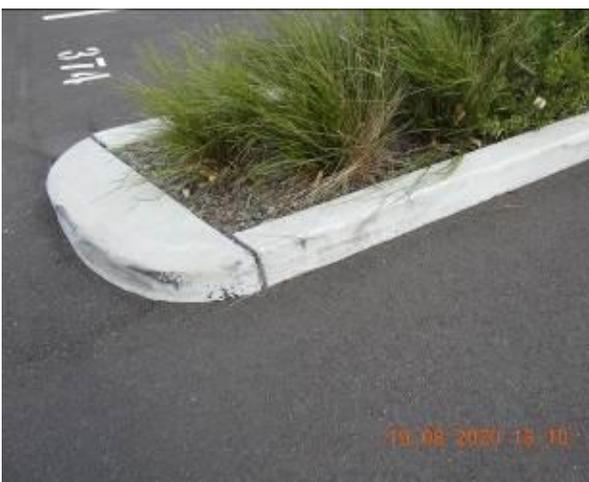
Figure 2185 – General condition of car park kerb

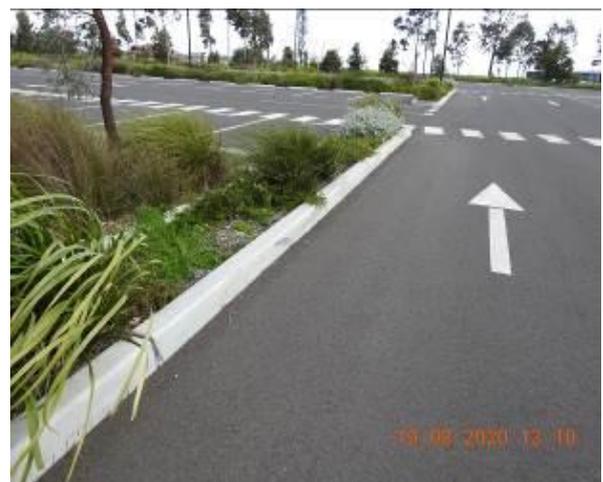
Figure 2186 – General condition of car park kerb

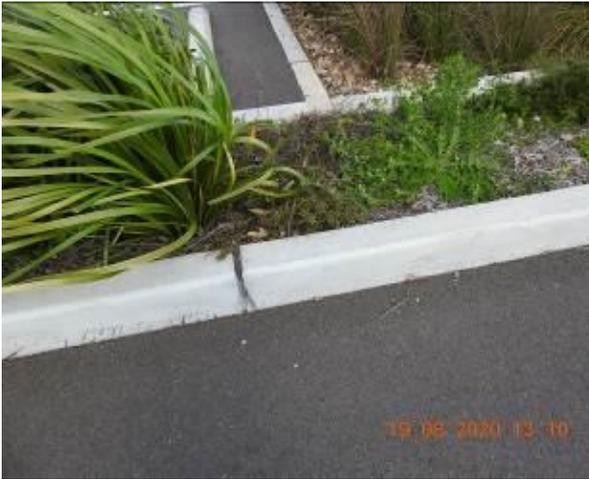
Figure 2187 – General condition of car park kerb

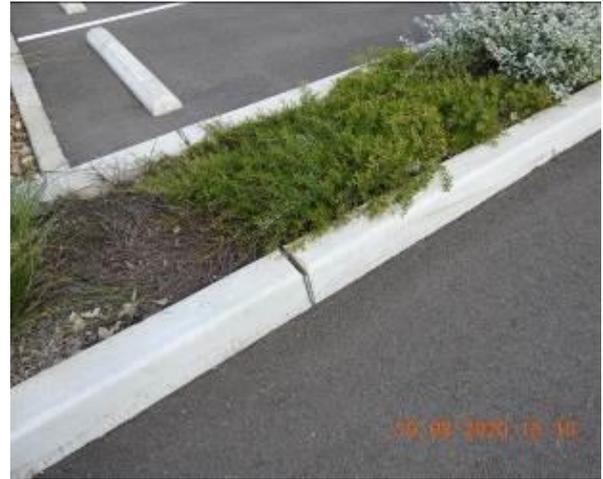
Figure 2188 – General condition of car park kerb

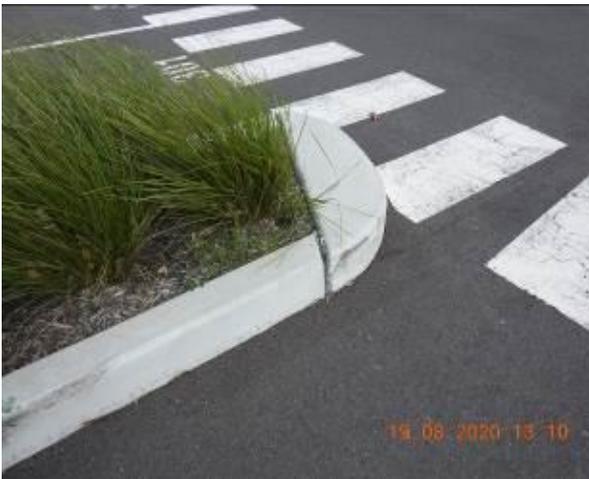
Figure 2189 – General condition of car park kerb

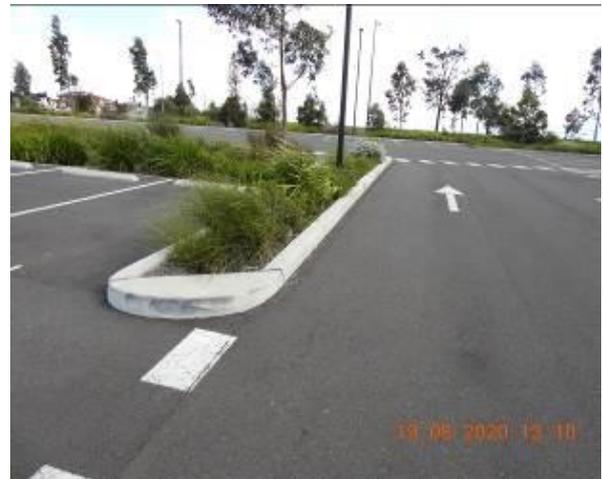
Figure 2190 – General condition of car park kerb

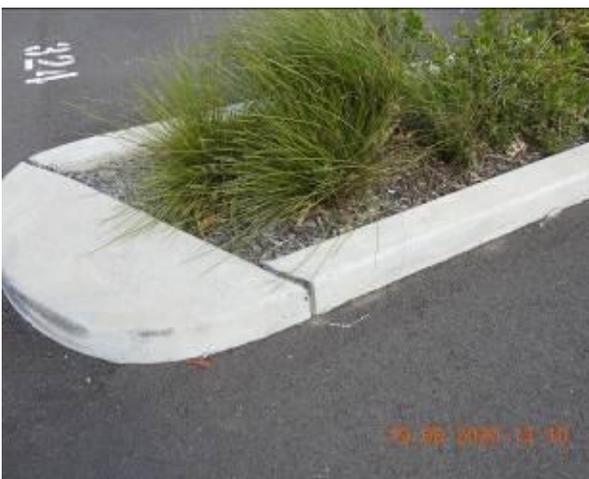
Figure 2191 – General condition of car park kerb

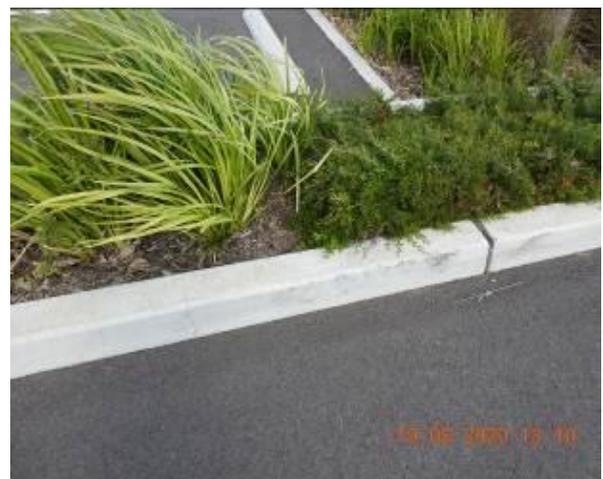
Figure 2192 – Crack propagation through car park kerb

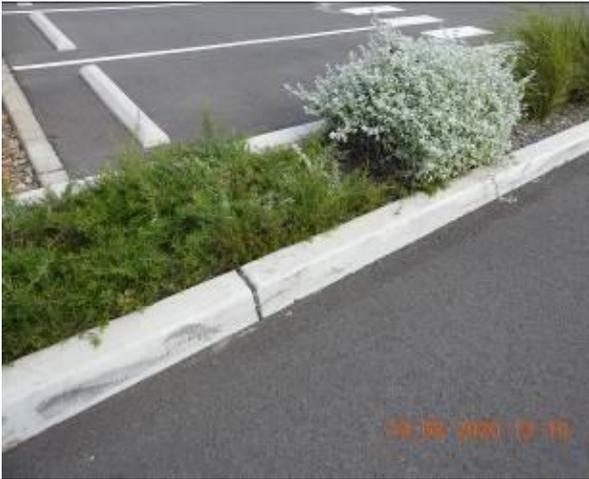
Figure 2193 – General condition of car park kerb

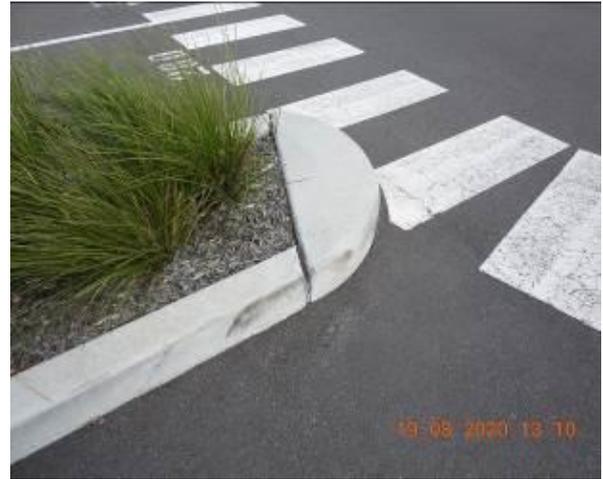
Figure 2194 – General condition of car park kerb

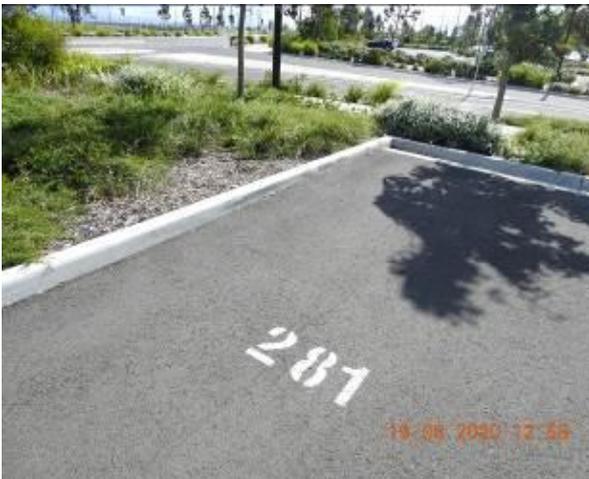
Figure 2195 – General condition of car park kerb

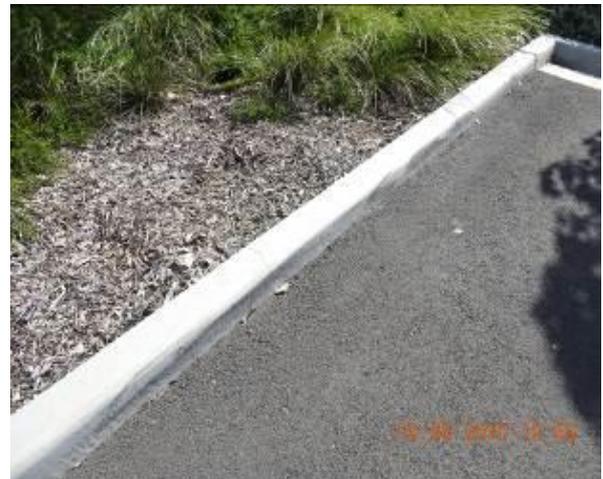
Figure 2196 – Crack propagation through car park kerb

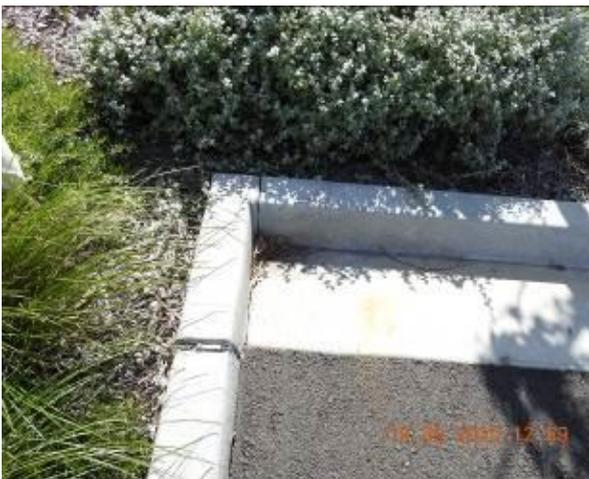
Figure 2197 – General condition of car park kerb and gutter

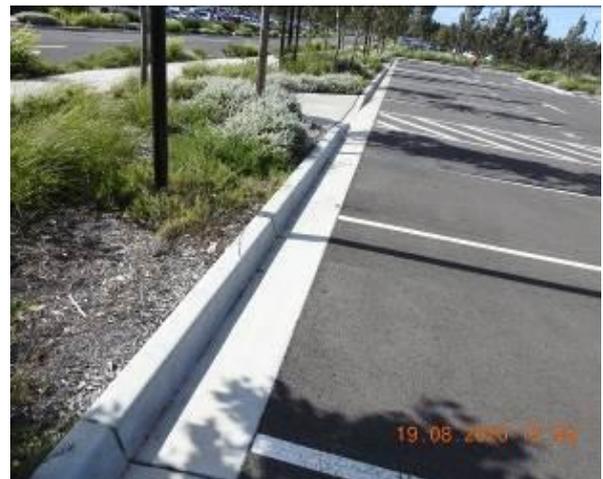
Figure 2198 – General condition of car park kerb and gutter

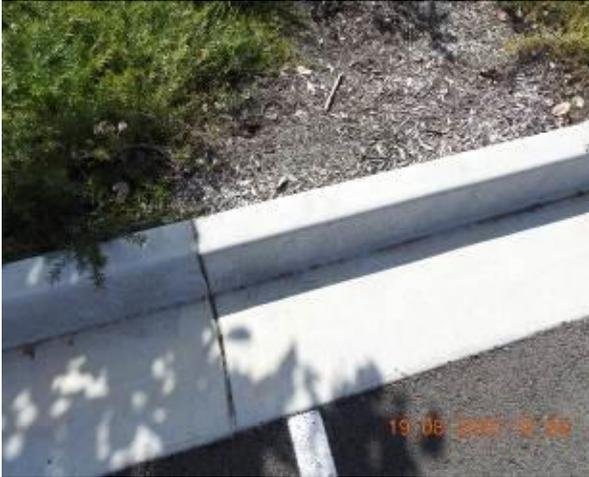
Figure 2199 – Crack propagation through car park kerb

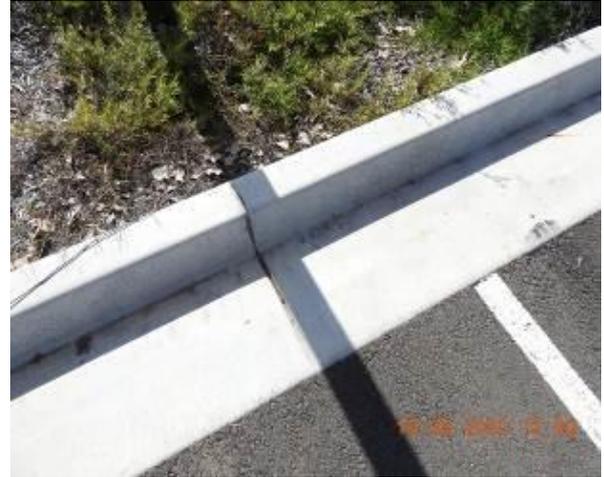
Figure 2200 – Crack propagation through car park kerb

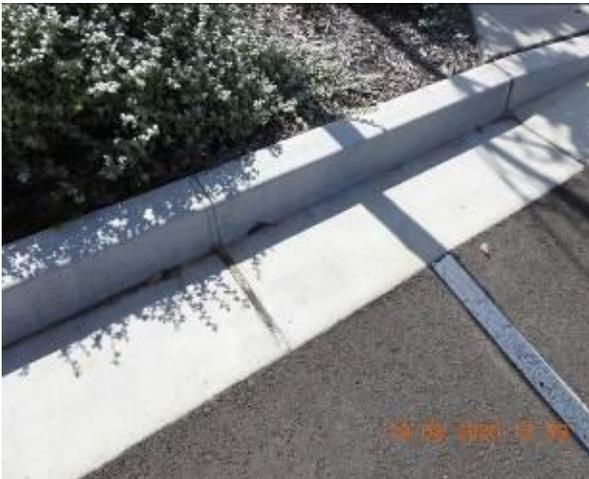
Figure 2201 – General condition of car park kerb and gutter

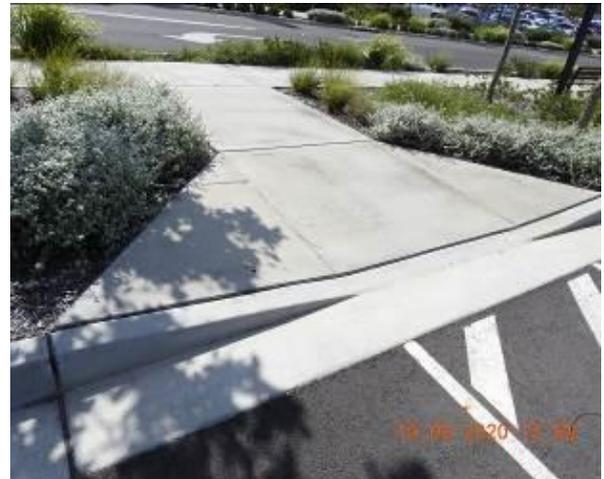
Figure 2202 – General condition of car park layback and gutter

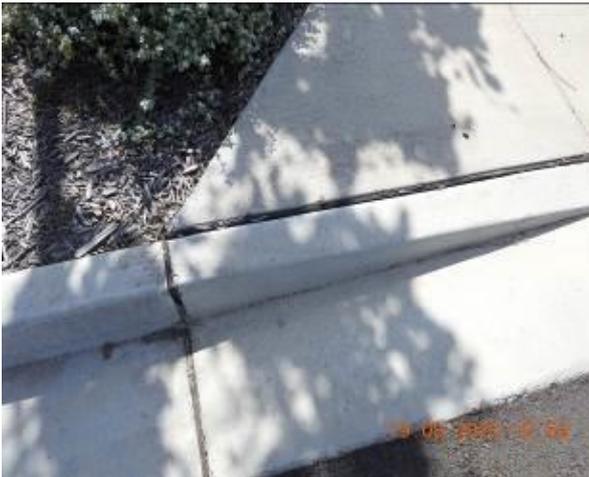
Figure 2203 – General condition of car park kerb and gutter

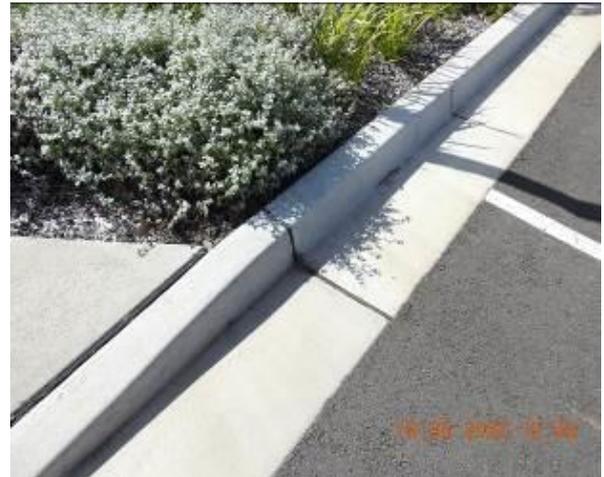
Figure 2204 – General condition of car park kerb and gutter

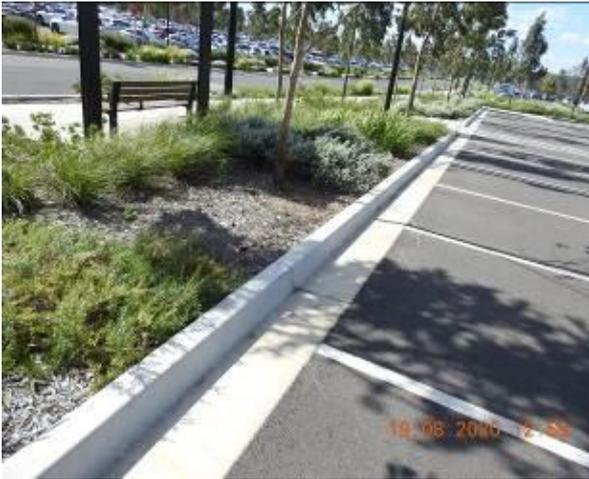
Figure 2205 – General condition of car park kerb and gutter

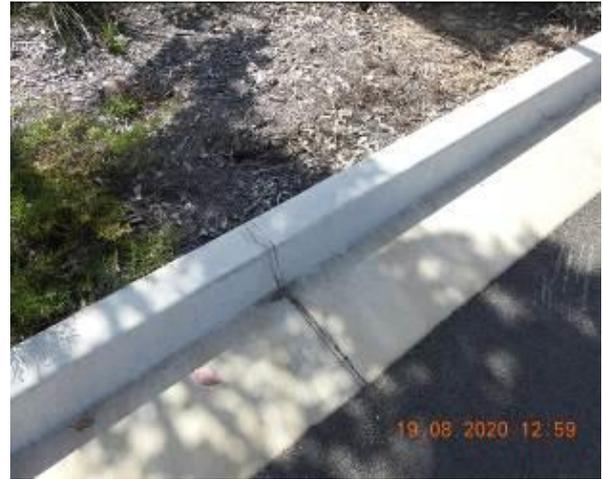
Figure 2206 – Crack propagation through car park kerb

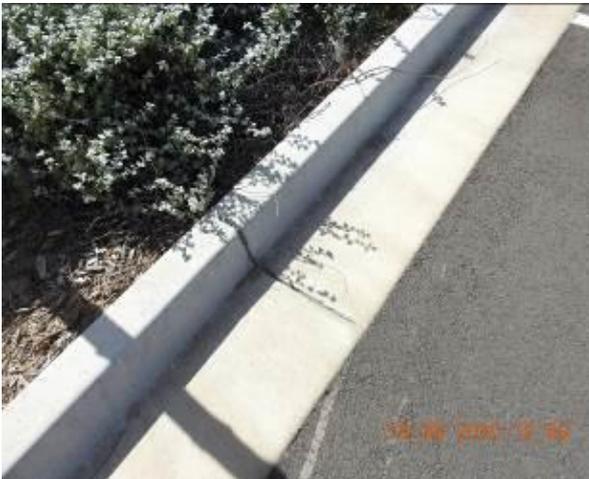
Figure 2207 – General condition of car park kerb and gutter

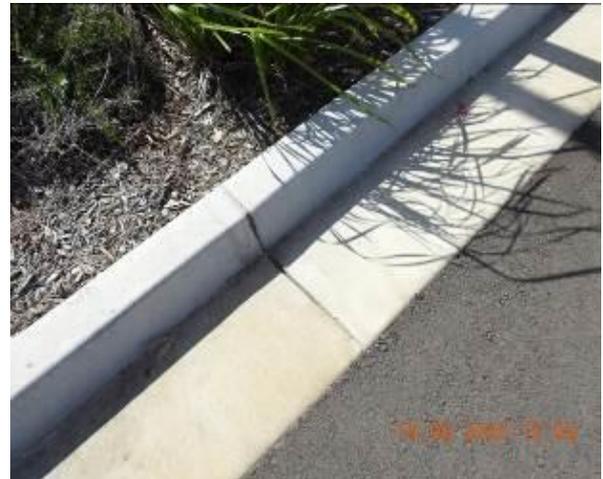
Figure 2208 – Crack propagation through car park kerb

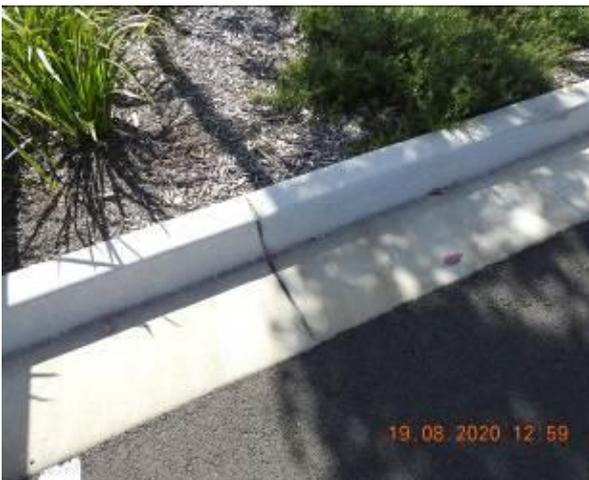
Figure 2209 – Crack propagation through car park kerb

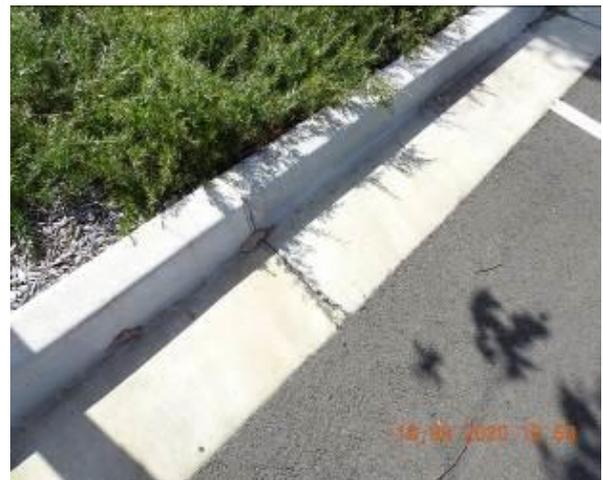
Figure 2210 – Crack propagation and loss of material through car park kerb and gutter

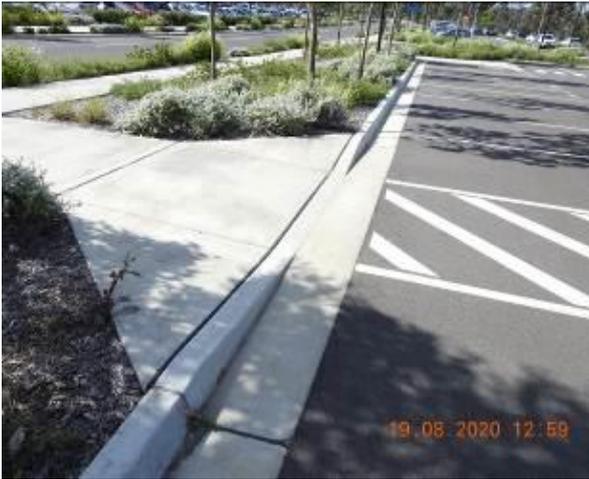
Figure 2211 – General condition of car park layback and gutter

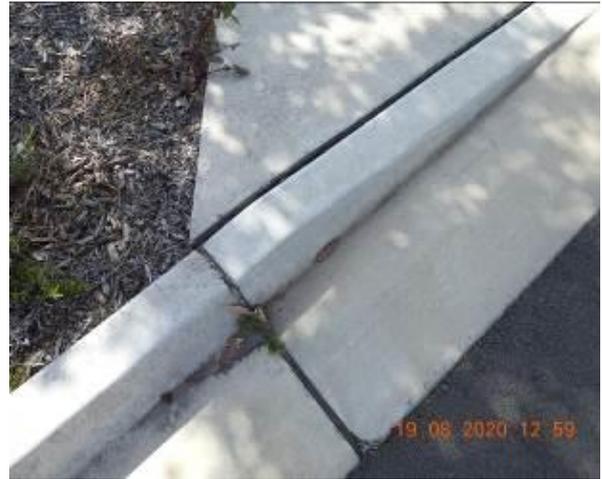
Figure 2212 – General condition of car park kerb and gutter
