The property Tallawong station – P2 Car Park, is the neighbouring property to our client’s site. It was photographed and inspected prior to any construction works on the subject site and was found to be in a reasonable condition. The property serves as a car park.

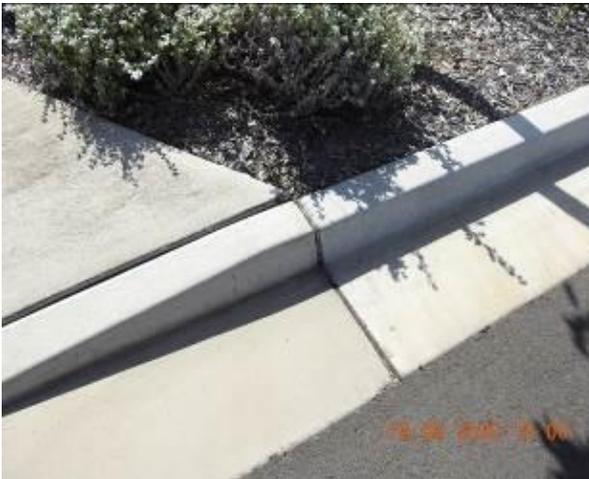
Figure 2213 – General condition of car park kerb and gutter

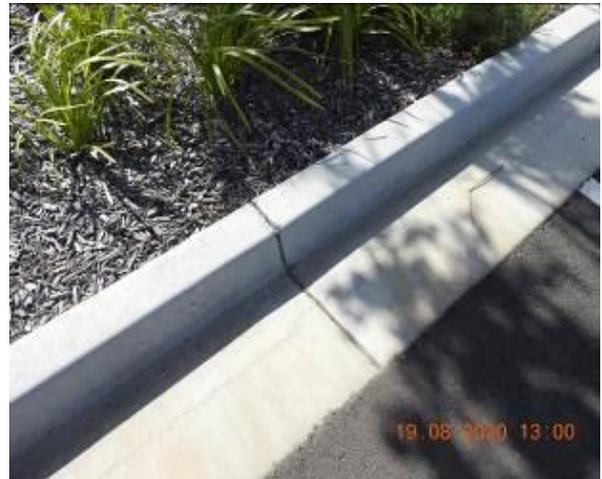
Figure 2214 – General condition of car park kerb and gutter

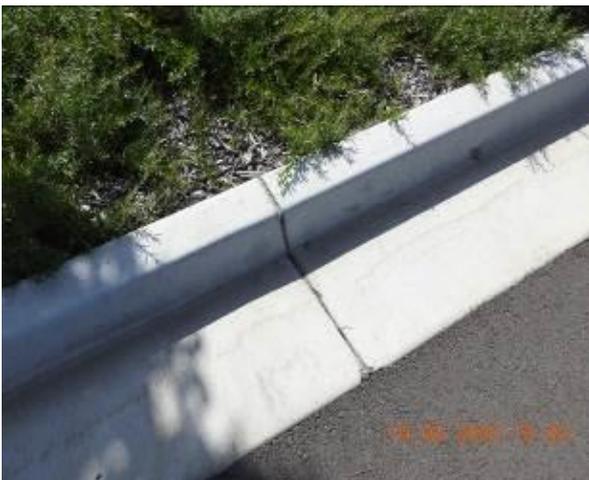
Figure 2215 – General condition of car park kerb and gutter

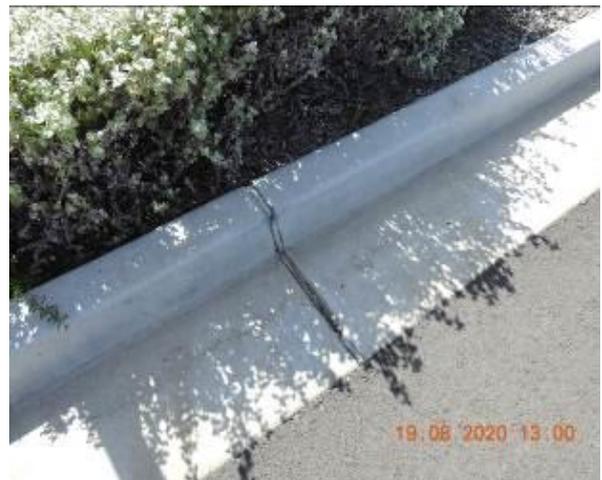
Figure 2216 – Crack propagation and loss of material through car park kerb and gutter

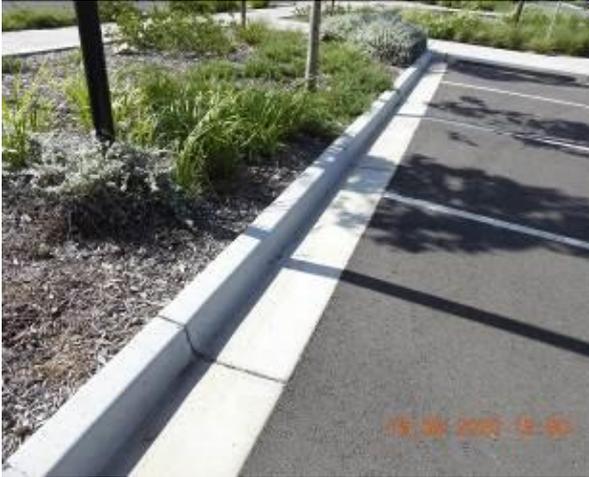
Figure 2217 – General condition of car park kerb and gutter

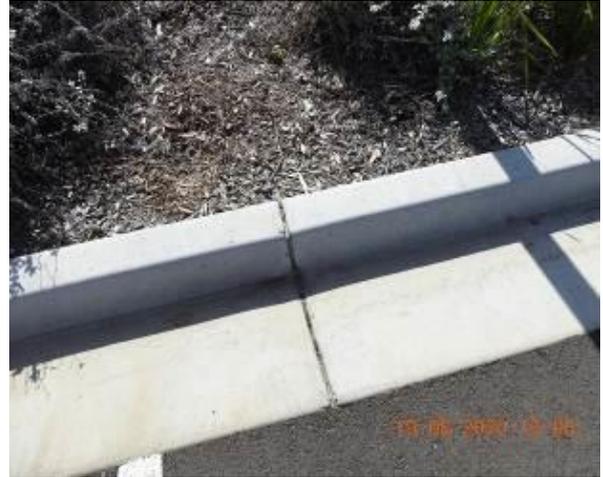
Figure 2218 – Crack propagation through car park kerb

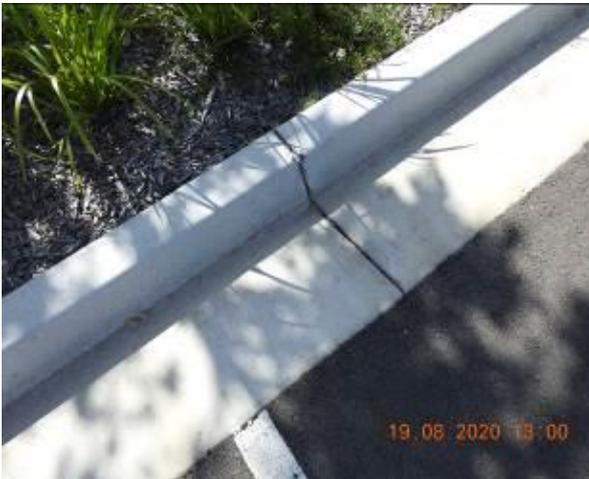
Figure 2219 – General condition of car park kerb and gutter

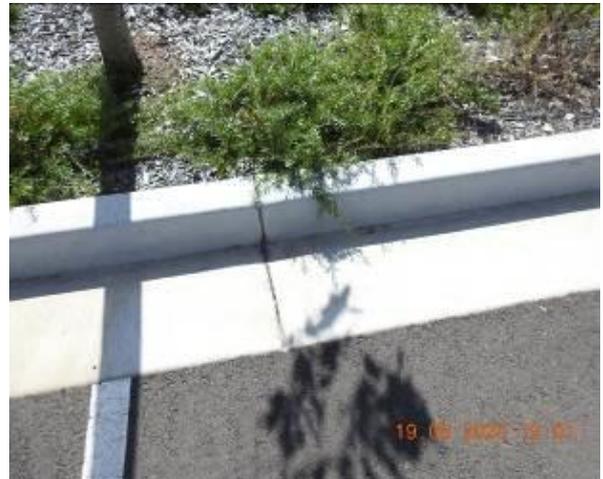
Figure 2220 – General condition of car park kerb and gutter

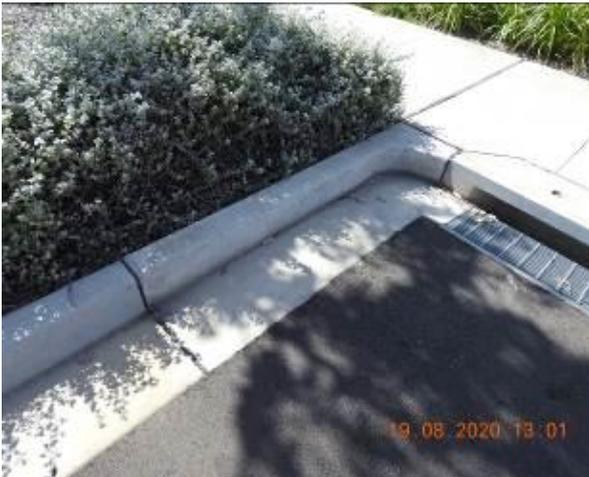
Figure 2221 – General condition of car park kerb and gutter

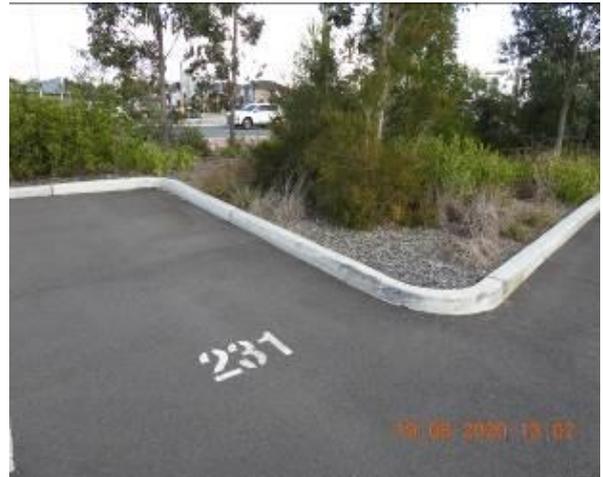
Figure 2222 – General condition of car park kerb

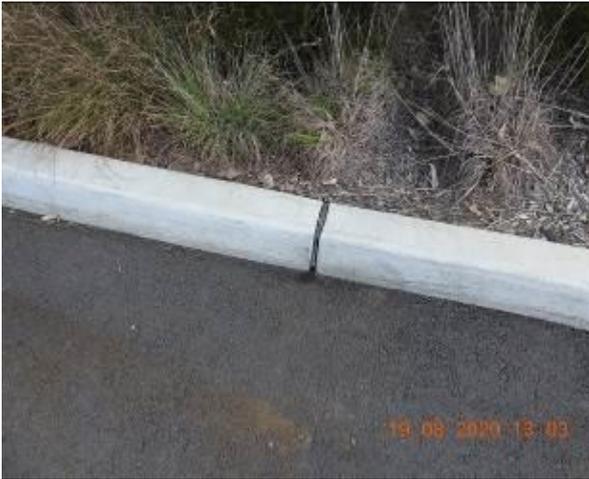
Figure 2223 – General condition of car park kerb

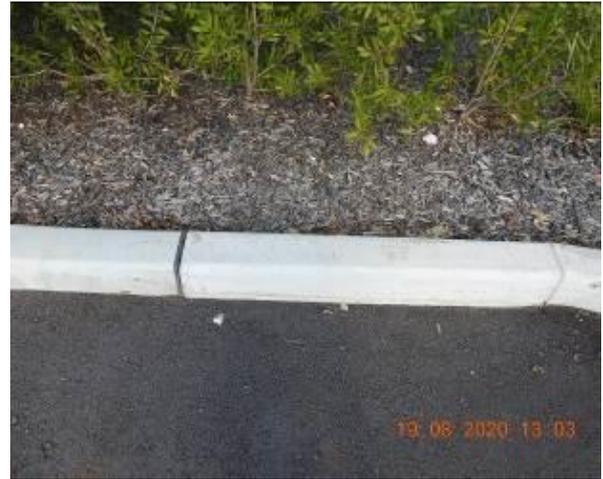
Figure 2224 – General condition of car park kerb

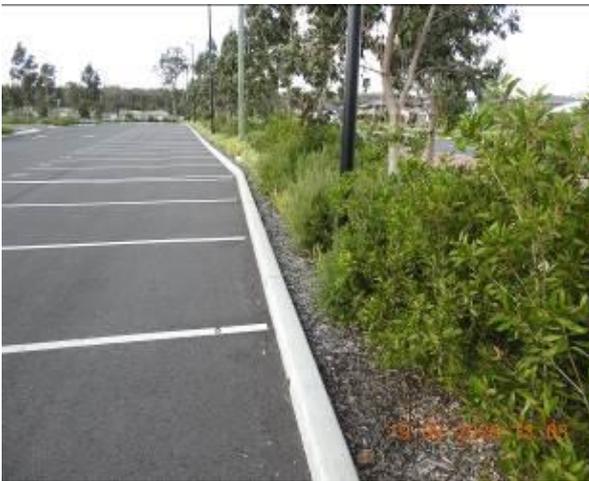
Figure 2225 – General condition of car park kerb

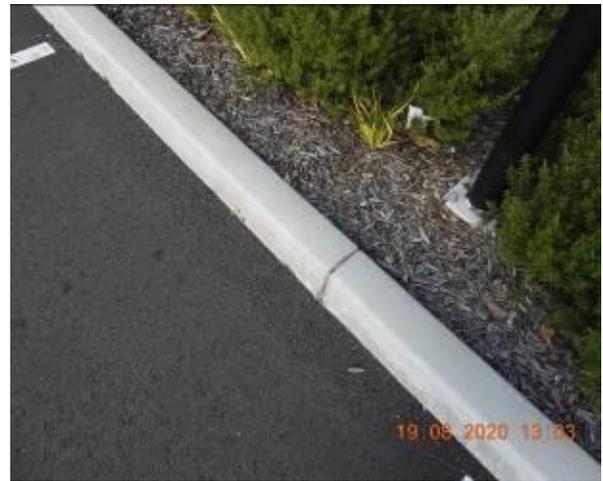
Figure 2226 – Crack propagation through car park kerb

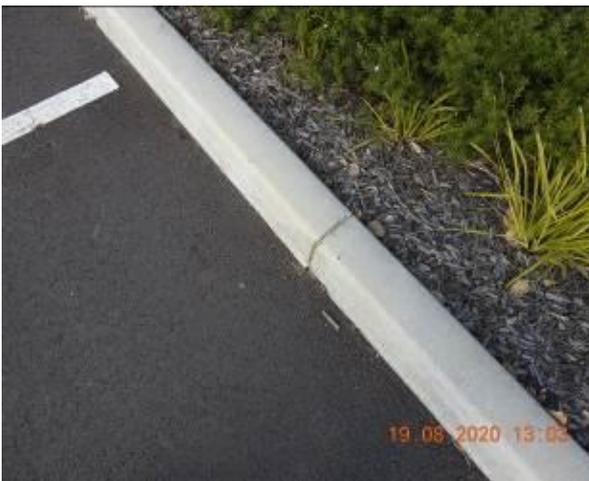
Figure 2227 – Crack propagation through car park kerb

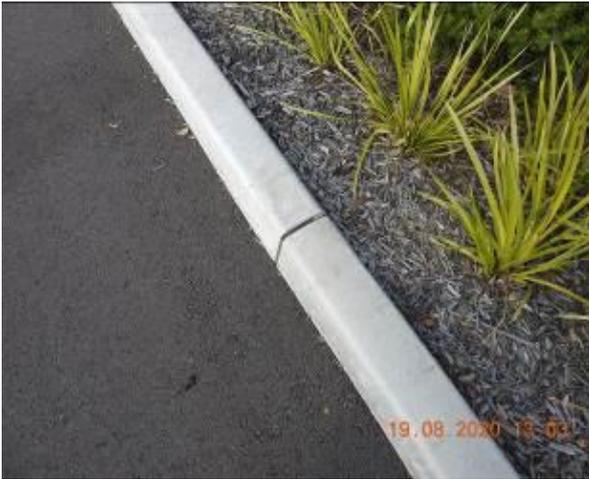
Figure 2229 – General condition of car park kerb

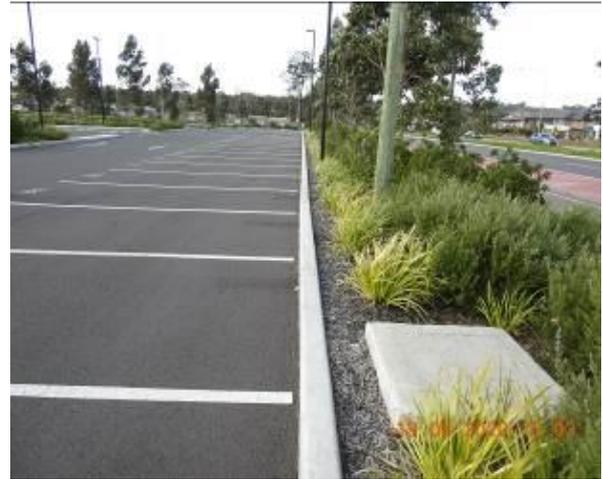
Figure 2230 – General condition of car park kerb

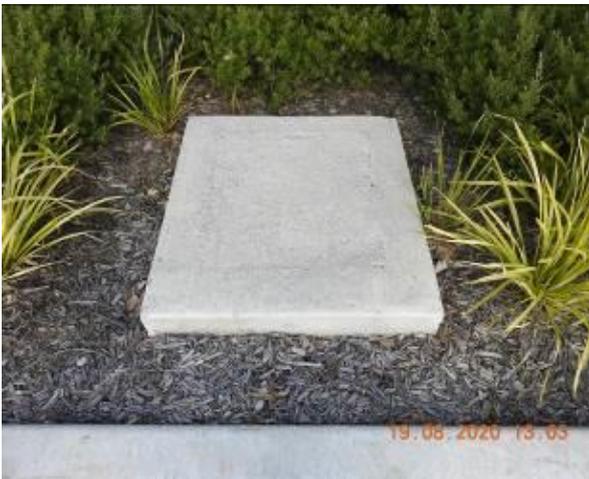
Figure 2231 – General condition of service pit

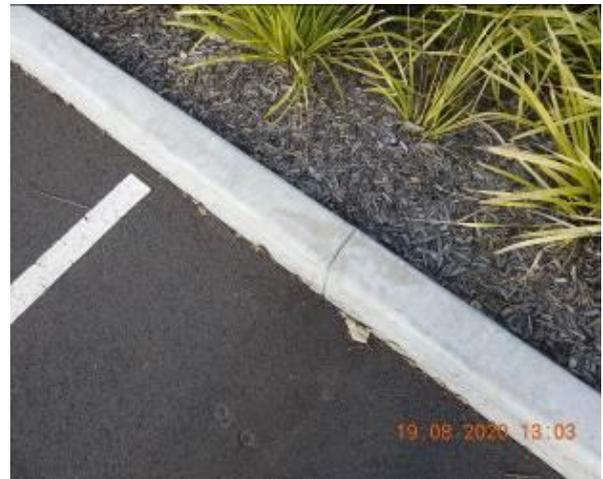
Figure 2232 – Crack propagation through car park kerb

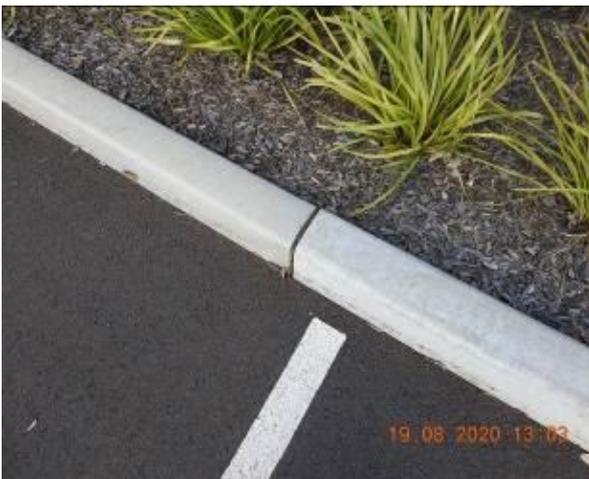
Figure 2233 – General condition of car park kerb

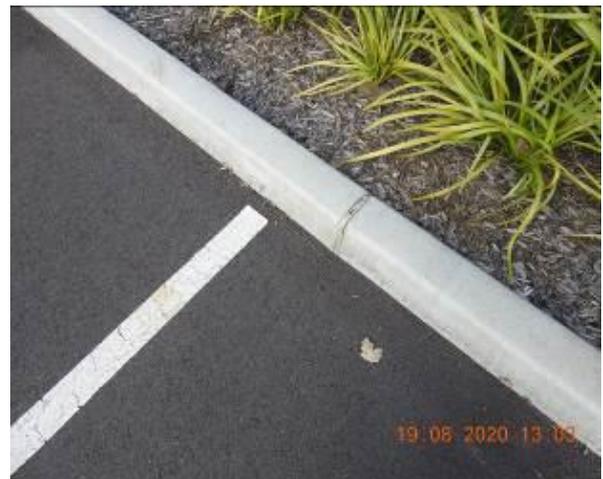
Figure 2234 – General condition of car park kerb

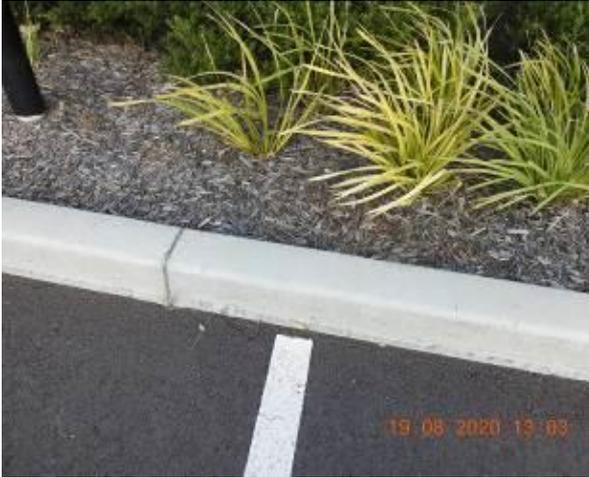
Figure 2235 – Crack propagation through car park kerb

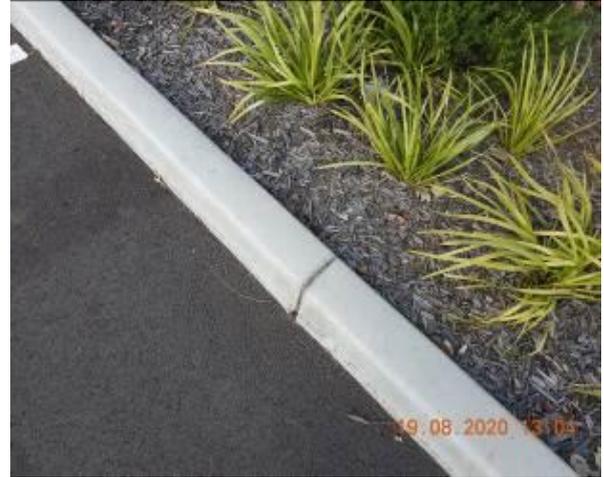
Figure 2236 – Crack propagation through car park kerb

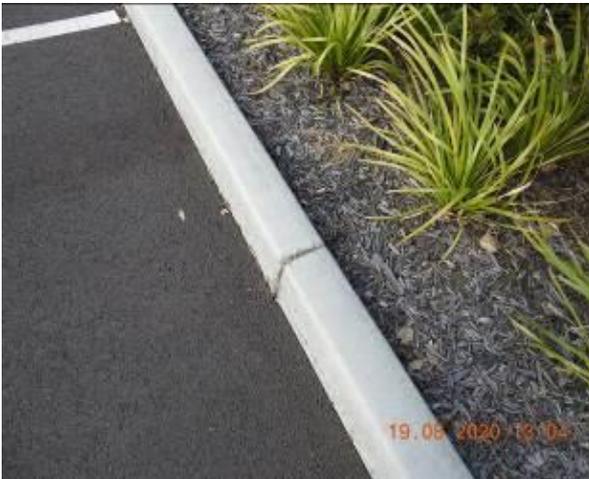
Figure 2237 – General condition of car park kerb

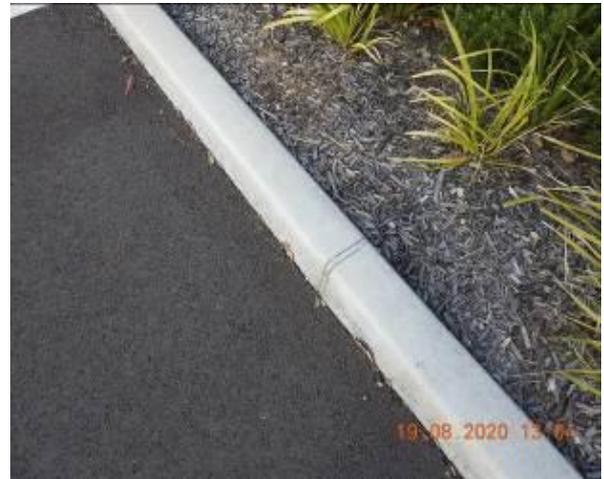
Figure 2238 – General condition of car park kerb

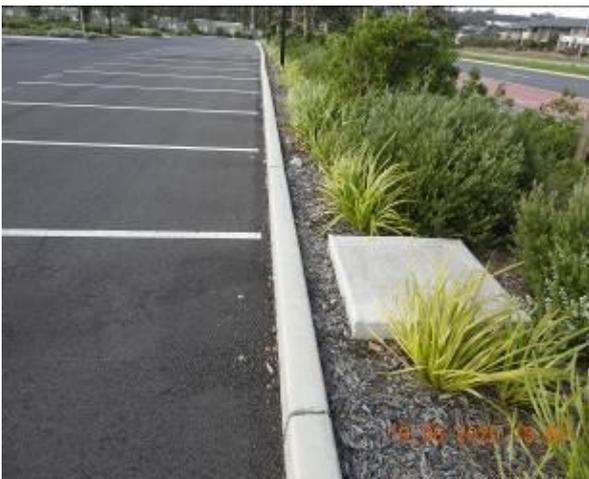
Figure 2239 – General condition of car park kerb

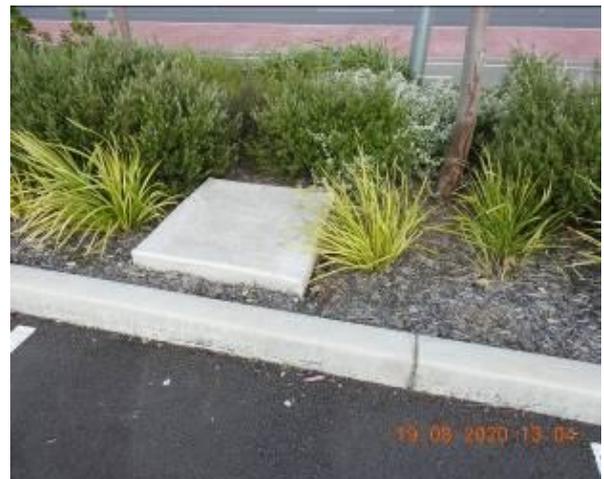
Figure 2240 – General condition of service pit

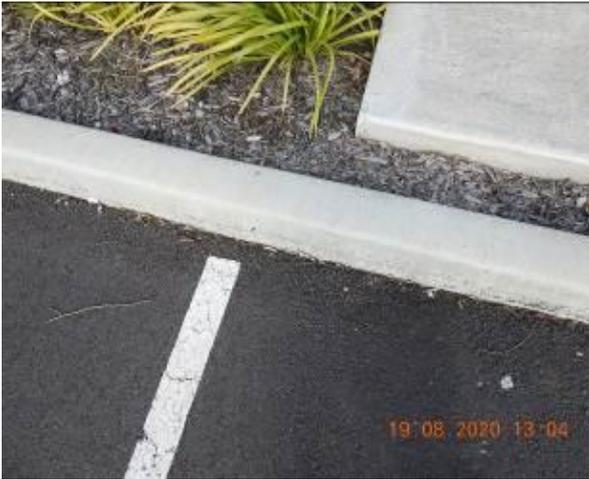
Figure 2241 – Crack propagation through car park kerb

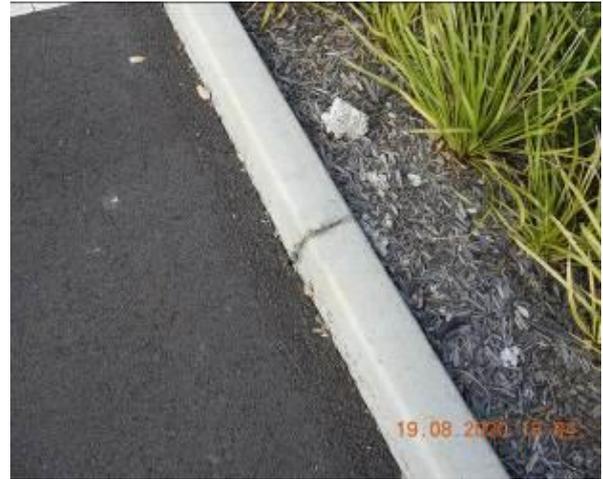
Figure 2242 – General condition of car park kerb

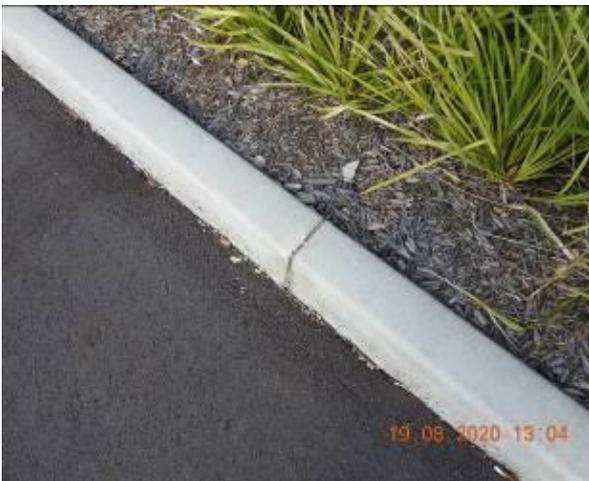
Figure 2243 – Crack propagation through car park kerb

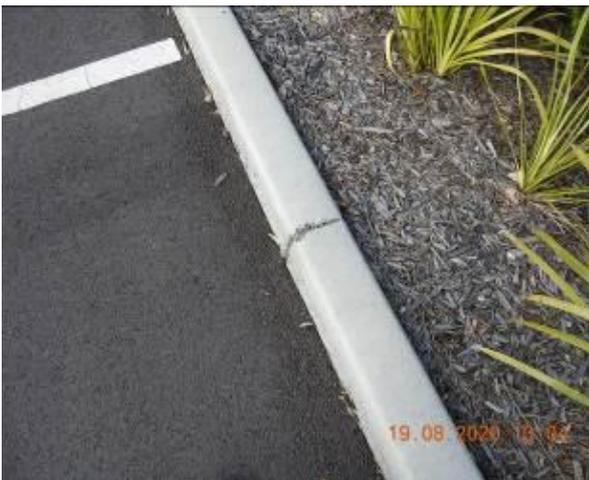
Figure 2245 – Crack propagation through car park kerb

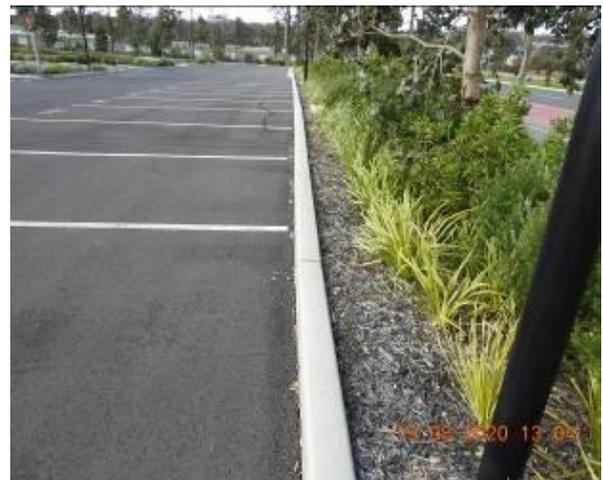
Figure 2246 – General condition of car park kerb

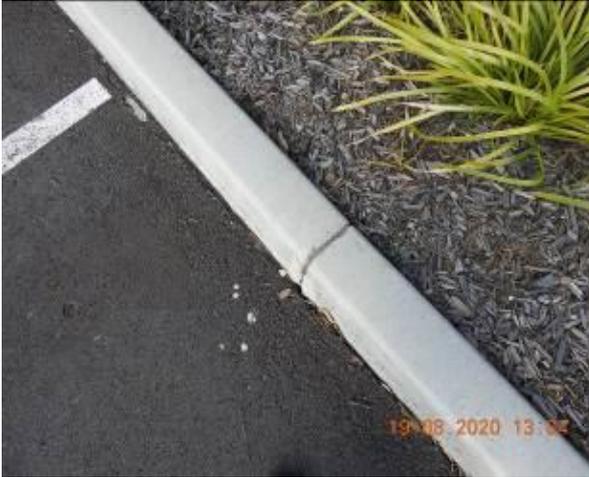
Figure 2247 – Crack propagation through car park kerb

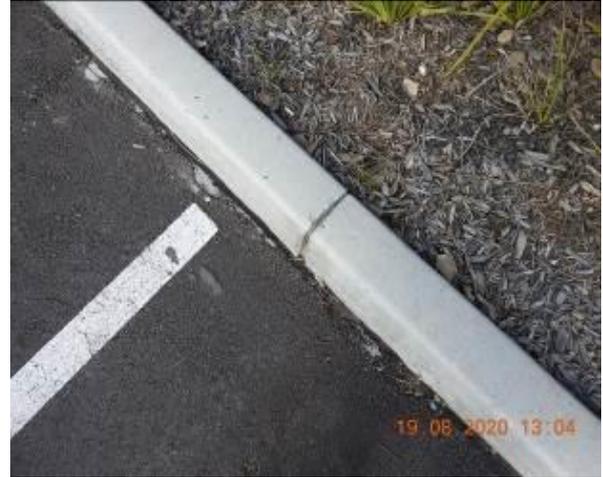
Figure 2248 – Crack propagation through car park kerb

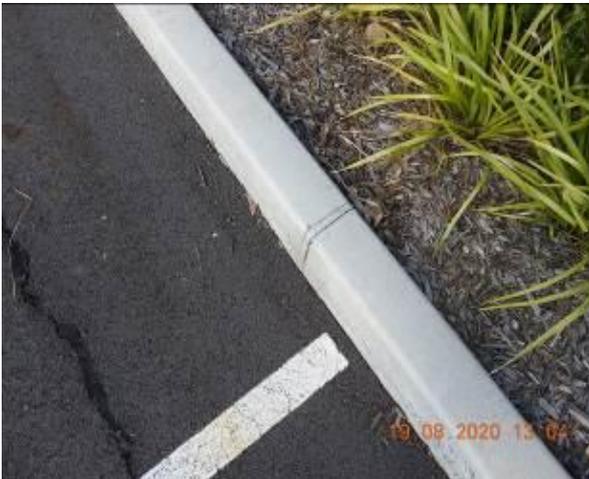
Figure 2249 – General condition of car park kerb

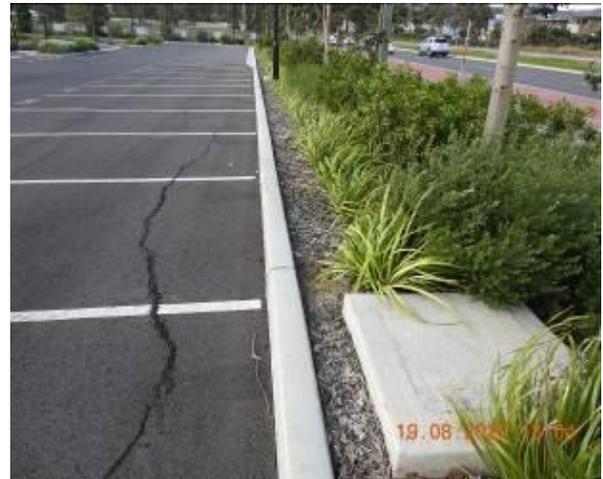
Figure 2250 – General condition of car park kerb

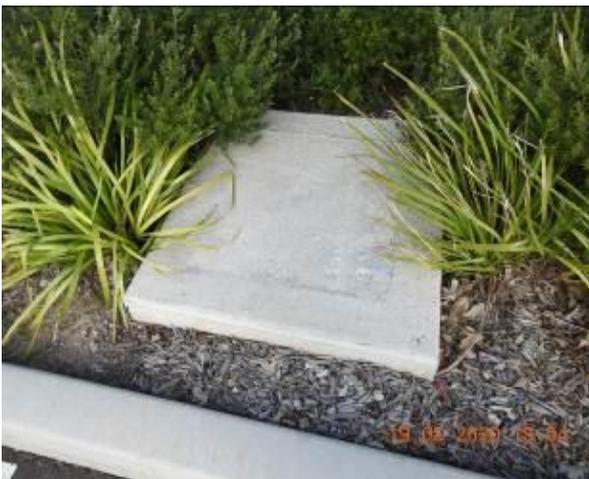
Figure 2251 – General condition of service pit

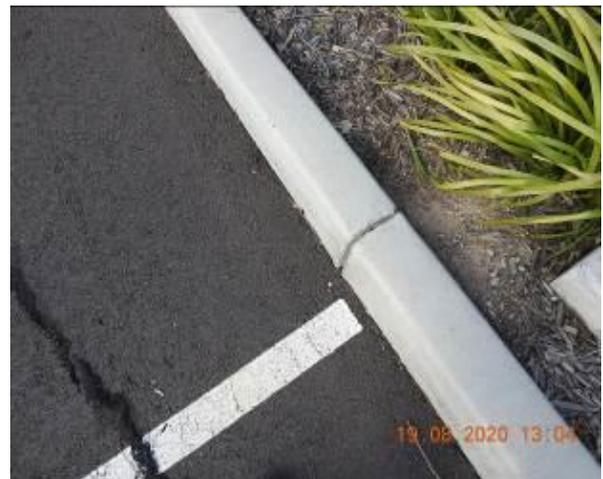
Figure 2252 – Crack propagation through car park kerb

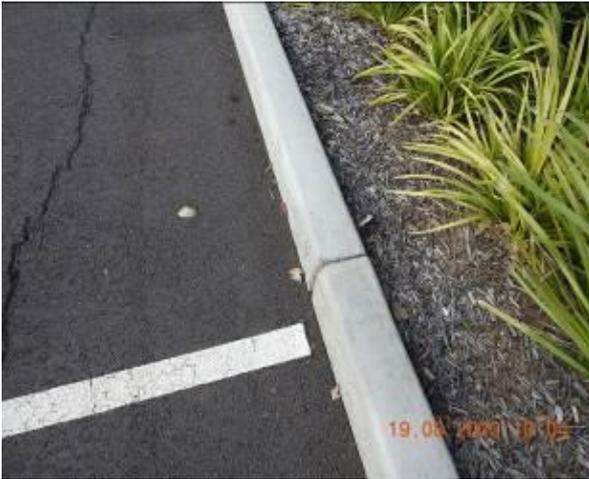
Figure 2253 – General condition of car park kerb

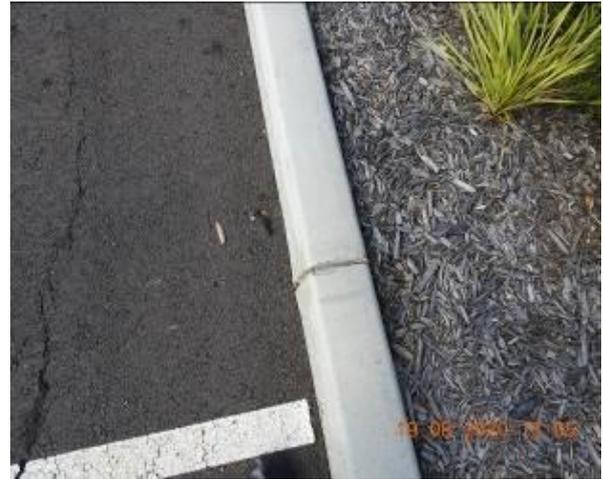
Figure 2254 – Crack propagation through car park kerb

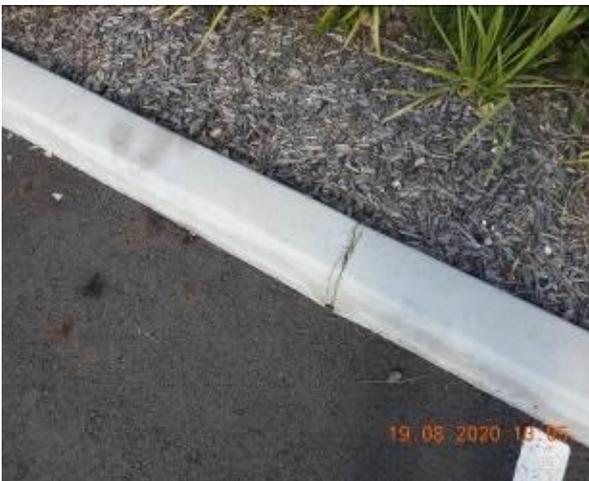
Figure 2255 – Crack propagation through car park kerb

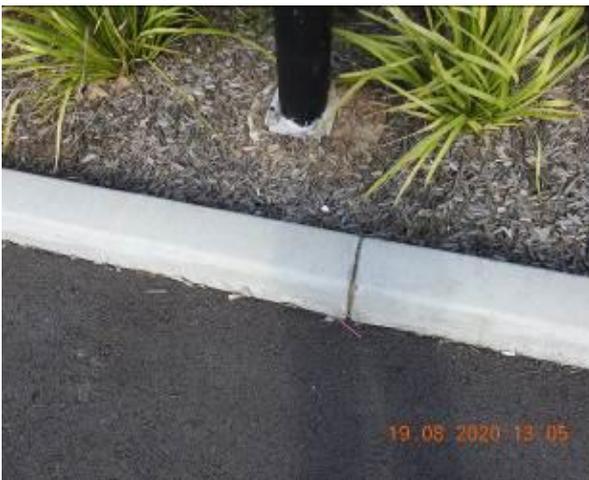
Figure 2257 – Crack propagation through car park kerb

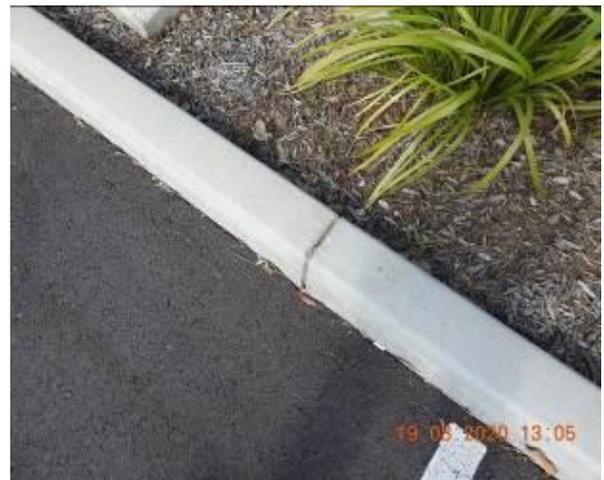
Figure 2258 – Crack propagation through car park kerb

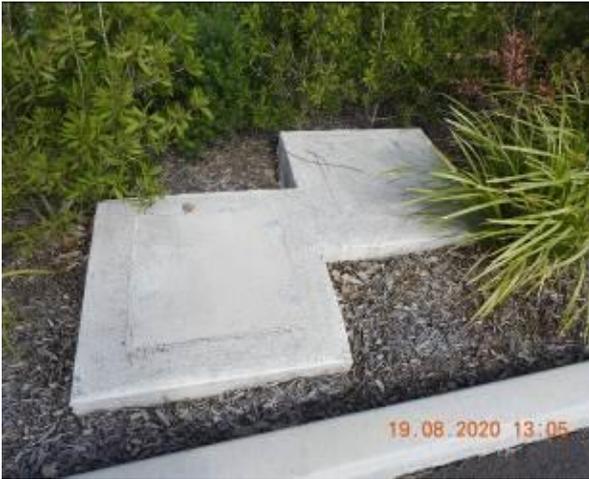
Figure 2259 – General condition of service pit

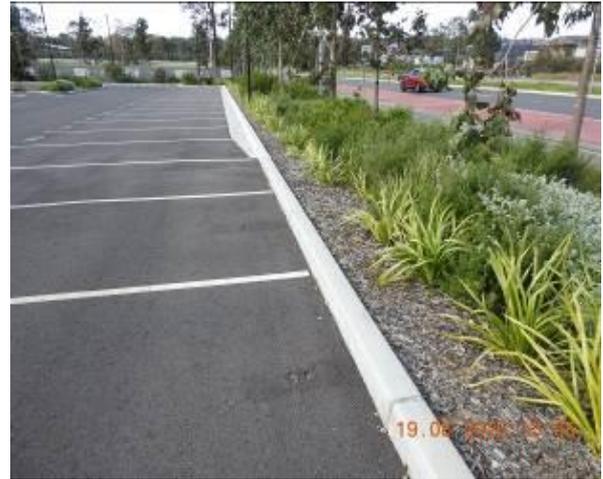
Figure 2260 – General condition of car park kerb

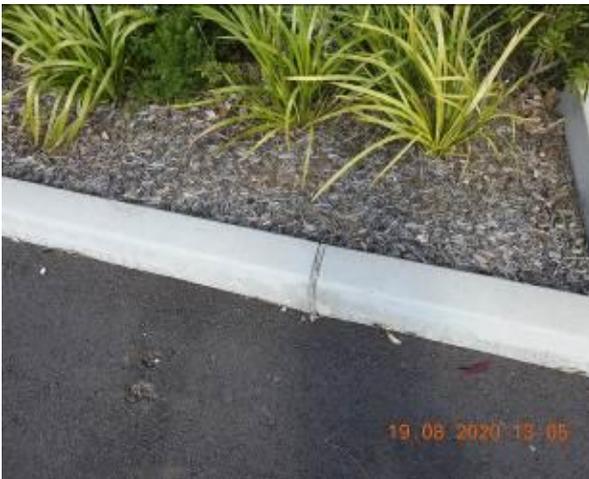
Figure 2261 – General condition of car park kerb

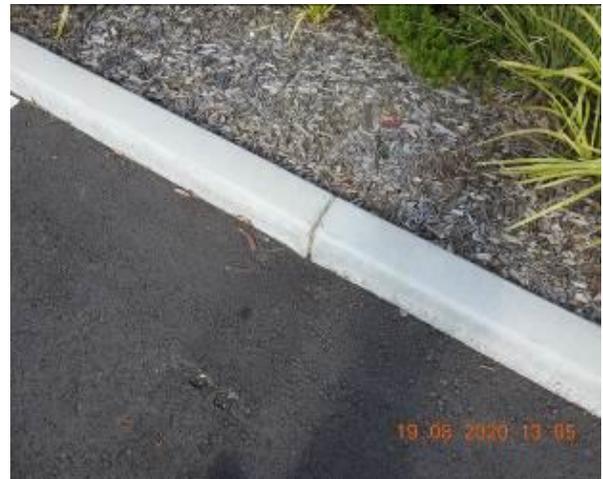
Figure 2262 – Crack propagation through car park kerb

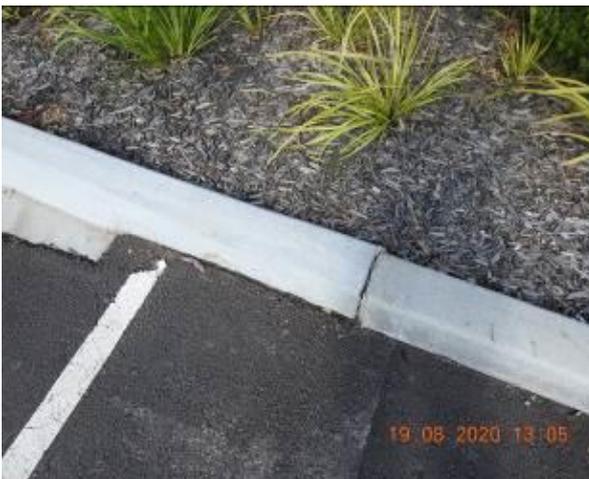
Figure 2263 – General condition of car park kerb

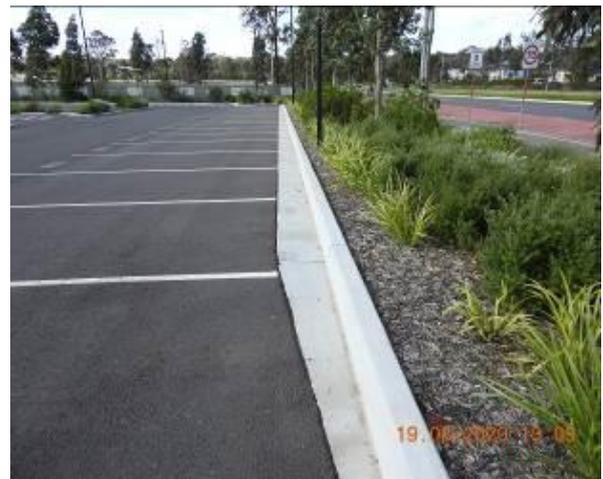
Figure 2264 – General condition of car park kerb and gutter

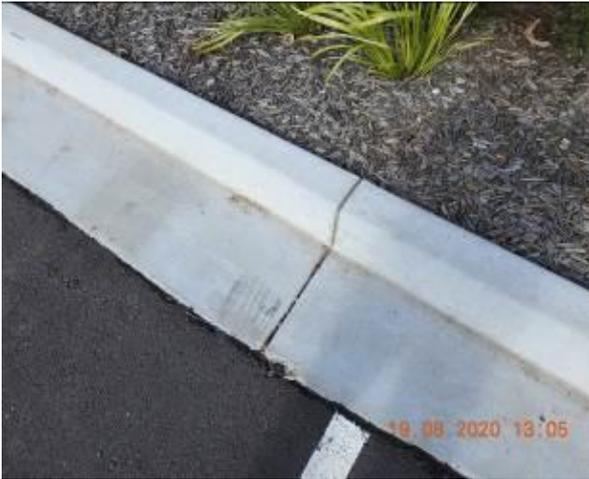
Figure 2265 – Crack propagation through car park kerb

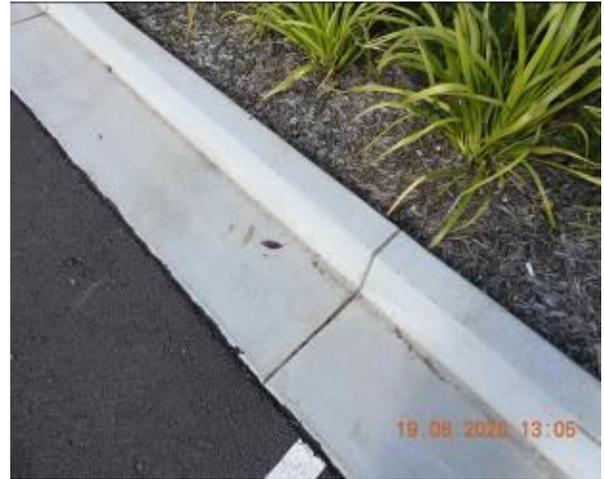
Figure 2266 – Crack propagation through car park kerb

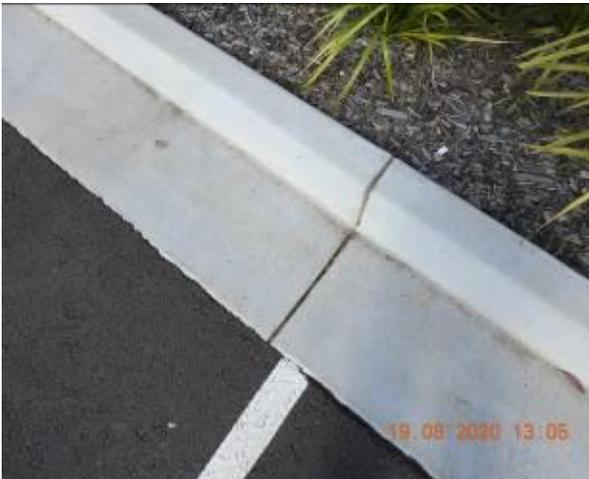
Figure 2267 – Crack propagation through car park kerb

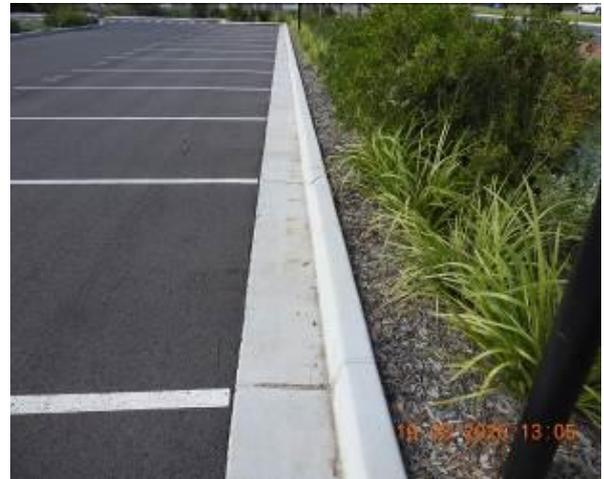
Figure 2268 – General condition of car park kerb and gutter

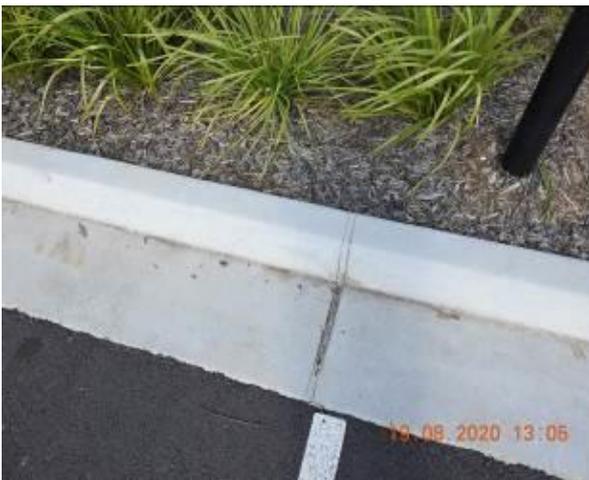
Figure 2269 – General condition of car park kerb and gutter

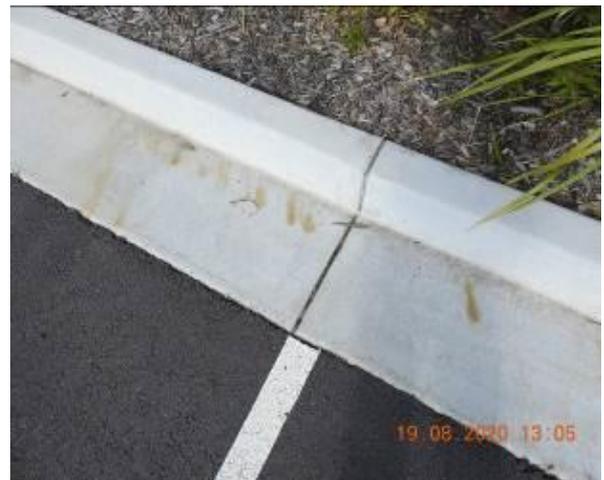
Figure 2270 – Crack propagation through car park kerb

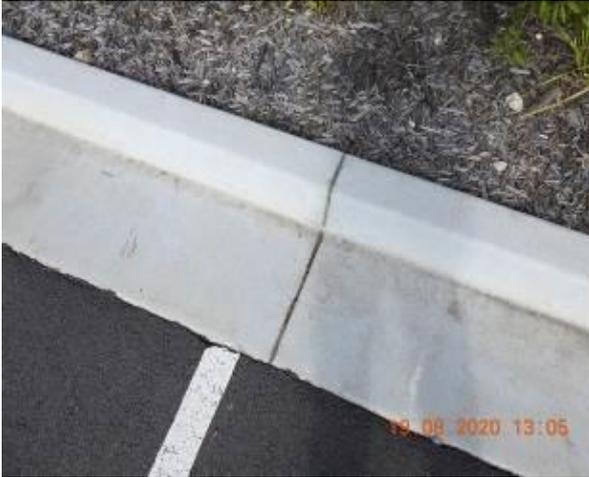
Figure 2271 – Crack propagation through car park kerb

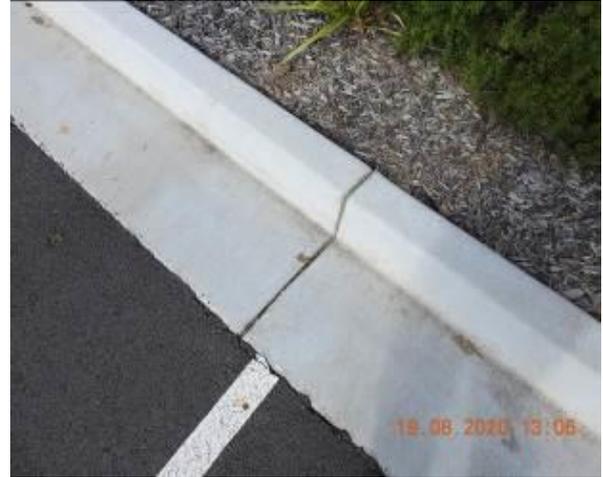
Figure 2272 – Crack propagation through car park kerb

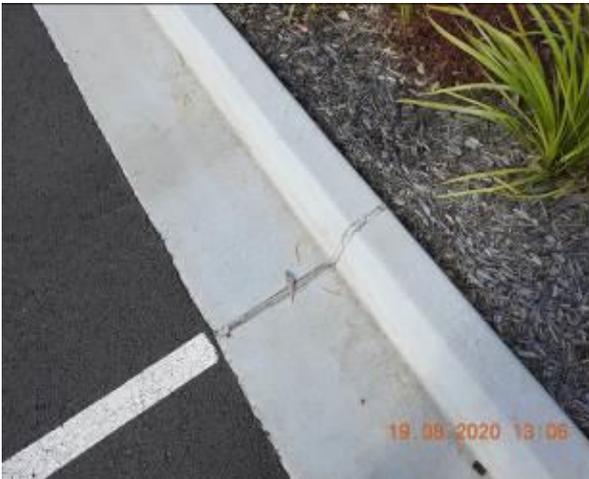
Figure 2273 – Crack propagation through car park kerb

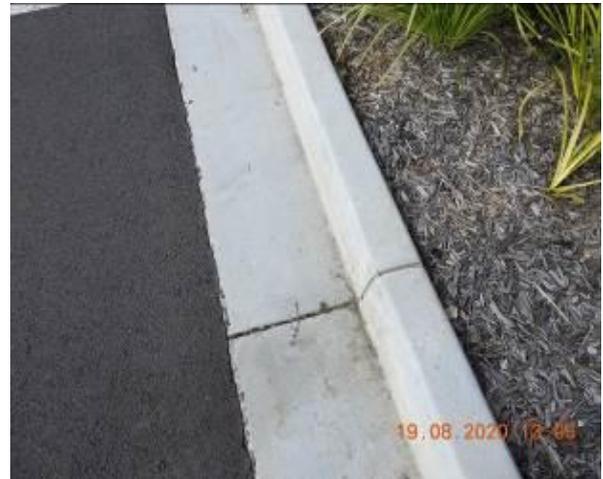
Figure 2274 – General condition of car park kerb and gutter

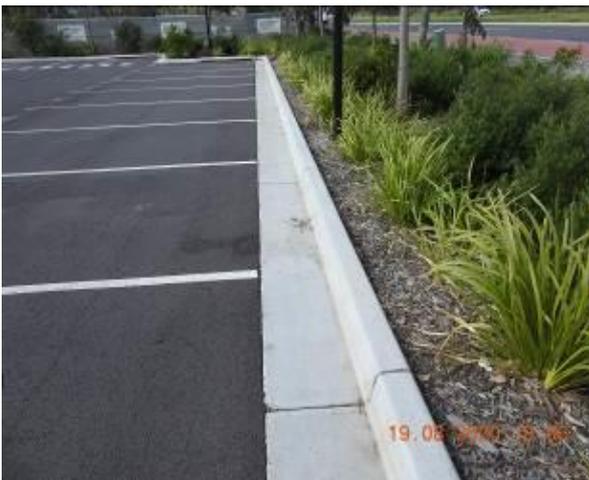
Figure 2275 – General condition of car park kerb and gutter

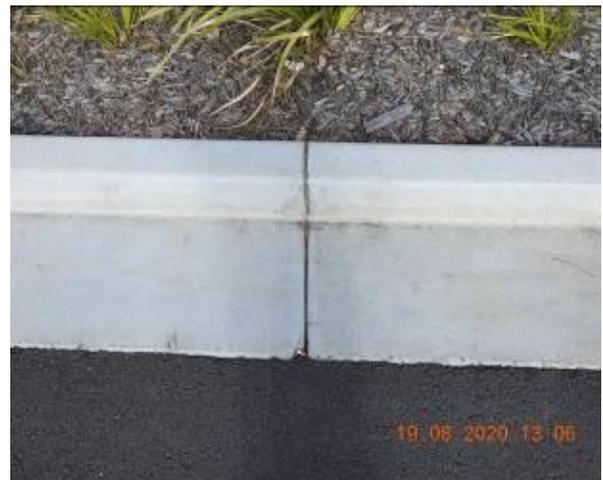
Figure 2276 – Crack propagation through car park kerb

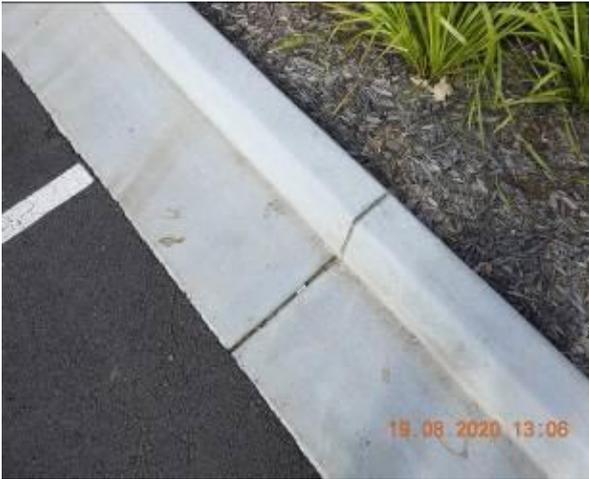
Figure 2277 – Crack propagation through car park kerb

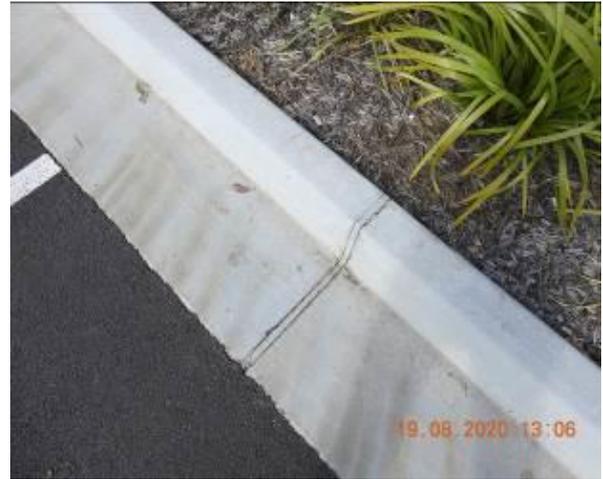
Figure 2278 – General condition of car park kerb and gutter

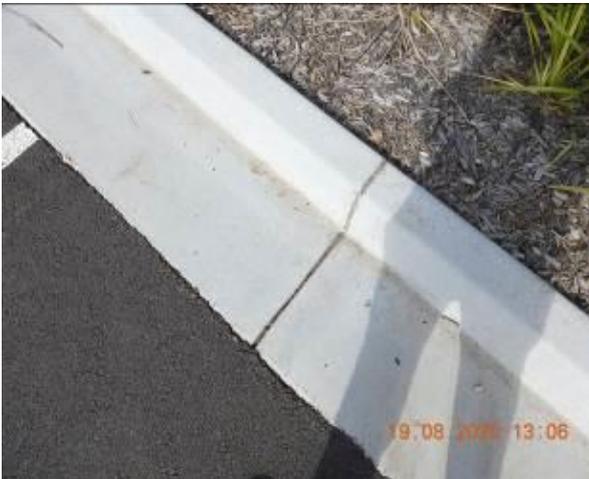
Figure 2279 – Crack propagation through car park kerb

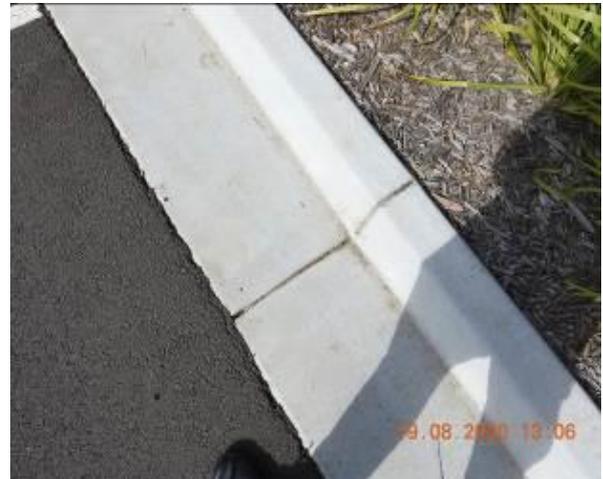
Figure 2280 – Crack propagation through car park kerb

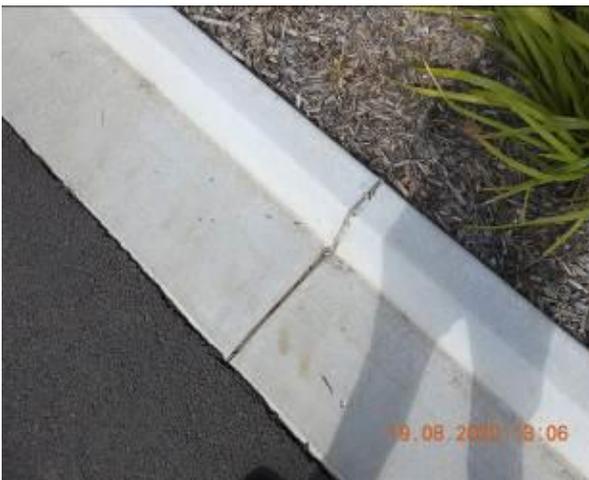
Figure 2281 – Crack propagation through car park kerb

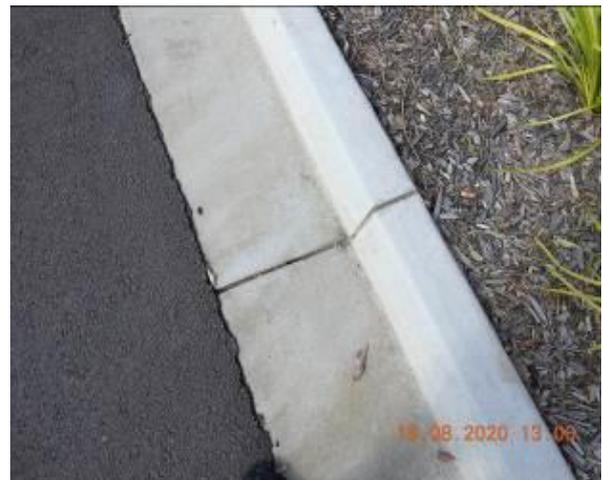
Figure 2282 – Crack propagation through car park kerb

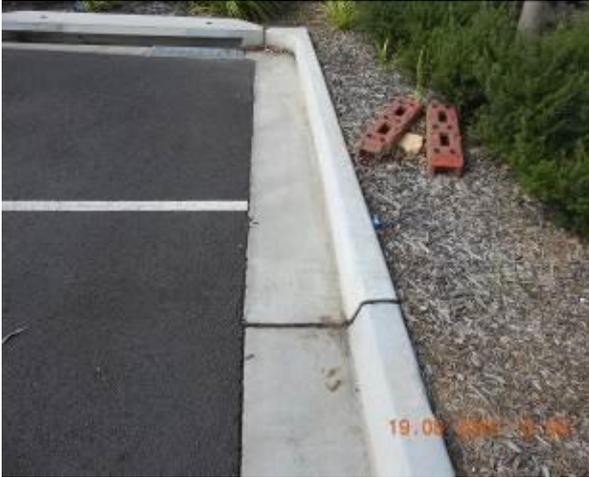
Figure 2283 – General condition of car park kerb and gutter

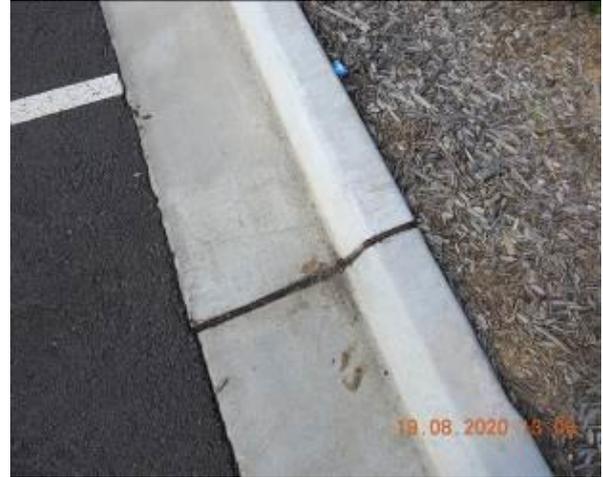
Figure 2284 – General condition of car park kerb and gutter

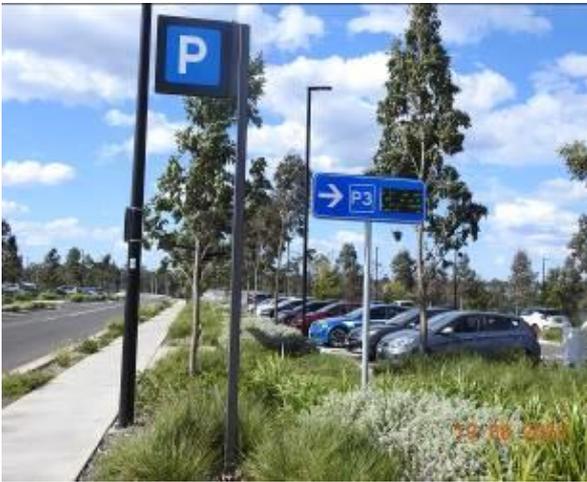
Figure 2285 – General condition of street sign

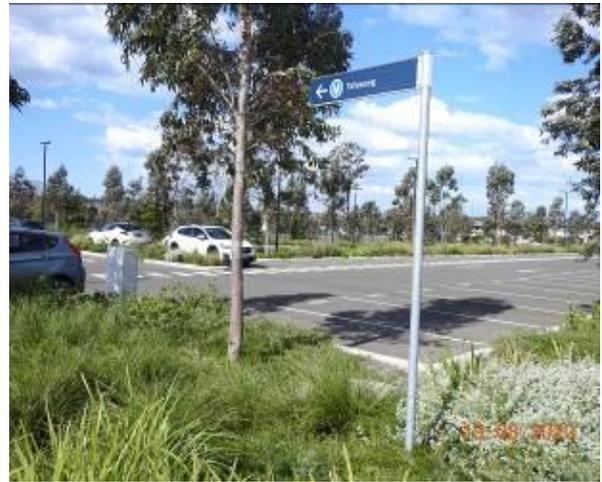
Figure 2286 – General condition of street sign

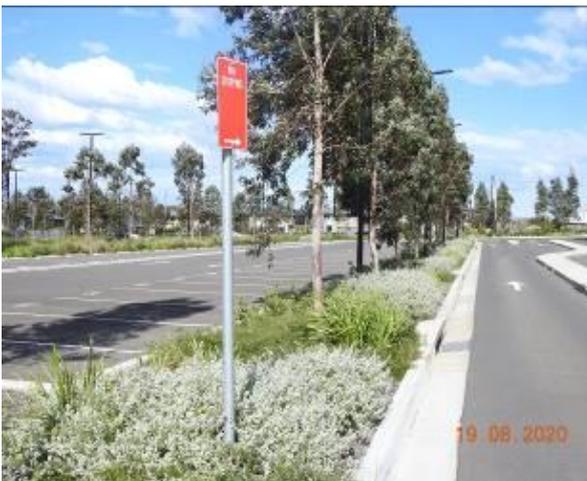
Figure 2287 – General condition of street sign

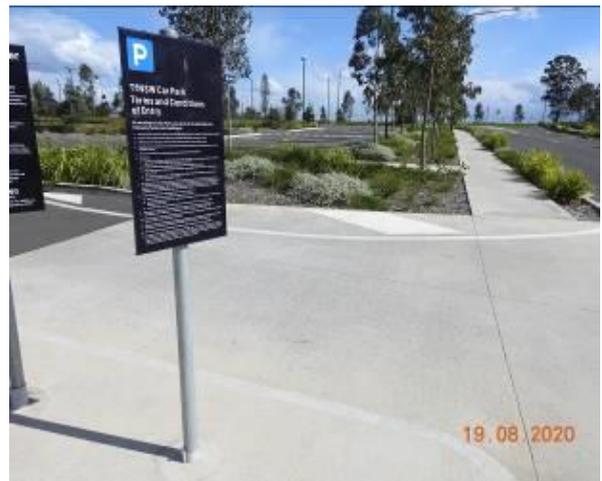
Figure 2288 – General condition of street sign

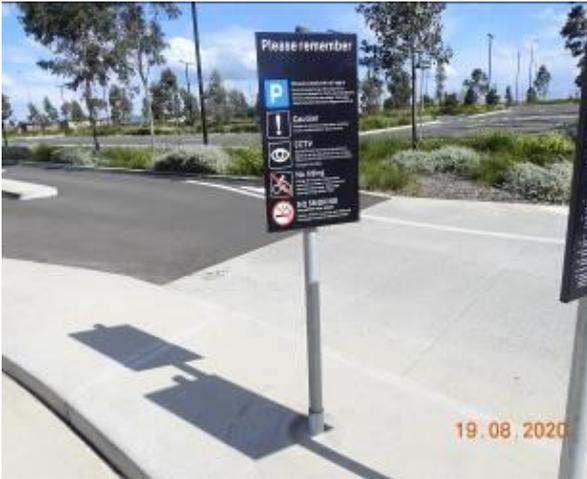
Figure 2289 – General condition of street sign

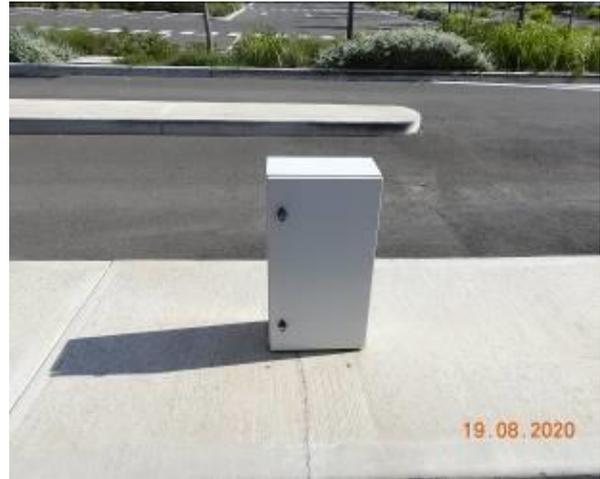
Figure 2290 – General condition of electricity box

The street signs, electricity boxes, lamp posts, plantation security camera pole, service pits and stormwater inlet pits were also inspected and were determined to be in a reasonable condition.

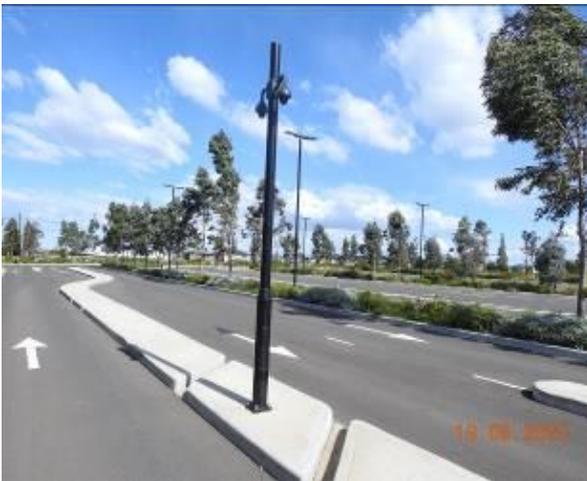
Figure 2291 – General condition of security camera pole

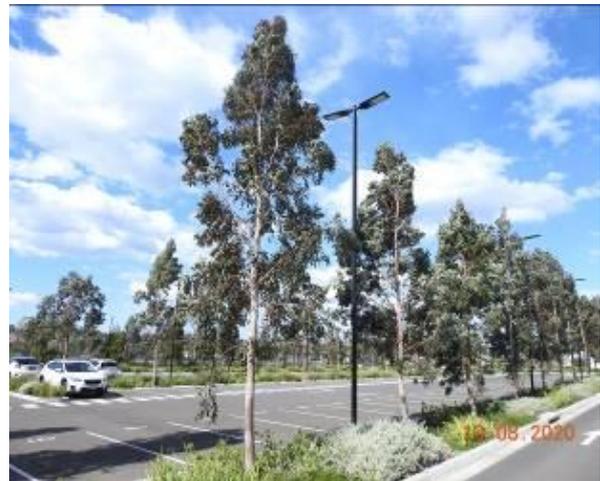
Figure 2292 – General condition of plantation and lamp post
