The property Tallawong station – P2 Car Park, is the neighbouring property to our client’s site. It was photographed and inspected prior to any construction works on the subject site and was found to be in a reasonable condition. The property serves as a car park.

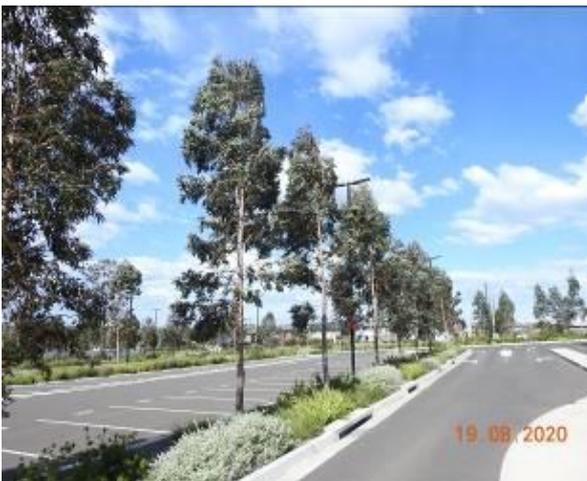
Figure 2293 – General condition of plantation and lamp post

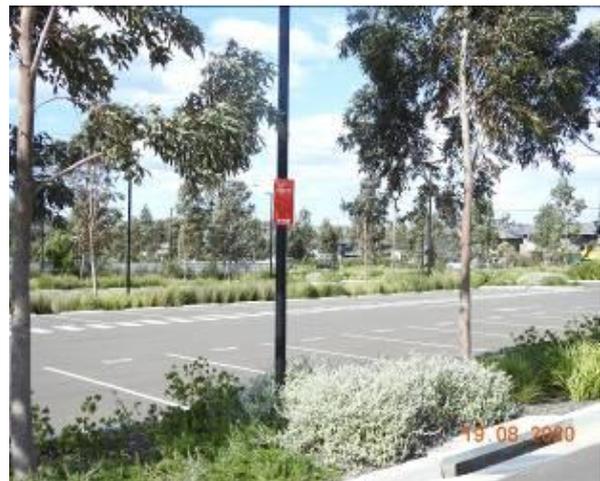
Figure 2294 – General condition of street sign

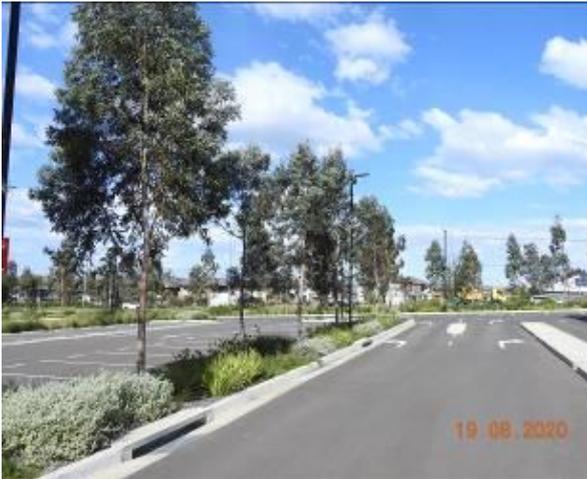
Figure 2295 – General condition of plantation and lamp post

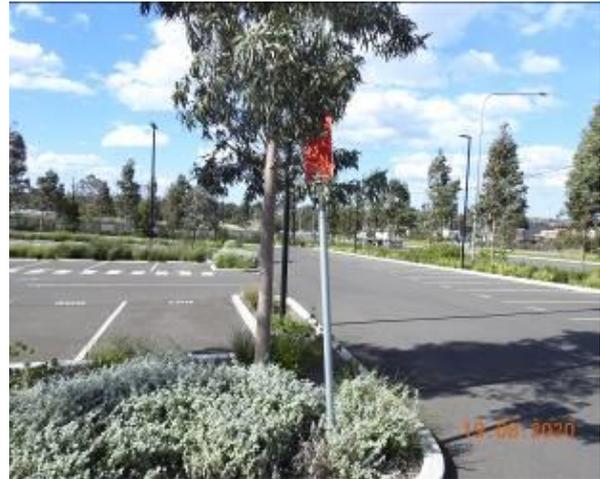
Figure 2296 – General condition of street sign

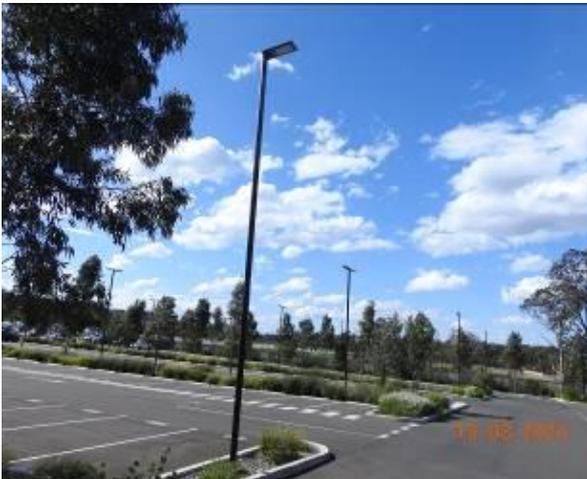
Figure 2297 – General condition of plantation and lamp post

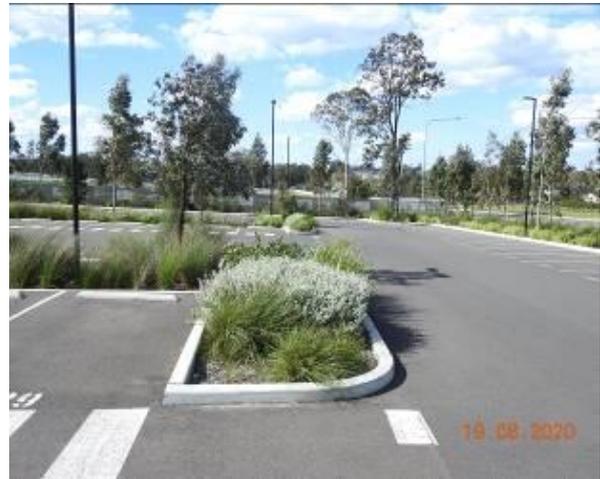
Figure 2298 – General condition of plantation and lamp post

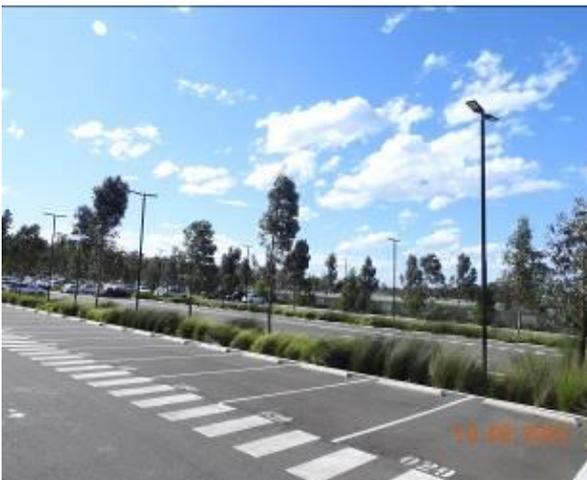
Figure 2299 – General condition of plantation and lamp post

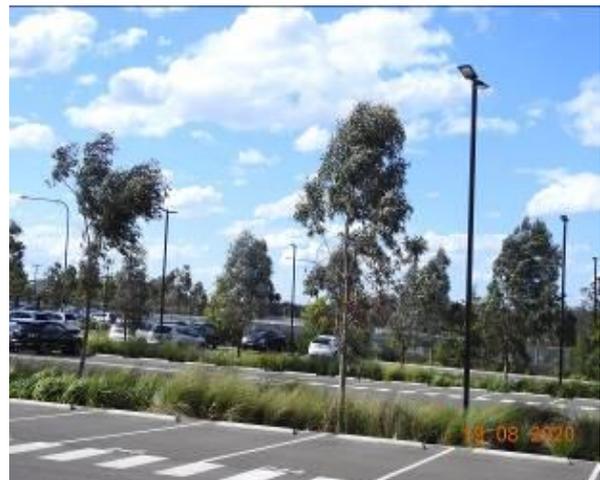
Figure 2300 – General condition of plantation and lamp post

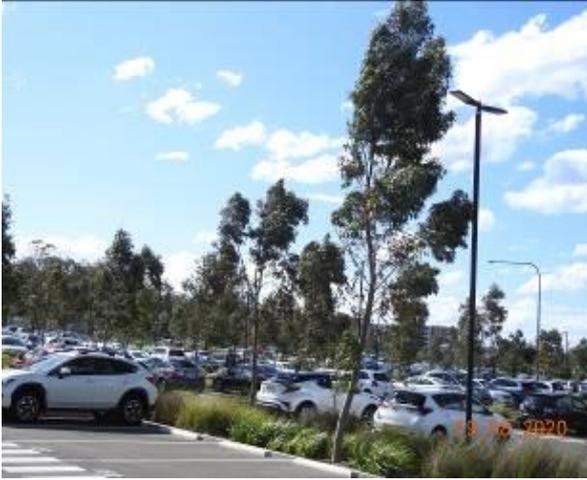
Figure 2301 – General condition of plantation and lamp post

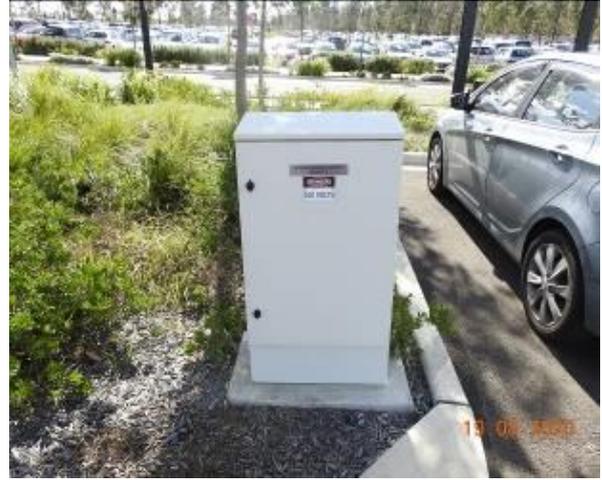
Figure 2302 – General condition of electricity box identification No. CUD-X-DEC-1G

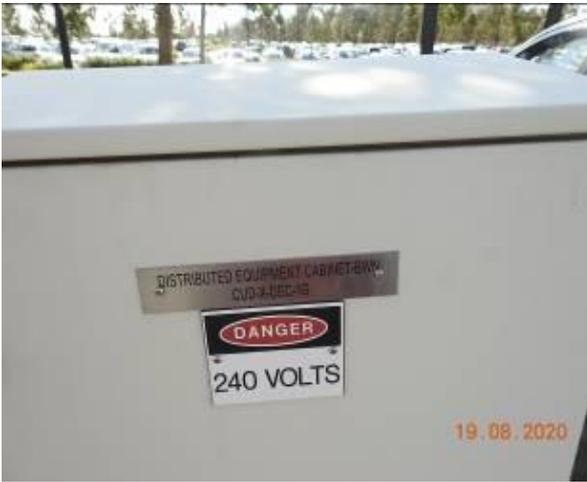
Figure 2303 – General condition of electricity box identification No. CUD-X-DEC-1G

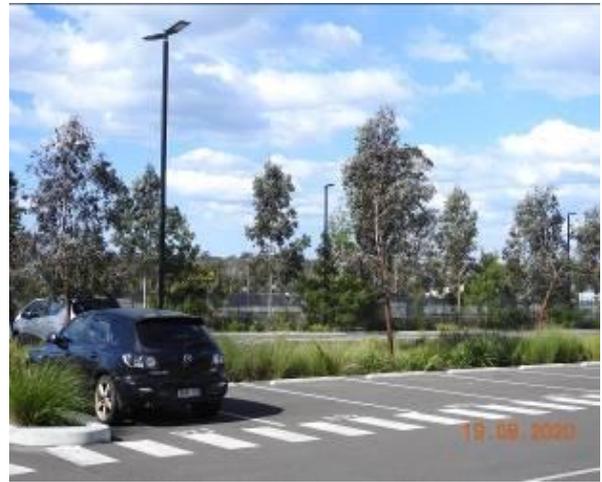
Figure 2304 – General condition of plantation and lamp post

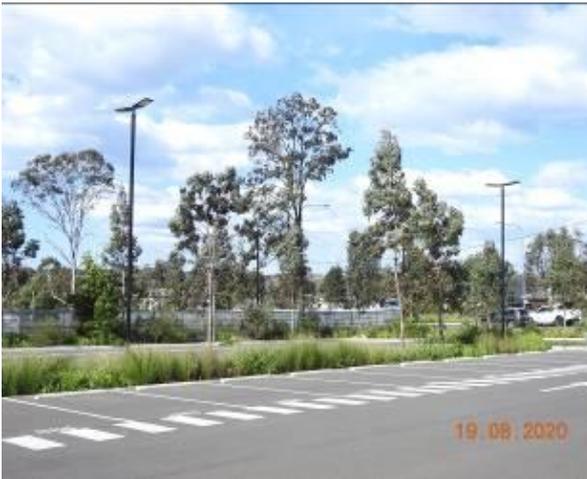
Figure 2305 – General condition of plantation and lamp post

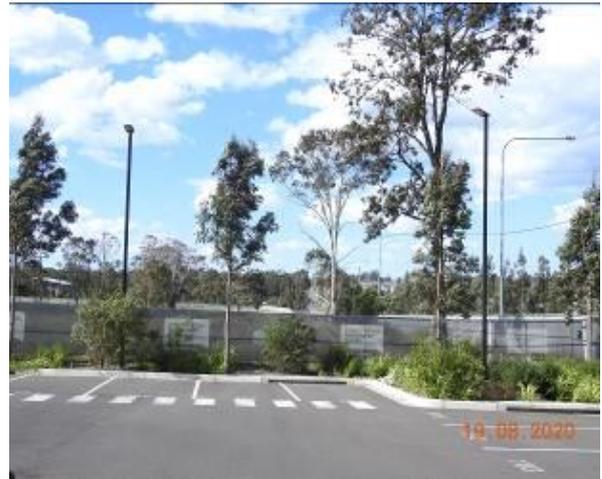
Figure 2306 – General condition of plantation and lamp post

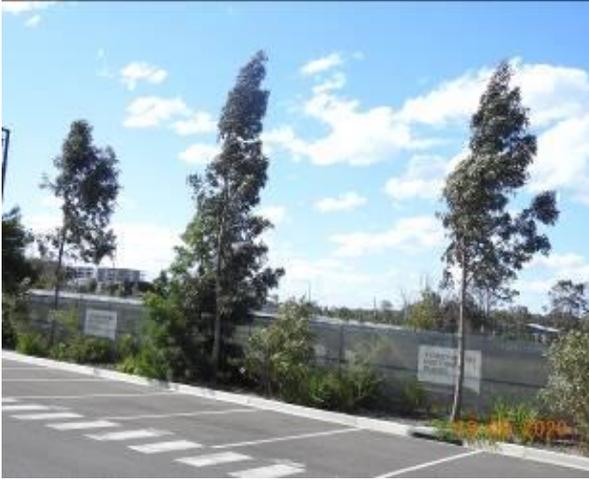
Figure 2307 – General condition of plantation and lamp post

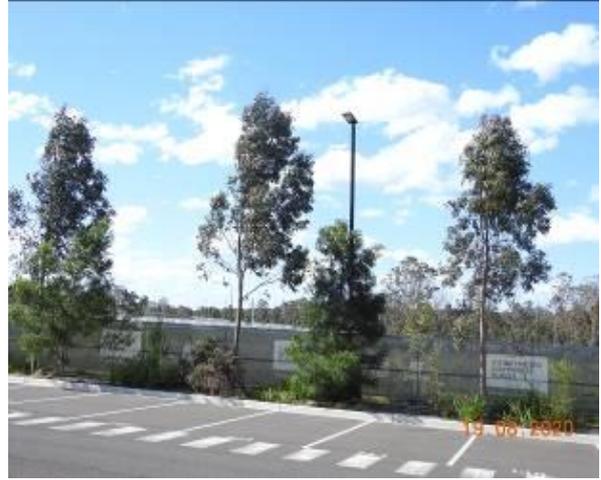
Figure 2308 – General condition of plantation and lamp post

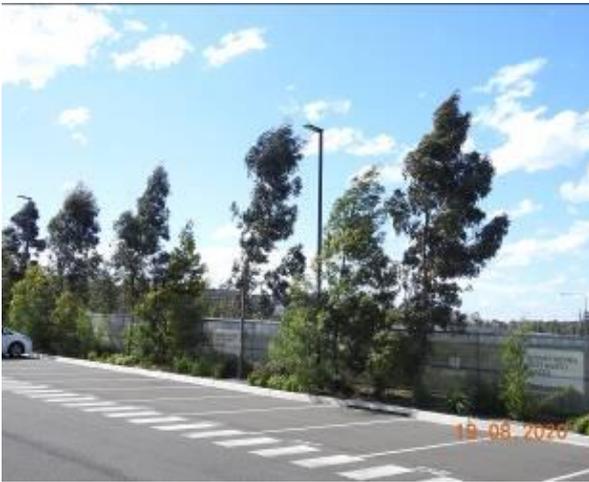
Figure 2309 – General condition of plantation and lamp post

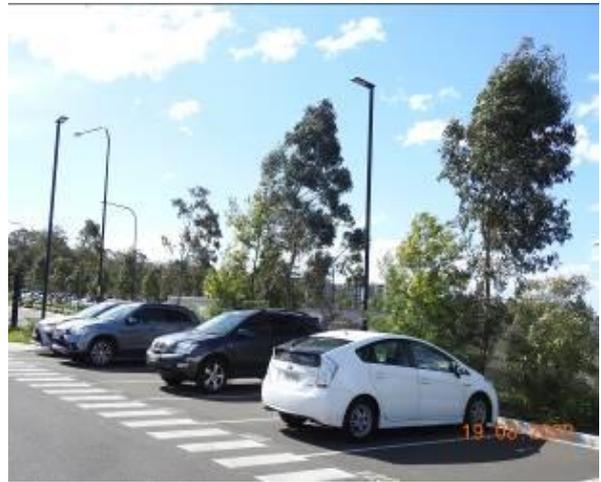
Figure 2310 – General condition of plantation and lamp post

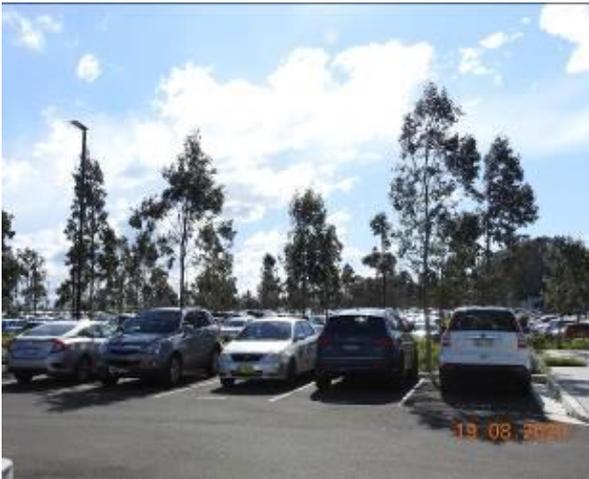
Figure 2311 – General condition of plantation and lamp post

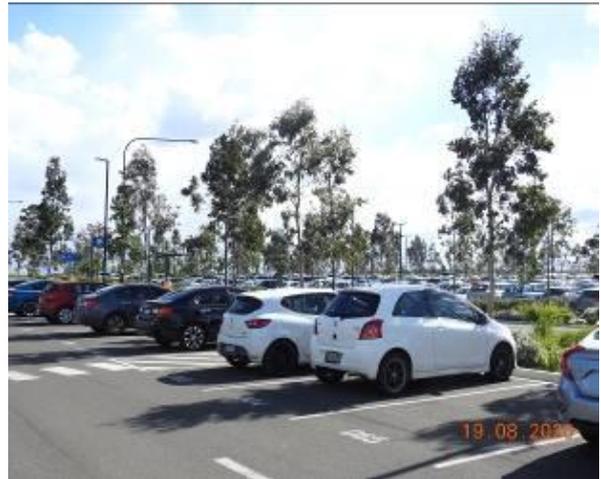
Figure 2312 – General condition of plantation and lamp post

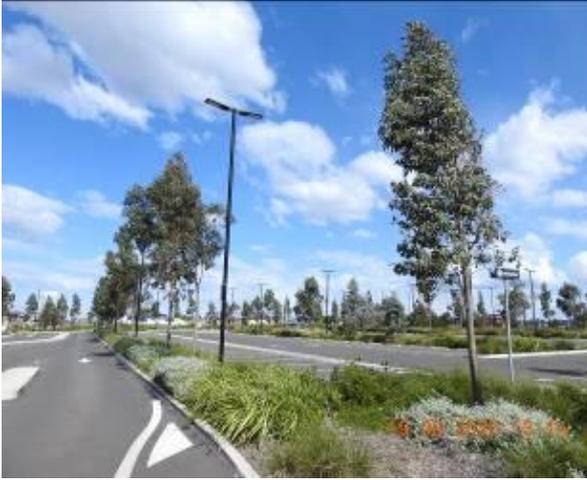
Figure 2313 – General condition of plantation and lamp post

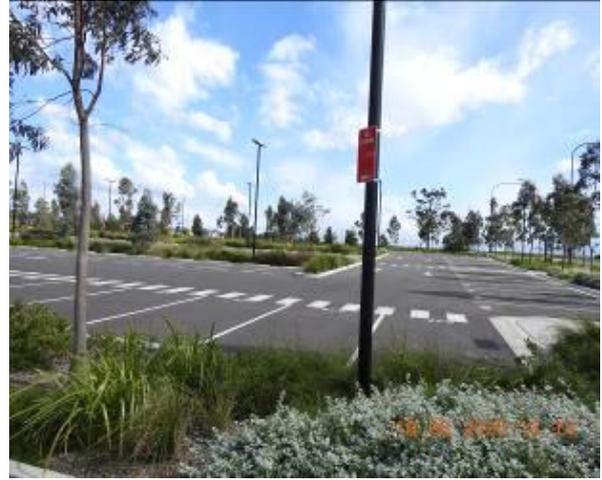
Figure 2314 – General condition of plantation and lamp post

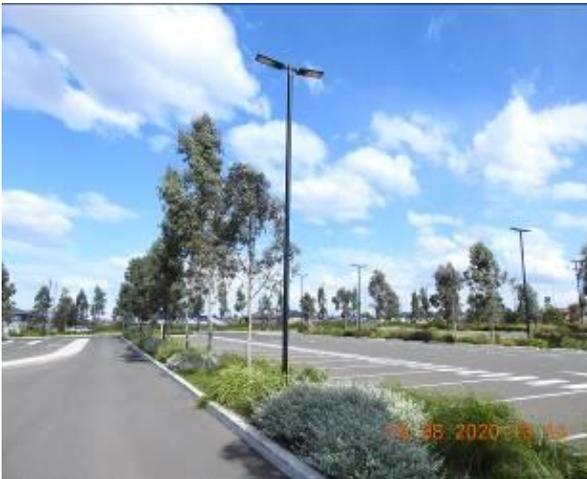
Figure 2315 – General condition of plantation and lamp post

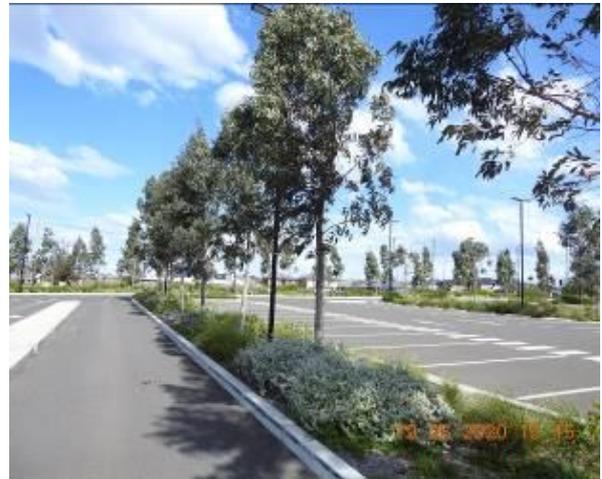
Figure 2316 – General condition of plantation and lamp post

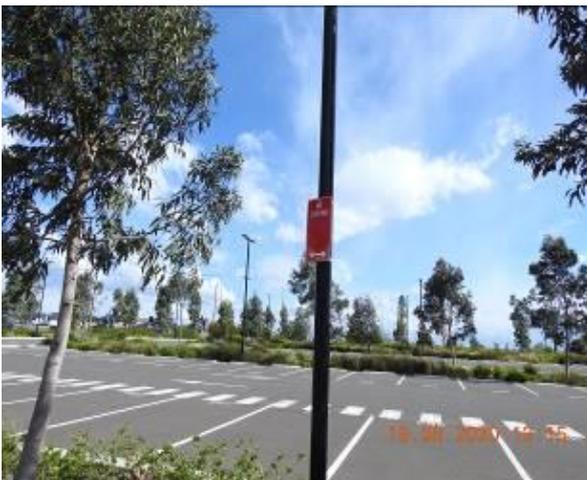
Figure 2317 – General condition of plantation and lamp post

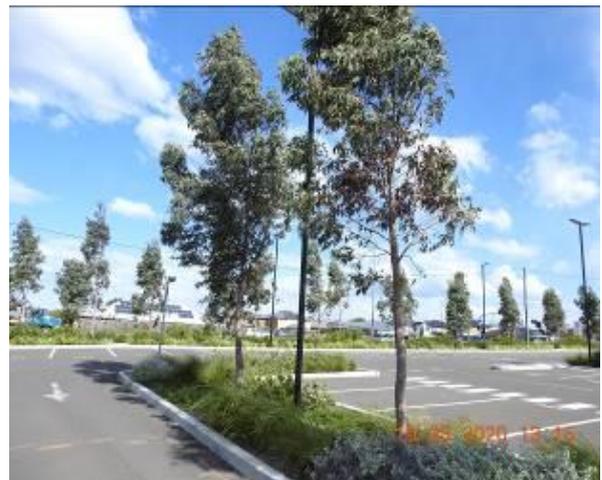
Figure 2318 – General condition of plantation and lamp post

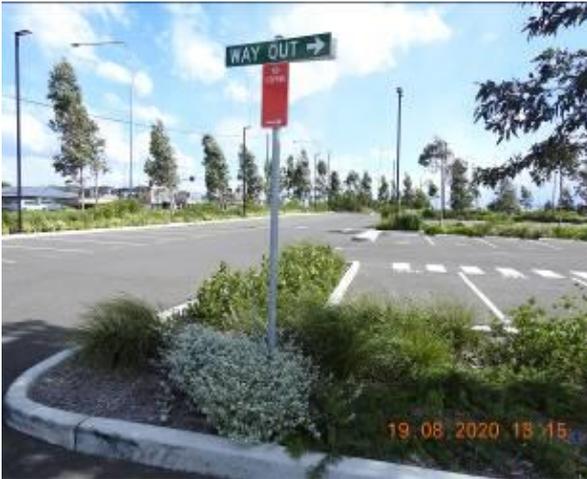
Figure 2319 – General condition of street sign

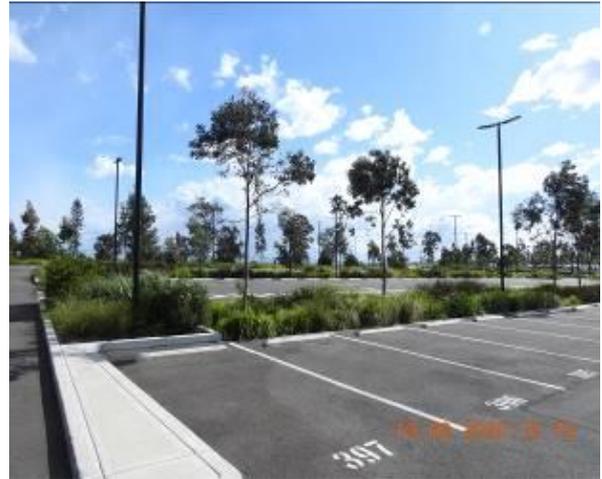
Figure 2320 – General condition of plantation and lamp post

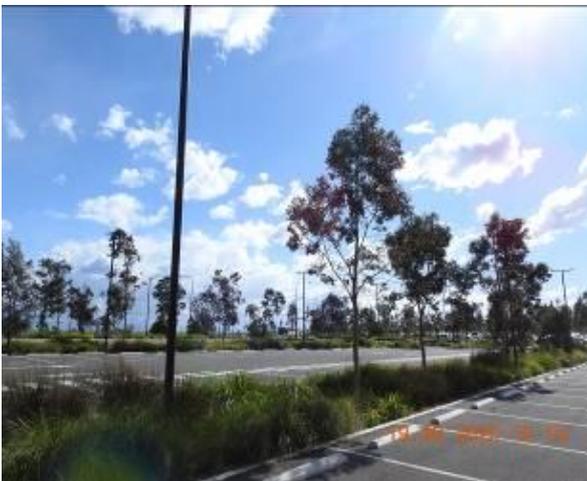
Figure 2321 – General condition of plantation and lamp post

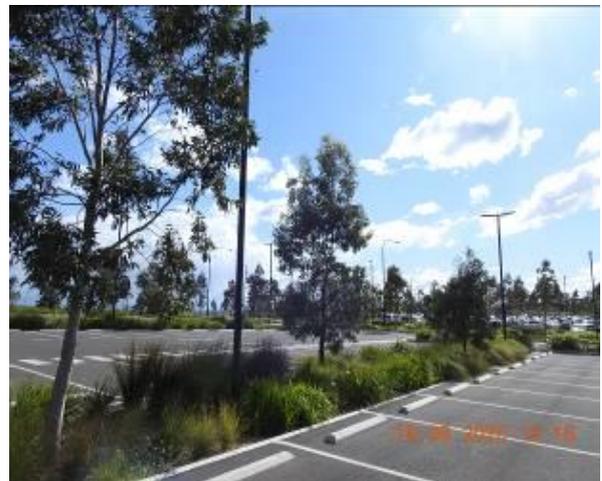
Figure 2322 – General condition of plantation and lamp post

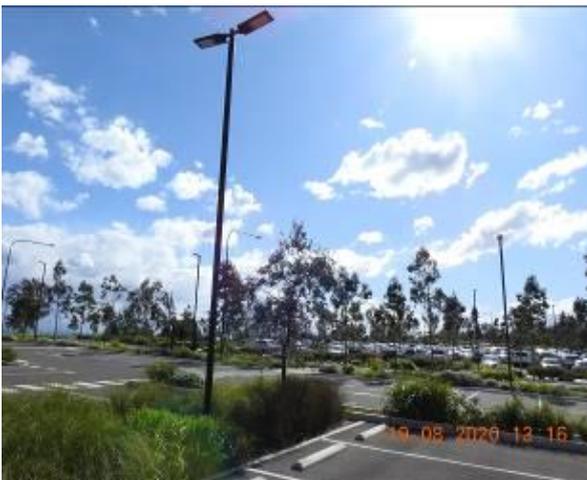
Figure 2323 – General condition of plantation and lamp post

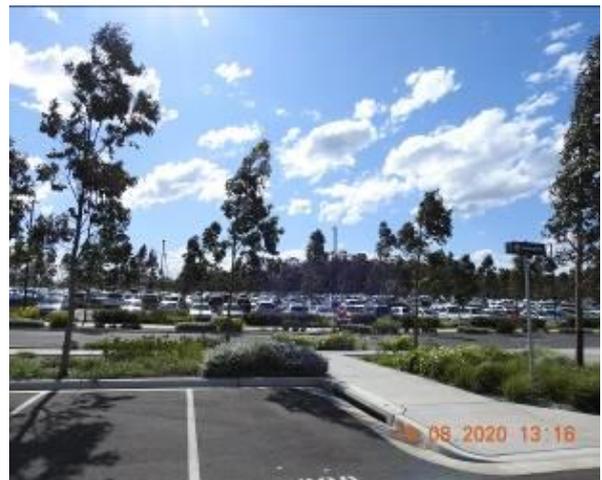
Figure 2324 – General condition of plantation and lamp post

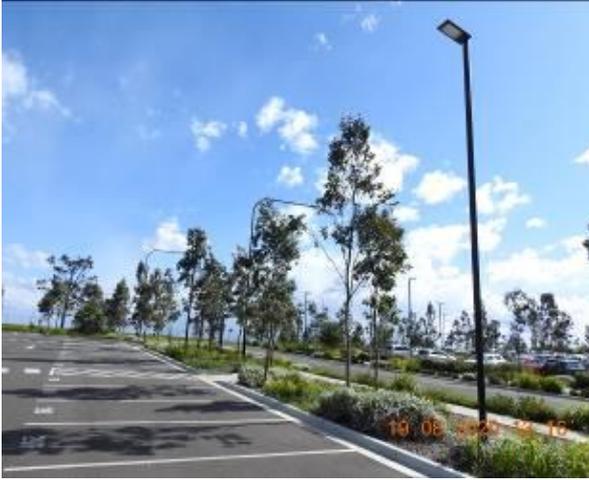
Figure 2325 – General condition of plantation and lamp post

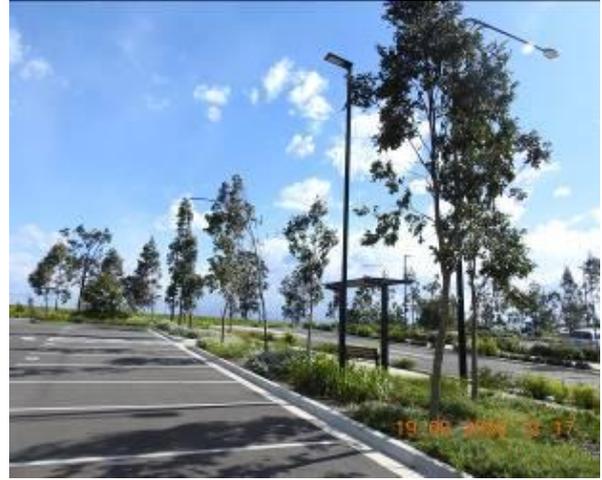
Figure 2326 – General condition of plantation and lamp post

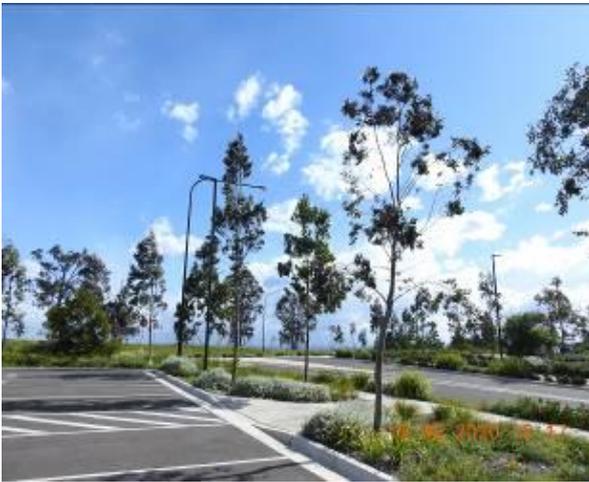
Figure 2327 – General condition of plantation and lamp post

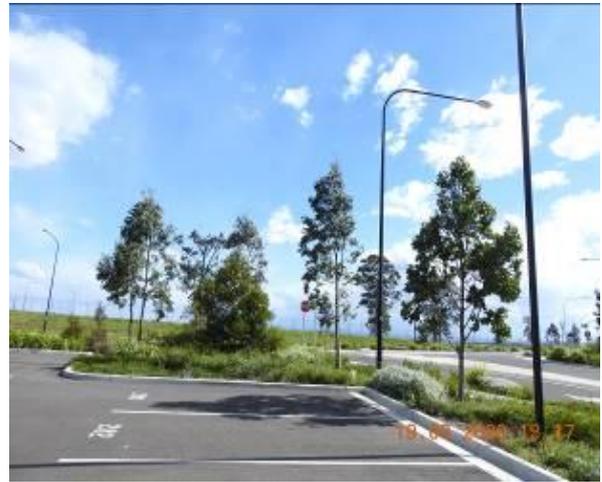
Figure 2328 – General condition of plantation and lamp post

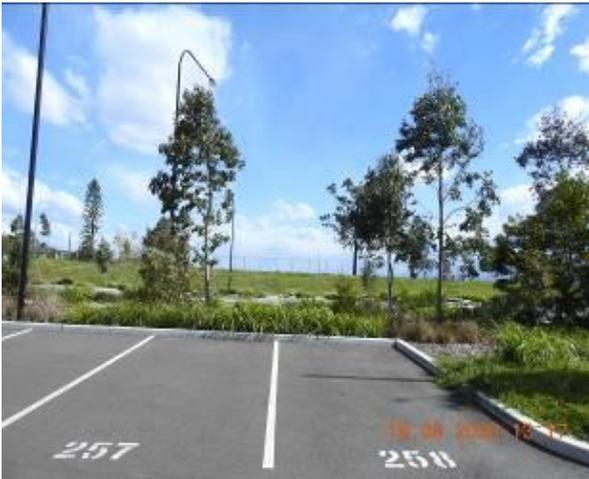
Figure 2329 – General condition of plantation and lamp post

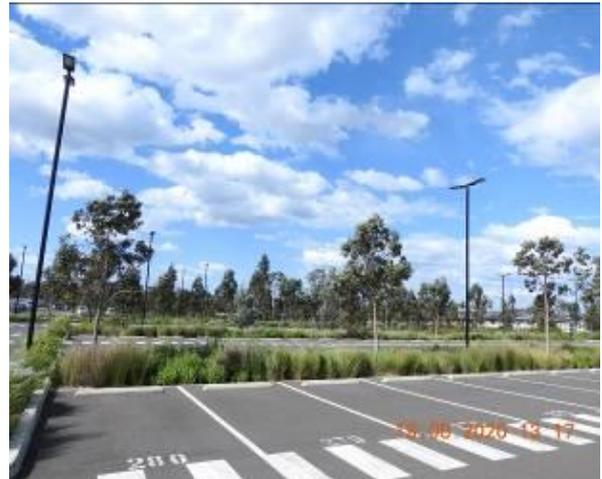
Figure 2330 – General condition of plantation and lamp post

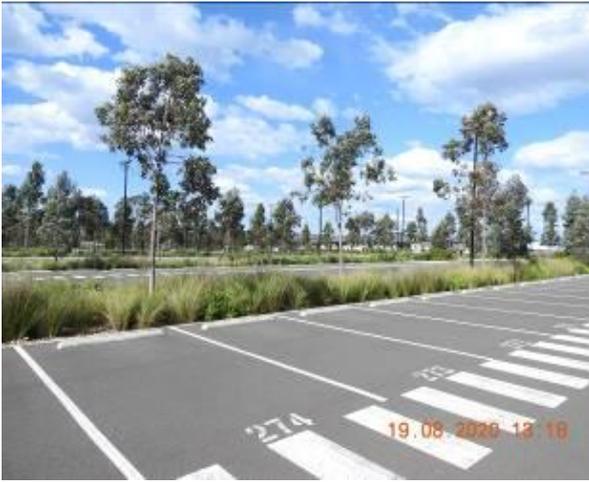
Figure 2331 – General condition of plantation

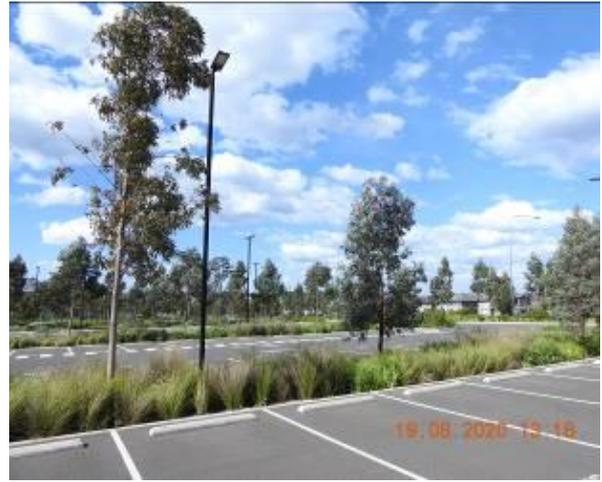
Figure 2332 – General condition of plantation and lamp post

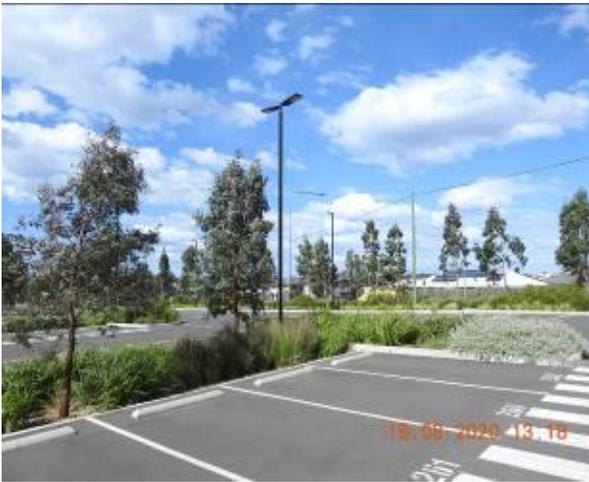
Figure 2333 – General condition of plantation and lamp post

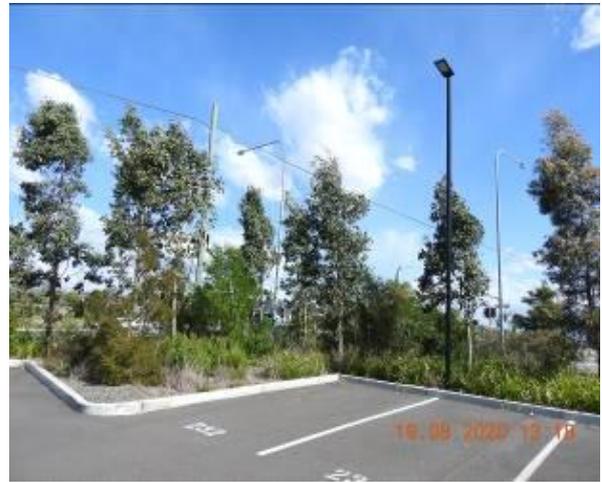
Figure 2334 – General condition of plantation and lamp post

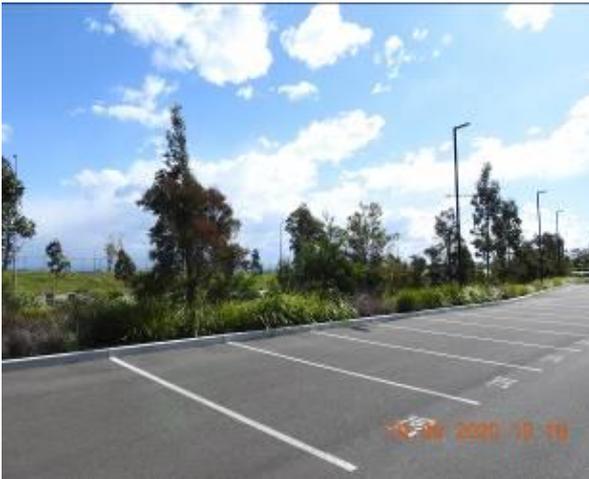
Figure 2335 – General condition of plantation and lamp post

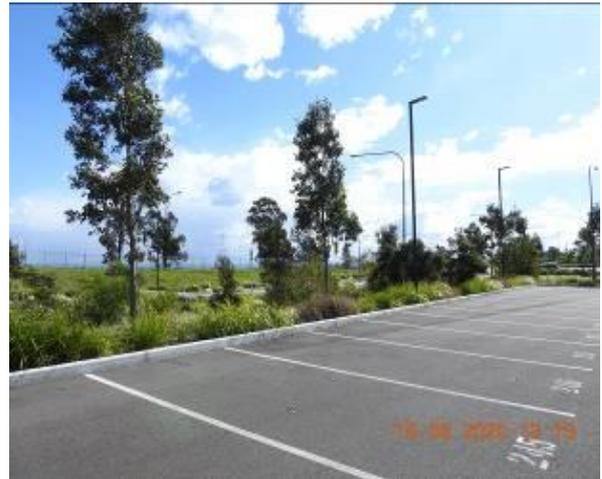
Figure 2336 – General condition of plantation and lamp post

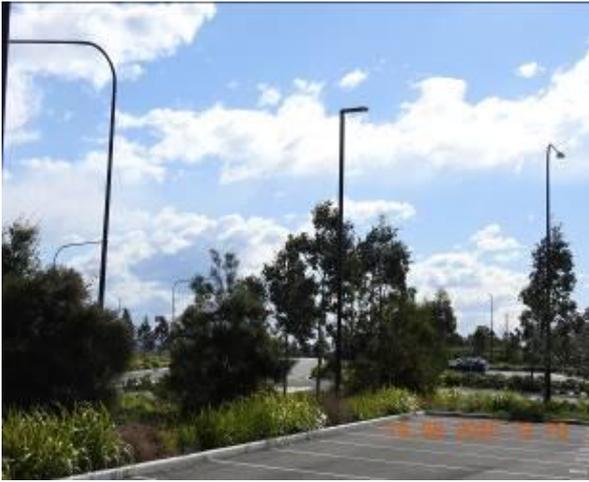
Figure 2337 – General condition of plantation and lamp post

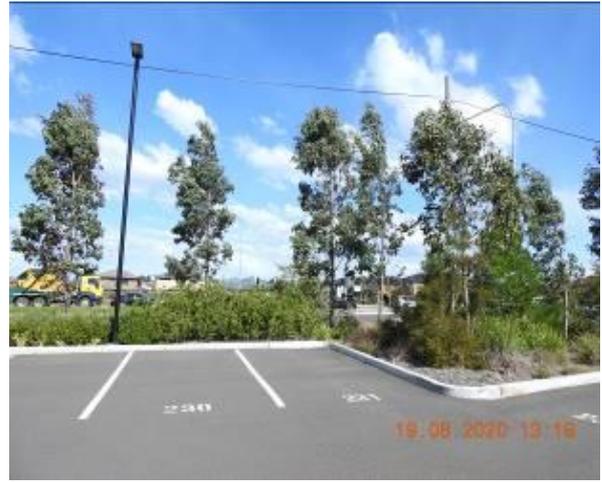
Figure 2338 – General condition of plantation and lamp post

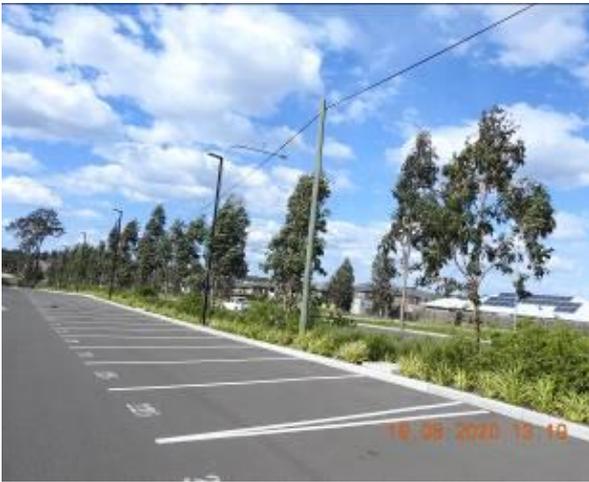
Figure 2339 – General condition of plantation and lamp post

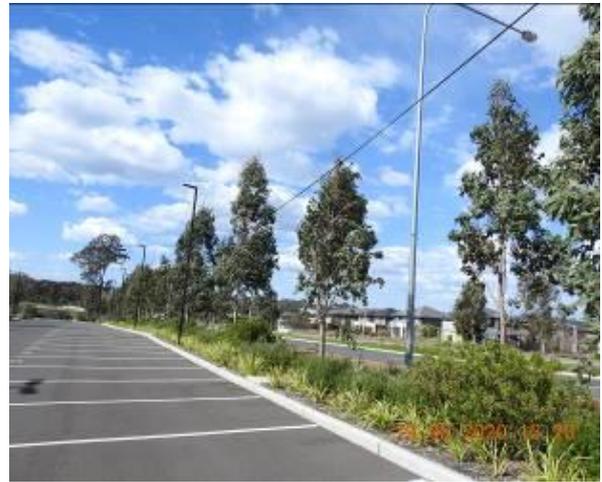
Figure 2340 – General condition of plantation and lamp post

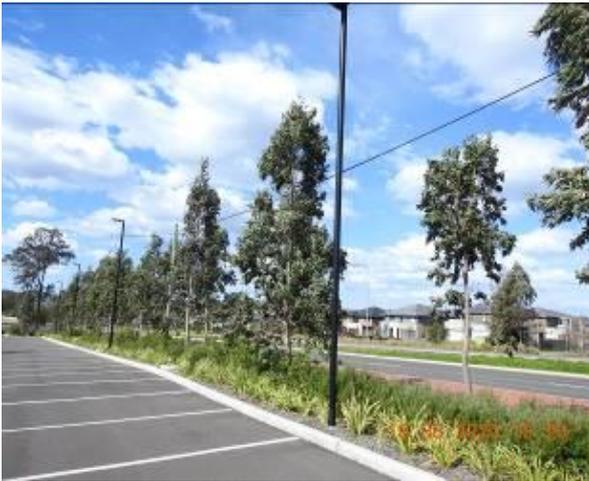
Figure 2341 – General condition of plantation and lamp post

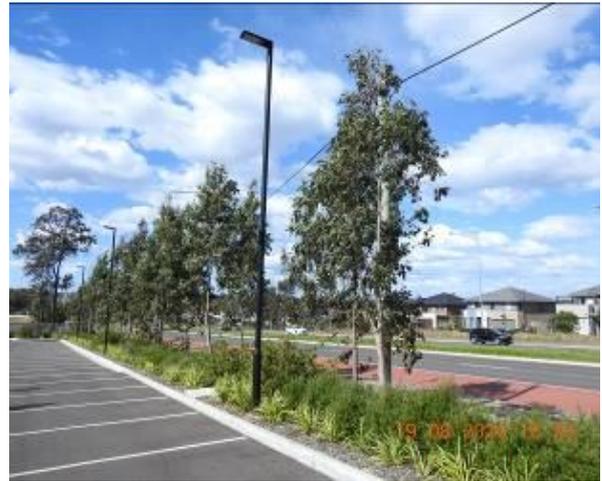
Figure 2342 – General condition of plantation and lamp post

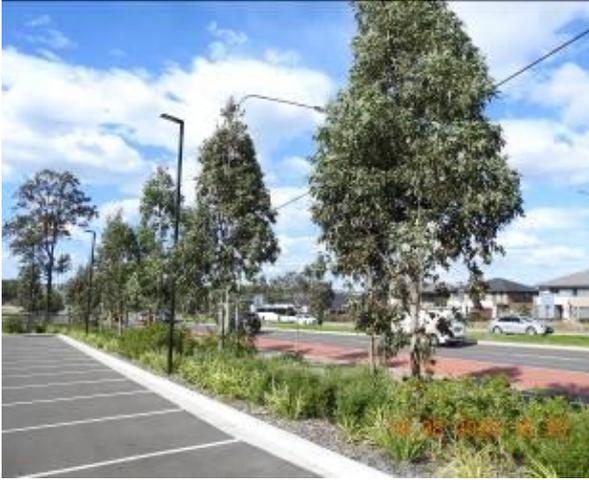
Figure 2343 – General condition of plantation and lamp post

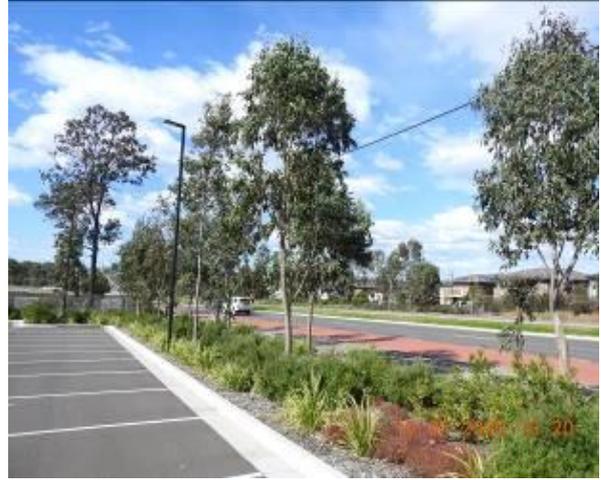
Figure 2344 – General condition of plantation and lamp post

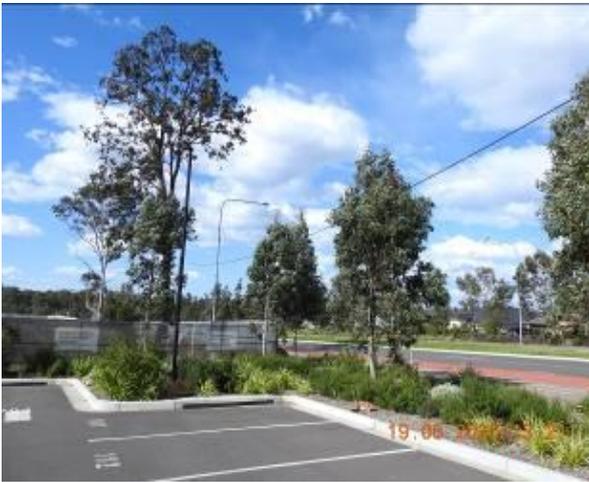
Figure 2345 – General condition of plantation and lamp post

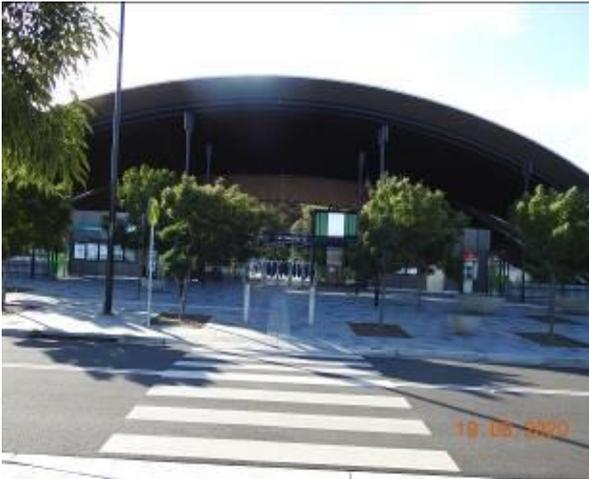
Figure 2346 – The following images display the condition of Tallawong Station

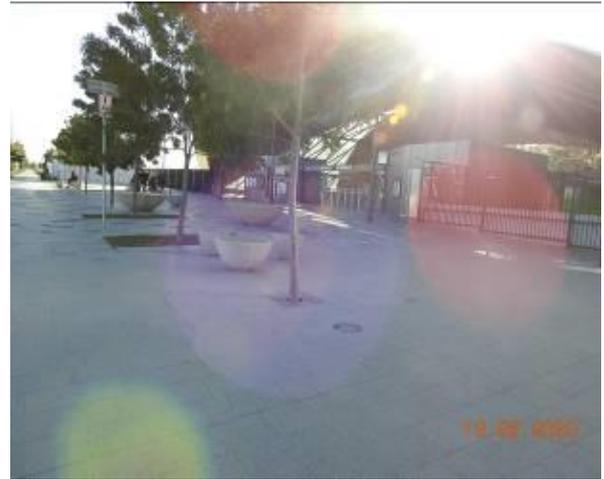
Figure 2347 – General condition of RailCorp assets along Southern elevation

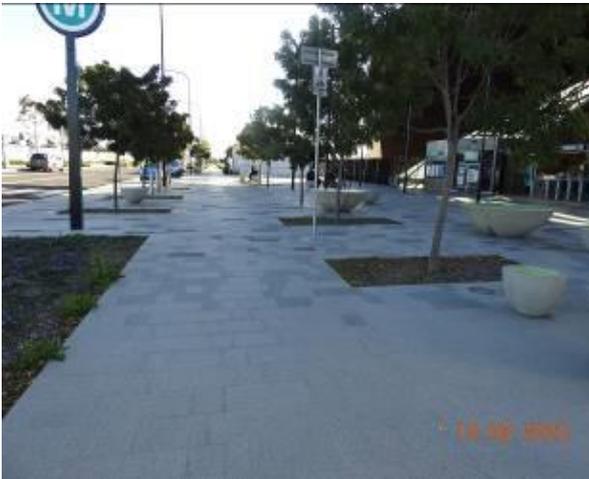
Figure 2348 – General condition of RailCorp assets

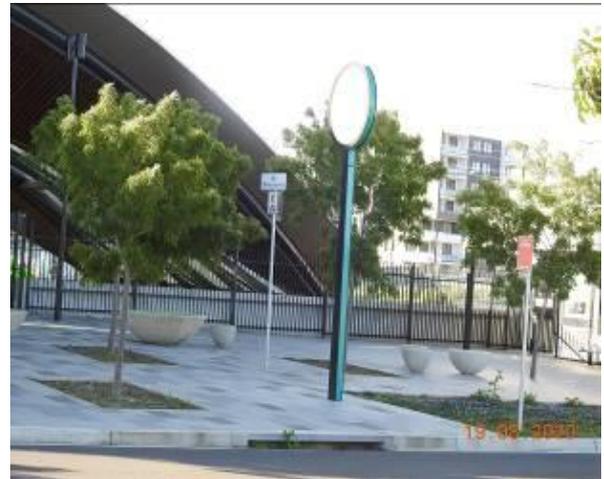
Figure 2349 – General condition of RailCorp assets

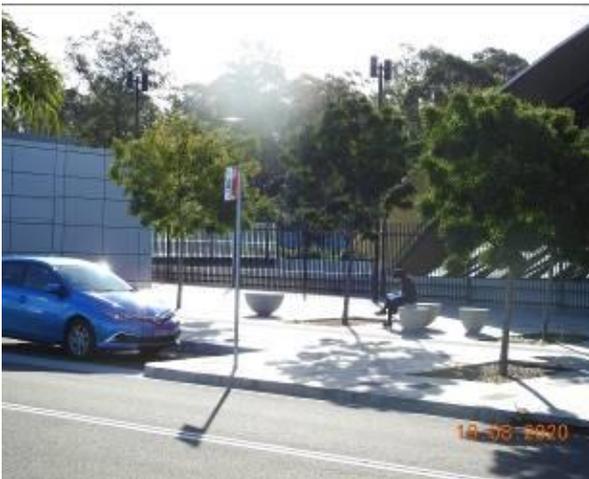
Figure 2350 – General condition of RailCorp assets

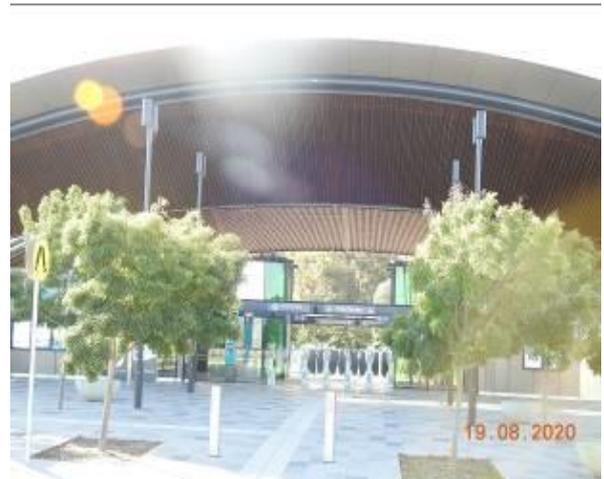
Figure 2351 – General condition of RailCorp assets

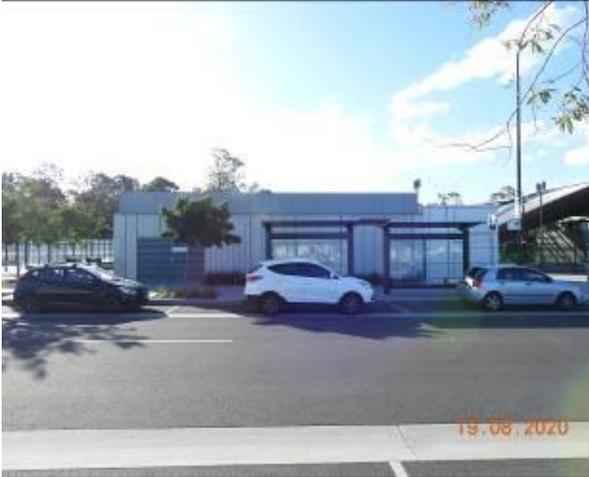
Figure 2352 – General condition of RailCorp assets

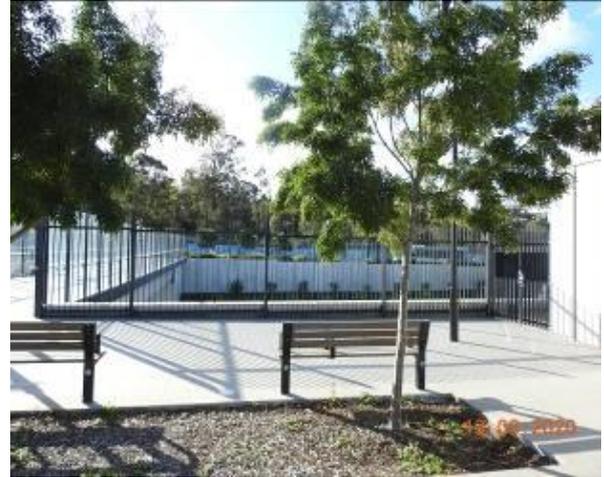
Figure 2353 – General condition of RailCorp assets

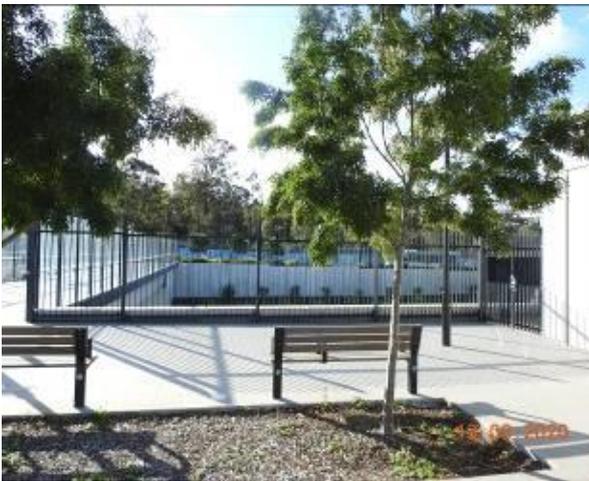
Figure 2354 – General condition of RailCorp assets

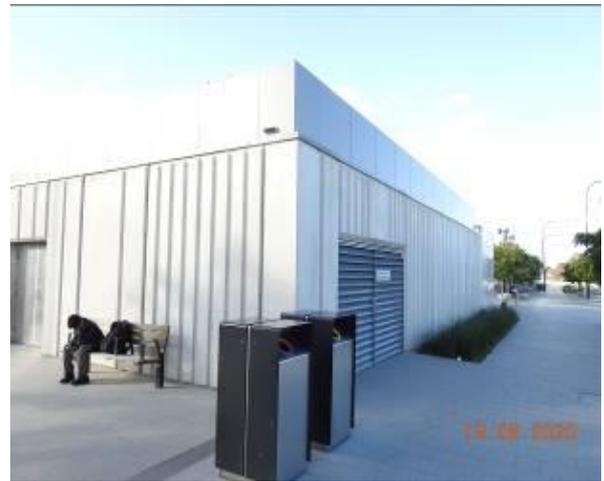
Figure 2355 – General condition of RailCorp assets

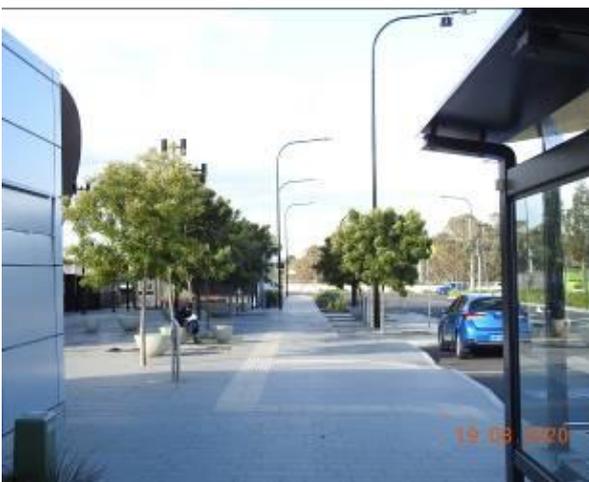
Figure 2356 – General condition of RailCorp assets

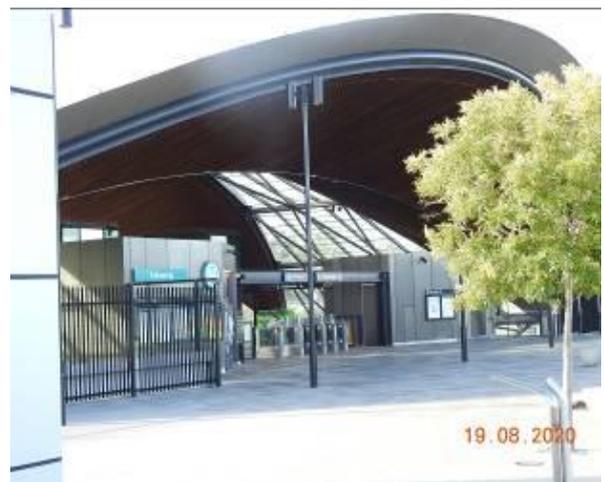
Figure 2357 – General condition of RailCorp assets

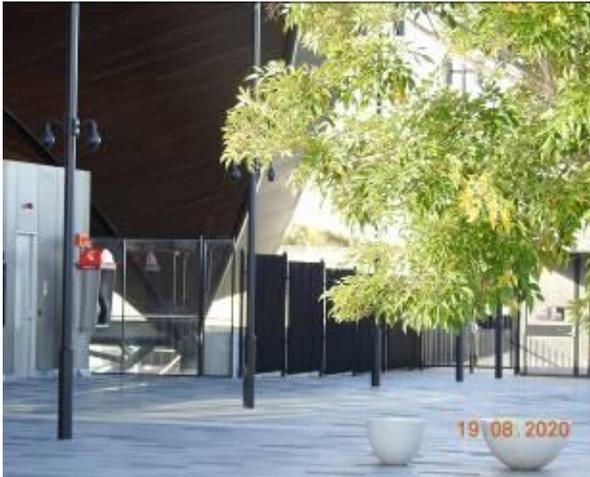
Figure 2358 – General condition of RailCorp assets

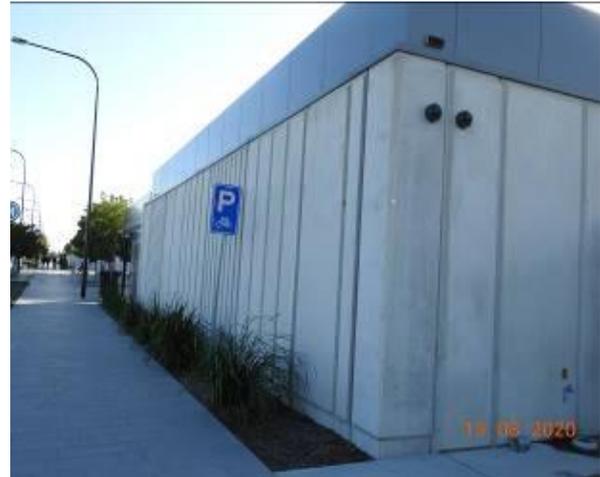
Figure 2359 – General condition of RailCorp external wall heading West

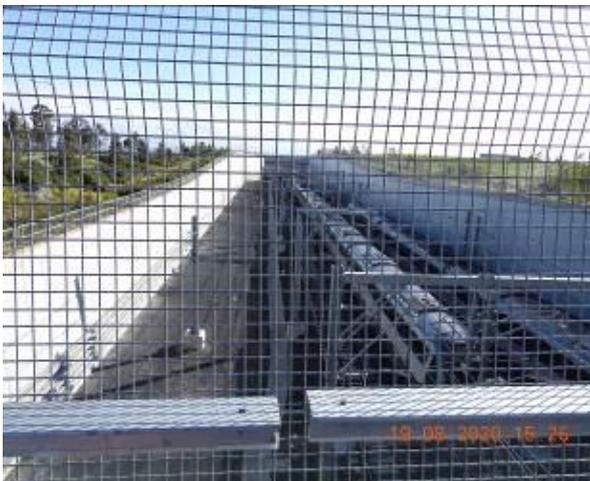
Figure 2360 – General condition of railway corridor, steel portal haunch and overhead power system along Western elevation of the station

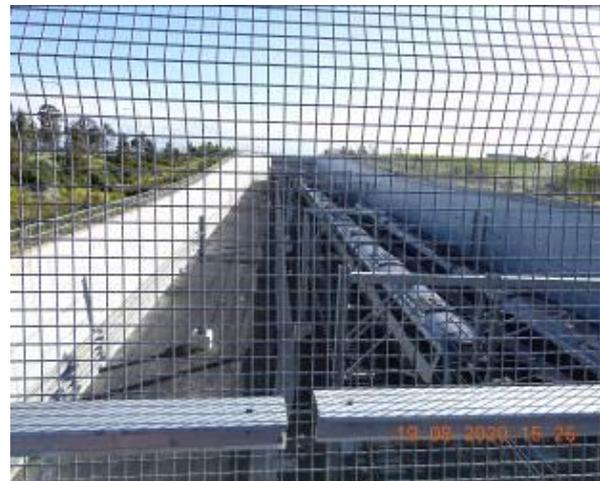
Figure 2361 – General condition of railway corridor, steel portal haunch and overhead power system

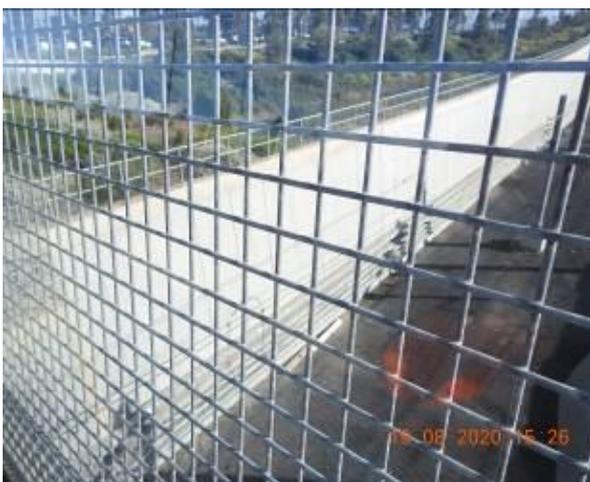
Figure 2362 – General condition of RailCorp retaining wall

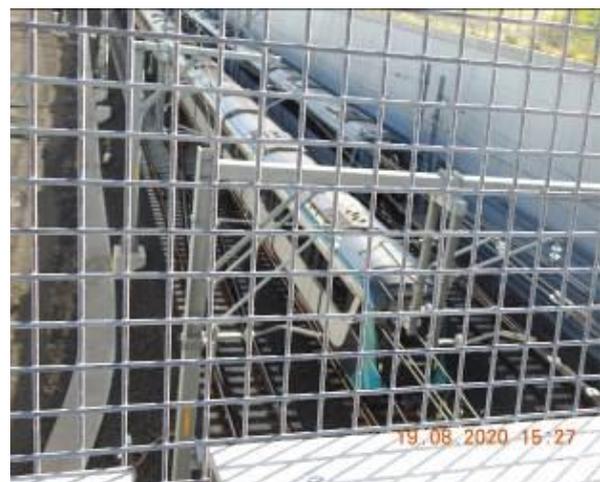
Figure 2363 – General condition of railway corridor, steel portal haunch and overhead power system

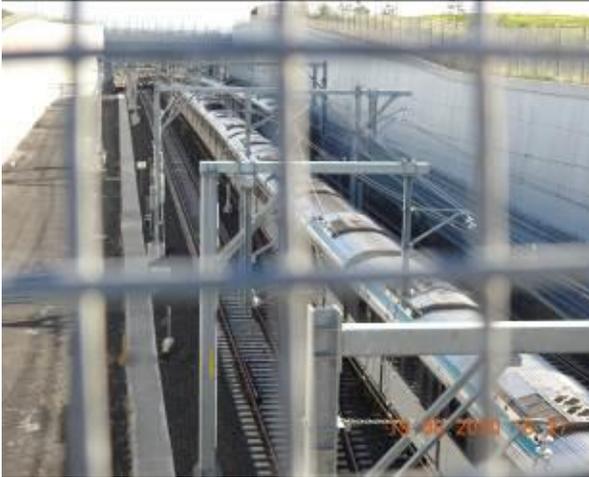
Figure 2364 – General condition of railway corridor, steel portal haunch and overhead power system

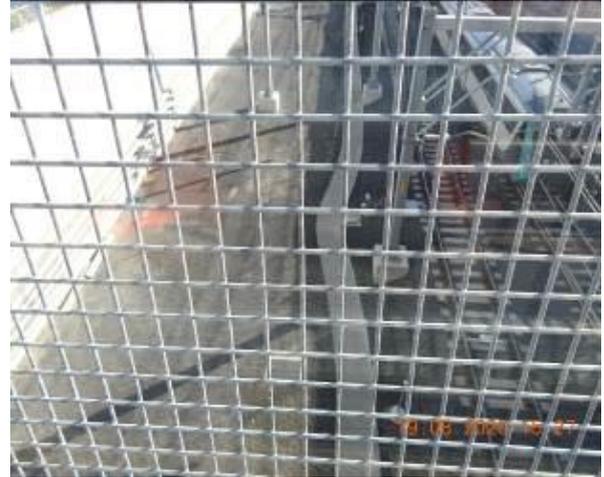
Figure 2365 – General condition of railway corridor, steel portal haunch and overhead power system

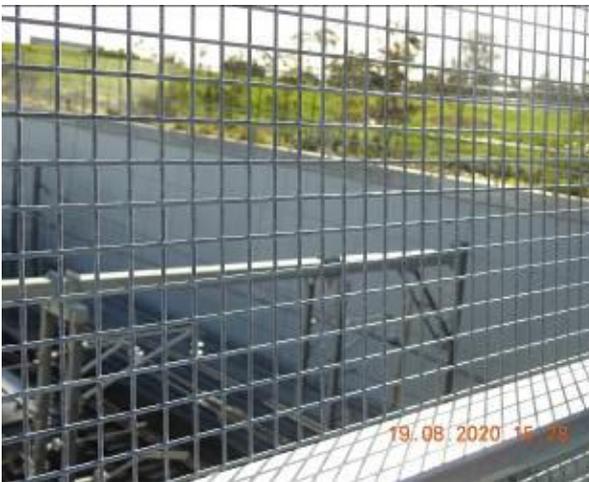
Figure 2366 – General condition of RailCorp retaining wall

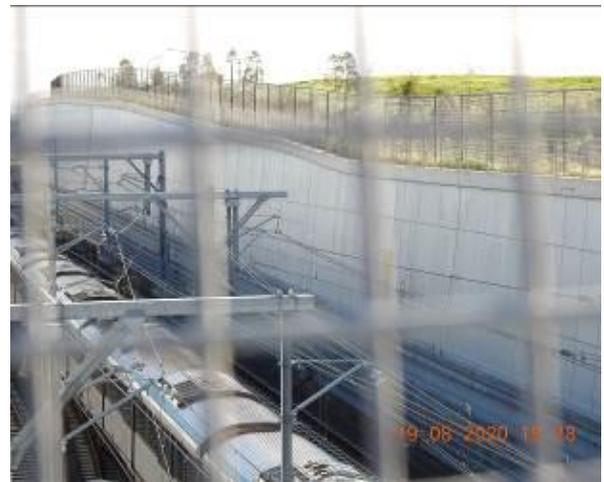
Figure 2367 – General condition of RailCorp retaining wall

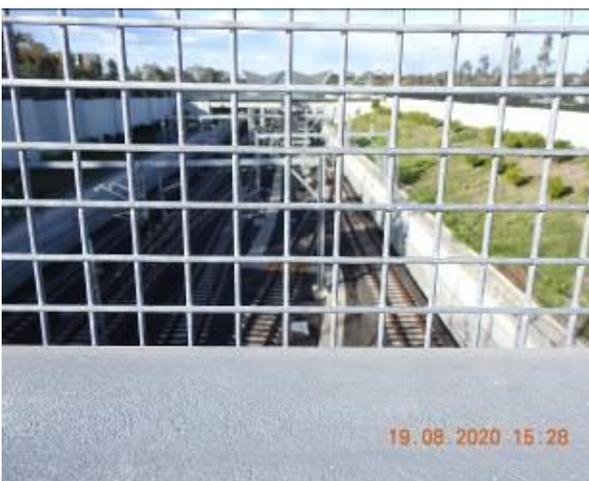
Figure 2368 – General condition of railway corridor, steel portal haunch and overhead power system
