The property Tallawong station – P2 Car Park, is the neighbouring property to our client’s site. It was photographed and inspected prior to any construction works on the subject site and was found to be in a reasonable condition. The property serves as a car park.

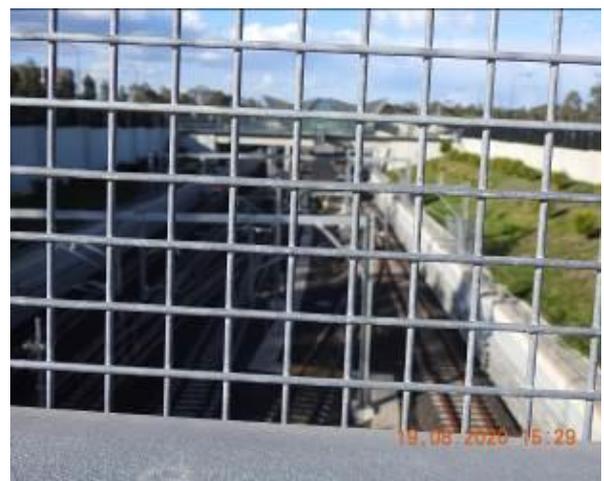
Figure 2369 – General condition of railway corridor, steel portal haunch and overhead power system

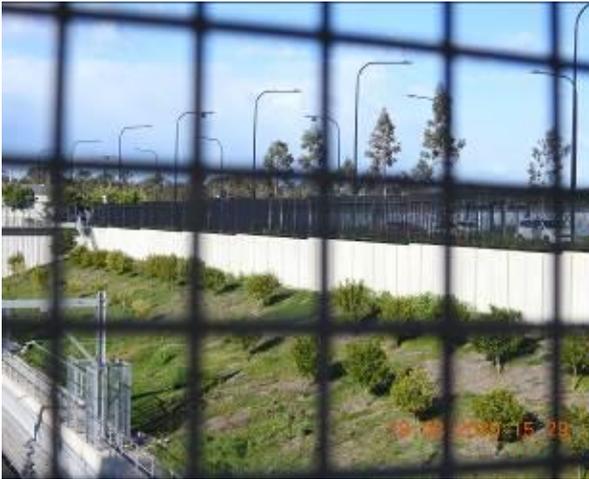
Figure 2370 – General condition of RailCorp retaining wall

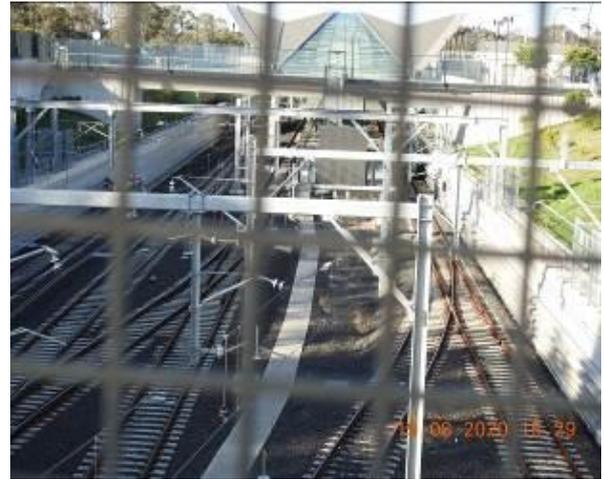
Figure 2371 – General condition of railway corridor, steel portal haunch and overhead power system

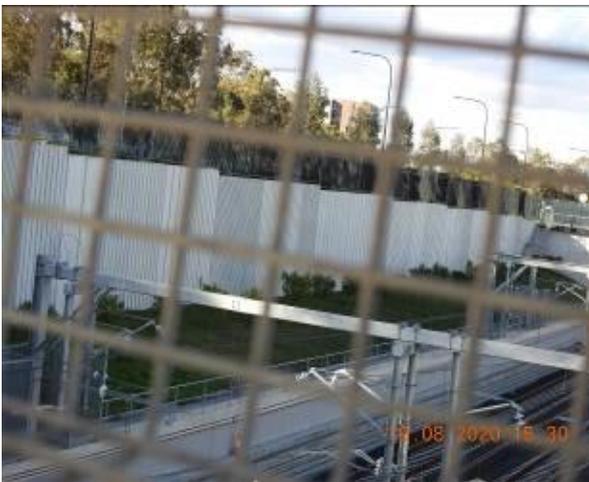
Figure 2372 – General condition of RailCorp retaining wall

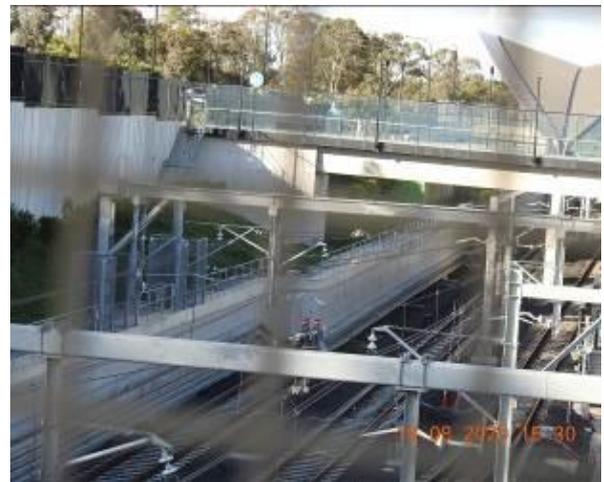
Figure 2373 – General condition of railway corridor, steel portal haunch and overhead power system

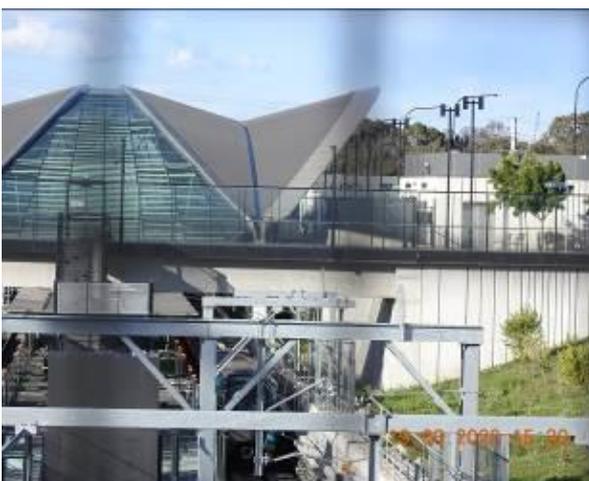
Figure 2374 – General condition of railway corridor, steel portal haunch and overhead power system

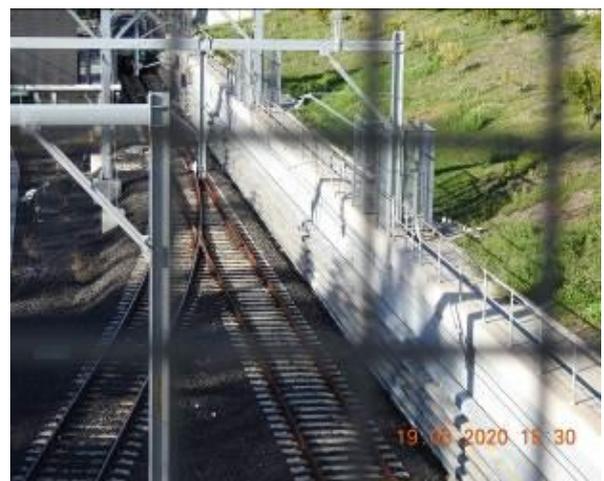
Figure 2375 – General condition of railway corridor, steel portal haunch and overhead power system

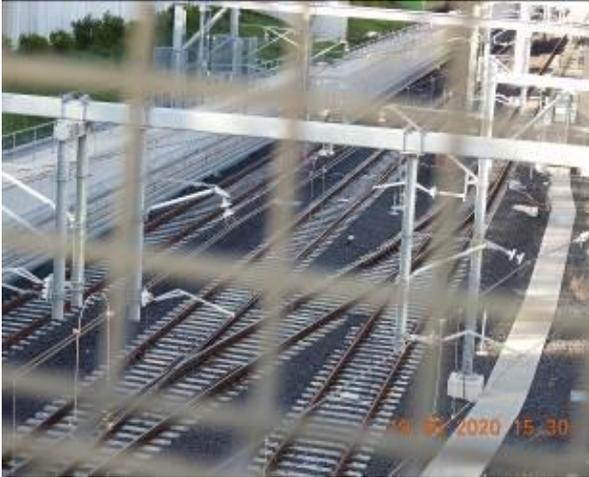
Figure 2376 – General condition of railway corridor, steel portal haunch and overhead power system

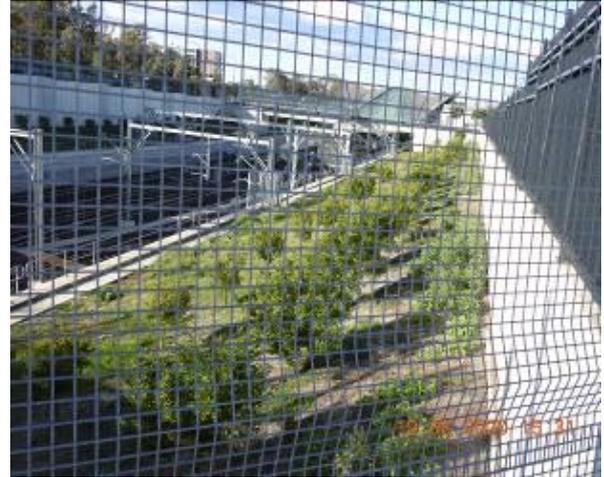
Figure 2377 – General condition of RailCorp retaining wall

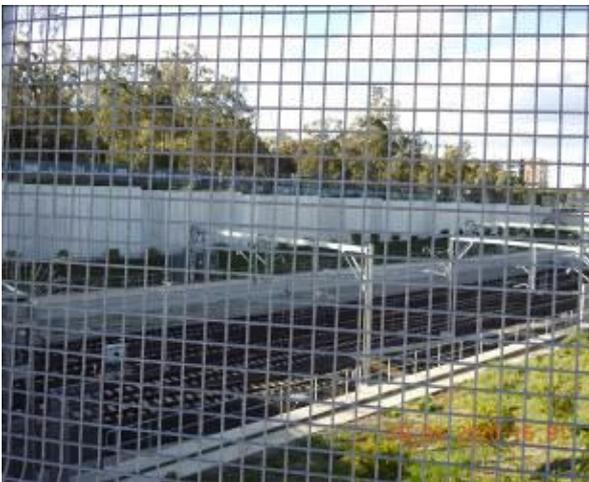
Figure 2378 – General condition of railway corridor, steel portal haunch and overhead power system

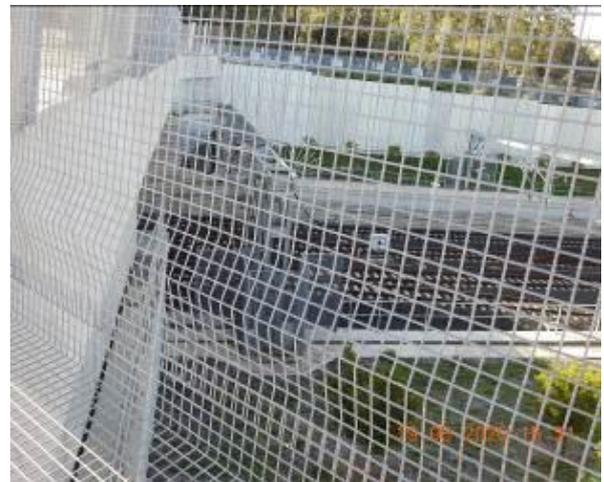
Figure 2379 – General condition of railway corridor, steel portal haunch and overhead power system

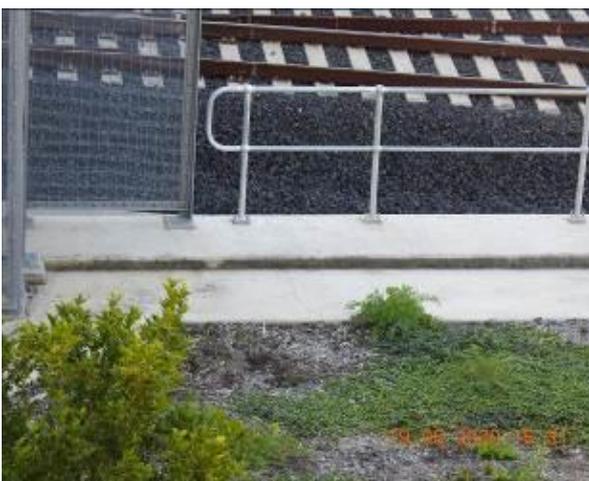
Figure 2380 – Crack propagation through RailCorp retaining wall

The section of the RailCorp infrastructure including the retaining walls, steel portal haunch, overhead supply system and Railway corridor and all other elements visible from the footpath were inspected and photographed and were determined to be in reasonable condition. There were, however cases of cracking and efflorescence observed through the retaining walls.

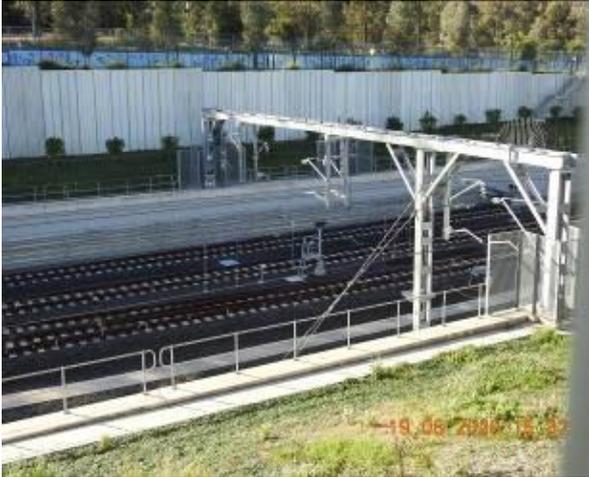
Figure 2382 – General condition of railway corridor, steel portal haunch and overhead power system

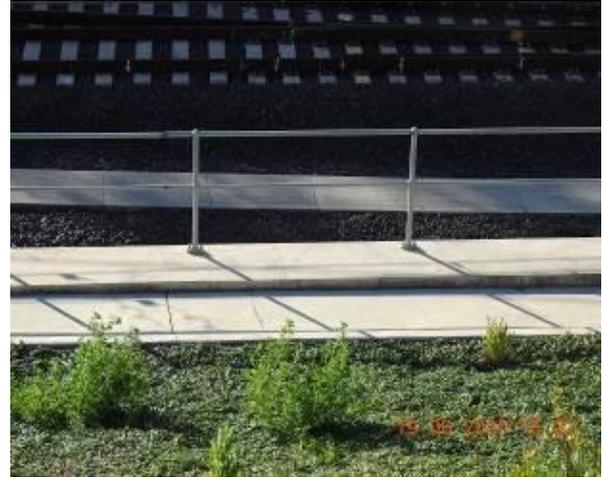
Figure 2383 – Crack propagation through RailCorp retaining wall

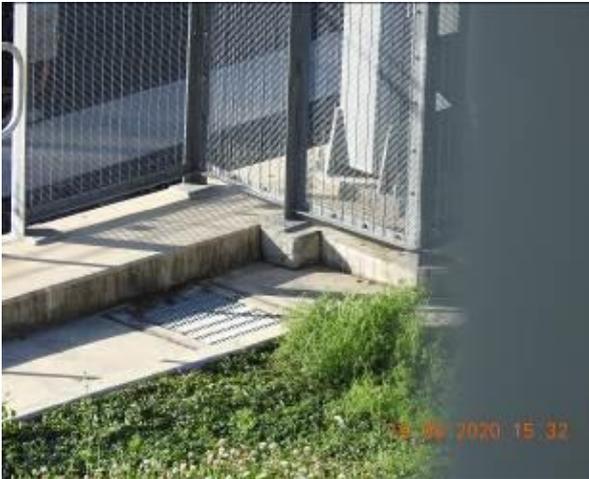
Figure 2384 – General condition of stormwater inlet pit and retaining wall

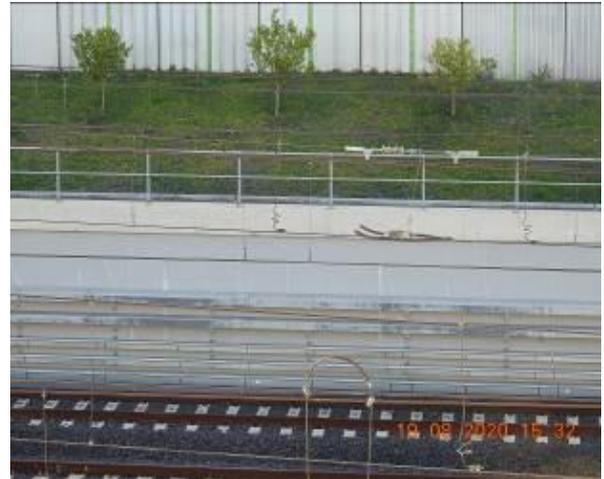
Figure 2385 – Crack propagation and efflorescence through RailCorp retaining wall

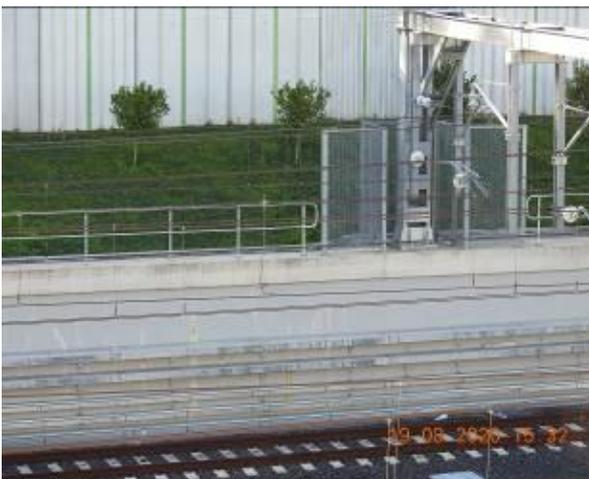
Figure 2386 – Crack propagation and efflorescence through RailCorp retaining wall

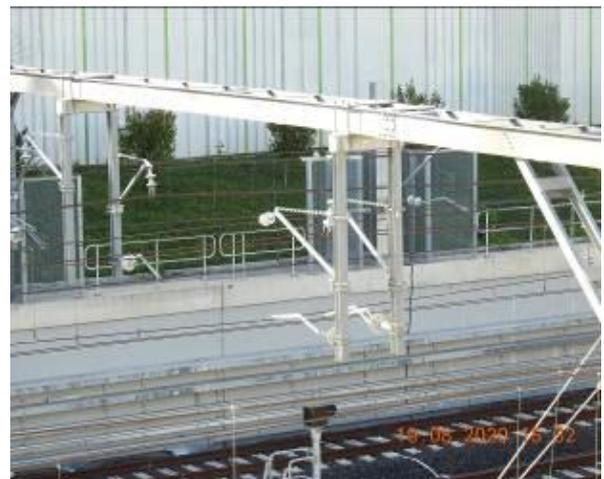
Figure 2387 – Crack propagation and efflorescence through RailCorp retaining wall

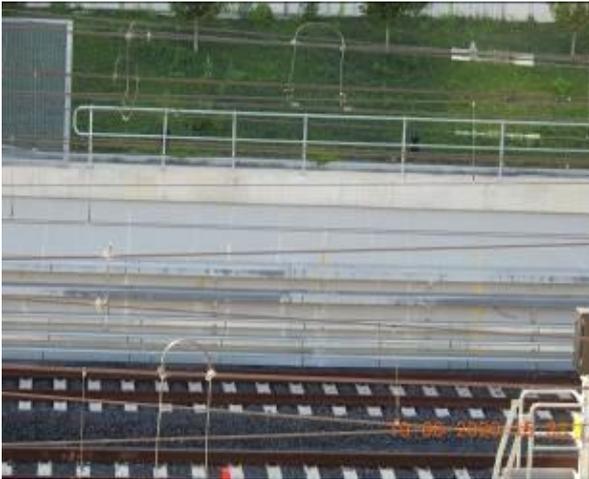
Figure 2388 – Crack propagation and efflorescence through RailCorp retaining wall

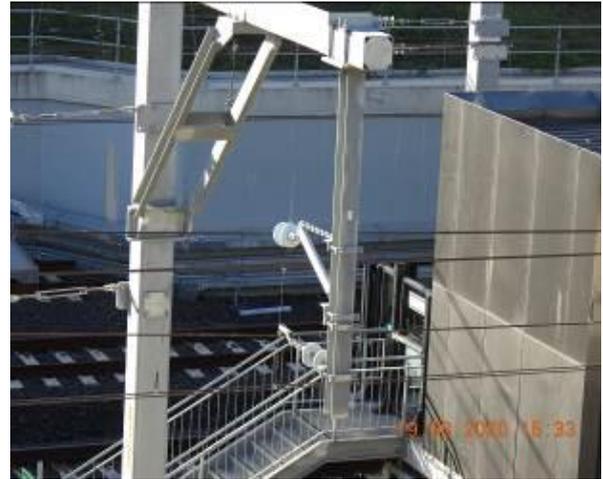
Figure 2389 – Crack propagation and efflorescence through RailCorp retaining wall

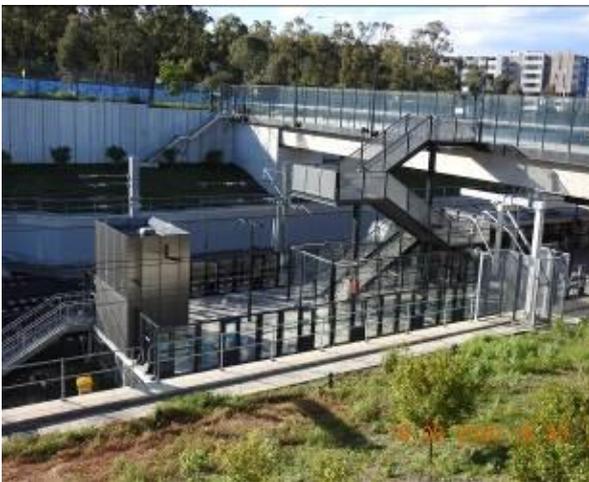
Figure 2390 – General condition of railway corridor, steel portal haunch and overhead power system

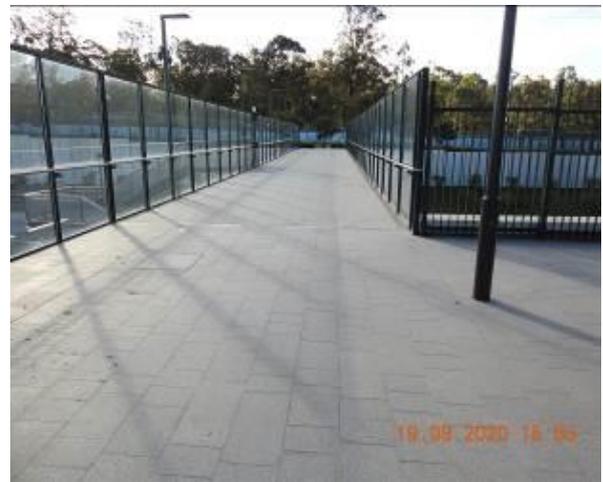
Figure 2391 – General condition of RailCorp overbridge pavement

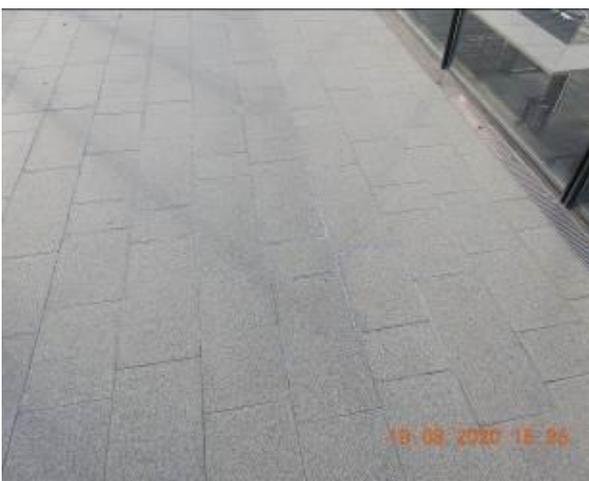
Figure 2392 – General condition of RailCorp overbridge pavement

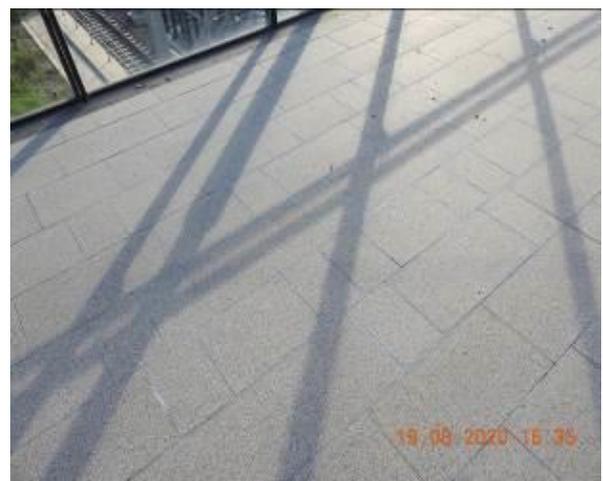
Figure 2393 – General condition of RailCorp overbridge pavement

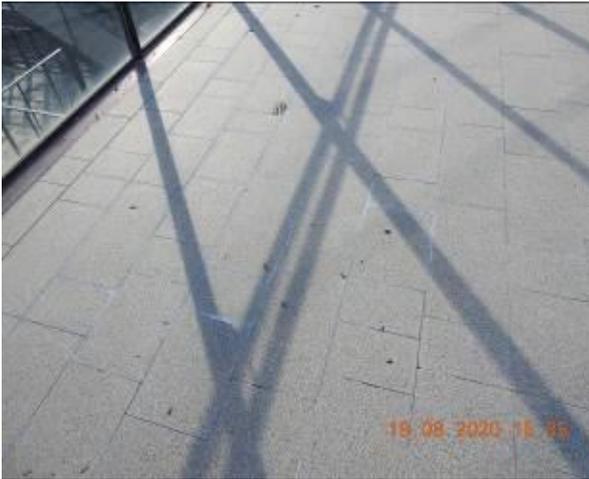
Figure 2394 – General condition of RailCorp overbridge pavement

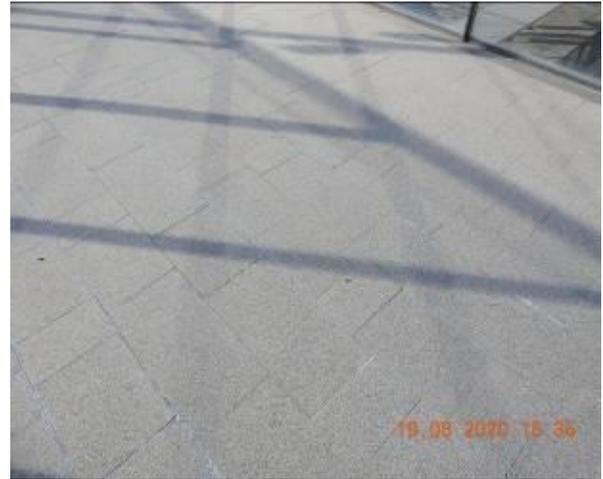
Figure 2395 – General condition of RailCorp overbridge pavement

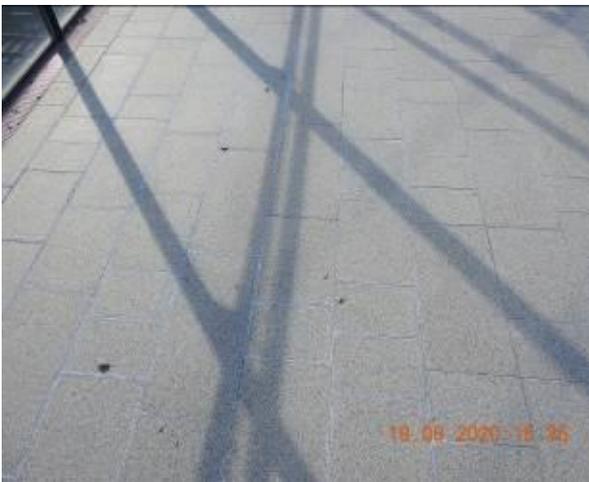
Figure 2396 – General condition of RailCorp overbridge pavement

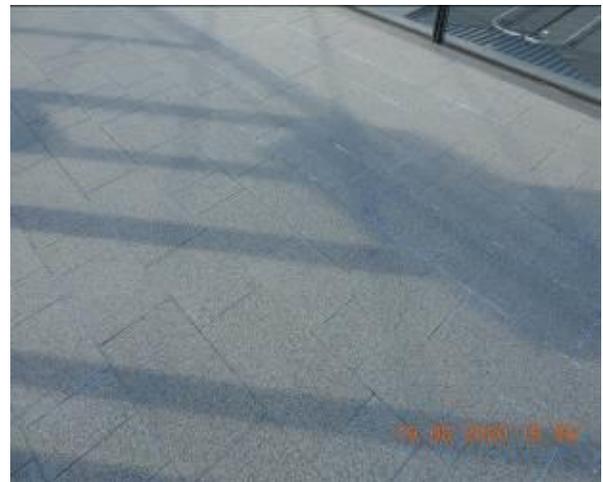
Figure 2397 – General condition of RailCorp overbridge pavement

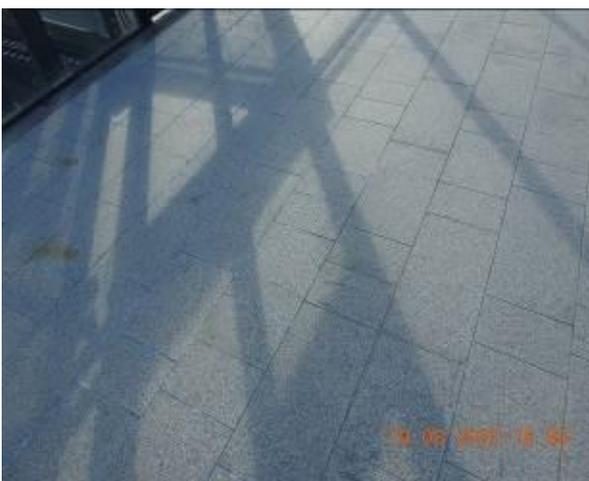
Figure 2398 – General condition of RailCorp overbridge pavement

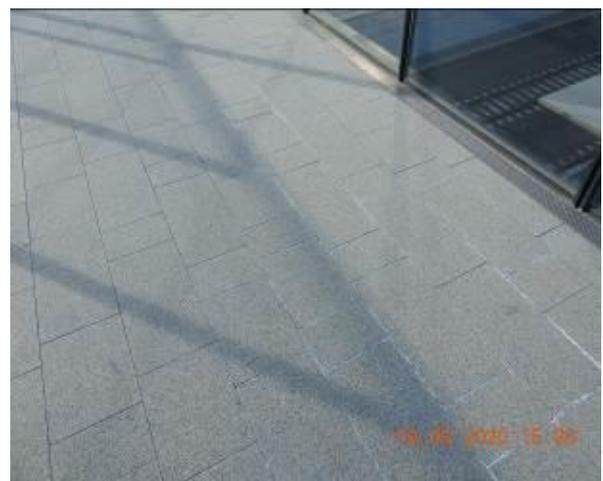
Figure 2399 – General condition of RailCorp overbridge pavement

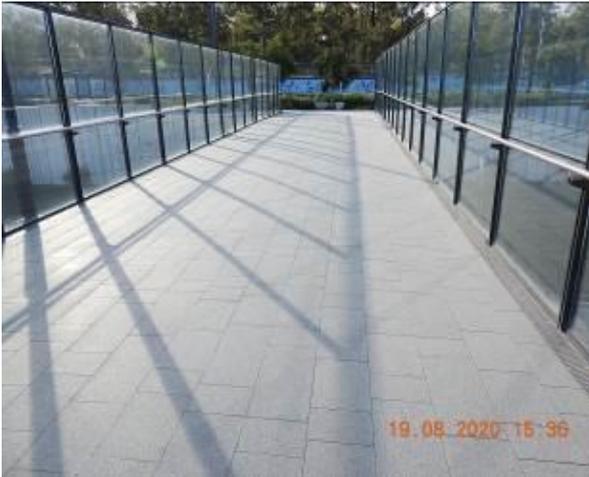
Figure 2400 – General condition of RailCorp overbridge pavement

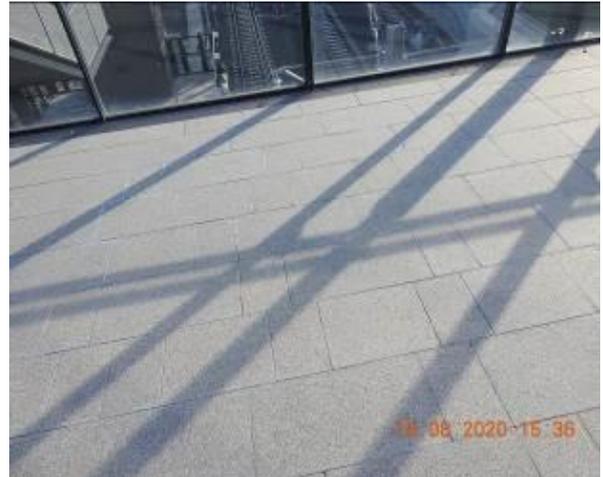
Figure 2401 – General condition of RailCorp overbridge pavement

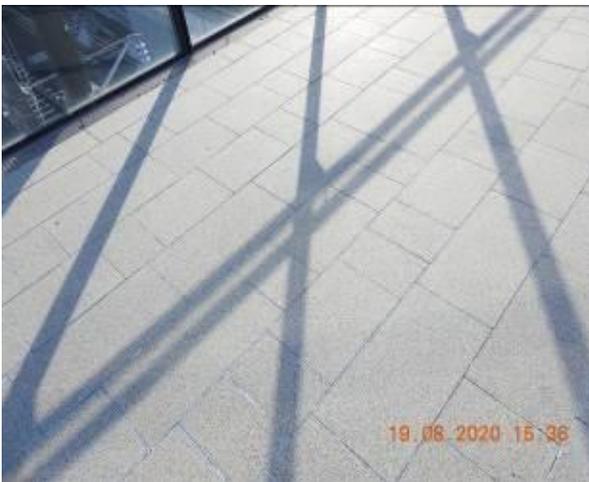
Figure 2402 – General condition of RailCorp overbridge pavement

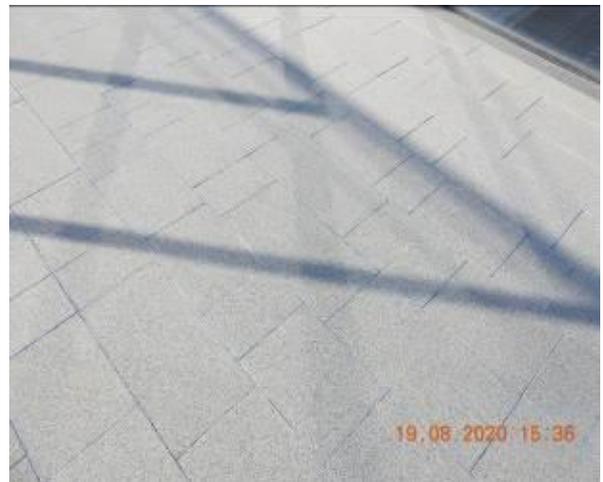
Figure 2403 – General condition of RailCorp overbridge pavement

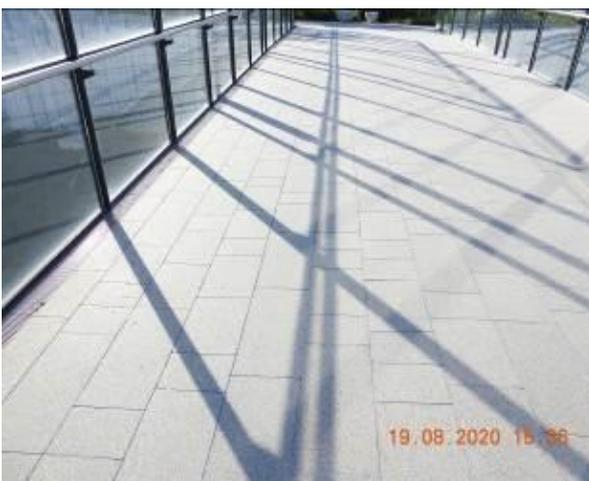
Figure 2404 – General condition of RailCorp overbridge pavement

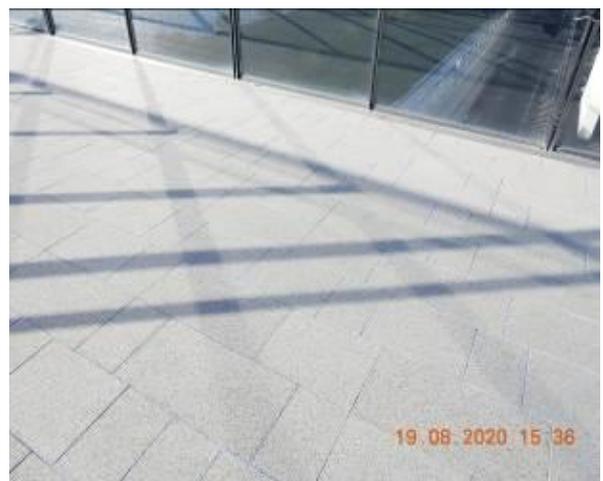
Figure 2405 – General condition of RailCorp overbridge pavement

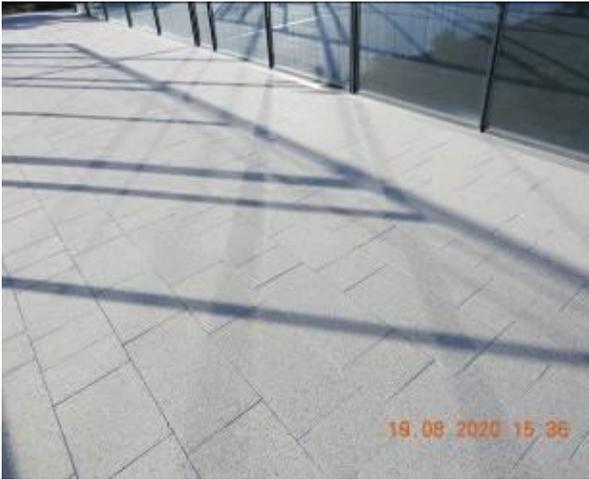
Figure 2406 – General condition of RailCorp overbridge pavement

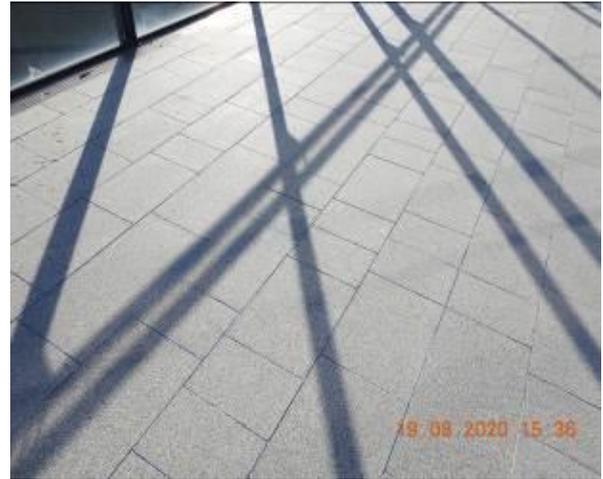
Figure 2407 – General condition of RailCorp overbridge pavement

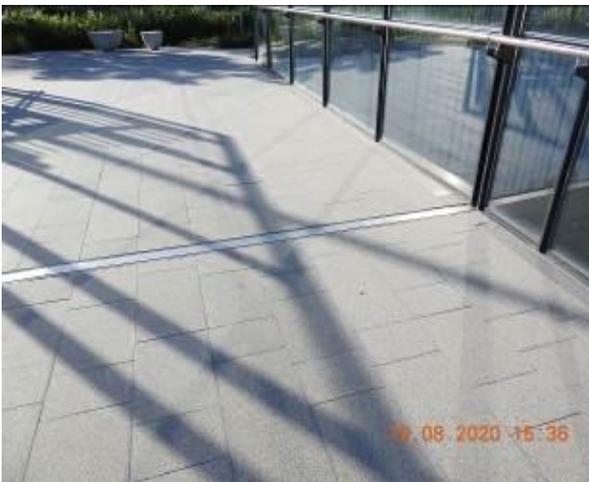
Figure 2408 – General condition of RailCorp overbridge pavement

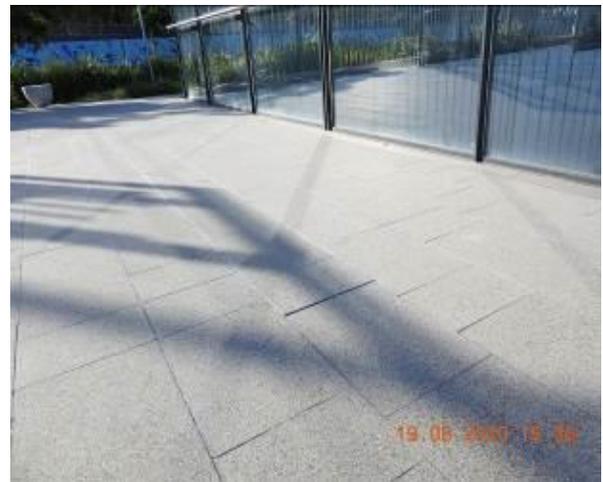
Figure 2409 – General condition of RailCorp overbridge pavement

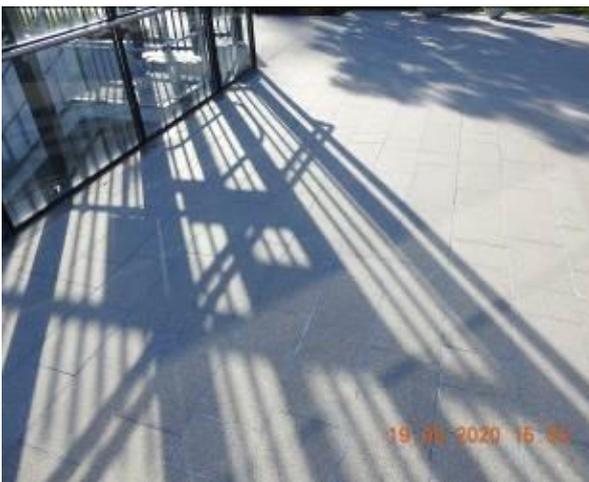
Figure 2410 – General condition of RailCorp overbridge pavement

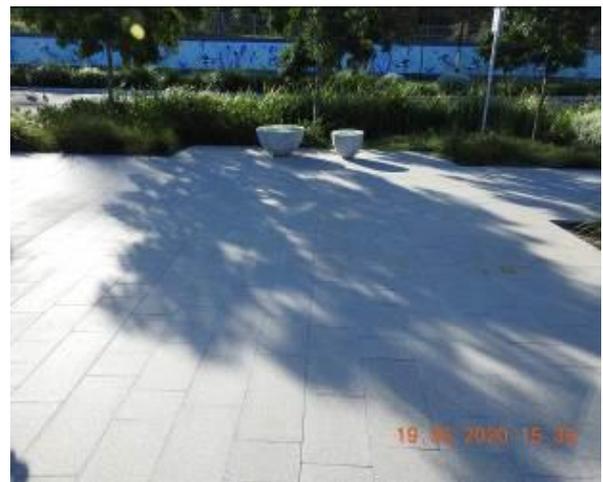
Figure 2411 – General condition of RailCorp overbridge pavement

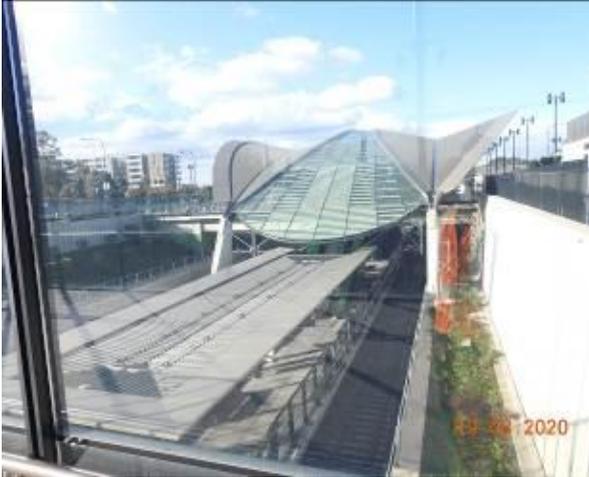
Figure 2412 – General condition of railway corridor, steel portal haunch and overhead power system

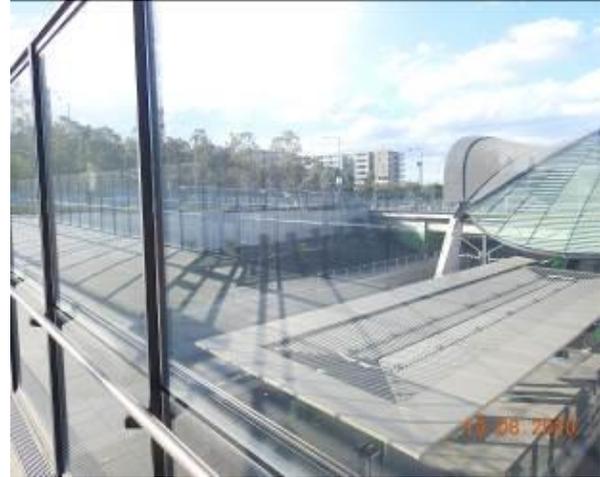
Figure 2413 – General condition of railway corridor, steel portal haunch and overhead power system

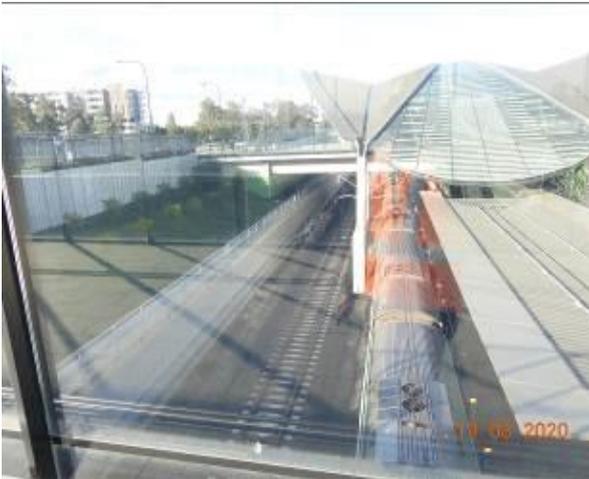
Figure 2414 – General condition of railway corridor, steel portal haunch and overhead power system

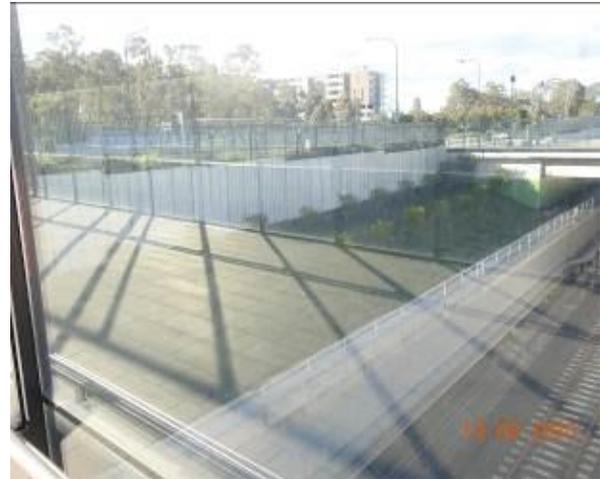
Figure 2415 – General condition of railway corridor, steel portal haunch and overhead power system

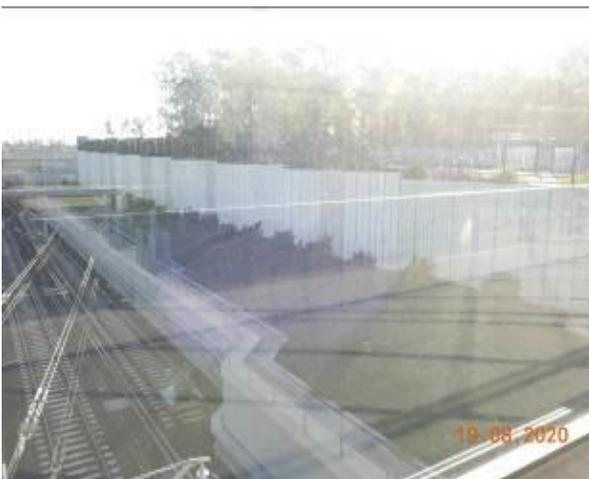
Figure 2416 – General condition of railway corridor, steel portal haunch and overhead power system

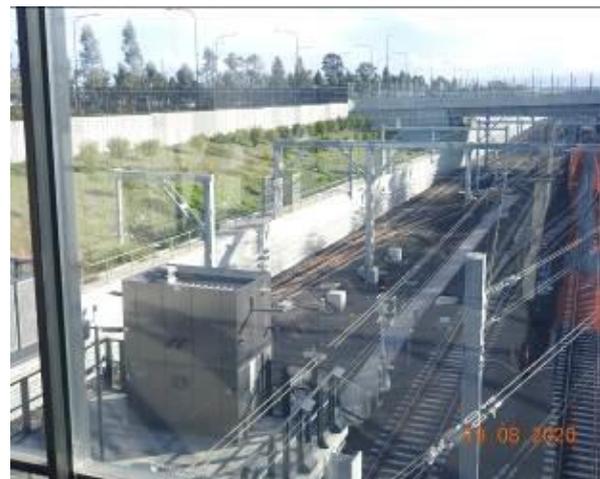
Figure 2417 – General condition of railway corridor, steel portal haunch and overhead power system

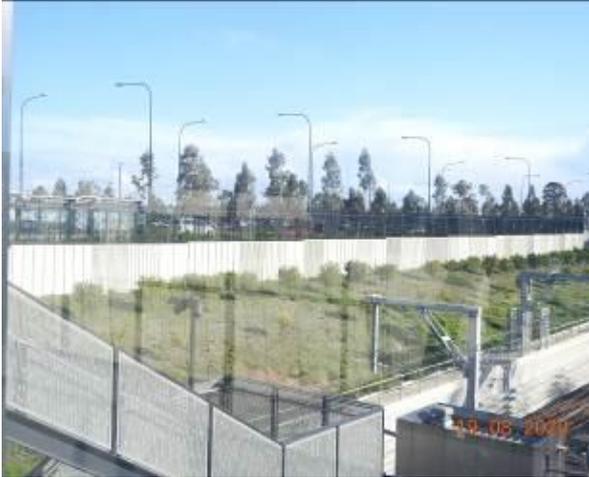
Figure 2418 – General condition of RailCorp retaining wall

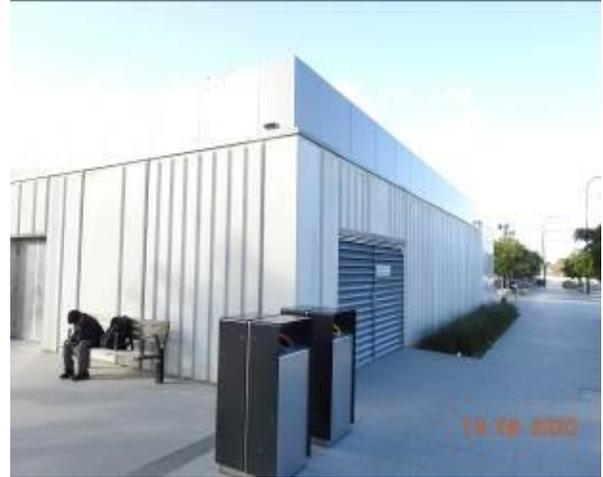
Figure 2419 – General condition of RailCorp external wall heading East

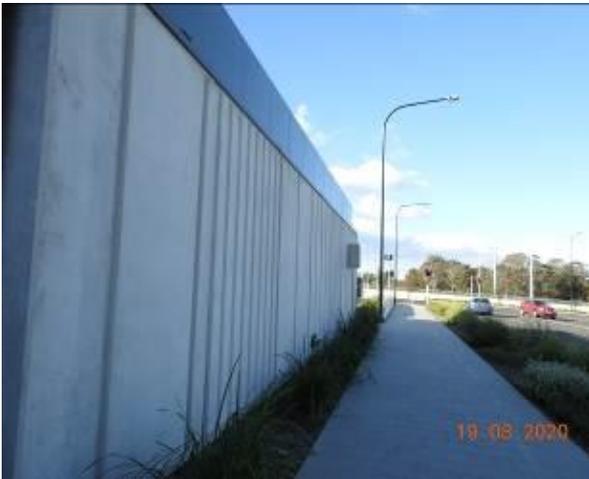
Figure 2420 – General condition of RailCorp external wall

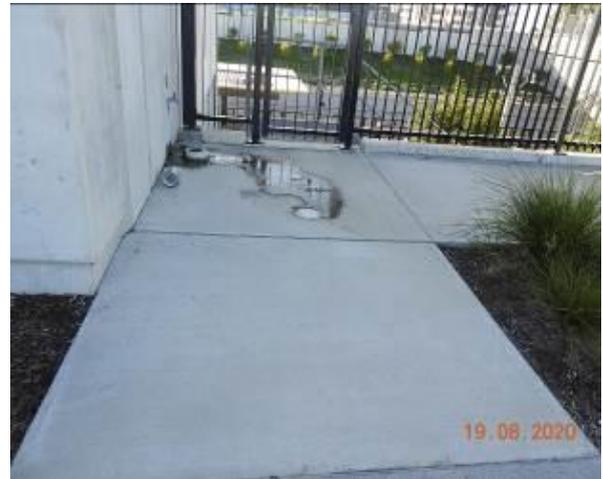
Figure 2421 – General condition of RailCorp footpath pavement

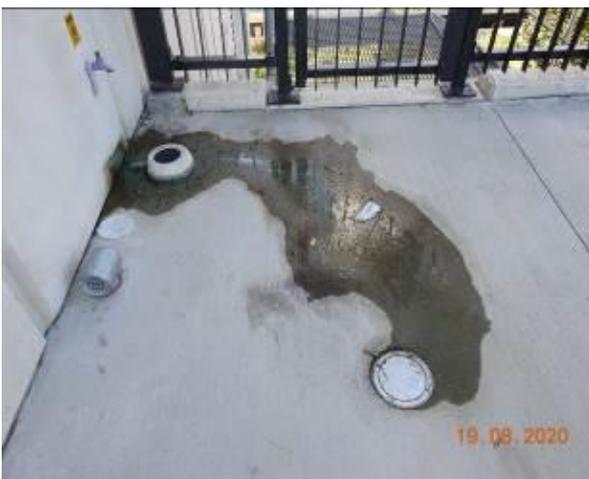
Figure 2422 – General condition of service pits

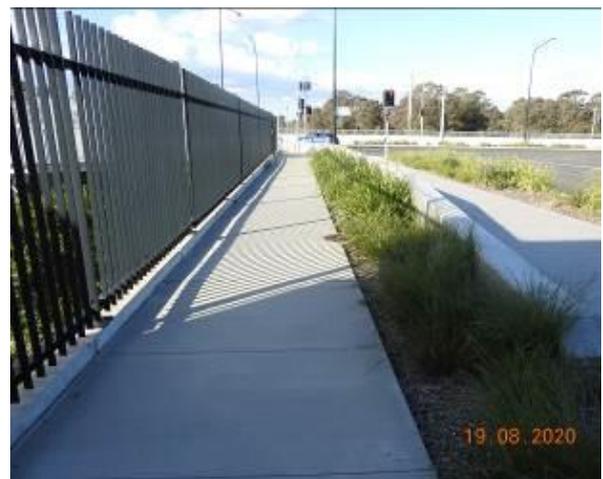
Figure 2423 – General condition of RailCorp footpath pavement

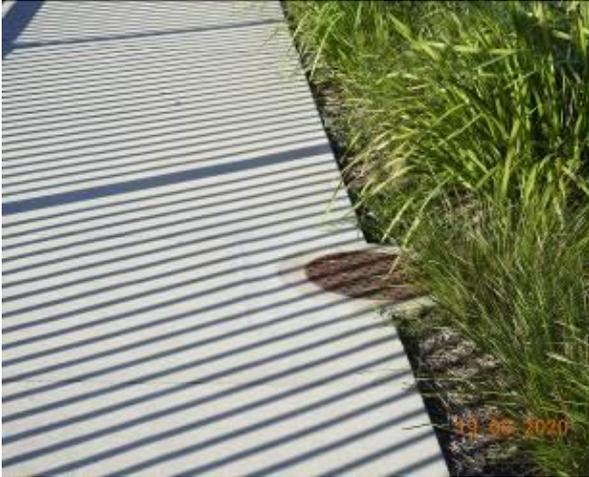
Figure 2424 – General condition of service pit

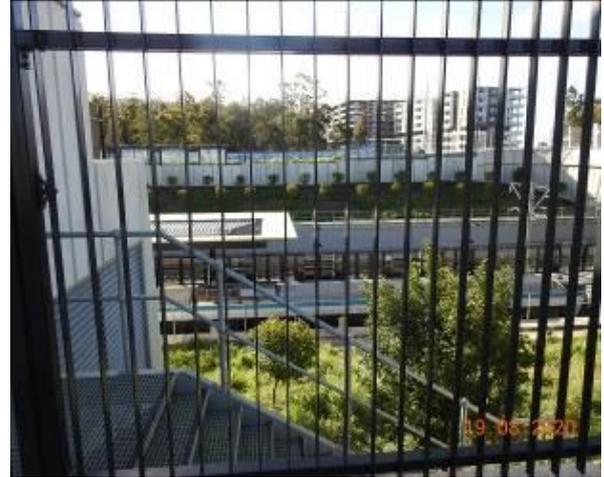
Figure 2425 – General condition of RailCorp platform and retaining wall

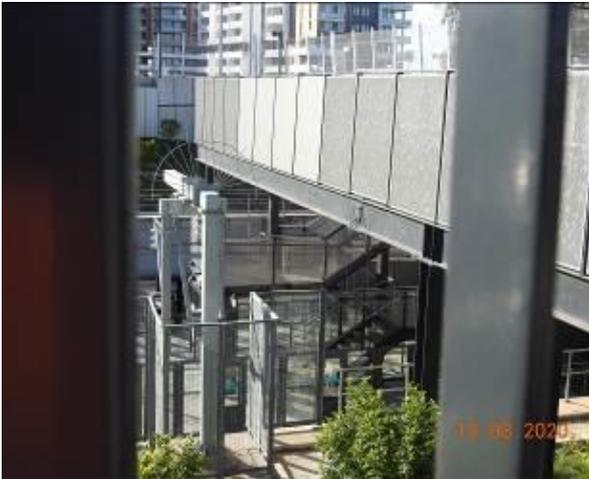
Figure 2426 – General condition of RailCorp staircase

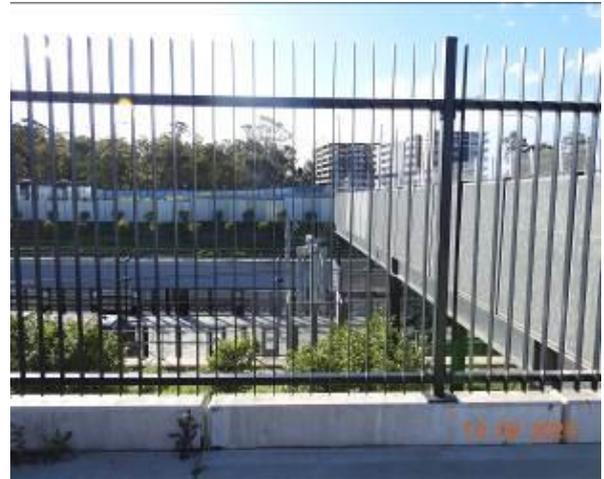
Figure 2427 – General condition of RailCorp platform and retaining wall

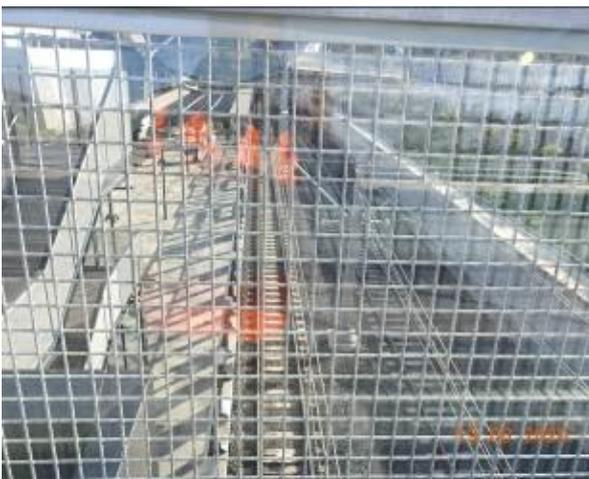
Figure 2428 – General condition of RailCorp platform and railway corridor

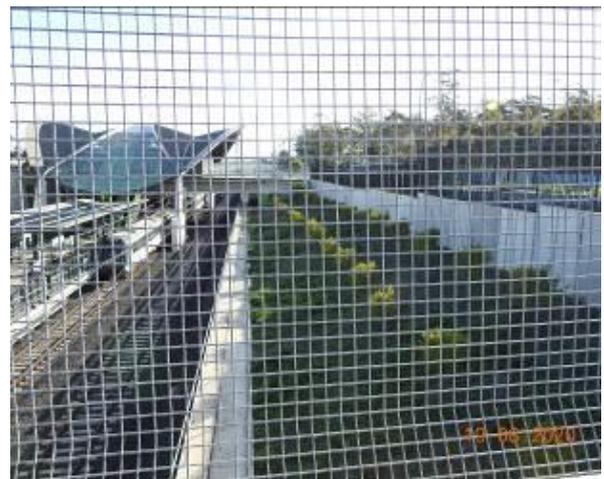
Figure 2429 – General condition of RailCorp platform railway corridor and retaining wall

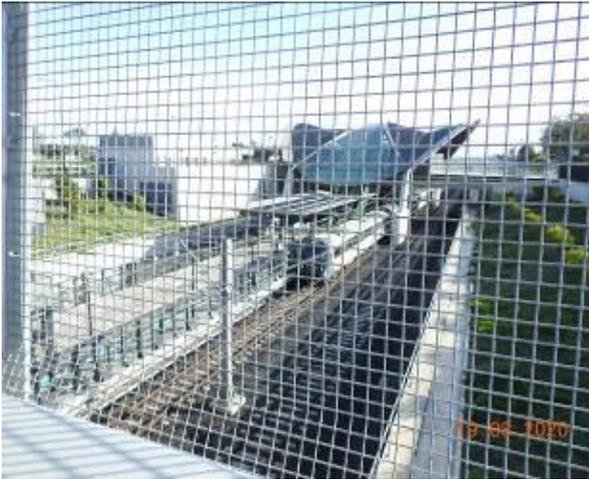
Figure 2430 – General condition of RailCorp overhead power system, platform and railway corridor
