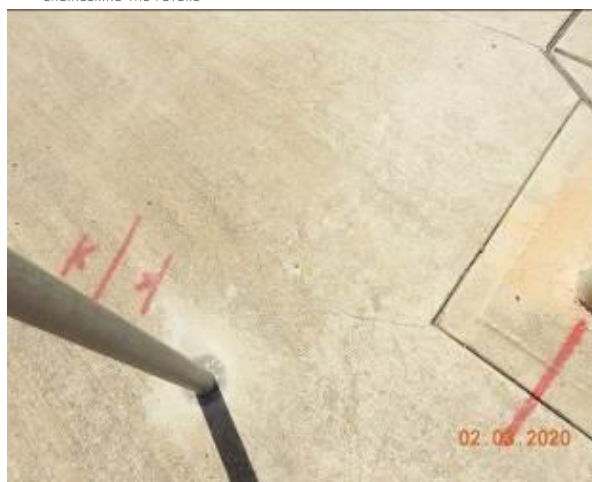
Figure 1468 – Crack propagation through footpath pavement

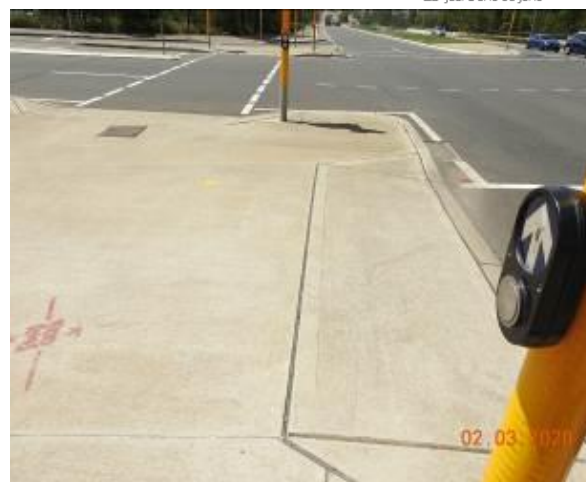
Figure 1469 – General Condition of footpath pavement

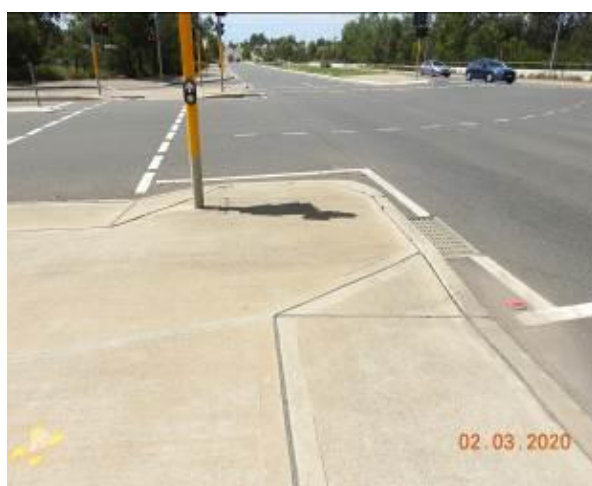
Figure 1470 – General Condition of footpath pavement

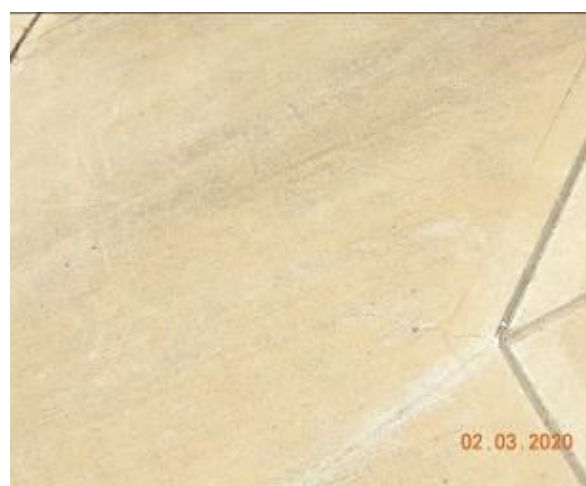
Figure 1471 – Crack propagation through footpath pavement

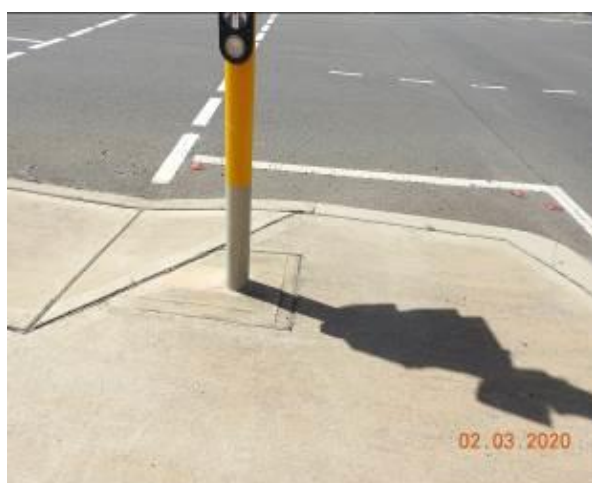
Figure 1472 – General Condition of footpath pavement

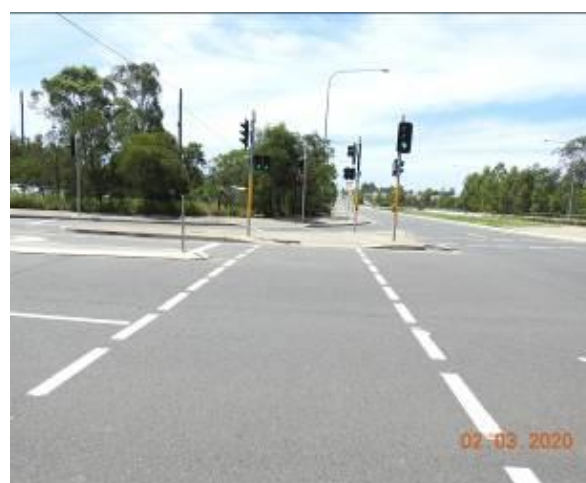
Figure 1473 – General Condition of road surface

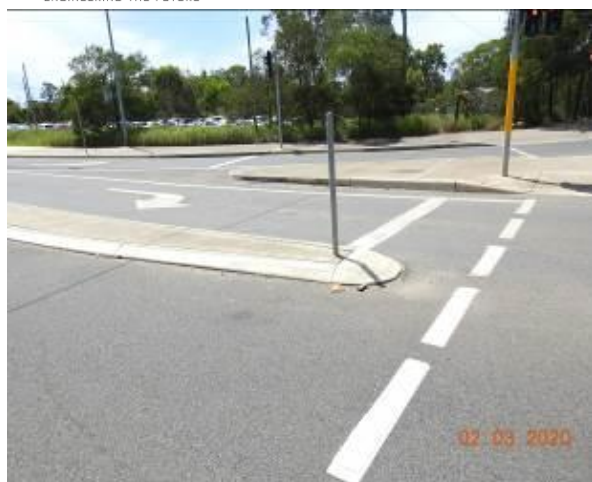
Figure 1474 – General Condition of traffic island

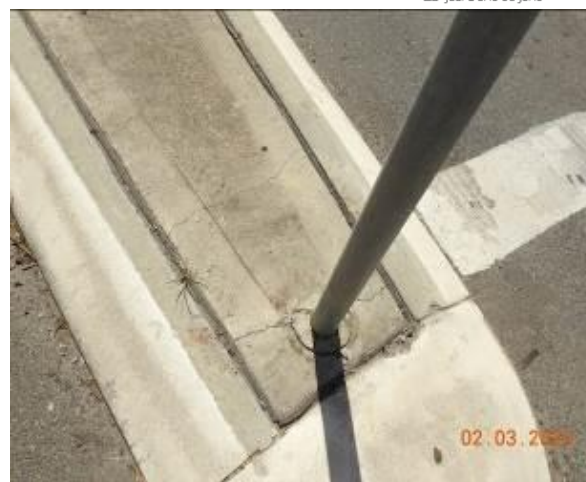
Figure 1475 – Crack propagation through traffic island footpath pavement

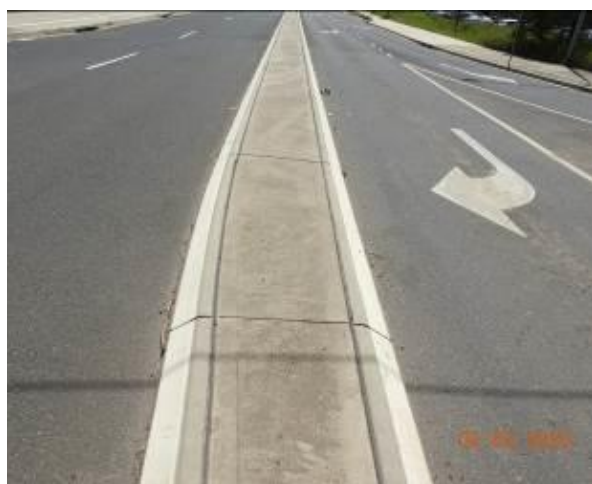
Figure 1476 – General Condition of traffic island

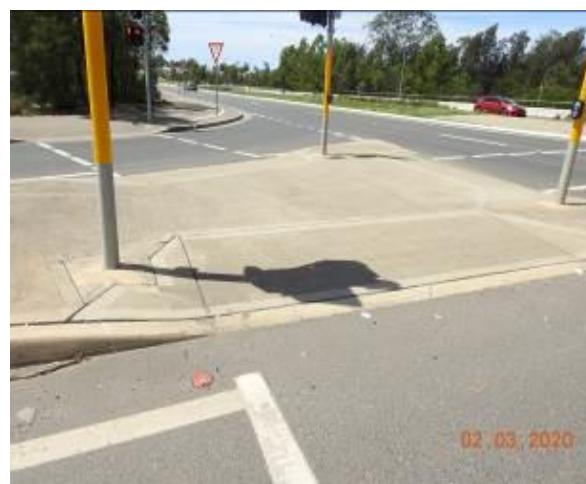
Figure 1477 – General Condition of footpath pavement

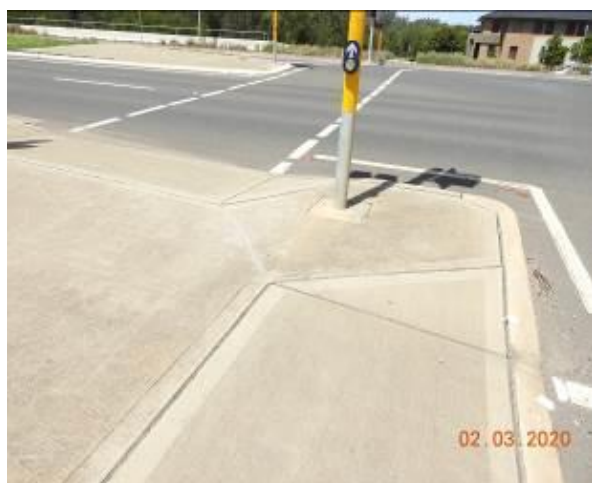
Figure 1478 – General Condition of footpath pavement

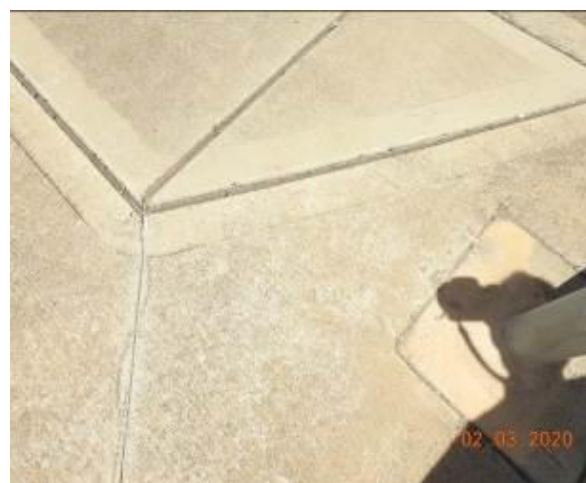
Figure 1479 – Crack propagation through footpath pavement

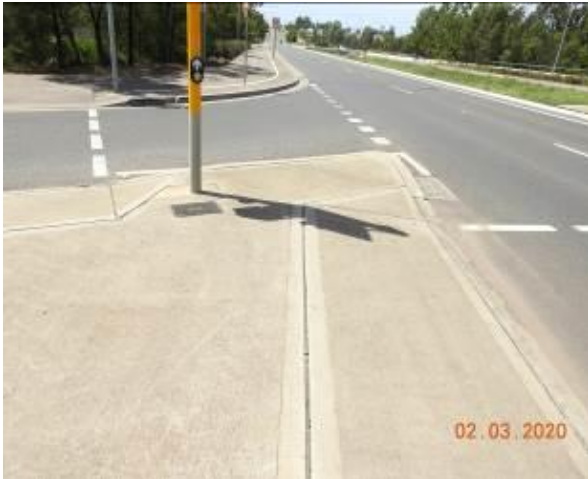
Figure 1480 – General Condition of footpath pavement

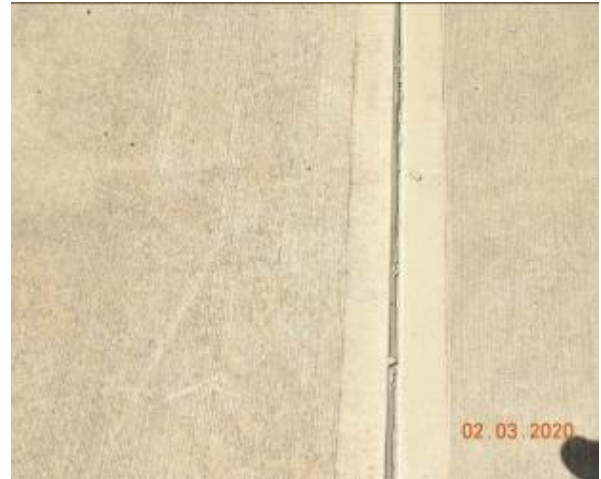
Figure 1481 – General Condition of footpath pavement

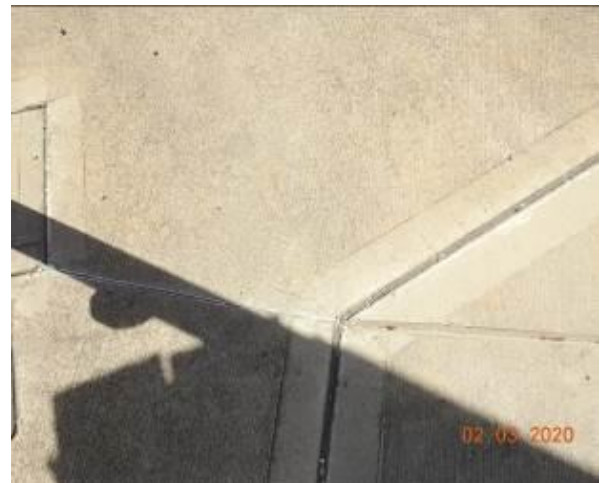
Figure 1483 – Crack propagation through footpath pavement

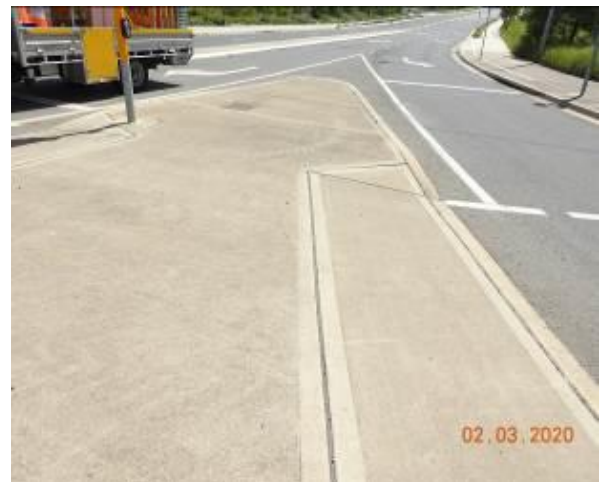
Figure 1485 – General Condition of footpath pavement

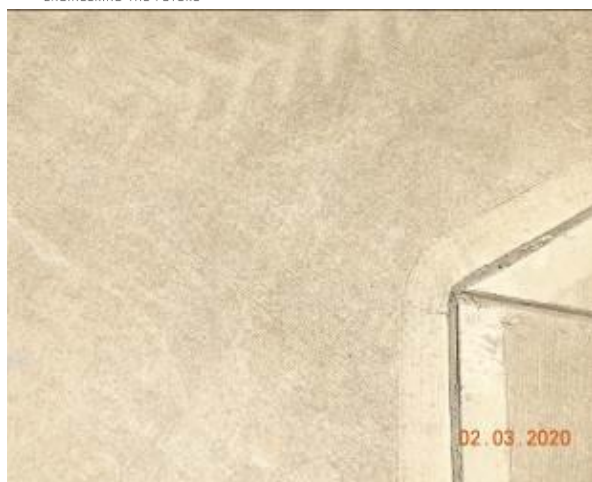
Figure 1486 – Crack propagation through footpath pavement

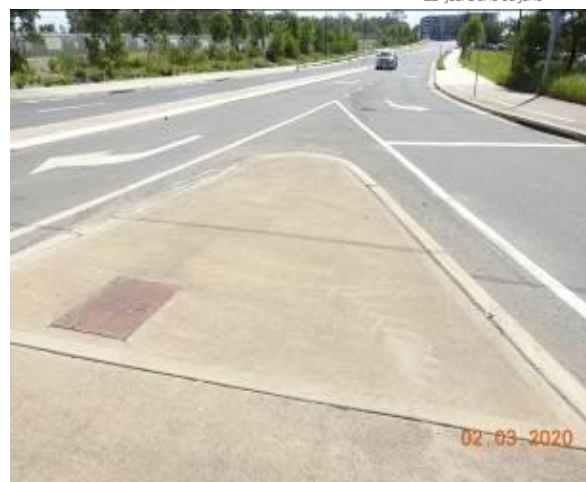
Figure 1487 – General Condition of footpath pavement

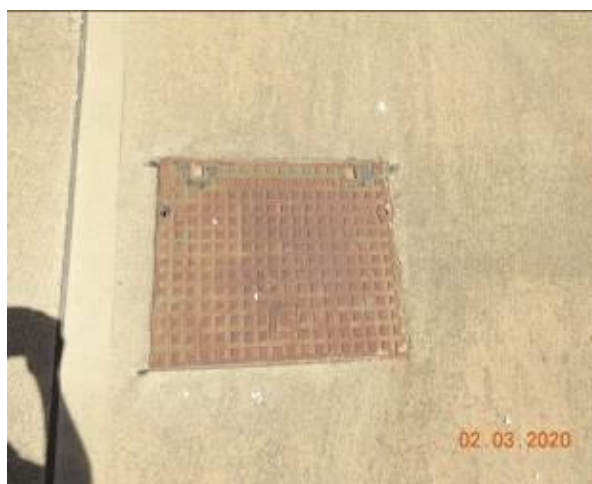
Figure 1488 – General Condition of service pit

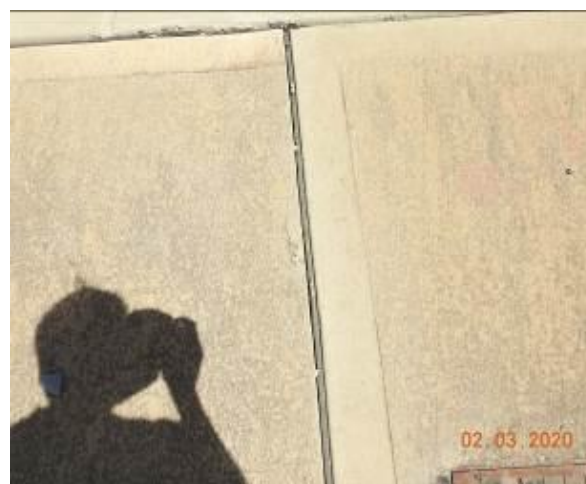
Figure 1489 – Crack propagation through footpath pavement

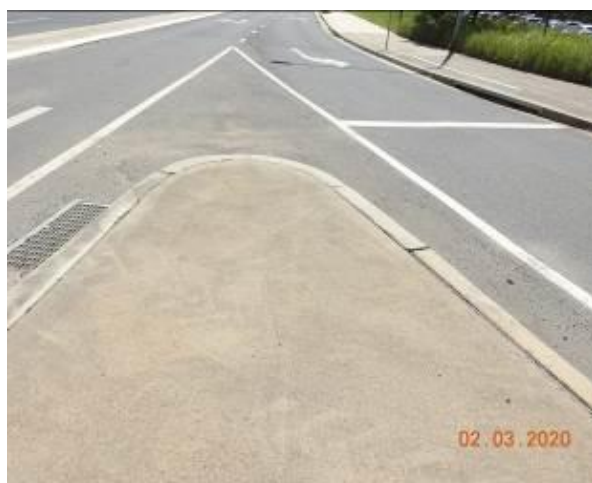
Figure 1490 – General Condition of footpath pavement

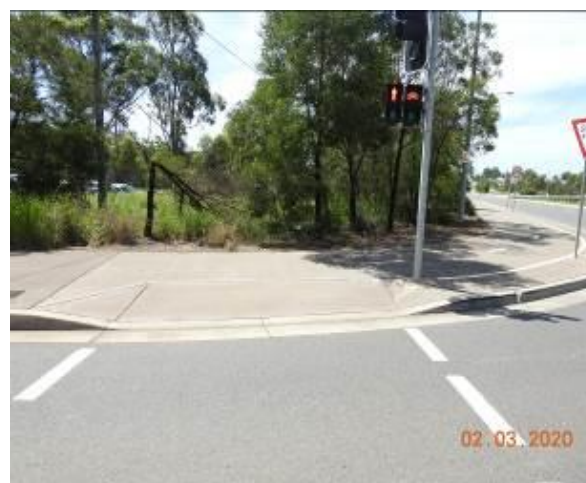
Figure 1491 – General Condition of footpath pavement

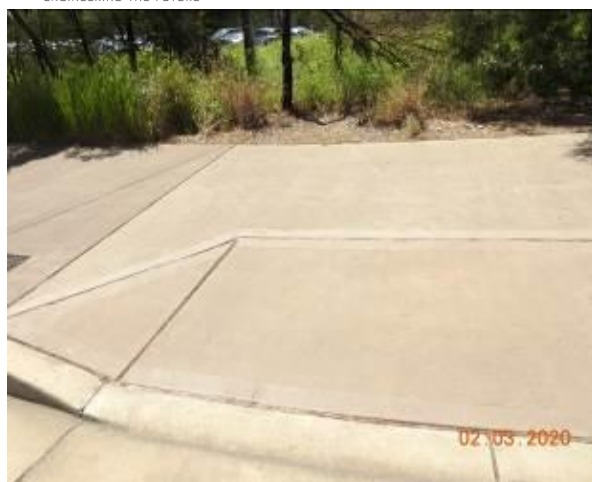
Figure 1492 – General Condition of footpath pavement

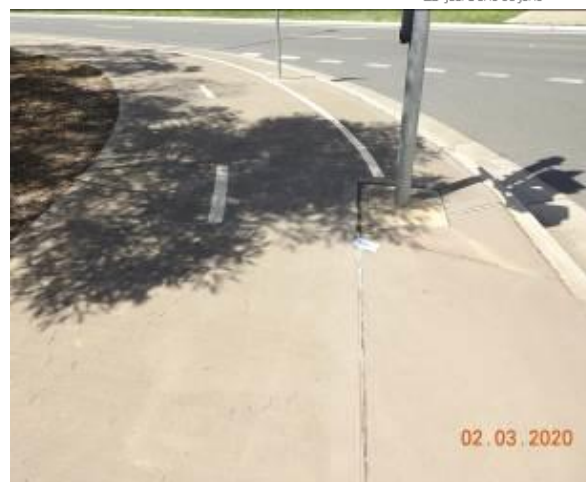
Figure 1493 – General Condition of footpath pavement

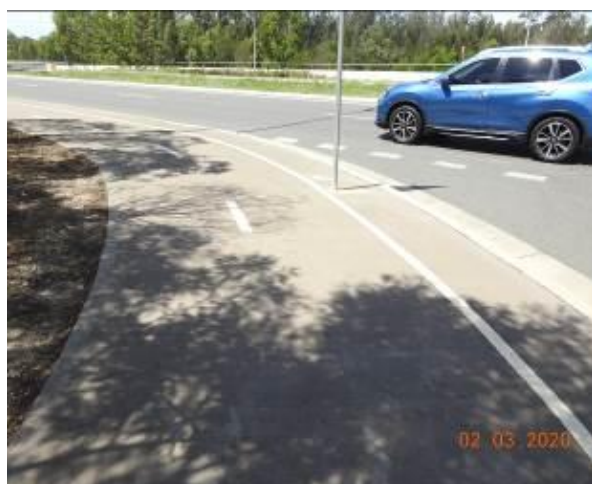
Figure 1494 – General Condition of footpath pavement

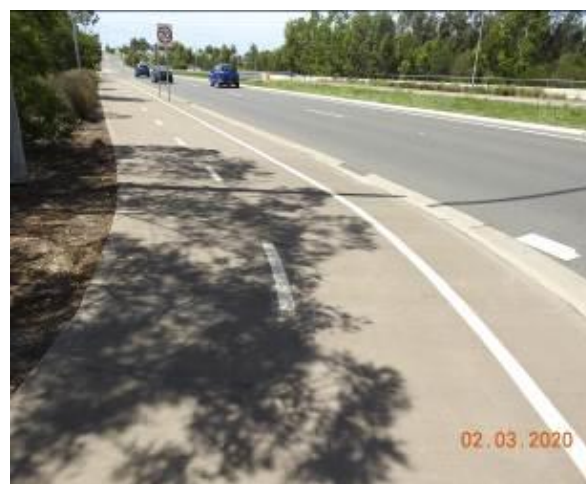
Figure 1495 – General Condition of footpath pavement

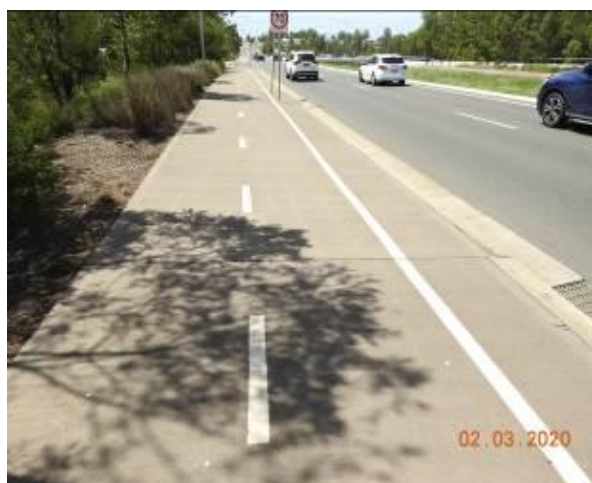
Figure 1496 – General Condition of footpath pavement

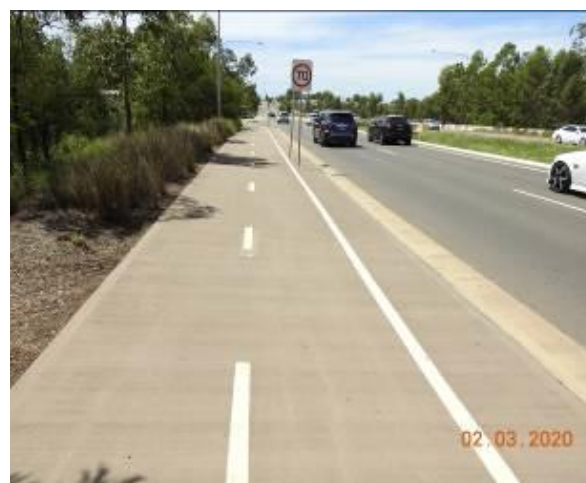
Figure 1497 – General Condition of footpath pavement

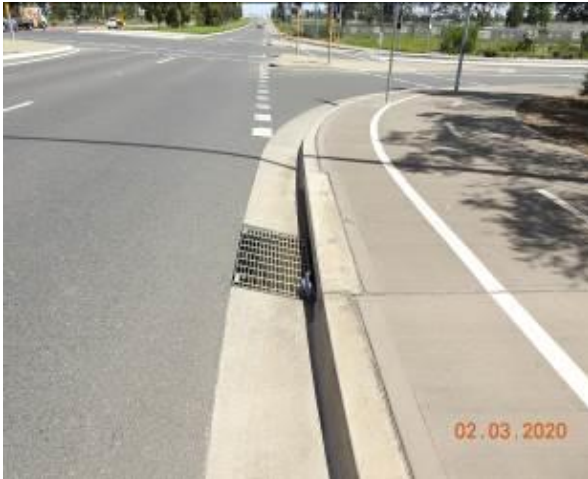
Figure 1498 – General Condition of kerb and gutter

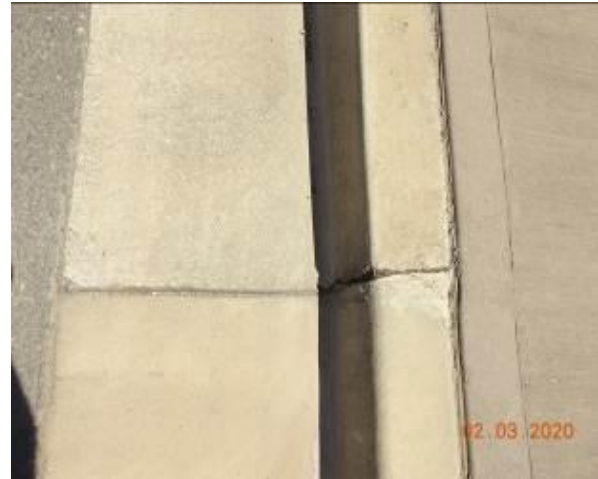
Figure 1499 – Crack propagation through kerb

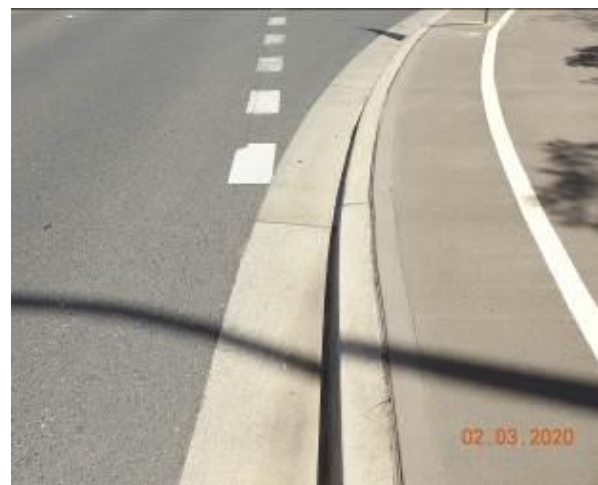
Figure 1501 – General Condition of kerb and gutter

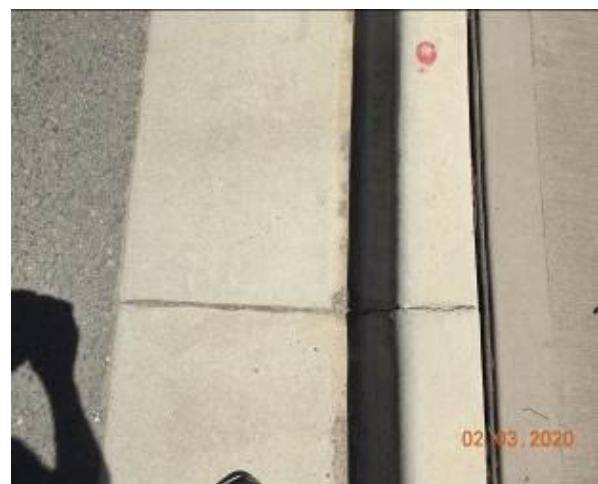
Figure 1503 – Crack propagation through kerb

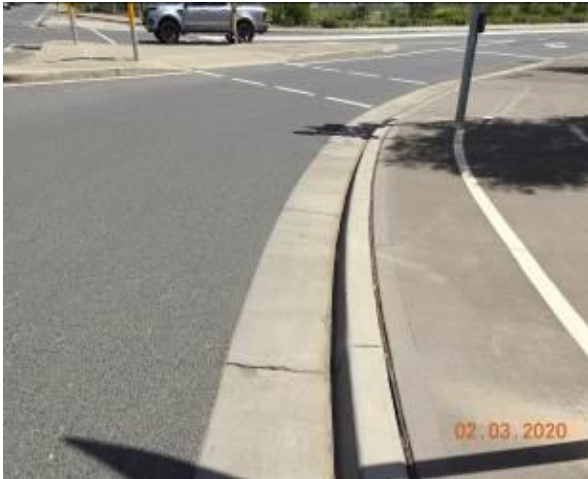
Figure 1504 – General Condition of kerb and gutter

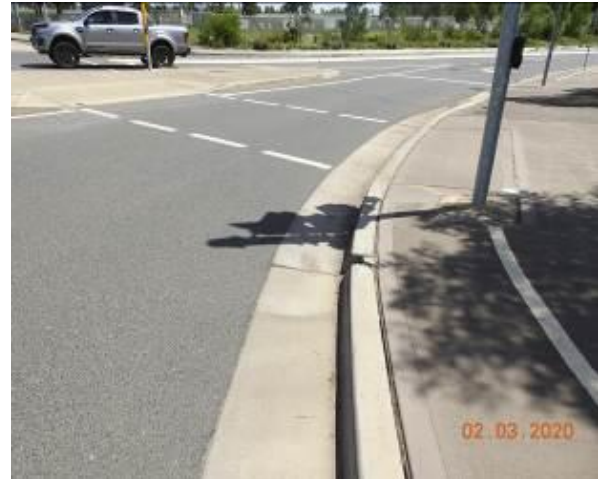
Figure 1505 – General Condition of kerb and gutter

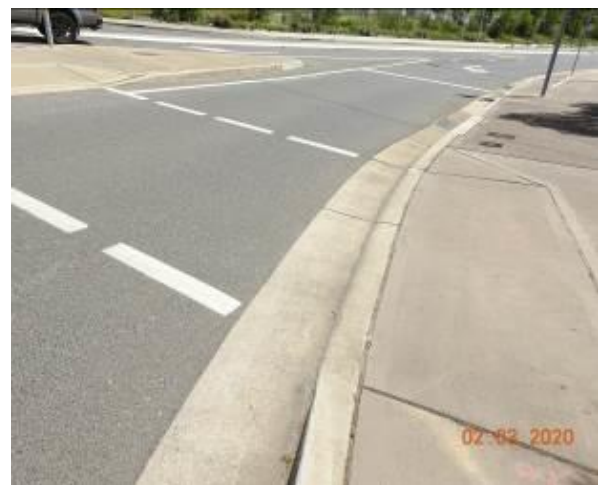
Figure 1507 – General Condition of kerb and gutter

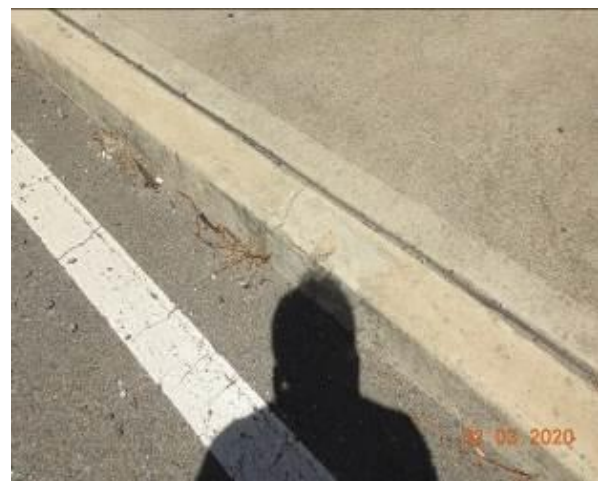
Figure 1509 – Crack propagation through kerb

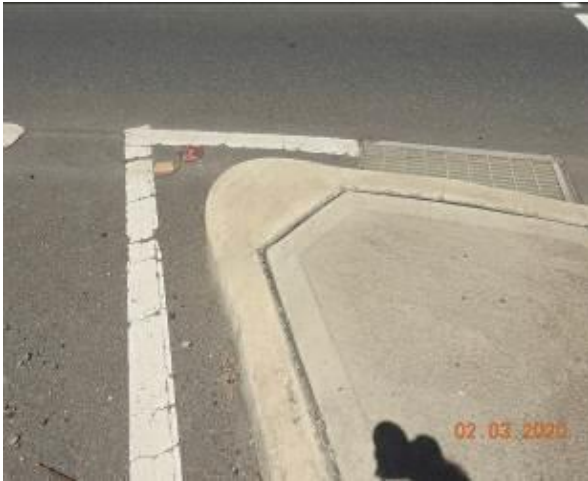
Figure 1510 – General Condition of kerb

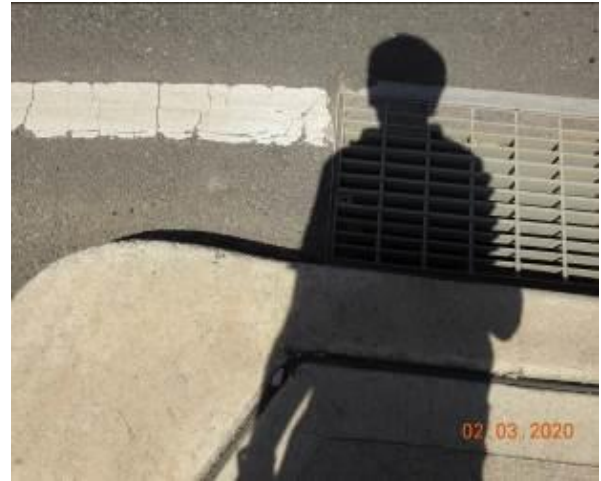
Figure 1511 – Crack propagation through kerb

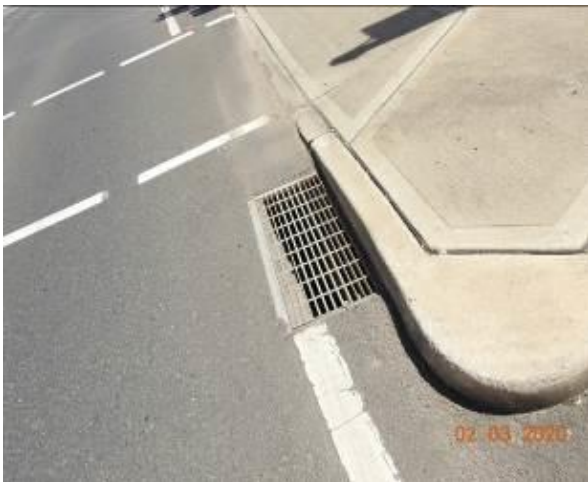
Figure 1512 – General Condition of stormwater inlet pit

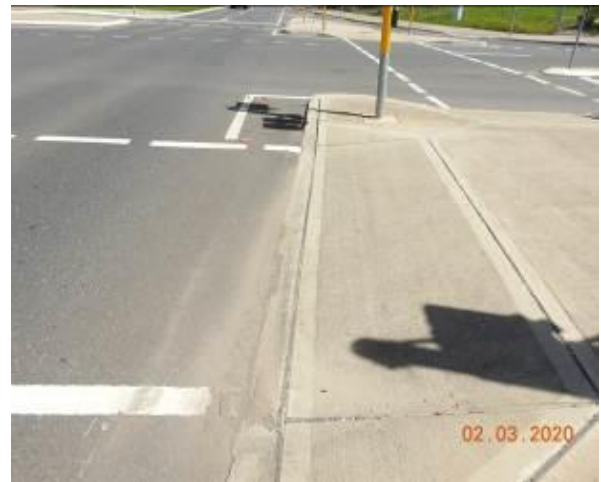
Figure 1513 – General Condition of layback

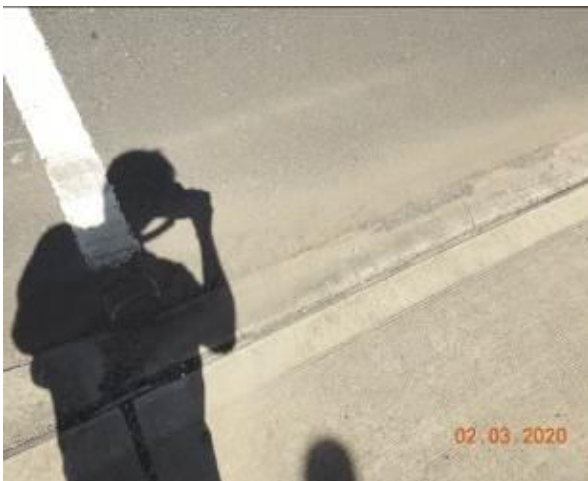
Figure 1514 – Crack propagation through layback

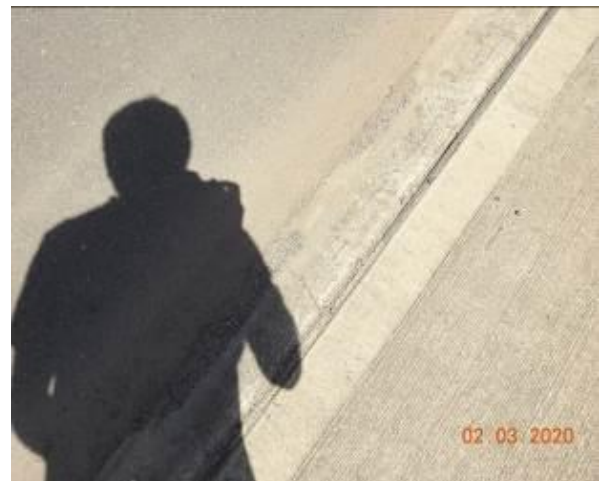
Figure 1515 – Crack propagation through layback

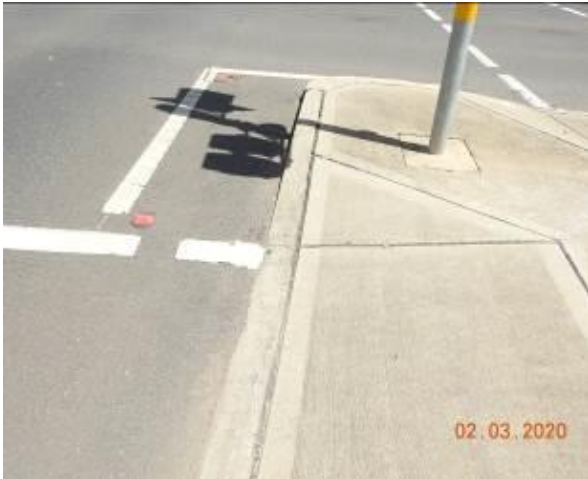
Figure 1516 – General Condition of layback

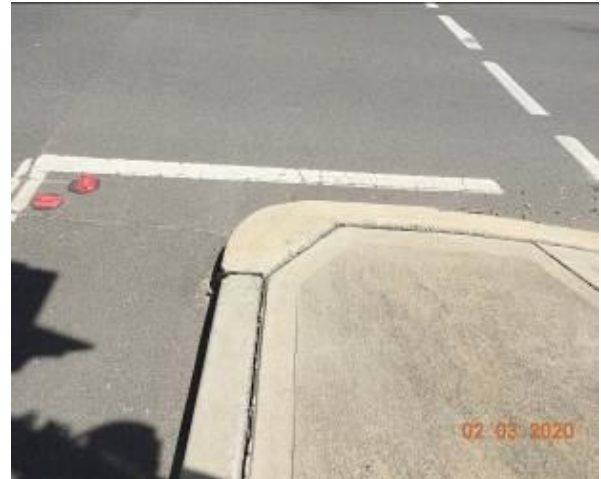
Figure 1517 – General Condition of kerb

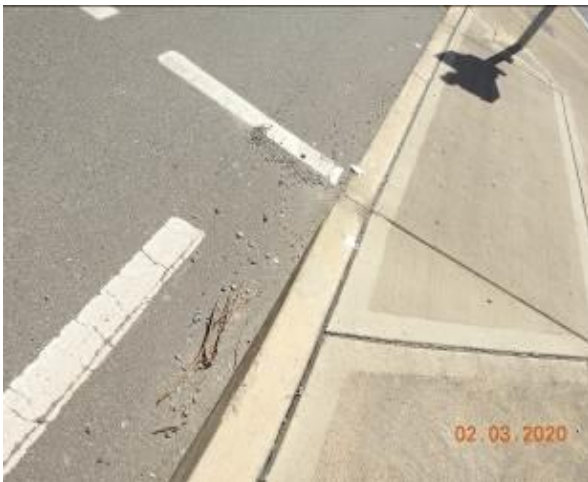
Figure 1518 – General Condition of kerb

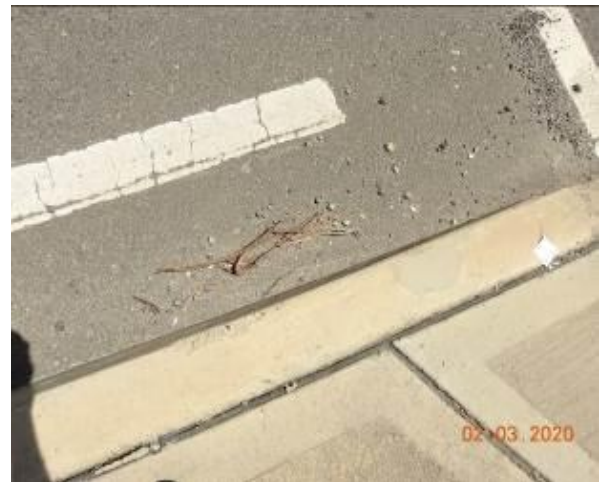
Figure 1519 – General Condition of kerb

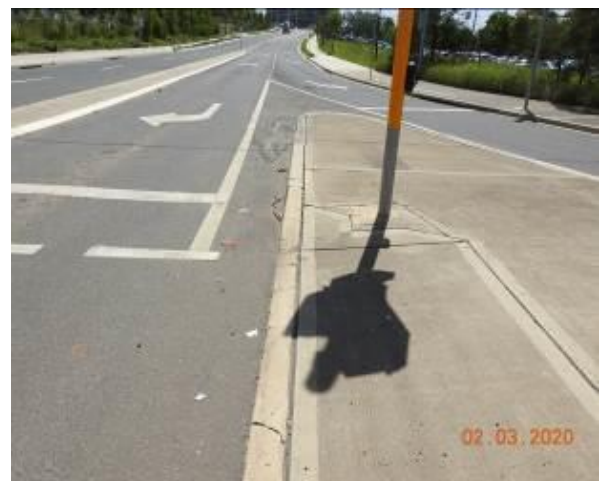
Figure 1521 – General Condition of layback

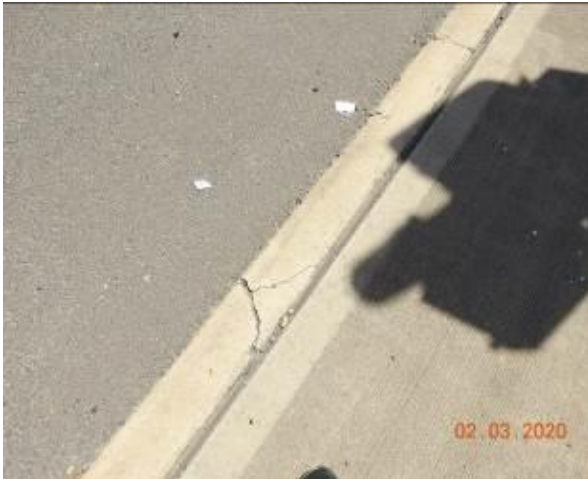
Figure 1522 – Crack propagation and loss of material through layback

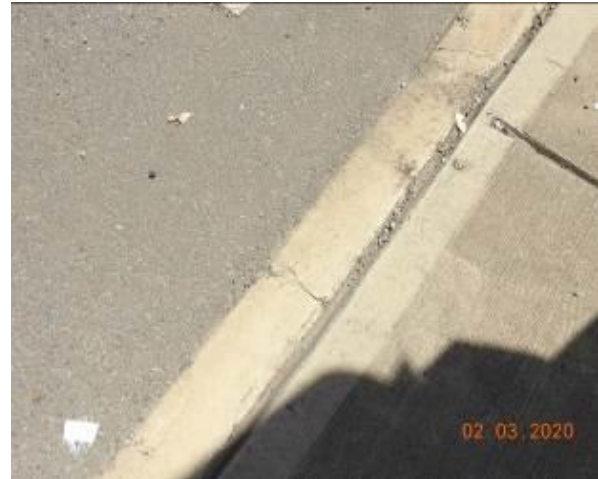
Figure 1523 – Crack propagation through layback

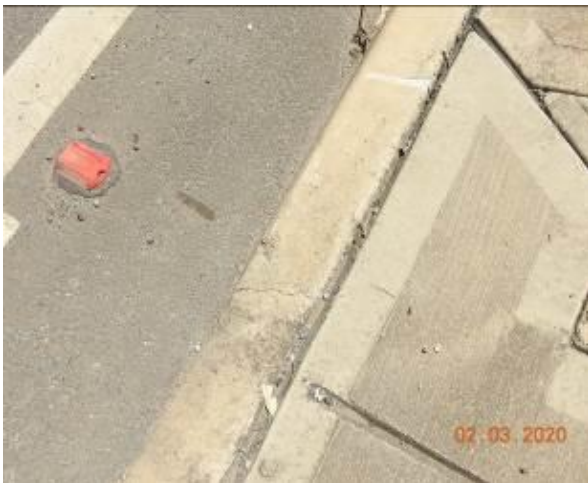
Figure 1524 – Crack propagation through layback

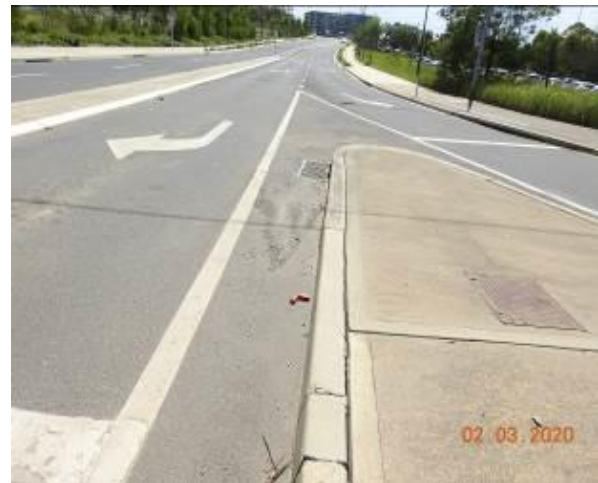
Figure 1525 – General Condition of kerb

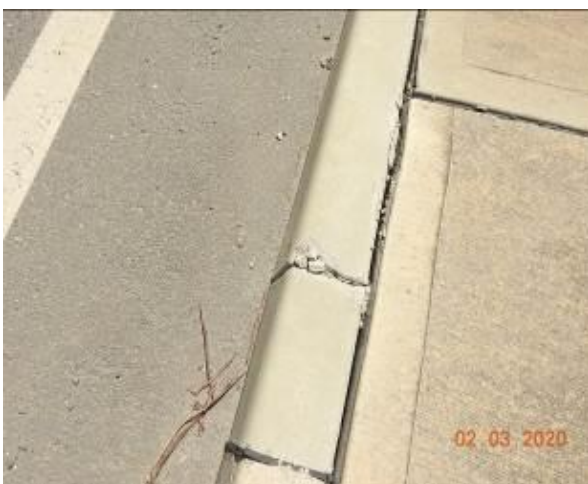
Figure 1526 – Crack propagation and loss of material through kerb

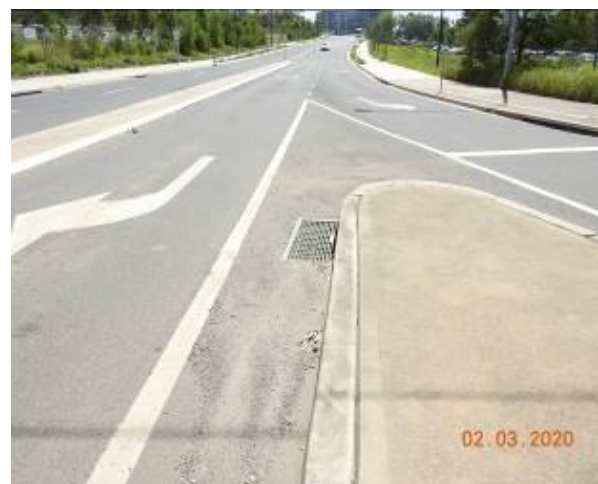
Figure 1527 – General Condition of kerb

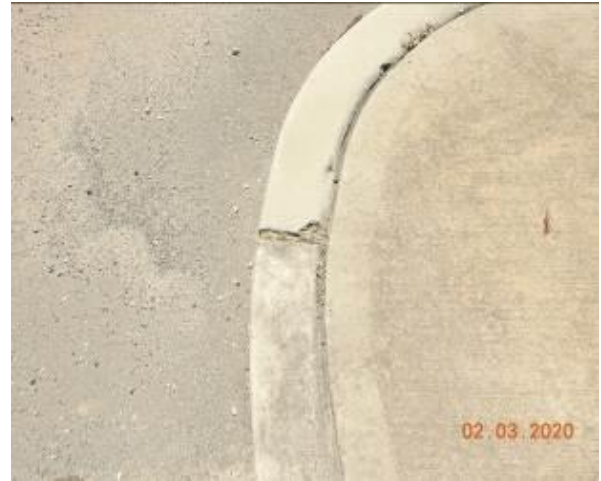
Figure 1529 – Loss of material through kerb

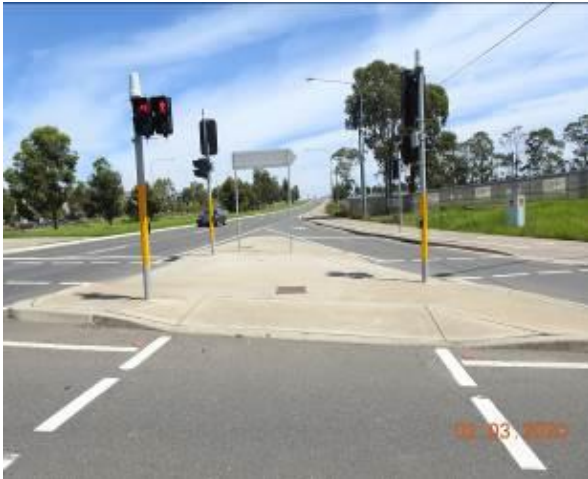
Figure 1534 – General Condition of traffic island

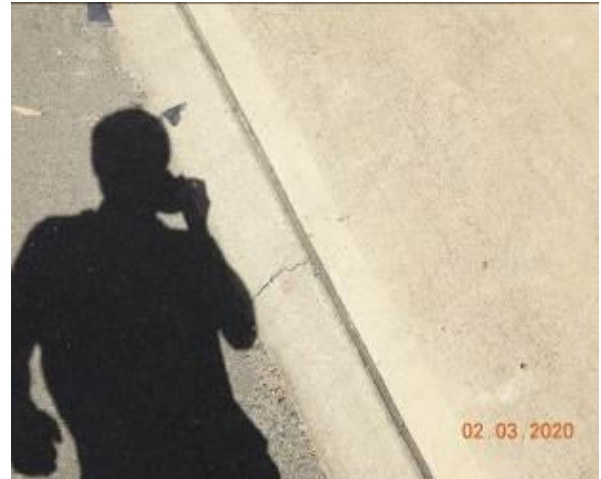
Figure 1535 – Crack propagation through kerb

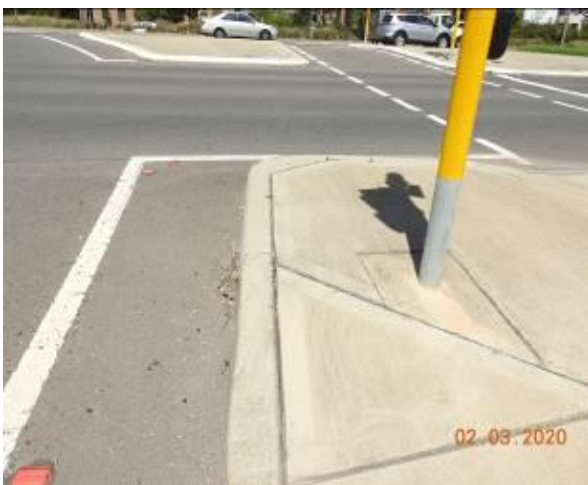
Figure 1536 – General Condition of kerb

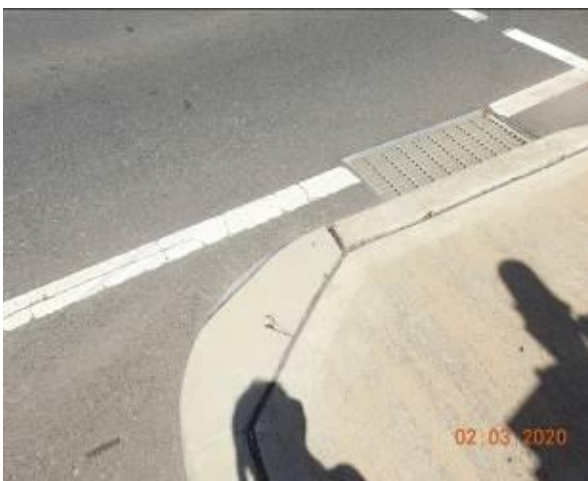
Figure 1538 – General Condition of kerb

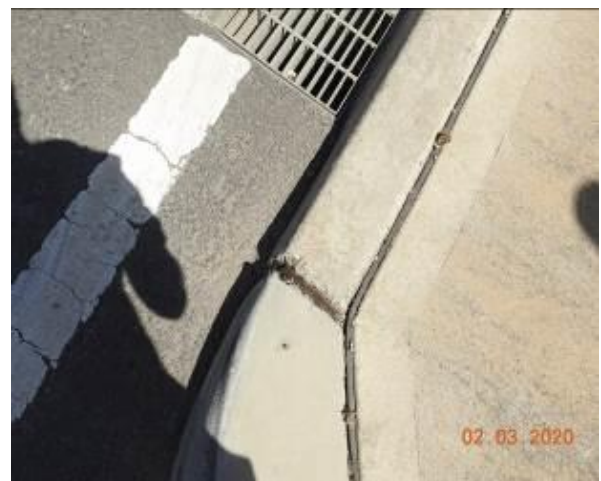
Figure 1539 – Loss of material through kerb

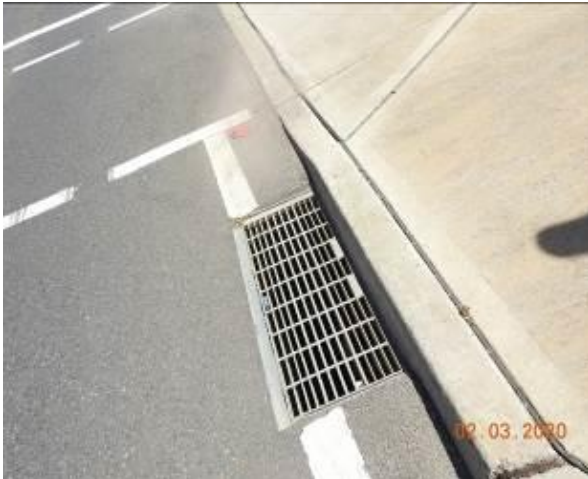
Figure 1540 – General Condition of stormwater inlet pit

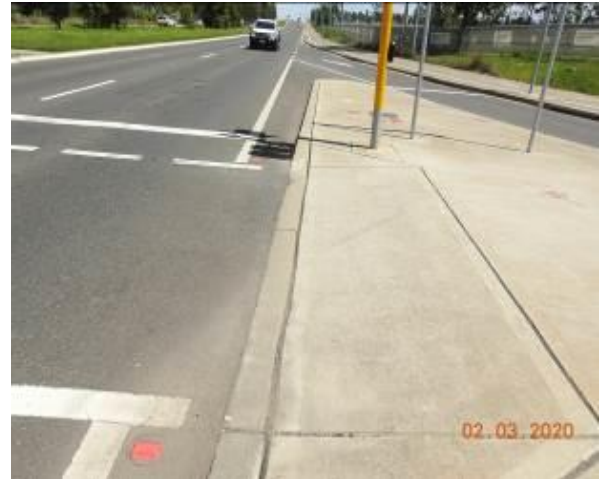
Figure 1541 – General Condition of layback

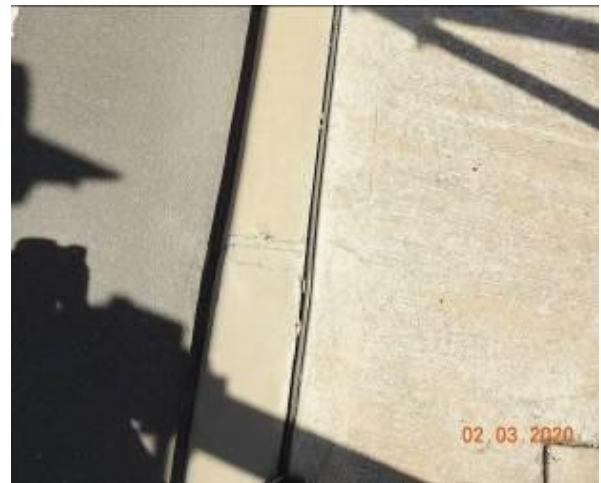
Figure 1543 – Crack propagation through kerb

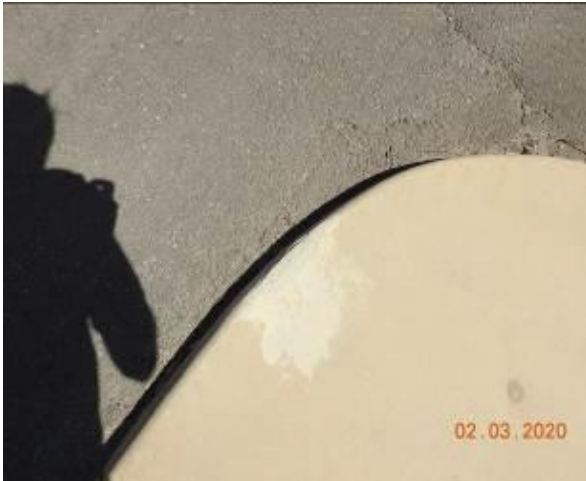
Figure 1546 – Loss of material through kerb

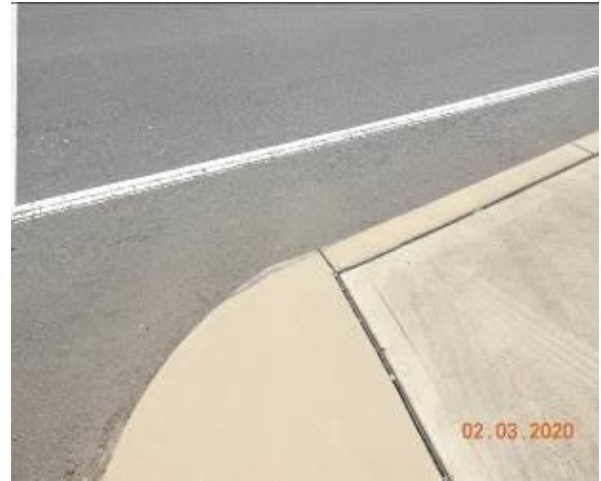
Figure 1547 – Crack propagation through kerb

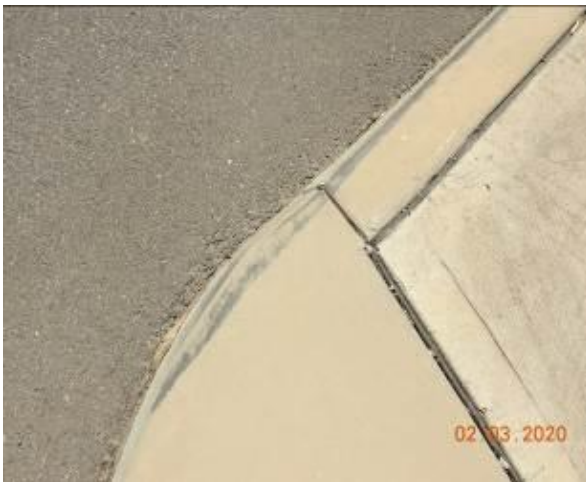
Figure 1548 – General Condition of kerb

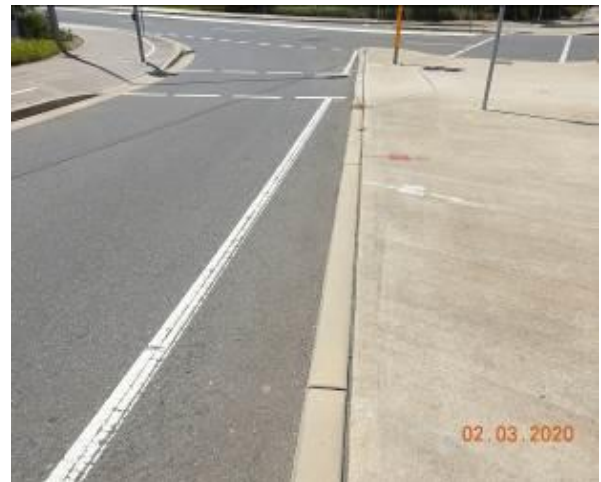
Figure 1549 – General Condition of kerb

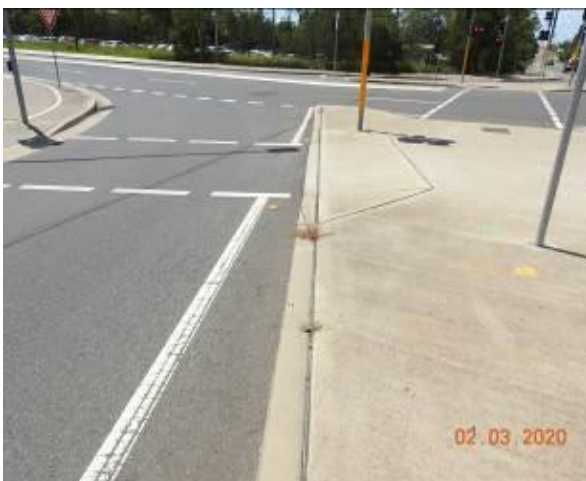
Figure 1550 – General Condition of kerb

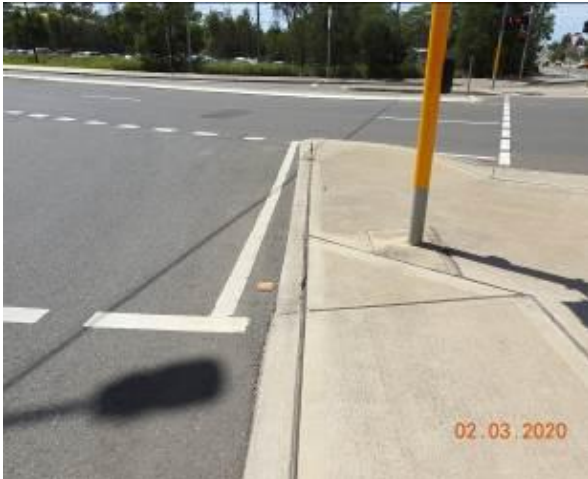
Figure 1552 – General Condition of layback

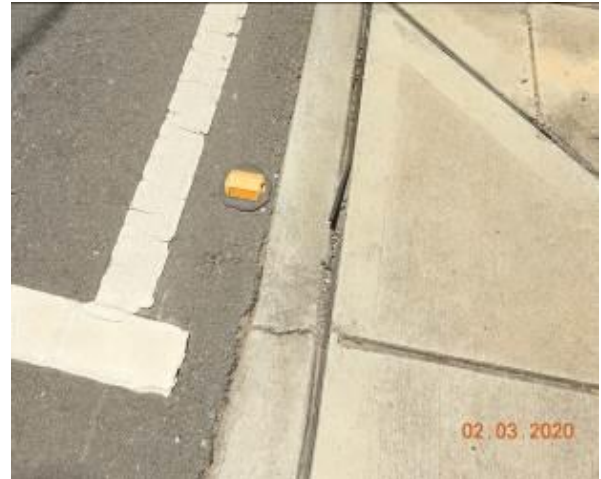
Figure 1553 – Crack propagation through kerb

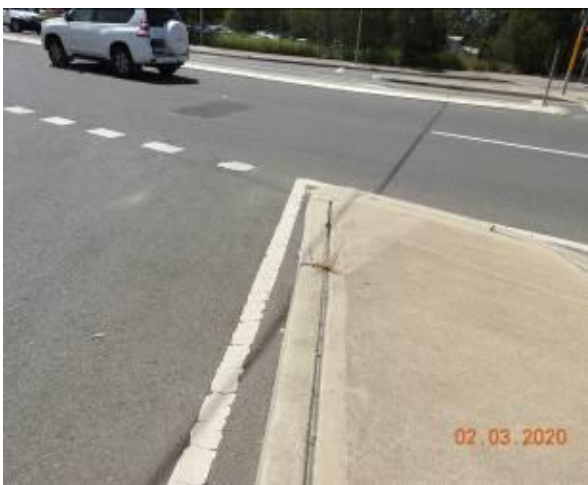
Figure 1554 – General Condition of kerb

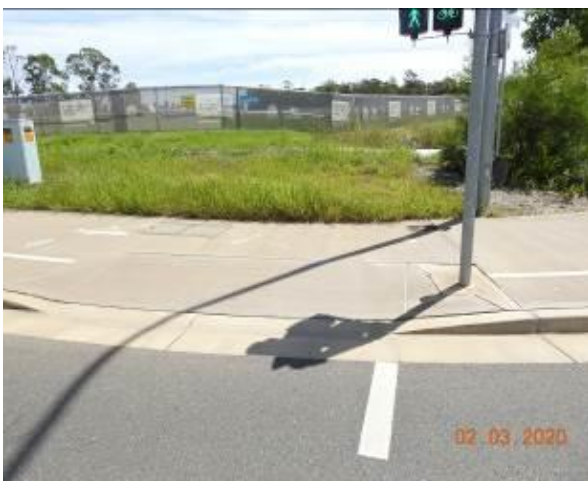
Figure 1556 – General Condition of layback and gutter

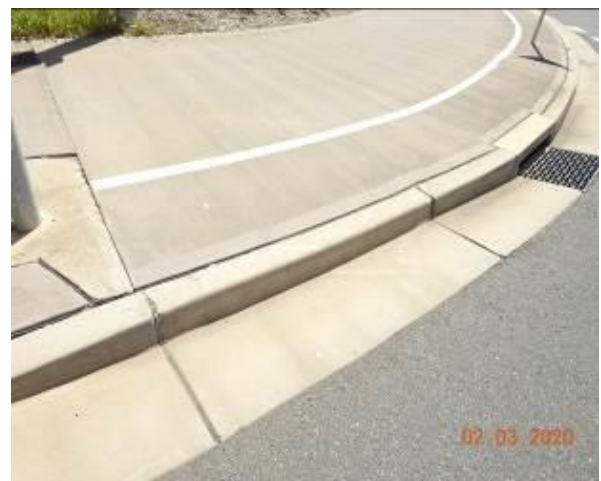
Figure 1557 – General Condition of kerb and gutter

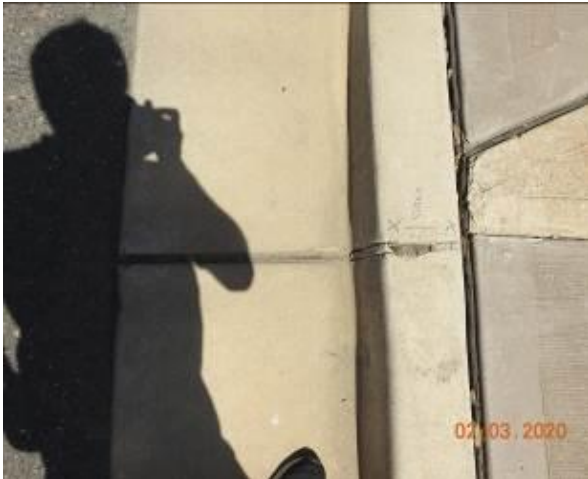
Figure 1558 – Crack propagation through kerb and gutter

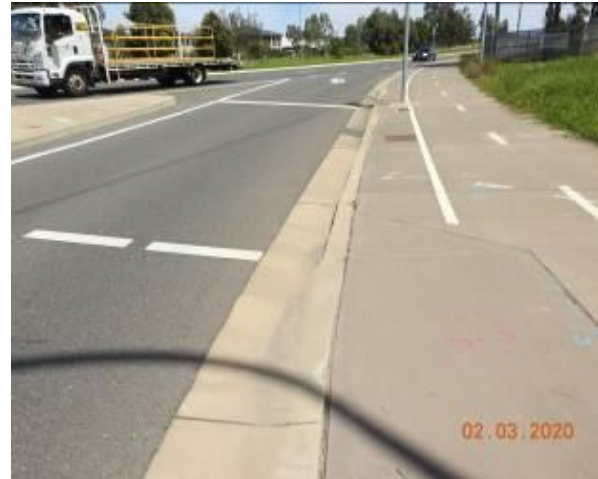
Figure 1559 – General Condition of gutter

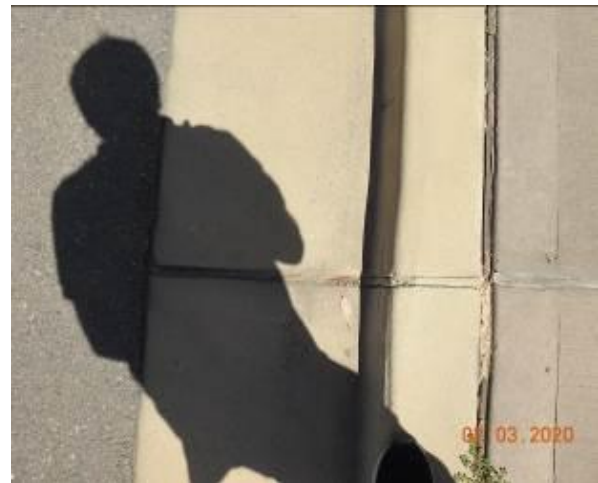
Figure 1561 – Crack propagation through kerb and gutter

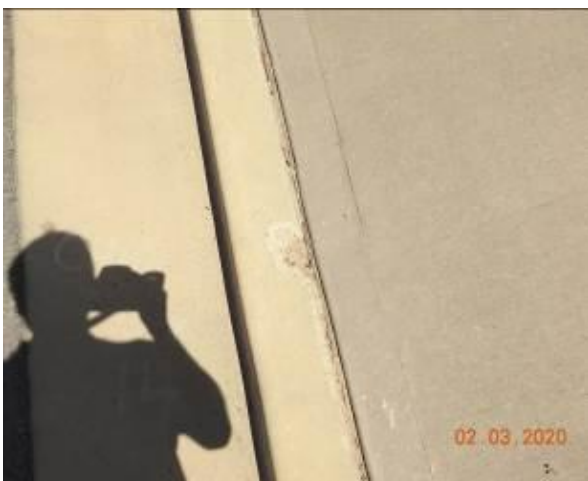
Figure 1562 – Loss of material through kerb

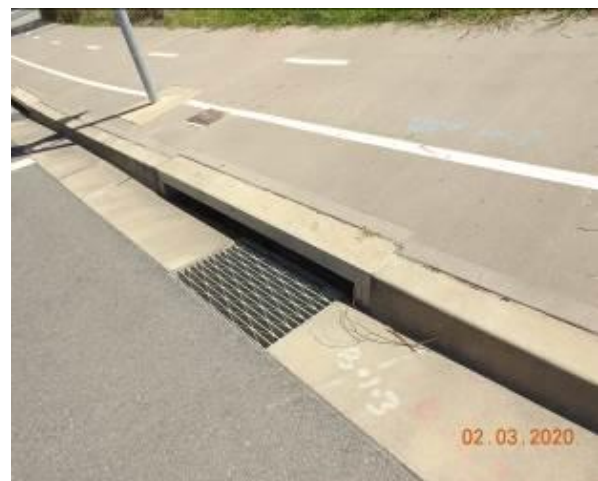
Figure 1563 – General Condition of stormwater inlet pit

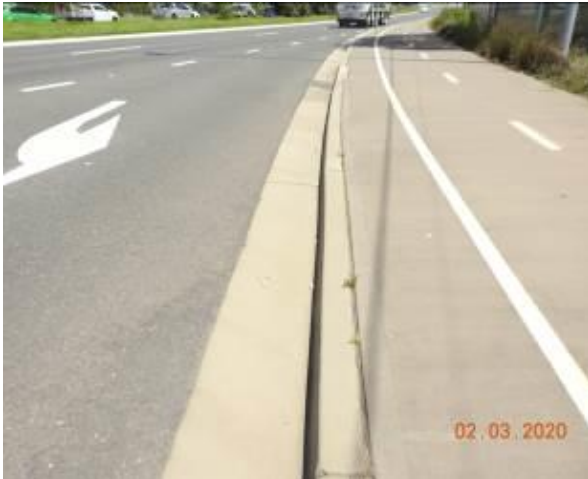
Figure 1570 – General Condition of kerb and gutter
