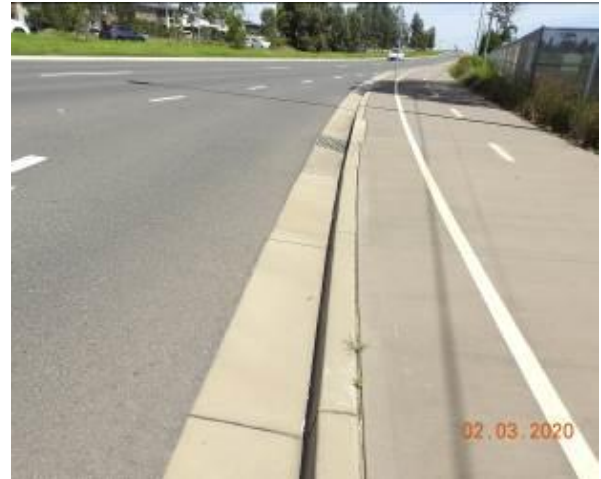
Figure 1571 – General Condition of kerb and gutter

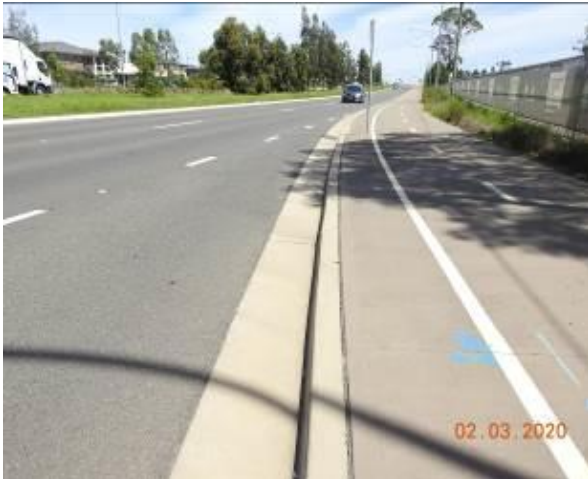
Figure 1576 – General Condition of kerb and gutter

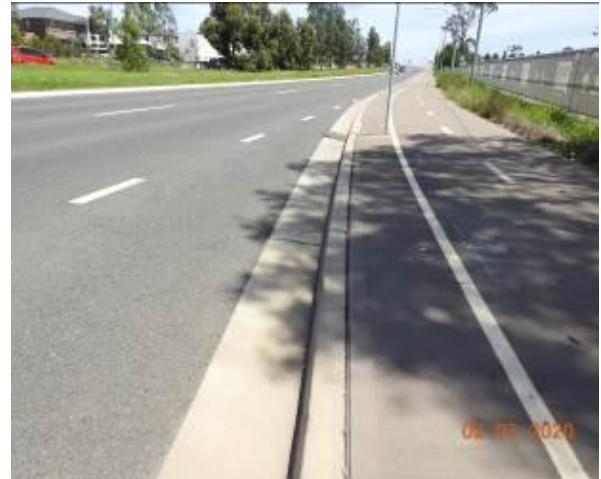
Figure 1577 – General Condition of kerb and gutter

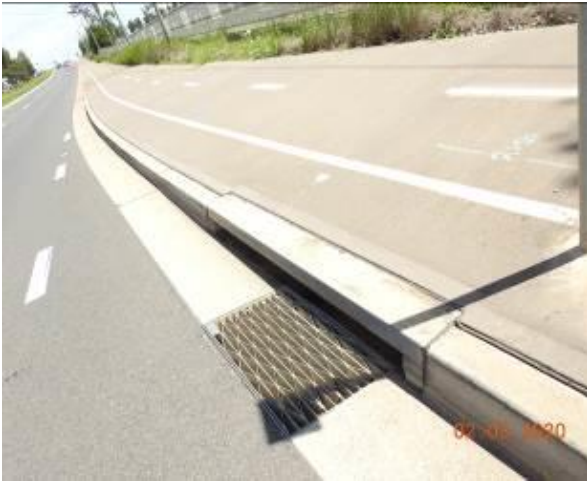
Figure 1582 – General Condition of stormwater inlet pit

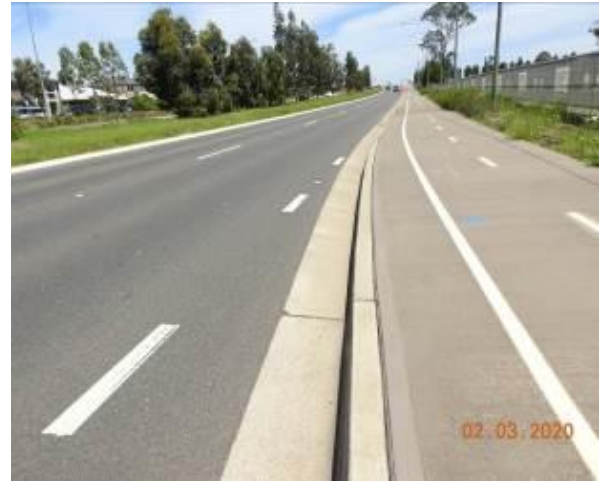
Figure 1583 – General Condition of kerb and gutter

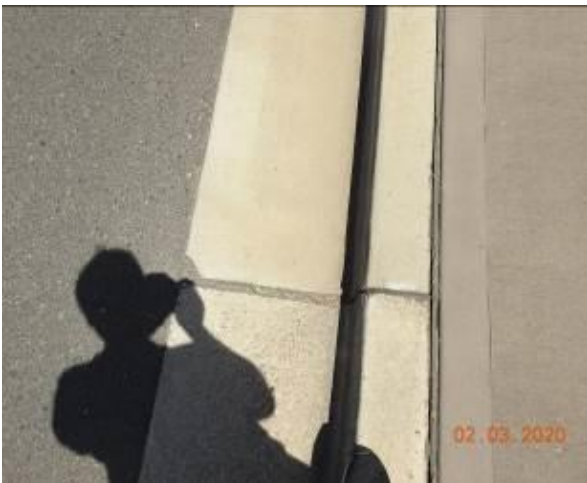
Figure 1584 – Loss of material through gutter

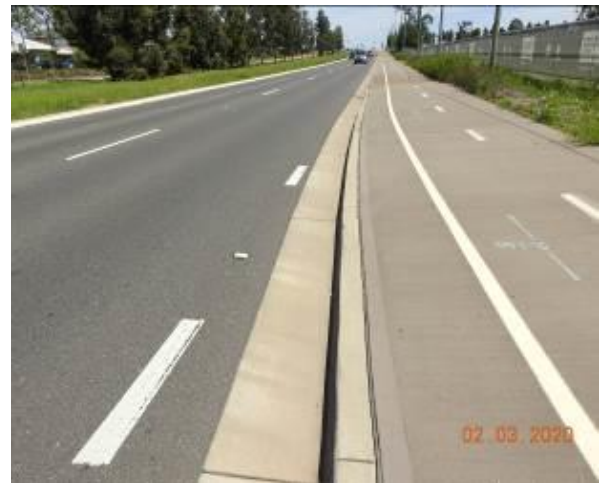
Figure 1585 – General Condition of kerb and gutter

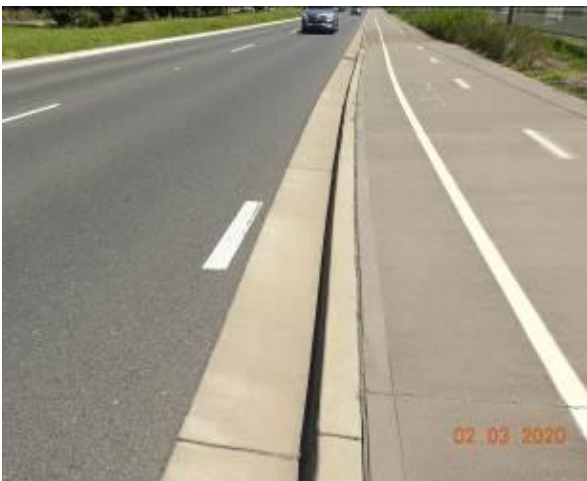
Figure 1586 – General Condition of kerb and gutter

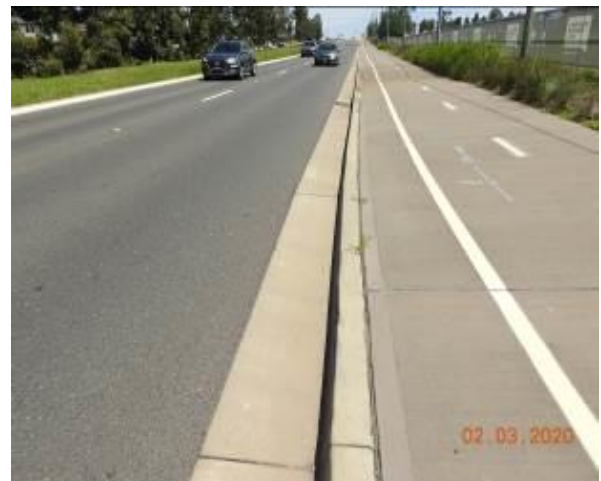
Figure 1587 – General Condition of kerb and gutter

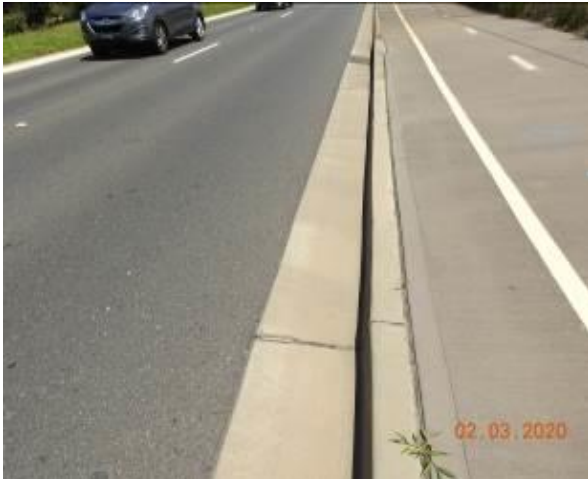
Figure 1588 – General Condition of kerb and gutter

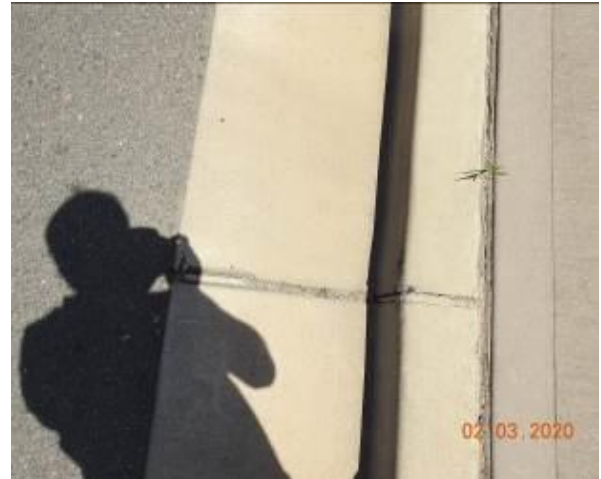
Figure 1589 – Crack propagation and loss of material through kerb and gutter

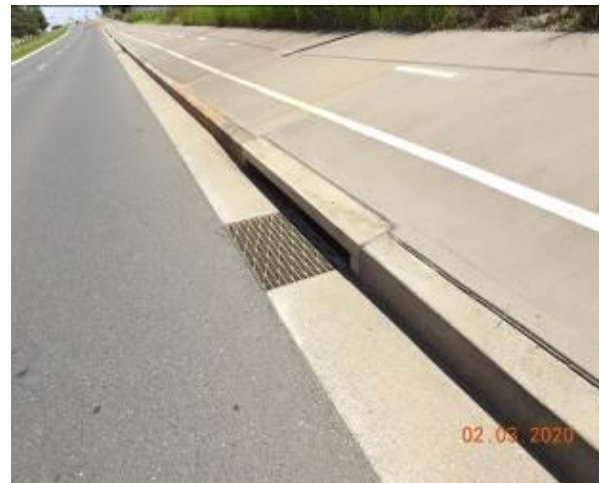
Figure 1591 – General Condition of stormwater inlet pit

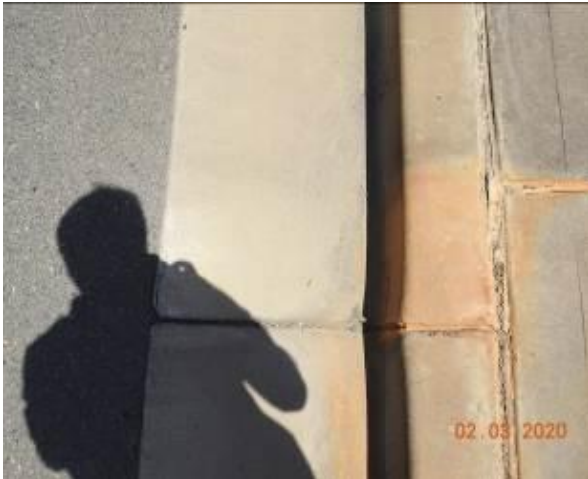
Figure 1594 – Loss of material through gutter

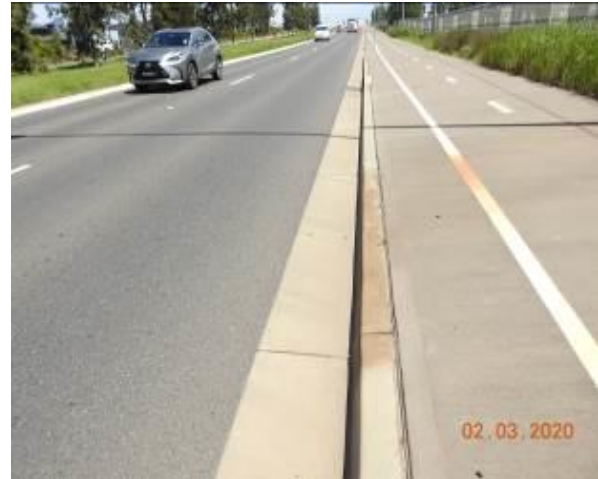
Figure 1595 – General Condition of kerb and gutter

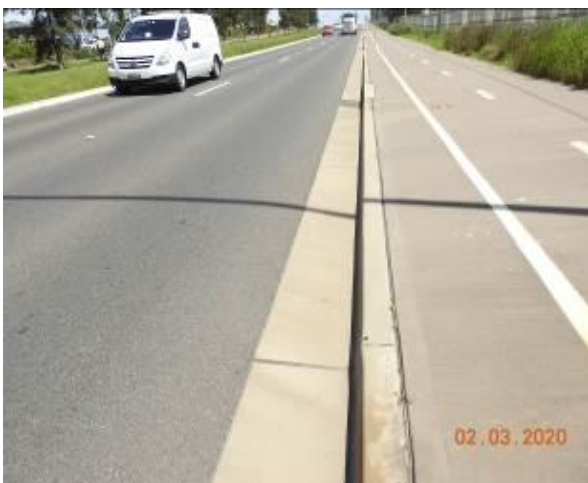
Figure 1596 – General Condition of kerb and gutter

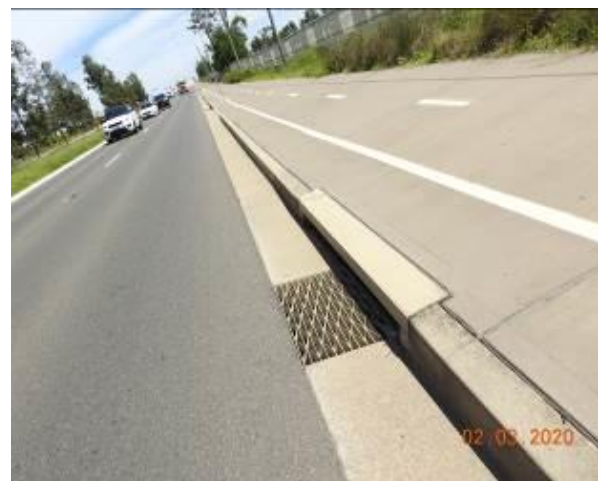
Figure 1599 – General Condition of stormwater inlet pit

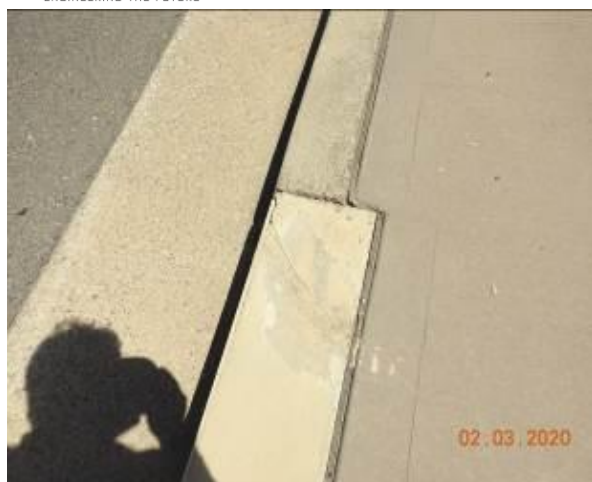
Figure 1600 – Crack propagation through stormwater inlet pit

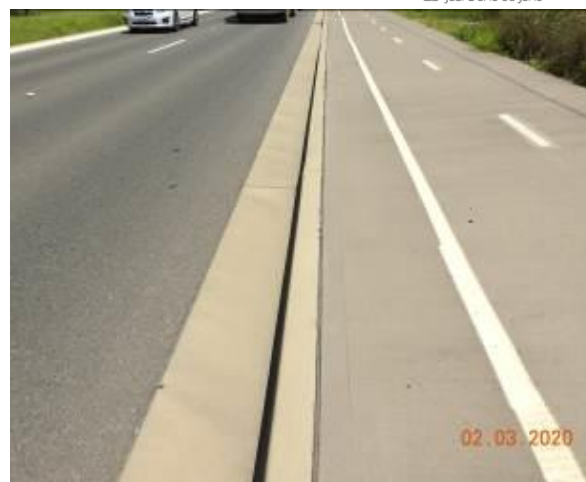
Figure 1601 – General Condition of kerb and gutter

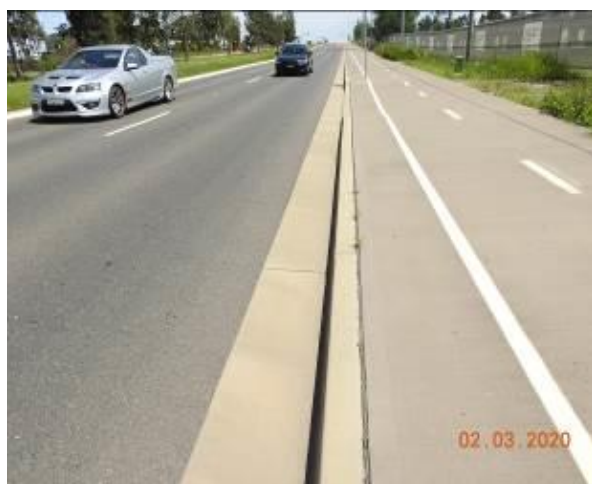
Figure 1602 – General Condition of kerb and gutter

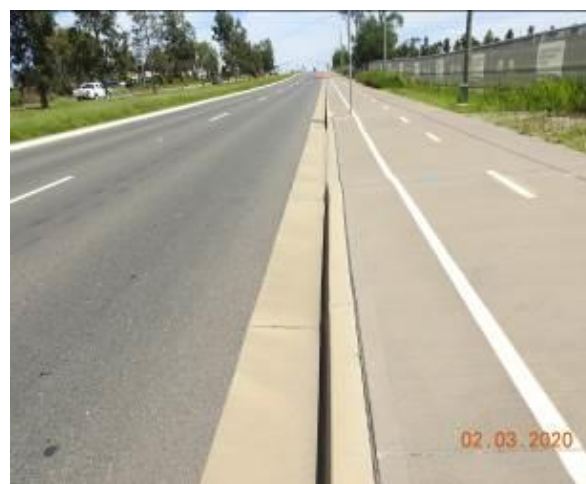
Figure 1603 – General Condition of kerb and gutter

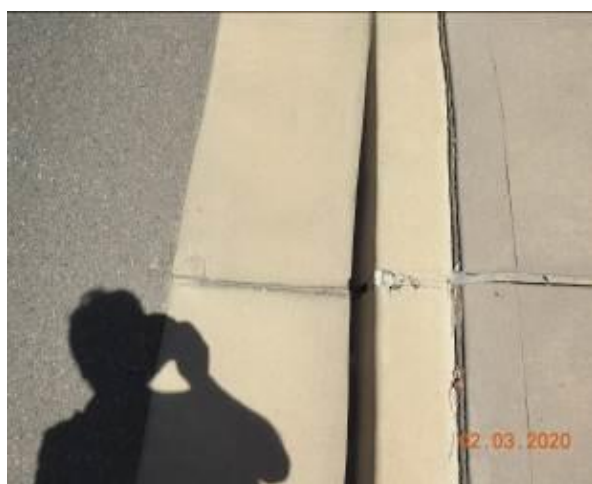
Figure 1604 – Loss of material through kerb and gutter

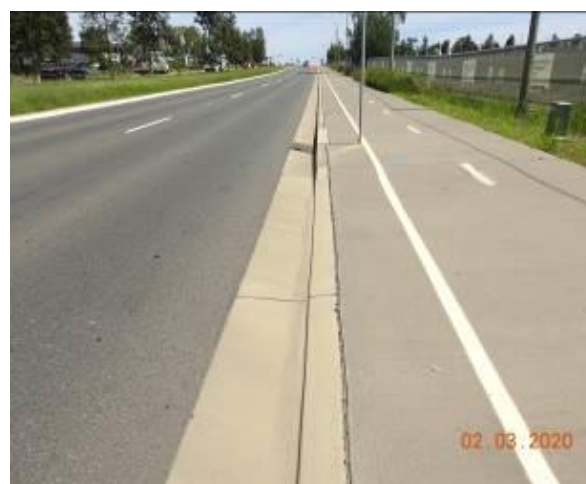
Figure 1605 – General Condition of kerb and gutter

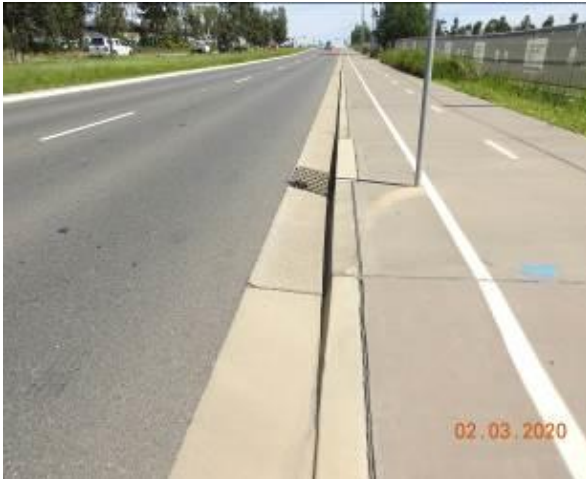
Figure 1606 – General Condition of kerb and gutter

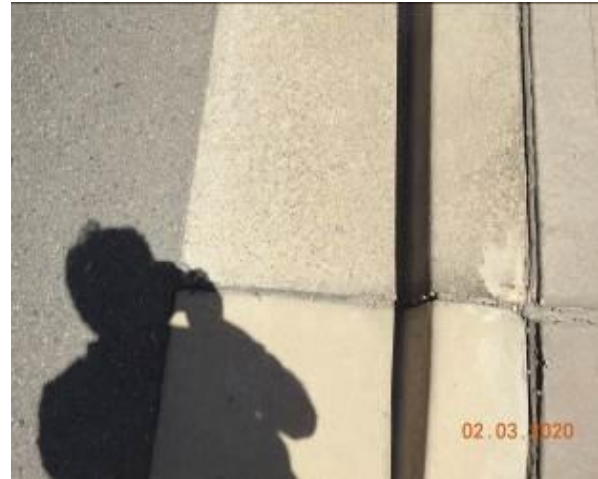
Figure 1607 – Loss of material through kerb

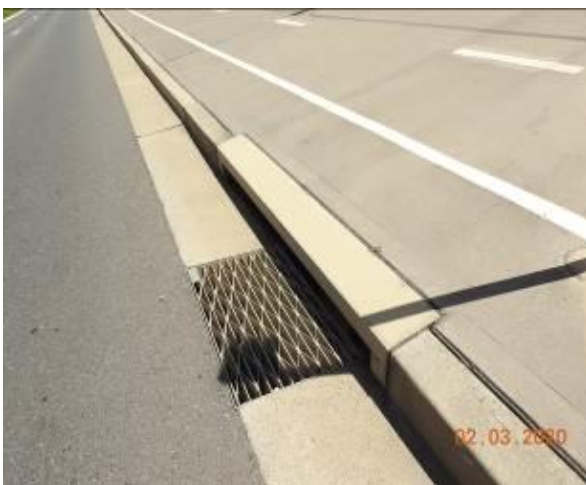
Figure 1608 – General Condition of stormwater inlet pit

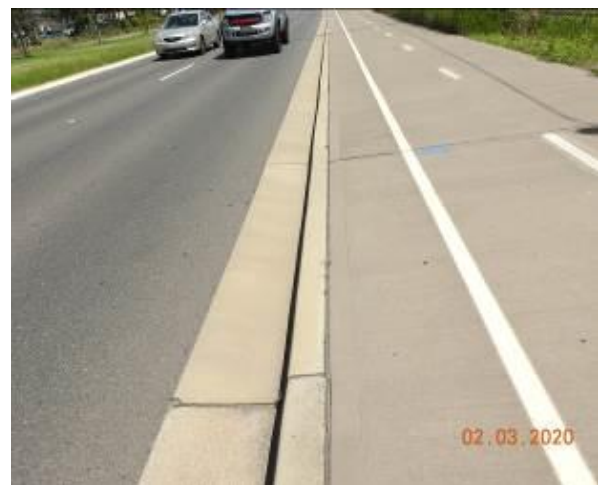
Figure 1609 – General Condition of kerb and gutter

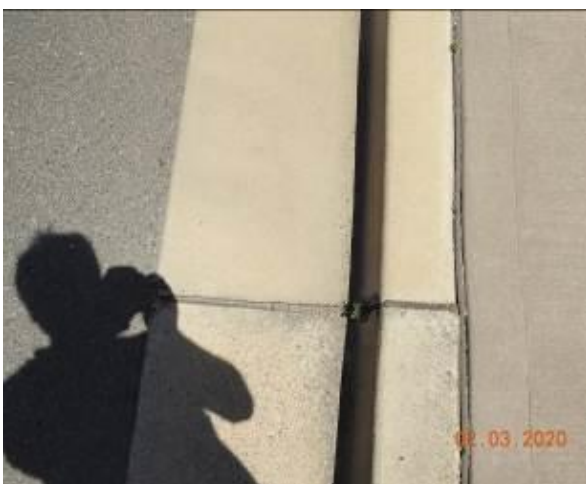
Figure 1610 – Crack propagation and loss of material through kerb and gutter

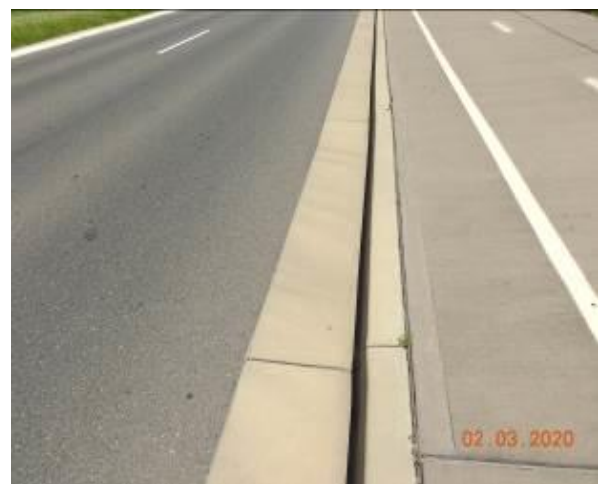
Figure 1611 – General Condition of kerb and gutter

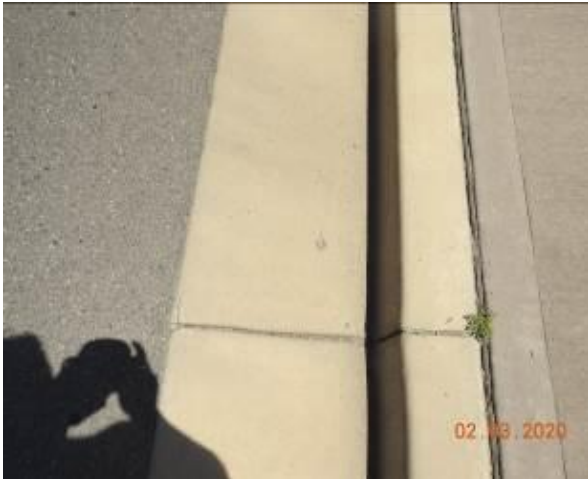
Figure 1612 – General Condition of kerb and gutter

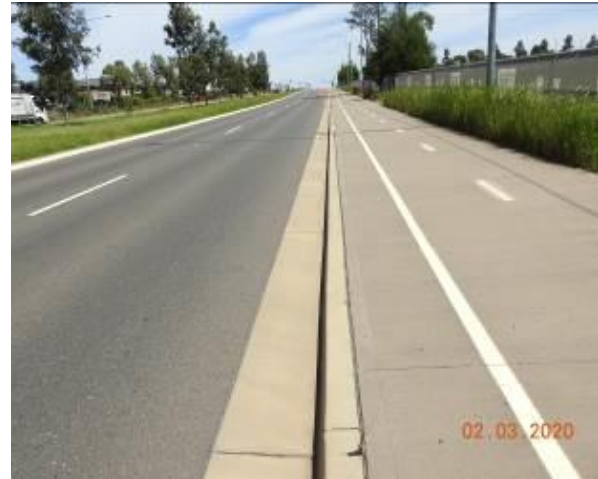
Figure 1613 – General Condition of kerb and gutter

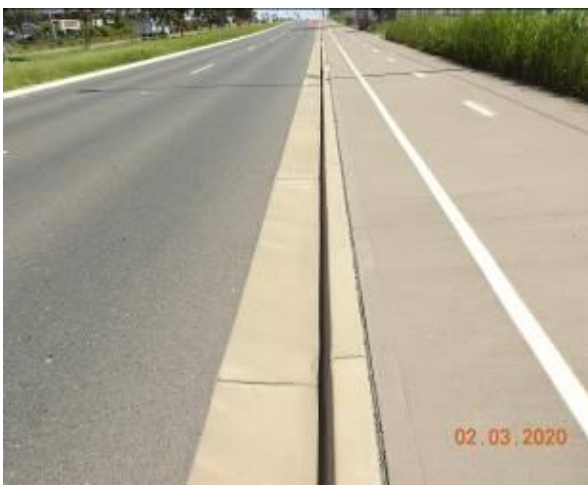
Figure 1614 – General Condition of kerb and gutter

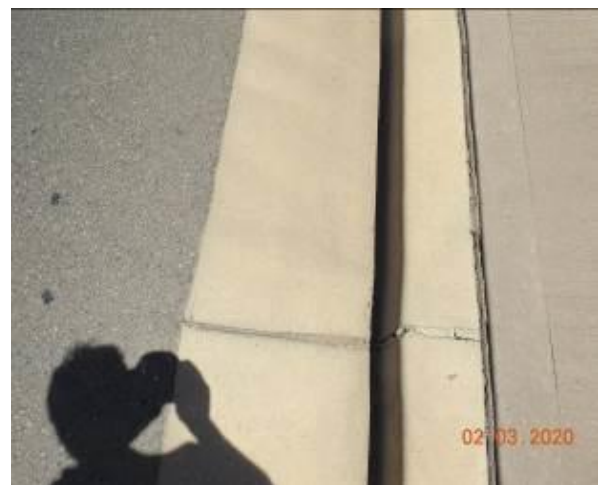
Figure 1615 – Crack propagation through kerb and gutter

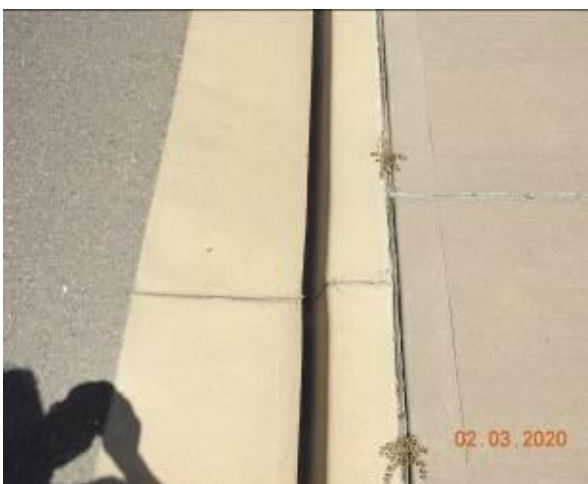
Figure 1616 – General Condition of kerb and gutter

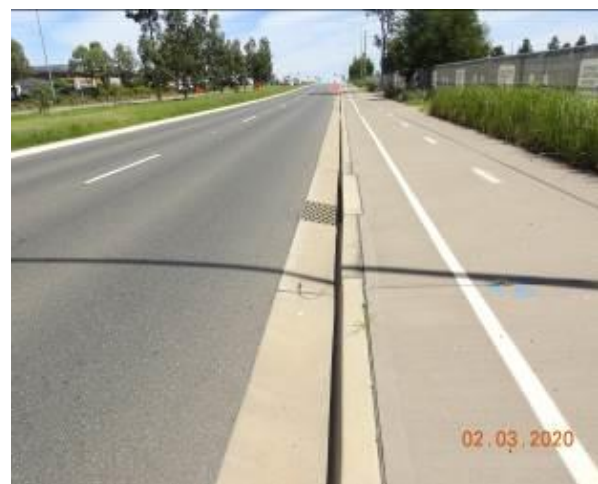
Figure 1617 – General Condition of kerb and gutter

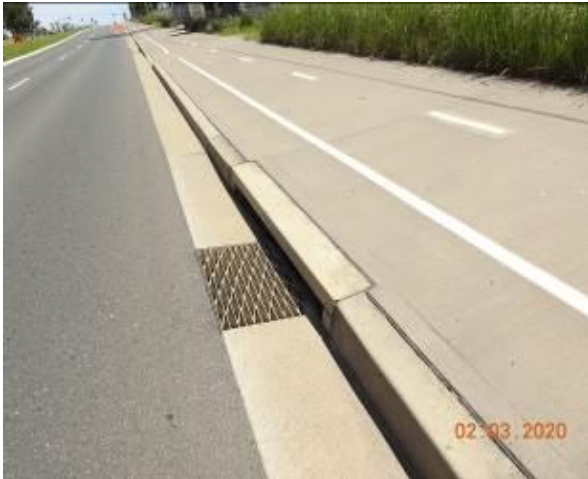
Figure 1618 – General Condition of stormwater inlet pit

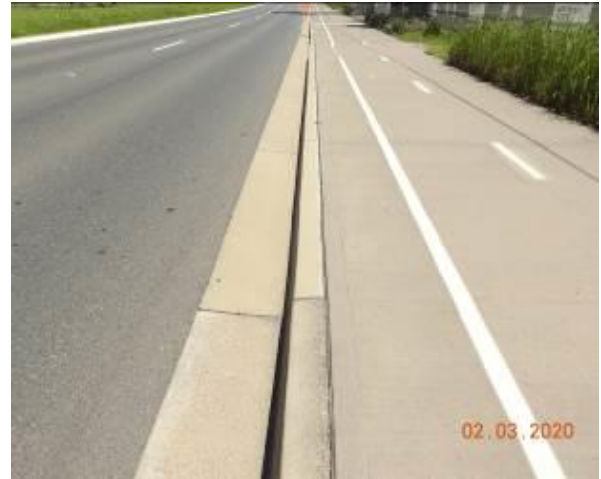
Figure 1619 – General Condition of kerb and gutter

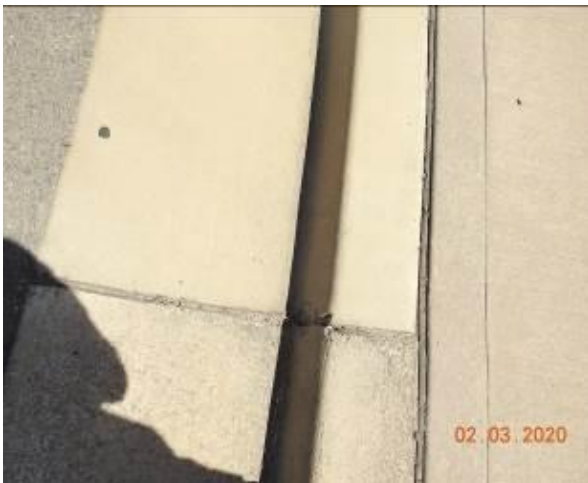
Figure 1620 – Loss of material through kerb

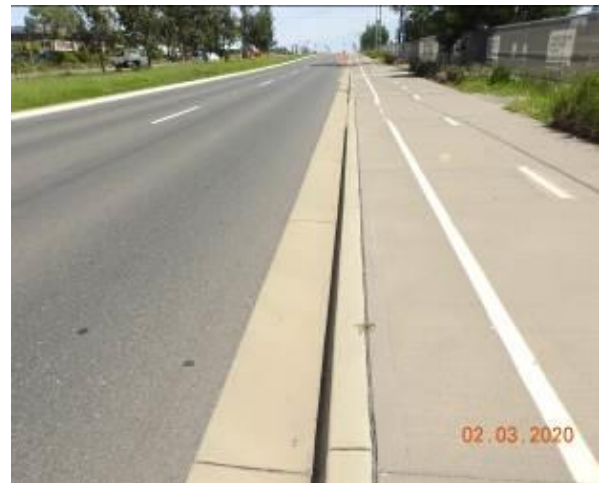
Figure 1621 – General Condition of kerb and gutter

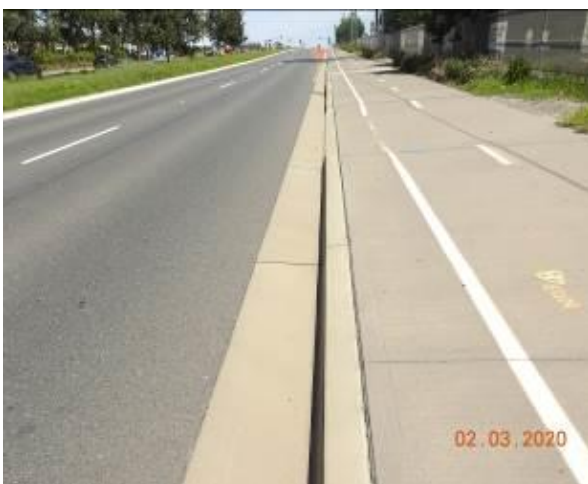
Figure 1622 – General Condition of kerb and gutter

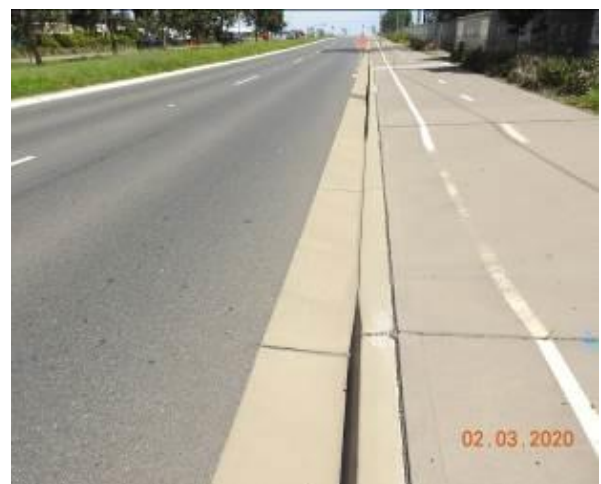
Figure 1623 – General Condition of kerb and gutter

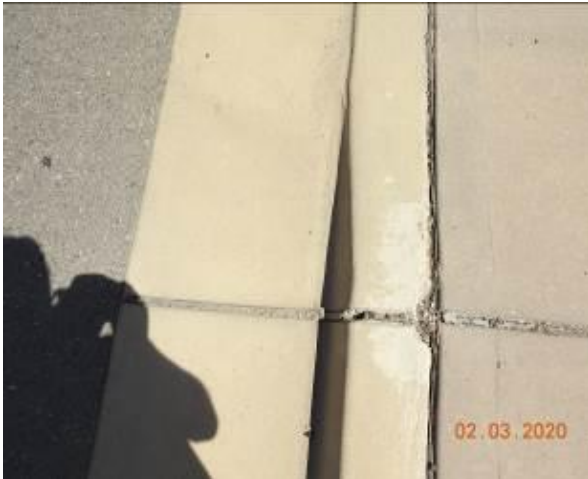
Figure 1624 – Loss of material through kerb

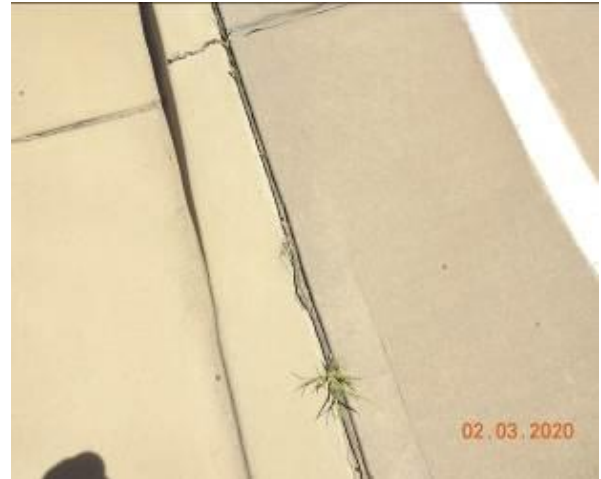
Figure 1625 – Loss of material through layback

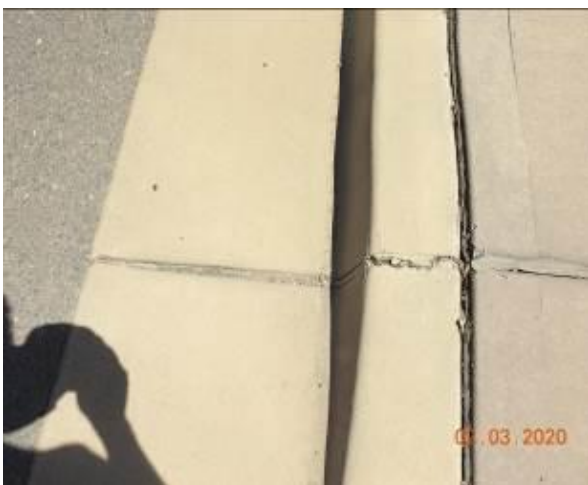
Figure 1626 – Crack propagation through kerb

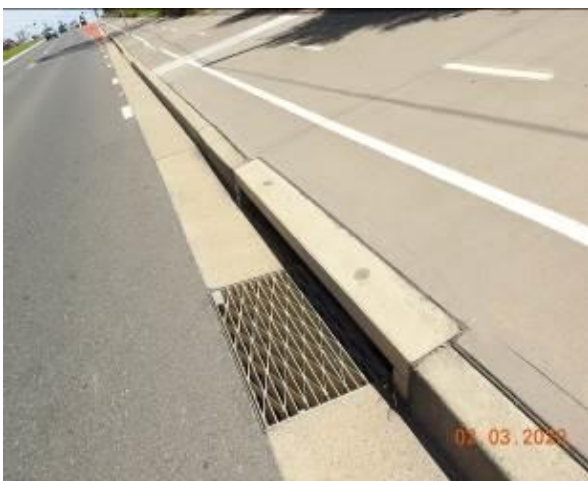
Figure 1628 – General Condition of stormwater inlet pit

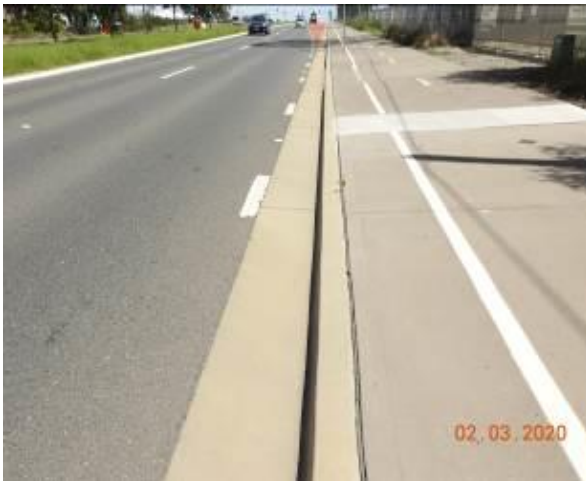
Figure 1630 – General Condition of kerb and gutter

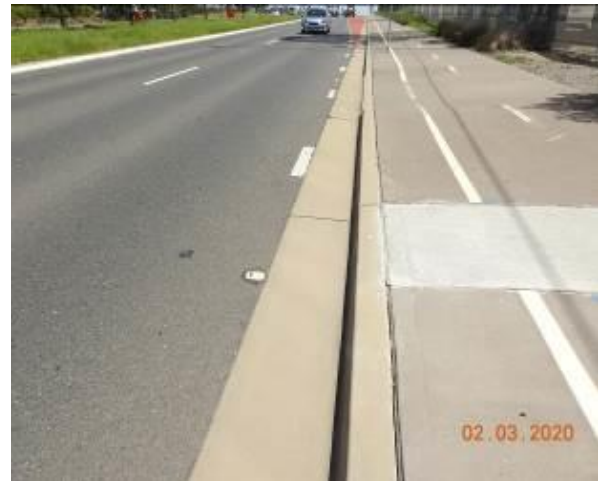
Figure 1631 – General Condition of kerb and gutter

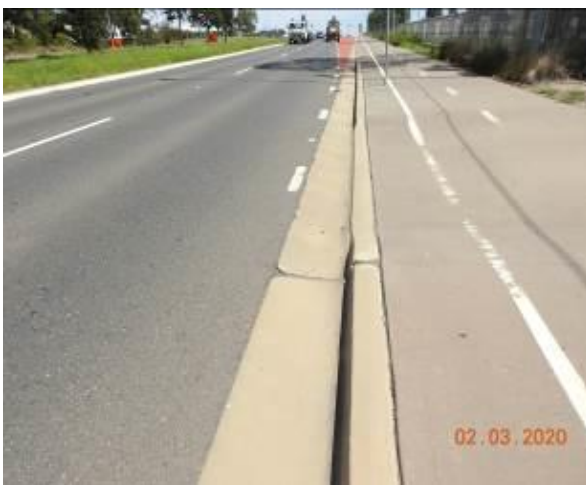
Figure 1632 – General Condition of kerb and gutter

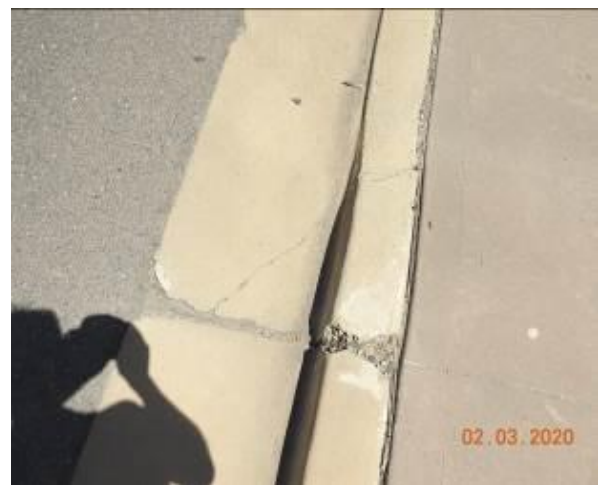
Figure 1633 – Crack propagation and loss of material through kerb and gutter

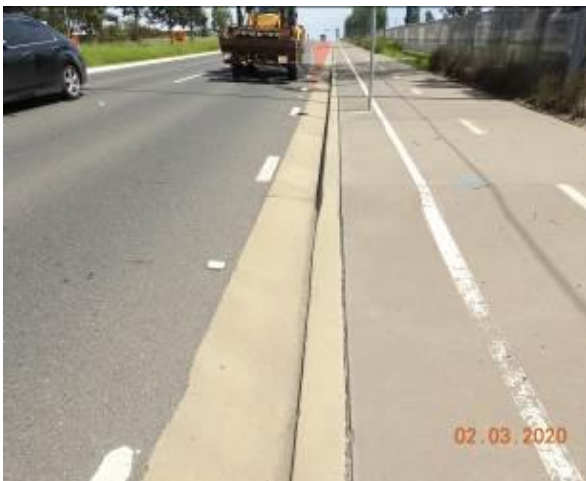
Figure 1634 – General Condition of layback and gutter

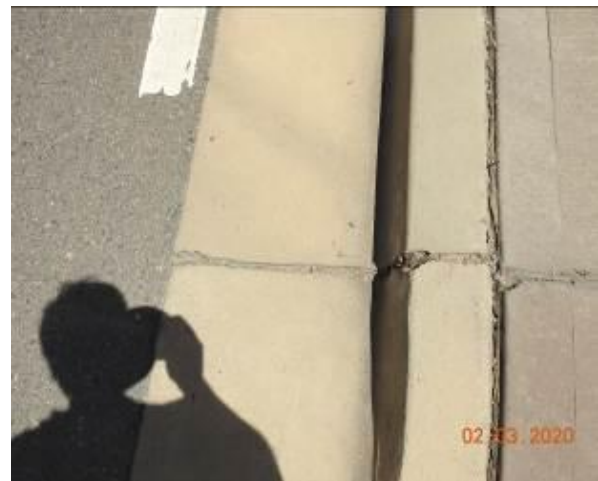
Figure 1635 – Loss of material through kerb

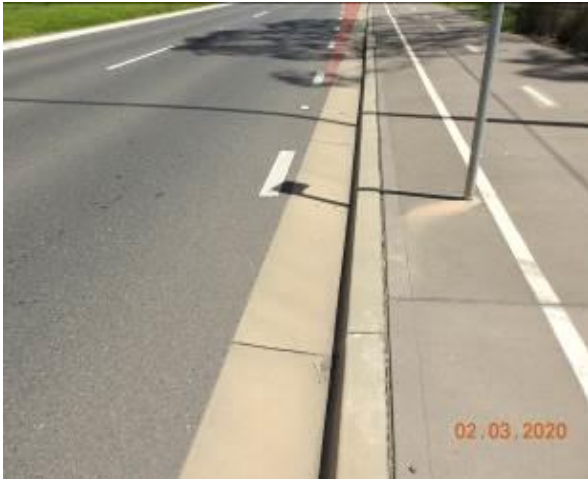
Figure 1636 – General Condition of kerb and gutter

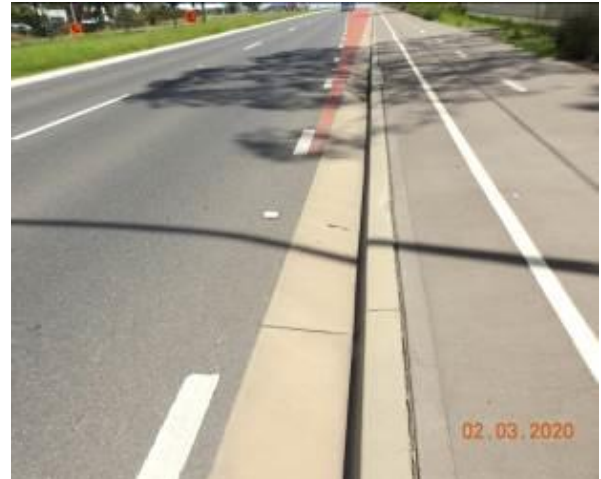
Figure 1637 – General Condition of kerb and gutter

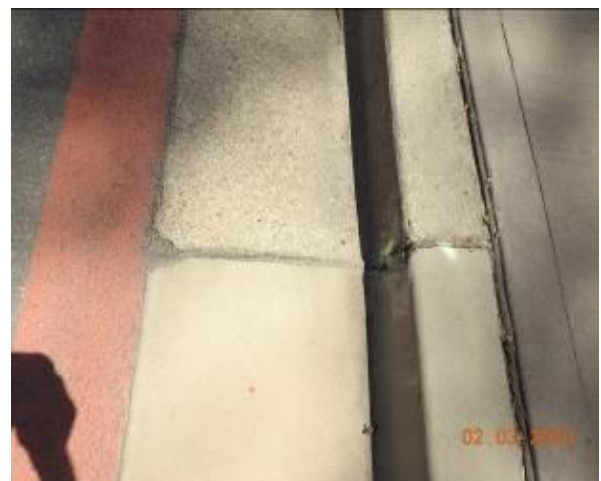
Figure 1641 – Loss of material through kerb and gutter

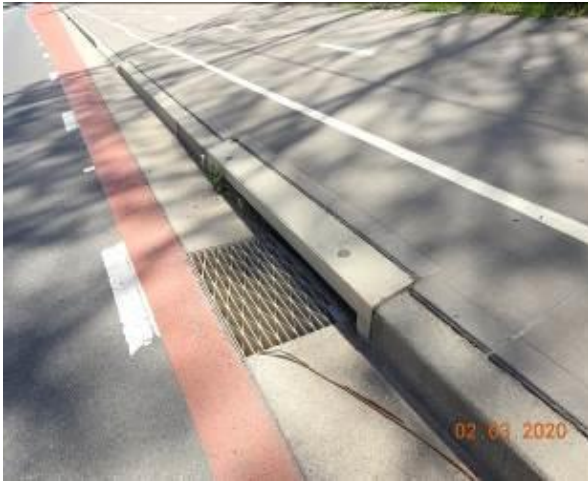
Figure 1642 – General Condition of stormwater inlet pit

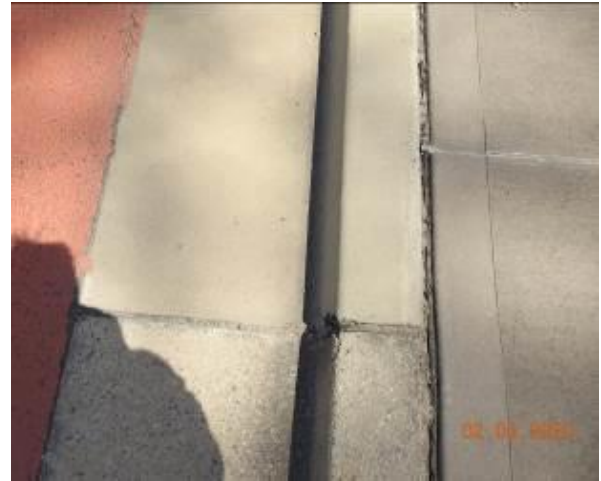
Figure 1643 – Loss of material through kerb

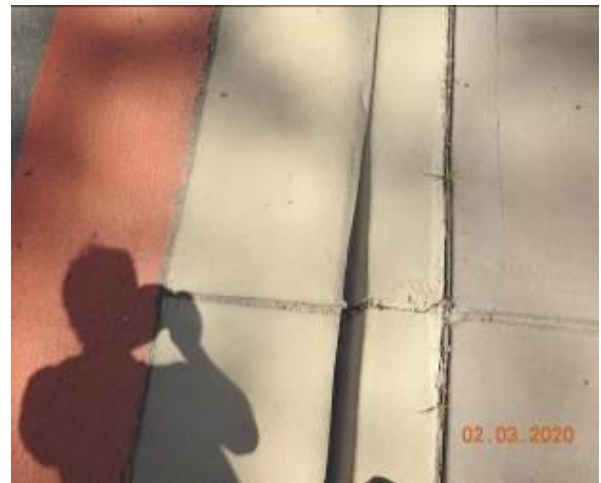
Figure 1645 – Loss of material through kerb

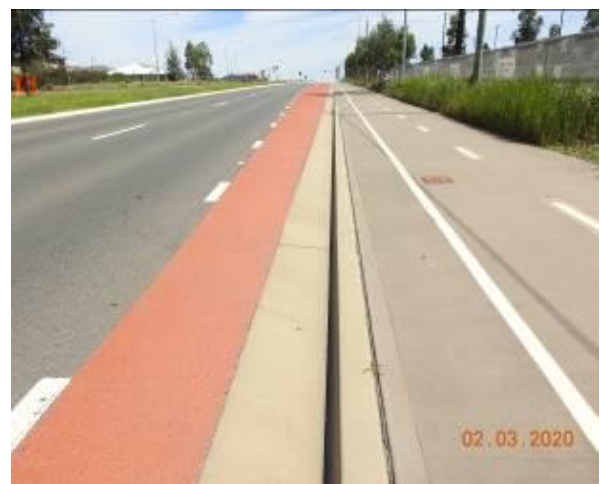
Figure 1647 – General Condition of kerb and gutter

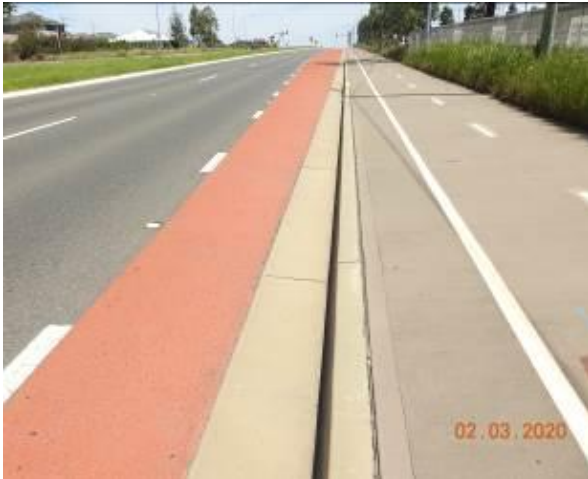
Figure 1648 – General Condition of kerb and gutter

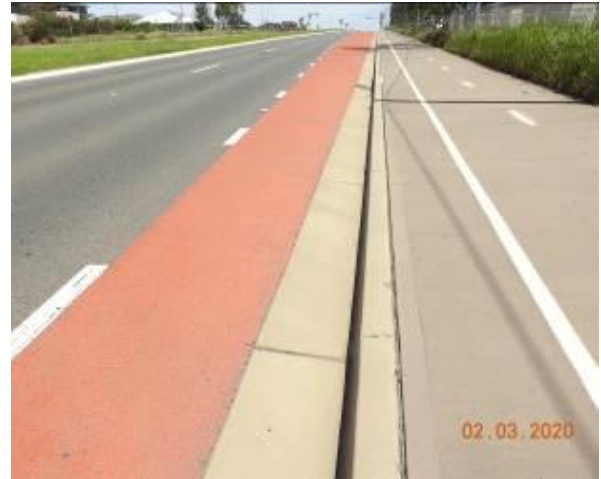
Figure 1649 – General Condition of kerb and gutter

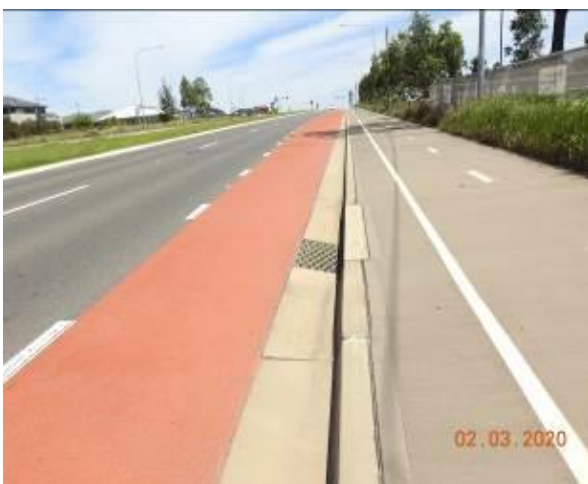
Figure 1652 – General Condition of kerb and gutter

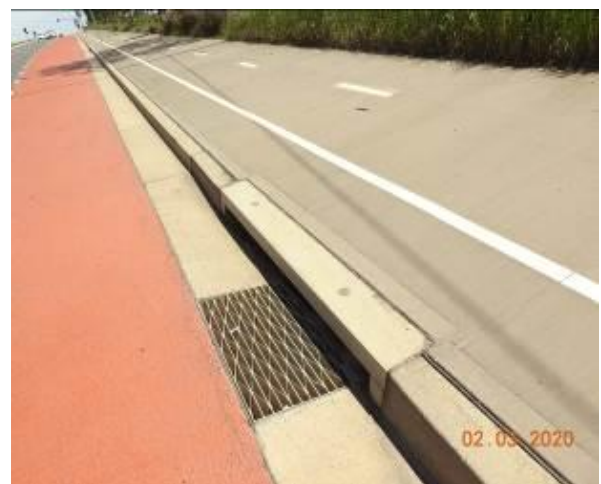
Figure 1653 – General Condition of stormwater inlet pit

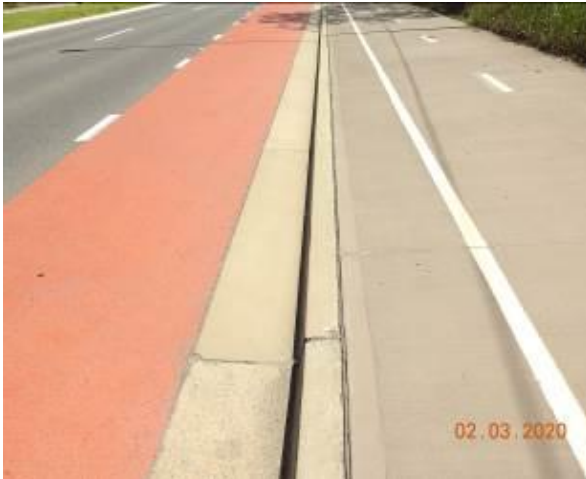
Figure 1654 – General Condition of kerb and gutter

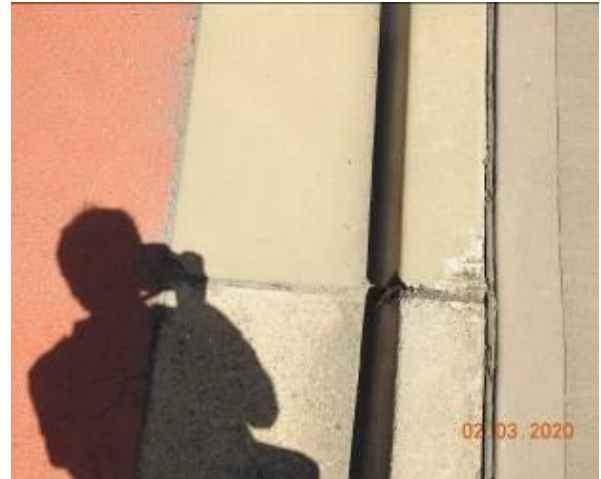
Figure 1655 – Loss of material through kerb and gutter

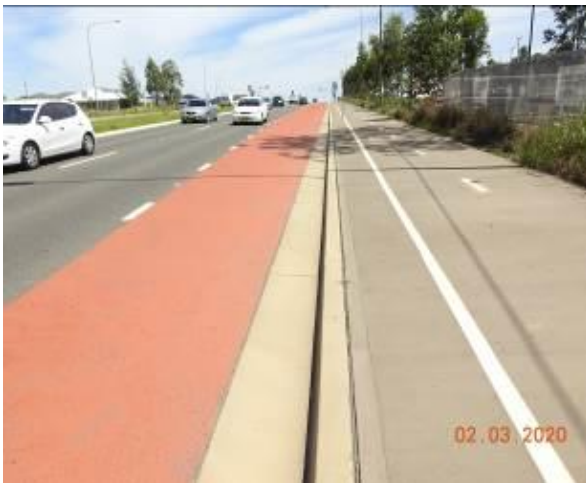
Figure 1656 – General Condition of kerb and gutter

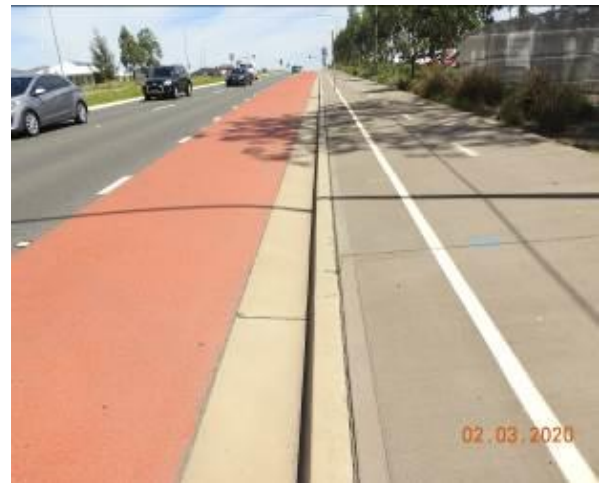
Figure 1657 – General Condition of kerb and gutter

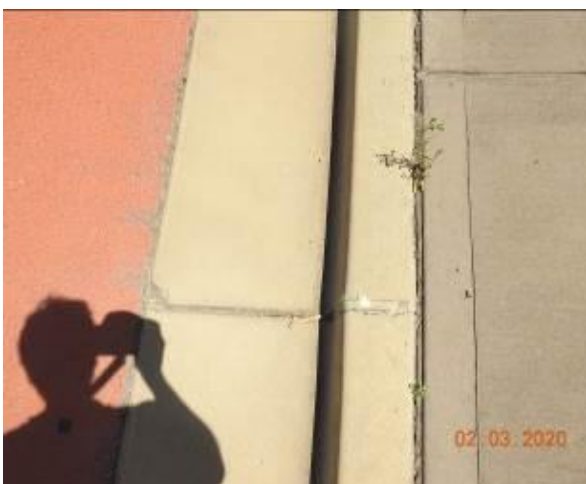
Figure 1658 – Crack propagation and loss of material through kerb and gutter

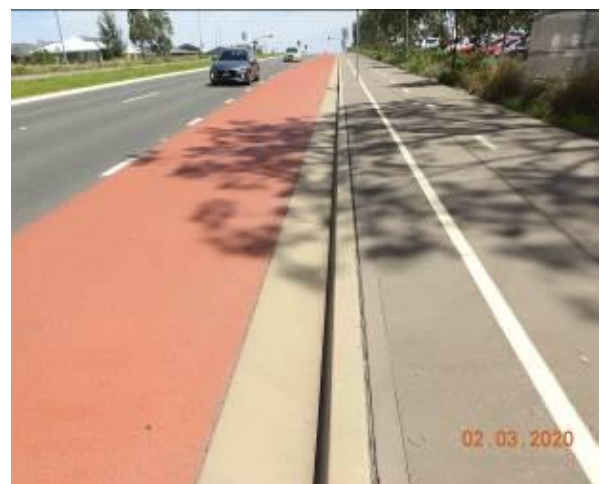
Figure 1659 – General Condition of kerb and gutter

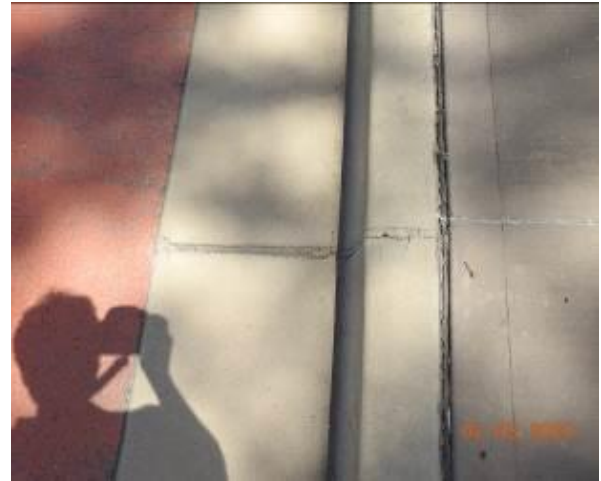
Figure 1661 – Crack propagation and loss of material through kerb and gutter

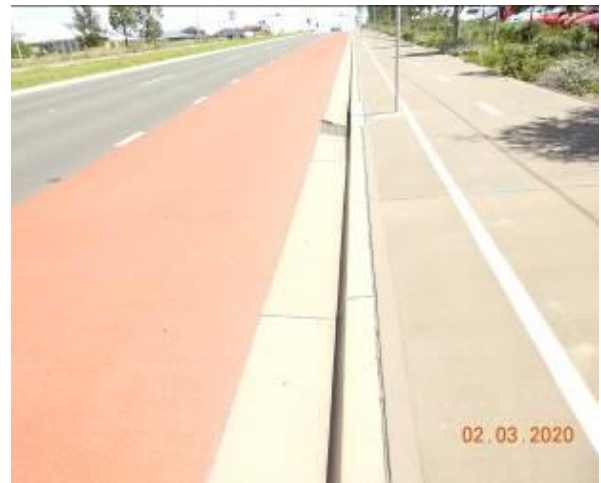
Figure 1663 – General Condition of kerb and gutter

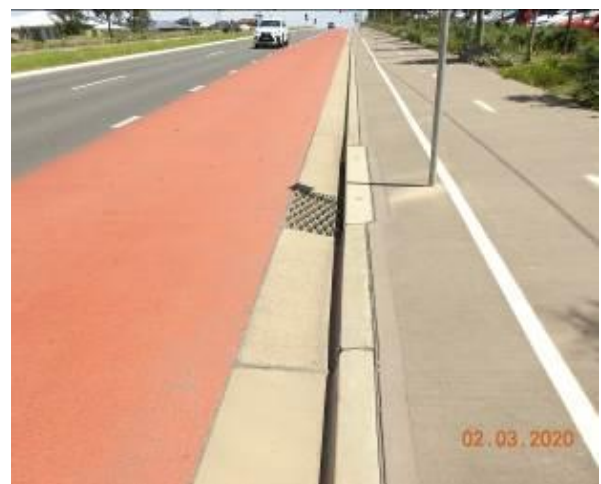
Figure 1665 – General Condition of kerb and gutter

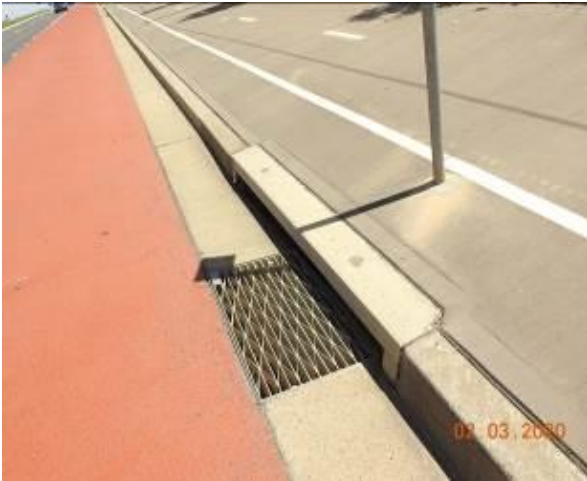
Figure 1666 – General Condition of stormwater inlet pit

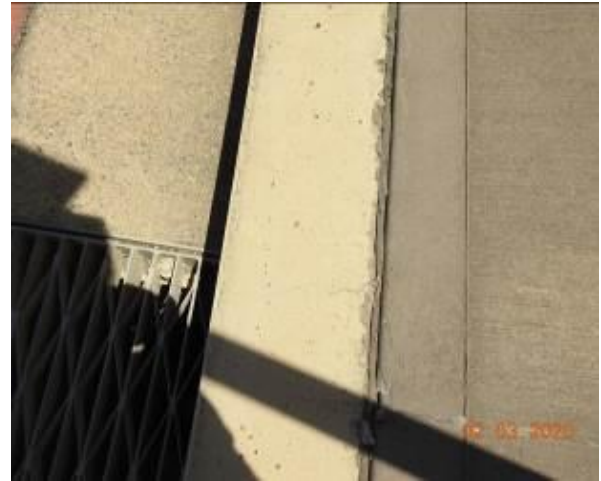
Figure 1667 – Crack propagation through stormwater inlet pit

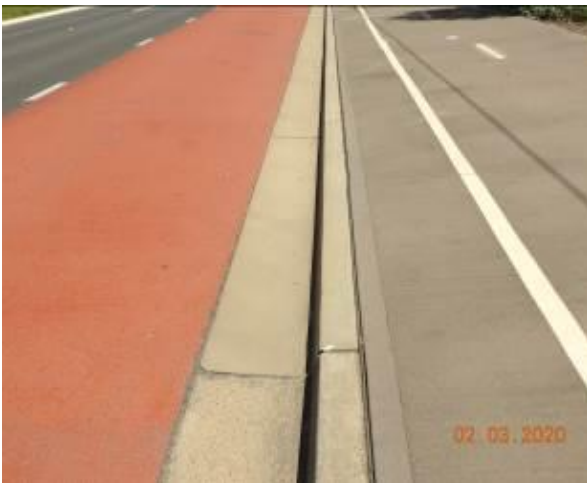
Figure 1668 – General Condition of kerb and gutter

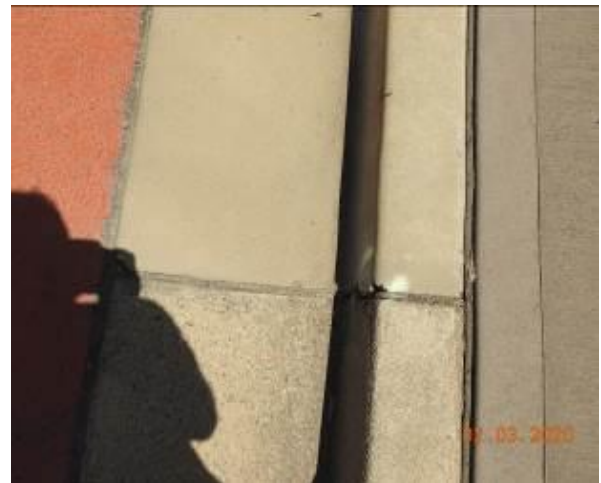
Figure 1669 – Loss of material through kerb

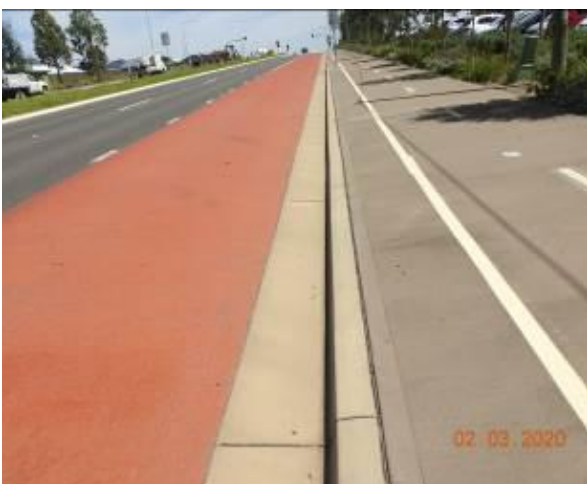
Figure 1670 – General Condition of kerb and gutter

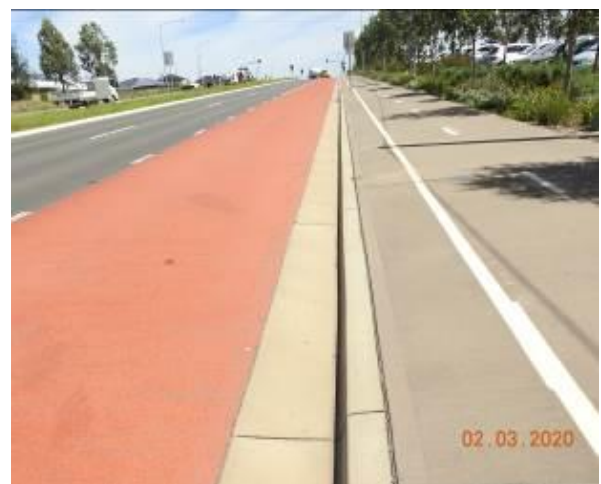
Figure 1671 – General Condition of kerb and gutter

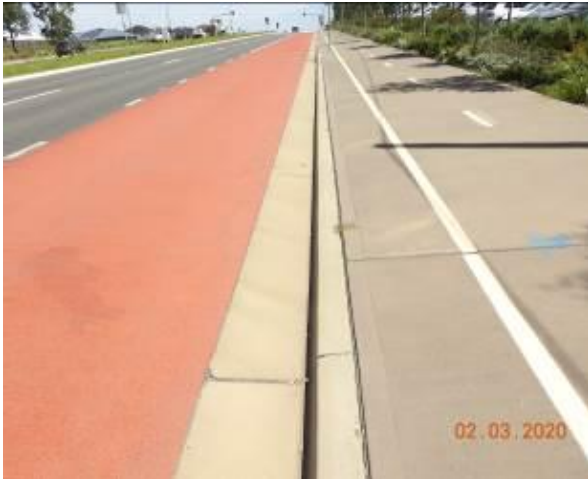
Figure 1672 – General Condition of kerb and gutter
