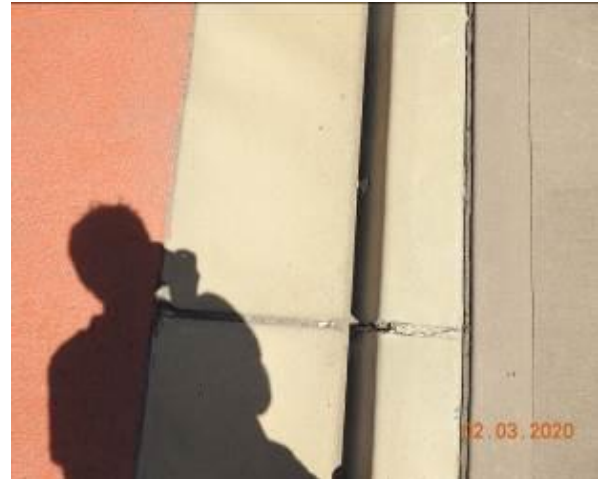
Figure 1673 – Crack propagation and loss of material through kerb and gutter

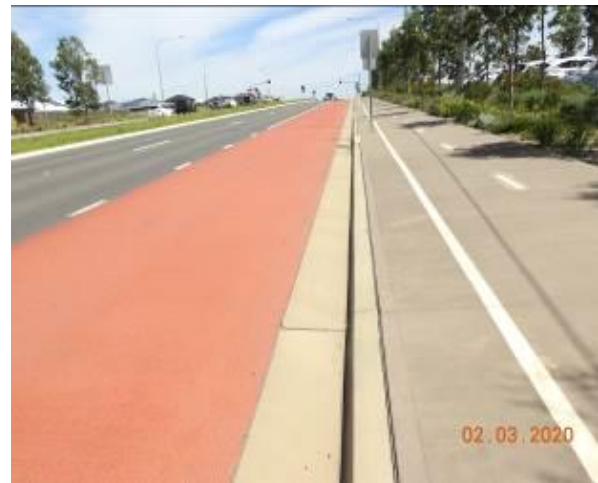
Figure 1675 – General Condition of kerb and gutter

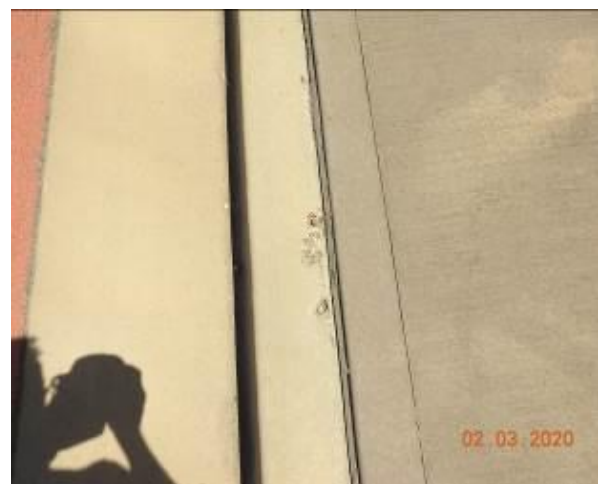
Figure 1677 – Loss of material through kerb

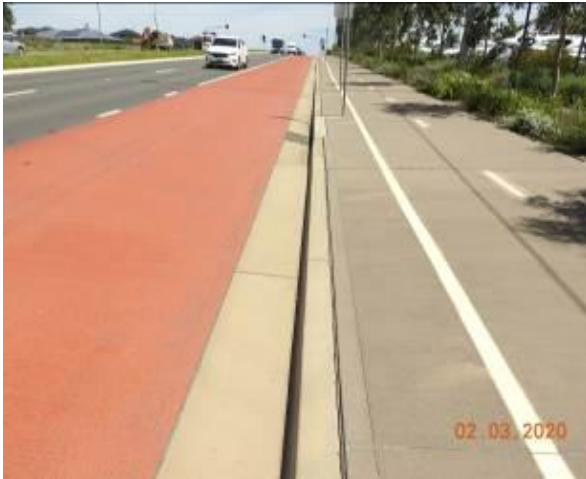
Figure 1678 – General Condition of kerb and gutter

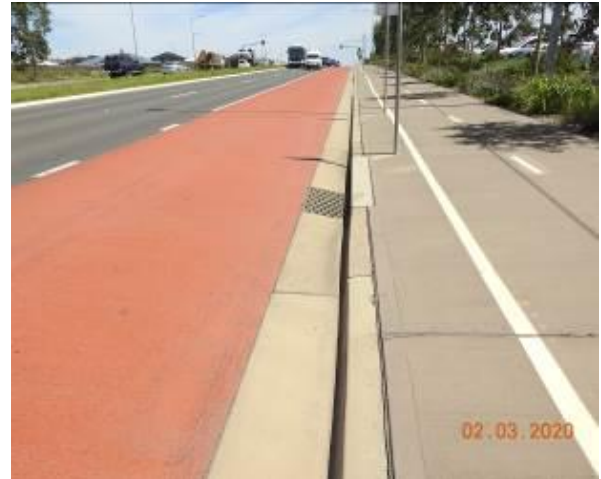
Figure 1679 – General Condition of kerb and gutter

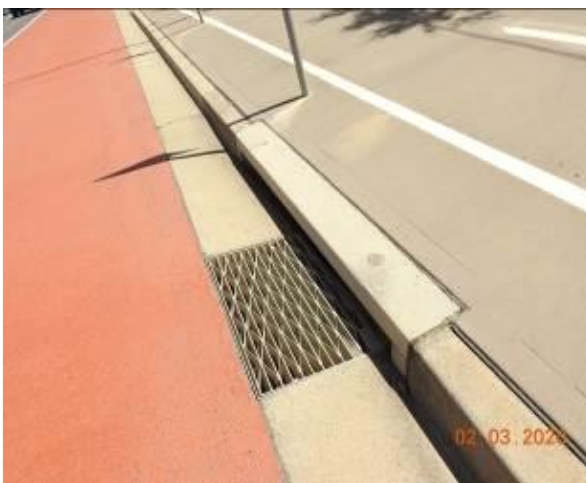
Figure 1680 – General Condition of stormwater inlet pit

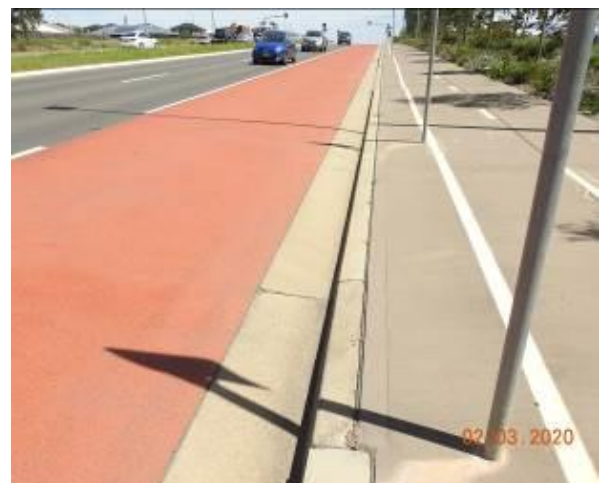
Figure 1681 – General Condition of kerb and gutter

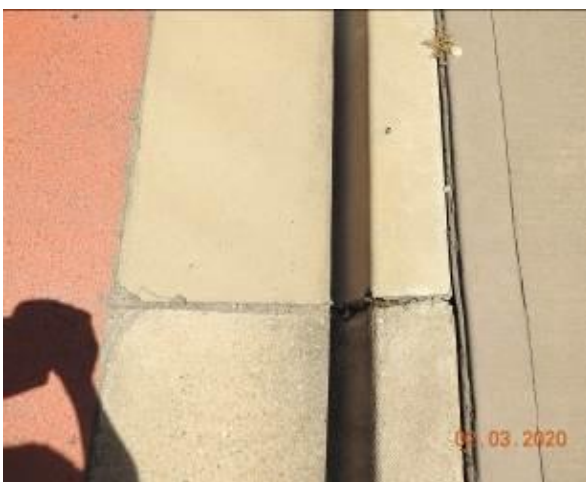
Figure 1682 – Crack propagation and loss of material through kerb and gutter

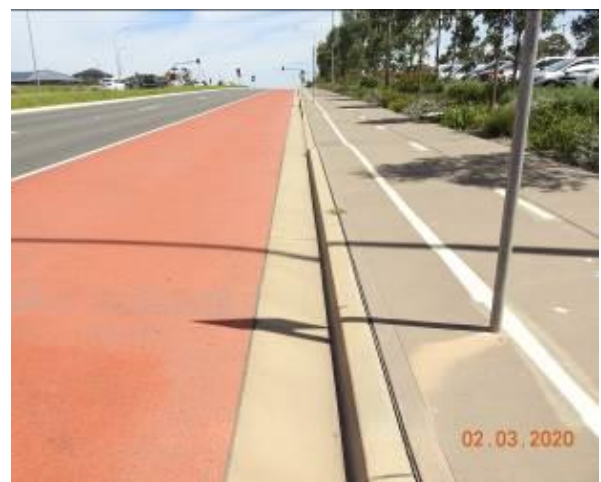
Figure 1683 – General Condition of kerb and gutter

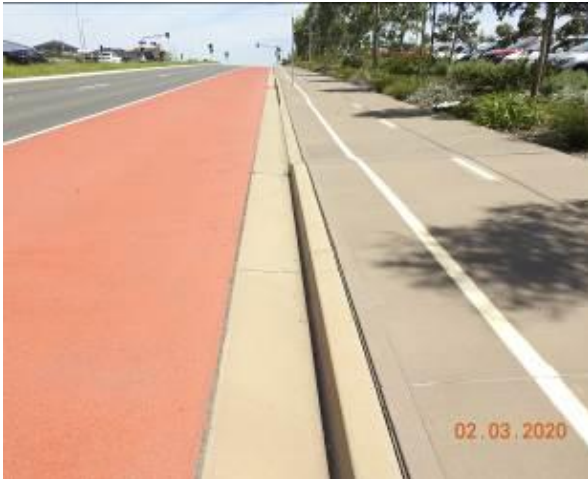
Figure 1684 – General Condition of kerb and gutter

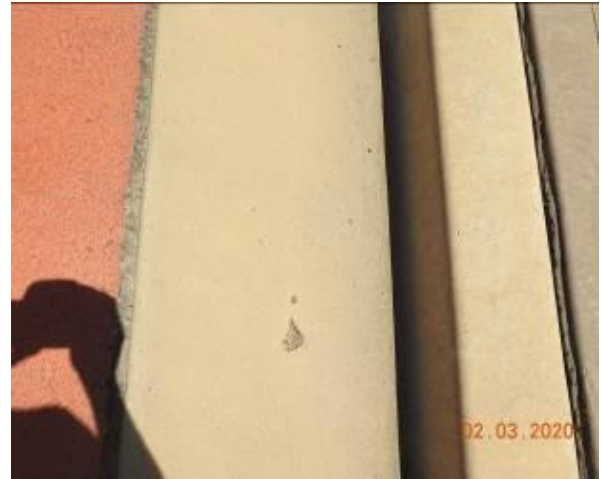
Figure 1685 – Loss of material through gutter

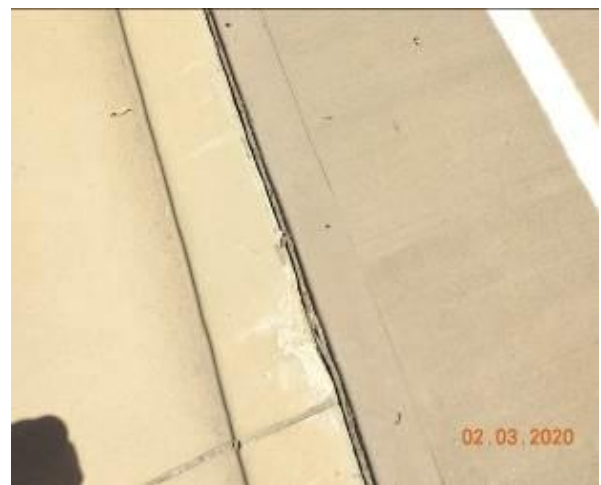
Figure 1687 – Loss of material through layback

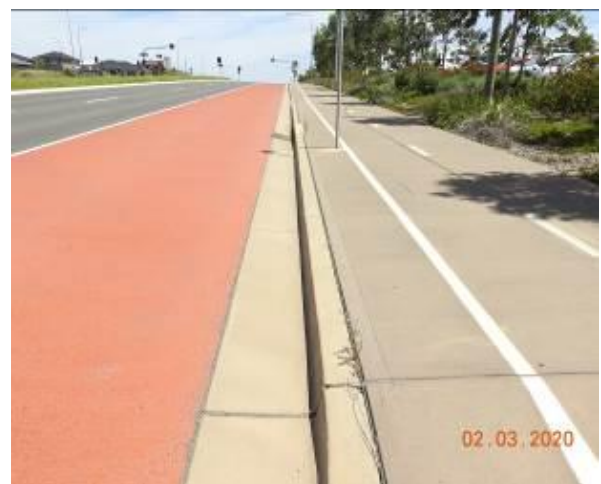
Figure 1689 – General Condition of kerb and gutter

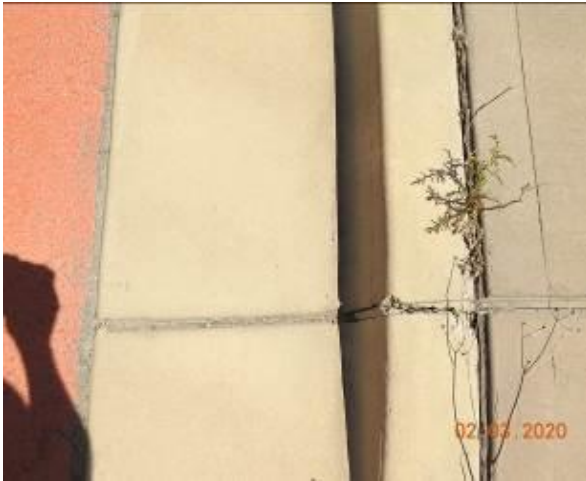
Figure 1690 – Crack propagation and loss of material through kerb

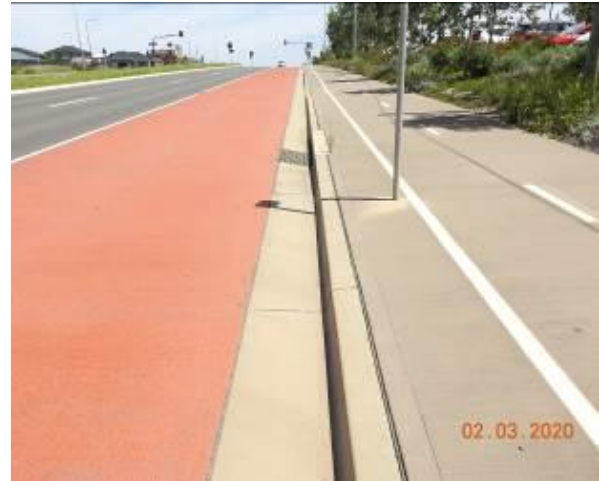
Figure 1691 – General Condition of kerb and gutter

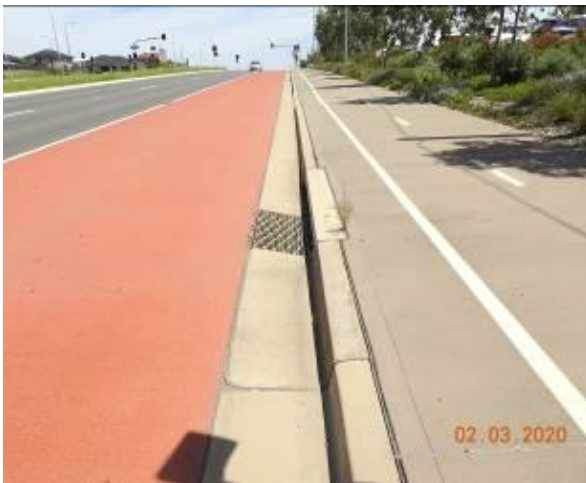
Figure 1692 – General Condition of kerb and gutter

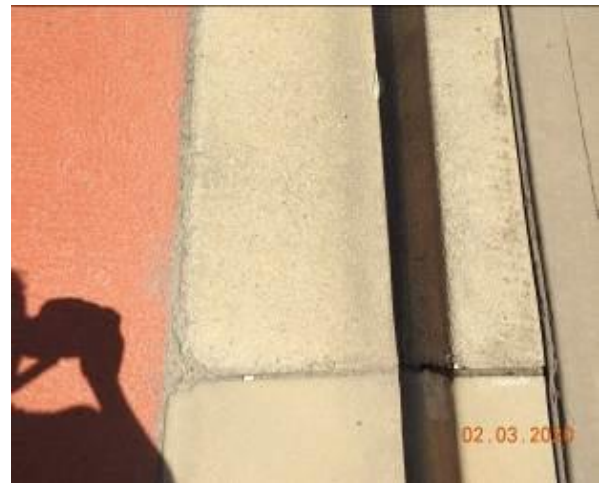
Figure 1693 – Crack propagation and loss of material through gutter

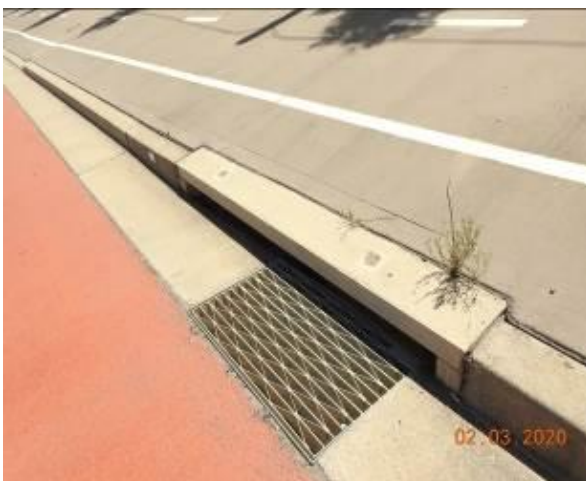
Figure 1694 – General Condition of stormwater inlet pit

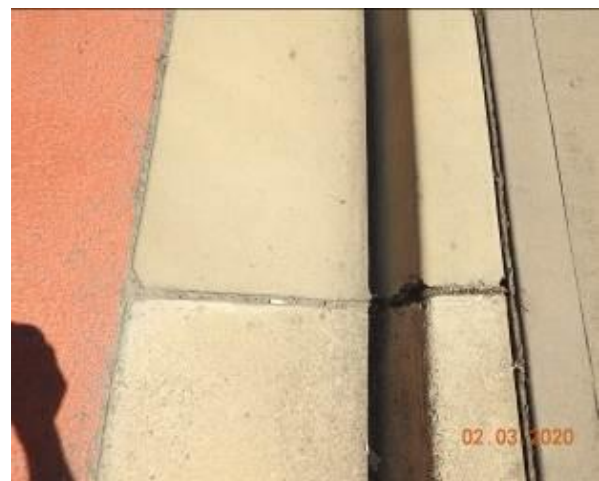
Figure 1695 – Loss of material through kerb and gutter

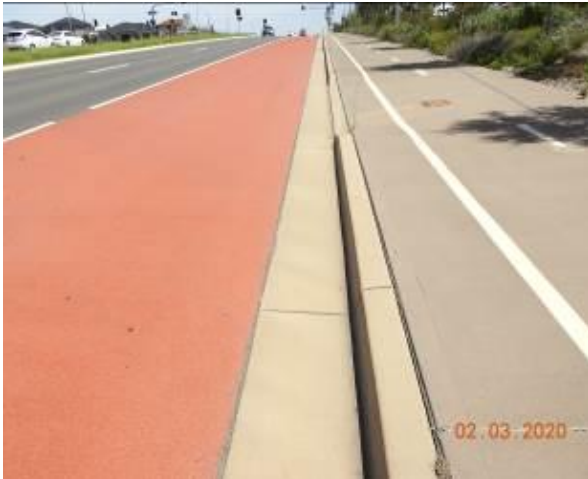
Figure 1696 – General Condition of kerb and gutter

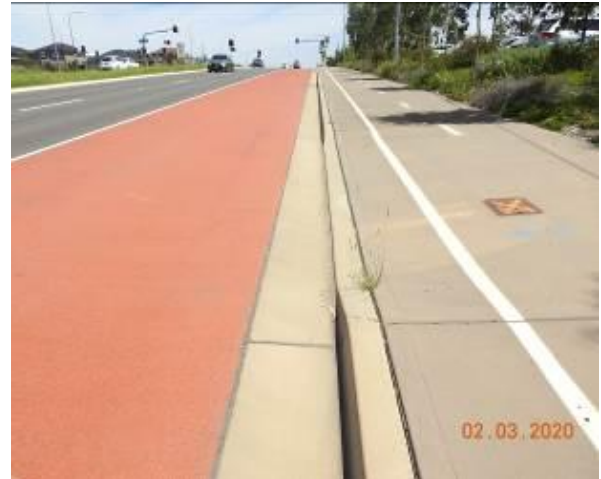
Figure 1697 – General Condition of layback and gutter

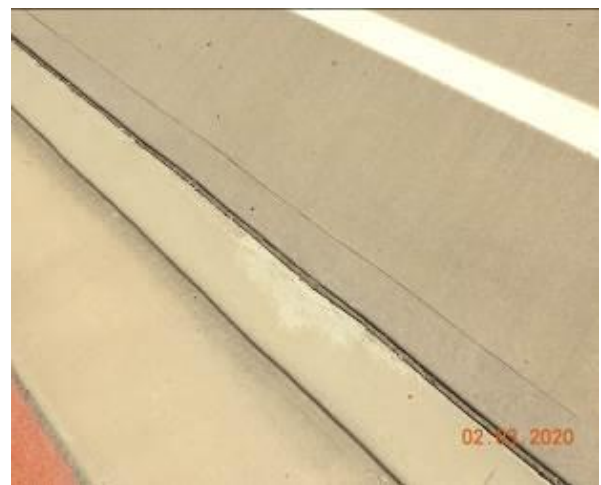
Figure 1699 – Loss of material through layback

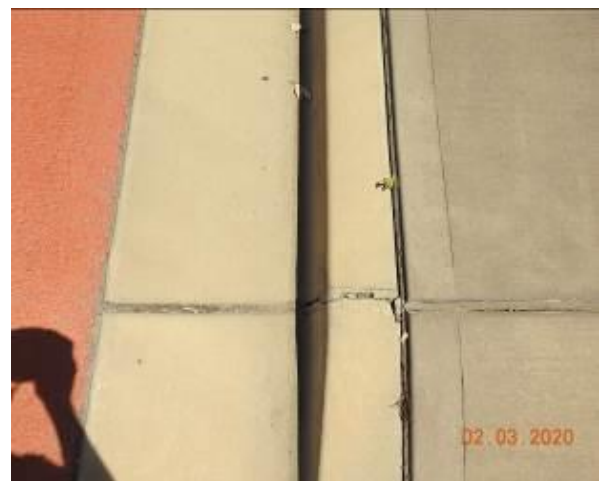
Figure 1701 – Crack propagation through kerb and gutter

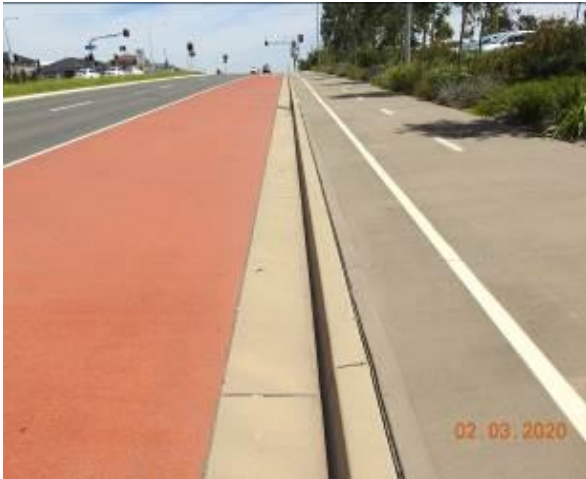
Figure 1702 – General Condition of kerb and gutter

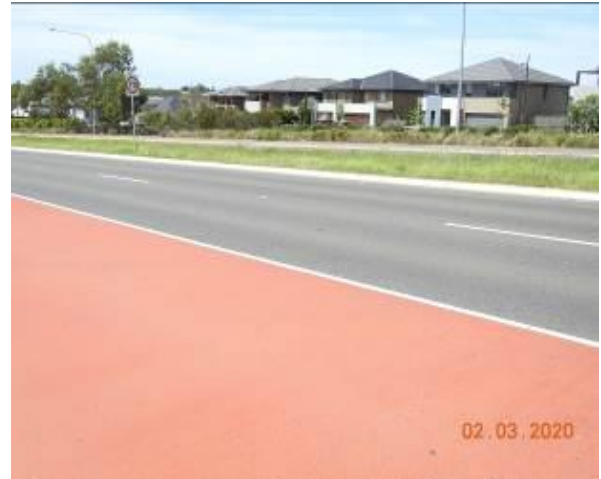
Figure 1703 – General Condition of road surface

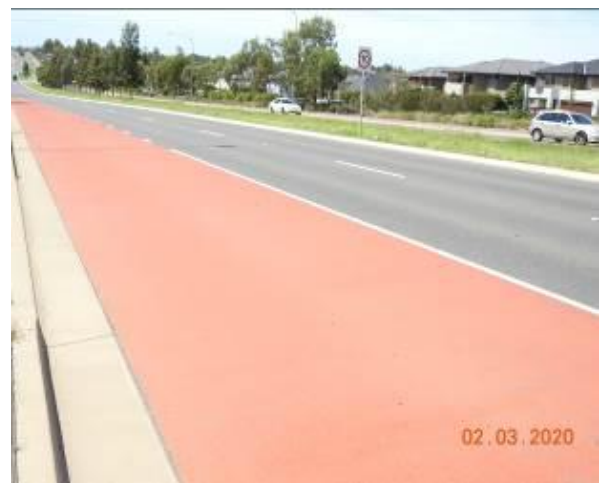
Figure 1705 – General Condition of road surface

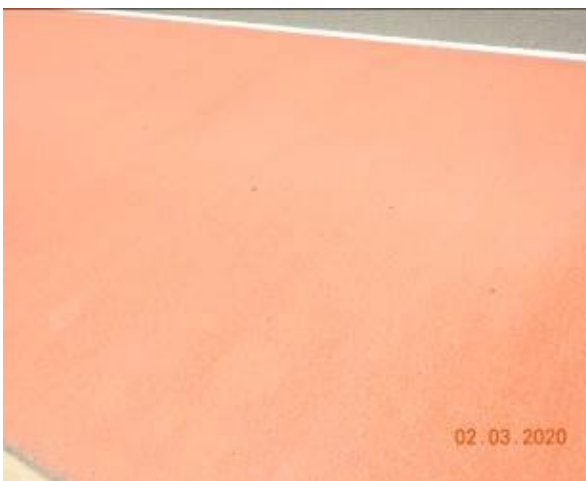
Figure 1706 – General Condition of road surface

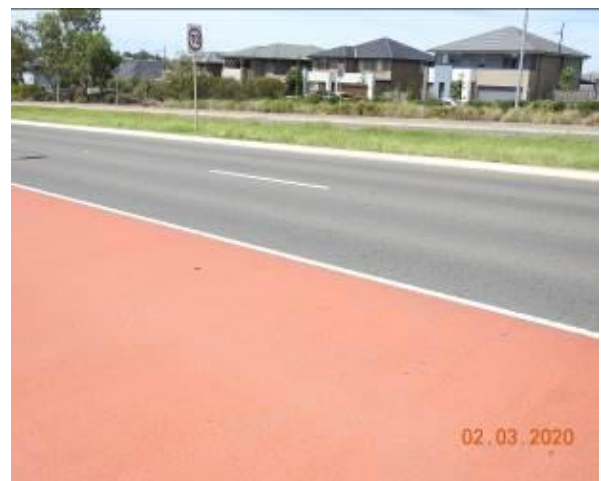
Figure 1707 – General Condition of road surface

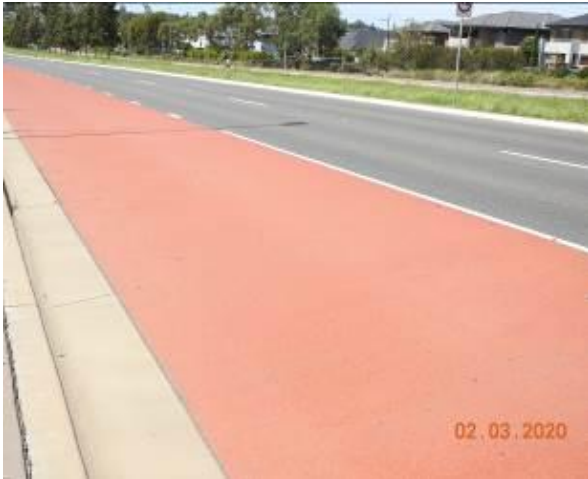
Figure 1708 – General Condition of road surface

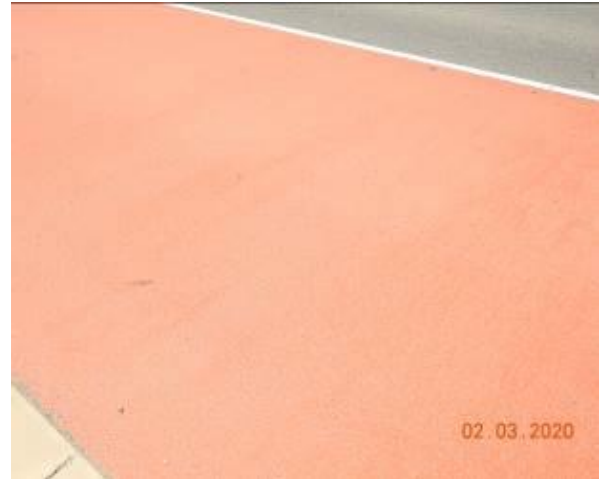
Figure 1709 – General Condition of road surface

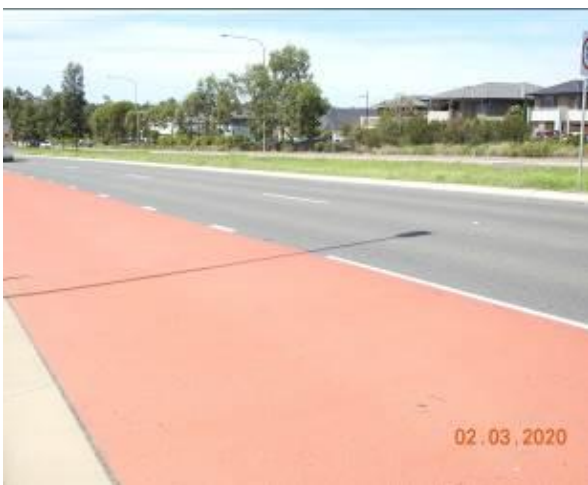
Figure 1710 – General Condition of road surface

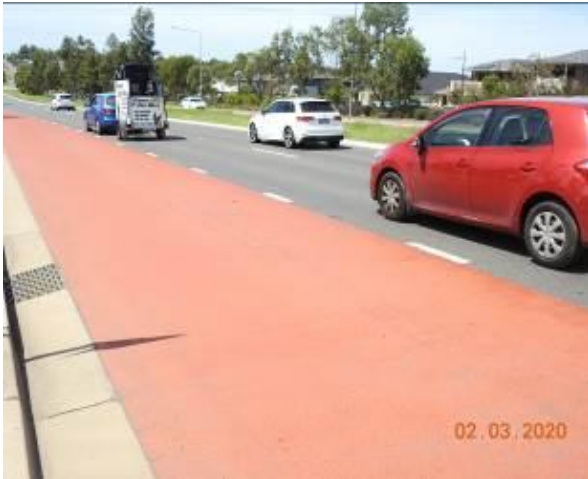
Figure 1714 – General Condition of road surface

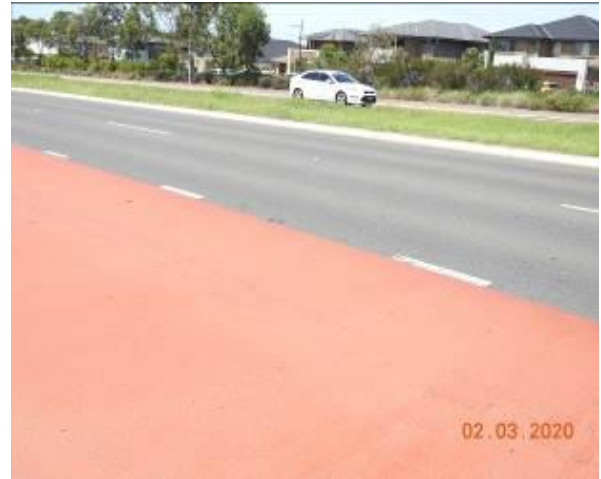
Figure 1715 – General Condition of road surface

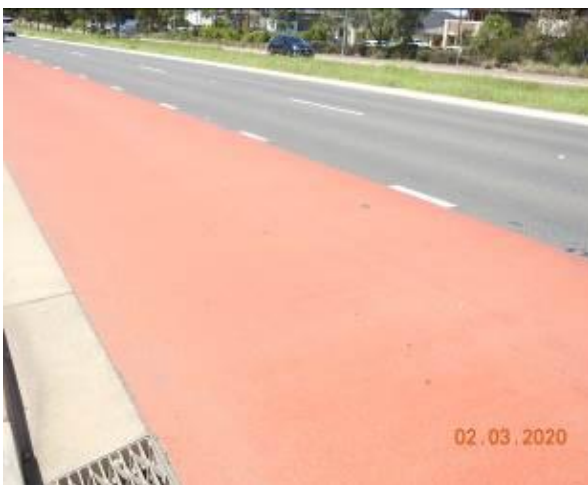
Figure 1716 – General Condition of road surface

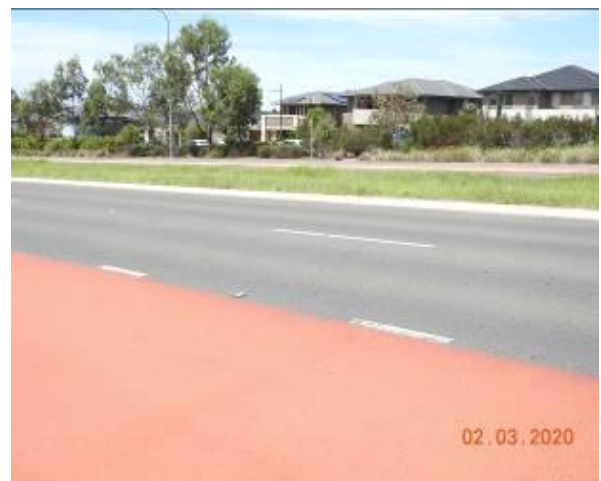
Figure 1719 – General Condition of road surface

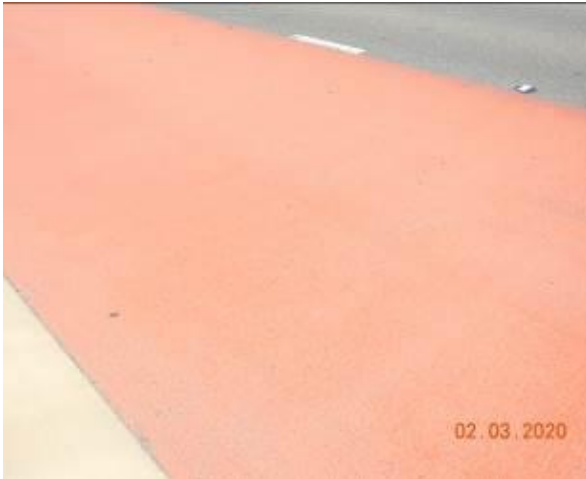
Figure 1720 – General Condition of road surface

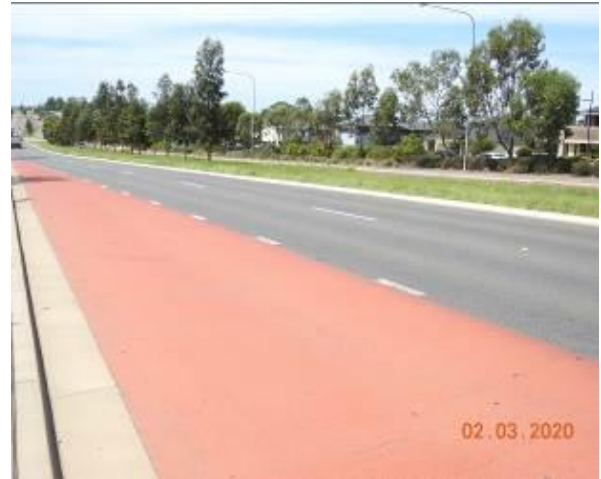
Figure 1721 – General Condition of road surface

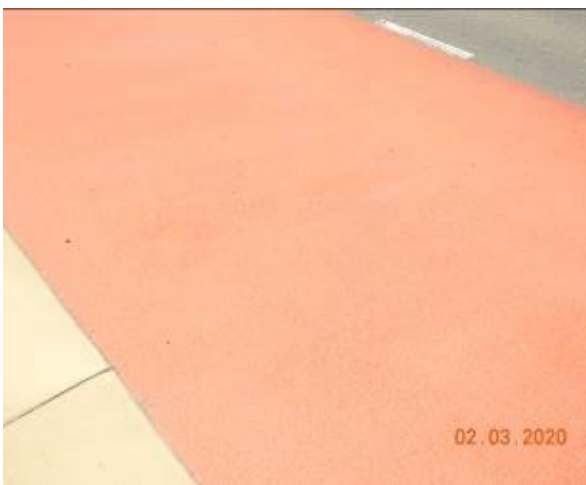
Figure 1722 – General Condition of road surface

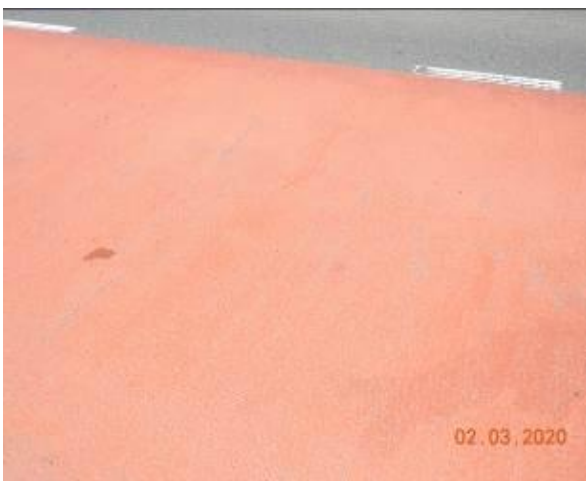
Figure 1724 – Crack propagation through road surface

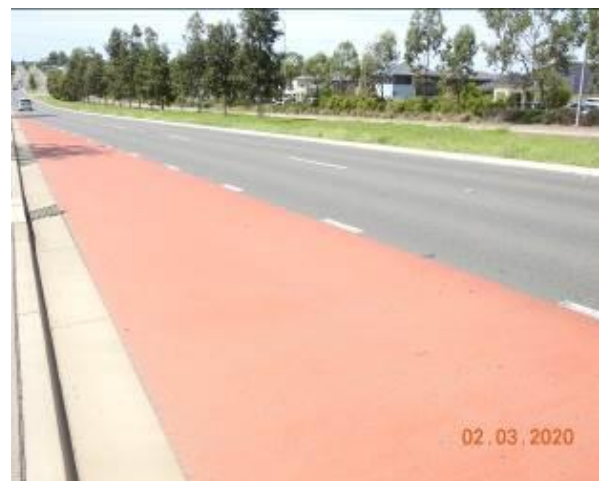
Figure 1725 – General Condition of road surface

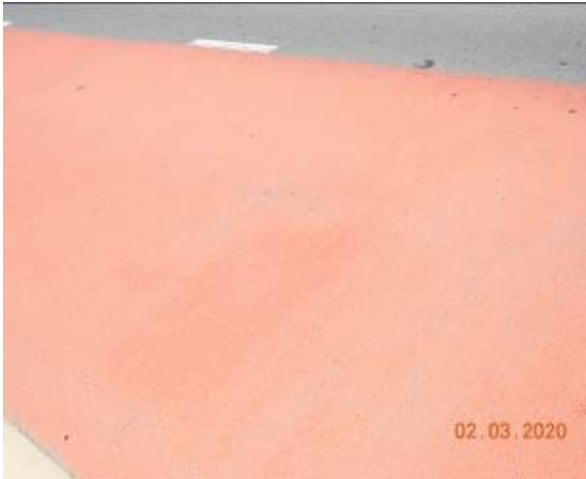
Figure 1726 – Crack propagation through road surface

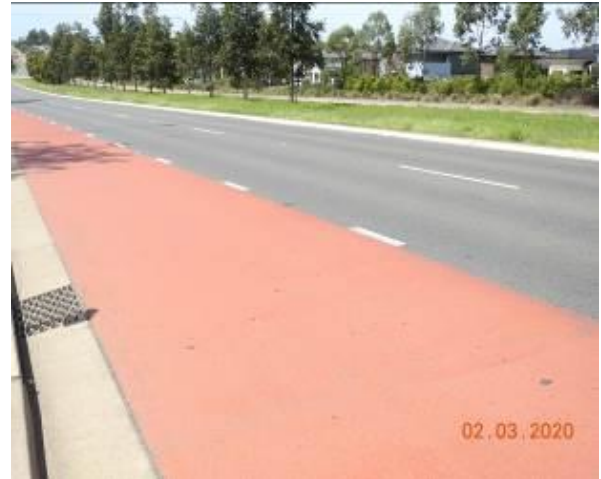
Figure 1727 – General Condition of road surface

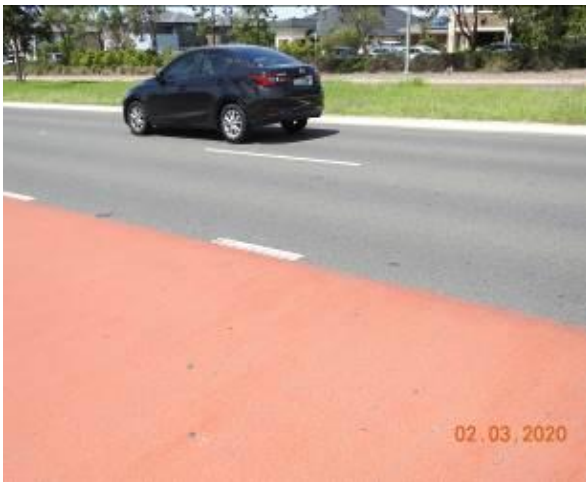
Figure 1728 – General Condition of road surface

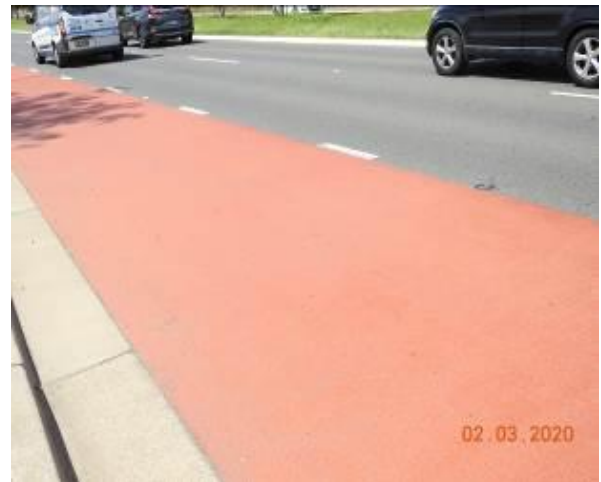
Figure 1729 – General Condition of road surface

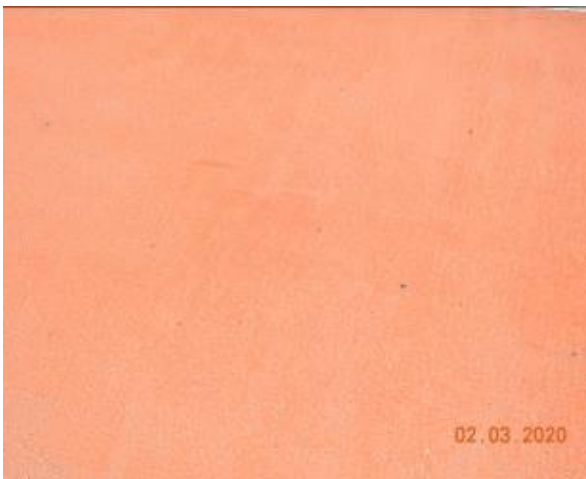
Figure 1730 – General Condition of road surface

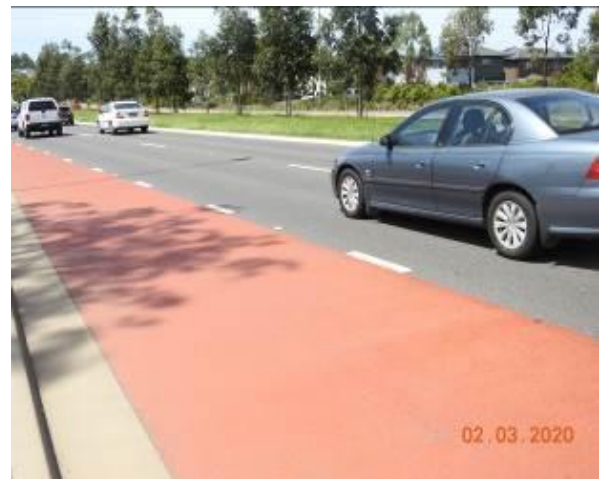
Figure 1731 – General Condition of road surface

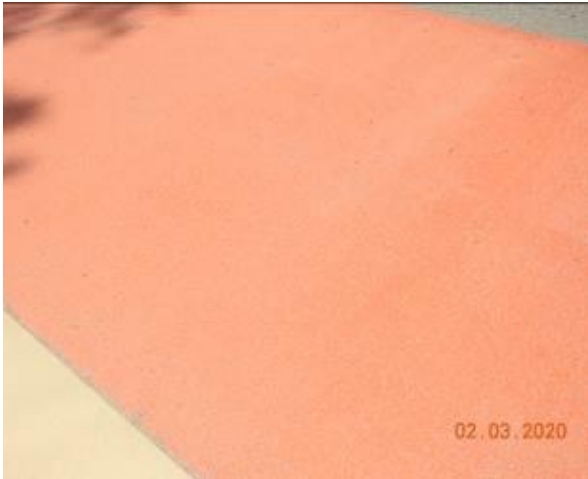
Figure 1732 – General Condition of road surface

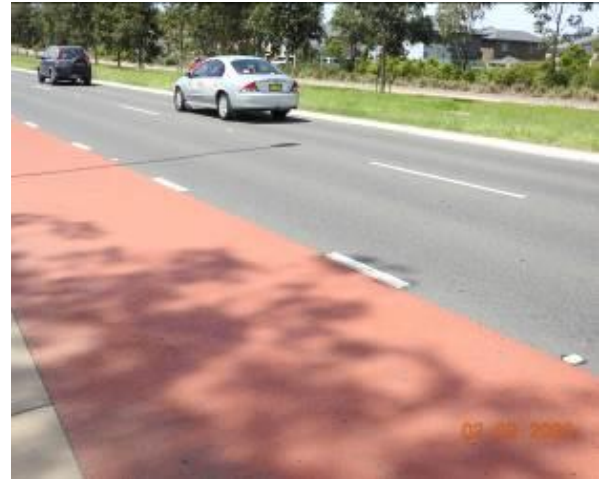
Figure 1733 – General Condition of road surface

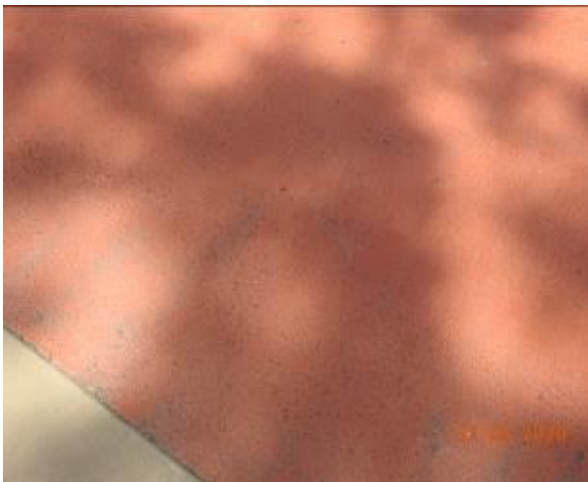
Figure 1734 – Crack propagation through road surface

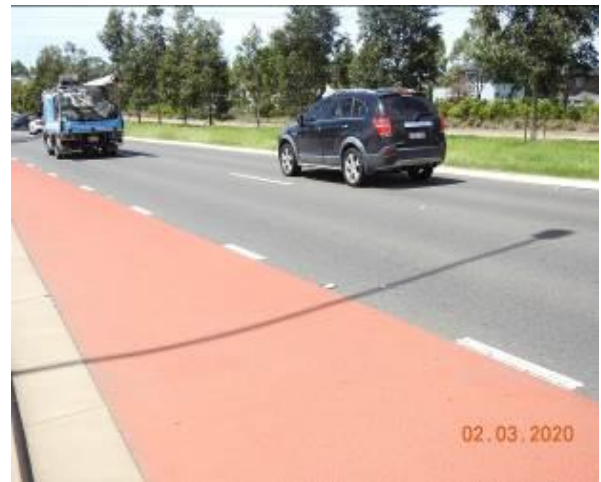
Figure 1735 – General Condition of road surface

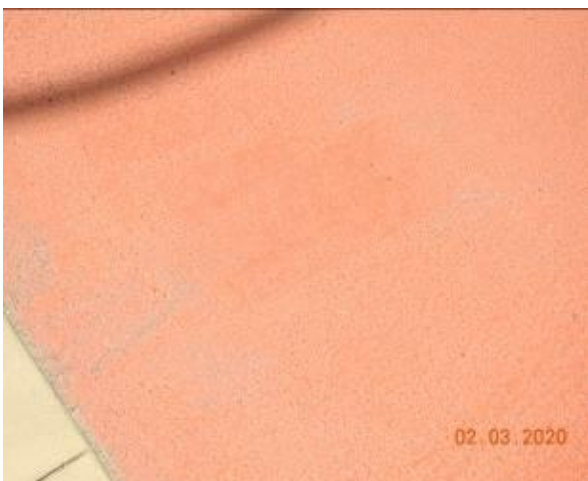
Figure 1736 – Crack propagation through road surface

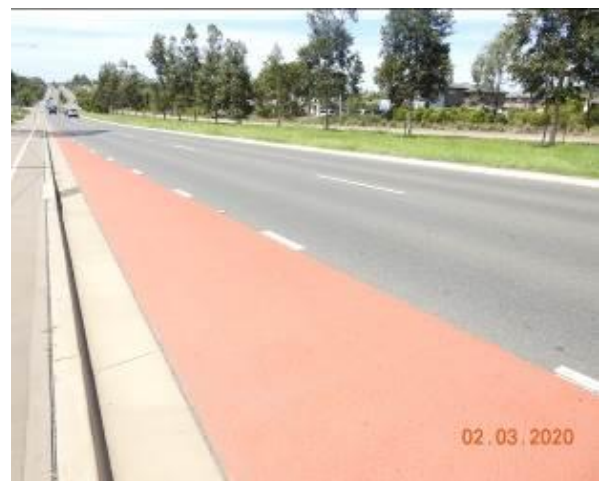
Figure 1737 – General Condition of road surface

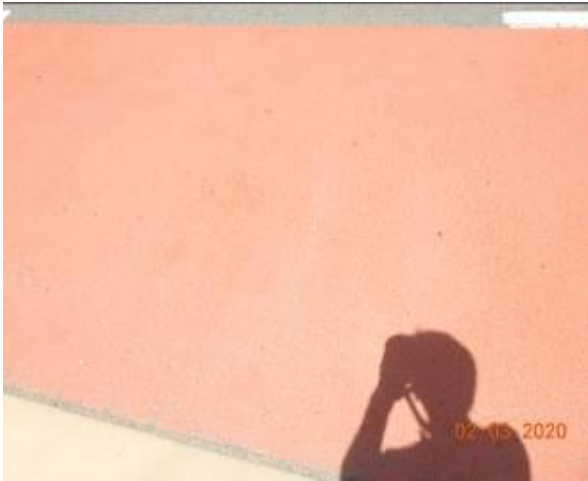
Figure 1738 – General Condition of road surface

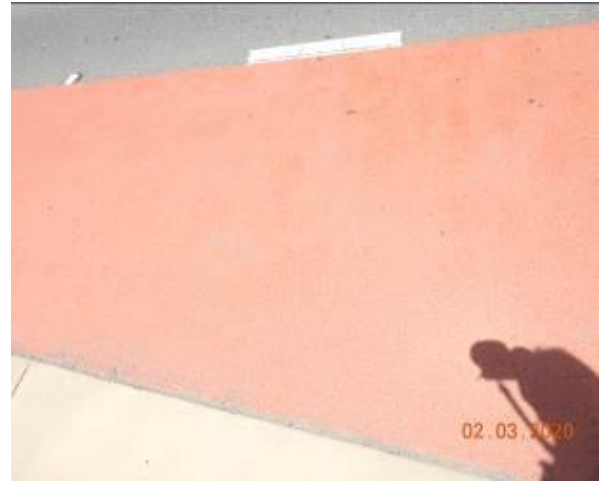
Figure 1739 – General Condition of road surface

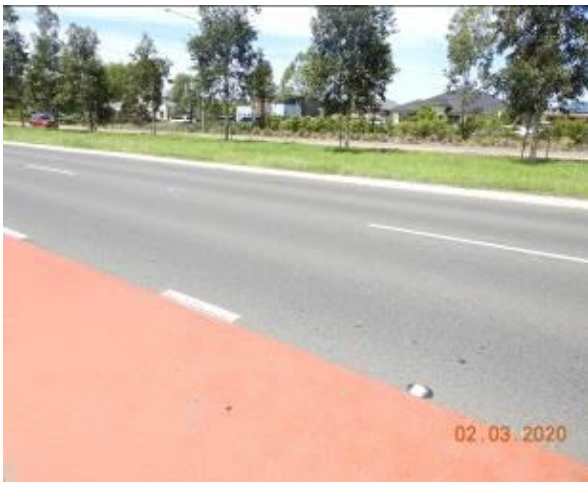
Figure 1740 – General Condition of road surface

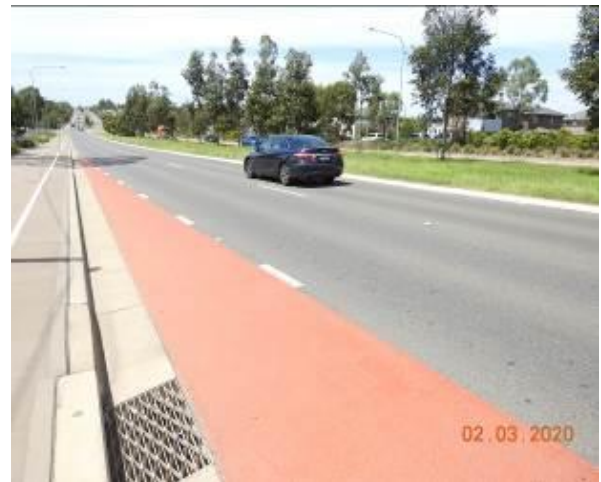
Figure 1741 – General Condition of road surface

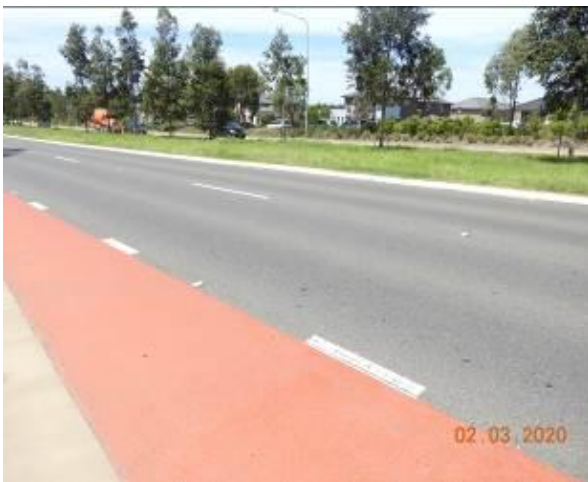
Figure 1742 – General Condition of road surface

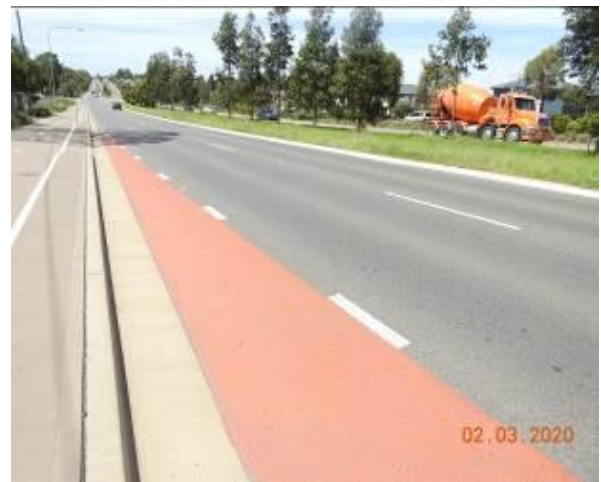
Figure 1743 – General Condition of road surface

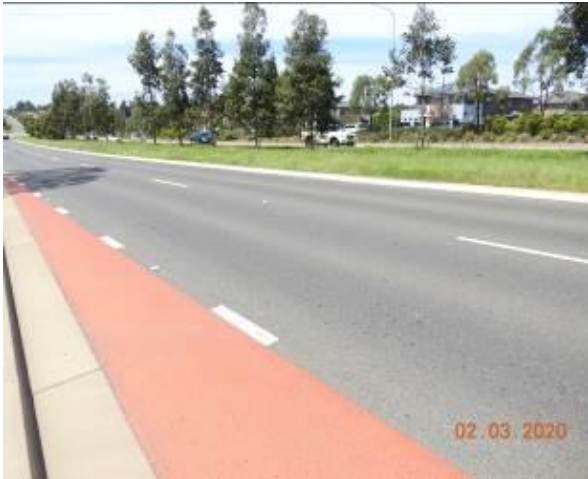
Figure 1744 – General Condition of road surface

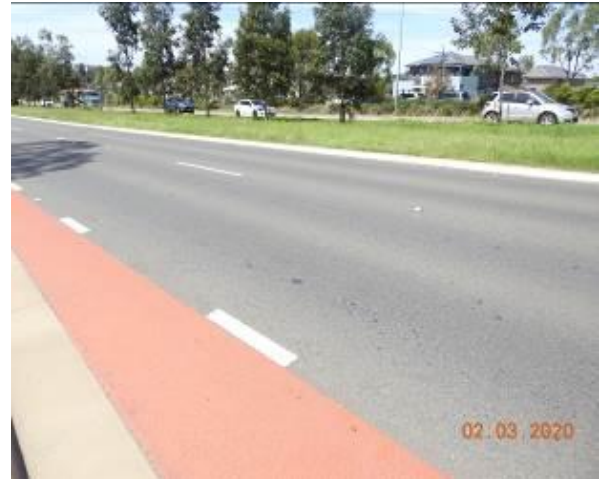
Figure 1745 – General Condition of road surface

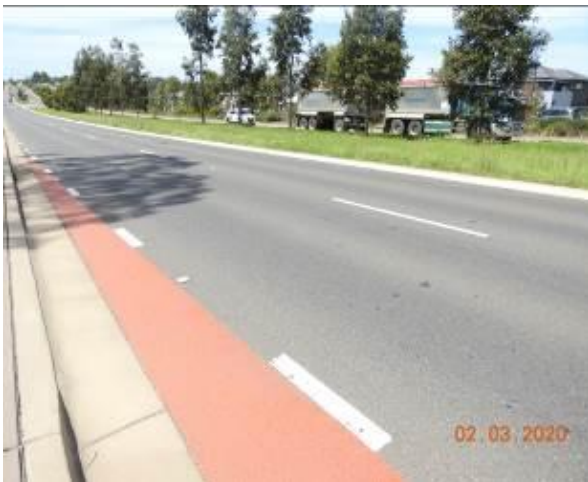
Figure 1746 – General Condition of road surface

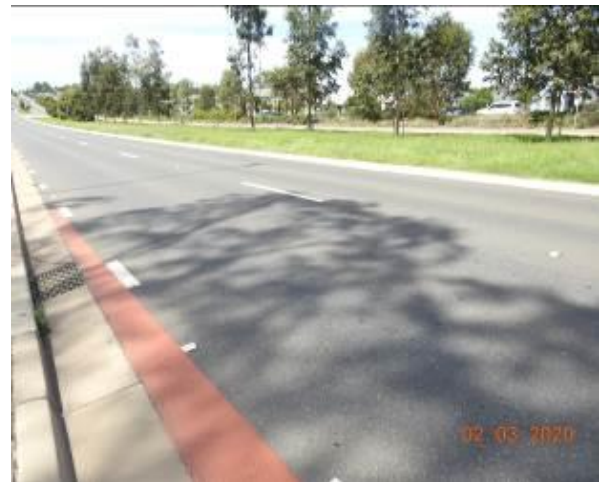
Figure 1747 – General Condition of road surface

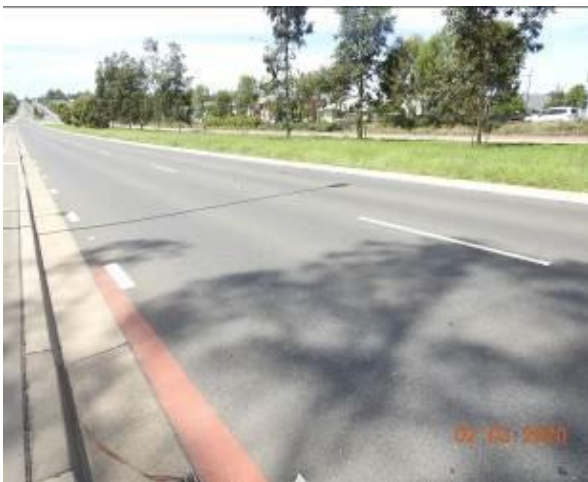
Figure 1748 – General Condition of road surface

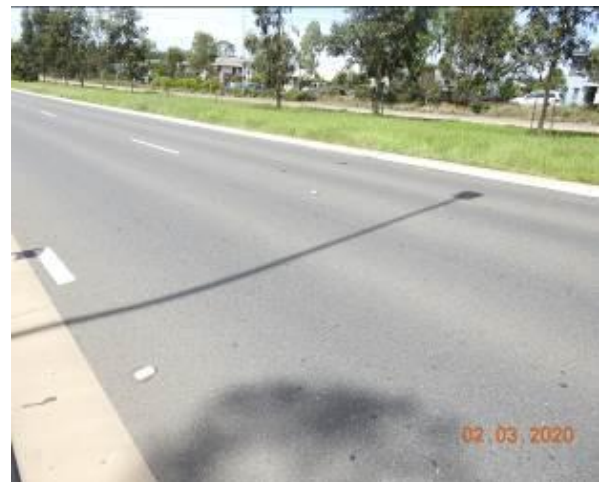
Figure 1749 – General Condition of road surface

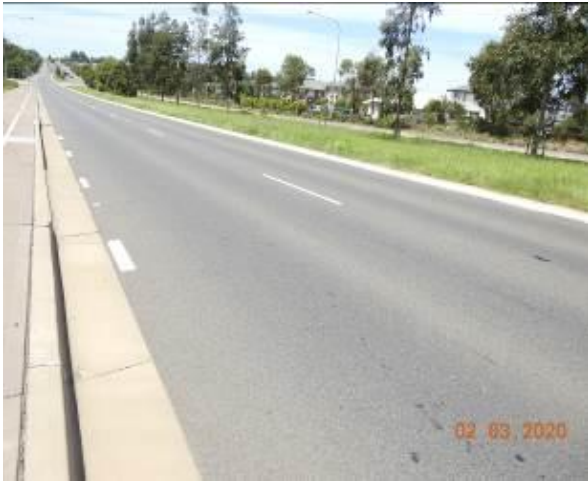
Figure 1750 – General Condition of road surface

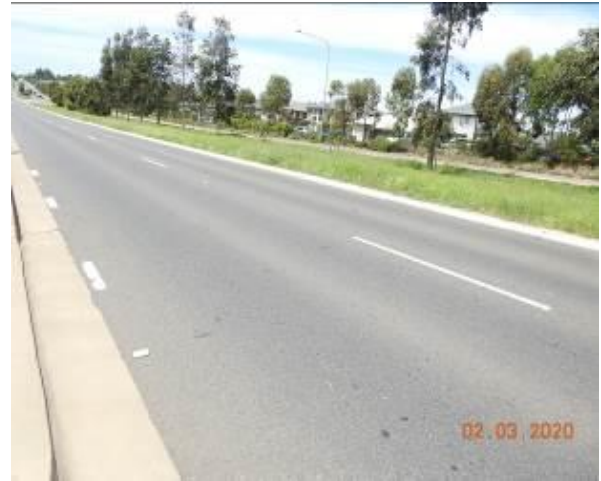
Figure 1751 – General Condition of road surface

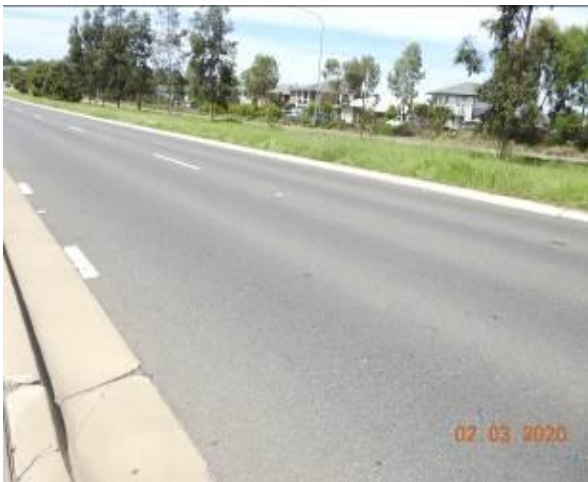
Figure 1752 – General Condition of road surface

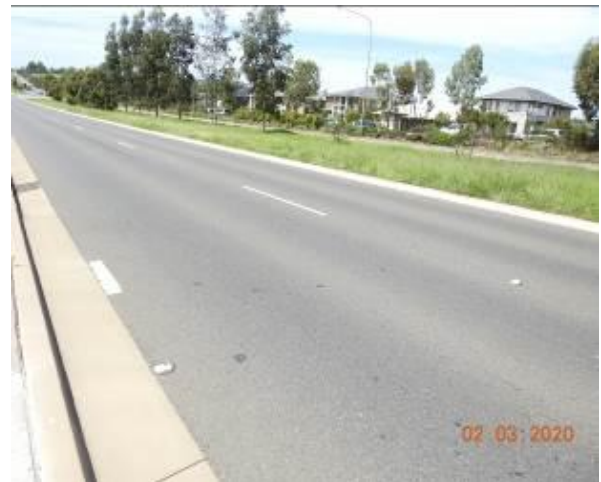
Figure 1753 – General Condition of road surface

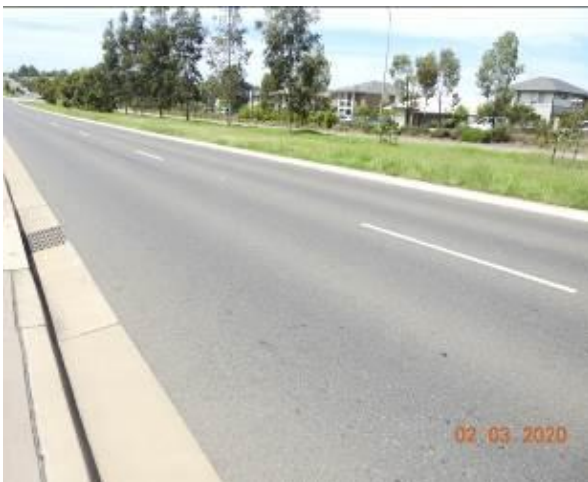
Figure 1754 – General Condition of road surface

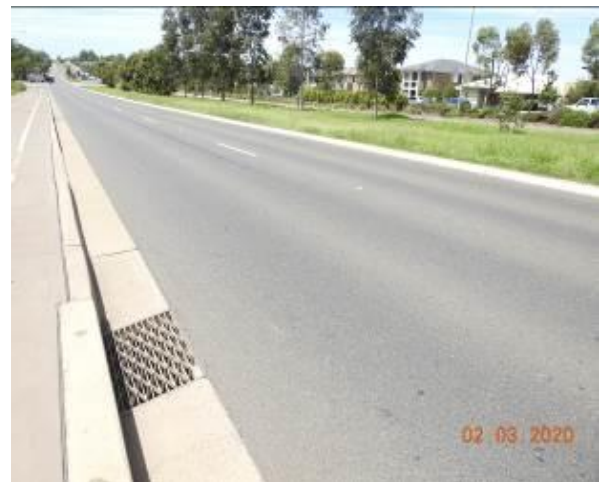
Figure 1755 – General Condition of road surface

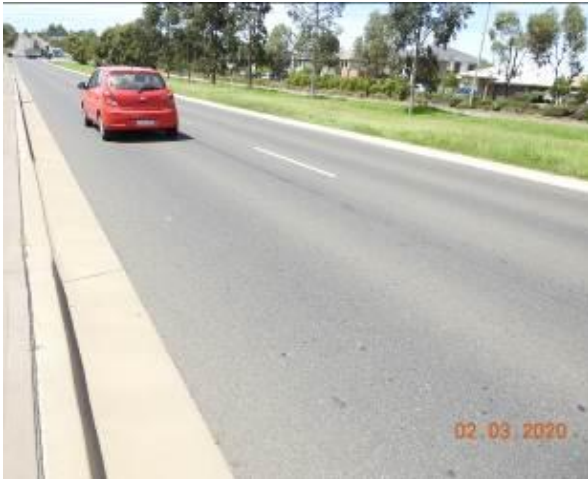
Figure 1756 – General Condition of road surface

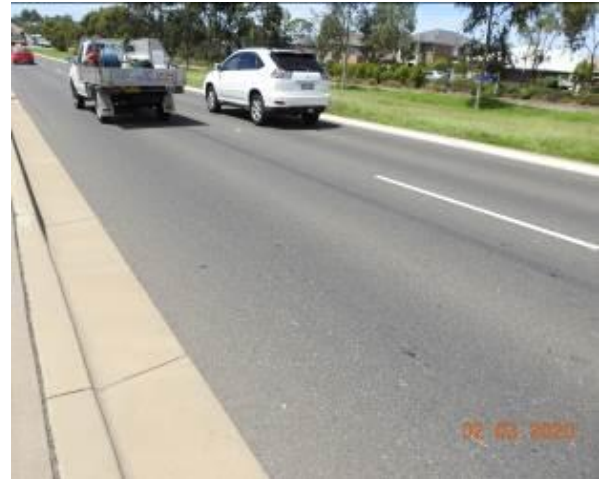
Figure 1757 – General Condition of road surface

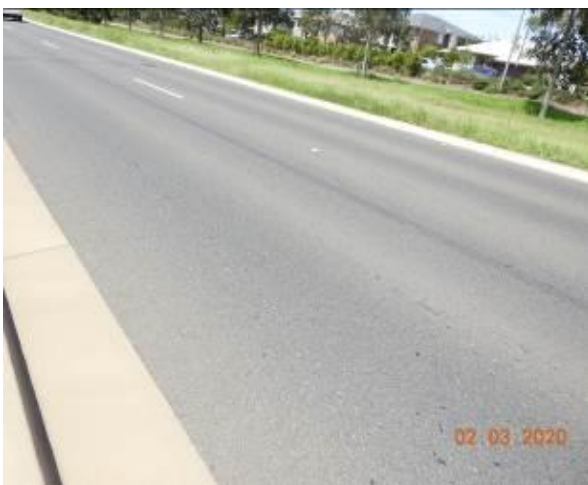
Figure 1758 – General Condition of road surface

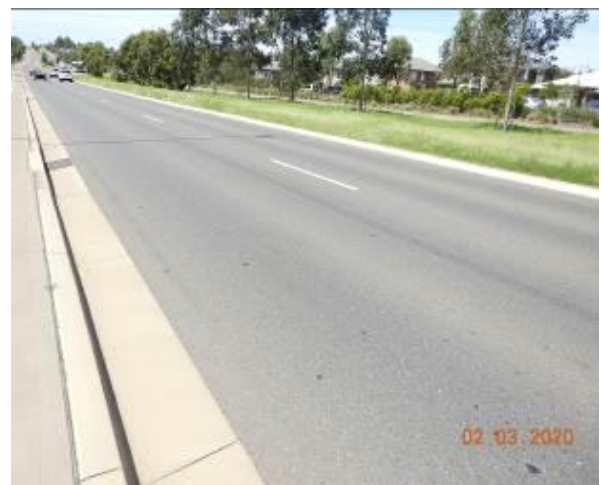
Figure 1759 – General Condition of road surface

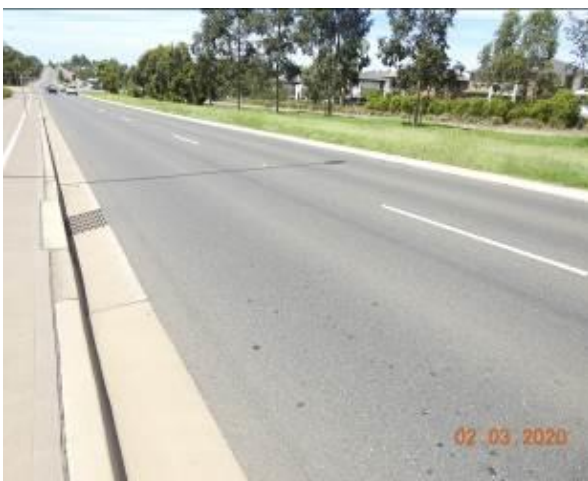
Figure 1760 – General Condition of road surface

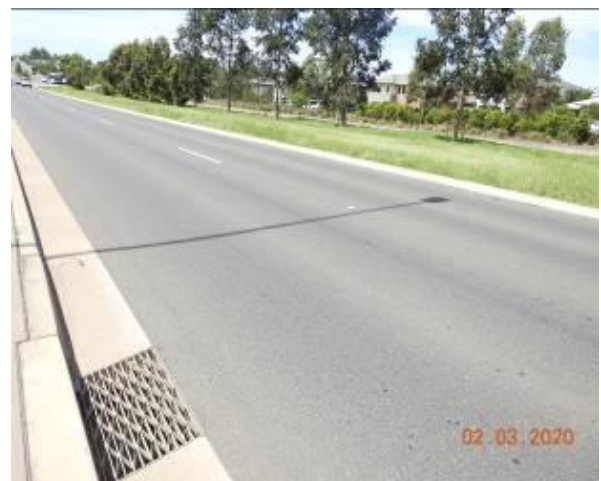
Figure 1761 – General Condition of road surface

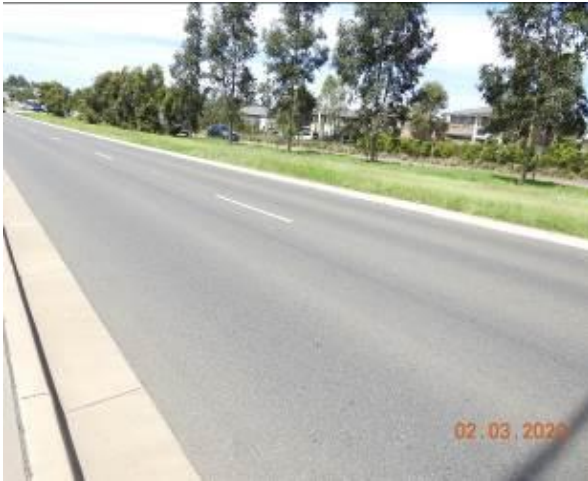
Figure 1762 – General Condition of road surface
