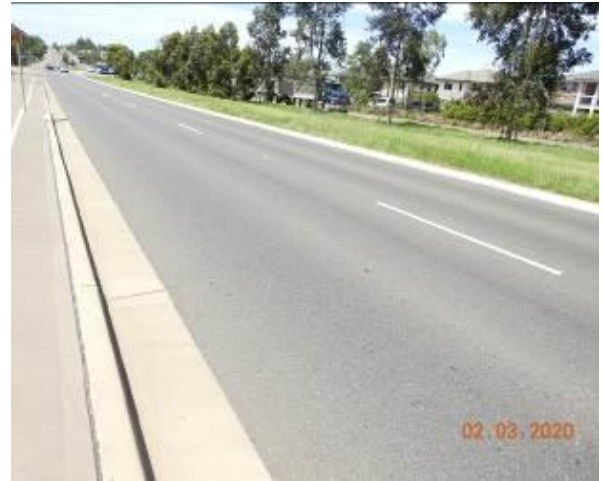
Figure 1763 – General Condition of road surface

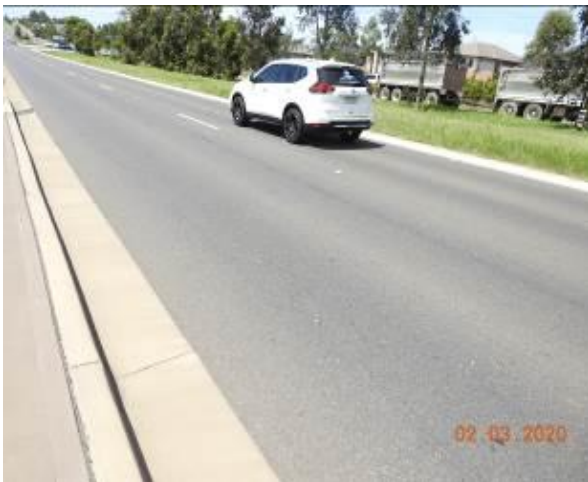
Figure 1764 – General Condition of road surface

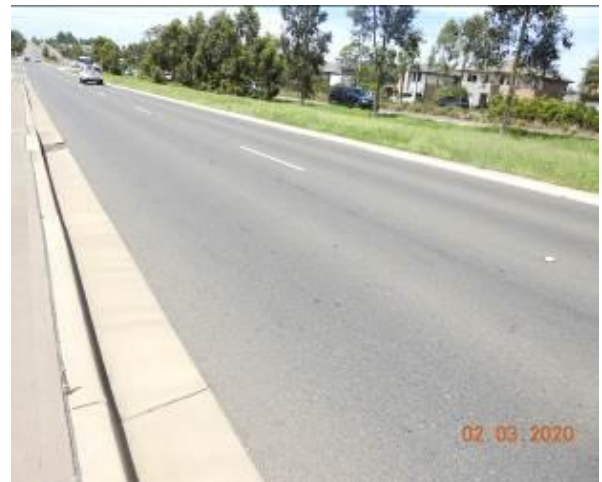
Figure 1765 – General Condition of road surface

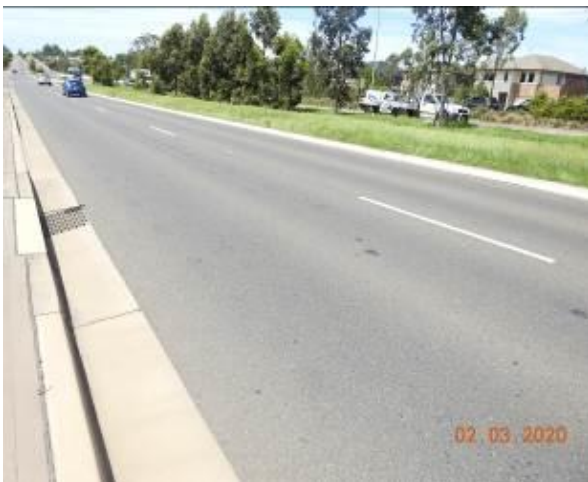
Figure 1766 – General Condition of road surface

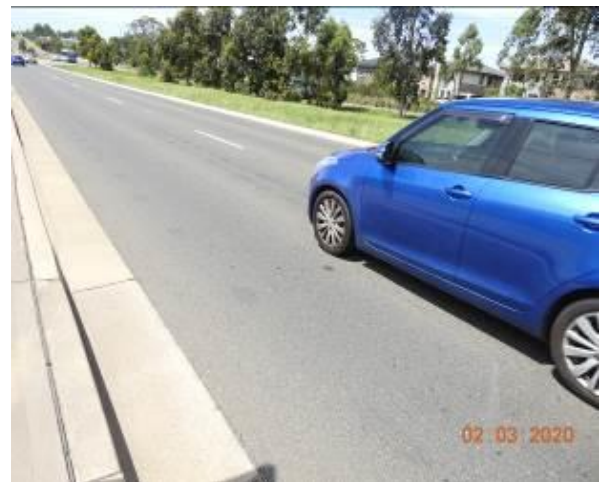
Figure 1767 – General Condition of road surface

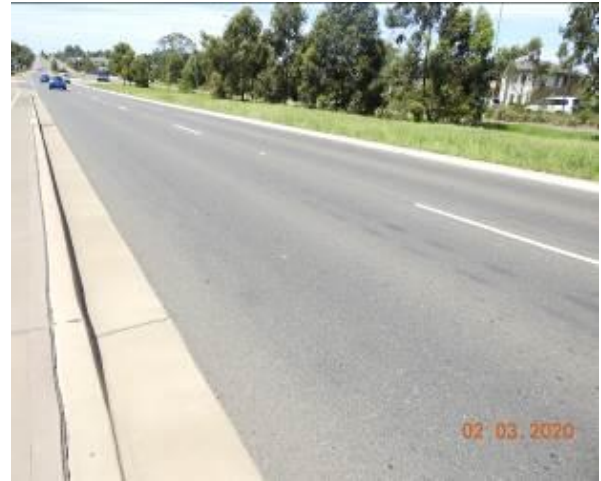
Figure 1769 – General Condition of road surface

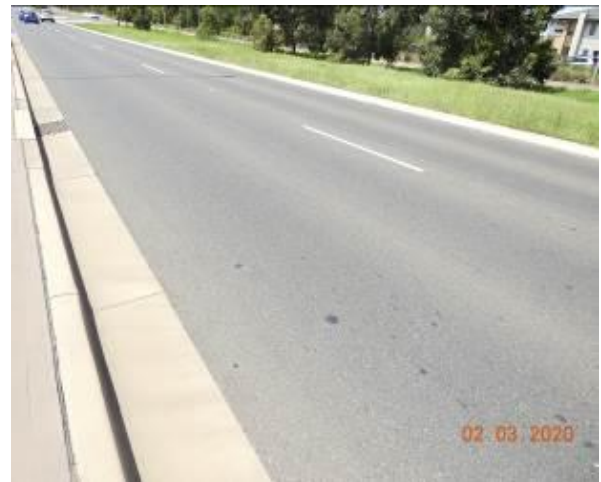
Figure 1771 – General Condition of road surface

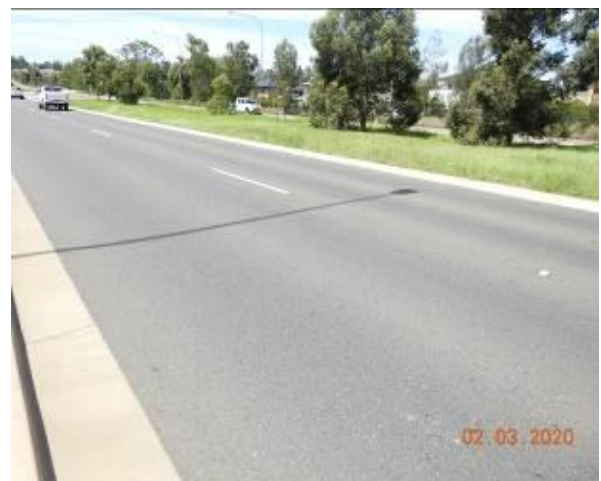
Figure 1773 – General Condition of road surface

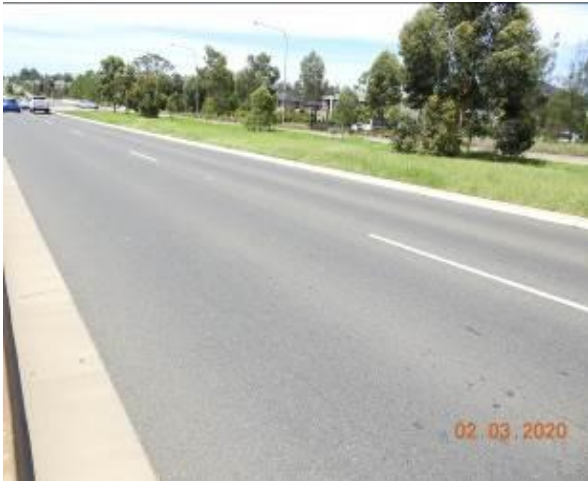
Figure 1774 – General Condition of road surface

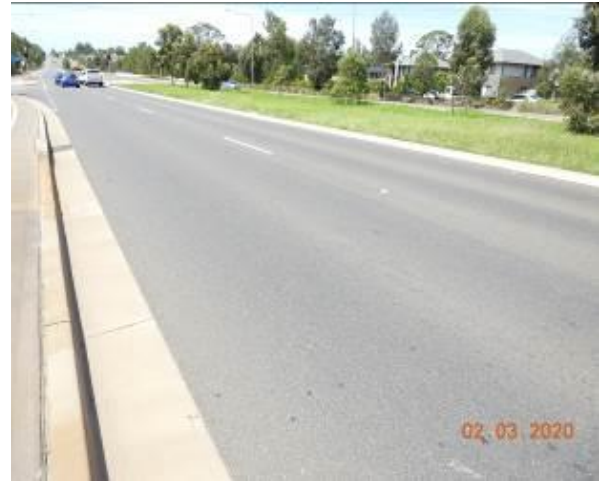
Figure 1775 – General Condition of road surface

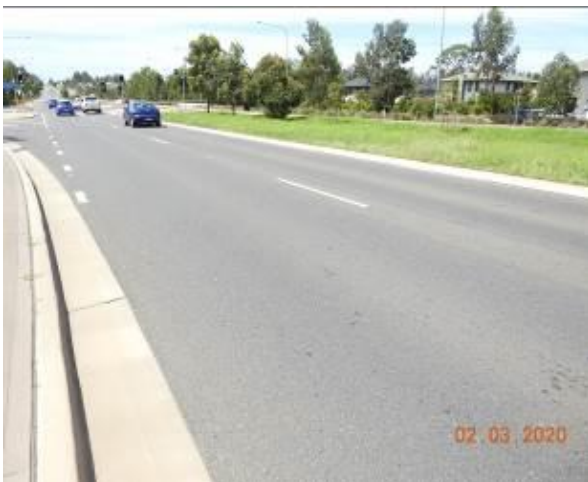
Figure 1778 – General Condition of road surface

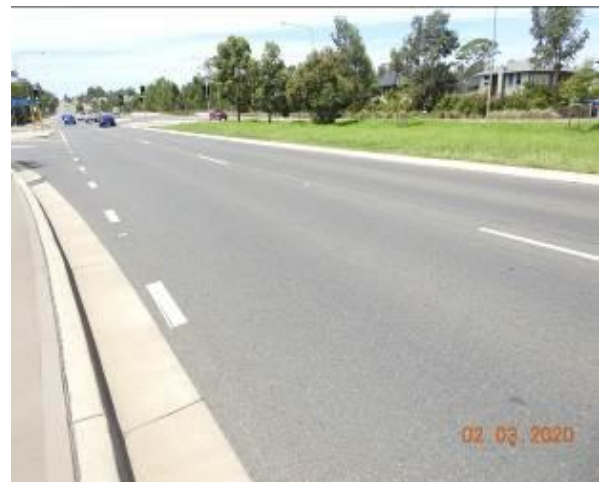
Figure 1779 – General Condition of road surface

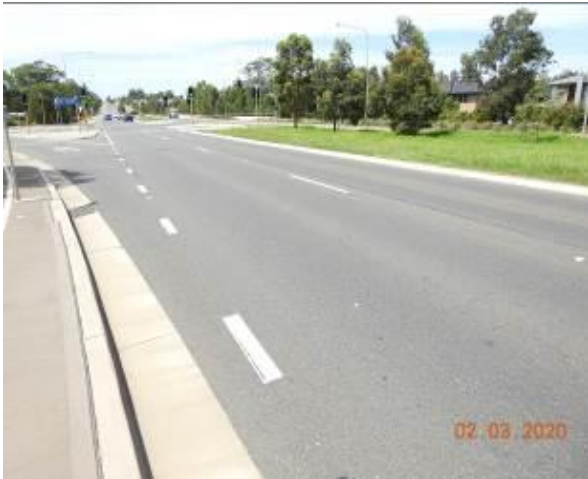
Figure 1780 – General Condition of road surface

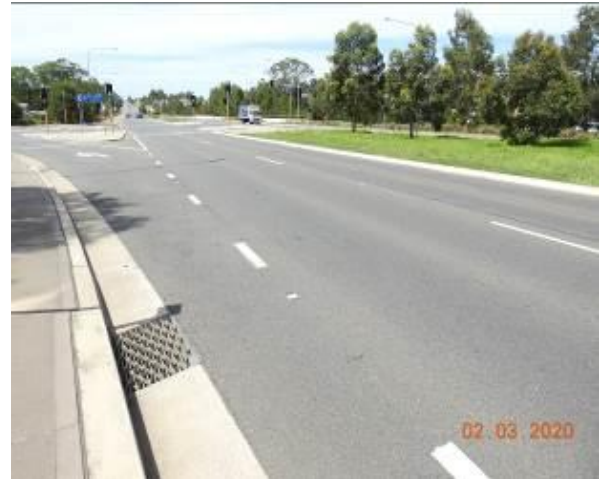
Figure 1781 – General Condition of road surface

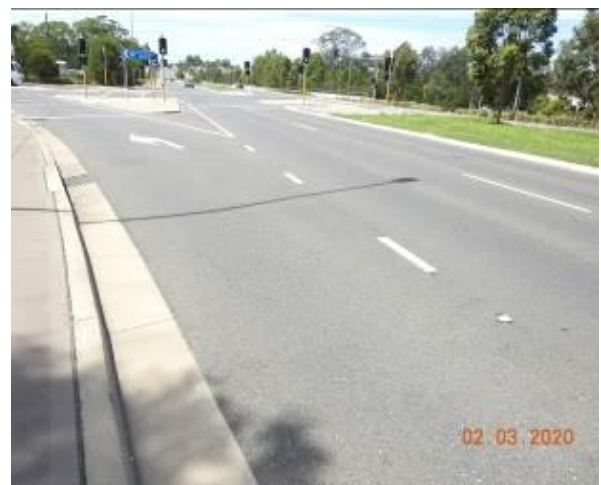
Figure 1783 – General Condition of road surface

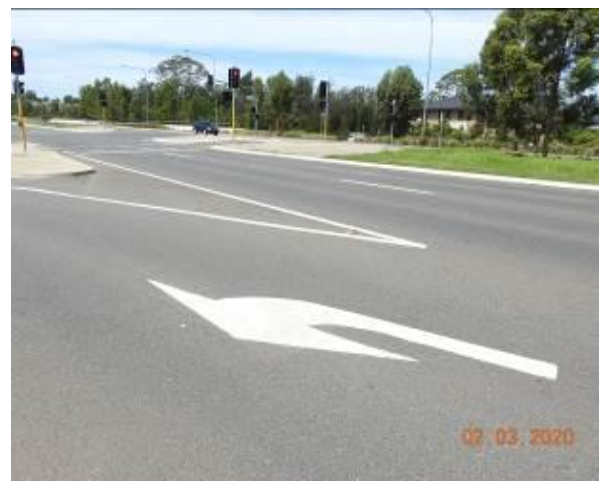
Figure 1785 – General Condition of road surface

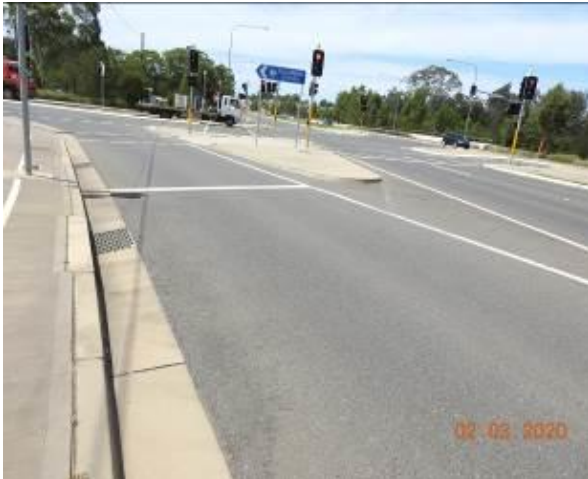
Figure 1786 – General Condition of road surface

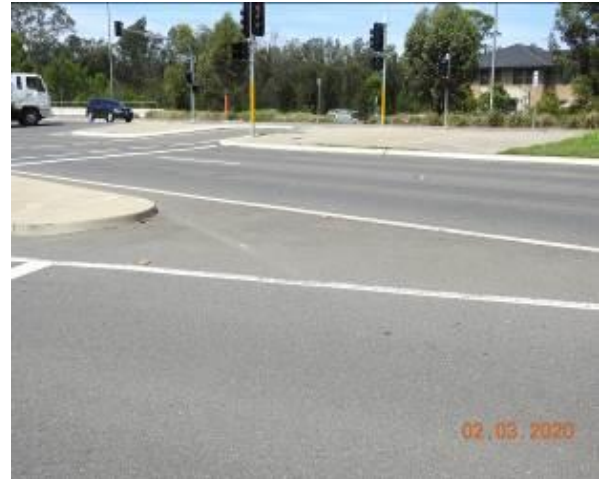
Figure 1787 – General Condition of road surface

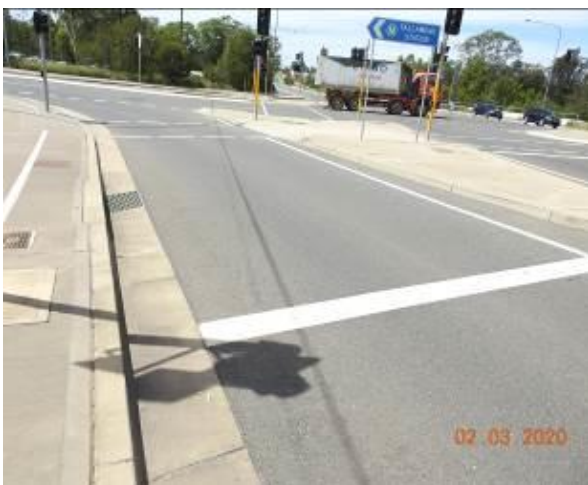
Figure 1788 – General Condition of road surface

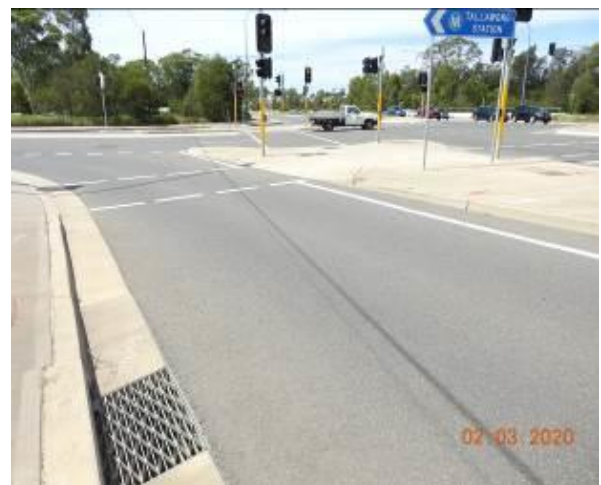
Figure 1789 – General Condition of road surface

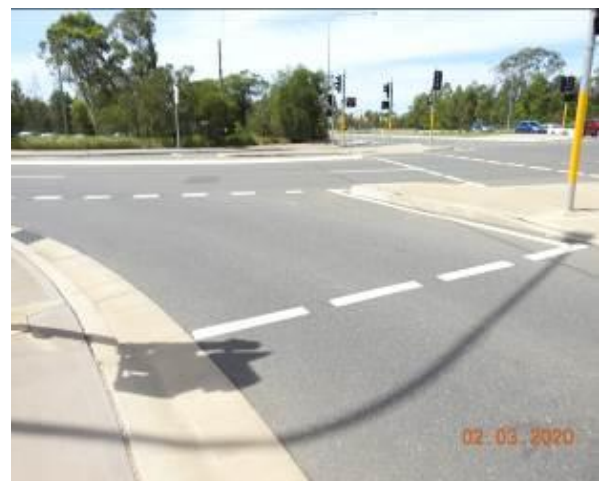
Figure 1791 – General Condition of road surface

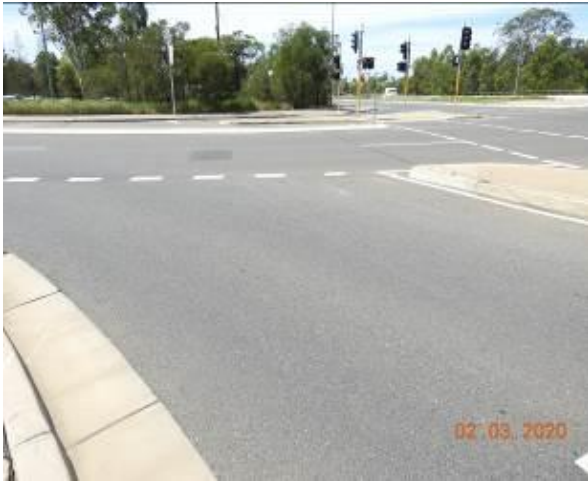
Figure 1792 – General Condition of road surface

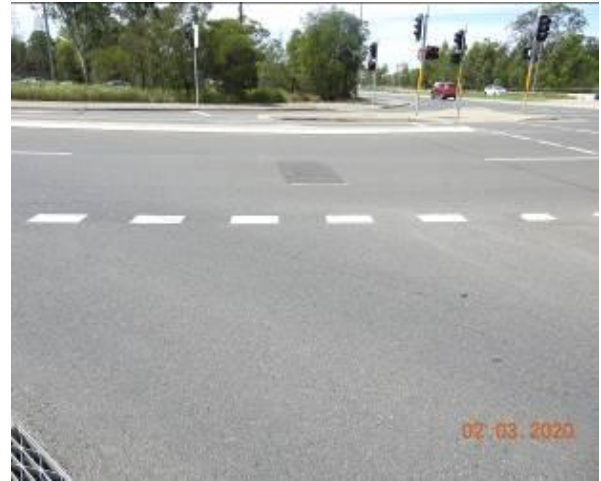
Figure 1793 – General Condition of road surface

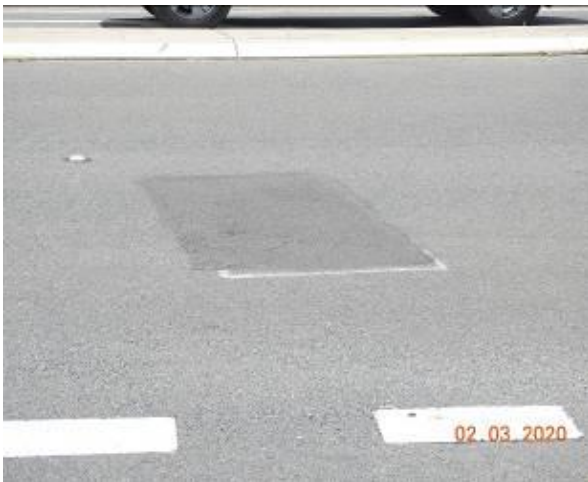
Figure 1794 – Evidence of patchwork through road surface

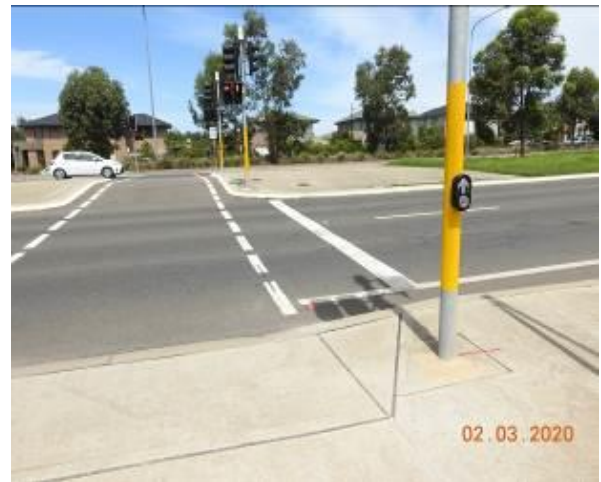
Figure 1795 – General Condition of road surface

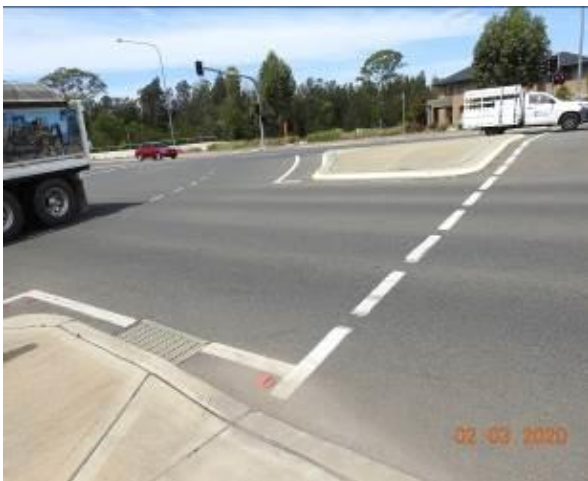
Figure 1796 – General Condition of road surface

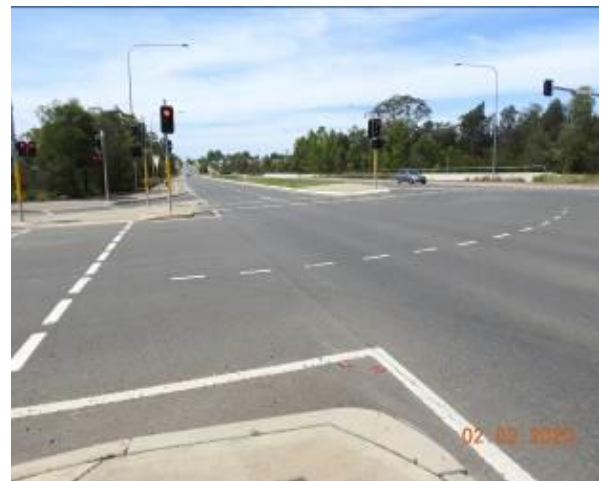
Figure 1797 – General Condition of road surface

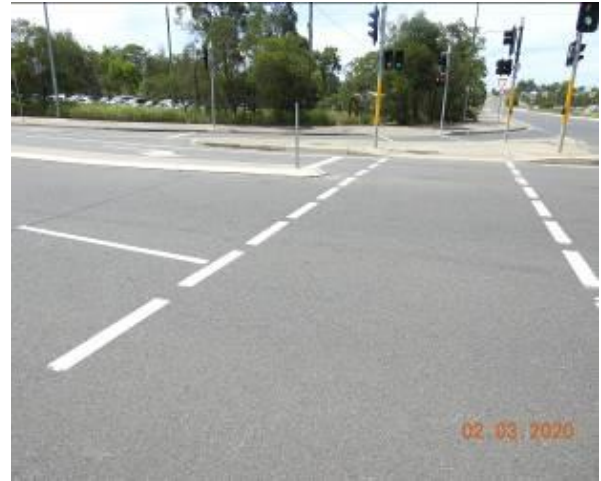
Figure 1799 – General Condition of road surface

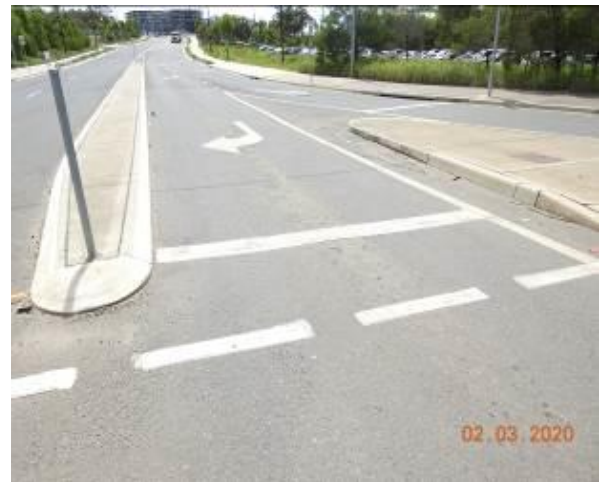
Figure 1801 – General Condition of road surface

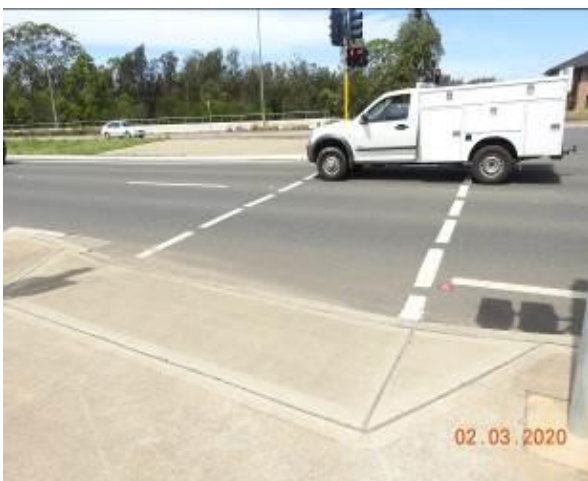
Figure 1802 – General Condition of road surface

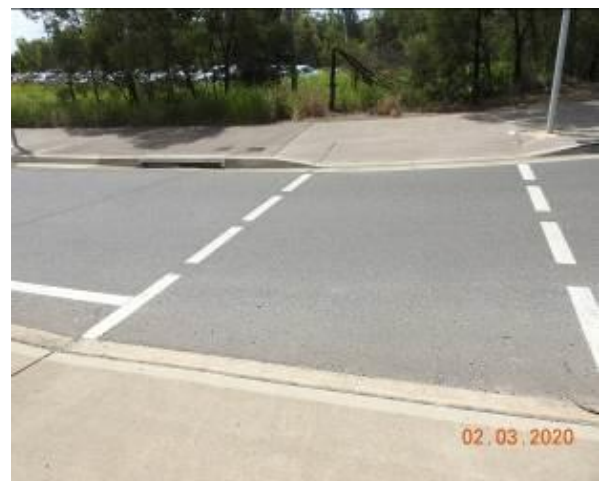
Figure 1803 – General Condition of road surface

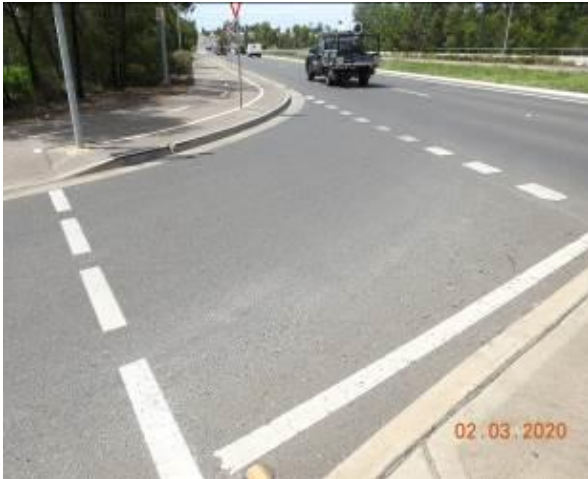
Figure 1804 – General Condition of road surface

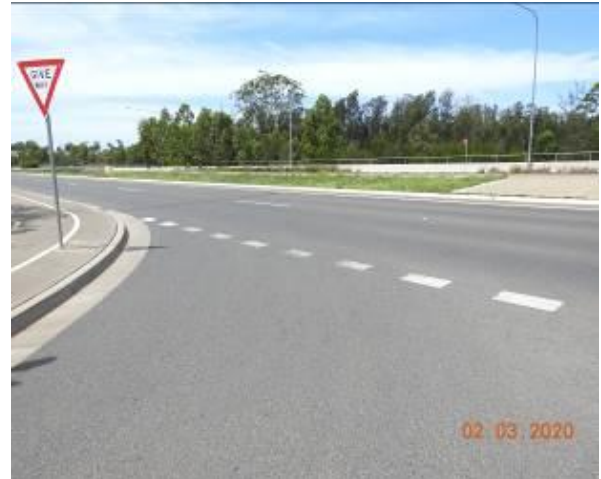
Figure 1805 – General Condition of road surface

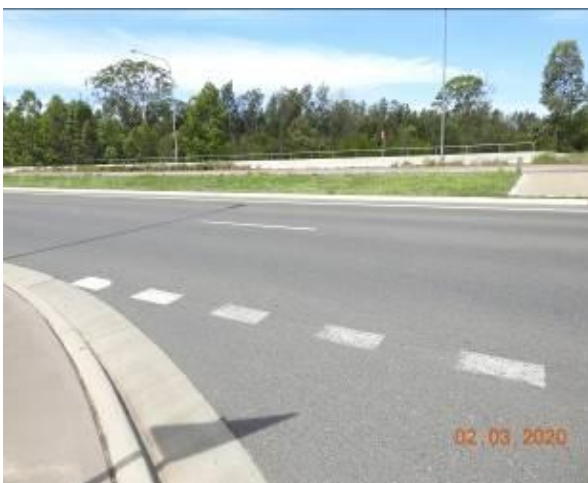
Figure 1806 – General Condition of road surface

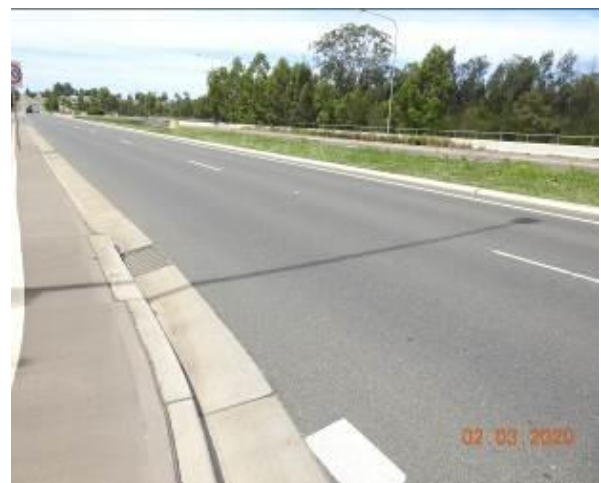
Figure 1807 – General Condition of road surface

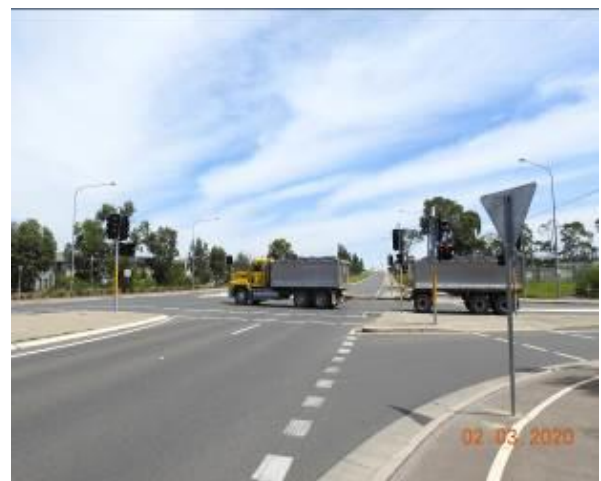
Figure 1809 – General Condition of road surface

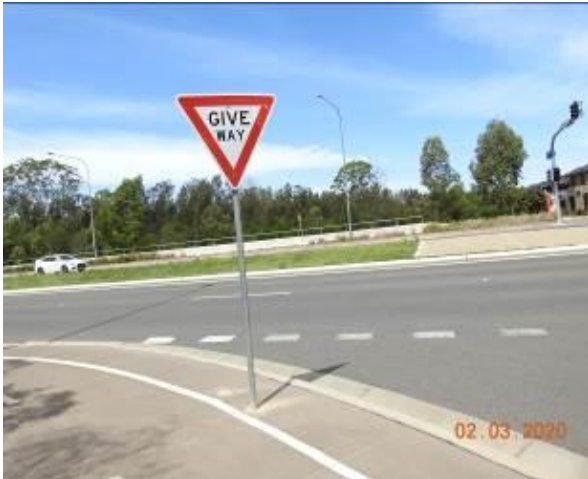
Figure 1810 –General Condition of street sign

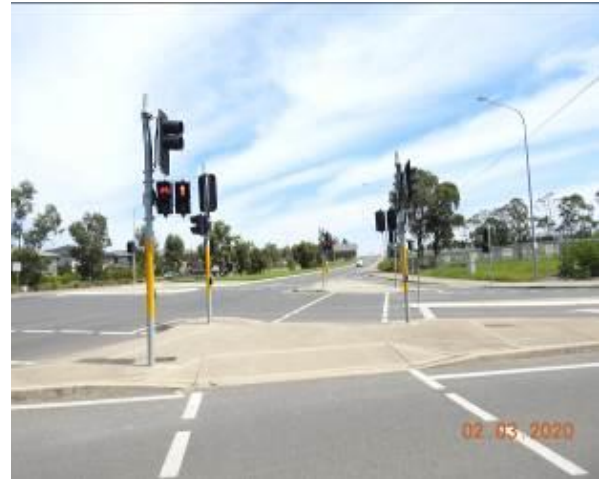
Figure 1811 – General Condition of traffic light

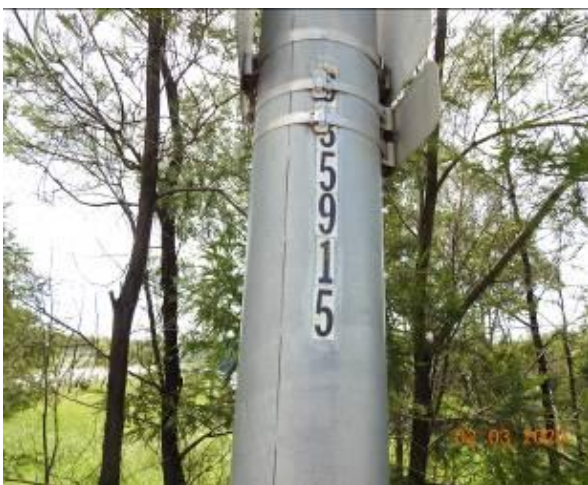
Figure 1812 – General Condition of lamp post
Identification No.835915

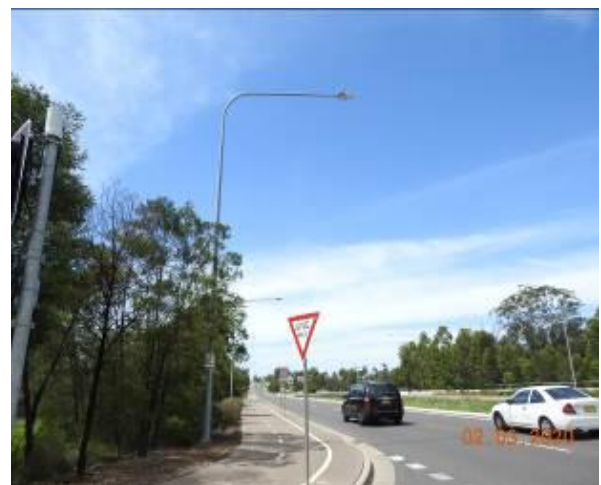
Figure 1813 – General Condition of lamp post

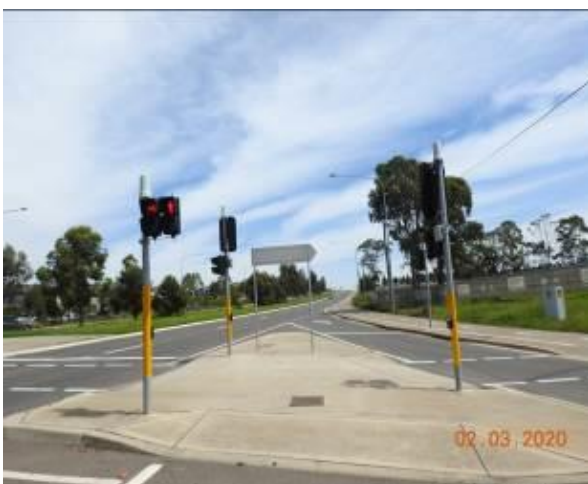
Figure 1814 – General Condition of traffic light

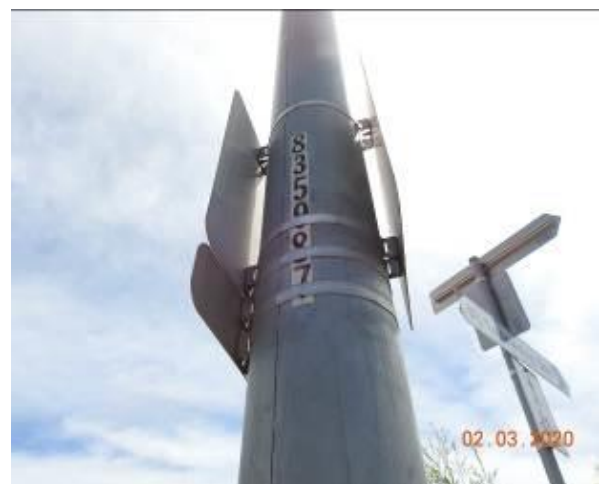
Figure 1815 – General Condition of lamp post
Identification No.835987

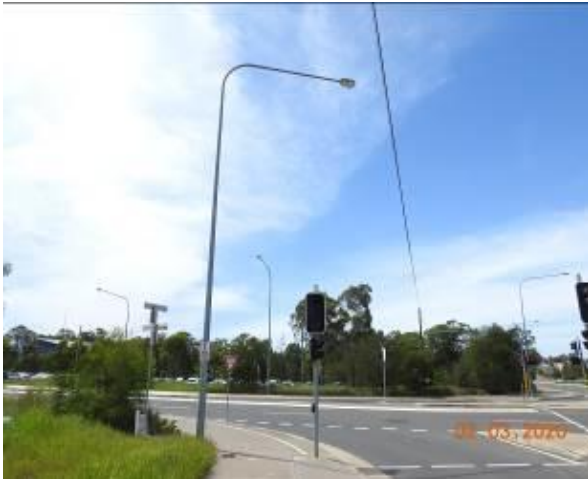
Figure 1816 – General Condition of lamp post

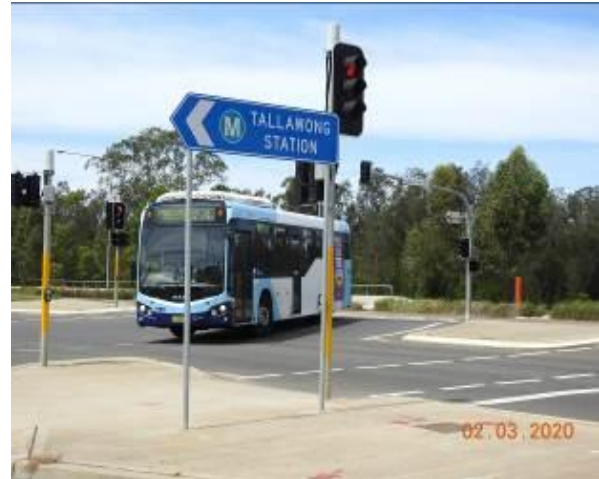
Figure 1817 – General Condition of street sign

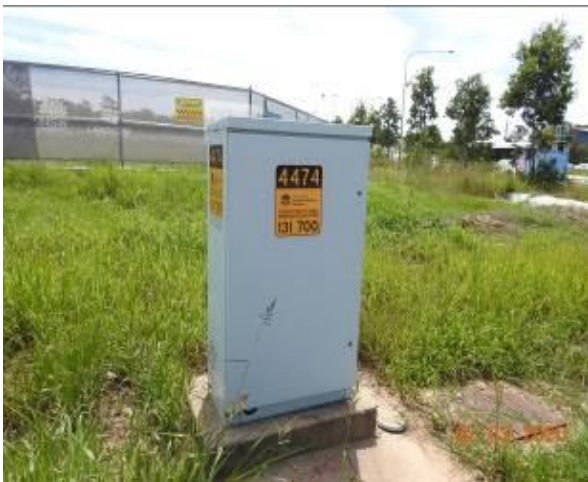
Figure 1818 – General Condition of electricity box
Identification No.4474

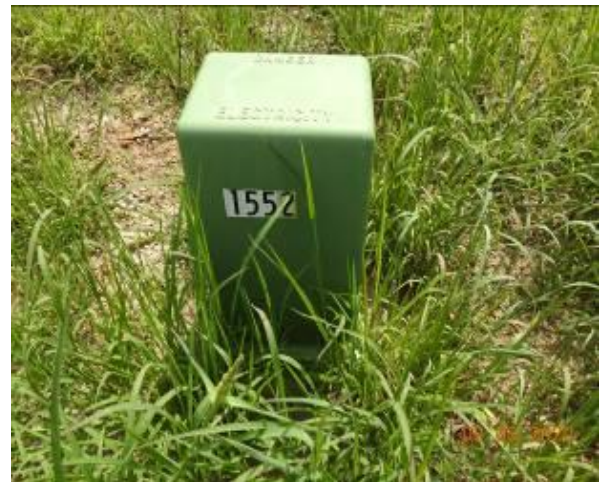
Figure 1819 – General Condition of electricity box
Identification No.1552

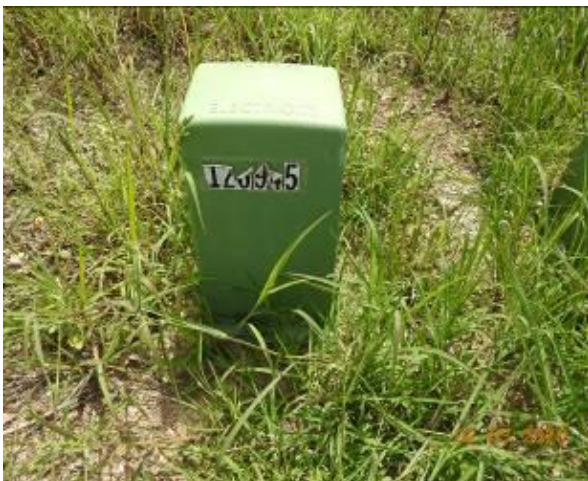
Figure 1820 – General Condition of electricity box
Identification No.126945

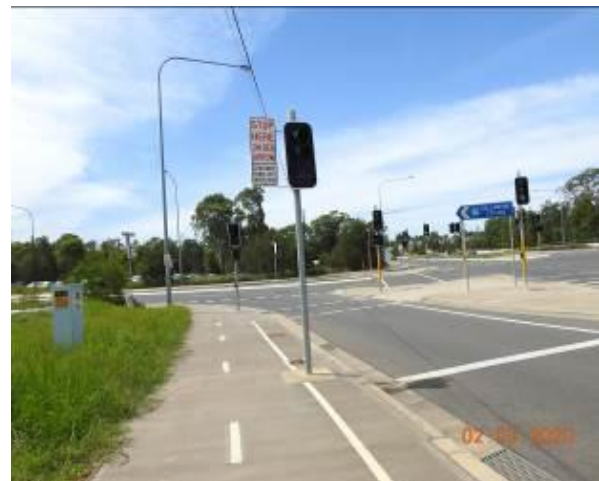
Figure 1821 – General Condition of street sign

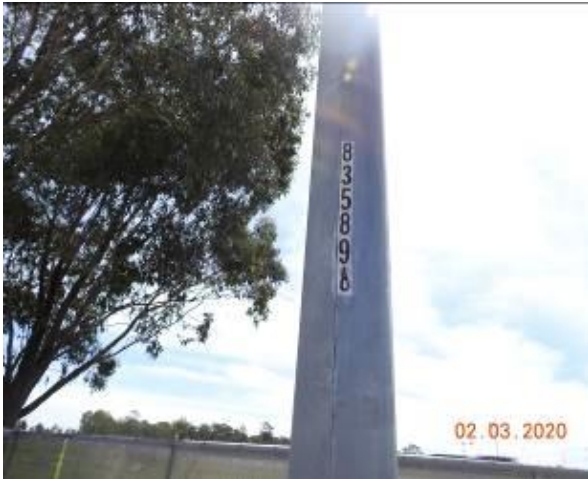
Figure 1822 – General Condition of lamp post
Identification No.835898

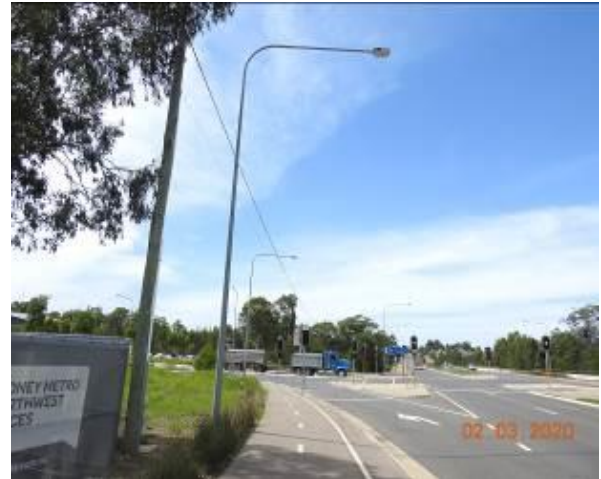
Figure 1823 – General Condition of lamp post

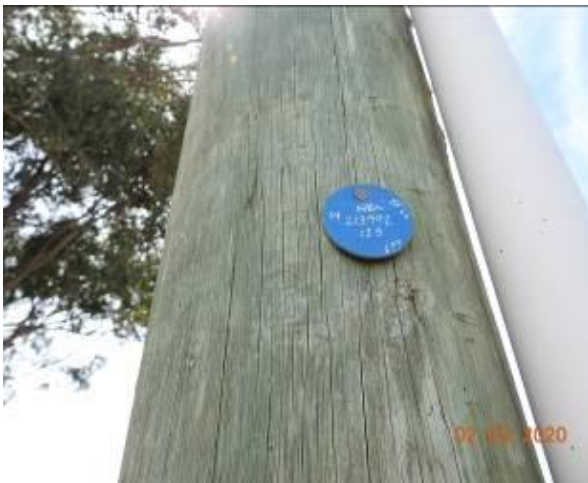
Figure 1824 – General Condition of telegraph pole
Identification No.213992/128

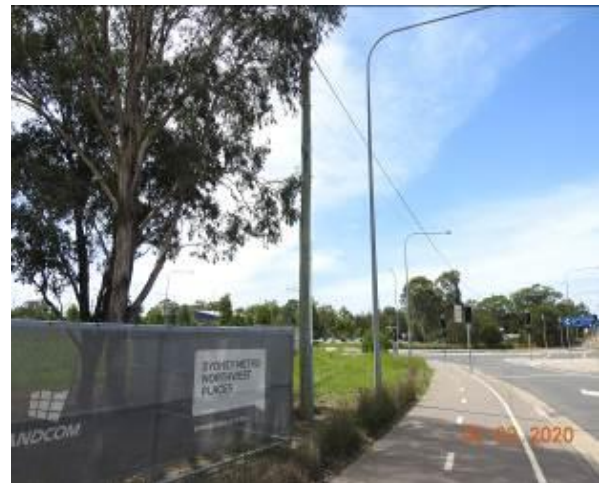
Figure 1825 – General Condition of telegraph pole

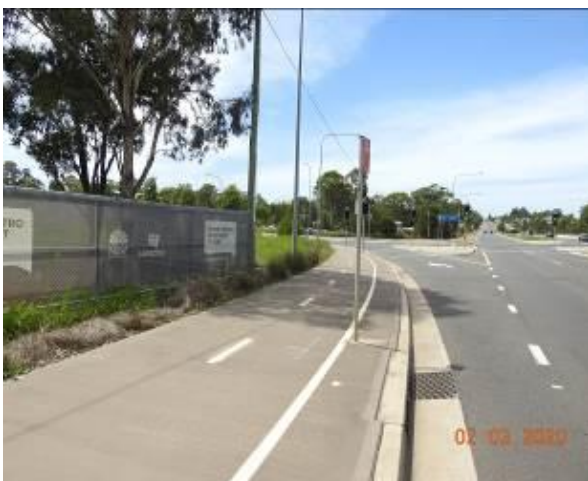
Figure 1826 – General Condition of street sign

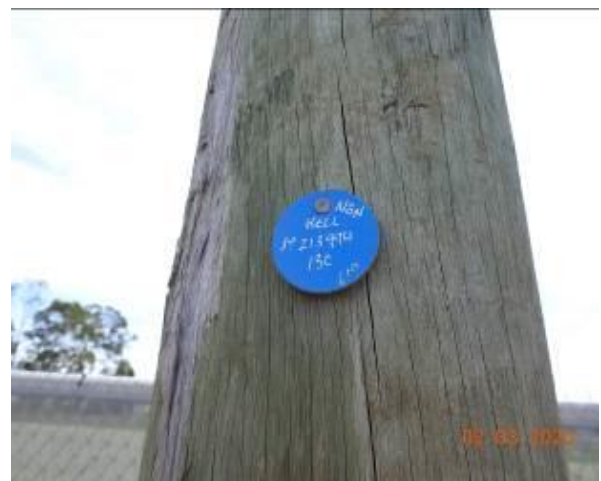
Figure 1827 – General Condition of telegraph pole
Identification No.213994/130

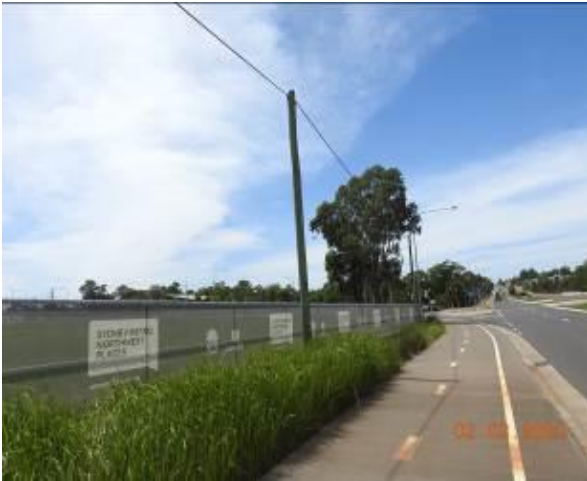
Figure 1828 – General Condition of telegraph pole

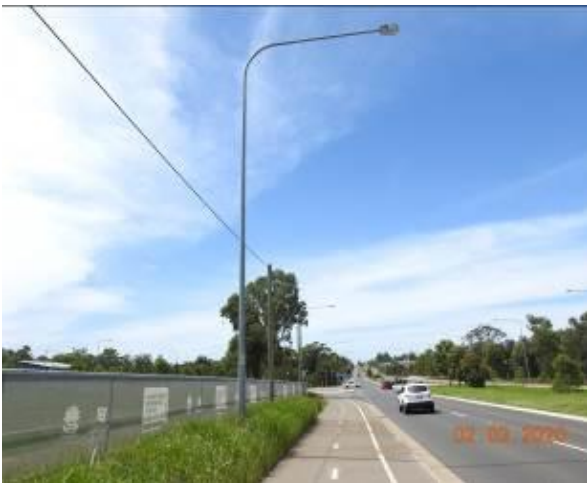
Figure 1830 – General Condition of lamp post

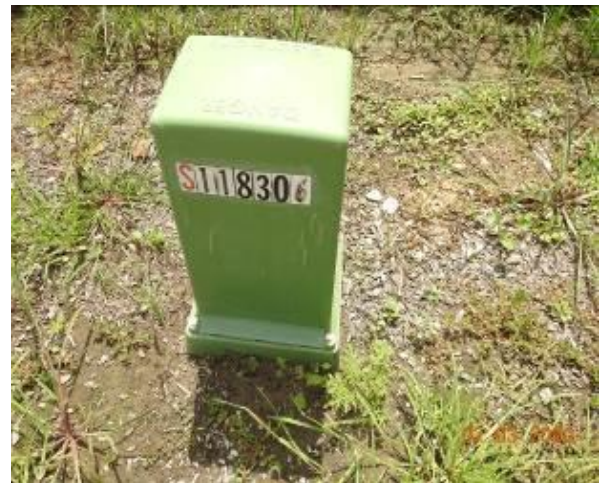
Figure 1831 – General Condition of electricity box
Identification No.S118306

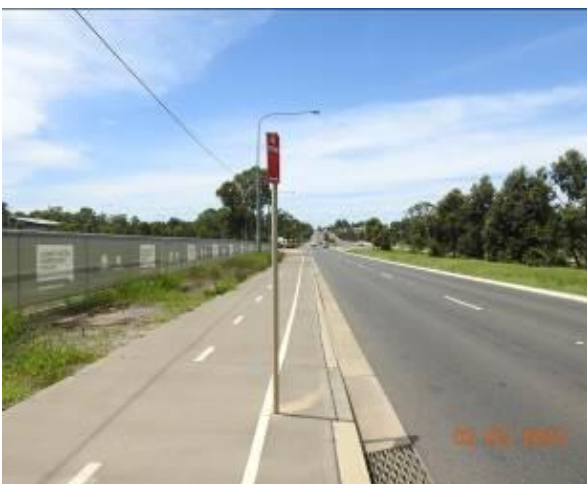
Figure 1832 – General Condition of street sign

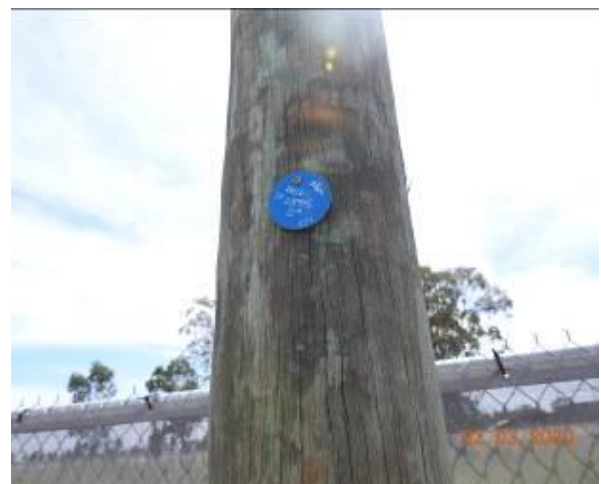
Figure 1833 – General Condition of telegraph pole
Identification No.213993 / 129

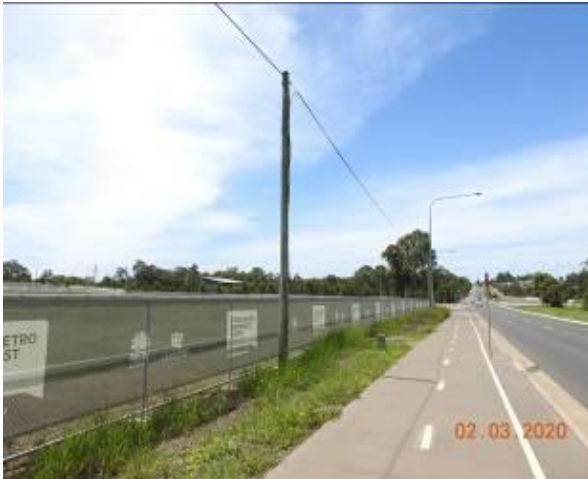
Figure 1834 – General Condition of telegraph pole

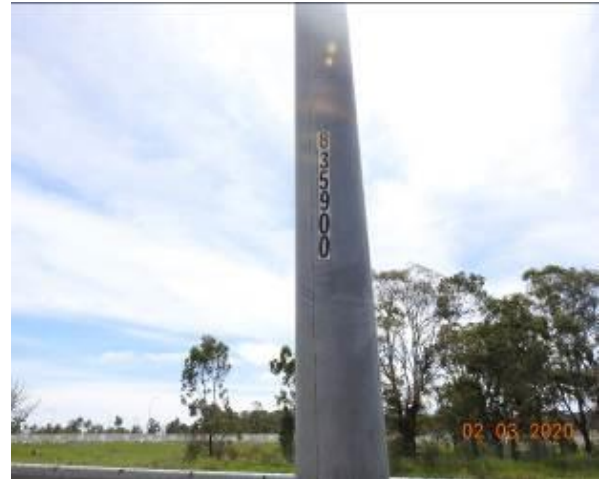
Figure 1835 – General Condition of lamp post
Identification No.835900

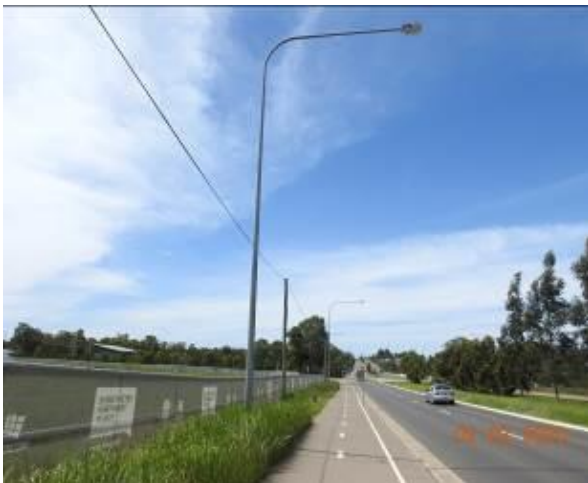
Figure 1836 – General Condition of lamp post

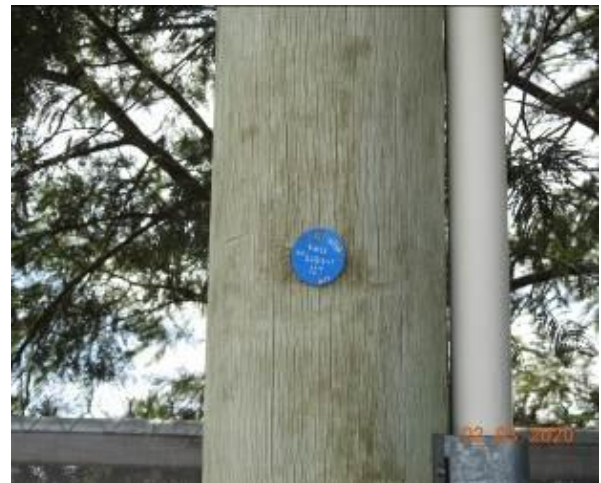
Figure 1837 – General Condition of telegraph pole
Identification No.213991 / 127

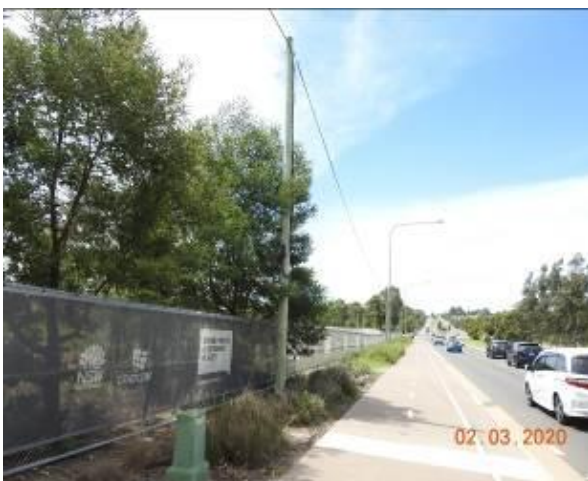
Figure 1838 – General Condition of telegraph pole

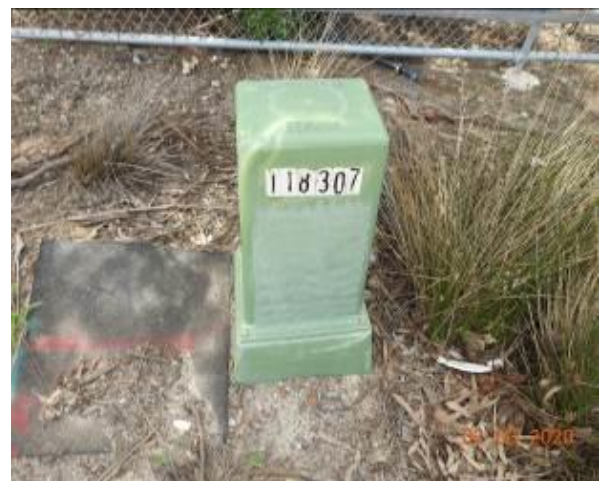
Figure 1839 – General Condition of electricity box
Identification No.118307

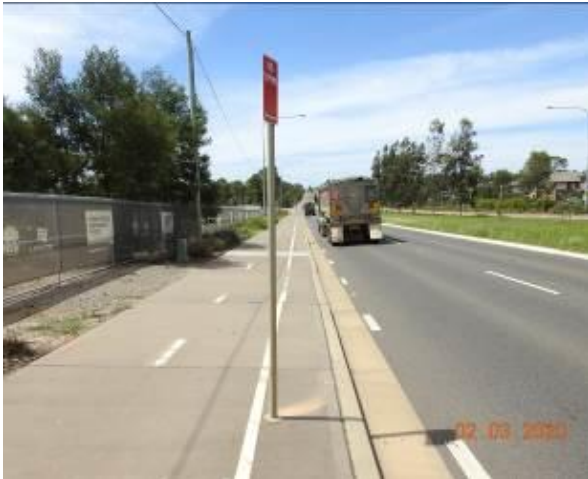
Figure 1840 – General Condition of street sign

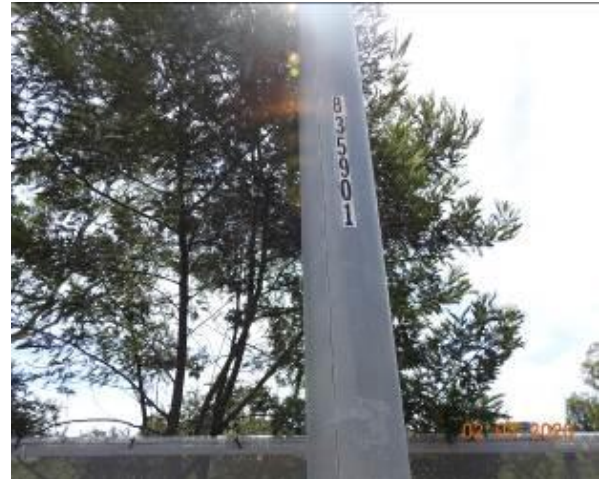
Figure 1841 – General Condition of lamp post
Identification No.835901

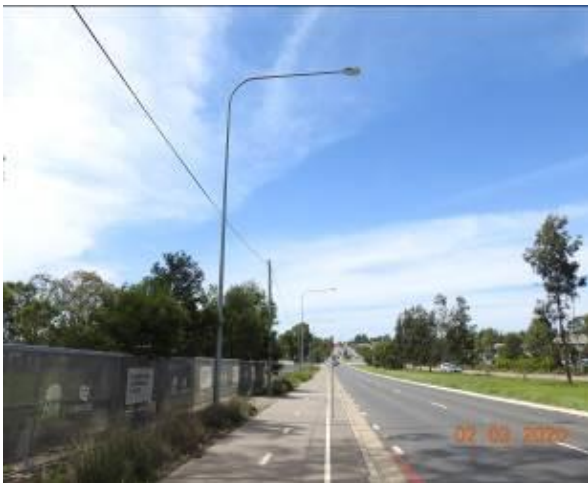
Figure 1842 – General Condition of lamp post

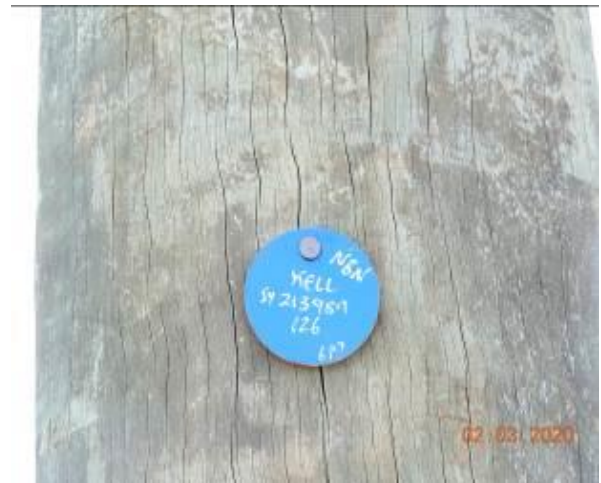
Figure 1843 – General Condition of telegraph pole
Identification No.213989 / 126

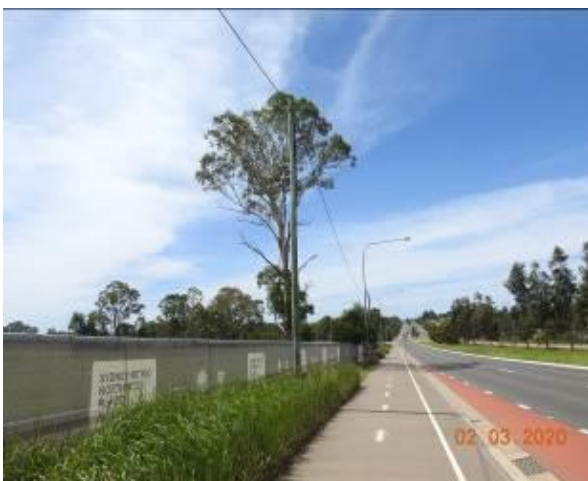
Figure 1844 – General Condition of telegraph pole

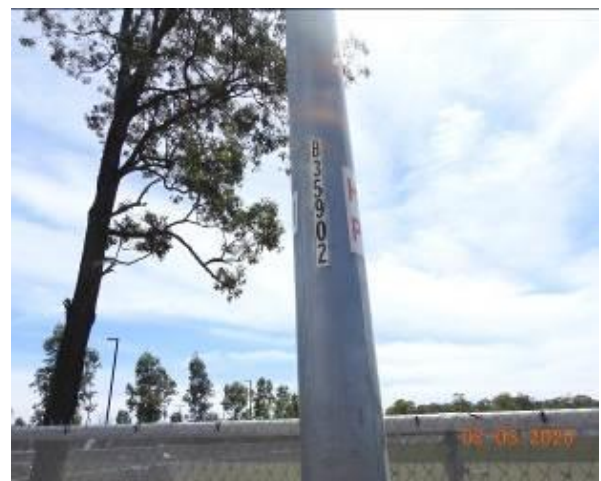
Figure 1845 – General Condition of lamp post
Identification No.835902

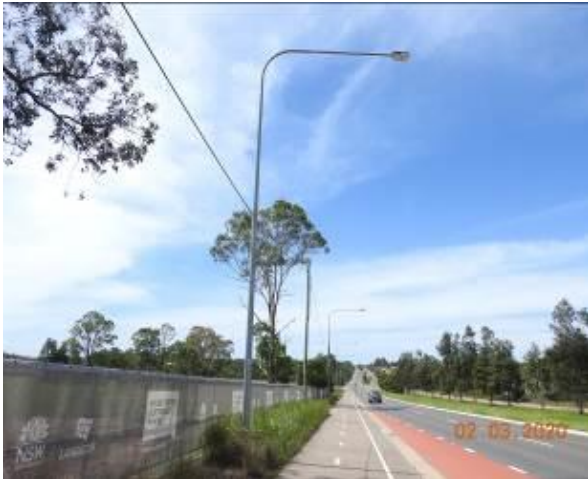
Figure 1846 – General Condition of lamp post

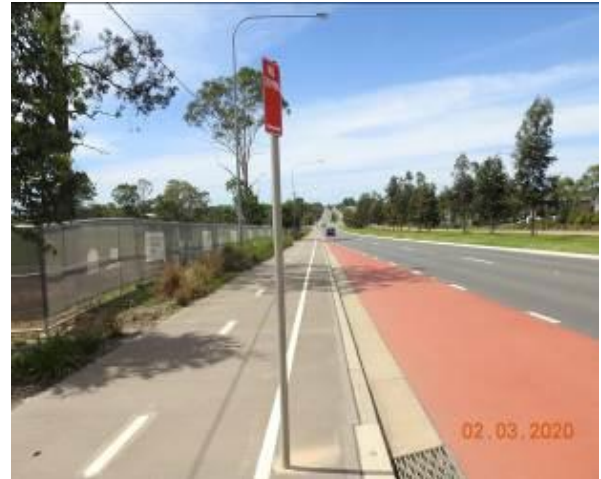
Figure 1847 – General Condition of street sign

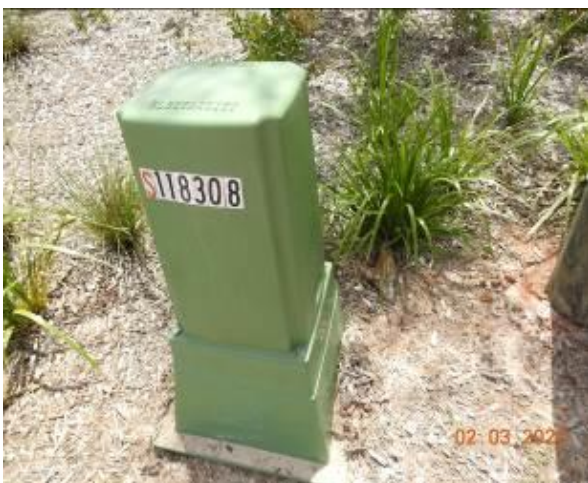
Figure 1848 – General Condition of electricity box
Identification No.S118308

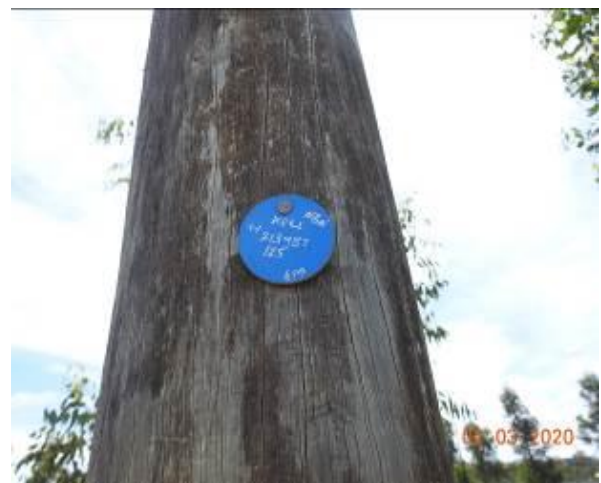
Figure 1849 – General Condition of telegraph pole
Identification No.213987 / 125

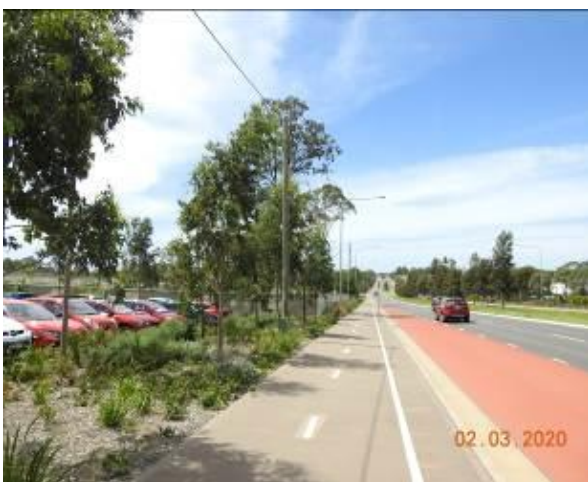
Figure 1850 – General Condition of telegraph pole

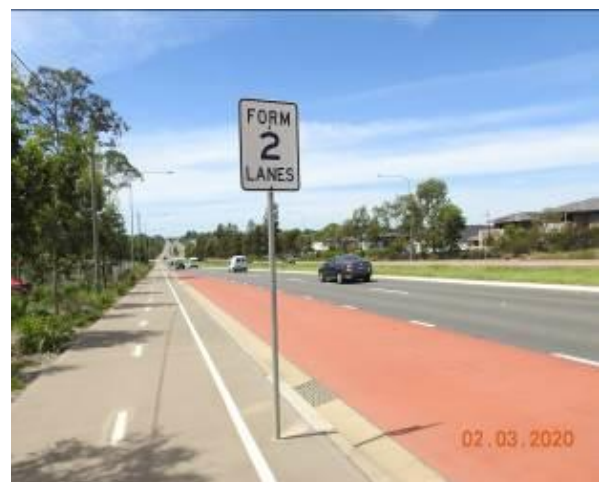
Figure 1851 – General Condition of street sign
